GEOTECHNICAL ENGINEERING RECONNAISSANCE OF THE 30 NOVEMBER 2018 M7.0 ANCHORAGE, ALASKA EARTHQUAKE

GEER Report GEER-059

January 2, 2019

GEER Team Co-Leaders: Kevin W. Franke (BYU) and Rich D. Koehler (UNR)

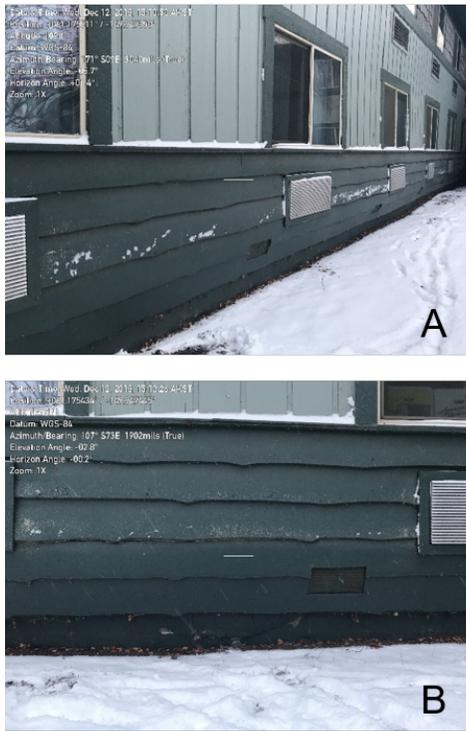
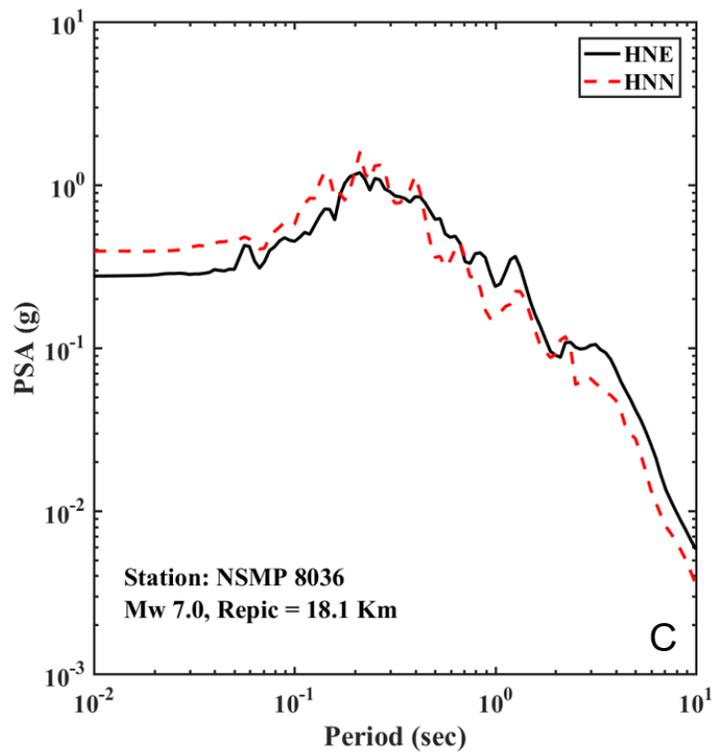
Recorded ground motions at stations NSMP 8036 (Lat/Long: 61.1779, -149.9657), and NSMP 8038 (Lat/Long: 61.2184, -149.8829) were also considered relevant by our team due to its closeness to damaged infrastructure and observed ground failures. Station NSMP 8036 at the Department of Interior, Office of Aviation Services is located less than 1 km away from the Coast International Inn (Lat/Long: 61.1752, -149.9475), where structural damage to its first floor caused the building to be deemed not safe to be occupied. At the time of inspection by our team members, a whole area of this two-story building, where walls had shifted and separated from the foundation, was closed. Information regarding the foundation design was not available. Figure 9 provides photos of the damaged walls as well as the pseudo-spectral accelerations obtained from the recorded motions nearby at station 8036. Largest values of PSA correspond to an oscillator period of approximately 0.2 sec.

Figure 9. Damage observed at the Coast International Inn (Lat/Long: 61.1752, -149.9475), A) Shifted walls on the first floor, B) details of the deformation, and C) Pseudo-acceleration response spectra (5% damping) for two horizontal components recorded at station 8036 (Lat/Long: 61.1779, -149.9657).

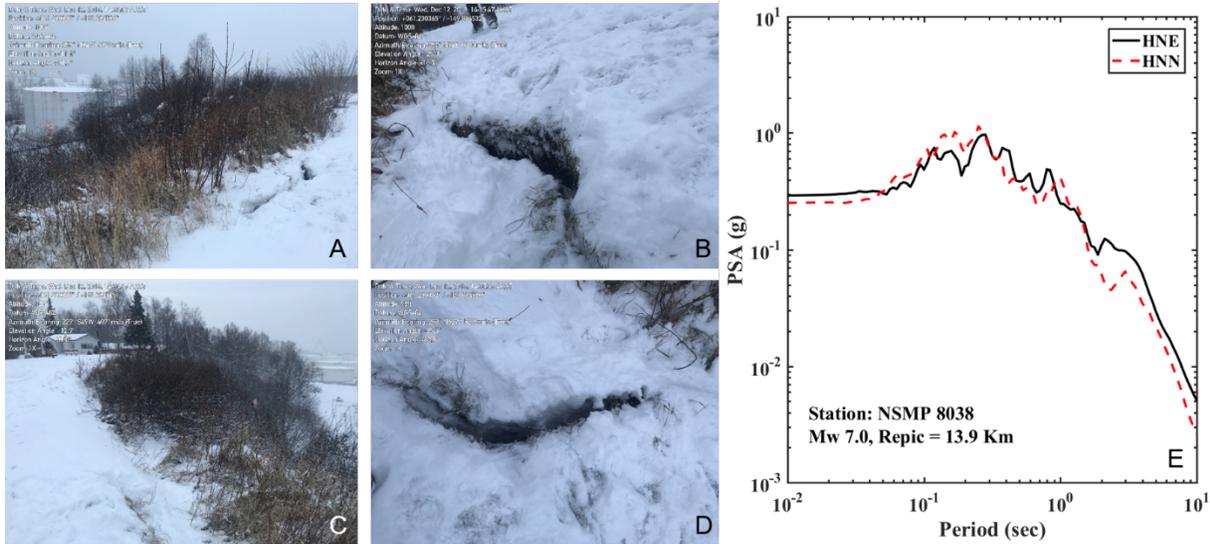
Station 8038 (Lat/Long: 61.2184, -149.8829) is close to the Port of Alaska (Lat/Long: 61.2304, -149.8846), which makes the corresponding recorded ground motions key information to assess the performance of this critical facility during a large magnitude seismic event. Members of our team identified a slope failure adjacent to the port during their inspection of the port facilities. Due to difficulties accessing this area from the port, other members of our team documented the slope failure from the top in a public park. Photos depicting key features of the slope failure are shown in Figure 10, including a scarp of about 50 cm. It is possible that other significant cracks had been covered by the snow by the time of our inspection.

Figure 10. Slope failure adjacent to the Port of Alaska (Lat/Long: 61.2304, -149.8846). (A) and (C) provide an overall view of the slope and some of the port facilities, (B) depicts the approximately 50-cm scarp and, (D) shows a specific crack at this site with a width of approximately 20 cm. (E) provides the pseudo-acceleration response spectra (5% damping) for two horizontal components recorded at a nearby station (i.e., NSMP 8038, Lat/Long: 61.2184, -149.8829)

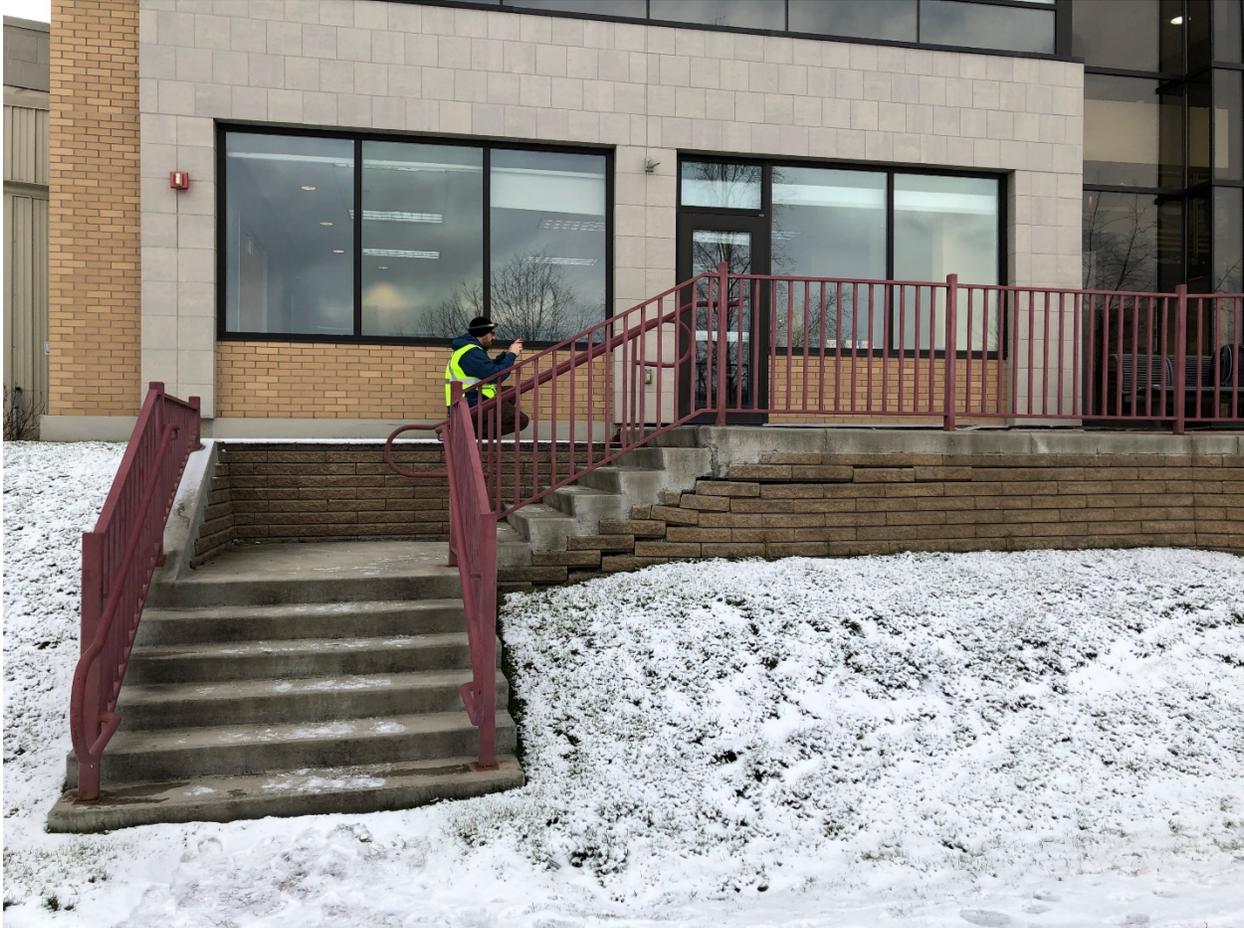
3900 and 4000 Ambassador Drive (Lat/Long: 61.1821, -149.8066 and 61.1828, -149.8061) are founded on steel pipe piles ranging in length from 12 to 15 m with diameters of 325 or 610 mm and installed with one, two, or three piles per building column. Damage to the interior of 3900 Ambassador Drive appeared limited to the entryway (sliding glass doors and access doors in the front vestibule were damaged, and settlements on the order of 10-22 mm were observed). Walls and door entryways resting on the slab-on-grade placed in between pile caps and providing access to offices along the exterior of the northeast corner also experienced settlement and tilt ranging from 5-10 mm and 1.2-3.1 degrees, respectively. Settlement of sloped fill immediately outside the building at these locations reached magnitudes of up to 100 mm, indicating that the ground loss of soil supporting the interior slabs resulted in movement relative to the pile caps. Damage to the interior of the adjacent (and internally-connected) 4000 Ambassador Drive building manifested in terms of loss of serviceability of some doorways and cracking of drywall along the eastern margin of the building. Along the eastern exterior of the building, an unconnected brick deck structure that had previously experienced settlement and lateral movement exhibited further movement downward and outward toward the pond to the east as a result of the earthquake (Figure 13). This outward lateral movement manifested over the length of the building exterior and joined at the concrete walkway and stairs separating this building and 3900 Ambassador Drive.

Figure 13. 4000 Ambassador Drive - brick deck structure exhibiting settlement and lateral movement (Lat/Long: 61.1826, -149.8061).

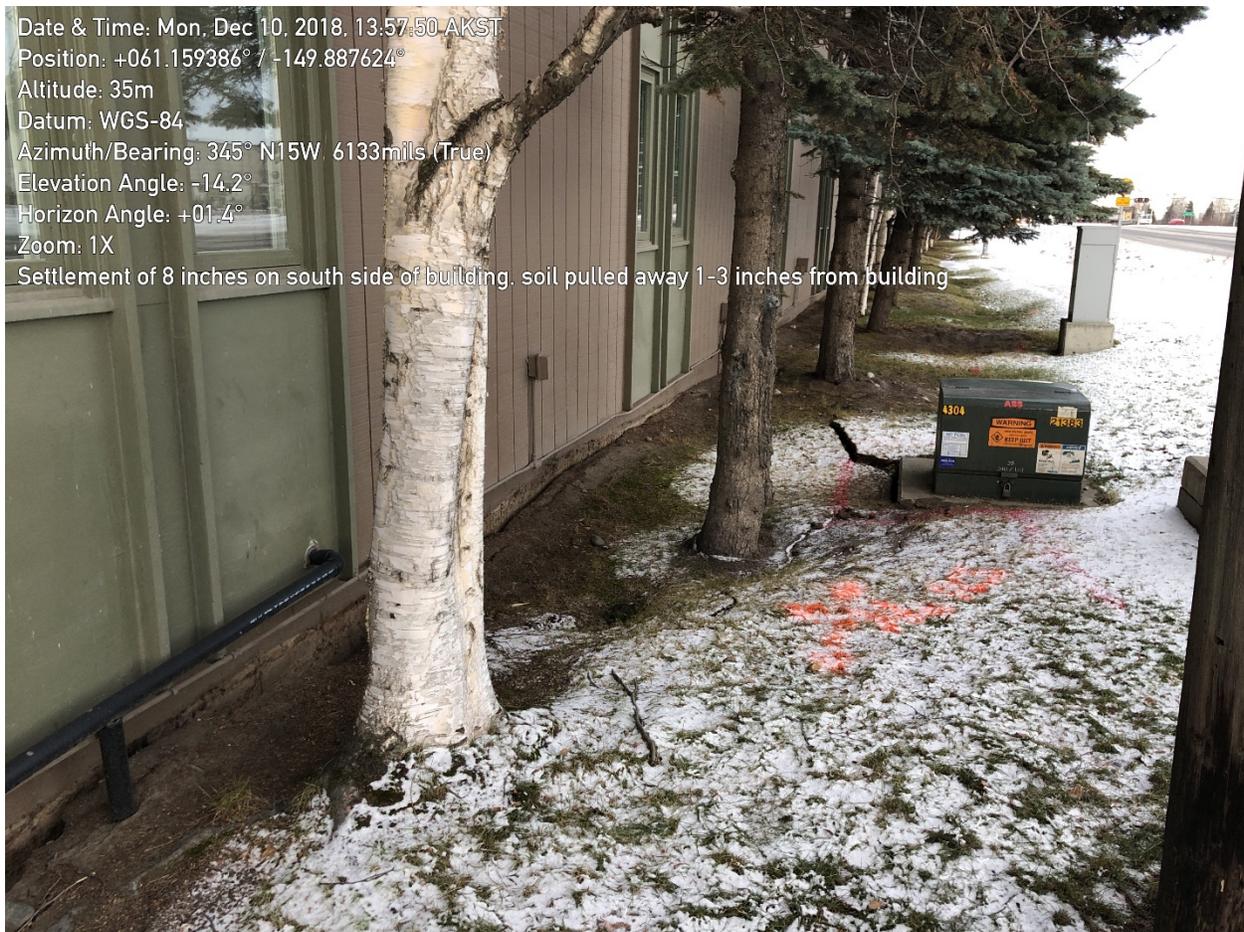
The Alaska Department of Fish and Game Building (333 Raspberry Rd, Anchorage; lat/long: 61.1593, -149.8879) showed signs of significant stress from settlement beneath the south wing of the building. The two-story wood frame structure is shaped as an “L.” Ground cracking was observed within about three meters of the structure, and the ground had visibly settled up to 16 cm directly along its east side. Employees in the building reported interior settlements “of about 1 foot (25 cm),” though those claims could not be substantiated by our team because that portion of the building had been evacuated and was closed to all non-essential personnel. Figure 14 shows the type of damage that was externally visible at the Department of Fish and Game building. No surface evidence of liquefaction was visible beyond about three meters from the building, suggesting that these observed effects may have been limited to beneath the building footprint.

The observed liquefaction-induced damages at the Department of Fish and Game Building is particularly significant because a ground motion recording station (NP 8027) is housed in a small warehouse next to the building, within about 30 meters of the observed damage.

Figure 14. Observed liquefaction evidence at the south wing of the Alaska Department of Fish and Game Building (Lat/Long: 61.1592, -149.8879).

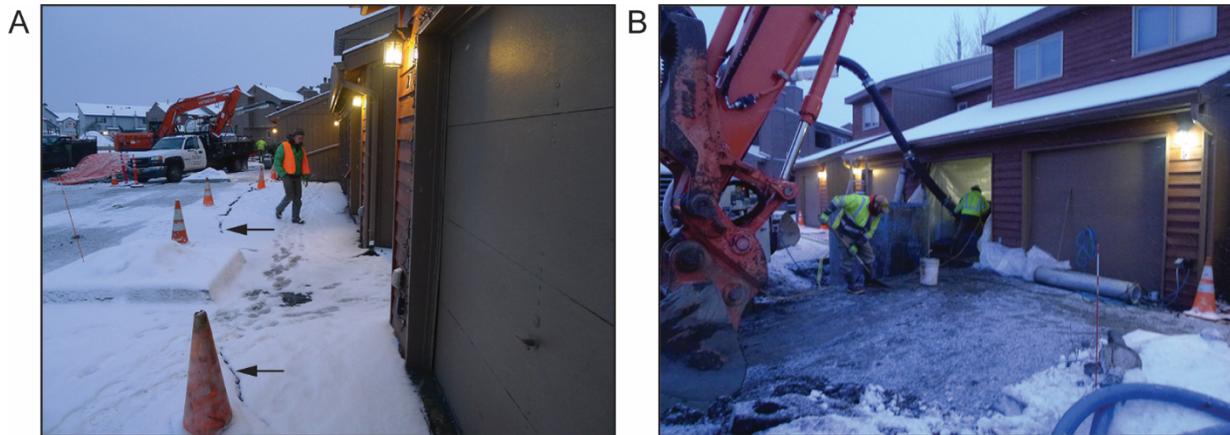
A series of condominium units (Lat/Long: 61.1295, -149.8459) were associated with significant settlement of up to 30 cm (Figure 15). Cracks extending across the front driveways of the units were about 7 cm wide and up to 23 cm deep. Fine sand was ejected onto the surface along deformation cracks. During the GEER team inspection, construction crews were vacuuming foundation materials from below the garage of one unit, presumably to backfill with more stable materials.

Figure 15. Settlement of condominium units along Jamestown Drive, Anchorage (Lat/Long: 61.1295, -149.8459). (A) Settlement cracks along the front driveways (black arrows). (B) Repair crews removing backfill materials.

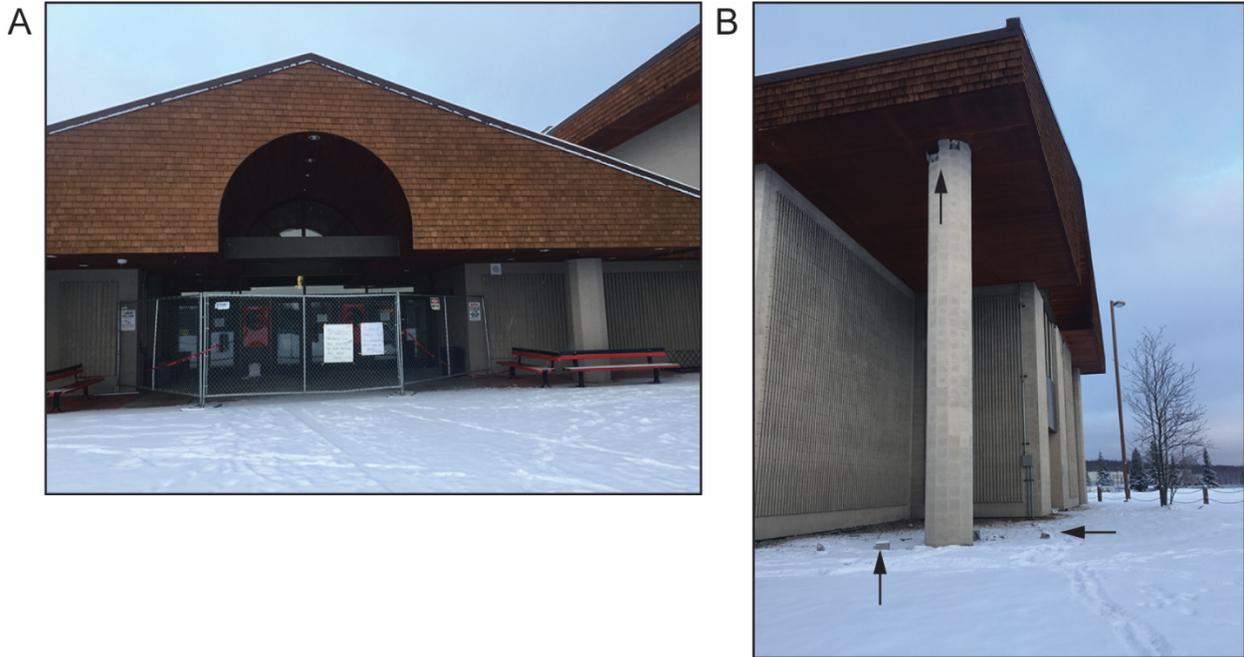
Initial inspection of the red-tagged Houston middle school (Lat/Long: 61.5863, -149.7719) indicated that there was limited evidence of damage to the exterior of the building, generally limited to minor cracking and dislodgement of several facade bricks from walls and the tops of columns (Figure 16). However, after discussions with the Mat-Su Borough emergency manager it was learned that the school had suffered extensive structural damage to the ceiling and the interior of the building and was not expected to reopen. Large chunks of concrete were reported to have fallen through the interior ceilings, and critical structural supporting elements inside the building were reported to have failed. Our team was not allowed inside the building due to safety concerns.

Figure 16. Red-tagged Houston Middle School in Houston (Lat/Long: 61.5863, -149.7719). (A) Fenced off entrance to the school. (B) Support column along southwest side of school showing displaced facade bricks (Black arrows).

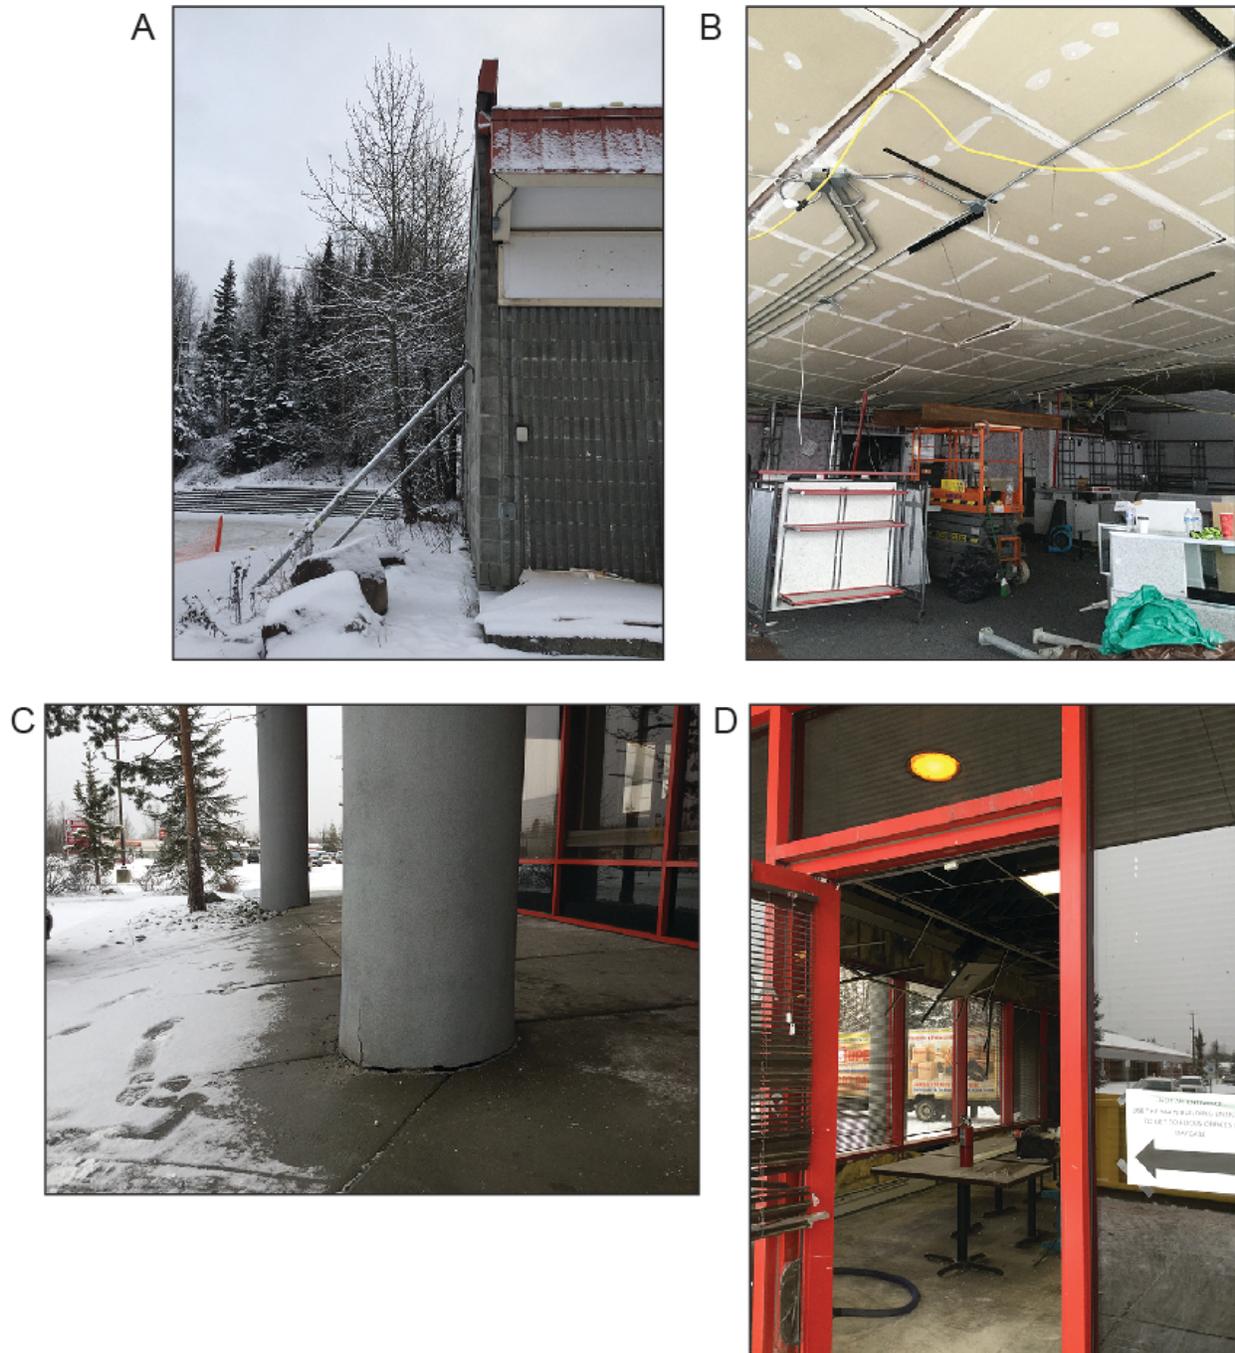
Extensive non-structural damage was observed throughout the main business district of Eagle River (Figure 17). Many businesses had broken windows and extensive water damage from broken water pipes. One building, including Garcias Cantina (Lat/Long: 61.3277, -149.5728), was associated with separation of support columns from the ground. Most of the support columns were cracked at their bases. Structural damage was also observed at an Eagle River pawn shop (Lat/Long: 61.3340, -149.5637) where the tilt-up cinder block wall panels had rotated out and the interior ceiling was partially collapsed inward. The walls had been braced and repairs were underway when our team was onsite.

Figure 17. Building damage in downtown Eagle River. (A) bowing and tilting of the cinder block walls of the Eagle River pawn shop (Lat/Long: 61.3340, -149.5637), (B) partial collapse of the ceiling in the Eagle River pawn shop (Lat/Long: 61.3340, -149.5637), (C) sheared and cracked columns in the Garcias Cantina building (Lat/Long: 61.3277, -149.5728), and (D) water damage and ceiling tile failure in the Garcias Cantina building (Lat/Long: 61.3277, -149.5728).

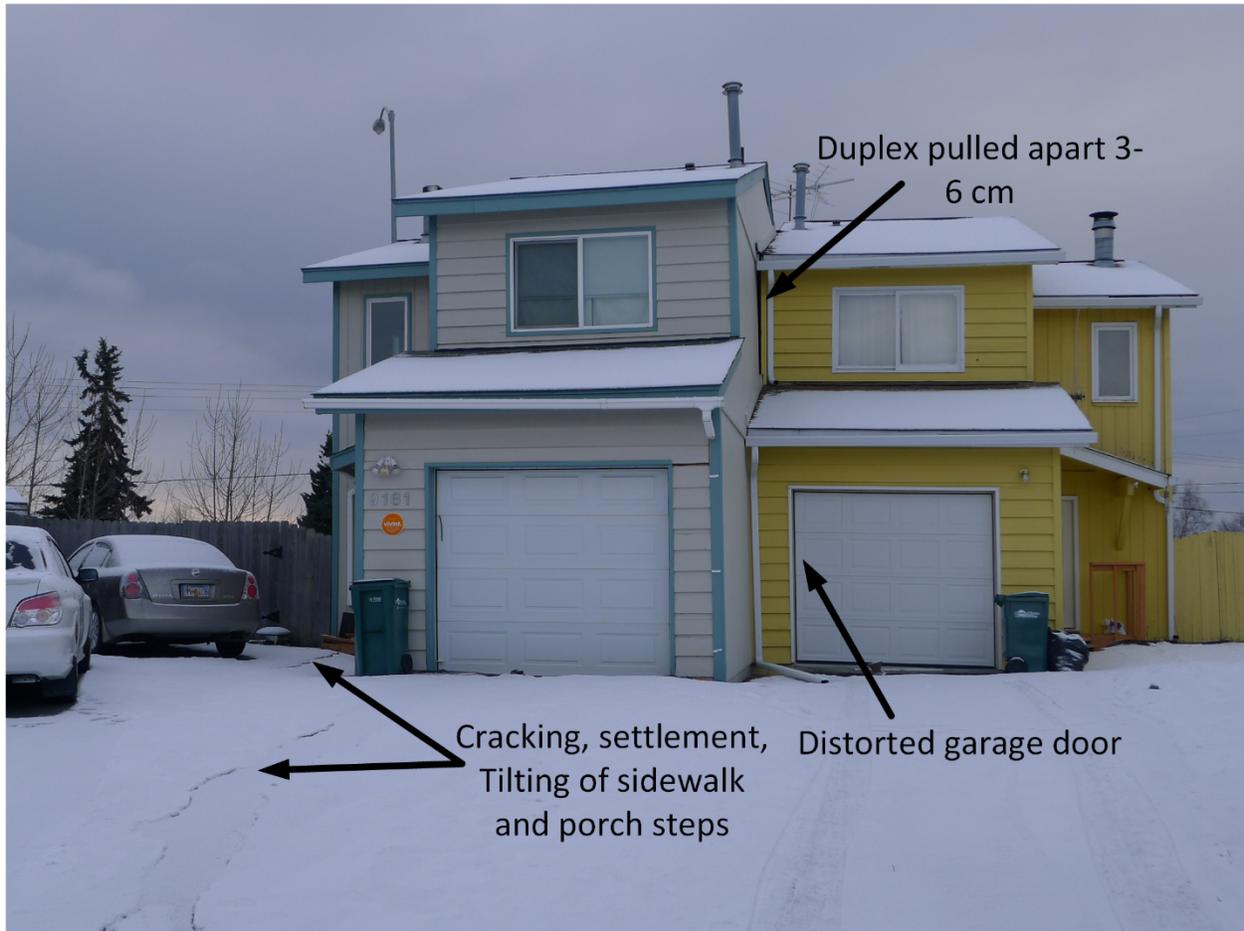
seemed to occur only beneath the structures themselves and not in the free field. Also interesting was the pattern of observed damage. For example, we would observe that one or more adjacent structures within a particular cul-de-sac would show similar evidences of liquefaction-induced damage (e.g., settlements of 1-20 cm, tilting, occasional sand boils in the crawl space, and cracking). However, the remaining structures in the cul-de-sac, often within meters of the damaged structures, would show no evidences of structural damage.

Figure 18. Example of the type of localized liquefaction-induced damage observed at many residences in Anchorage (Lat/Long: 61.1378, -149.9382).

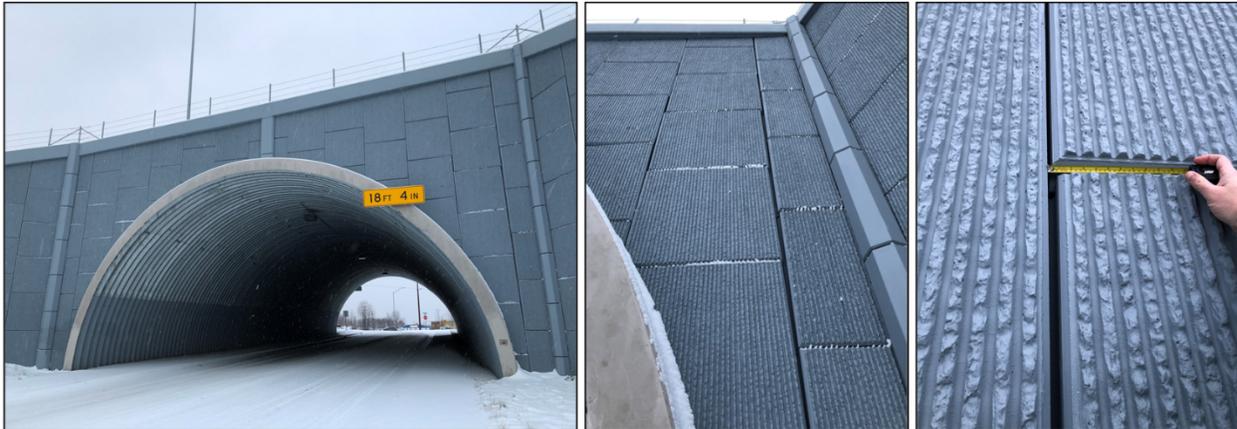
No ground failure or signs of large differential soil movements were observed at the bridge approaches and abutments. A minor slope failure on the southern face of the eastern approach was noted, exhibited spreading-type cracks 100 mm wide and characterized by vertical scarp faces 300 mm tall. Planted saplings exhibited significant rotation commensurate with the slope failure.

Figure 19. West Dowling Road Bridge – overview and close-ups of wall panel movements (Lat/Long: 61.1651, -149.8991).

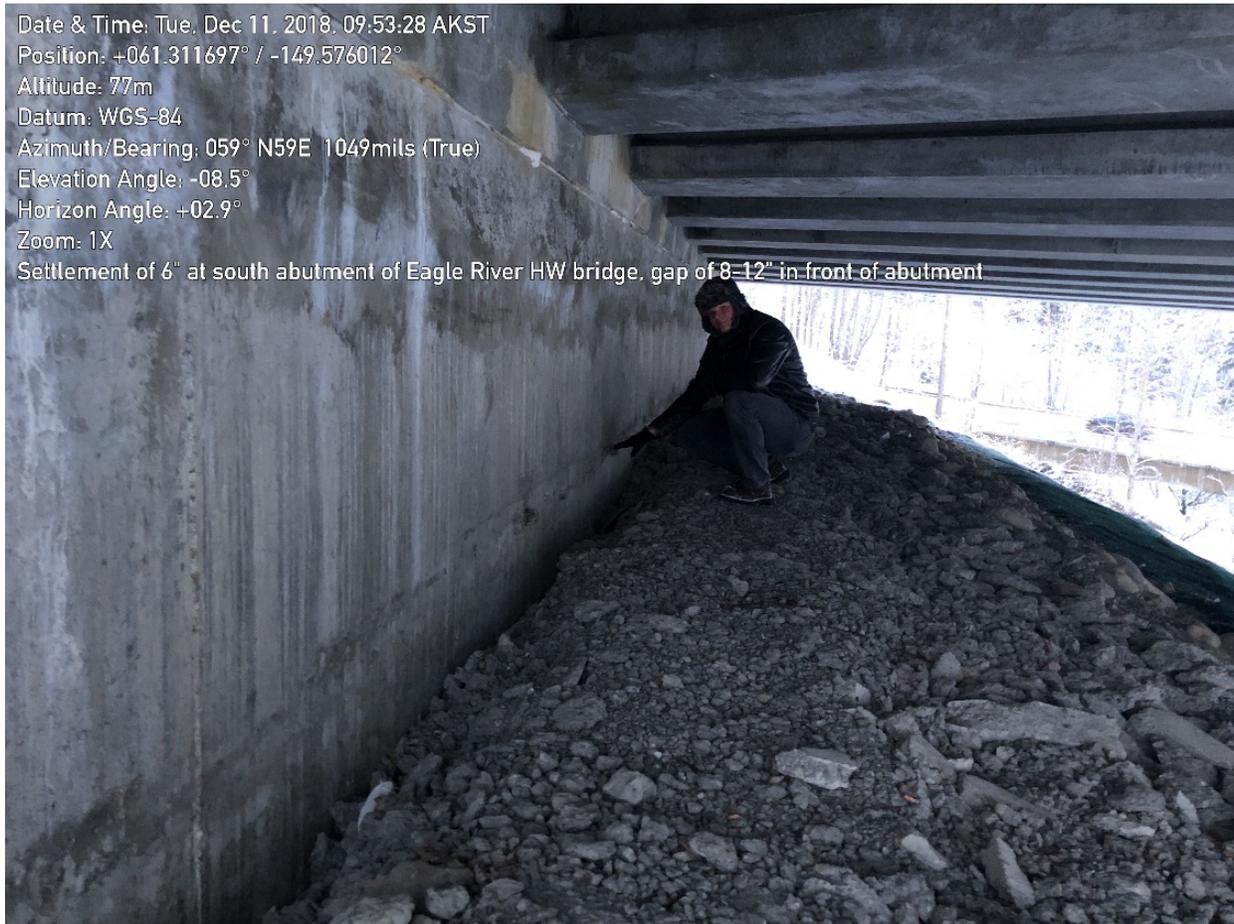
Figure 20. Settlements and lateral deformations in the spill slope at the south abutment of the northbound Glenn Highway Bridge over Eagle River (Lat/long: 61.3117, -149.5760).

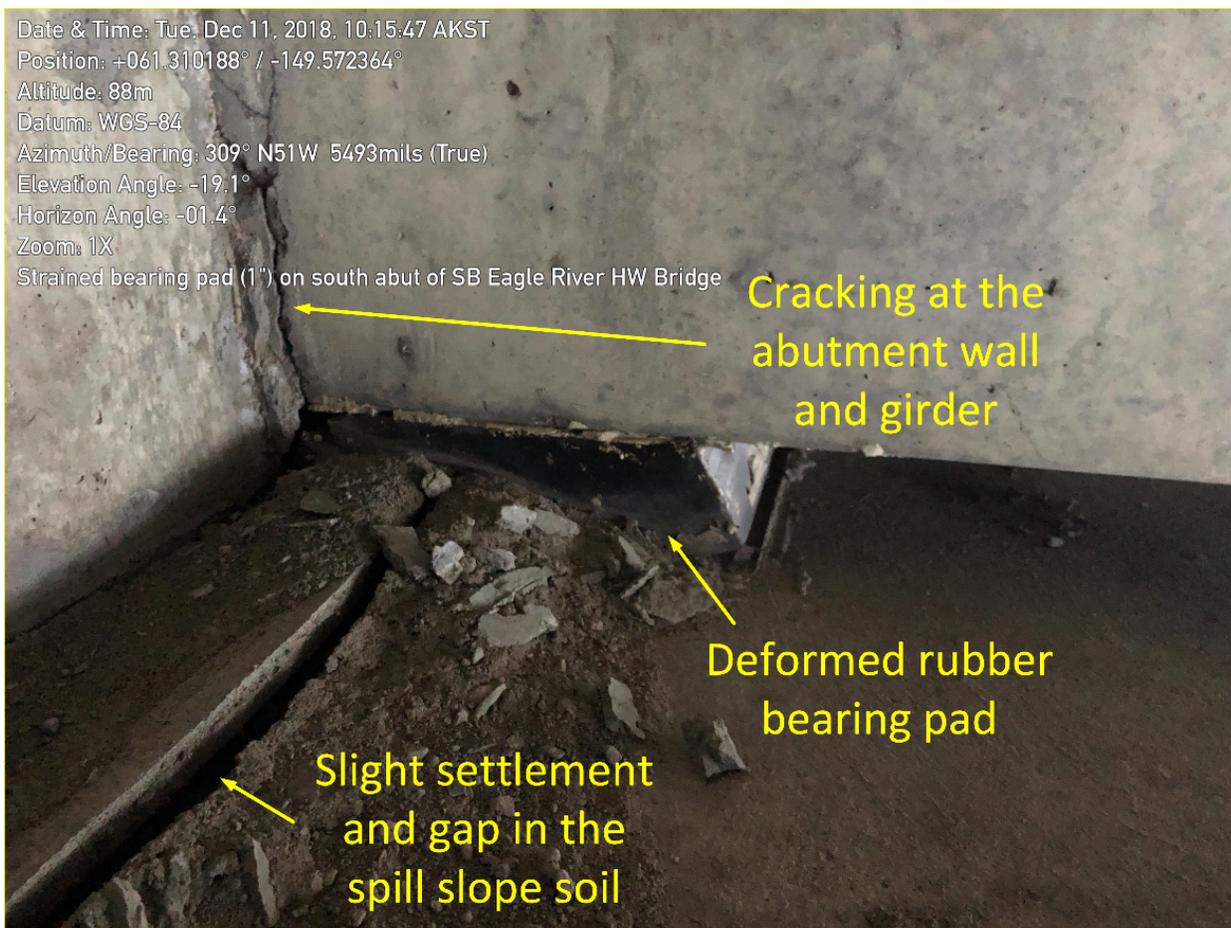
Figure 21. Observed girders and abutment seat at the southern abutment of the southbound Glenn Highway Bridge over Eagle River (Lat/Long: 61.1310, -149.5724).

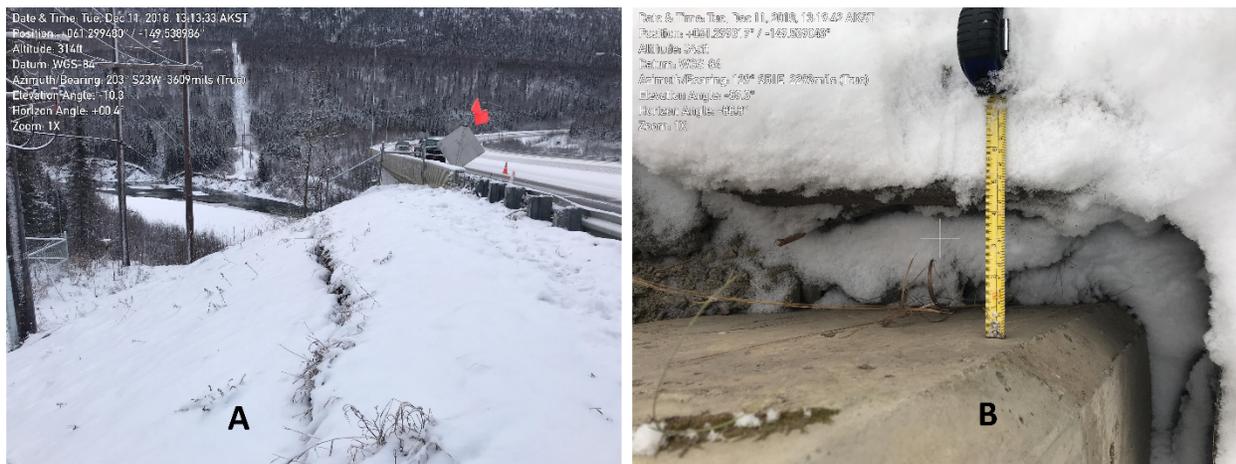
the western wingwalls (see Figure 22). At the south abutment, surrounding soil conditions were obscured by ice and snow. Evidence of soil movement or cracking was not observed beneath the bridge when moving from the east to west side. The bolt on the west side was in a vertical position while the bolt on the east side was observed to have tilted inward toward the abutment. Looking north from the south abutment, minor slope failures were observed at the north abutment and extending west in slopes along the river.

Figure 22. Evidence of slope deformation at the north abutment of the Briggs Bridge over Eagle River (Lat/Long: 61.2995, -149.5390). (A) Cracking apparent in the slope through the snow visible at both sides of the abutment. (B) Separation of approximately 12 cm between the abutment face and the spill slope soil.

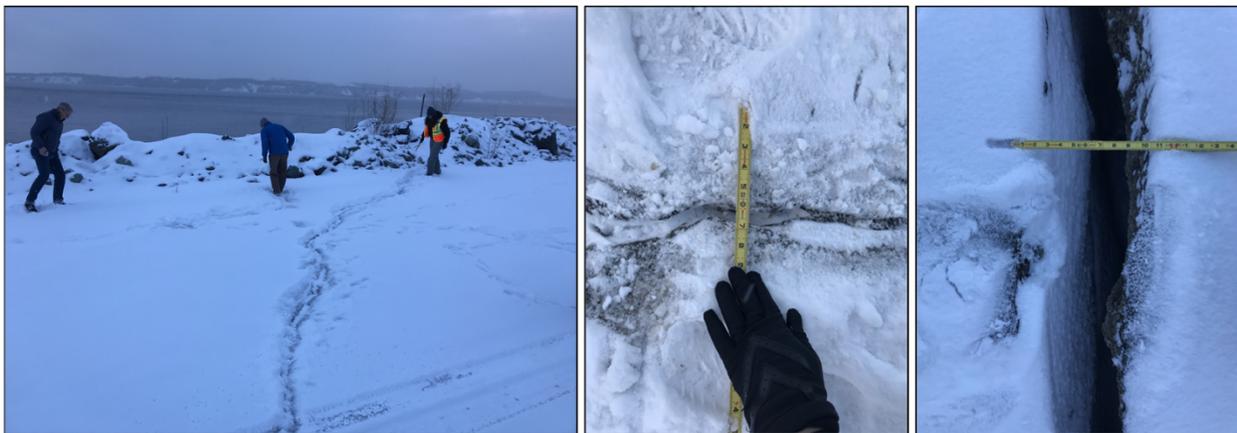
The north expansion area of the PoA represents port development that had initiated in 2009 but was terminated following the observation of loss of fill behind sheet pile bulkhead structures. The site presently consists of rip-rap lined and partially submerged slopes and vertical grade separations behind open sheet pile cells designed to act as a membrane structure. No significant differential movements or connection interlock failures were observed within the sheet pile structure. Lateral spreading-type ground failure with multiple blocks of failed soil were observed by Port personnel in the north expansion area in close proximity to the rip-rap lined slope immediately following the earthquake with crack widths of up to 300 mm in width and up to and possibly exceeding 3 m depth. Photos taken by the Port personnel show widespread water on the ground surface but unaccompanied by ejecta. These cracks had closed somewhat by the time our team visited but were readily identifiable despite new snow and ice mantling the asphalt surface. However, a new or previously undetected crack approximately 200 mm wide and approximately 1 m deep had opened and was observed by our team (Figure 23).

Figure 23. Port of Alaska – segments of lateral crack system (Lat/Long: 61.2531, -149.8804).

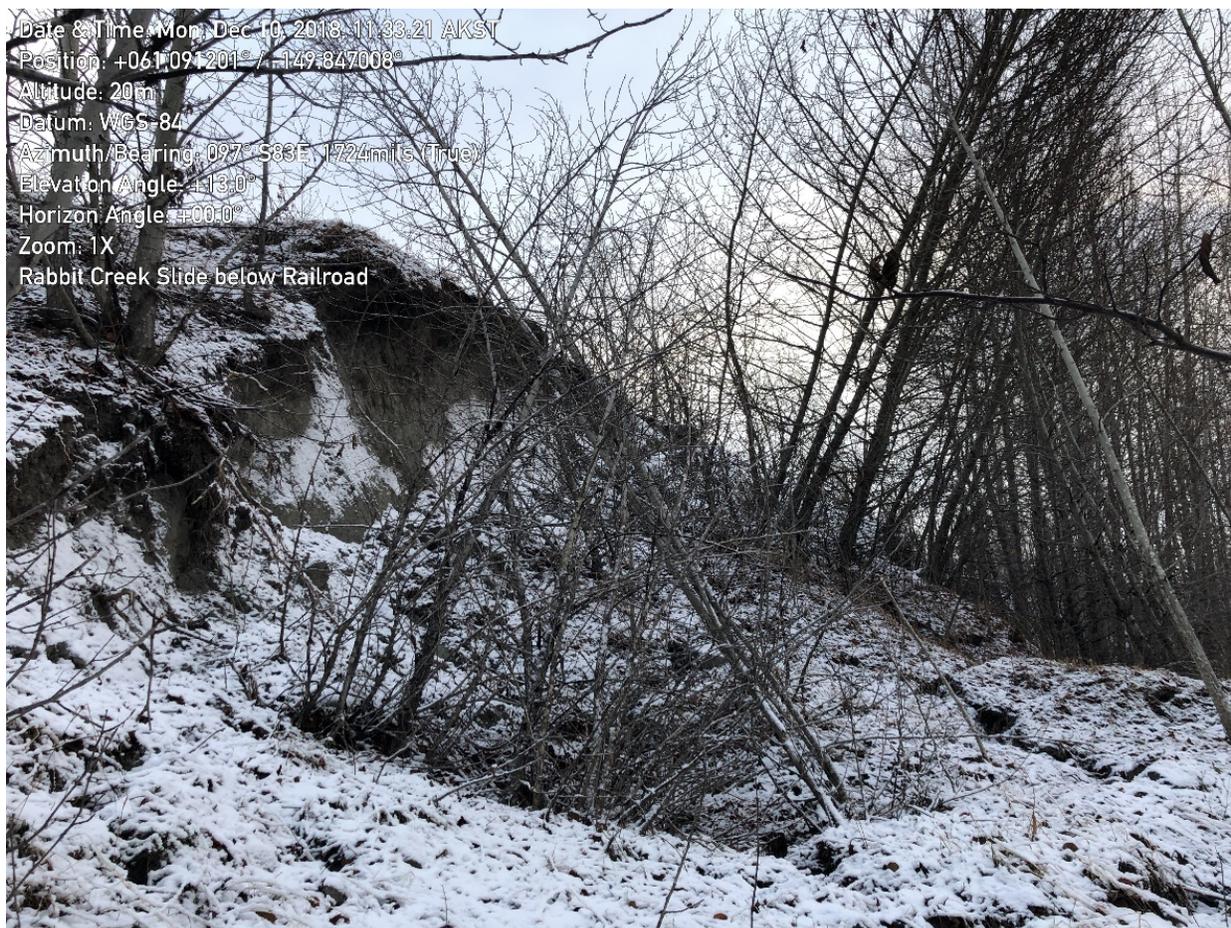
deposits. The head scarp along the landslide was observed to range from 2-3 meters high, and it encroached within 50 meters of the coastal railroad line. Landsliding in this area also occurred during the 1964 earthquake (Potter Hill landslide), indicating that the bluffs in this area are particularly susceptible to slope failures. Figure 24 presents an image of the head scarp of the landslide, which was measured to be 2.3 m high in this location.

Figure 24. Head scarp of the Rabbit Creek Landslide Complex (Lat/Long: 61.0912, -149.8470).

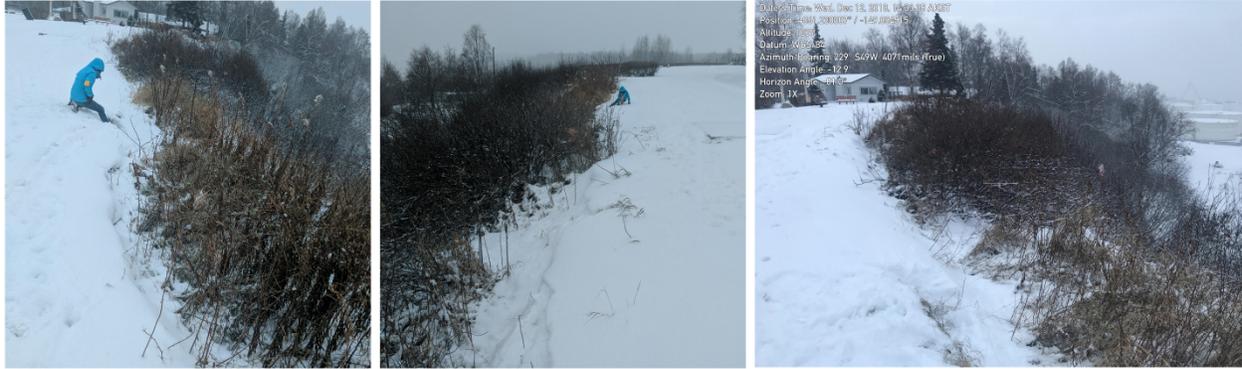
Figure 25. Bluff landslide located above the Port of Alaska (Lat/Long: 61.2303, -149.8849).

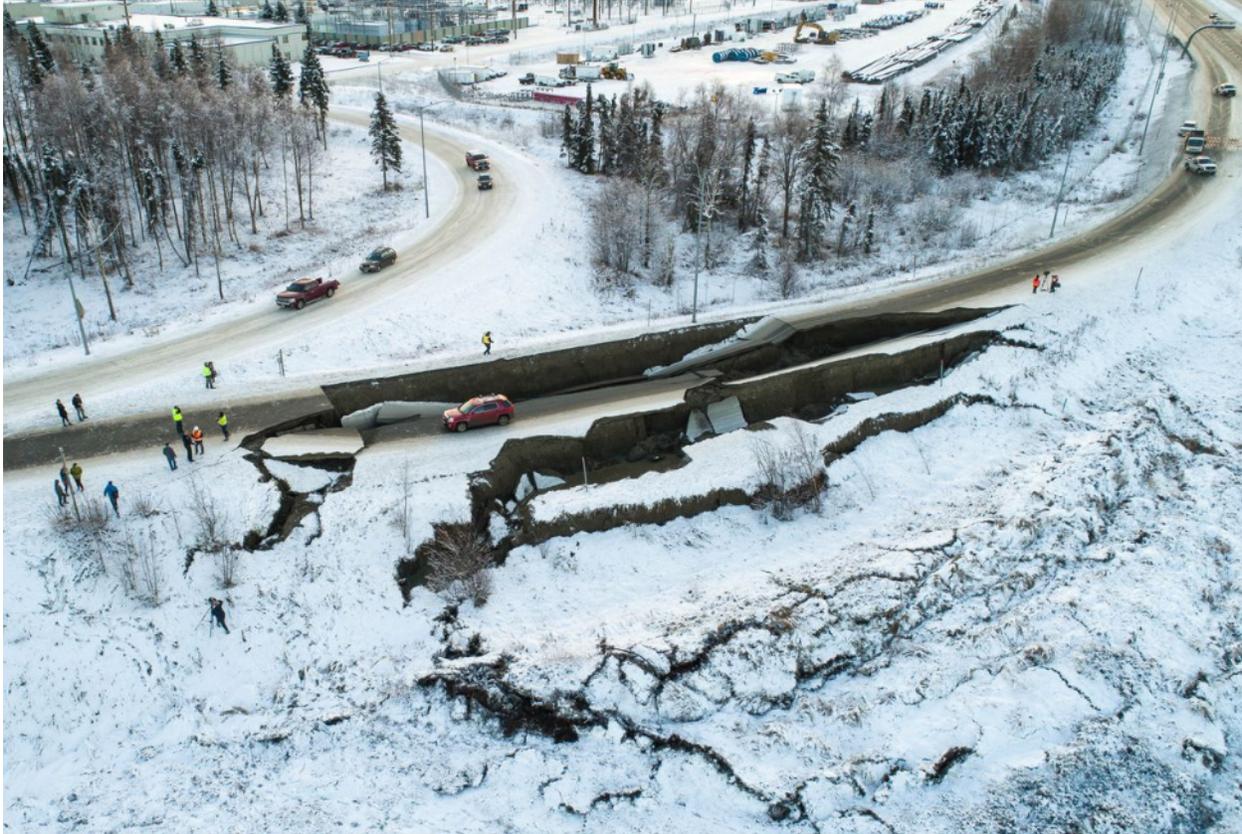
Figure 26. Aerial image of the Minnesota Boulevard embankment failure (Lat/Long: 61.1713, -149.9155). Photo source: Ryan Marlow, Alaska Aerial Media.

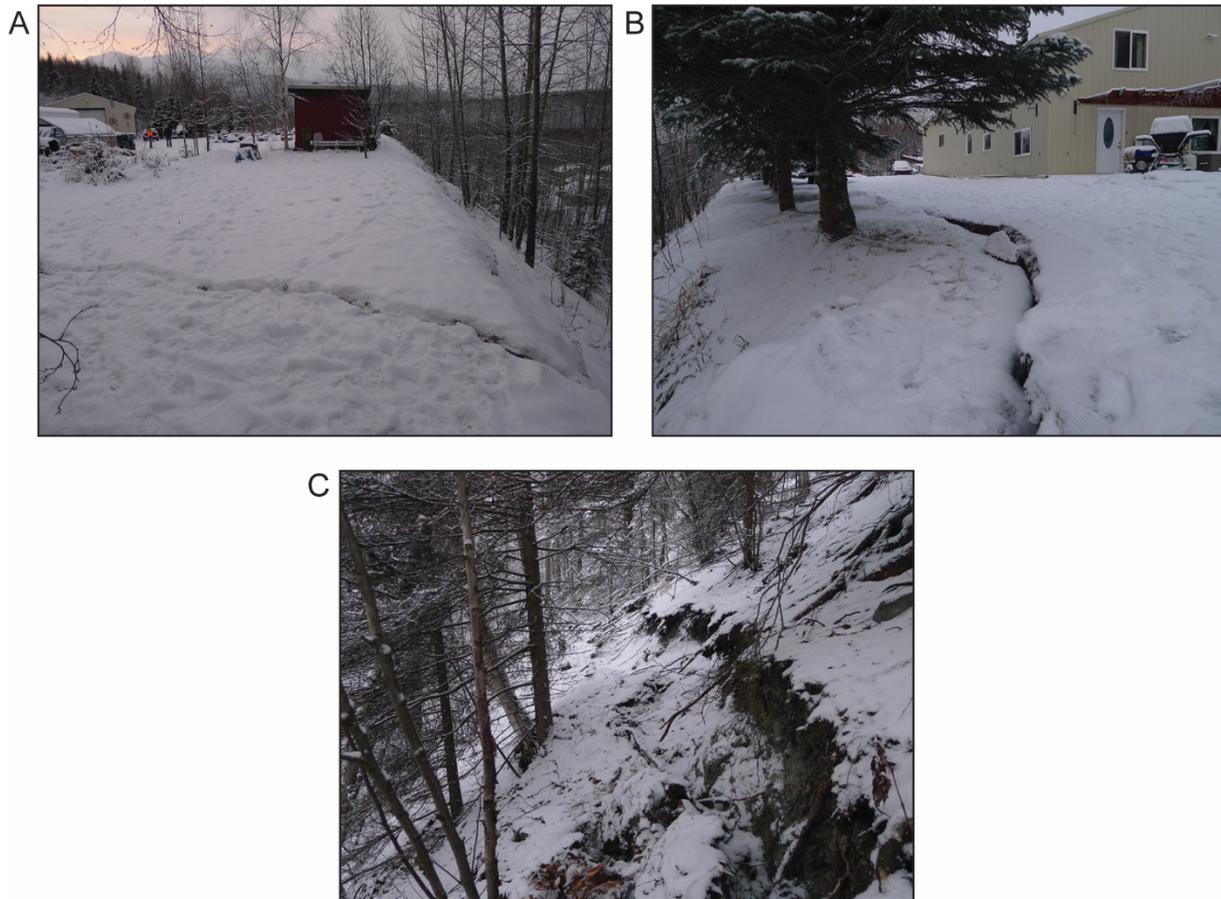
Figure 27. Photographs of the Riverview Heights landslide in Eagle River. Cracks at the crest of the slope extend for 100 m from the north (A) to the south (B) part of a flat graded residential property (Lat/Long: 61.3121, -149.5704). The cracks extend down the slope and intersect the head scarp of a small landslide (C) at the base of the slope (Lat/Long: 61.3123, -149.5714) that is associated with a 1-1.5 m high head scarp.

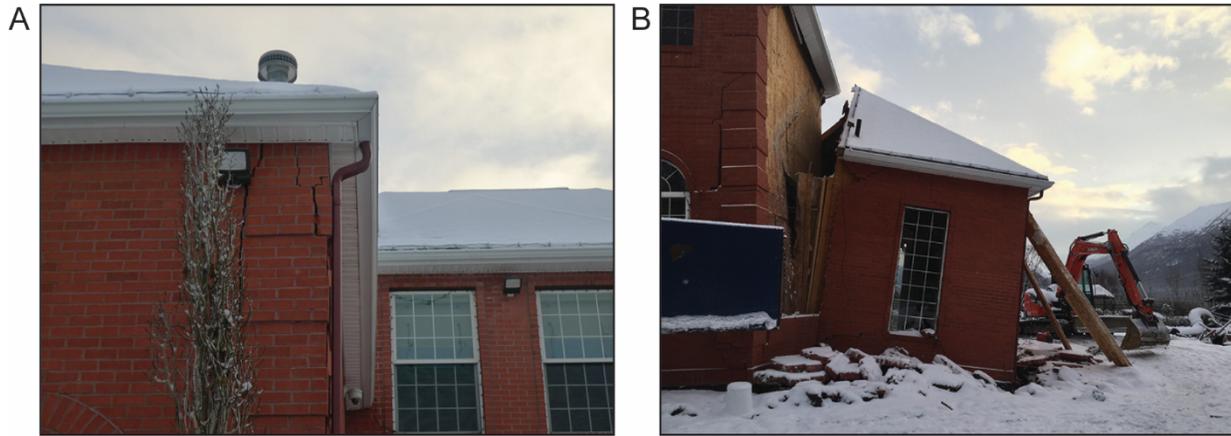
Figure 28. Damage to residence in the Ptarmagin Drive area of Eagle River (Lat/Long: 61.3049, -149.4958). Extensive facade cracking (A) and fill failure related tilting of a room associated with complete facade brick failure (B).

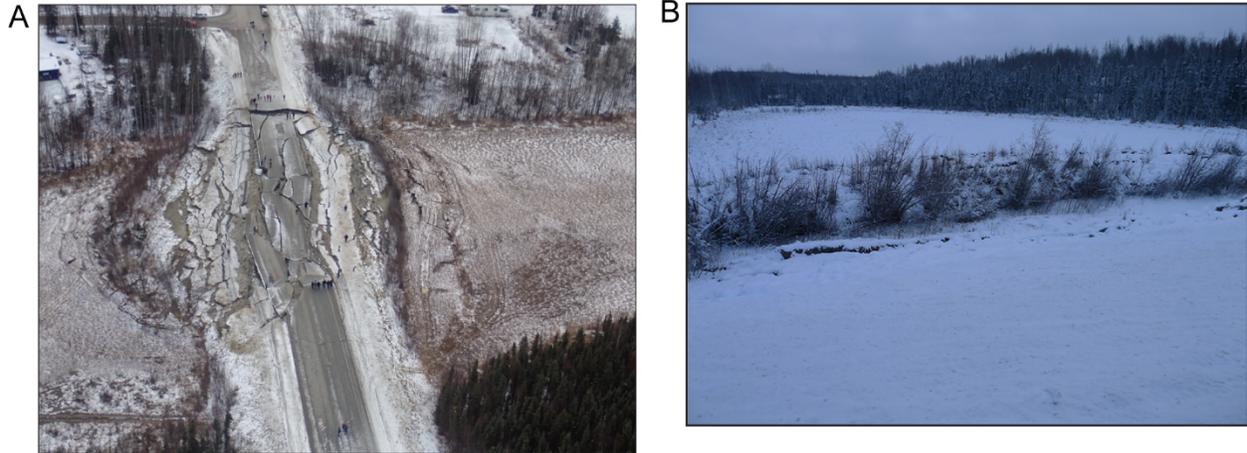
Figure 29. Damage to Vine Road (Lat/Long: 61.5686, -149.6022) south of Wasilla (A) immediately after the earthquake (photo taken by Rob Witter (USGS) during helicopter reconnaissance). (B) Pressure ridges (peat mounds) west of the road formed by lateral motion of the road fill. Note back-tilted trees.

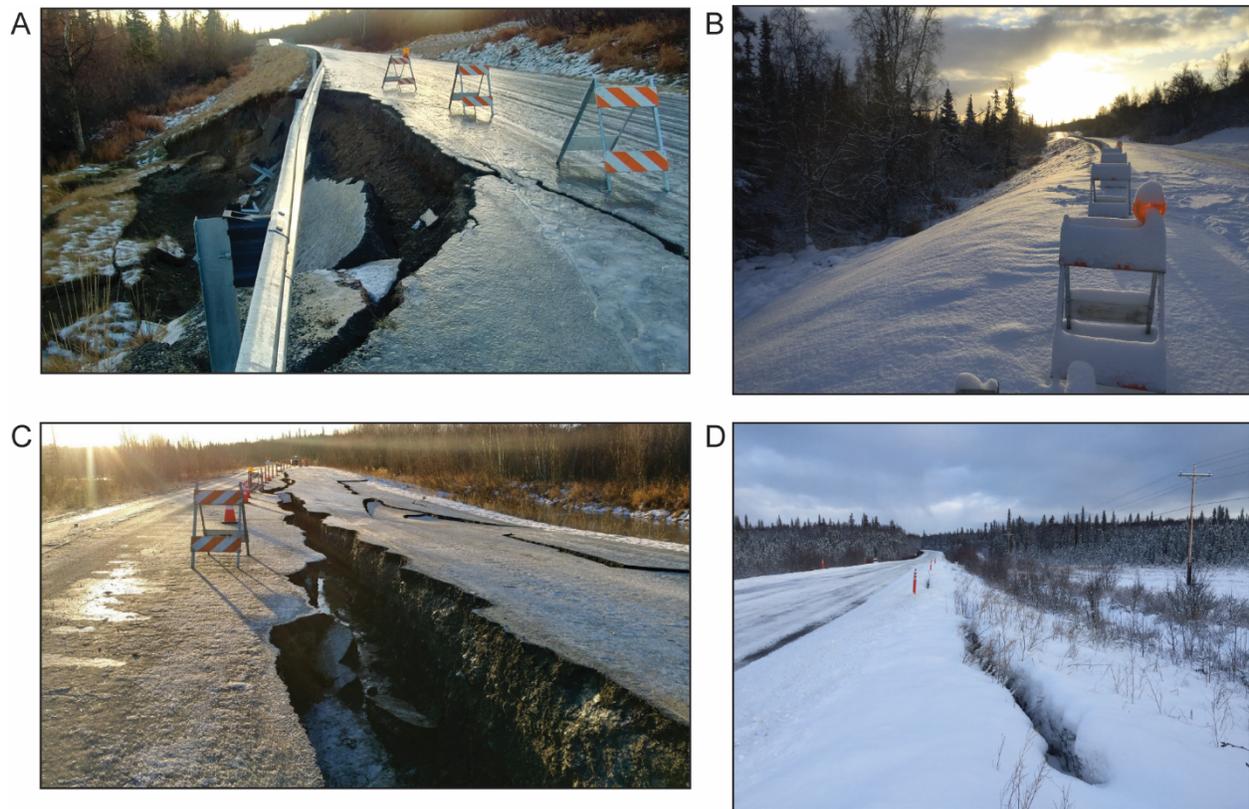
Figure 30. Road failure along the Port Mackenzie industrial area access road (Lou Young Road, Lat/Long: 61.28178, -149.9300) before (A) and after (B) repair. Road failure at mile 15.5 of the Port Mackenzie Road (Lat/Long: 61.3158, -150.02623) before (C) and after (D) repair. Pre-snow photographs courtesy of Bob Walden of Mat-Su Borough.

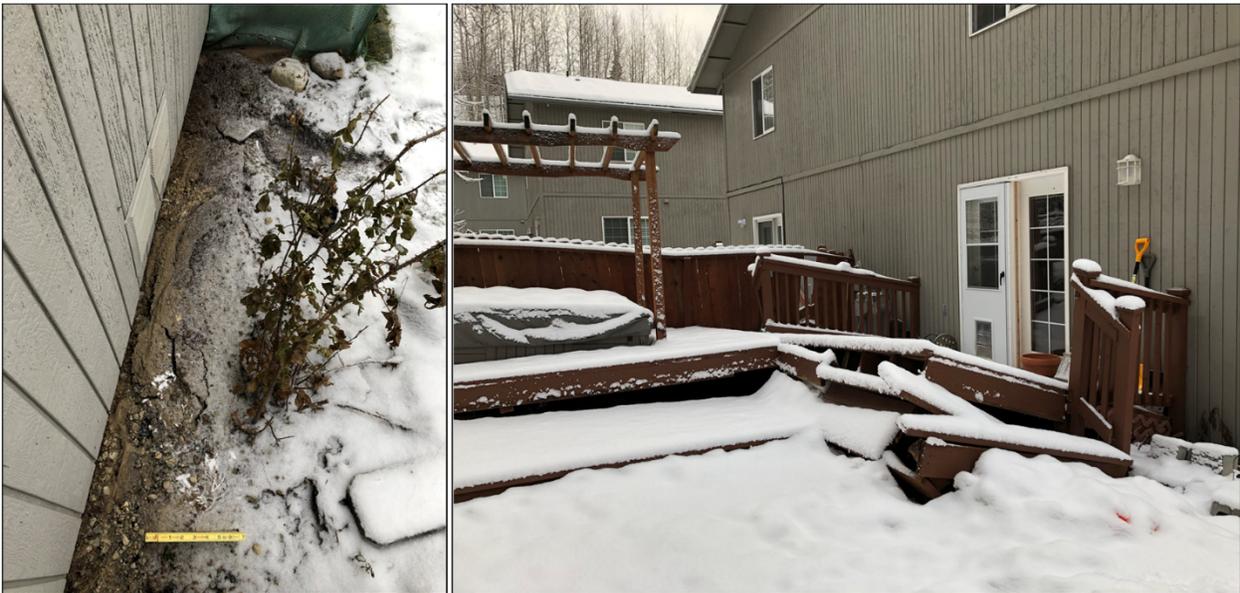
Figure 31. (Left) Ejecta observed at red-tagged home (Lat/Long: 61.3121, -149.5714); (Right) Backyard damage at another red-tagged home (Lat/Long: 61.3121, -149.5721).
