GEOTECHNICAL ENGINEERING RECONNAISSANCE OF THE 30 NOVEMBER 2018 M7.0 ANCHORAGE, ALASKA EARTHQUAKE

GEER Report GEER-059

January 2, 2019

GEER Team Co-Leaders: Kevin W. Franke (BYU) and Rich D. Koehler (UNR)

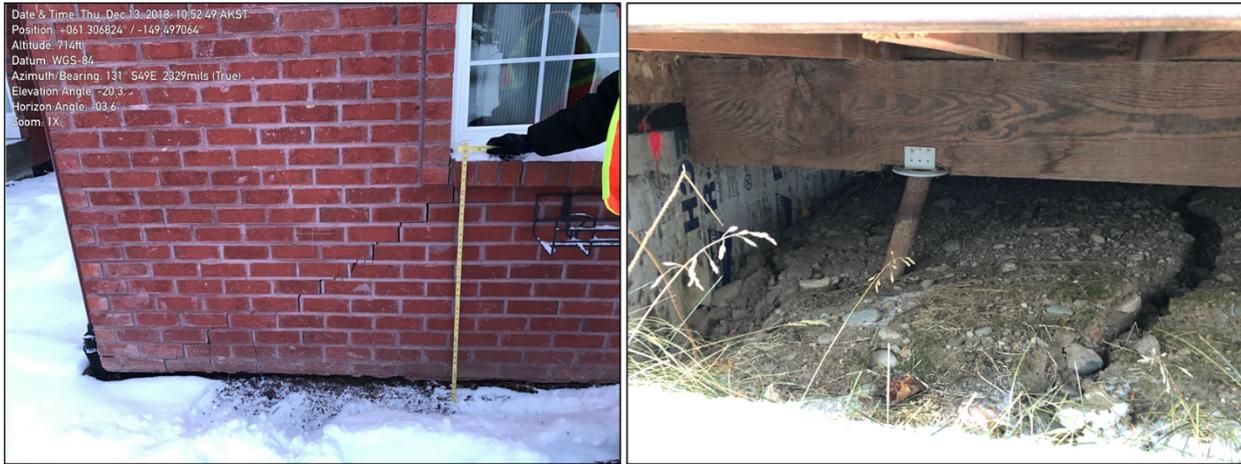
Figure 32. Ptarmigan Drive residential settlement (left) and ground failure (right) (Lat/Long: 61.3067, -149.4968).

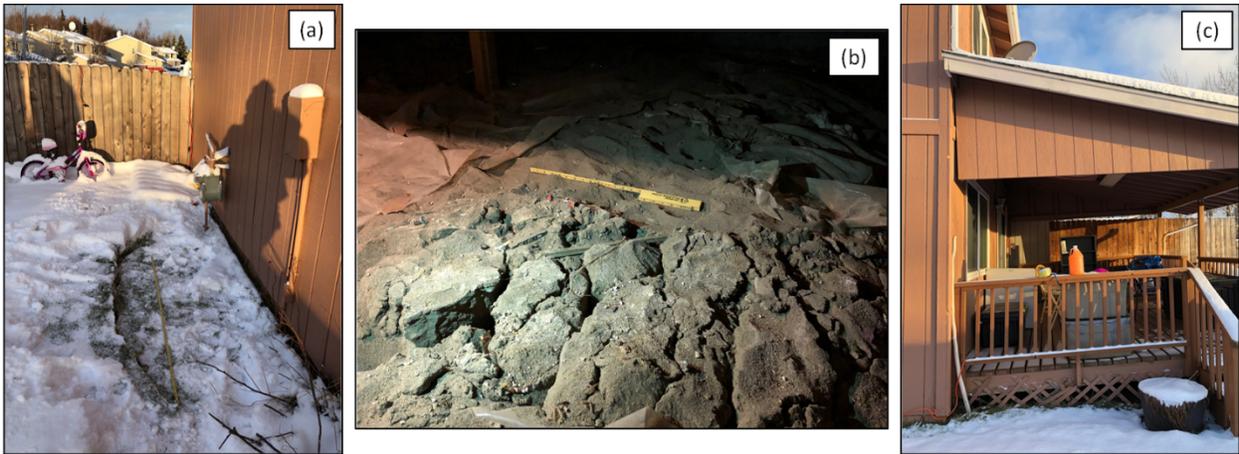
Figure 33. Jewel Lake residential damage: (a) settlement along foundation perimeter, (b) ground failure and possible ejecta in crawl space under the home, (c) settlement relative to back porch. Lat/long: (61.1380, -149.9380).

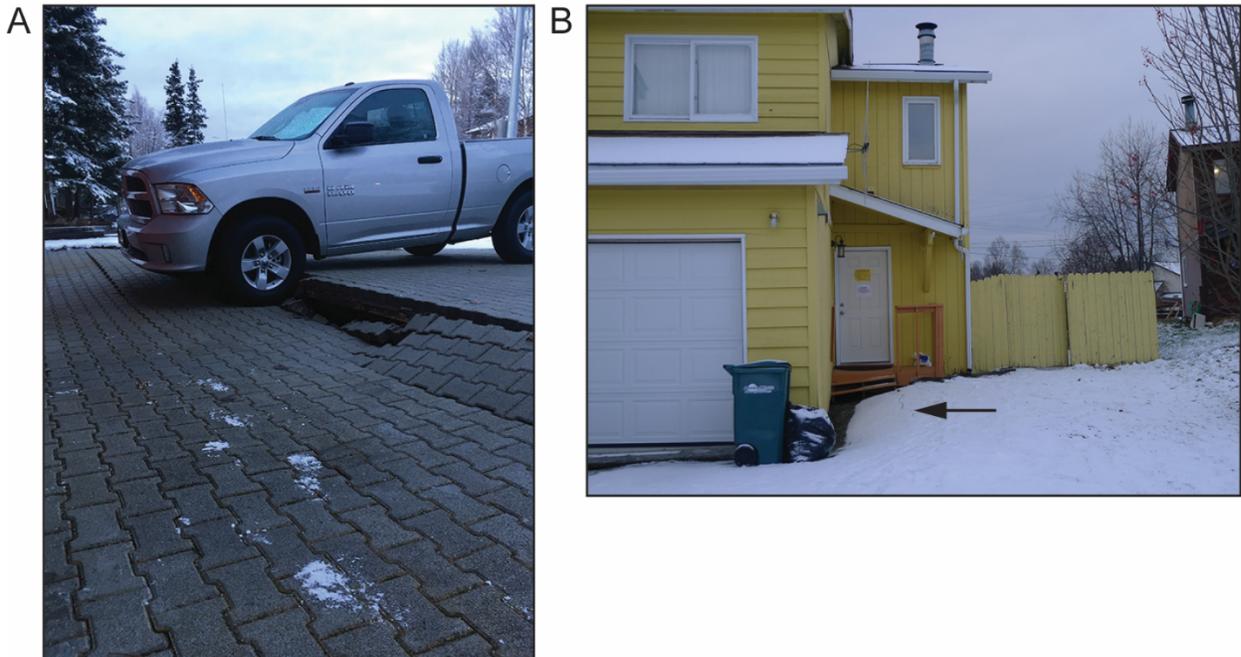
Figure 34. Typical foundation settlement damage in the Campbell Lake area of south Anchorage. (A) Drive way settlement (Lat/Long: 61.1334, -149.9313). (B) Duplex settlement along arrow (Lat/Long: 61.1379, -149.9380). Settlement was about 30 cm at each site.

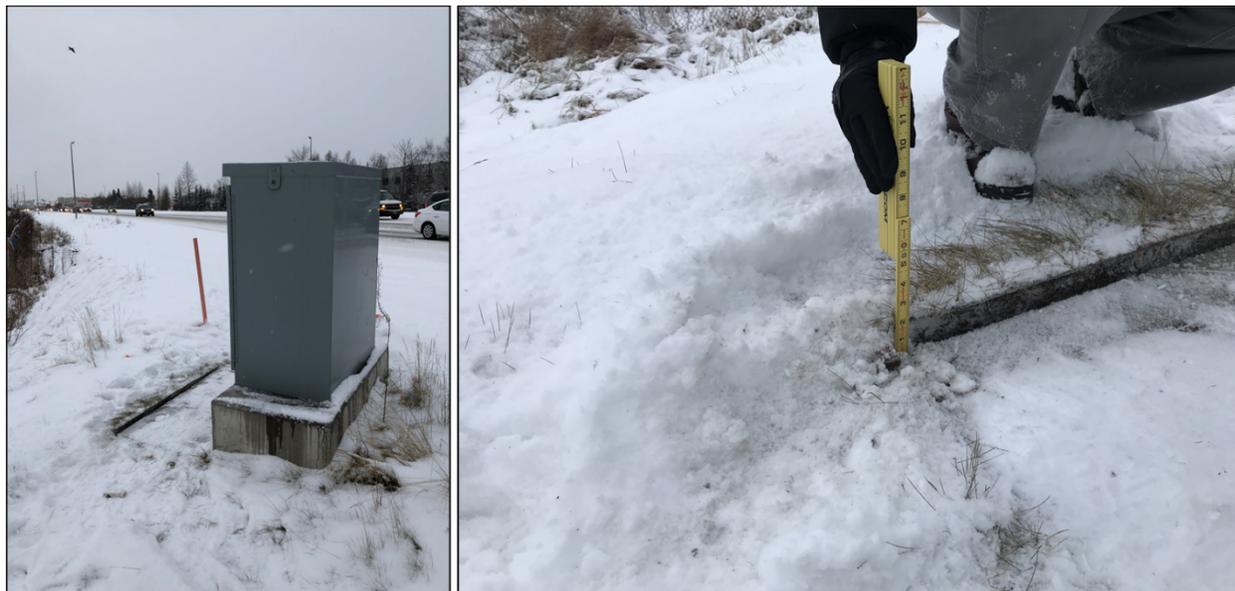
Figure 35. C Street & Dowling Road Intersection - settlement at electrical junction box (Lat/Long: (Lat/Long: 61.1670, -149.8870).
