April 6 2009 L'Aquila (Abruzzo) Earthquake in Central Italy

Jonathan P. Stewart GEER Team Leader

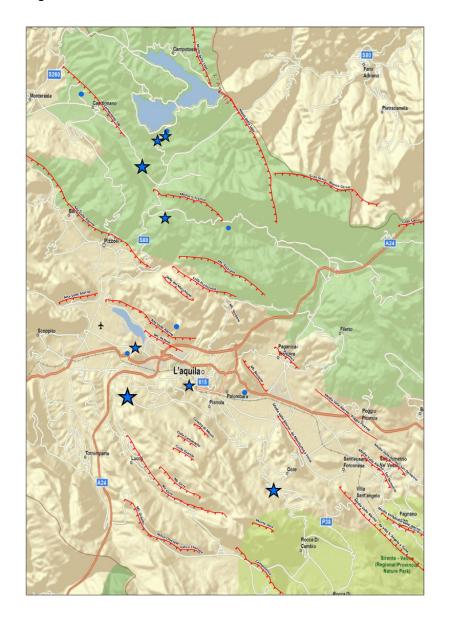
- Some deformation reported:
 - Paganica
 - Poggio
 - Aterno
- Consensus: No SR from primary fault
- Controversial: Co-seismic origin of displacements near mapped faults
