# GEER Response to the Niigata Chuetsu-Oki Earthquake of July 16, 2007

Robert Kayen, Ph.D., P.E.  
Research Civil Engineer  
U.S. Geological Survey  
Menlo Park, CA

## Investigation of the M6.6 Niigata-Chuetsu Oki, Japan, Earthquake of July 16, 2007

Open File Report 2007-1365

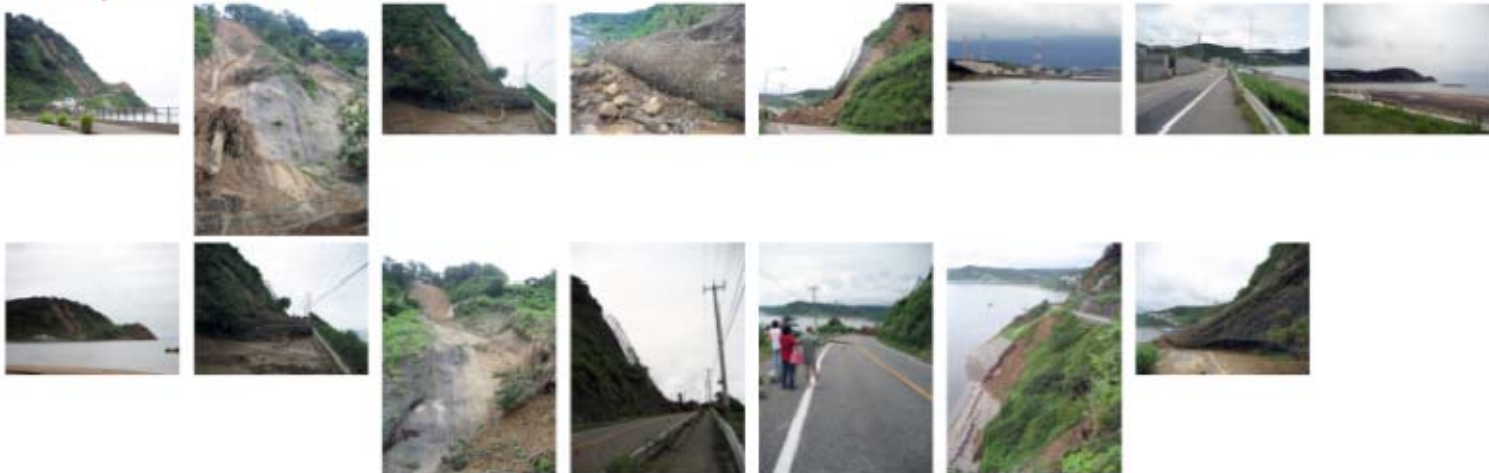
## RK34

- Site Number -- RK34
- Name -- Coastal Landslides South of Route 373 - Several colluvial/residual slides in this area. Beginning in the north, five small (volume Less than 25 m<sup>3</sup> each), shallow failures were observed behind some nearby structures. These are considered minor failures. Several other major failures were observed and investigated in more detail. The road in this location were closed due to Slides 1, 2, 3 as described below:

- Slide 1 - Located in previous area of instability, a shotcrete stabilization system is in effect for the bottom 50 m of this slope (total slope height is ~115m), and overlain with a wire-mesh rock deflection system. Slide is 50-60 m wide, 65 m long, Less than 1m thick. Slide initiated above shotcrete slope, moved into wire-mesh, causing failure of meshing and pulling out of steel wire-mesh steel supports. Wire-mesh caught most of debris, depositing the majority on the road, with only slight quantity of debris over road edge. Failure plane has approximate 60° inclination.

- Slide 2 - Similar to Slide 1. Slide is 10 m wide, 15 m long, 0.5m thick. Failure plane has approximate 70° inclination.
  - Slide 3 - Similar to Slide 1. Slide is 10 m wide, 15 m long, 1 m thick. Failure plane has approximate 50° inclination. At this location, the wire-mesh and supports were torn away from the slope.

- Slide 4 - Similar to Slide 3, however slide debris did not reach wire-mesh protection, and was instead deposited in the middle of the slope. Slide is 10 m wide, 25 m long, 0.5 m thick. Failure plane has approximate 50° inclination.

- Slide 6 and 7 - Slide area consists of two slopes with raveling failures that toe onto the beach. Only minimal debris was observed on the beach, suggesting that this slope has undergone failure in the recent past. Failure plane has approximate 55° inclination.

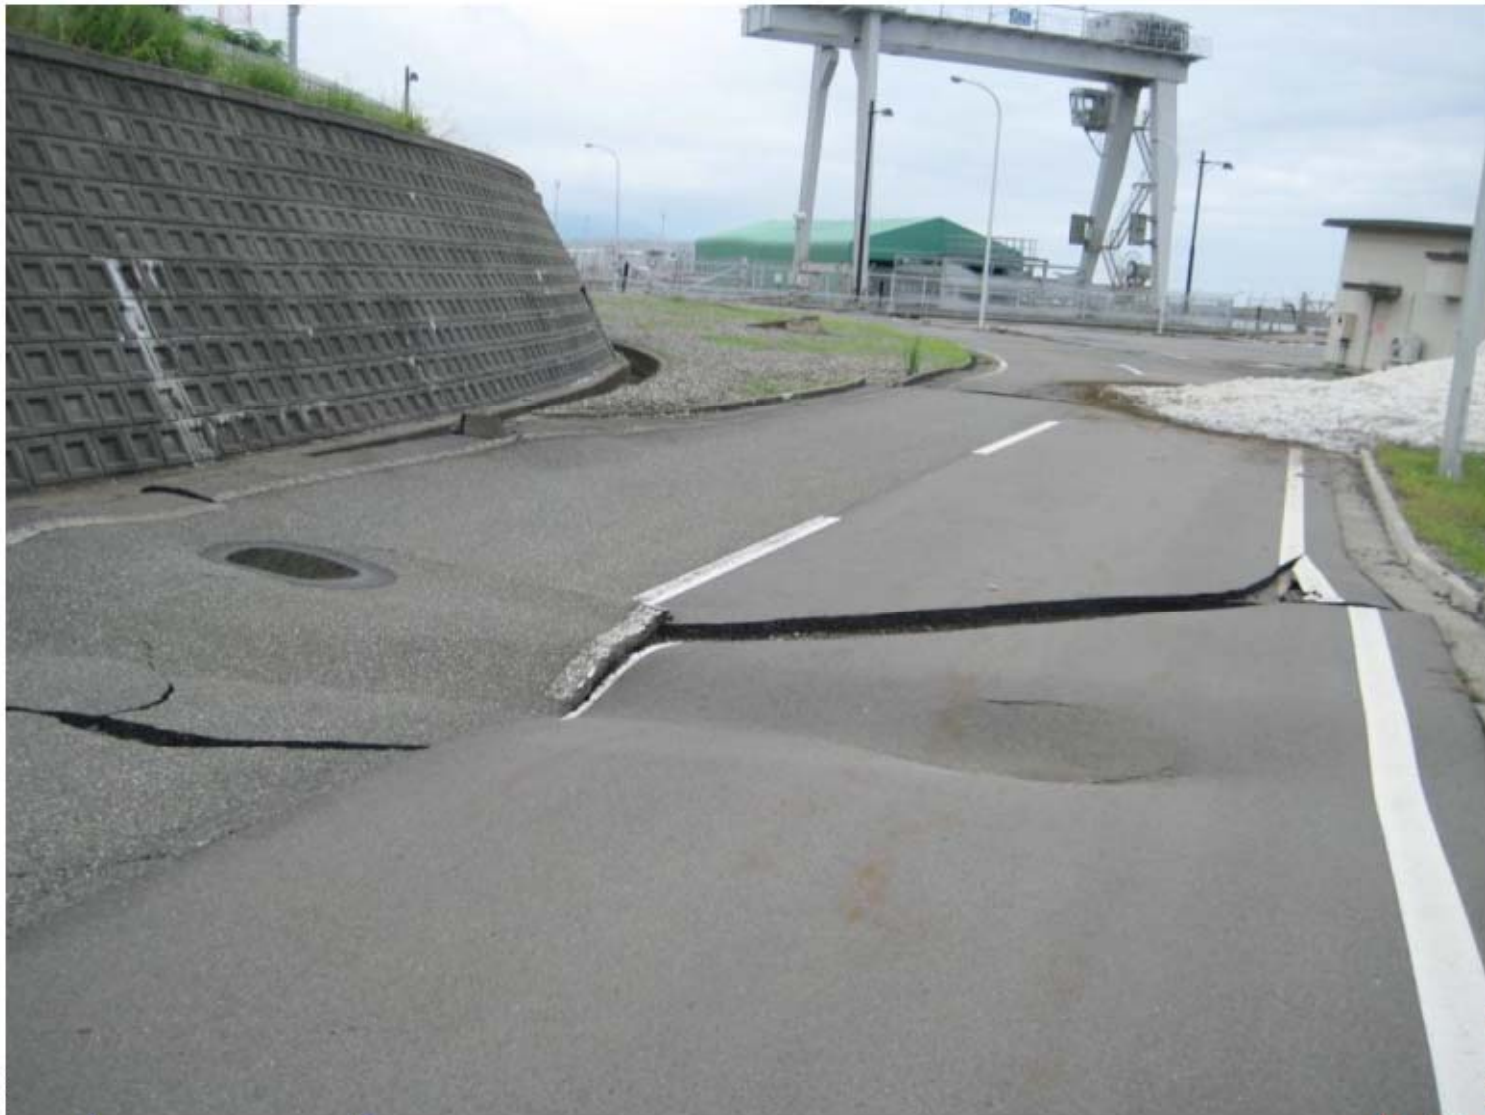
## Liquefaction damage at the KK-NPP: Road Access

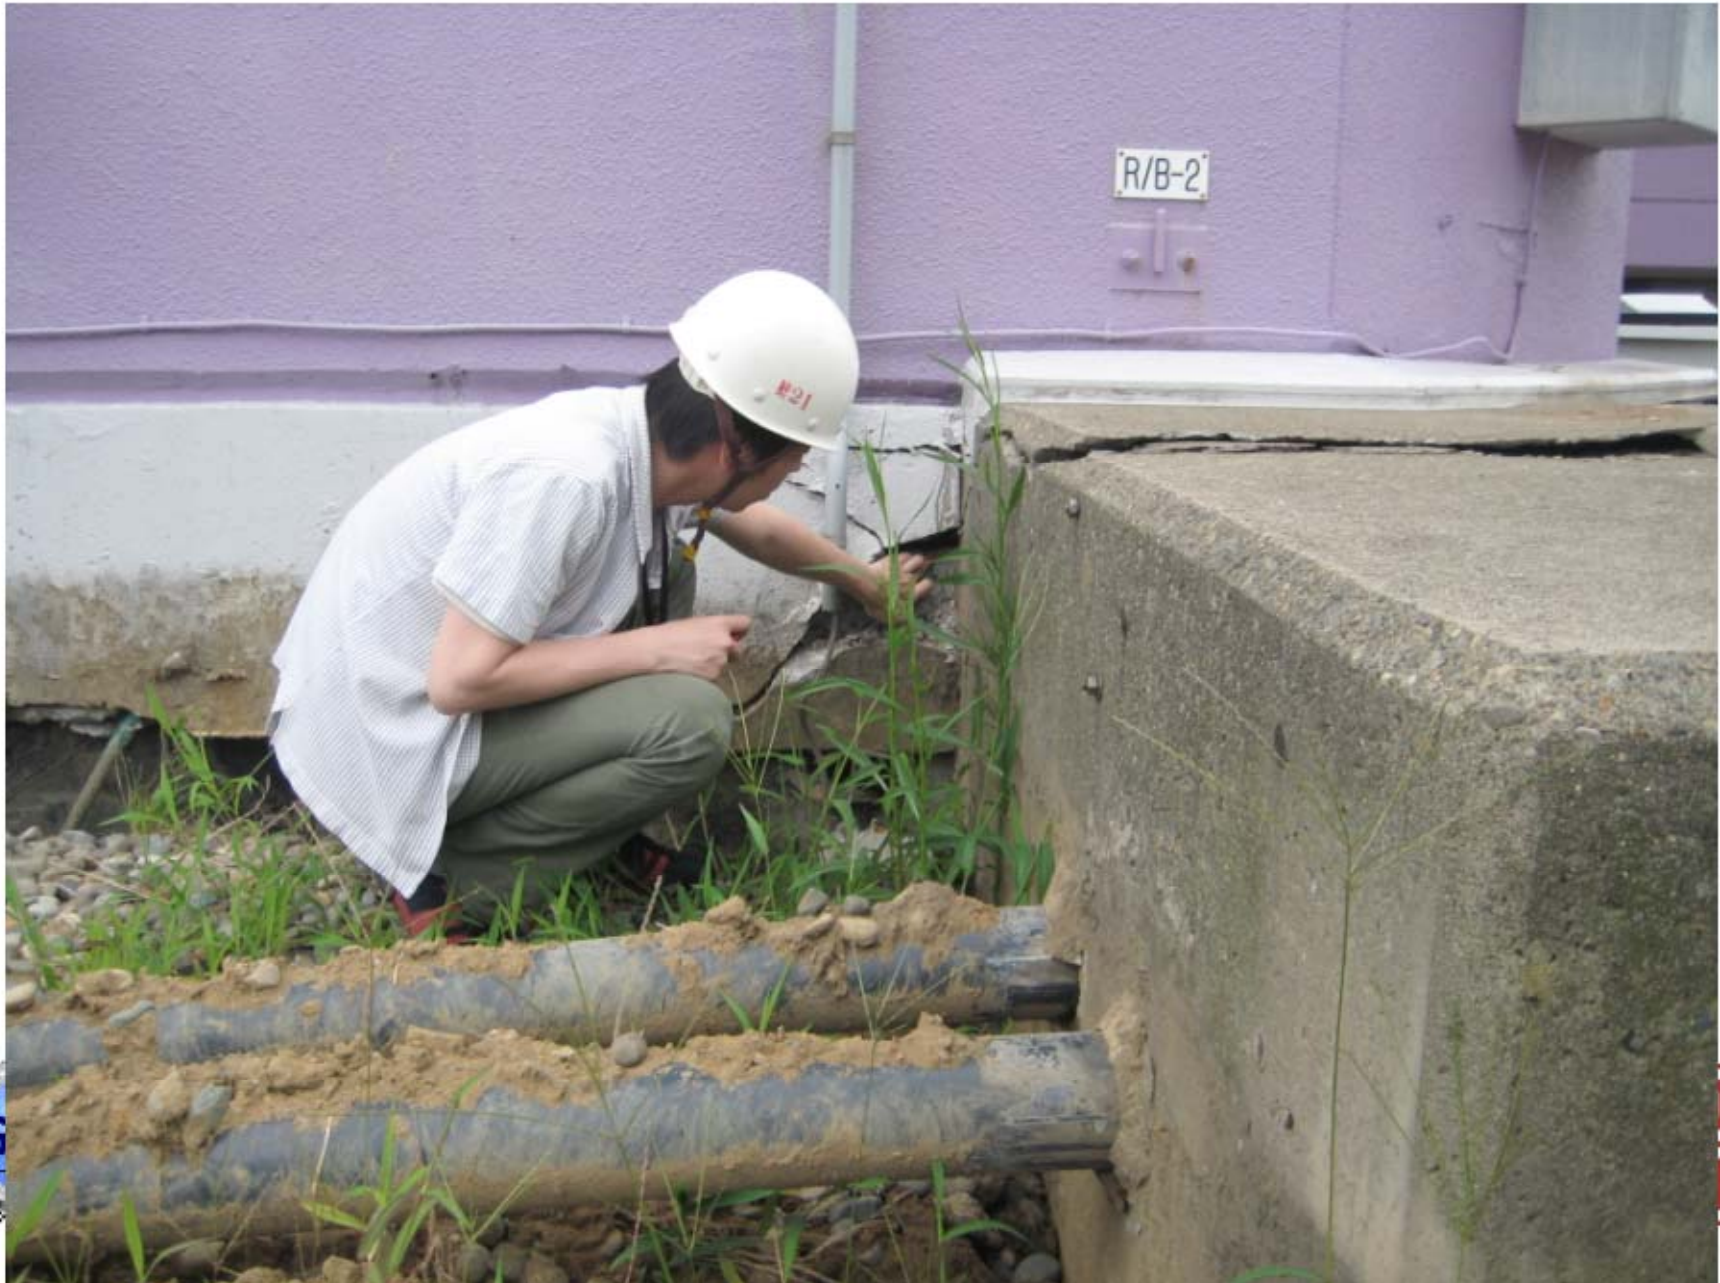
## Liquefaction damage at the KK-NPP: Settlement of piers

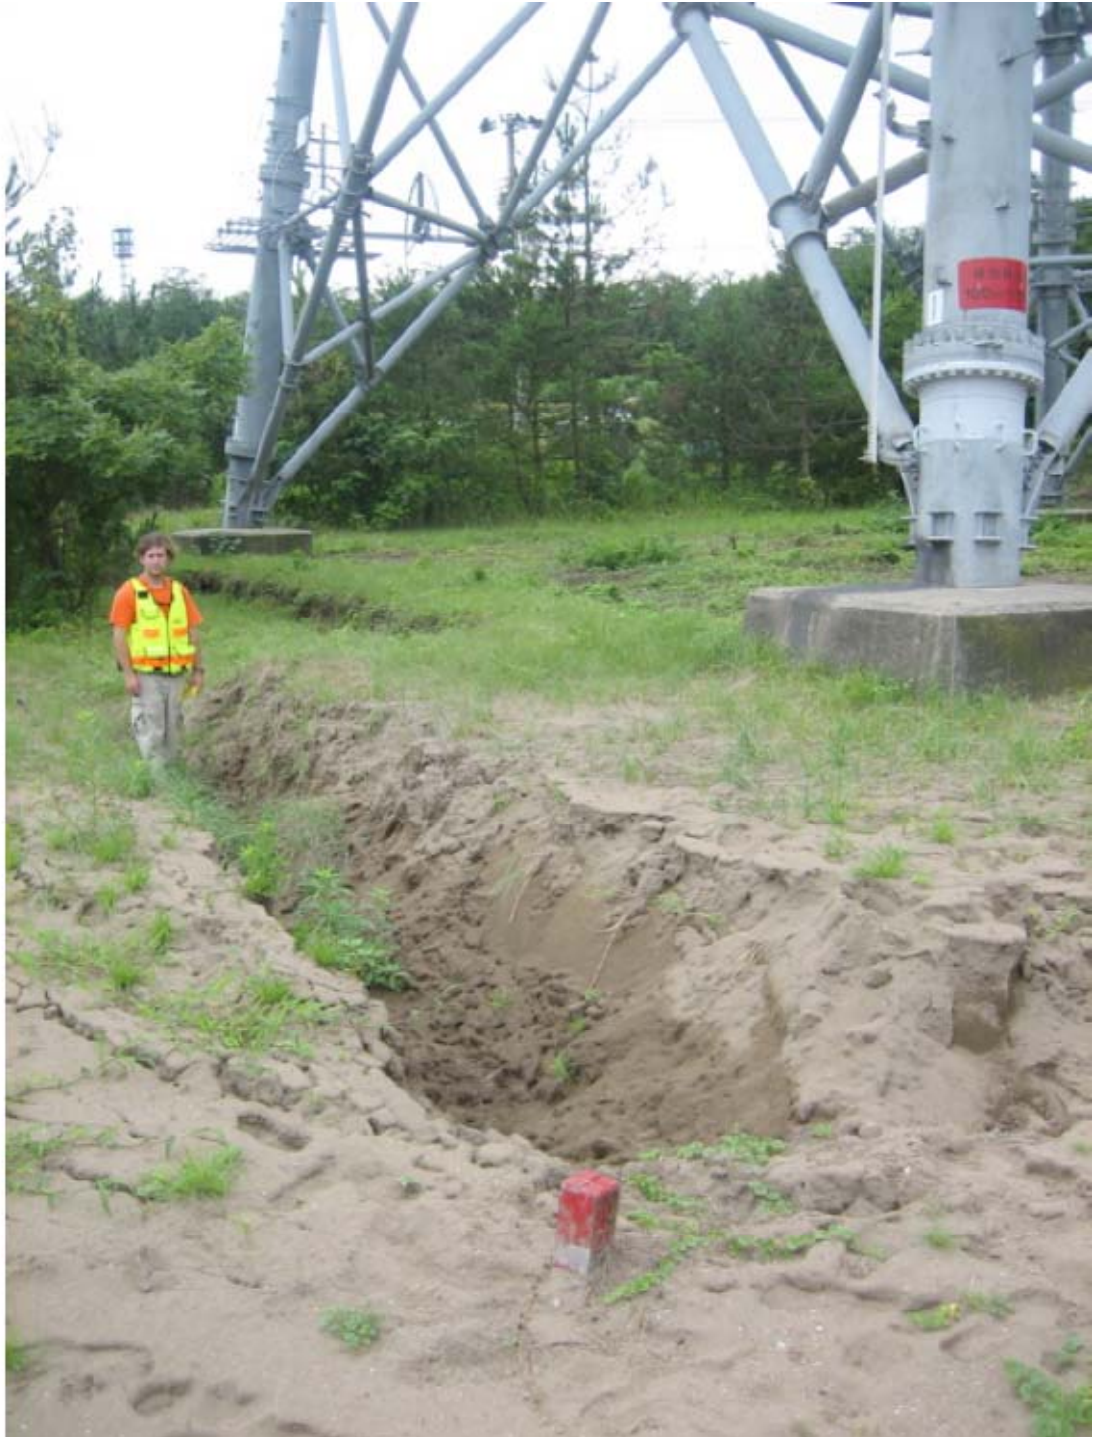
- Lateral spread and settlement of dune sand below the grade beam supporting a KK-NPP high-tension power-line tower

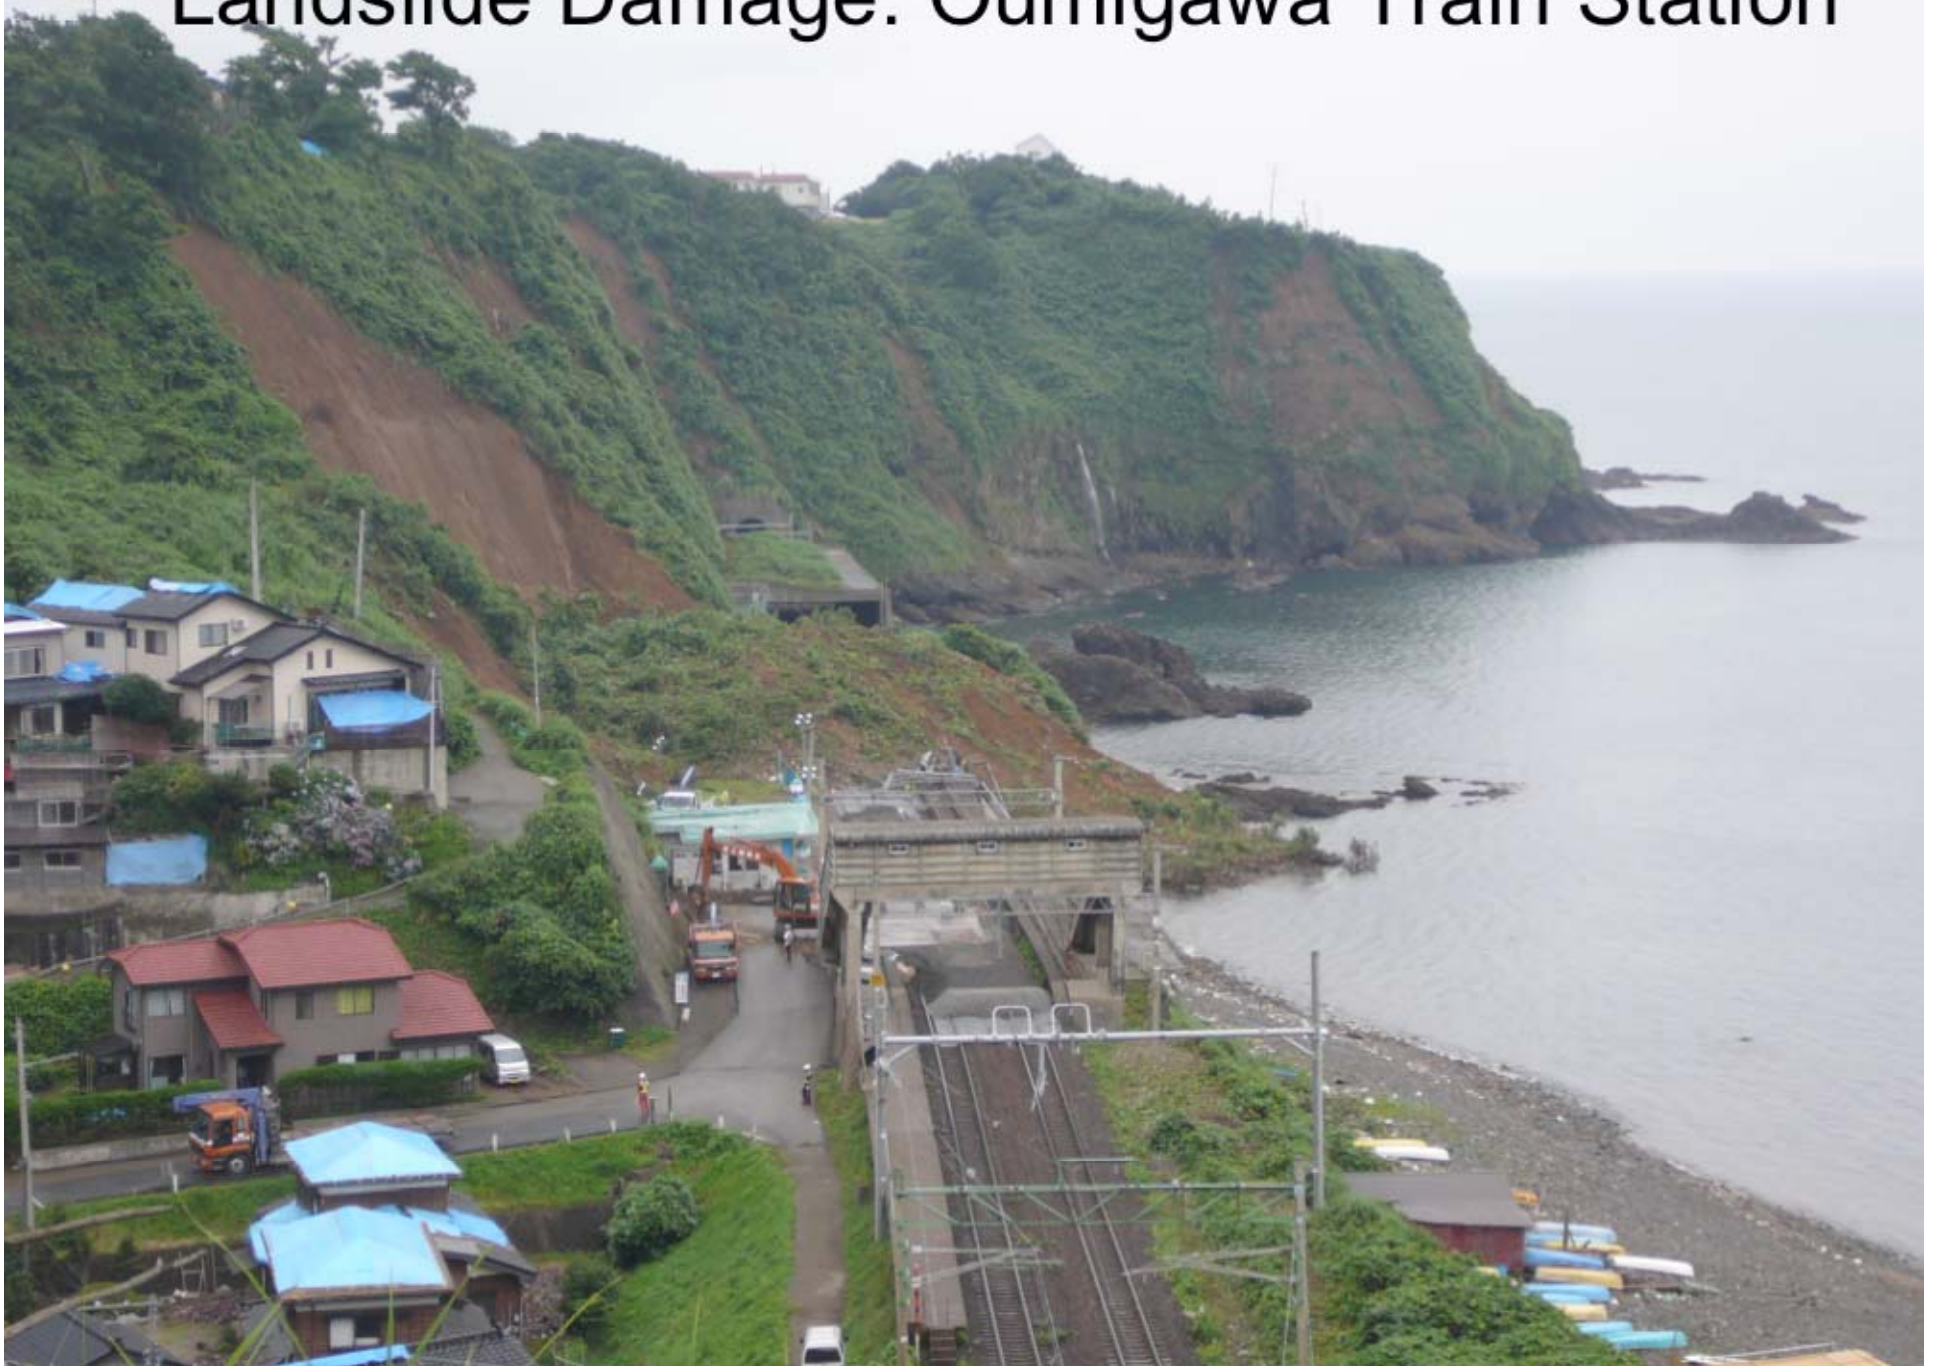
# Landslide Damage: Oumigawa Train Station

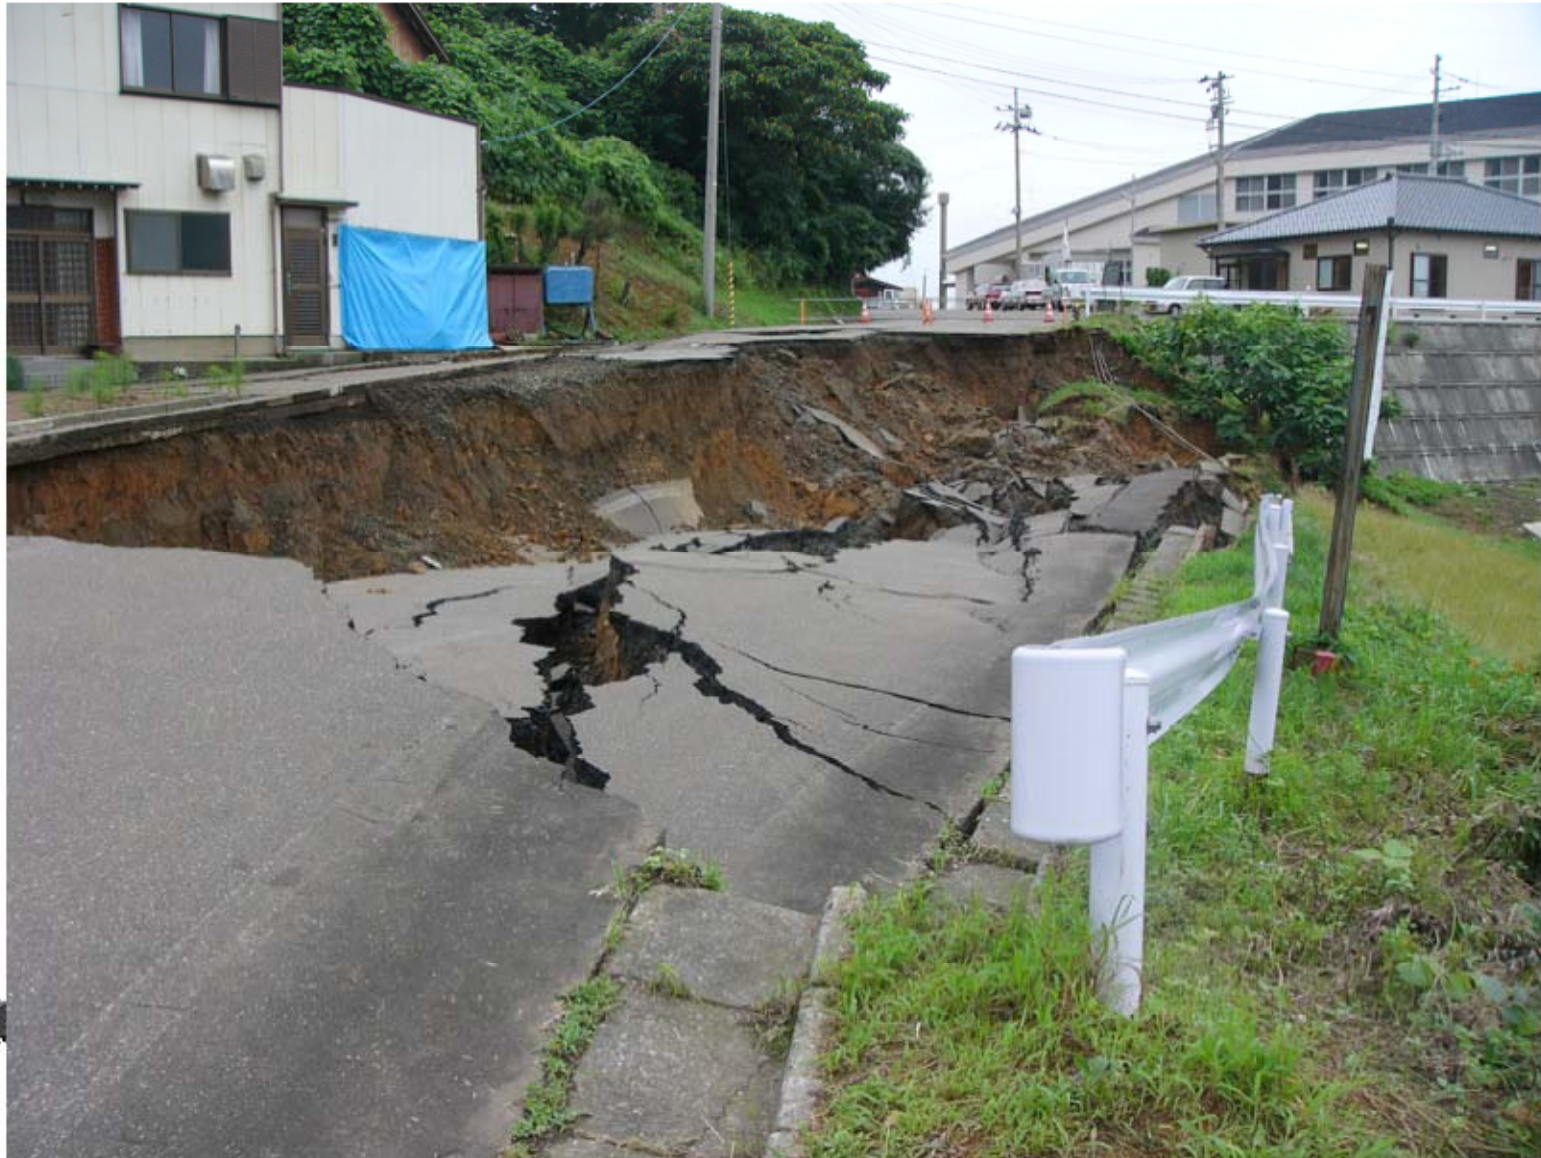
# Cut-and-fill road embankment failures were common

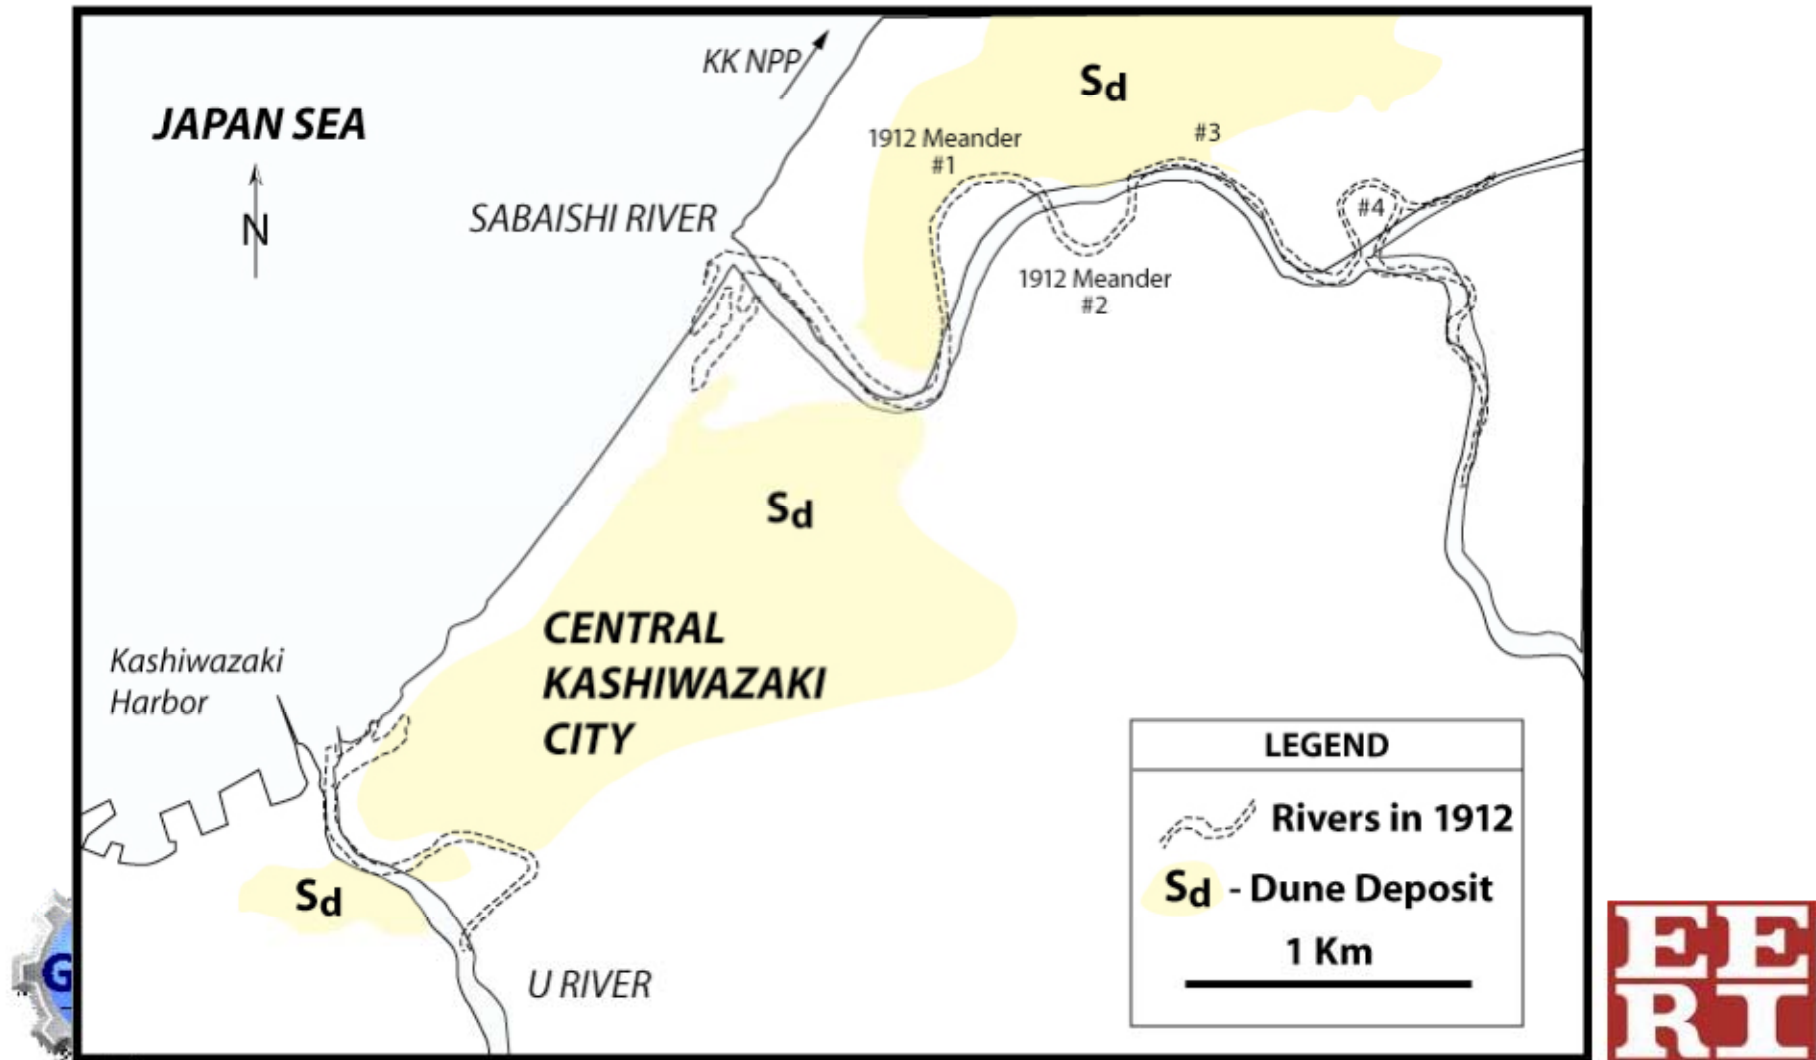
Liquefaction was most severe along the old buried river meanders of the U and Sabaishi Rivers

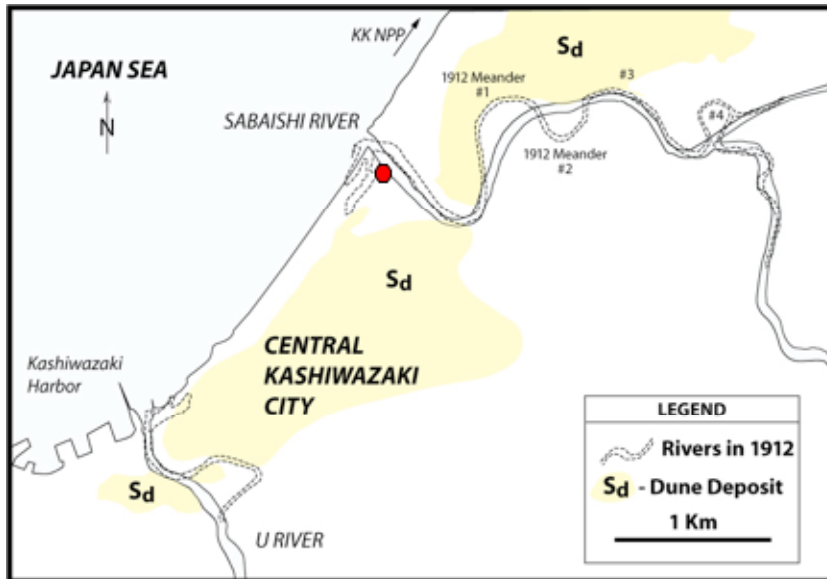
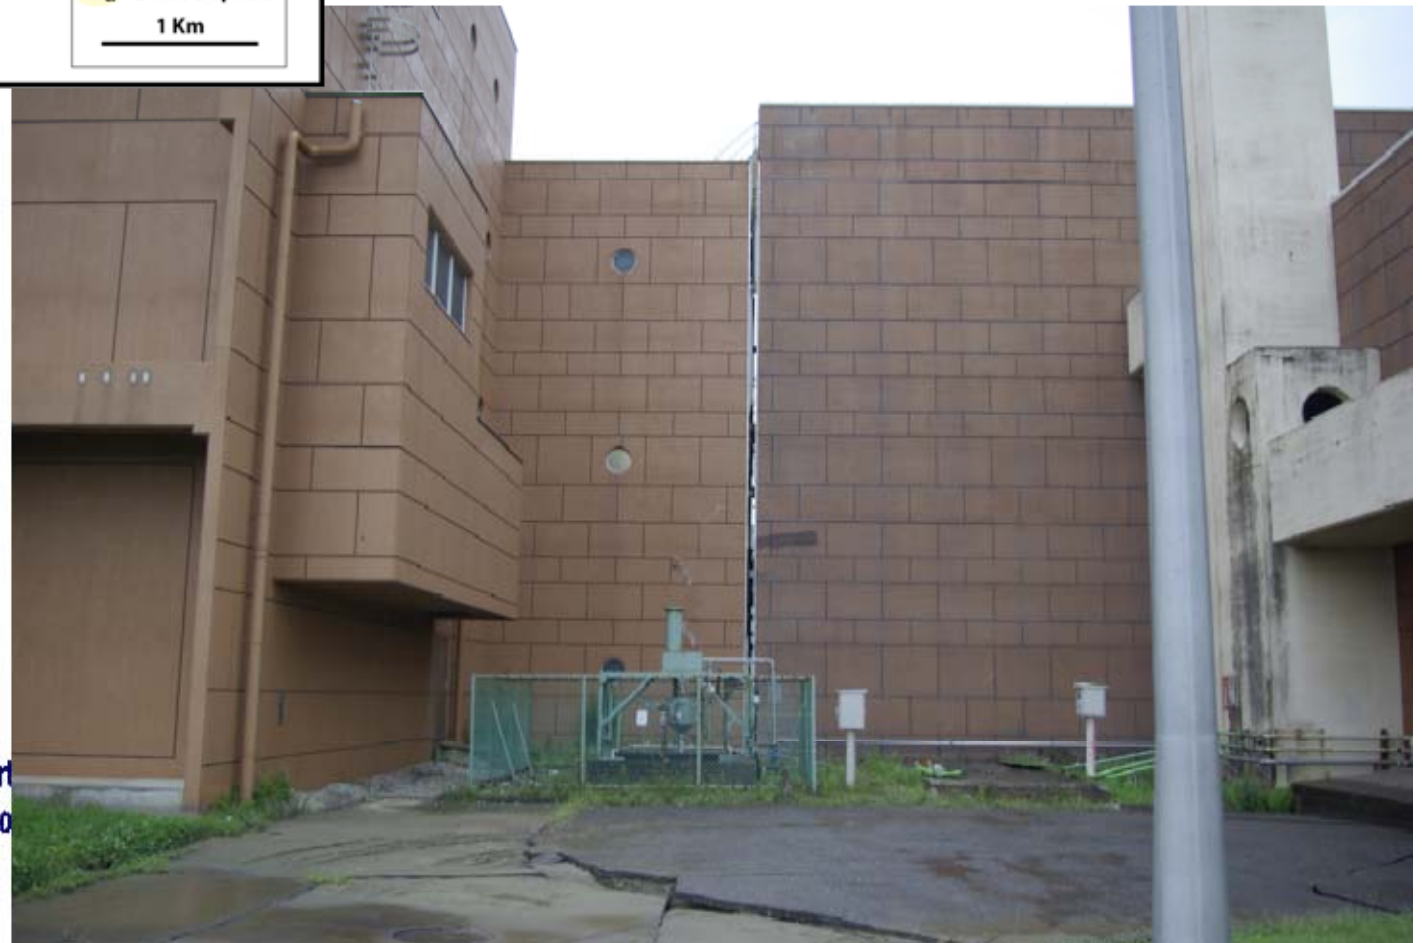
# Liquefaction pulled apart Kashiwazaki waste water treatment plant

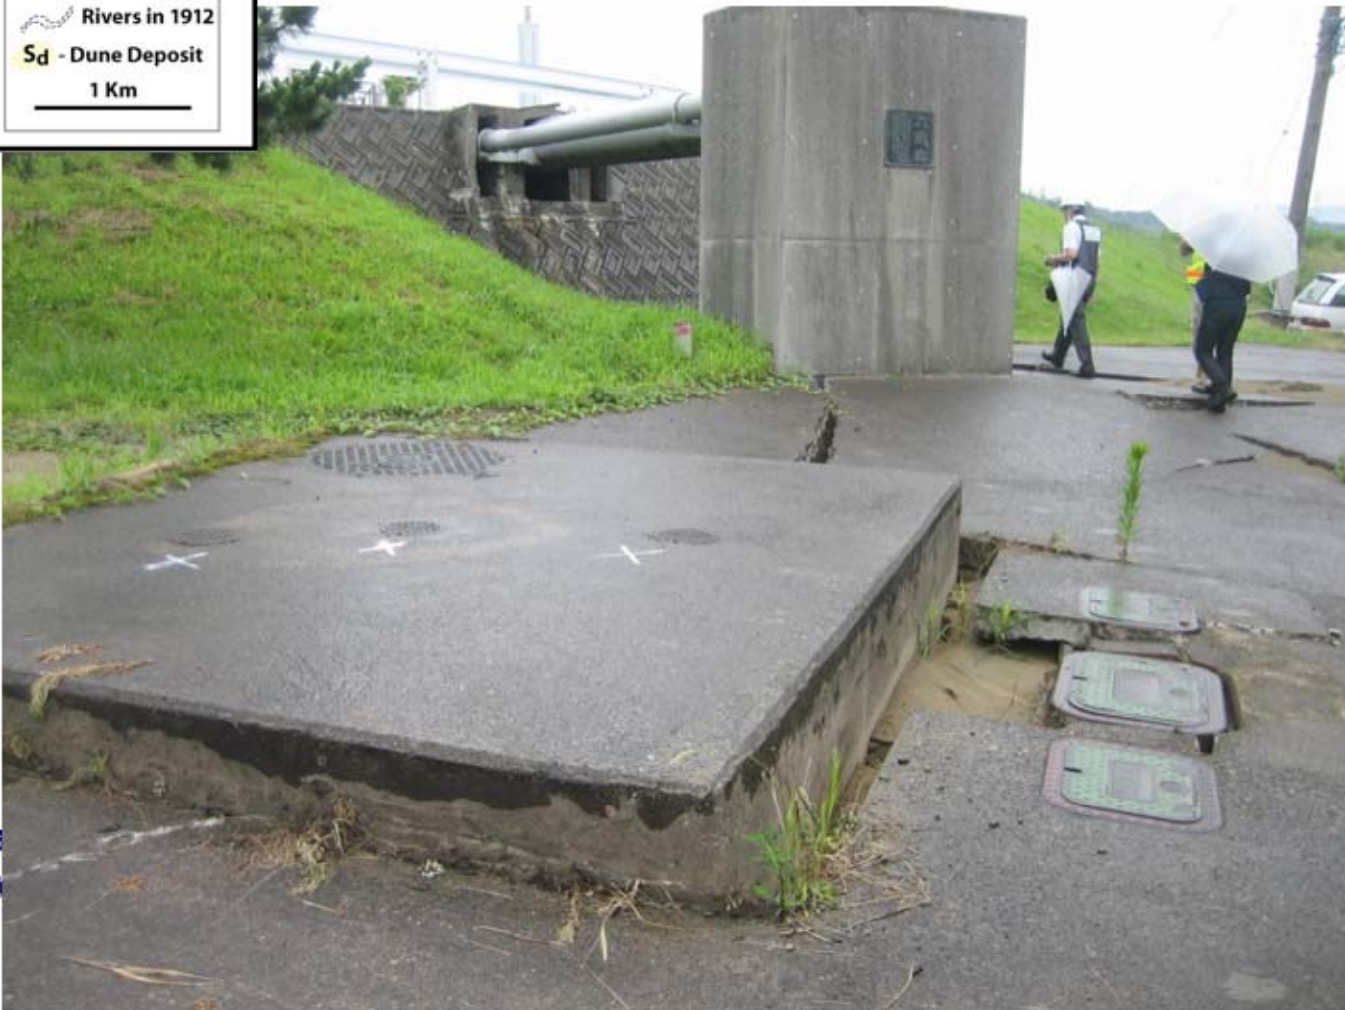
# Uplift and failure of water cistern, Sabaishi River

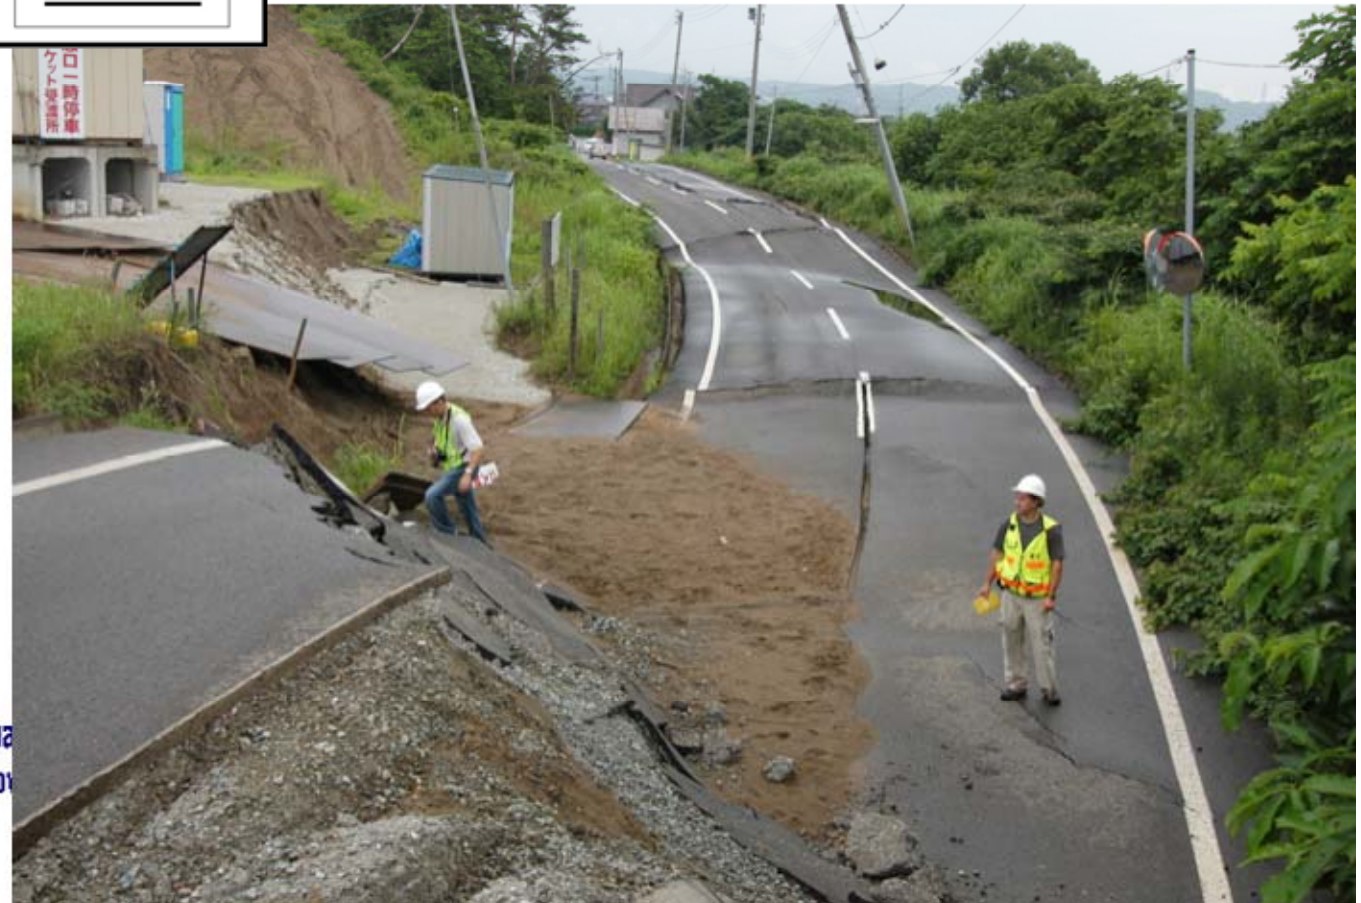
# Massive lateral spread on the old Sabaishi river course

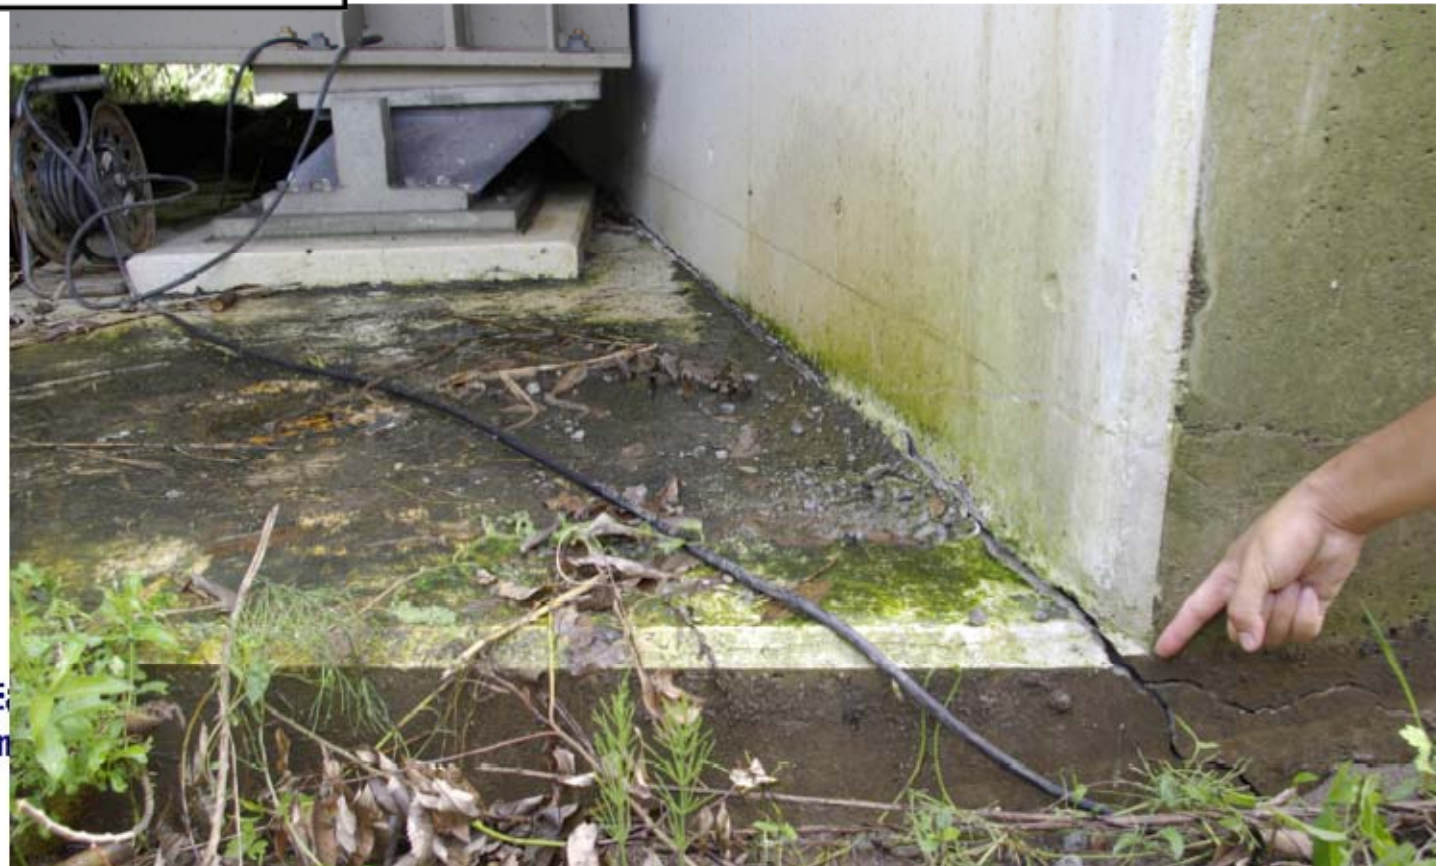
River narrowing due to embankment settlements:  
 Bridge abutment cracking,  
 Elastomeric bearing strains

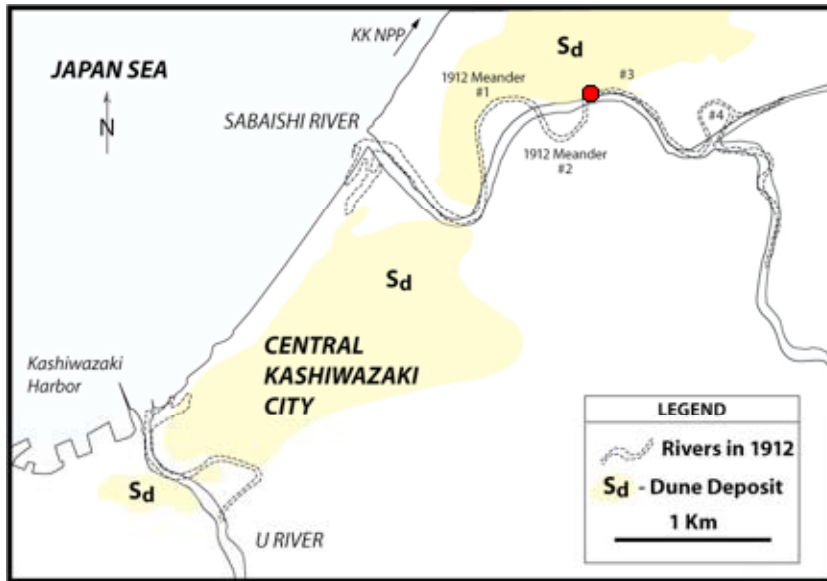
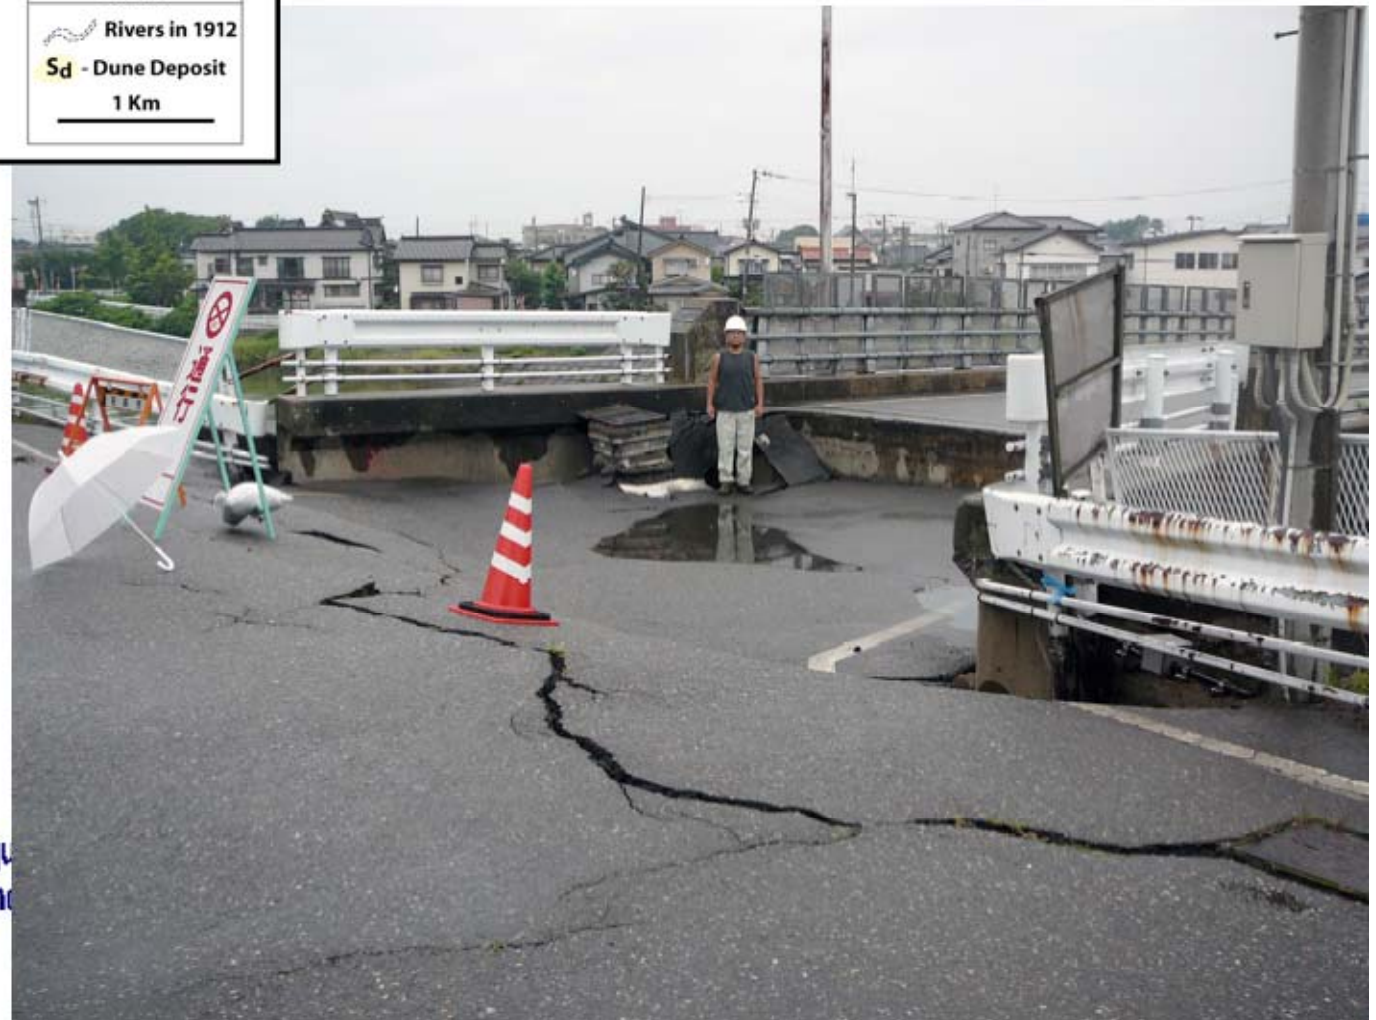
# Approach fill settlement impeded emergency response: Sabaishi River

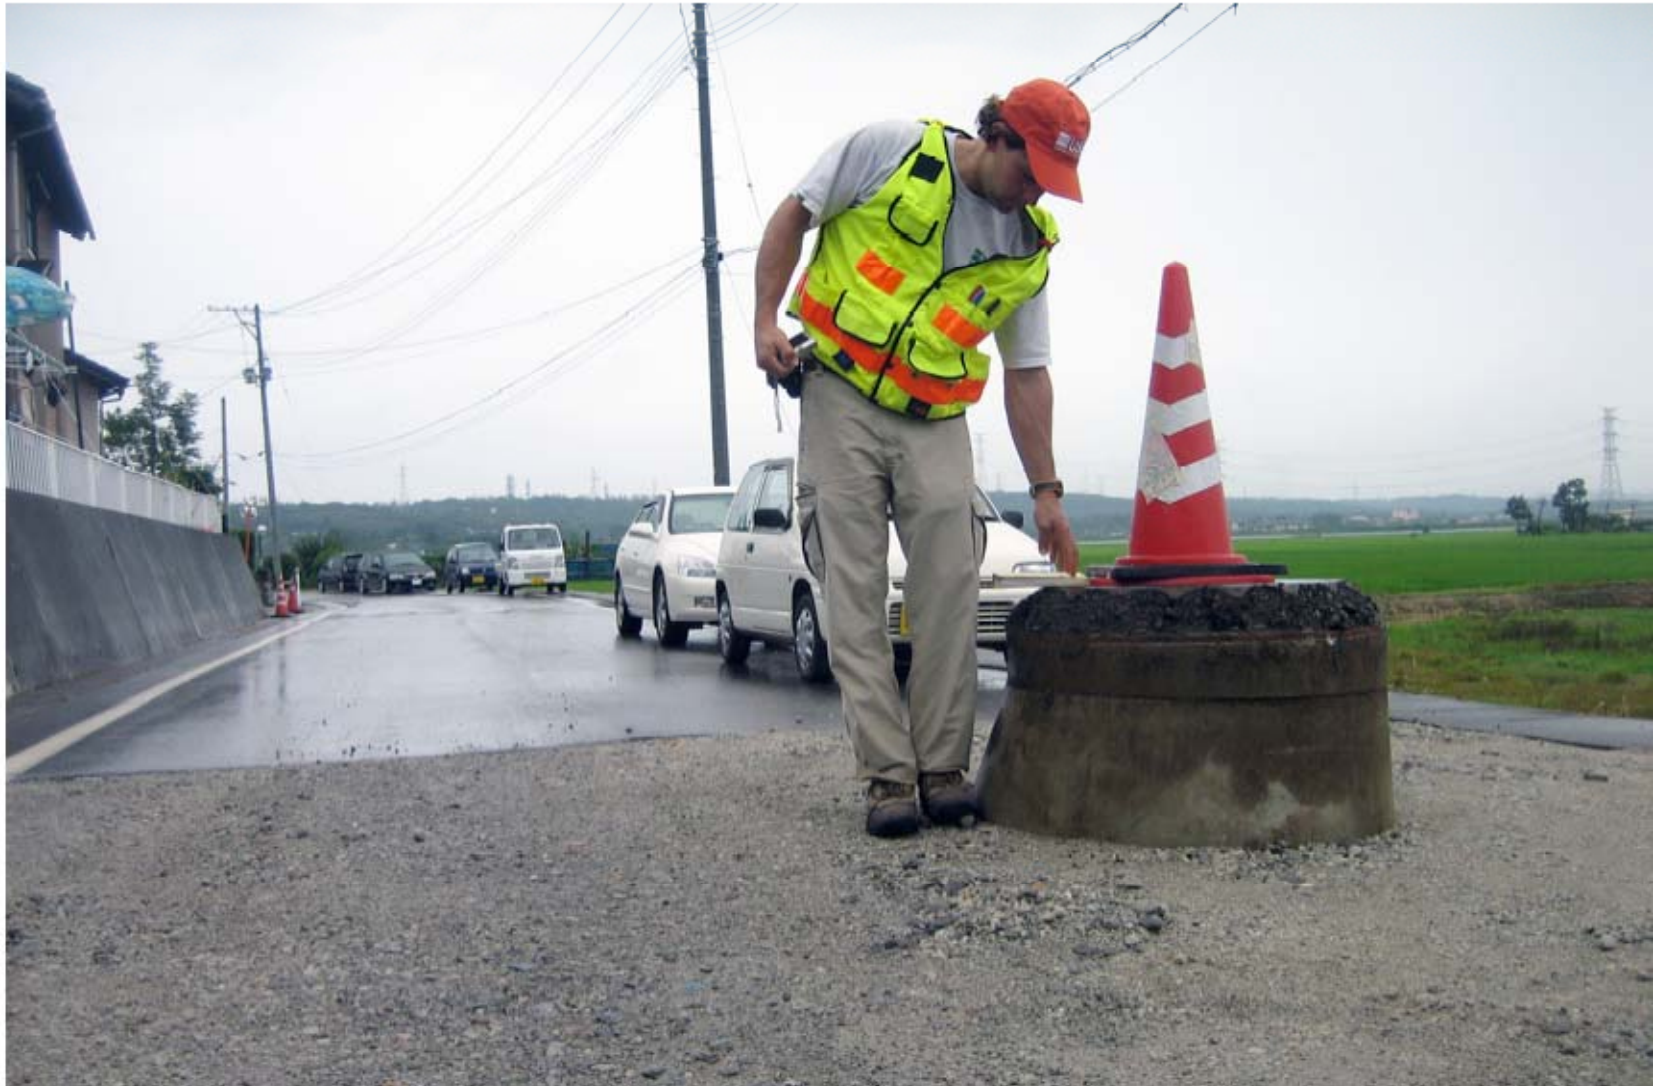
# Poor performance of trench backfill throughout region: uplifted manholes
