5. LIQUEFACTION EFFECTS AND ASSOCIATED DAMAGE AT THE PORT OF WELLINGTON

5.1 Introduction

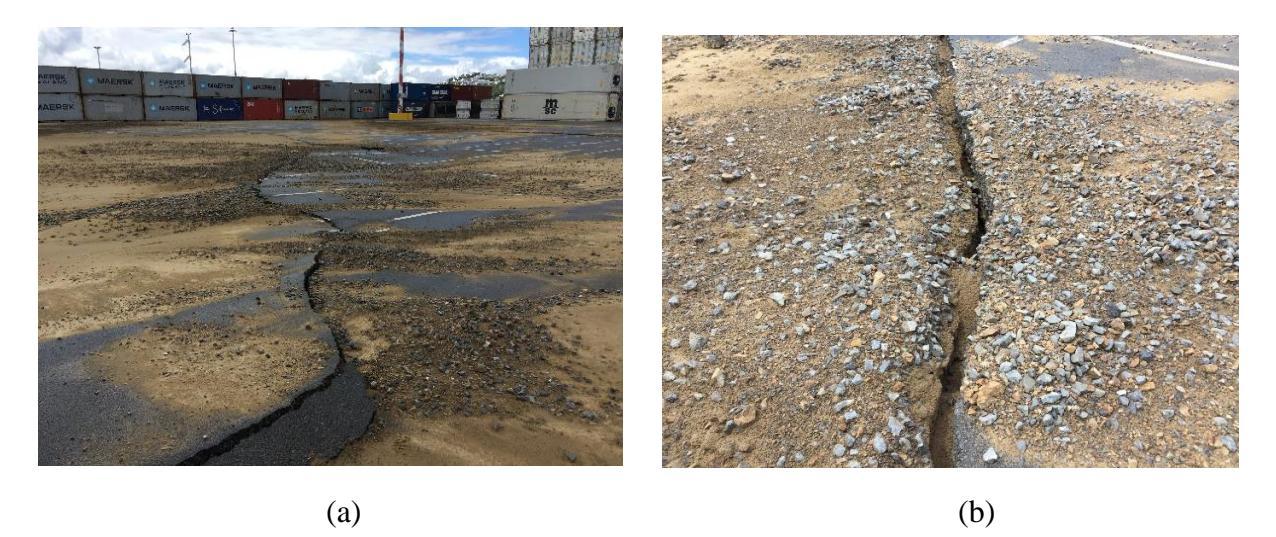
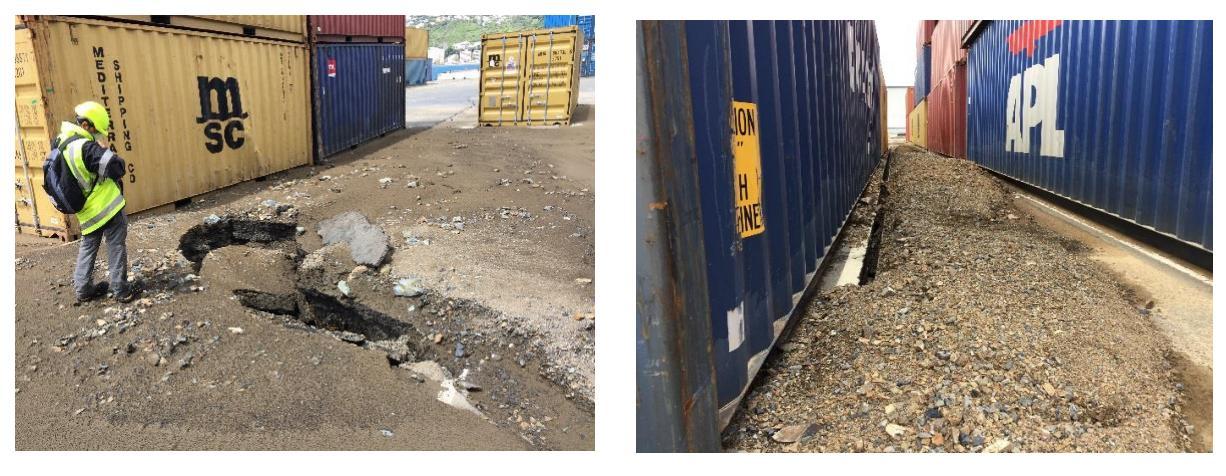
Figure 5.17: Gravelly ejecta at the Thorndon Container Terminal: (a) pavement cracking and ejected gravelly material (S41.280175°, E174.787308°); (b) characteristic gravel-size fractions of the ejecta with some cobbles observed in this area (S41.280206°, E174.787431°); (c) larger amount of gravelly ejecta around a cavity and collapsed pavement surface (S41.280361°, E174.789336°); (d) large volumes of ejecta observed along drainage lines (S41.278347°, E174.788069°, taken on 17NOV16).

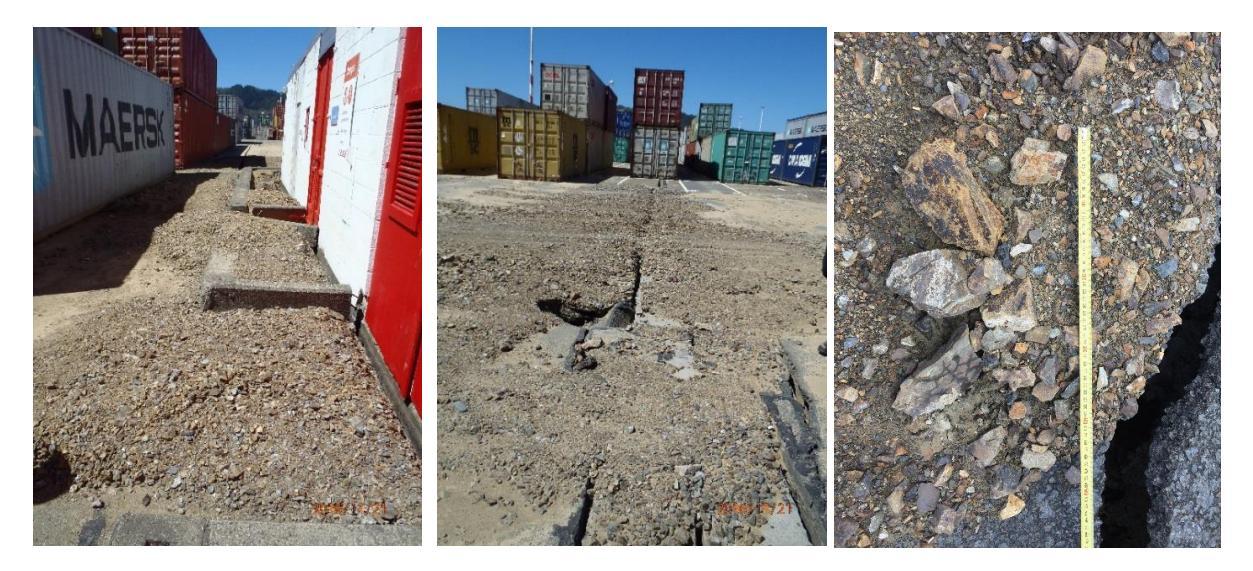
Figure 5.18: High gravel content quarry rock ejecta in the container storage area upland of Thorndon Container Wharf. (a) Looking south along eastern wall of Substation B (S41.277699°, E174.788277°), (b) looking south along lateral spread crack and ejecta 45 m upland of bulkhead at approximately STA 230 (S41.278286°, E174.788830°), (c) coarse gravel and cobble ejecta (S41.280225° E174.787828°), (d) containers 20 m south of Substation B (S41.278020°, E174.788213°), and (e) looking south along lateral spread crack and ejecta 12.5 m upland of bulkhead at approximately STA 150 (S41.278887°, E174.789413°, taken on 21NOV16).

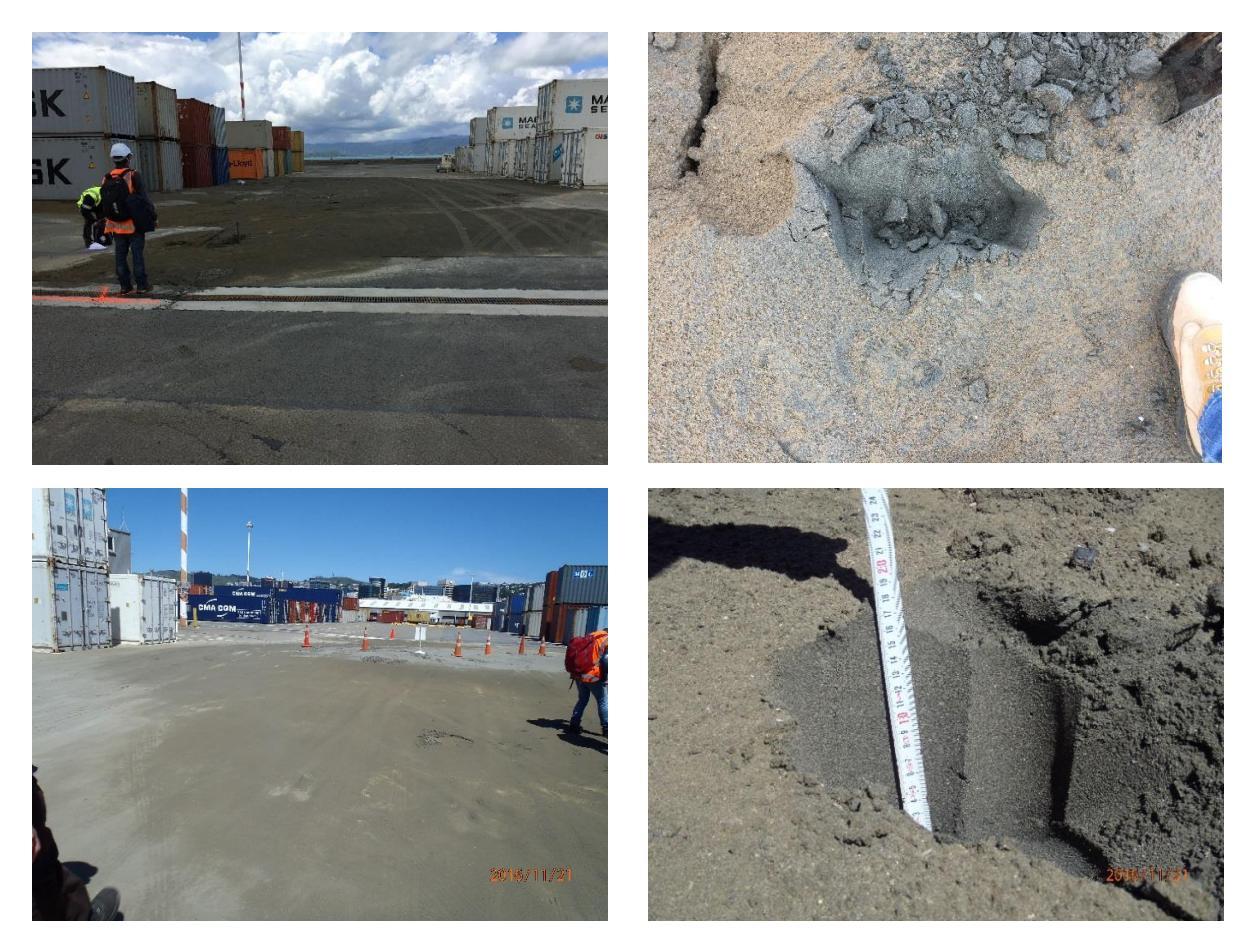
Figure 5.19: Sandy liquefaction ejecta with trace gravel among area of 1970's end-dumped quarry rock reclamation (i.e., Thorndon Reclamation) at STA 145 and approximately 60 m upland of the bulkhead. The ejecta deposit was approximately 170 mm thick at this location. Samples S11 and S12 were collected here (S41.279067°, E174.788792°, taken on 17NOV2016 and 21NOV16).

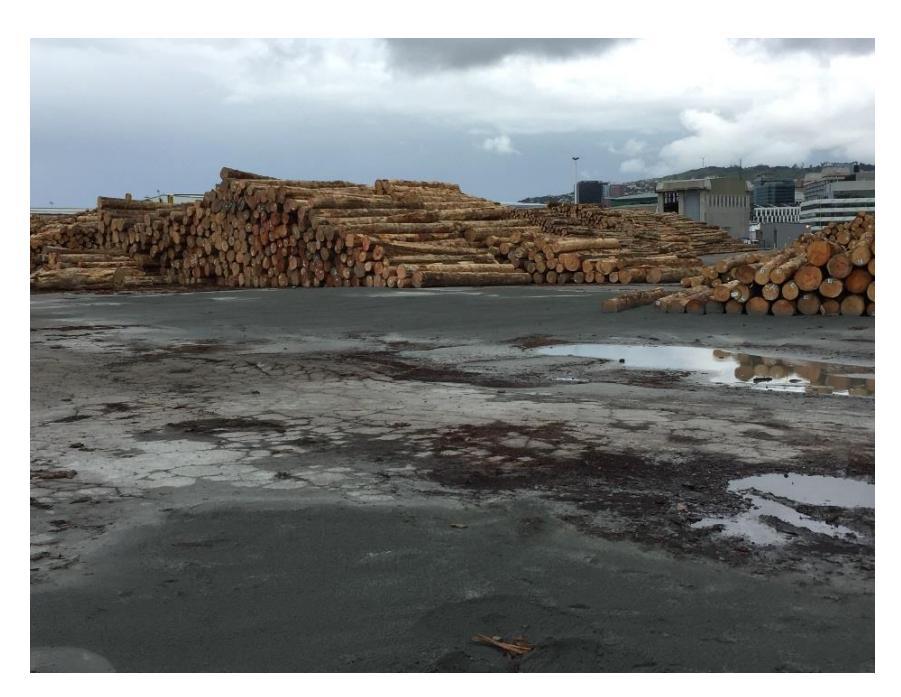
Figure 5.21: Sandy liquefaction ejecta in the log stacking area in the northeast corner of CentrePort (Sample S13). Area of hydraulic fill reclamation. (S41.274972°, E174.788347°, taken on 17 NOV16)

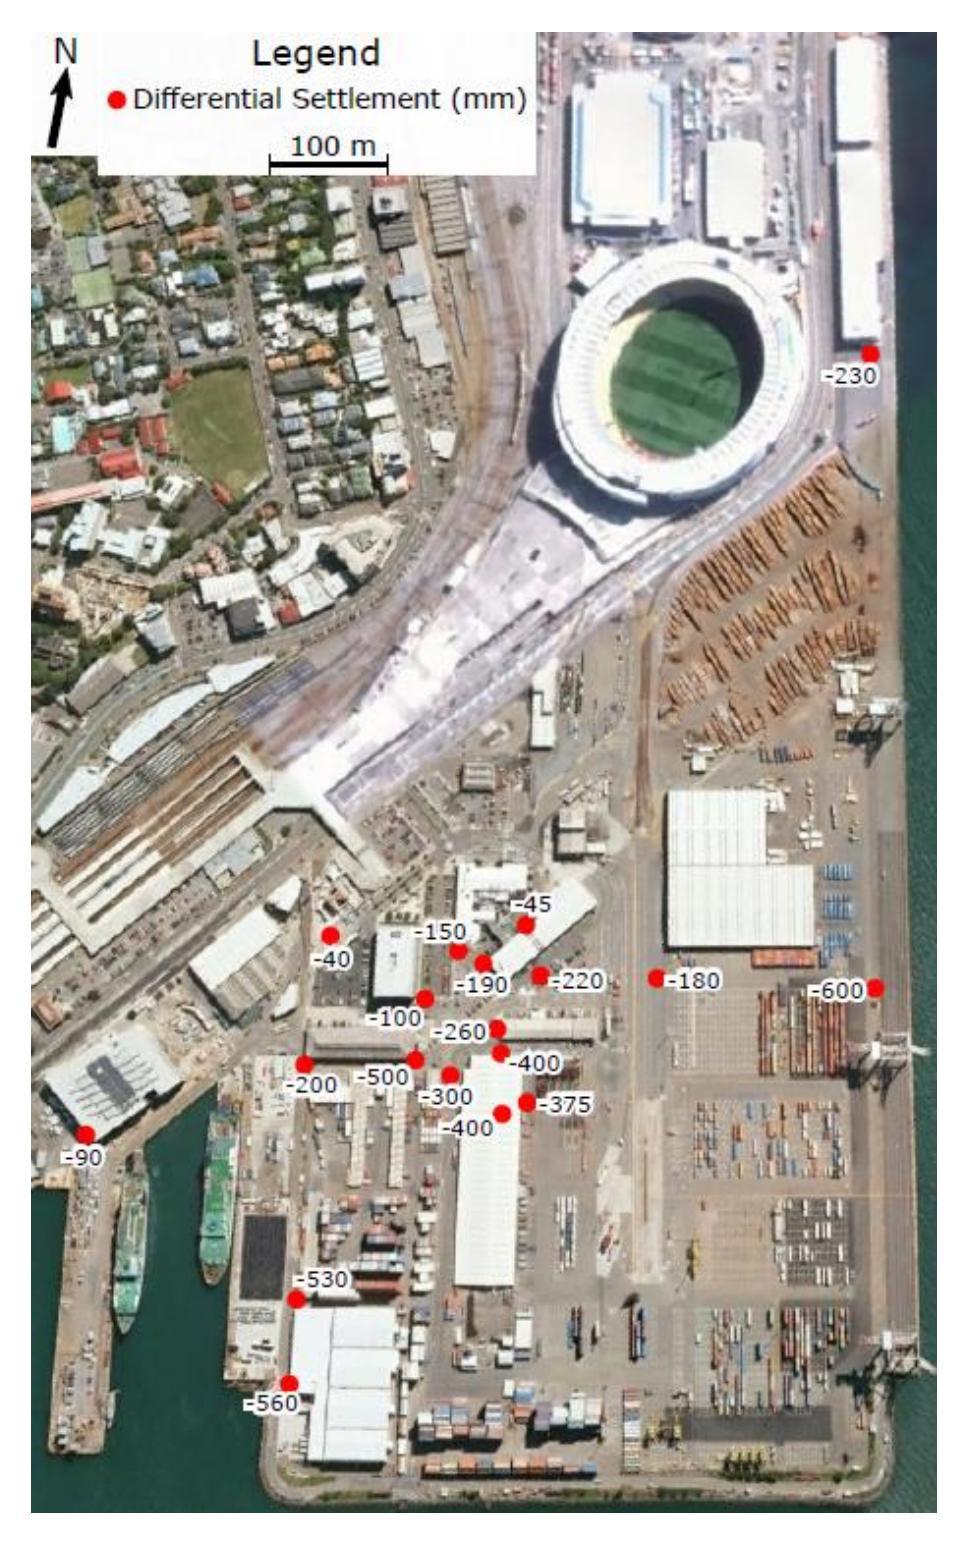
Differential hand-measured vertical settlement measurements are summarized in Figure 5.24. These measurements are of ground settlement relative to pile supported structures. Settlement of fill relative to buildings supported on a shallow foundation are excluded from this figure. The settlement of the fill south of the Old Seawall is generally in the range from 300 mm to 500 mm, whereas settlement of the order of 100 mm to 200 mm was observed in the hydraulic fill north of the seawall. The largest settlement was observed at the Thorndon Container Terminal just behind the wharf where a vertical offset of about 600 mm was observed. Approximately 180 meters inland of the Thorndon Wharf bulkhead, 180 mm of settlement were measured relative to what appeared to be the piles of the historic gantry crane at North Rail (see Figure 5.2).

Figure 5.24: Location and magnitude of differential settlement measurements obtained during inspections. All values are in mm, and represent settlement of the ground surface relative to a pile supported structure. (Base image from Google EarthTM)

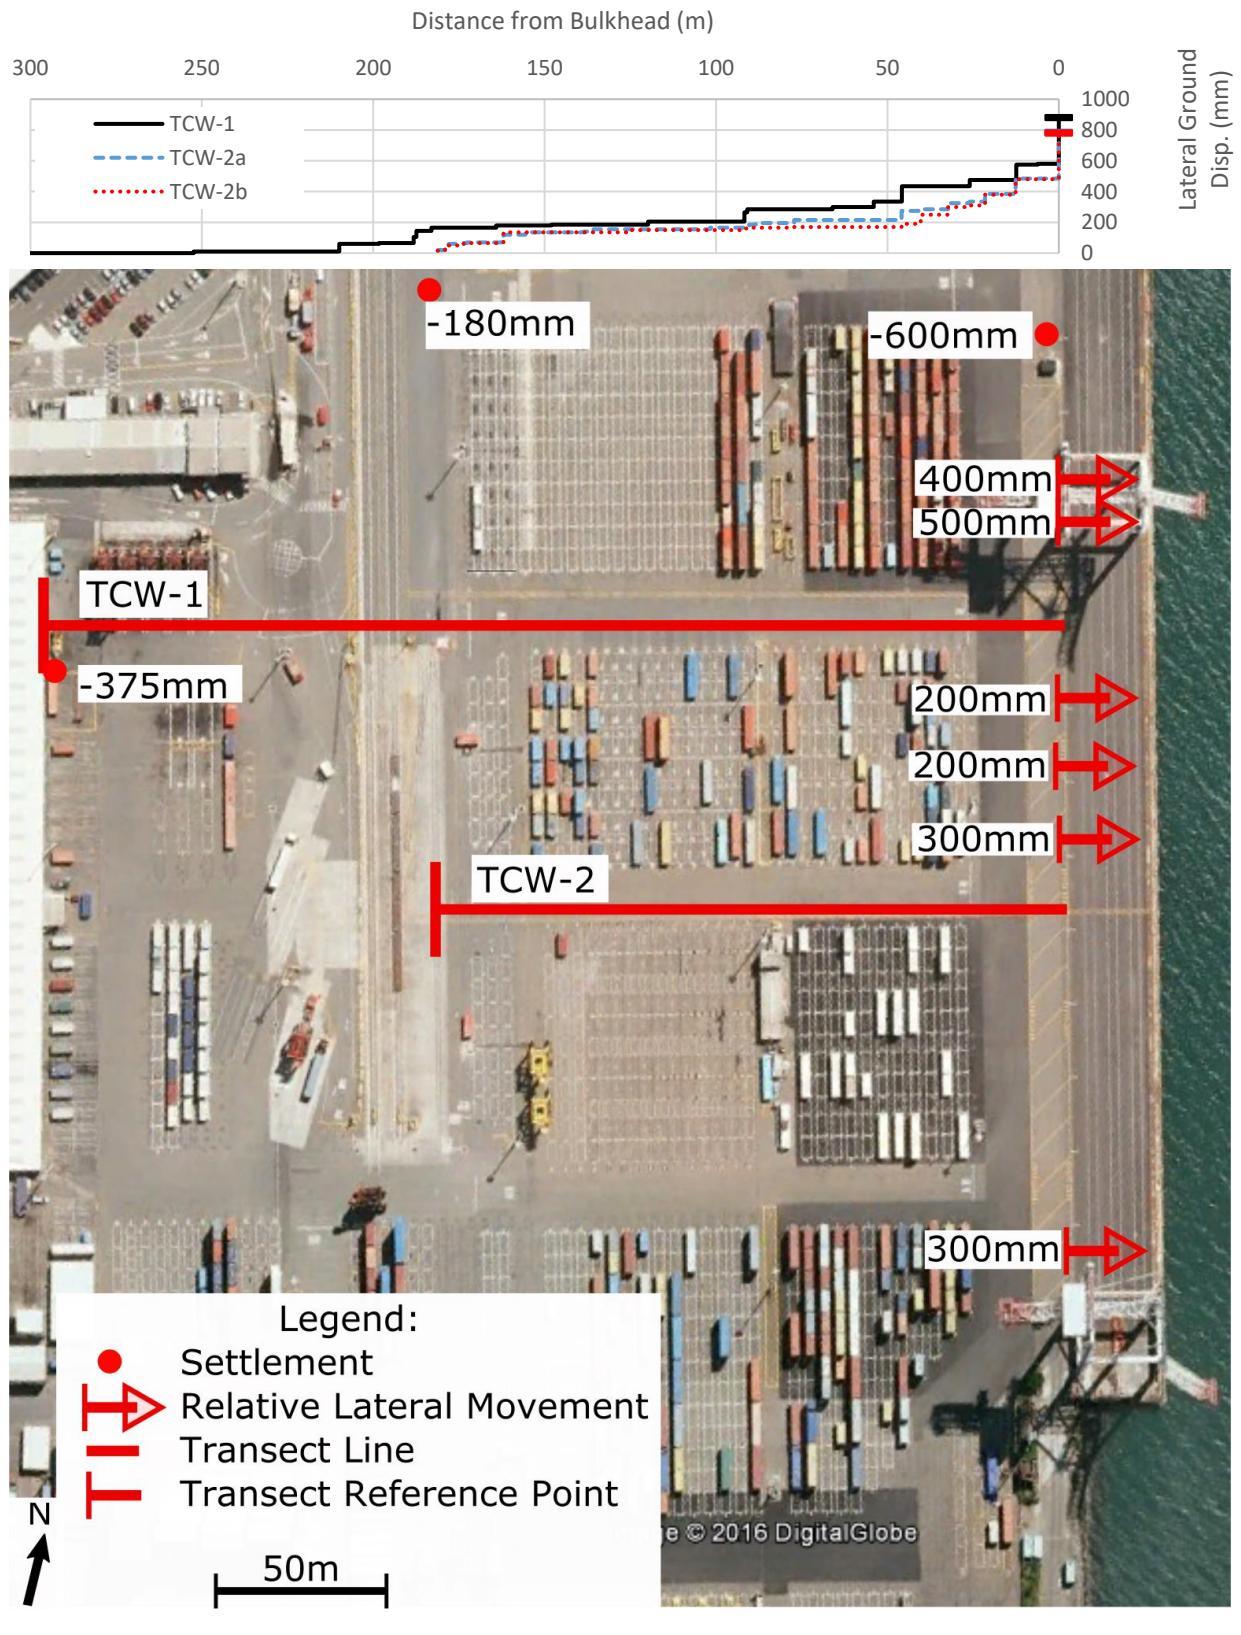
To quantify the magnitude and spatial distribution of lateral spreading at TCT, lateral spreading measurements were performed by ground surveying along two transects in the east-west direction, denoted as TCW-1 and TCW-2 in Figure 5.25. Along each transect, ground cracks were identified and their location (horizontal distance from a reference point) and width were recorded. By summing up the crack widths one can estimate the size of lateral ground displacements as a function of the distance inland from the wharf, as illustrated in the plot shown at the top of Figure 5.25. Note that along TCW-2 two independent transects were performed approximately 10 m apart (in the N-S direction) to check the accuracy in the estimates of ground displacements. Table 5.4 lists the width and horizontal distance to each crack from the reference point of each transect. The cumulative opening of the cracks measured across TCW-1 and TCW-2 are 960 and 785 mm, respectively, implying that the edge of the fill moved laterally towards the sea (Thorndon Wharf) about 0.8 m to 1.0 m.

Figure 5.25: Location of west-to-east transects for lateral spreading measurements towards Thorndon Wharf during inspections. Plots at the top show cumulative lateral ground displacement versus horizontal distance from the bulkhead. Transect measurements are in Table 5.4. (Base image from Google EarthTM)

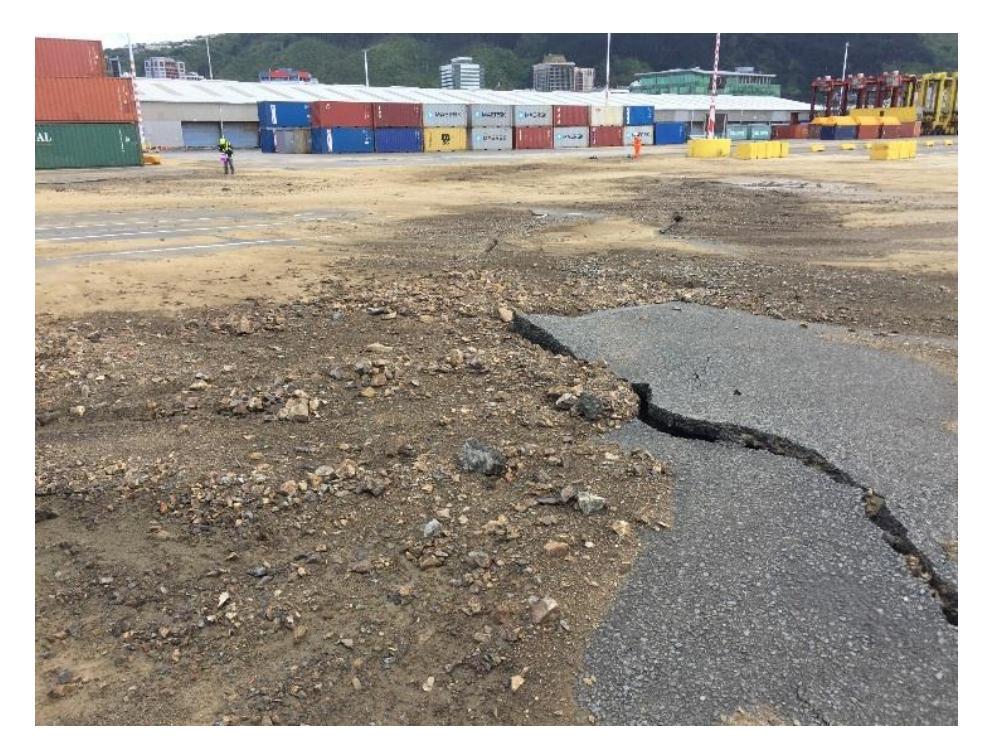
Figure 5.34: Widespread liquefaction of gravelly end-dumped quarry rock reclamation in container stacking area inland of Thorndon Wharf (S41.276608° E174.786309°, taken on 21NOV16)

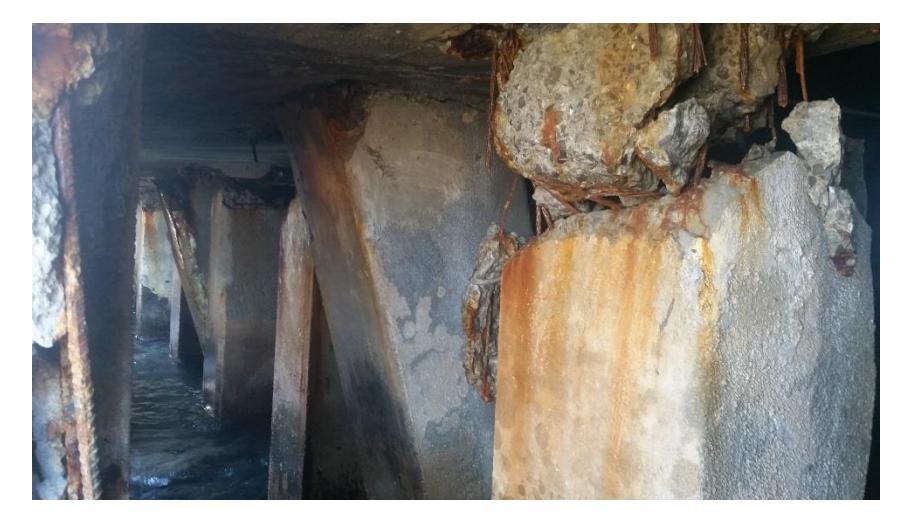
The QuakeCoRE-GEER team was informed that concrete piles had been sheared near the pile cap (from a boat survey by others; T+T (2016) private communication). From the south side of the port, the QuakeCoRE-GEER team did observe a vertical bulkhead pile sheared just below the pile cap (Figure 5.37a). During a site visit in May 2017, the team observed that the bulkhead piles (both plumb and battered) near the north end of the Thorndon Reclamation were damaged immediately below the deck (Figure 5.37b). Cardno performed an aerial survey of the port that captured vertical settlement and lateral movement, which is shown in Figure 5.38. The magnitude of lateral spreading displacement and settlement measured by Cardno are generally consistent with those measured by the QuakeCoRE-GEER team, which are provided in this report.

Figure 5.37: (a) Looking north towards the southern end of Thorndon Wharf. The vertical bulkhead pile is sheared just below the pile cap. QuakeCoRE-GEER team was informed that many piles in this area were sheared near the pile cap (from a boat survey by others; T+T (2016) private communication) (S41.280219° E174.789974°, taken at 1152 hrs on 22NOV16) (b) Looking north under the Thorndon Wharf bulkhead toward damaged plumb and battered bulkhead piles. (S41.277312° E174.789081°, taken at 13:38 hrs on 08MAY17)

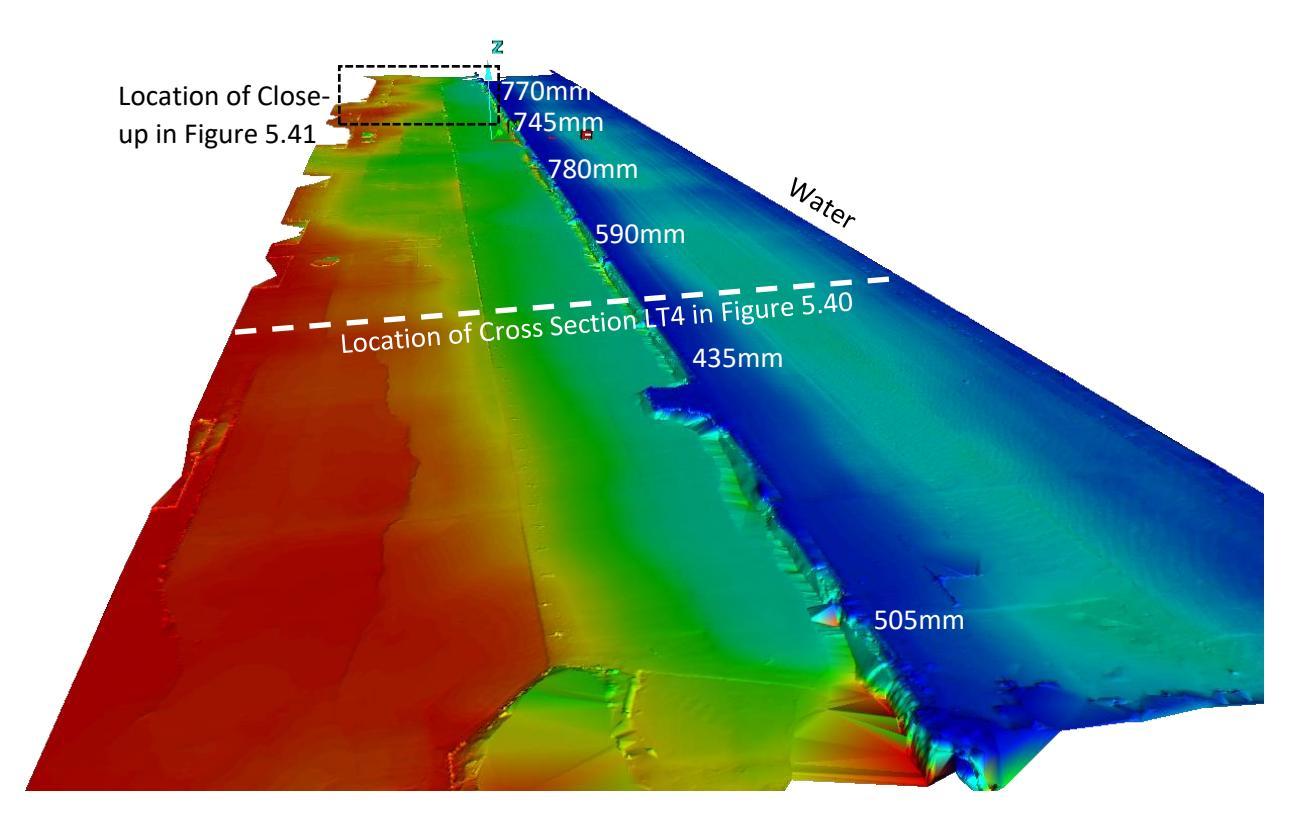
Figure 5.39 shows the LiDAR-derived DEM for the Thorndon Wharf and surrounding terrain. The wharf deck has substantial concavity as observed in the cross section in Figure 5.40. Differential settlements between the wharf deck and adjacent pavement ranged from 435 mm to 780 mm, generally increasing towards the North. Figure 5.41 provides a close up of ejecta and offsets at the northern end of this portion of the wharf.

Figure 5.39: Perspective view of the LiDAR DEM of the eastern section of the port looking northward including the Thorndon Wharf and surrounding area colored by elevation to highlight discontinuities from cracks. Elevation ranges from approximately 2.60 m (red) to 3.60 m (dark blue). Differential settlements between the Wharf and Port are identified.

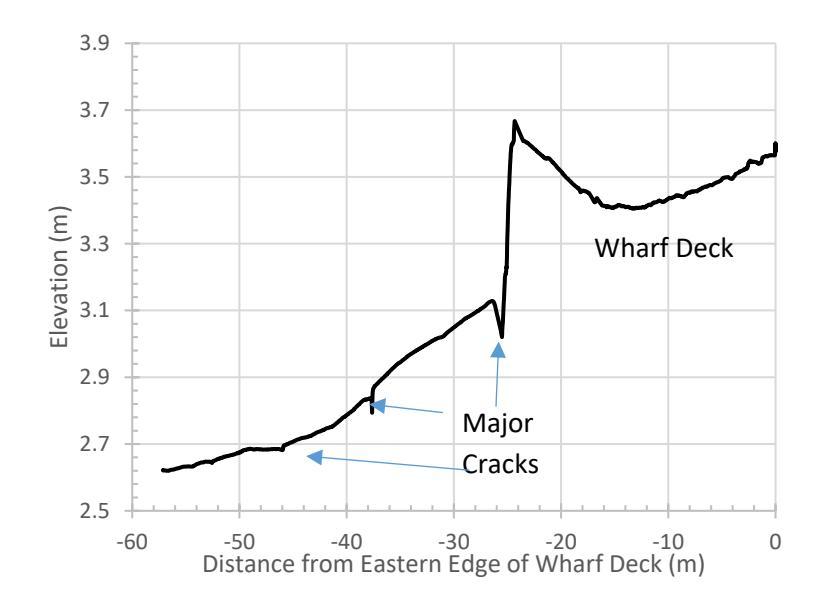
Figure 5.40: Elevation profile for cross section LT4 across Thorndon Wharf and inland fill. The location of the cross section is shown in Figure 5.39.

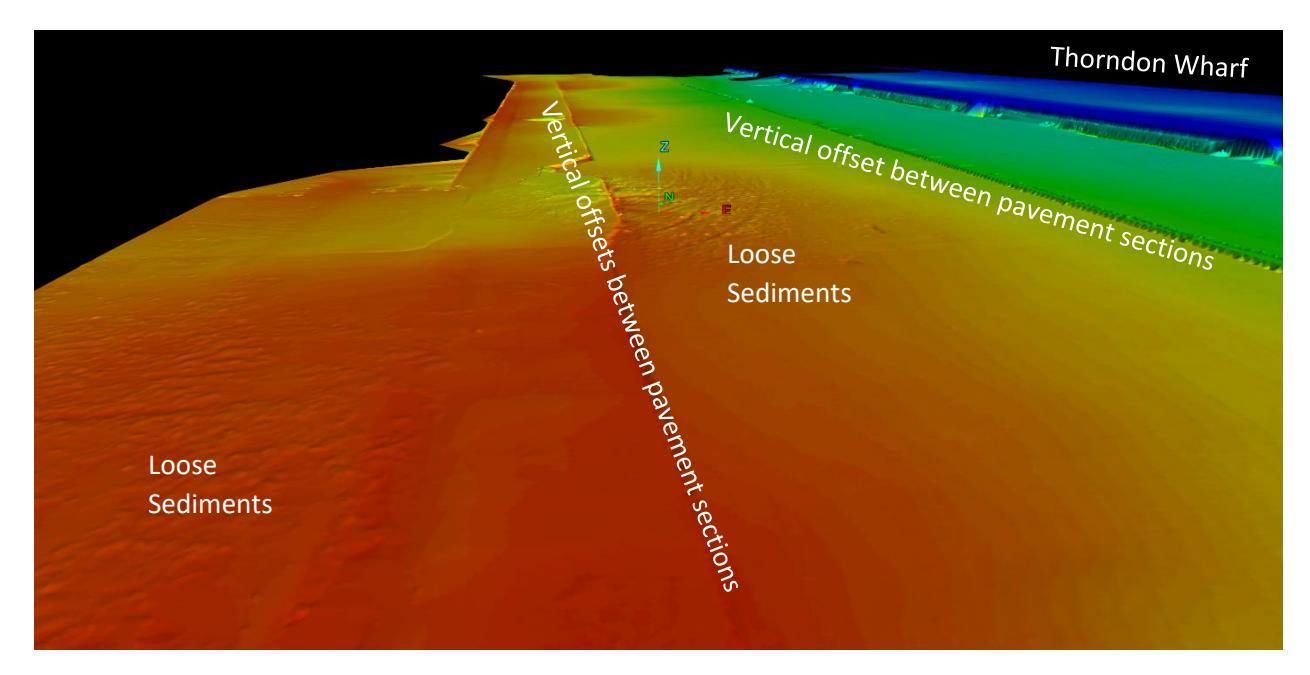
Figure 5.41: Close-up of the port surface highlighting cracking and separation between asphalt sections as well as loose sediments from ejecta (rougher sections of DEM) in the vicinity of Thorndon Wharf (see Figure 5.39).

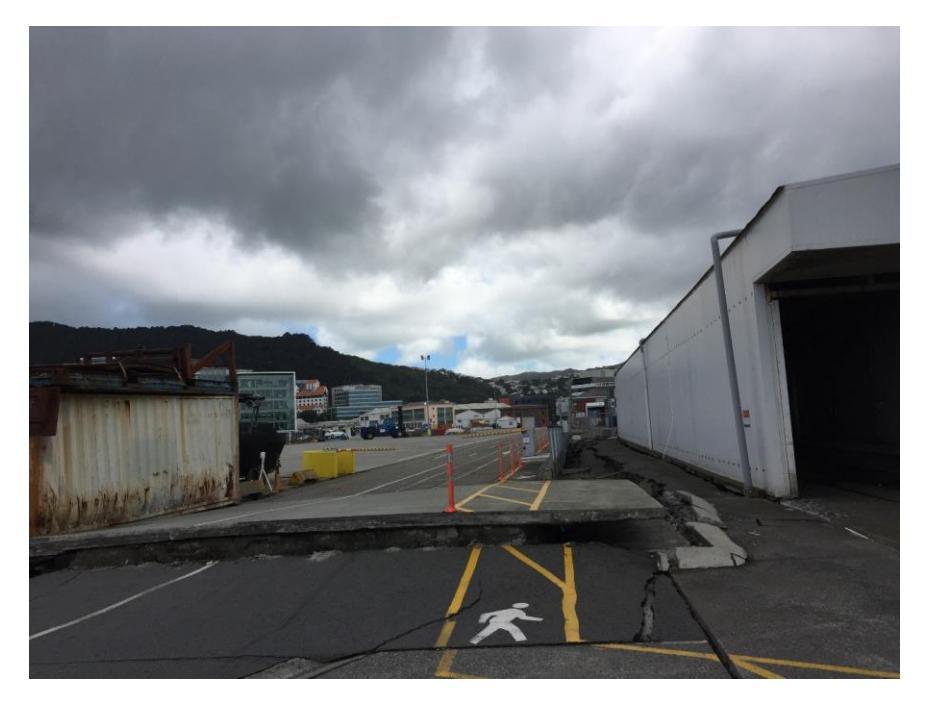
Figure 5.42: Looking North along bulkhead of King's Wharf. Approximately 560 mm of ground settlement relative to deck at southeast corner of King's Wharf. The west wall of the Cold Store shed is visible to the right of the photograph. (S41.281142° W174.784444°, taken at 1416 hrs on 21NOV16)

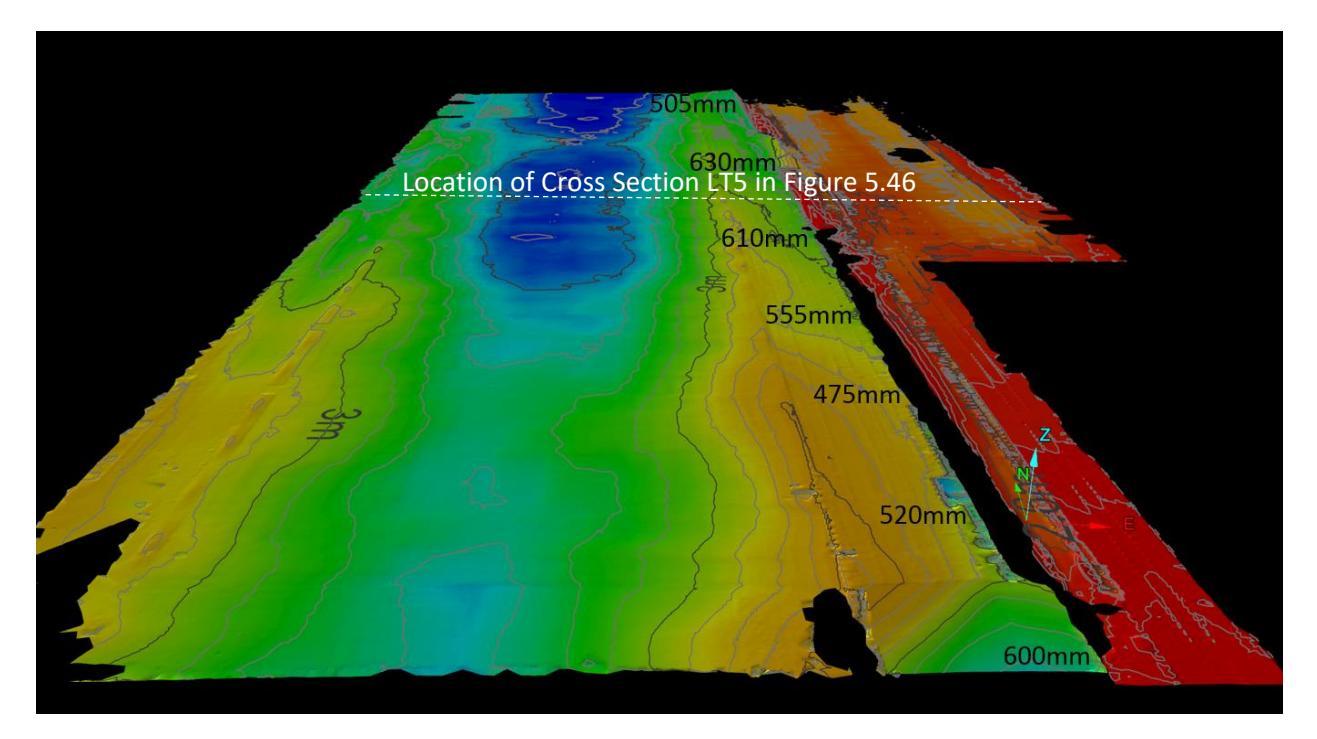
Figure 5.45: Perspective view of the LiDAR derived DEM (looking northward) of the pile supported King's Wharf showing measurements of differential settlement the adjacent ground. Elevation ranges from approximately 2.50 m (red) to 3.30 m (dark blue)

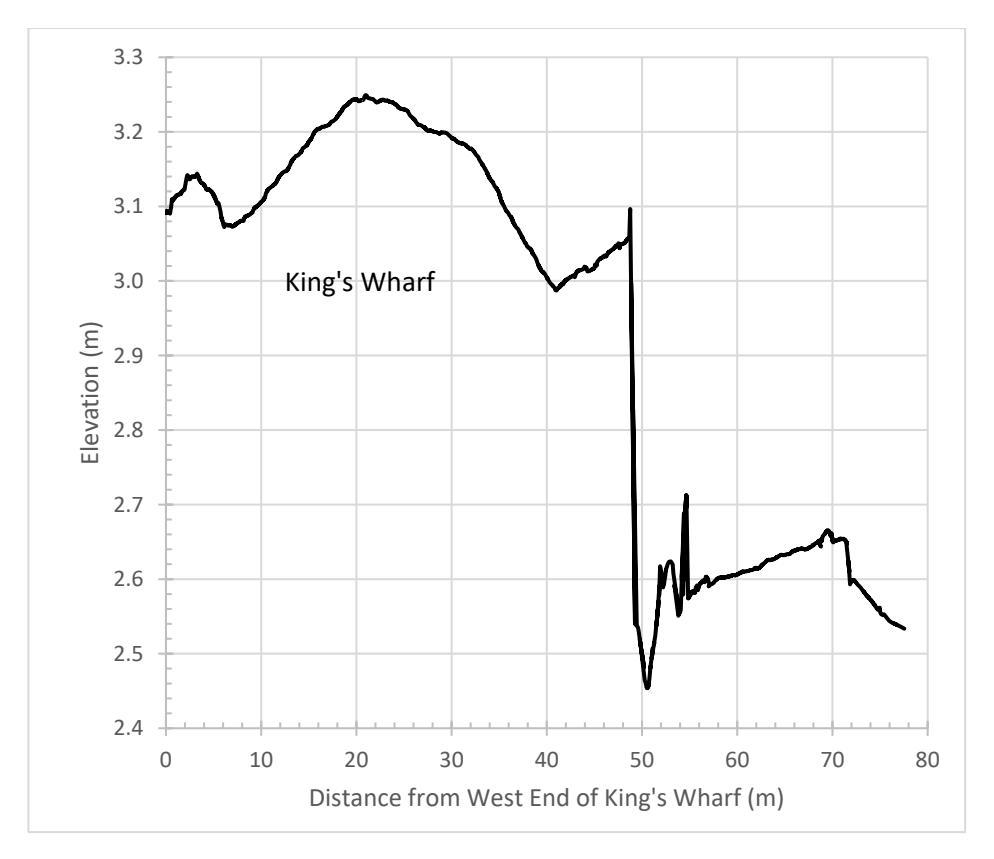
The inland timber piles split due to seaward (westward) lateral movement of the deck relative to the piles (Figure 5.43). Westward movement of the structure is visible in Figure 5.44, in which the southern row of piles is shown leaning to the west. Some vertical curvature of the wharf deck can be observed in the LiDAR DEM (Figure 5.45) and associated cross section in Figure 5.46. Differential settlement between the wharf and adjacent ground range from 475 mm to 630 mm as measured from the LiDAR-derived DEM. The wharf deck exhibits significant concavity (downward) as observed in the cross section plotted on Figure 5.46.

Figure 5.46: Cross section LT5 taken across King's Wharf and the adjacent ground based on LiDAR data shown in Figure 5.45.

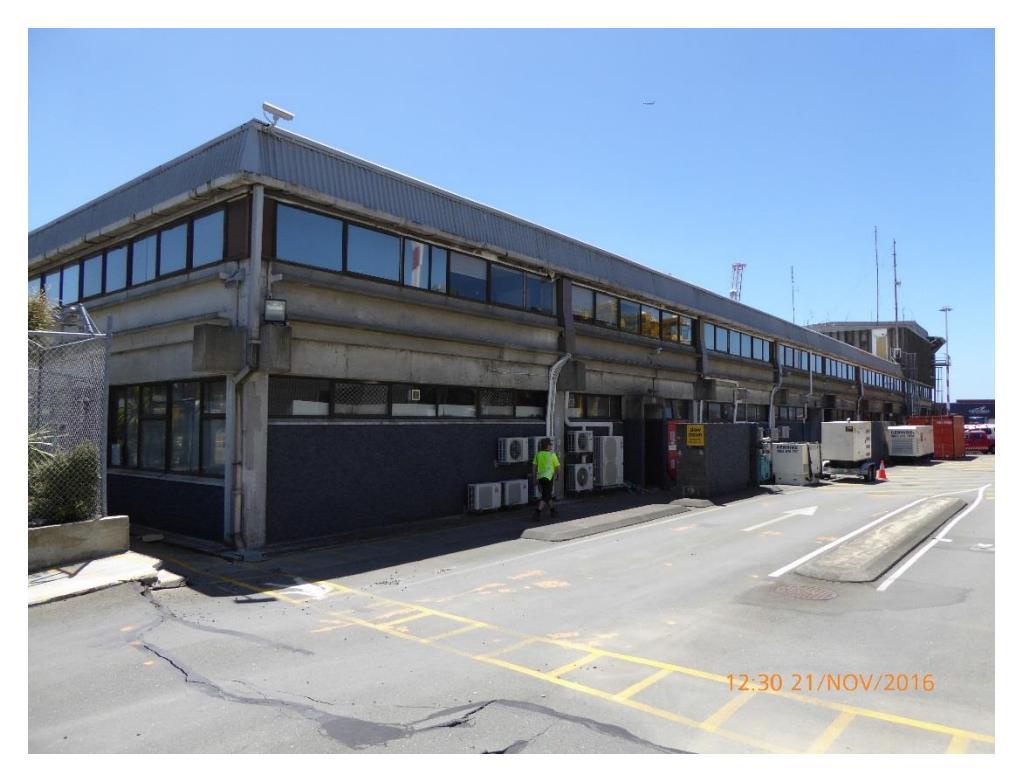
The CPH building (S41.27829° E174.78618°) is founded on reinforced concrete (RC) spread footings connected with RC grade beams (Figure 5.48). There were no apparent signs of structural distress, and the building was operational at the time of the reconnaissance in late November 2016. The building and surrounding fill settled relatively uniformly, however, ground a few meters to the west of the CPH building did not appear to settle significantly as it was elevated relative to the surrounding ground and the floor level of the CPH building. The elevated ground was likely supported by the old bulkhead piles of the demolished Pipitea Wharf (see Figure 5.2), which minimized liquefaction-induced settlement of the ground and pavement above it. The building and fill settled approximately 230 to 260 mm relative to the ground supported on piles, as shown in Figure 5.49. Settlement appeared to be more or less uniform across the building footprint, as there were no apparent signs of relative movement or tilt of the ground floor of the CPH building from the visual investigation. However, a preliminary analysis of the LiDAR scans indicate a slight tilt (i.e., of 0.105 degrees) in the large operations room on the east end of the building.

Figure 5.48: Uniform settlement of CPH building which is founded on shallow foundations that apparently displaced downward the same amount as the surrounding fill. This photo is looking northeast at the southwest corner of the building. (S41.278395° E174.785639°, taken at 1230 hrs on 21NOV16)

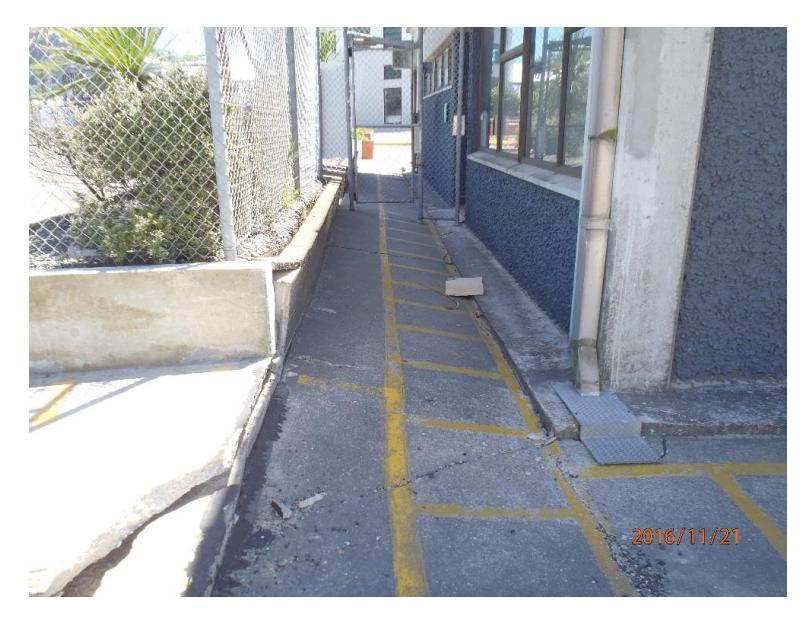
Figure 5.49: Uniform settlement (230-260 mm) of the building relative to ground supported on old bulkhead piles of Pipitea Wharf. Looking north along western wall of CPH building. The perimeter walkway slopes down towards the building at 11 degrees over 1.35 meters. (S41.278395° E174.785639°, taken at 1225 hrs on 22NOV16)

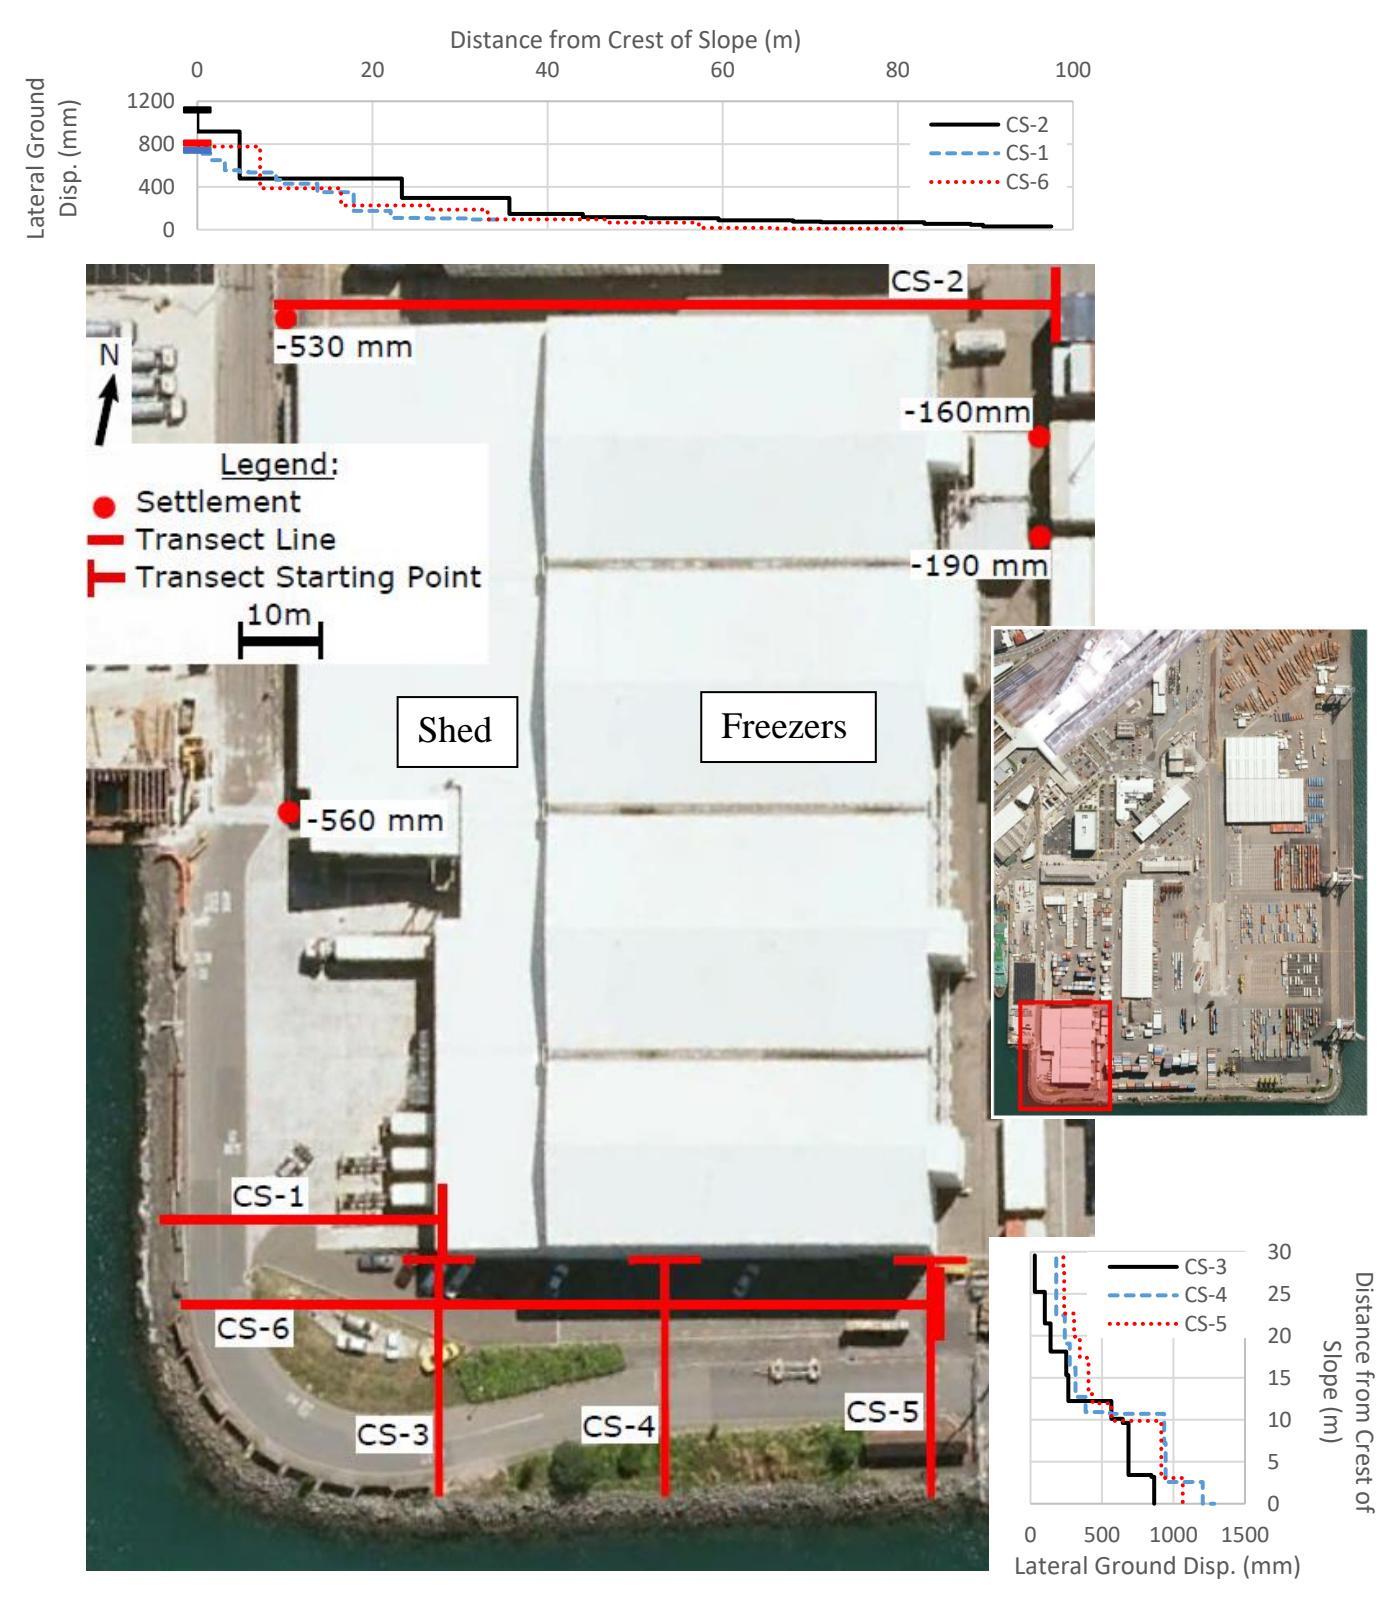
The differential ground movements across the building footprint induced structural deformation in the CS building. Seaward lateral ground movements on the order of 1 m occurred towards the western and southern slopes in the southwest corner the CentrePort reclaimed land. Figure 5.50 shows the location of six transects along which the location and width of lateral ground cracks in the pavement surrounding the CS building were recorded. Superimposed on this figure are plots of cumulative lateral ground displacement as a function of distance from the crest of the waterfront slopes for each transect. They show that, at the south side of the building, the fill moved towards the sea (southward) approximately 0.8 to 1.3 m. Similarly, the fill moved 0.8 to 1.1 m to the west direction. The top plot in Figure 5.50 indicates that the foundations of the building were subjected to a lateral stretch of approximately 200 mm. This stretch occurred over a column span of approximately 8.8 m, which corresponds to a lateral strain of about 2.3 percent. Tables 5.8 and 5.9 provide the measured crack widths and distances from the transect reference point for the east-to-west (CS-1, CS-2, and CS-6) and north-to-south (CS-3, CS-4, and CS-5) transects, respectively. Data for all six transects are plotted in Figure 5.51.

Figure 5.50: CS building lateral ground movement transects and vertical settlement measurement locations. Cumulative ground displacement versus distance from crest of slope are provided. Note that the crest of slope is further east at CS-2 than at CS-1 and CS-6, therefore, displacement plots do not perfectly align with satellite image for CS-2. Settlement measurements to the northeast are relative to the building which also settled.

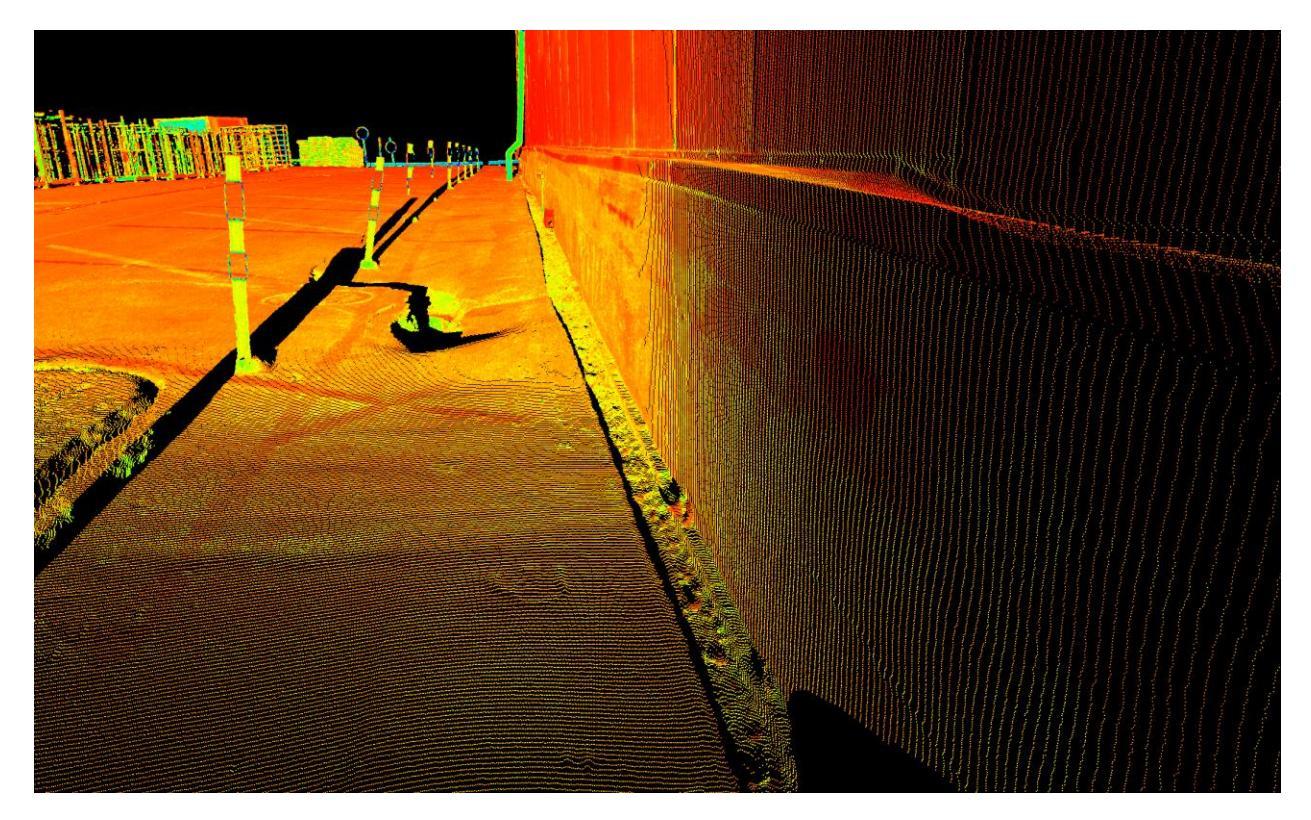
Significant separation between the CS building foundation and pavement slab were observed on the south side of the building (as well as settlement and spreading of the surrounding pavement). Figure 5.52 shows a LiDAR scan documenting this separation, which ranges from 30 mm (west) to 230 mm (east).

Figure 5.52: Perspective view of LiDAR scan looking westward showing the horizontal separation from building foundation and settlement of pavement observed on the south side of the CS building looking west (colored indicates intensity). The separation varies from 0.23 m wide to 0.03 m wide horizontally from the building's eastern side to its western side.

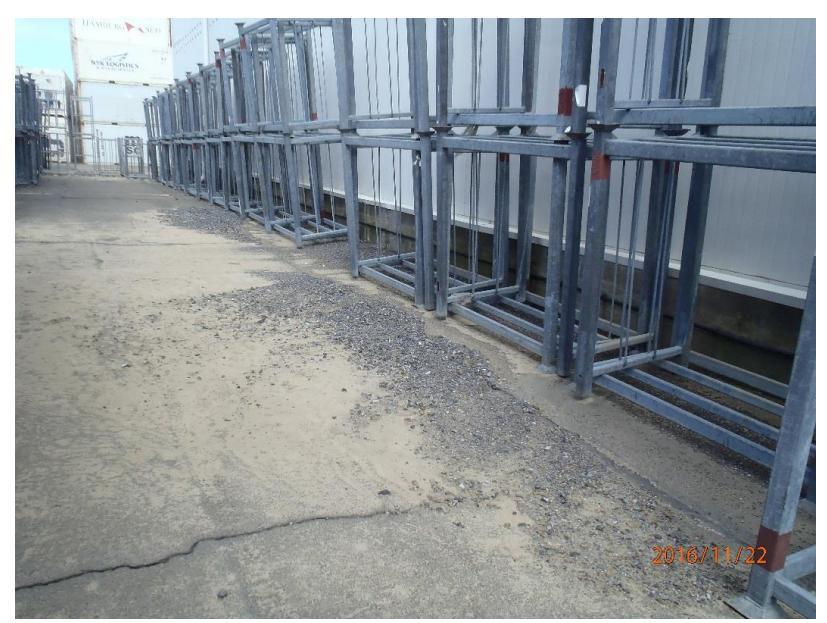
Gravelly liquefaction ejecta was observed around the building (Figure 5.53). Figure 5.54 shows lateral ground movements and partial collapse of the slope at the reclamation edge along the western wall of the Shed of the CS building (which is parallel and adjacent to King's Wharf), where the ground settled approximately 530 mm relative to the King's Wharf. This part of the building is closest to the crest of the slope and it underwent the largest lateral movement. Figure 5.55 shows lateral movements near the crest of the western slope, and Figures 5.56 and Figure 5.57 show lateral spreading towards the southern slope with a vertical offset of approximately 1.1 m. In these large cracks and vertical offsets, shallow soils beneath the pavement were visible and consist of gravelly quarry rock reclamation fill. Crack widths and locations along the bottom of the outside walls of the CS building were also measured. Figure 5.58 shows results of this survey, which are consistent with the previously described lateral spreading measurements and indicate a lateral stretch of the shallow foundation of the Shed of approximately 200 mm in the westward direction.

Figure 5.53: Gravelly liquefaction ejecta looking east along the northern wall of the CS building. (S41.280528° E174.784984°, taken at 1651 hrs on 22NOV16)
