5. LIQUEFACTION EFFECTS AND ASSOCIATED DAMAGE AT THE PORT OF WELLINGTON

5.1 Introduction

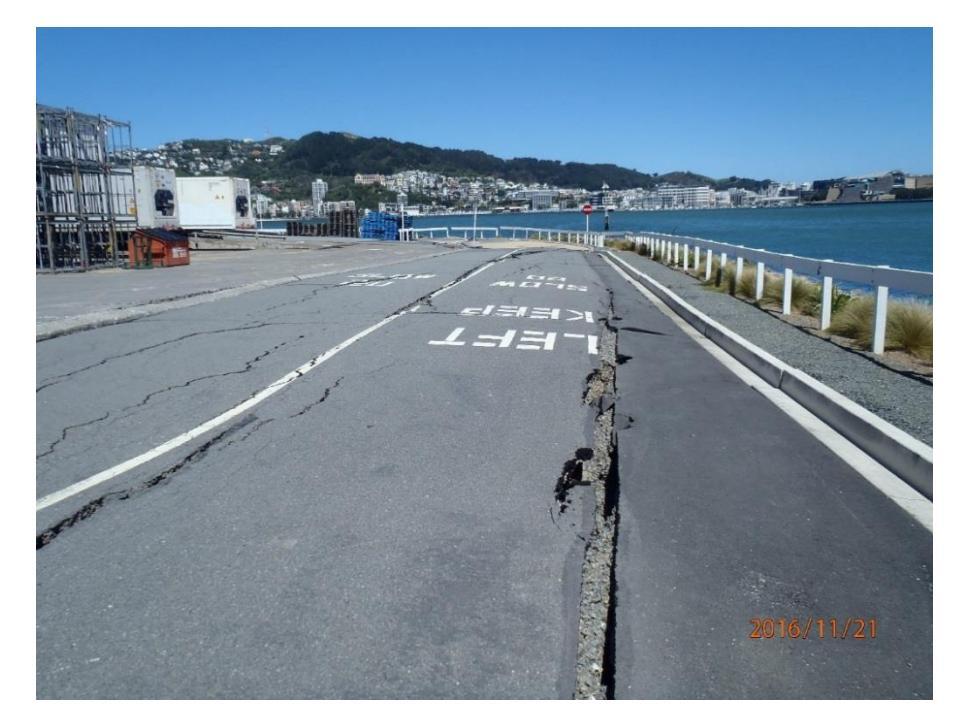
Figure 5.55: Ground cracks in area west of the CS building and along the southwestern slopes of CentrePort (looking south). The CS building can be partially seen on the upper left corner of the photograph. (S41.281478° E174.784430°, taken at 1418 hrs on 21NOV16)

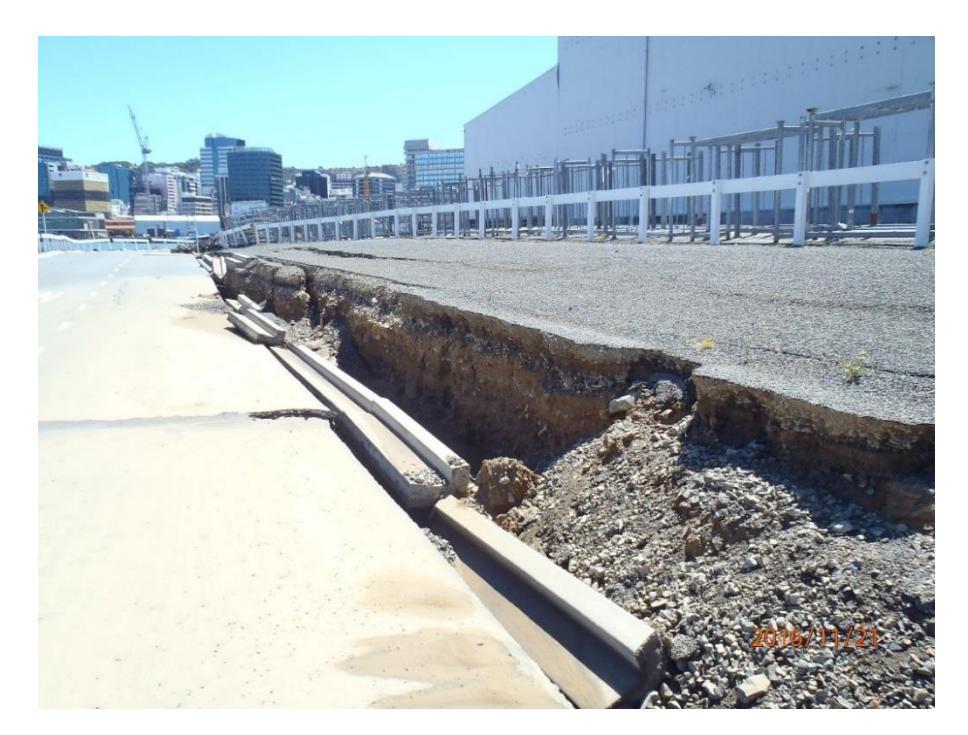
Figure 5.56: Approximately 1.1 m of vertical offset resulting from the southward lateral movement of the southern edge of CentrePort reclaimed land near its western side. Looking west near the southern wall of the CS building. (S41.281701° E174.785268°, taken at 1427 hrs on 21NOV16)

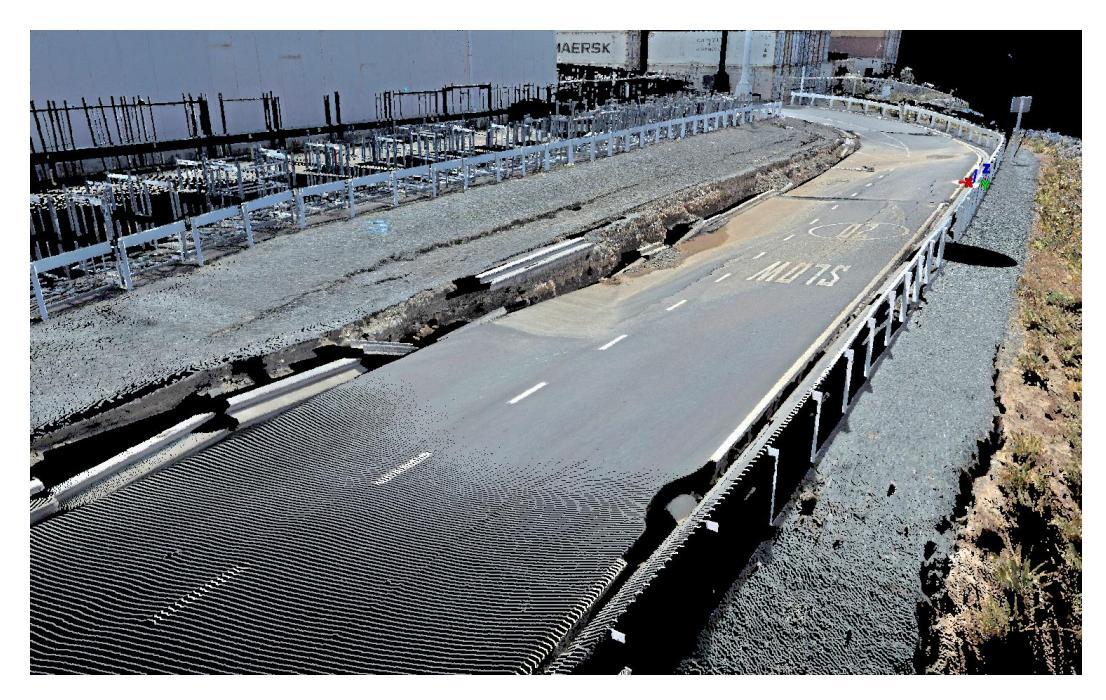
Figure 5.57: LiDAR scan of damage to the asphalt pavement and concrete curbs on the access road located south of the CS building. The vertical offset is approximately 1.1 m. This view is looking to the northeast.

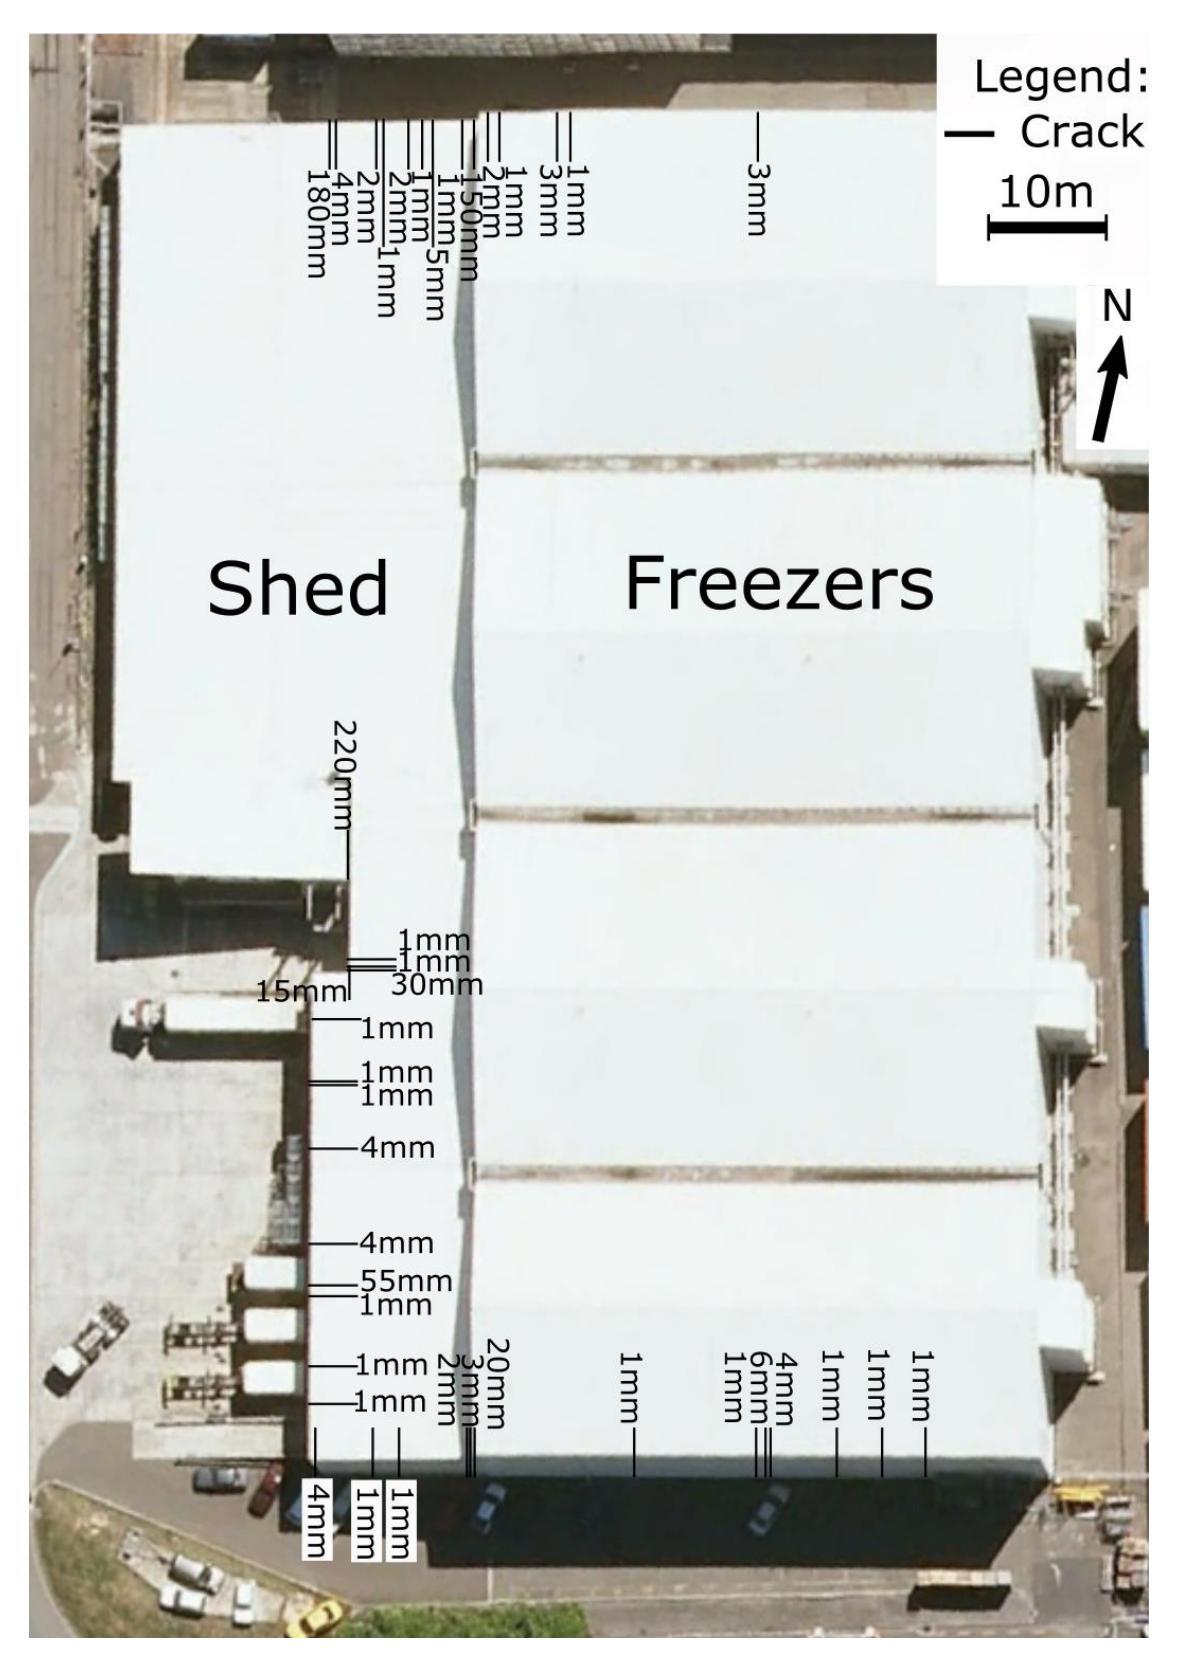
Figure 5.58: Location and width of lateral ground movement-induced cracks in the RC concrete walls at the base of the exterior building walls of the CS building. Crack openings are parallel to each wall.

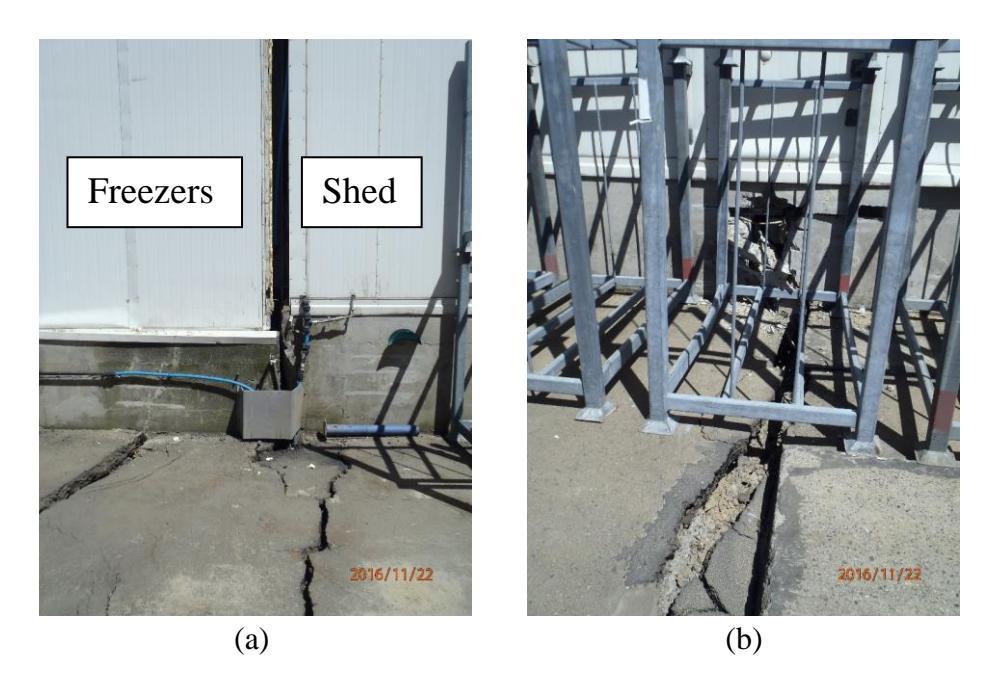
Figure 5.60: Cracks along the exterior north wall of CS building: (a) 150 mm of separation between Shed and Freezers (i.e., westward/seaward movement of the Shed relative to the Freezers), (S41.280584° E174.784705°, taken at 1445 hrs on 22NOV16), and (b) 180 mm crack in the shed from westward lateral spreading (also shown in Figure 5.59b). (S41.280607° E174.784533°, taken at 1444 hrs on 22NOV16)

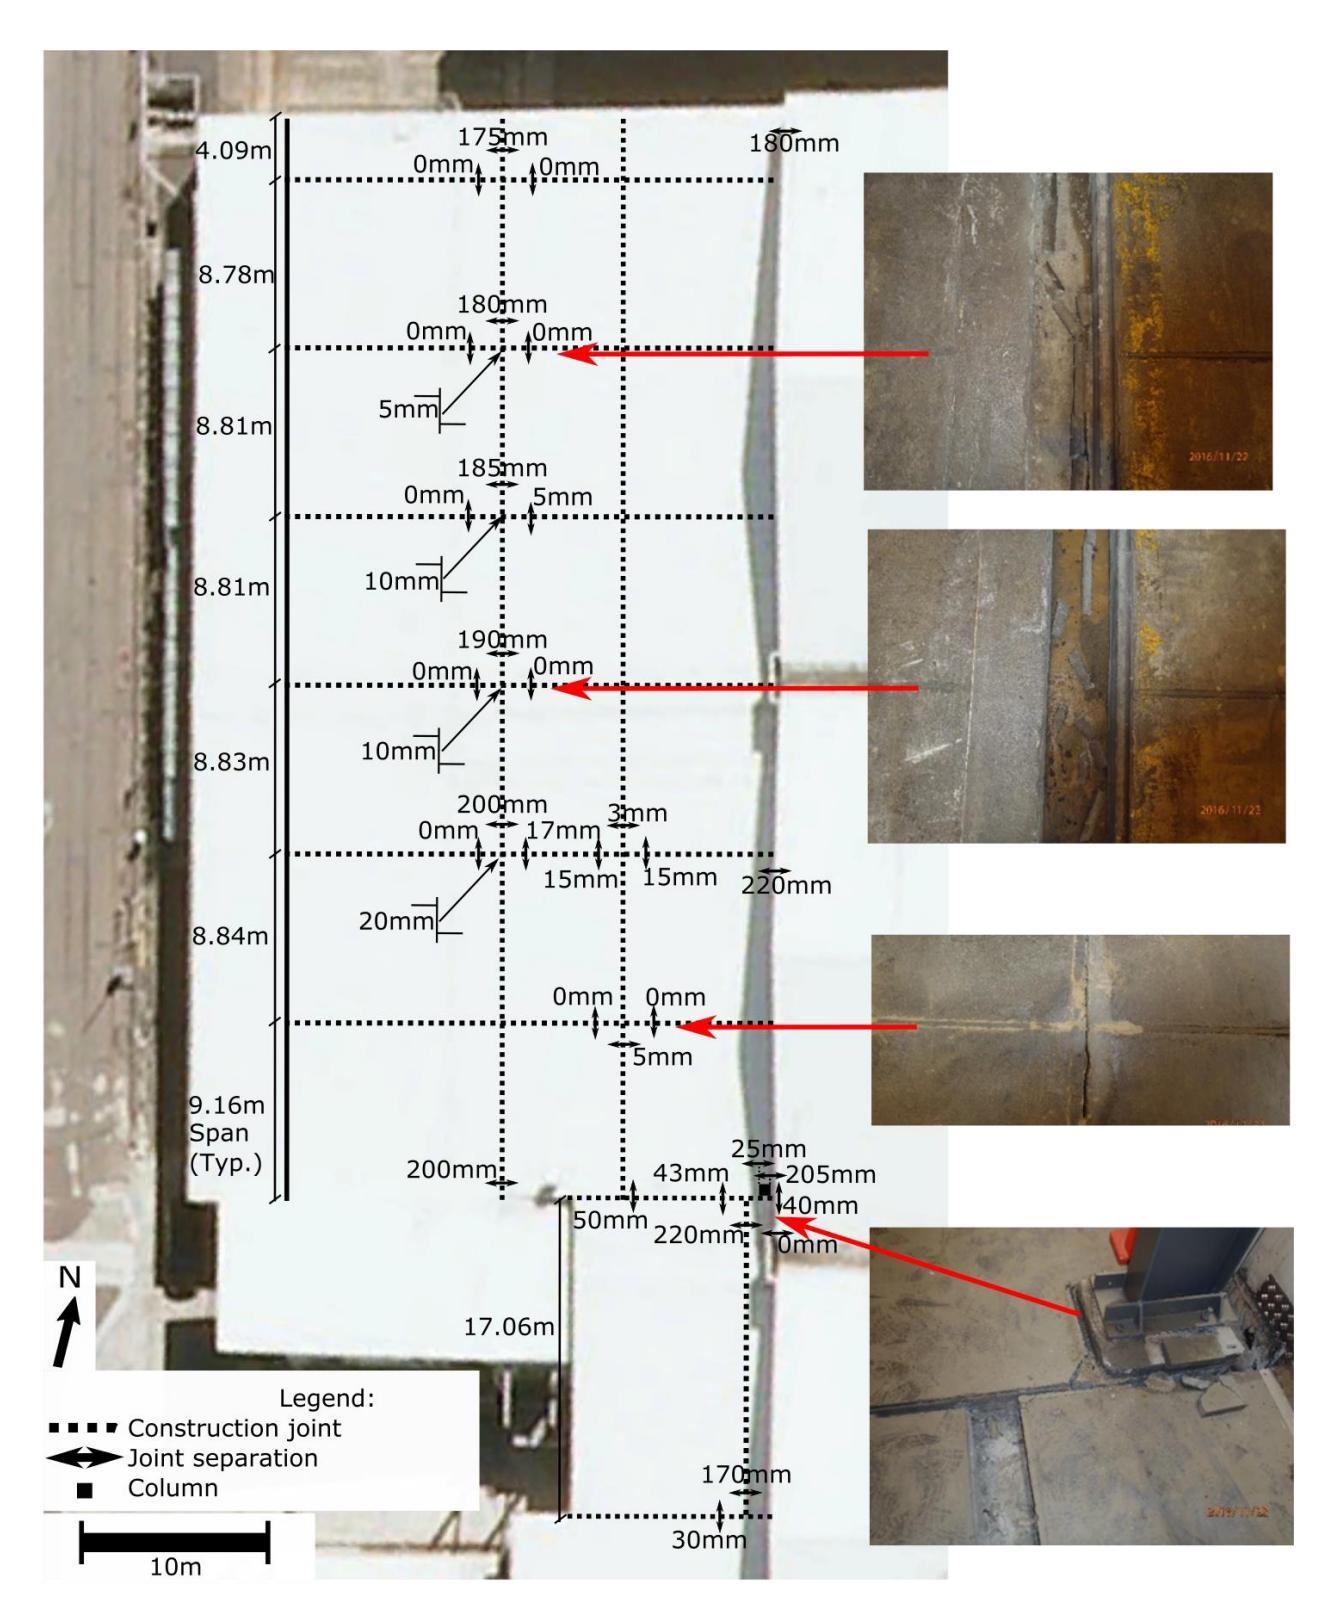
Figure 5.61: Northern part of Shed floor slab contraction joint separation measurements. Photographs along right side of figure are of contraction joints at which measurements were taken and are aligned vertically with each depicted joint. (Taken 22NOV16)

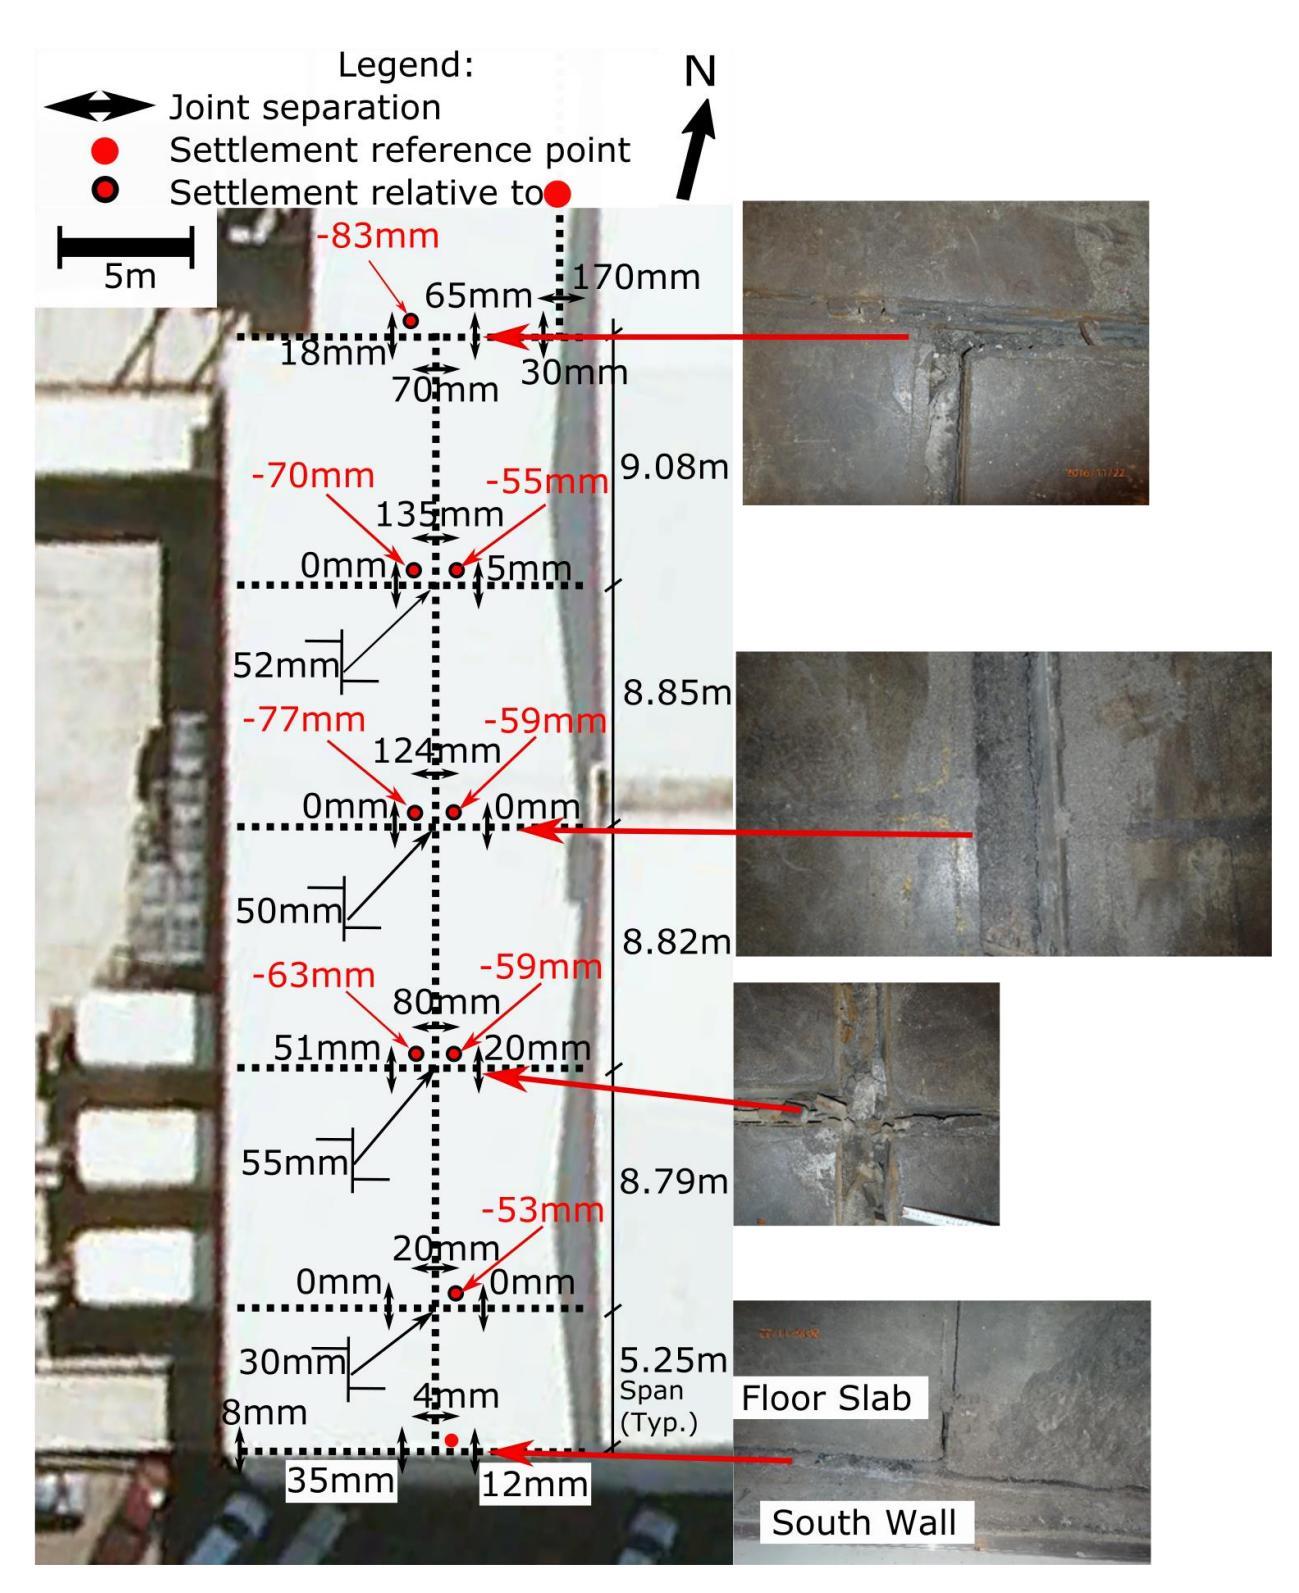
Figure 5.62: Southern part of Shed floor slab contraction joint separation measurements. Photographs along right side of figure are of contraction joints at which measurements were taken and are aligned vertically with each depicted joint. (Taken 22NOV16)

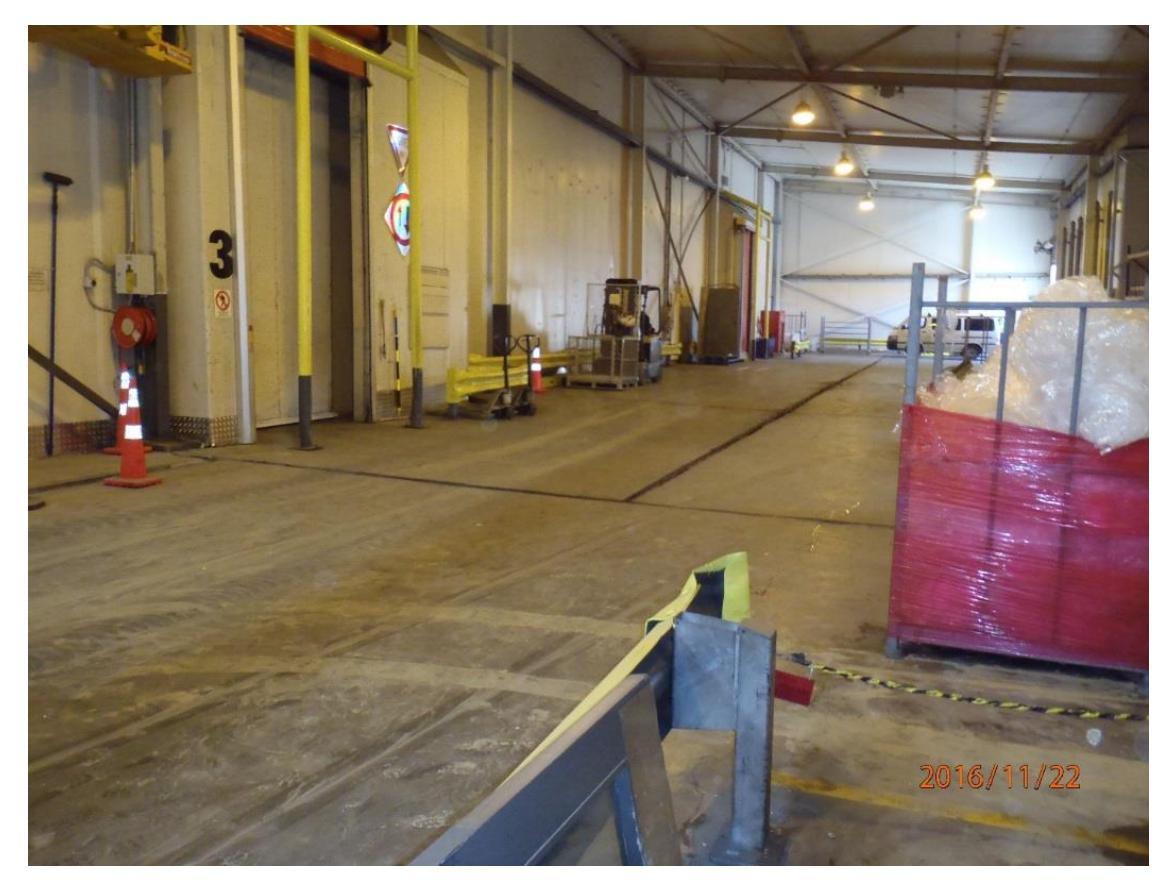
Figure 5.63: Contraction joint separation of ground floor slab inside the Shed of CS building looking south. As shown in photo, joint separations occurred in two orthogonal directions. (S41.281255° E174.784797°, taken at 1520 hrs on 22NOV16)

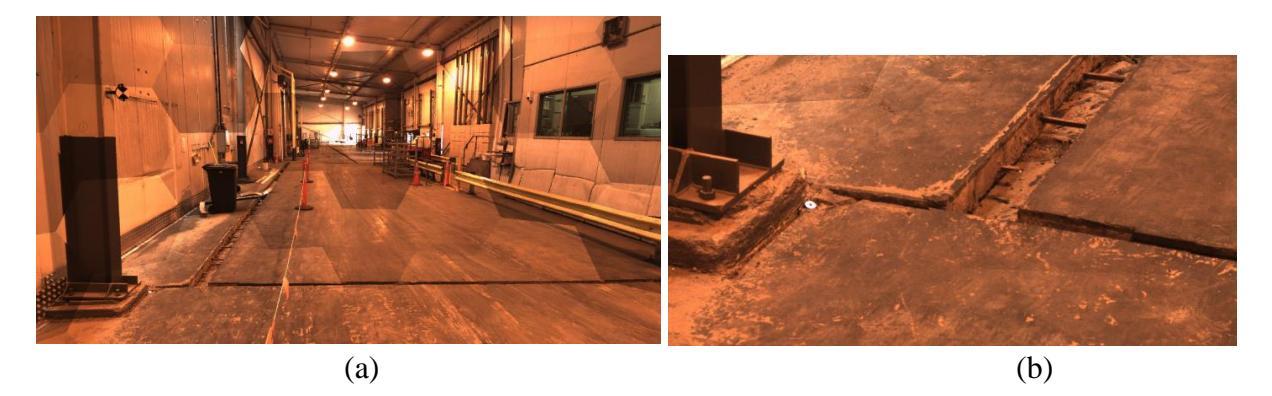
Figure 5.64: Example panoramic imagery co-acquired with the laser scans: (a) overview, and (b) close-up of floor separation in the CS building. The larger crack measures 230 mm in width and the smaller crack measures 75 mm in width.

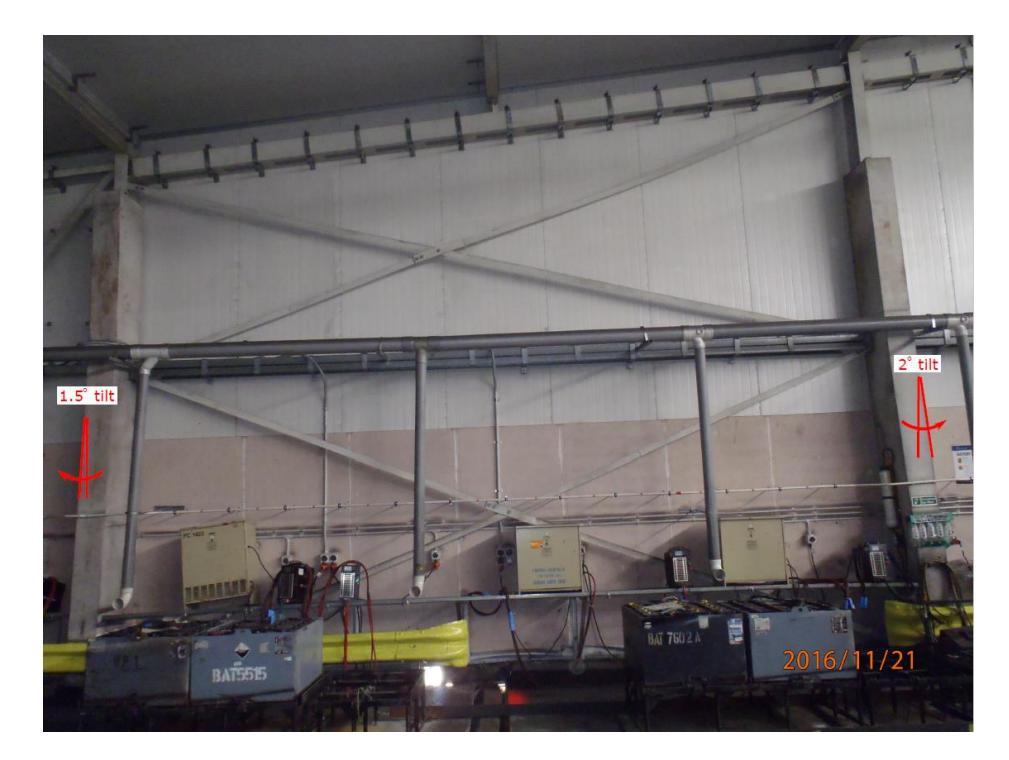
Figure 5.65: Internal north wall of Shed of CS building showing 1.5° clockwise tilt of the left column (2^{nd} column from the west along north wall), and 2° counterclockwise tilt of the right column (3^{rd} column from the west along north wall). This deformation was caused by a 180 mm opening in the RC base wall, which is visible in the bottom middle of the photograph where light is entering building. This column span is 8.789 m from centerline of column to centerline at a height of 1.5 m above the floor slab. (S41.280626° W174.784450°, taken at 1452 hrs on 21NOV16)

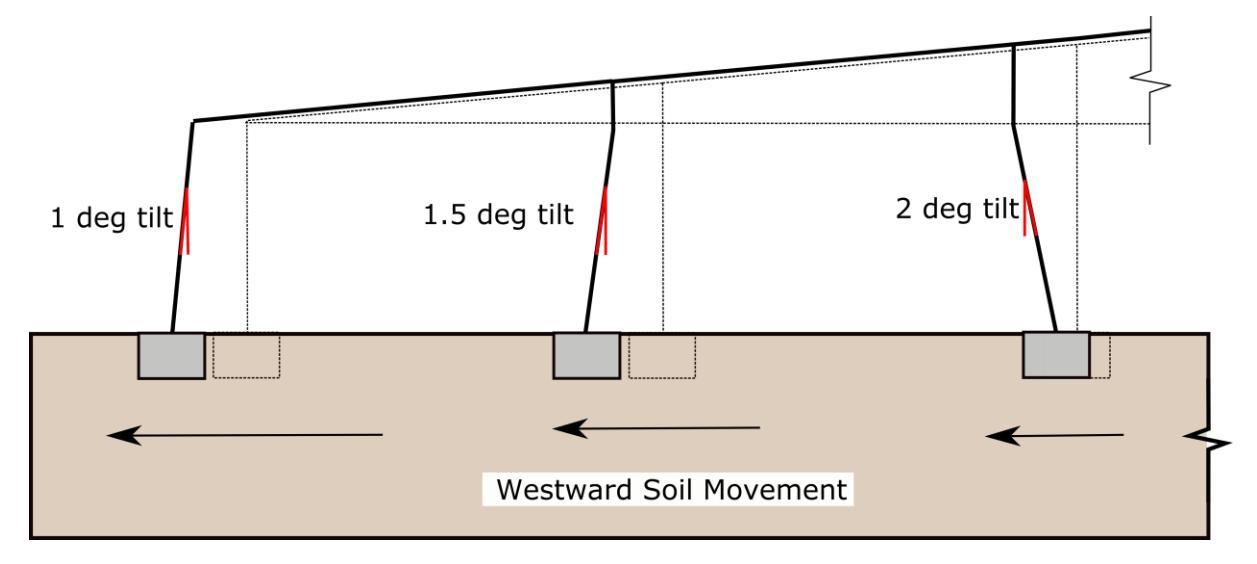
Figure 5.66: Schematic of deformation pattern of steel frame along the north wall of CS building (3 west-most columns of the Shed; looking north from interior).

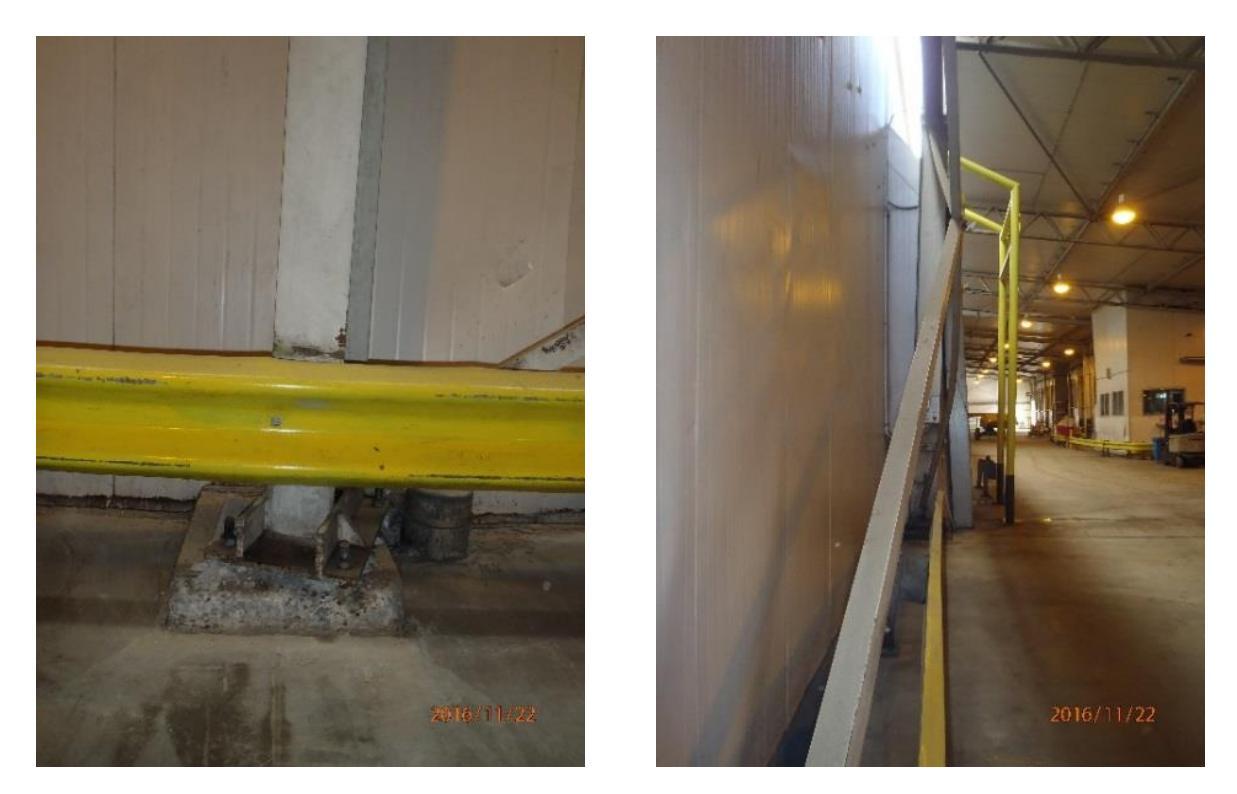
Figure 5.67: Internal east wall in northern part of the Shed, which shows column-pedestal connection failure due to rotation of the base of the column and buckling of concentric bracing. (Approx. at S41.280939° E174.784778°, taken at 1615 hrs on 22NOV16)

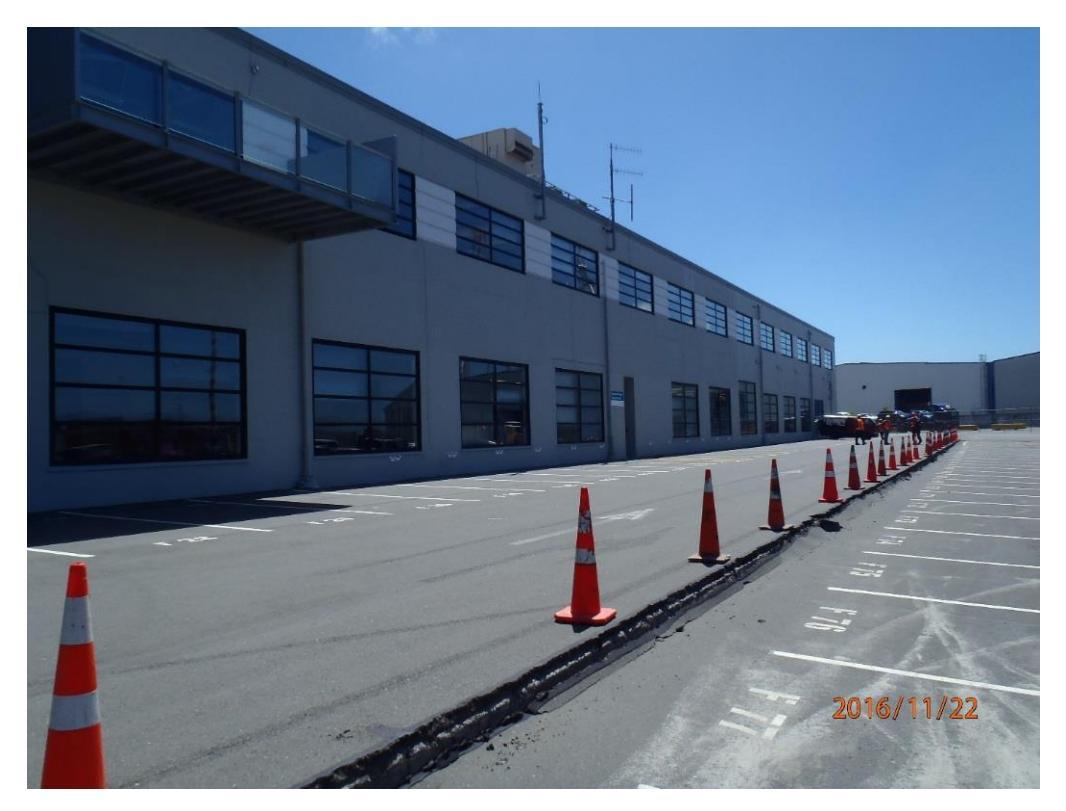
Figure 5.68: Southeast side of Building S39 and a buried segment of the Fryatt Quay Wharf deck parallel to the building. Fill to the south of the buried mass concrete seawall/wharf settled 220 mm relative to the pile-supported building and wharf deck. (S41.277984°, E174.785776°, taken at 1230 hrs on 22NOV16)

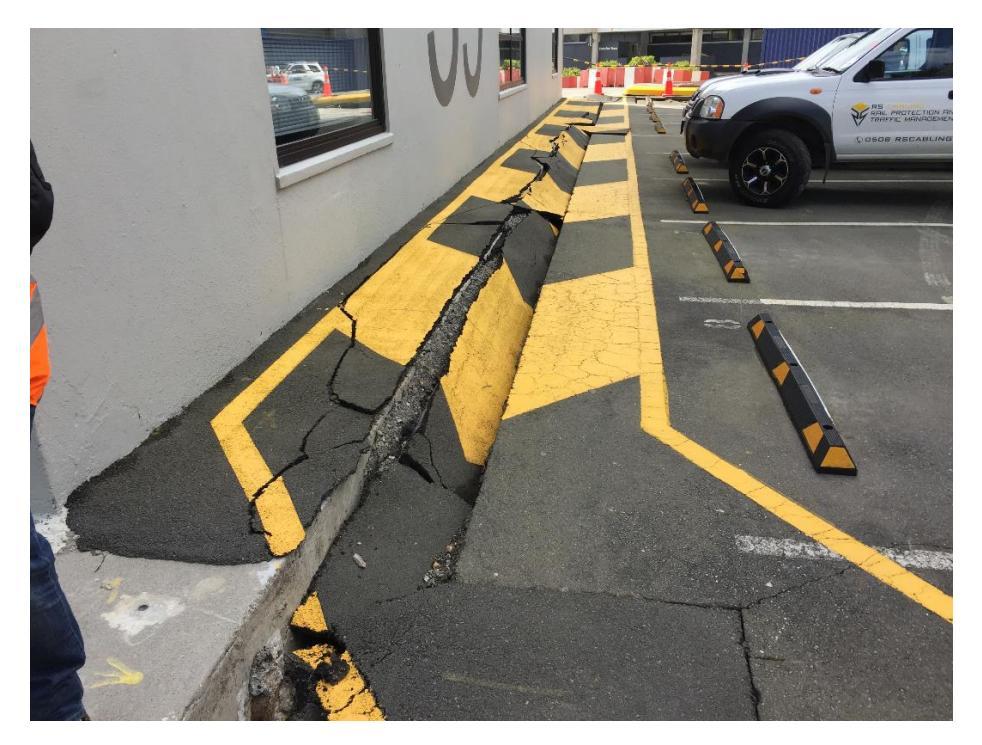
Figure 5.69: Looking southeast along southwest wall of S39. Fill settled approximately 190 mm relative to pile-supported building at the northwest corner of the building (shown on lower left corner of photo), and magnitude of settlement decreased south-eastward along this wall. (S41.277994°, E174.785467°, taken on 17NOV16)

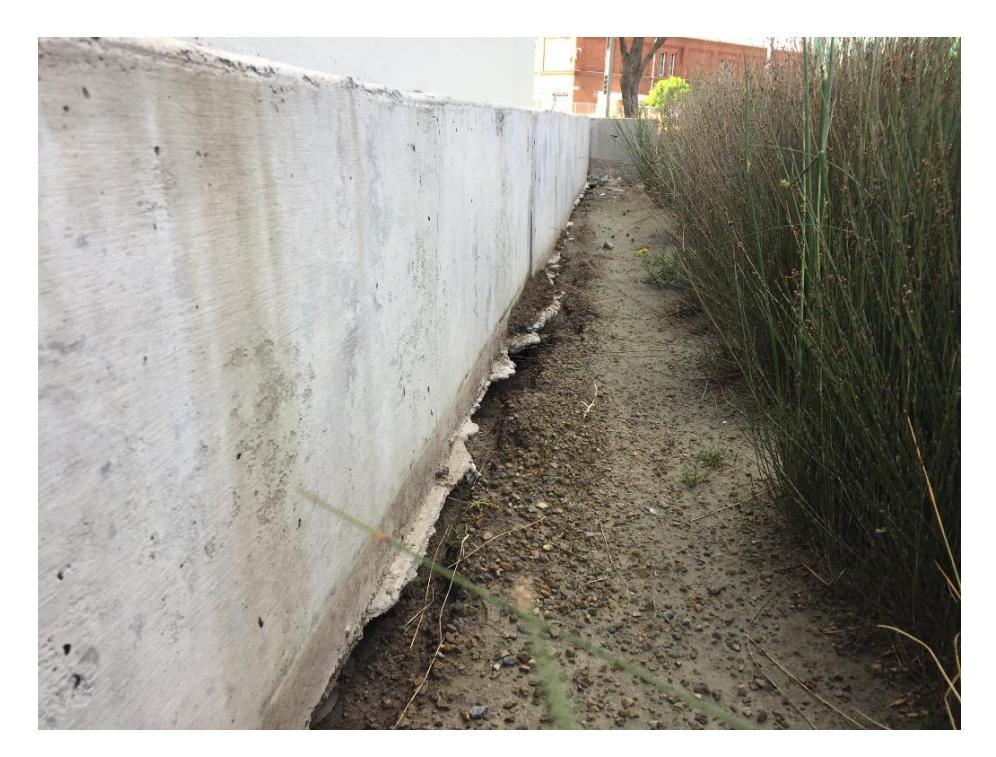
Figure 5.70: Looking southwest along northwest wall of S39. Fill settled 50-100 mm relative to pile-supported building. (S41.277882°, E174.785371°, taken on 17NOV16)

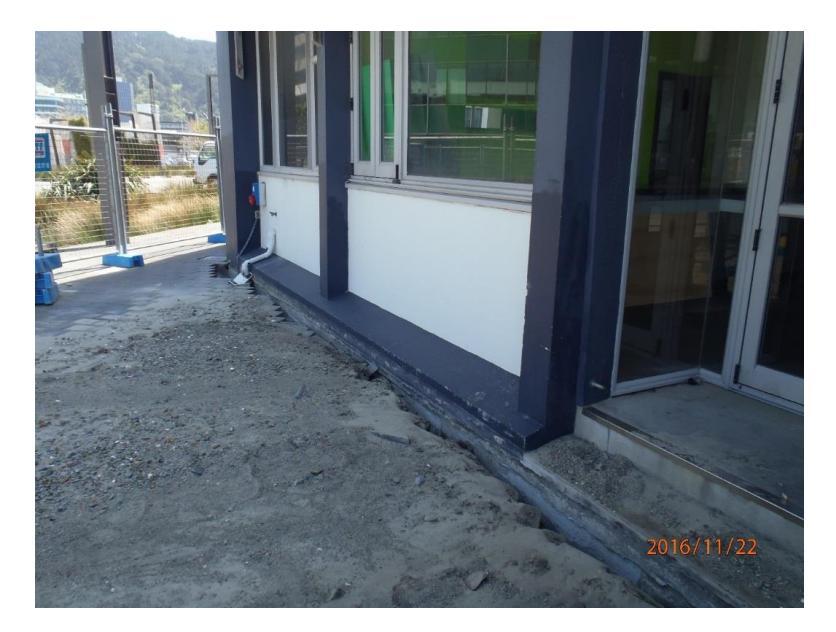
Figure 5.71: Southwest wall of TC building with liquefaction ejecta and 150 mm of ground settlement relative to building. (S41.277858°, E174.785081°, taken at 1246 hrs on 22NOV16)

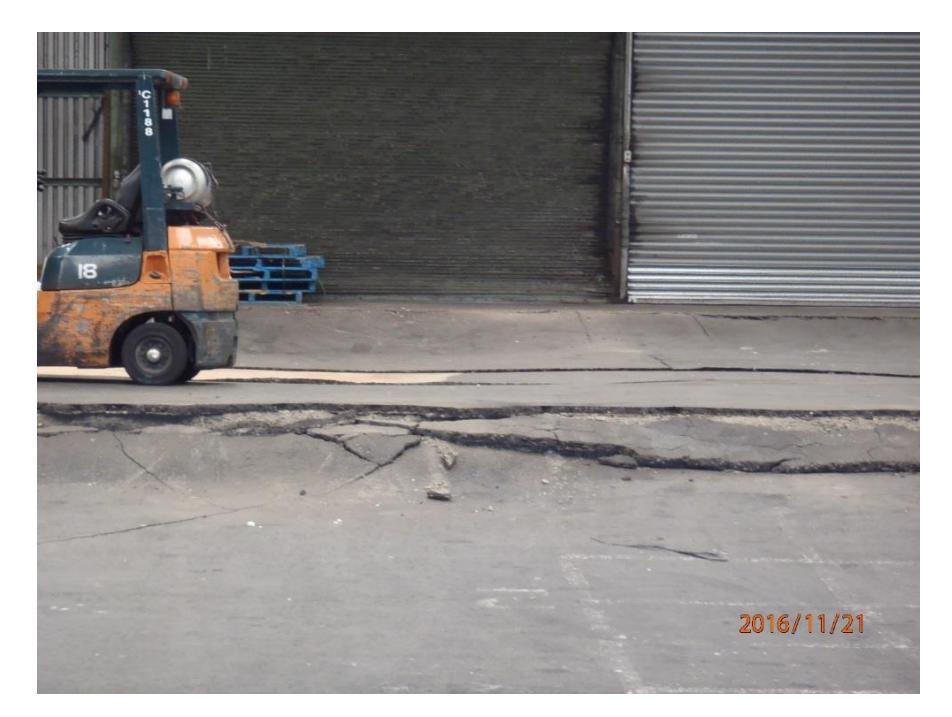
Figure 5.72: Looking west across inside of the S37 building. Approximately 400-550 mm of differential settlement between the ground and the buried precast concrete seawall that runs south-to-north through the center of the building. (S41.279065°, E174.785787°, taken at 1220 hrs on 21NOV16)

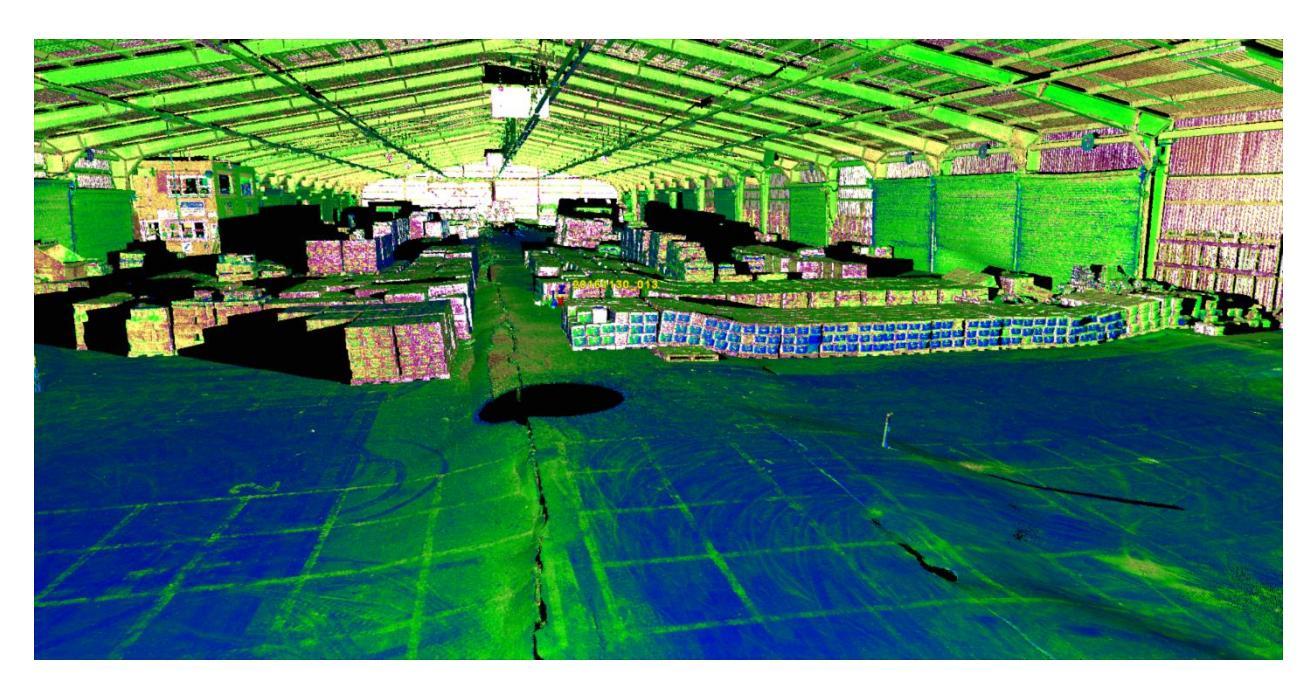
Figure 5.75: LiDAR scan obtained inside Building S37 showing cracking and settlement of the pavement around the buried precast concrete seawall (up to 550 mm of differential settlement occurred).

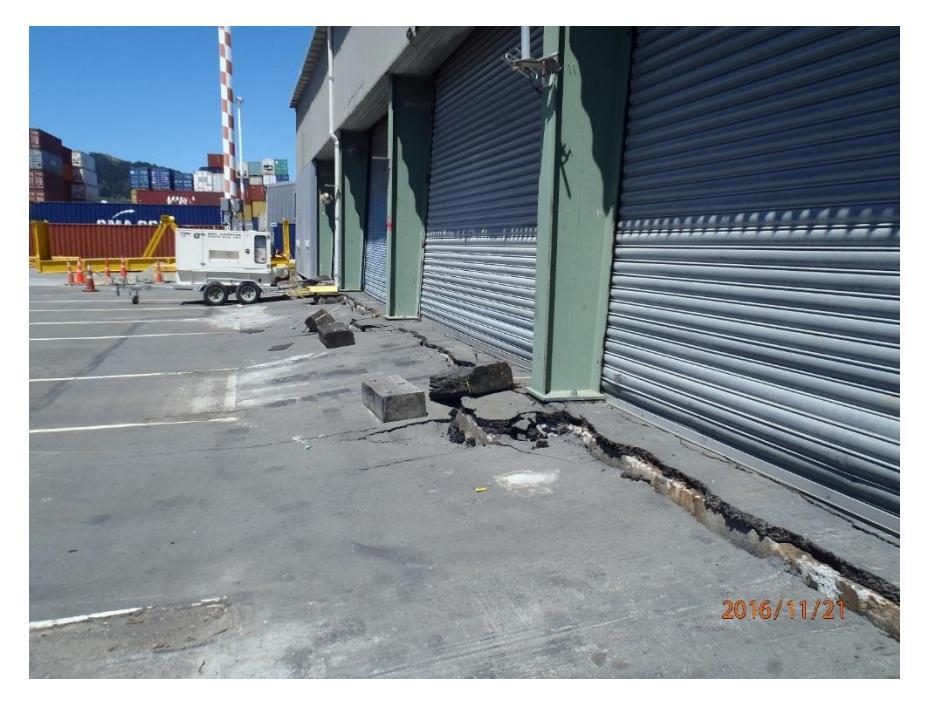
Figure 5.76: Looking south along east wall of Building S37, which shows approximately 375 mm of differential settlement between fill and pile-supported east wall of the building. (S41.279065°, E174.785787°, taken at 1220 hrs on 21NOV16)

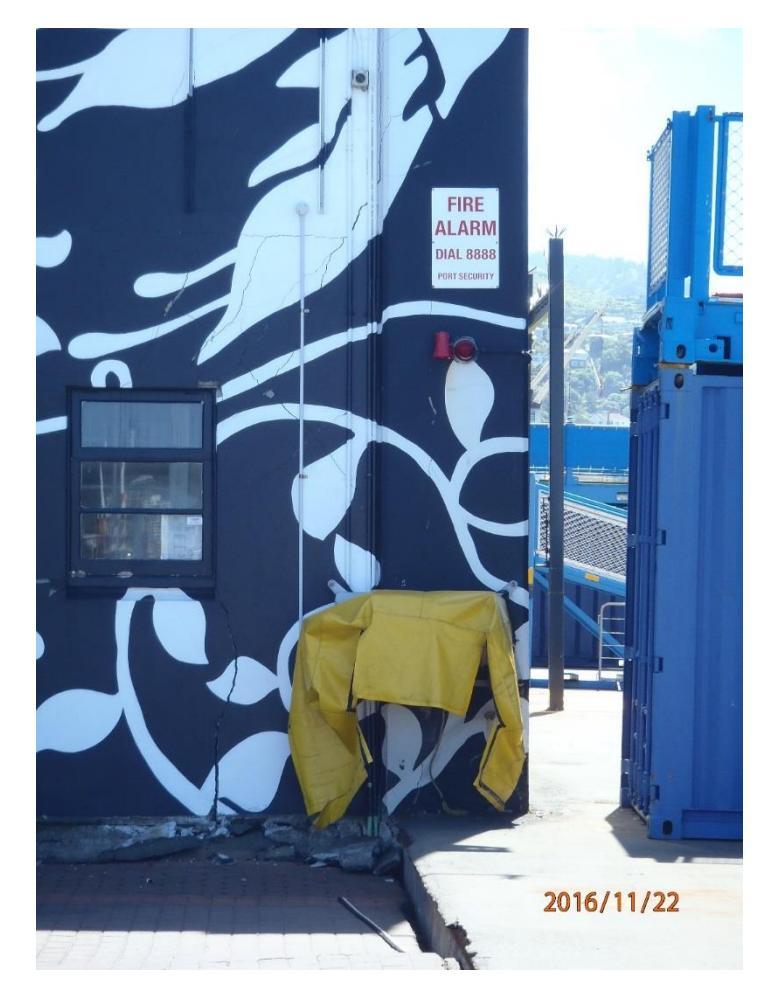
Figure 5.78: Southeast corner of Building S51 looking north, which shows 230 mm of differential settlement between wharf that supports its east wall and the inland fill. Also visible is 35 mm crack from seaward movement of wharf relative to adjacent ground. (S41.272404°, E174.787815°, taken at 1303 hrs on 22NOV16)

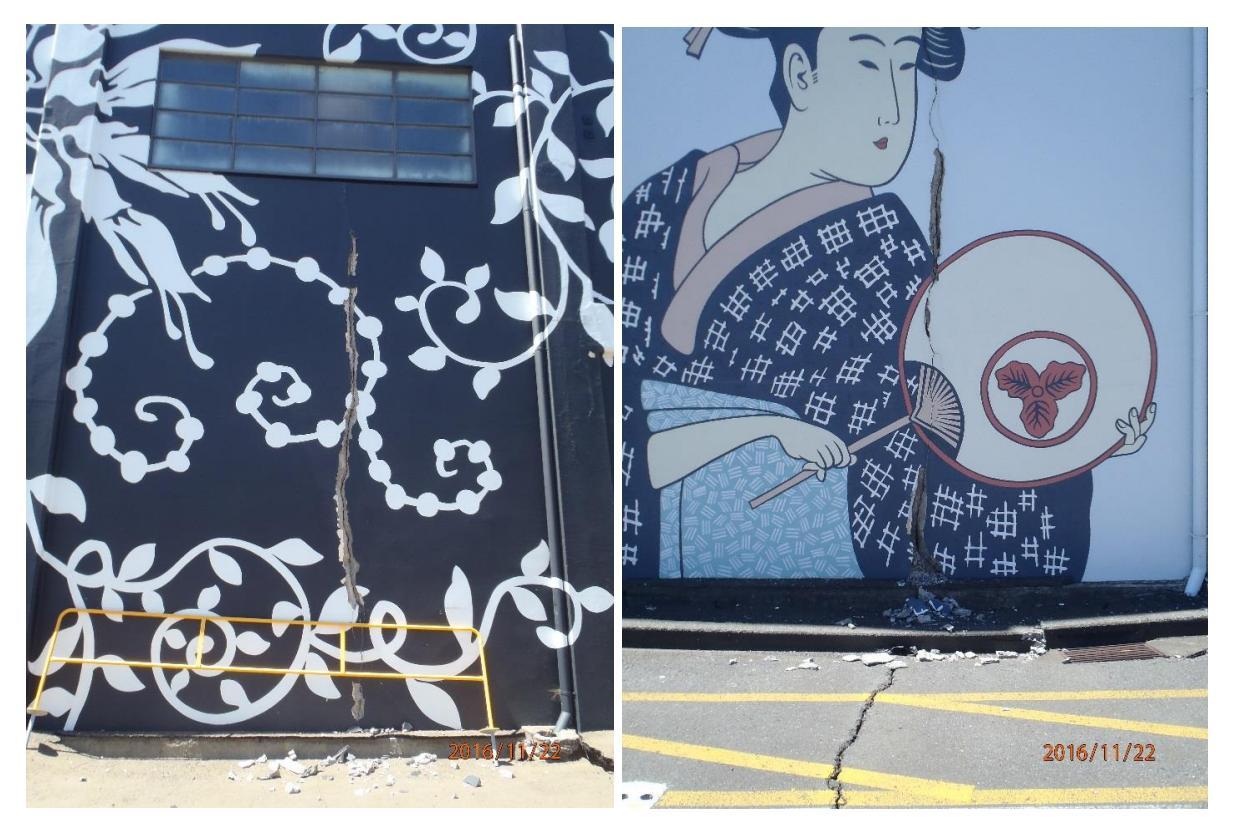
Figure 5.79: Vertical cracks along exterior west wall of S51 located at approximately 25 meters (left photo), and 60 meters (right photo) north of the southwest building corner. (Left: S41.272224°, E174.787391°, taken at 1316 hrs on 22NOV16. Right: S41.271906°, E174.787307°, taken at 1312 hrs on 22NOV16)

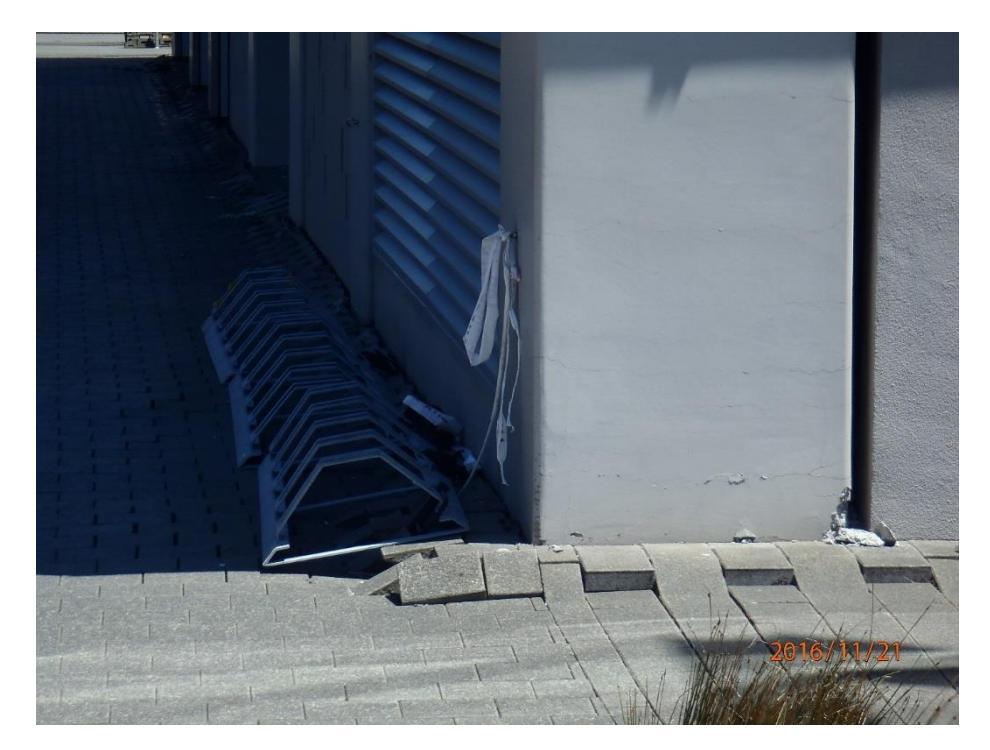
Figure 5.80: Looking west at southeast corner of the S building at which fill settled approximately 100 to 200 mm relative to pile-supported building. (S41.278285°, E174.784757°, taken at 1243 hrs on 21NOV16)

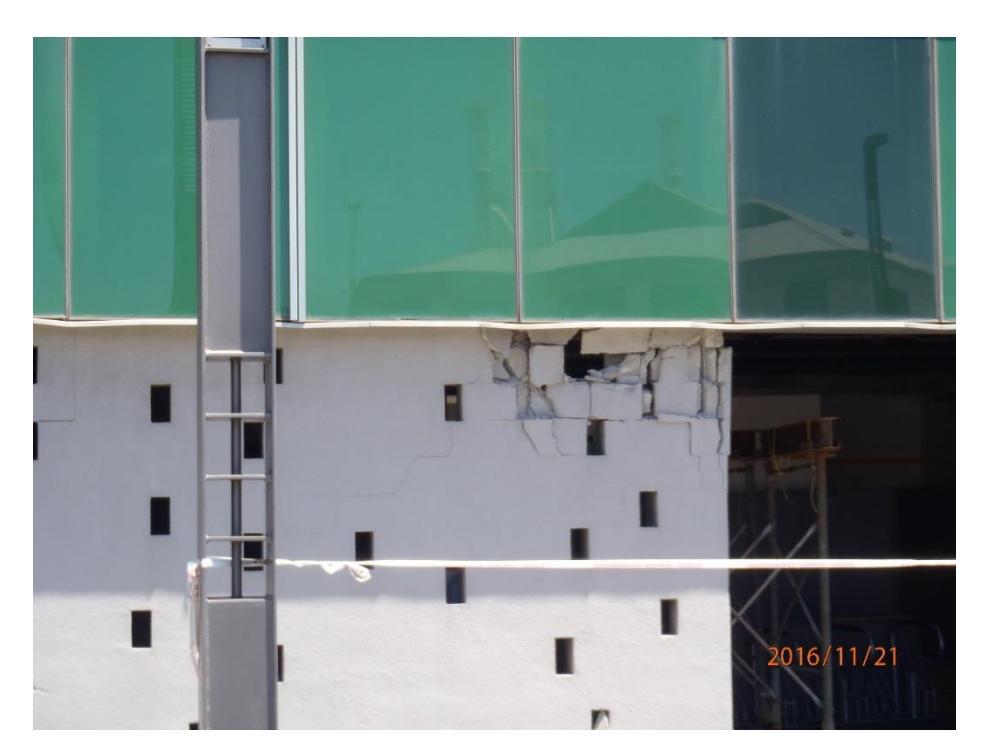
Figure 5.81: Damage to ground floor infill wall on the east side of the S building (S41.278114°, E174.784715°, 1241 hrs on 21NOV16)
