Editors: Youssef M.A. Hashash & Sissy Nikolaou

GEER Team Leaders: Youssef Hashash (University of Illinois at Urbana-Champaign), Sissy Nikolaou (Mueser Rutledge Consulting Engineers, MRCE)

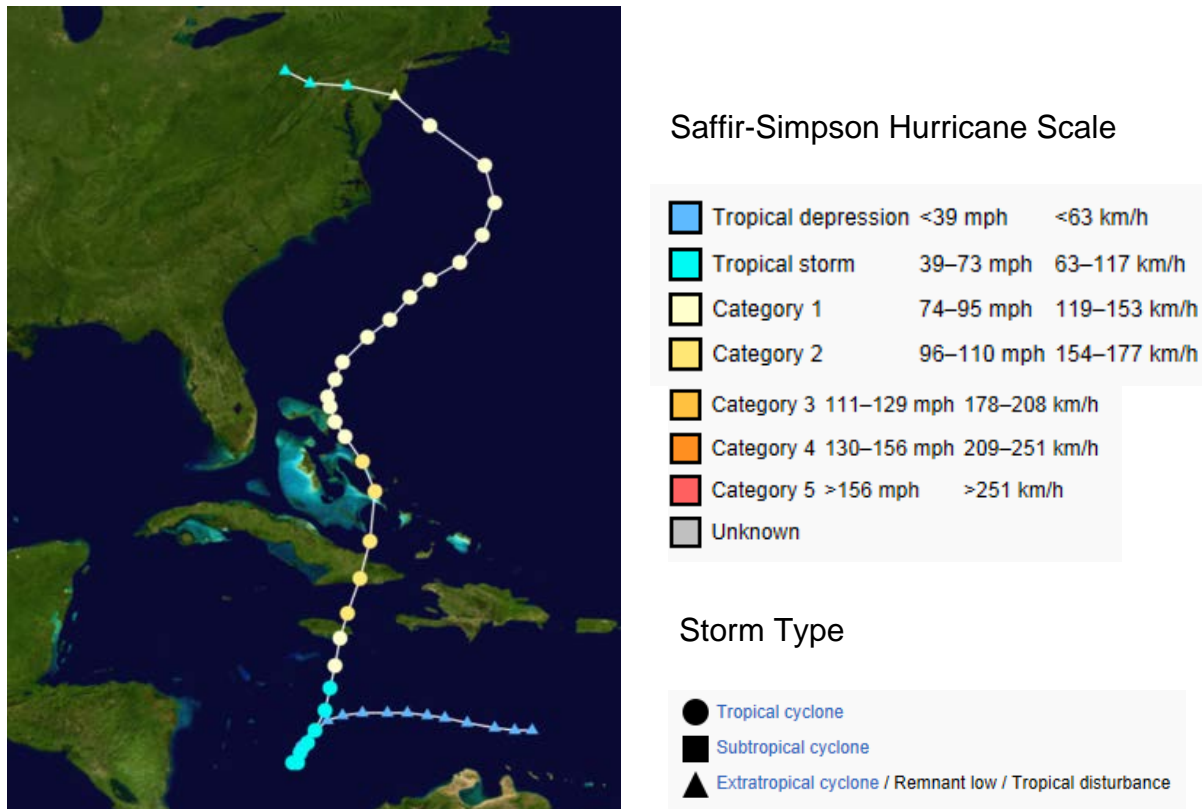
Figure 2.1 Track map of Hurricane Sandy at 6-hour intervals. The color represents the storm's maximum sustained wind speeds as classified in the Saffir-Simpson Hurricane Scale and the shape of the data points represent the nature of the storm. [Ref: Wikipedia.org; Created by Cyclonebiskit with background image from NASA] .

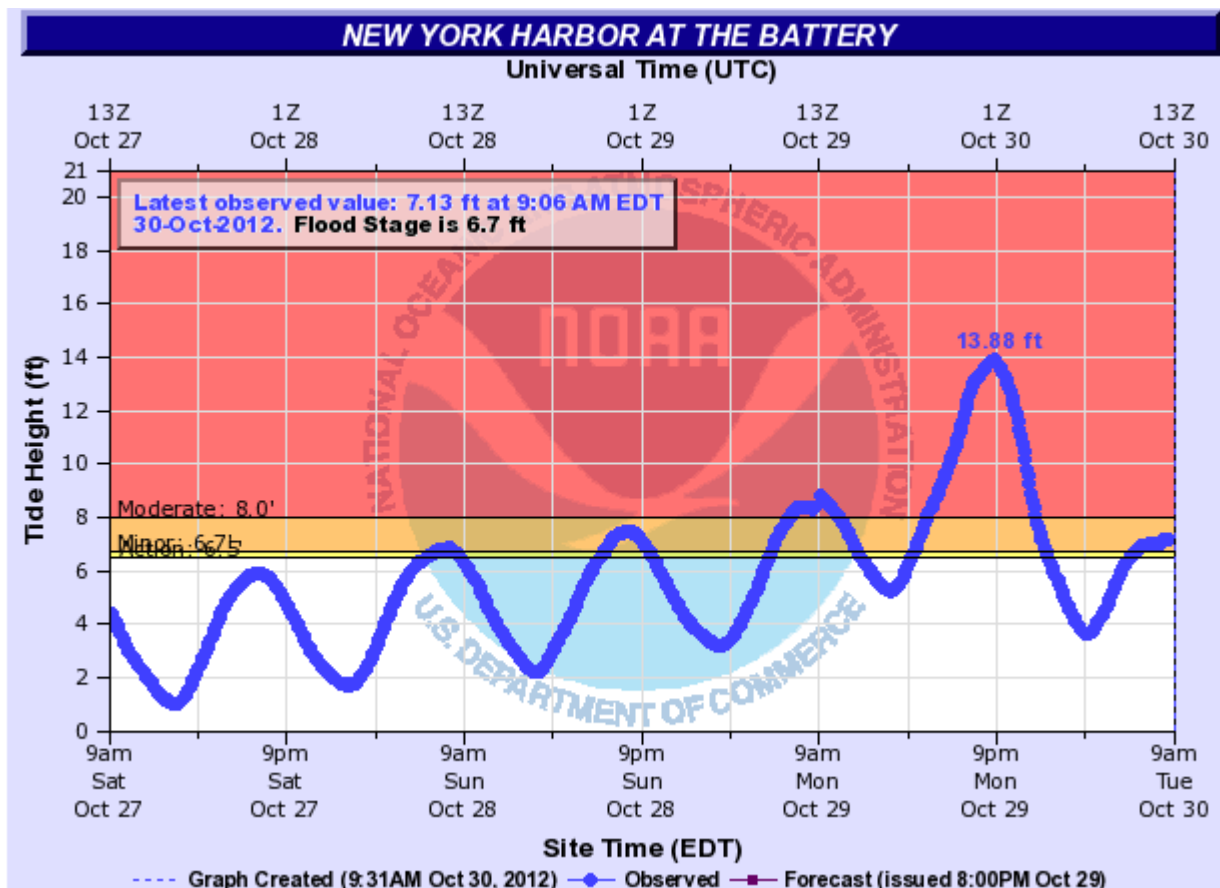
Figure 2.2 Hurricane Sandy surge at the NYC Battery (NOAA; provided by T.D. O'Rourke).

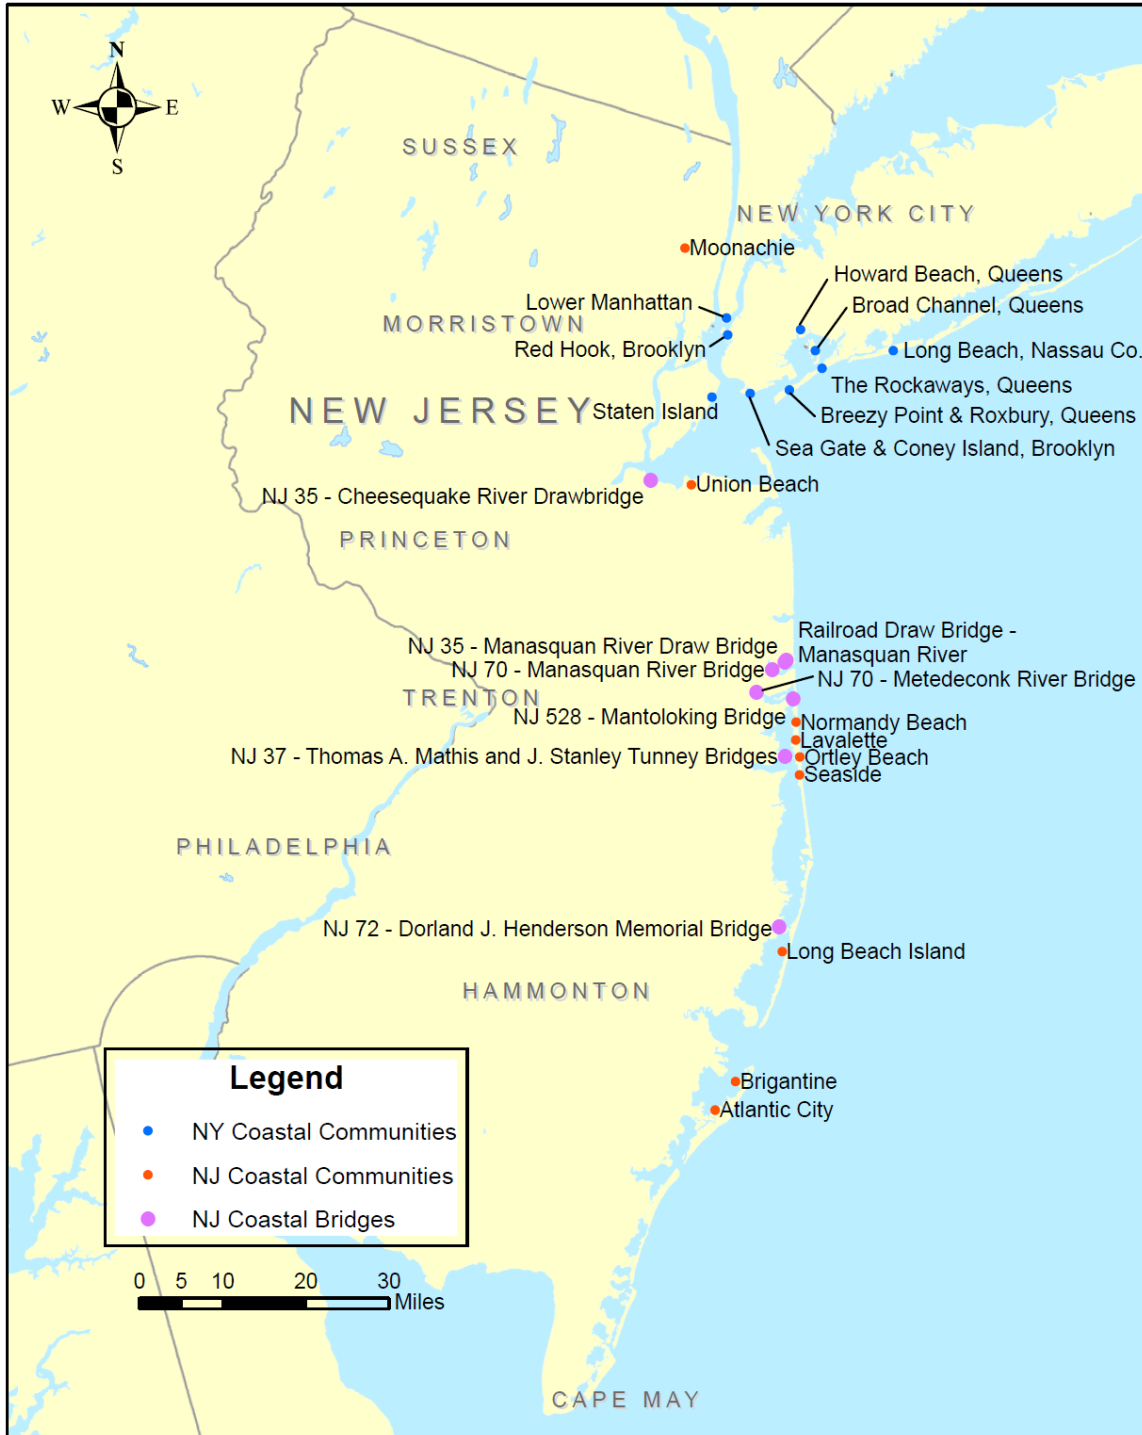
Figure 3.1 GEER observation locations, including site visits in the days following the storm, and information gained through collaboration with city and state agencies over the subsequent weeks.

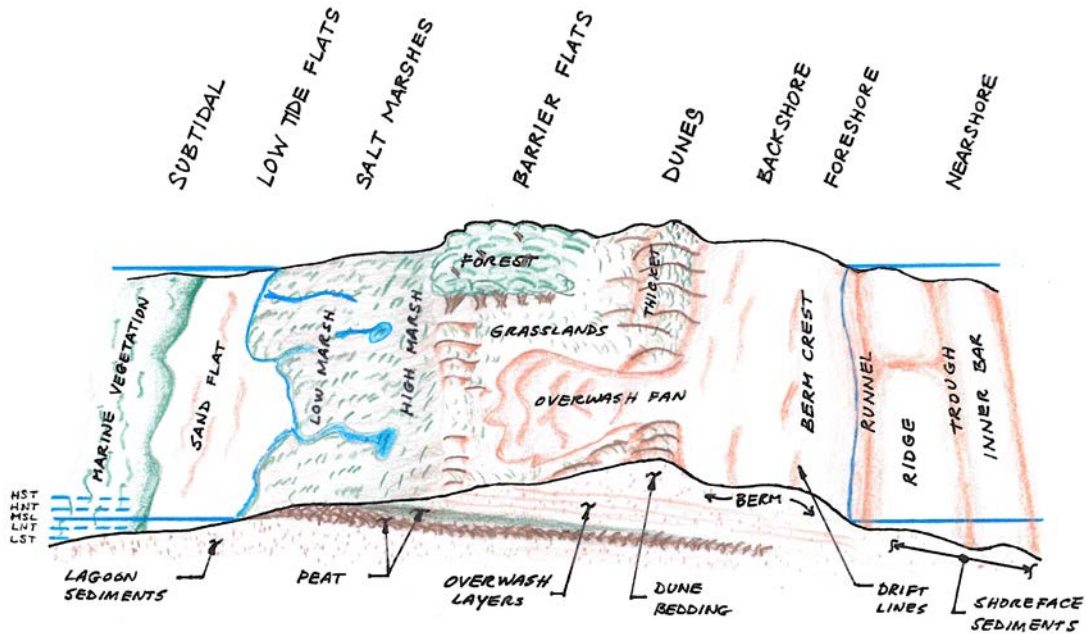
Figure 4.1 Barrier environments (modified by A. Dyer from Leatherman, S.P., 1979; original in Godfrey, 1976).

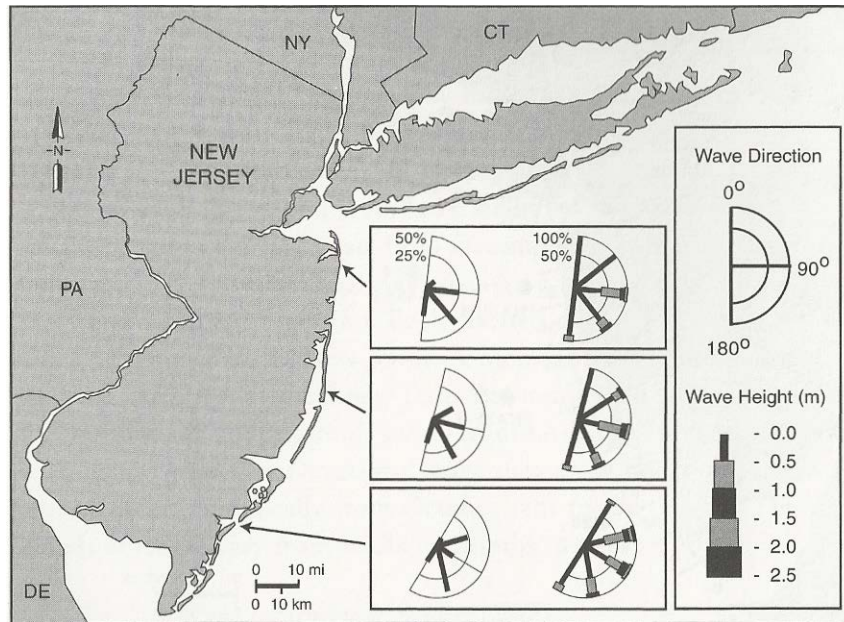
Figure 4.4 Wave roses showing the quadrants of oncoming waves, by percent (left) and percentage of waves of differing heights (right). Source: Psuty and Ofiara, 2002.

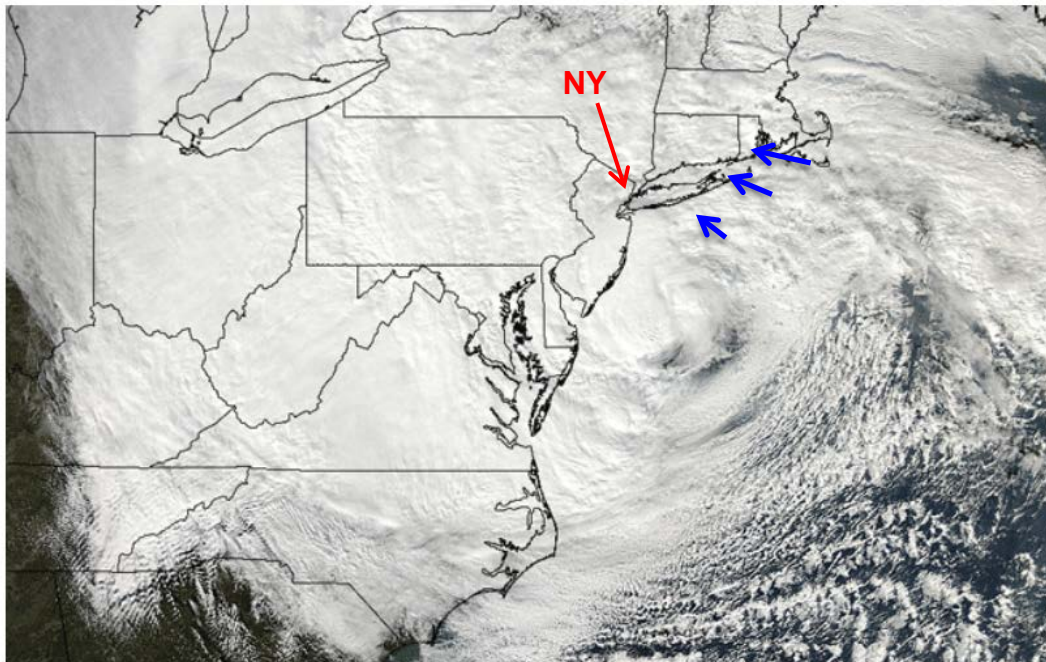
Figure 4.5 Image of Sandy's circulation on Oct. 29 at 2:20 p.m. EDT, as captured by NASA's Aqua satellite (Ref: www.nasa.gov/mission_pages/hurricanes/archives/2012/h2012_Sandy.html) Blue arrows show the direction of the wind as the storm approached landfall in southern NJ. The strongest winds are in the storm's NE quadrant. In the case of Sandy the strongest winds were directed at the NJ and Long Island shorelines. Given the long fetch across the open ocean and the full length of Long Island Sound, extremely large storm surges were allowed to build up and funnel into New York Harbor and into the East River through Long Island Sound.

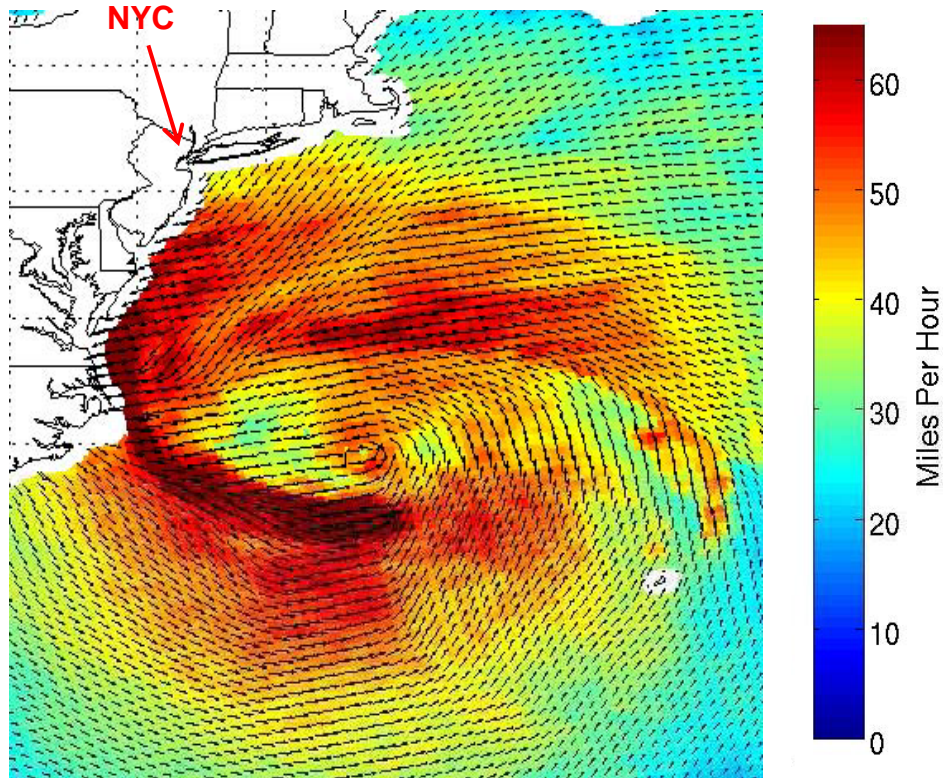
Figure 4.6 Ocean surface winds for Sandy observed at 12:00 a.m. EDT Oct. 29 by the OSCAT radar scatterometer on the Indian Space Research Organization's (ISRO) OceanSat-2 satellite. Colors indicate wind speed and arrows indicate direction. (Ref: www.nasa.gov/mission_pages/hurricanes/archives/2012/h2012_Sandy.html)

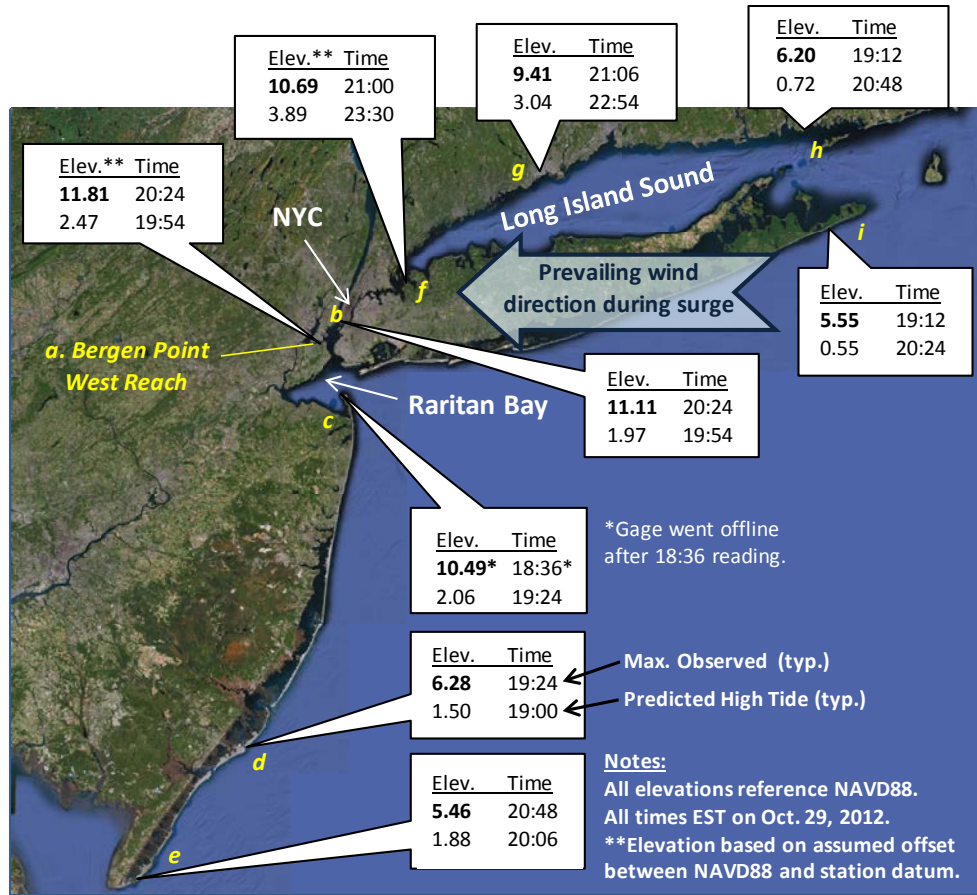
Figure 4.7 Observed and predicted tide data from selected NOAA stations on October 29, 2012 [tidesandcurrents.noaa.gov] with base image from Google Maps (© 2013). See Table 4.1 for station names.

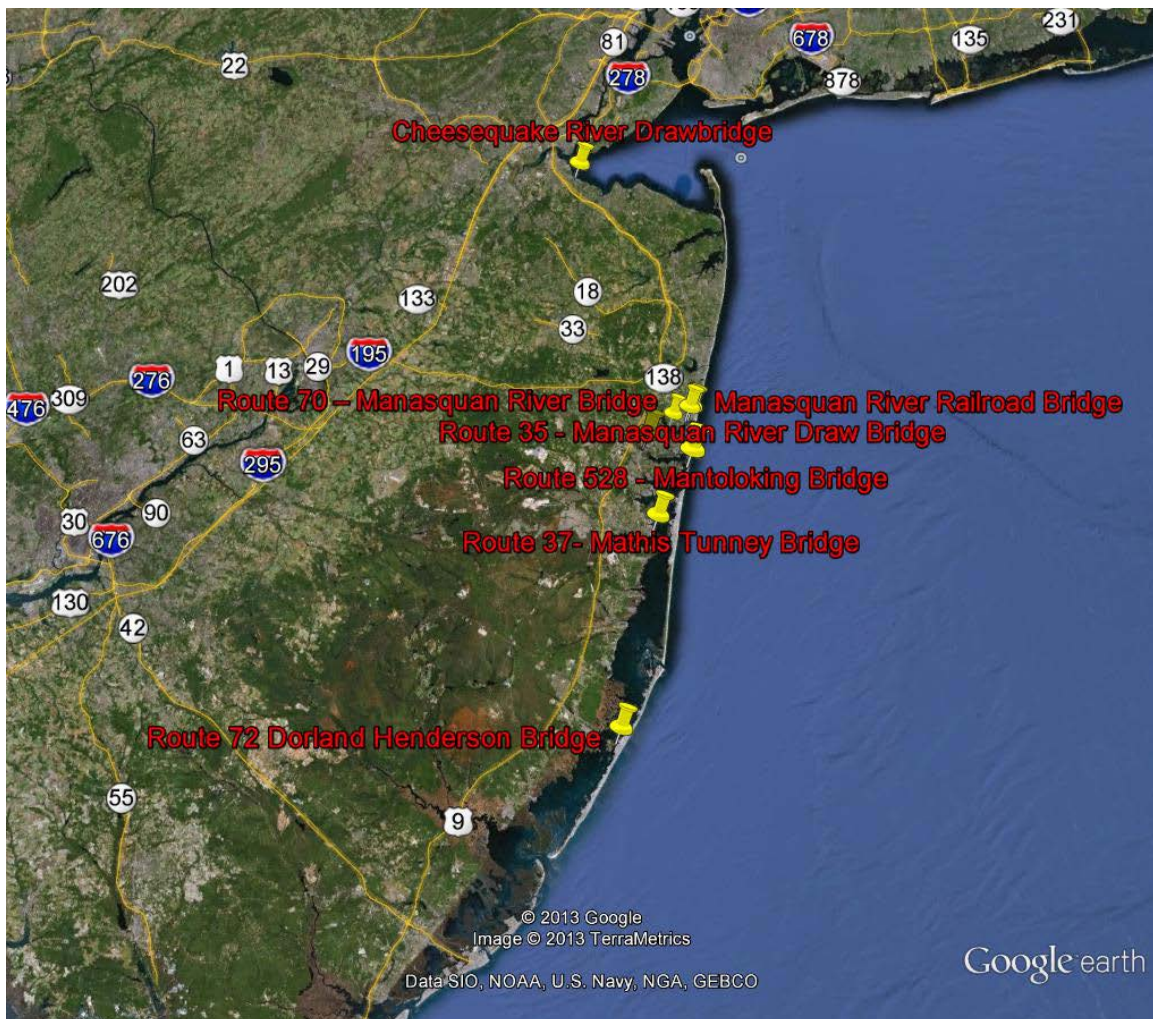
Figure 5.1 Vicinity map showing the locations of coastal New Jersey bridges that were inspected by the GEER team or had gathered information on from other sources (Google Earth)

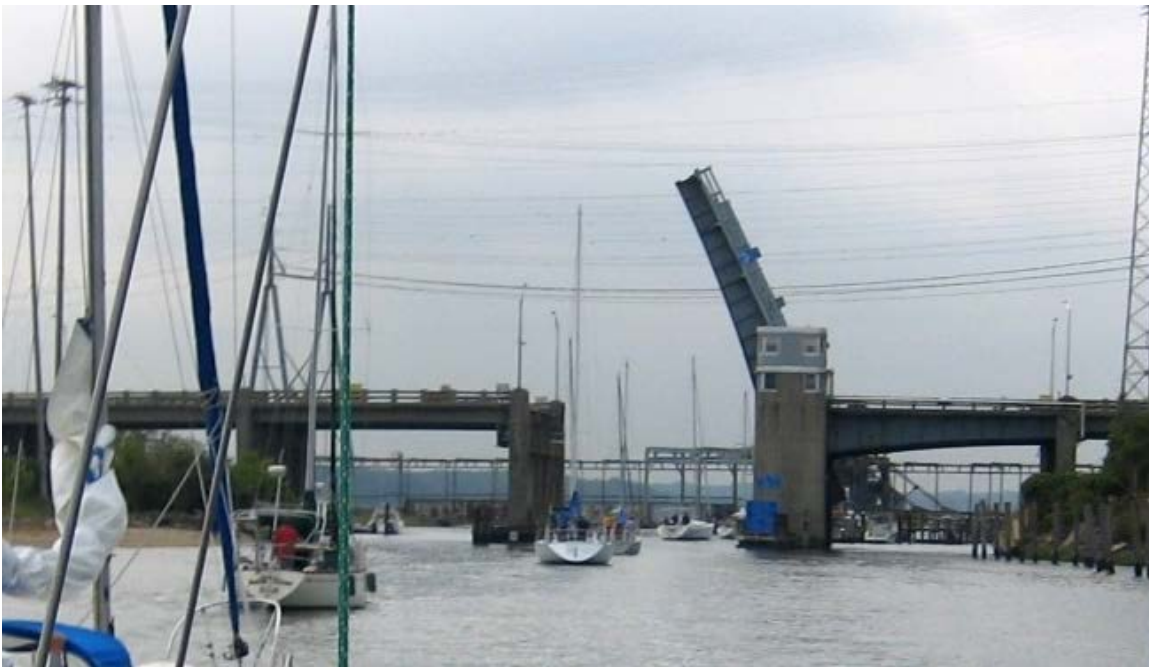
Figure 5.2 Cheesequake River Drawbridge looking eastward (NJDOT 2012b)

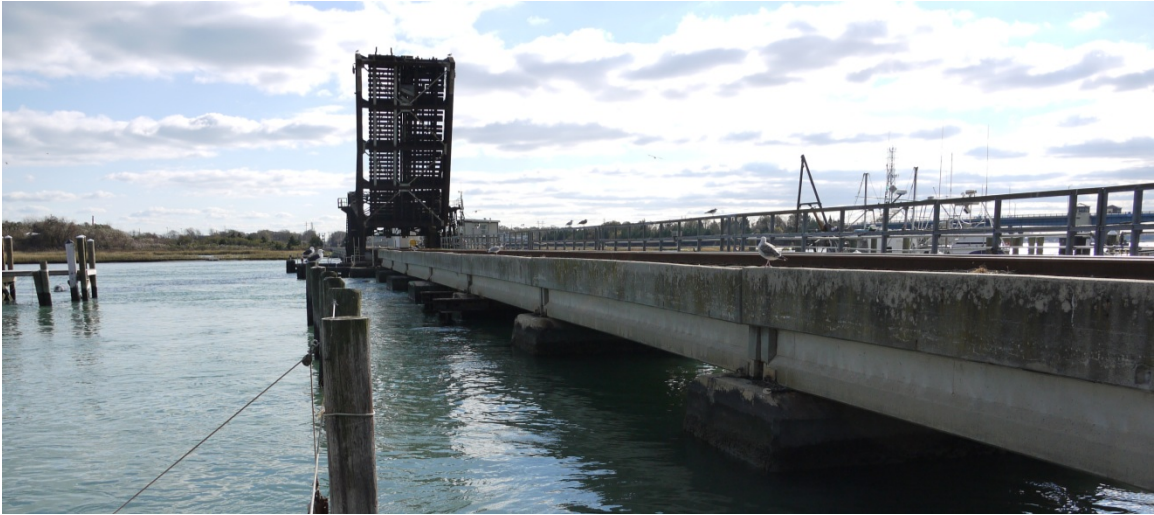
Figure 5.4 Railroad draw bridge at Manasquan River looking south (40.10700°N, 74.04998°W, November 5, 2012)

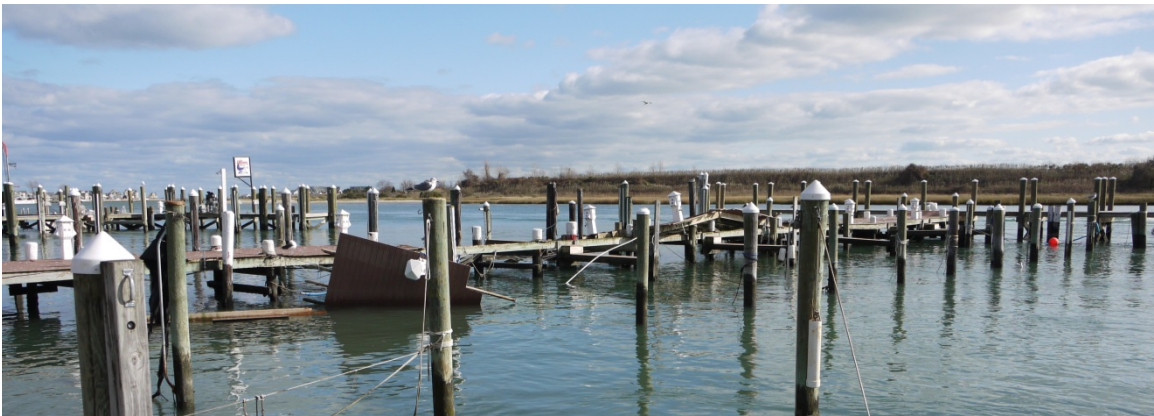
Figure 5.5 Damage to boat piers north of Manasquan River railroad drawbridge (40.10700°N, 74.04998°W, November 5, 2012)

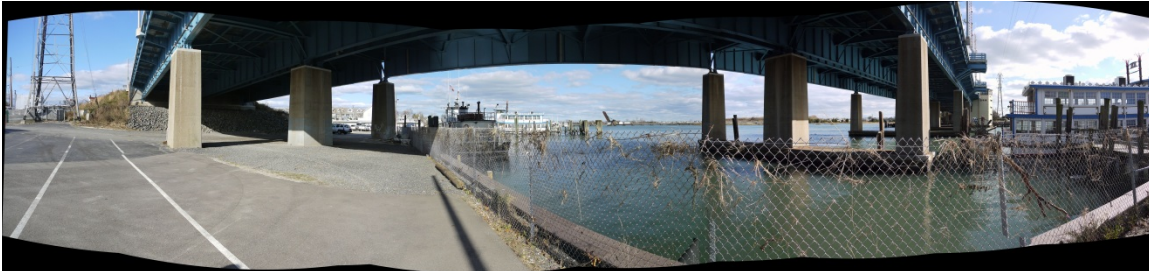
Figure 5.6 North abutment of Route 35 draw bridge over Manasquan River. Note possible high water debris in fence. (40.10495°N, 74.05422°W, November 5, 2012)

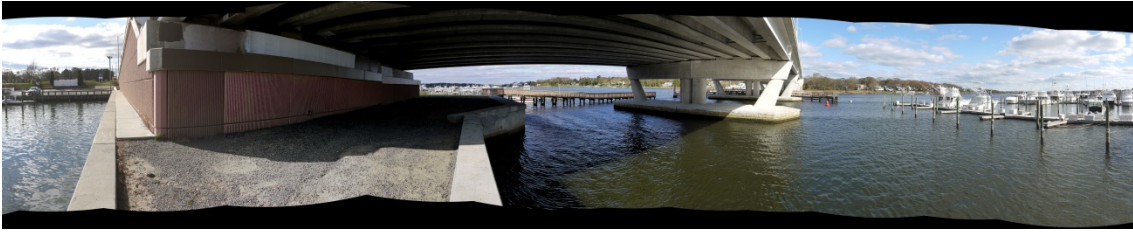
Figure 5.8 Route 70 Bridge over the Manasquan River (40.09686°N, 74.08663°W, November 5, 2012)

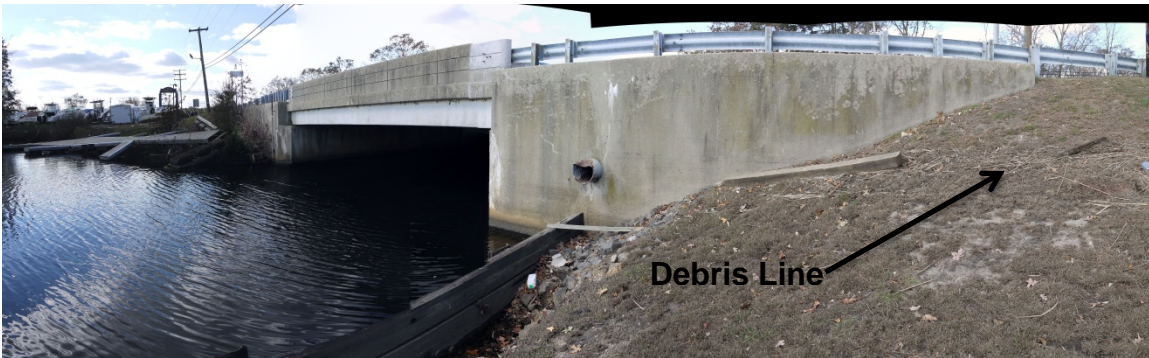
Figure 5.9 Route 70 bridge over the Metedeconk River (40.06607°N, 74.13284°W, November 5, 2012)

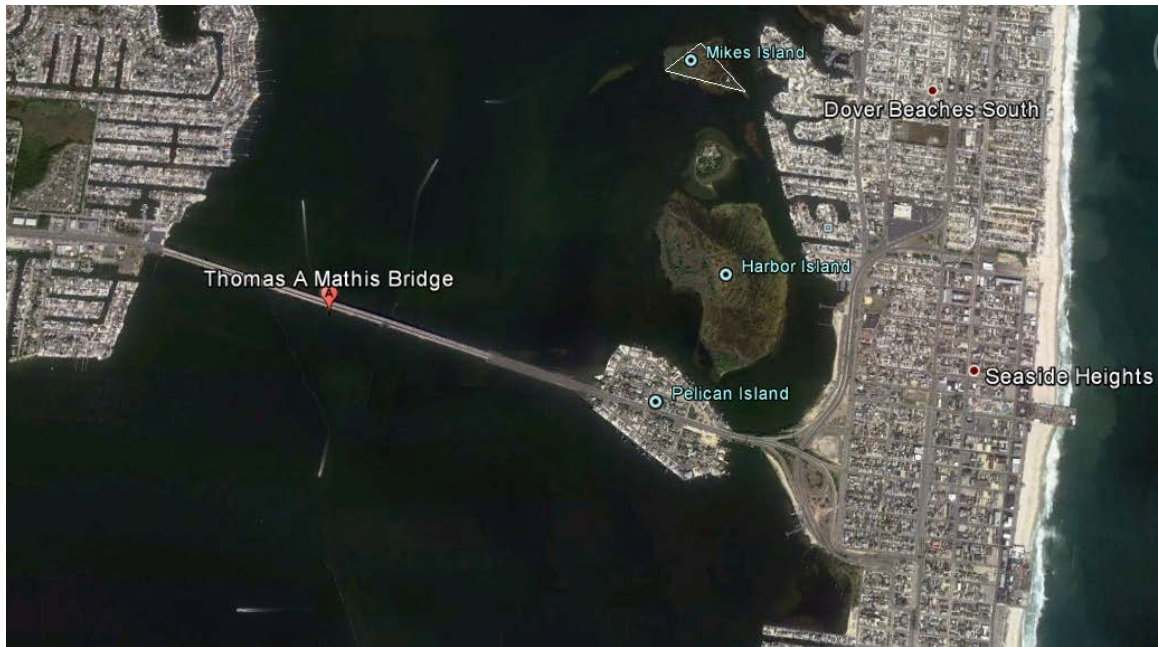
Figure 5.10 Location of Thomas A. Mathis and J. Stanley Tunney Bridges (Route 37). The approximate location of the center spans is 39° 56.7894" N, 74° 06.2559" W (Google Earth)

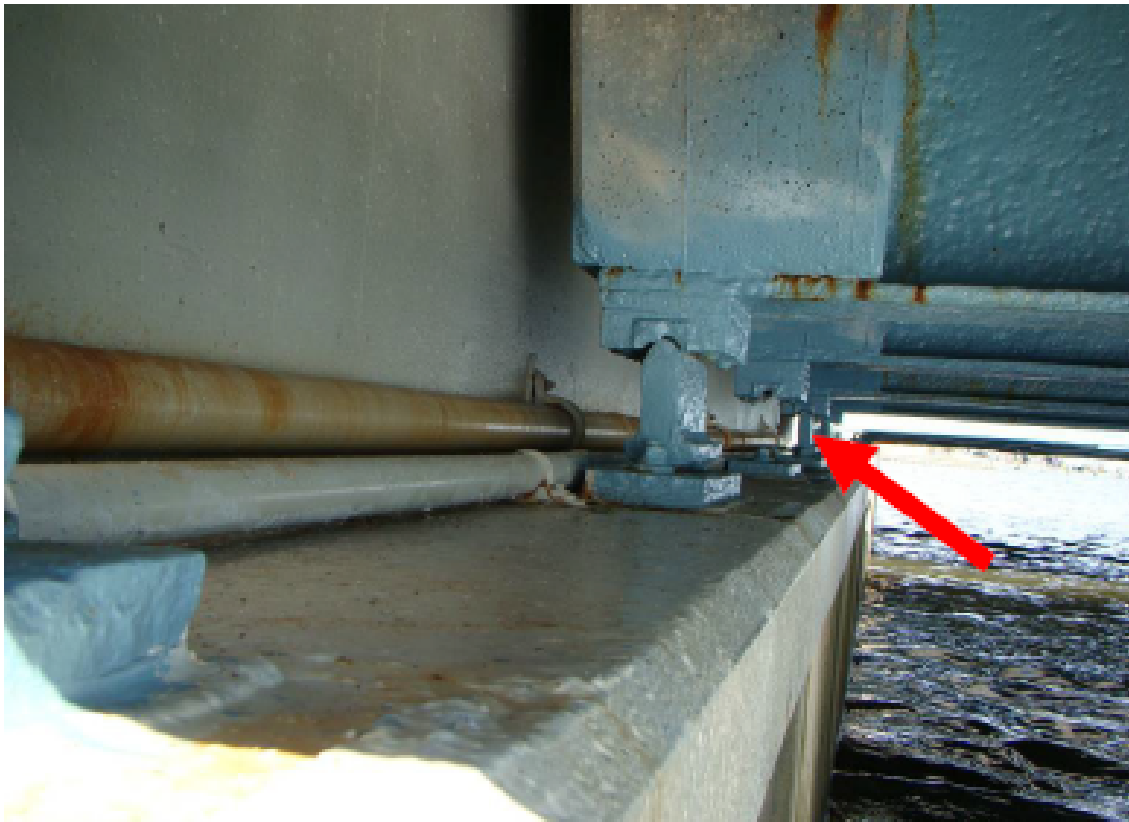
Figure 5.11 Mathis Bridge (eastbound) looking north showing a missing bearing for Stringer 3 (NJDOT, 2012a)

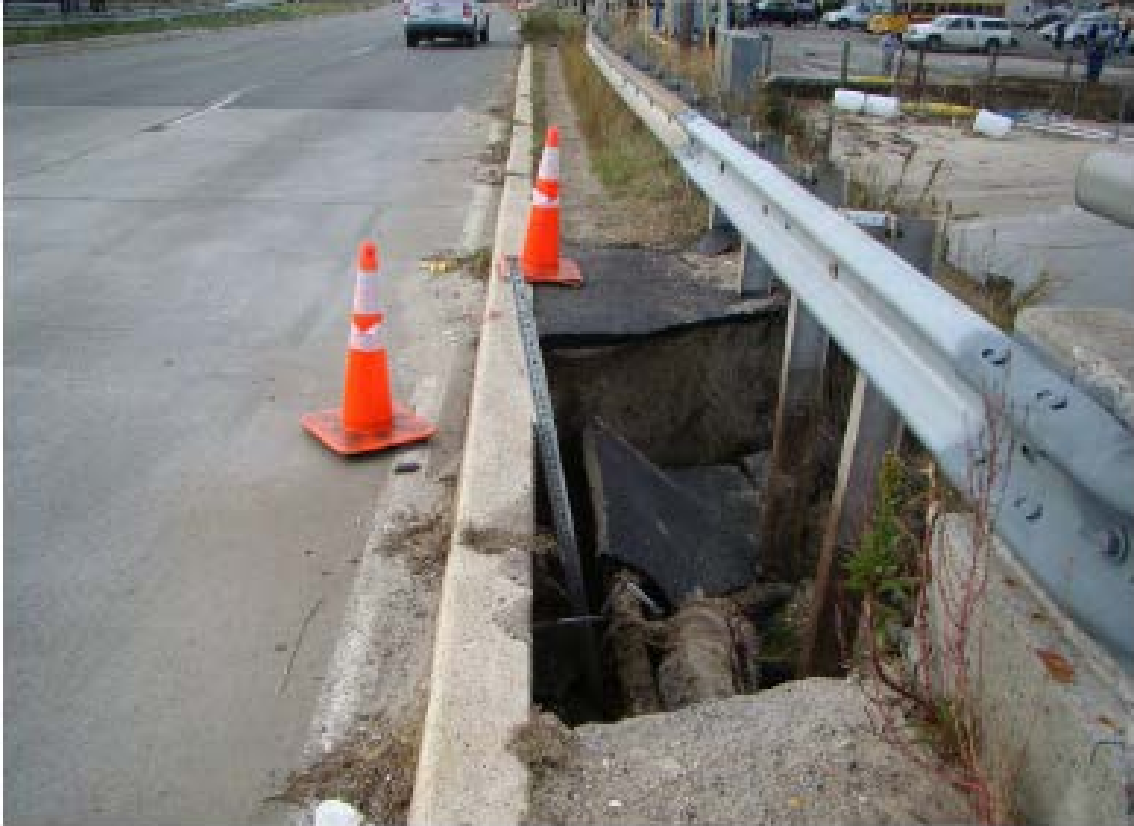
Figure 5.12 Erosion along the northwest abutment of the Tunney Bridge (westbound Route 37) 39° 56.9610" N, 74° 06.8341 W (NJDOT 2012a)

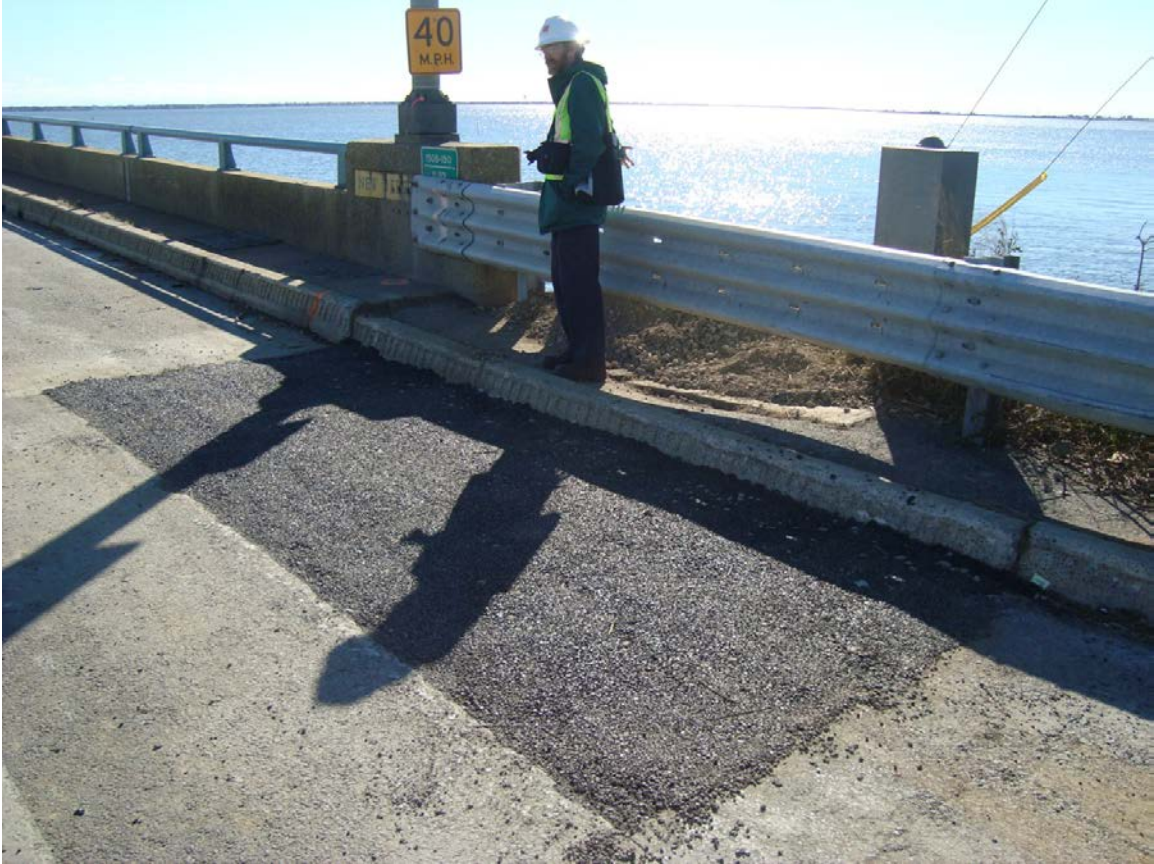
Figure 5.14 Evidence of erosion and recent repair of roadway along the southwest abutment of the Mathis Bridge (eastbound Route 37) 39°56.9610" N, 74° 06.8341 W

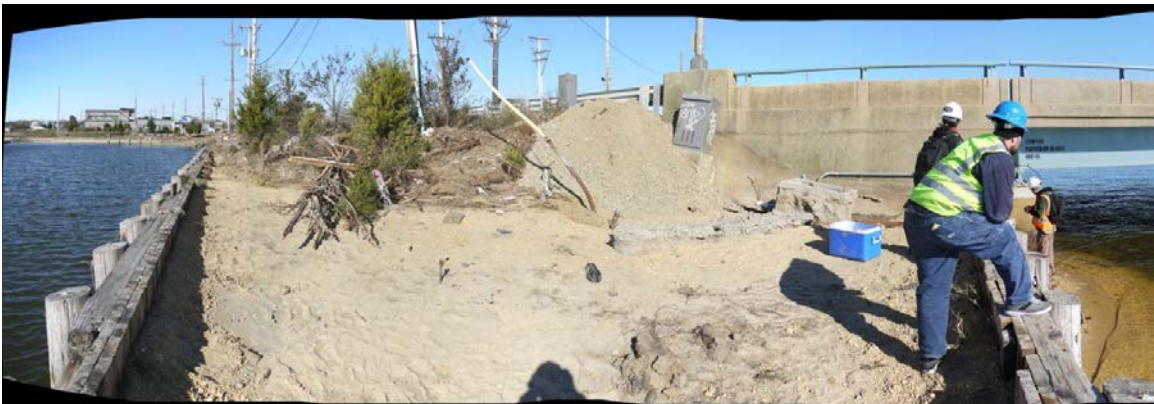
Figure 5.15 Erosion along the southwest abutment of the Mathis Bridge (eastbound Route 37) 39° 56.9610" N, 74° 06.8341 W

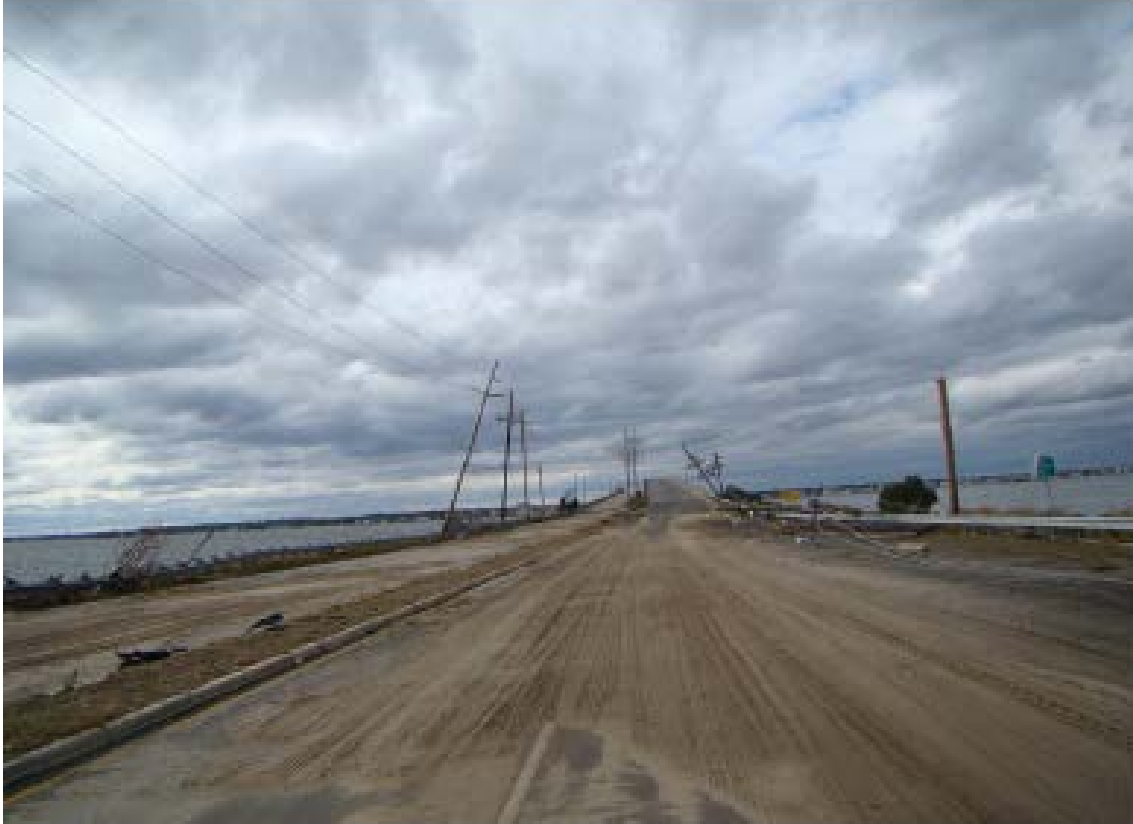
Figure 5.16 Damaged utility poles along eastern approach of Mathis and Tunney Bridges (westbound Route 37) (NJDOT 2012a)

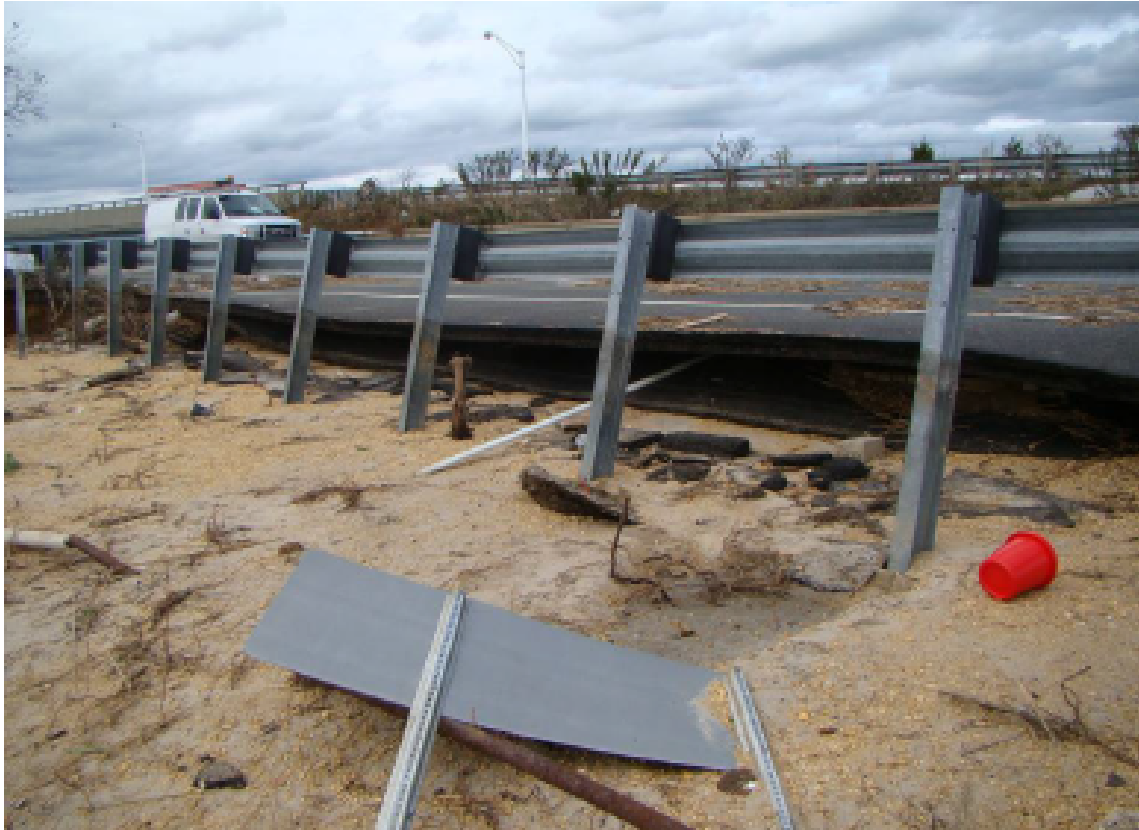
Figure 5.17 Erosion of embankment and roadway along southeast approach of Mathis Bridge (looking northwest) (NJDOT 2012a)

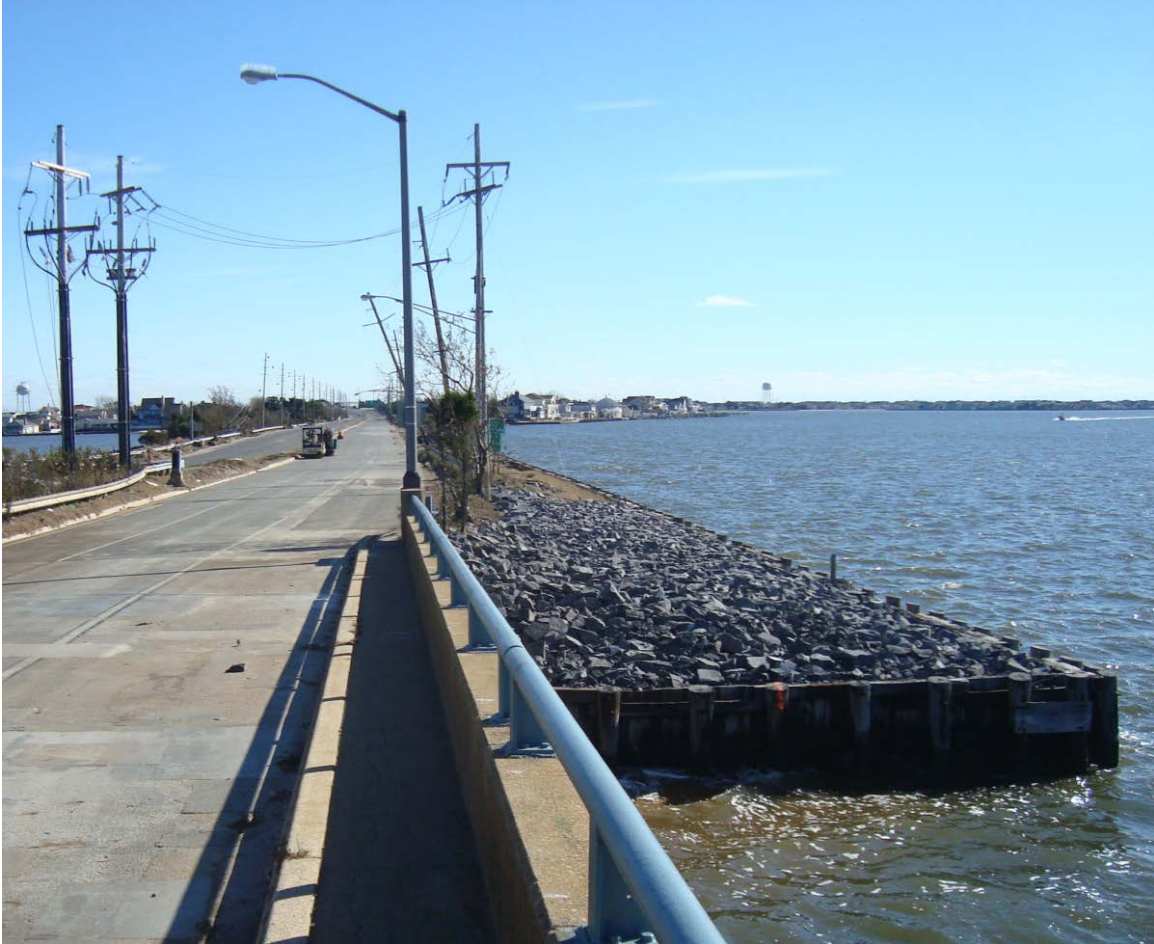
Figure 5.18 Condition of the southeast abutment of Mathis Bridge during the GEER visit (eastbound Route 37)

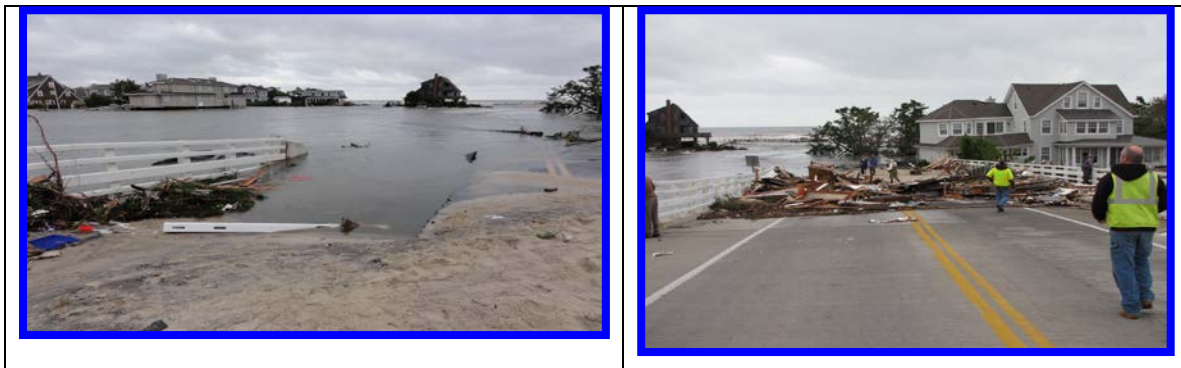
Figure 5.19 Approach to Mantoloking Bridge, which was flooded soon after the storm and inundated by debris (40° 2'24.21" N, 74° 3'6.79" W , Ocean County Engineering, 2012)

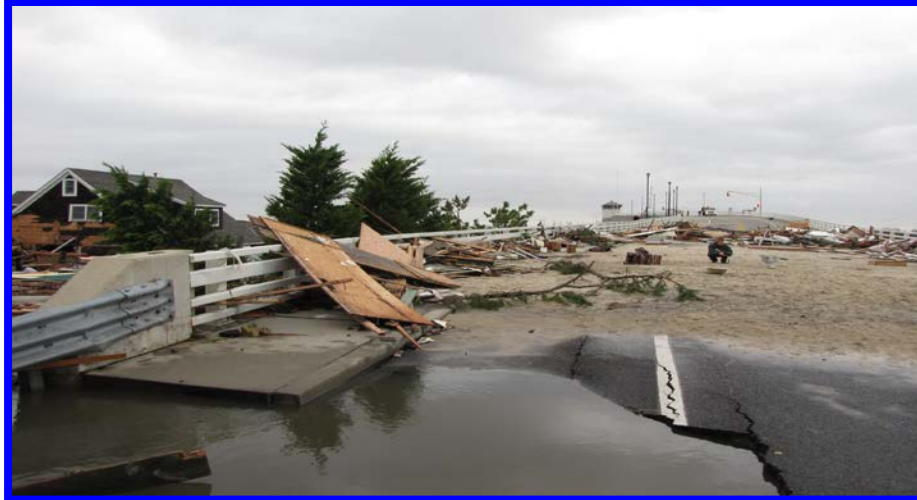
Figure 5.20 Damage to the east abutment of the bridge due to erosion undermining the foundation (40° 2'24.21" N, 74° 3'6.79" W , Ocean County Engineering, 2012)

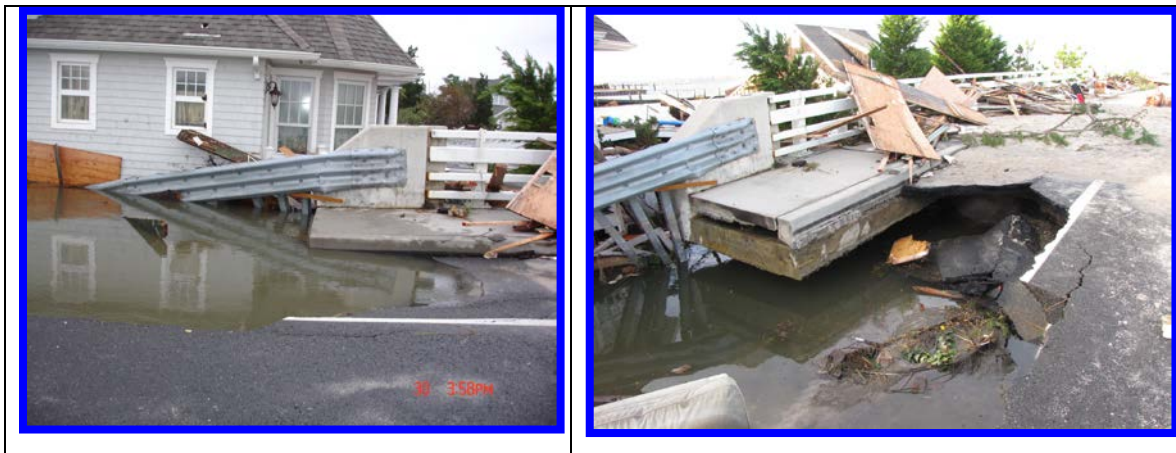
Figure 5.21 Damage to the south side of the east abutment due to erosion and large floating debris such as homes caused the loss of the T-wall, which allowed the coping and sidewalk to be cantilevered out approximately 10 ft (40° 2'24.21" N, 74° 3'6.79" W , Ocean County Engineering, 2012)

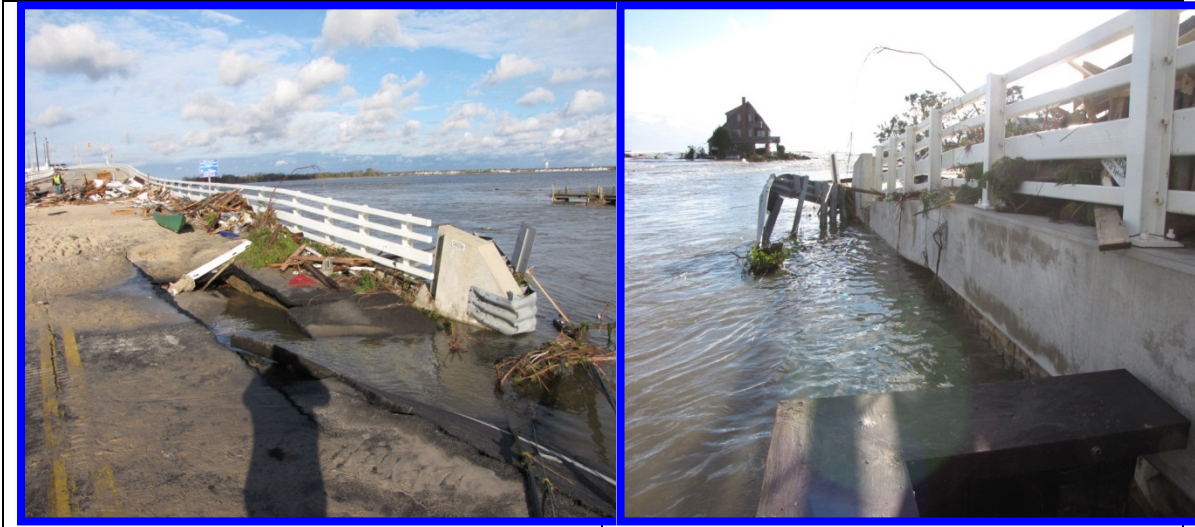
Figure 5.22 Damage to the north side of the east abutment due to erosion caused the T-wall to settle 4 ft (40° 2'24.21" N, 74° 3'6.79" W, Ocean County Engineering, 2012)

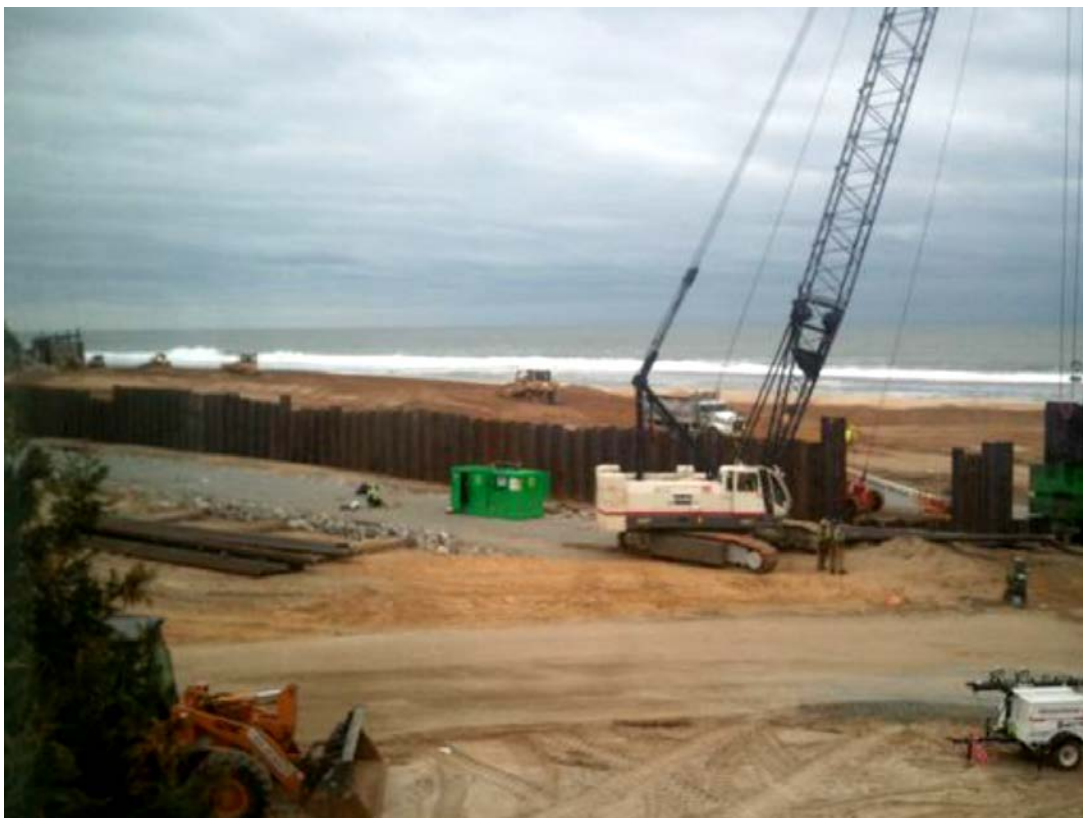
Figure 5.23 Sheet Piles driven in Mantoloking along the breached section (40° 2'22.95"N, 74° 3'0.53"W, NJ Task Force 1)
