Editors: Youssef M.A. Hashash & Sissy Nikolaou

GEER Team Leaders: Youssef Hashash (University of Illinois at Urbana-Champaign), Sissy Nikolaou (Mueser Rutledge Consulting Engineers, MRCE)

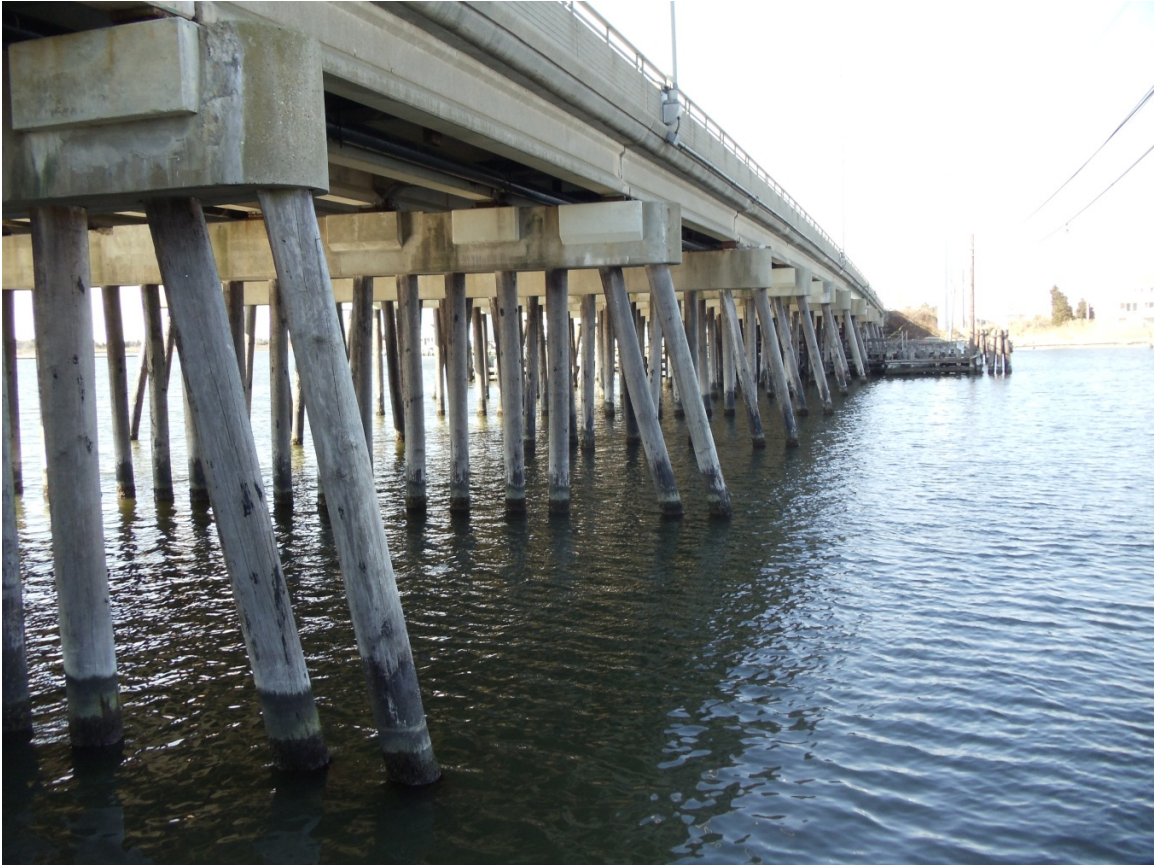
Figure 5.25 Easternmost section of the Highway 72 Bridge looking westward (39°39'13.77"N, 74°11'4.11"W).

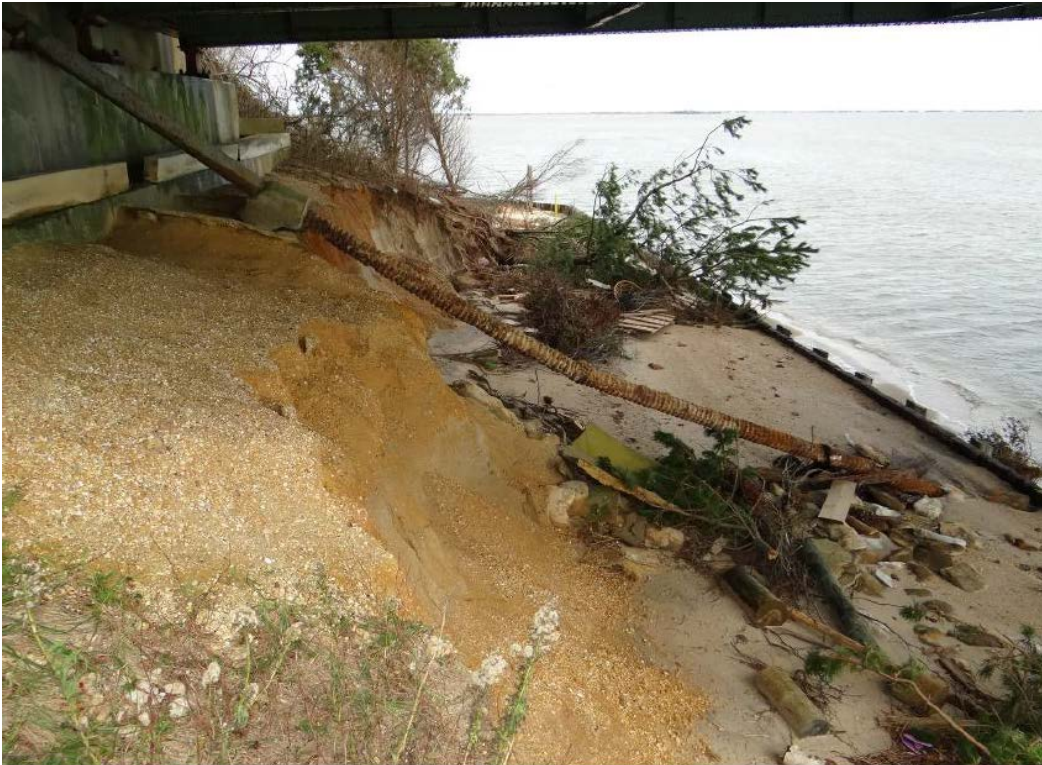
Figure 5.26 Severe erosion observed at the Rt. 72 east abutment, looking north (NJDOT 2012a).

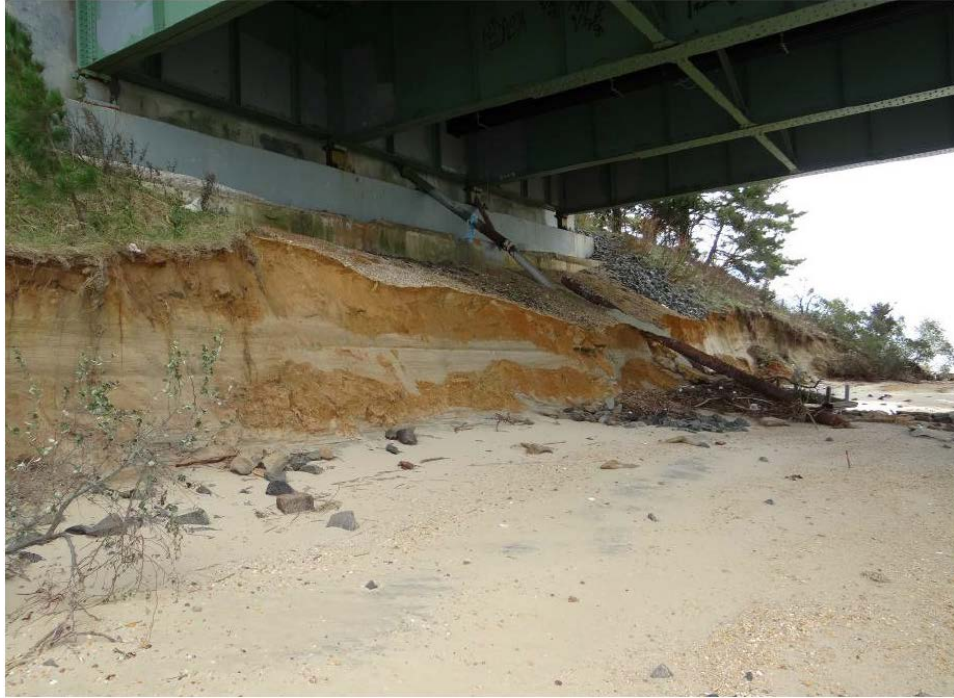
Figure 5.27 Severe erosion observed at Rt. 72 east abutment, looking south-east (NJDOT 2012a).

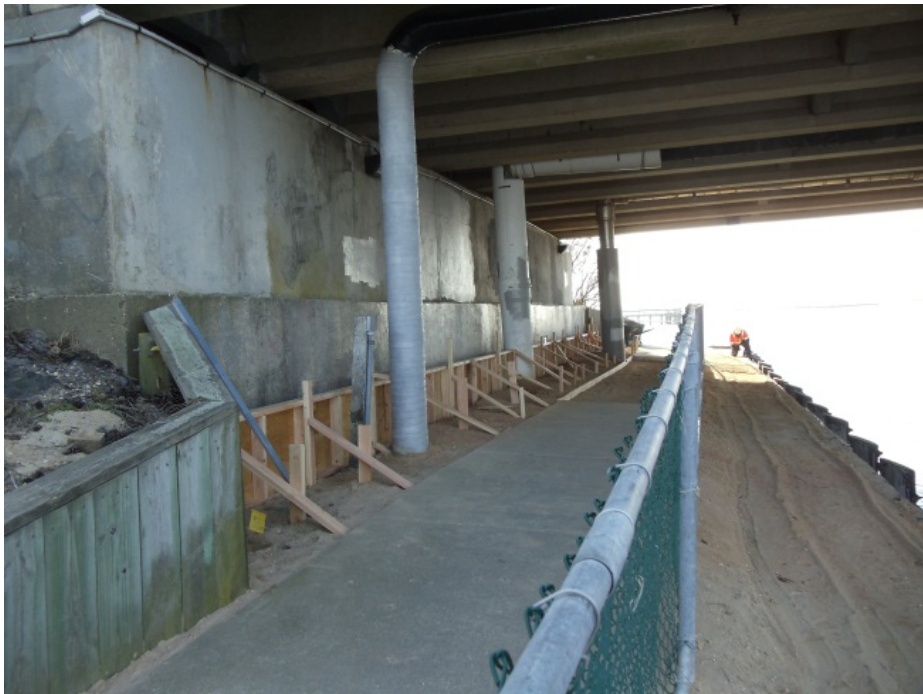
Figure 5.28 Replacement of the concrete walkway adjacent to Rt. 72 east abutment (39°39'13.44"N, 74°11'4.91"W).

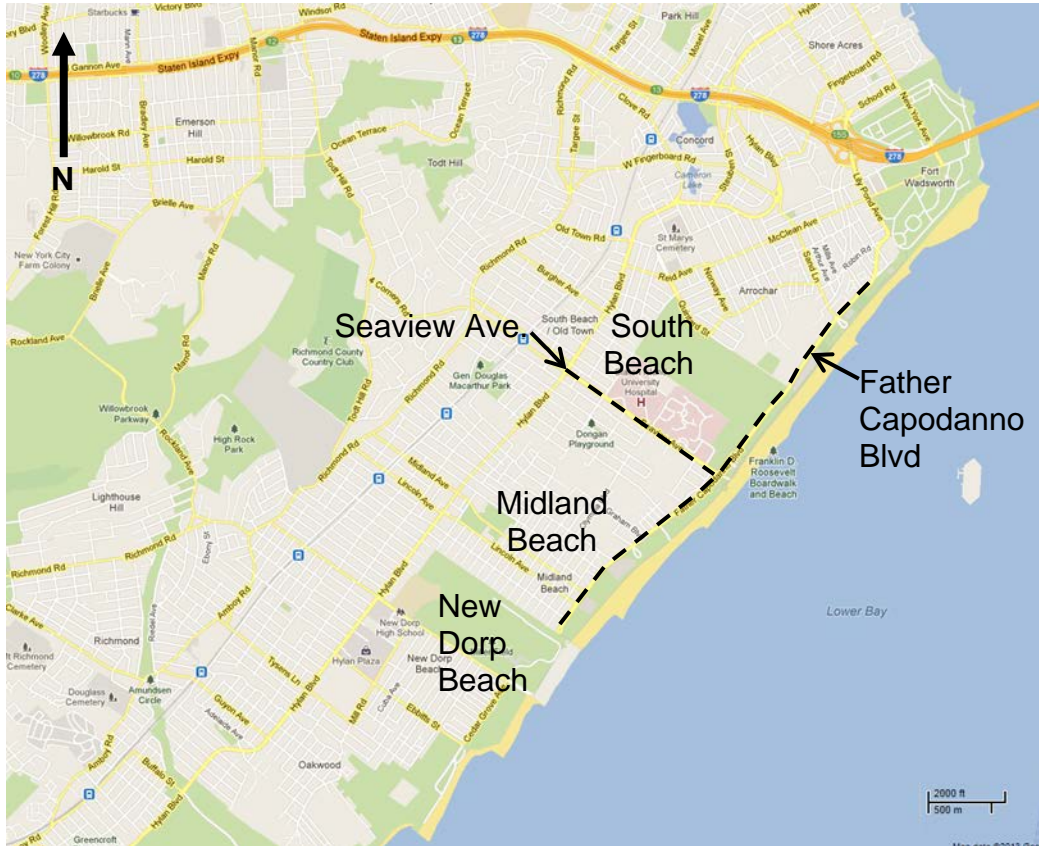
Figure 6.6 Map of a portion of Staten Island.

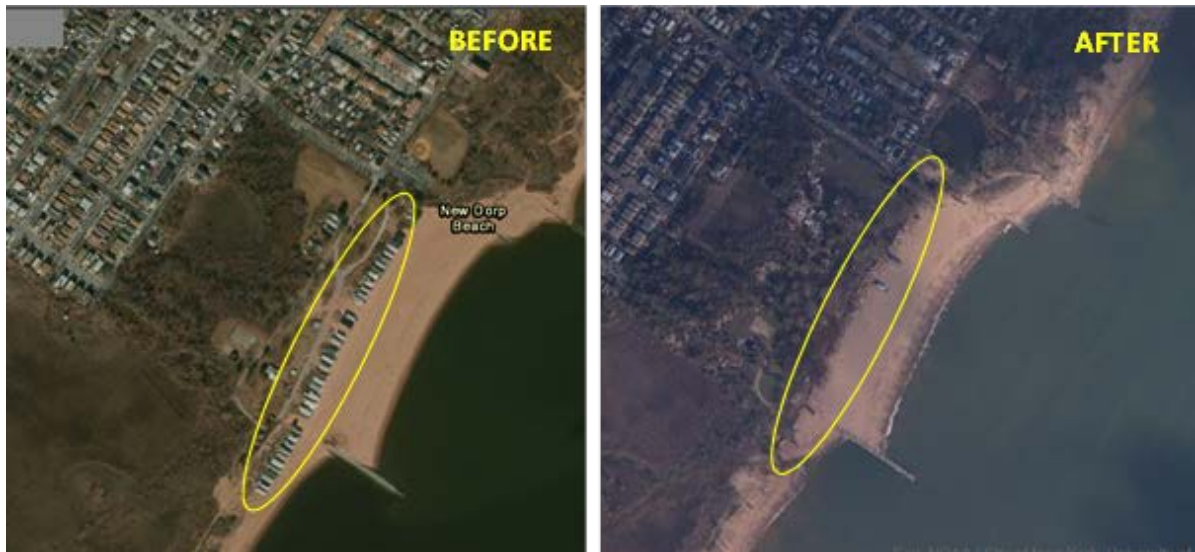
Figure 6.7 Aerial photographs of portion of New Dorp Beach, Staten Island before and after Sandy showing row of houses completely removed, with debris moved inland. Imagery from: tmappsevents.esri.com/website/swipe_sandy/.

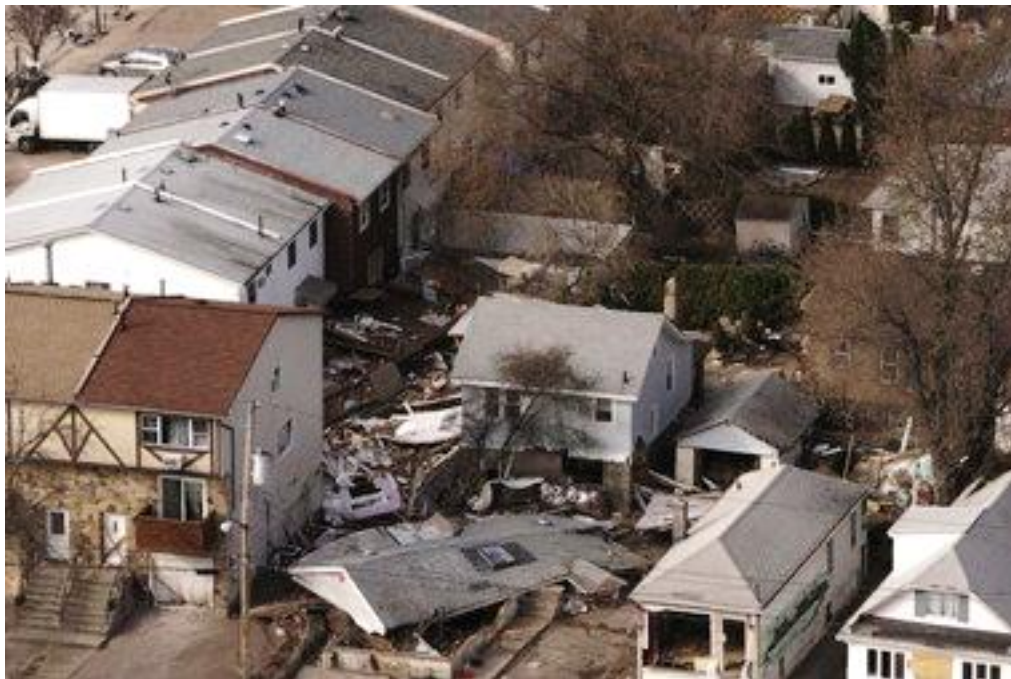
Figure 6.8 Aerial photograph of damaged homes on Cedar Grove Ave. in New Dorp Beach. Imagery from Staten Island Advance by B. Lyons at www.silive.com/news/index.ssf/2013/02/hurricane_sandy_was_the_second.html

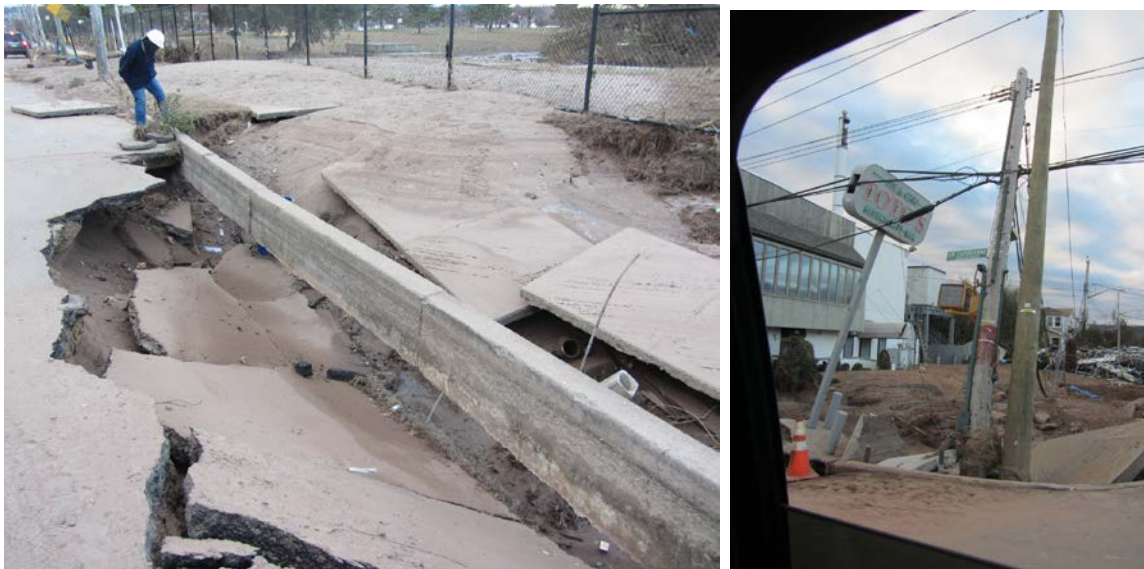
Figure 6.9 Scour undermining street, curb, sidewalk, and utilities, Seaview Blvd and Father Capodanno Blvd, Staten Island (40.579283° N, 74.077849° W, November 4, 2012). GEER team co-leader Dr. Sissy Nikolaou in background.

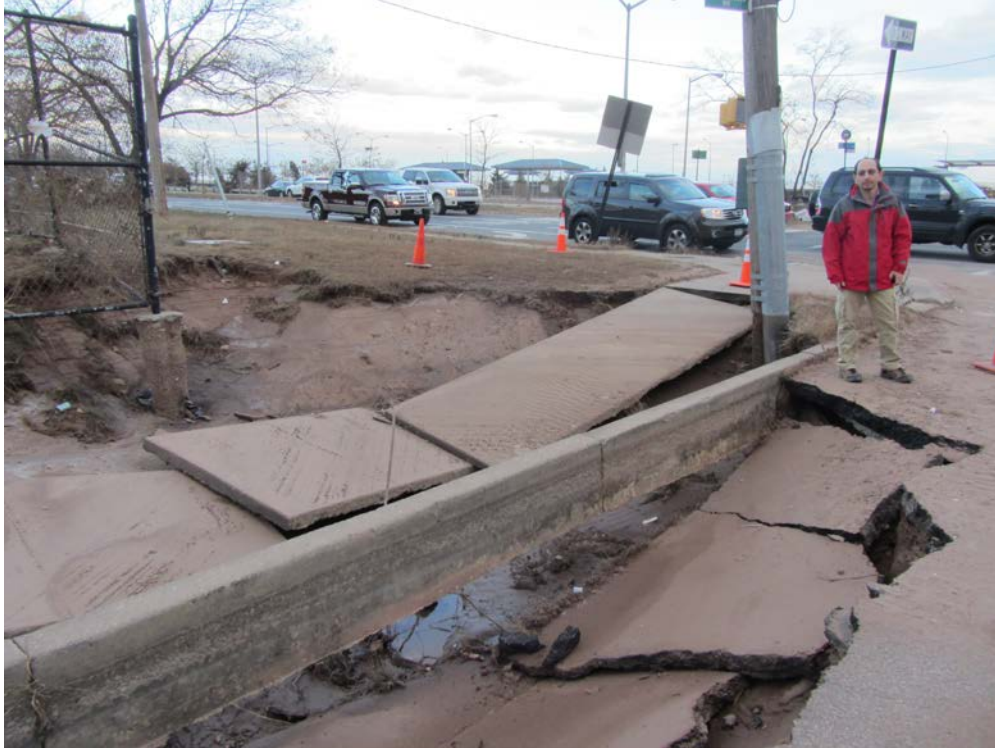
Figure 6.10 Scour undermining overhead power pole and sign, Slater Blvd and Father Capodanno Blvd, Staten Island (40.576173° N, 74.082629° W, Nov. 4, 2012). GEER team co-leader Dr. Youssef Hashash in background.

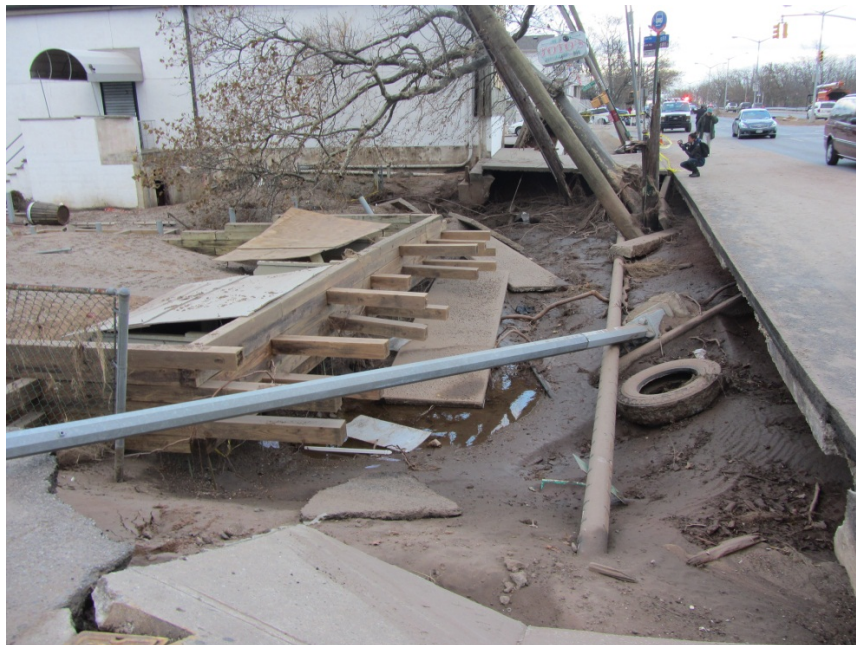
Figure 6.11 Scour undermining sidewalk, infrastructure utilities, and light pole foundation, Seaver Ave and Father Capodanno Blvd, Staten Island (40.575944° N, 74.083015° W, November 4, 2012).

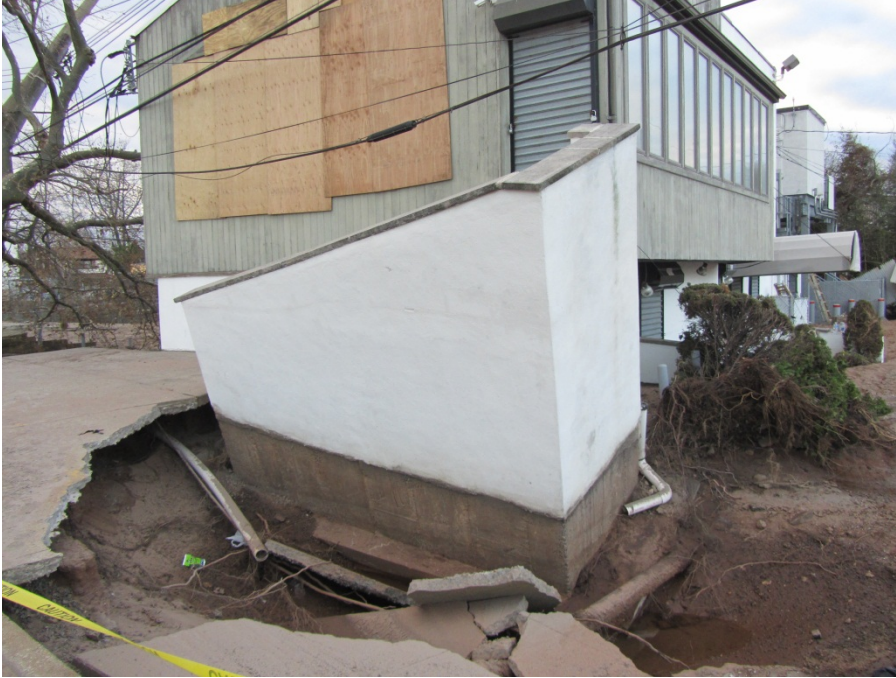
Figure 6.12 Scour undermining stair foundation and foundation drain, Seaver Ave and Father Capodanno Blvd, Staten Island (40.575944° N, 74.083015° W, November 4, 2012).

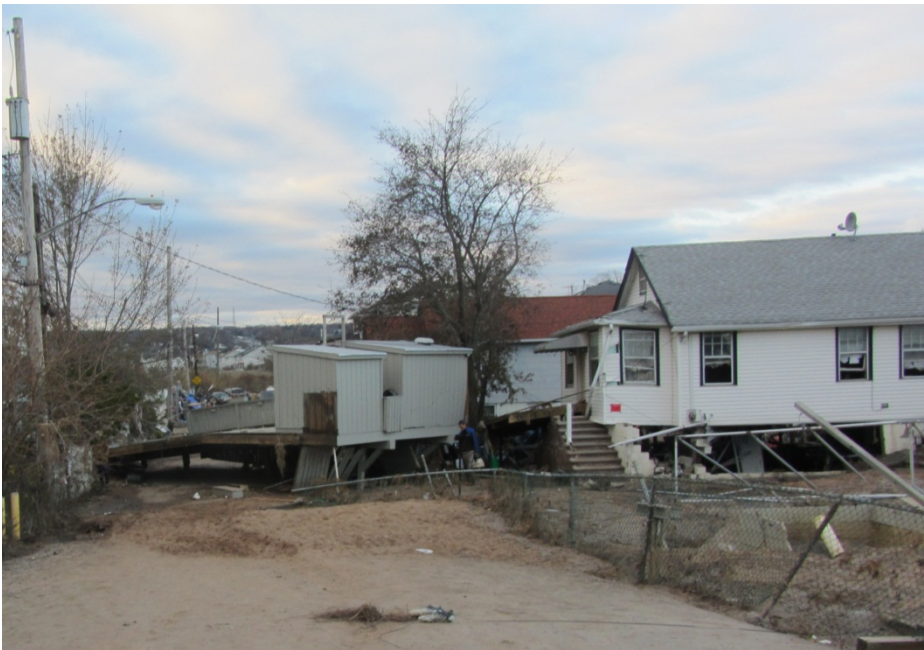
Figure 6.13 Damaged CMU block foundation, distressed timber frame house, and relocated wood deck, Staten Island (40.575944° N, 74.083015° W, November 4, 2012).

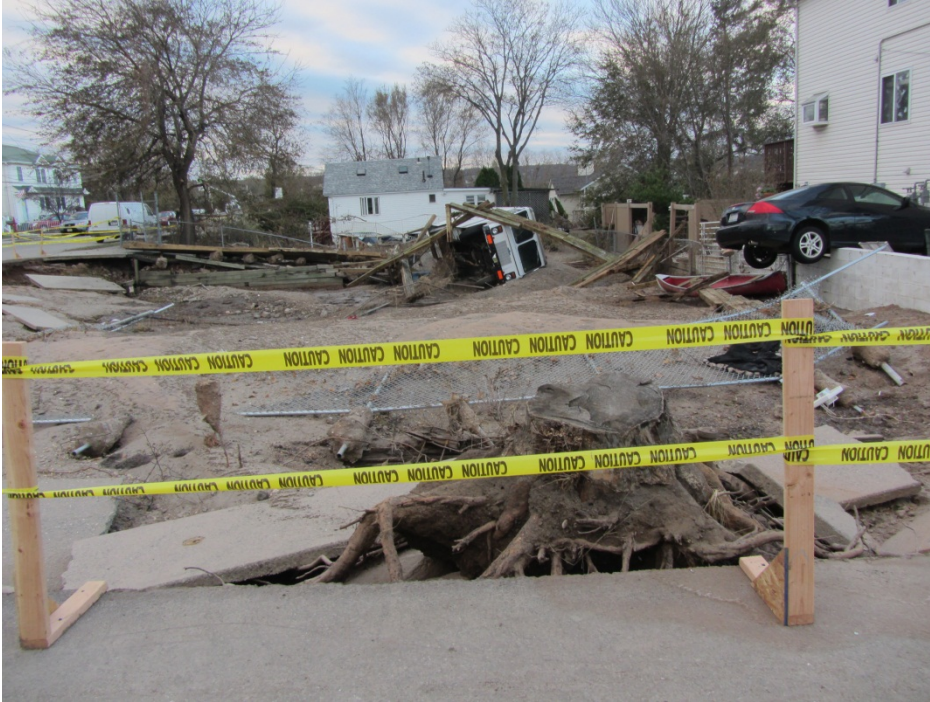
Figure 6.14 Flood water displaced timber debris and cars, Staten Island (40.575944° N, 74.083015° W, November 4, 2012).

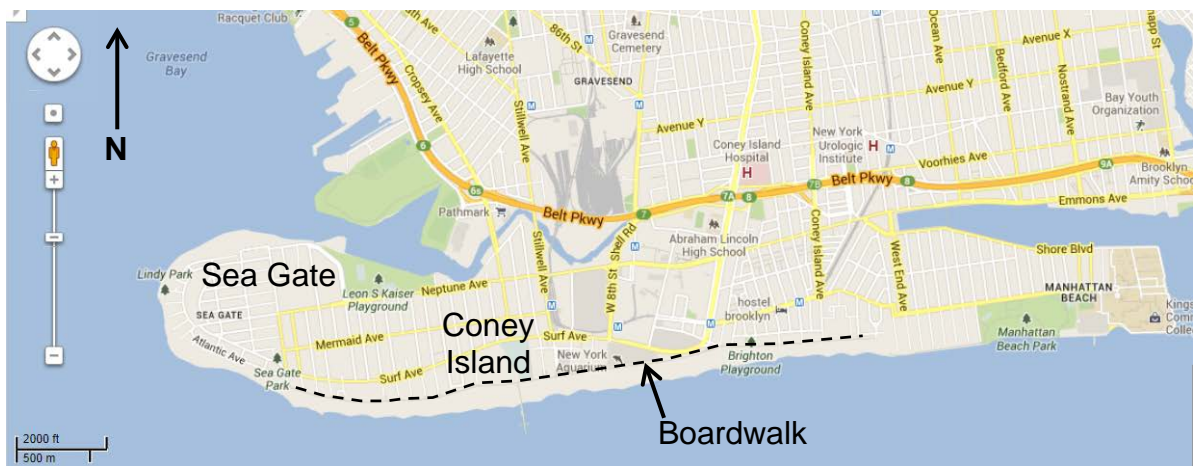
Figure 6.18 Map of Sea Gate and Coney Island, Brooklyn

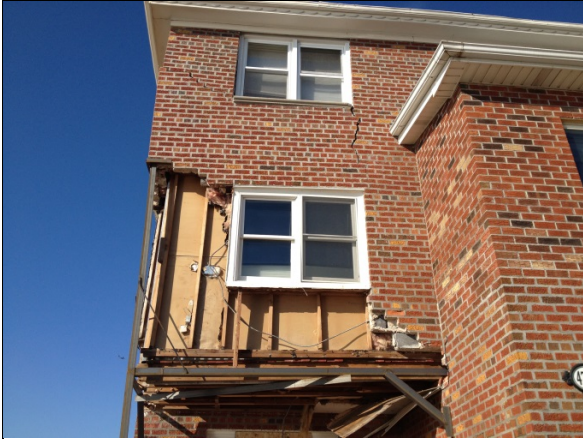
Figure 6.19 Damage to brick siding, Sea Gate, Brooklyn (November 9, 2012 – MRCE in collaboration with NYCDOB)

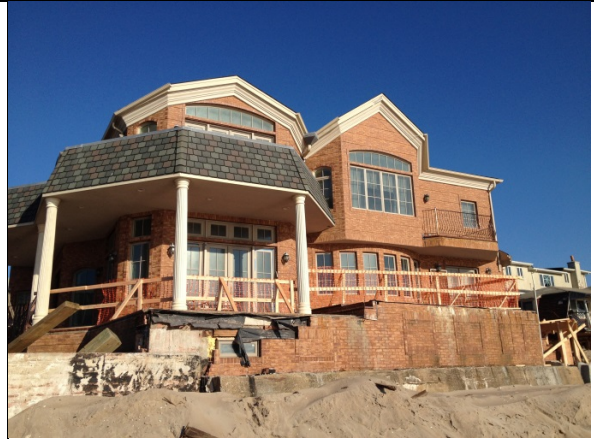
Figure 6.20 Brick veneer building on concrete wall foundation, Sea Gate, Brooklyn (November 9, 2012 – MRCE in collaboration with NYCDOB)

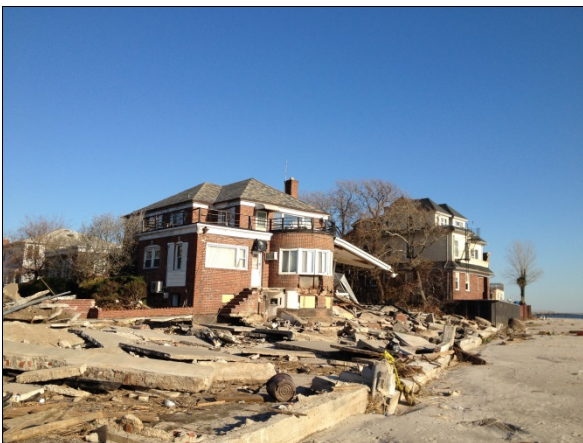
Figure 6.21 Undermining of beachfront retaining wall and loss of retained soil, Sea Gate, Brooklyn (November 9, 2012 – MRCE in collaboration with NYCDOB)

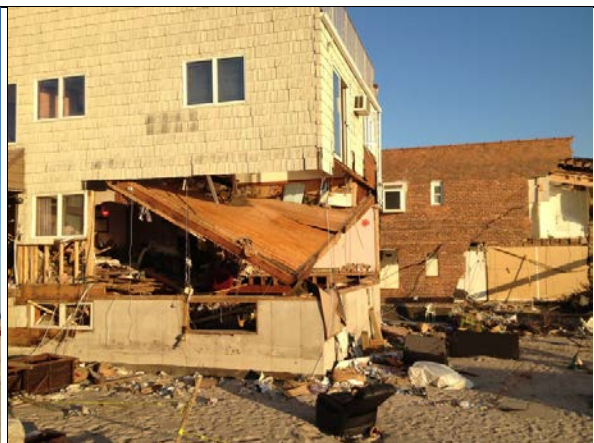
Figure 6.22 Partial wall and floor collapse, wood building on concrete wall foundation. Sea Gate, Brooklyn (November 9, 2012 – MRCE in collaboration with NYCDOB)

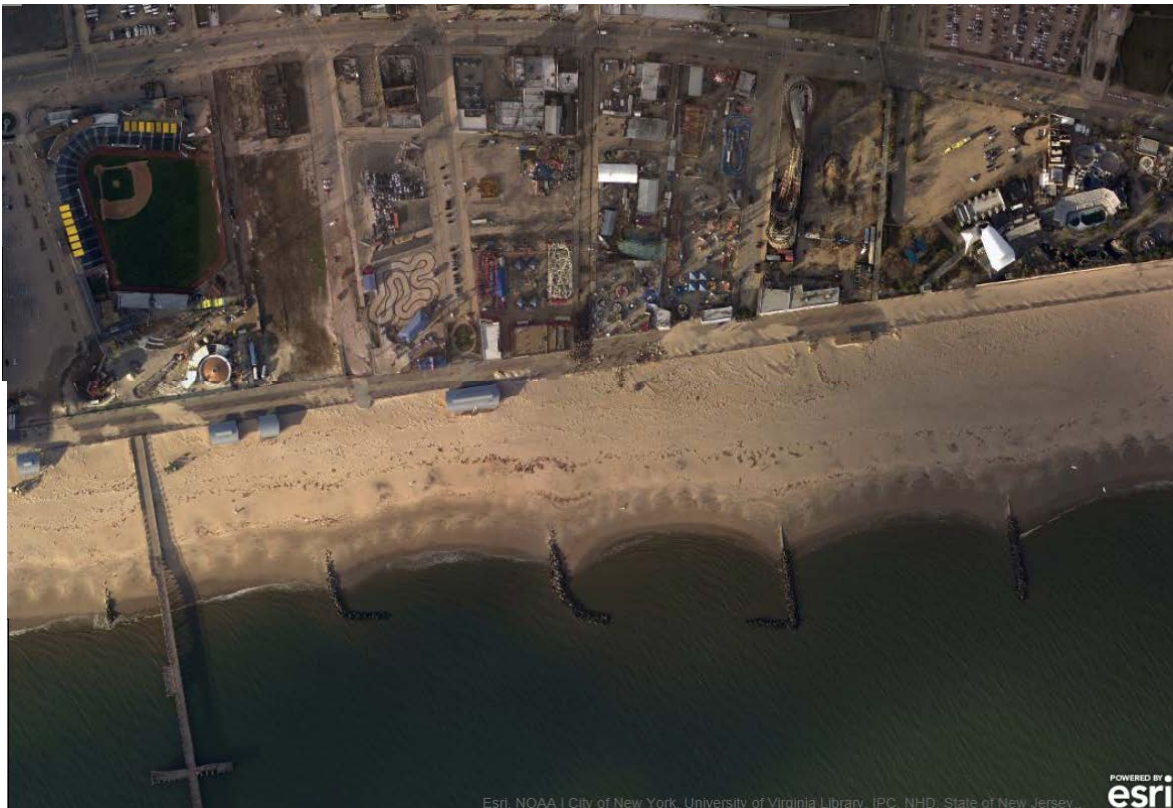
Figure 6.23 Aerial view of Coney Island boardwalk after Sandy showing sand movement but no major structural damage. Imagery from: tmappsevents.esri.com/website/swipe_sandy/

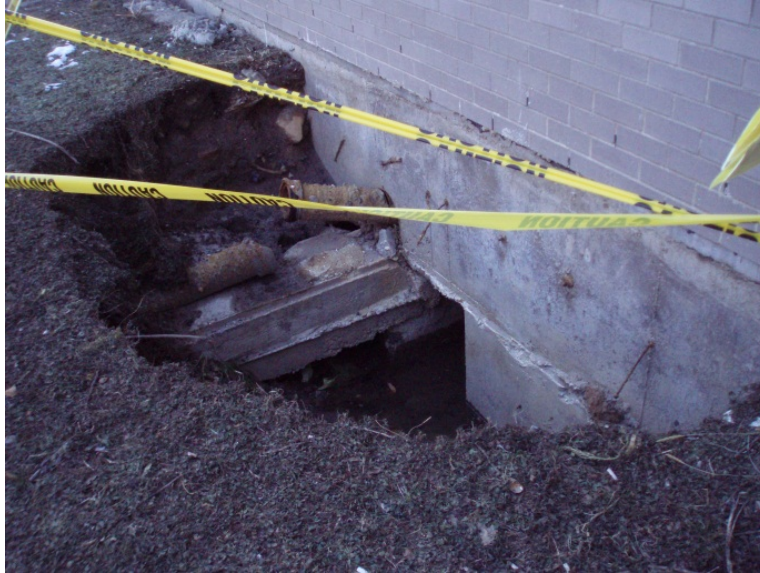
Figure 6.24 Sinkhole created by erosion and piping of flood water into building crawl space, Coney Island, Brooklyn. Note broken utilities undermined by the sinkhole.

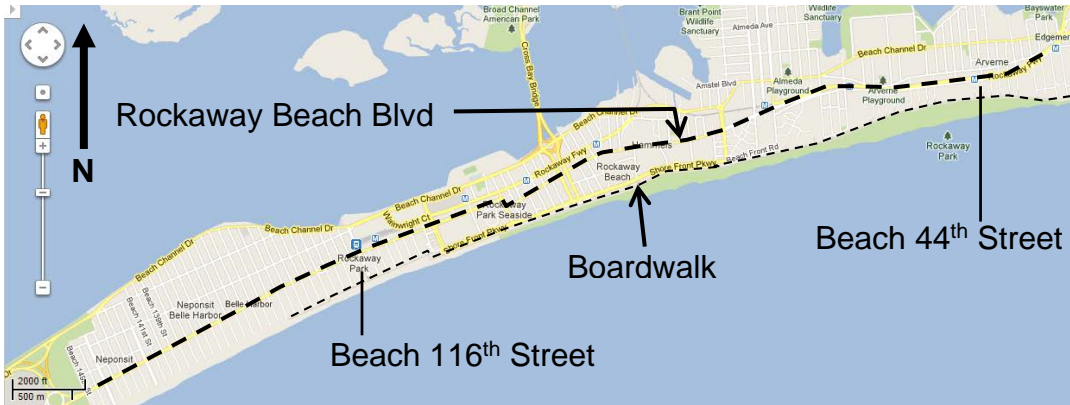
Figure 6.25 Map of a portion of the Rockaways, Queens.

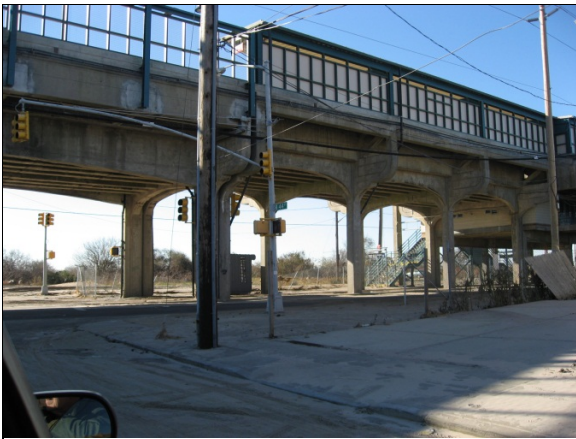
Figure 6.26 Elevated subway structure at Beach 44th Street showing little visible damage, Arverne, Queens (40.593287° N, -73.775318° W, November 4, 2012)

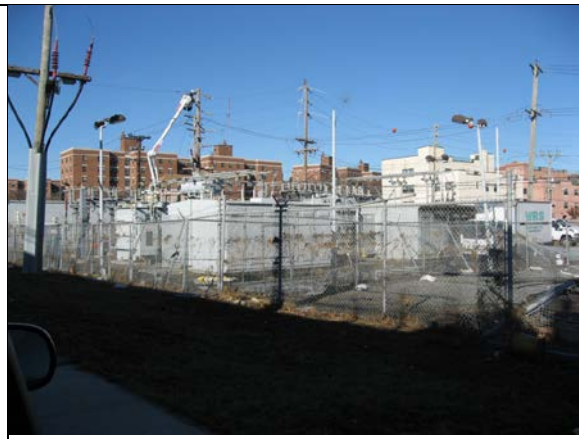
Figure 6.27 Electrical substation at Beach 53rd Street with high water mark at 4.8 feet on fence, Arverne, Queens (40.592752° N, 73.783396° W, November 4, 2012)

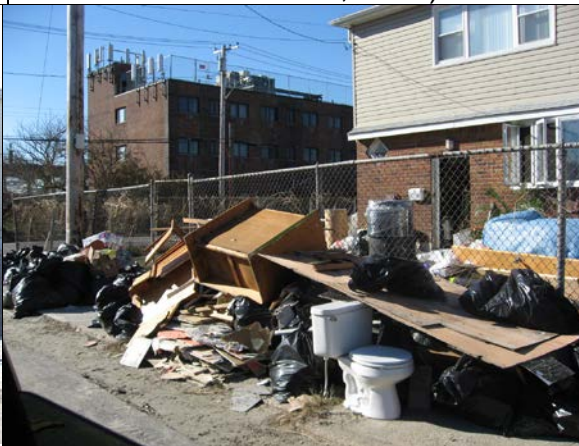
Figure 6.29 Typical evidence of flood damage, Beach 46th Street, Rockaway Beach (40.594322° N, 73.777252° W, November 4, 2012)

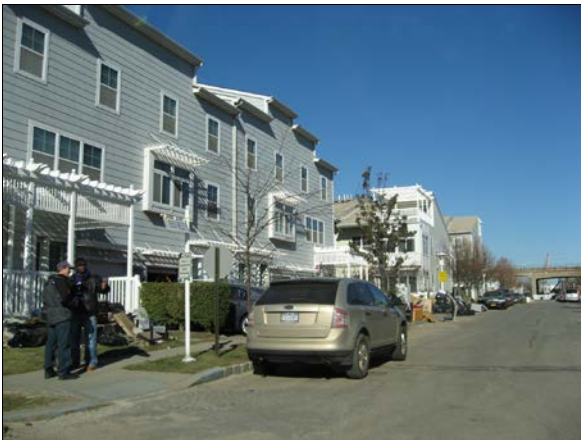
Figure 6.31 Three-story buildings with little visible structural damage, Beach 76th Street and Rockaway Beach Blvd, Rockaway Beach, Queens (40.588689° N, 73.803595° W, November 4, 2012)

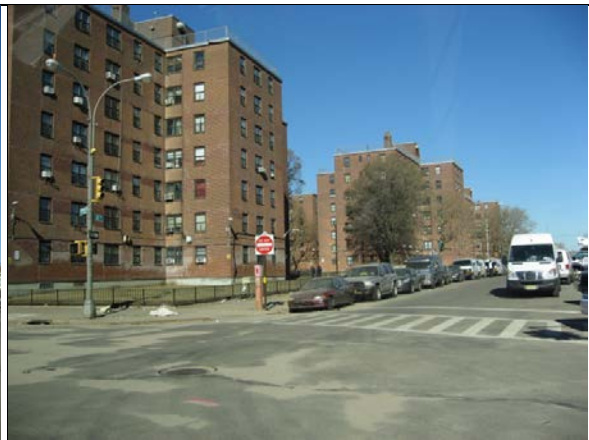
Figure 6.32 Seven-story buildings with little visible structural damage, Beach 81st Street & Rockaway Beach Blvd, Rockaway Beach, Queens (40.587999° N, 73.807333° W, Nov. 4, 2012)

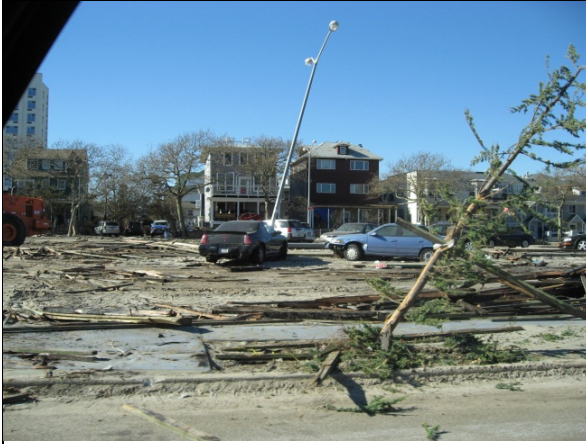
Figure 6.33 Debris and cars moved inland, Beach 94th Street and Shore Front Road, Rockaway Beach, Queens (40.584691°N, 73.815873° W, November 4, 2012)

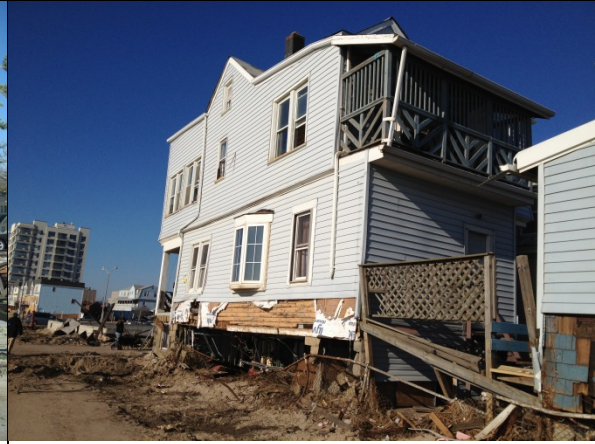
Figure 6.34 Void in CMU block foundation wall; wood frame building still standing, Rockaway, Queens (November 17, 2012 – MRCE in collaboration with NYCDOB)

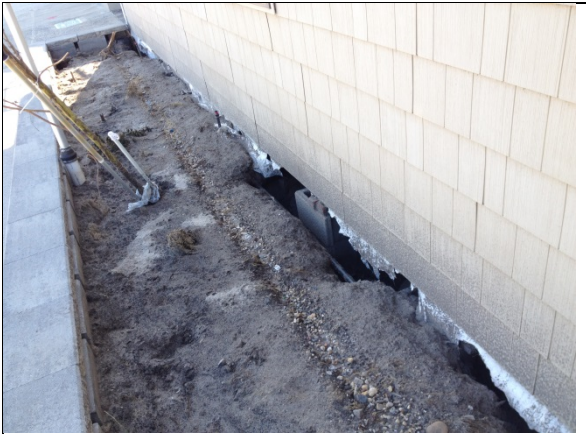
Figure 6.35 Erosion at CMU foundation wall, Rockaway, Queens (November 17, 2012 – MRCE in collaboration with NYCDOB)

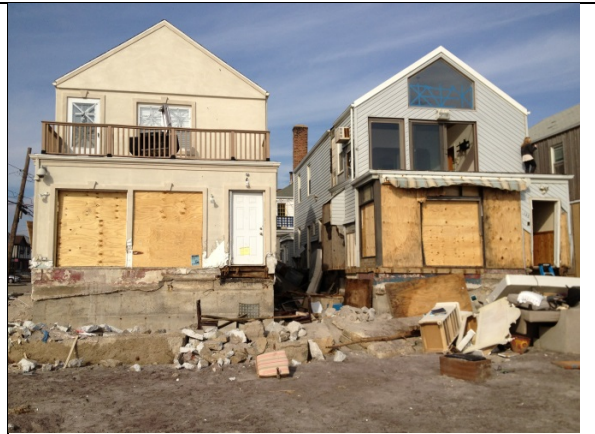
Figure 6.36 Beachfront houses with concrete wall foundations, Rockaway, Queens (November 18, 2012 – MRCE in collaboration with NYCDOB)

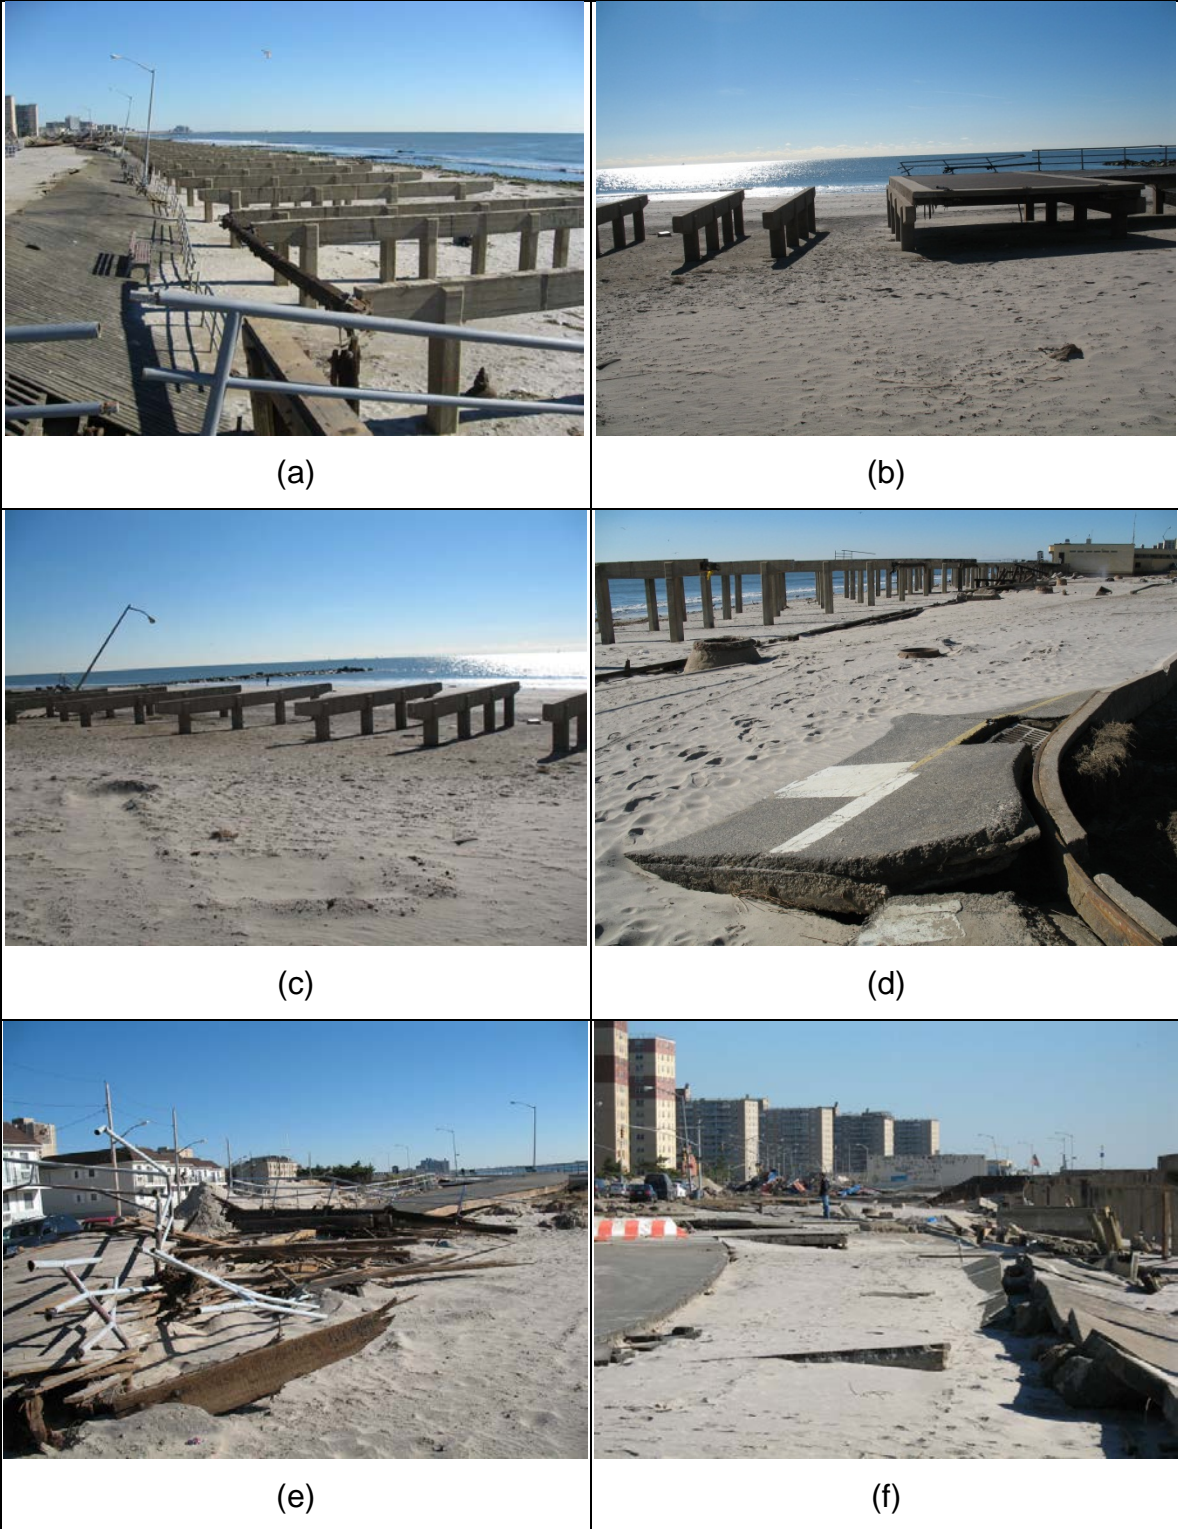
Figure 6.37 Typical damage to boardwalk and shore front road, Beach 95th Street, Rockaway Beach, Queens (40.583445° N, 73.815529° W, Nov. 4, 2012)

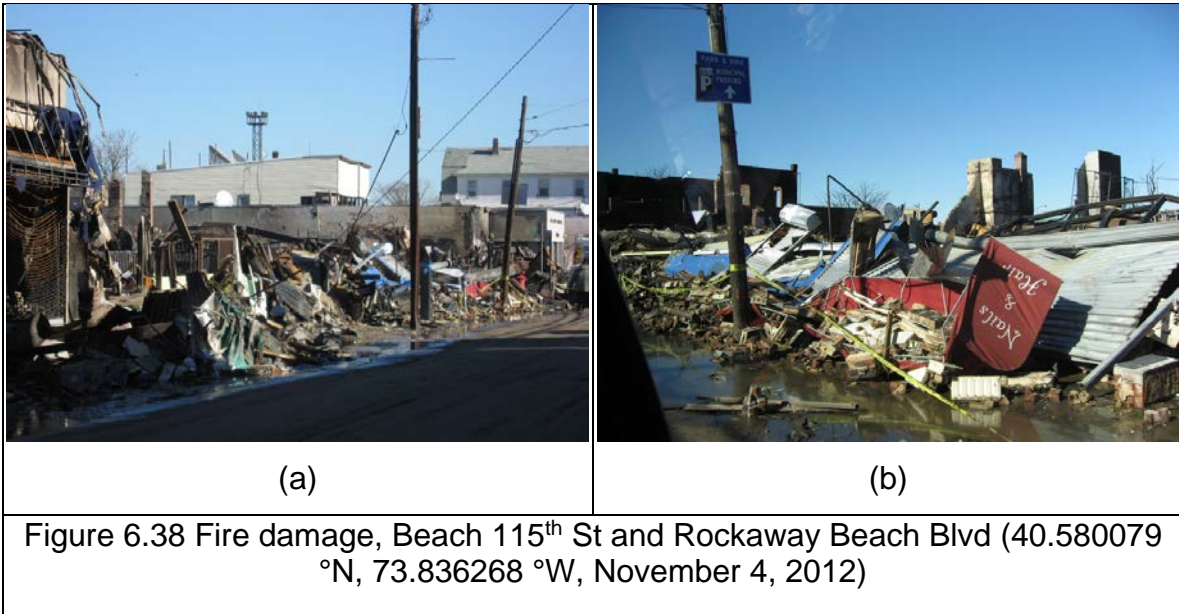
6.3.4. The Rockaways – Breezy Point and Roxbury

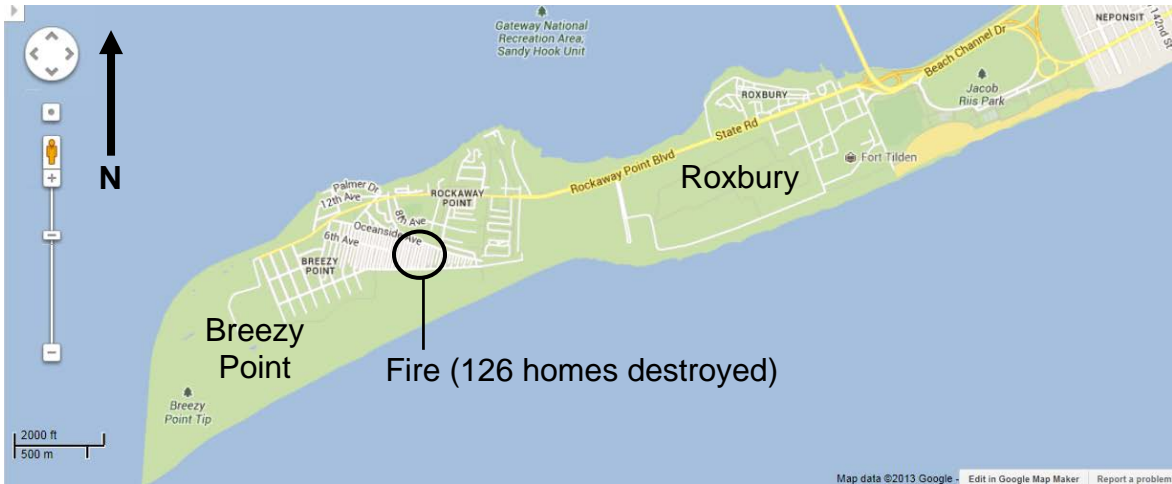
Figure 6.39 Map of Breezy Point and Roxbury, Queens.

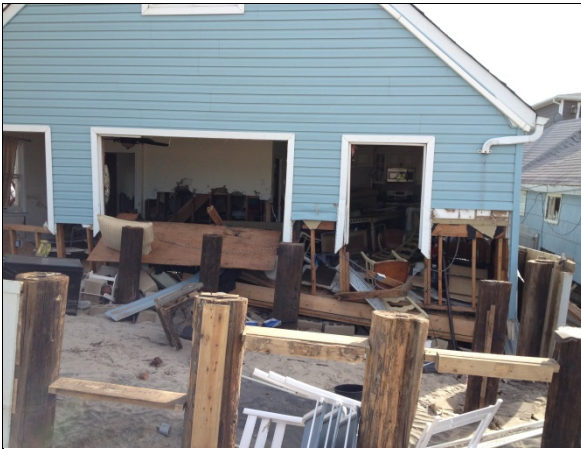
Figure 6.40 House washed off of pile foundations, Breezy Point, Queens (November 5, 2012 – MRCE in collaboration with NYCDOB)

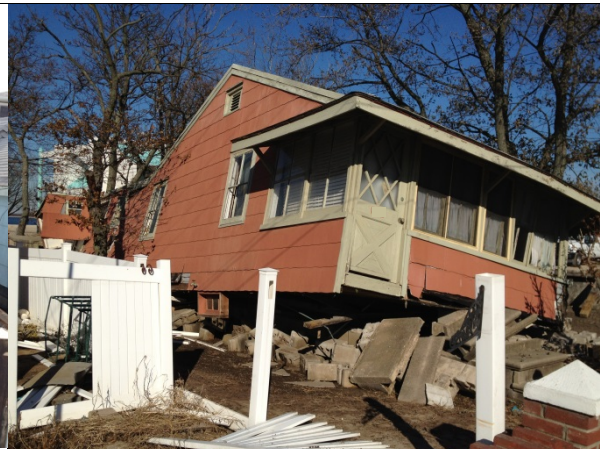
Figure 6.41 Destroyed CMU wall foundation, Breezy Point, Queens (November 5, 2012 – MRCE in collaboration with NYCDOB)

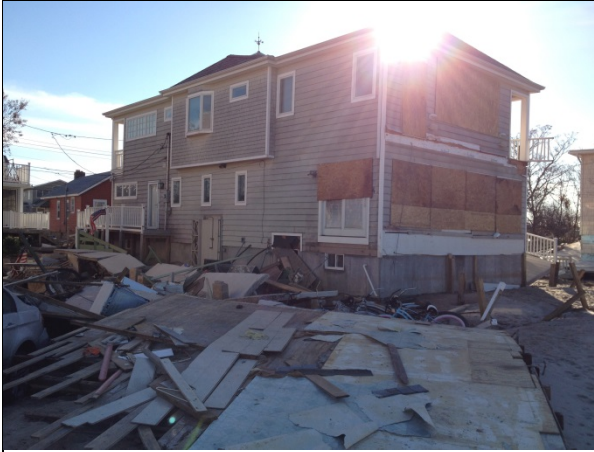
Figure 6.42 Concrete wall foundation with minor structural damage, Breezy Point, Queens (November 5, 2012 – MRCE in collaboration with NYCDOB)

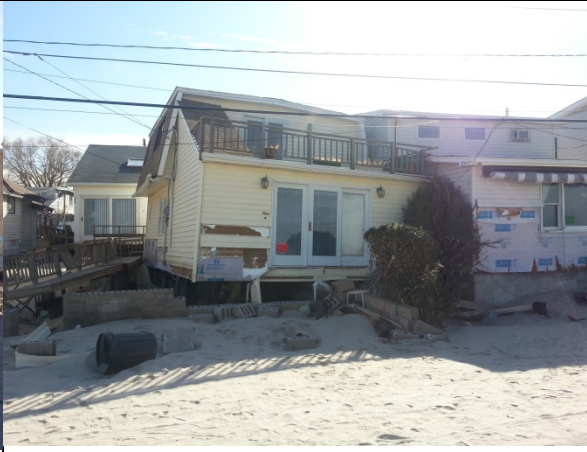
Figure 6.43 House washed off of CMU wall foundation, Breezy Point, Queens (November 5, 2012 – MRCE in collaboration with NYCDOB)

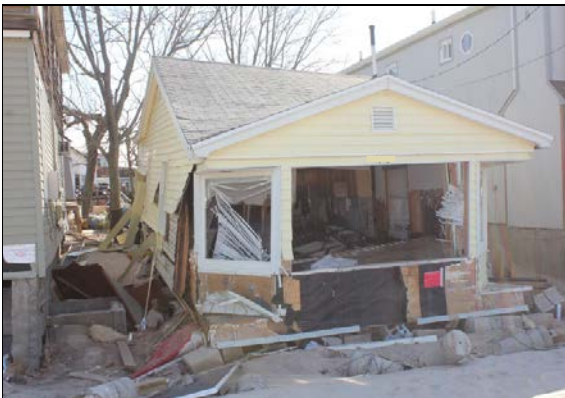
Figure 6.44 Collapsed CMU wall foundation, Breezy Point, Queens (November 5, 2012 – MRCE in collaboration with NYCDOB)

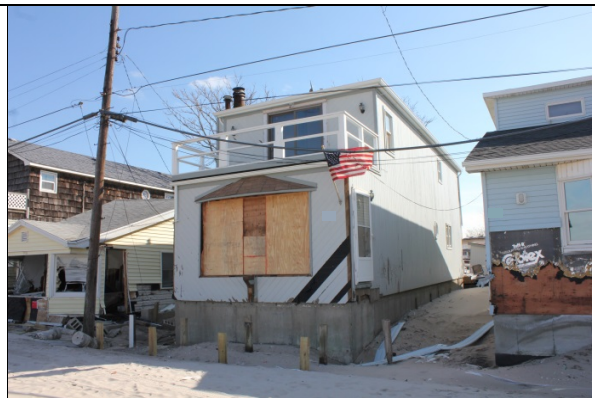
Figure 6.45 Concrete wall foundation with minor structural damage, Breezy Point, Queens (November 5, 2012 – MRCE in collaboration with NYCDOB)

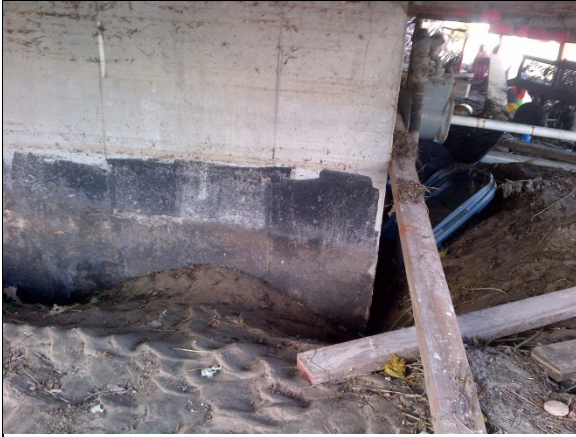
Figure 6.46 Scour and erosion at concrete wall foundation, Breezy Point, Queens (November 5, 2012 – MRCE in collaboration with NYCDOB)

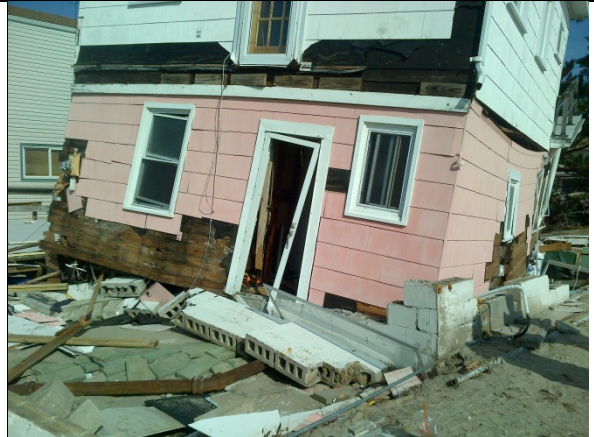
Figure 6.47 Destroyed CMU wall foundation, Breezy Point, Queens (November 12, 2012 – MRCE in collaboration with NYCDOB)

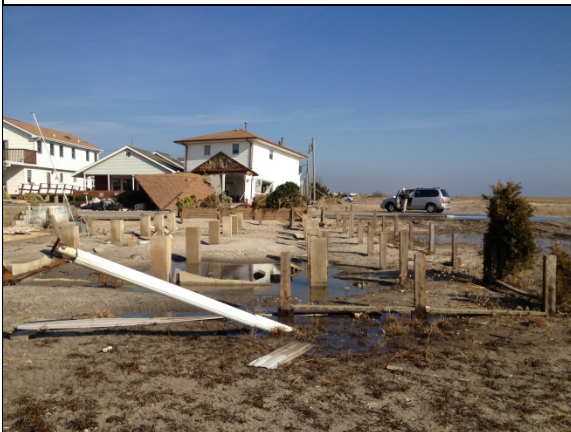
Figure 6.48 House washed off of pile foundation, Breezy Point, Queens (November 12, 2012 – MRCE in collaboration with NYCDOB)

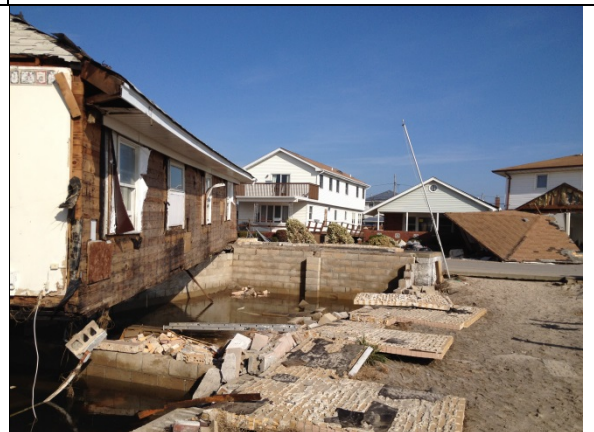
Figure 6.49 House washed off of CMU wall foundation, Breezy Point, Queens (November 12, 2012 – MRCE in collaboration with NYCDOB)
