Editors: Youssef M.A. Hashash & Sissy Nikolaou

GEER Team Leaders: Youssef Hashash (University of Illinois at Urbana-Champaign), Sissy Nikolaou (Mueser Rutledge Consulting Engineers, MRCE)

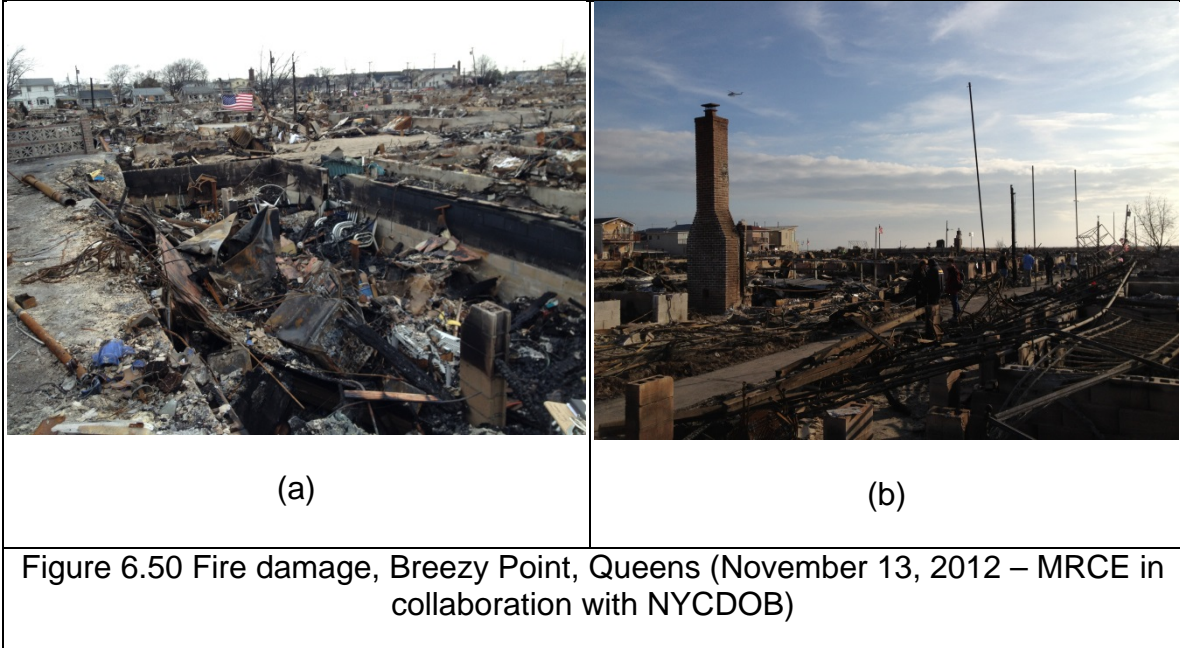
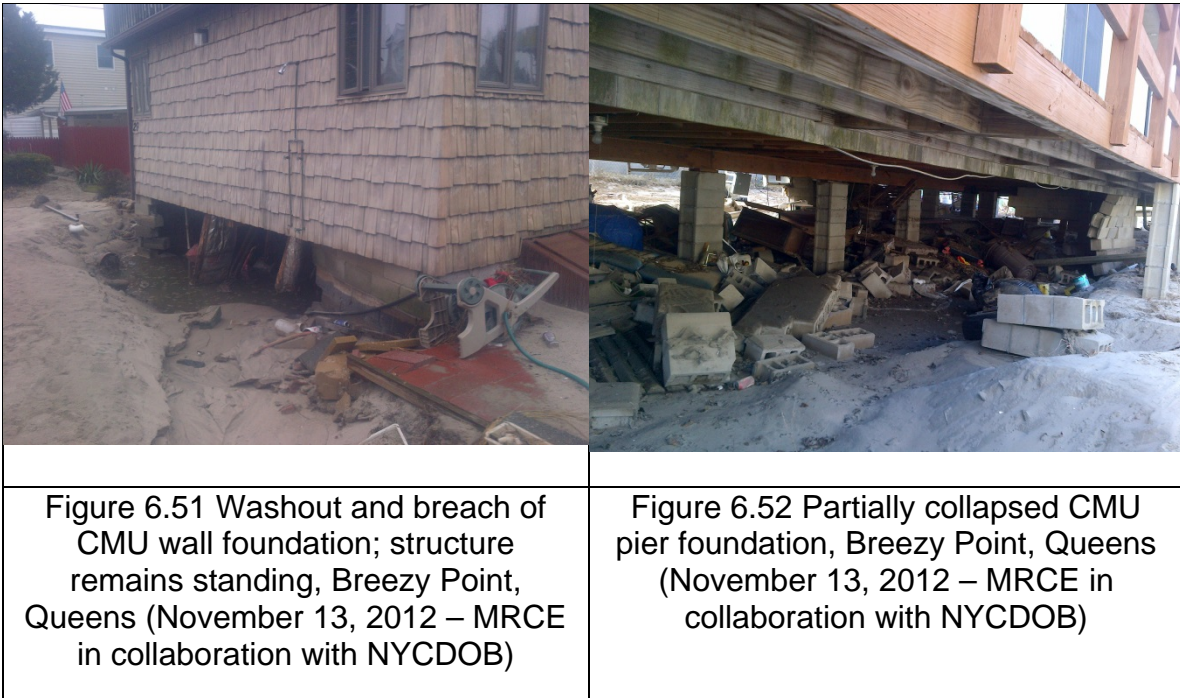
Figure 6.49 House washed off of CMU wall foundation, Breezy Point, Queens (November 12, 2012 – MRCE in collaboration with NYCDOB)

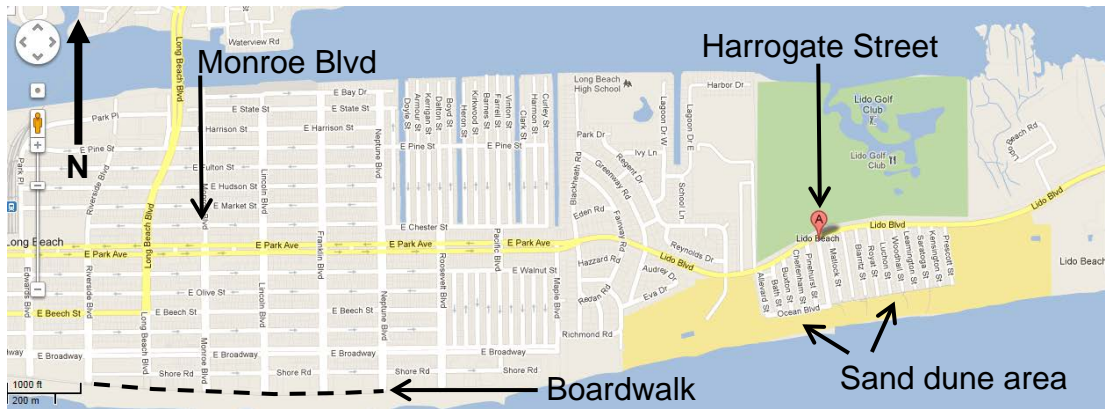
Figure 6.53 Map of a portion of Long Beach, Nassau County.

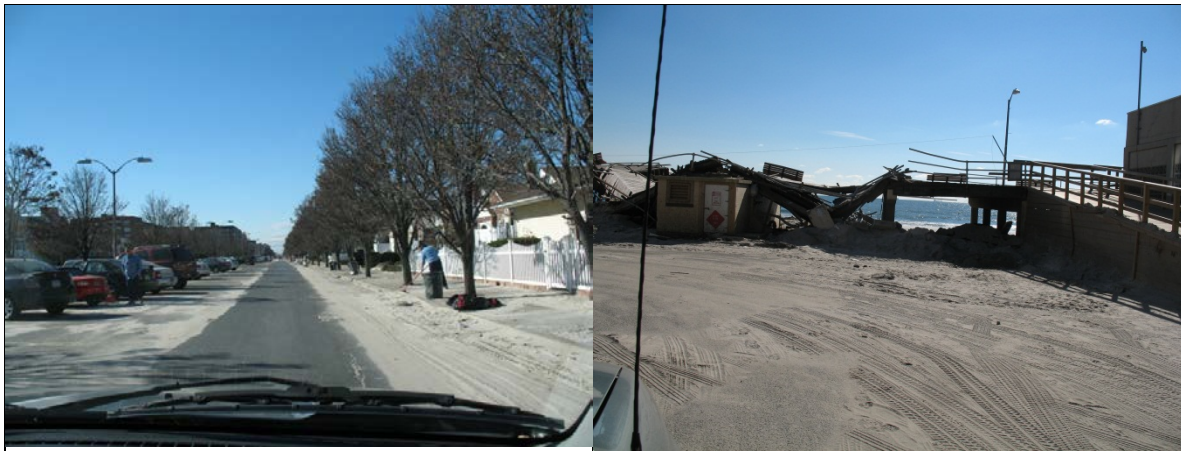
Figure 6.54 Sand deposited on street East Broadway, Long Beach (40.584842° N, 73.646121° W, November 4, 2012)

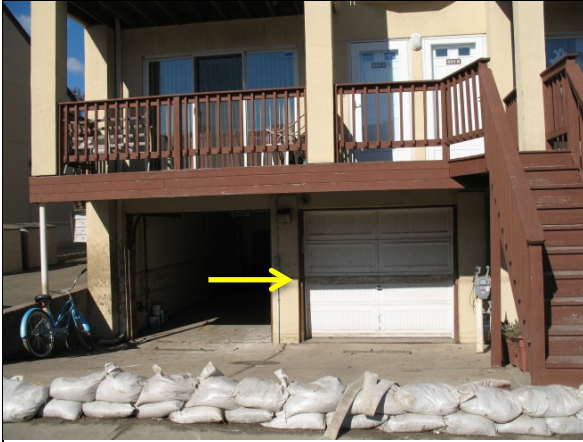
Figure 6.56 Sandbags and high water mark on garage door, East Broadway, Long Beach (40.584989 °N, 73.644769 °W, November 4, 2012)

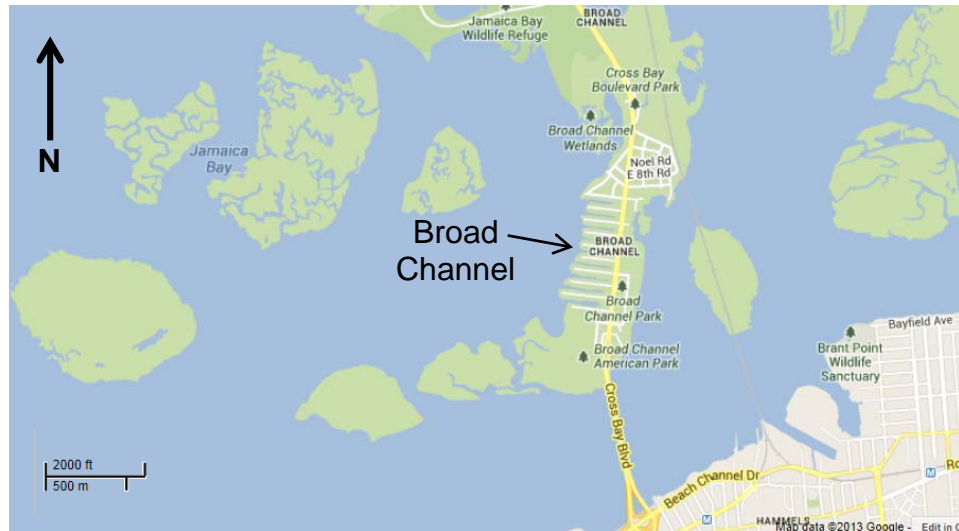
Figure 6.60 Map of Broad Channel, Queens

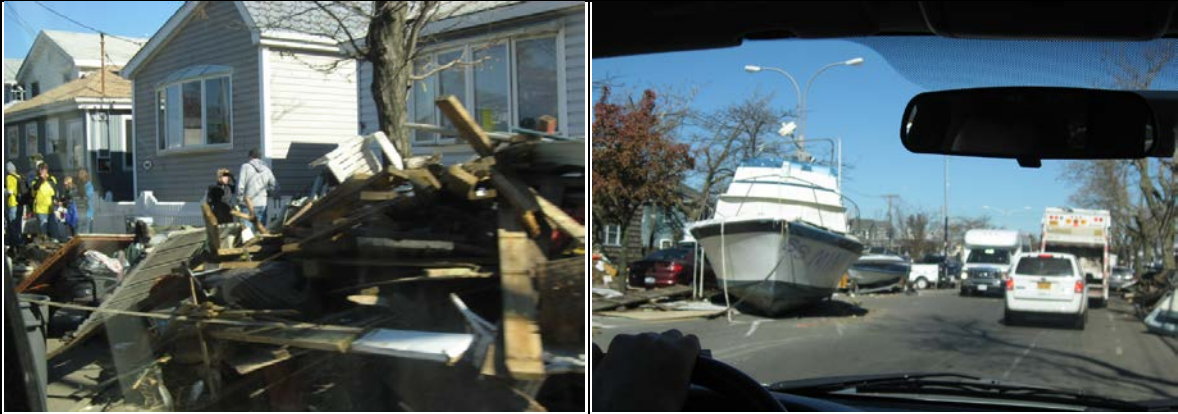
Extensive debris was piled outside buildings and on the road, and several boats were encountered in the median and along the sides of the road. At many homes, exterior residential heating oil tanks had floated, in some cases tipping and rupturing connections. Some soil washout was observed.

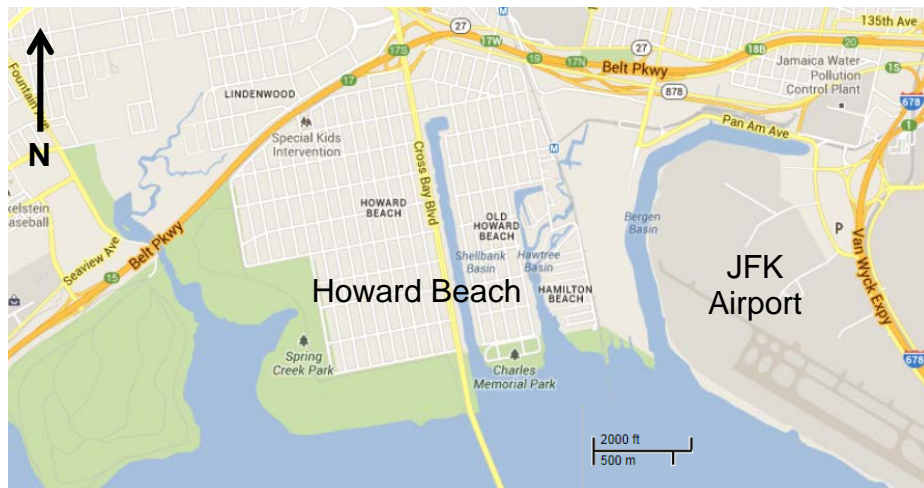
Figure 6.64 Map of Howard Beach, Queens

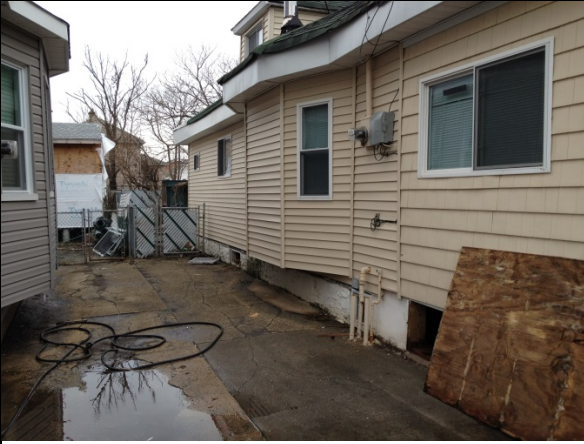
Figure 6.65 Typical home with flooding damage, Howard Beach, Queens. (November 16, 2012 – MRCE in collaboration with NYCDOB)

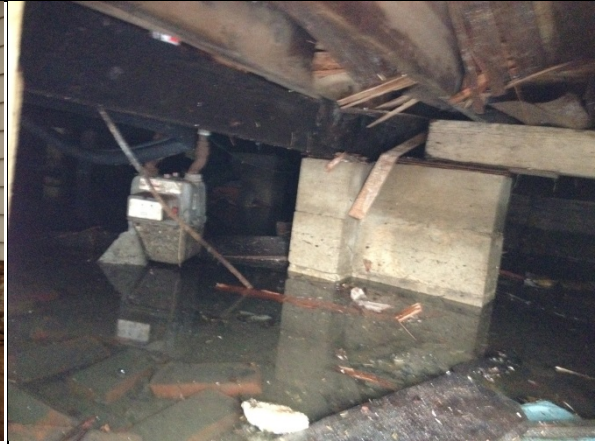
Figure 6.66 Basement flooding, Howard Beach, Queens. (November 16, 2012 – MRCE in collaboration with NYCDOB)

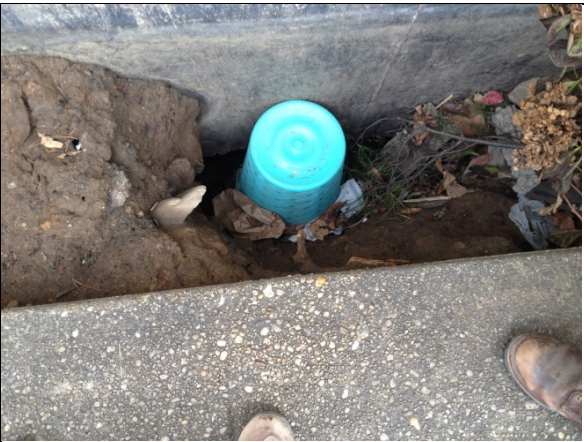
Figure 6.67 Soil washout at foundation wall, Howard Beach, Queens. (November 16, 2012 – MRCE in collaboration with NYCDOB)

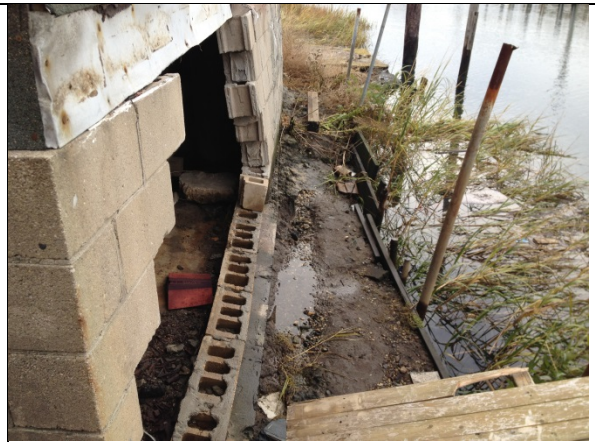
Figure 6.68 Partial collapse of CMU foundation wall, possibly related to erosion at footing, Howard Beach, Queens. (November 16, 2012 – MRCE in collaboration with NYCDOB)

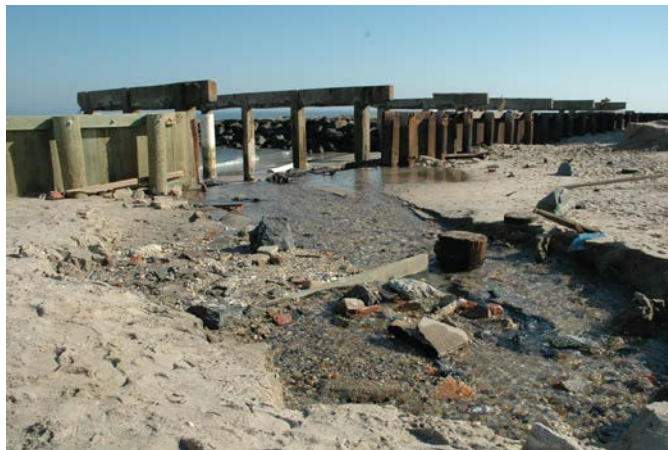
Figure 6.69 One of the breaches in the bulkheads along the coastline; in the backdrop are the remains of the boardwalk.

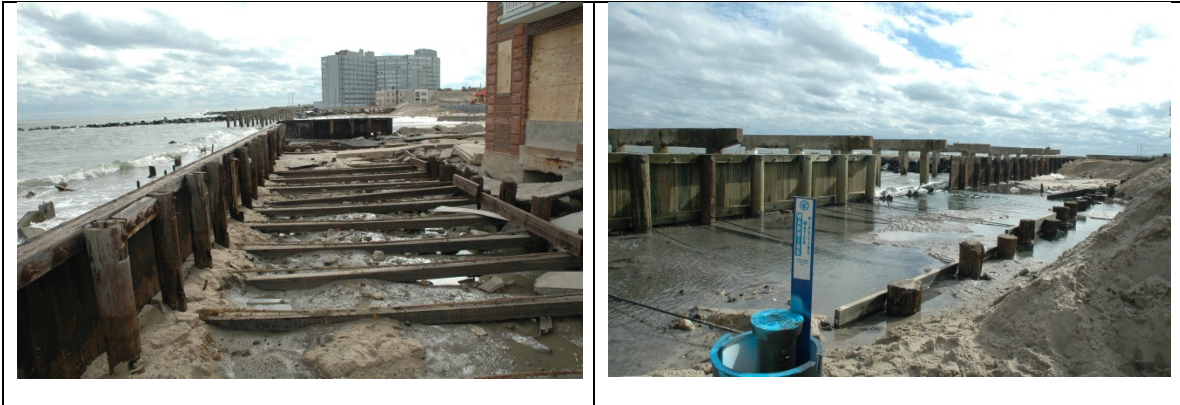
Figure 6.70 The backfill soil had been washed away exposing the severely corroded tie rods.

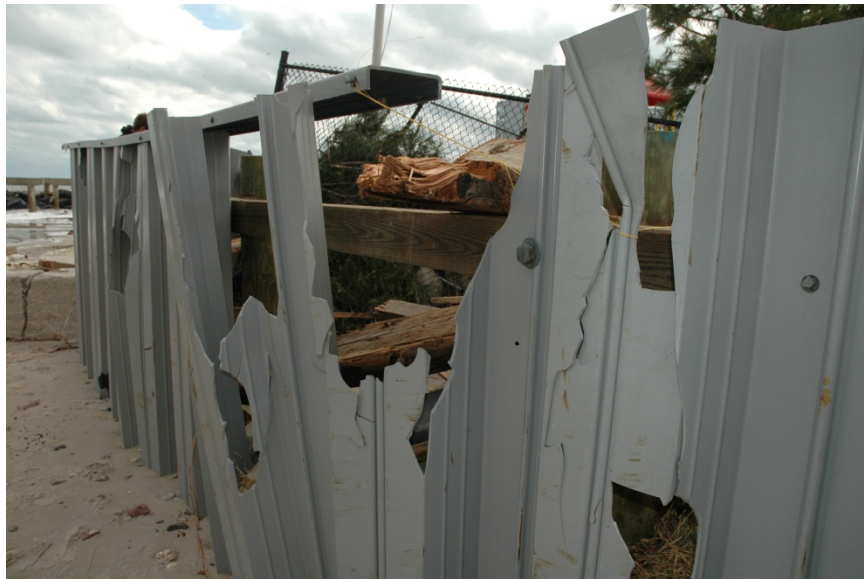
Figure 6.71 Damaged vinyl sheeting surrounding a children's playground.

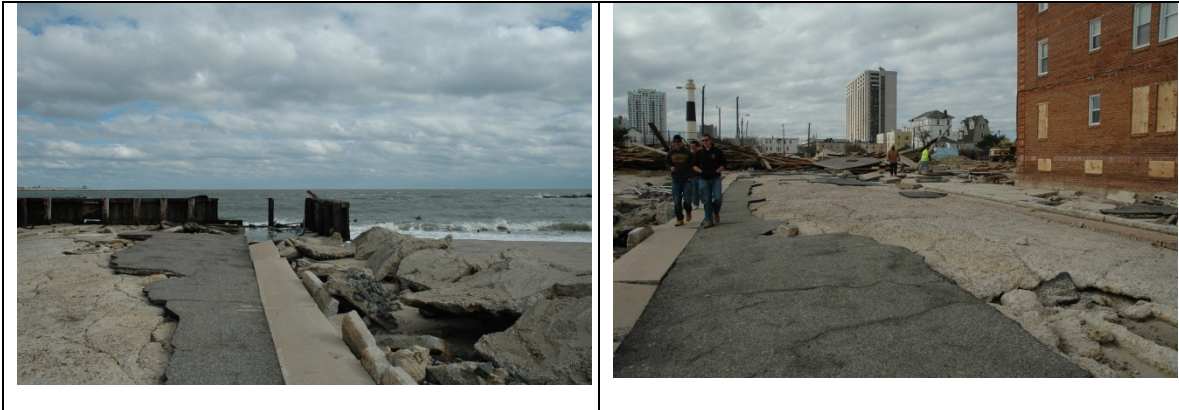
Figure 6.72 Erosion undermined the foundation causing significant damage to walkways and roadways.

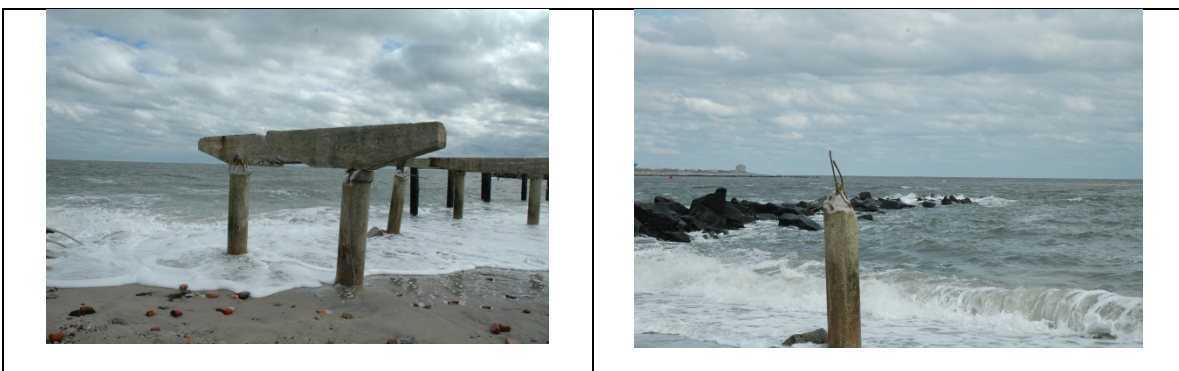
Figure 6.73 Damaged concrete piers that served as the supports for the boardwalk.

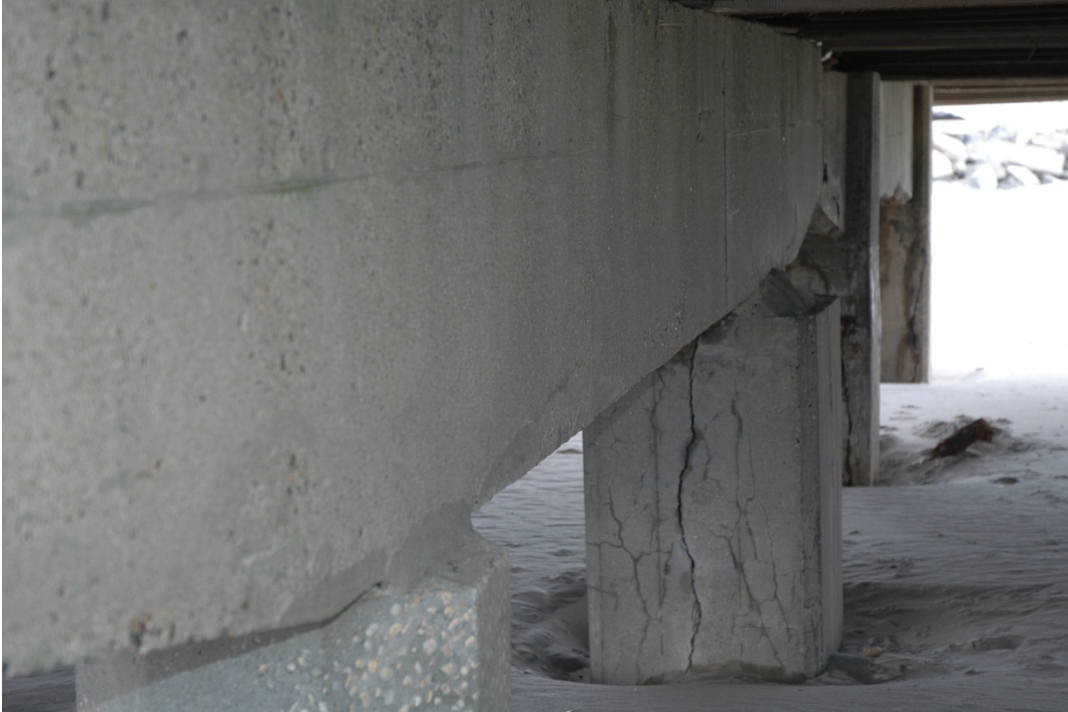
Figure 6.74 Existing concrete piers with evidence of cracking and some scour
An example of the waste generated by this storm is evident from Figure 6.75.
The reported data for Atlantic County shown in Table 6.1 shows the scale of the problem being faced even though Atlantic County did not suffer the damage experienced by Ocean County.

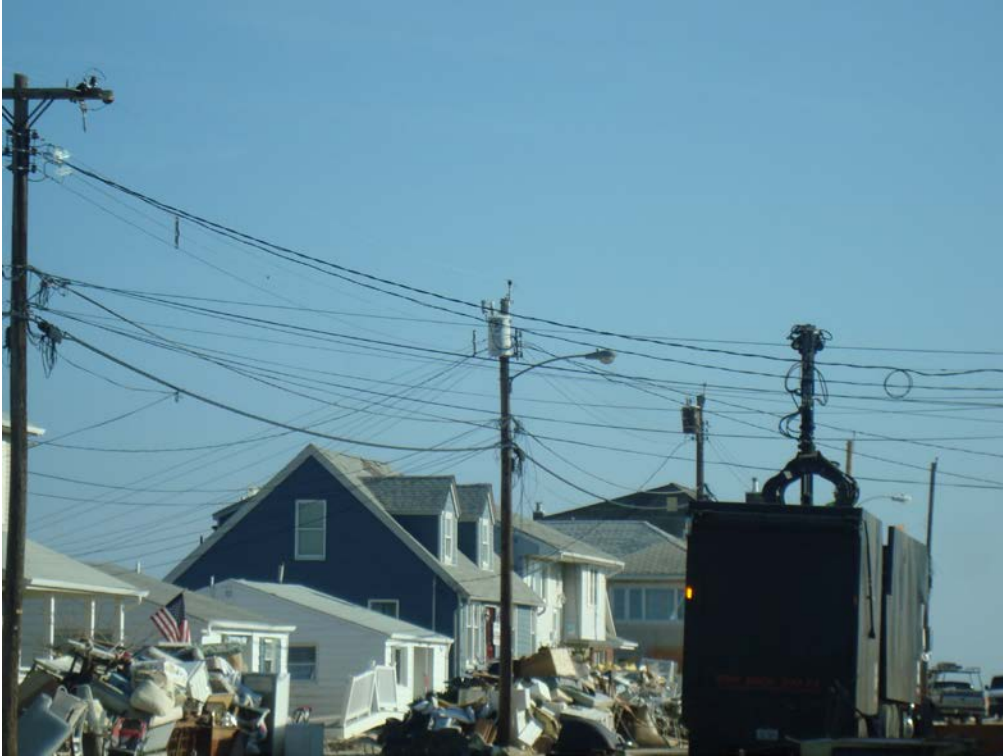
Figure 6.75 Waste generated by the storm includes hazardous waste such as refrigerators, home appliances and considerable debris

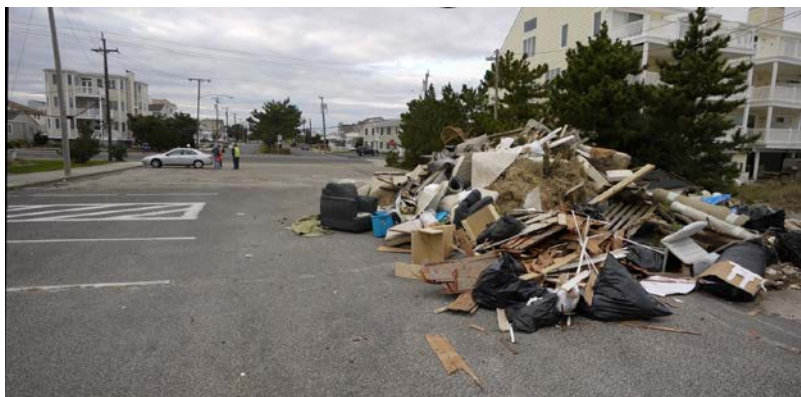
Figure 6.76 Discarded materials from residential clean-up (39.40756° N, 74.36239° W, November 3, 2012)

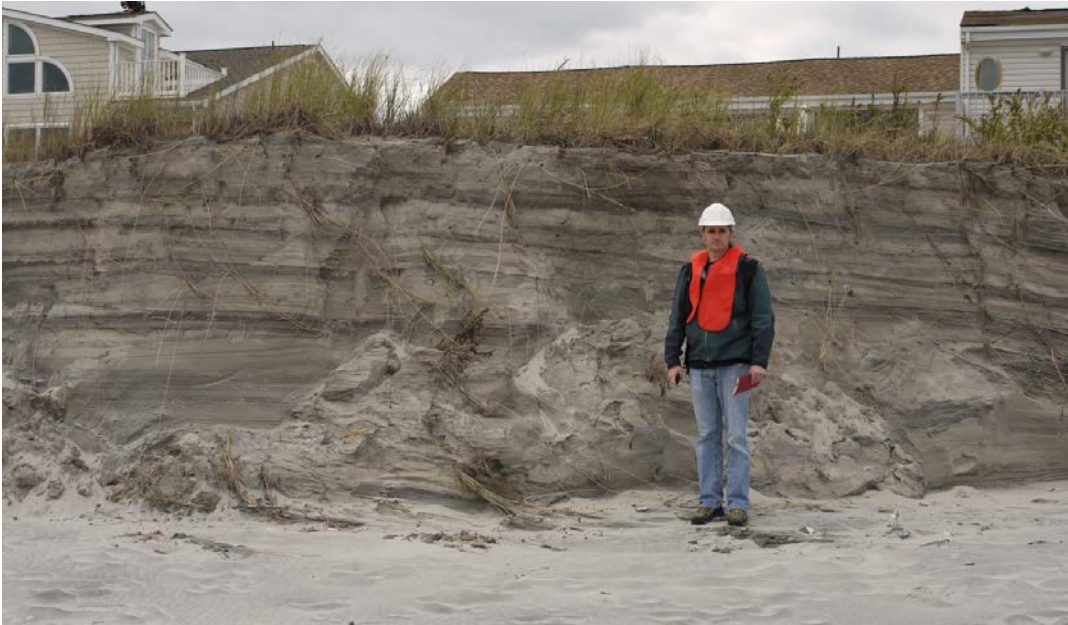
Figure 6.77 Barrier dune erosion (39.40929 ° N, 74.35996 ° W, November 3, 2012)

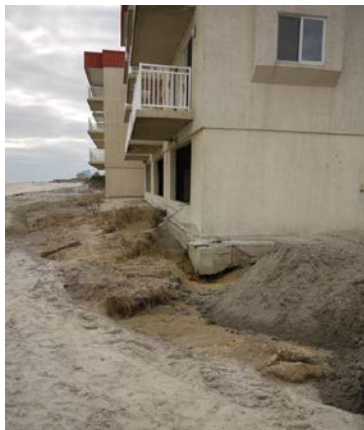
Figure 6.78 Erosion around the foundation of a beachfront condo at a location with little or no barrier dune (39.41112 ° N, 74.35811 ° W, November 3, 2012)

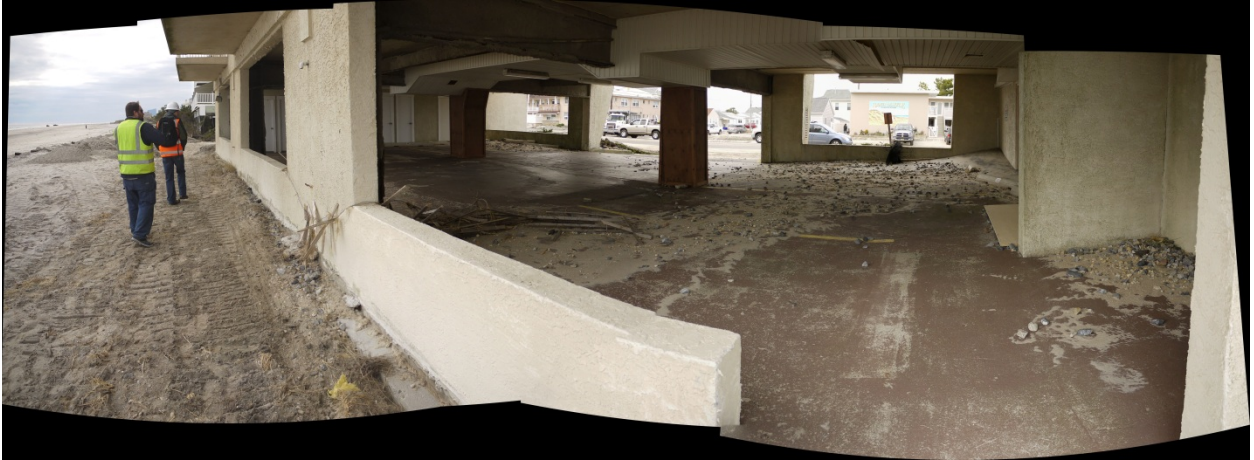
Figure 6.79 Sand deposition in the first floor garage of that same condo (39.41112 ° N, 74.35811 ° W, November 3, 2012)

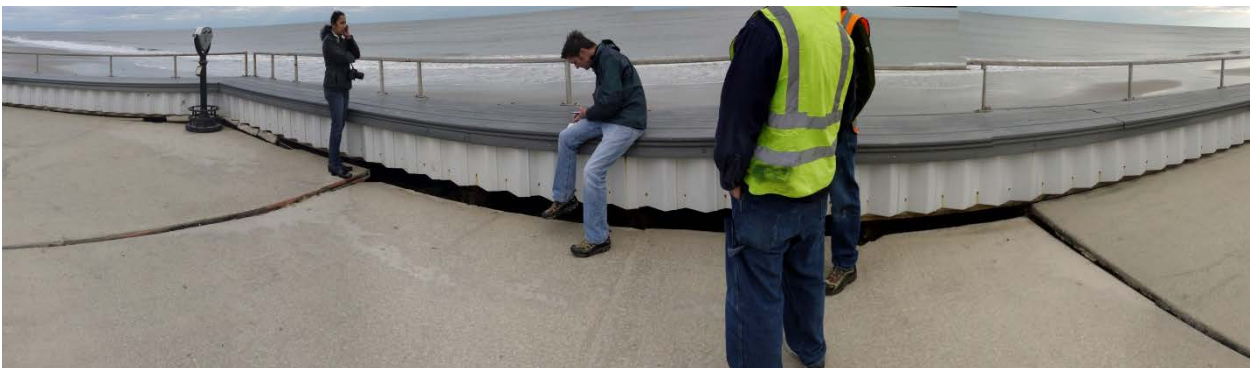
Figure 6.82 Settlement along the top of the seawall (39.41440 ° N, 74.35395 ° W, November 3, 2012)

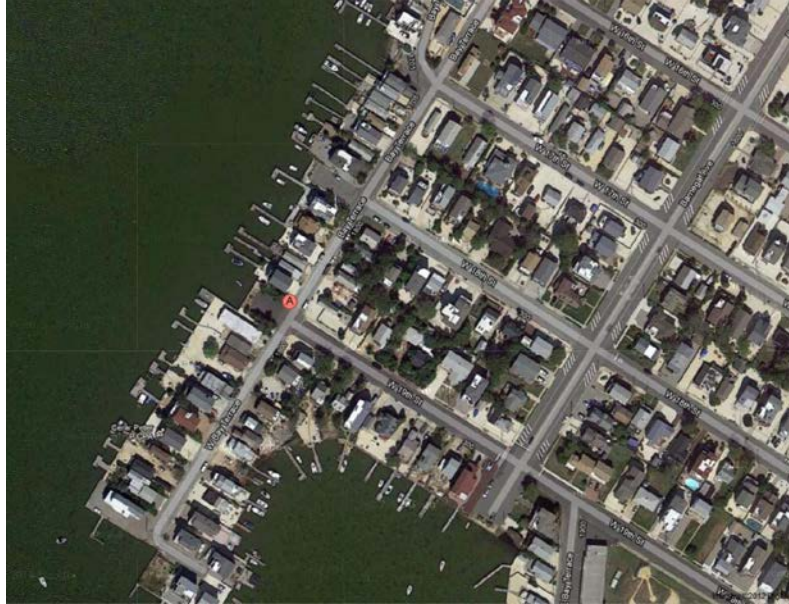
Figure 6.83 Bayside area that appeared to suffer the most damage in Ship Bottom (39°38'45.88"N, 74°11'12.80"W).

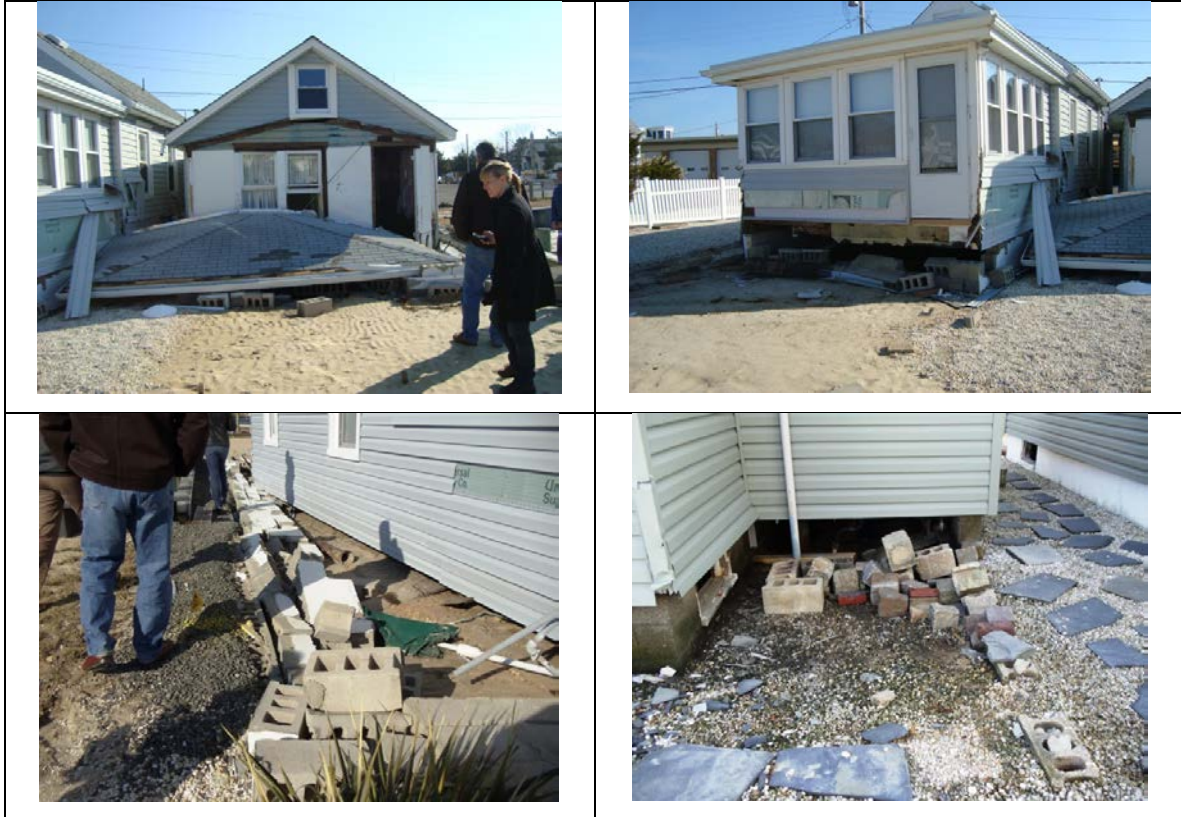
Figure 6.84 Damage to older structures on shallow foundations (39°38'41.15"N, 74°11'7.01"W)

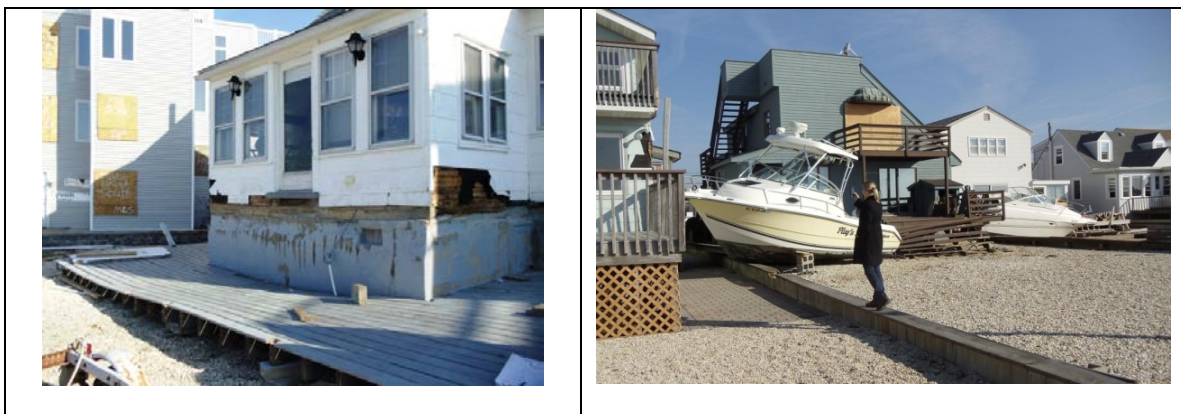
Figure 6.85 Damage to structures due to collision with floating objects such as boats (39°38'22.57"N, 74°11'18.89"W).

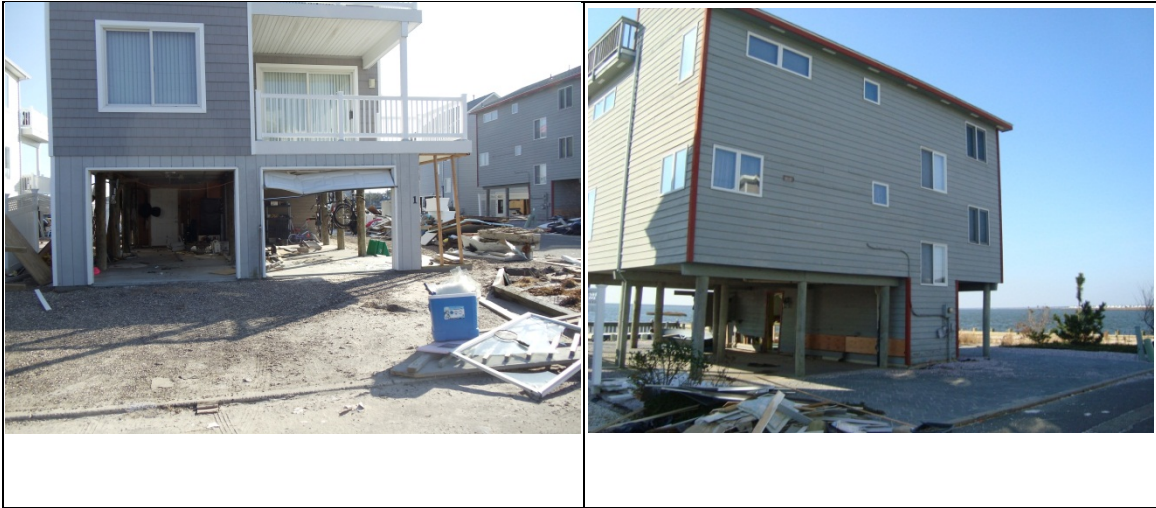
Figure 6.86 Breakaway walls that yielded under the lateral loading imposed by the storm surge as they were designed to perform (39°38'45.13"N, 74°11'12.87"W).

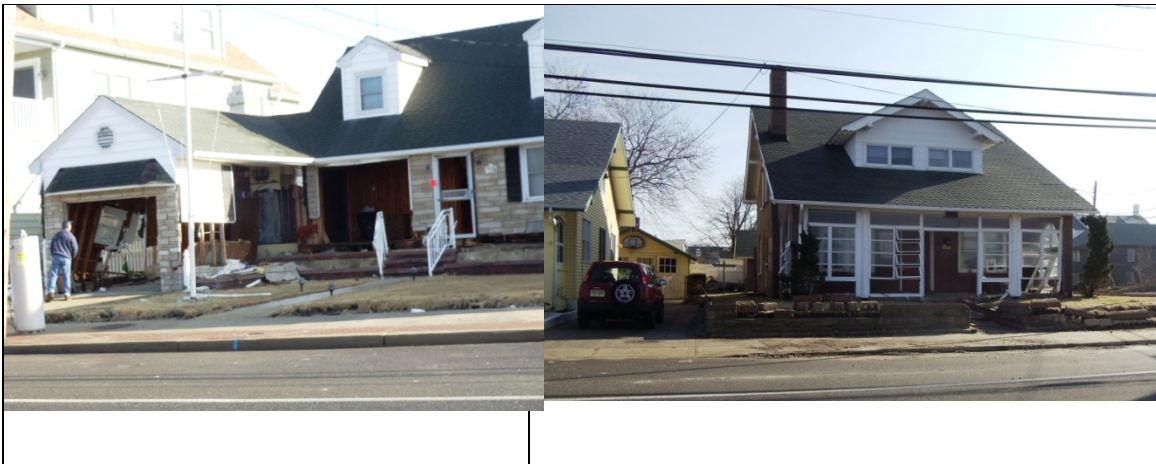
Figure 6.87 Bayside homes without (left) and with (right) a beach buffer between them and the bay.

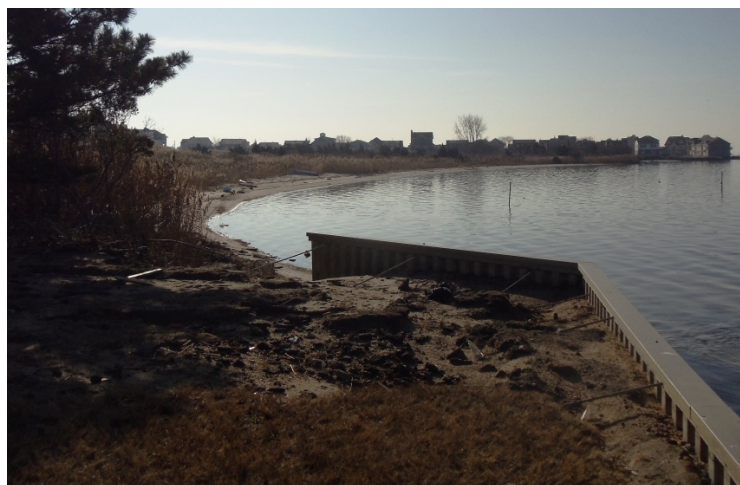
Figure 6.89 Erosion exposing steel tie-back anchors for bulkhead, bayside
(39°37'17.62"N, 74°11'55.88"W)

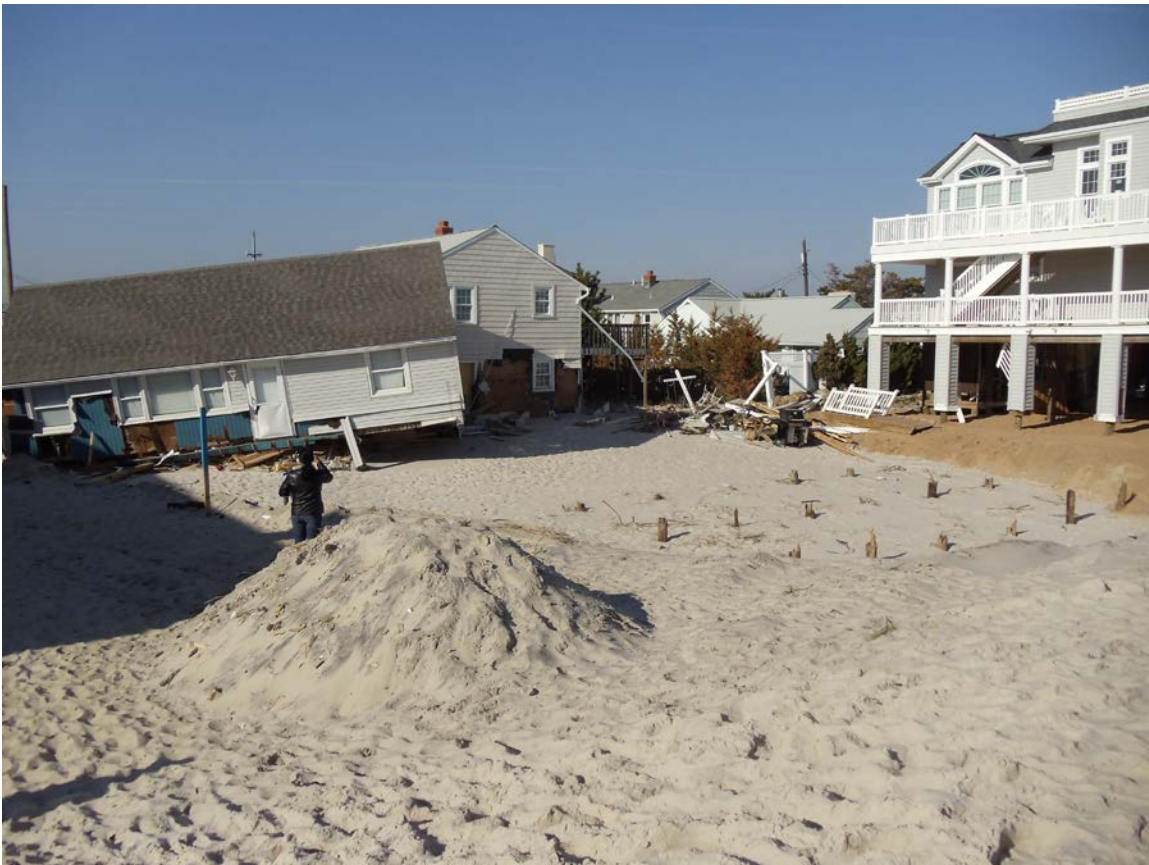
Figure 6.90 Timber pile foundation remains after home was sheared off, ocean-side in Pehola Park (39.610016, -74.206657)

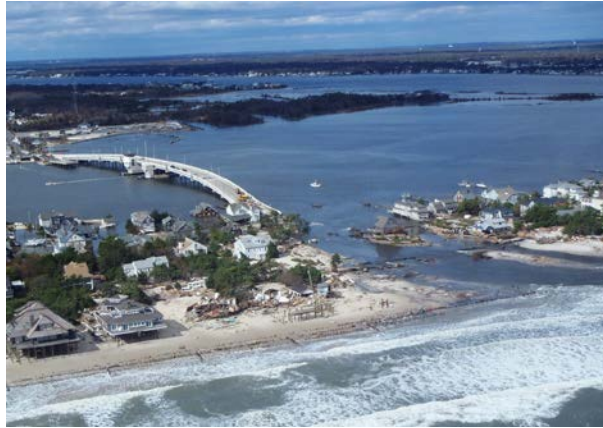
Figure 6.91 Post-Sandy conditions, Borough of Mantoloking. The bay has joined the ocean at the Route 528 Bridge, 40° 2'24.21"N, 74° 3'8.32"W (NJ Task Force 1).

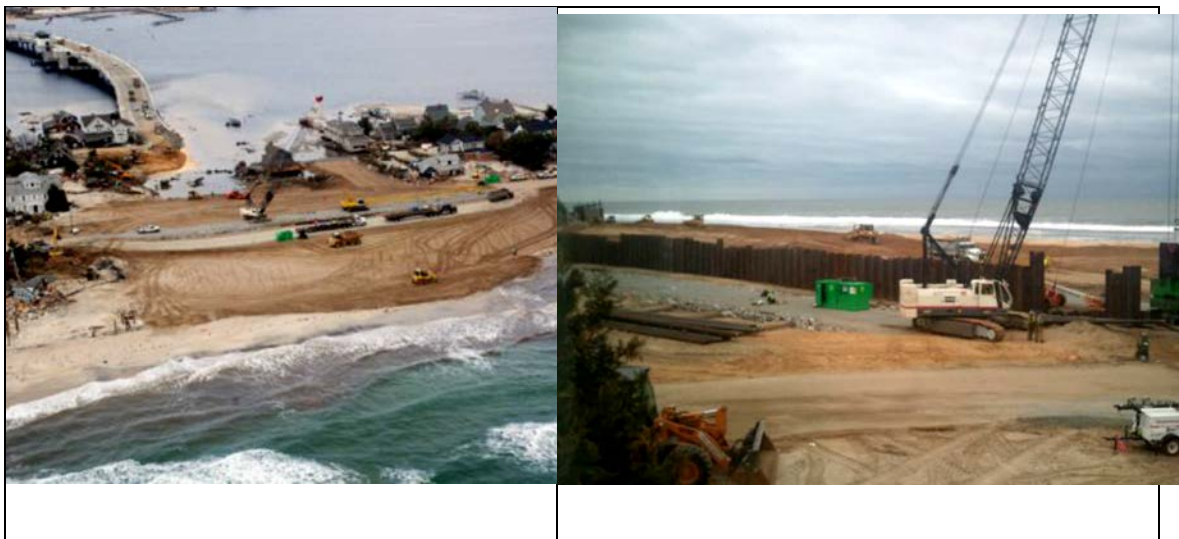
Figure 6.92 Installation of sheet piles to allow backfilling erosional channel and rebuilding of Route 528, Borough of Mantoloking, 40° 2'24.21"N, 74° 3'8.32"W (Mantoloking, 2012).

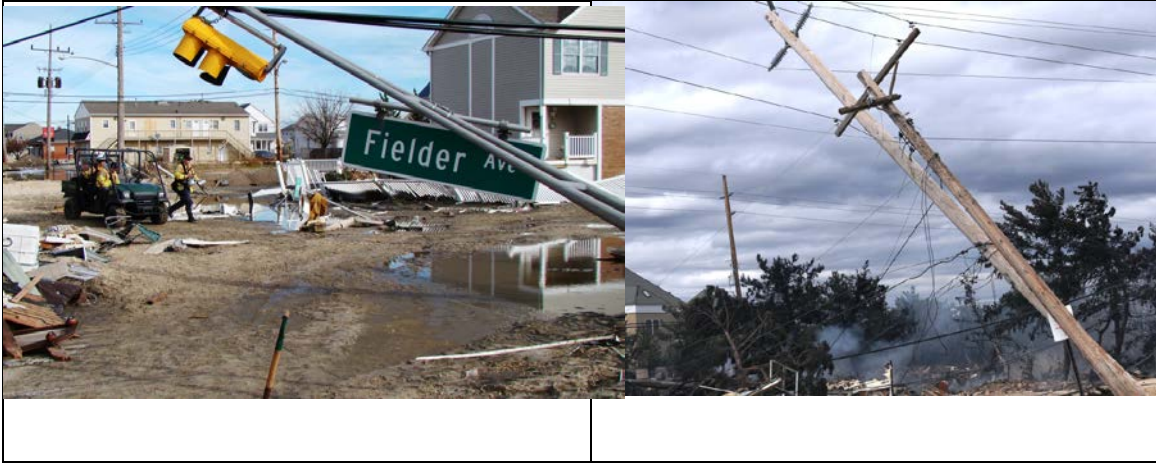
Figure 6.93 Foundation failures of utility poles (left) and damage to traffic signals, 39°57'12.03"N, 74° 4'25.09"W (NJ Task Force 1, 2012)

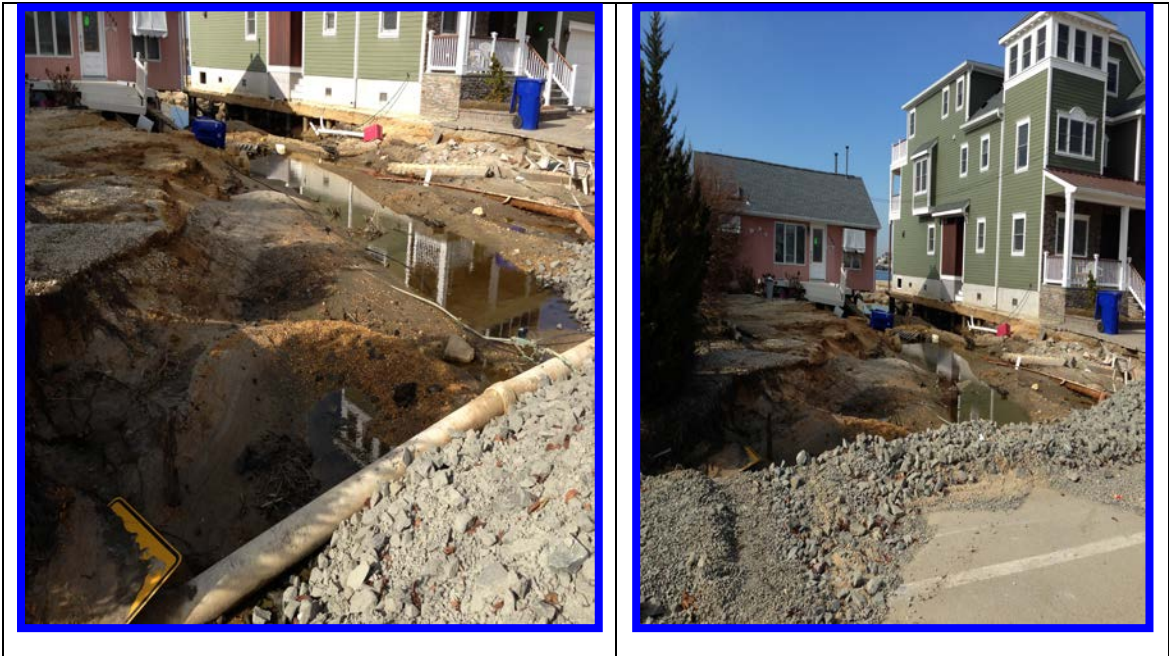
Figure 6.94 Sinkhole due to broken water/sewer line (Ocean County Engineering, 2012)

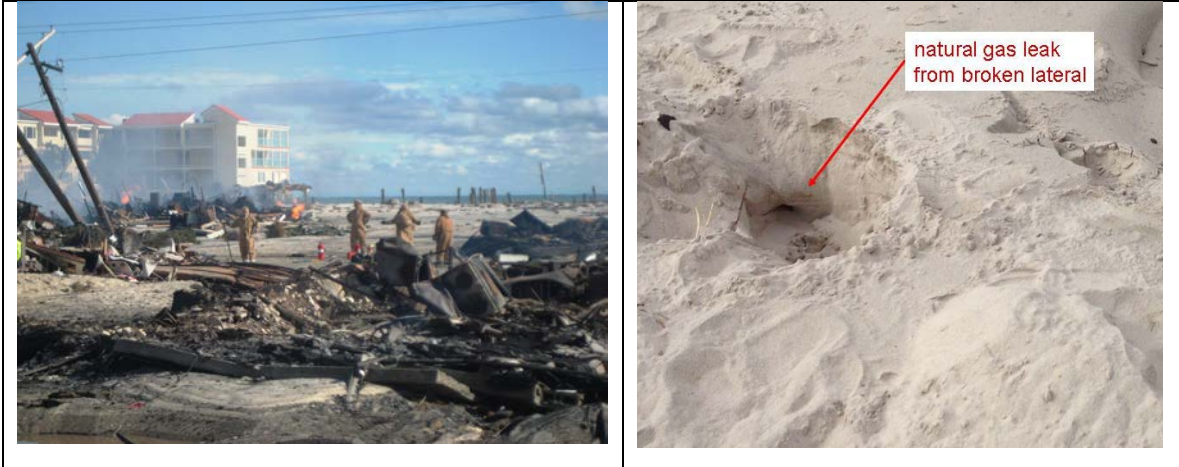
Figure 6.95 Natural gas leak and fires (NJ Task Force 1, 2012)

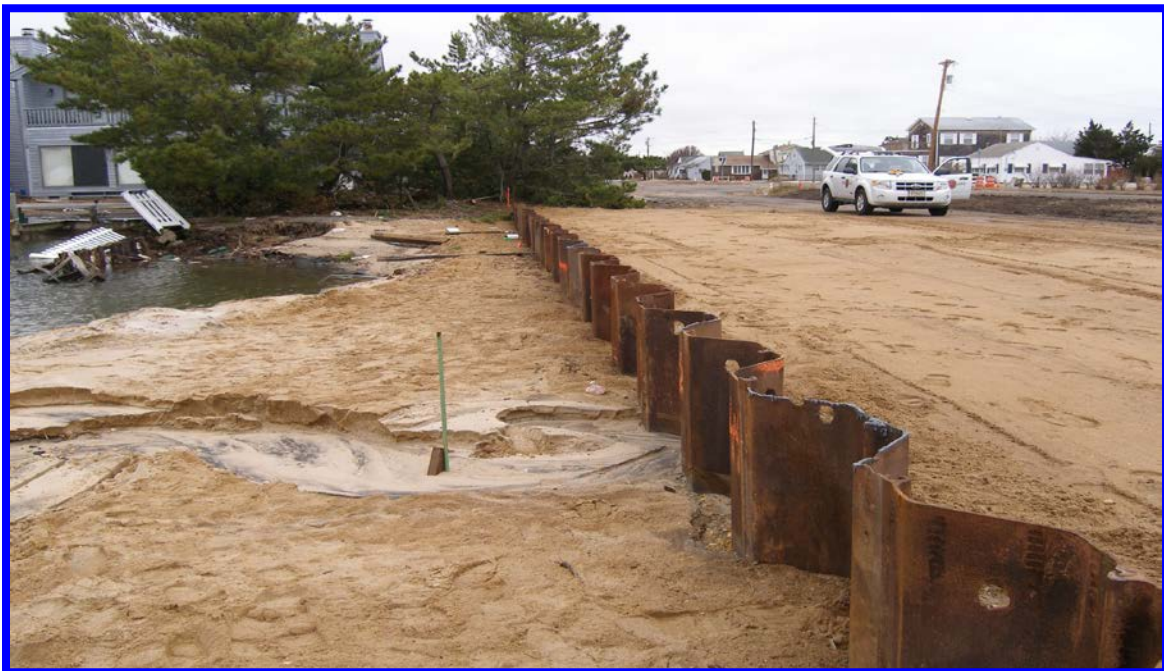
Figure 6.96 Bulkheads and roadway that was washed away at Brinley Avenue, Ortley Beach (39°57'41.63"N, 74° 4'38.29"W, Ocean County Engineering, 2012)

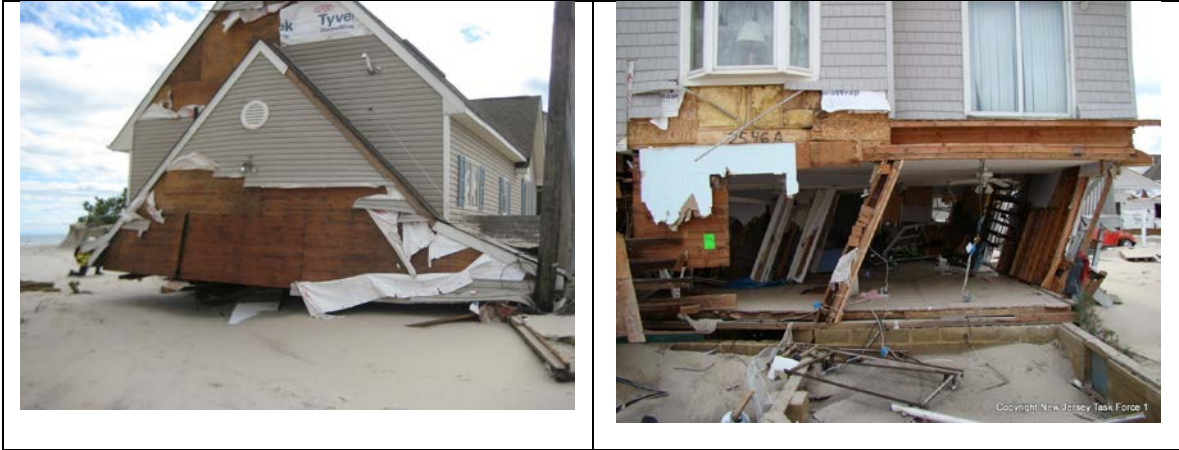
Figure 6.97 Remnants of the upper story of a home and home on the verge of collapse (NJ Task Force 1, 2012-left and A. Brenner, 2012-right).

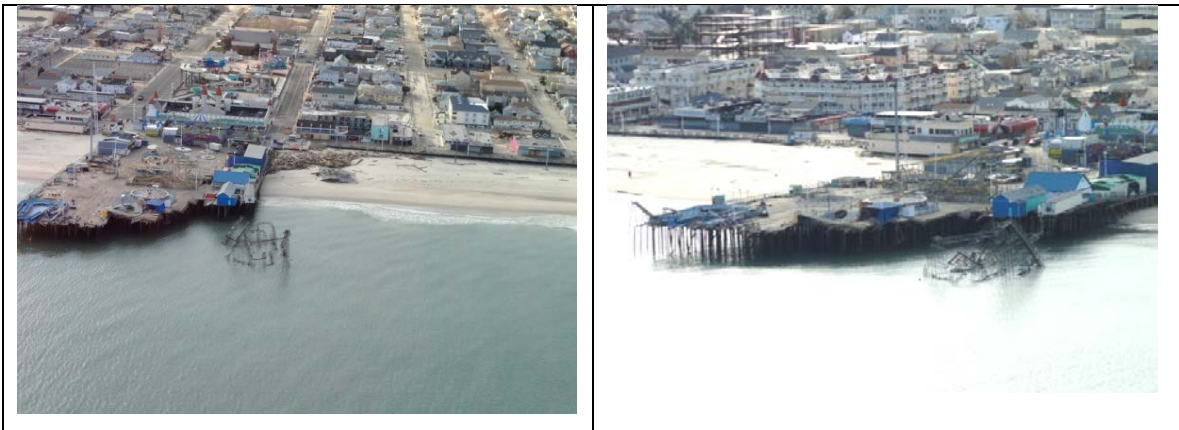
Figure 6.98 Damaged amusement pier with missing timber piles, 39°56'33.52"N, 74° 4'9.26"W (A. Brenner, 2012), Seaside Park. See also Piazza, G. (2013)

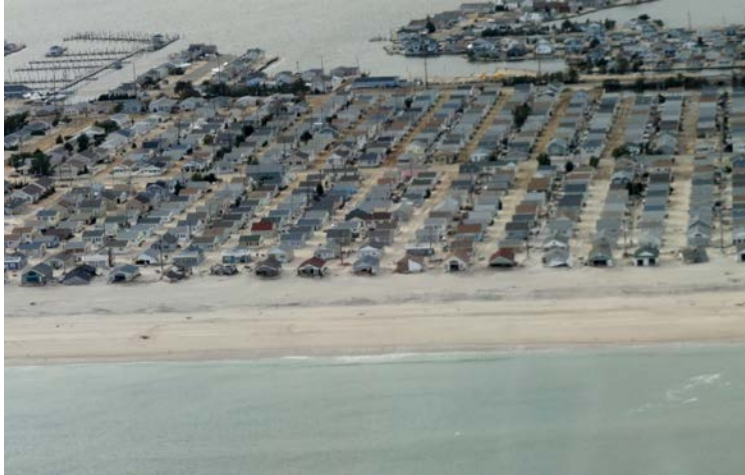
Figure 6.99 Homes partially buried in ocean sand, Borough of Lavallette (A. Brenner, 2012)

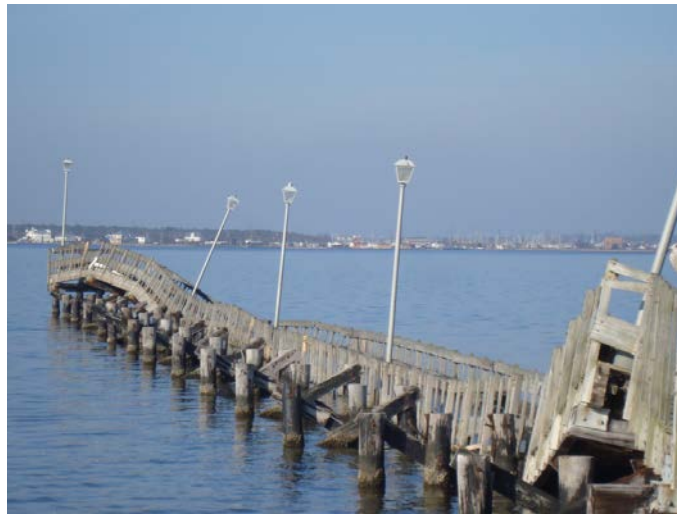
Figure 6.101 Boat Pier at Ocean Beach Yacht Club, Lavalette, NJ
(39°59'15.14"N, 74° 4'19.41"W)

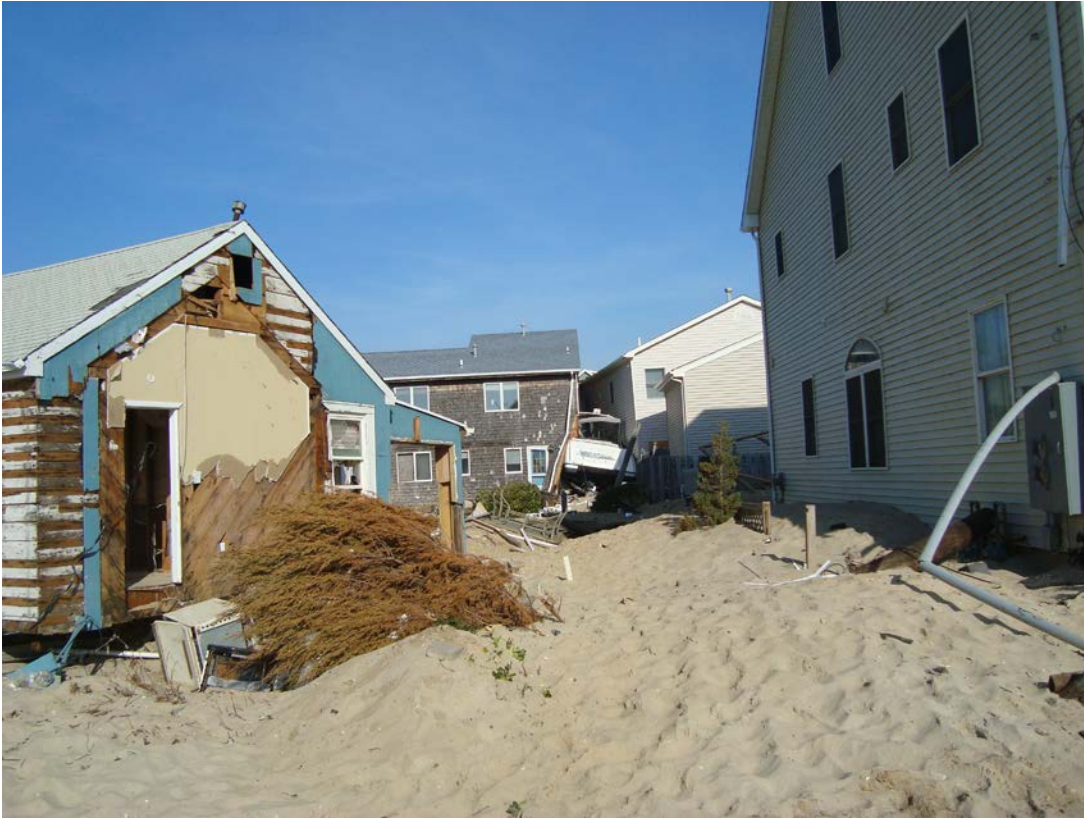
Figure 6.102 The building on the left, which was on shallow foundations was displaced. In the far end, there is a boat that is stuck in between the buildings.
