Editors: Youssef M.A. Hashash & Sissy Nikolaou

GEER Team Leaders: Youssef Hashash (University of Illinois at Urbana-Champaign), Sissy Nikolaou (Mueser Rutledge Consulting Engineers, MRCE)

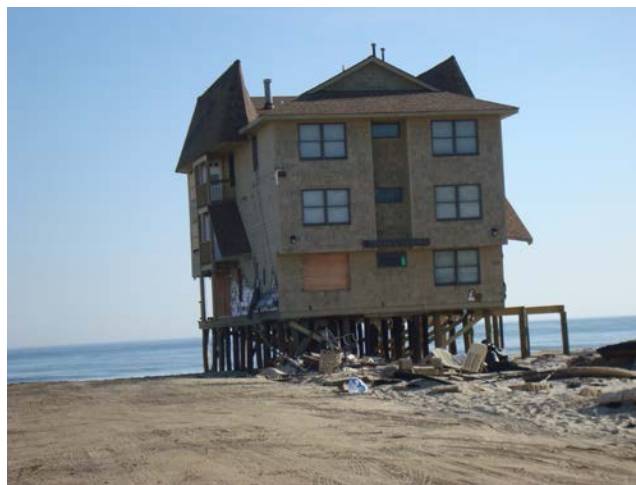
Figure 6.103 Buildings on deep foundations survived with serious structural damage

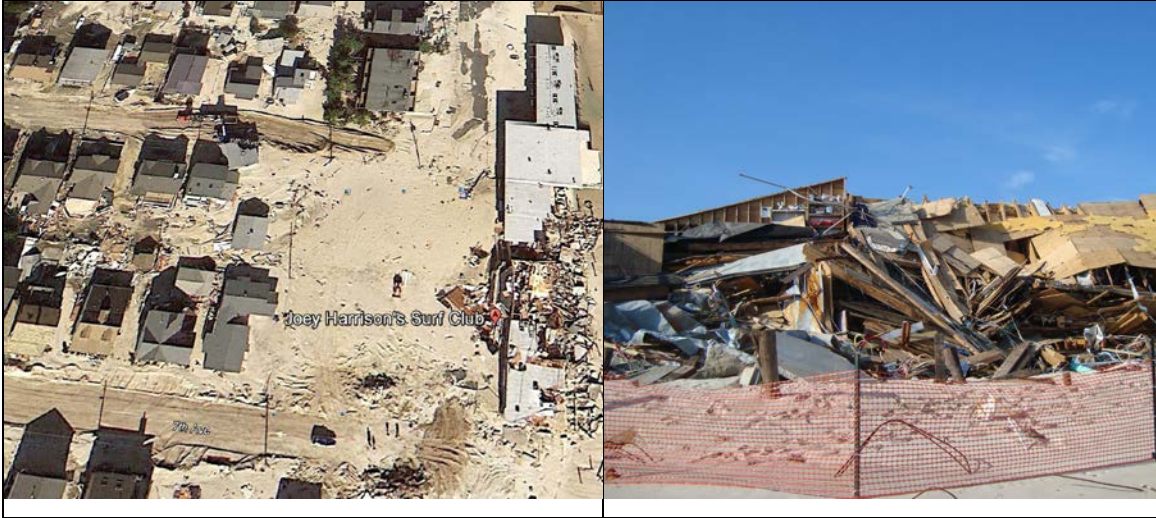
Figure 6.104 Collapse of a structure on the ocean front due to the storm surge along with an aerial shot of the area from Google Earth (39°57'16.47"N, 74°4'6.09"W)

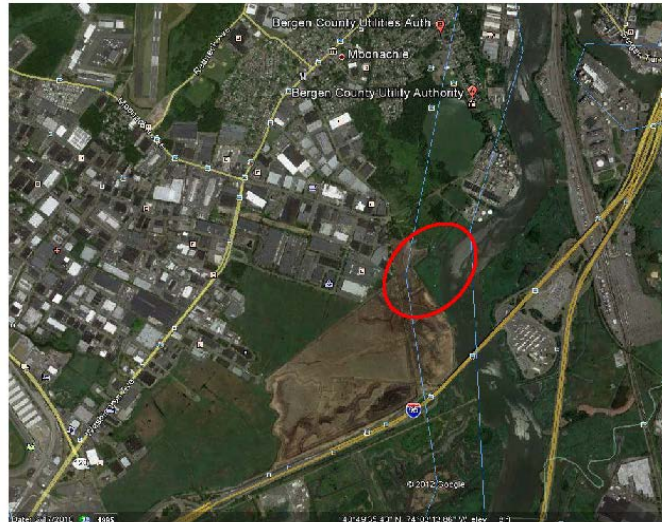
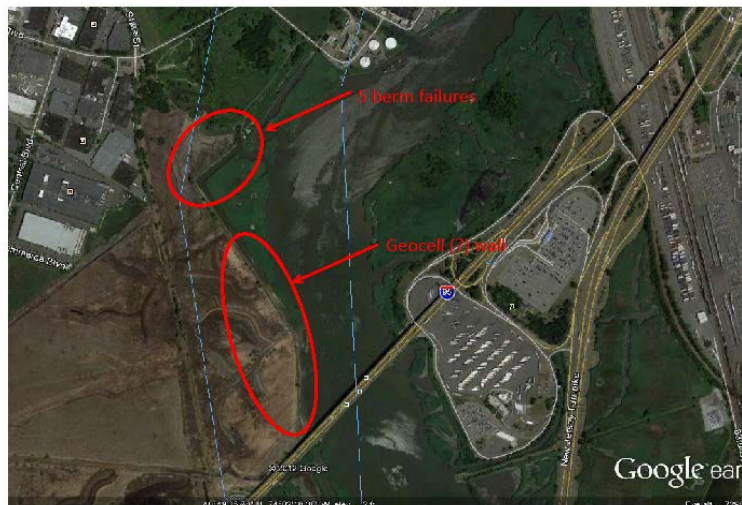
Figure 6.105 Location of the earthen berm and geocell wall with respect to the Hackensack River (40°49'36.51"N, 74° 2'18.12"W); Bergen County Utility Authority is also seen in the upper central portion; brown area is a wetlands enhancement project.

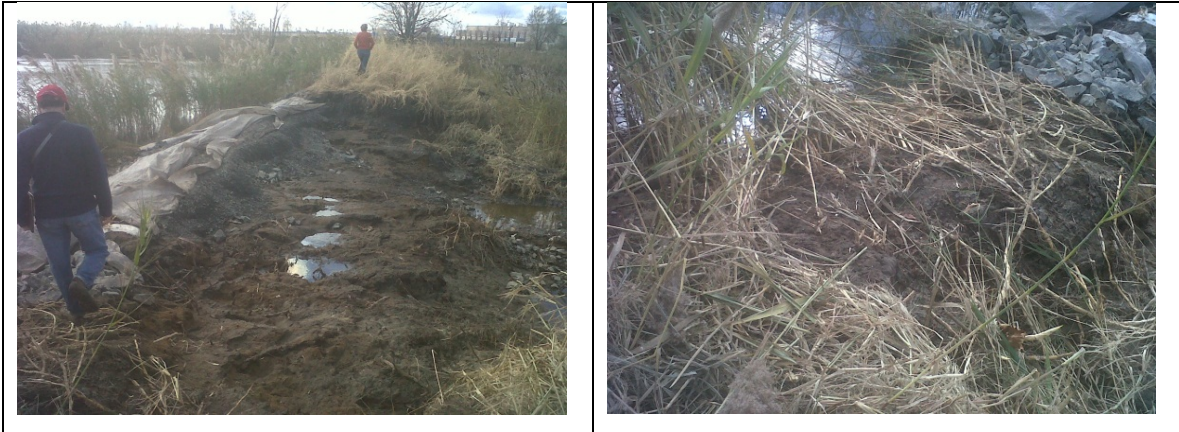
Figure 6.106 Breached section of the earthen berm showing remnants of sections with crushed stone (40°49'43.45"N, 74° 2'19.87"W).

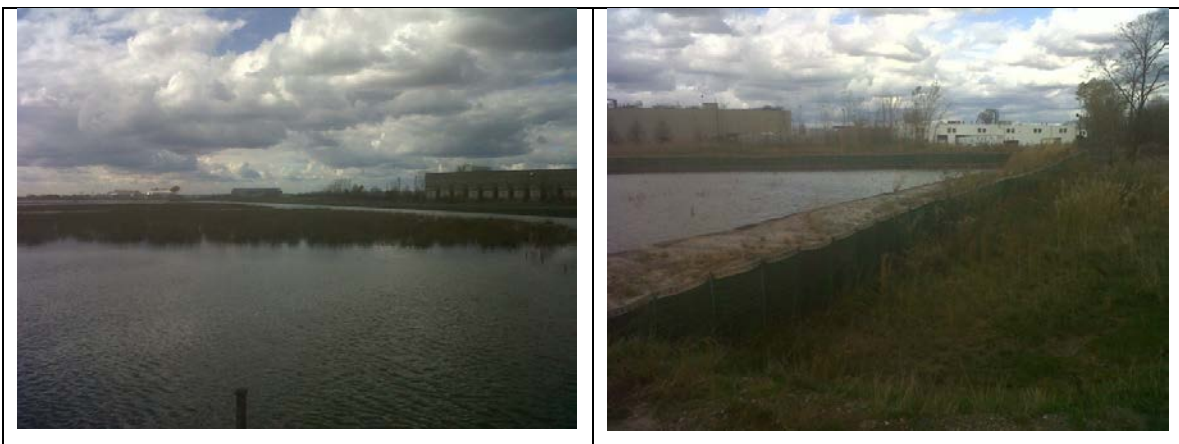
Figure 6.107 Location of the Geocell wall along the Hackensack River; a closer view of the Geocell wall can be seen on the right (40°49'37.27"N, 74° 2'18.16"W).

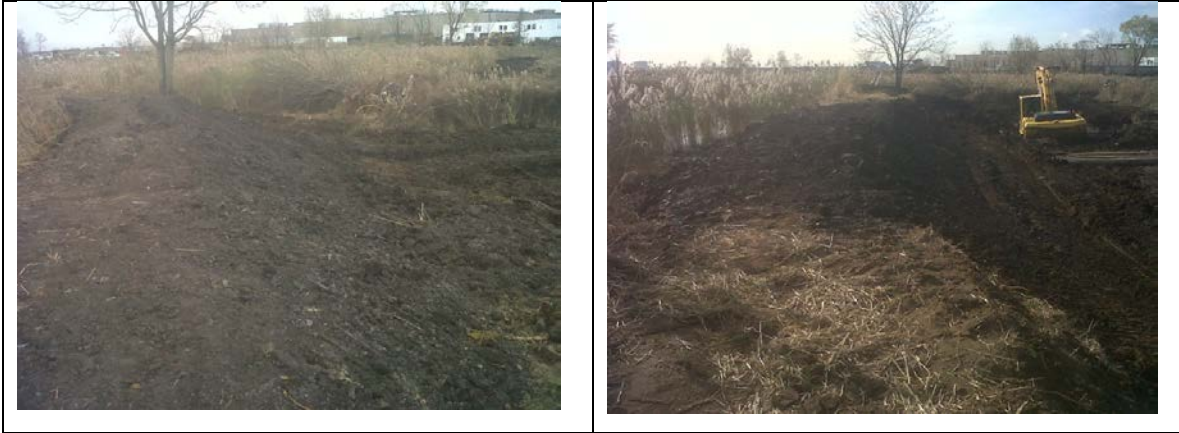
Figure 6.108 Repair of the breached section with compacted clay at flatter slopes (40°49'43.45"N, 74° 2'19.87"W)

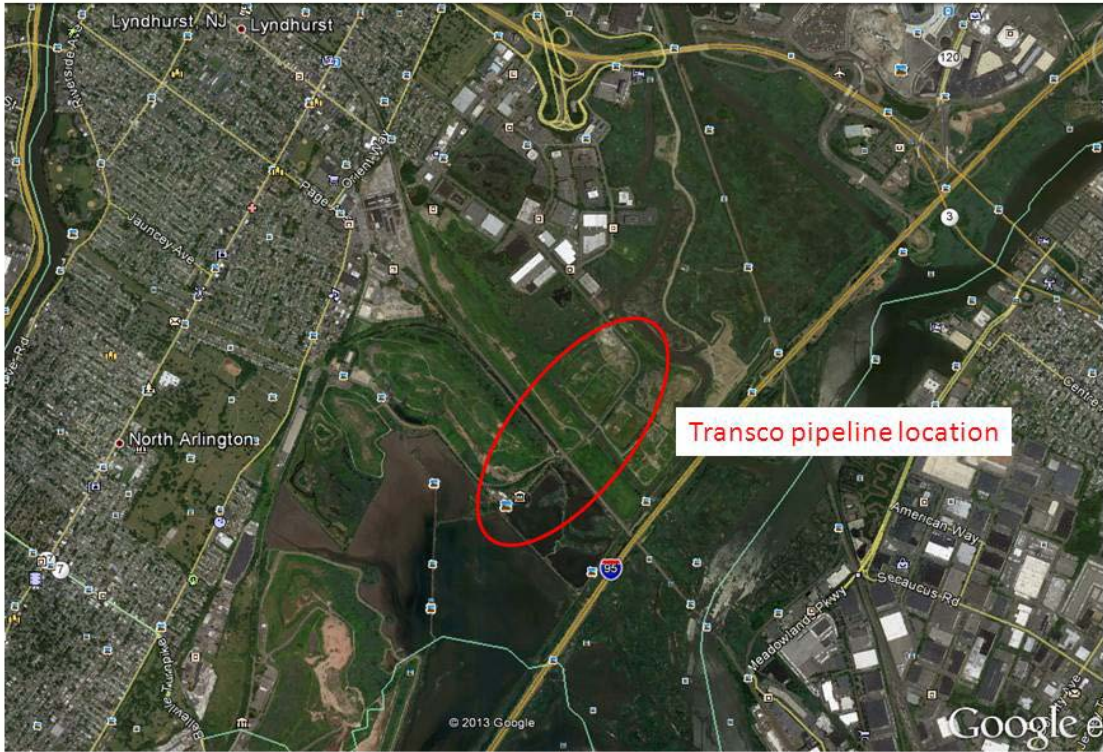
Figure 6.109 Location of the Transco Pipeline Failure

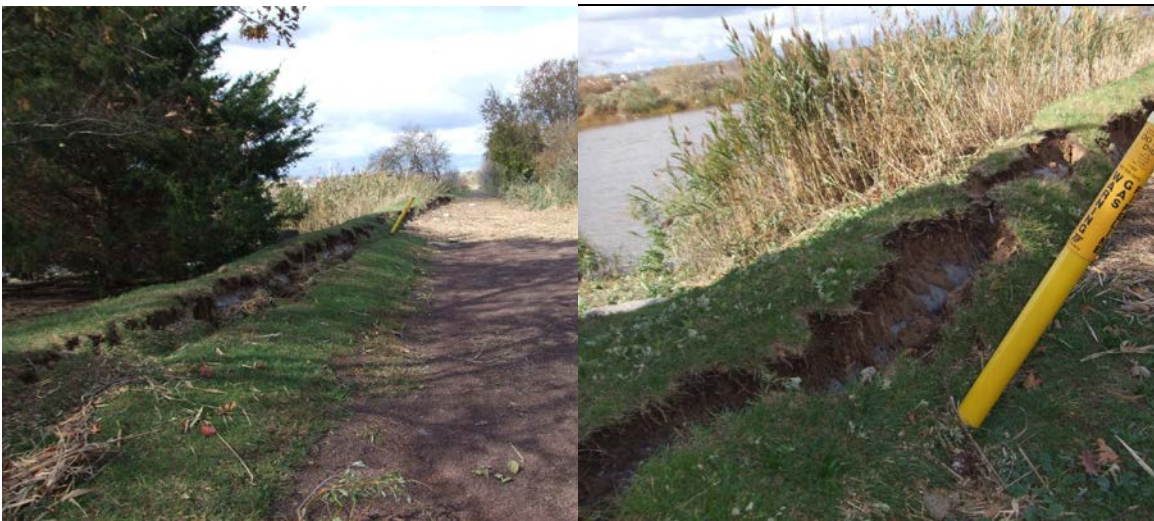
Figure 6.110 Pipeline exposed soon after Hurricane Sandy

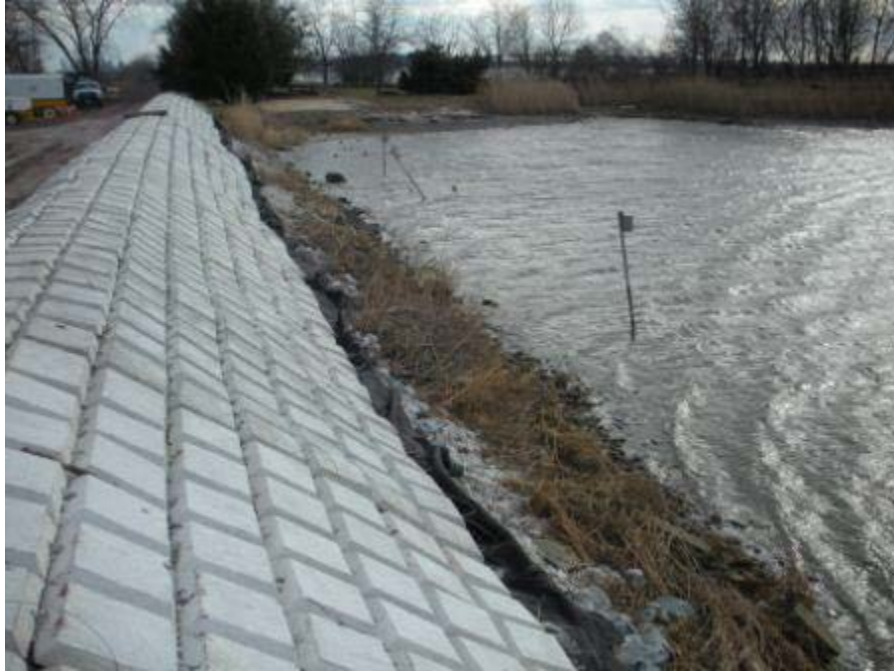
Figure 6.111 Repair work was completed by placing articulating concrete mats over displaced pipeline.

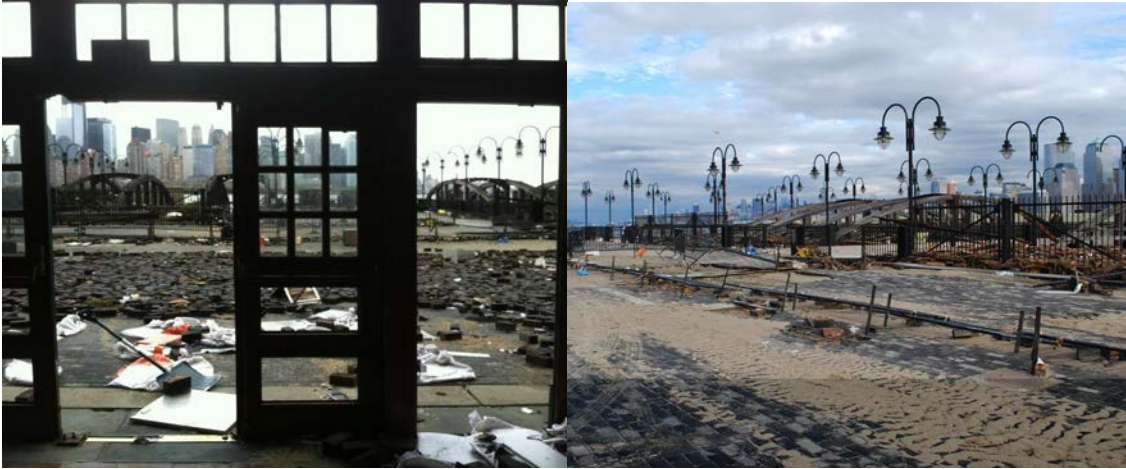
Figure 6.112 Damage to stone pavers at Liberty State Park occurred but these protected subsoil from erosion (40°42'26"N, 74°02'05"W).

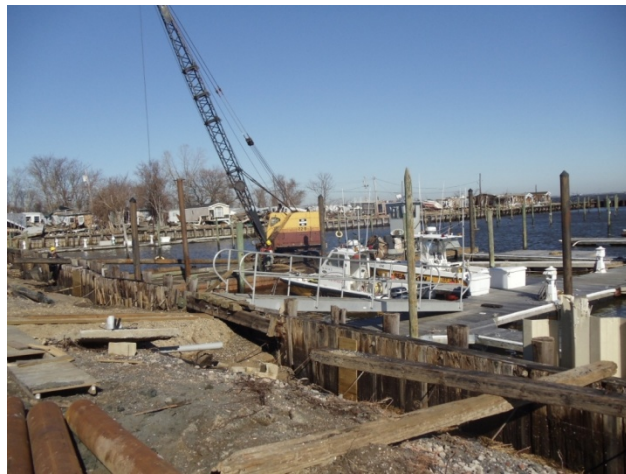
Figure 6.113 Erosion of sandy soils behind bulkhead (40°24'36"N, 74°00'02"W).

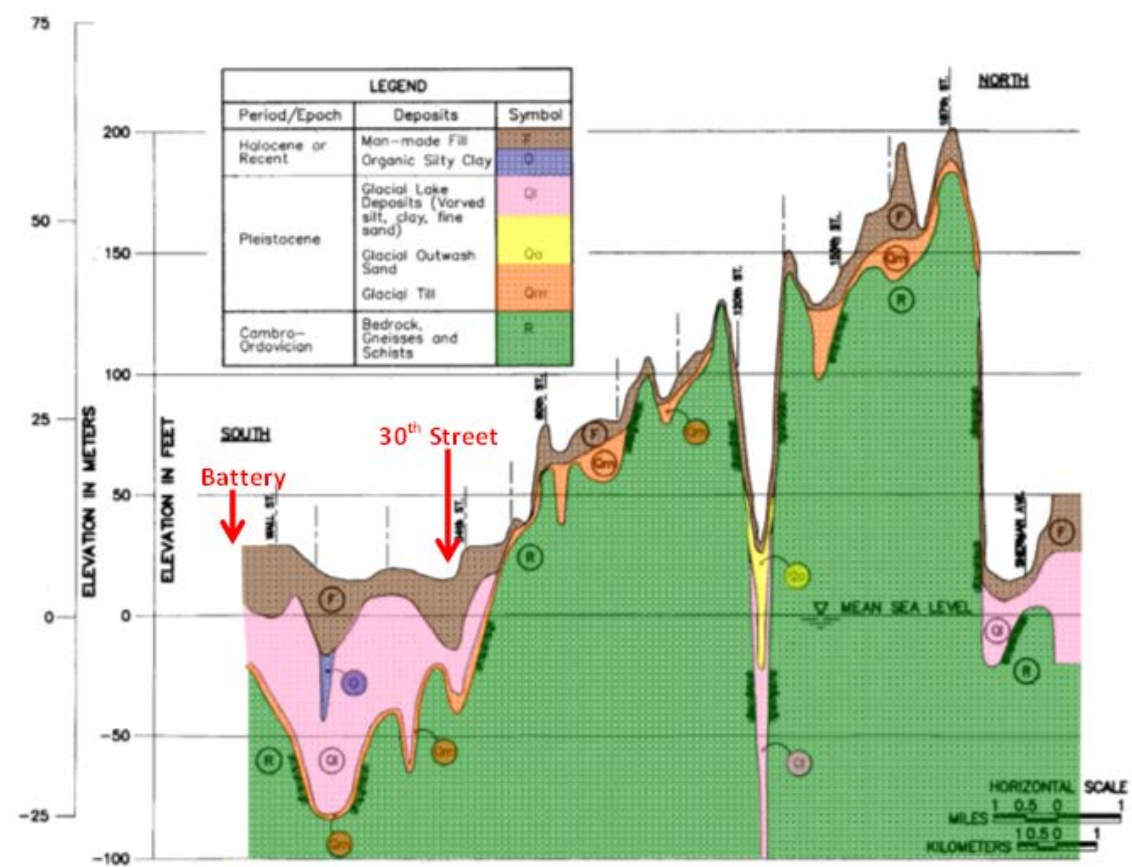
Figure 7.2 North-south Geologic Section of Manhattan (Tamaro et al 2000).

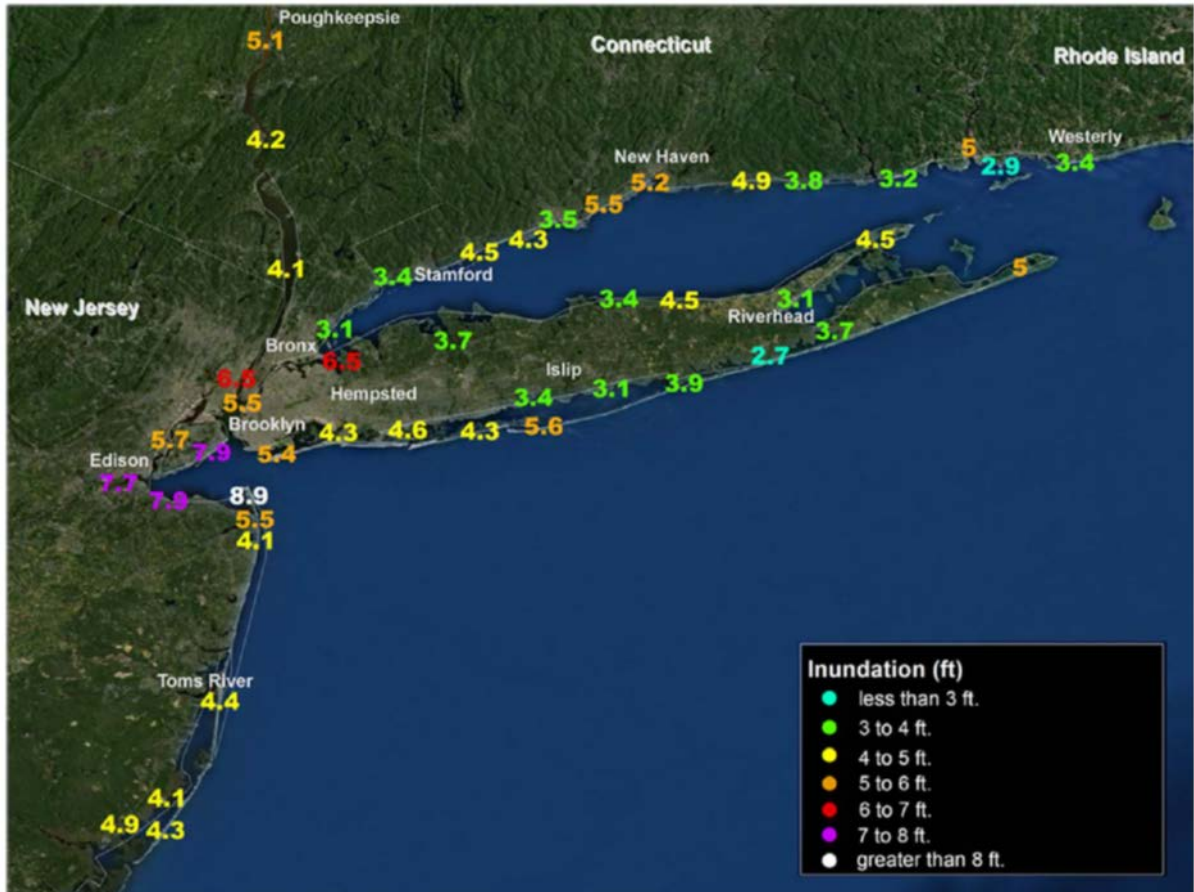
Figure 7.3 Estimated inundation (feet above ground level) calculated from USGS high-water marks and NOS tide gages in New Jersey, New York, and Connecticut from Sandy (Blake et al 2013).

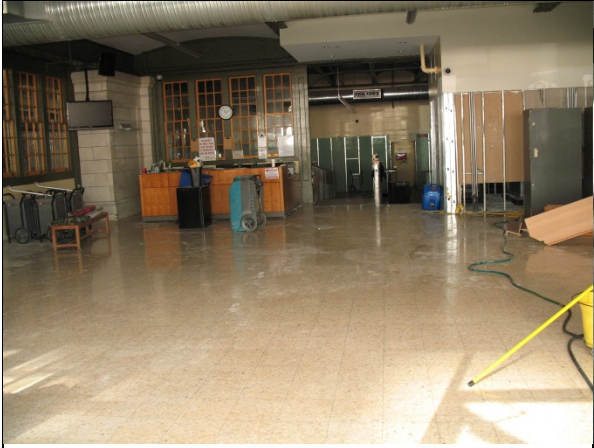
Figure 7.4 Flood damage, Governors Island ferry terminal (40.701061° N, 74.01177° W, November 3, 2012)

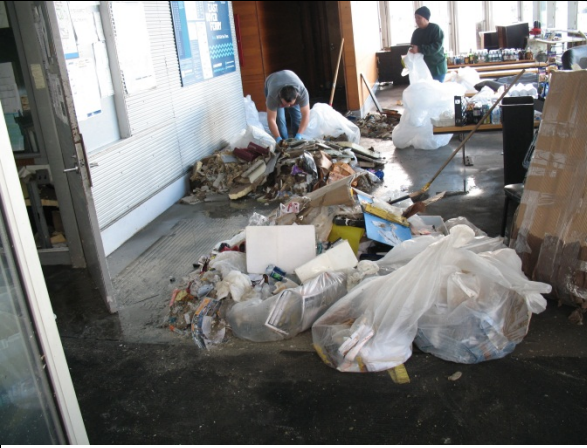
Figure 7.5 Flood damage, Pier 11 water taxi terminal (40.703277° N, 74.006237° W, November 3, 2012)

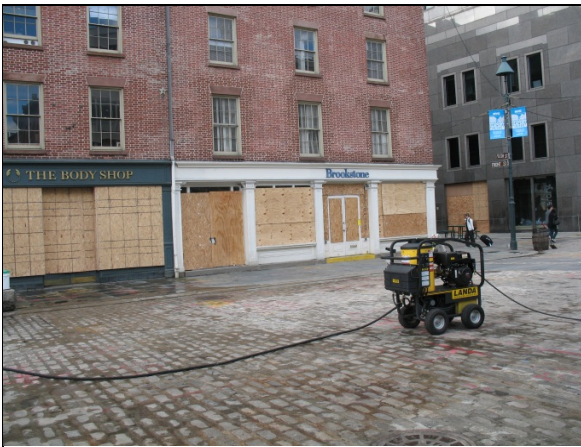
Figure 7.6 Flood damage, South Street seaport (40.706685° N, 74.003554° W, November 3, 2012).

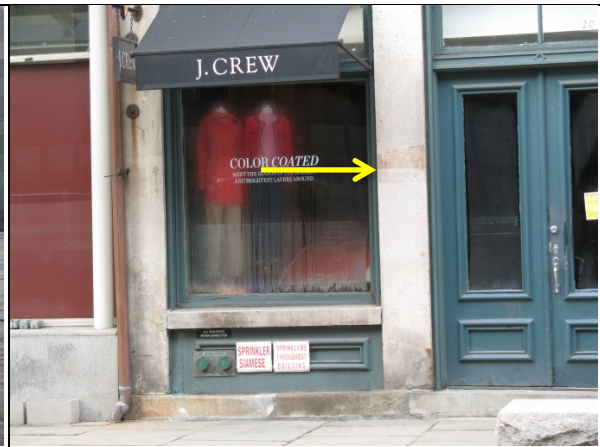
Figure 7.7 High water line at 5.7 feet on storefront window, South Street seaport (40.706935° N, 74.003322° W, November 3, 2012).

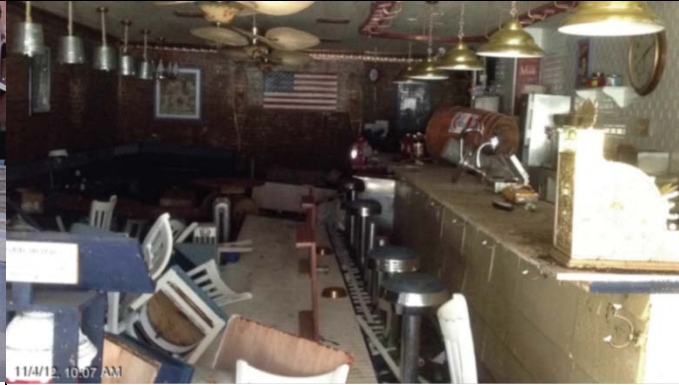
Figure 7.9 Damage at restaurant due to flooding. Water at 5 feet reached electric system in restaurant, which has no basement. (40.708314° N, 74.001959° W, November 4, 2012)

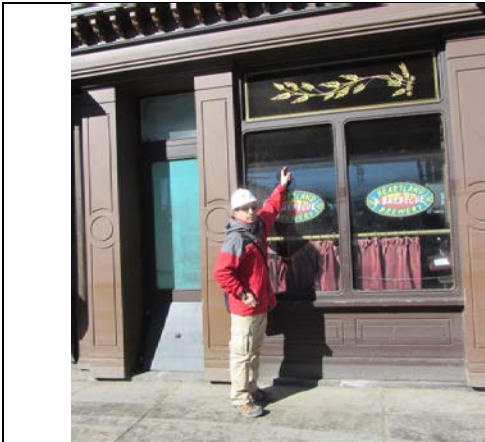
Figure 7.10 High water line on restaurant window, South Street seaport (40.706233° N, 74.003284° W, November 4, 2012). GEER Team co-leader Youssef Hashash.

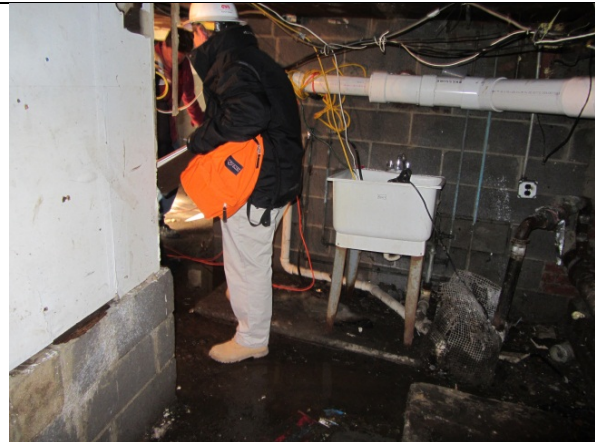
Figure 7.11 Typical flooded basement, South Street seaport (40.708301° N, 74.000605° W, November 4, 2012).

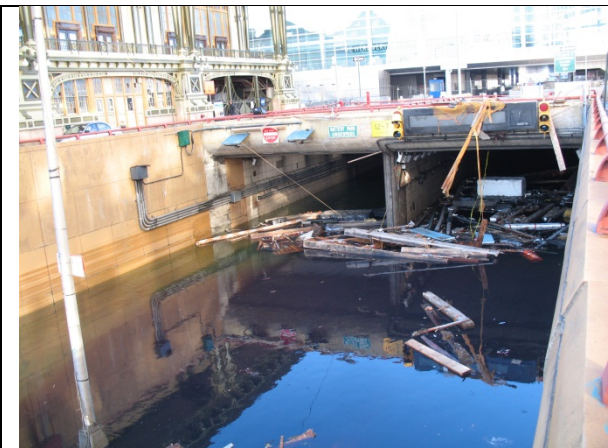
Figure 7.12 Flooded Battery Park underpass, Lower Manhattan. (40.701603° N, 74.011742° W, November 3, 2012).

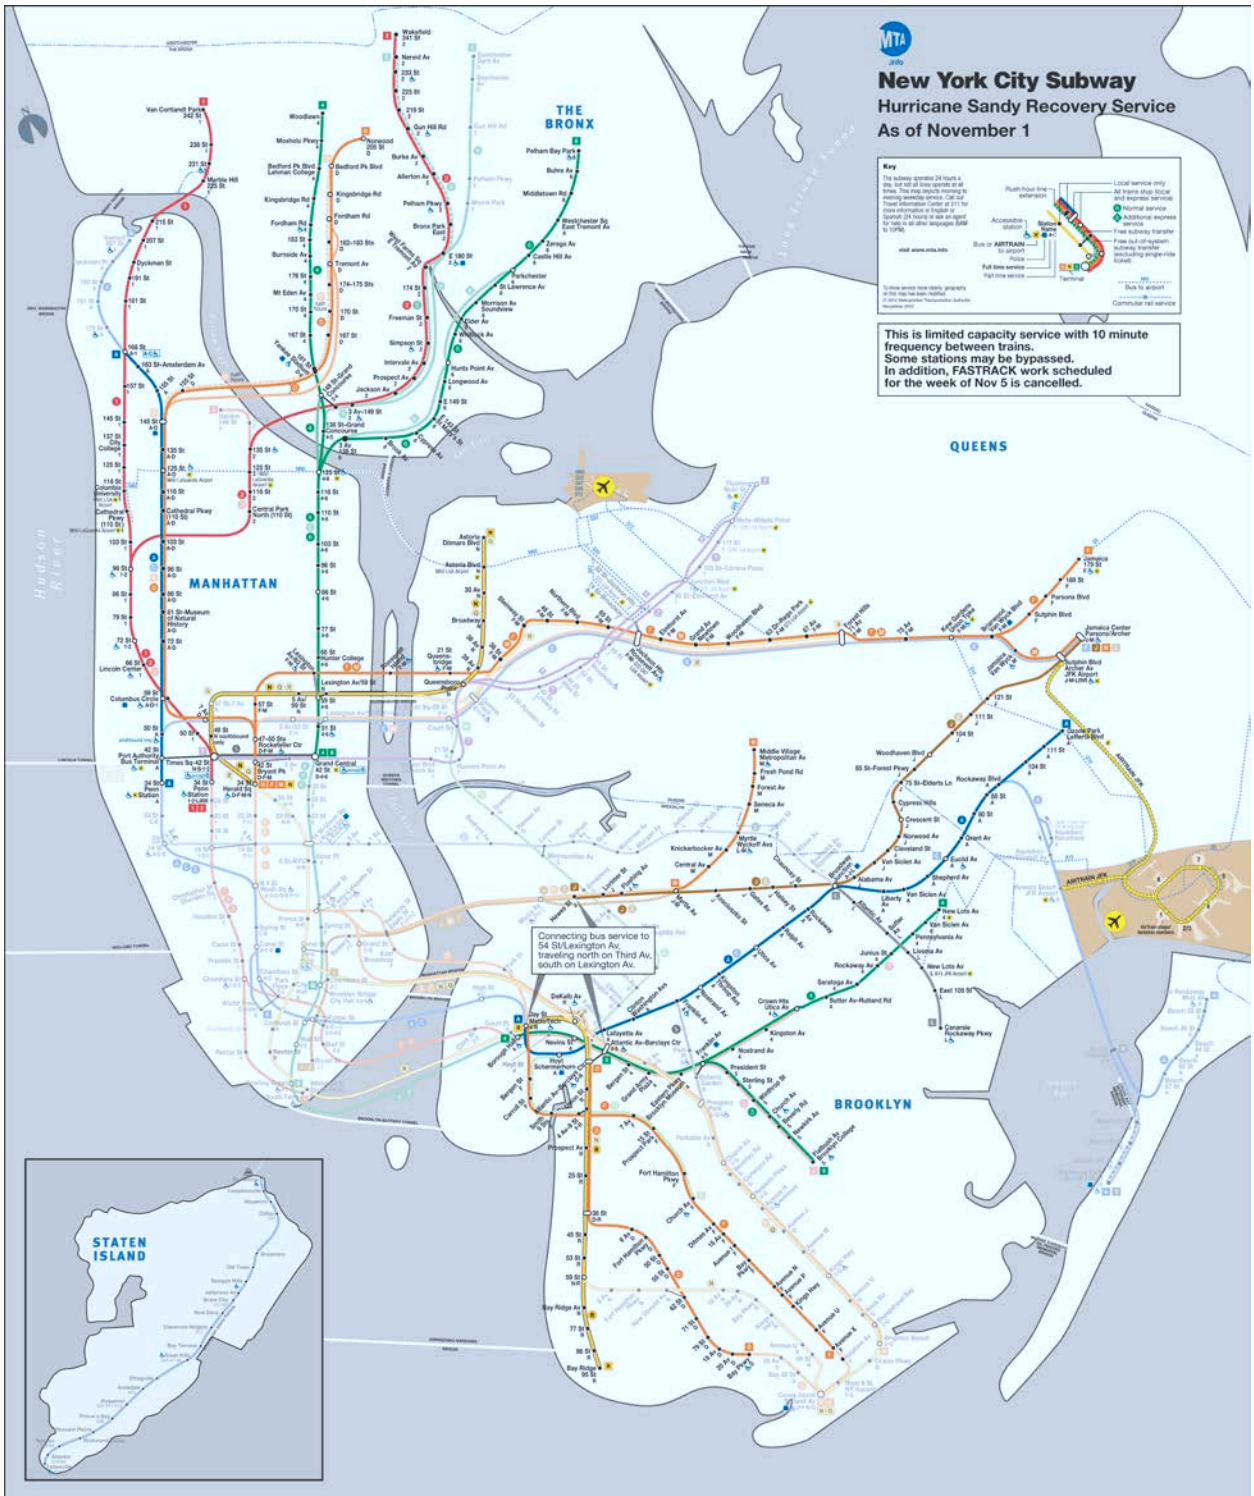
Figure 7.18 NYC Subway Rd Recovery Map, Nov 1, 2012 (shaded lines indicate no service).

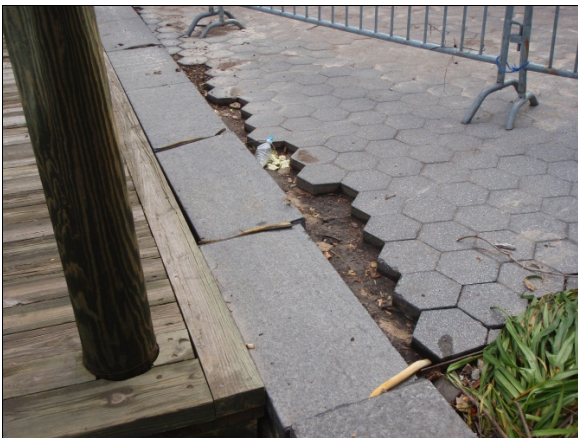
Figure 7.19 Displaced paving stones along Lower Manhattan waterfront, typical (40.706952° N, 74.01892° W, November 1, 2012).

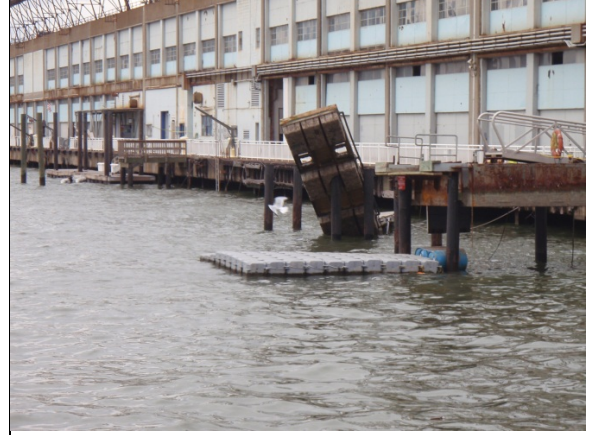
Figure 7.22 Damage to floating dock at Hudson River Park, Pier 40, west side of Manhattan (40.728161° N, 74.011395° W, November 2, 2012).

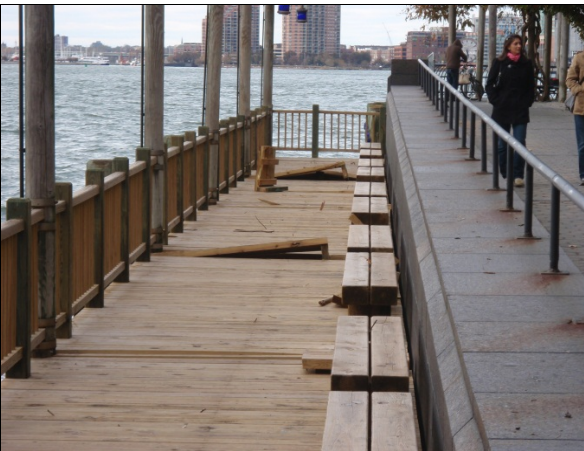
Figure 7.23 Damage to floating timber dock, Battery Park, Lower Manhattan. Note lifted planks (40.707888° N, 74.018282° W, November 1, 2012).

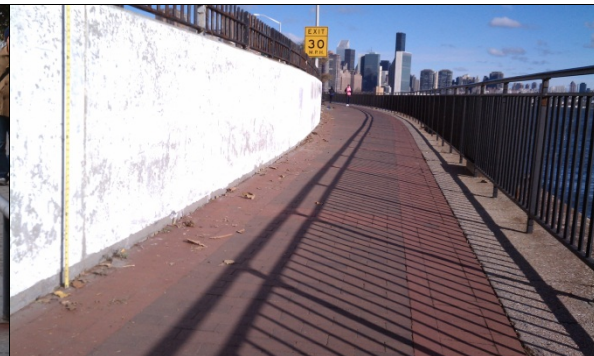
Figure 7.24 Settlement of waterfront walkway between East 15th and East 16th Streets, indicated by band of exposed unpainted concrete on wall. Damage not confirmed to be storm related (40.728454° N, 73.971484° W, November 3, 2012).

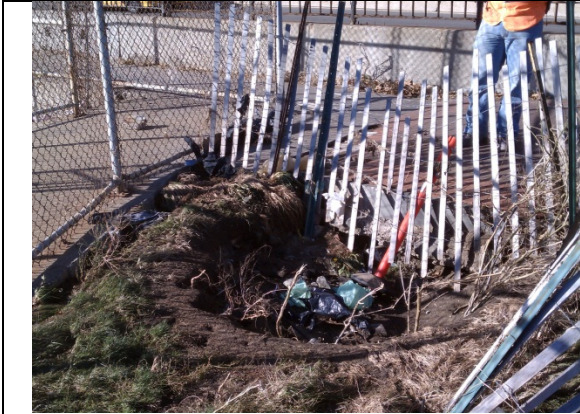
Figure 7.25 Washout at bulkhead type change, East 15th Street (40.727755° N, 73.971612° W, November 3, 2012).

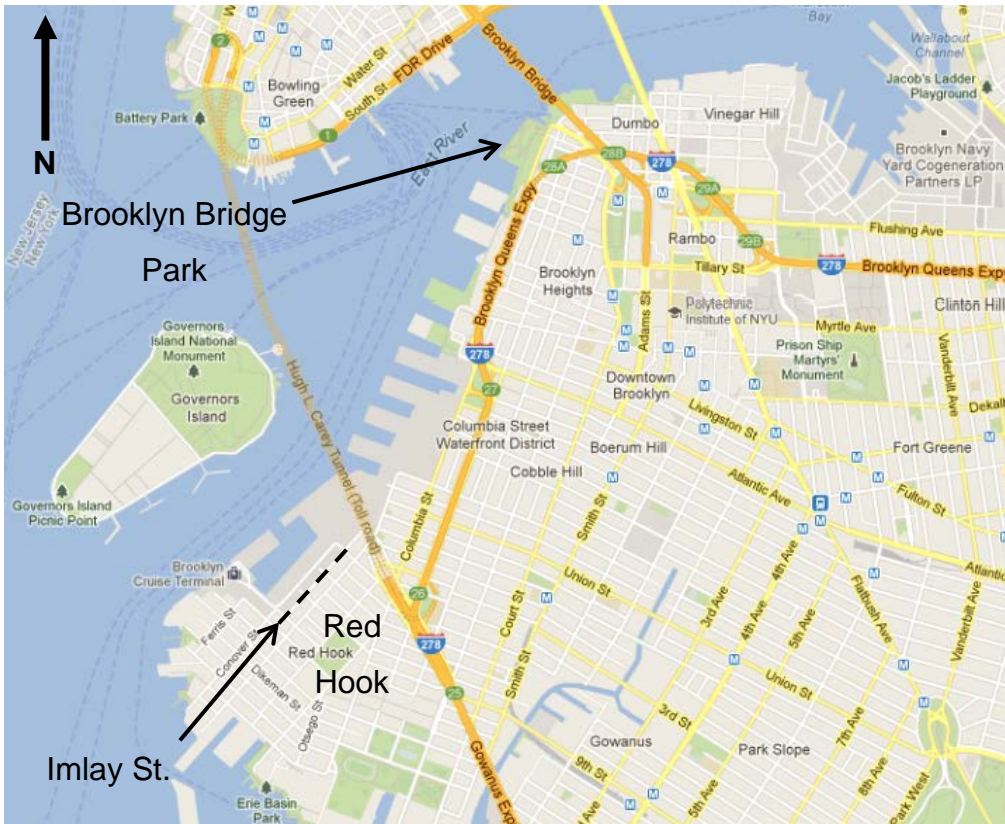
Figure 7.27 Map of a portion of Brooklyn

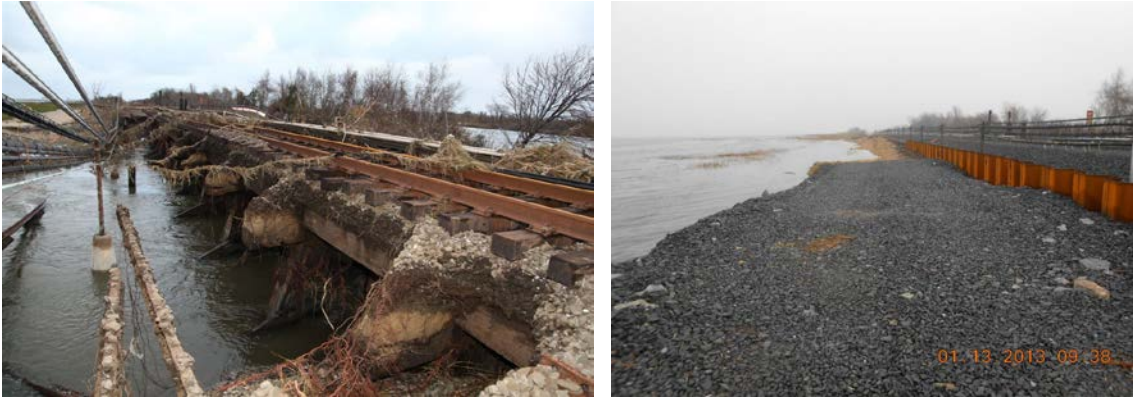
Figure 7.29 Washouts in Queens, along Rockaway subway [A] line after Sandy (left) and post mitigation work (right). Damage to earth embankment exposed old LIRR infrastructure (left). Photos credit: Khinda, J.S., ed., 2013.

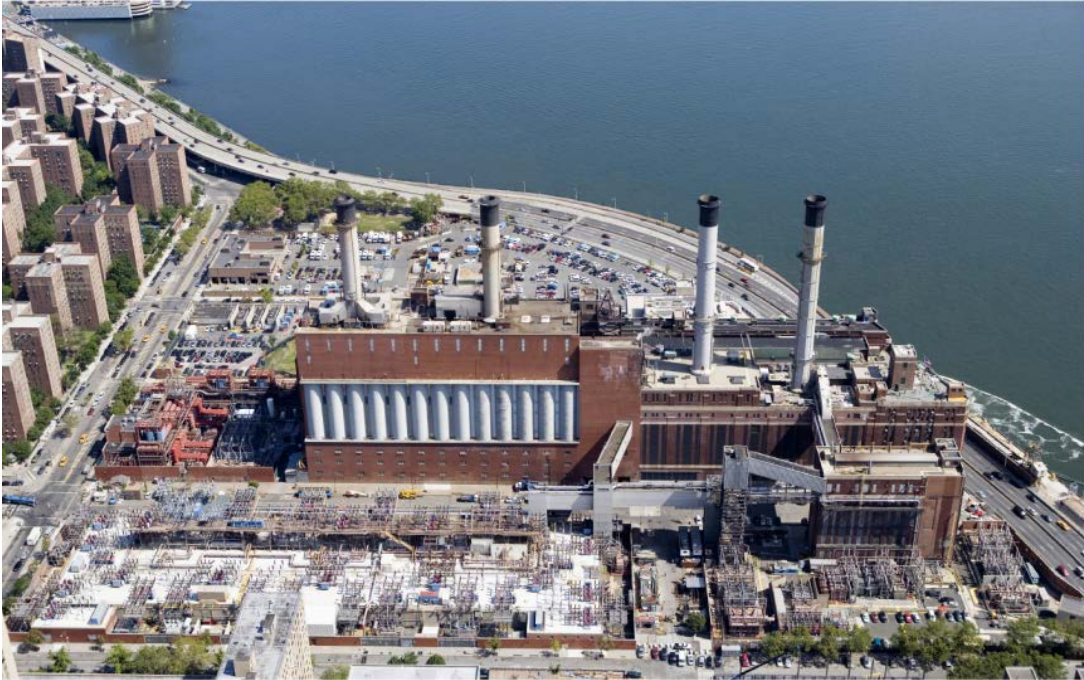
Figure 7.30 Consolidated Edison's East 13th Street complex, which was flooded in Hurricane Sandy. Photo credit: Consolidated Edison, in Khinda et al (2013).

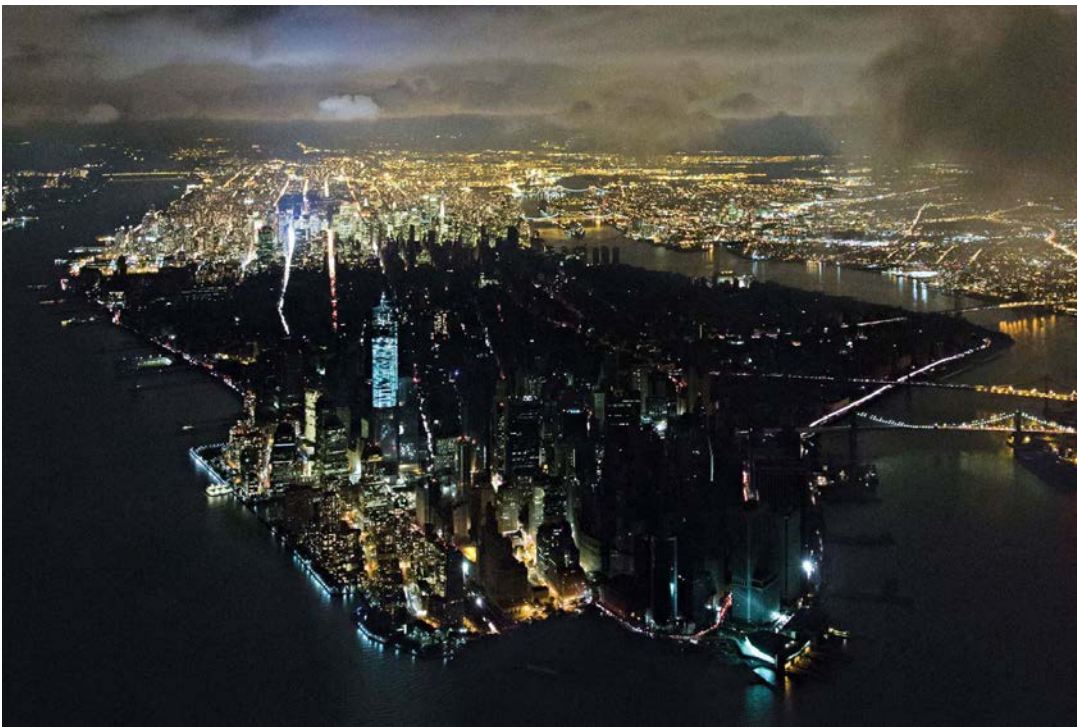
Figure 7.31 Power outage in Lower Manhattan after Hurricane Sandy, October 29, 2012. The power outage affected most of Lower Manhattan south of 34th Street. Power was not fully restored for four days. Photo credit: Iwan Baan for New York Magazine.

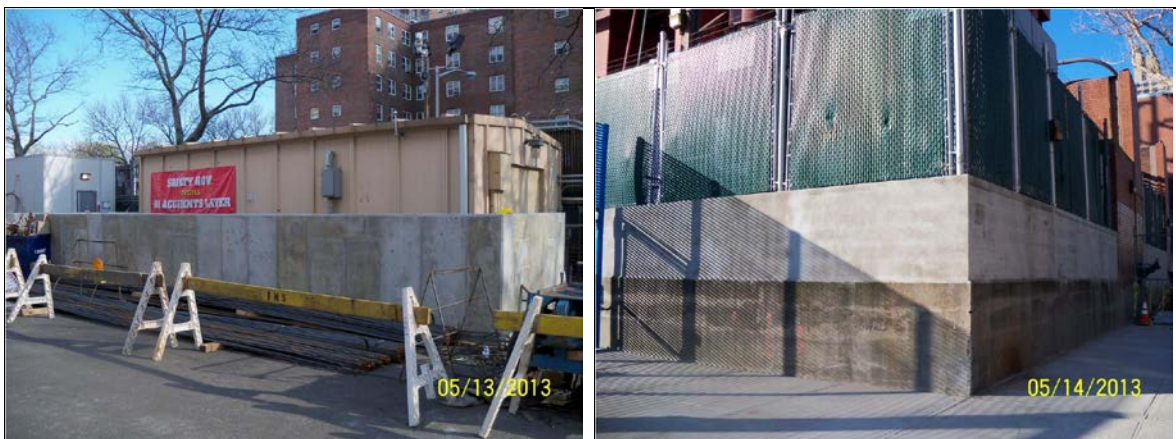
Figure 7.32 Examples of raised walls around critical equipment installed by Consolidated Edison soon after Hurricane Sandy for storm hardening. Photos provided by L. Villani (Consolidated Edison), May 2013.

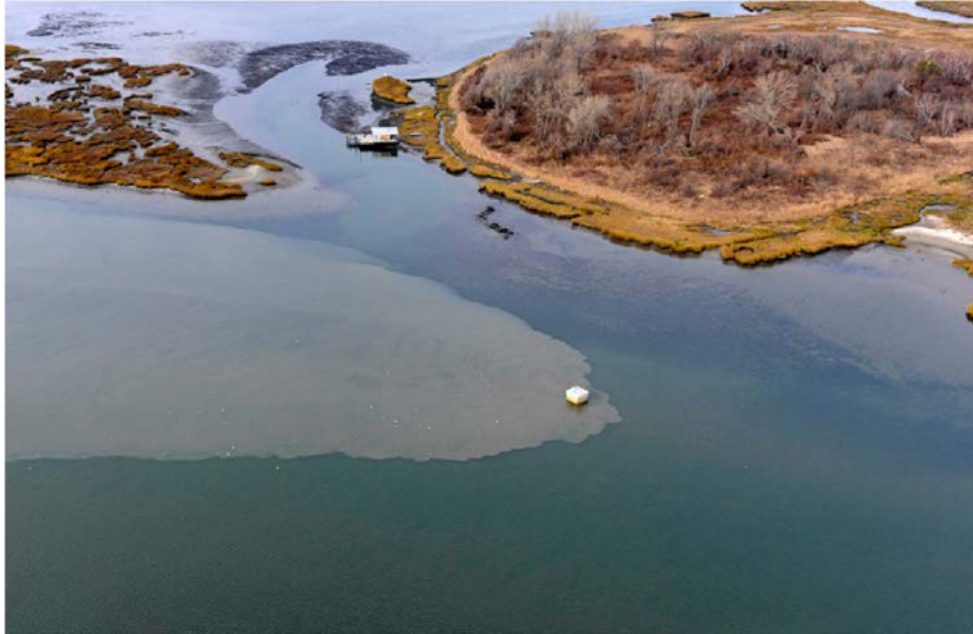
Figure 7.33 Overflow from the Bay Park Sewage Treatment Plant in East Rockaway, N.Y. Hurricane Sandy resulted in over 2 billion gallons of sewage overflow from this facility. Some of this overflow (estimated at 68 million gallons) was released adjacent to the Western Long Island South Shore Estuary (above). Photo courtesy of Doug Kuntz. *Modified from Kenward, Yawitz and Raja, 2013.*

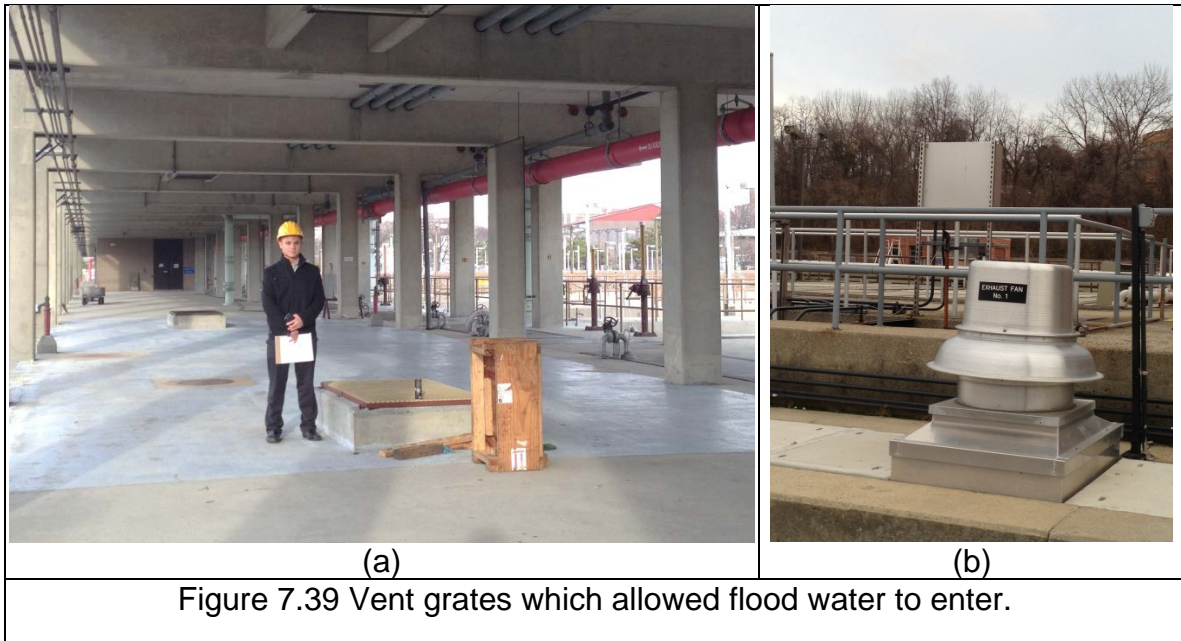
Figure 7.39 Vent grates which allowed flood water to enter.

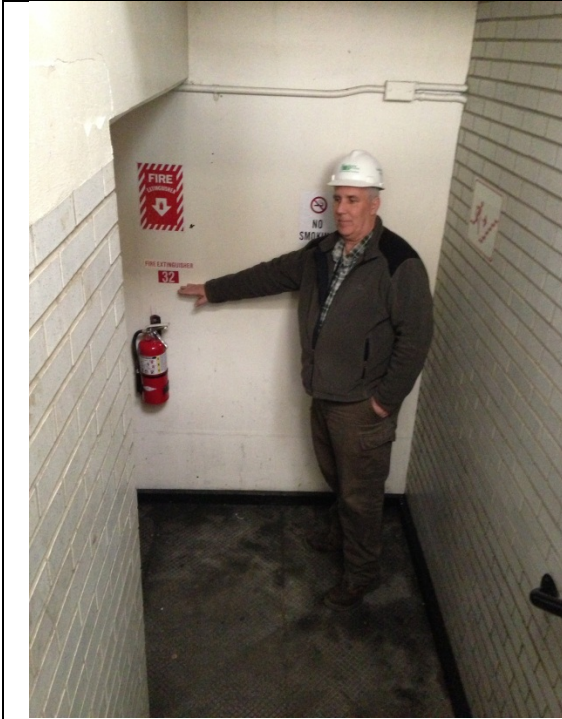
Figure 7.40 Flood level reached in aeration blower building stairwell.

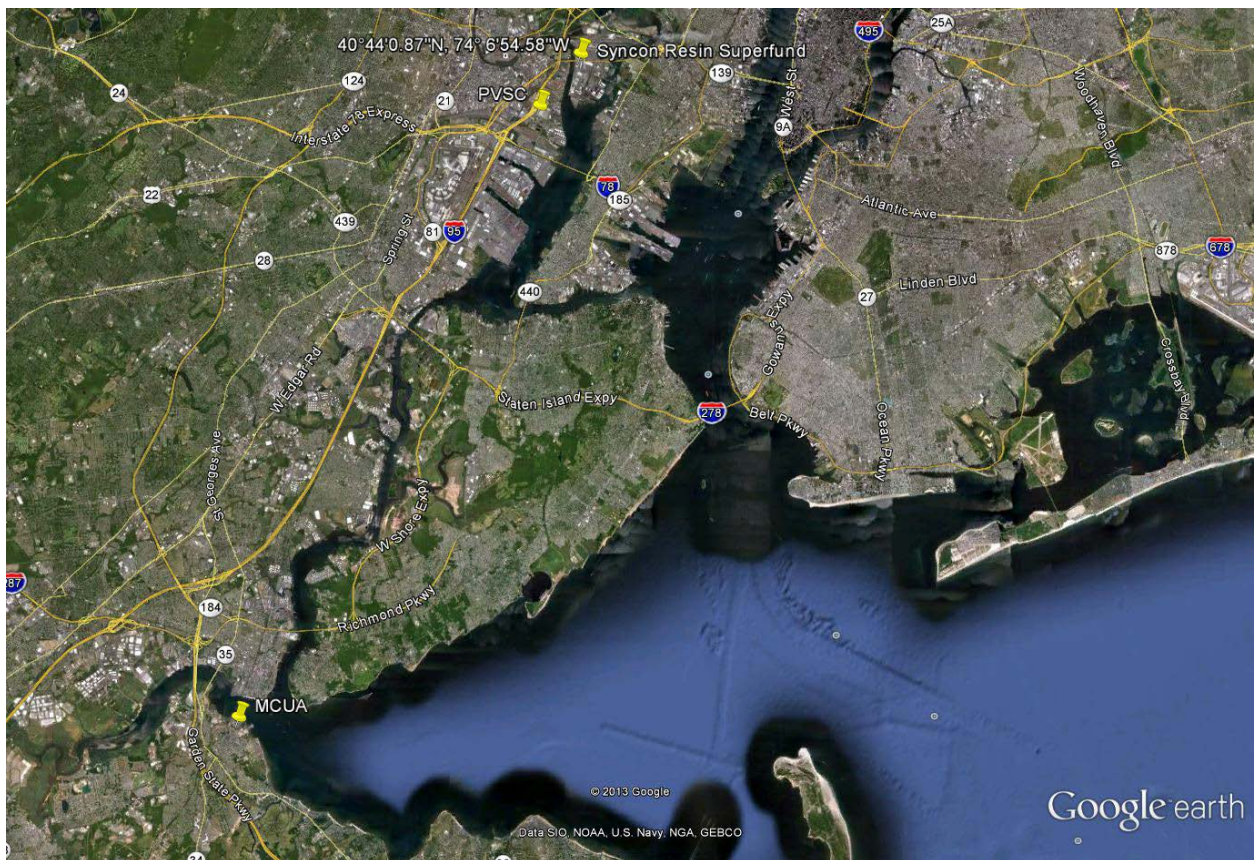
Figure 7.49 Location of the sewerage treatment plants and Superfund sites within the Newark Bay/Raritan Bay Complex

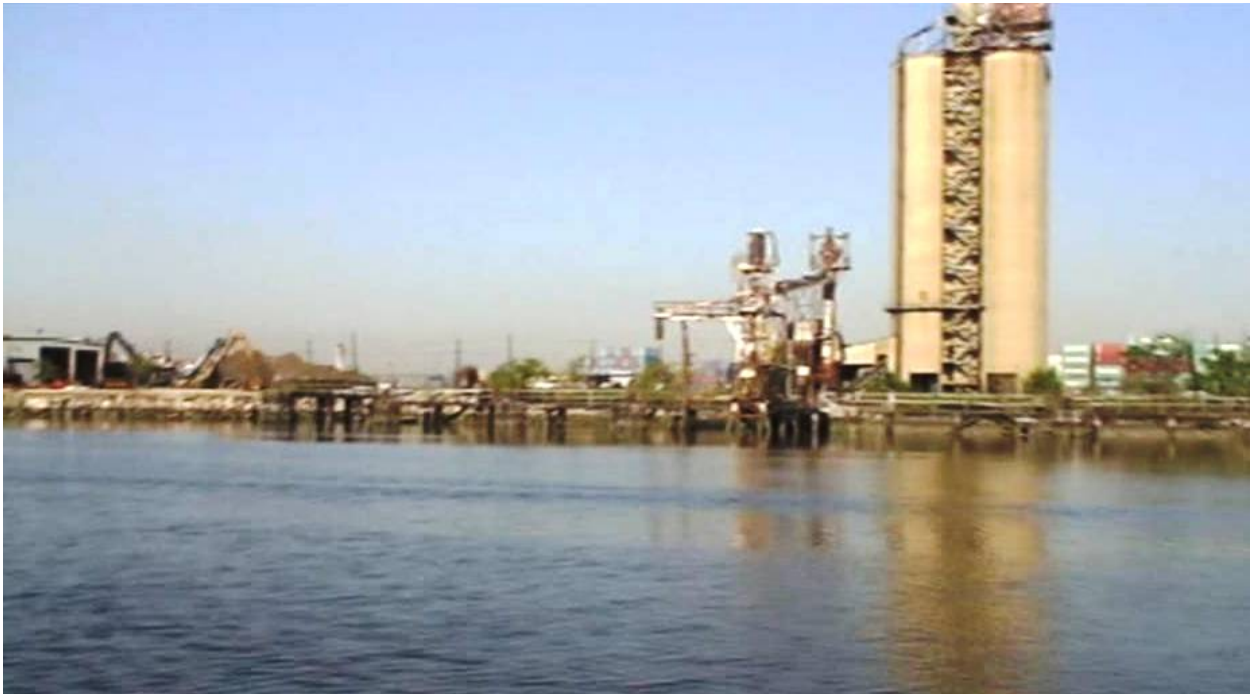
Figure 7.50 Passaic River Shoreline near Newark Bay

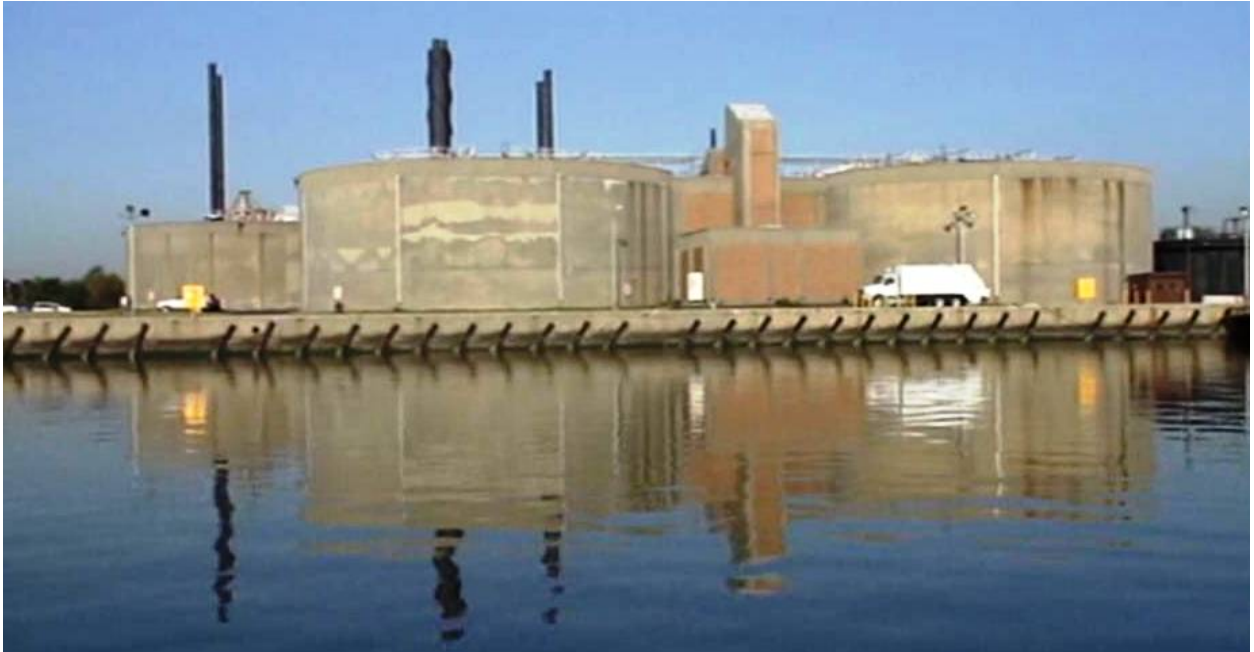
Figure 7.51 PVSC Wastewater Treatment Plant from Newark Bay
