Editors: Youssef M.A. Hashash & Sissy Nikolaou

GEER Team Leaders: Youssef Hashash (University of Illinois at Urbana-Champaign), Sissy Nikolaou (Mueser Rutledge Consulting Engineers, MRCE)

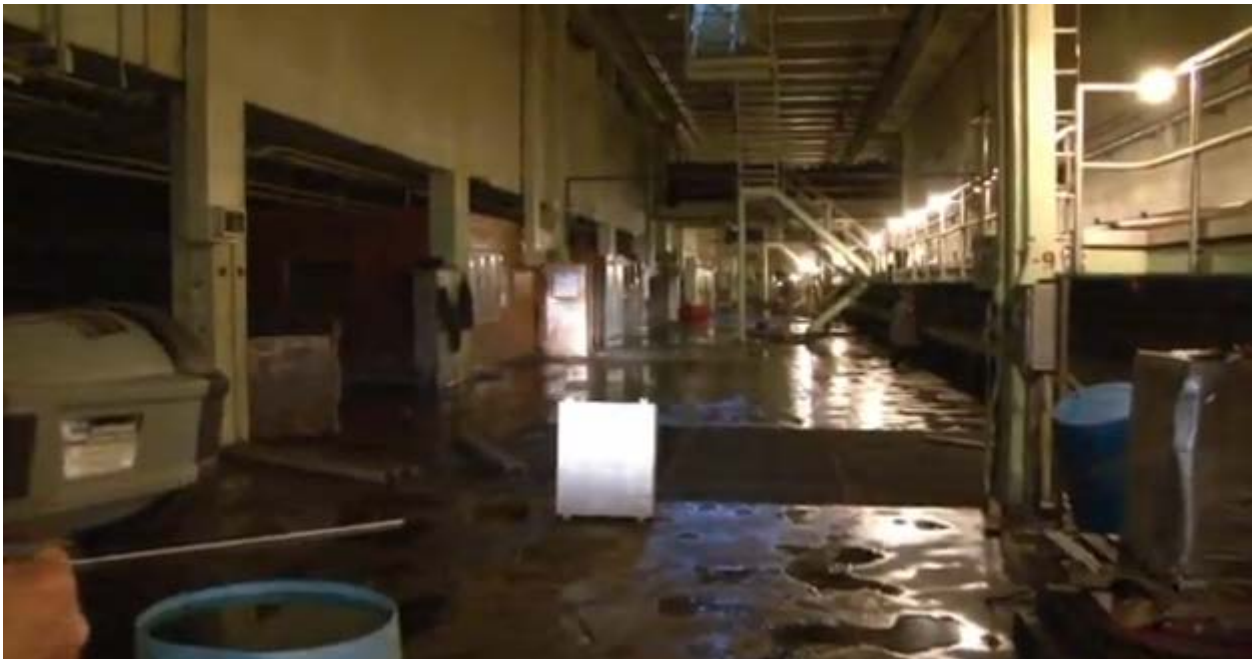
Figure 7.52 Tunnels housing pumps, controls, and worker offices at PVSC (USACE, Nov. 2012).

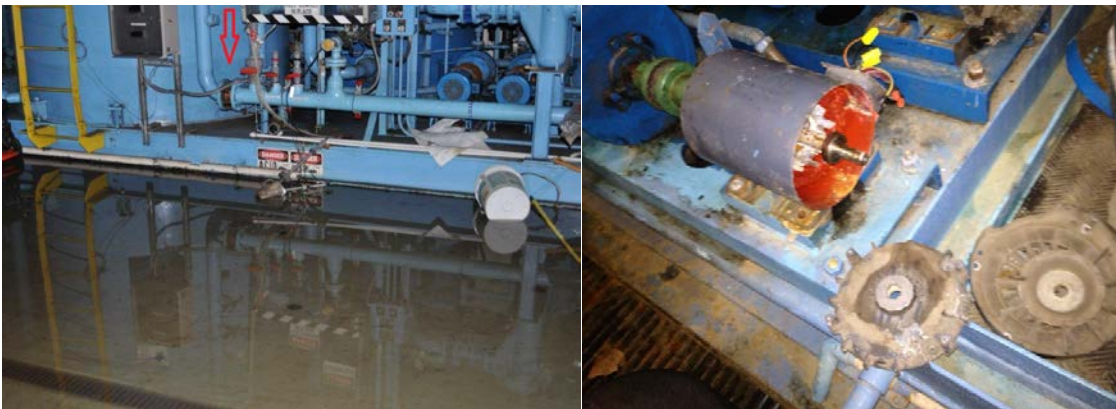
Figure 7.53 Syncon Resins Superfund Site Treatment Plant. Arrow shows high water mark (left). Motor cleaning and drying (right).

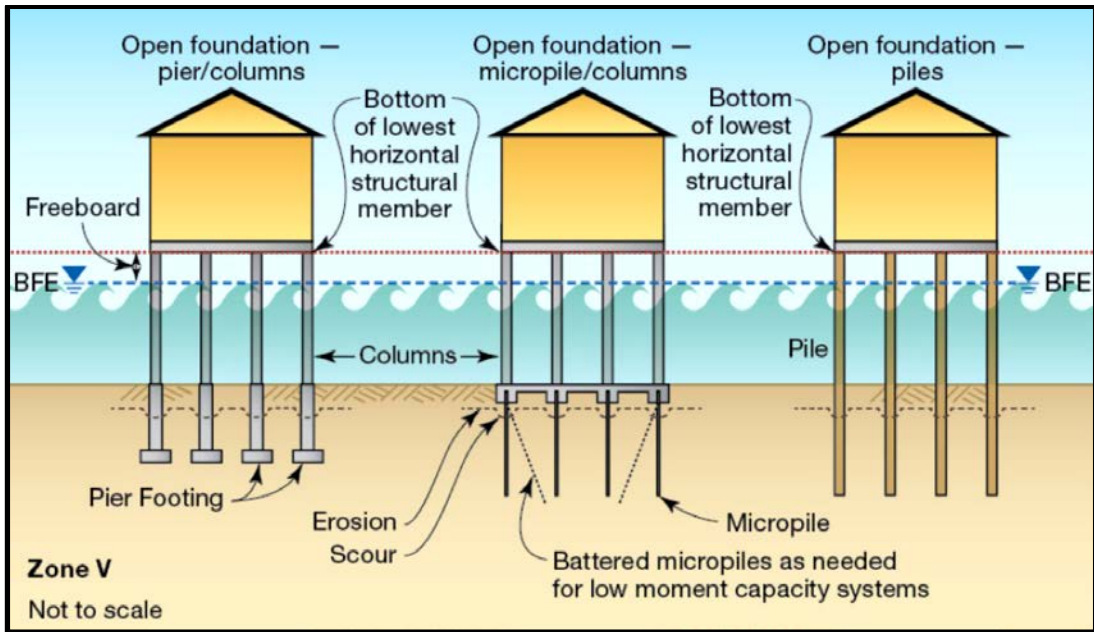
Figure 9.1 Examples of NFIP-compliant foundations in Zone V where bottom of lowest horizontal structural member is located above the BFE. (FEMA, 2013).

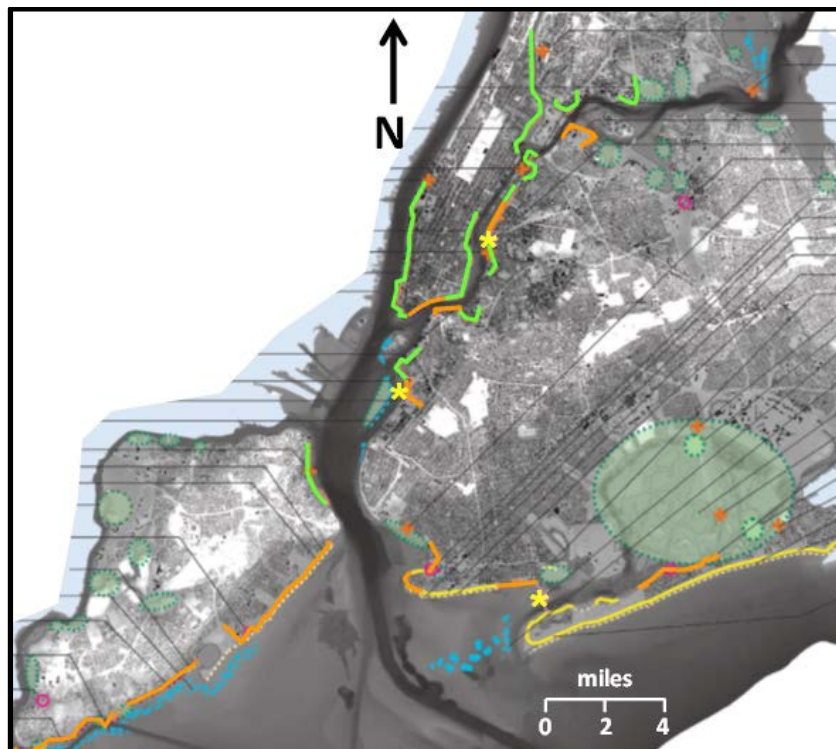
Figure 9.2 NYC Mayor's Comprehensive Coastal Protection Plan, indicating proposed: (i) orange lines - bulkheads, revetments, or levees; (ii) yellow lines - dunes; (iii) green lines - Integrated Flood Protection System; (iv) yellow asterisks - local surge barriers; (v) blue dots - offshore breakwaters; (vi) green shaded areas - wetlands (ref: NYC Special Initiative for Rebuilding & Resiliency, 2013).
