Geotechnical Reconnaissance and Engineering Effects of the December 29, 2020, M6.4 Petrinja, Croatia Earthquake, and Associated Seismic Sequence

Chapter 7: Liquefaction and Related Building Damage

7. Liquefaction and Related Building Damage

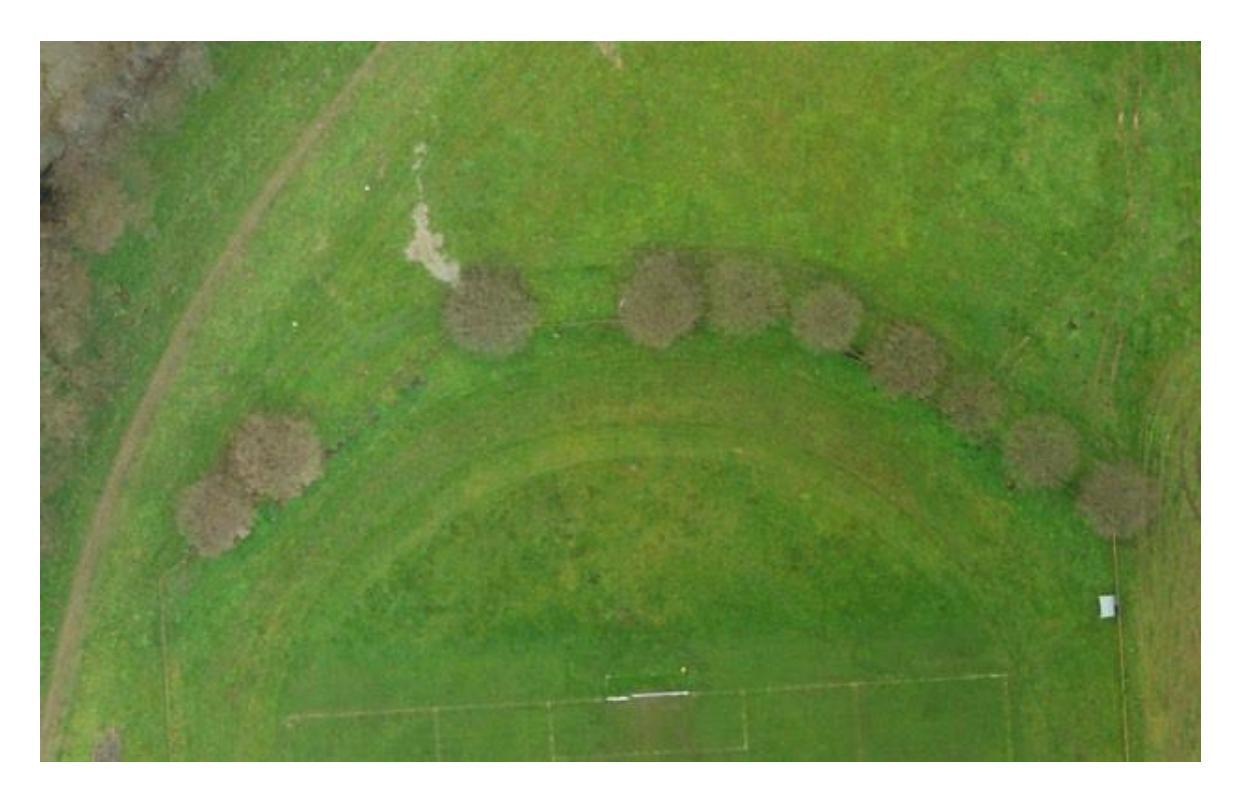
Figure 7.10 Linear pattern of sand boils at a field north of Glina (45.343889N, 16.084722E).

One common observation in both the aerial and field images was the linear pattern of sand boils emerging from surface cracks (e.g., **Figures 7.10 - 7.13**). For the locations shown in **Figures 7.10-7.13**, no ejecta were observed without cracks. Ejecta were also commonly observed within water wells in residential areas that penetrate through the overlying non-liquefiable soil layers to the sandy liquefiable soils below. **Figure 7.14** shows a nearby water well that was partially filled with sand following the earthquake, as well as the road settlement in Drenačka Street, Petrinja, without the presence of ejecta. This non-liquefiable crust found in this region may partially explain the lack of significant damage associated with liquefaction.

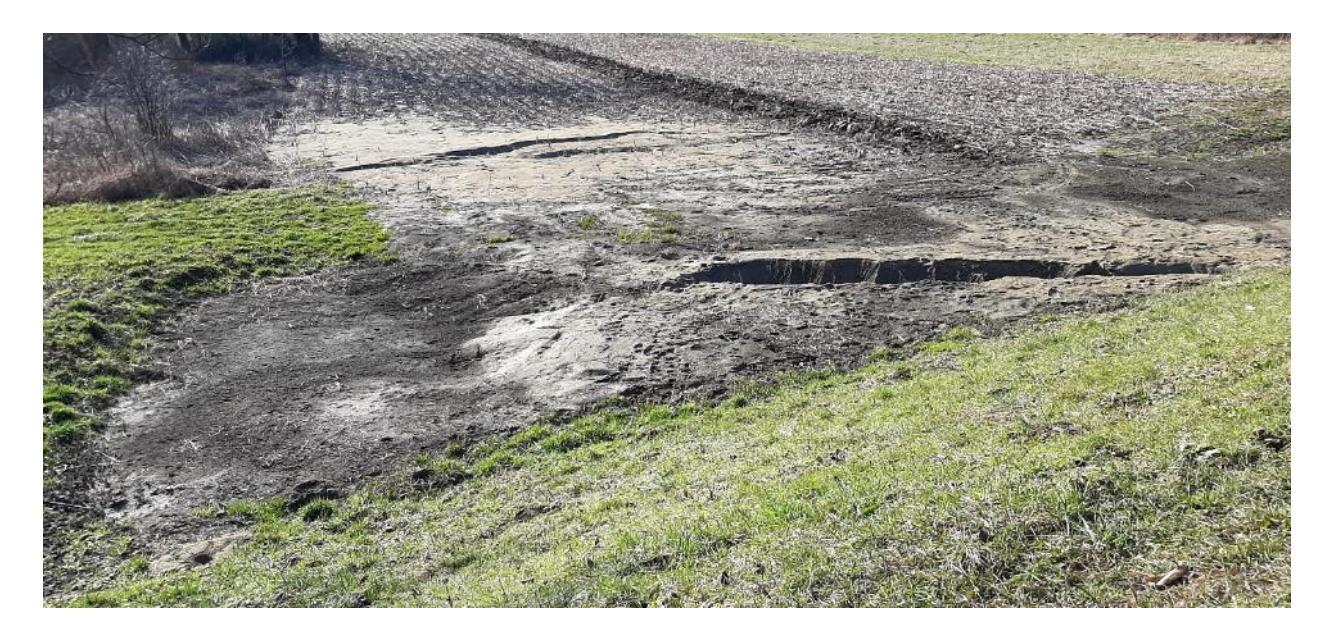
Figure 7.11 Ejecta in an agricultural field near Hrastelnica (45.5009N, 16.4166E).

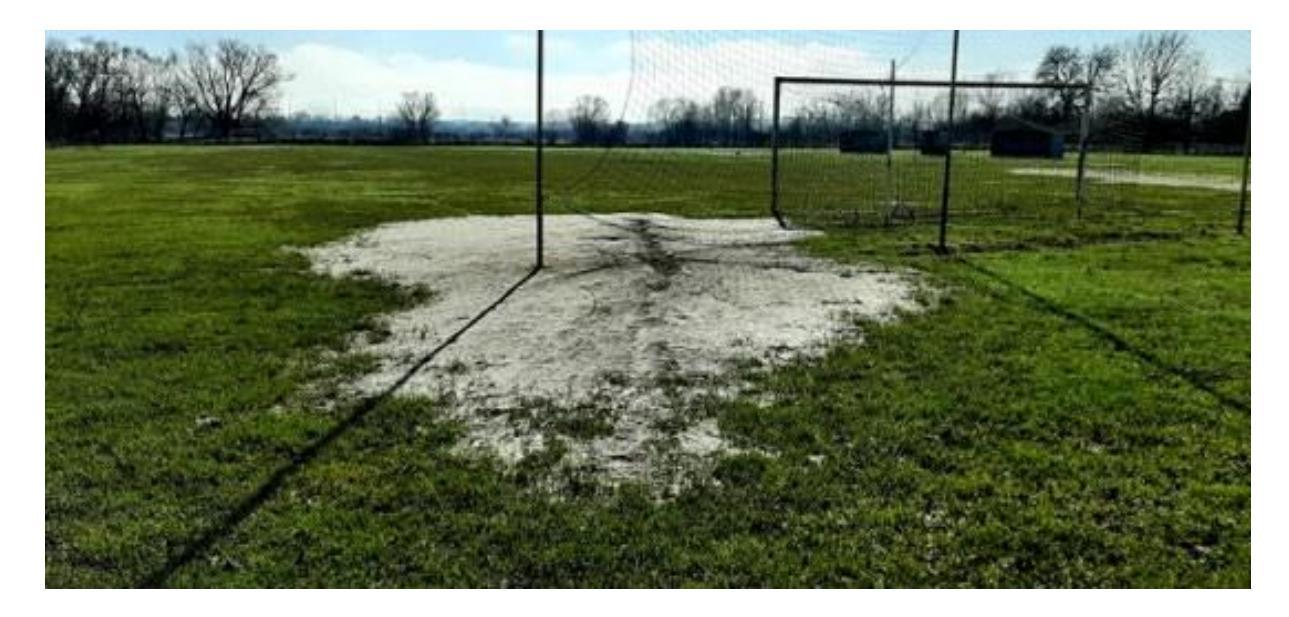
Figure 7.12 Ejecta in a football field near Letovanić (45.506095N, 16.198165E).

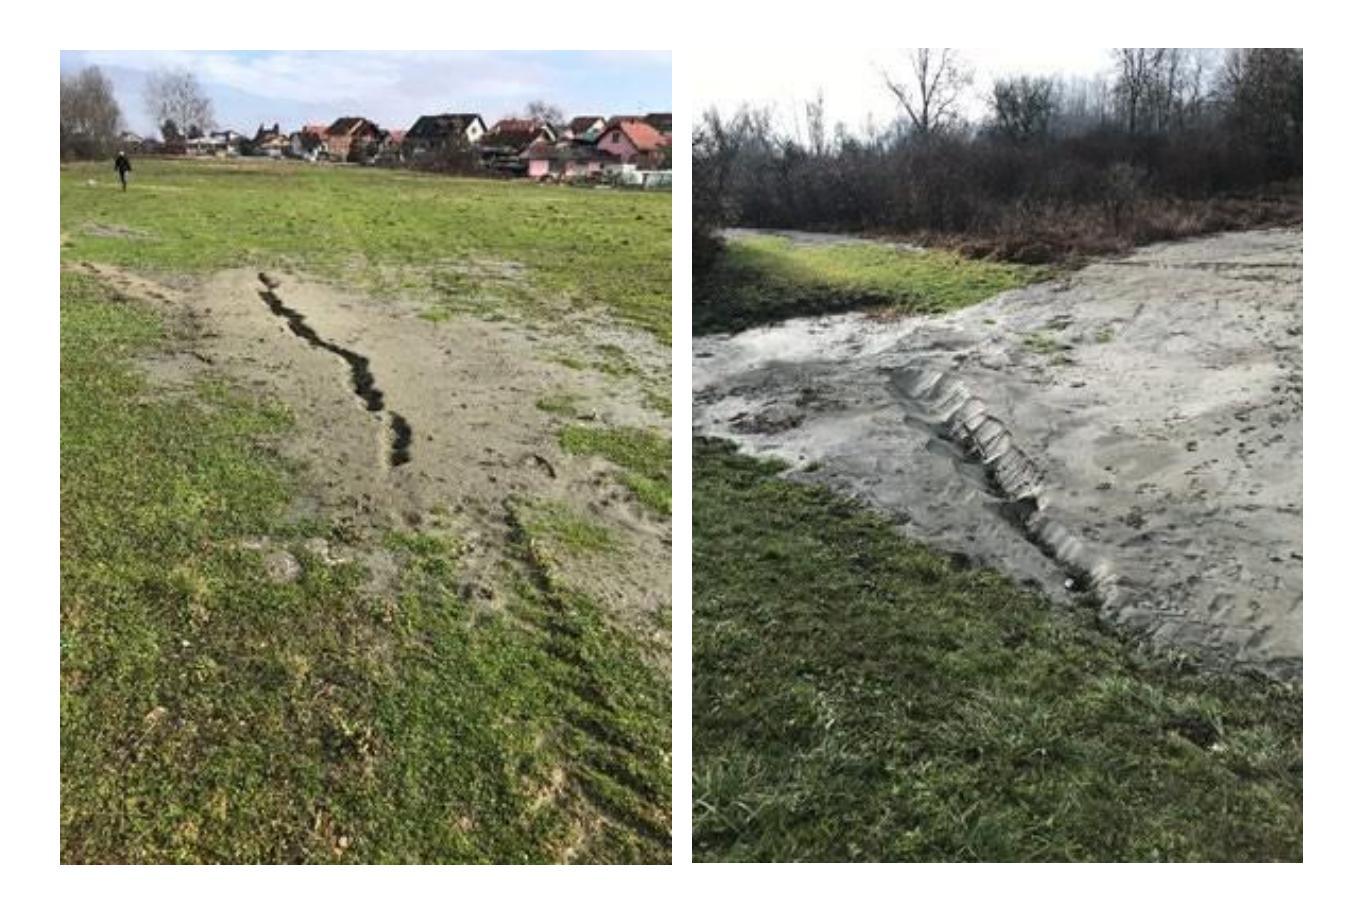
Figure 7.13 Linear patterns of ejecta located along cracks in Petrinja (left; 45.444714N, 16.274728E) and Hrastelnica (45.500594N, 16.416287E).

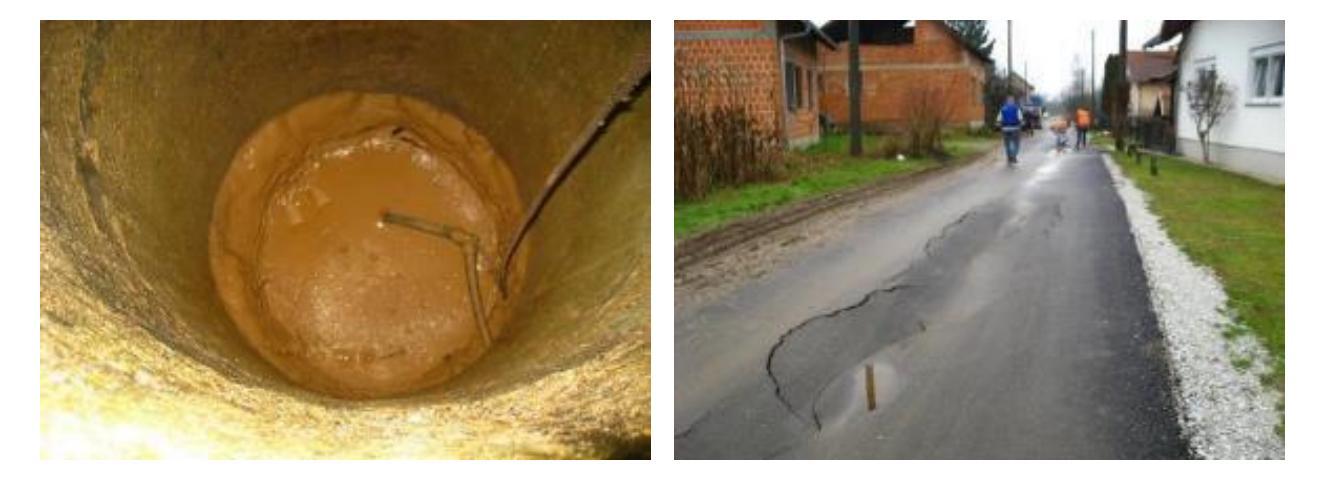
Figure 7.14 Liquefaction under the Drenačka Street in Petrinja (45.4560936N,16.3173009E) and sand in the well nearby (45.4562236N, 16.3164433E).

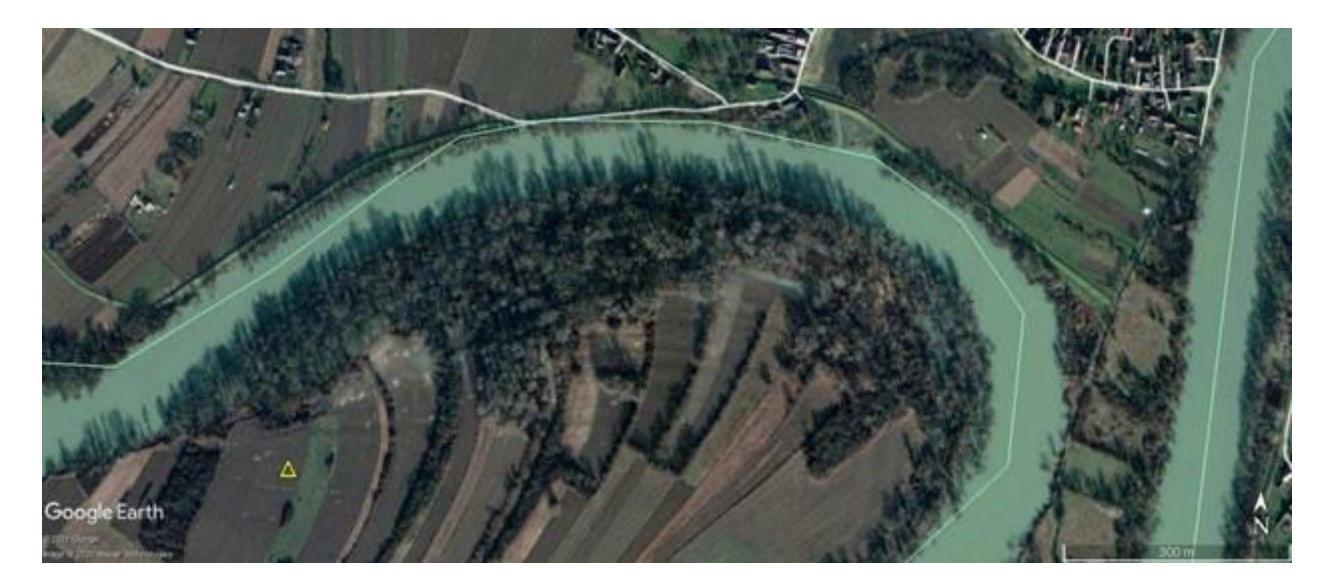
Lateral spreading is shown for two locations in Figure 7.2. Additional spreading and cracking of levees is discussed in Chapter 8. In Bok Palanječki, cracking and lateral offsets were observed on both sides of the river (**Figure 7.15**). Vertical offsets of approximately 30 cm and lateral offsets of approximately 10 cm were observed for the driveway of one of the residences in Bok Palanječki (**Figure 7.16**). Cracks were observed in the fields too, but no damage to the structures in this area was noted.

Figure 7.15 Post-earthquake satellite imagery (01/27/2021) near Bok Palanječki (45.510N, 16.409E). The yellow triangles indicate locations where cracking was observed.

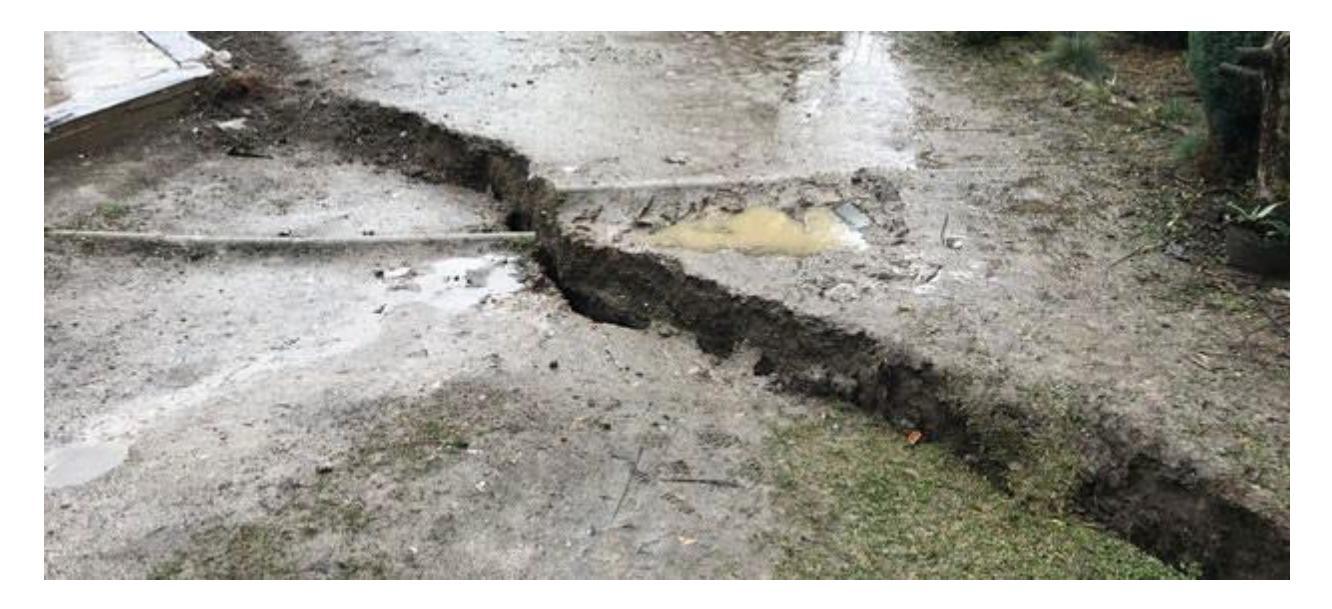
Figure 7.16 Cracks in the driveway of one of the residences in Bok Palanječki (45.510058N, 16.410803E).

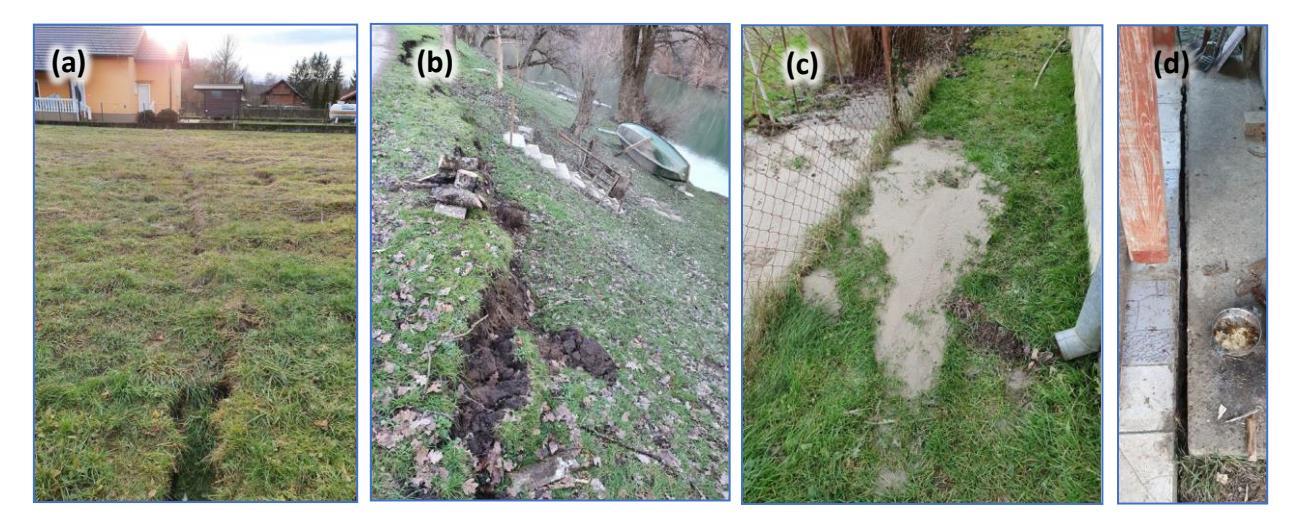
Figure 7.18a shows a crack in the yard of the house at 97 Ižišća Street that propagated through the neighboring yards, on the western side, while **Figure 7.18b** shows a crack on the eastern, river side. Both cracks are parallel with the riverbank. The property also had sand ejecta (**Figure 7.18c**). The house is slightly inclined towards the river suggesting the land is sliding towards the river. The house itself was not severely damaged, although some damages are to be repaired and further settlement due to liquefaction could be expected. **Figure 7.18d** shows the crack between the terrace and the house.

Figure 7.18 (a) Crack in the yard west from the house, (b) crack along the riverbank, (c) sand ejecta around the house, and (d) crack due to settlement of the terrace, at 97 Ižišća Street, Stari Brod (45.4801N, 16.1841E) (Taus 2021e). The cracks are parallel with the riverbank.

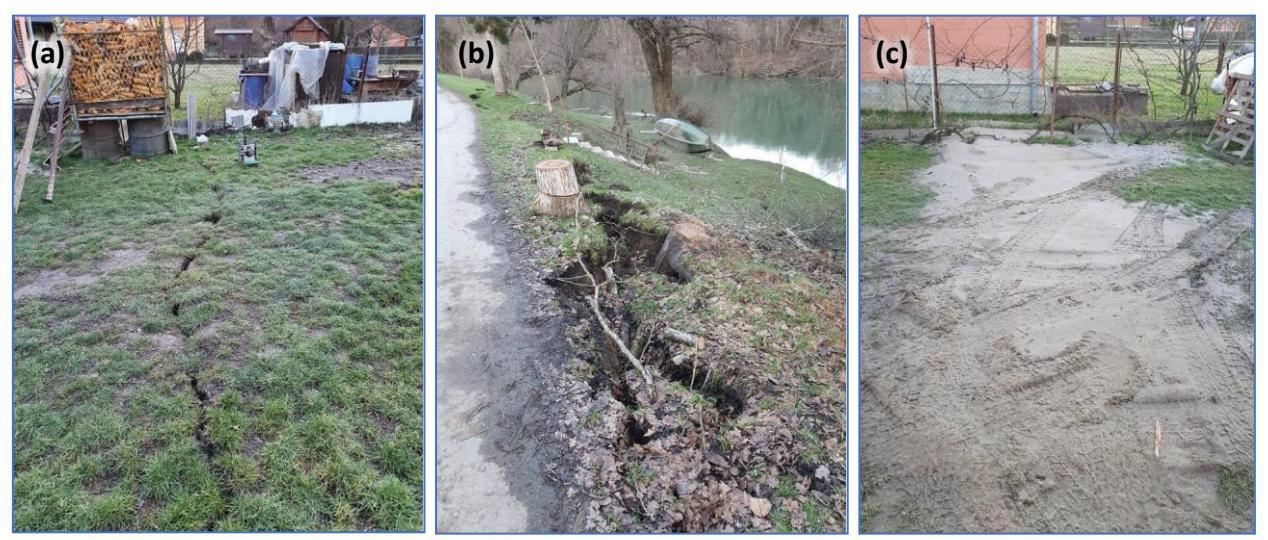
The 98 Ižišća Street property contained the same ground crack observed in the western yard of the house at 97 Ižišća Street (further referred to as the "western" crack). The house at 98 Ižišća Street was damaged and in danger due to differential settlement and possible sliding. The crack in the yard and the crack along the riverbank that progressed from 97 Ižišća Street—both parallel with the riverbank — as well as sand ejecta are shown in **Figure 7.19**. Therefore, it may be concluded that the sliding was caused or contributed to by liquefaction of underlying sandy layers.

Figure 7.19 (a) Crack in the yard west from the house, (b) crack along the bank, and (c) sand ejecta around the house at 98 Ižišća Street, Stari Brod (45.480158N, 16.184210E) (Taus 2021f). The cracks are parallel with the riverbank.

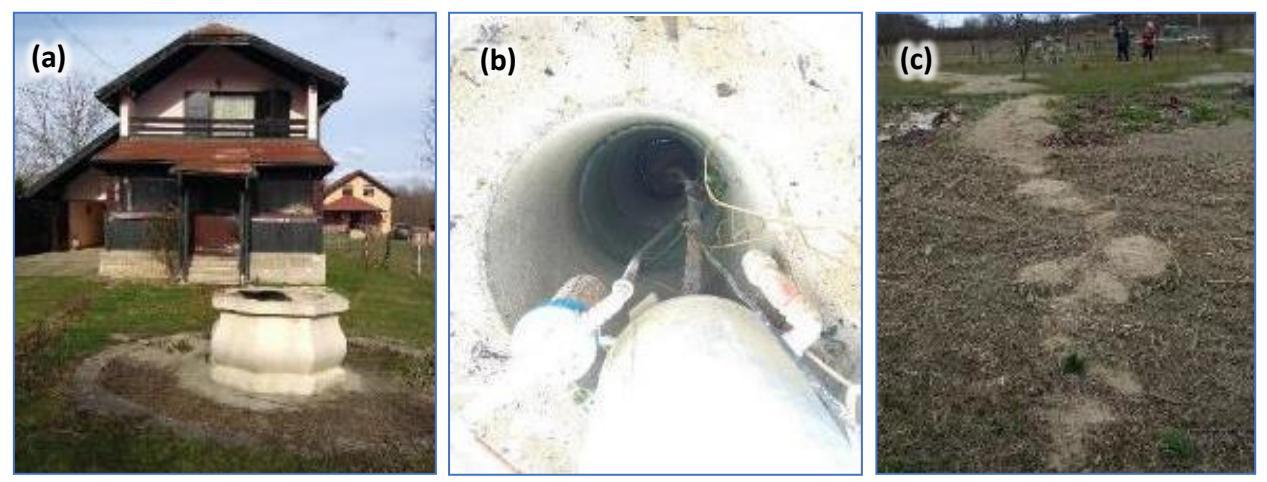
Furthermore, the neighboring 99 Ižišća Street property had the same "western" crack that now passed through the house causing severe damage and the same crack on the bank side that originated at 97 Ižišća Street. **Figure 7.20** gives a southeastern view of the house and the water

well at the property. During the earthquake, sand was ejected upward through the well and onto the surrounding ground, as visible in **Figure 7.20a**. The well remained filled with sand up to the 6-m depth below the ground surface level (**Figure 7.20b**).

Figure 7.20 (a) The southeastern view of the house at 99 Ižišće Street (45.480248N, 16.184285E) with the water well and sand ejected through the well and onto the ground during the Mw 6.4 earthquake and (b) the water well filled with sand to a depth of 6 m below the ground surface level. (c) Sand ejecta.

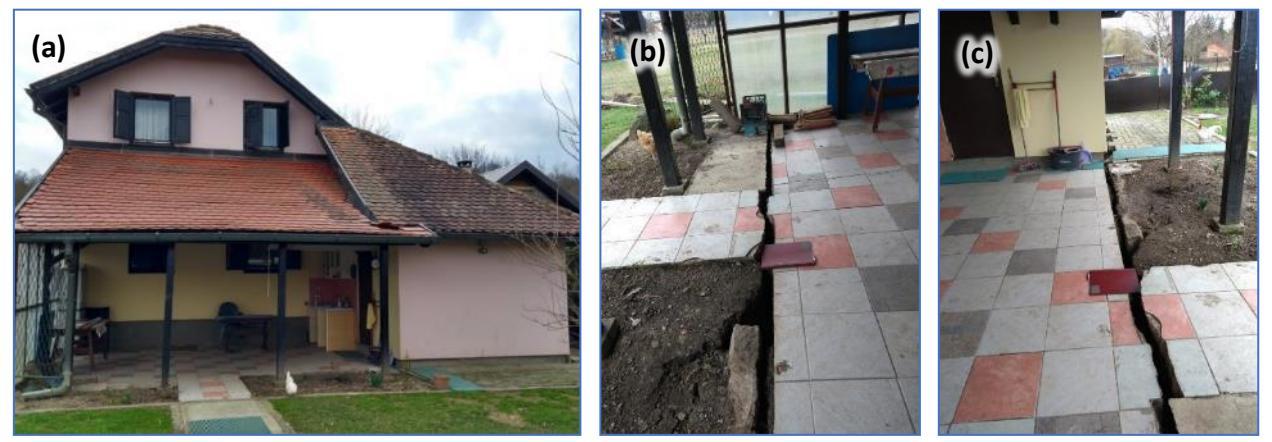
The cracks passing through the house floor at 99 Ižišća Street (**Figure 7.21** and **Figure 7.22**) were aligned with the crack in the neighboring yards at 97 and 98 Ižišće Street. Ejecta at this property were also observed, as shown in Figure 7.23. The cracks were mapped across the different homes (**Figure 7.24**) and indicated this portion of the bank was moving towards the free face of the river.

Figure 7.21 (a) Northwestern side of the house at 99 Ižišća Street (45.480248N, 16.184285E) in Stari Brod, (b, c) the propagation of the crack through the western yards of the houses at 97 and 98 Ižišća Street marked (1) in Figure 7.23. Crack is deeper than 1m, with opening of around 10 cm and a vertical offset of 8cm.

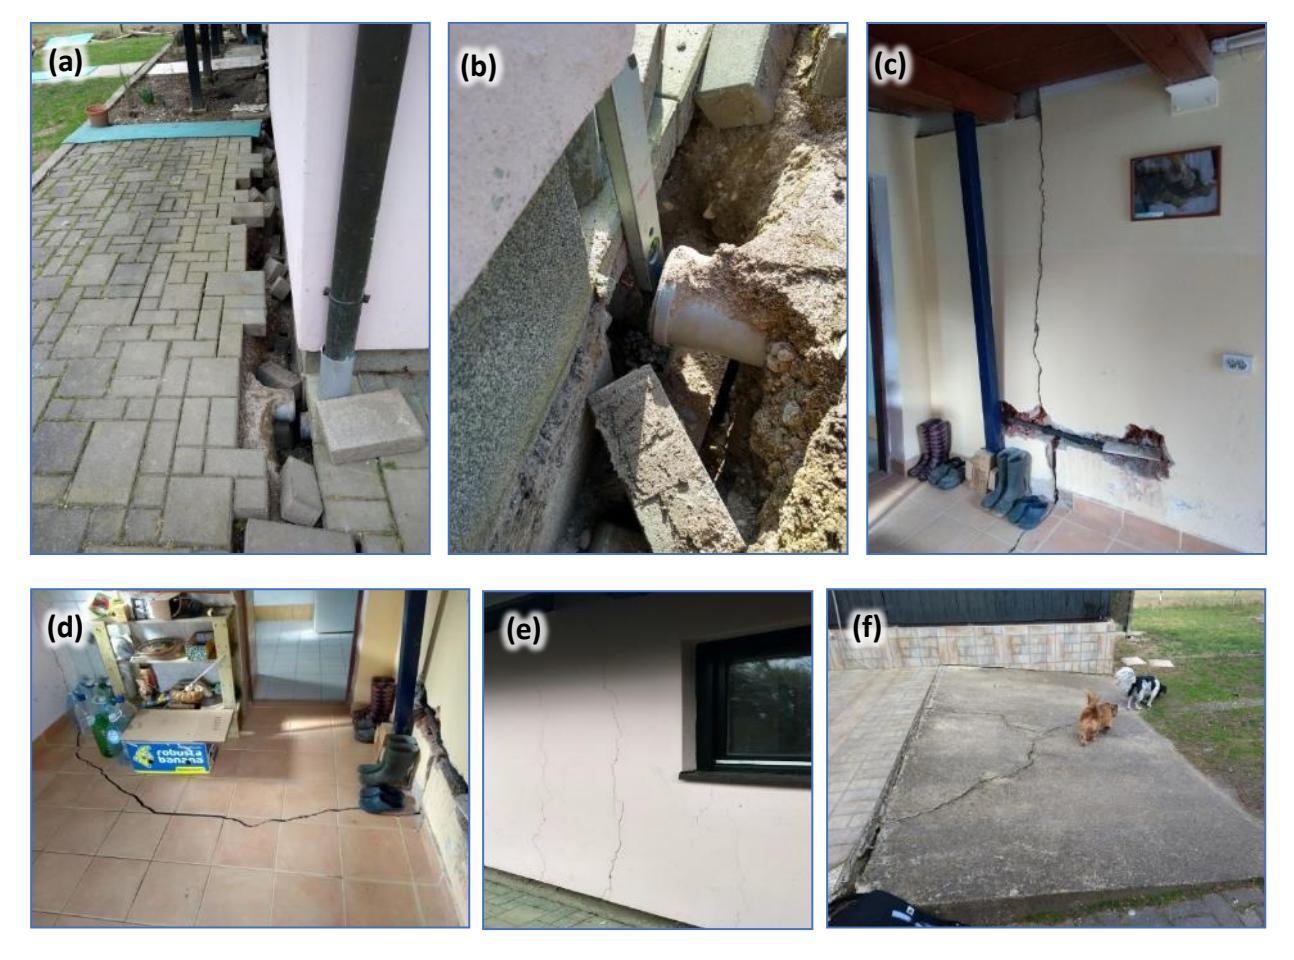
Figure 7.22 (a, b) Western corner of the house at 99 Ižišća Street (45.480248N, 16.184285E) in Stari Brod with pavement heave of 8 cm and rupture of the roof drainage pipe, marked (2) in Figure 7.23. (c, d) Water pipe rupture caused by vertical crack in the wall and crack on the garage floor between the terrace and house foundation on the line marked (3) in Figure 7.23 and (e) corresponding crack on the outside. (f) Cracks on the pavement at the garage entrance marked (4) in Figure 7.23.

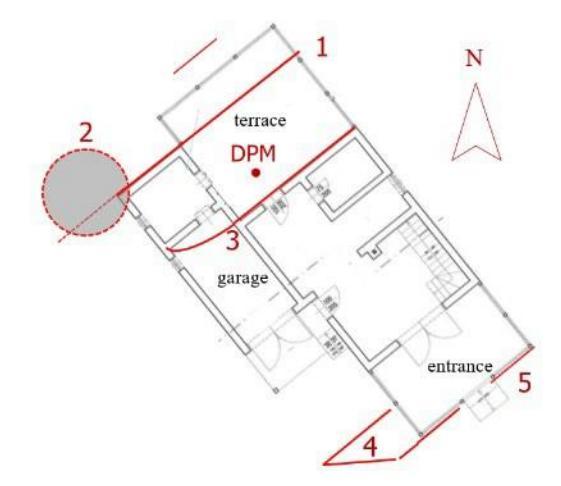
Figure 7.23 Plan of house at 99 Ižišće Street (45.480248N, 16.184285E) in Stari Brod and cracks shown in red. Numbers indicate features of interest: (1) Crack shown in Figure 7.21; (2) Pavement deformation shown in Figure 7.22a-b; (3) Water pipe rupture caused shown in Figure 7.22c-d; (4) Cracks in the pavement as in Figure 7.22f; (5) Cracks along the south east wall, probably widening. Steps are moving away from the terrace. Red dot: DPM location.

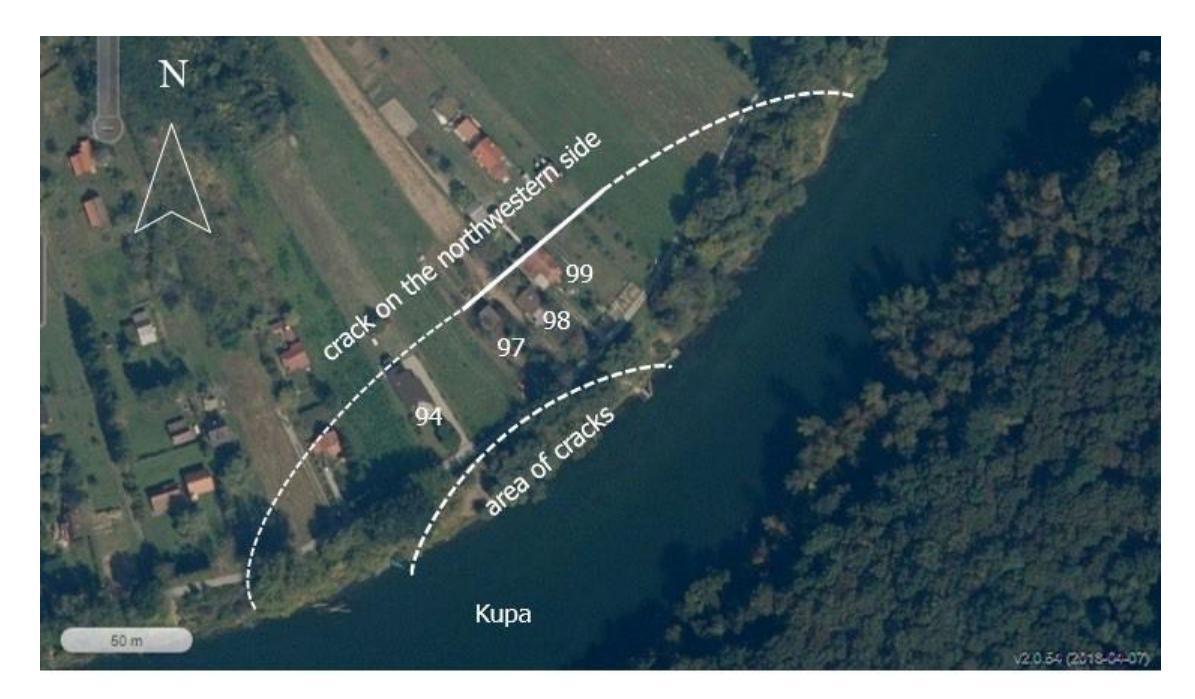
Figure 7.24 Position of the cracks mapped at 97, 98, 99, 99 Ižišće Street in Stari Brod due to lateral spreading along the Kupa River (45.480N, 16.183E; Geoportal, https://geoportal.dgu.hr/).

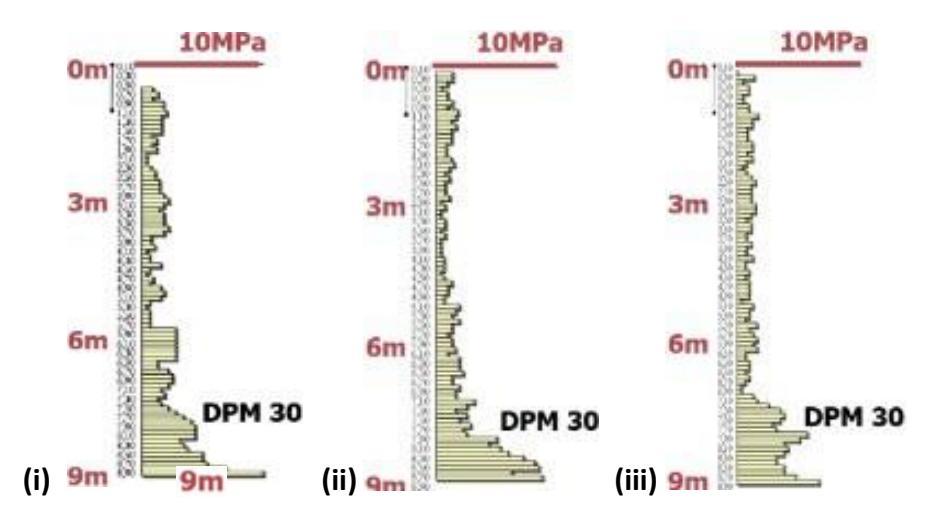
the height of 20 cm and the number of blows required to drive the crown 10 cm into the soil is counted. The counted values are then converted into dynamic cone resistance. The test results indicate low penetration resistance in the upper 6 meters of the soil profiles.

Figure 7.25 The DMP 30 test results obtained at (i) 97 lžišća St (45.480060N, 16.184103E), (ii) 98 lžišća St (45.480158N, 16.184210E), and (iii) 99 lžišća St (45.480229N, 16.18433E7) (Taus 2021e-g).

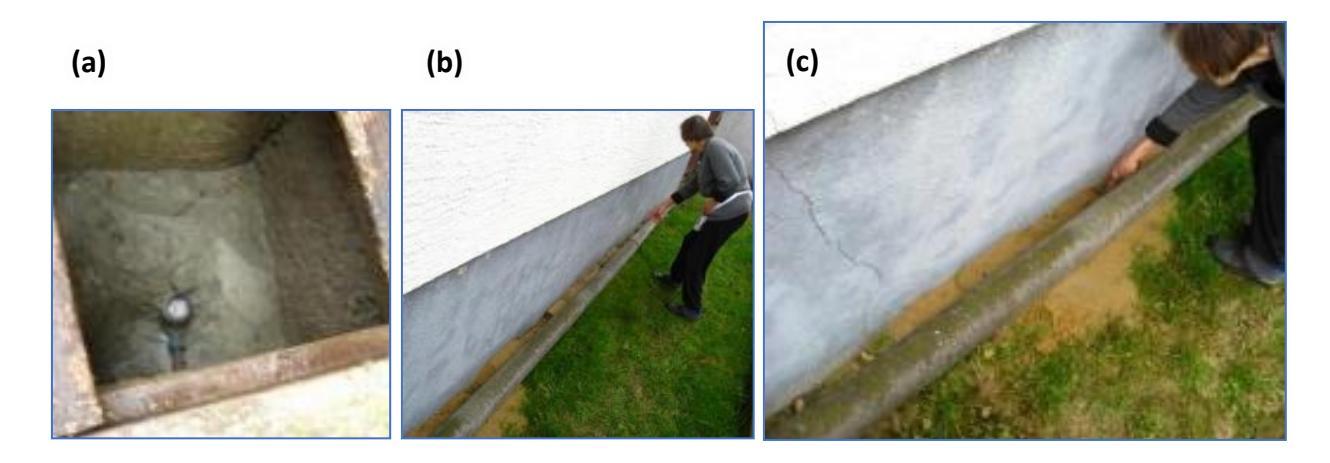
Many residential properties in Petrinja had sand ejecta in yards or around house foundations. **Figure 7.26** illustrates thin cracks above the foundation of a house in Petrinja. At the property across the street from this house, the sand ejecta were visible in the yard and along the fence foundation, and part of the yard heaved, all contributing to the formation of thin cracks in the house wall around the balcony near the single column, as shown in **Figure 7.27**.

Figure 7.26 (a) Sediment ejecta in the water meter shaft, (b) sand ejecta by the house, and (c) cracks above the foundation near the sand ejecta pointed at by the owner in Petrinja (45.4349N, 16.2683E).

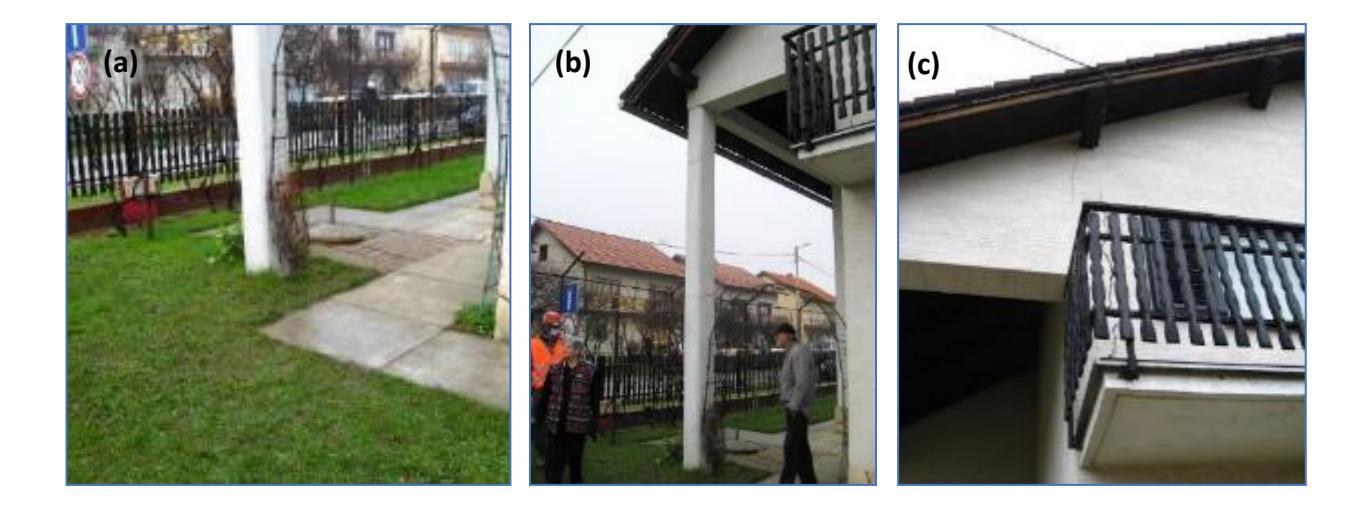
Figure 7.27 (a, b) During the main shock, sandy soil appeared along the fence foundation and the central part of the yard heaved. (c) Several thin cracks appeared in the house wall around the column and the balcony in Petrinja (45.43515N, 16.26844E).

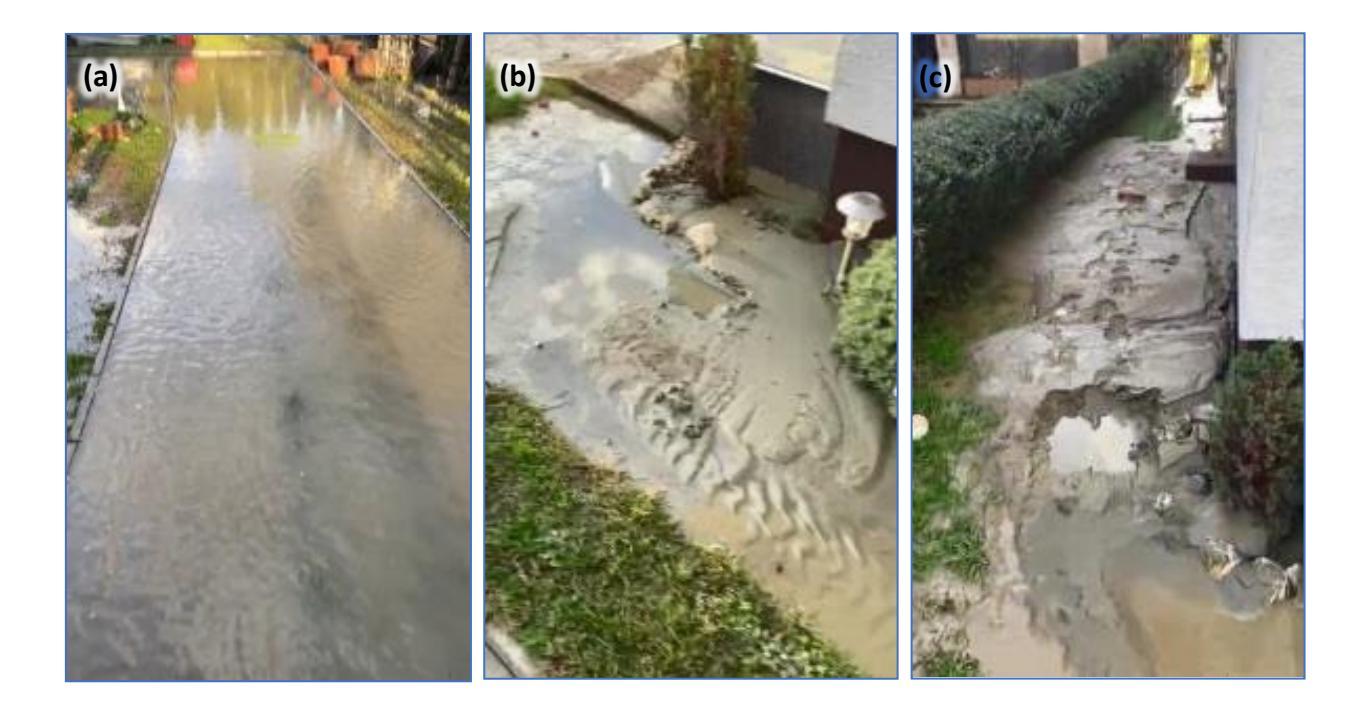
Evidence of liquefaction was found at residential properties in Milana Makanca Street in Petrinja starting from the house number 1 all the way to the house number 44, with the volume of the ejecta around each house measuring typically up to 1.5 m³ (Gulam 2021). At 11 Milana Makanca Street, liquefaction induced flooding of the property by groundwater mixed with some soil sediments, as illustrated in **Figure 7.28**. The house itself was not damaged, but it was suggested that further investigations be undertaken. In accordance with that, a dynamic penetrometer (DPM 30) test was performed at the house corner (Taus 2021a). The test results provided in **Figure 7.29** show that the soil in the upper 3 m is very loose.

Figure 7.28 (a) Flooding groundwater and sediment ejecta: (b) south corner, (c) northwest side around the house at 11 Milana Makanca Street, Petrinja (45.436061N, 16.262898E), recorded by the owner, Tomislav Zorčić, minutes after the Mw 6.4 earthquake.

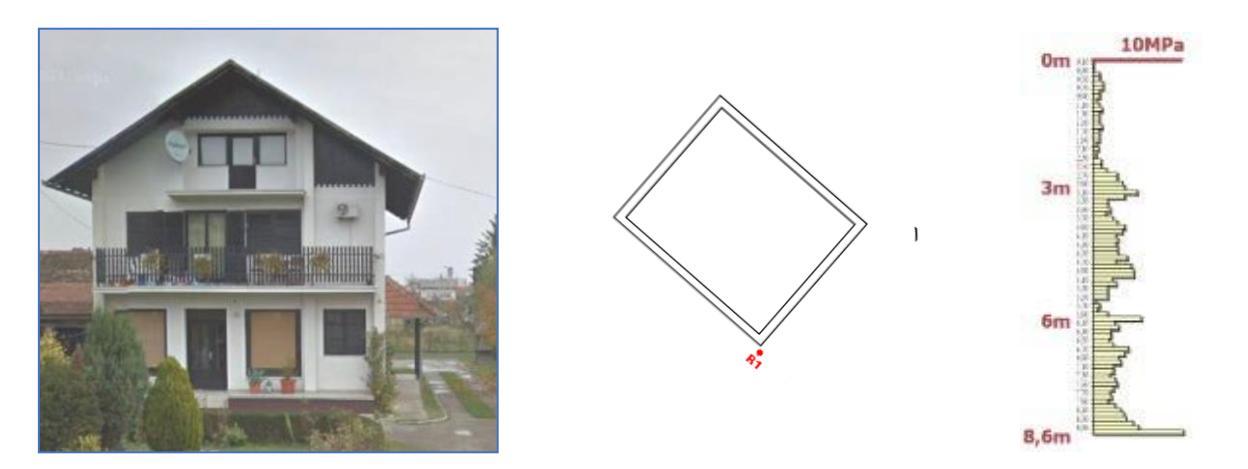
Figure 7.29 The house at 11 Milana Makanca Street in Petrinja (45.436061N, 16.262898E), test location at the southern corner of house, and DMP 30 test results (Taus 2021a).

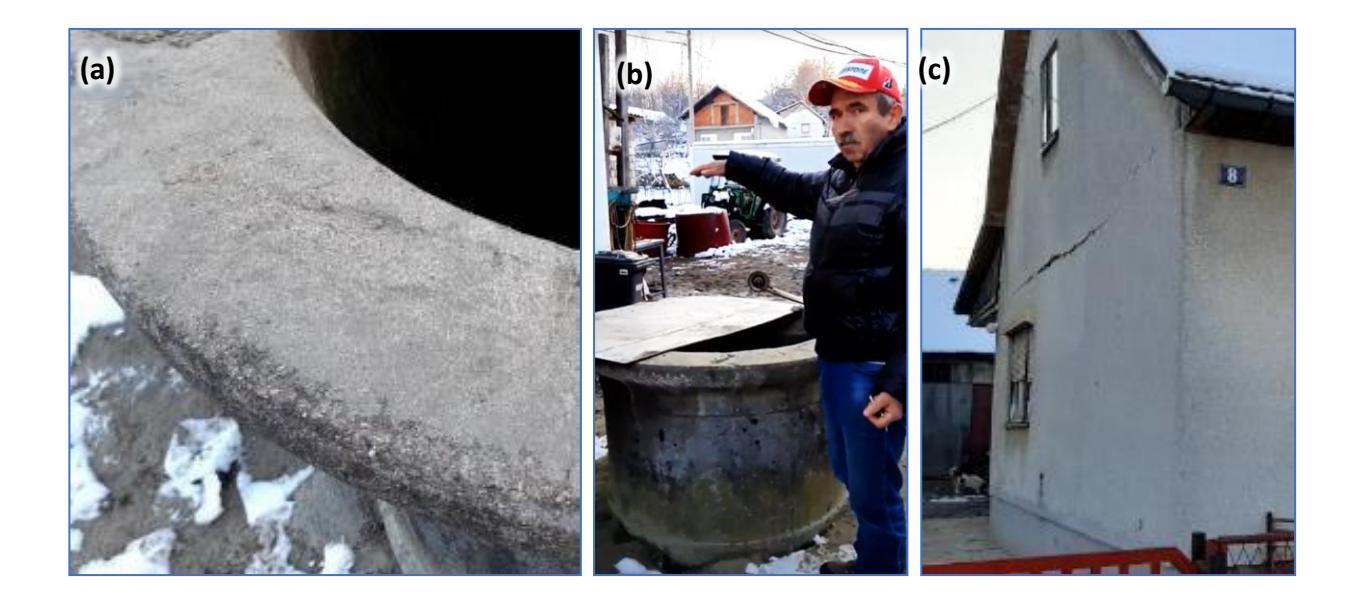
Many water wells in the area were filled with liquefied sandy soil. A well at 8 Milana Makanca Street in Petrinja was seen to eject sand some 150 cm above the ground level, as shown in **Figure 7.30**, causing cracks in the nearby house that was abandoned before the earthquake (also shown, in **Figure 7.30c**). The neighboring house at 10 Milana Makanca Street, also abandoned before the earthquake, had damage in the ceiling visible at **Figure 7.31**.

Figure 7.30 (a) Rim of the water well at 8 Milana Makanca Street in Petrinja (45.4359N, 16.2627E) covered by the ejected sand. (b) A neighbor shows that during the earthquake sand and water were ejected upward from this well, around 150 cm above the ground level. (c) The abandoned house near the well.

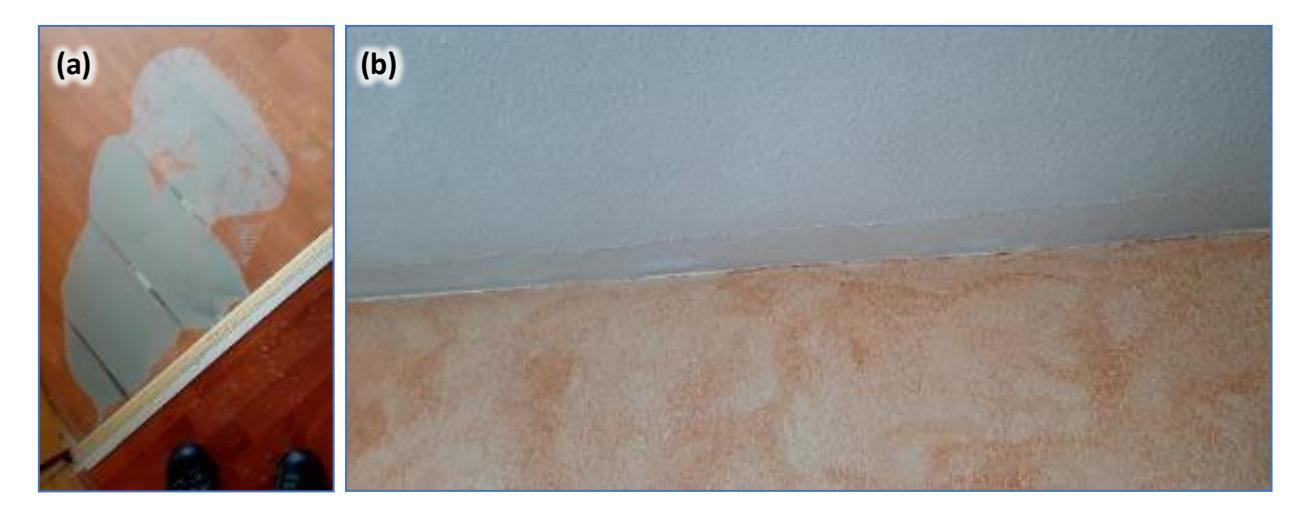
Figure 7.31 (a) Traces of sand ejecta and (b) the crack in the ceiling inside the house at 10 Milana Makanca Street in Petrinja (45.4358N, 16.2628E).

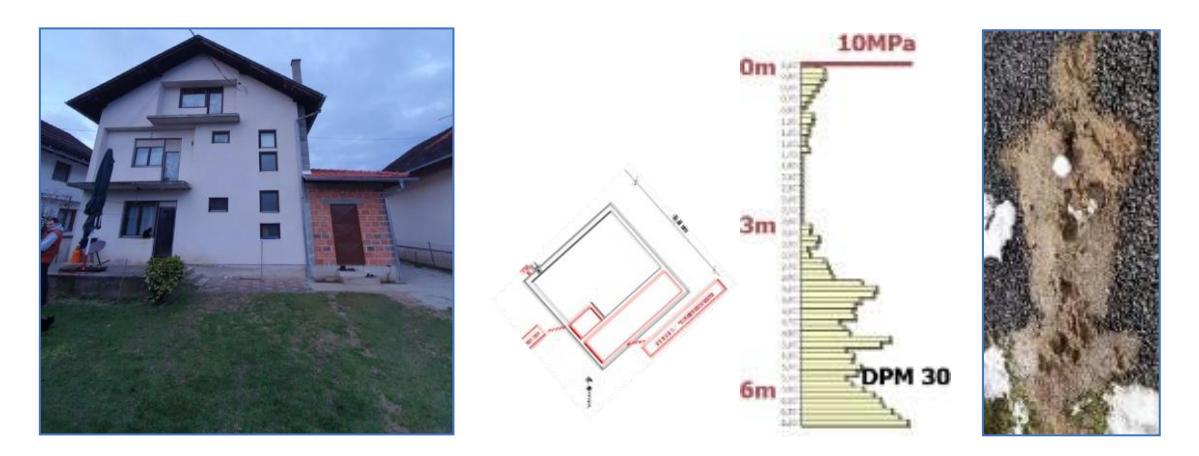
DPM 30 testing was also performed at several locations in Glina, approximately 12 km from the epicenter, to evaluate the subsurface conditions. Evidence of liquefaction was identified in the streets as well as at the properties. Liquefaction effects were especially notable in the streets along the former riverbed of the Maja River. DMP 30 testing was performed at one of these locations (20 6. kolovoza 1995. Street) with the results presented in **Figure 7.32.** The test results show that the soil in the upper 3 m of the profile (especially from the 1.5-m to 3-m depth) is extremely loose. Similar soil conditions were observed across the street (25 6. kolovoza 1995.

Figure 7.32 The house at 20 6. kolovoza 1995. Street (45.3430N, 16.0911E), test location at the western corner, DMP 30 test results, and characteristic ejecta (Taus 2021b).

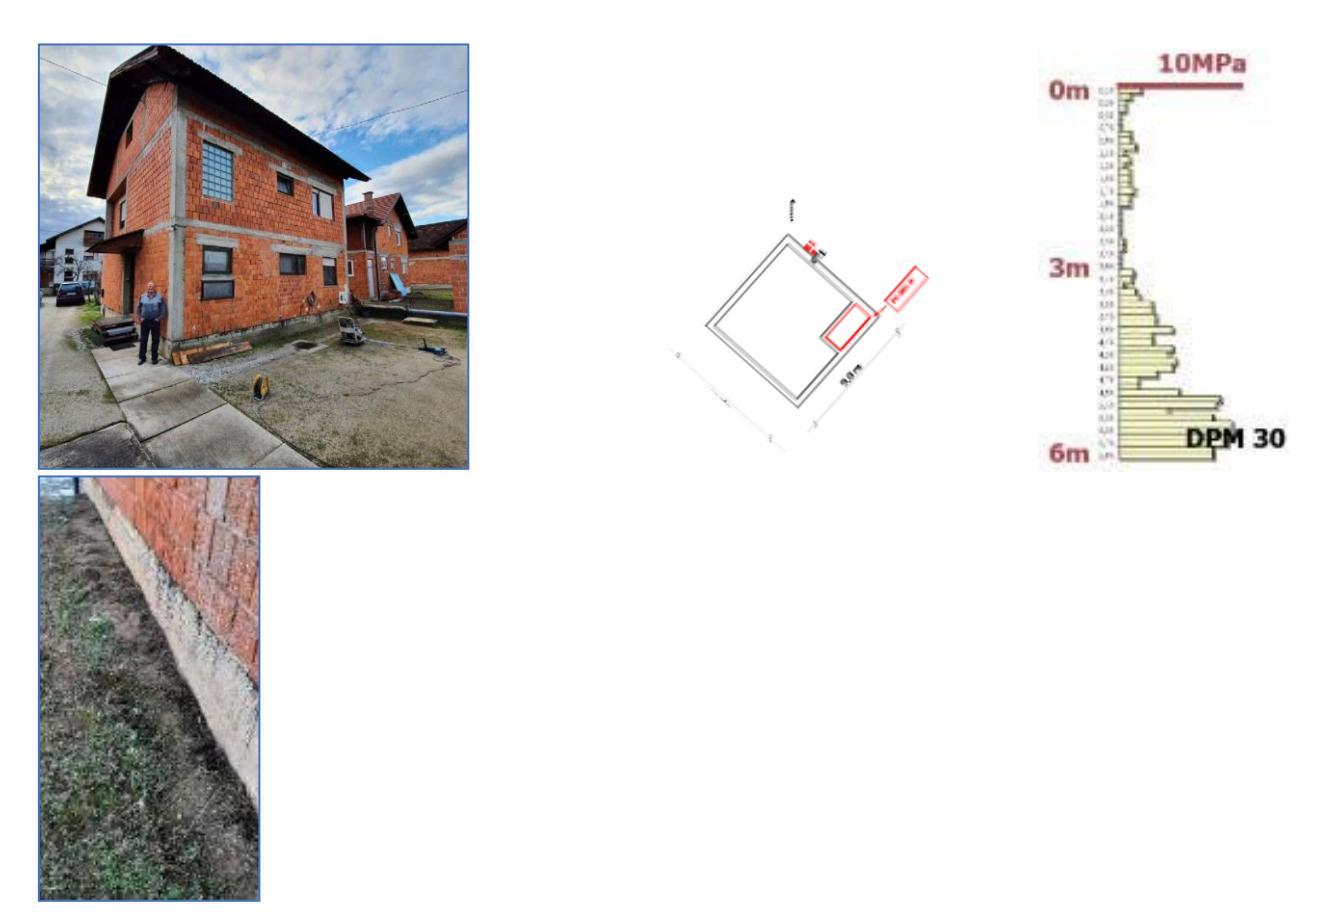
Street), as shown in **Figure 7.33**. Slightly stronger soils were found at the nearby location (35 6. kolovoza 1995. Street), as shown in **Figure 7.34**.

Figure 7.33 The house at 25 6. kolovoza 1995. Street (45.3431N, 16.0911E), test location near the northern corner, DMP 30 test results, and characteristic ejecta (Taus 2021c).

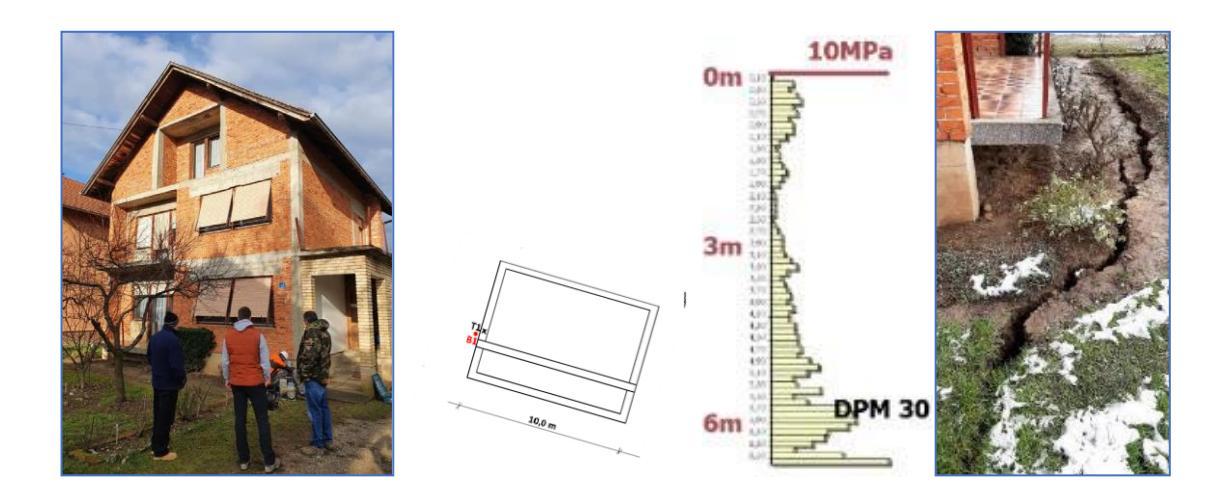
Figure 7.34 The house at 35 6. kolovoza 1995. Street (45.3429N, 16.0920E), location of the testing near the eastern wall, DMP 30 test results, and characteristic crack (Taus 2021d).
