#### **Geotechnical Effects of Hurricane Florence**

Geotechnical Extreme Events Reconnaissance (GEER) Association.

GEER Association Report No. GEER-063

April 2019 Revision 1 - June 2019

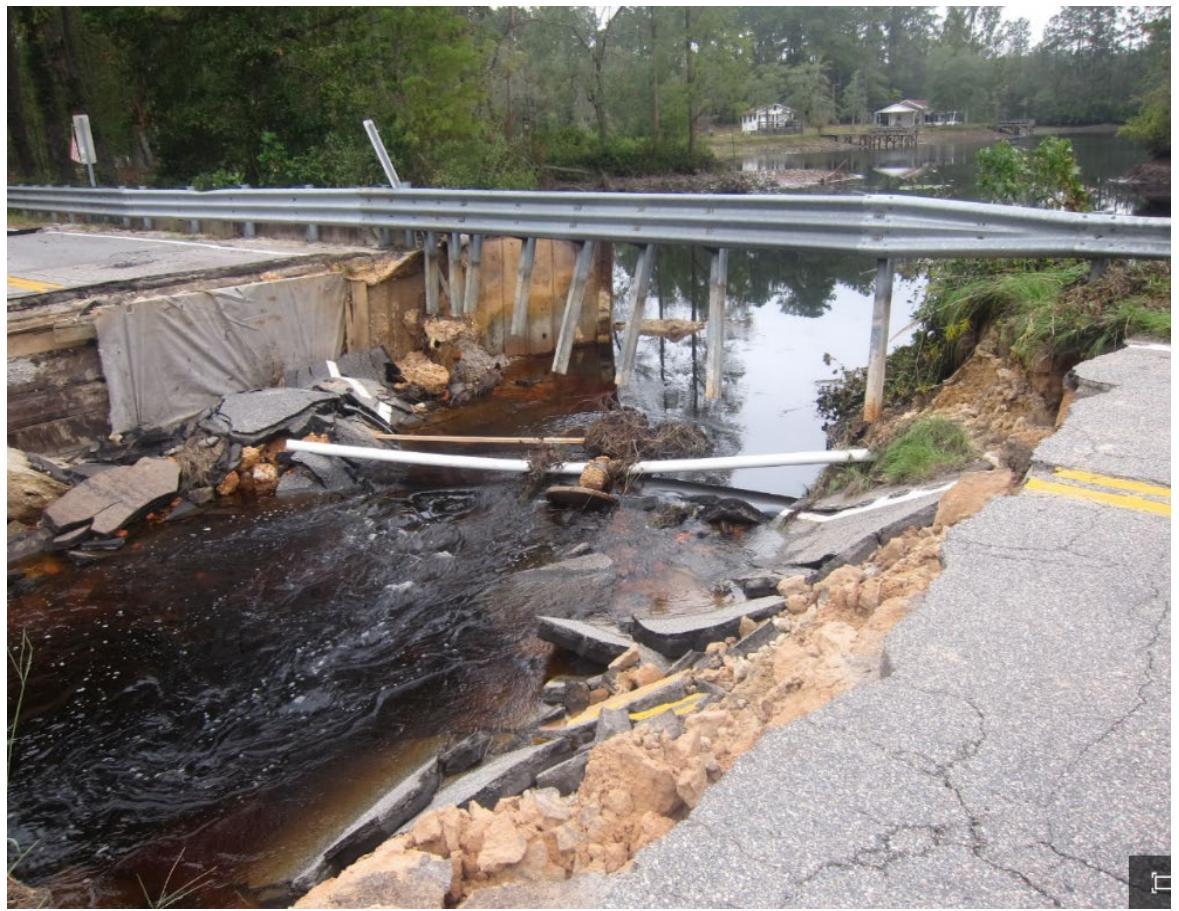
Of the 14 breached dams that we visited, eight were clustered near the NC-SC border, near Laurinburg, NC. This area is on the eastern side of the Piedmont, the middle of three physiographic provinces in NC and SC. The Coastal Plain physiographic province to the east is generally flat and less than 600 feet in elevation. Circumstances that may have factored into the cluster of dam failures could include intensity of rainfall due to elevation effects, a higher density of historical dam development in the hillier terrain, and increased runoff due to lower-permeability soils. All of the eight dams in this cluster were small in size and low or significant hazard, dam categories for which state regulations allow less stringent spillway design floods (SDFs). A typical dam breach in this area is shown in Fig. 4.2-1.

Fig. 4.2-1 - McMeekin Pond Dam, Wallace, SC, looking from downstream corner of the breach upstream (September 25, 2018, 34.737 N, 79.799 W)

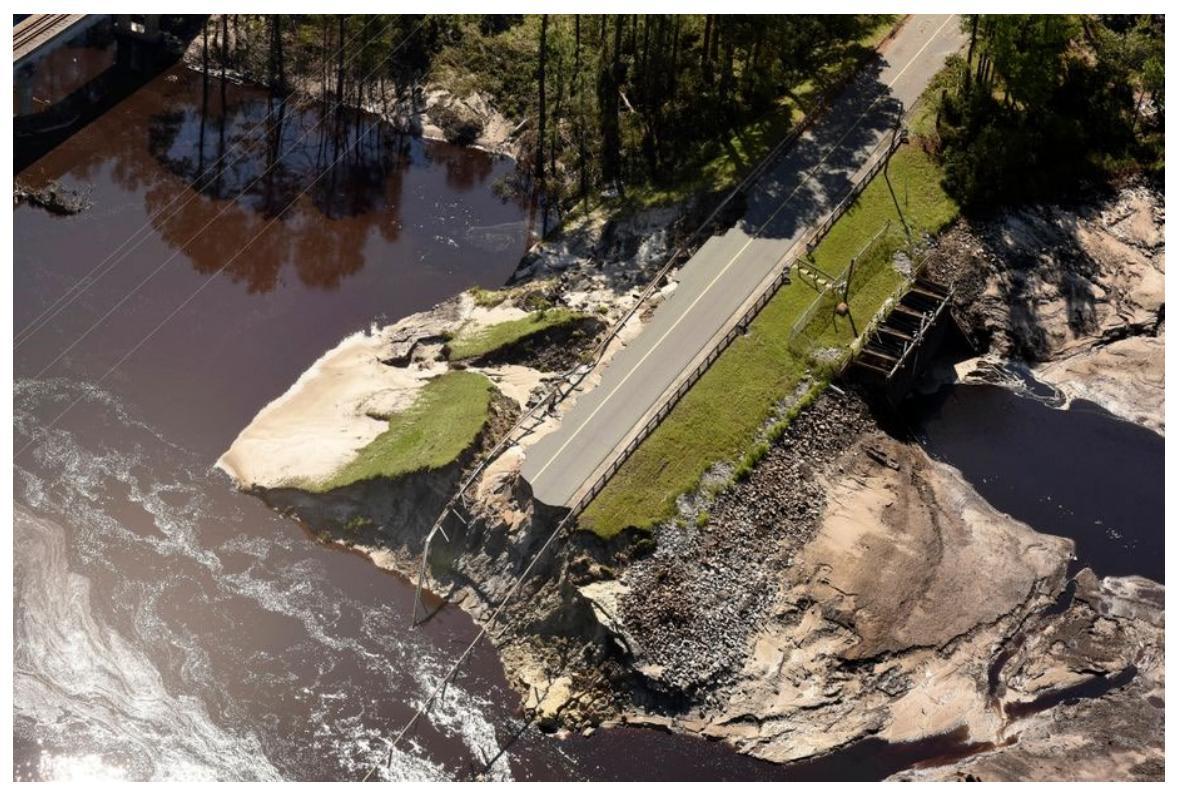
The breach of the dam occurred near the mid-length point of the dam and was about 200 ft wide (Fig. 4.2.1-3). We saw evidence of overtopping in the form of erosion along downstream face at multiple locations. We also observed sand deposits on the downstream slope and toe. Because there were no indications of piping on the upstream face, and no sinkholes, voids or settlements, we expect that the sand was breach erosion material left by backwater flows. We were told by a resident that on Saturday, September 15, 2018, around 11:15 p.m., the dam started to overtop and that it failed around 11:30 p.m.

We observed five areas of interest around the dam -(1) the ~200-ft-wide breach section, (2) the right side of the dam where overtopping eroded part of the downstream slope around the outlet works without breaching the dam, (3) an eroded section of the downstream slope on the embankment to the left of the breach, (4) the left abutment contact where local responders attempted to create an emergency spillway to divert and reduce overtopping flows, and (5) the apparent robust response of the downstream rail structures to the high flows.

Fig. 4.2.1-4 – Breach, right side of dam, and outlet structure (September 26, 2018, 34.0462 N, 78.0373 W)

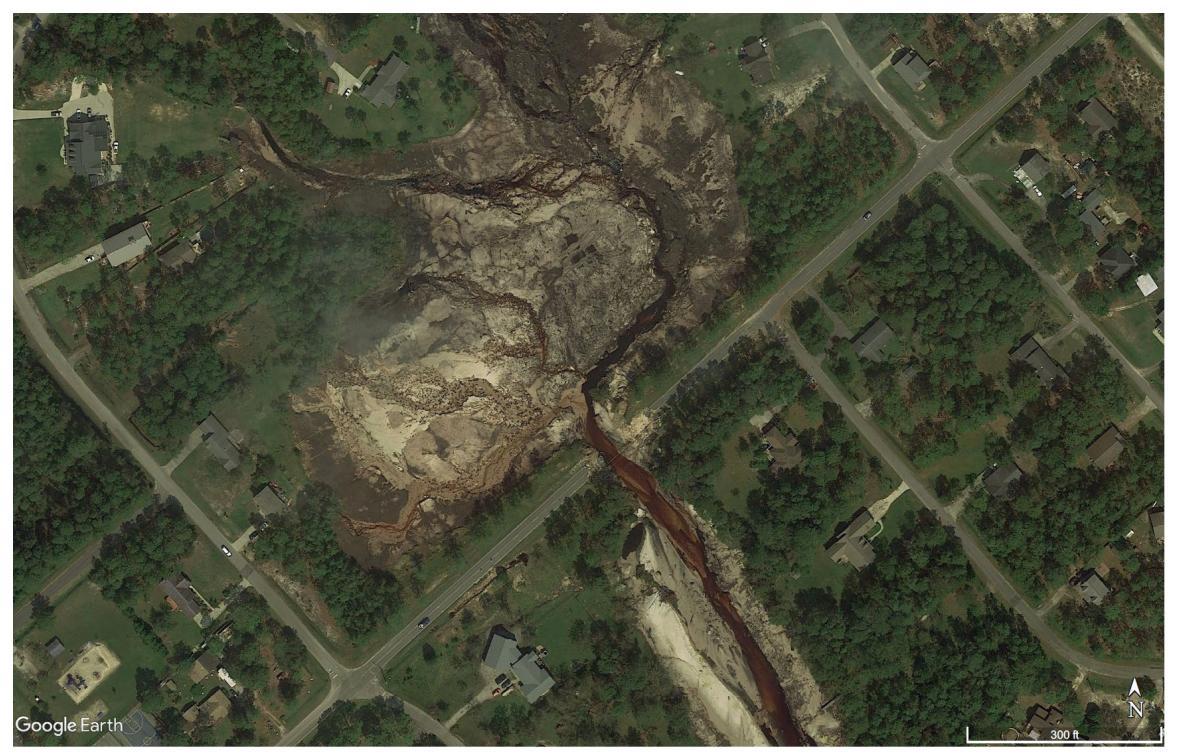
The breach occurred at the location of the low-level pipe (Figs. 4.2.2-1, -2, -3). We observed indications of overtopping and toe cutting downstream of dam at multiple locations. NC DEQ informed us that the dam failed after the failure of downstream Boiling Springs Dam. The sudden drawdown of Boiling Springs Lake and the added exposure of the downstream slope to overtopping erosion without the cover of the downstream lake may have contributed to the dam failure.

Fig. 4.2.2-1 – Post-failure aerial photograph (Google Earth, September 19, 2018, 34.034 N, 78.064 W)

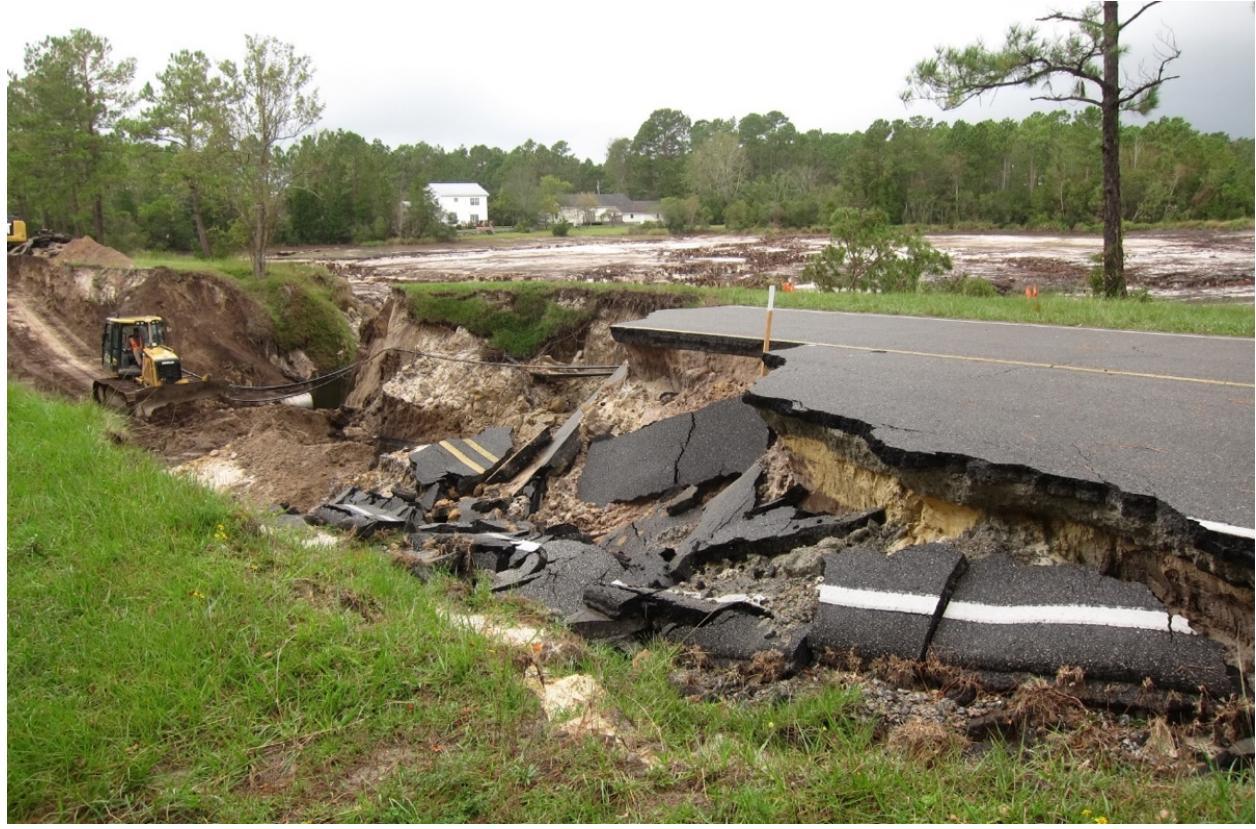
Fig. 4.2.2-2 – Looking from downstream left abutment to overtopping erosion, breach and empty reservoir (September 28, 2018, 34.0334 N, 78.0635 W)

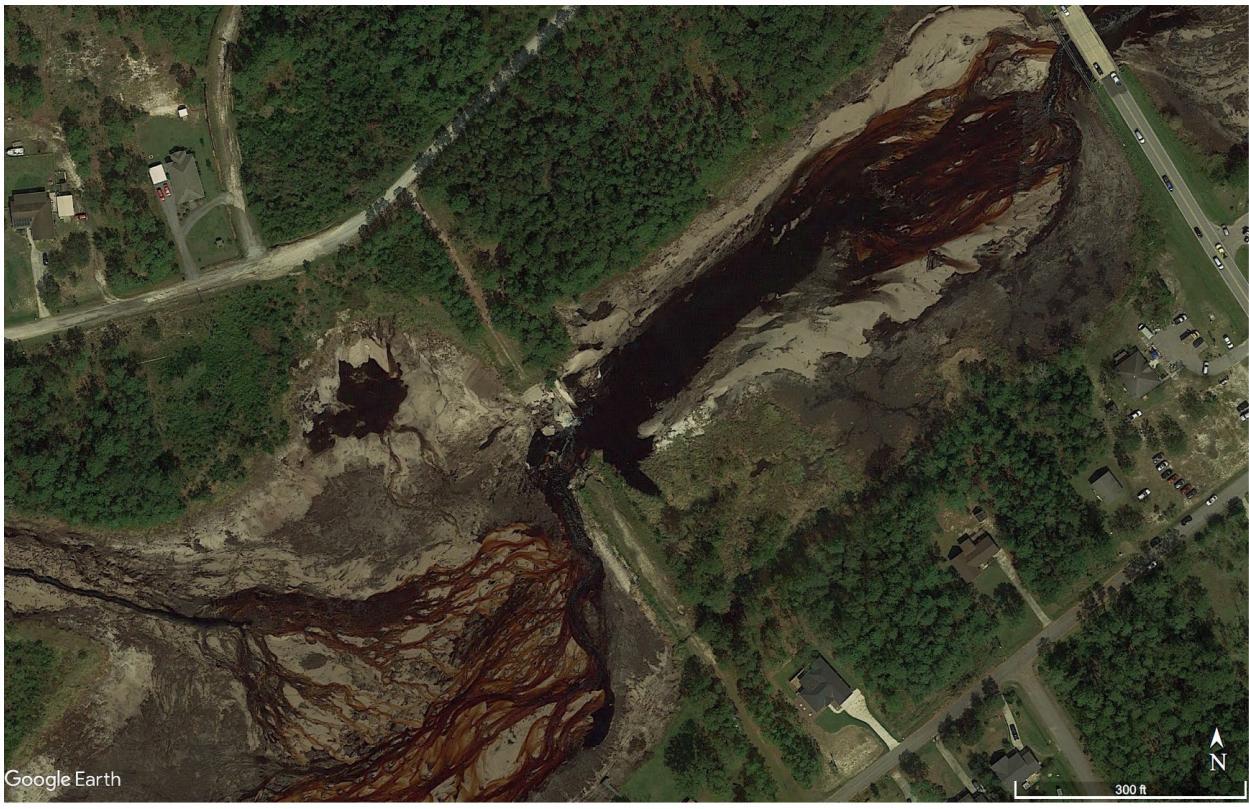
Fig. 4.2.4-1 shows the Google Earth aerial photograph of the dam breach taken on September 19, 2018. Fig. 4.2.4-2 shows the breach from ground level at the time of our visit. Figs 4.2.4-3 and - 4 show evidence that the dam was overtopped, which, in possible combination with the rapid drawdown of Boiling Spring Lake downstream and lack of backwater to mitigate erosion, was a likely cause of the breach.

Fig. 4.2.4-1 – Middle Dam aerial image (Google Earth, September 19, 2018, 34.024 N, 78.066 W)

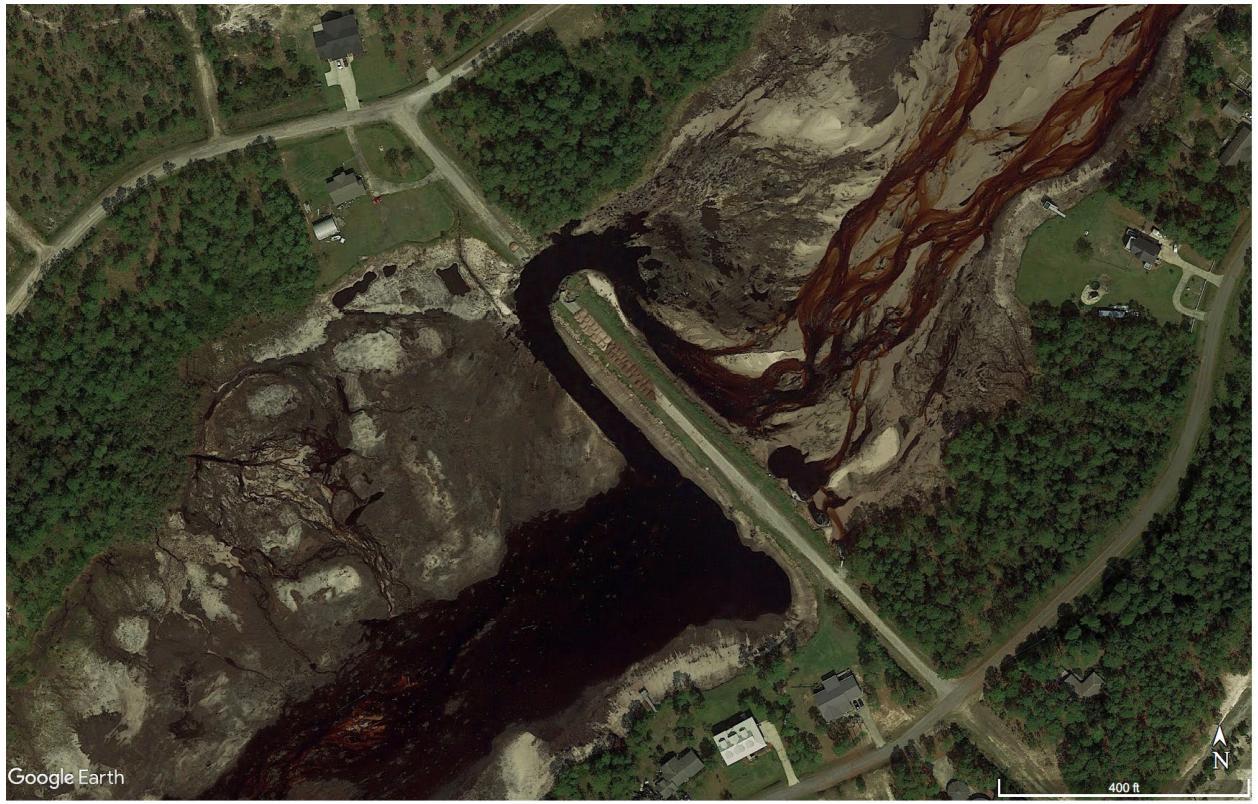
Fig. 4.2.5-1 shows the Google Earth aerial photograph of the dam breach taken on September 19, 2018. Fig. 4.2.5-2 shows the breach from ground level at the time of our visit. Fig 4.2.4-3 shows evidence that the dam was overtopped, which, in possible combination with the rapid drawdown of the Middle Dam impoundment downstream and lack of backwater to mitigate erosion, was a likely cause of the breach.

Fig. 4.2.5-1 – Upper Dam aerial image (Google Earth, September 19, 2018, 34.022 N, 78.070 W)

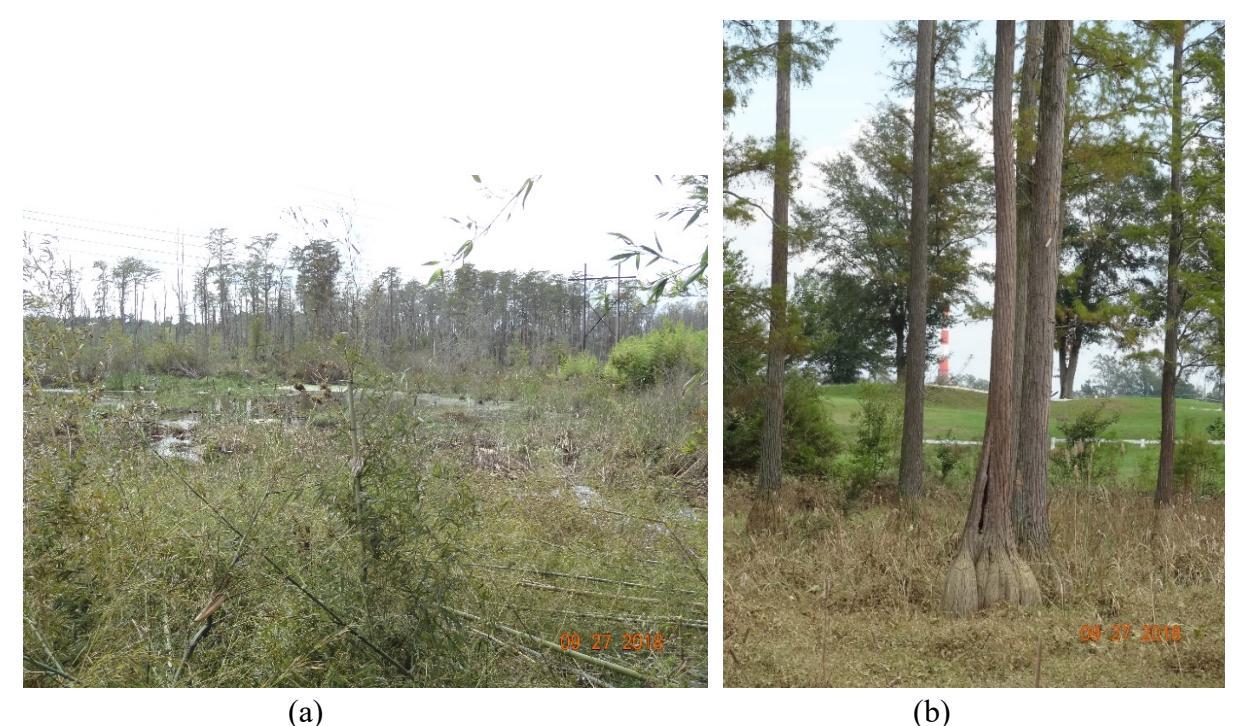
Fig. 4.2.8-4(a) - Emptied reservoir and (b) - Exposed cypress trees showing level of reservoir water on root system (September 27, 2018, 34.7516 N, 79.4145 W).

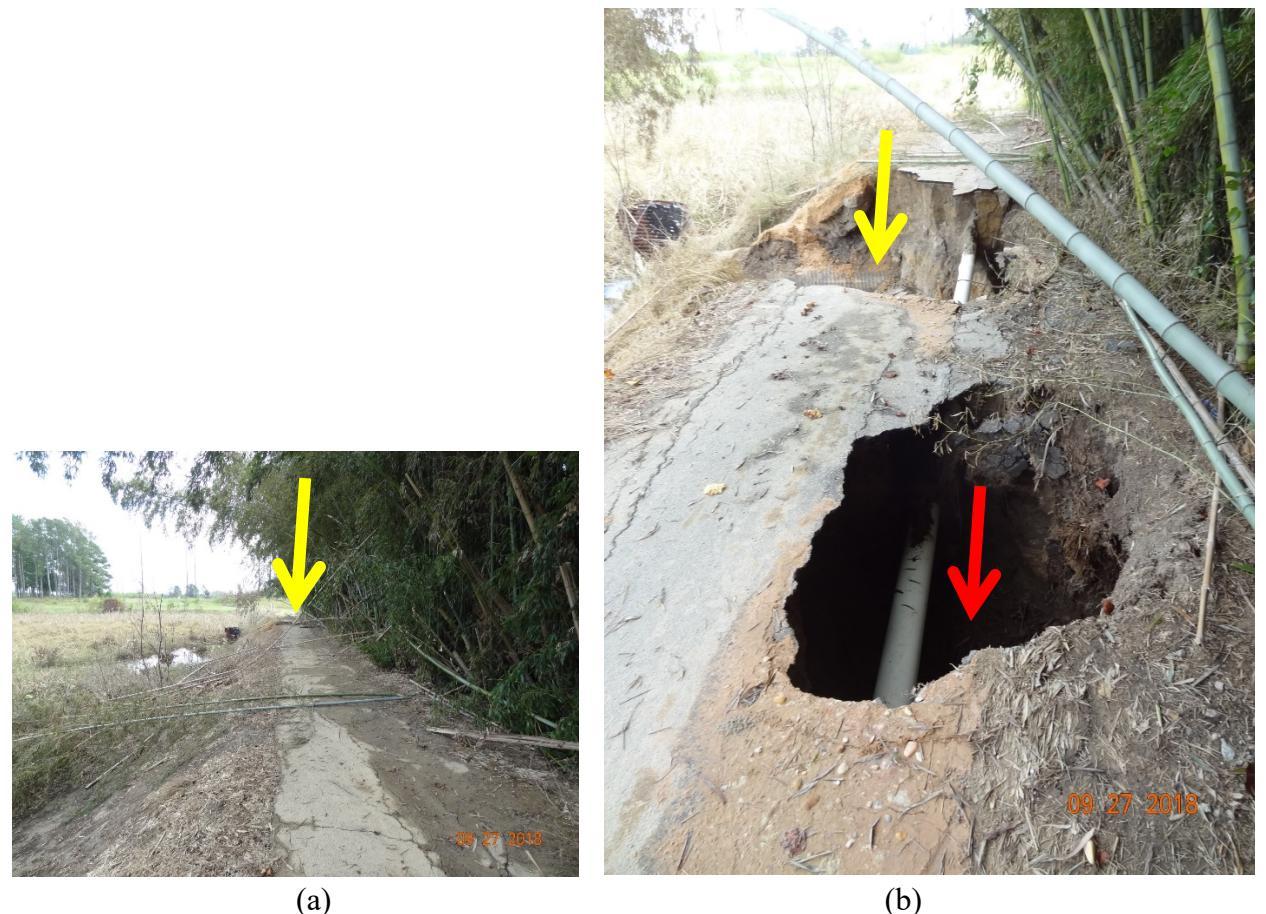
Fig. 4.2.8-5(a) - Overview of the axis of the dam from the right abutment and the failure area (see yellow arrow) and (b) - Close-up of the failed area (yellow arrow) and a partial breach (red arrow) (September 27, 2018, 34.7509 N, 79.4150 W)

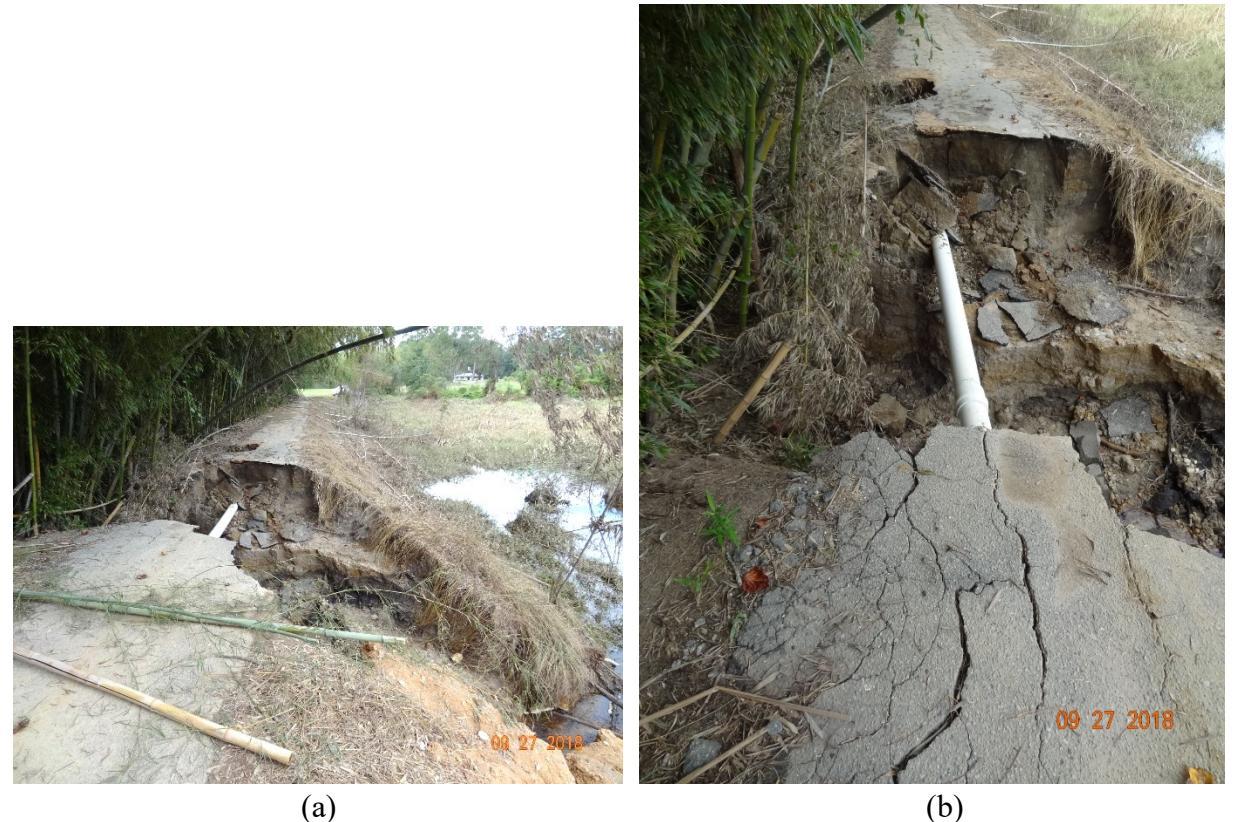
Fig. 4.2.8-6(a) - Overview of the axis of the dam looking towards the right abutment and the failure area and (b) - Close-up of the failed area from the crest of the dam (September 27, 2018, 34.7509 N, 79.4150 W).

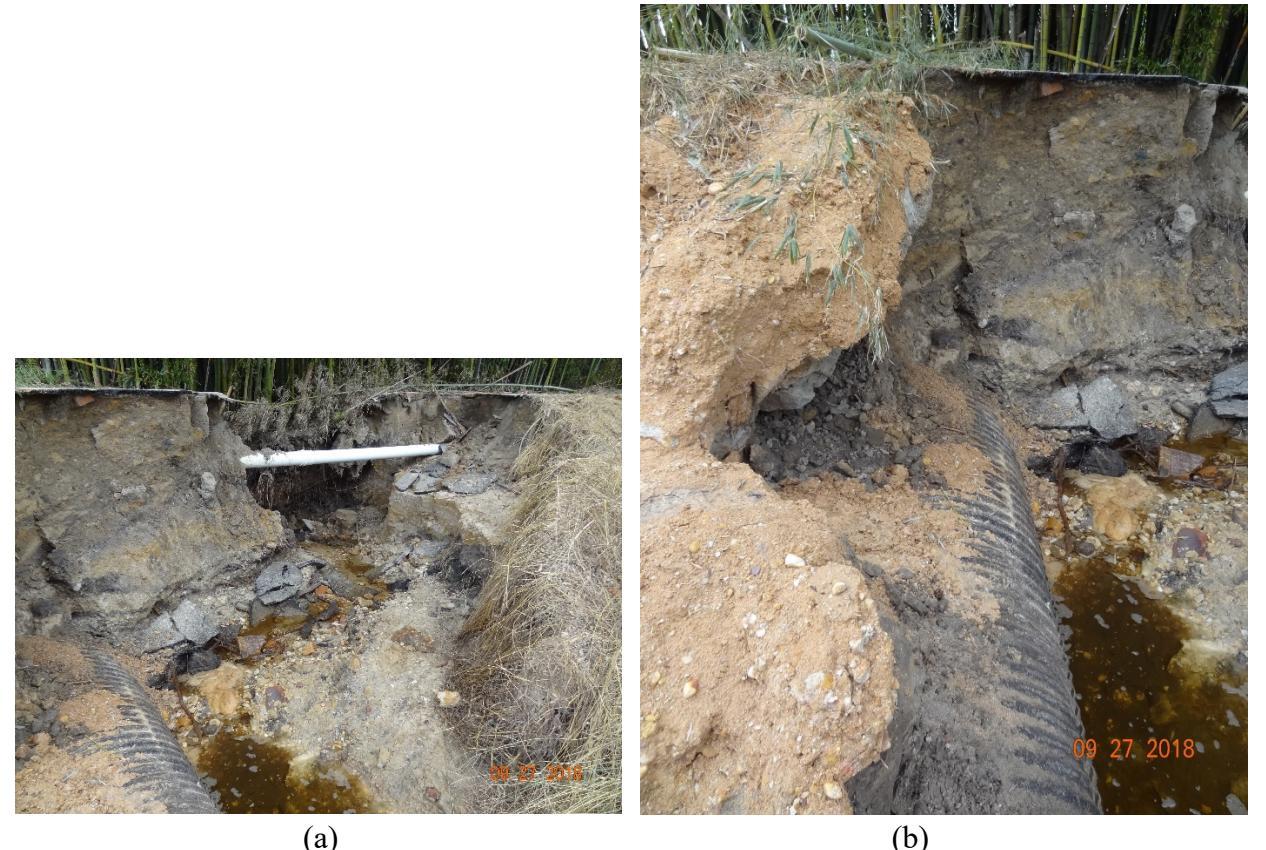
Fig. 4.2.8-9(a) - Water flowing through the breach area and (b) - Close-up of significant settlement of the crest where the dam was overtopped (September 27, 2018, 34.7509 N, 79.4150 W).

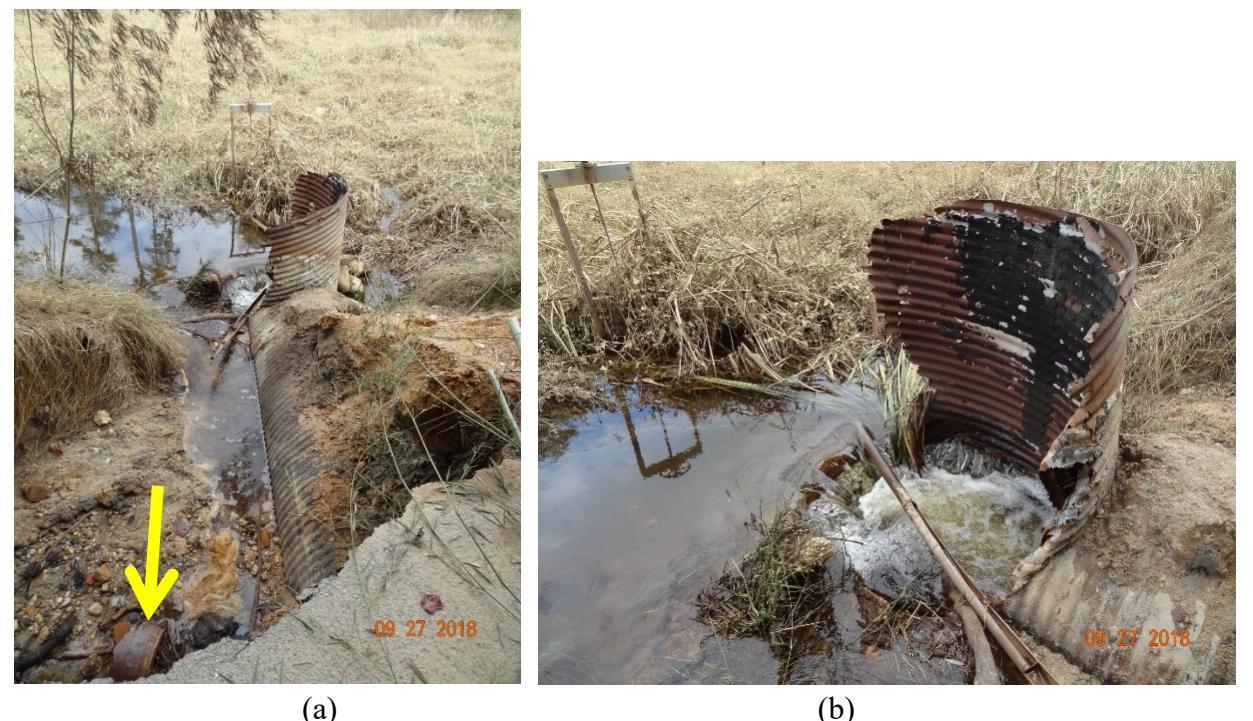
Fig. 4.2.8-10(a) - Water flowing into the outlet conduit and the upstream slope of the dam area and (b) - Close-up of damaged riser pipe for the outlet conduit with the flow gate in the background (September 27, 2018, 34.7509 N, 79.4150 W).

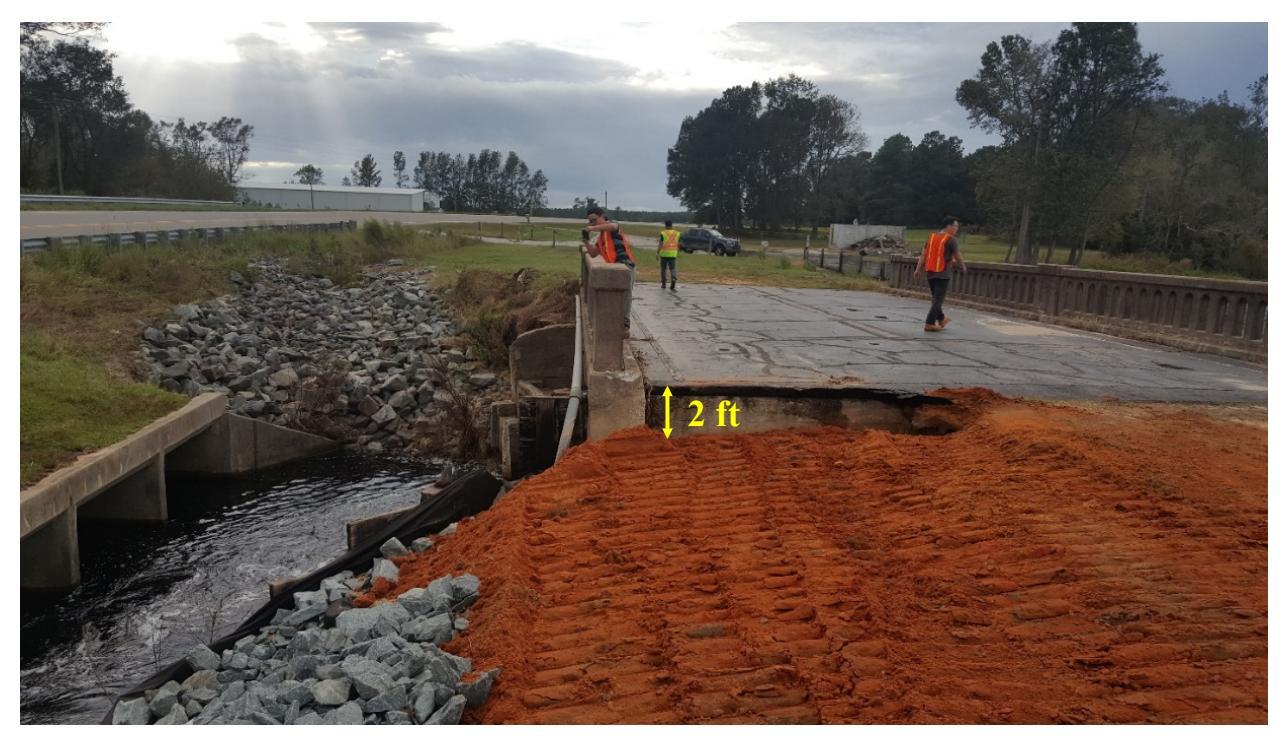
Fig. 4.3.1-5 - Downstream slope and part of the crest adjacent to the east end of the bridge showing eroded embankment repair (red soil, September 25, 2018, 35.1867 N, 77.9841 W)

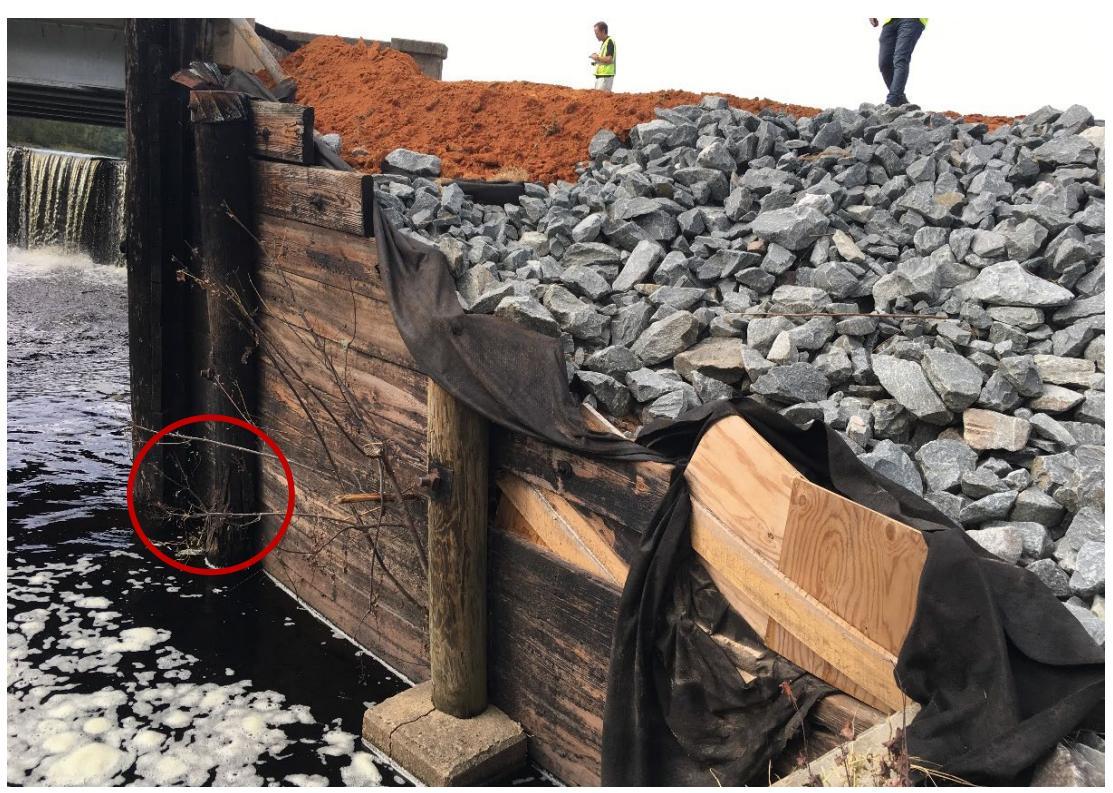
Fig. 4.3.1-6 - Timber soldier post retaining wall at the east end of the bridge shows some damages of lagging panels, which contributed to erosion. Geotextile and temporary wooden boards were recently added. One post shows some sign of failure (September 25, 2018, 35.1867 N, 77.9841 W)

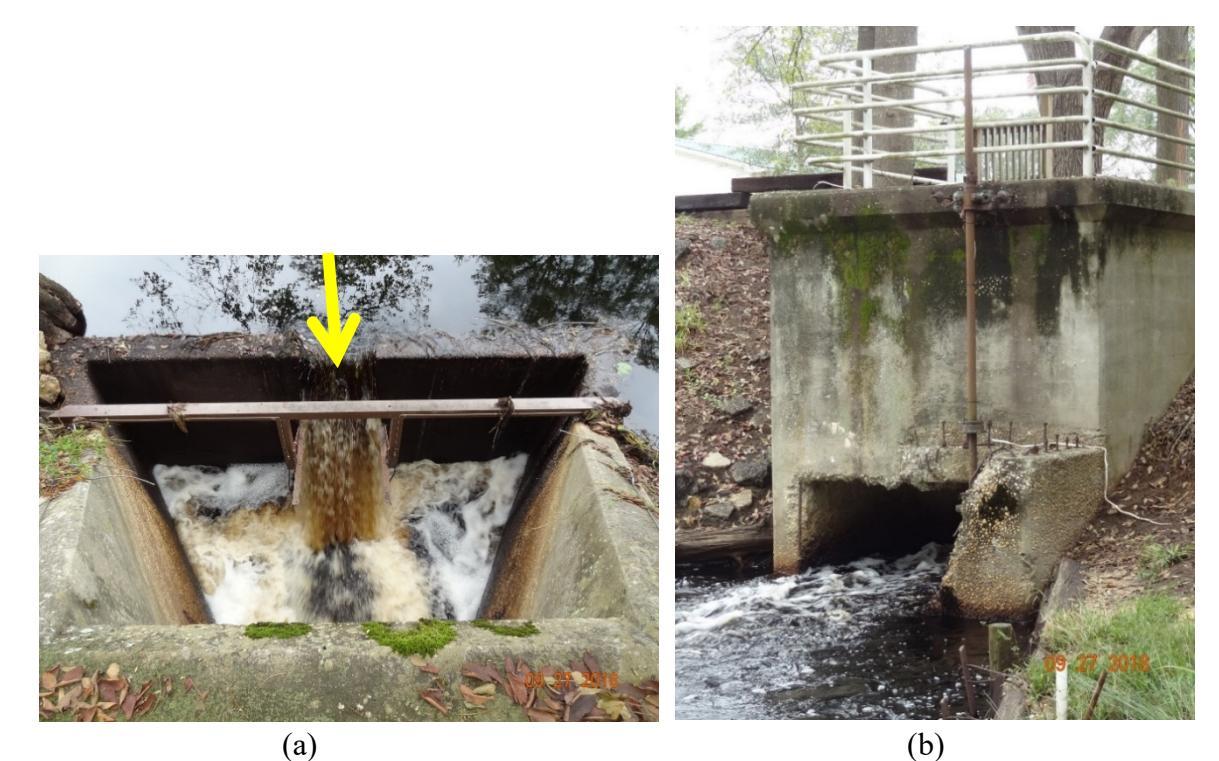
Fig. 4.3.3-5(a) - Outlet structure weir (yellow arrow shows inflow slot) and (b) Outlet structure outflow (September 27, 2018, 34.7042 N, 79.7315 W)

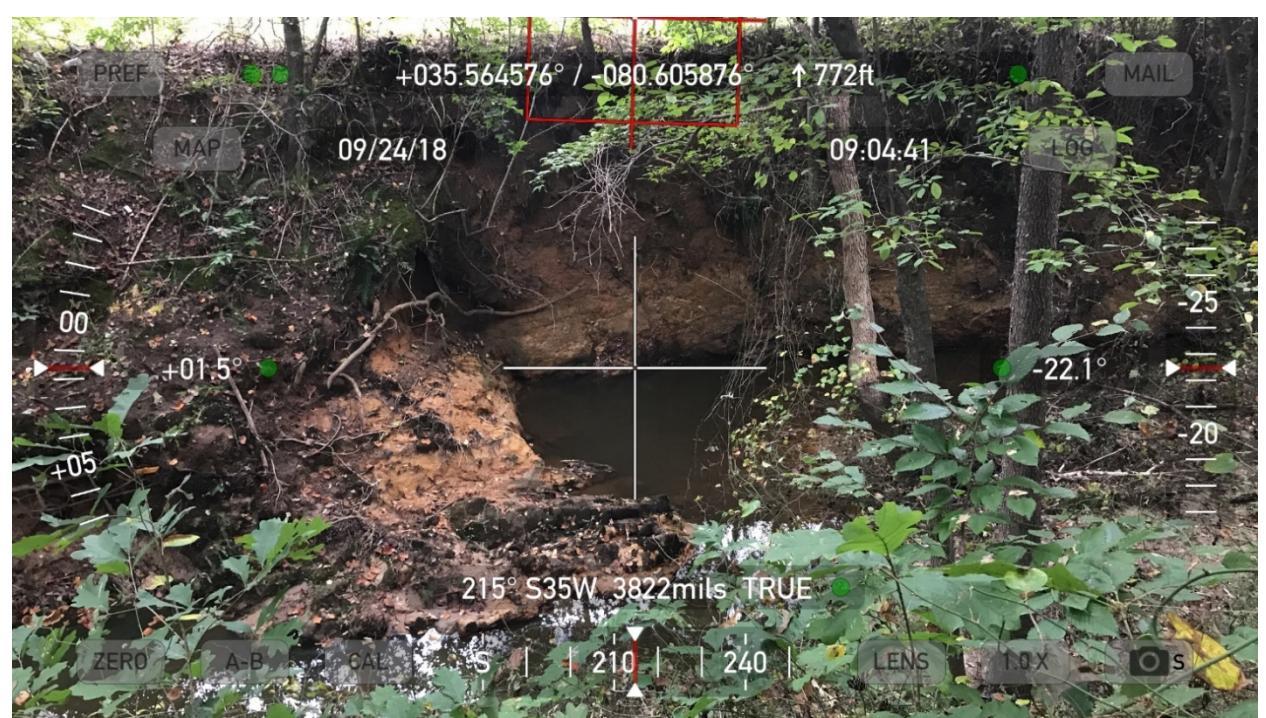
Fig. 4.4.1-5 – Erosion observed on Landis Lake levee (September 24, 2018, 35.5646 N, 80.6059 W)

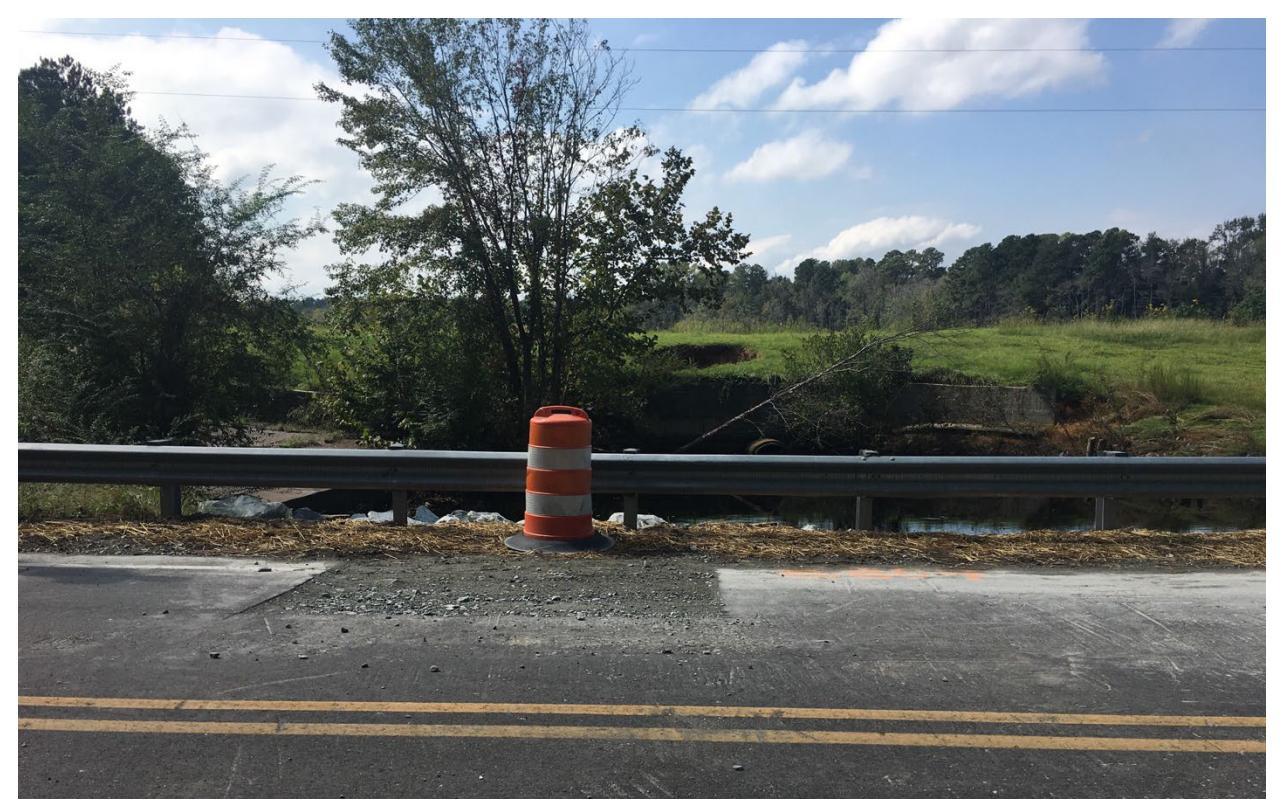
Fig. 4.4.5-6 – Road damage, fresh straw, and new riprap on Holly Grove Road (September 27, 2018, 35.2909 N, 78.4765 W)

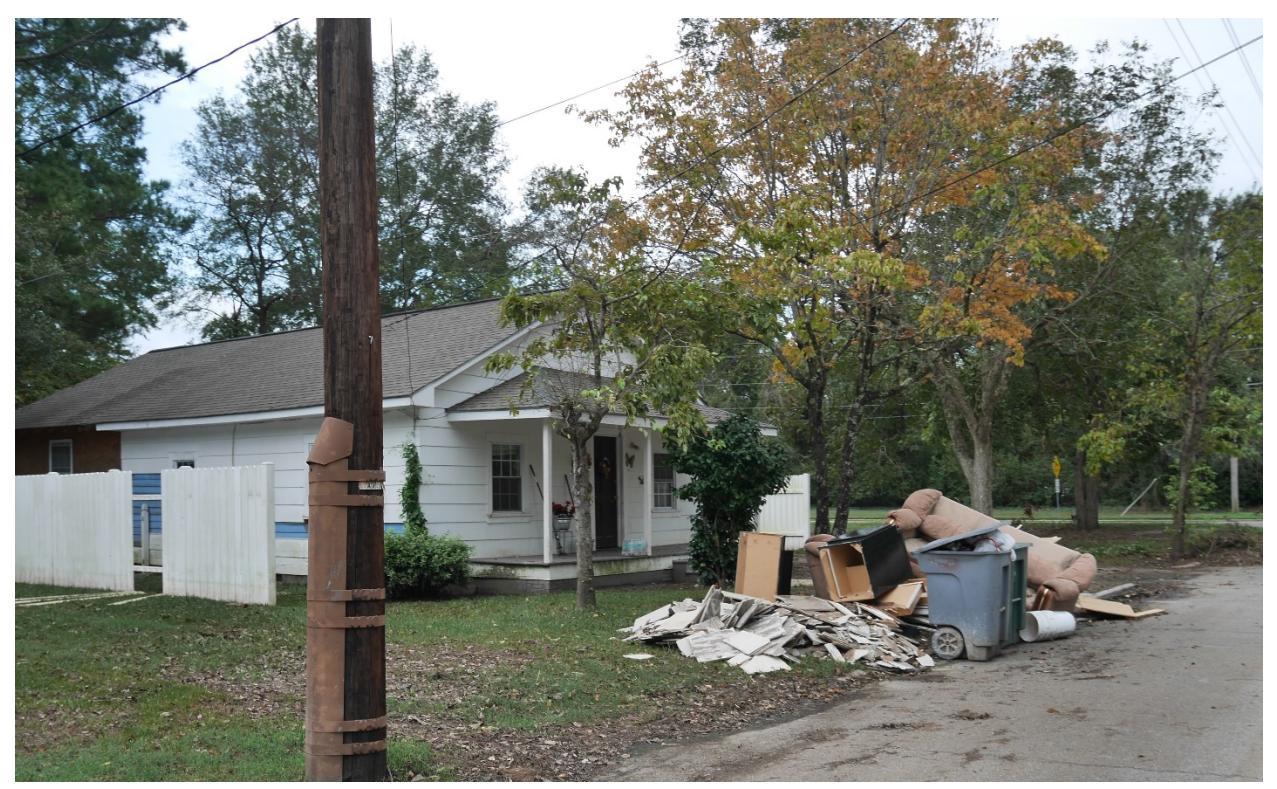
Fig. 5.1-19 – Residential damage, south Lumberton (September 27, 2018, 34.61 N, 79.01 W)

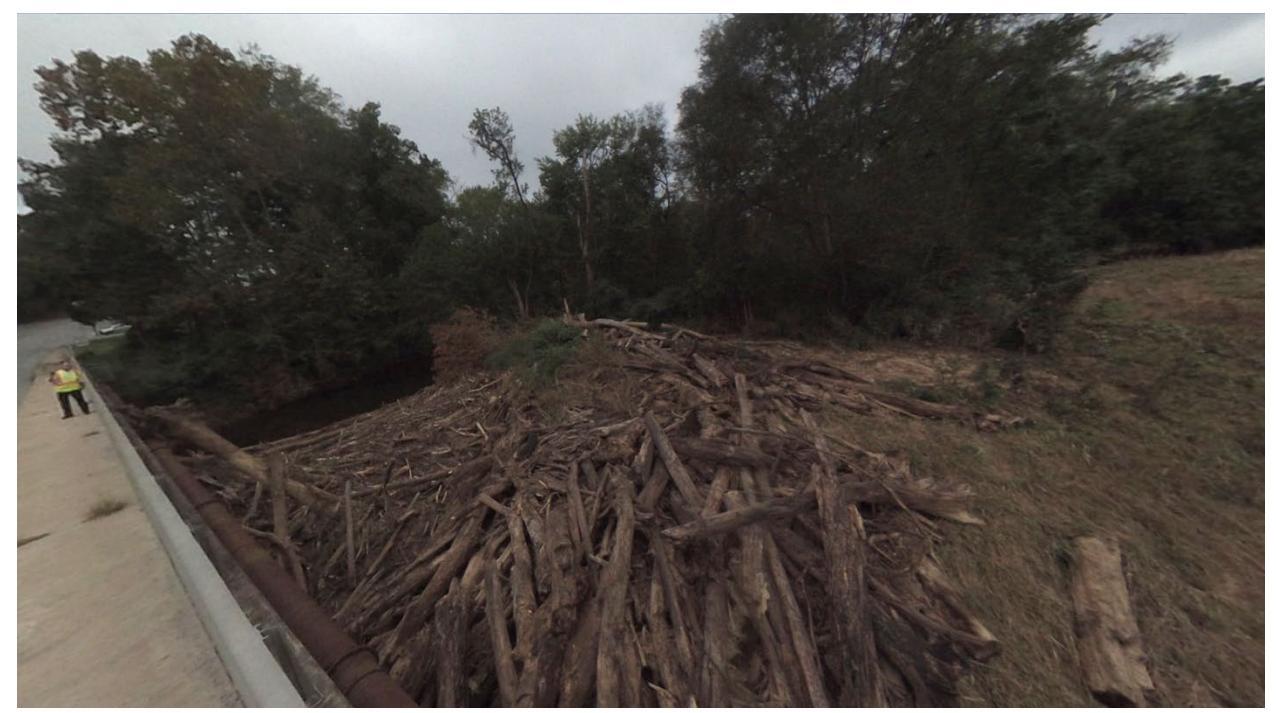
Fig. 6.2.6-3 – H.F. Bell Bridge debris pile (September 25, 2018, 34.7286 N, 80.0638 W)
#### 6.2.7 David's Millpond Bridge, Bennettsville, SC

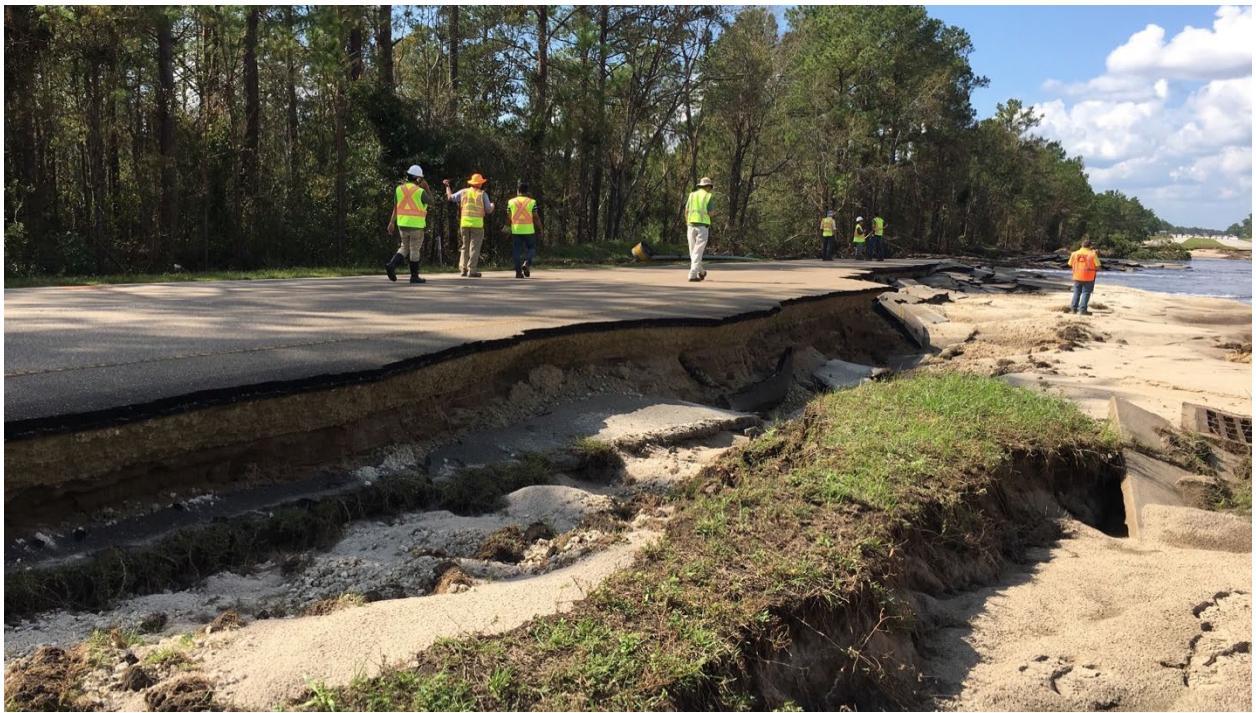
Fig. 6.3.1-5 – US 421 washout by Cape Fear River, looking northwest across washout, undermined roadway and foundation soil in foreground (September 26, 2018, 34.3304 N, 77.9993 W)

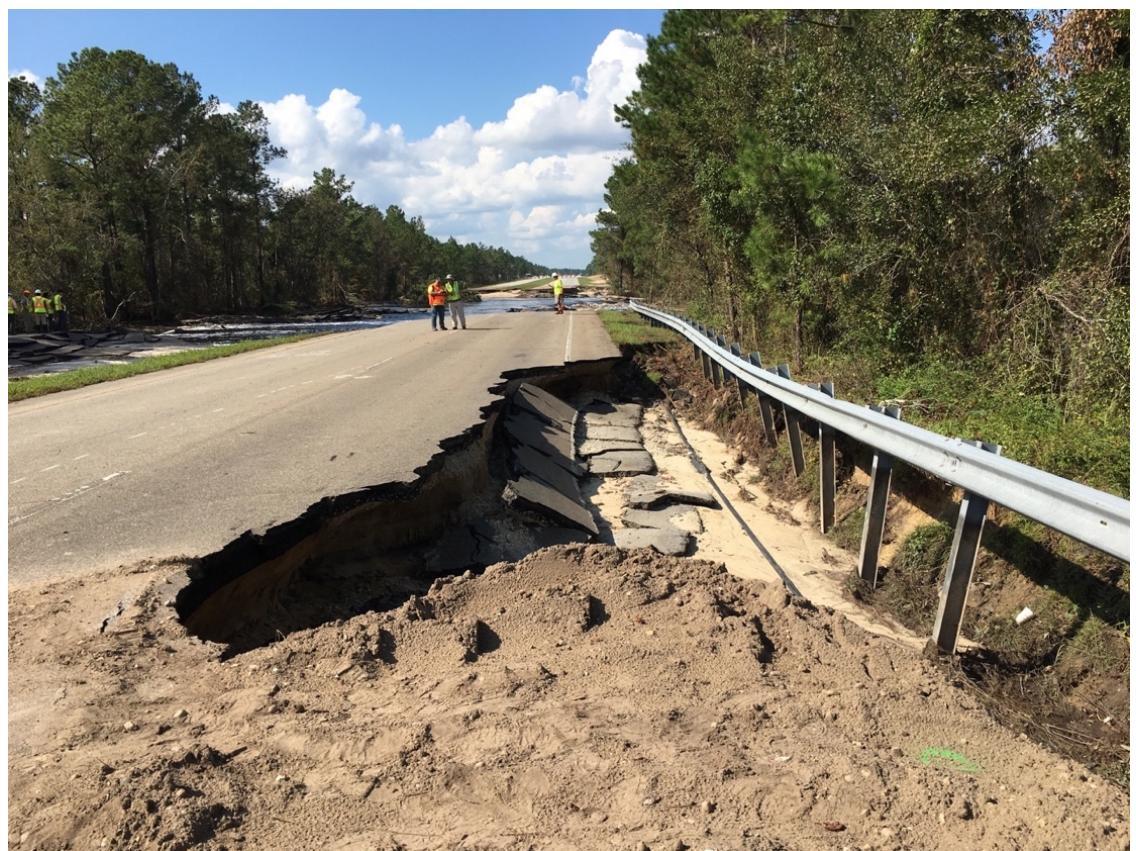
Fig. 6.3.1-8 – US 421 eroded by Cape Fear River flood water (September 26, 2018, 34.3306 N, 77.9993 W)

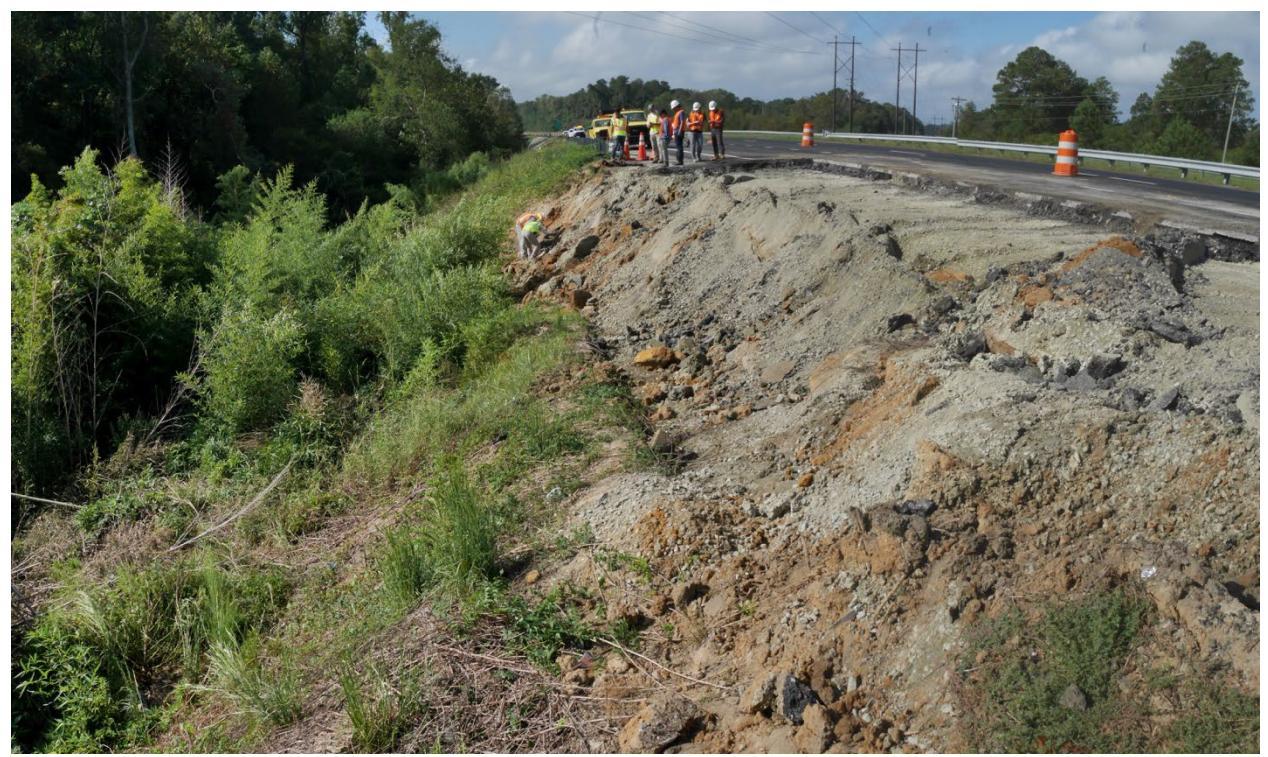
Fig. 6.3.2-4 – I-795 slope failure at northbound lane (September 25, 2018, 35.4201 N, 77.9976 W)
