#### **Geotechnical Effects of Hurricane Florence**

Geotechnical Extreme Events Reconnaissance (GEER) Association.

GEER Association Report No. GEER-063

April 2019 Revision 1 - June 2019

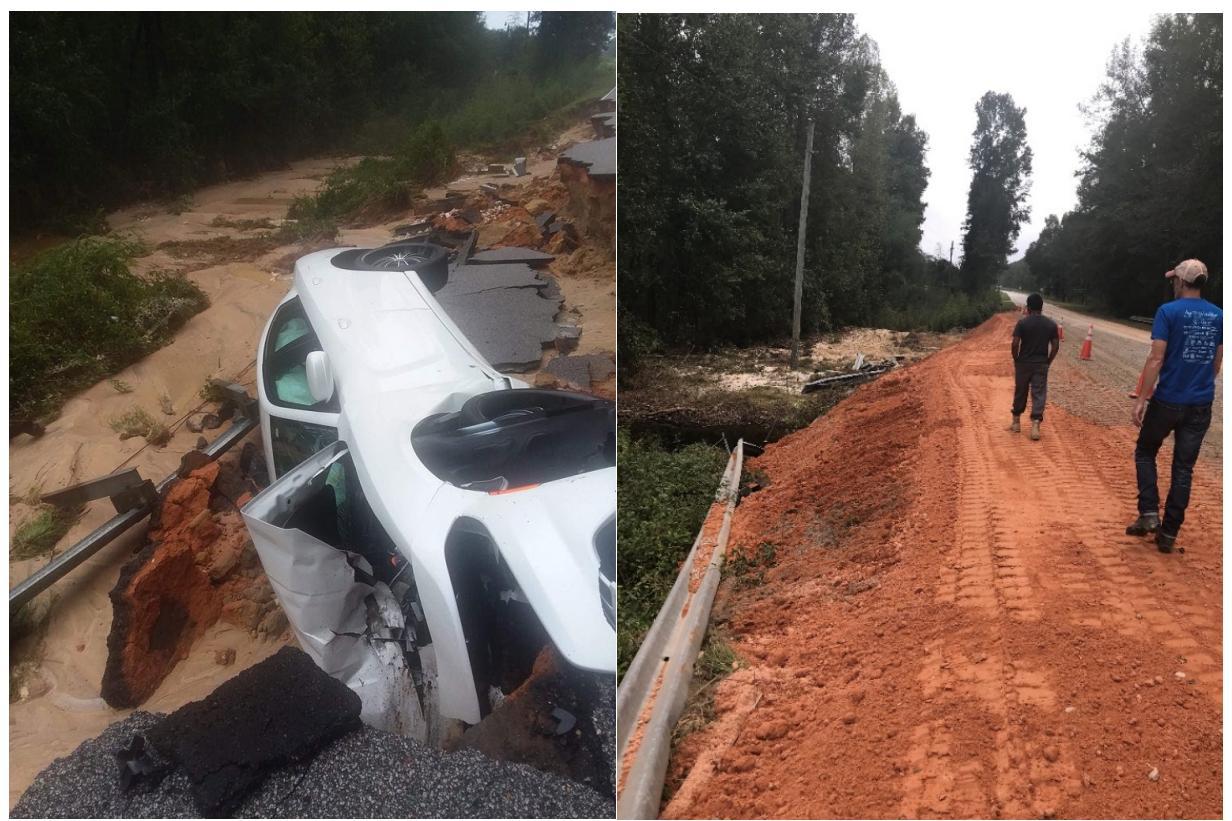
Fig. 6.3.3-2 – Failed culvert off SC 145 Location 1 East with repairs (September 25, 2018, 34.8090 N, 80.0432 W)

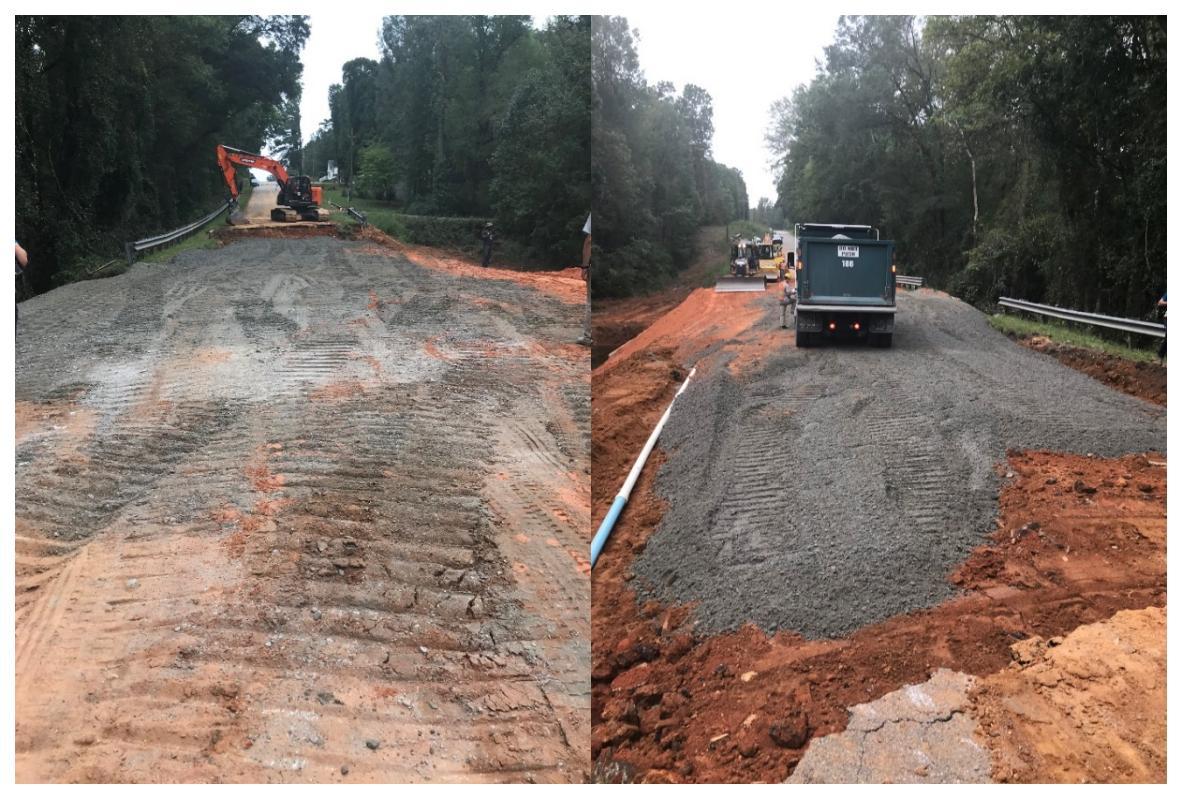
Fig. 6.3.4-2 – Repairs to failed culvert off SC 145 Location 2 West (September 25, 2018, 34.7747 N, 80.0763 W)

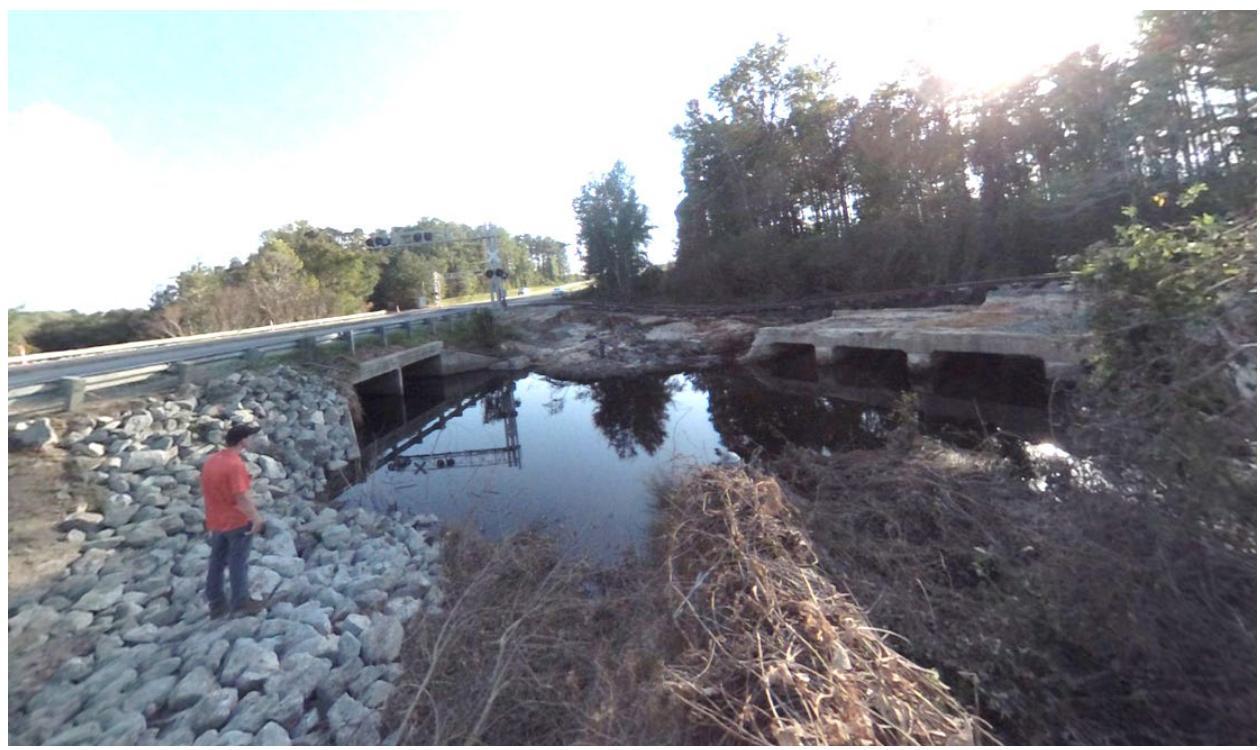
Fig. 6.4.2-4 – View of US15-501 and rail culverts looking south (September 25, 2018, 34.7936 N, 79.4619 W)

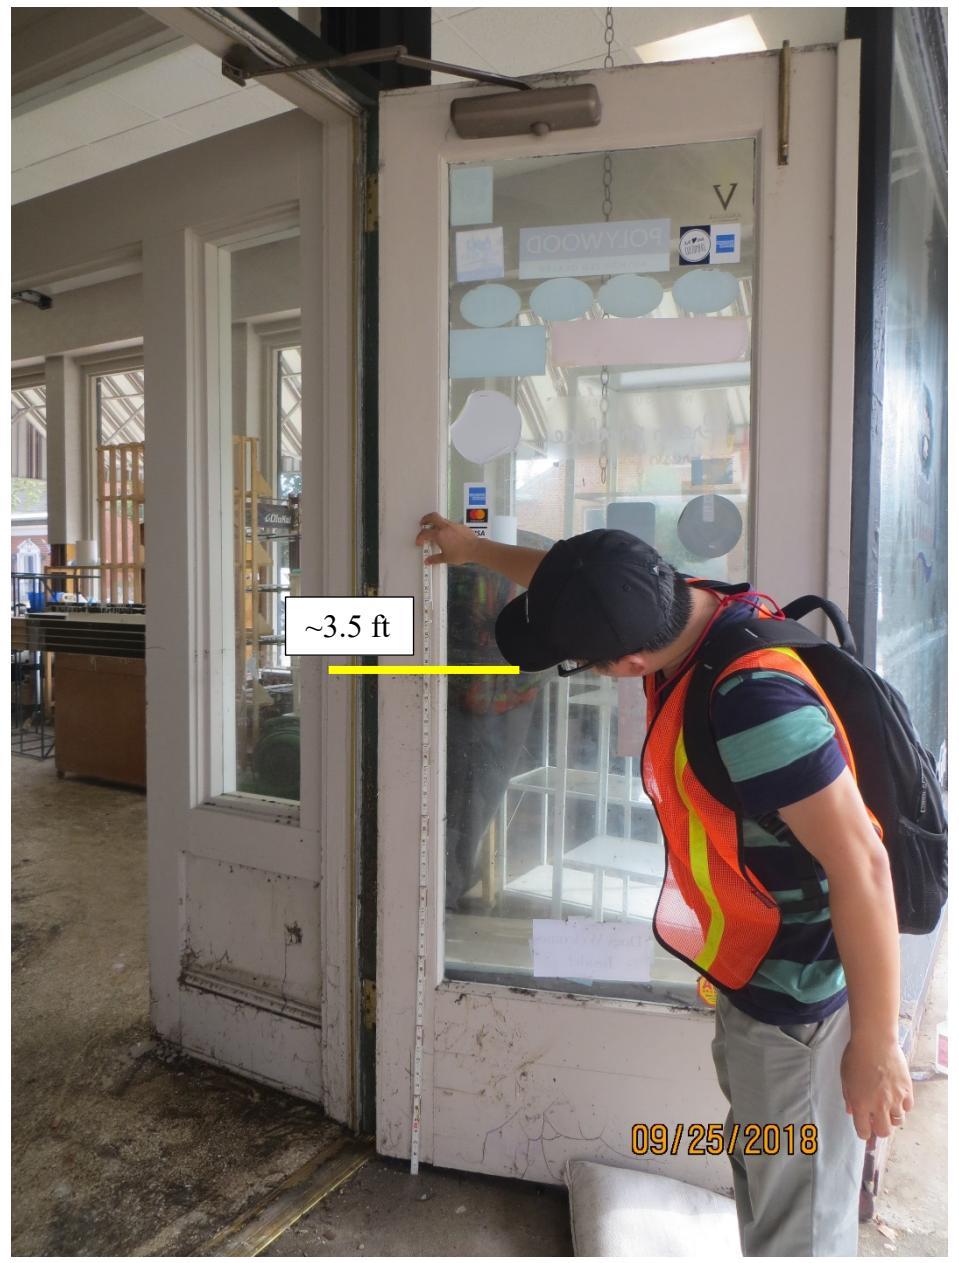
Fig. 7.3-5 - Evidence of flooding to a relative depth of 3.5 ft in downtown New Bern, NC (September 25, 2018, 35.10484 N, 77.03856 W).

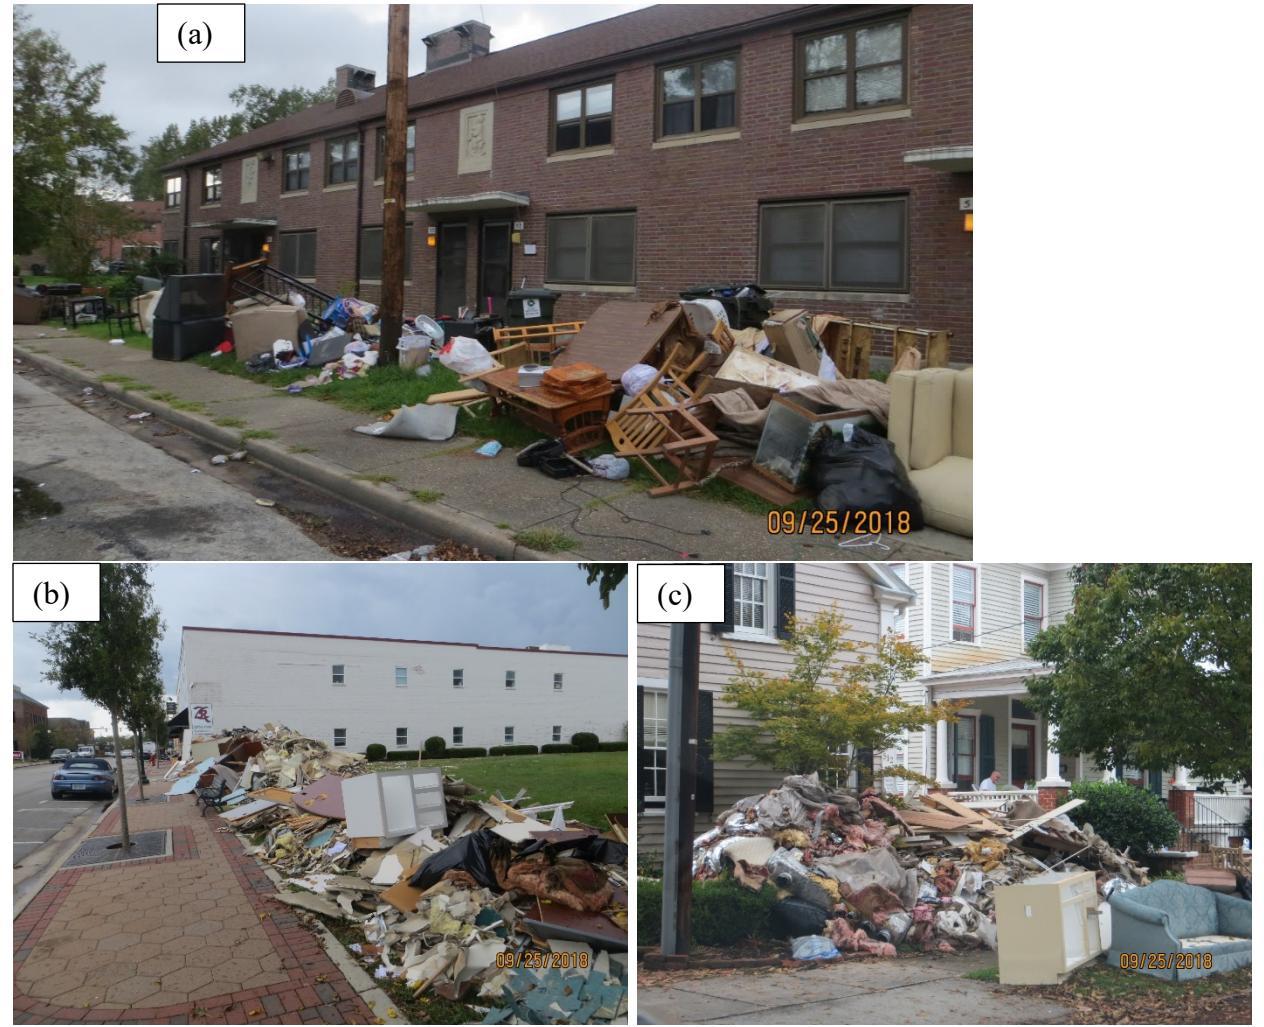
Fig. 7.3-8 - Disaster debris piles located at the curbside that were yet to be collected 10 days after Hurricane Florence made landfall (September 25, 2018, Photo A: 35.10557 N, 77.04676 W) (Photo B: Latitude 35.10489 N, 77.03888 W, Photo C: N/A)

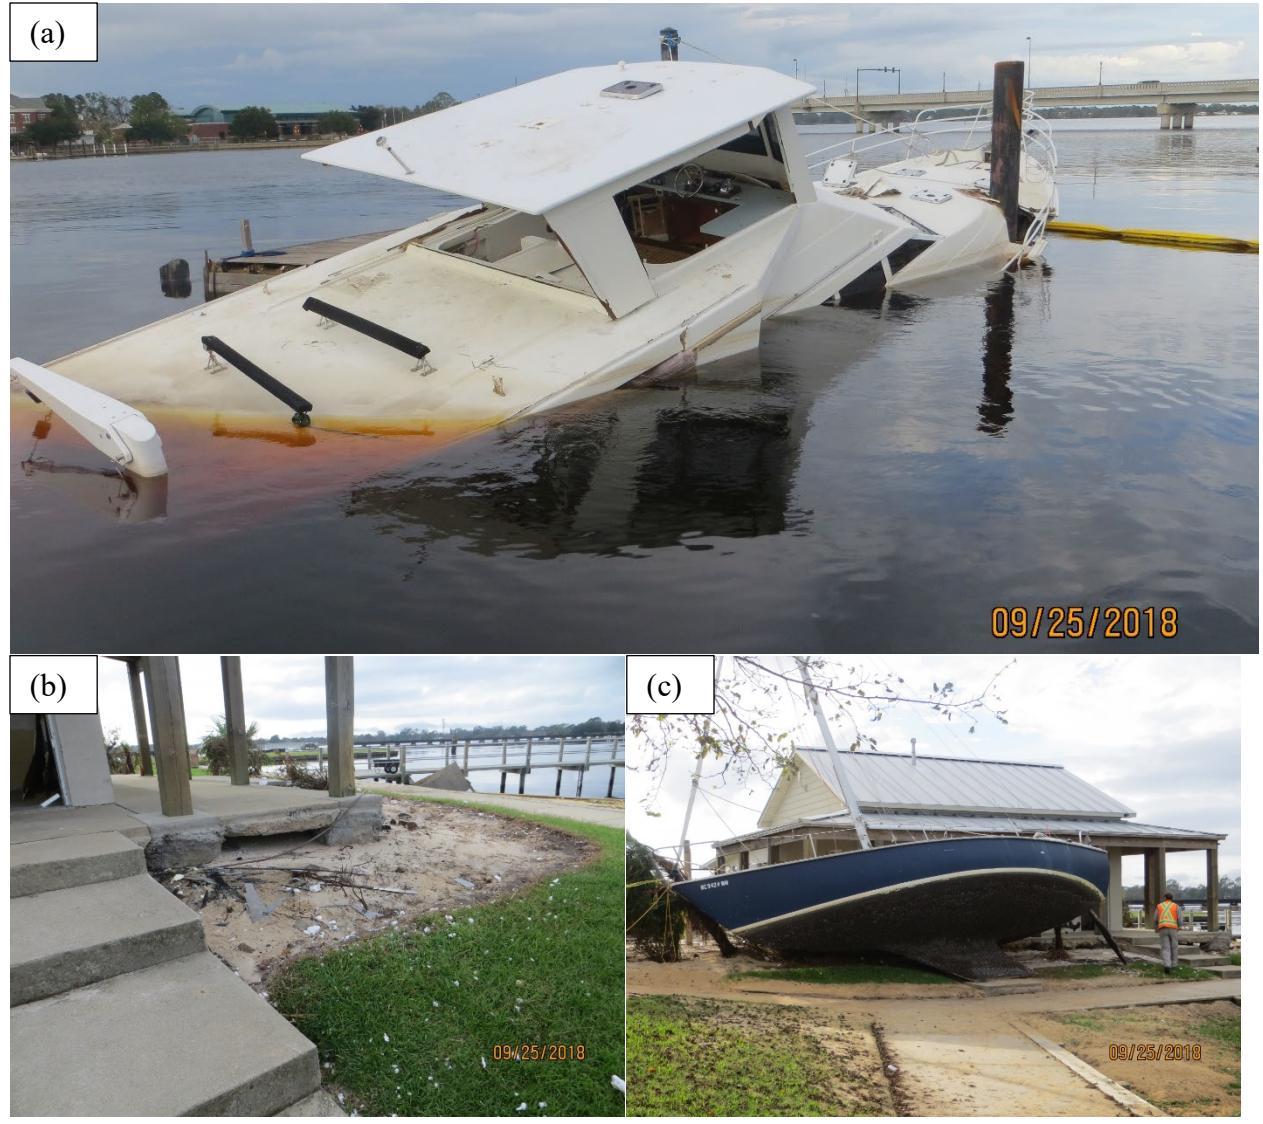
Fig. 7.3-9 - Damage to the New Bern Grand Marina: (a) Recreational boats, (b) Scour at building foundation, and (c) Displaced sailing boat adjacent to building. (September 25, 2018, Photo A: 35.10054 N, 77.03888 W) (Photo B and C: 35.09923 N, 77.03925 W)

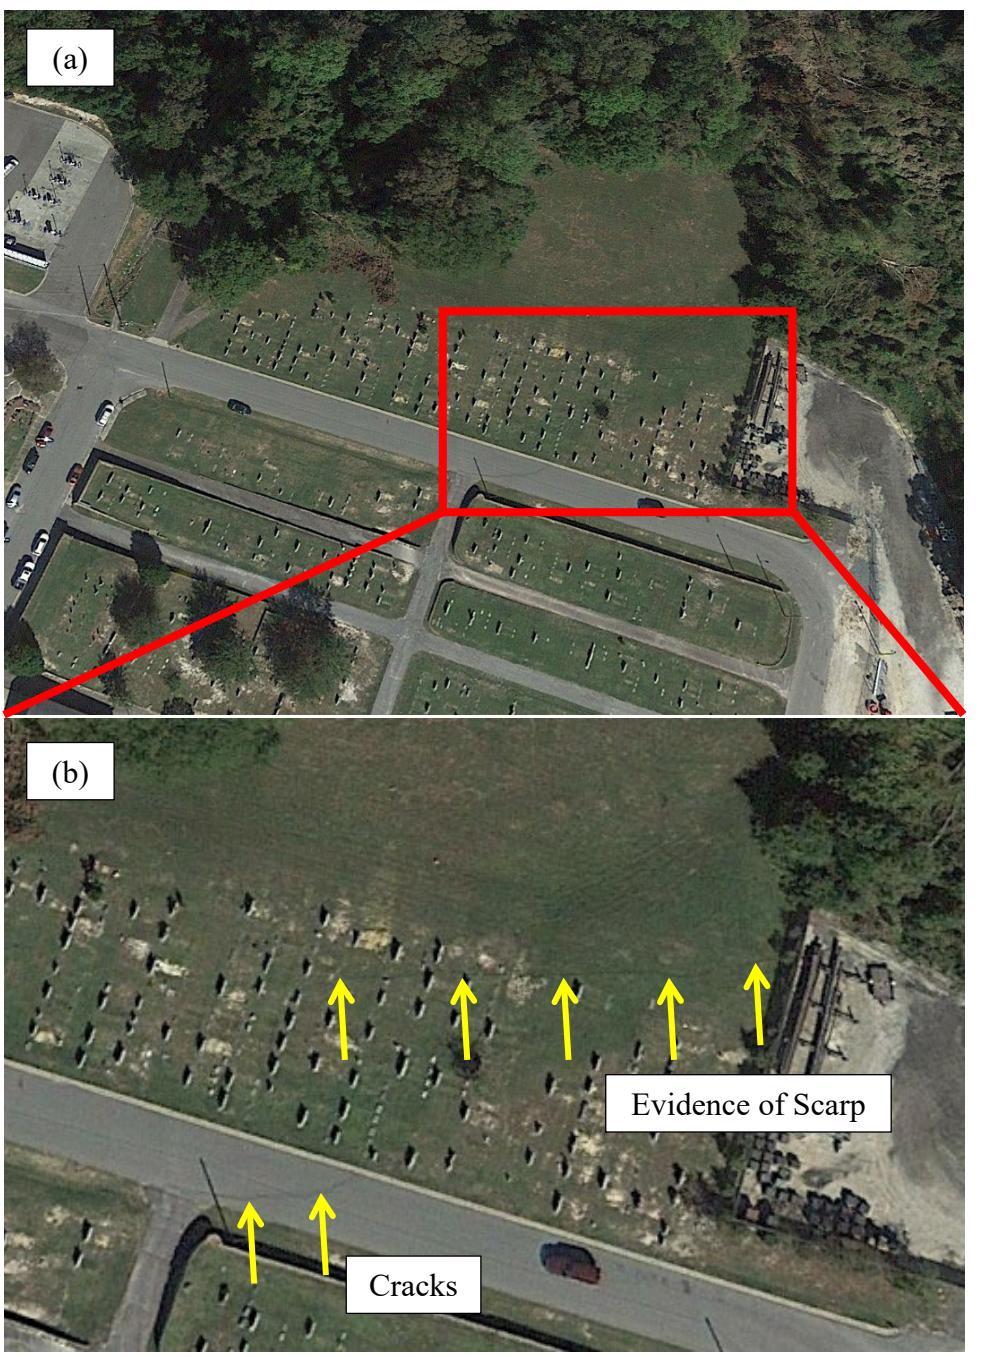
Figure 8.1-2 - Aerial imagery of the site: (a) cemetery and road, (b) inset showing evidence of pavement cracks and a scarp (Google Earth, October 25, 2016, 34.6297 N, 78.6027 W)

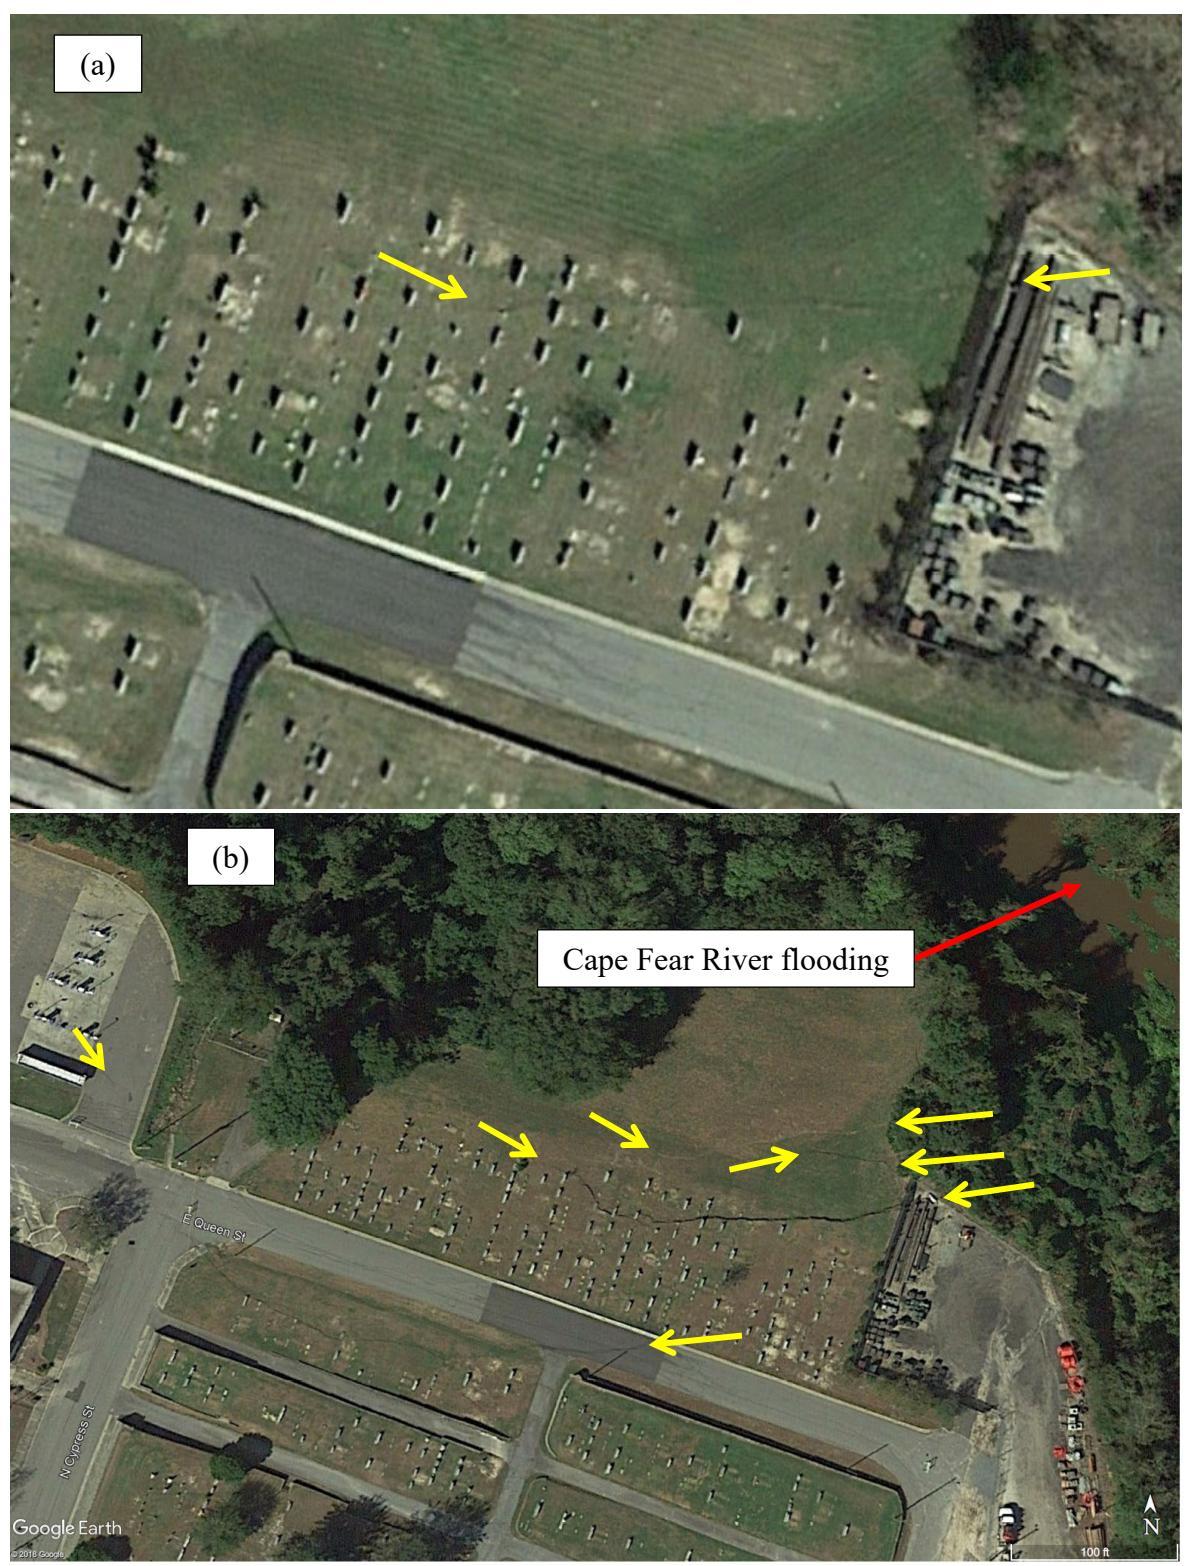
Figure 8.1-3 - Progressive aerial imagery of the site: (a) March 4, 2018 with repaved road and scarp, (b) September 18, 2018 during Florence flooding, yellow arrows show visible ends of cracks/scarps (Google Earth, March 4, 2018, September 18, 2018, 34.6297 N, 78.6027 W)

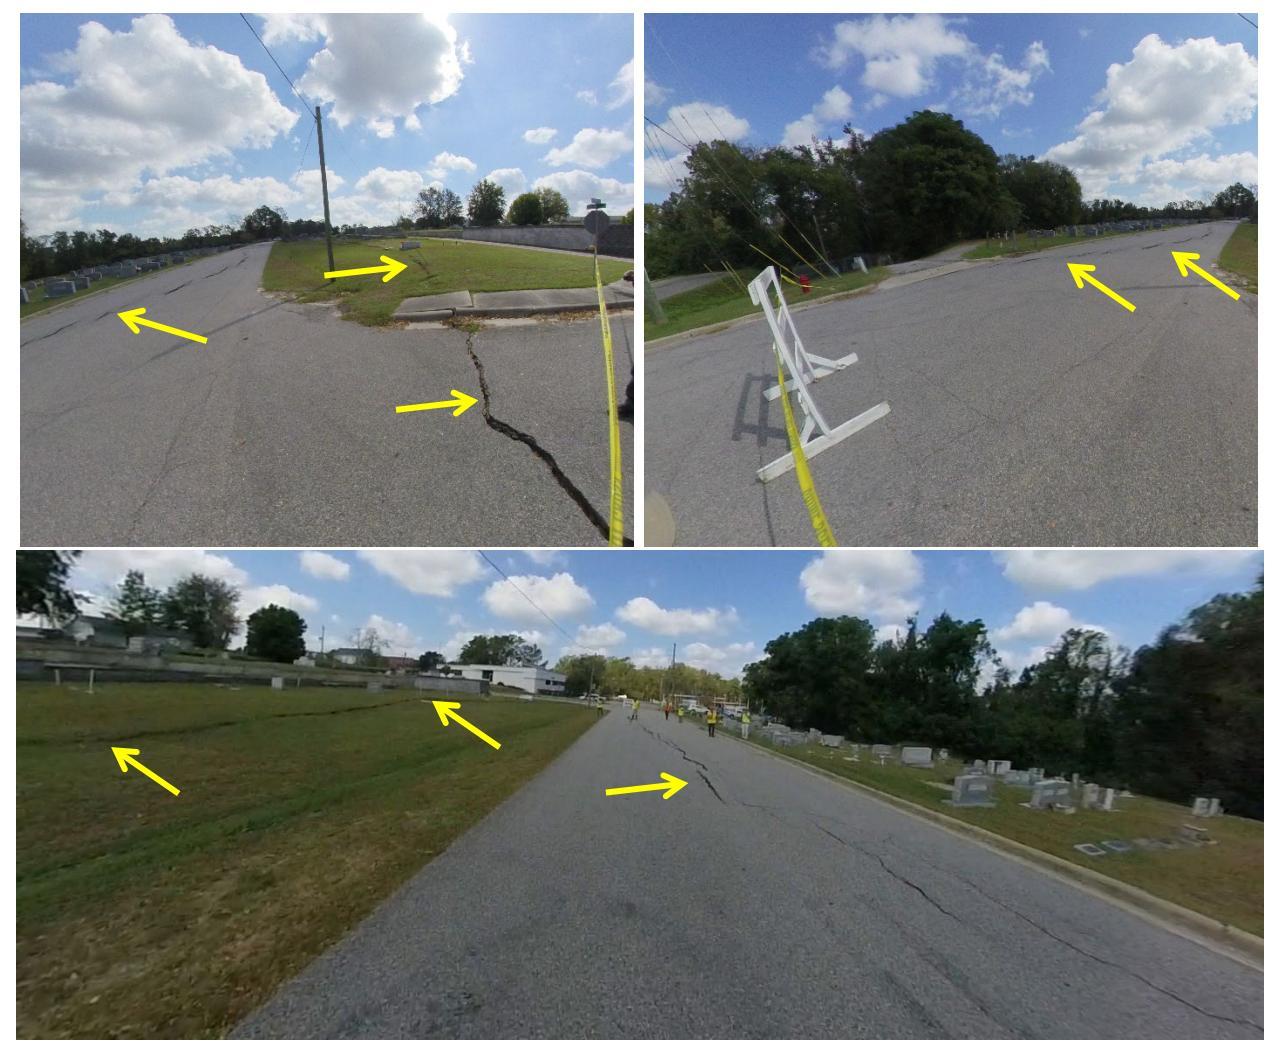
One site of geotechnical interest that did not fit into our categories was the Cape Fear river bank in Elizabethtown. We observed several scarps, which were long ( $\sim$ 500 ft) with short heights ( $\sim$ 2 ft) in the area around a cemetery at this location indicating movement of a large part of the river bank (Fig. 1.3-9). We did not have enough information to assign a likely cause, but investigators could consider elevated seepage pressures and rapid-drawdown-induced shear stresses.

**Figure 8.1-5** Scarp or cracks of the Elizabethtown slide along East Queen St and just north in the cemetery (September 26, 2018, ~34.6295 N, 78.6032 W)

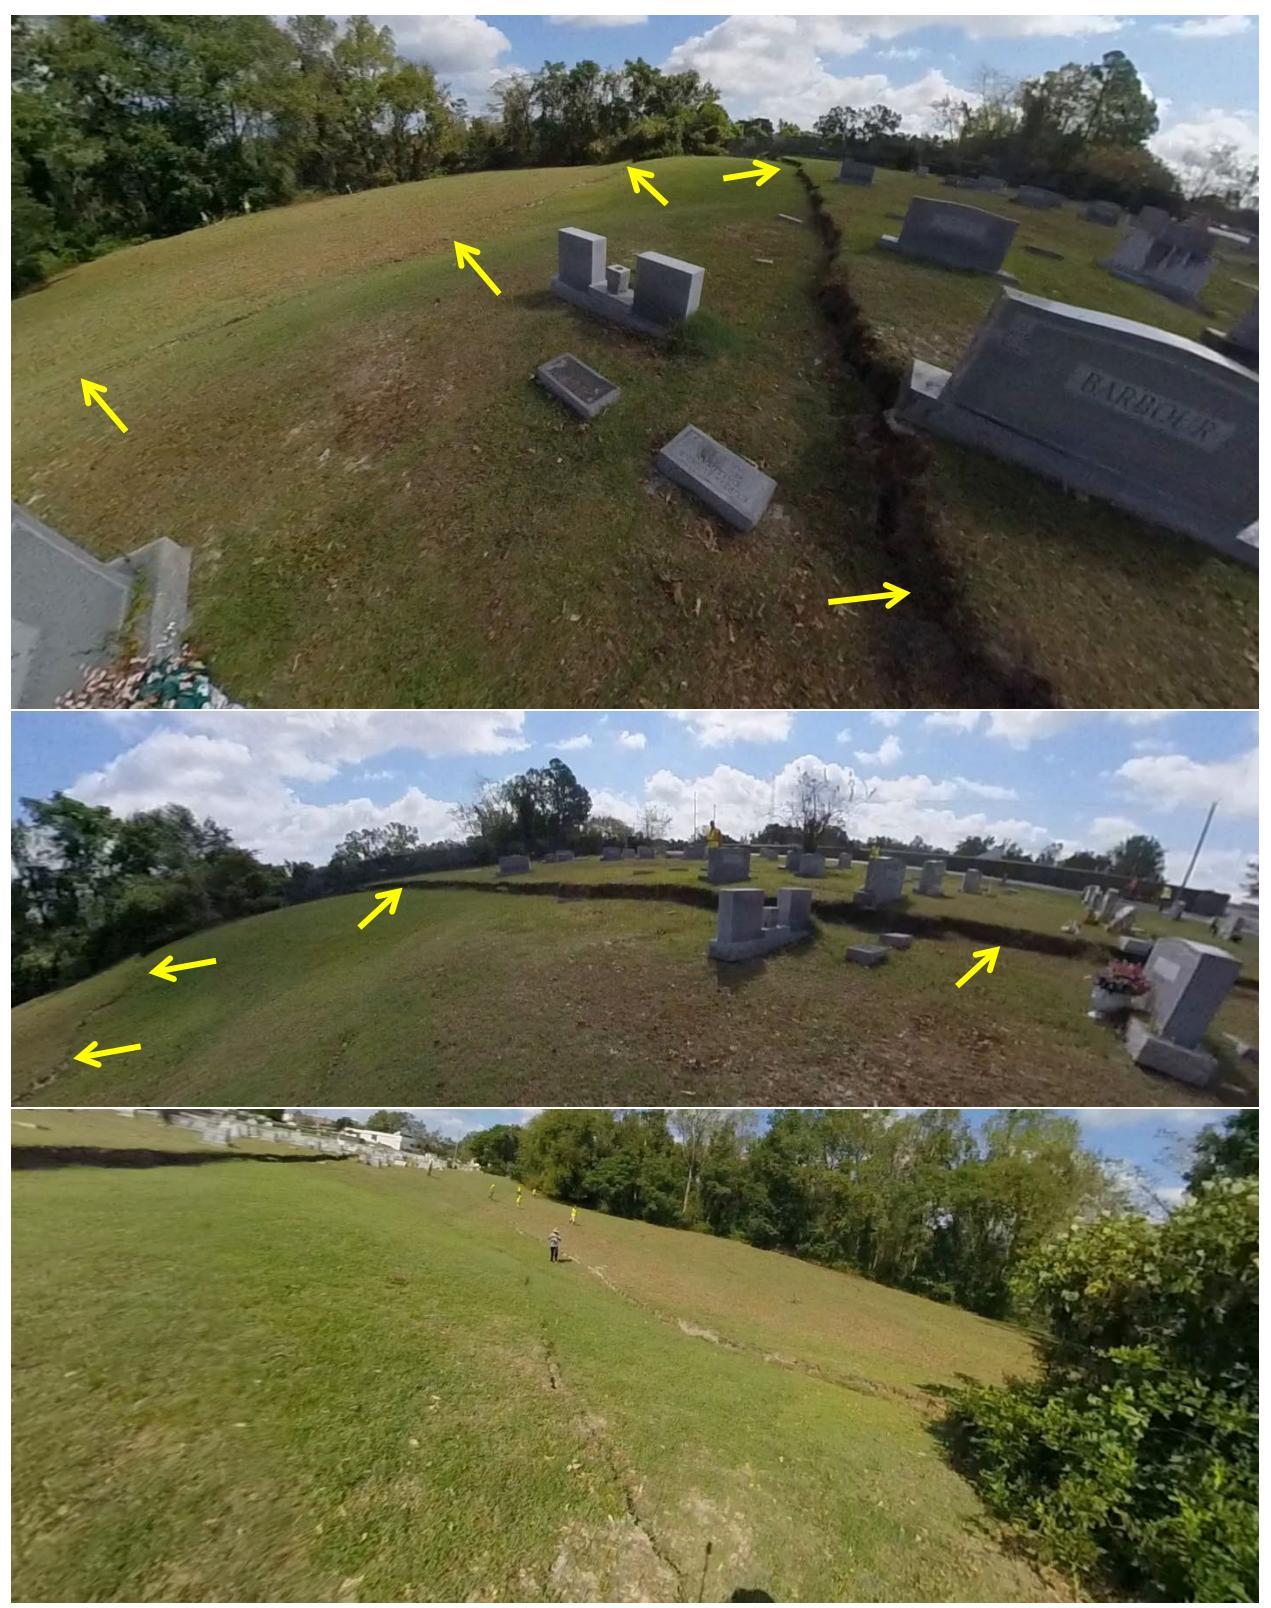
Figure 8.1-6 - Scarp or cracks of the Elizabethtown slide along across the cemetery and midslope towards the Cape Fear River (September 26, 2018, ~34.6297 N, 78.6023 W)

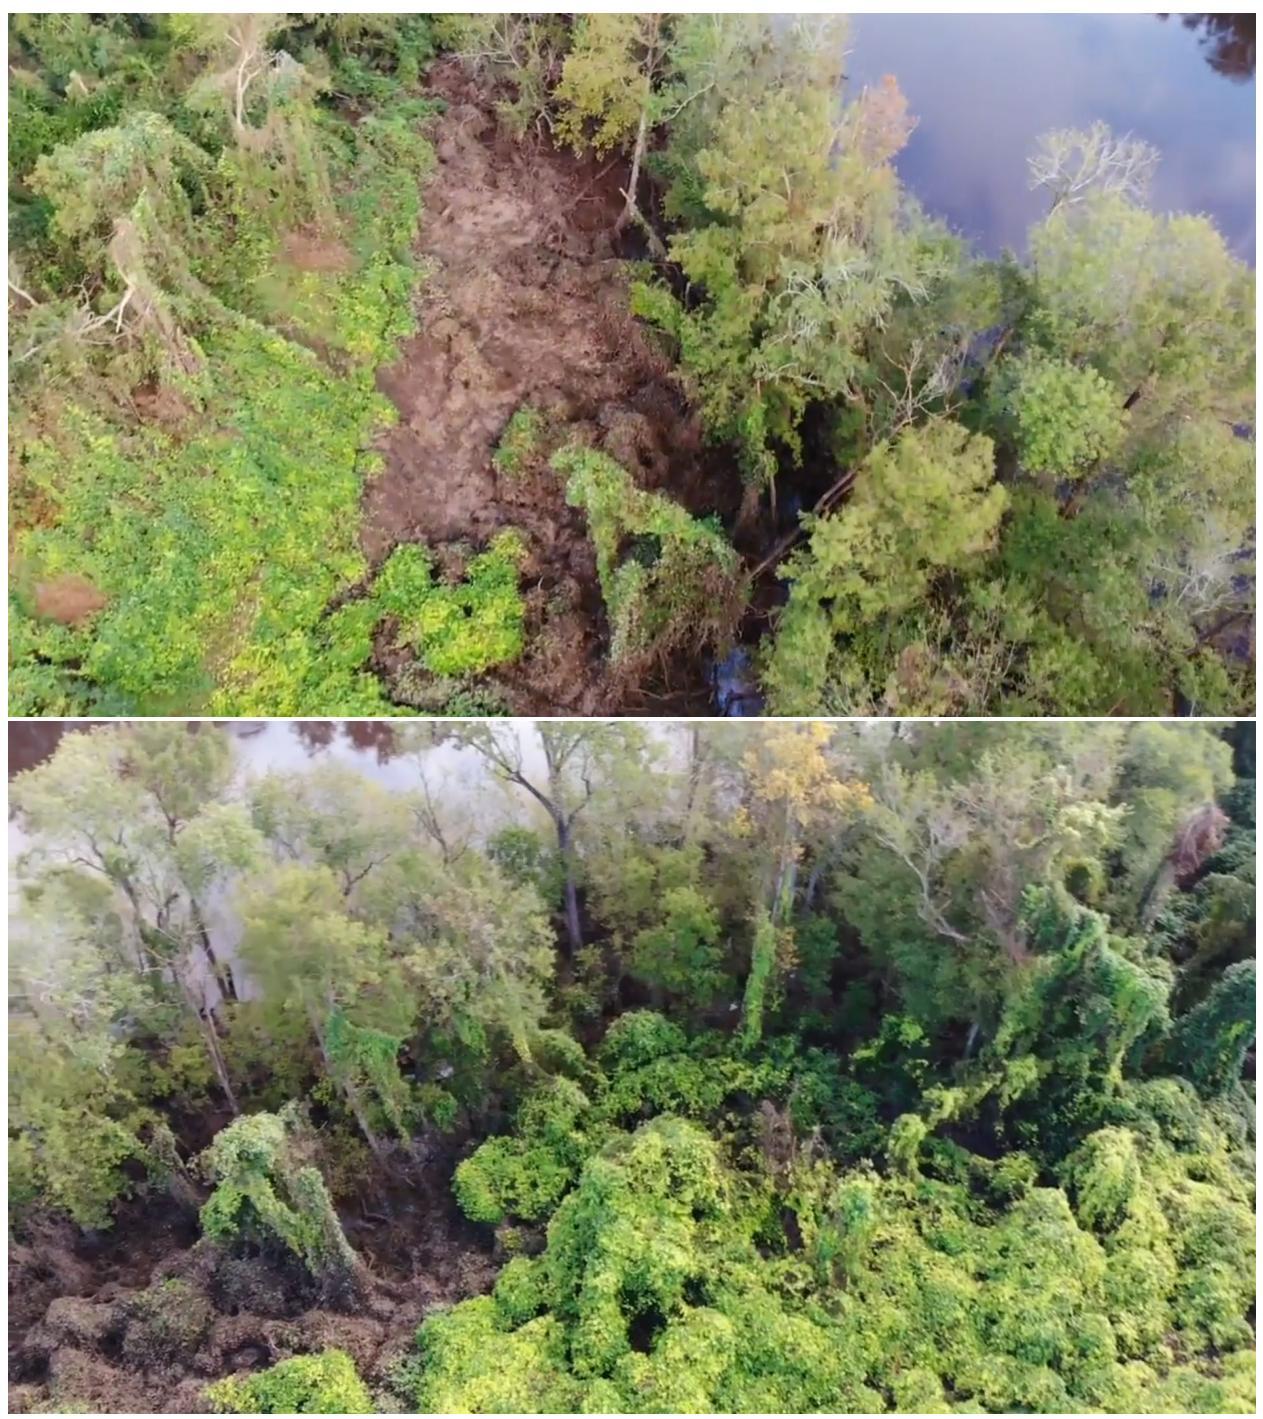
Figure 8.1-7 - Drone photographs showing the vegetation browning indicative of the inundation extent by the Cape Fear River at peak flow (September 26, 2018, ~34.630 N, 78.602 W)

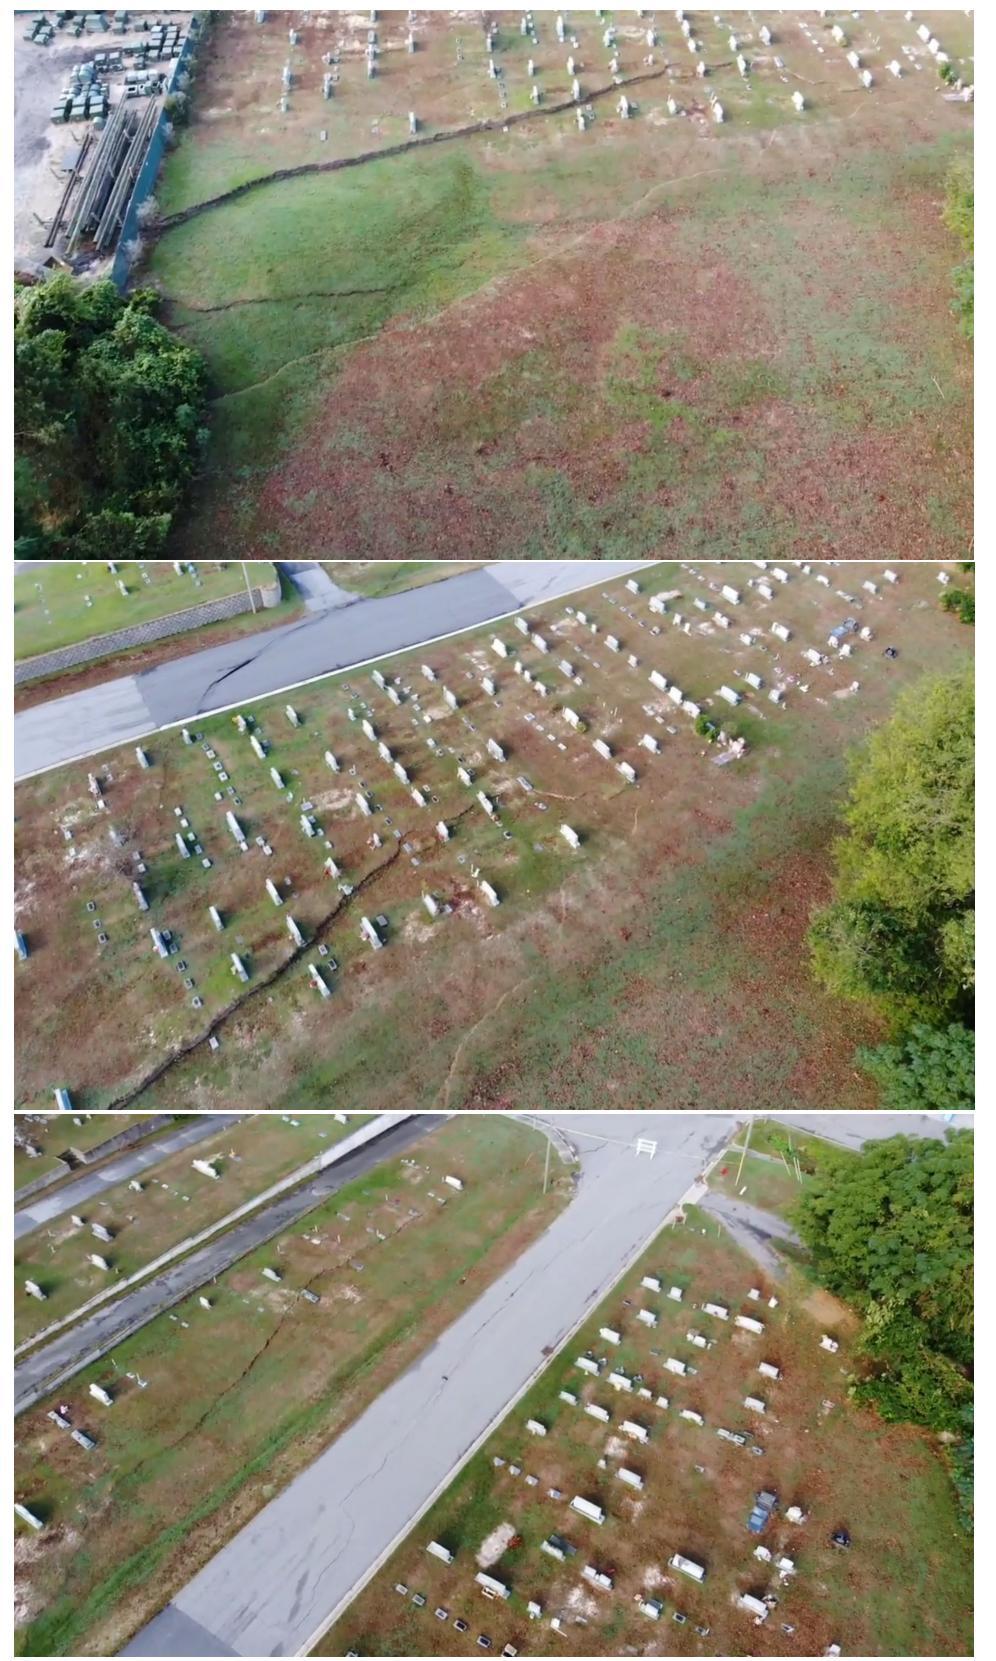
Figure 8.1-8 - Drone photographs showing the tension cracks across the site (September 26, 2018, ~34.630 N, 78.603 W)
