# 11.0 DAMS, LEVEES, AND MINE TAILINGS DAMS

#### 11. 1 Water Storage Dams

## 11.1.1 Coiheuco Dam (S36.637166°, W71.797530°)

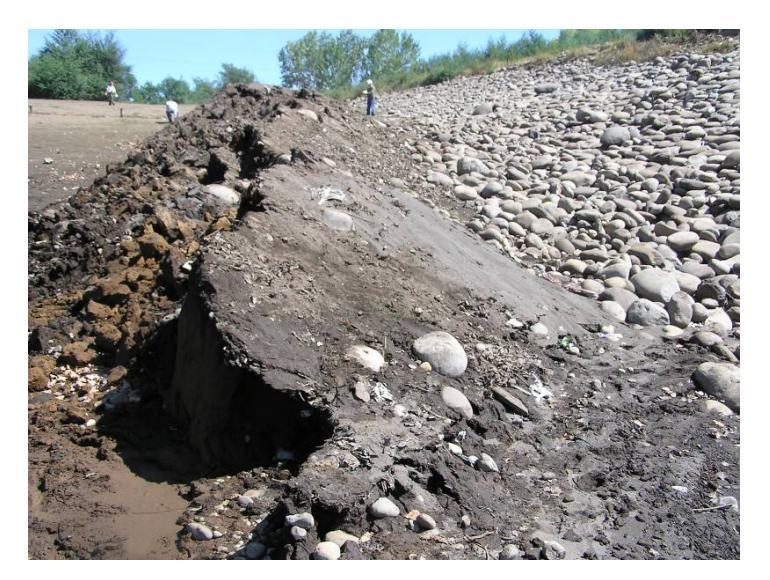
**Figure 11.1c** View of toe bulge area near left abutment of main dam, showing fine sand at the ground surface; due to the foot traffic it was not possible to see evidence that would allow one to classify these features as sand ejecta from soil liquefaction.

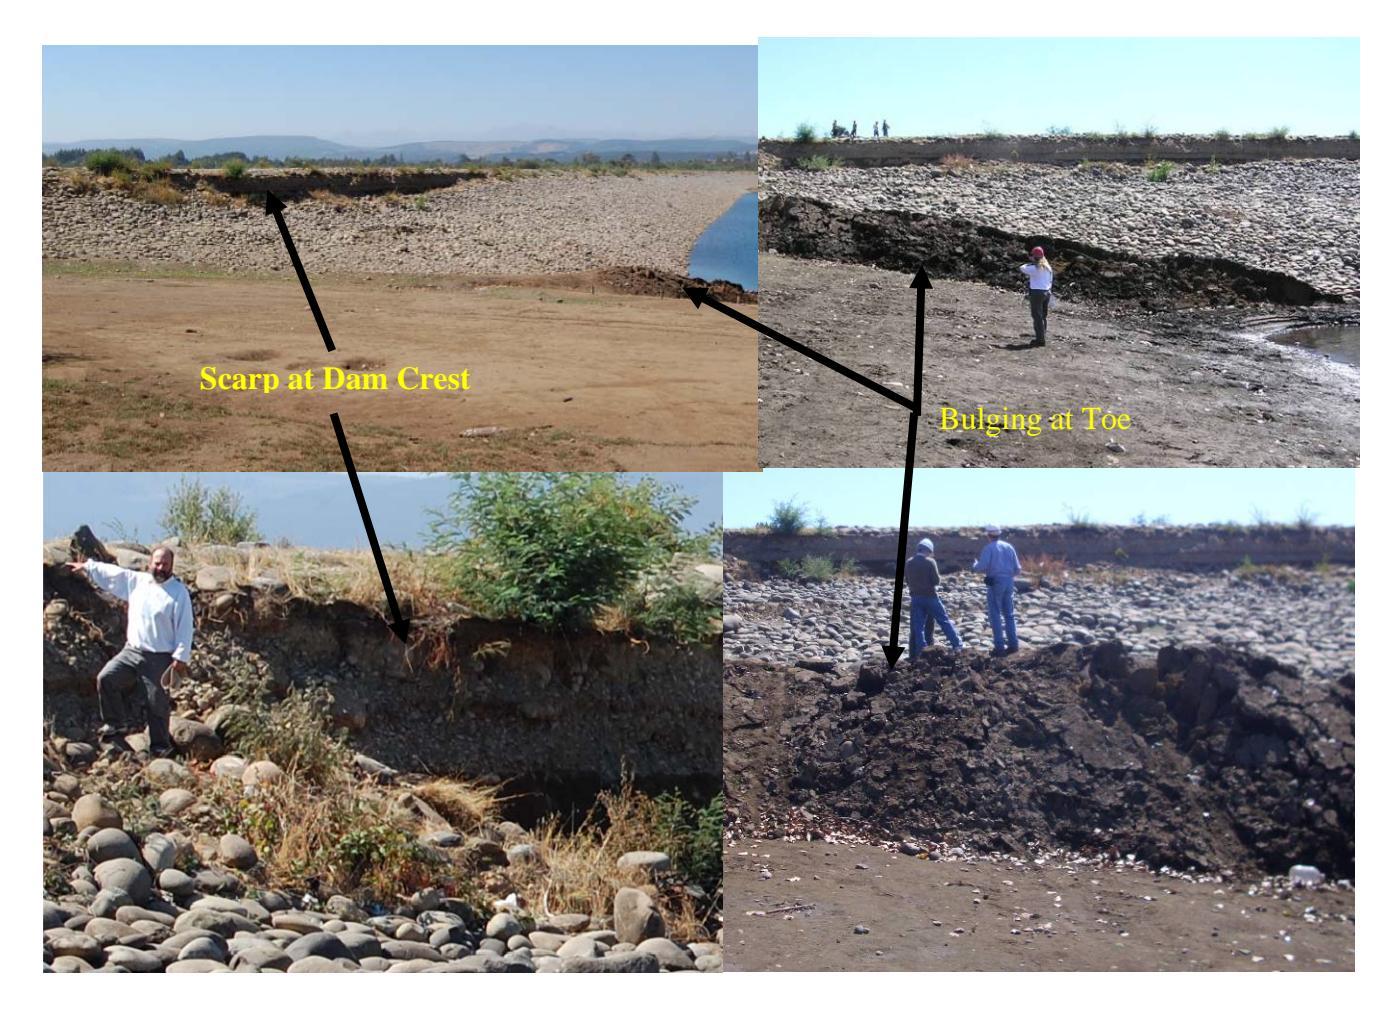
Figure 11.2. March 10, 2010. Slump of the upstream face of Coihueco Dam near the left abutment (\$36.637166°, \$W71.797530°)

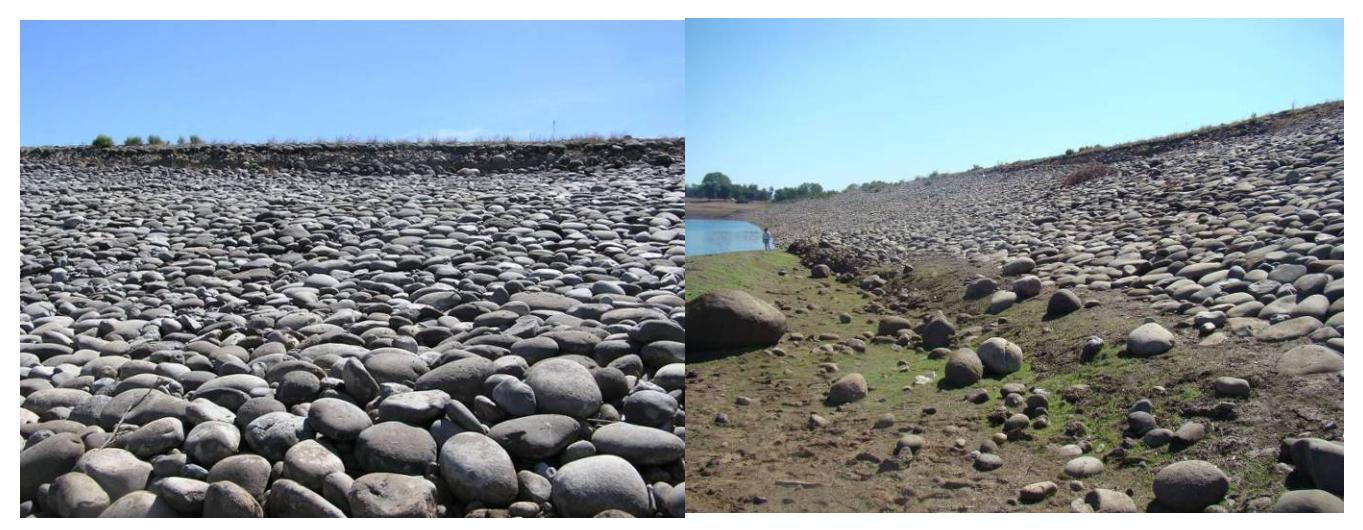
Figure 11.3. March 10, 2010. Slumping at Coiheuco Dam Crest and Bulging at Dam Toe. (S36.636508°, W71.792505°)

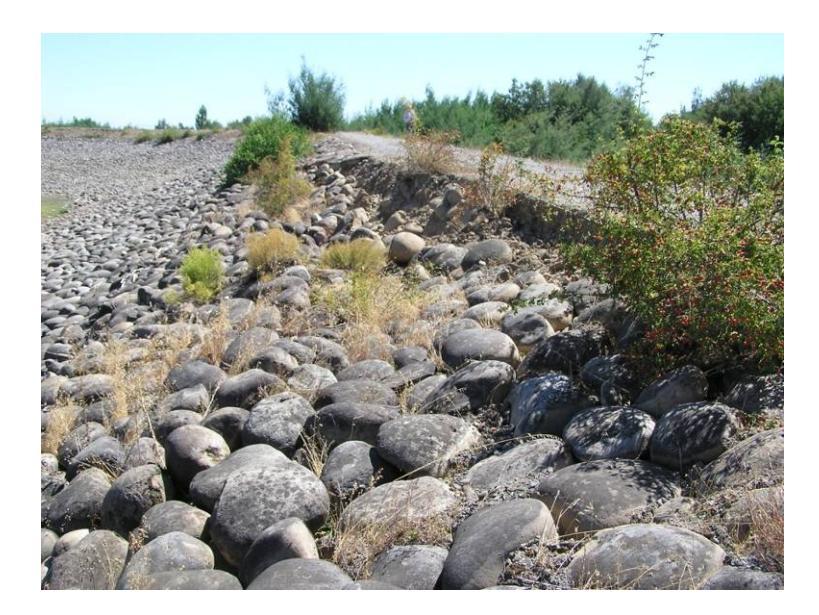
Figure 11.4. March 10, 2010. Small Area of Upstream Crest Slumping on Coiheuco Dam (S36.636902°, W71.788897°)

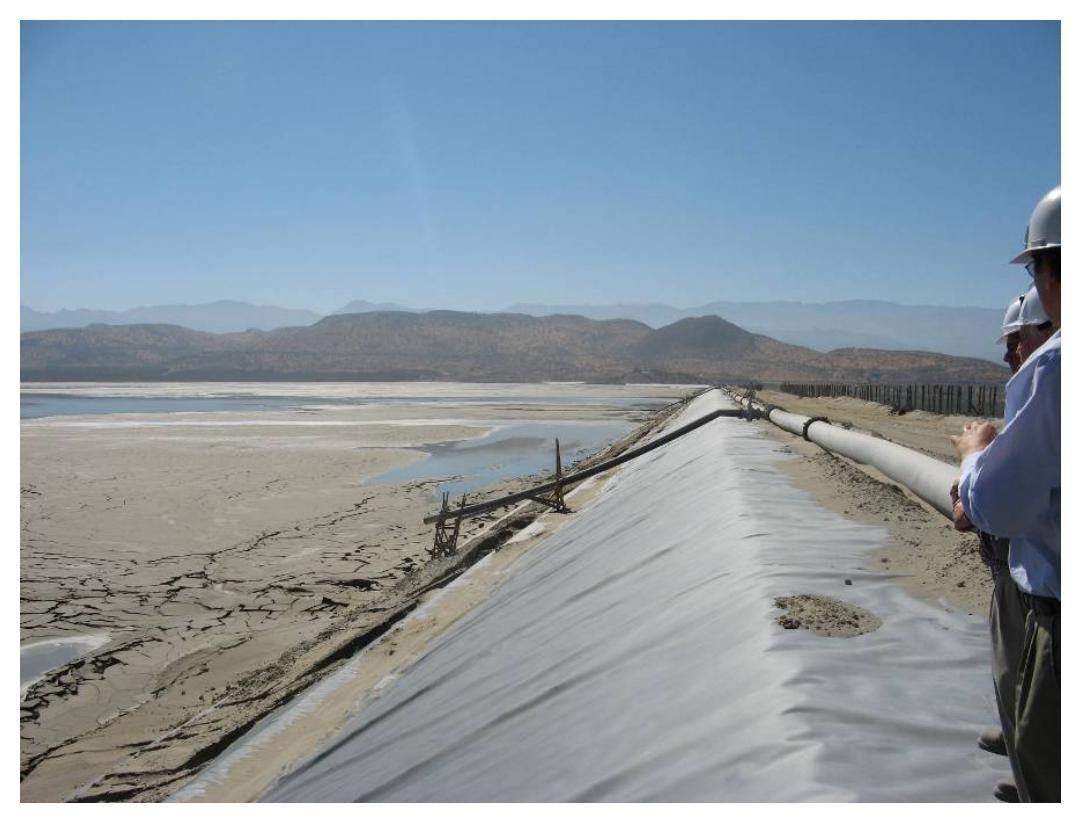
Figure 11.10. March 9, 2010 View along the Upstream Face of the Ovejeria Tailings Dam. There is no damage to the liner and no signs of slumping of the sand beneath the liner (S33.052911°, W70.807067°)

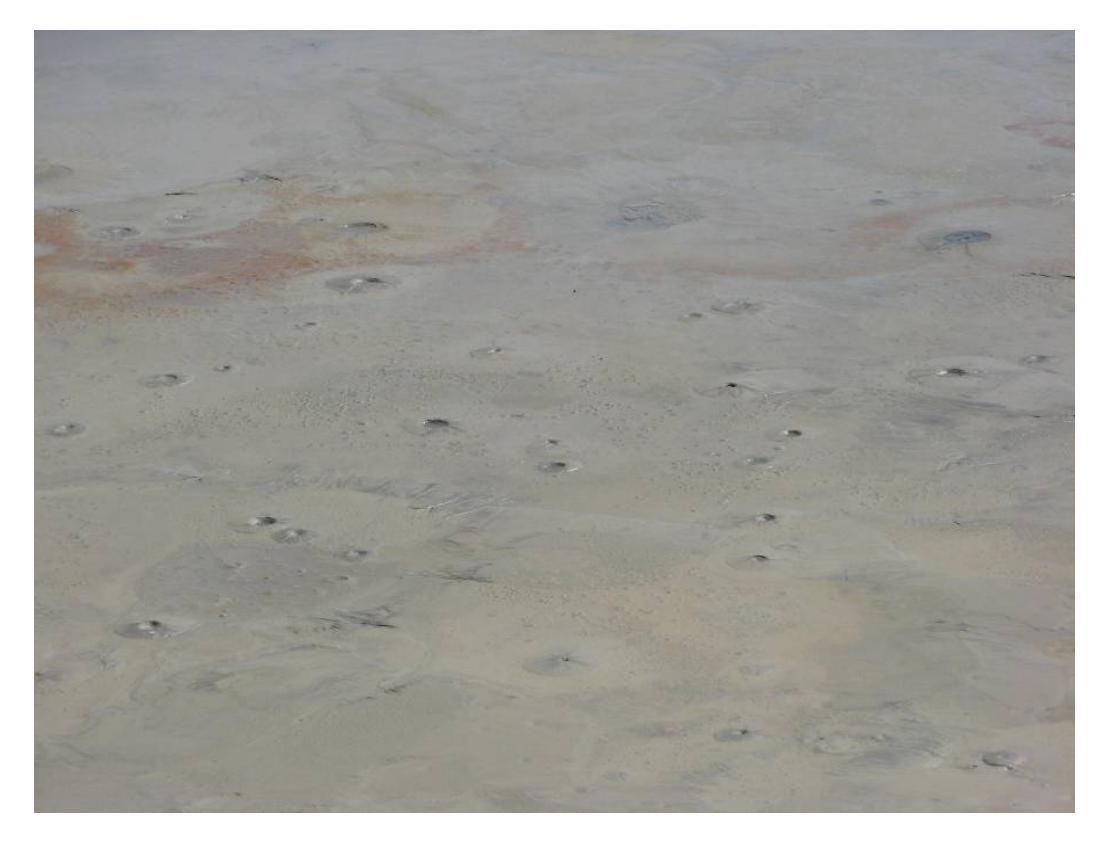
Both the on-ground inspection and the helicopter reconnaissance identified no problems with the tailings sand dam. There were many expressions of high pore pressure (sand boils) in the tailings upstream of the dam and the maximum settlement of the tailings near the dam was about 0.5 m, representing a strain of about 1%. The liner on the upstream showed no signs of dam. Several large valves rest directly on the liner, and there was not stretching or tearing of the liner at these valves. No cracks were observed on the crest or on the downstream face.

Figure 11.11. March 9, 2010 Sand Boils in Tailings about 10 m Upstream of Ovejeria Tailings Dam (S33.052016°, W70.798687°)

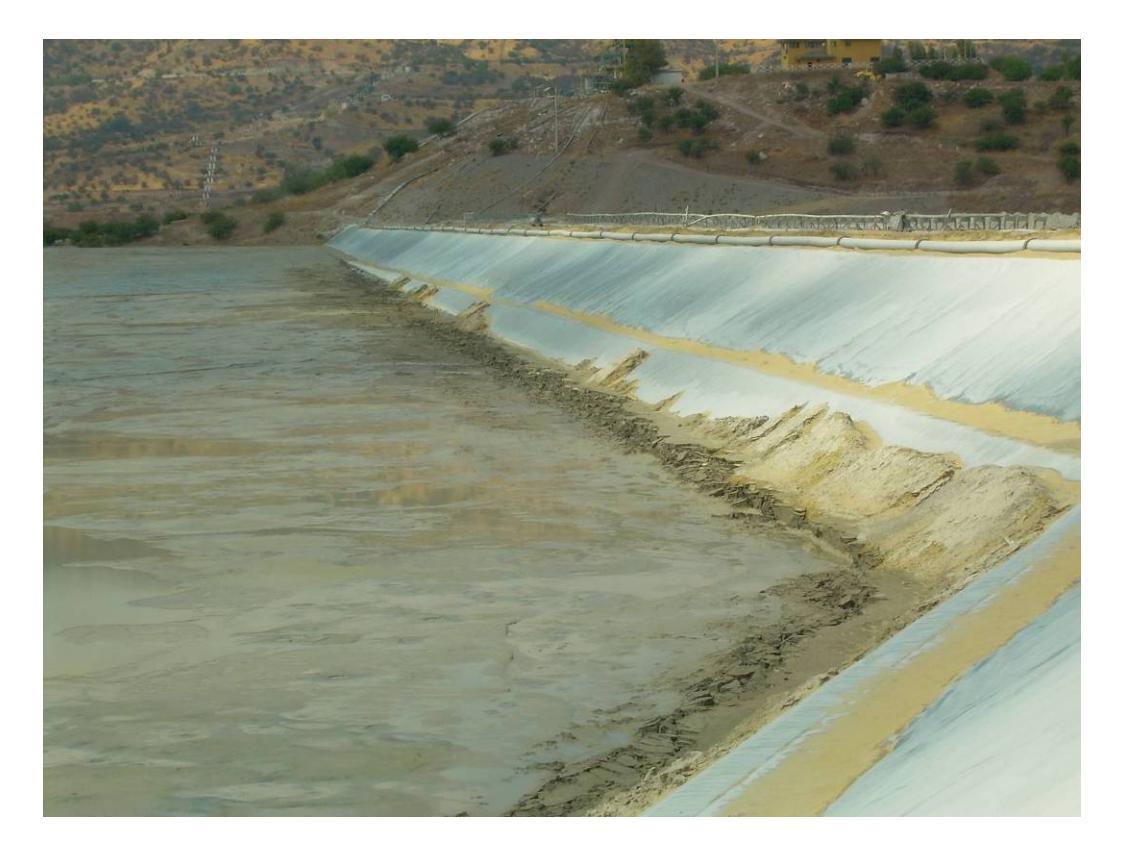
Figure 11.12. March 10, 2010. Upstream face of the Ovejeria Tailings Dam showing approximately 0.5 m of the tailings adjacent to the dam. (S33.052081, W70.792067)

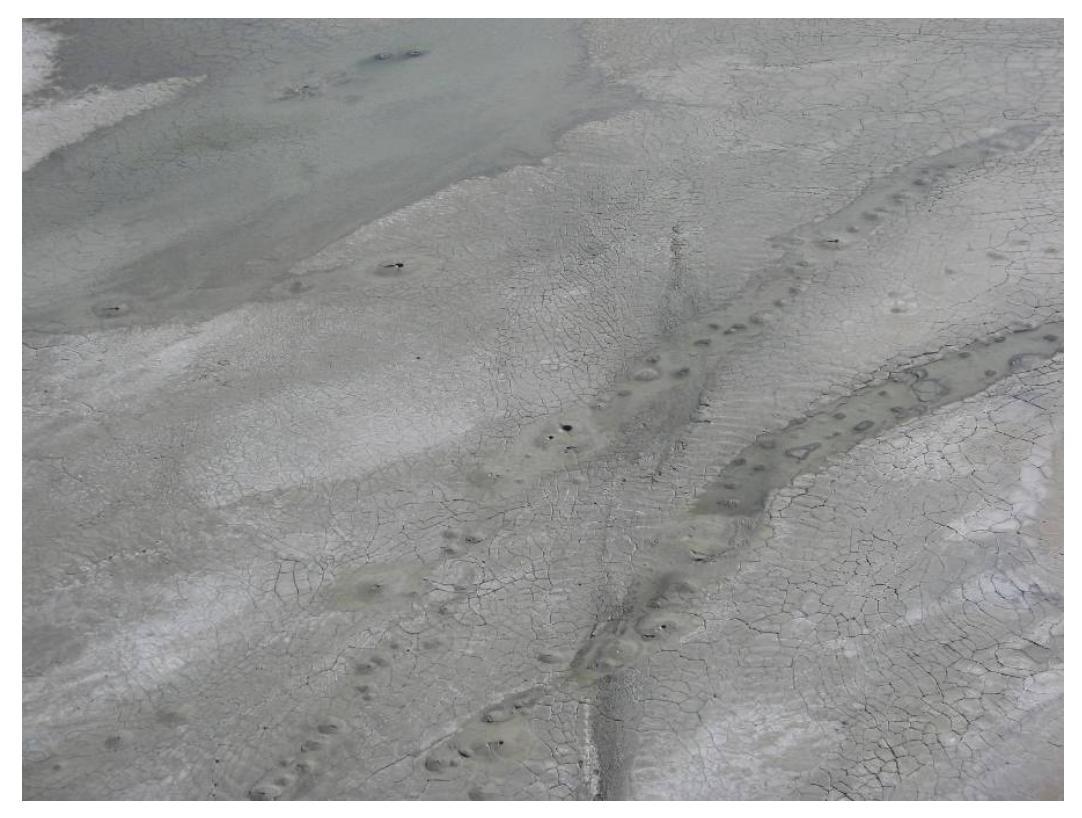
The Caren Tailings Dam is a zoned earthfill embankment using a sloping upstream core. The dam is raised using the downstream method. Dam raise construction was in progress at the time of the February 27, 2010 earthquake. Foundation preparation was complete for the downstream raise and compacted rockfill had been placed to about original ground level. The dam was visited on March 10, 2010. The March 11, 2010 M6.9 aftershock also affected this dam, but the site was not visited by GEER personnel following this second event. Minor (mm width) transverse cracking observed near each abutment, Figure 11.19. Evidence of settlement or movement of the downstream face not observed. Tailings upstream of the dam liquefied. Sand boils were observed in many areas of the tailings beach, Figure 11.17.

Figure 11.17. March 10, 2010 Sand Boils in Tailings Upstream of Caren Dam (S34.111476°, W71.141992°)

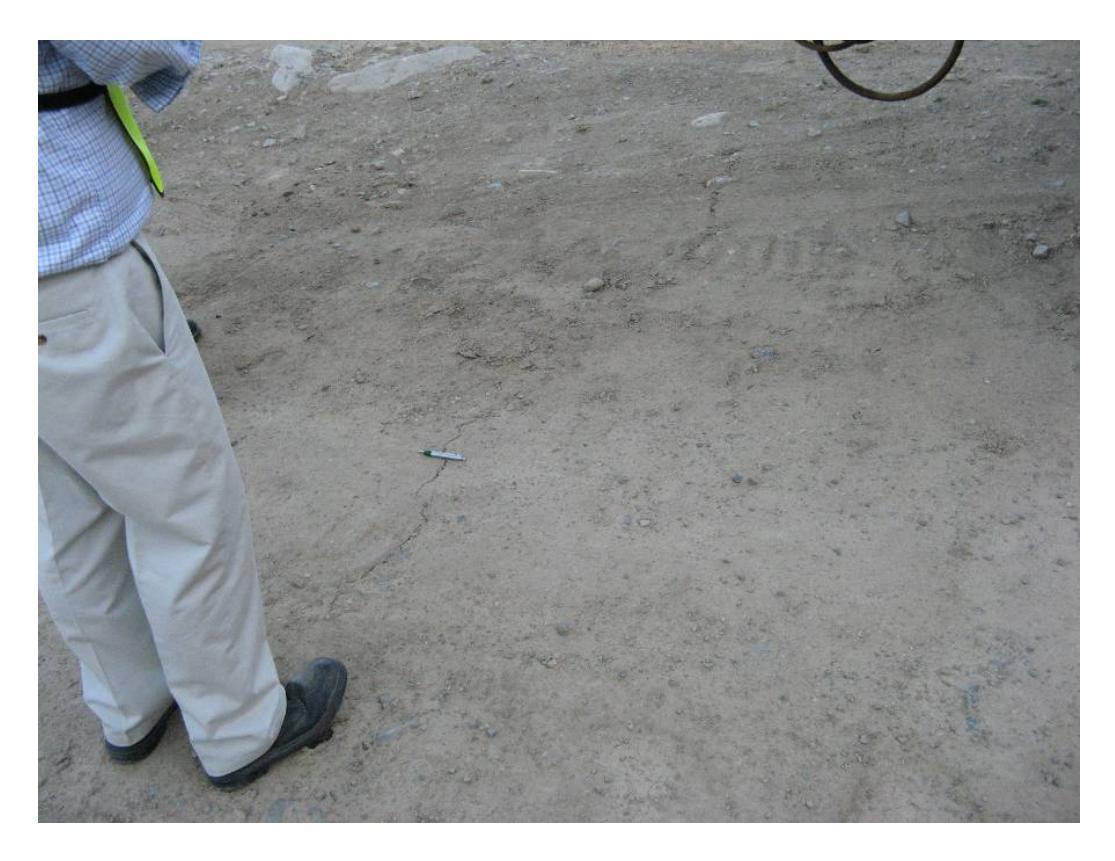
Figure 11.19. March 10, 2010 Millimeter Width Transverse Crack Near the Left Abutment of Caren Tailings Dam (S34.096050°, W71.180748°)

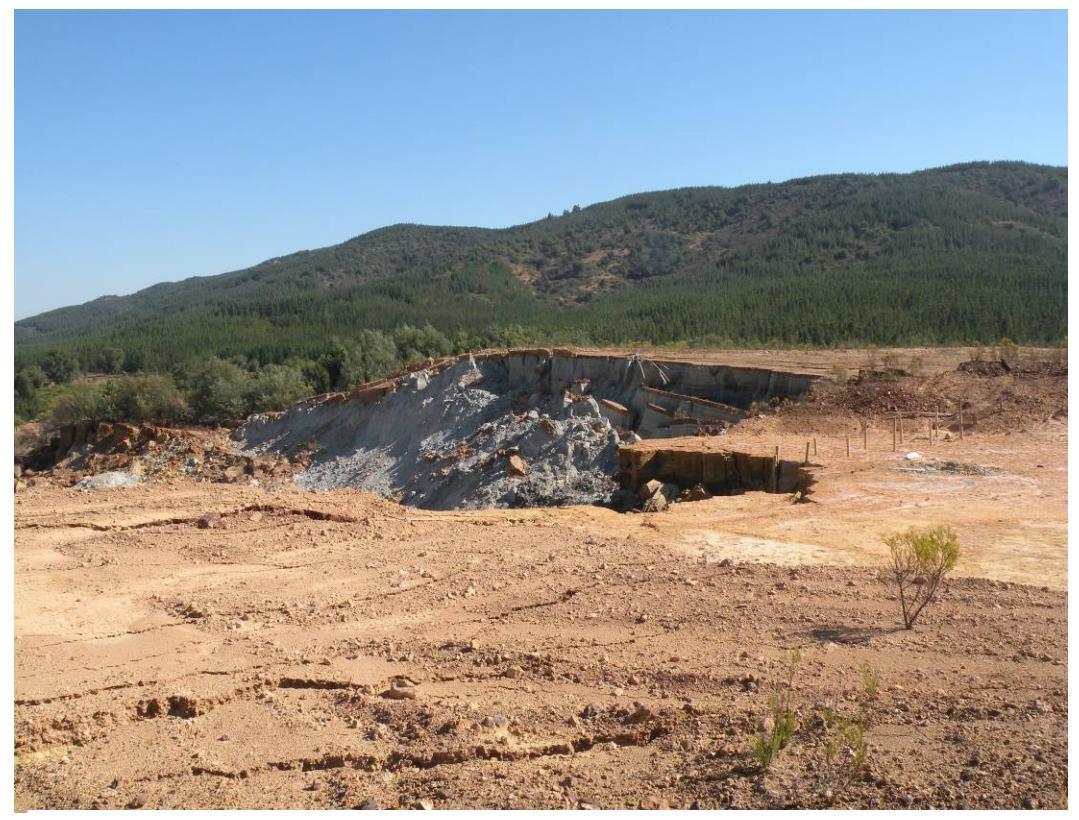
Las Palmas mine was operated from the early 1980's until 1997. The mine was closed and the tailings area partially covered with a thin (+/- 6") layer of gravelly material. Drilling of the tailings is reported to have been carried out in January and February 2010 to assess reprocessing of tailings for additional gold recovery. The profile seen at the upper failure scarp shows the gravelly cover layer and unsaturated tailings. Variable oxidation of the tailings has occurred with colours varying from tan to rusty in oxidized tailings to grey in unoxidized tailings. Clear evidence of liquefaction of the tailings with sand boils and ejecta along cracks indicating some portion of the tailings was saturated . Tailings flowed almost 0.5 kilometers.

Figure 11.23. March 11, 2010. Upper Scarp of Failed Tailings Impoundment Looking Southwest (35.184679° S, 71.759410° W)

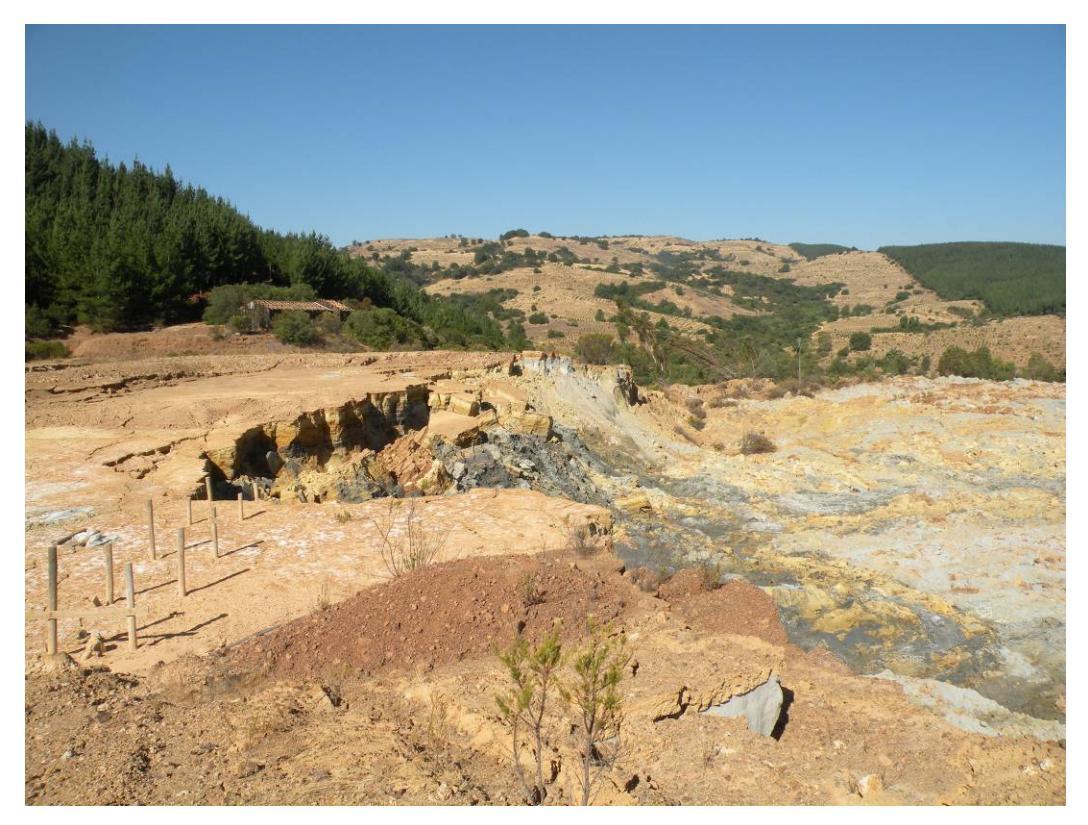
Figure 11.24. Upper Scarp of Failed Tailings Impoundment Looking Northeast (35.184679° S, 71.759410° W)

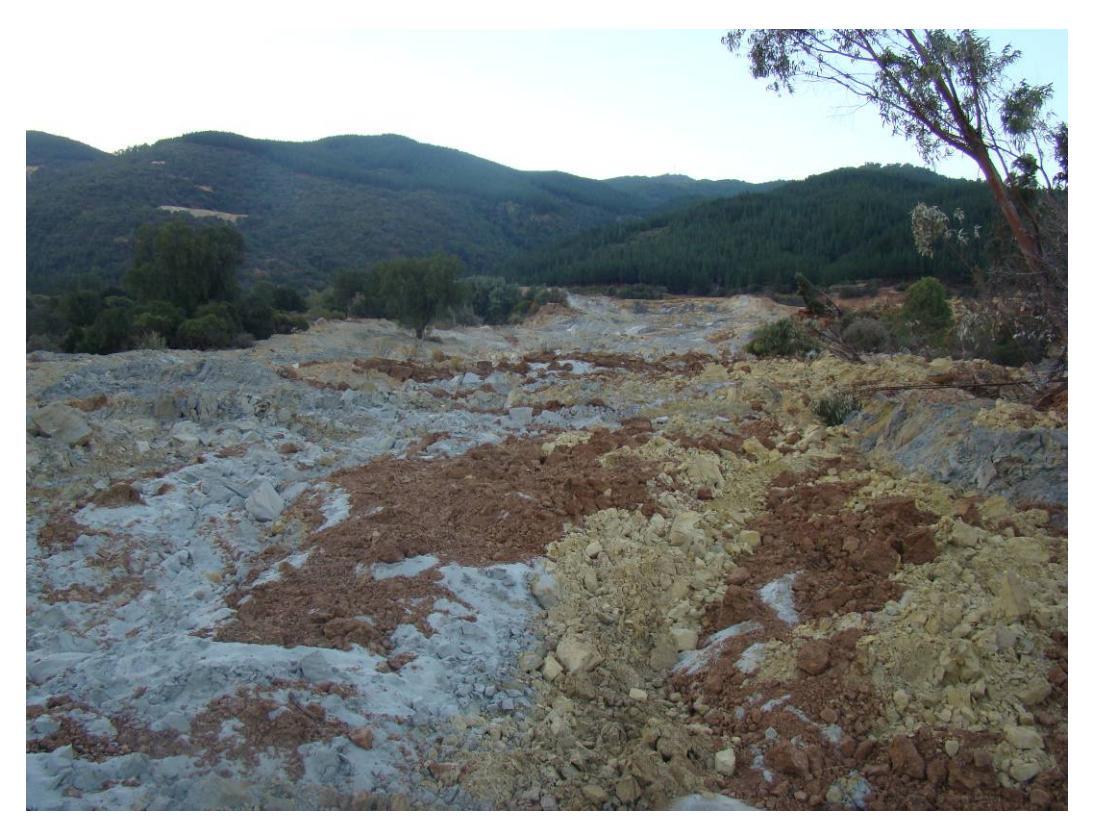
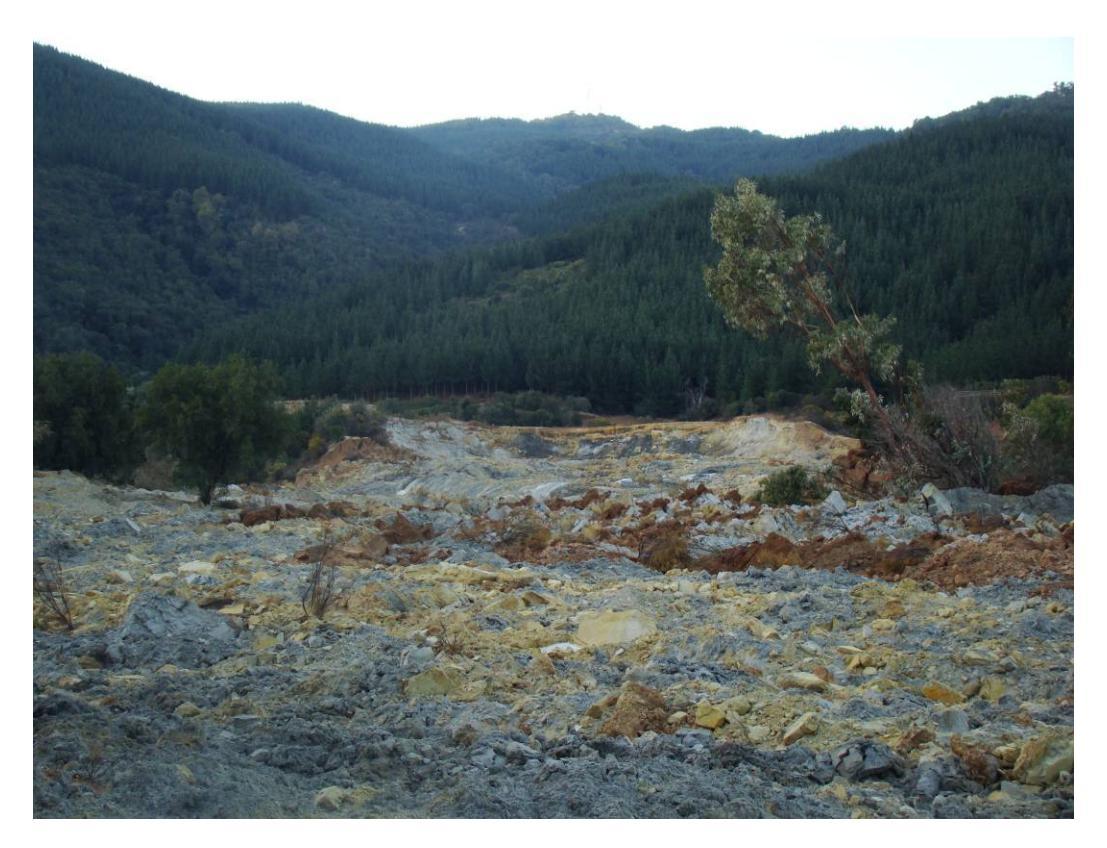
Figure 11.25. March 11, 2010. View Along Flowpath of Tailings (35.18468° S, 71.759410° W)

Figure 11.26. March 11, 2010. View Along Flowpath of Tailings  $(35.18468^{\circ} \text{ S}, 71.759410^{\circ} \text{ W})$

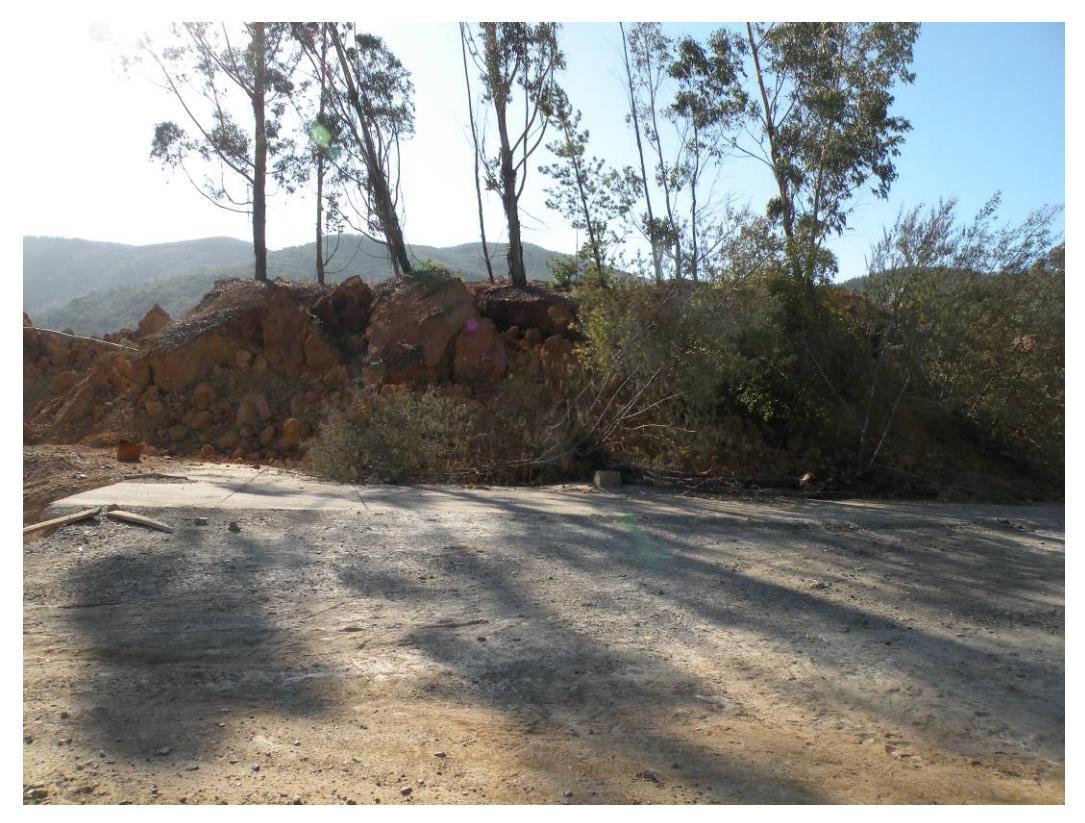
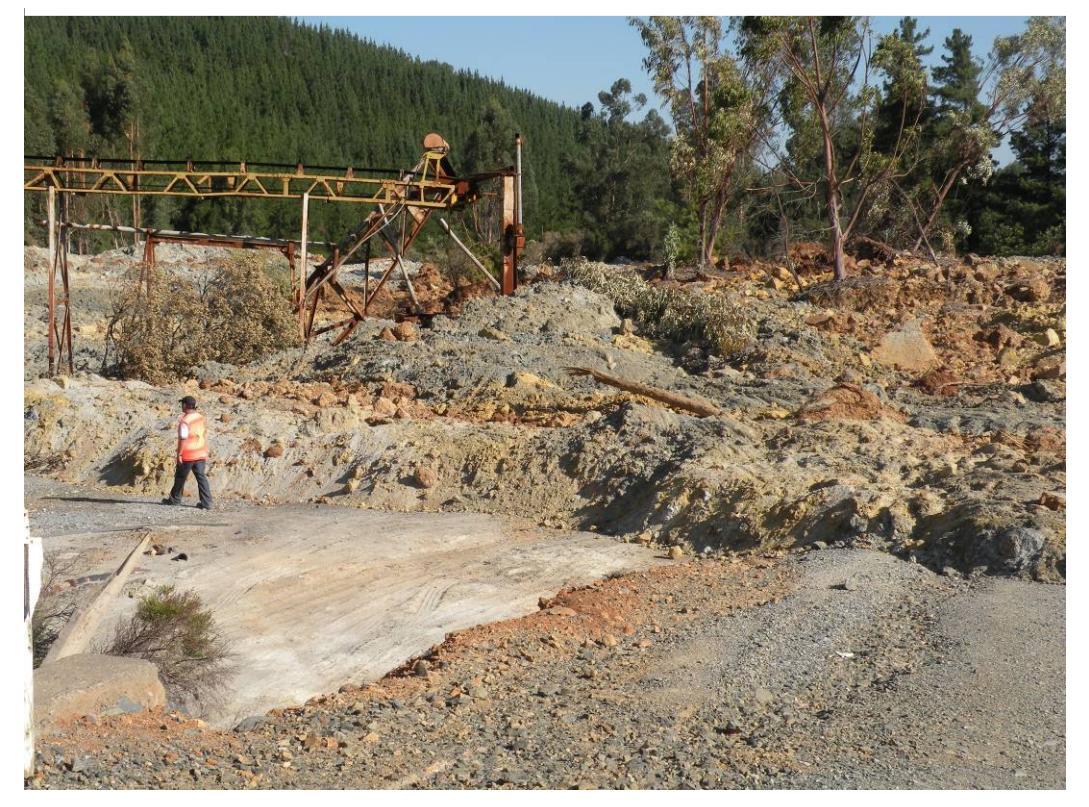
Figure 11.27. March 11, 2010. Side View of Tailings Flow (35.186864°, 71.757873°W)

Figure 11.28. March 11, 2010. Side View of Tailings Flow (35.187204° S, 71.757997° W)

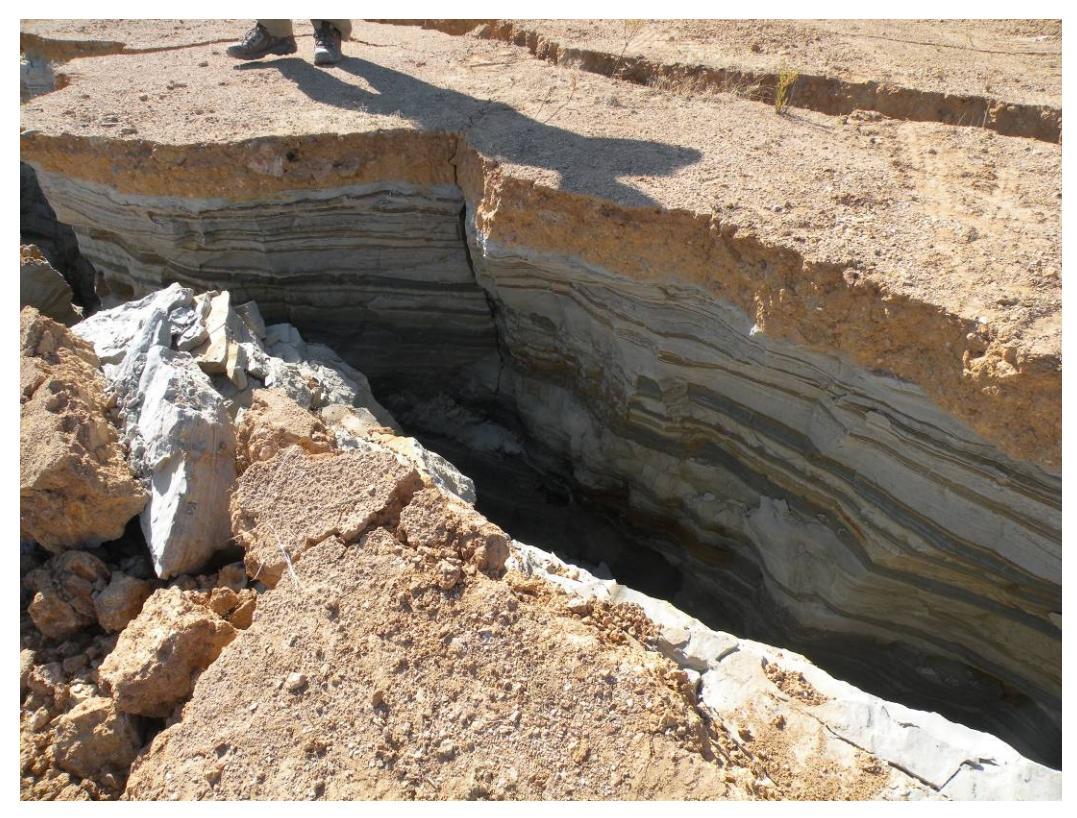
Figure 11.29. March 11, 2010. Gravelly Cover Layer Over Oxidized and Unsaturated Tailings (35.184679° S, 71.759410° W)

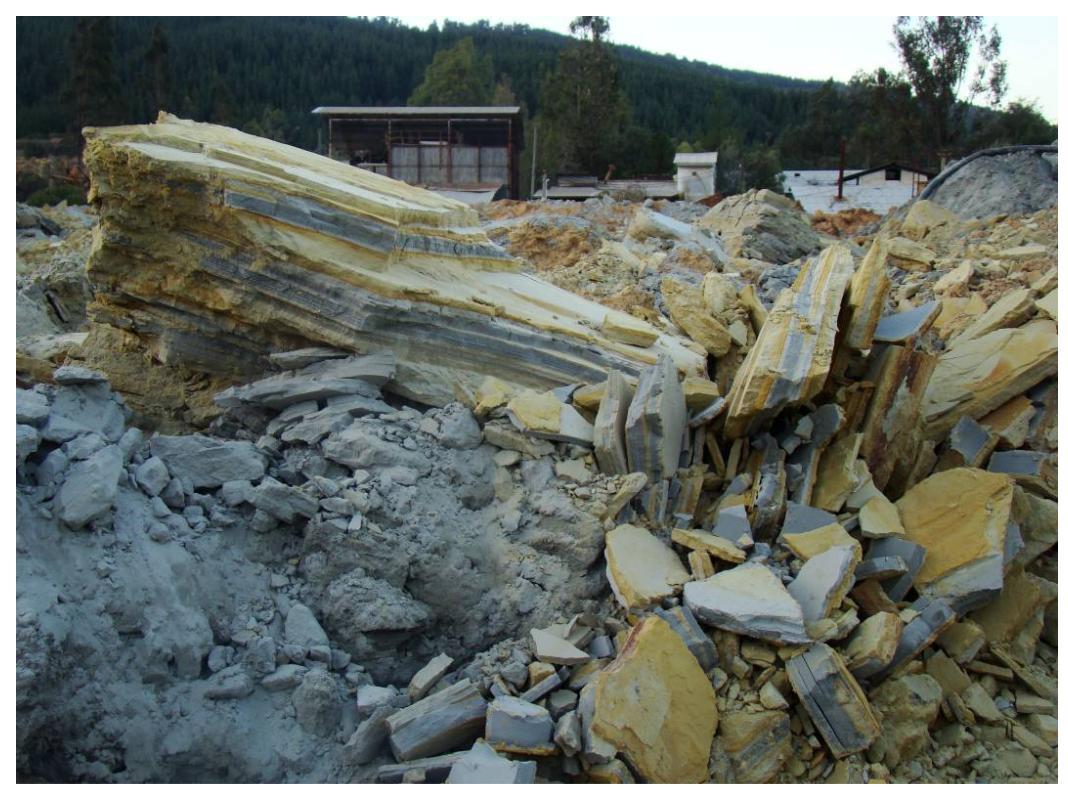
Figure 11.30. March 11, 2010. Variably Oxidized Tailings – Unsaturated Conditions in Upper Portion of Tailings Impoundment (S35.18728°, W71.75781°)

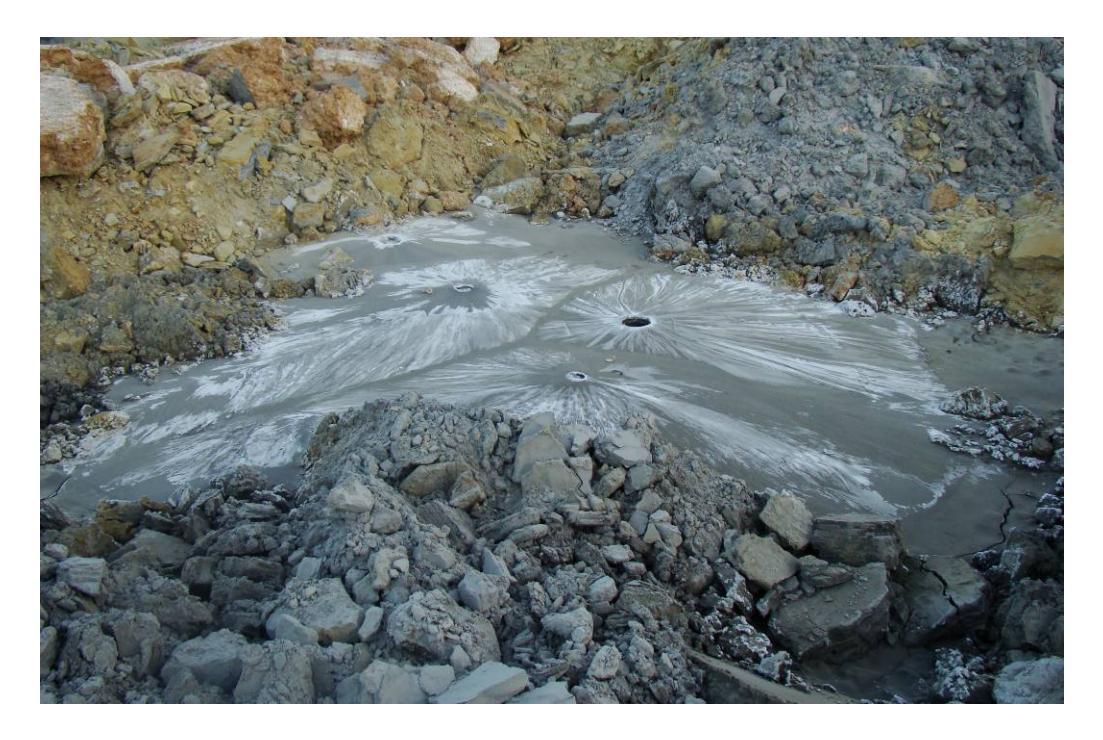
Figure 11.31. March 11, 2010. Sand Boil in Tailings (S35.18872°, W71.75764°)

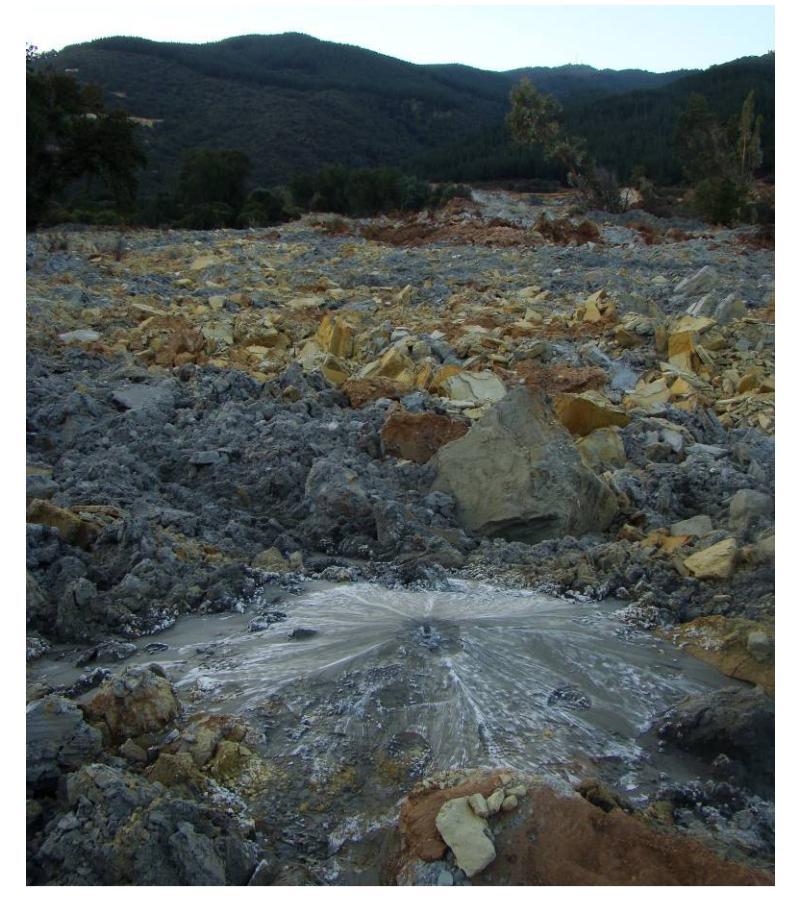
Figure 11.32. March 11, 2010. Sand Boil In Tailings along Flow Path (S35.18872°, W71.75777°)

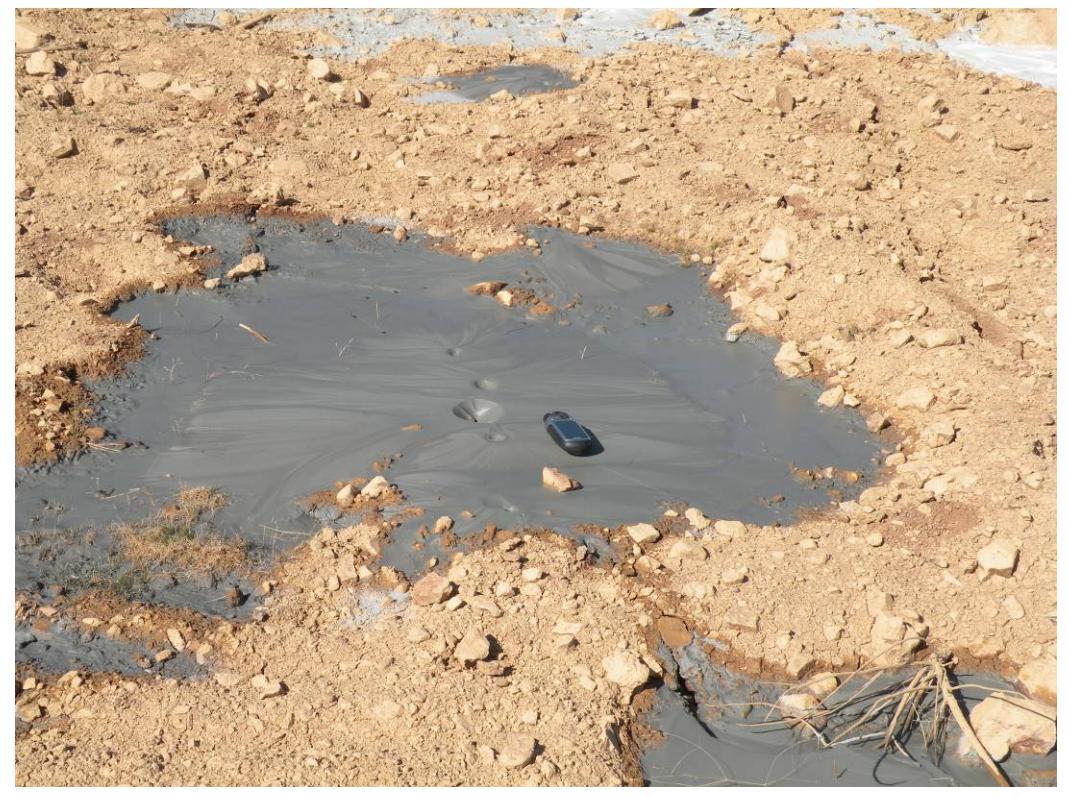
Figure 11.33. March 11, 2010. Tailings Sand Boil Due to March 11, 2010 M6.9 Earthquake near Rancagua (S35.184146°, W71.761118°)

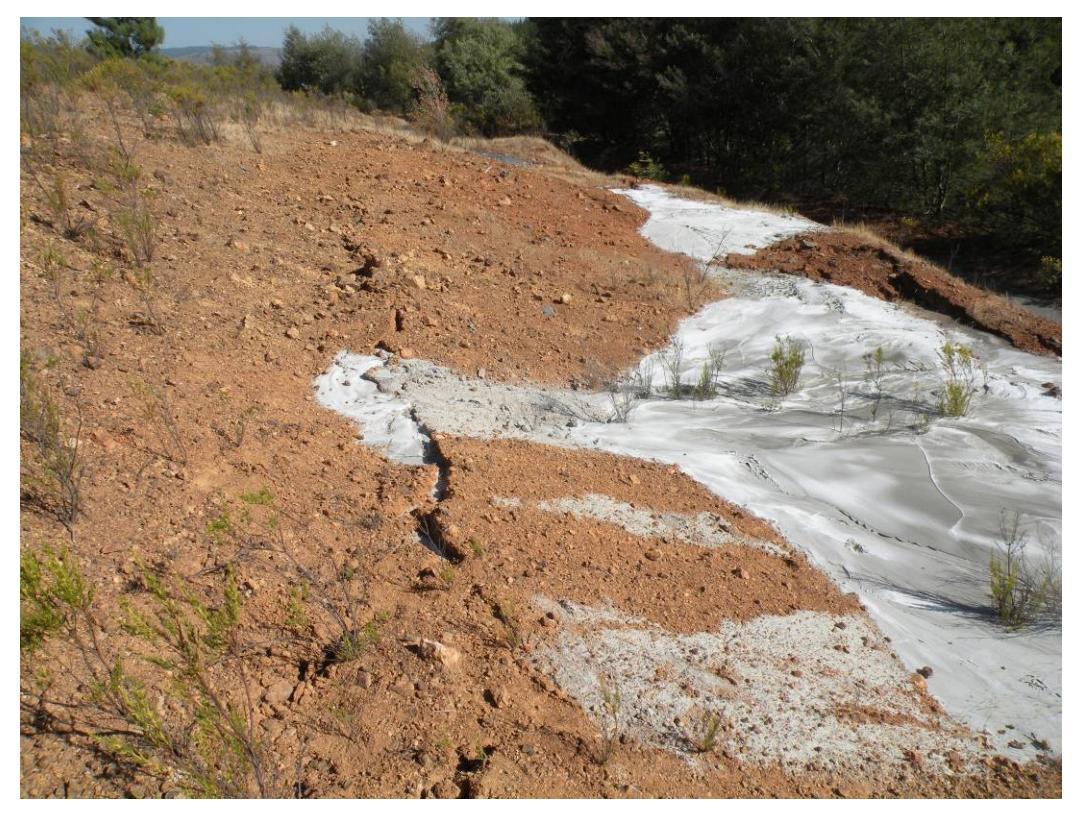
Figure 11.34. March 11, 2010. Ejecta of Tailings from Cracks Indicating Liquefaction of Tailings ( S35.183986°, W71.761844°)

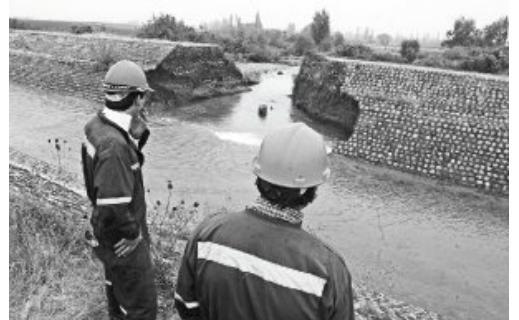
An earth levee that is located west of Colbun failed at 6:50 pm on March 13, 2010 (Figure 11.35), two days after the  $M_w$ =6.9 aftershock (epicenter at S34.259°, W71.929°) that occurred on March 11, 2010 at 11:40 am. The levee was inspected after the  $M_w$ =8.8 main shock of February 27, 2010, and no evidence of distress was noted. Additionally, a rapid inspection of the levee after the significant aftershocks on March 13, 2010 did not identify evidence of distress. The levee breach reportedly released a discharge of 80 cm, which is reported to have flooded a few neighboring homes in this agricultural area of Chile, but none of the homes were significantly damaged.

Figure 11.35. Earthen levee breach west of Colbun (S35.698672°, W71.487294°; photograph taken by Mr. Juan Carlos Romo of the El Mercurio on March 12, 2010; <u>http://diario.elmercurio.cl</u>).

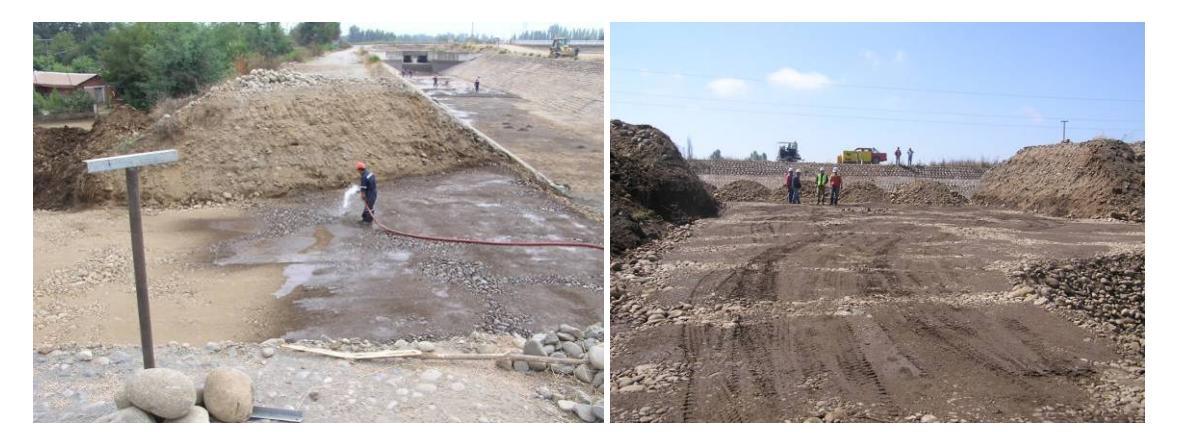
The levee breach site was visited by GEER team members on March 18, 2010. At that time the levee was being reconstructed as shown in Figure. 11.36. A sample of the levee fill material was taken and is in the process of being classified. The levee fill material appears to be a silty sandy gravel material with a significant amount of cobbles. The levee is approximately 7 m high with a crest width of 6 m. Its side are sloped at about 1.5H:1V with cobble facing on its water side. The width of the zone being rebuilt was 15 m. The levee was reported to have been built 25 years ago. Whereas at other locations the existing material was excavated to build the levee, it is reported that no or little excavation occurred at this location because the natural ground surface elevation was already low at this location.

Figure 11.36. Site of earthen levee breach during reconstruction on March 18, 2010 (S35.698672°, W71.487294°).

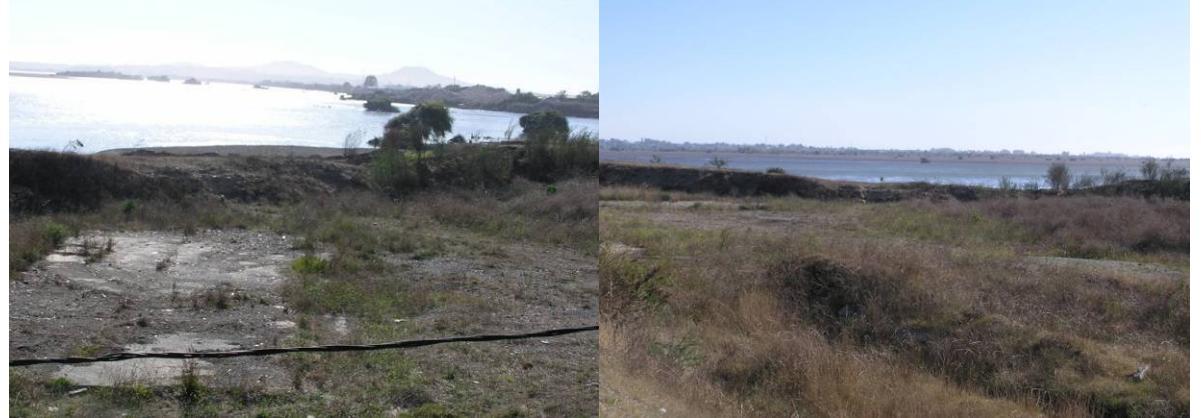
A liquefaction-induced levee slump occurred along the River Bio Bio north of the Juan Pablo II bridge's NE abutment (Figure 11.37). The water level was well below the top elevation of the slumped crest of the levee so there was no breach at this location. Details of the levee construction are not known.

Figure 11.37. View obliquely down on the slumped levee from the NE approach of the Juan Pablo II bridge with evidence of sand ejecta in the foreground, and ground level view looking back at slumped level crest (S36.814555°, W73.084624°); 1700 hrs on 3/15/10).
