13.0 TSUNAMI EFFECTS

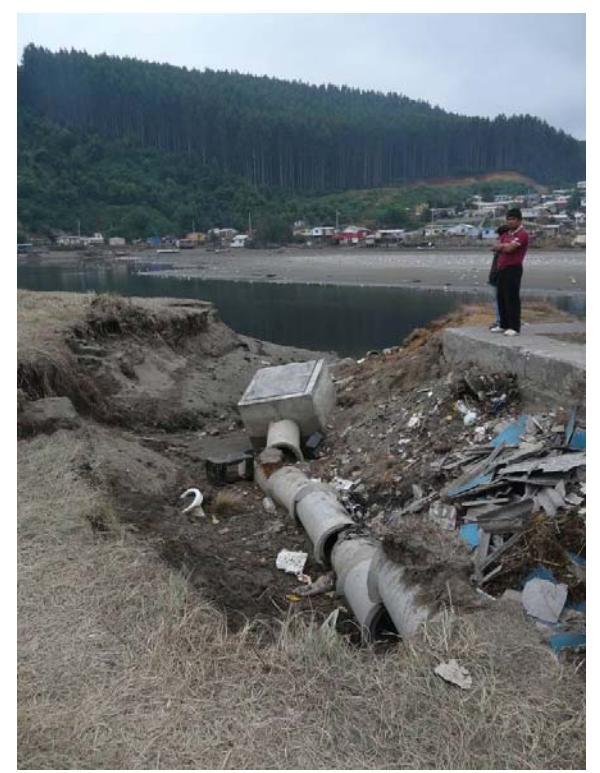
In Laraquete, sand blanketing the road along the beach and accounts from local residents indicate the tsunami reached the first row of houses. Considerable flooding of the beach and along the river channel is evident by deep scouring that damaged the outfall of a storm sewer near the river bank (Figure 13.1). At one beach front house a car was pushed tens of meters landward and water marks on the foundation indicate a minimum flow depth of 0.55 m (Figure 13.2).

Figure 13.1. Tsunami scoured out the foundation of this storm sewer outfall at Laraquete (\$37.165352° W73.188051, 1907 hrs on 03/16/2010).

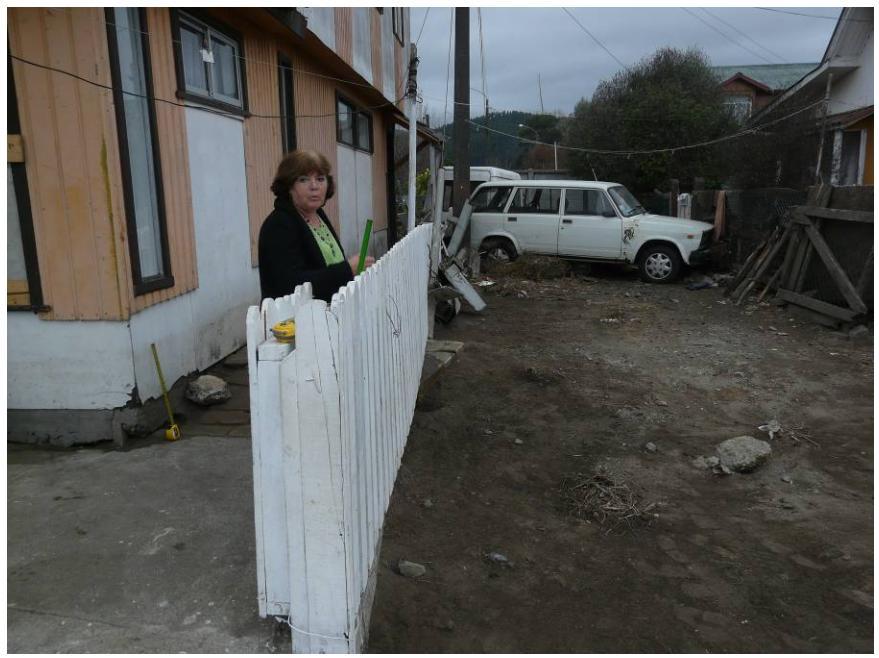
Figure 13.2. Beach-front homes in Laraquete were inundated by the tsunami. At this woman's home, tsunami flow depths reached at least 0.55 m, which transported the white car from the street to the backyard. The tape measure left of the woman indicates the flow depth measured from a water stain on the building (S37.165650° W73.188136, 1915 hrs on 03/16/2010).

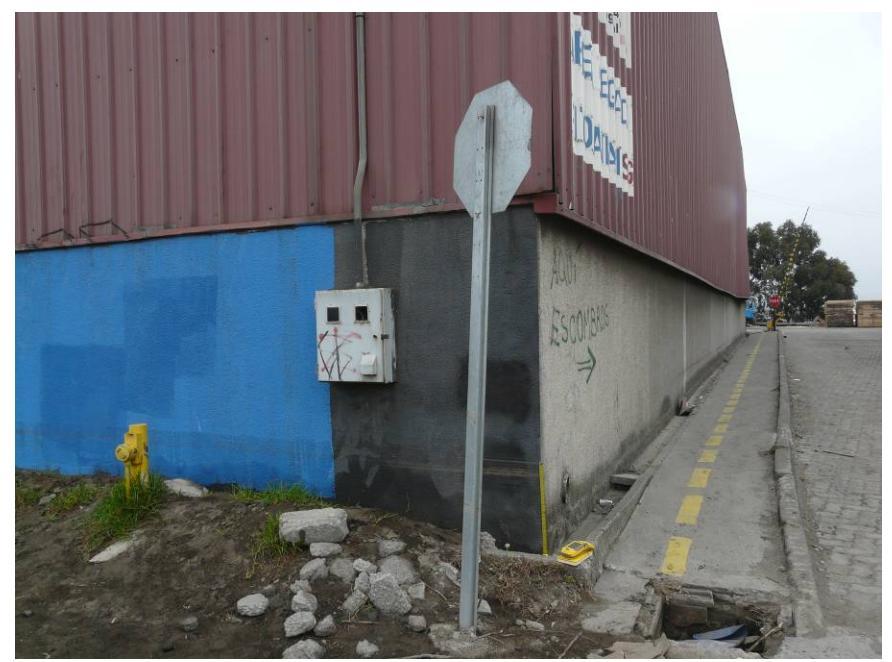
Minimum tsunami flow depths were measured at four sites in Talcahuano. At the storage warehouse, water lines left by flooding indicate 0.65 m flow depths along Perez Gacitua Street near Rio Andalien (Figure 13.3). West of the warehouse, high water marks showed sustained flow depths of about 0.63 m (Figure 13.4). To the north, sites closer to the bay experienced greater flow depths. At one building along Avenue Manuel Rodriquez the tsunami left marks 1.6 m high above ground (Figure 13.5). Port facilities along the shore of Bahia San Vicente experienced heavy damage caused by ground failure due to liquefaction and tsunami inundation. Near a fish processing plant at the port in west Talcahuano, lateral spreading dropped the waterfront down making it more susceptible to moderate tsunami flooding. Here the tsunami left a 1-m-high, indelible dark tarry stain along waterfront buildings that had slid toward the bay (Figure 13.6). At adjacent areas unaffected by lateral spreading and settlement, including a vast fuel tank farm, little or no flooding occurred. In light of the relatively modest tsunami inundation in western Talcahuano compared to more extensive inundation and damage observed in the eastern part of the city, we propose that Punta Pardo and the massive Tumbes Peninsula may have offered some protection to the northeastern shoreline of Bahia San Vicente, especially if tsunami waves propagated from north to south.

Figure 13.3. Tsunami flow depths reached a minimum of 0.65 m at this waterfront warehouse in Talcahuano along Perez Gacitua Street (S36.728263° W73.109199°, 1136 hrs on 03/16/2010).

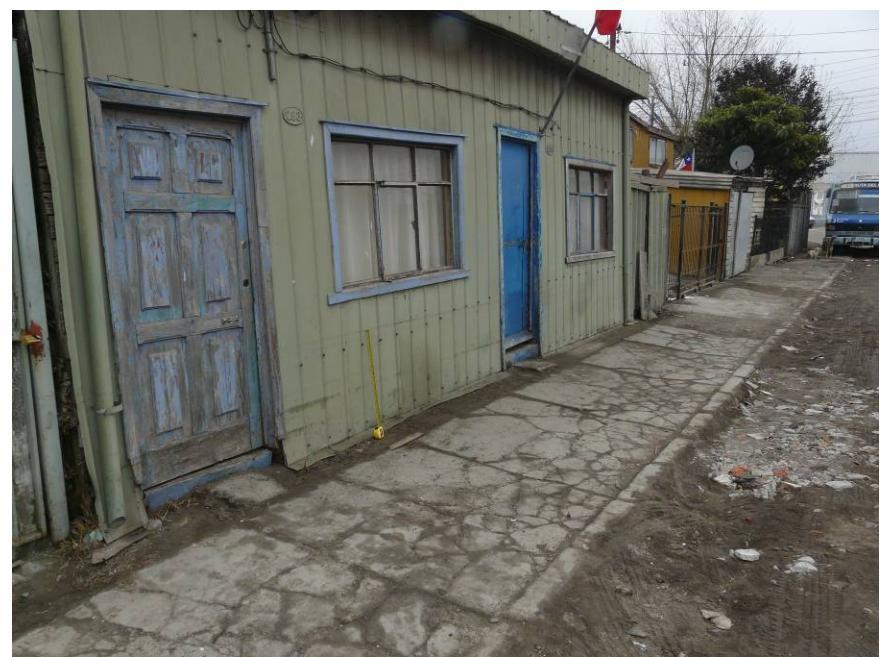
Figure 13.4. Tsunami flow depths reached a minimum of 0.63 m at this green house on El Morro Street in Talcahuano (S36.727354° W73.109530°, 1206 hrs on 03/16/2010).

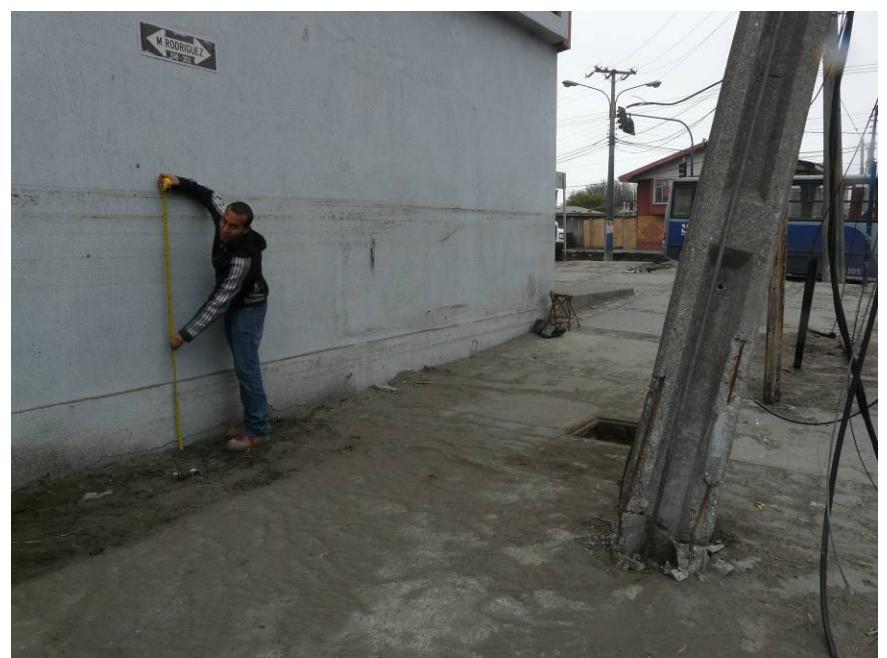
Figure 13.5. Along Avenue Manuel Rodriquez in Talcahuano, the tsunami reached minimum flow depths of 1.6 m (S36.725249° W73.106313°, 1215 hrs on 03/16/2010).

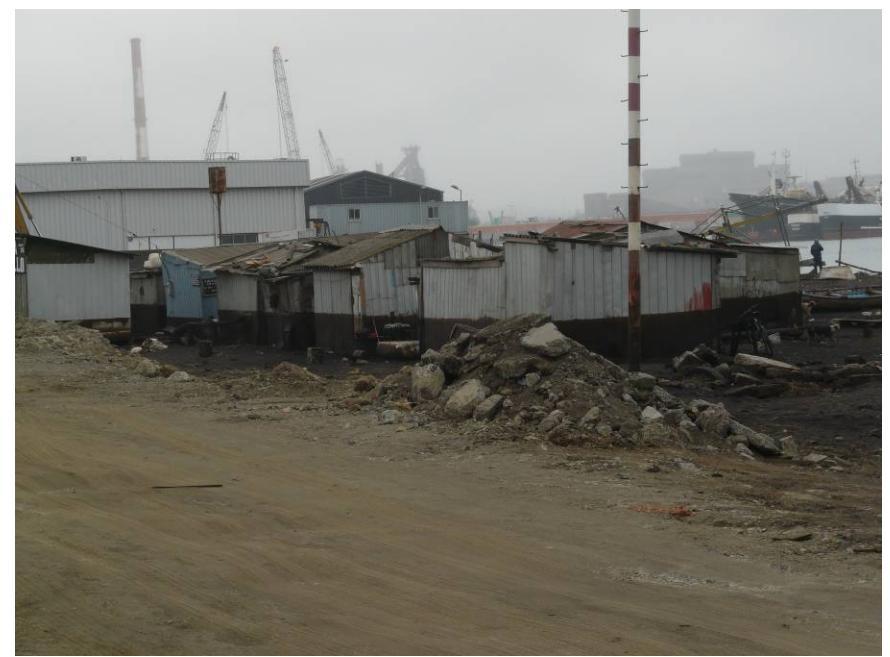
Figure 13.6. One-meter high dark stains on buildings at Talcahuano port facilities along Bahia San Vicente mark the elevation of the tsunami. Major damage of port facilities, including a fish processing plant were caused by a combination of factors, including modest tsunami inundation in areas that dropped vertically due to liquefaction-induced lateral spreading (S36.727076° W73.128058°, 1258 hrs on 03/16/2010).

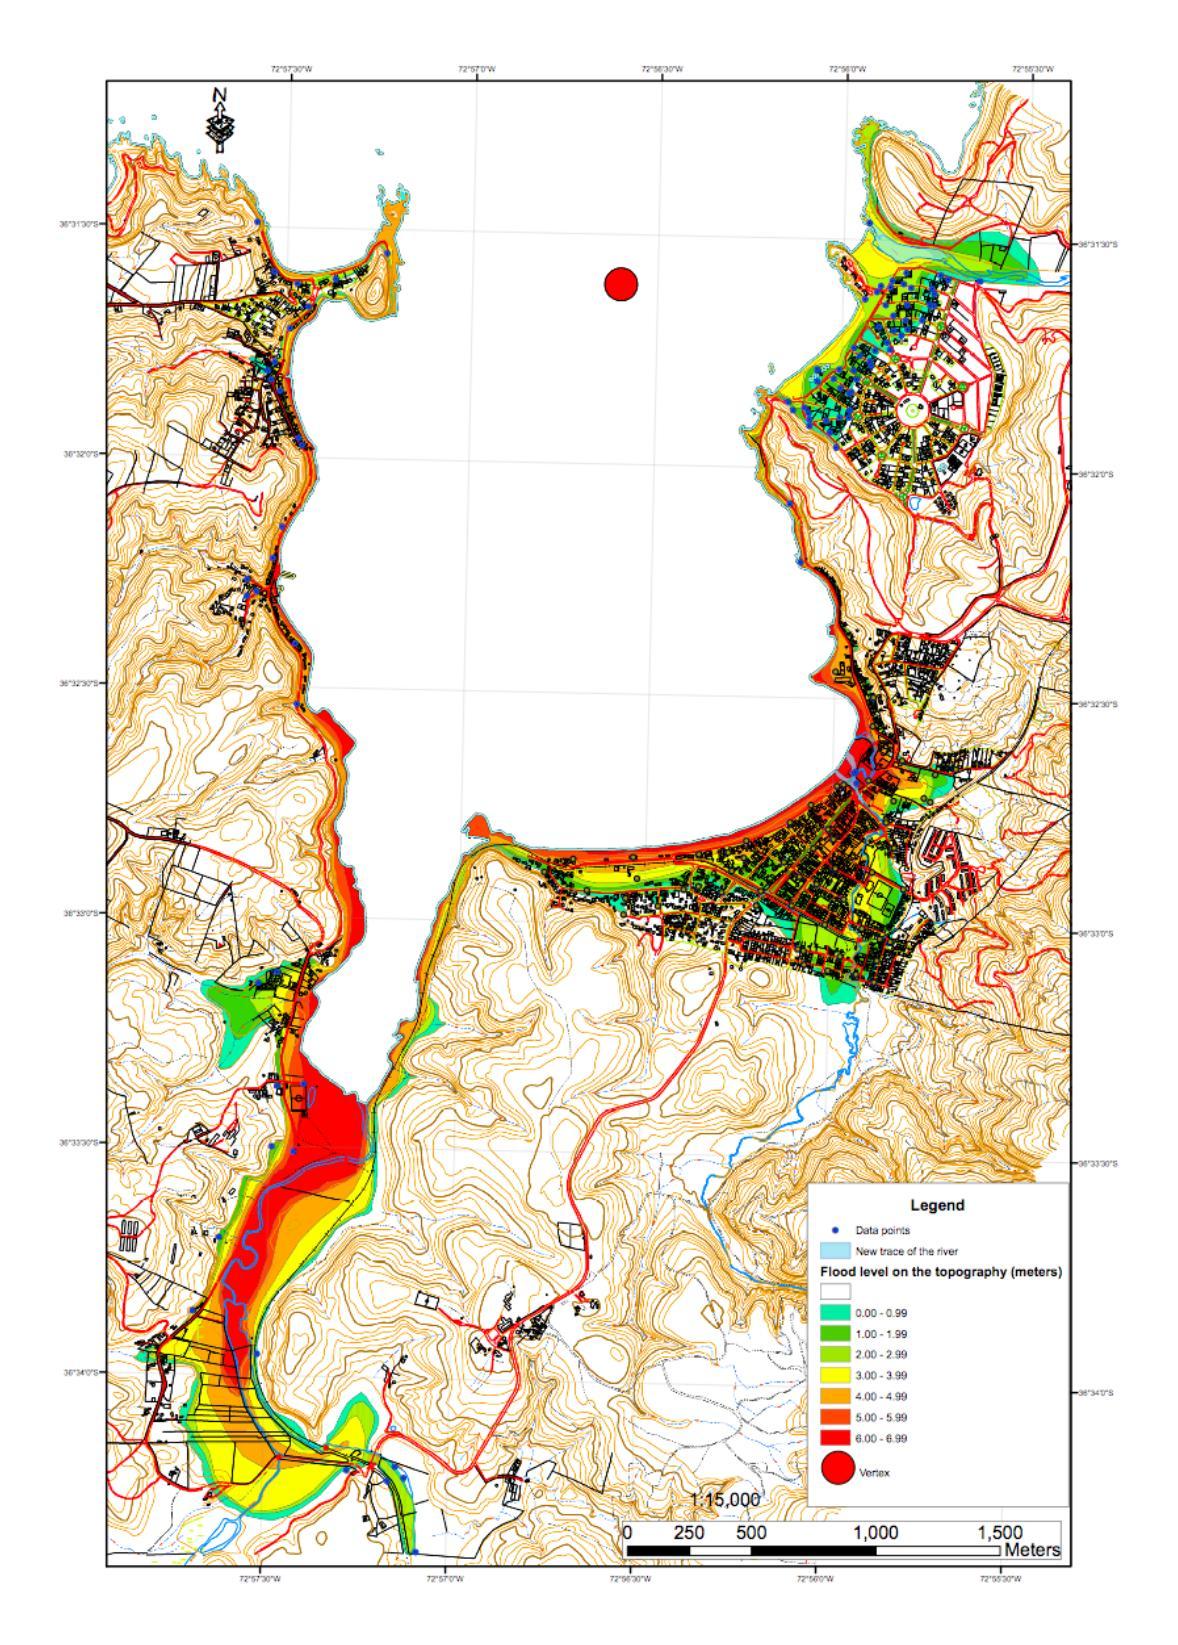
The maximum inland incursion of the tsunami in the Dichato area was about 2.2 kilometers. Based on ground measurements, it is estimated that the maximum depth of the water in the town of Dichato was about 6 m, and about 6.5 m in the agricultural valley that extends to the South of Coliumo Bay west of Dichato as shown in Figure 13.8. A photograph of a large portion of the town of Dichato taken during an aerial reconnaissance flight is shown in Figure 13.9. An expanded view of the inundation extent and depth based on ground observations at the location of the black open dots is shown in Figure 13.10. Structure locations are overlaid in Figure 13.11. Most residents of the Dichato area agree that the first wave arrived within an hour after the earthquake. A second set of waves entered Coliumo Bay between 6:30 and 7:00 am. A third surge of water entered the bay at about 10:00 a.m. Depending on location, the largest and most destructive waves were either the second or third set of waves. Eyewitness accounts stated that the waves did not generally advance as cresting breakers, but moved into the bay and onto the land as surges, first causing flooding and then creating an outwash that carried structures and debris back into the ocean.

Figure 13.8 Inundation extent and depth for Dichato region based on ground observations by Zoa et al.

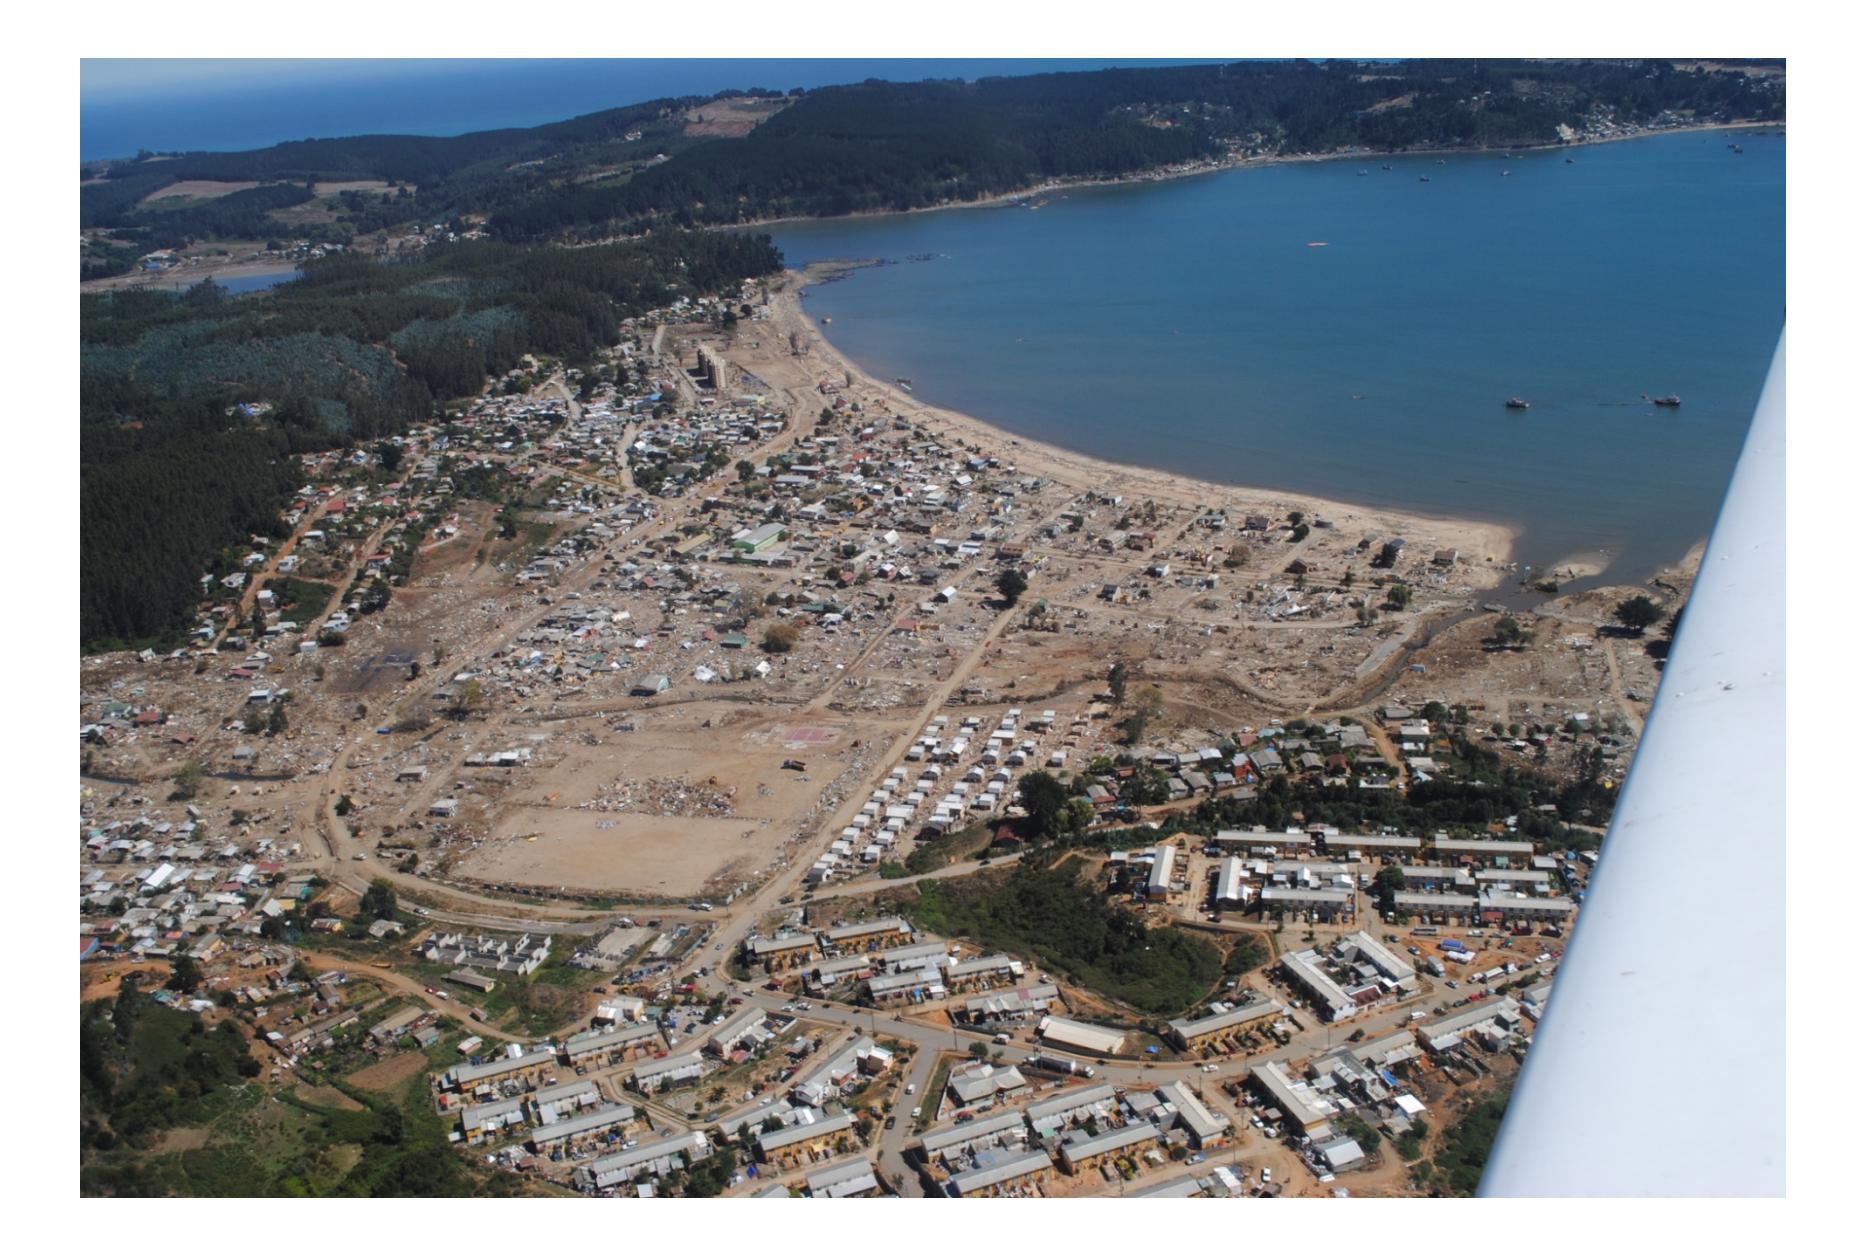
Figure 13.9 Aerial reconnaissance photograph of portion of Dichato and Coliumo Bay (S 36.5488° W72.9314°)

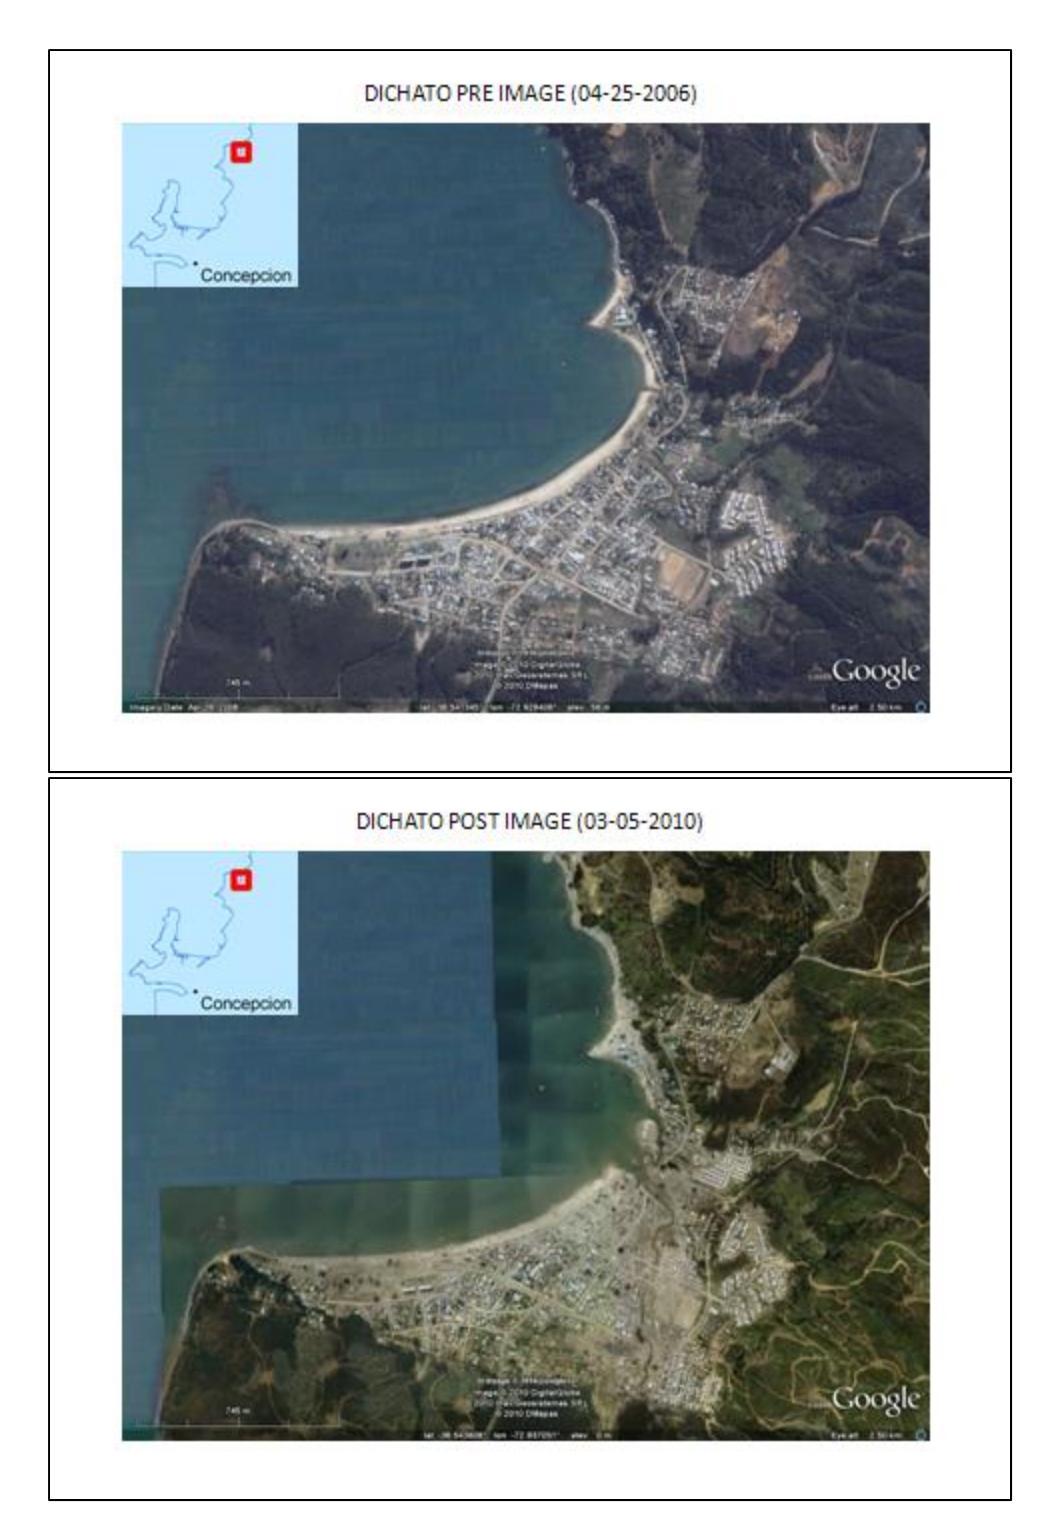
Although the motion of the water was primarily north-south, fishermen on the west side of the bay observed east-west surges during the morning of the 27th February. Large waves that struck the west side of the bay seemed to have been reflected off the eastern shore. Pre and post event image pairs showing tsunami damage are given in Figures 13.12 and 13.13.

Figure 13.12 Pre/Post Imagery of Dichato (S36.546°, W72.933°)

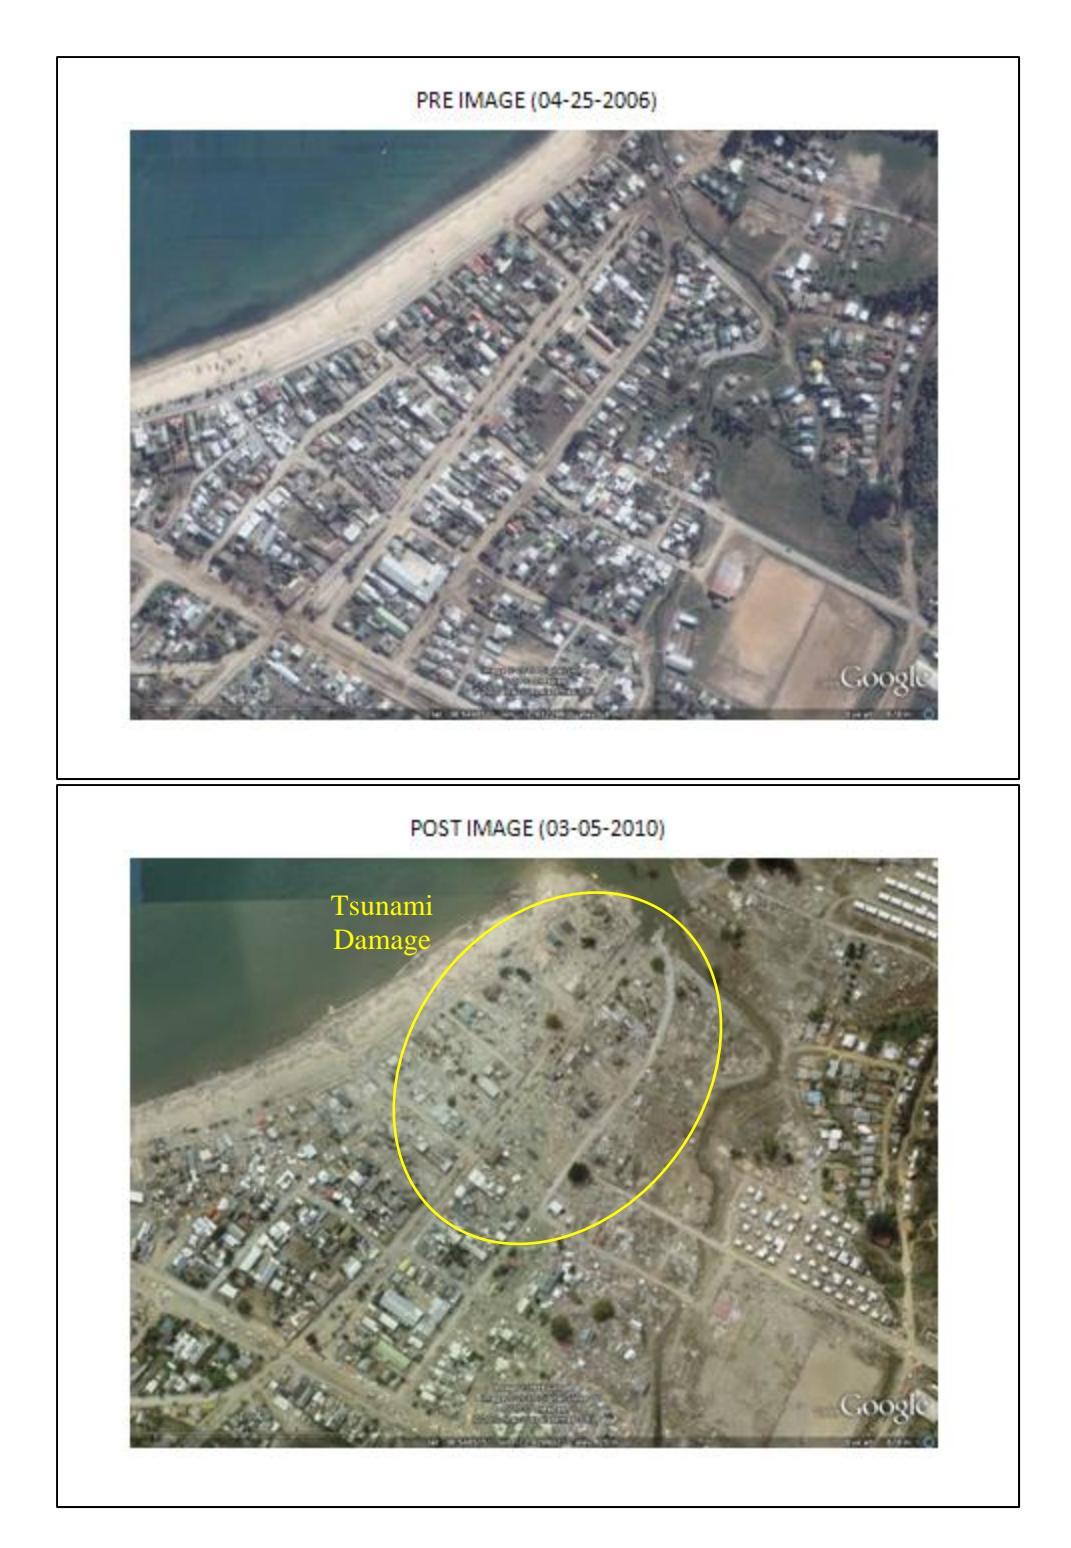
Figure 13.13 Pre/Post Imagery of Dichato (S36.548°, W72.935°)

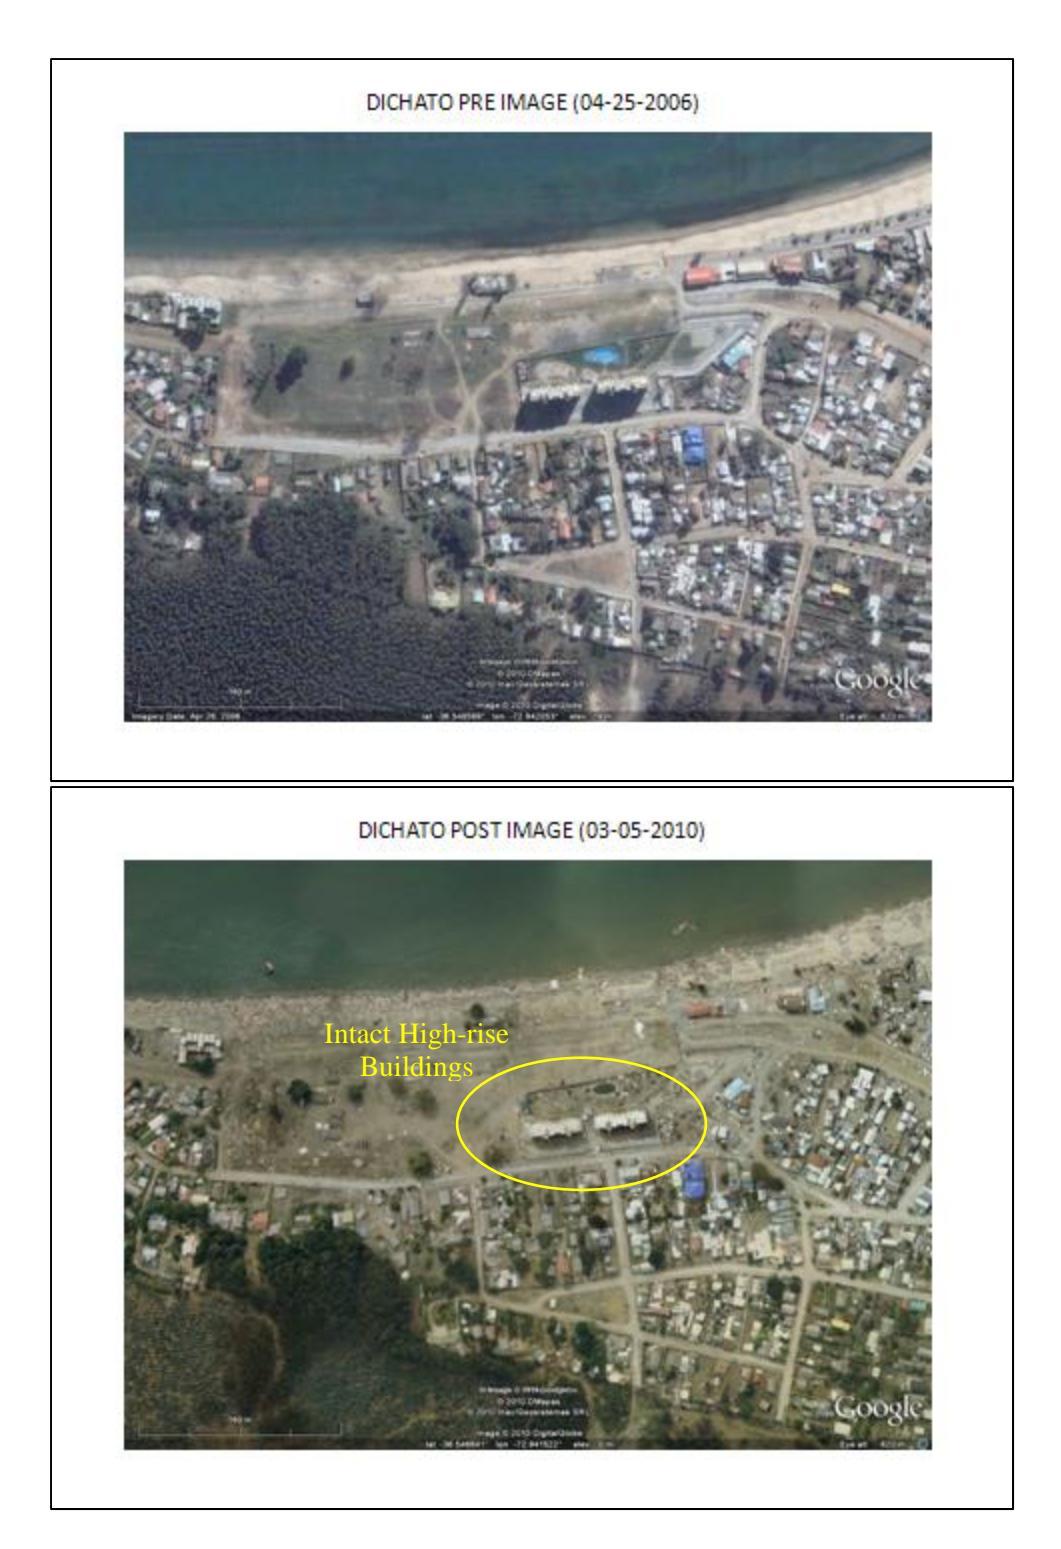
On the west side of Dichato there are two 10 story apartment buildings. These buildings incurred no obvious structural damage as shown in the pre and post images in Figure 13.14 and the aerial reconnaissance photo in Figure 13.15. They withstood the earthquake and at least one 3 m wave. Although the first floor apartments and the basement show significant flooding damage, the upper floor apartments were intact and were available to be reoccupied after the residents cleaned up broken items inside them. Behind the 10-story apartment buildings are about a dozen homes and shops which are constructed of lightweight materials, such as wood and corrugated metal. Little damage occurred to these structures suggesting that they may have been sheltered from a direct impact from the tsunami by the 10-story apartment buildings shows significant damage to smaller structures much further inland (Figure 13.16). Severe damage to homes in central Dichato illustrate the effects of the tsunami with a wave depth of about 5 meters (Figures 13.17 and 13.18).

Figure 13.14 Pre/Post Imagery of Dichato (S36.548°, W72.942°)

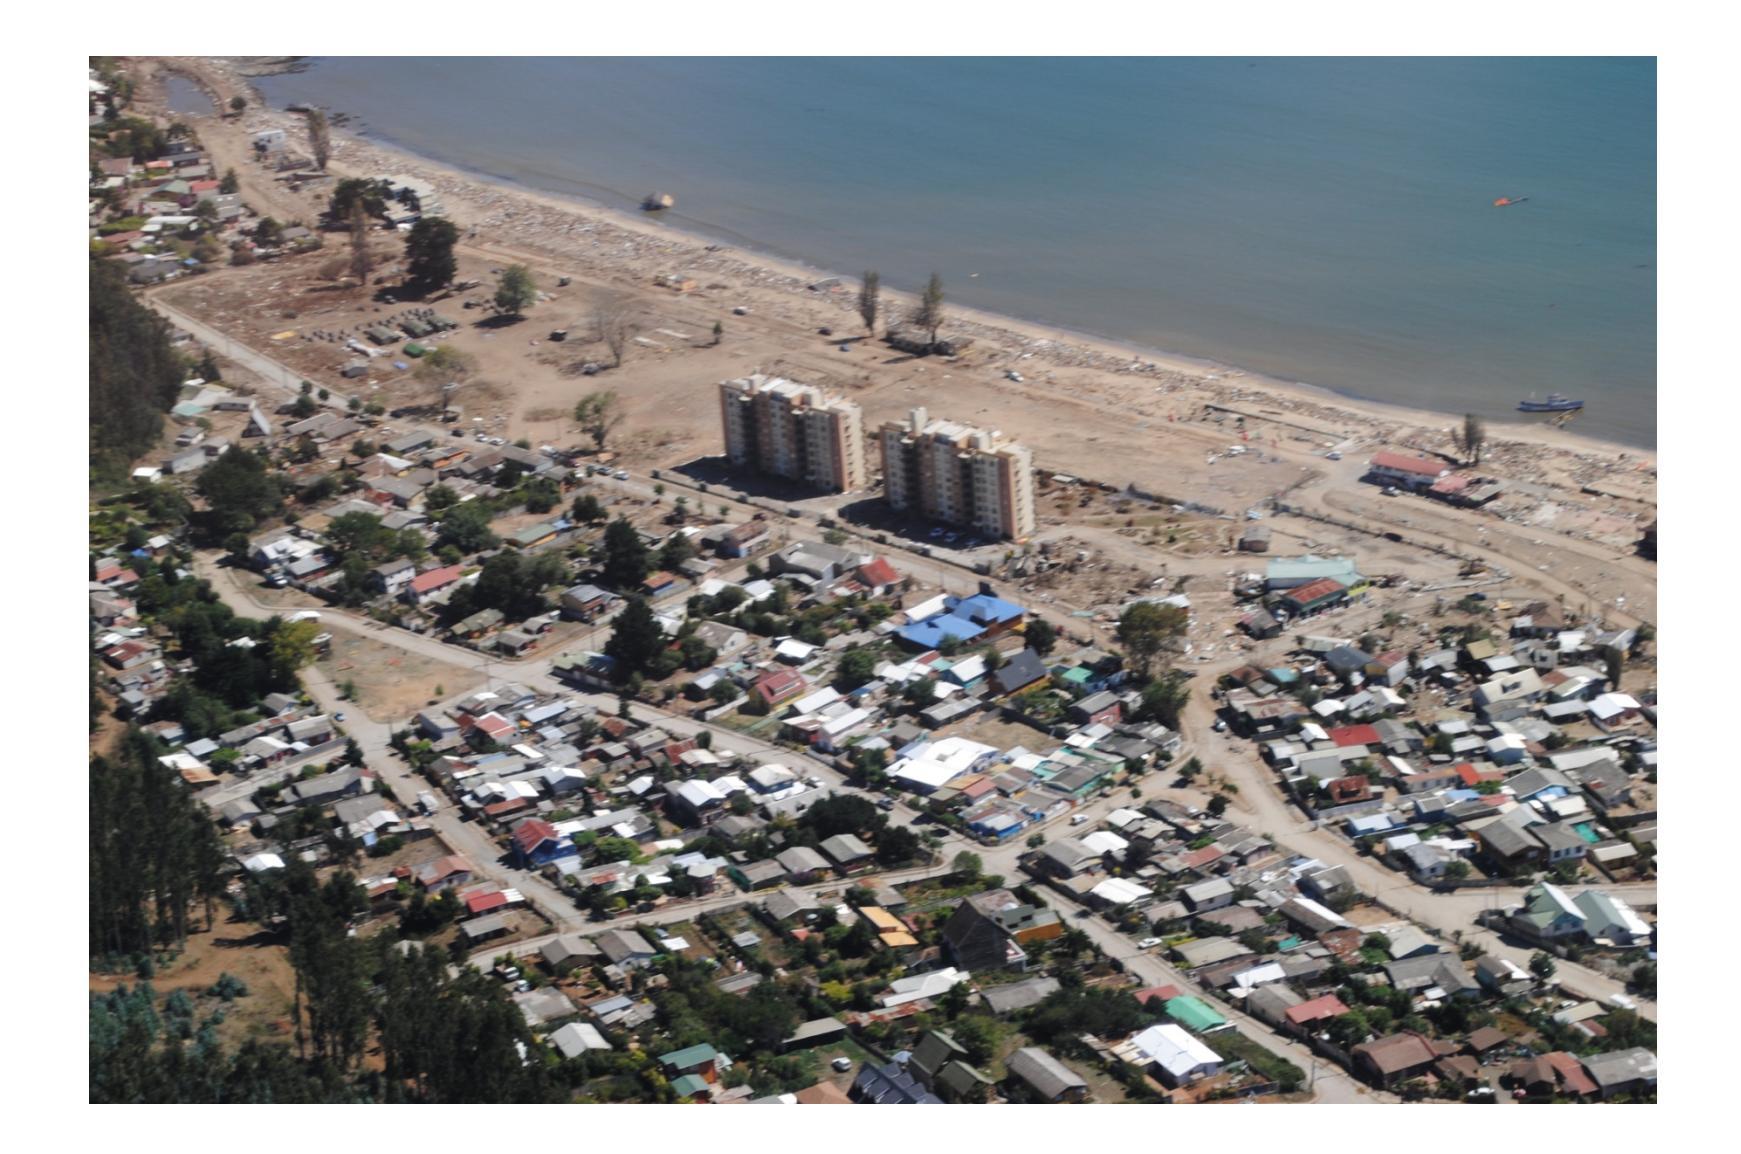
Figure 13.15. Aerial reconnaissance photograph of high-rise apartment buildings (S36.548°, W72.942°)

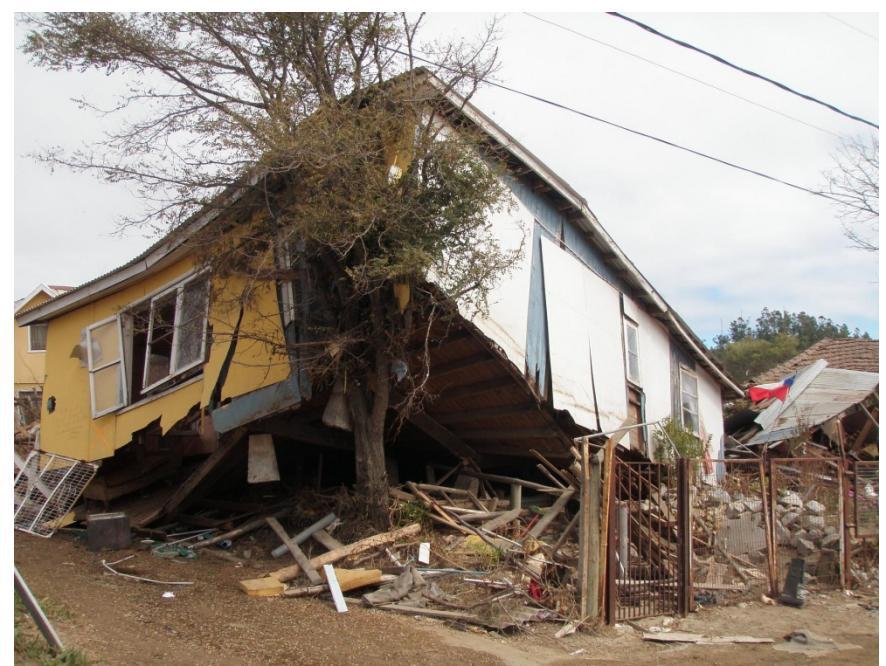
Figure 13.17 The home in this picture was lifted by the 3rd wave and dropped onto a tree (S36.547°, W72.939°, 2010 hrs, 3/13/10).

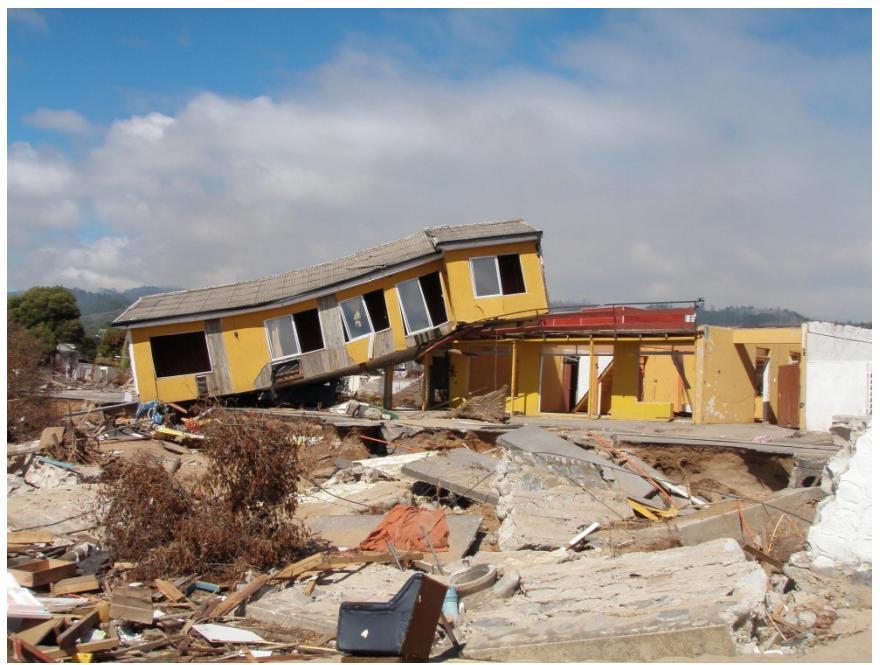
Figure 13.18 The tsunami wave removed the lightweight wooden second story of this house from its more substantial masonry and concrete block first floor (\$36.546°, W72.935°, 2010 hrs, 3/13/10).

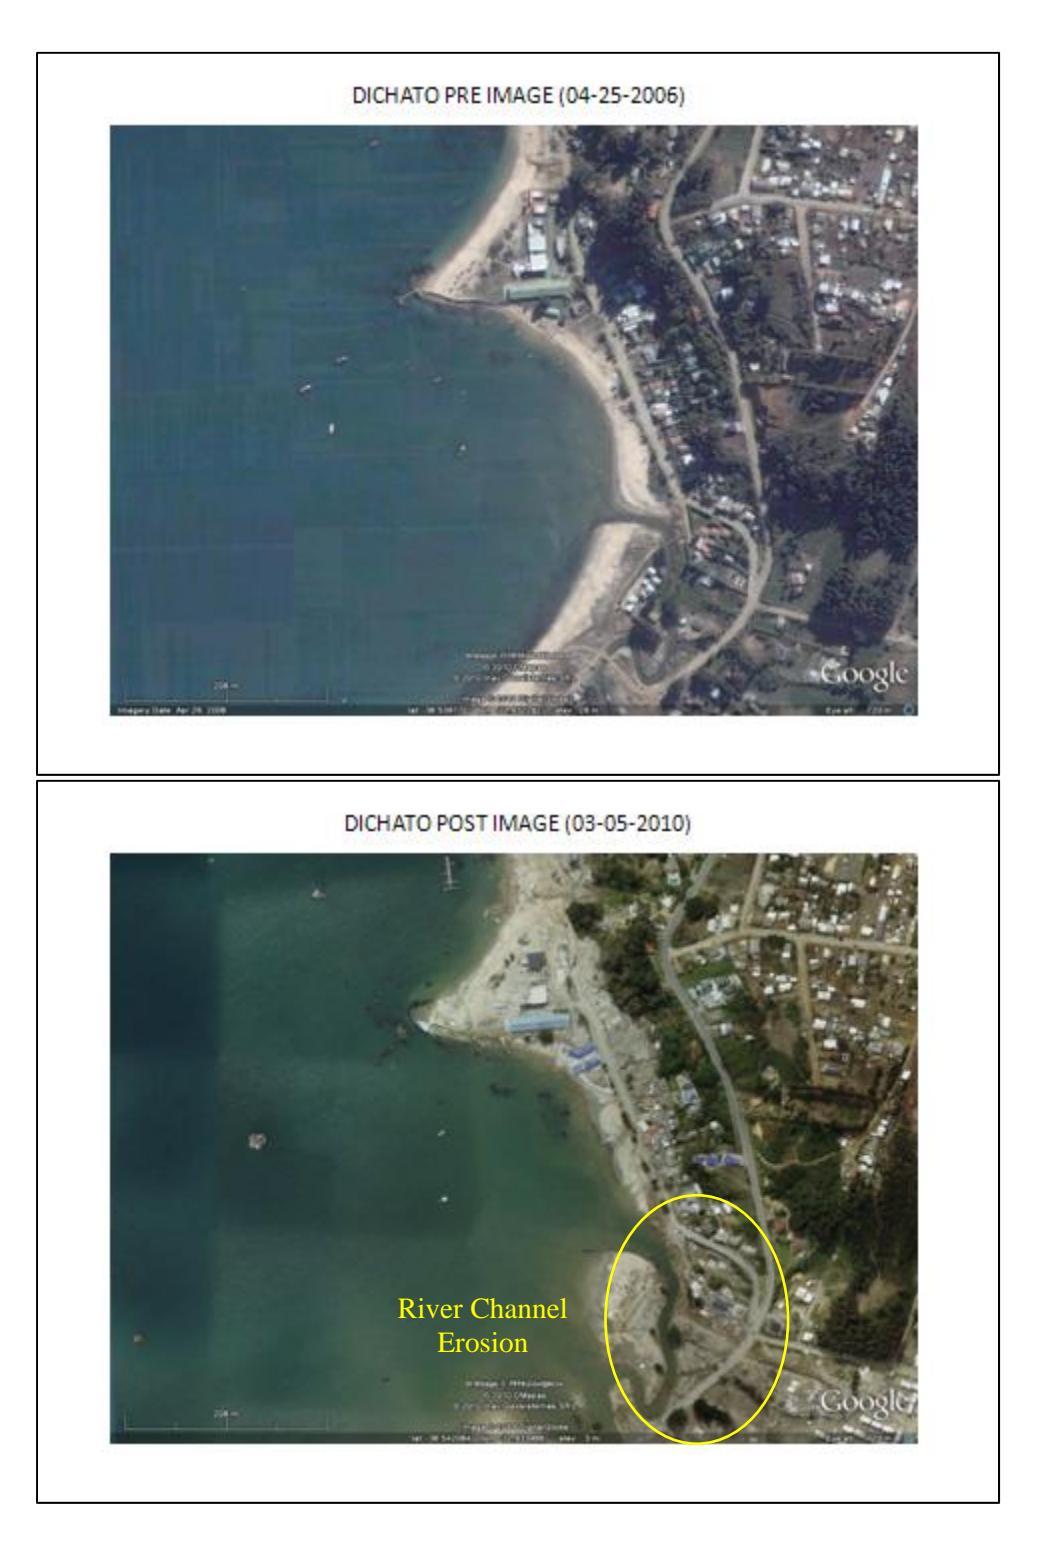
The course of the Rio Dichato has been altered as shown in Figure 13.17. Prior to the earthquake, the river meandered through a neighborhood with gardens abutting the river, before exiting to the bay at the east end of town. The tsunami's greatest water depth -- and presumably the most destructive erosional power -- was in the area of this meander. The tsunami removed the soft sediments that formed a barrier between the river and the bay and the meander has been eliminated. Now, the mouth of the river is about 100 meters southwest of its former location. A delta is forming where a neighborhood used to be. The area of the former river bed is now a low-lying mudflat, which floods at high tide.

Figure 13.17 Pre/Post Imagery of Dichato (S36.541°, W72.933°)

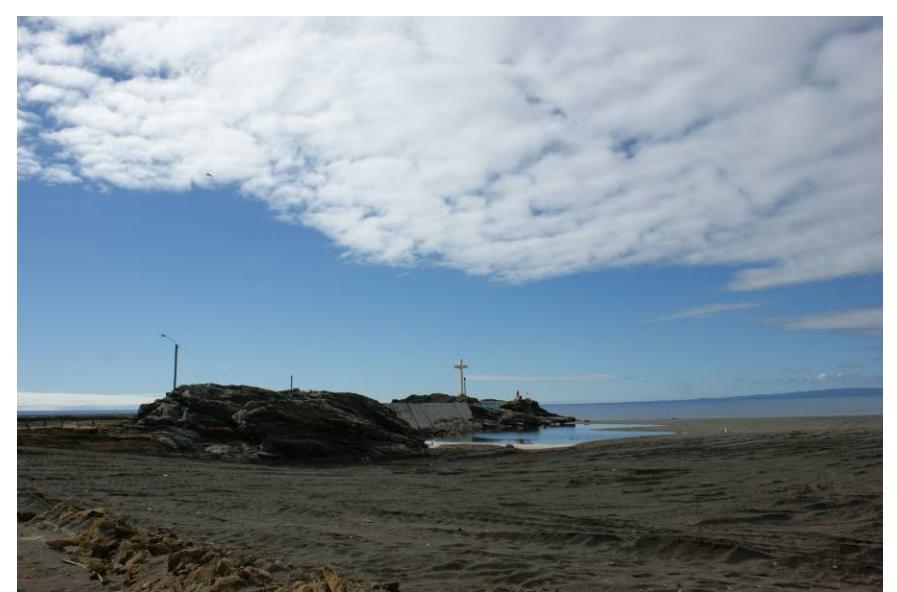
Figure 13.20. Roca San Pedro, a prominent landmark in Curanipe, was almost entirely submerged by the tsunami says one local resident. Only the cross remained above the water (S35.8436°, W72.6390°, 03/17/2010).

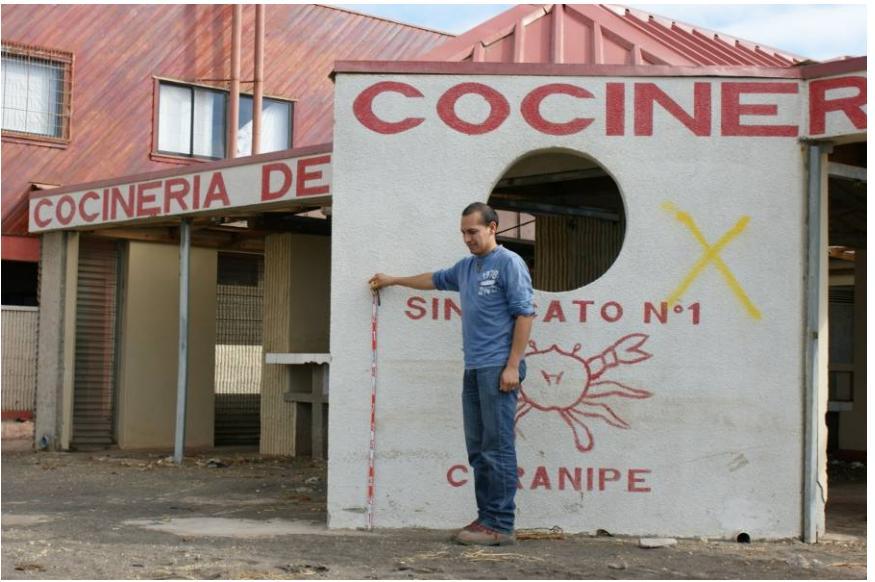
Communities we visited along the coast between Curanipe and Constitución were particularly hard hit by tsunami inundation. At Curanipe two local women we interviewed reported that the tsunami came from the north and noted that much of the sand had been removed from the beach, possibly due to erosion by the tsunami. Emilia Sagado Alveal, a Curinape resident, said she witnessed the first wave arrive about 10 minutes after the earthquake. She remembers three waves in all and the water nearly covered the Roca San Pedro leaving only the cross on top above water (Figure 13.20). Alveal also indicated that geographers from the Universidad de Catolica had surveyed the area and estimated average tsunami wave heights of 6.5 m. Water stains on the wall of a restaurant near the beach indicate that minimum flow depths at this site were about 1 m (Figure 13.21).

Figure 13.21. Watermarks on a restaurant in Curanipe indicate minimum tsunami flow depths of 1 m at this location (S35.8436°, W72.6365°, 03/17/2010).

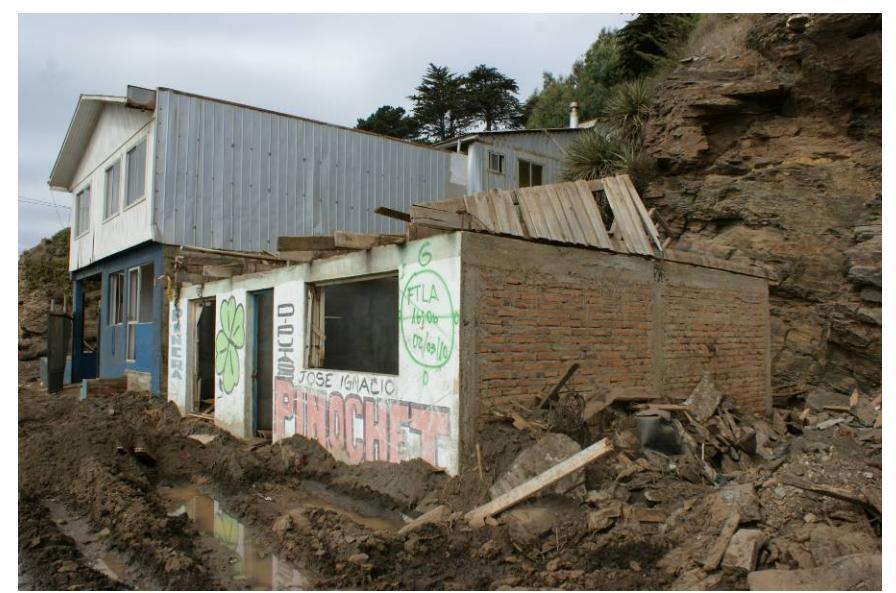
At El Torreon, a small beach community south of Pelluhue, the tsunami destroyed a number of houses and caused at least 5 fatalities (Figure 13.22). Witnesses interviewed included Chilean Army Lieutenant Alfredo Diaz and local residents of the community. One resident reported that the earthquake seemed to last for 5 minutes and the first tsunami wave arrived about 30 minutes later at 4:05 am. Some witnesses noted that the ocean did not recede after the earthquake and they assumed no tsunami was coming until the first wave arrived. A total of 7 to 13 waves continued to arrive over the next 4 hours, according to different accounts. The flow depths remained high until 8 am when the water level started to retreat. At one house that partially survived the tsunami, water marks indicate minimum flow depths between 1.6 and 2.2 m (Figure 13.23). The brother of the owner of the house said debris carried by the tsunami broke the windows on the first floor not the wave and also noted that water did not enter the second floor.

Figure 13.22. The blue and white two-story house in the beach community of El Torreon was heavily damaged by the tsunami and all but the walls of the adjacent vacation house was destroyed. The tsunami arrived at 4:05 am, about 30 minutes after the earthquake, and the water remained high for four hours when it started to retreat around 8 am (S35.8215°, W72.5990°, 03/17/2010).

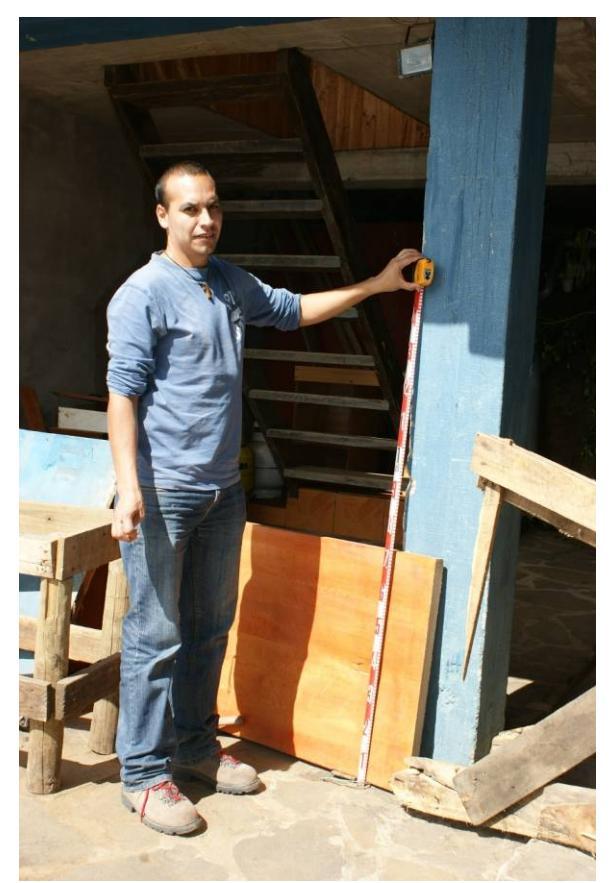
Figure 13.23. On this post inside the first floor of a beach front house in El Torreon, a small community south of Pelluhue, visible lines mark the water height 1.6 m above the ground providing a minimum estimate of the tsunami flow depth at this location (S35.8214°, W72.8215°, ~1556 hrs on 03/17/2010).
