13.0 TSUNAMI EFFECTS

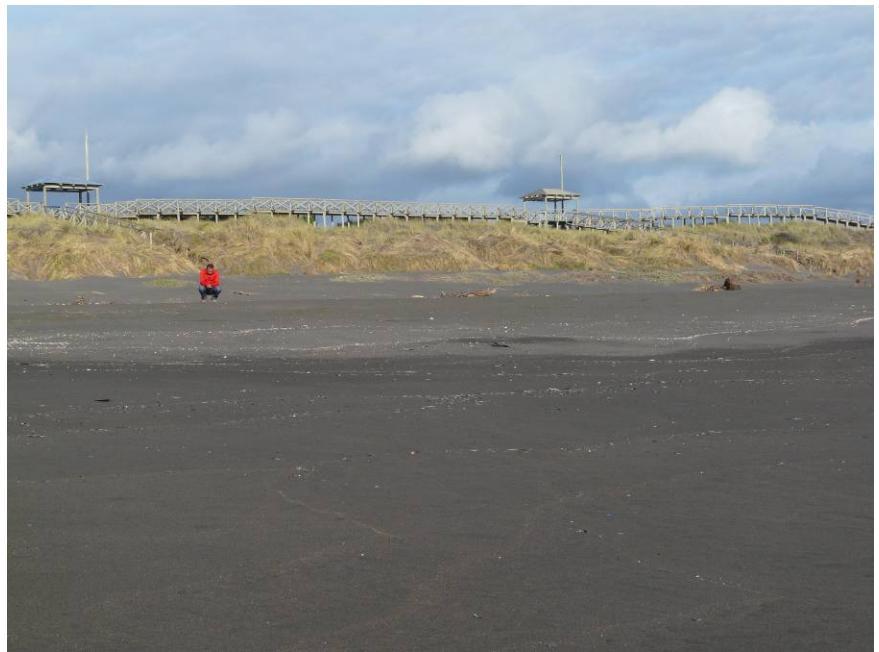
In communities between Pelluhue and Constitución, buildings in low-lying areas within a few hundred meters of the coast sustained heavy damage. For example, beach front houses in the small fishing village of Los Pellines were severely impacted as was a derelict wood pulp processing plant in Las Cañas. However, in other areas coastal dunes appeared to present barriers to tsunami inundation preventing more extensive damage. In Reserva Nacional Frederico Albert near Chanco, 3- to 4-m-high dunes on the beach apparently prevented the tsunami from penetrating further inland (Figure 13.24).

Figure 13.24. The tsunami carried wood and debris about halfway up these dunes near Chanco but left the walkway along the dune crest undamaged (S35.739239° W72.571586°, 1829 hrs on 03/17/2010).

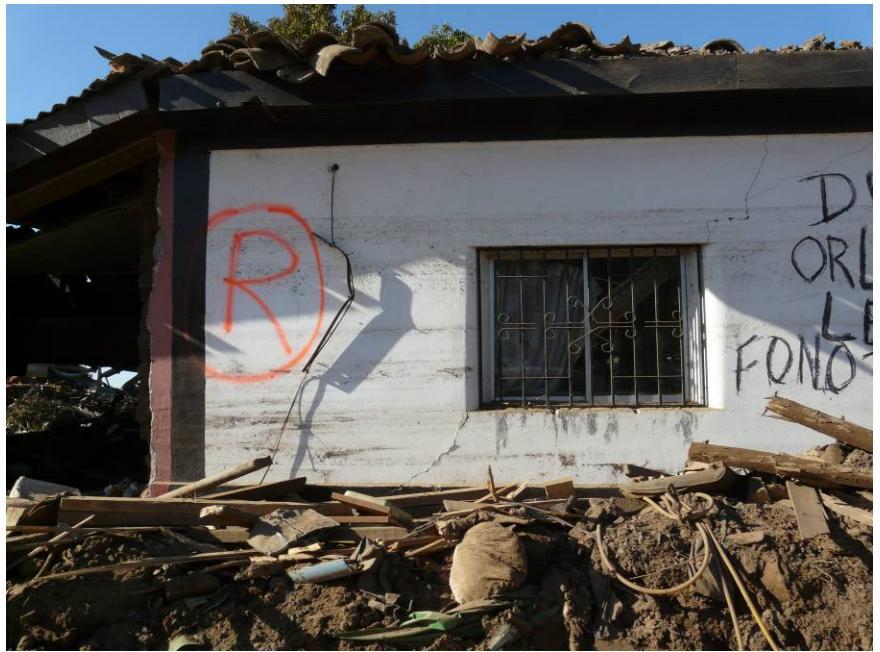
Figure 13.25. Watermarks on damaged buildings in Constitución indicate tsunami flow depths reached at least 2 m along the waterfront on Calle Blanco (\$35.336 W72.403, 1757 hrs on 03/15/2010).

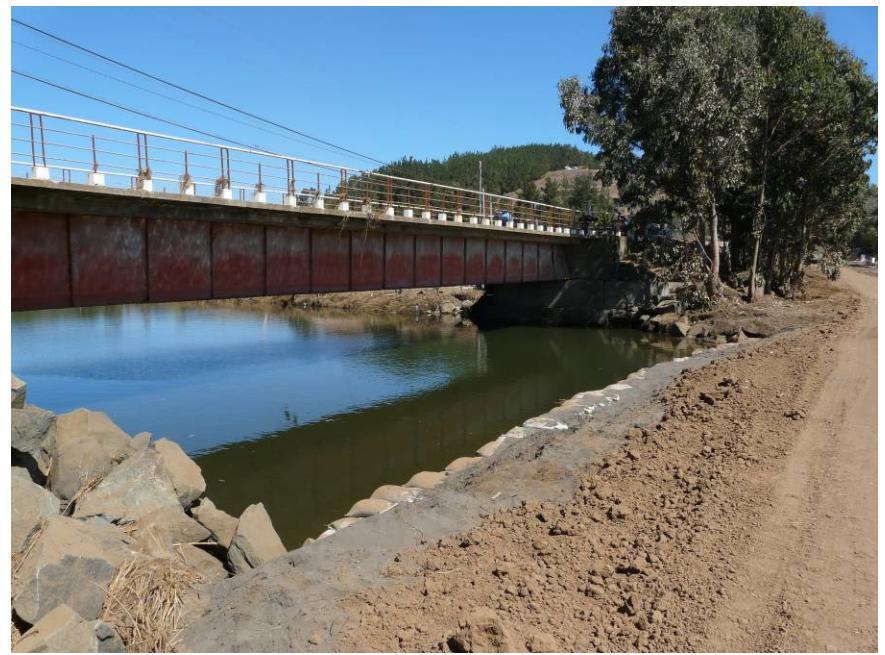
Communities between Iloca and Bucalemu may have been more severely impacted by the tsunami because this region of the coast may have dropped vertically during the earthquake (see evidence in Section 4). Evidence of high flow depths comes from debris caught in the railings of a bridge damaged by the tsunami at Pichibudi. A temporary road had been constructed over the river to detour around the bridge. Grass debris in the bridge indicates minimum flow depths of 5.2 m above the river (Figure 13.26). Local residents encountered at the bridge attest the wave topped 6.6 m and report of a bus that was carried 80 m inland.

Figure 13.26. Debris clinging to the railing of this damaged bridge in Pichibudi suggests minimum tsunami flow depths reached 5.15 m. Local residents reported flow depths of 6.65 m above the creek. Anecdotal accounts suggest the tsunami moved a bus 80 m up the creek valley. Tsunami damage along coast becomes heavier toward the south of this site in Iloca (S34.880055° W72.155819°, 1515 hrs on 03/15/2010).

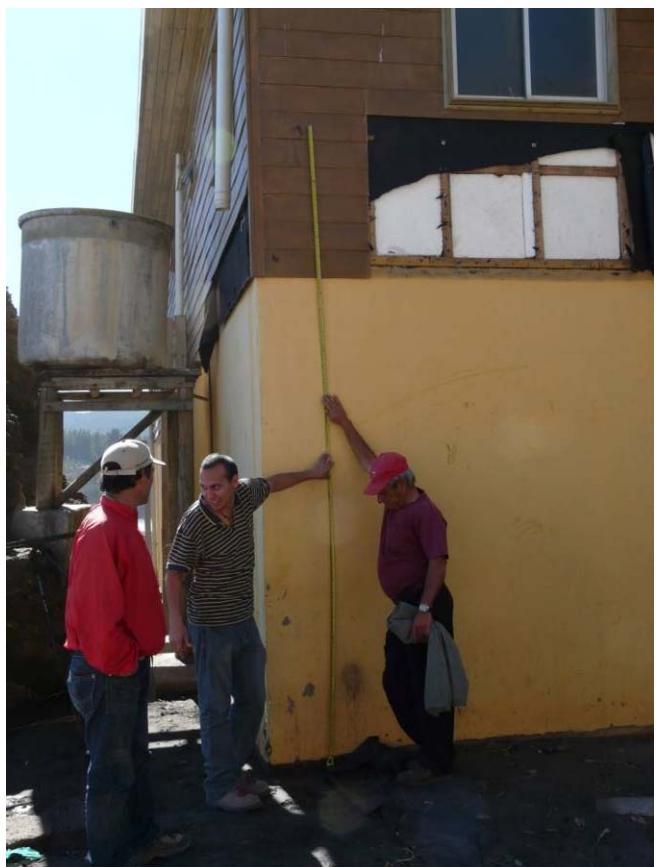
Figure 13.27. Damaged siding on this building suggests tsunami flow depths reached at least 3.5 m at the west end of Bucalemu (S34.640097° W72.044194°, 1130 hrs on 03/15/2010).

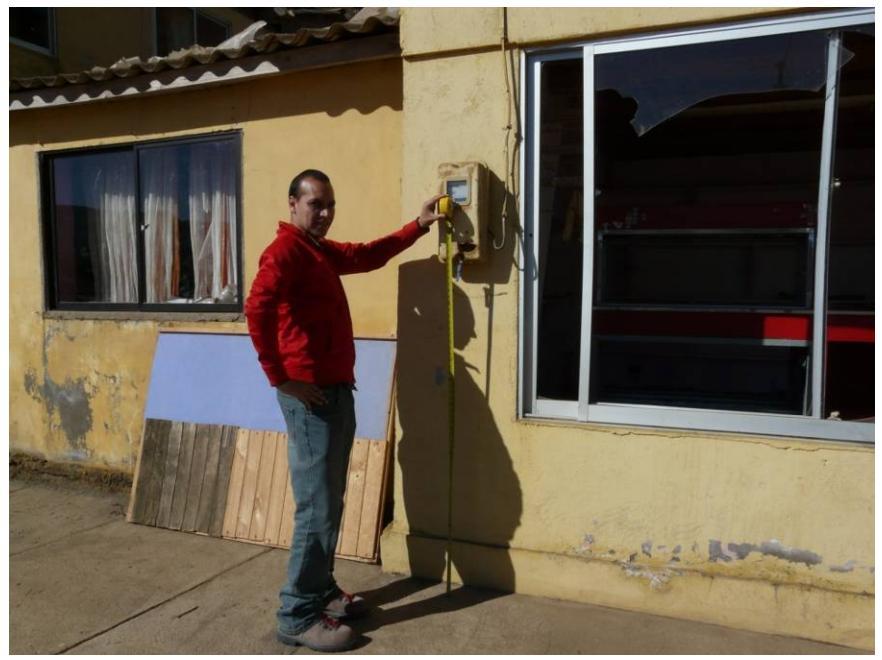
Figure 13.28. Tsunami flow depths reached a minimum of 1.5 m along the waterfront in Bucalemu (S34.641882° W72.043158°, 1051 hrs on 03/15/2010).

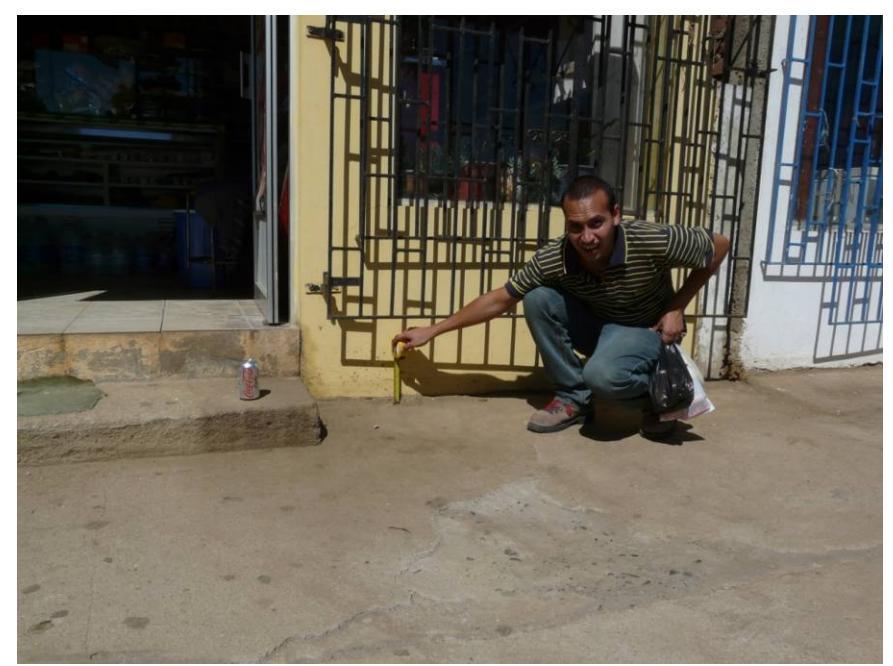
Bucalemu was clearly harder hit by the tsunami than Pichilemu. Residents say the wave was ~ 2 m deep in the valley at the river mouth. Flow depth measurements show the highest water levels in the west end of town decreasing toward the east. Damaged siding at a restaurant on the waterfront suggests wave heights of 3.5 m or more near the beach (Figure 13.27). At La Estrella, in a small sandwich shop near the lagoon, water marks on the building and in the interior of the store indicate flow depths of 1.35 to 1.5 m (Figure 13.28). At the east end of Bucalemu, water marks on buildings indicate flow depth of 0.1 m or less near the limit of inundation (Figure 13.29).

Figure 13.29. Tsunami flow depths at the east end of Bucalemu reached 0.1 m or less near the landward limit of tsunami inundation (S34.642586° W72.037371°, 1228 hrs on 03/15/2010).

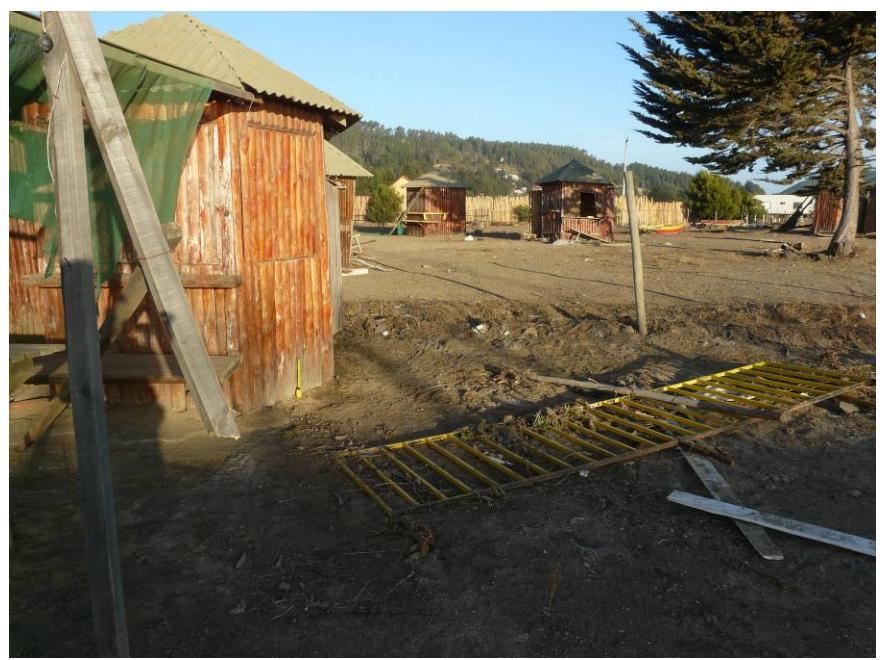
At Puente Cahuil, a bridge over Rio Est Nilahue, we investigated tsunami impacts at a campground with small wooden kiosks and a fence that appear to have been moved around by high water. Near the first intact fence and kiosk evidence of high water offers measurements of tsunami flow depth near the probable upper limit of inundation (Figure 13.30). Dead and dried vegetation strewn in wooden lattice fencing along with what appears to be a water mark on the adjacent kiosk indicate water depths of 0.3 to 0.4 m. Between this location and the river, small cabanas or kiosks appear to have been transported ~30 m landward. A yellow metal fence has been pushed over in the direction of a wave flowing inland.

Figure 13.30. At Puente Cahuil tsunami flow depths reached a minimum of 0.3 to 0.4 m and pushed kiosks at a campground several tens of meters landward (S34.479276° W72.017610°, 1922 hrs on 03/14/2010).

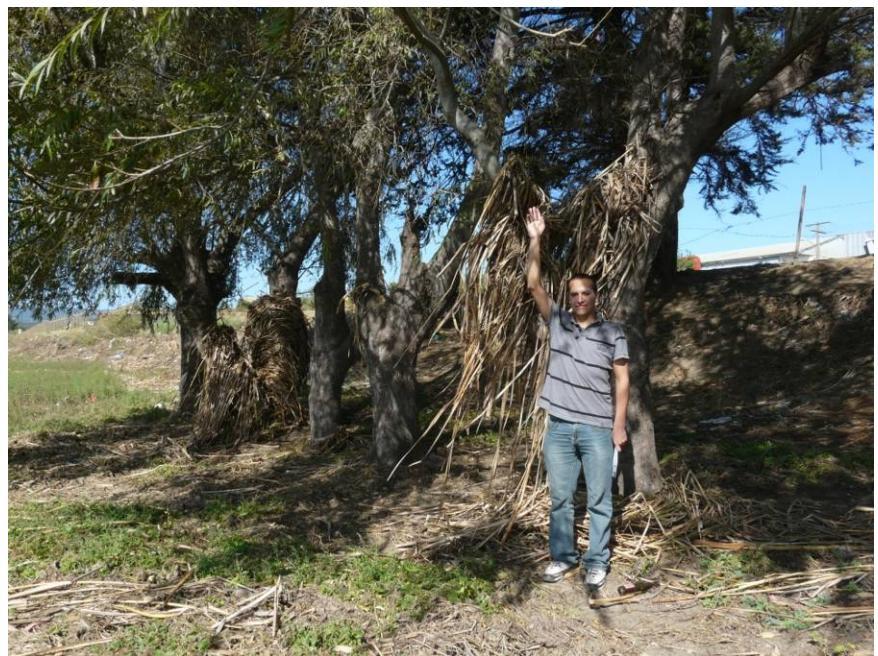
Figure 13.31. Debris suspended in trees along a lagoon north of Pichilemu indicate tsunami flow depths exceed 3 m at this site (S34.385195° W71.999901°, 1619 hrs on 03/14/2010).

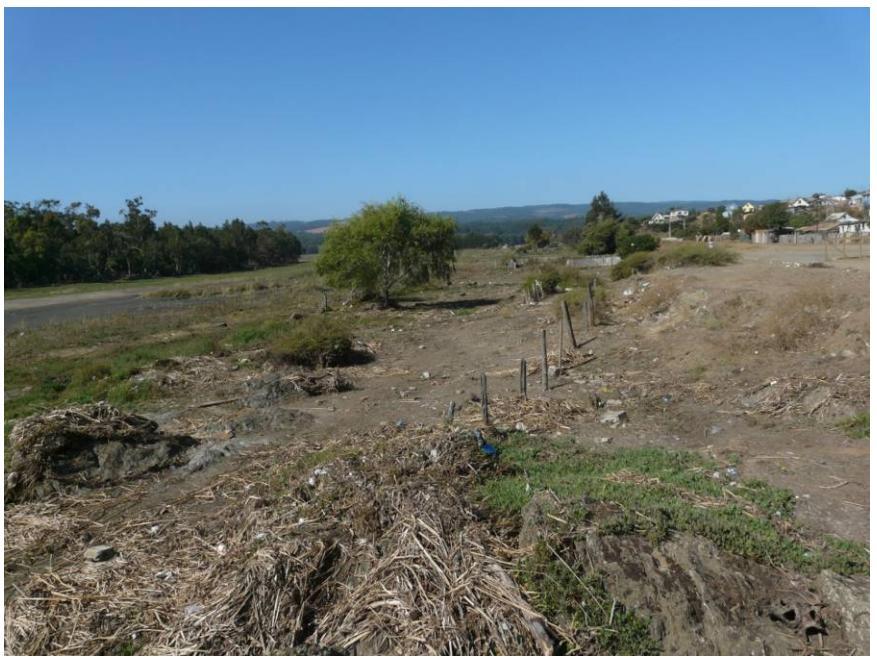
The impact of the tsunami in Pichilemu was considerably less relative to the severe damage observed at locations to the south. Residents report that at least 3 waves arrived beginning about 10 minutes after the earthquake. The first two waves were slow rises of water level, the third wave was the largest. Other witnesses noted that there was no receding wave at Playa Hermosa and Playa Infernio. The tsunami did fill a small lagoon north of Pichilemu, evident as you enter the town, then the water flowed out. Debris dangling from limbs of trees east of the lagoon indicate minimum flow depths of 2.5 to 3 m (Figure 13.31). Tracing the wrack line of debris inland showed that tsunami inundation in the lagoon extended several hundred meters east of the beach (Figure 13.32).

Figure 13.32. Tsunami inundation north of Pichilemu was restricted to a small coastal lagoon, leaving stems of reeds, trash and other debris near the landward limit of inundation. The "wrack line" of debris indicates the tsunami reached the fence in the distance but probably did not overtop the higher ground in the right of the photo (S34.384558° W71.996936°, 1631 hrs on 03/14/2010).

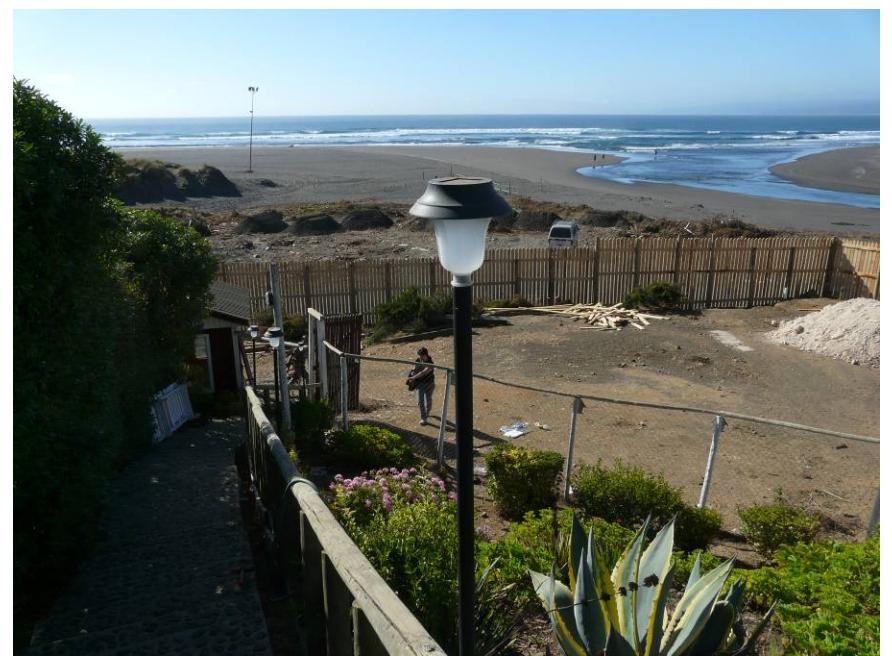
The daughter in law of the owner of Cabanas Gusman-Lyon testified that the height of the first wave reached about 1.5 m high on a chain-link fence near the beach and about the same height in a small shed a few meters away (Figure 13.33). She said the first wave arrived between 3:30 and 4 am in the morning.

Figure 13.33. Below Cabanas Gusman-Lyon, a local lodging along the water front in Pichimelu, tsunami flow depths reached about 1.5 m, destroyed a wooden fence (in this photo the fence has been replaced by a new one) and washed away cars in the parking area (S34.384288° W72.003774°, 1711 hrs on 03/14/2010).
