9.0 EFFECTS OF GROUND FAILURE ON BRIDGES, ROADS, RAILROADS, AND LIFELINE SYSTEMS

9.1 Introduction

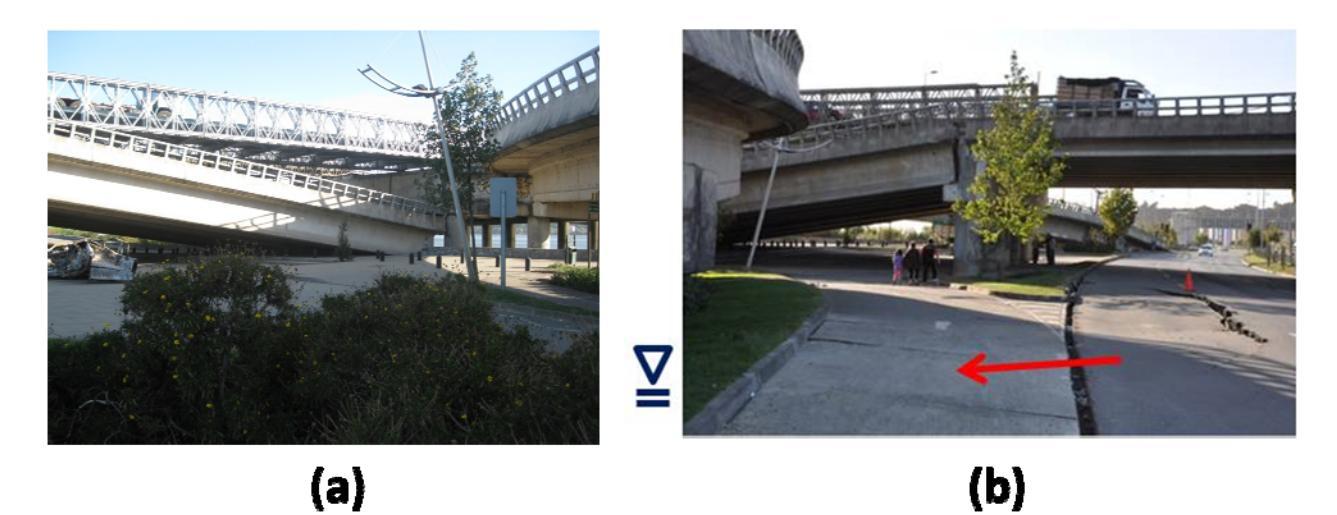
The Llacolén Bridge in Concepción was constructed in 2000 and spans 2,160 m across the Bio Bio river supporting four lanes of vehicular as well as pedestrian access to downtown Concepción (Figure 9.1). During the earthquake the north approach (S36.830108°; W73.067991°) suffered deck unseating and lateral spreading shore (Figure 9.2). Ground damage at this approach was observed to extend inland into the southbound traffic lane of Calle Nueva road and south below the bridge's exit ramp continuing along a pedestrian walkway (Figure 9.4). Calle Nueva parallels the coastline and runs under the approach to the bridge. The lateral spreading ground resulted in unseating of the west and east bound traffic support deck (Figure 9.5). Flexural cracks on the river-side face of the 1.5 m diameter support columns were observed near the ground surface typically tightly spaced at approximately 0.10-0.20 m on center (Figure 9.6). The distribution of flexural cracking was more severe for those columns supporting the unseated deck, however, all columns at the north shoreline support observed flexural cracking at their construction joint (between 2-2.5m above ground surface). Ground settlement of 0.25-0.30 m was also noted to surround each of the exit ramp bents (Figure 9.7).

Figure 9.5. Deck unseating at Llacolén bridge in Concepción. (note the temporary deck supporting approach traffic). View South (S36.829707°, W73.068220°, 1809 hrs on 3/14/2010) and (b) view north (S36.830380°, W73.067541°, 1911 hrs on 3/14/2010).

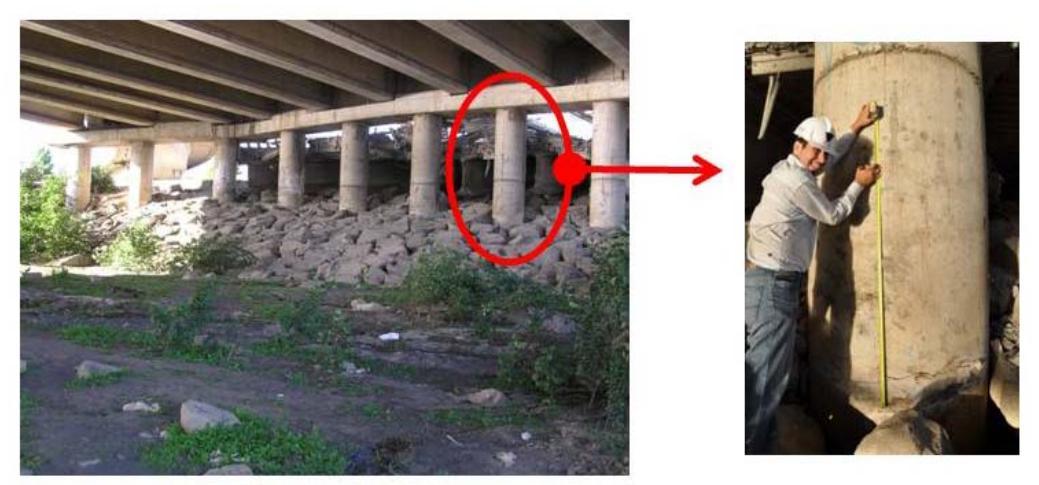
Figure 9.6. Substructure of the north approach at the damaged Llacolén bridge in Concepción showing the unseated deck in the foreground. Flexural cracking of the column supports was observed at ground level and extending to the construction joint (2-2.5m above groun

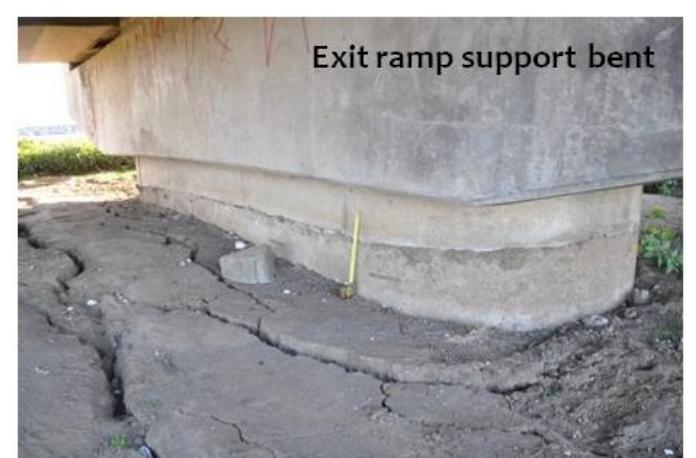
Figure 9.7. Ground settlement surrounding an exit ramp support bent at the Llacolén bridge in Concepción (S36.830380°, W73.067541°, 1901 hrs. on 3/14/2010).

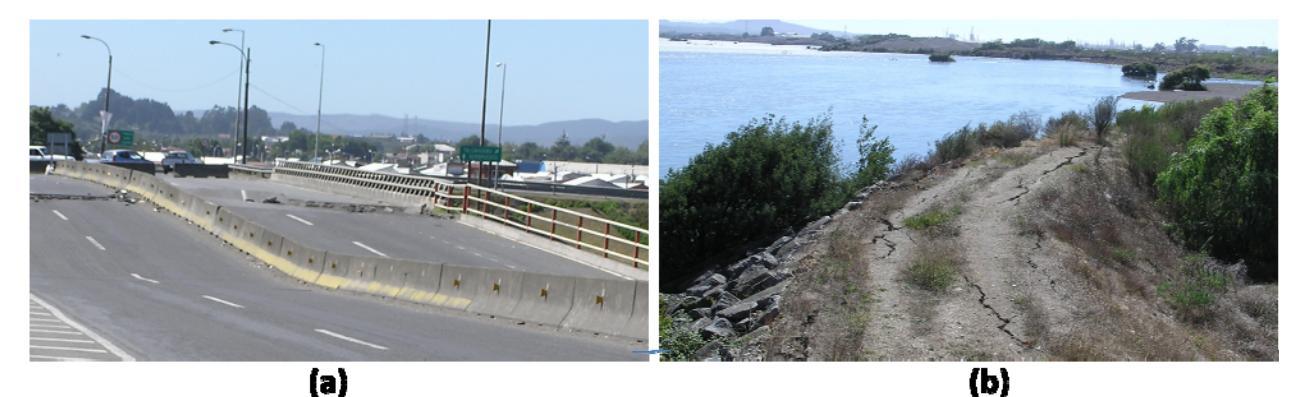
Figure 9.10. Juan Pablo II northeast approach: (a) Settlement of bridge deck near bridge approach (S36.815900° W73.084064°; 1455 hrs on 3/15/2010), (b) Lateral spreading on northeast bridge abutment.

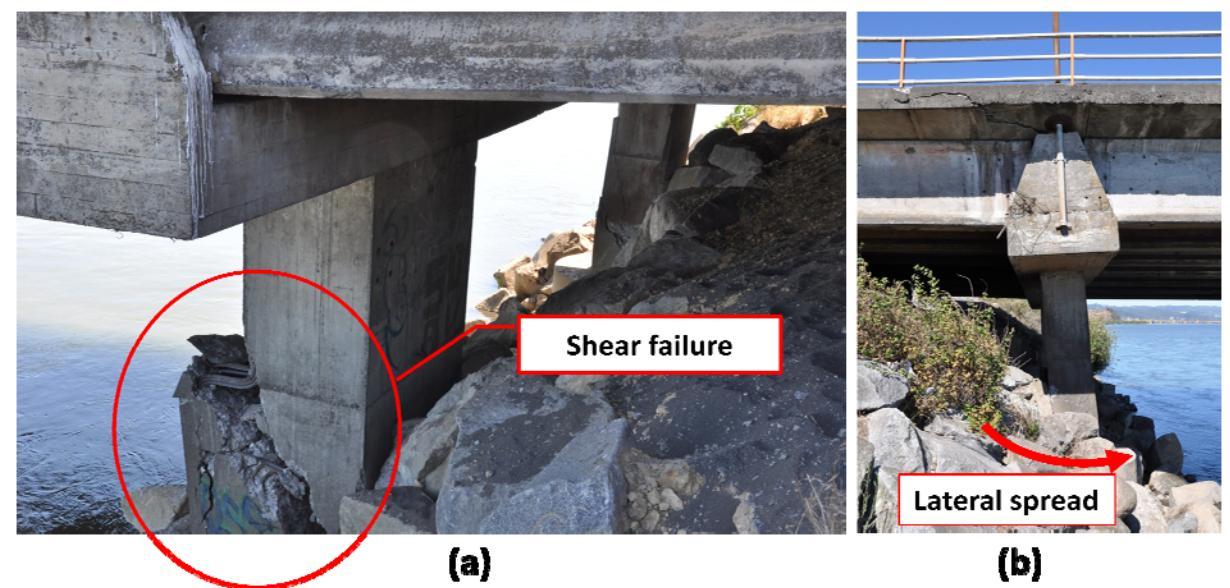
Column shear failure and significant displacements and rotation of the bridge bent were observed on the north-east approach Figure 9.11(a) shows shear failure of the column facing the bent's south side. The north column, shown in Figure 9.11(b), indicates evidence of tension cracks and rotation and also suffered shear failure. In contrast with the damage observed at the northeast approach to the bridge, the southwest approach suffered minor damage.

Figure 9.11. Juan Pablo II northeast approach: (a) Column shear failure (S36.816233 W73.084144°; 1528 hrs on 3/15/2010) (b) Rotation and lateral displacement of bridge bent (S36.816233° W73.084144°; 1530 hrs on 3/15/2010)

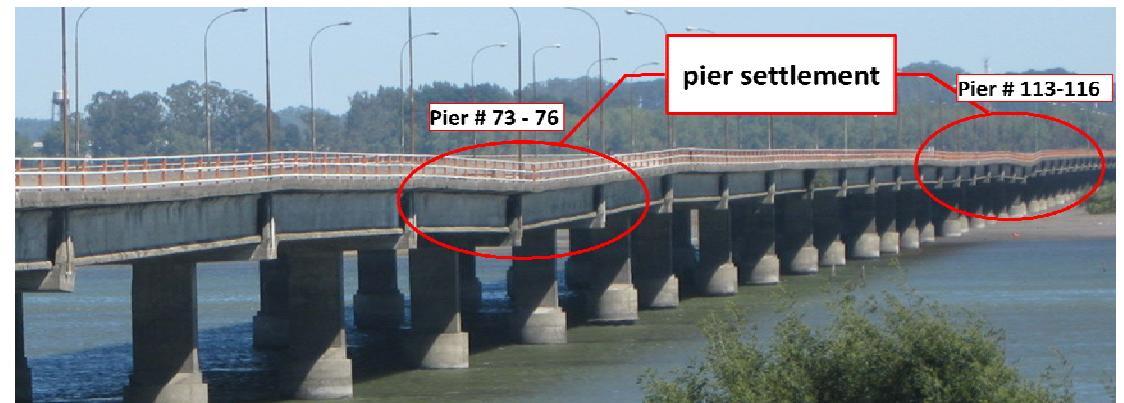
Settlements on the order of 0.50 m to 0.70 m were observed in piers #73-76 and piers #113-116 as indicated in Figure 9.13 (odd numbers for piers on the north side and even numbers for piers on the south side). The bridge deck accommodated these settlements with large vertical deformations and relatively minor damage of the asphaltic layer. This is observed in Figure 9.14(b). Settlements of piers #73, 75, 113 and 115 on the south side were larger than those of piers #74, 76, 114, and 116 on the north side indicating rotation of the bridge bents.

Figure 9.13. Juan Pablo II bridge - Pier settlements (S36.815122° W73.084369°; 1453 hrs on 3/15/2010)

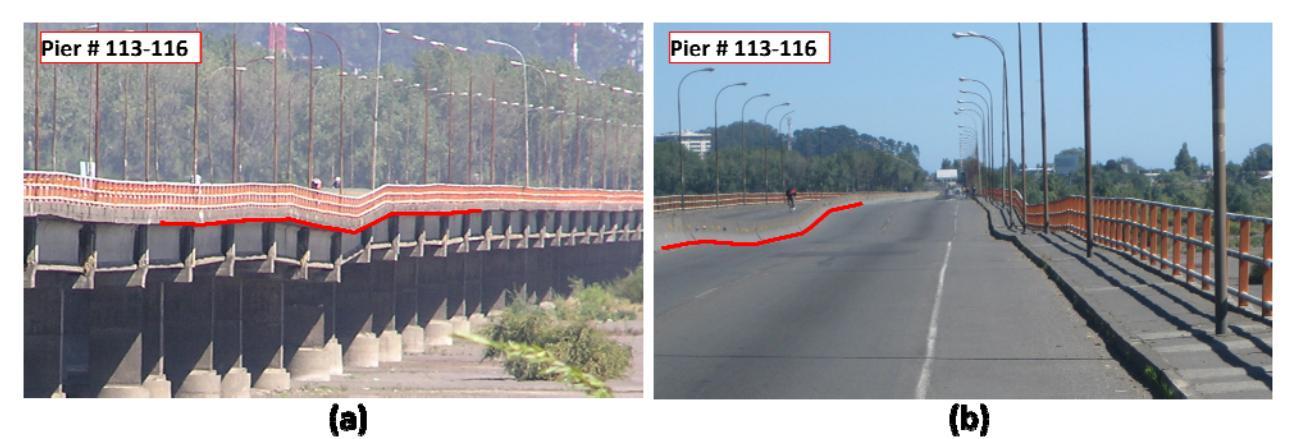
Noticeable pier settlements were observed at several locations along the length of the bridge. Vertical settlements appeared to be due to liquefaction of the soil near the pier foundations. Visual inspection of the surrounding soils indicated the presence of loose sands near the surface. Although the Bio Bio River was once navigable by ship up to the City of Nacimiento over-logging during the twentieth century has led to heavy erosion that has choked the river with silt and rendered it impossible to ship traffic. Near Concepción the river behaves as a meandering river with fine-grained material deposited on the floodplains. The GEER team identified several sand boils near the approaches (e.g. Figure 9.12a) and

Figure 9.14. Juan Pablo II bridge (a) View of bridge bent settlement (S36.826596° W73.094345° on 3/15/2010)(b) View of bridge deck settlement (S36.826596° W73.094345° on 3/15/2010)

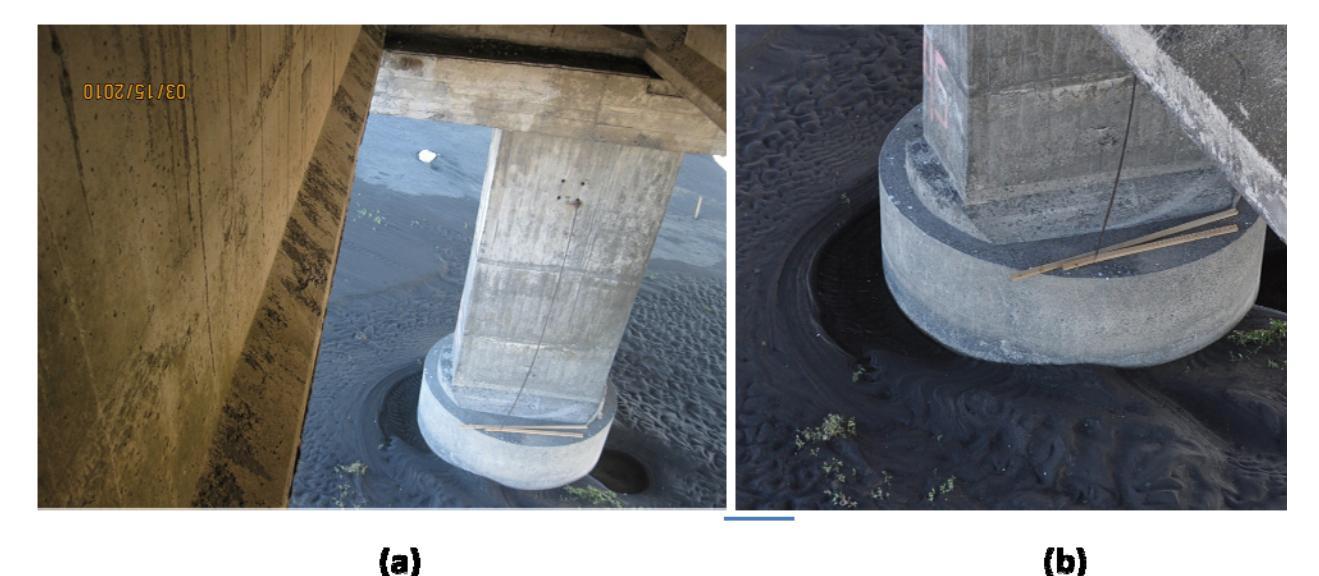
Although the GEER team had no direct access to the piers subjected to liquefaction and settlement it was possible to obtain some photos of the affected foundations. Figure 9.15(a) and (b) show a top view of a pier corresponding to pier group #113-116 and a close-up of the soil-pier interface. The figure shows the effects of liquefaction of the soil surrounding the pier with soil depressions and standing water covering an annular section around the pier. The soil in the vicinity of the pier shows evidence of water being brought to the surface and accumulation of sand probably ejected during the liquefaction event.

Figure 9.15. Juan Pablo II bridge–Evidence of liquefaction at piers subjected to settlements. (a) column and pier, (b) detail of pier and surrounding soil. (S36.826596° W73.094345° on 3/15/2010)

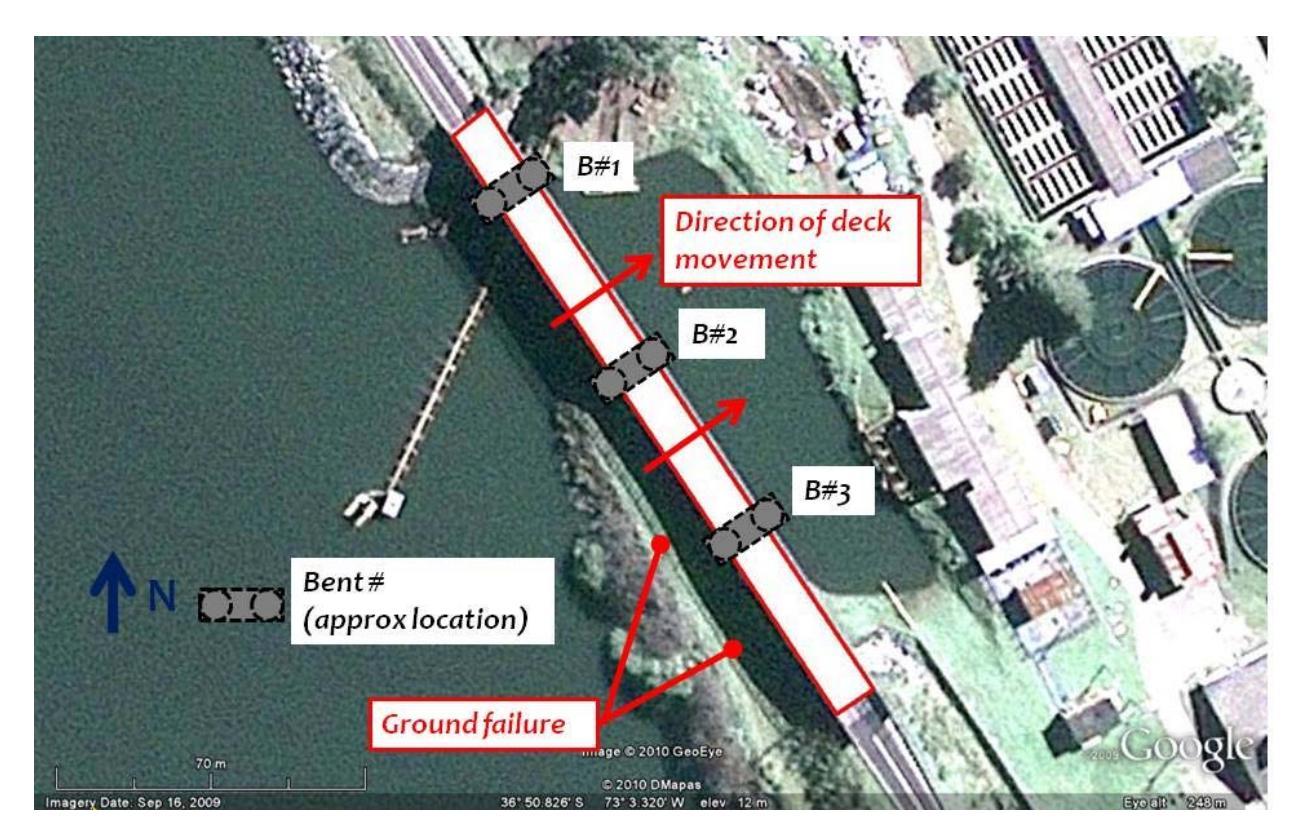
La Mochita bridge, shown in Figure 9.16 (S36.846841°; W73.055496°), is a 4-span concrete bridge supported by seat-type abutments at each end and two-column bents at the interior locations. At this site, ground failure occurred which induced transverse movement of the bridge superstructure.

Figure 9.16. Plan view of the La Mochita bridge in south Concepción describing observed damage (S36.846841° W73.055496°).

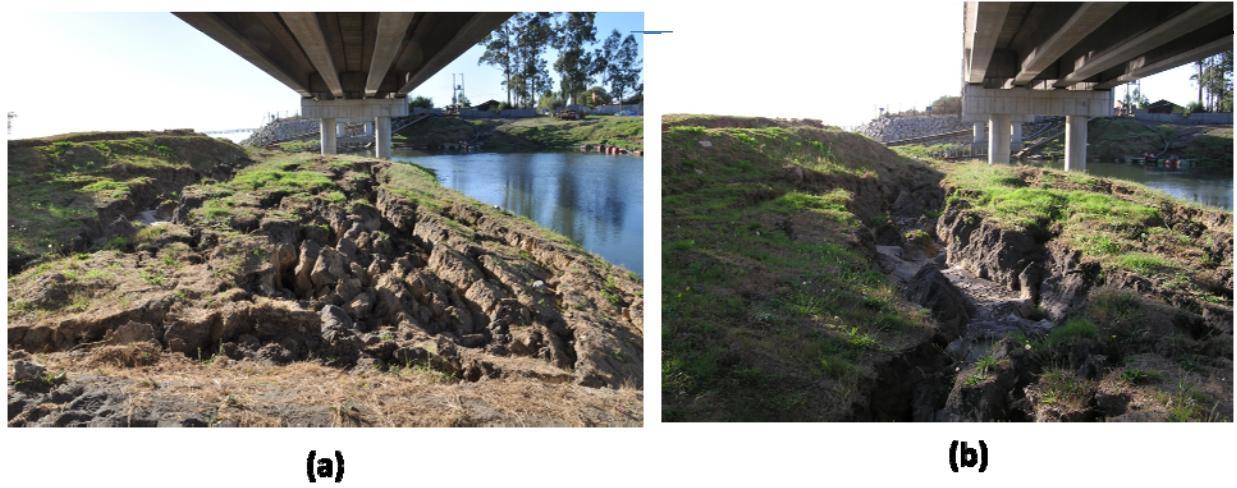
The bridge superstructure shifted transversely largely as a unit towards the east due to failure of the soil mass surrounding bents 2 and 3. Upon inspection of the ground at bents 2 and 3, significant spreadinglike failure towards the water treatment plant inlet water was observed (Figure 9.17). This failure may have been attribute to either a deep seated slope instability or liquefaction-induced lateral spreading mechanism. Sand boils below the bridge were observed near bent #2 and 3 (Figure 9.18). Follow-up site investigation is being conducted by GEER to more fully understand the characteristics of soils at the site and understand the underlying ground failure mechanism. Measurements taken by the team on March 15, 2010 indicated that the north end of the bridge deck shifted 0.5 m to the east relative to the approach fill, while the south end of the bridge shifted 0.9 m towards the east relative to the approach fill on that side. Bents 2 and 3 subassemblies (columns, bent cap and pile cap) were observed to rotate about the longitudinal axis of the bridge towards the east in consistent fashion with the deck movement. Rotations of bents 2 and 3 were measured as 2 and 4 degrees, respectively (Figure 9.19a). Bent 1 could not be accessed at the time of the teams visit, however, views from the land mass at bent 2 indicate that the deck moved independently of bent 1 (Figure 9.19b). In addition, ground failure was not immediately visible from this vantage point, or above the north shore of the bridge. Movement of the abutments was observed to be minimal, with the resulting damage to the superstructure largely attributed to the rotation of the bents (Figure 9.21). It is noted that movement of the bridge resulted in damage on both east and west end transverse shear keys of the interior bents (Figure 9.22). In addition, the approach road from the north observed significant ground movement and distress leading to the bridge (Figure 9.23).

Figure 9.17. Ground failure at the La Mochita bridge, (a) looking north at bent #3 (\$36.847389°, W73.055219°; 1831 hrs on 3/15/2010) and (b) looking north at bent #2 (\$36.847495°, W73.055027°; 1835 hrs on 3/15/2010)

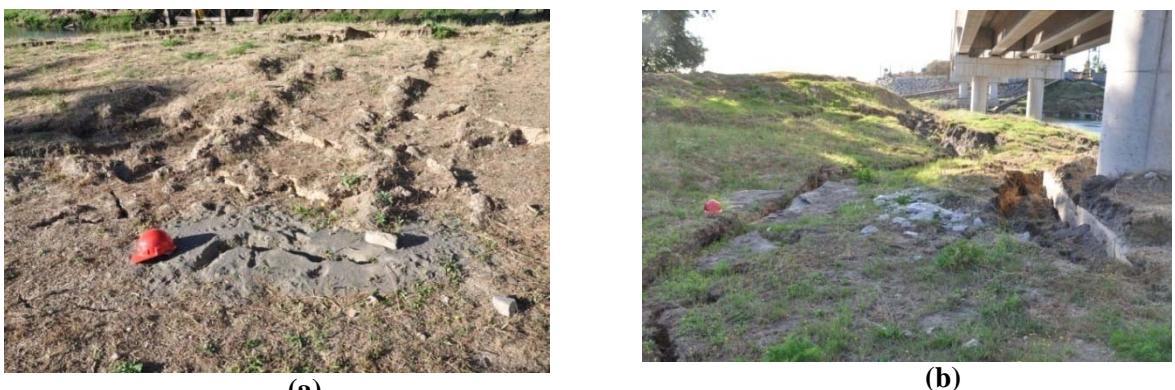
Figure 9.18. La Mochita bridge: (a) Sand boils observed below the bridge (S36.847456°, W73.055129°; 1830 hrs on 3/15/2010), and (b)View looking north (\$36.847453° W73.055225°; 1830 hrs on 3/15/2010)

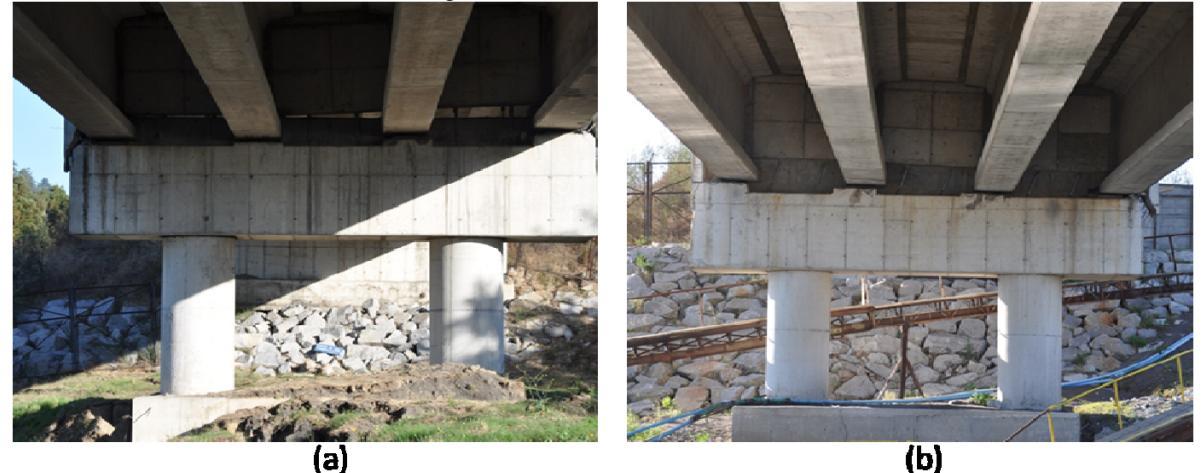
Figure 9.19. La Mochita bridge: (a) Rotation of bent #3 and surrounding ground failure at La Mochita bridge. View looking south (S36.847302°, W73.055151°; 1835hrs on 3/15/2010), and (b) Transverse shift of deck relative to bent #1. (the tilt of bent #1 could not be measured at the time of site visit). Ground failure surrounding bent #1 was not observed from this vantage point. View looking north (\$36.847049°, W73.055443°; 1835 hrs on 3/15/2010).

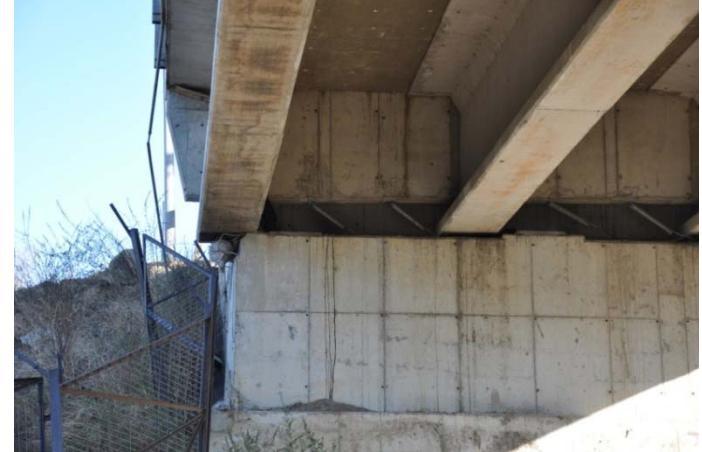
Figure 9.20. Transverse shift of deck relative to south abutment at the La Mochita bridge (S36.847547°, W73.054876°; 1834 hrs on 3/15/2010).

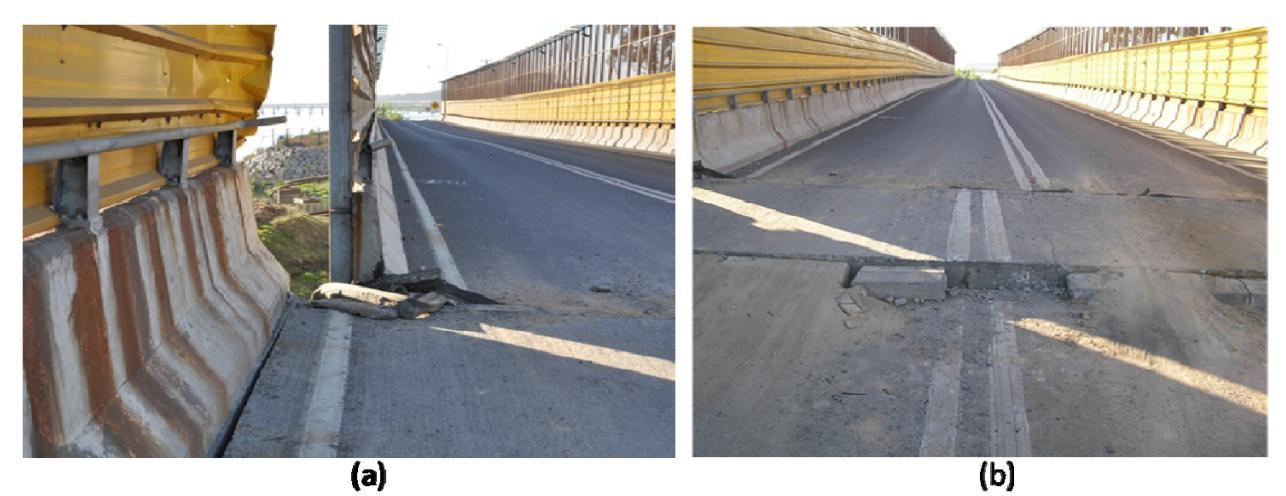
Figure 9.21. La Mochita bridge (a)Transverse gap developed between deck and south abutment. View looking north. (-36.847798°, -73.054797°; 1856 hrs on 3/15/2010), (b) Damage at the south abutment-road-deck interface due to transverse shift of the deck. View looking north. (S36.847761°, W73.054777°; 1856 hrs on 3/15/2010).

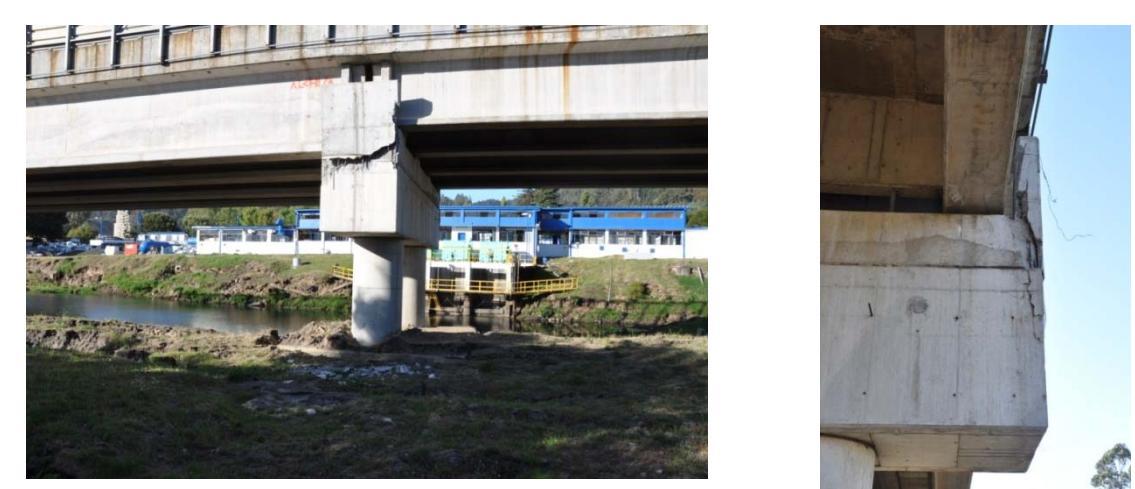
Figure 9.22. Damage to transverse shear keys at bent #3 due to movement of the La Mochita bridge (S36.847405°, W73.055084°; 1830 hrs on 3/15/2010).

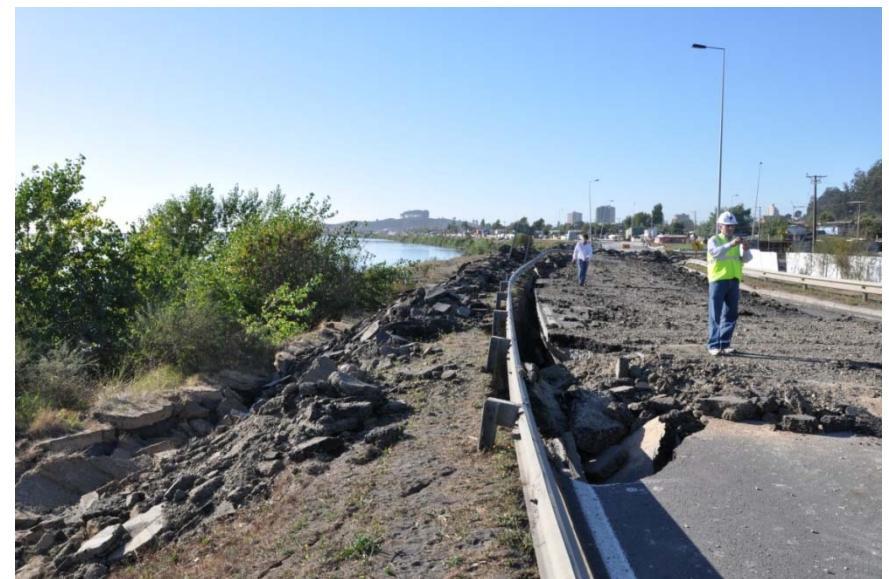
Figure 9.23. Damage to the approach road north of the La Mochita Bridge (S36.846473°, W73.055881° on 3/15/2010). View looking north. The Bio Bio river is shown on the left (west) of the view.

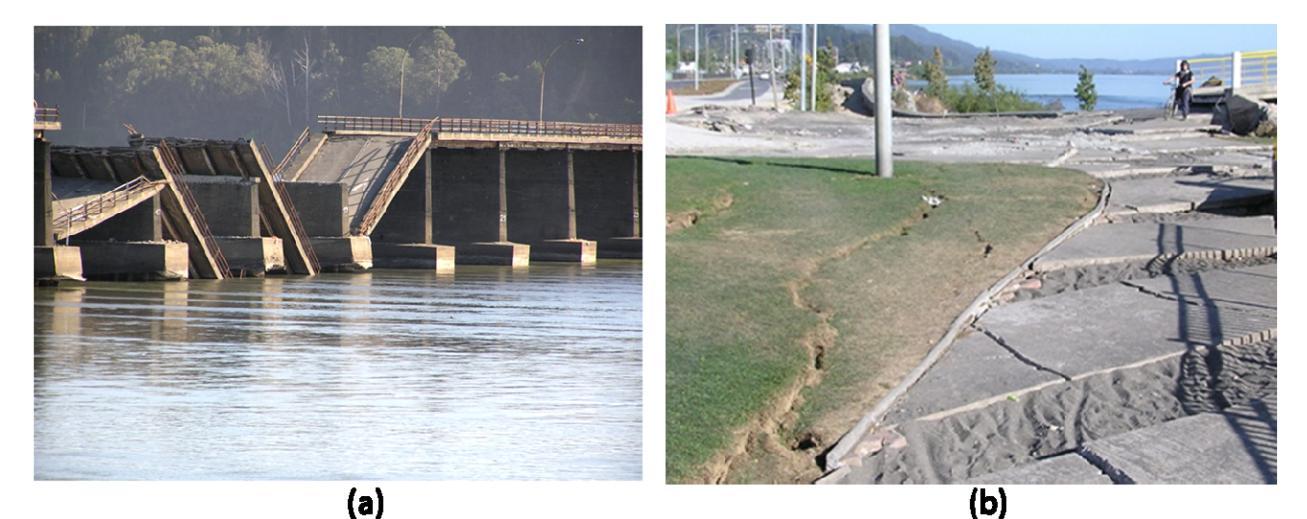
The Bio-Bio bridge, also known as Puente Viejo (Old Bridge), was built in the 1930s and inaugurated in 1937. The bridge connected the cities of Concepción and San Pedro de la Paz and had a length of 1,419 m. For many years it was the only vehicular bridge connecting the two cities. Due to its precarious structural condition the bridge was closed in May 2002 and used only for pedestrian transit. During the 2010 Chile earthquake the bridge suffered severe damaged with many slab sections collapsing (Figure 9.24a). Several bridge bents also collapsed during the seismic event (Figure 9.25). Evidence of liquefaction was observed at the East bridge abutment with visible lateral deformations and vertical settlements.

Figure 9.24. Puente Bio-Bio: (a) Collapsed slabs (S36.836789° W73.062203° on 3/15/2010), (b) Evidence of lateral spreading near East bridge approach (S36.837311° -73.061831°; 1753 hrs on 3/15/2010).

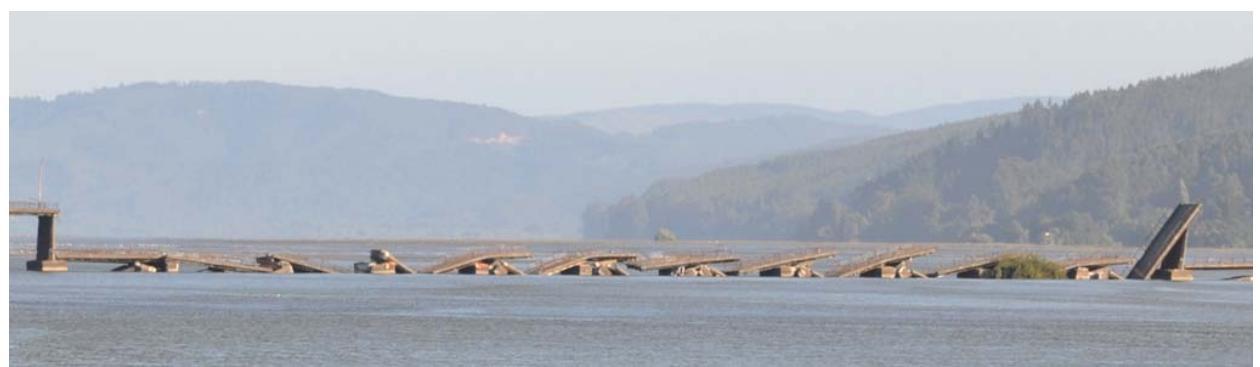
Figure 9.25. Puente Bi-Bio's collapsed slab sections and bridge bents (S36.837968° W73.062896° on 3/15/2010).

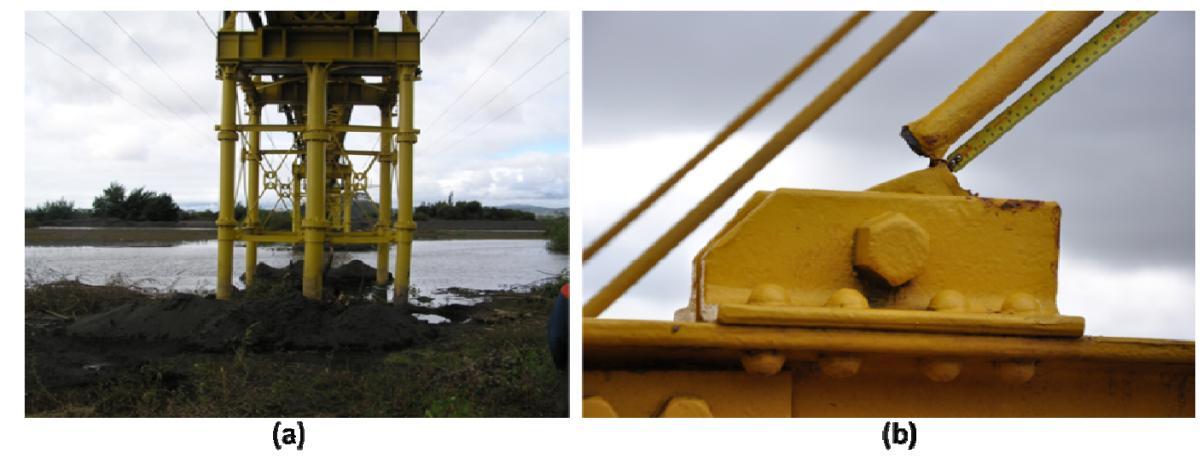
The Bio Bio river railroad bridge is one of the oldest crossings of the Bio Bio river. Originally built in 1889 m, it was completely retrofitted in 2005. This railroad structure is composed of parallel top and bottom chords separated by diagonal and vertical members in a Warren truss arrangement. Three hundred and seventy pillars support the structure covering a length of 1889 m. The bridge was damaged during the 2010 Chile earthquake due to strong shaking and possibly lateral spreading of the river banks. Of the 370 pillars of the bridge, 19 were damage during the earthquake and several portions of the rail were bent or miss-aligned (Figure 9.27).Visual inspection of pillars near the West abutment seems to indicate several piles moved in the lateral direction and rotated (Figure 9.26). The rail lines were moved out of alignment as shown in Figure 9.27b.

Figure 9.26. Bio Bio Railroad crossing (a) Pillars move and rotated during earthquake (b) Detail of broken crossbar, (S36.836075° W73.086969°; 1717 hrs on 3/17/2010)

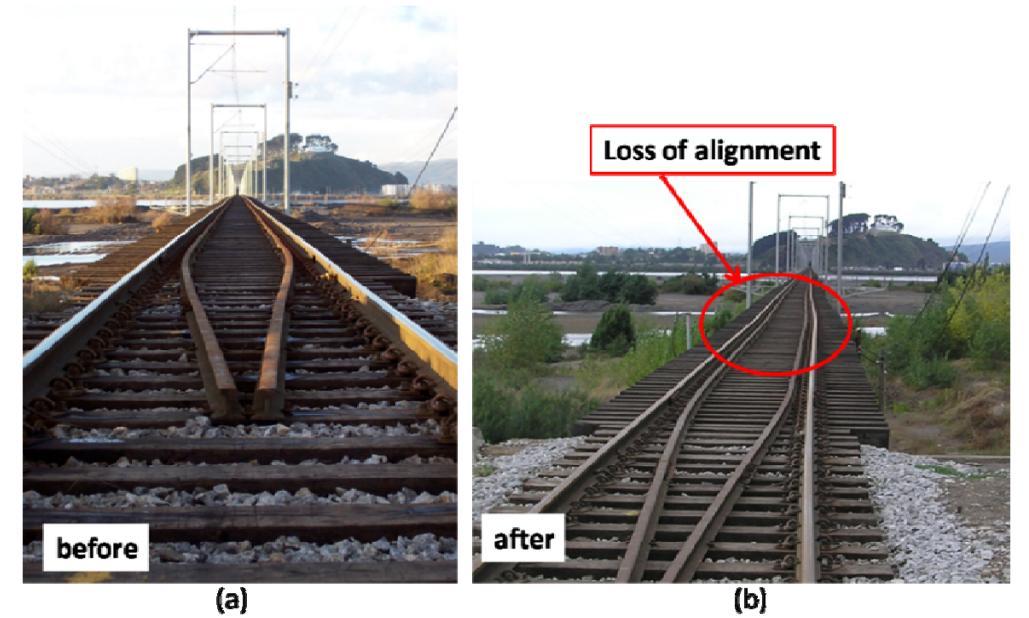
Figure 9.27. Bio Bio Railroad crossing (a) rails aligned before earthquake, (b) rails bended after earthquake (S36.836097° W73.087094° on 3/17/2010)

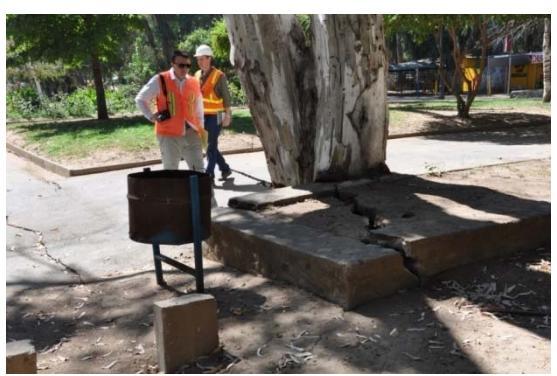
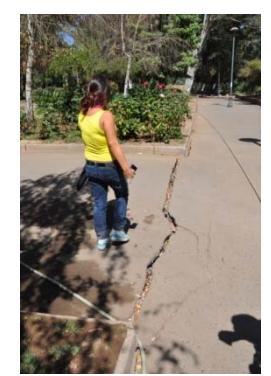
Local ground failure was observed approximately 50 m north of the Puente Rio Claro Nuevo (vehicular bridge) (Figure 9.32 and Figure 9.33). Two distinct regions were observed, a smaller lateral spread near shore (Figure 9.33), and a larger ground failure more characteristic of a soft clay failure confined within a park area (Figure 9.32). Soils near the shore area were predominantly gravely materials, likely with pockets of sand (one sand boil was observed at the near shore failure), whereas the park area indicated the presence of a soft clayey material. The ground failure extended approximately 90 m by 33 m north-south, however, it had no impact on the vehicular bridge, as it was open to traffic with no visible distress noted from the team's inspection on the east shore area. In contrast, the Puente Rio Claro Viejo (pedestrian bridge) suffered unseating of the longitudinally spanning girders and subsequent shear failure of the

Figure 9.32. Ground failure in a park area near the shore of the Rio Claro in Talca (S35.419919°, W71.682289°; 1408 hrs on 3/18/2010), views looking north and south, for left and right images, respectively.

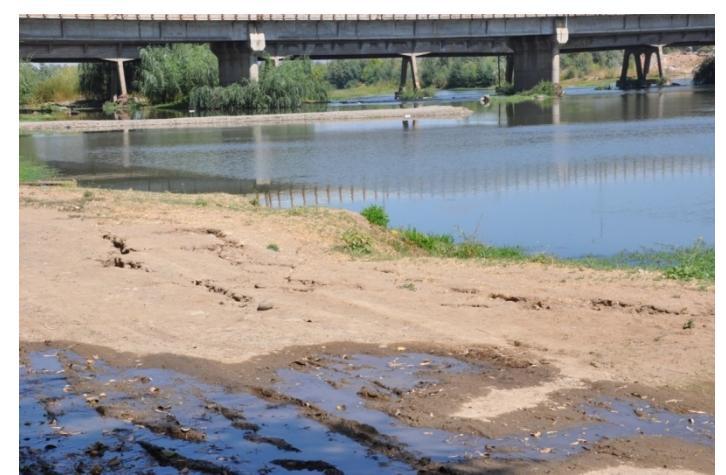
Figure 9.33. Near shore lateral spread on the western shore of the Rio Claro in Talca, view looking south. (S35.419682°, W71.682359° on 3/18/2010). Both the pedestrian and vehicular crossing bridges are shown in the background.

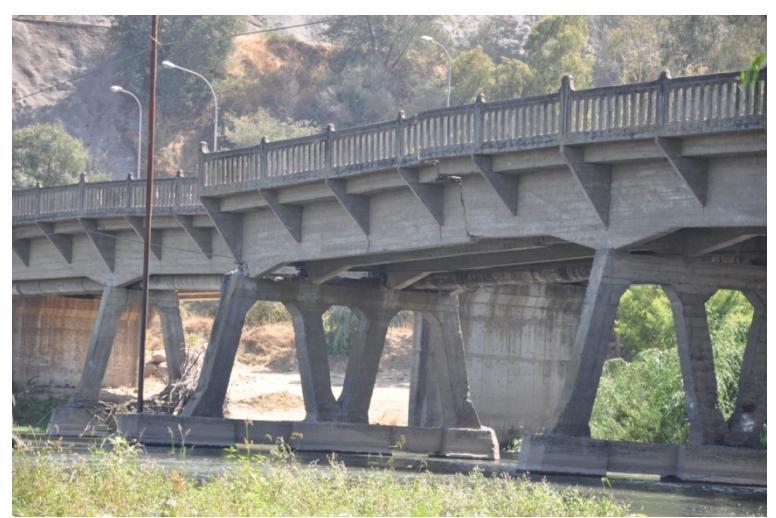
southern-most girder at a vista point near the mid-span of the bridge (Figure 9.34). From the team's limited access to the bridge it was not clear if the deck unseating was due to movement of the bent due to ground failure or excessive structural deformation at the bent.

Figure 9.34. Deck unseating and shear failure of longitudinal spanning girders of the Talca pedestrian bridge at the vista area (S35.421044, W71.683197; 1354 hrs on 3/18/2010)

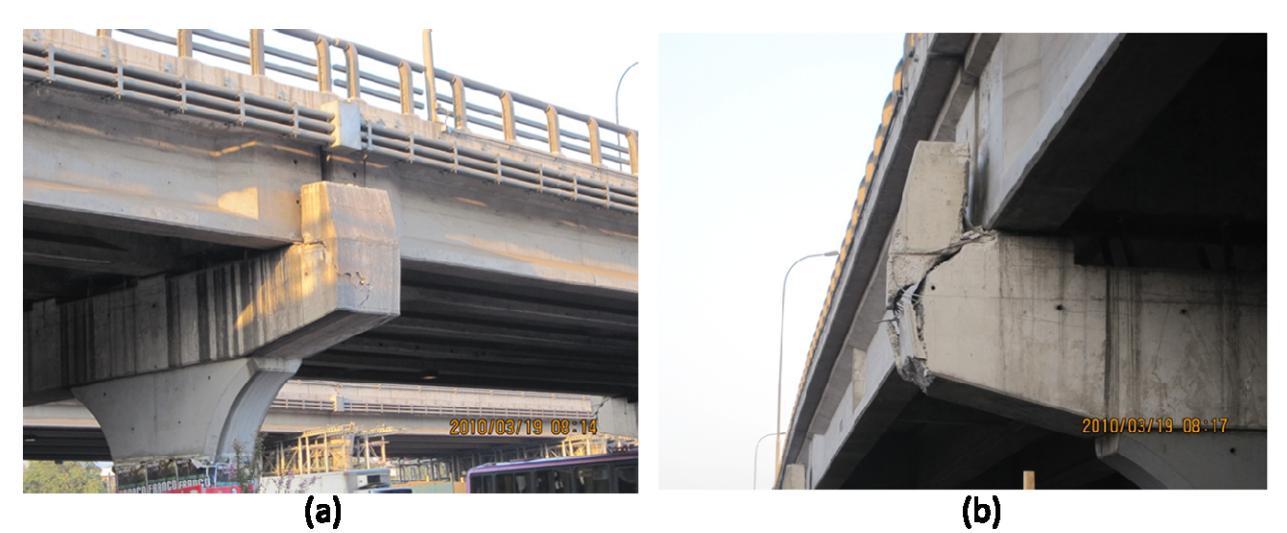
Several transportation structures along the Autopista Vespucio Norte Express (i.e., Vespucio Norte Expressway) were damaged in the Quilicura area of North West Santiago (Figure 9.35). There was at least one collapse and several spans were unseated requiring temporary support (Figure 9.36). Both older and newer structures were damaged, and the damage appeared to be the result of strong shaking. Since the damage appeared localized only as the Vespucio Norte Expressway came through the Quilicura area, it is suspected that local site effects, resulting from either soil conditions or subsurface topography contributed to the strong shaking. Retaining walls and mechanically stabilized embankment (MSE) walls appeared to perform well in the area (Figure 9.37). No other signs of geotechnical conditions influencing the performance, such as liquefaction or slope movements, were observed.

Figure 9.35. (a) Damaged shear key is an example of typical performance on bridges along this section of Vespucio Norte Expressway in Quilicura (S33.365585, W70.688657; 814 hrs on 3/19/2010), (b) Close up of damaged shear key along Vespucio Norte Expressway (S33.365893, W70.688584; 817 hrs on 3/19/2010).

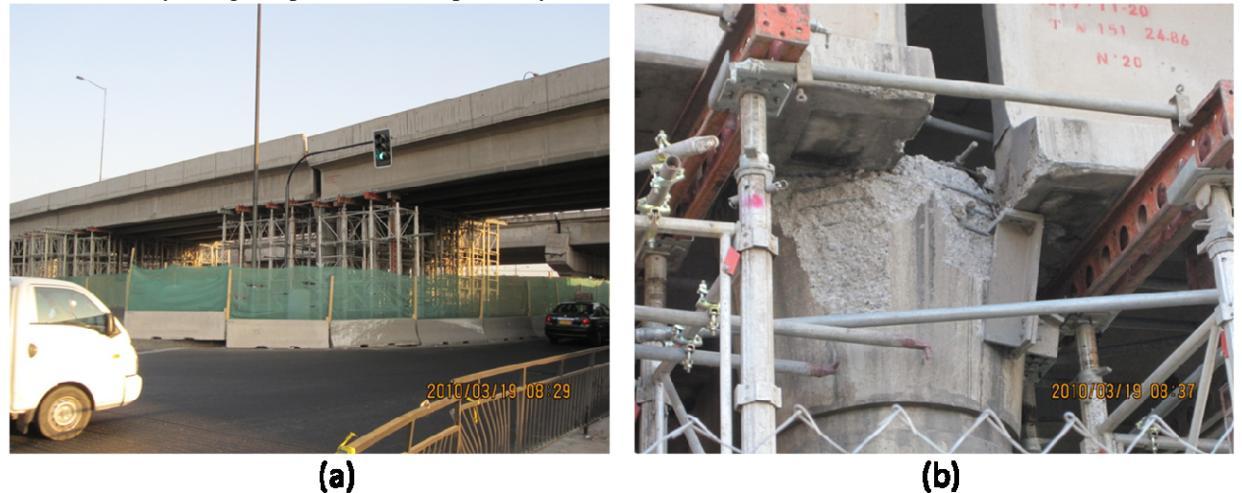
Figure 9.36 (a). Example of one of the newer under crossings that suffered damage along the Vespucio Norte Expressway. The right span became unseated due to excessive transverse movement (S33.36245, W70.688865; 829 hrs on 3/19/2010) (b) Close-up of shear key area on bent cap, with metal shear key or keeper bar hanging on right side of bent cap. Note complete unseating of I-girder on right side of bent cap (S33.366638, W70.689301; 837 hrs on 3/19/2010).

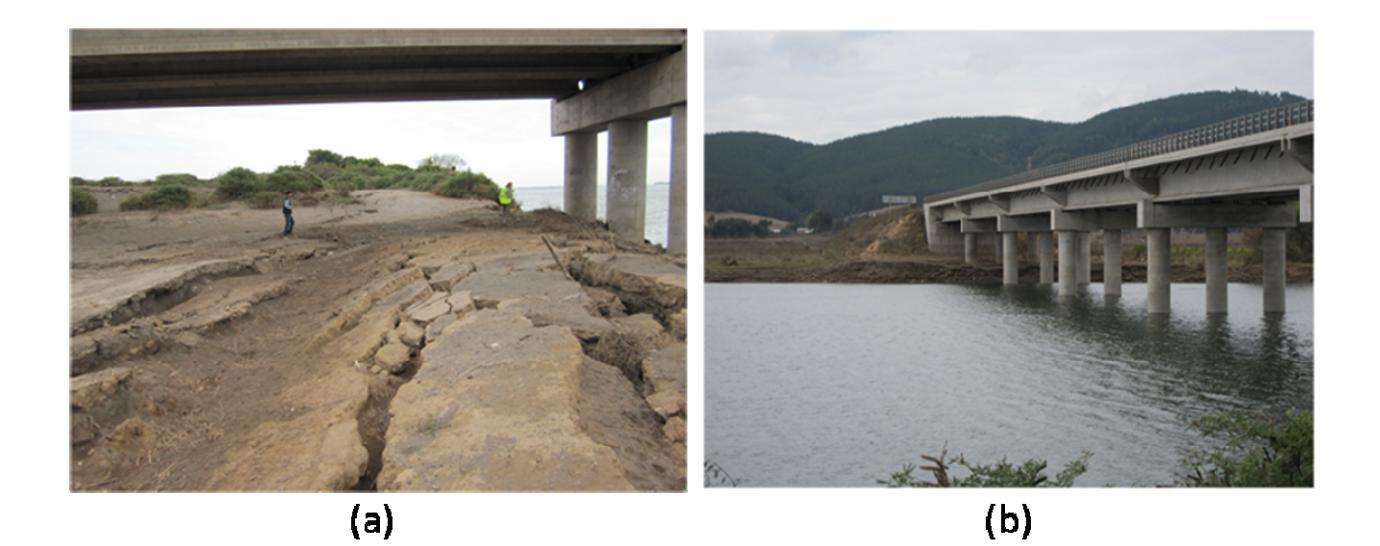
This bridge crosses the Mataquito river close to the Pacific Ocean. During the 2007 Maule earthquake extensive liquefaction and lateral spreading occurred at the north and south abutments and in the adjacent fields. Figure 9.39 through Figure 9.43 show photos of the bridge and the damage. The lateral spreading on the south abutment appeared to be more confined due to the topography of the area. In contrast, on the north side, and due to the large extent of the fields that are around the bridge, extensive lateral spreading was observed going back almost 270 m from the river edge. The lateral spreading from the edge of the abutment wall to the first row of piers was about 54 cm and the total lateral spreading from the edge of the abutment wall to the river's edge was about 180 cm (over a distance of about 65 m). The approach embankment is about 7.6 m high, and settled about 70 cm relative to the bridge deck. The approach embankment experienced outward transverse movement of about 60 cm from the center line as manifested by cracking of the asphalt along a distance of about 200m. This appears due to liquefaction and failure of the underlying soil and is evidenced by compression ridged in the field at the toe of the embankments. Despite evidence of liquefaction at both abutments of this bridge, its overall seismic performance was good.

Figure 9.39 (a) Lateral spreading on the south end of the bridge, Puente Mataquito, S35.050712°,W72.162258°, April 16, 2010. (b)Lateral spreading on the north end of the bridge, Puente Mataquito, S35.050712°,W72.162258°, April 16, 2010.

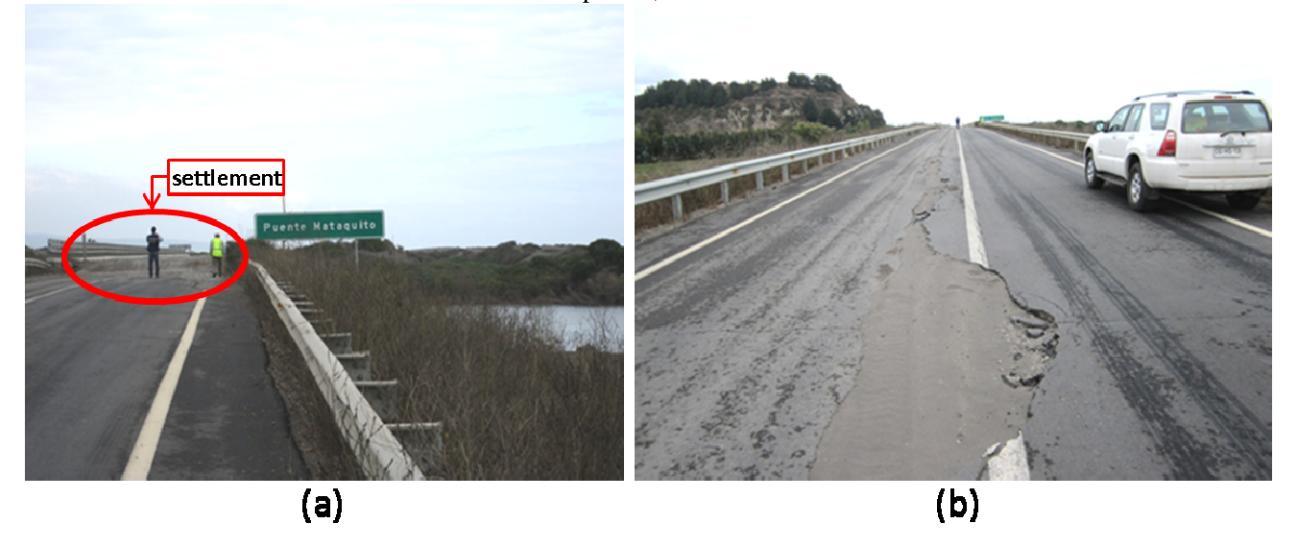
Figure 9.40. (a) Settlement of the north abutment of the bridge, 70 cm offset at the bridge deck, Puente Mataquito, S35.050712°,W72.162258°, April 16, 2010. (b) Cracking and transverse movement (60 cm on each side) of embankment due to liquefaction of underlying soi

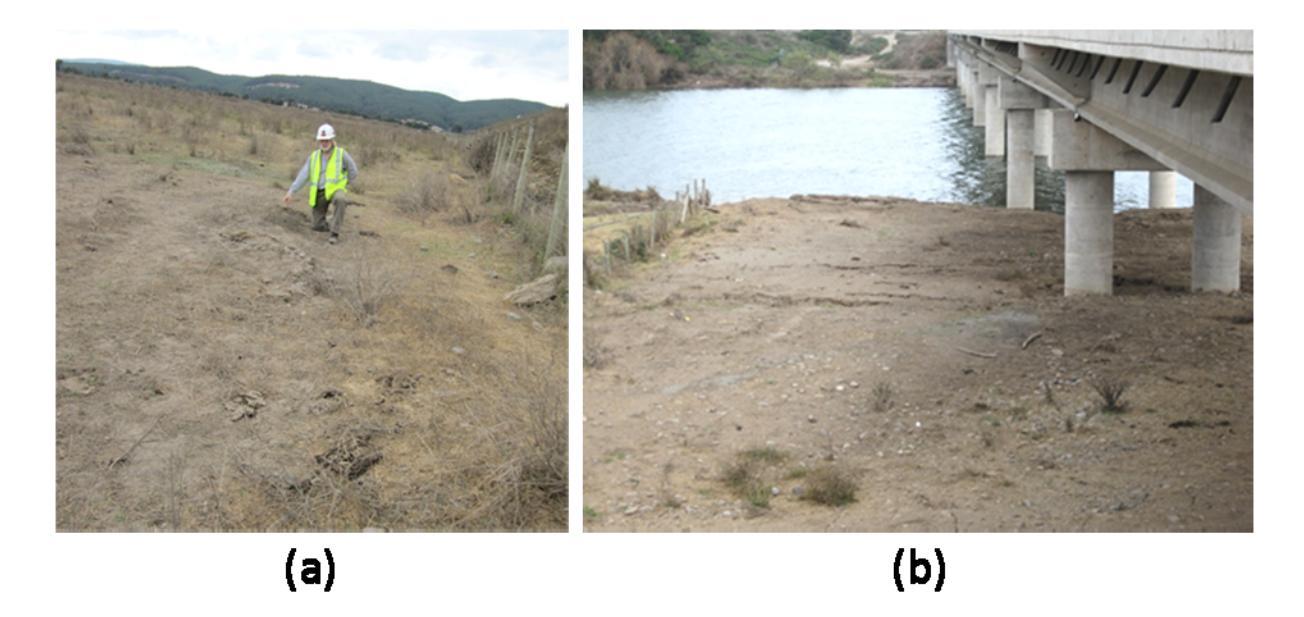
Figure 9.41 (a) Compression ridges at toe of embankment, due to liquefaction of underlying soil and settlement of embankment, north abutment of the bridge, Puente Mataquito, S35.050712°,W72.162258°, April 16, 2010. (b) Lateral Spreading towards the river, north abutment of the bridge, Puente Mataquito, S35.050712°,W72.162258°, April 16, 2010.

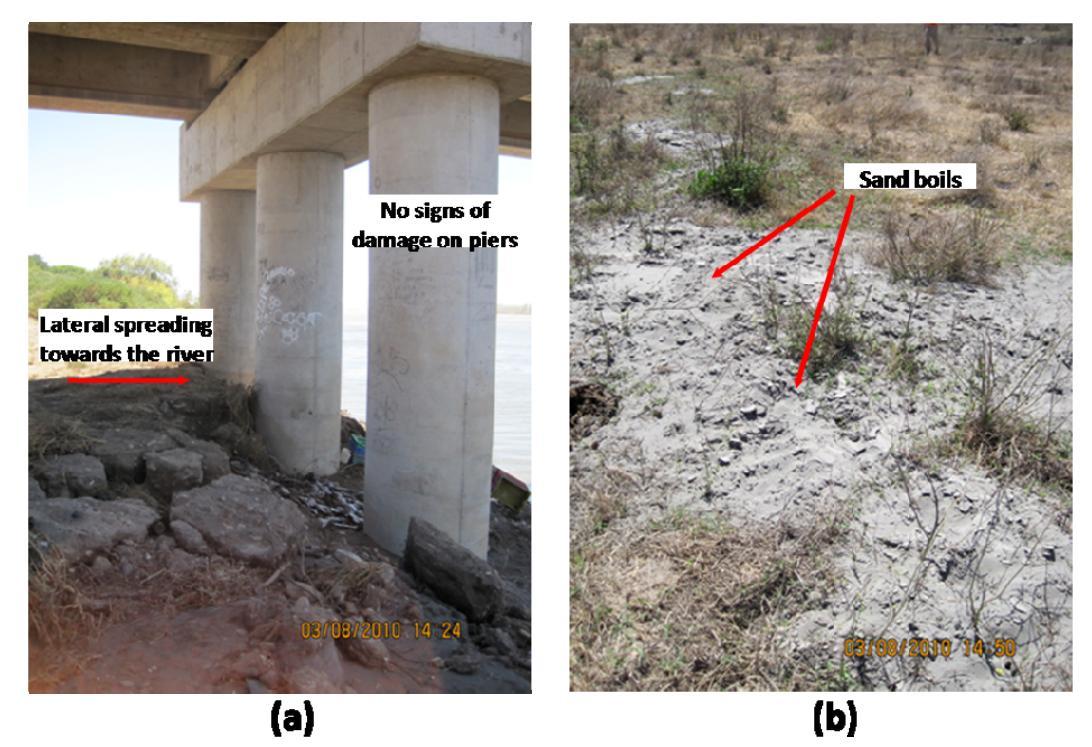
Figure 9.42. Mataquito bridge-(a) Blocks of soil crust against piers at the south end, (b) Sand boils at the north end of the bridge (S35.051961, W72.163217; 1450 hrs on 3/08/2010)

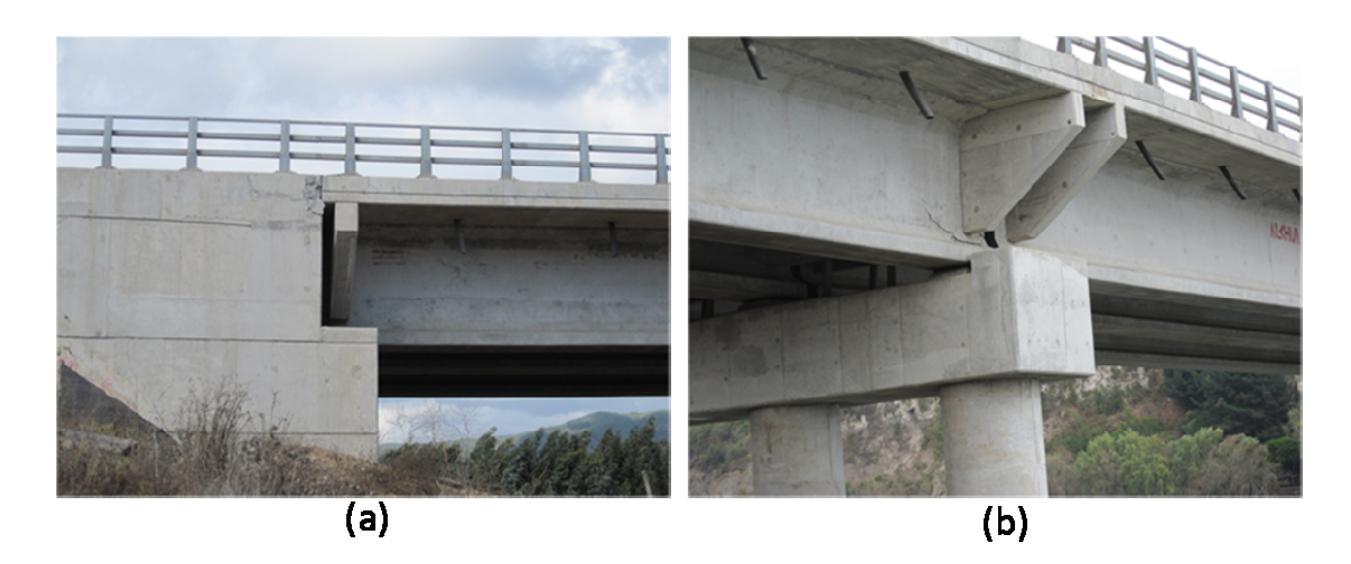
Figure 9.43 (a) North abutment shoved into bridge deck due to lateral spreading, Puente Mataquito, S35.050712°,W72.162258°, April 16, 2010, (b) Shearing of bridge girder, North abutment of bridge, Puente Mataquito, S35.050712°,W72.162258°, April 16, 2010.
