9.0 EFFECTS OF GROUND FAILURE ON BRIDGES, ROADS, RAILROADS, AND LIFELINE SYSTEMS

9.1 Introduction

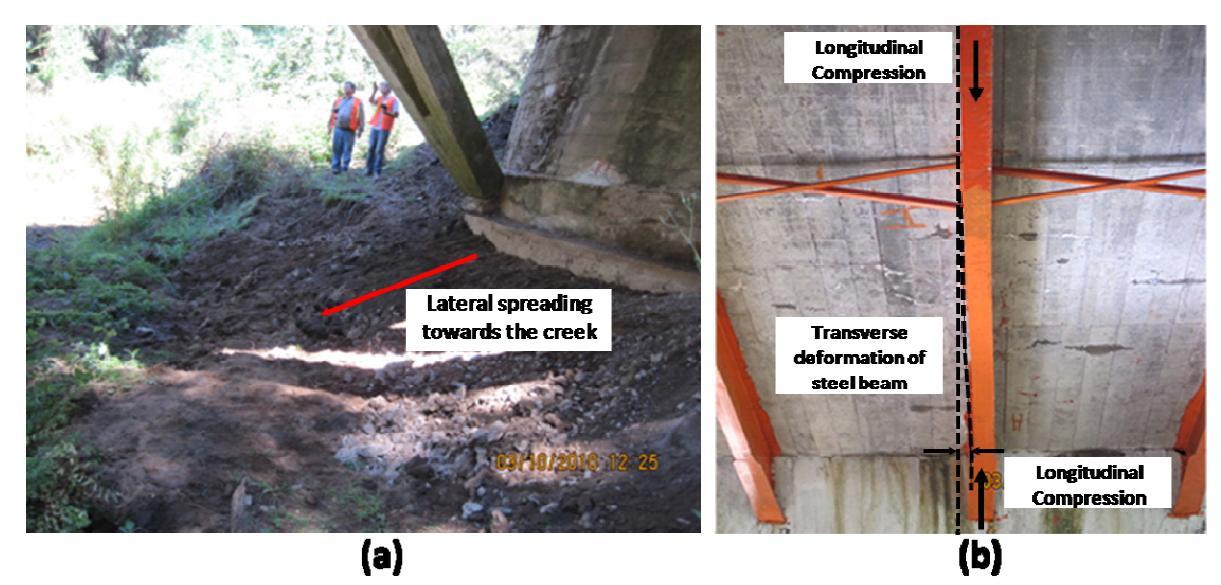
There was moderate damage of these bridges due to liquefaction and lateral spreading. These two-lane single-span old reinforced concrete bridges were close to each other. In these bridges the longitudinal movement due to lateral spreading of both abutments seemed to have compressed the bridges causing geometric distortion and moderate damage. The originally horizontal decks of the bridges ended up with a concave-down shape. Some transverse cracks were observed on the bridge deck due to this effect. Information provided by local authorities indicates that most of these bridges, if not all, have been recently surveyed as a part of a broad bridge assessment and improvement program, so there may be accurate survey points that could be used for future detailed analysis of the deformations.

Figure 9.44. Pulen Bridge-(a)Evidence of lateral spreading at the north abutment (b) Loss of longitudinal alignment of steel I-beam (S37.112036, W72.986902, 1225 hrs on 3/10/2010)

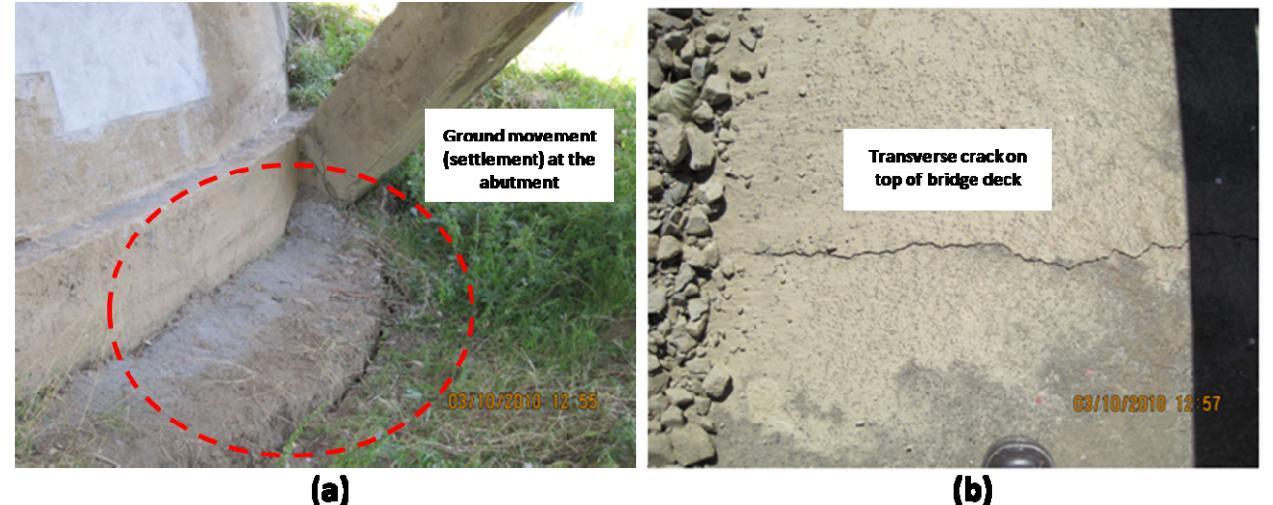
Figure 9.45. Patagual Bridge-(a) Ground movement at the abutment (b) Sidewalk crack in the transverse direction on the top of the bridge deck(S37.111325, W72.987583, 1257 hrs on 3/10/2010).

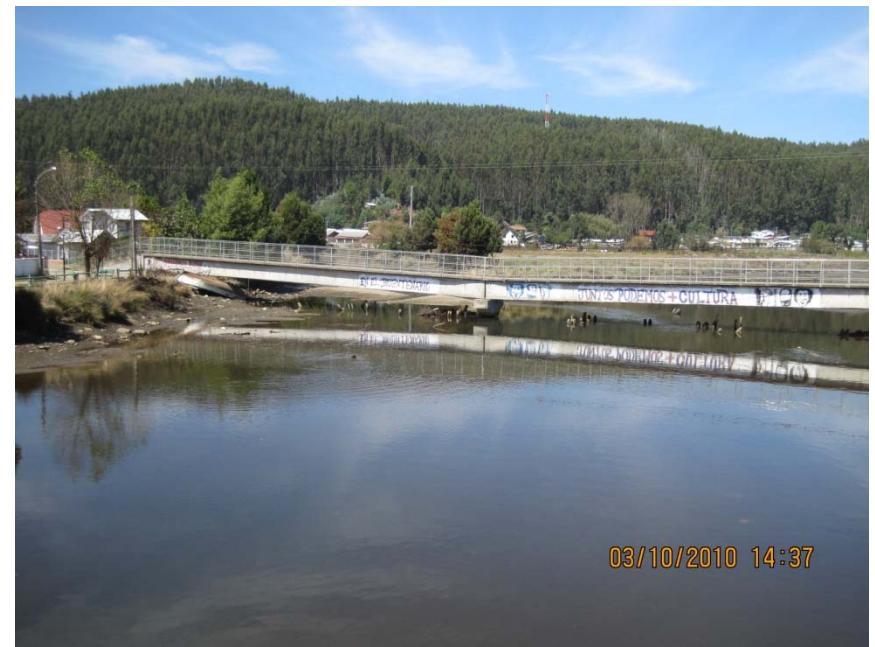
Two bridges were inspected in the Town of Laraquete, which is 50 km south of Concepción: A pedestrian two span bridge and an adjacent vehicular three span reinforced concrete bridge. The pedestrian bridge experienced damage due to foundation settlement of the middle bent with an estimated 0.50 m vertical deformation. Figure 9.47 shows the deformed bridge with noticeable inclination of the bridge deck. The adjacent reinforced concrete bridge, shown in Figure 9.46, suffered minor damage near the approaches due to pounding with the concrete structure and settlement due to poorly compacted fill. This bridge did not show evidence of foundation settlement.

Figure 9.47. Pedestrian Laraquete Bridge showing large settlement of middle pier (S37.166742° W73.184384°; 1437 hrs on 3/10/2010).

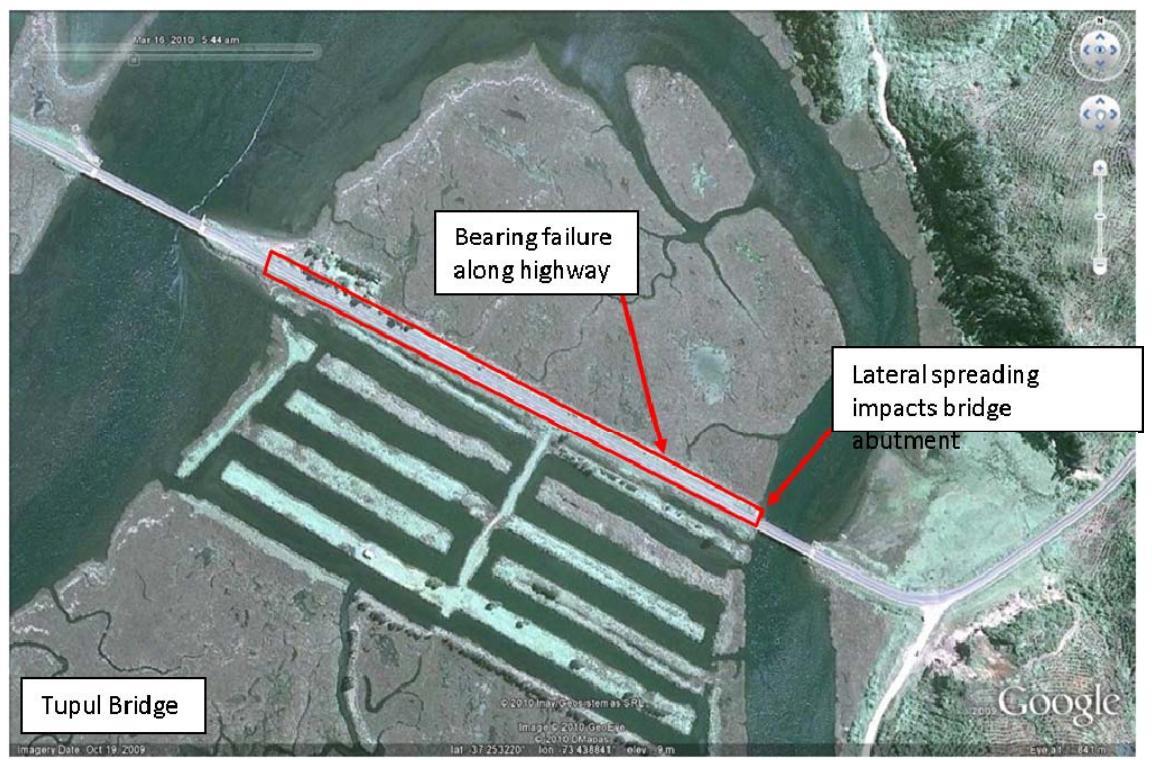
A roadway and bridge near the small town of Tubul were damaged due to ground failure. The layout of the bridge and roadway is shown in Figure 9.50. The roadway is about 0.33 km long and single span bridges cross the river on the east and west ends. Damage to the roadway and the bridge on the east end closed the road to traffic following the earthquake. The two lane roadway, with an embankment height of about 2 m, traverses a swampy, low-lying area adjacent to a small river which flows northward into the Pacific Ocean. Therefore, soils in this area are likely to be soft and saturated. The eastern bridge, which is about 50 m long, is supported by steel beams, which rest on a seat type abutment.

Figure 9.50. Damage to roadway and bridge due to ground failure near town of Tubul, Chile (S37.254345°, W73.437021°).

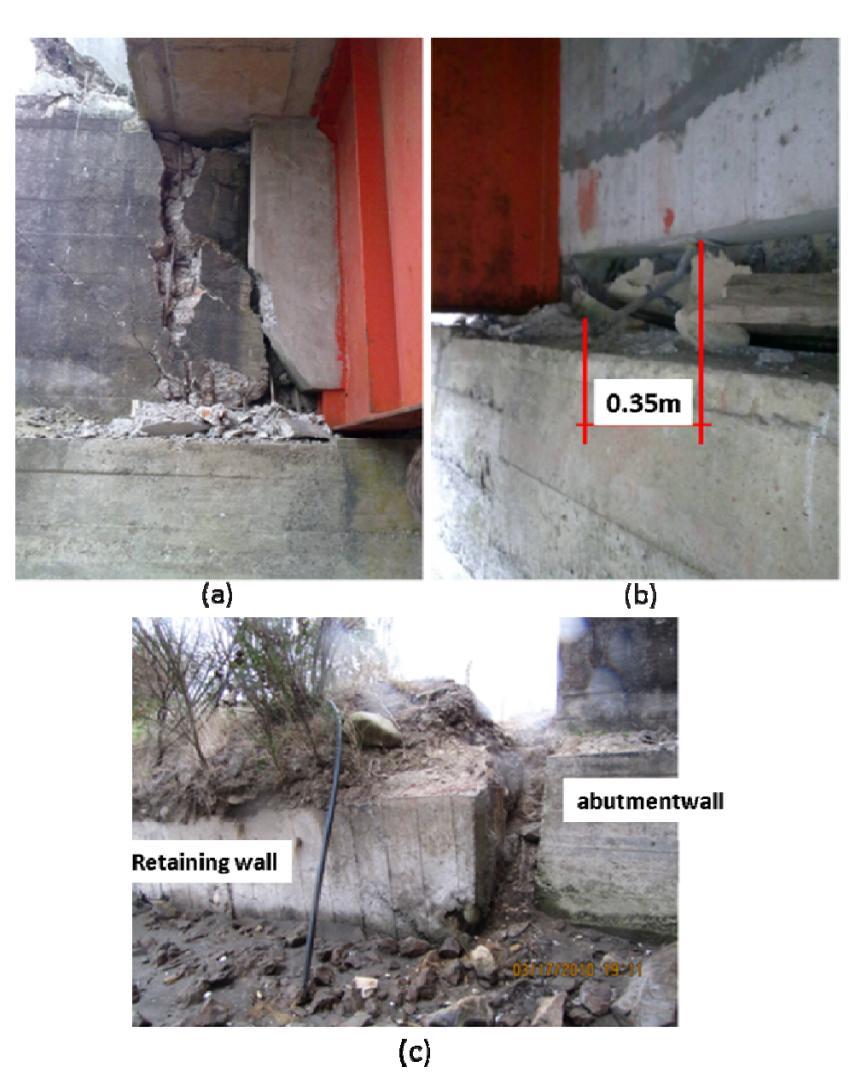
Figure 9.51. Damage to bridge abutment due to lateral spreading of soil around bridge abutment. (a) abutment wall movement relative to beams, (b) deformation of vertical restraining bar due to abutment movement relative to beams, (c) movement of retaining wall relative to abutment. (S37.254345°, W73.437021°; 1911 hrs on 3/17/2010)

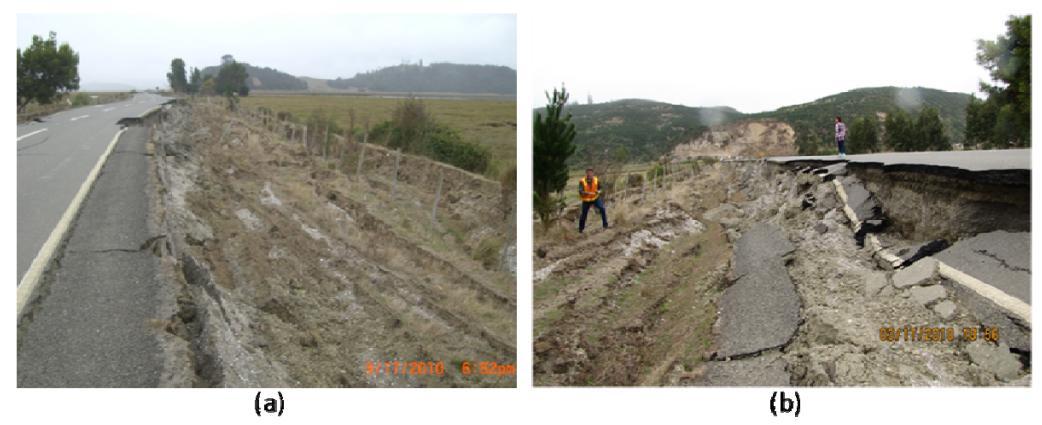
On both sides of the roadway, slumps developed along nearly the entire length of the roadway leaving vertical scarps 1.0 to 2.0 m in height as shown in Figure 9.52. The slopes on both sides of the roadway appear to have rotated downward causing an upward heave and rotation of the outer edge of the failure surface similar to a bearing capacity failure surface. In addition to the slumping along the sides of the road, the middle section of the road experienced lateral displacement towards the north as evidenced by the bow in the centerline of the road evident in Figure 9.52(a).

Figure 9.52. Photos showing scarps along both sides of the roadway due to bearing capacity failure in soil underlying the fill. Note lateral spreading in upper photo (S37.254161°, W73.437577° on 3/17/2010)

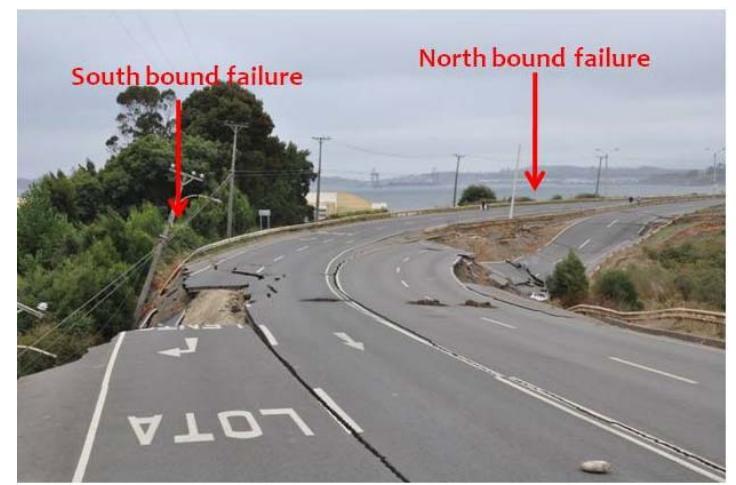
The north bound ground failure appeared to be deeply seated, perhaps due to softening of the foundation materials. It was not clear whether the south bound failure was due to a deep seated foundation failure or due to poorly compacted earth fill in the embankment section. A gray sandy fill overlaid by compacted clay fill was used in the elevated road embankment. The roadway elevation was approximately 10–15m above the valley area (10 m nearest to the overcrossing bridges, with high point above the housing development area). The bridge overcrossings, and therefore the road embankments, of the north and south bound sections may have been constructed at different times, as evident in the differences in construction type of the bridges (Figure 9.56(a)). The neighboring elevated railroad failure is characterized by a slumping and spreading of the elevated section, which is likely due to movement of the compacted fill (Figure 9.56(b)). The railroad was approximately 5-7 m above the low lying marshy area along its failure zone.

Figure 9.54. View looking north on route 160 showing south bound and north bound failure areas (S37.0744°, W73.1480°; 1220 hrs on 3/16/2010).

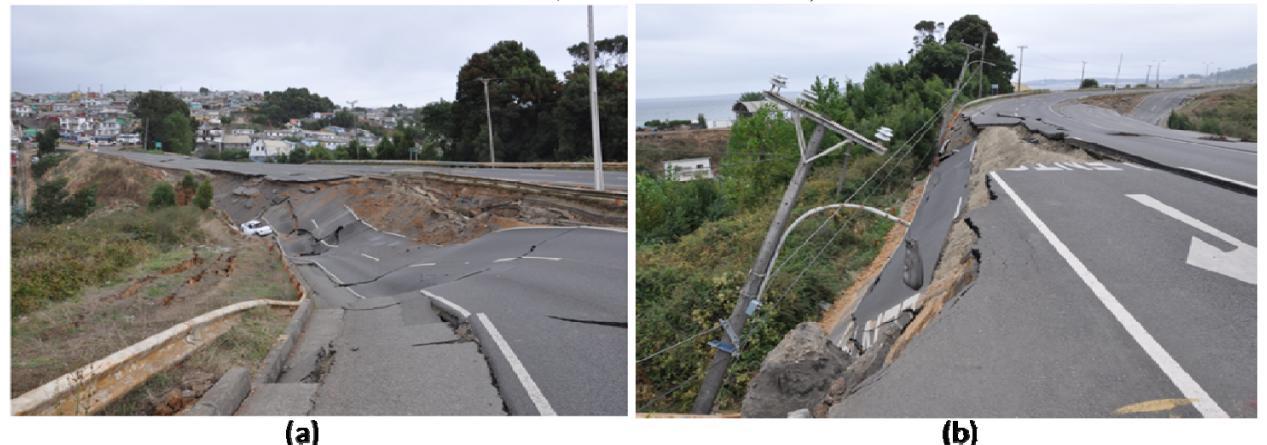
Figure 9.55. Lota (a)View looking south on route 160 showing north bound failure area (S37.0730°,W73.1475°; 1145 hrs on 3/16/2010) (b)View looking north on route 160 showing south bound failure area (S37.0746°, W73.1479°; 1215 hrs on 3/16/2010).

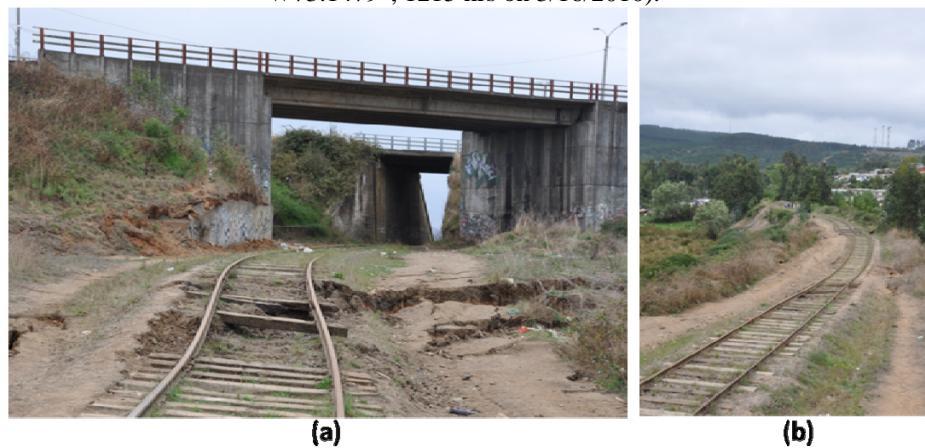
Figure 9.56. Lota (a) Slab and girder-type overpasses at northern end of road embankment failure area, showing railroad and supporting ground settlement. View looking west. (S37.0729°, W73.1469°; 1150 hrs on 3/16/2010), (b) Ground failure below elevated railroad east of road embankment failure. (image looking east; S37.0727°, W73.1471°; 1150 hrs on 3/16/2010)

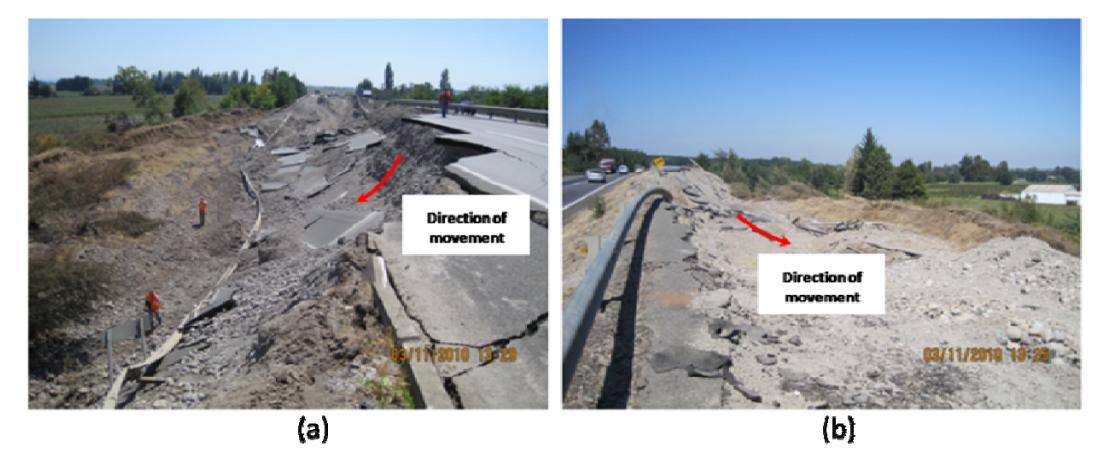
Two collapsed embankment fills were identified near Copihue and Parral. The first, shown in Figure 9.57, occurred on a straight section of Ruta 5 located ~ 8 km North of Parral (S36.0796 W71.7881). The Southbound lanes collapsed to the West and appeared to involve a shallow translational slide in near surface foundation soils as evidenced by the location of the failed soil mass including a mound of soil pushed up at West toe of the embankment (Figure 9.57a). The embankment failed along a length of approximately 150 m at a location where a low lying softer soil area was located at the toe.

Figure 9.57. This embankment fill collapsed together with an overhead near Copihue, north of Parral, closing the South bound of Route 5 (a) View from the South, (b) View from the North (S36.087891, W71.791513, 1325 hrs on 3/11/2010)

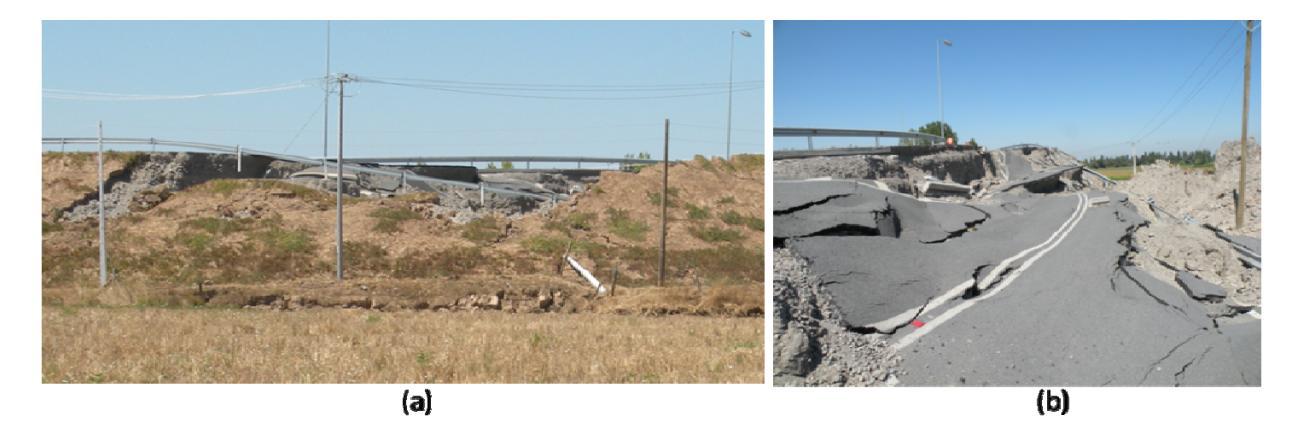
The second failure, shown in Figure 9.58, occurred on an overpass of Ruta 5 located ~ 13 km North of Parral. (S36.0347, W71.7558). The overpass embankment was curved and the embankment failed over a length of about 80 m towards the outside of the curved section. Again, the failure appeared to involve a shallow translational slide in the near surface foundation soils as evidenced by the intact failed soil mass and the mound of soil pushed up at the toe (Figure 9.58a). Foundation soils in the region appeared to be relatively competent (unlike the above case) suggesting possible elevated pore pressures in the foundation soils played a role in the observed failure with 3-D effects leading to failure to the outside of the curved embankment section as opposed to the inside of the embankment. The outside section of the slide mass remained completely intact as evidenced in Figure 9.58b.

Figure 9.58. Curved overpass embankment failure 13 km North of Parral (a) Translational 3-D slide failure, (S36.0343 W71.7568; 1405 hrs on 3/11/2010) and (b) Failed outside of the curved embankment (S36.0347 W71.7558; 1409 hrs on 3/11/2010)

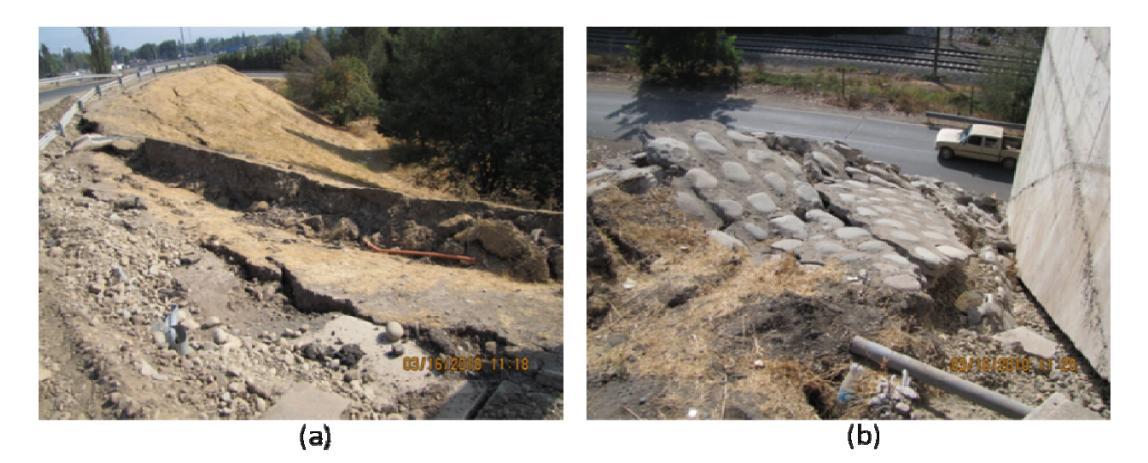
Figure 9.59. Highway 5 crossing near Paine; (a)View of bridge approach from East (S33.854592° W70.747687°; 1118 hrs on 3/16/2010); (b) View of damaged bridge abutment (S33.854211° W70.747784°; 1120 hrs on 3/16/2010)

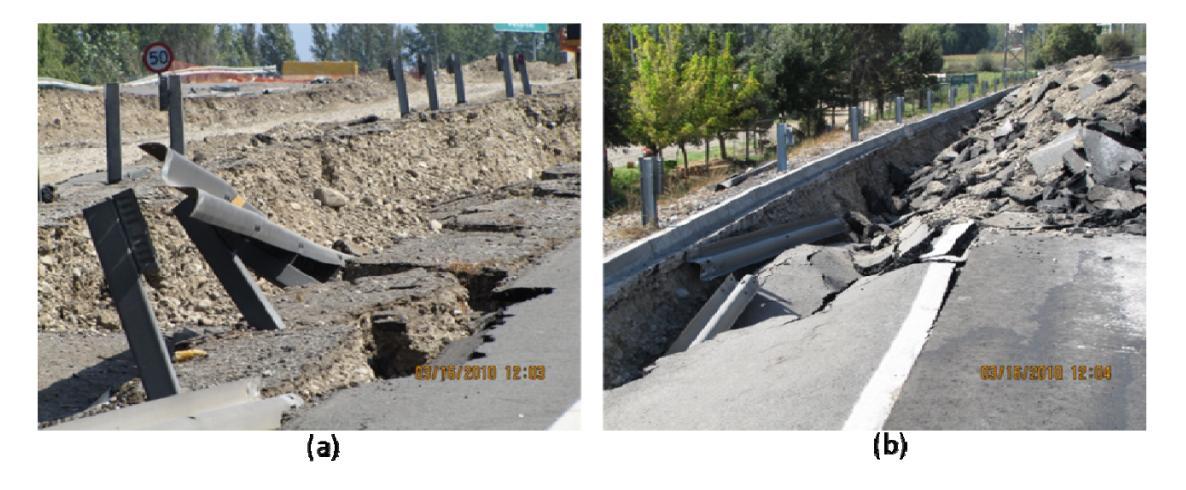
Figure 9.60. Highway 5 failure near Paine; (a)shoulder settlement due to poorly compacted soil (S33.864897° W70.742222° 1203 hrs on 3/16/2010), and (b) road failure due to poorly compacted soil (S33.864897° W70.742222°; 1204 hrs on 03/16/2010)

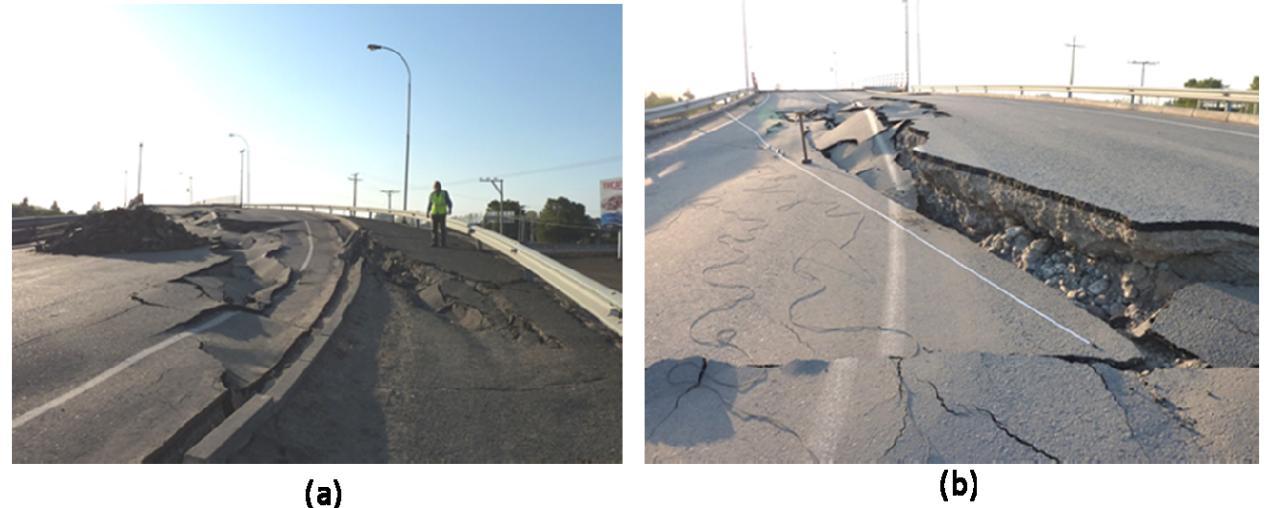
Figure 9.62 (a) Damage to overpadd embankment, Ruta 5 Sur overpass embankment, to Retiro at Tucapel Mill, April 15, 2010 (S36.051209°,W71.768005°), (b) SASW line, Ruta 5 Sur overpass embankment, to Retiro at Tucapel Mill, April 15, 2010 (S36.051209°,W71.768005°).

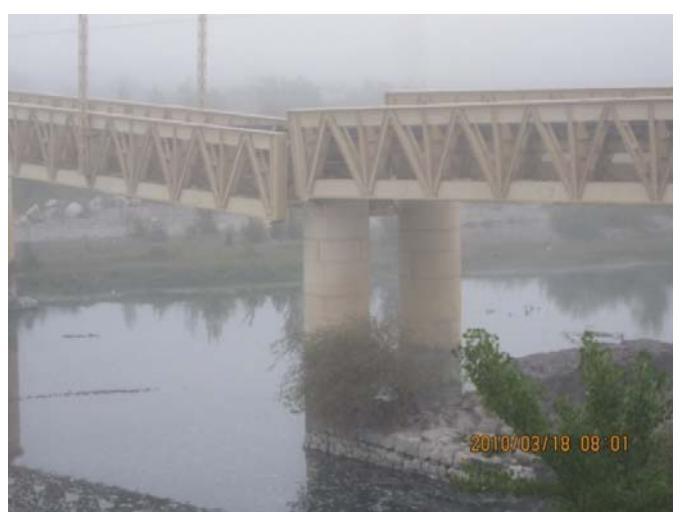
Figure 9.63. Unseated railway bridge span near Longavi from excessive transverse movement (\$36.004136, W71.726193, 0801 hrs on 3/18/2010)

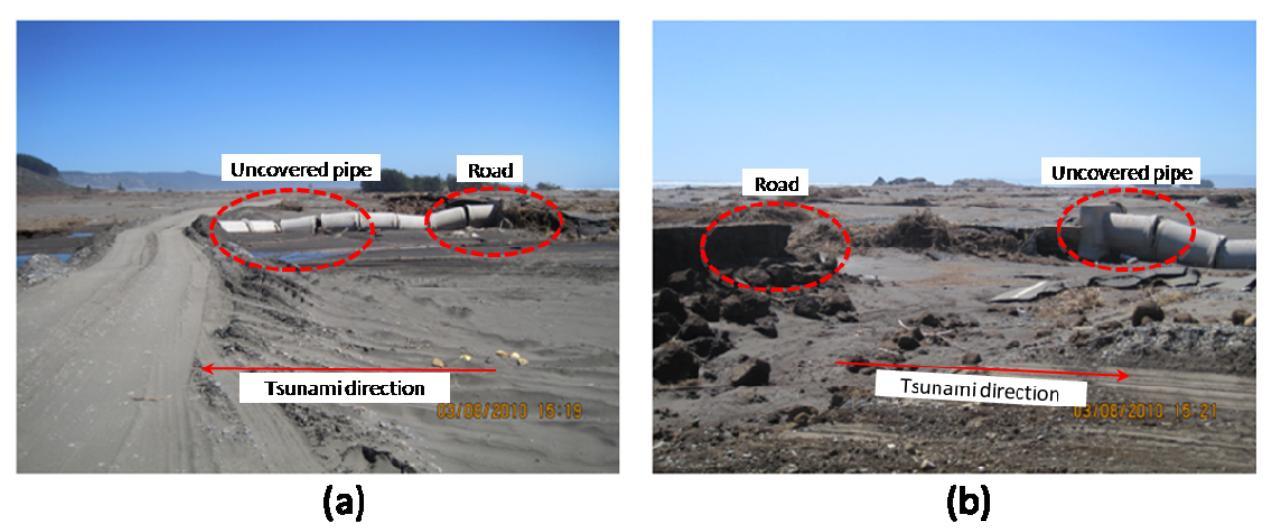
Figure 9.64. Failed culvert pipe: (a) View from the north, and (b) View from the south (S35.115611, W72.203245, 1519 hrs on 3/8/2010)
