The September 18-20 2020 Medicane Ianos Impact on Greece

Phase I Reconnaissance Report

Geotechnical Extreme Events Reconnaissance Association

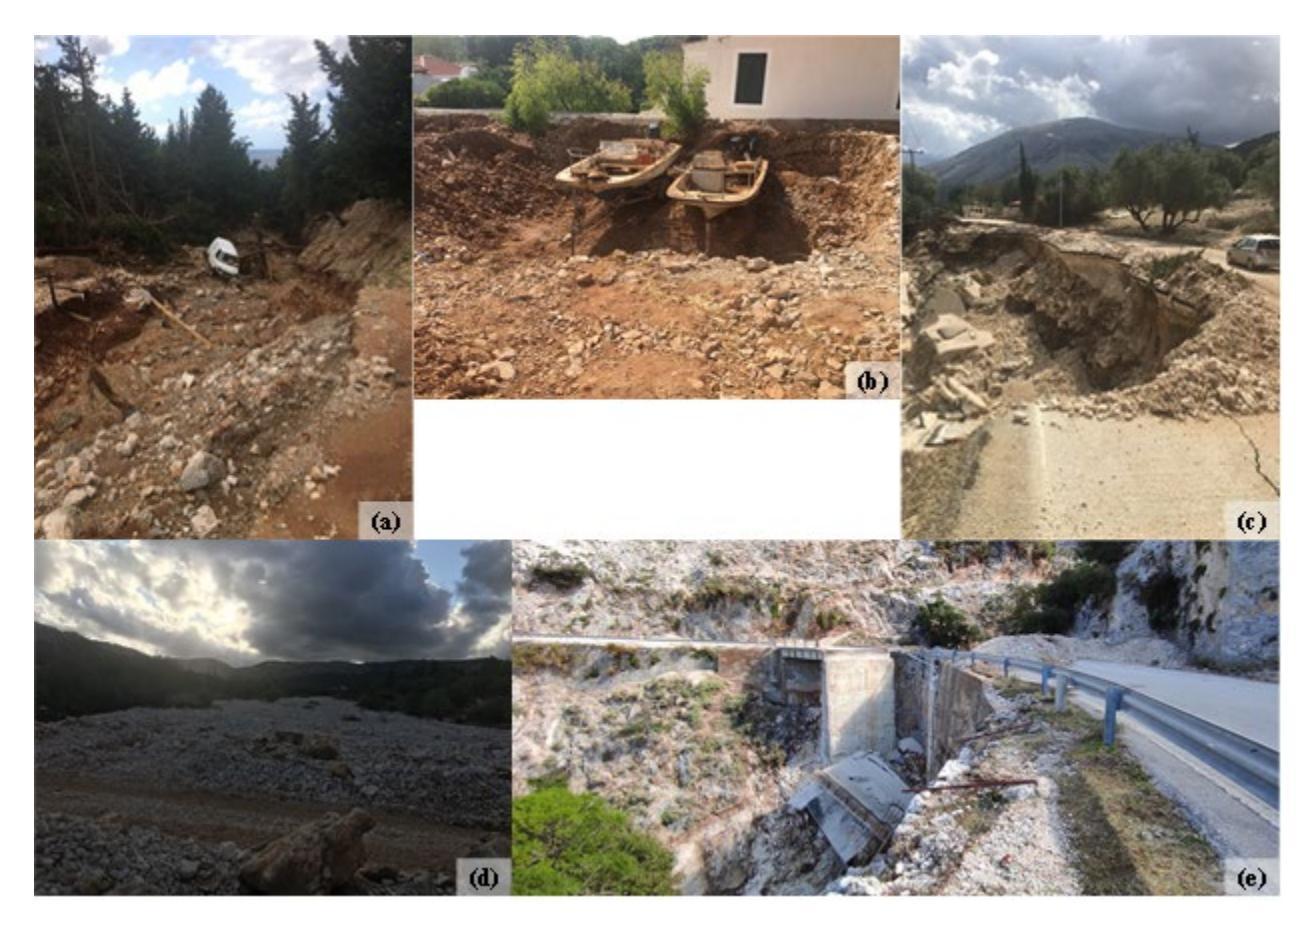
Figure 4.6. Characteristic damages in Cephalonia island following Medicane Ianos: a) Riverbank Erosion, b) debris flow within a rural community, c) road embankment failure, d) extensive debris flow, e) bridge collapse.

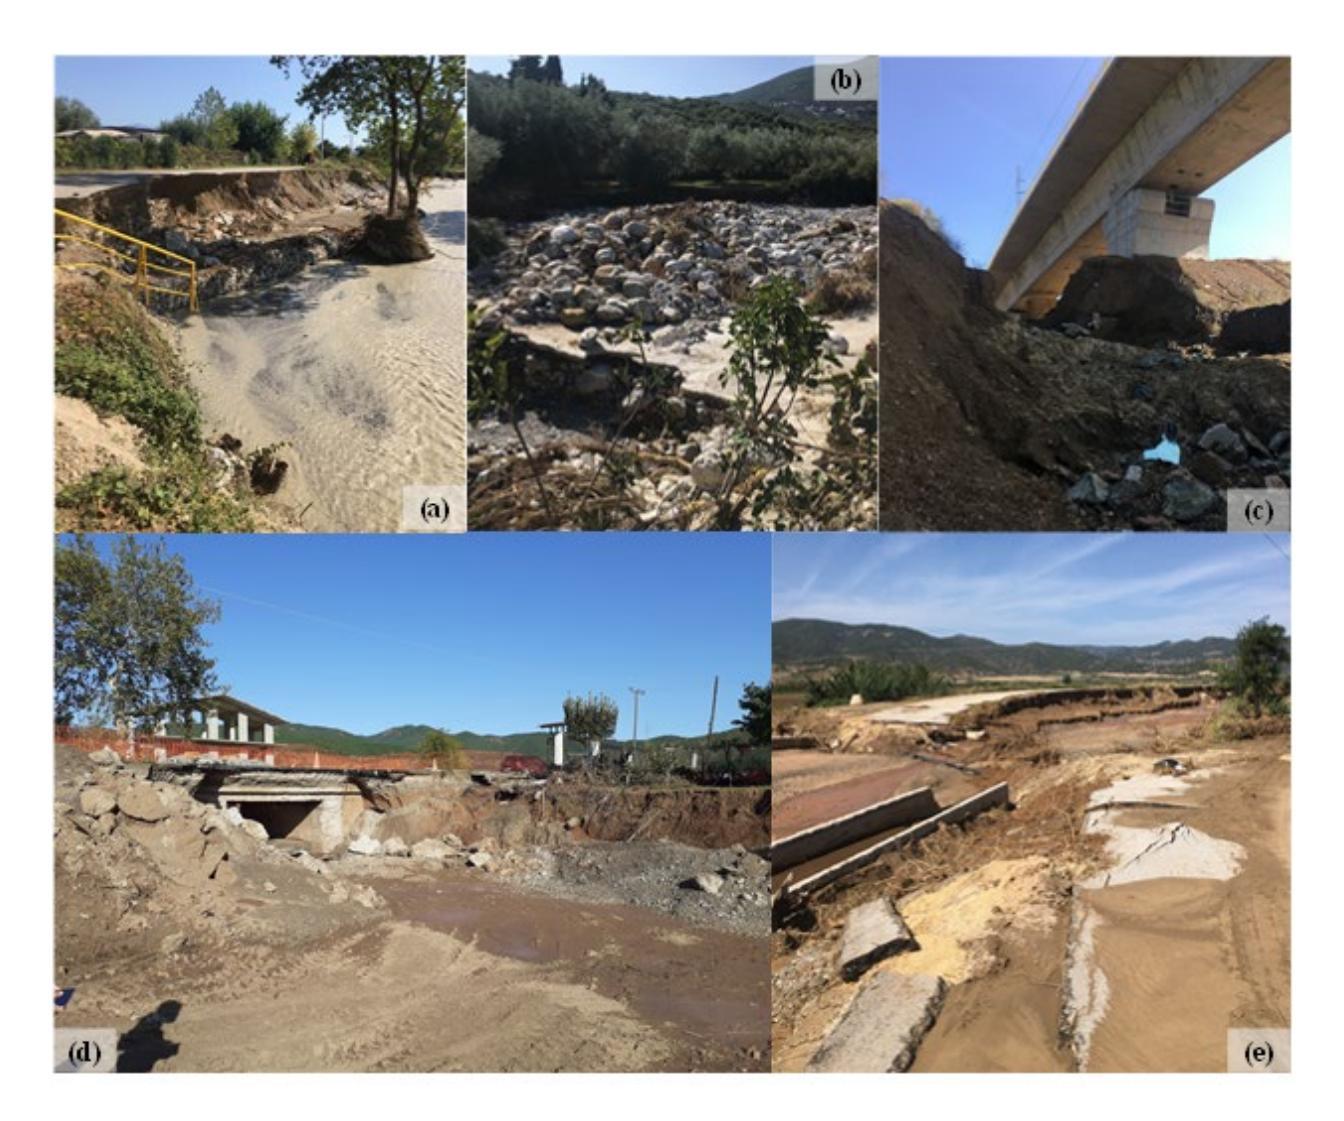
Figure 4.14. Characteristic damages in the region of Lamia following Medicane Ianos: a) riverbank erosion and road embankment failure, b) extensive debris flow, c) bridge foundation scour, d) riverbank erosion, and e) road embankment failure

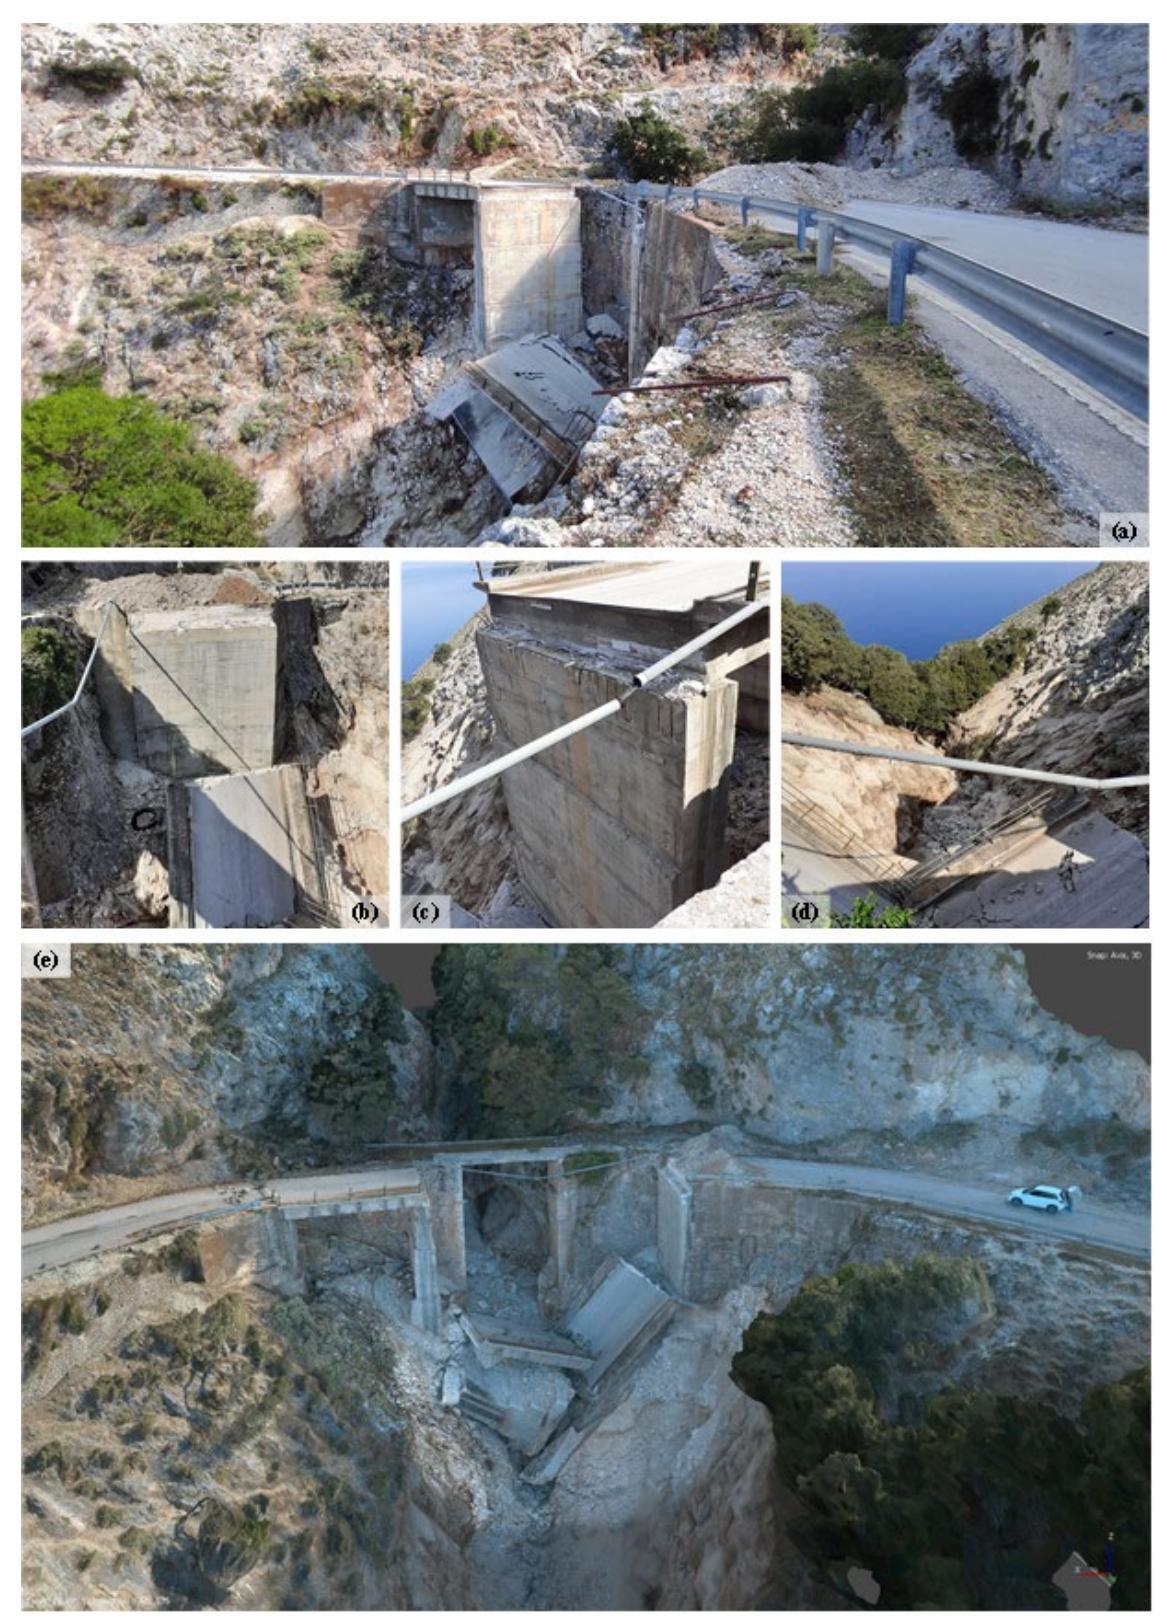
Figure 5.1. Collapsed multi-span RC bridge on E.O. Argostoliou-Fiskardou (38.319506°N, 20.508197°E): a-d) roadside photos, e) UAV-enabled 3D texture mesh - perspective view (view 3D model at: <u>https://skfb.ly/6WyYT</u>)

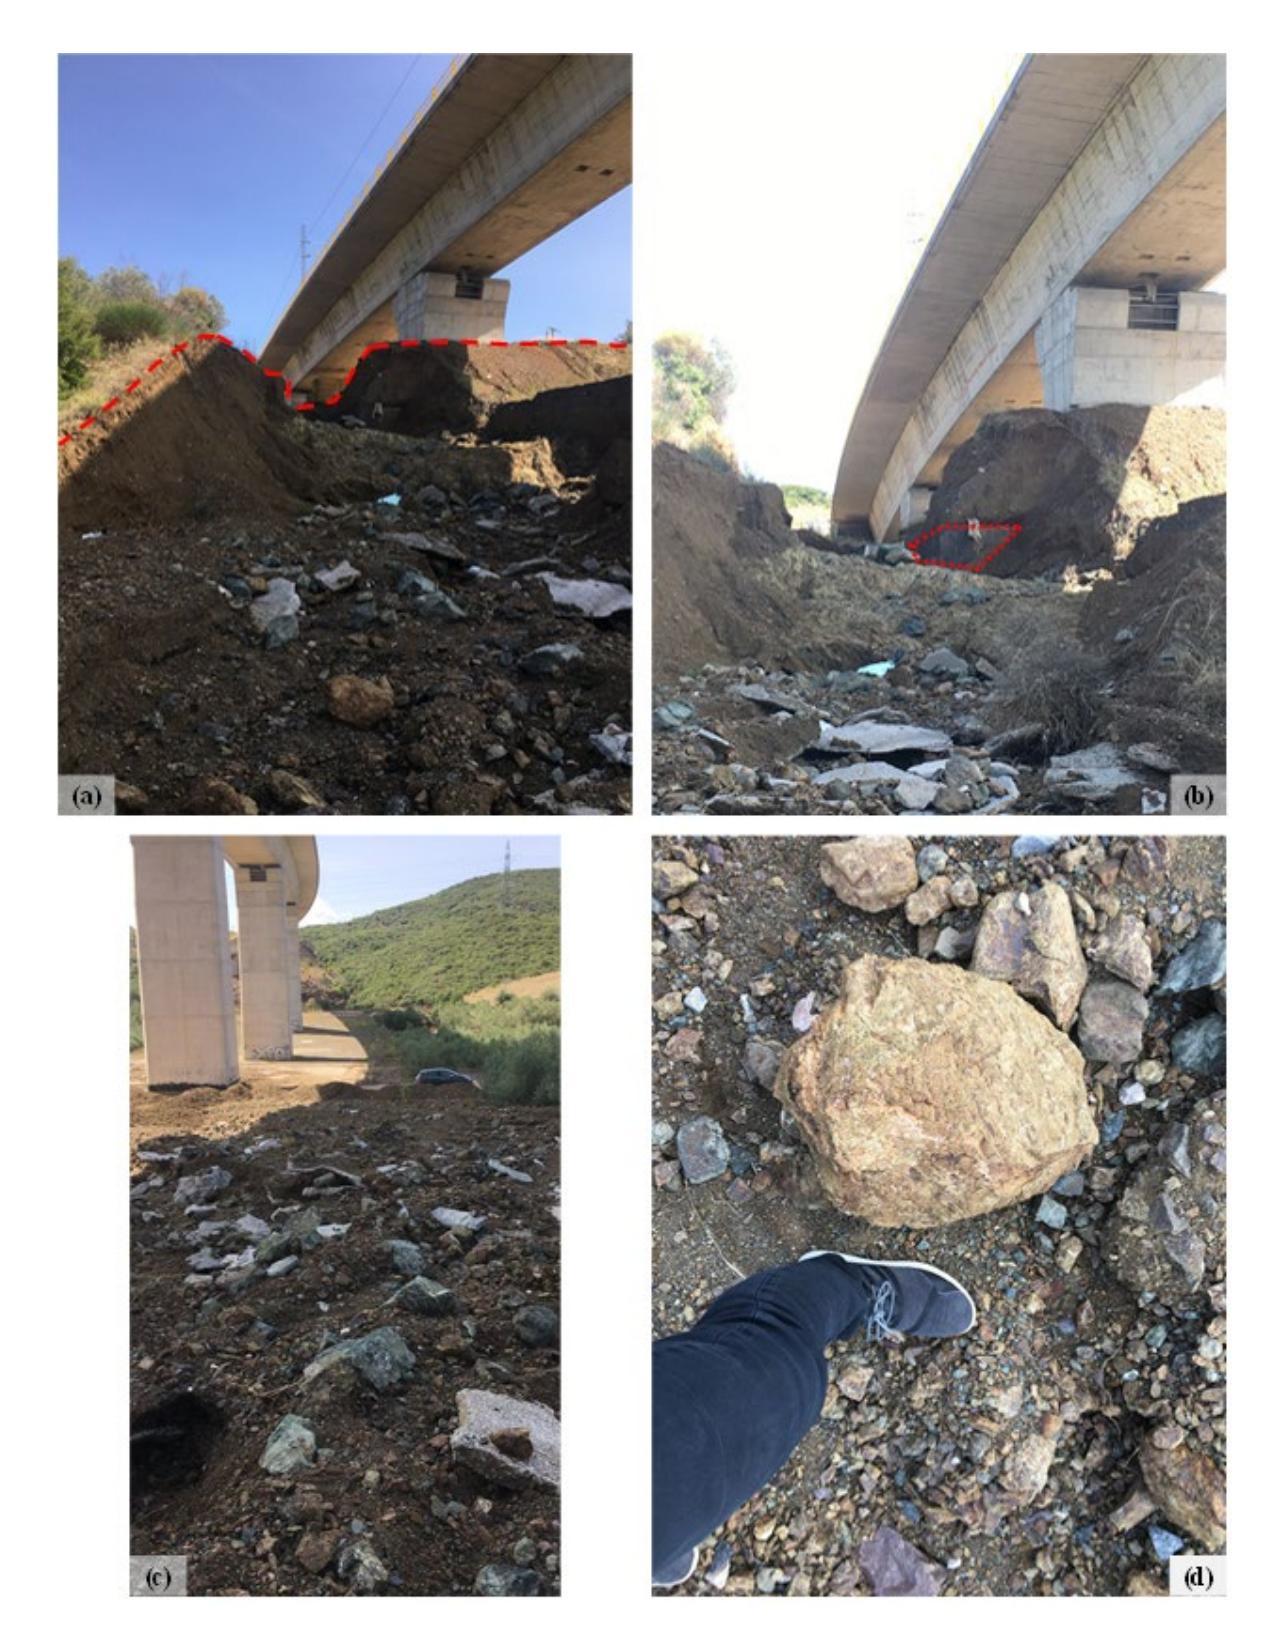
Figure 5.4. Railway bridge foundation scour (38.9609999722°N, 22.3005999722°E): a) eroded scar of bridge foundation embankment, b) exposed pier foundation, c) view of bridge and eroded embankment, and d) indicative size of debris on site

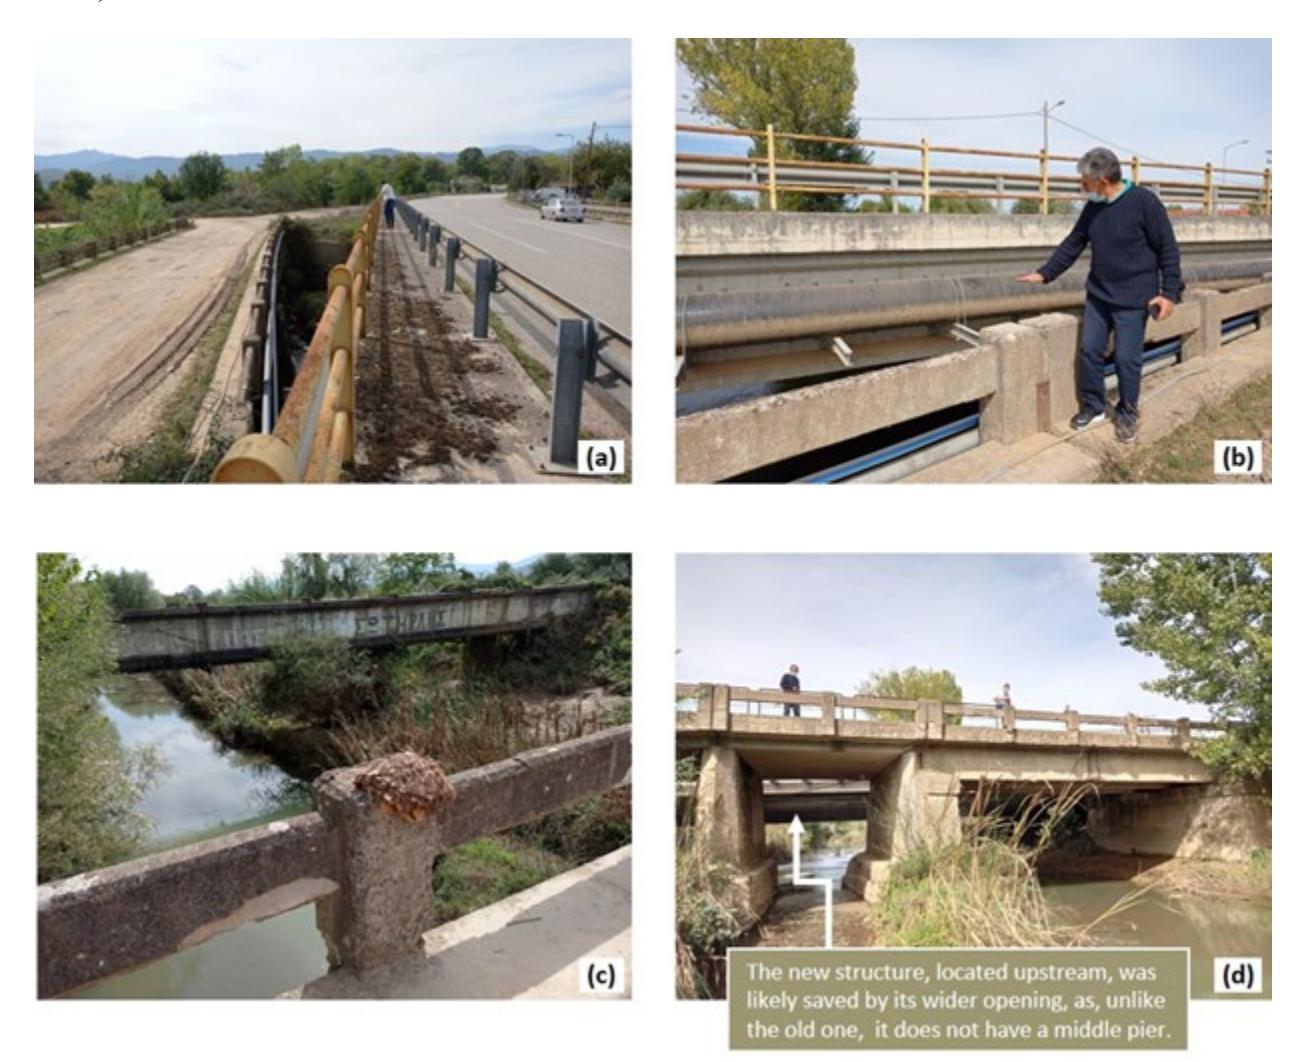
Figure 5.6. Photos of Bridge No. 3: a pair of RC bridges crossing the Gavria Rema along the Karditsa – Kastania provincial road (39.344589222°N; 21.894189833°E): (a) evidence of overflow over the older bridge, which is located a few meters downstream of the younger structure; (b) level of water height; (c) debris remains at the deck; and (d) side view of the structure showing no structural damage.

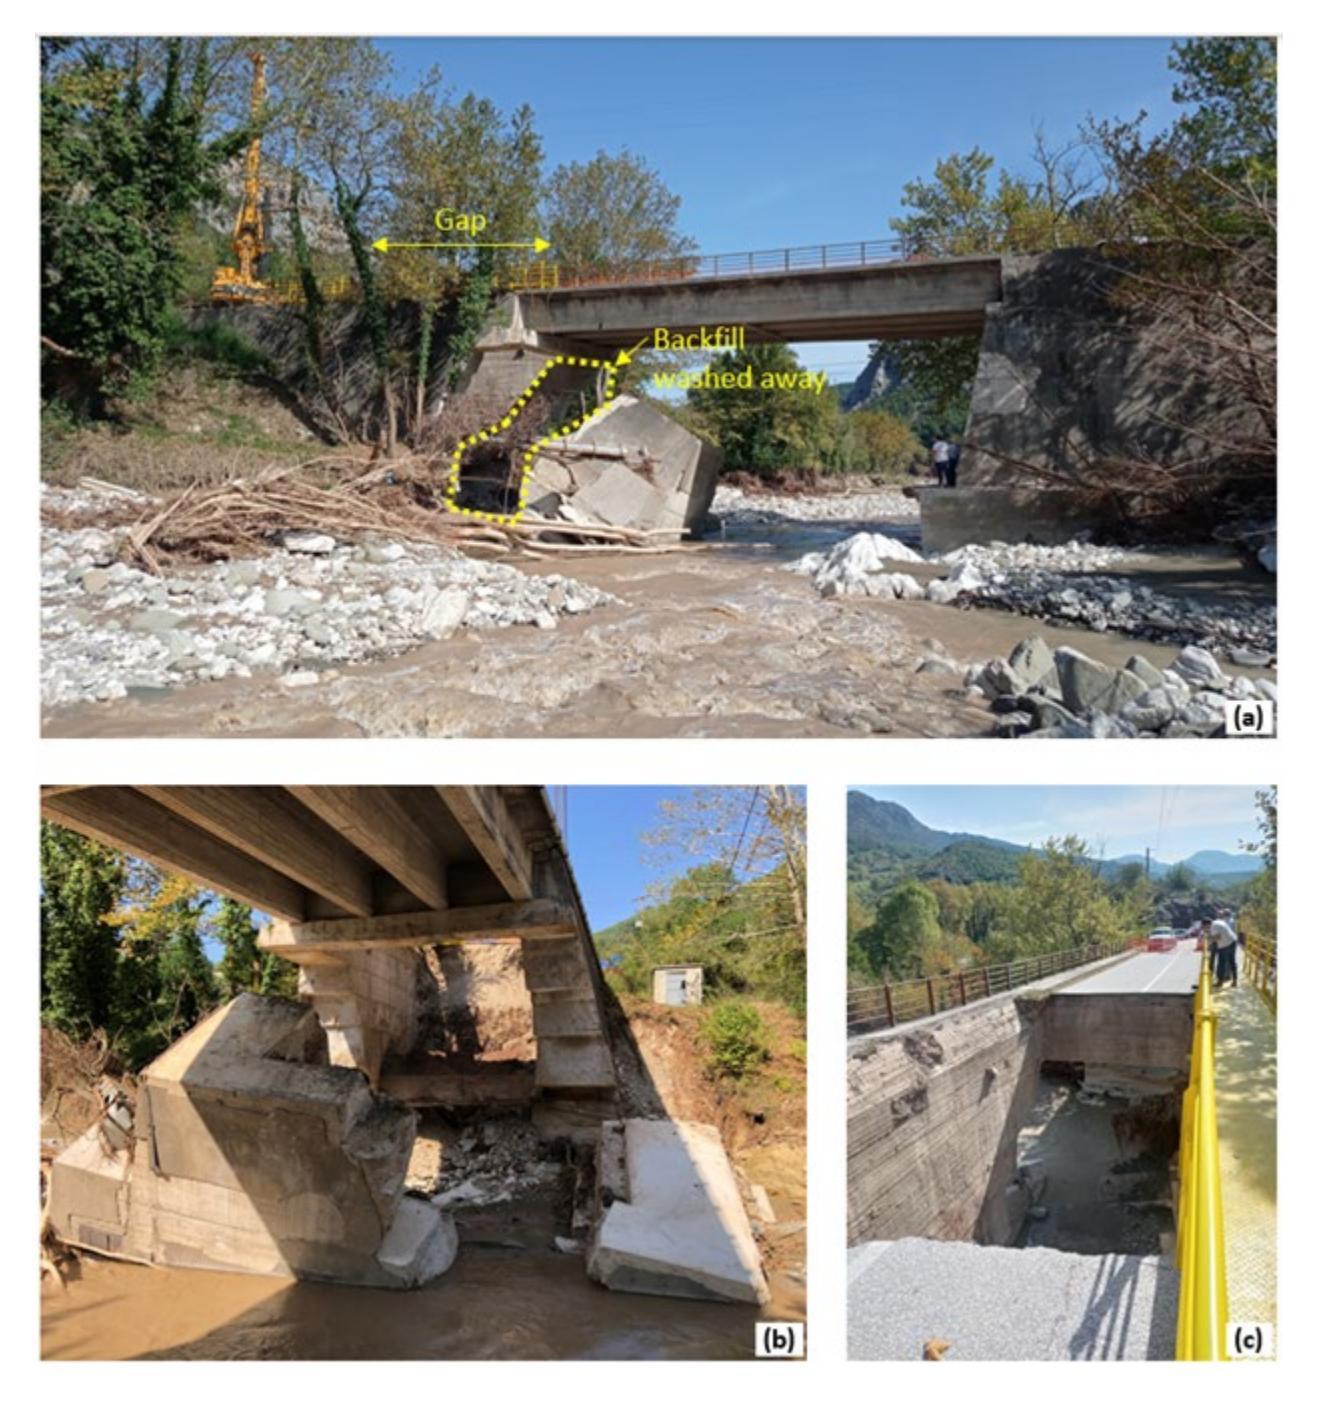
Figure 5.12. Photos of the collapsed Bridge No. 9 crossing Pamisos river about 2 km north of Mouzaki (39.406108333°N; 21.663150000°E): (a) side view indicating abutment backfill erosion and the location of the collapsed roadway segment; (b) closer view of failed abutment wall; and (c) the roadway gap.

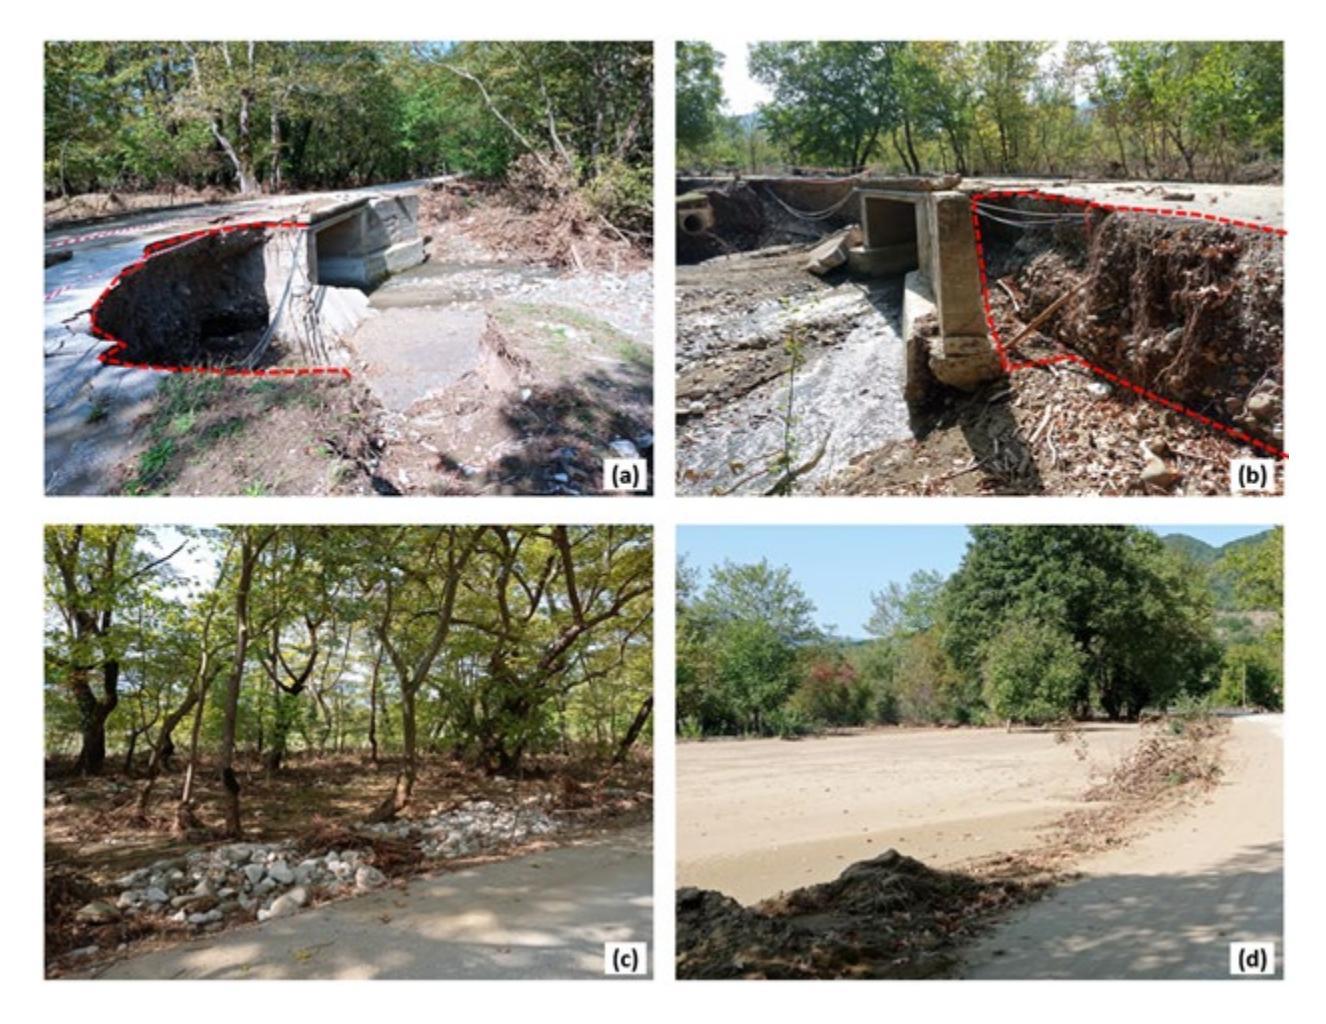
Figure 5.13. Bridge No. 10 crossing a secondary gully on the way from Mouzaki to Ellinokastro $(39.401844000^{\circ} \text{ N}; 21.668420778^{\circ} \text{ E})$: (a) western abutment; (b) eastern abutment; and (c) – (d) photos of surrounding fields indicating widespread flooding.

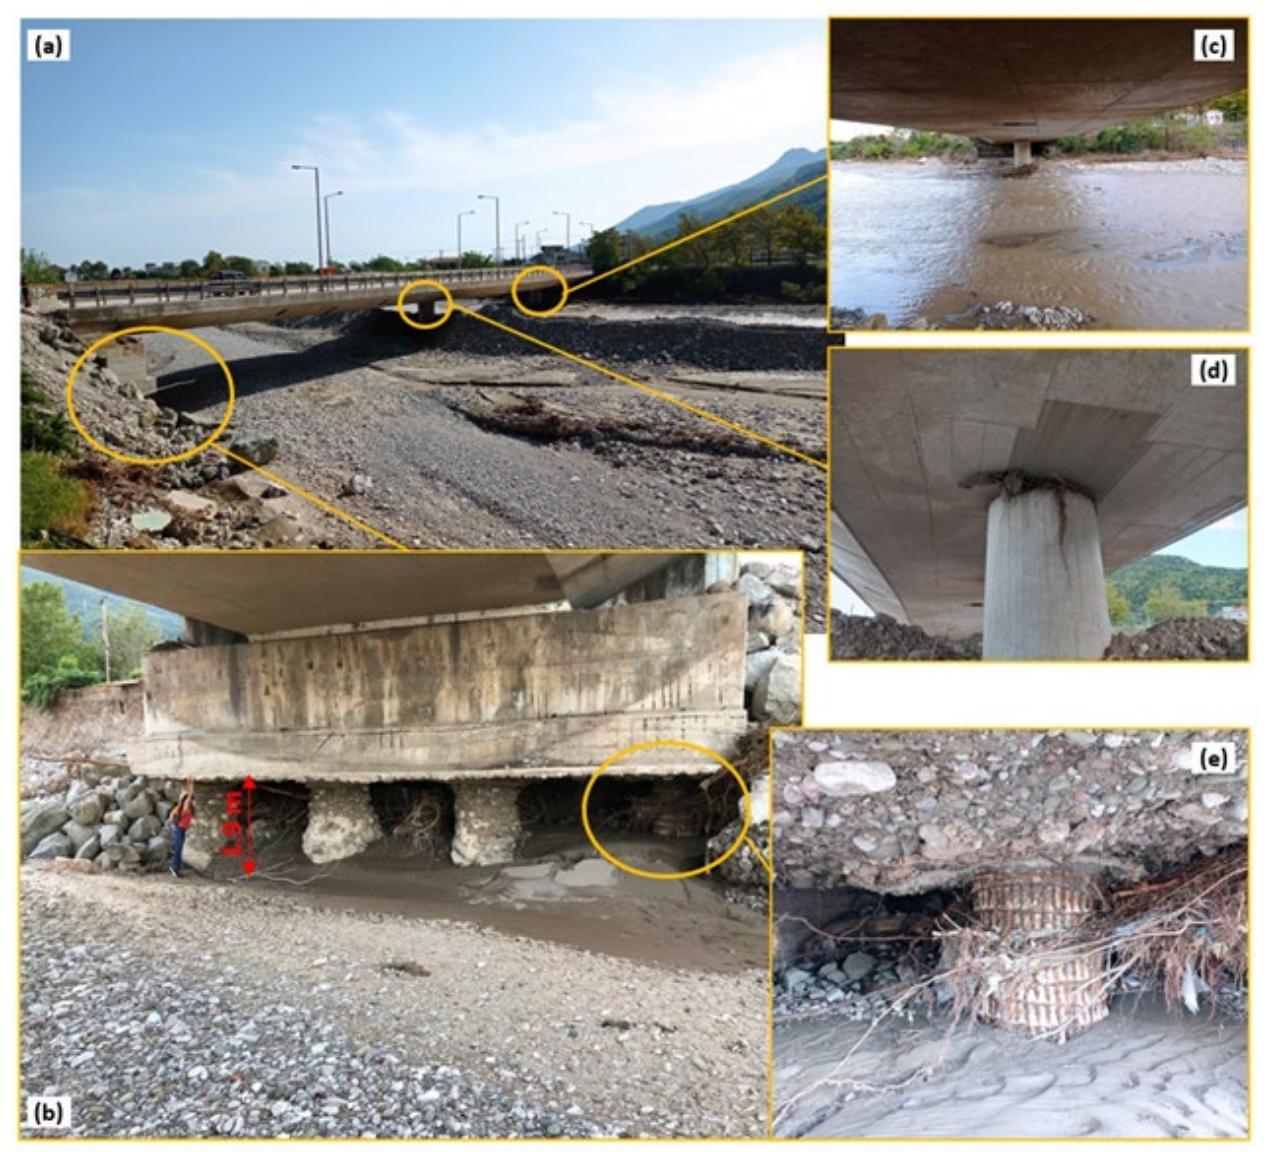
Figure 5.15. Photos of Bridge No. 7, the road bridge crossing Pamissos river in the center of Mouzaki (39.427341667°N; 21.667275000°E): (a) side view; (b) abutment scour; (c) unaffected, opposite (SE) side; (d) debris stuck within the connection between pier and deck indicating flood water height.

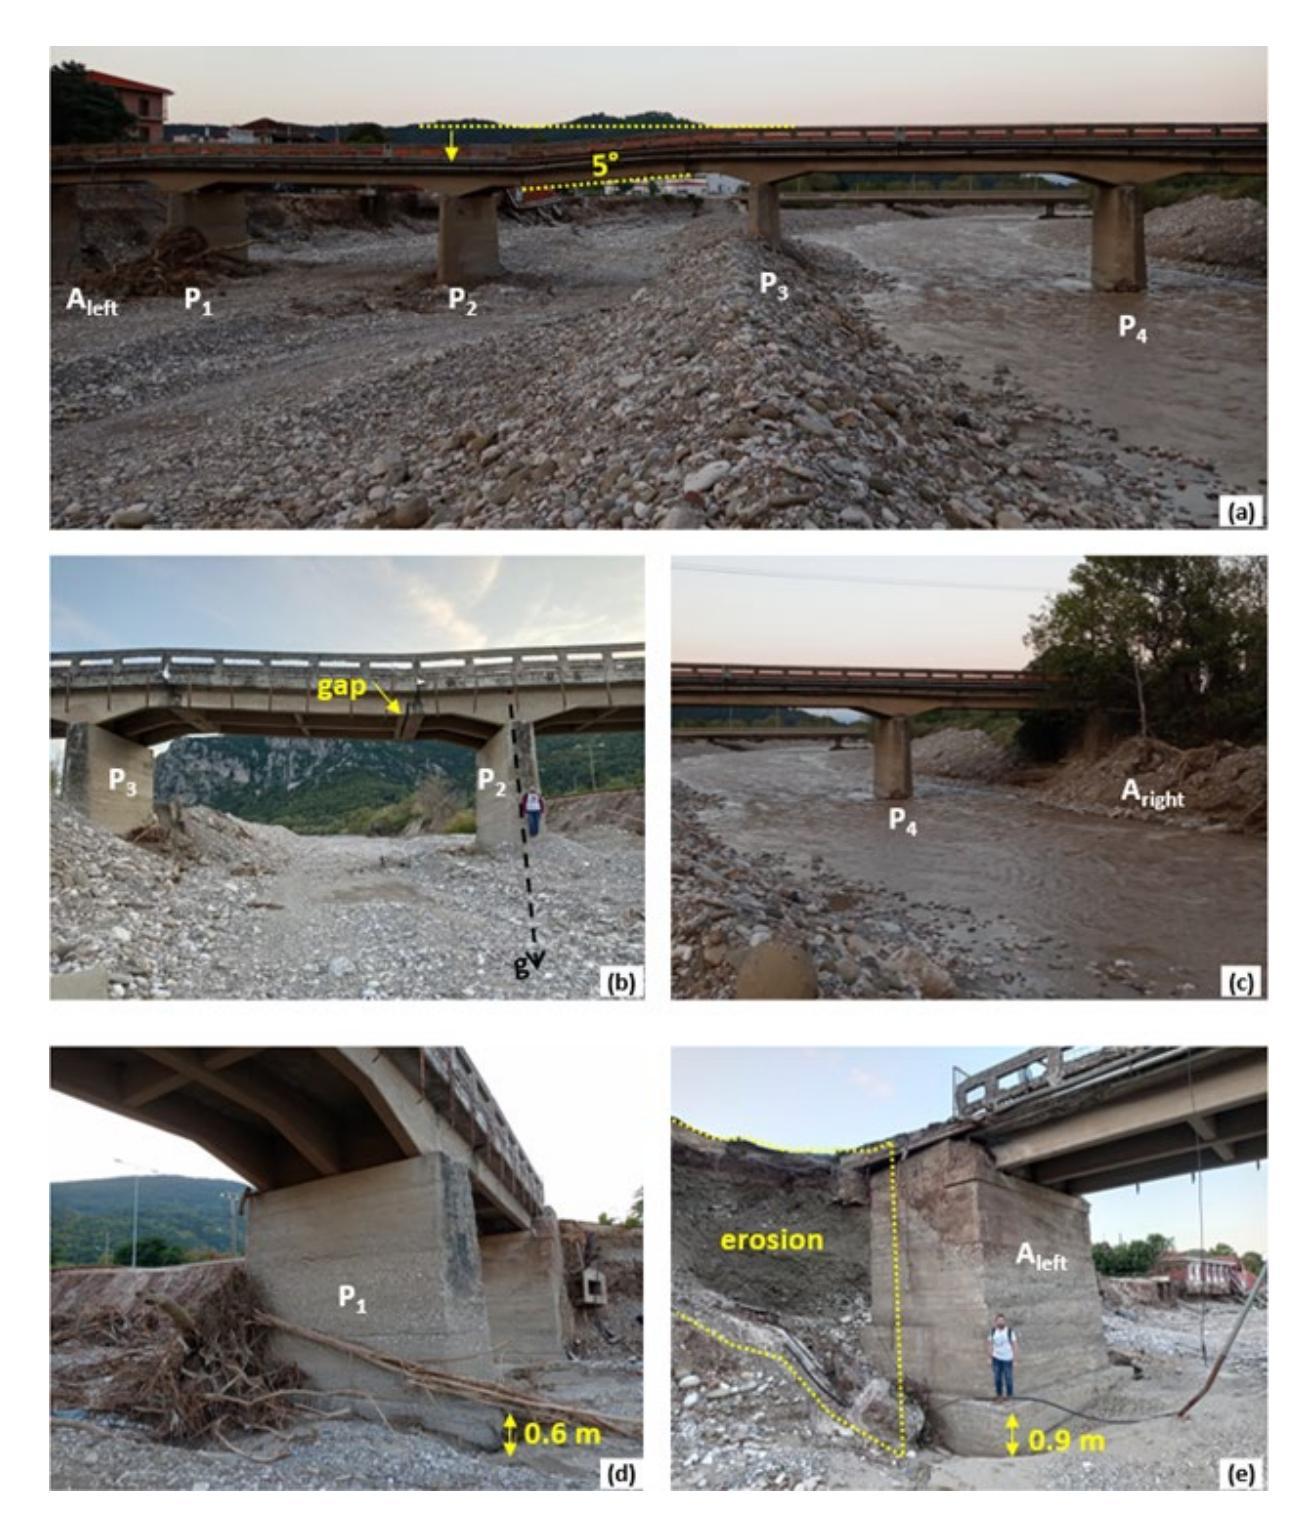
Figure 5.17. Photos of the severely damaged pedestrian bridge in Mouzaki, i.e. Bridge No. 8 (39.425804111°N; 21.666233056°E): (a) longitudinal direction indicating the substantial settlement of the left side (Pier 2) and the associated rotation of the deck; (b) closer view of piers 2 and 3; (c) the evidently unaffected right side; (d) scour at P1; and (e) abutment scour and backfill erosion.

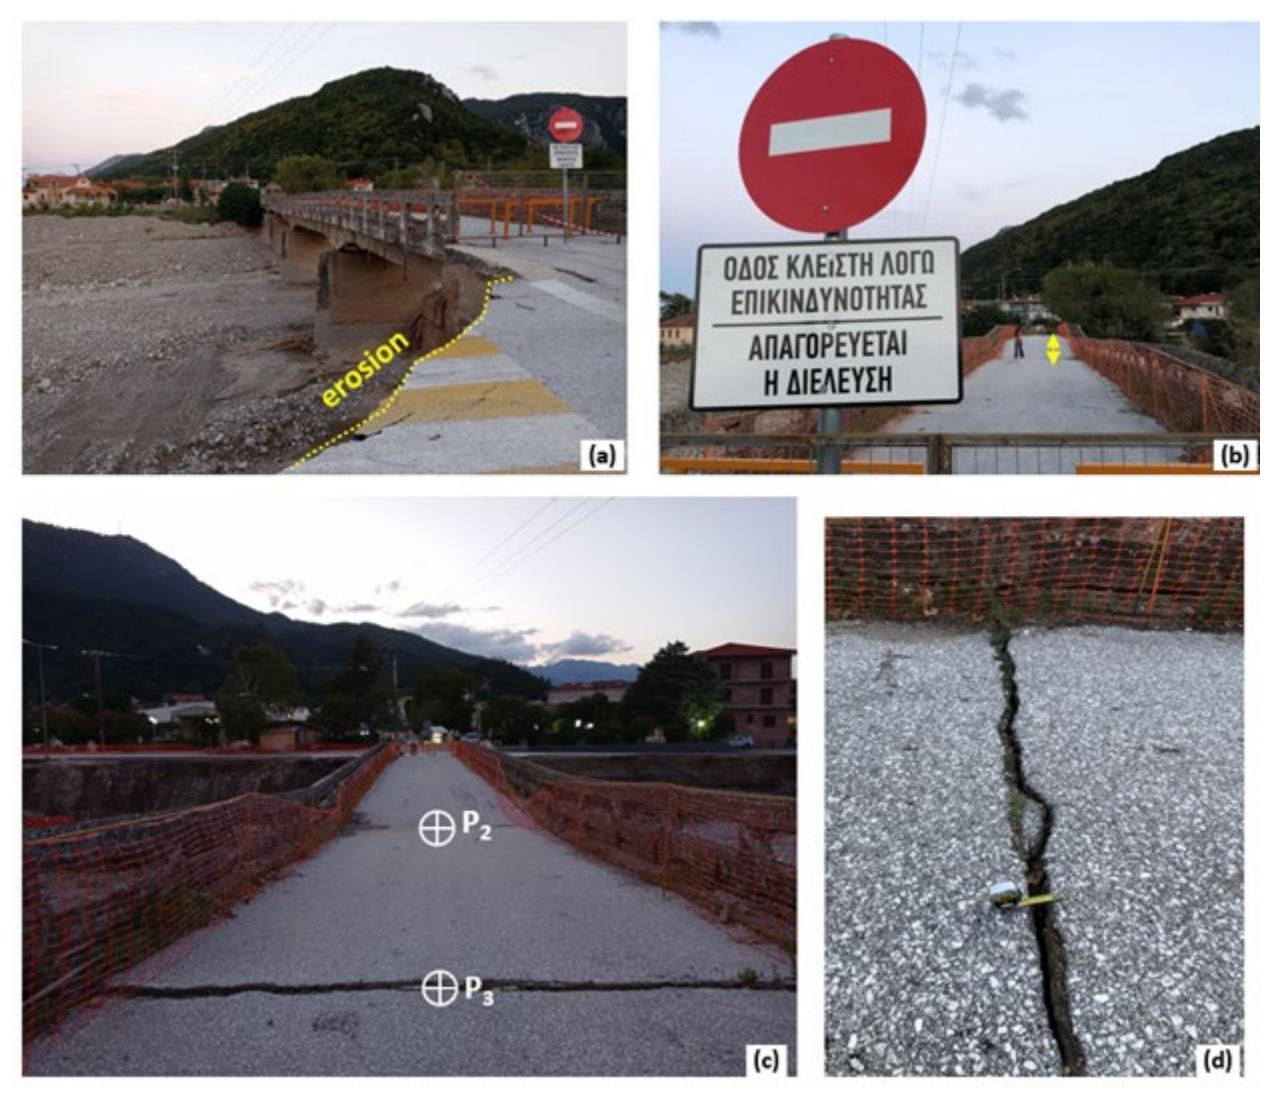
Figure 5.18. Photos of Bridge No. 8 taken from the level of the roadway: (a) abutment erosion; (b) settlement induced step; (c) – (d) extension cracks over Pier 3.

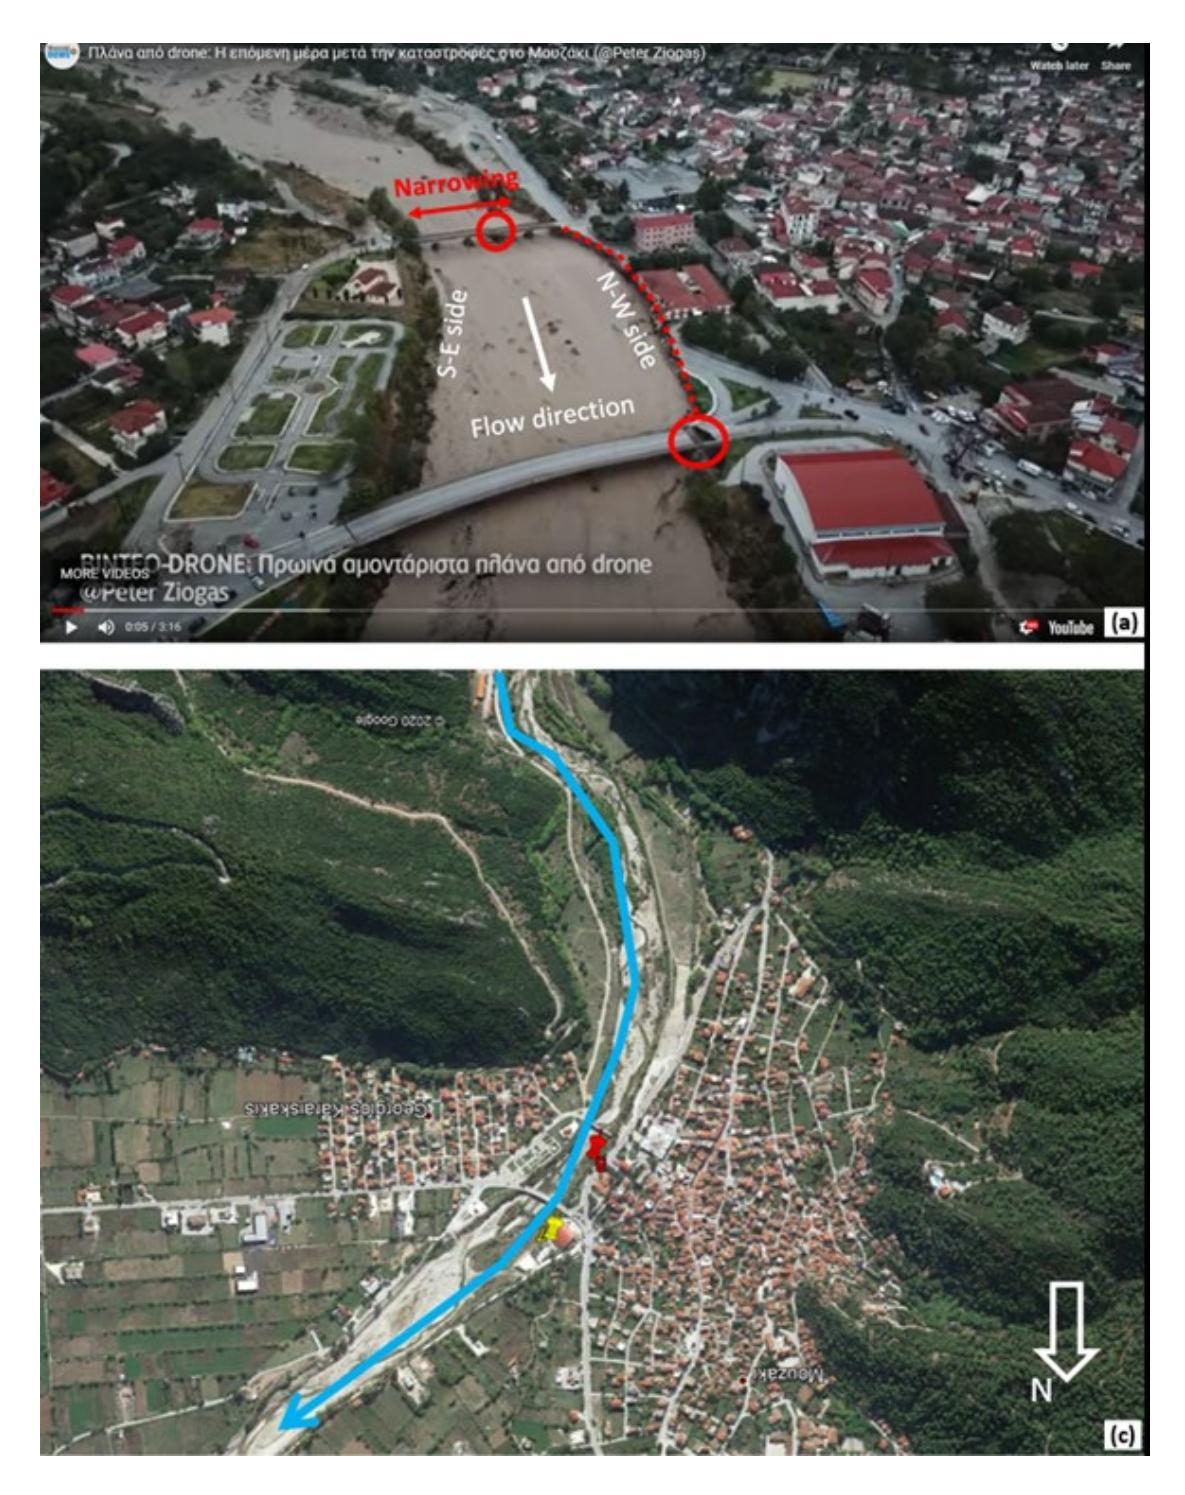
Figure 5.19. (a) Drone footage captured on September 19, 2020 (source: <u>https://www.youtube.com/watch?v=3bqDobqMuC0</u>) showing that erosion damage was concentrated on the left (N-W) riverbank while the right (S-E) side remained unaffected; (b) river course geometry that helps explain the scour of the exterior bank of the river.

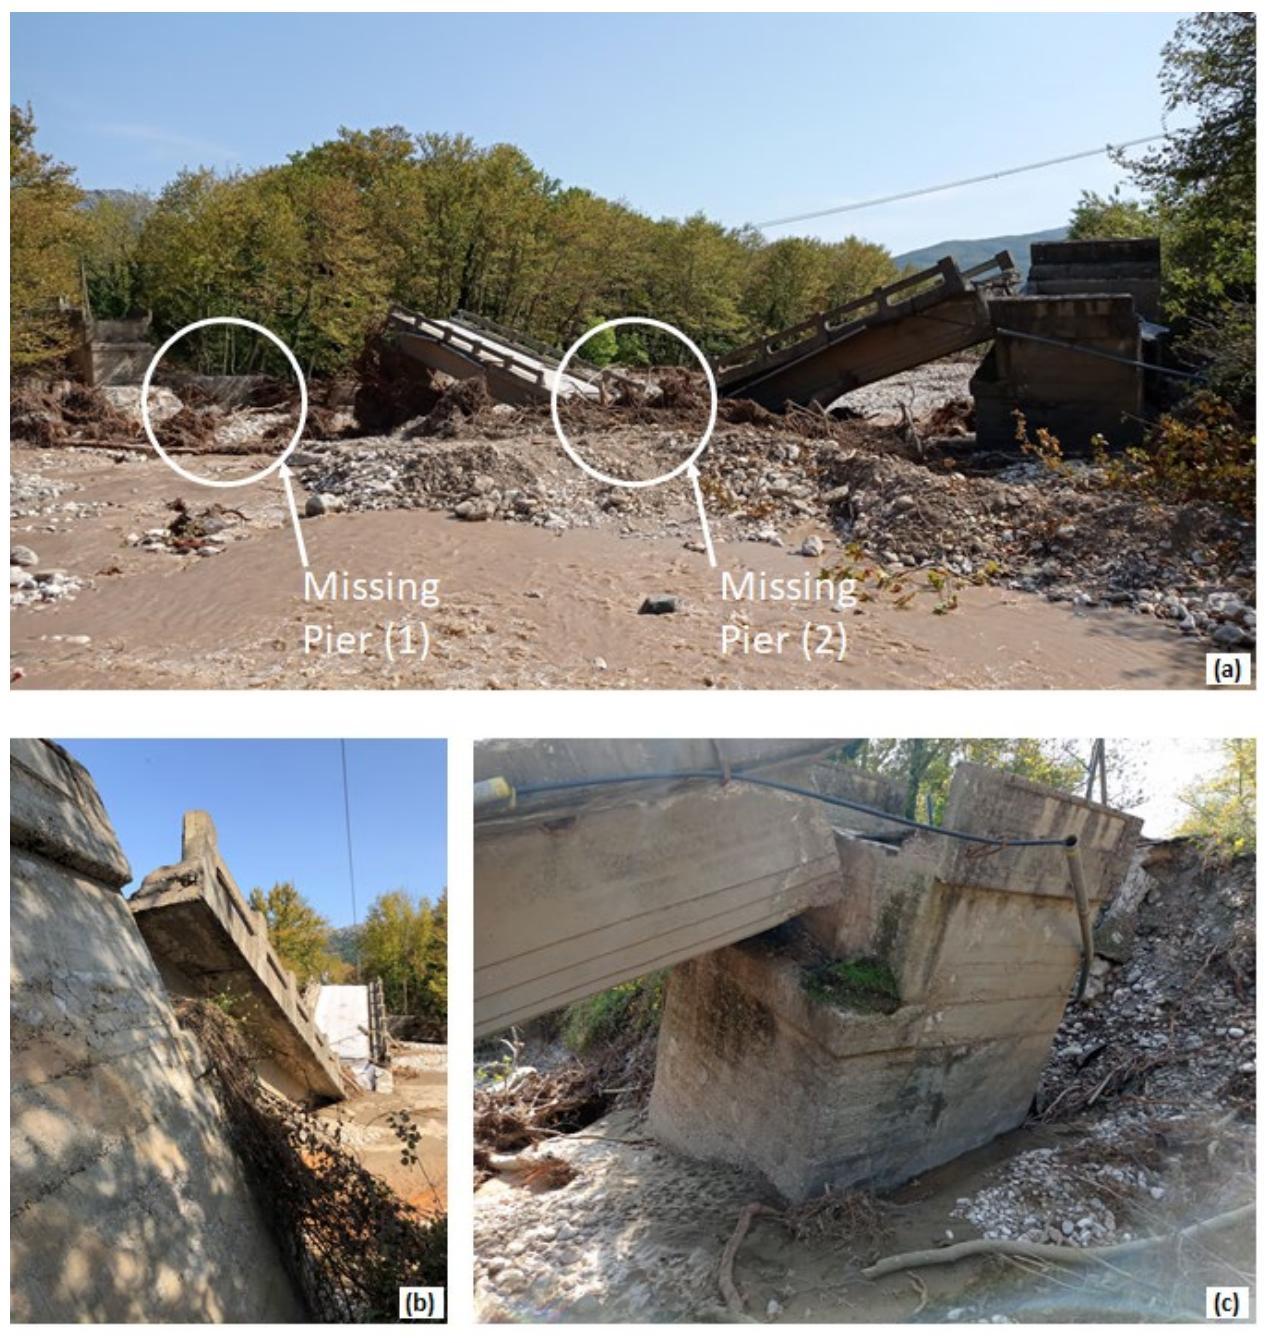
Figure 5.21. Photos of Bridge No. 11 (39.401172611°N; 21.652868250°E) which evidently collapsed due to a combination of abutment and pier scour: (a) side view, (b) - (c) bearing capacity failure of the abutment and deck collapse.

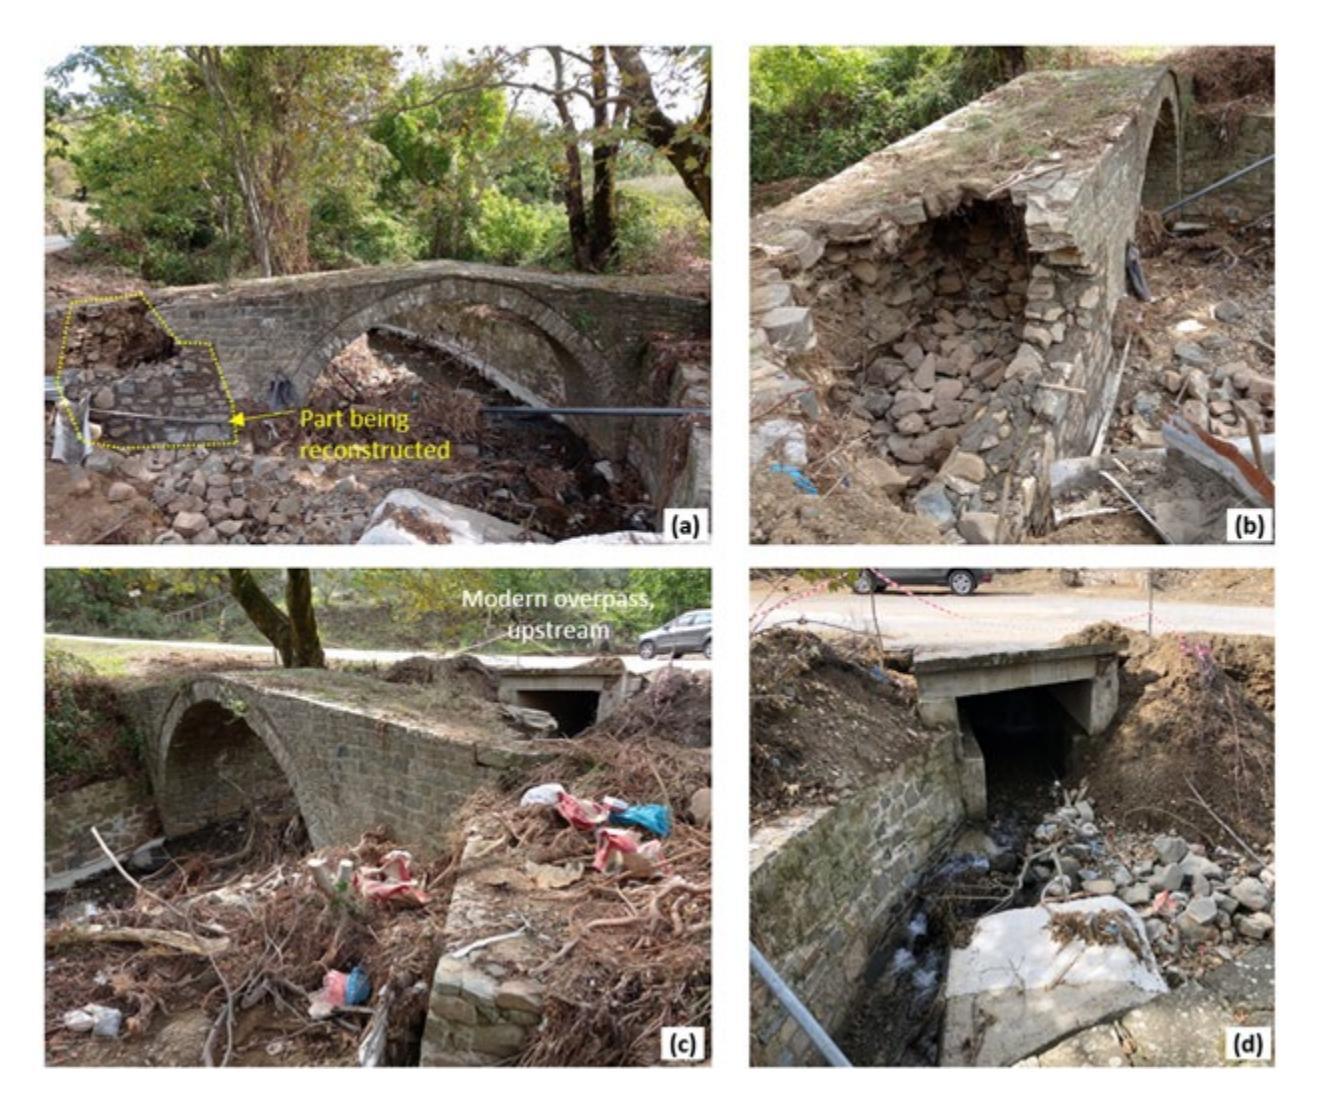
Figure 5.25. Photos of Bridge No.2, a masonry arch near Moschato $(39.32248333^{\circ}N; 21.79625000^{\circ}E)$: (a) – (b) part of it was being reconstructed on 2/10/2020, while (c) there was a significant amount of debris upstream, especially in the (d) modern (RC) overpass.
