The September 18-20 2020 Medicane Ianos Impact on Greece

Phase I Reconnaissance Report

Geotechnical Extreme Events Reconnaissance Association

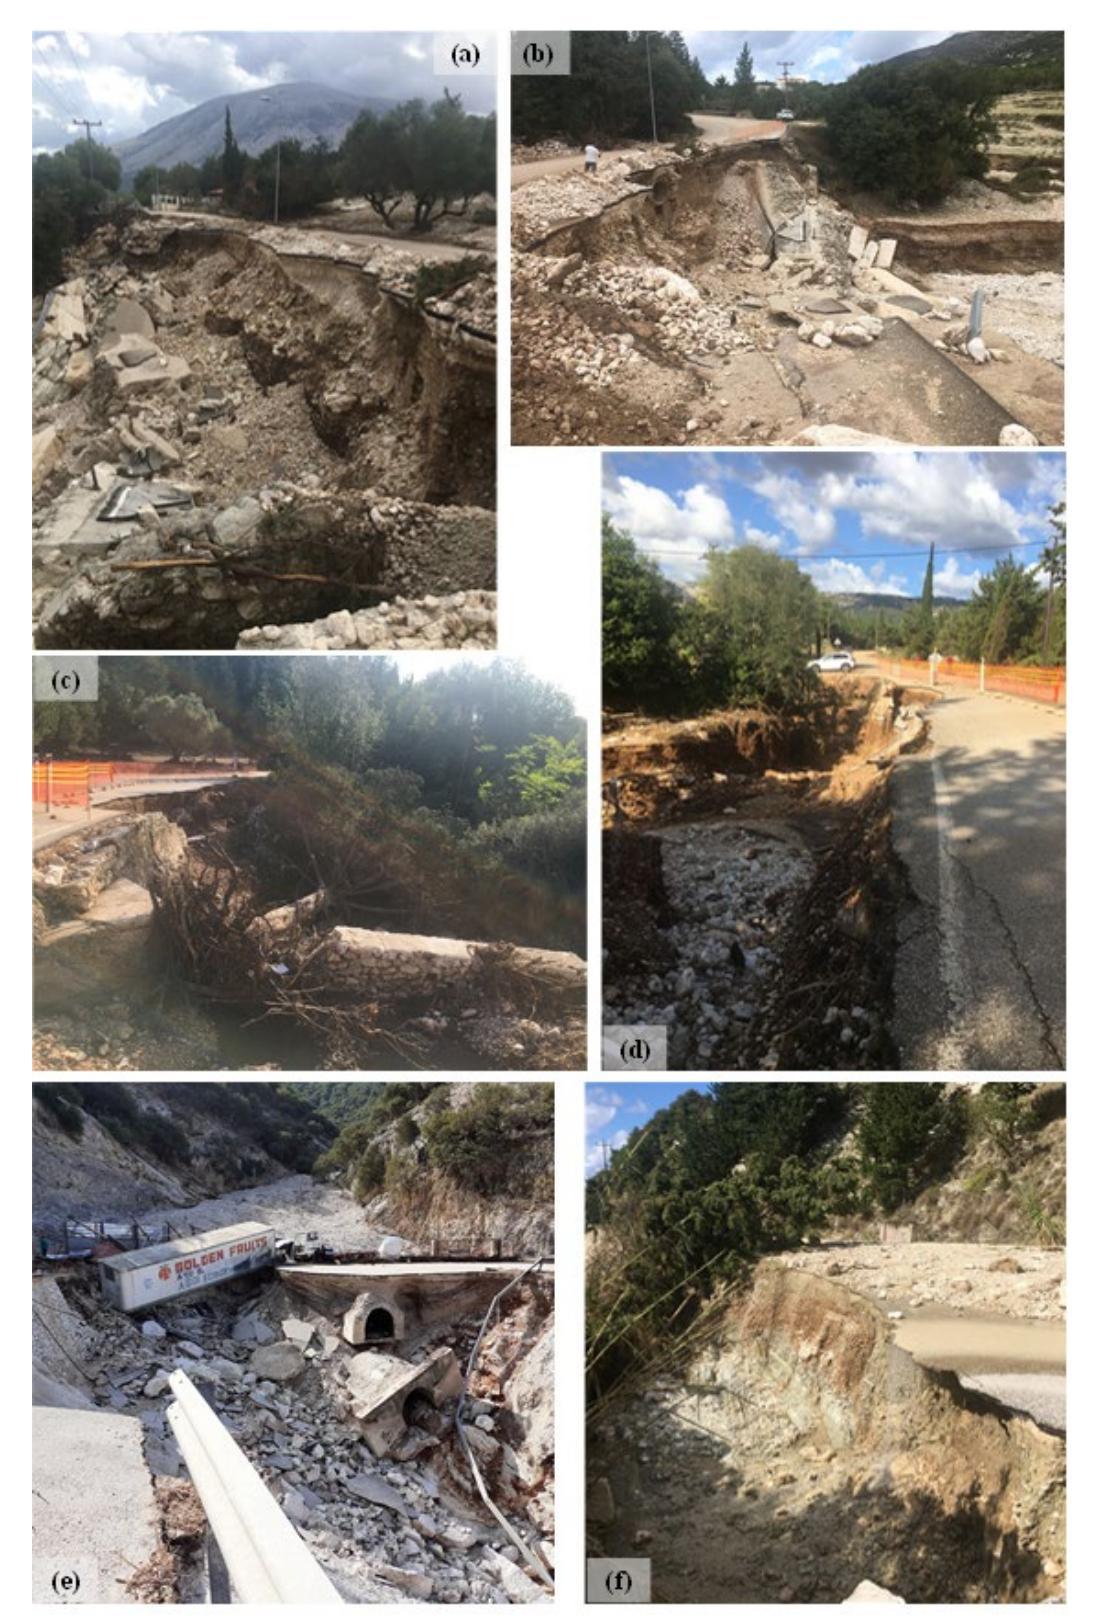
Figure 5.27. Road embankment failures across Cephalonia due to flood/debris related erosion: a,b) 38.325680556°N, 20.551658333°E, c,d) 38.310936111°N, 20.576272222°E, e) 38.326667°N, 20.518333°E, and f) 38.335719444°N, 20.543761111°E

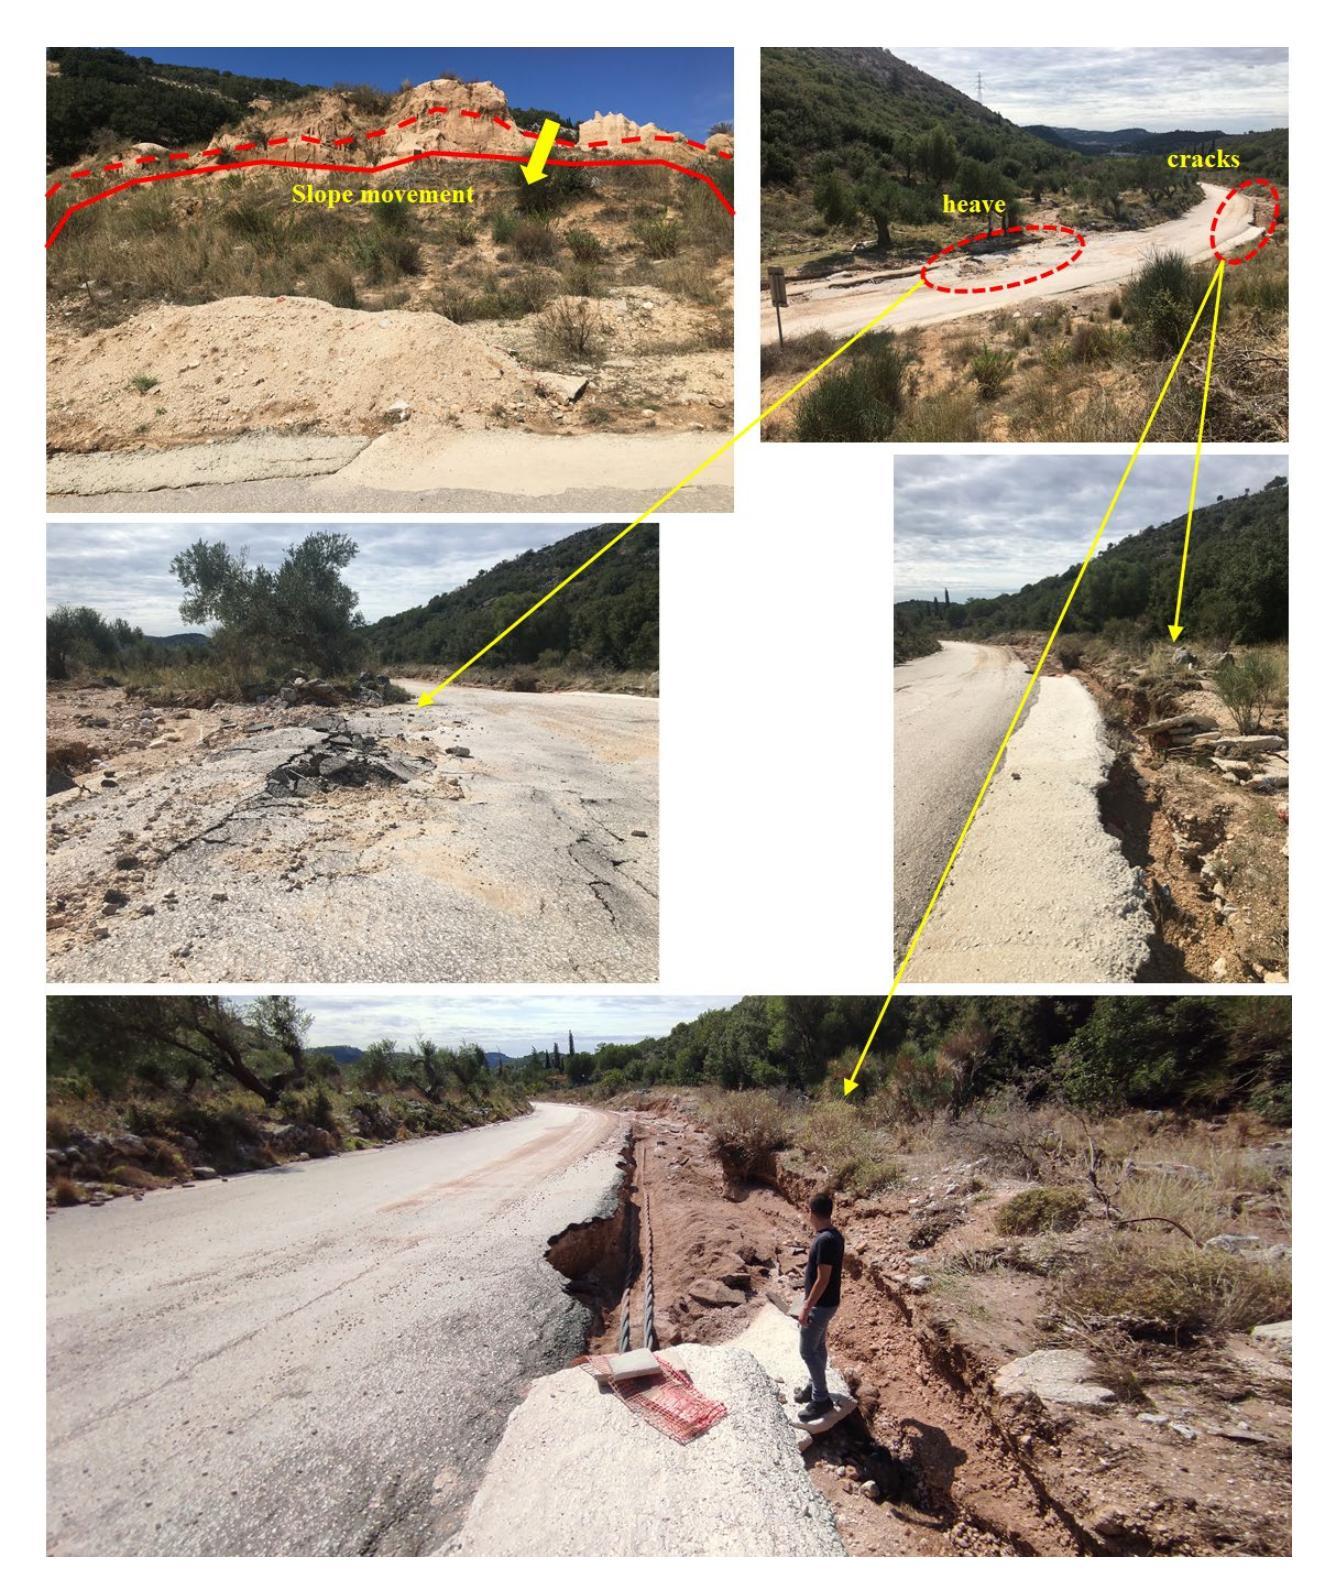
Figure 5.28. Roadside slope failure that led to road heave and cracks along a 150 m stretch (38.201636111°N, 20.502291667°E)

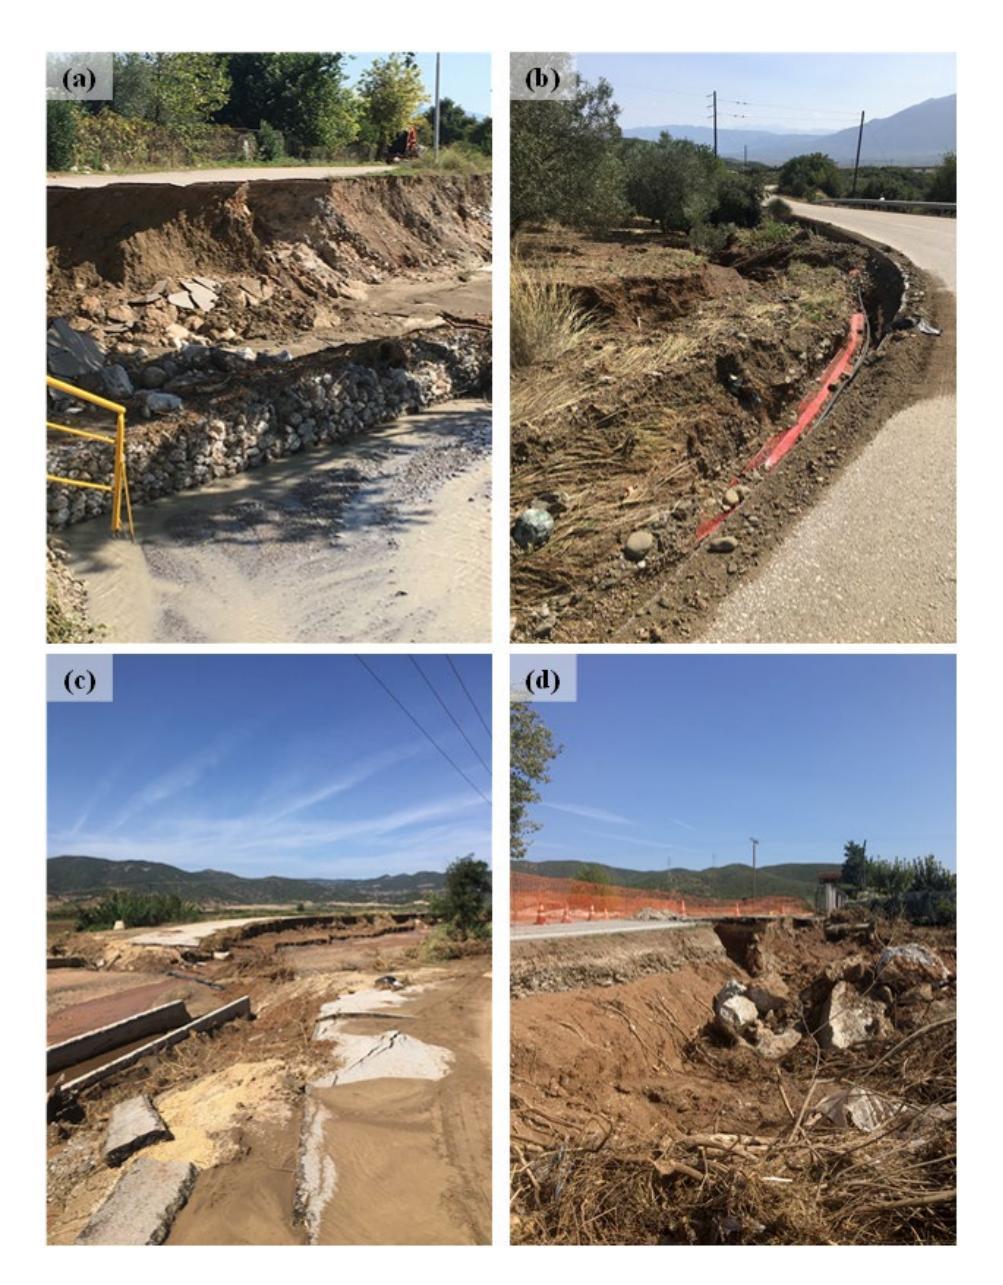
Figure 5.29. Road embankment failures in the region of Lamia: a) at Gorgopotamos (38.83451944°N, 22.39527499°E); b) north of Stirfaka (38.96918055°N, 22.29513611°E); c) along the E.O. Lamia Karpenisi (38.92455°N, 22.27771944°E); d) near Paliouri (38.94233611°N, 22.21619722°E)

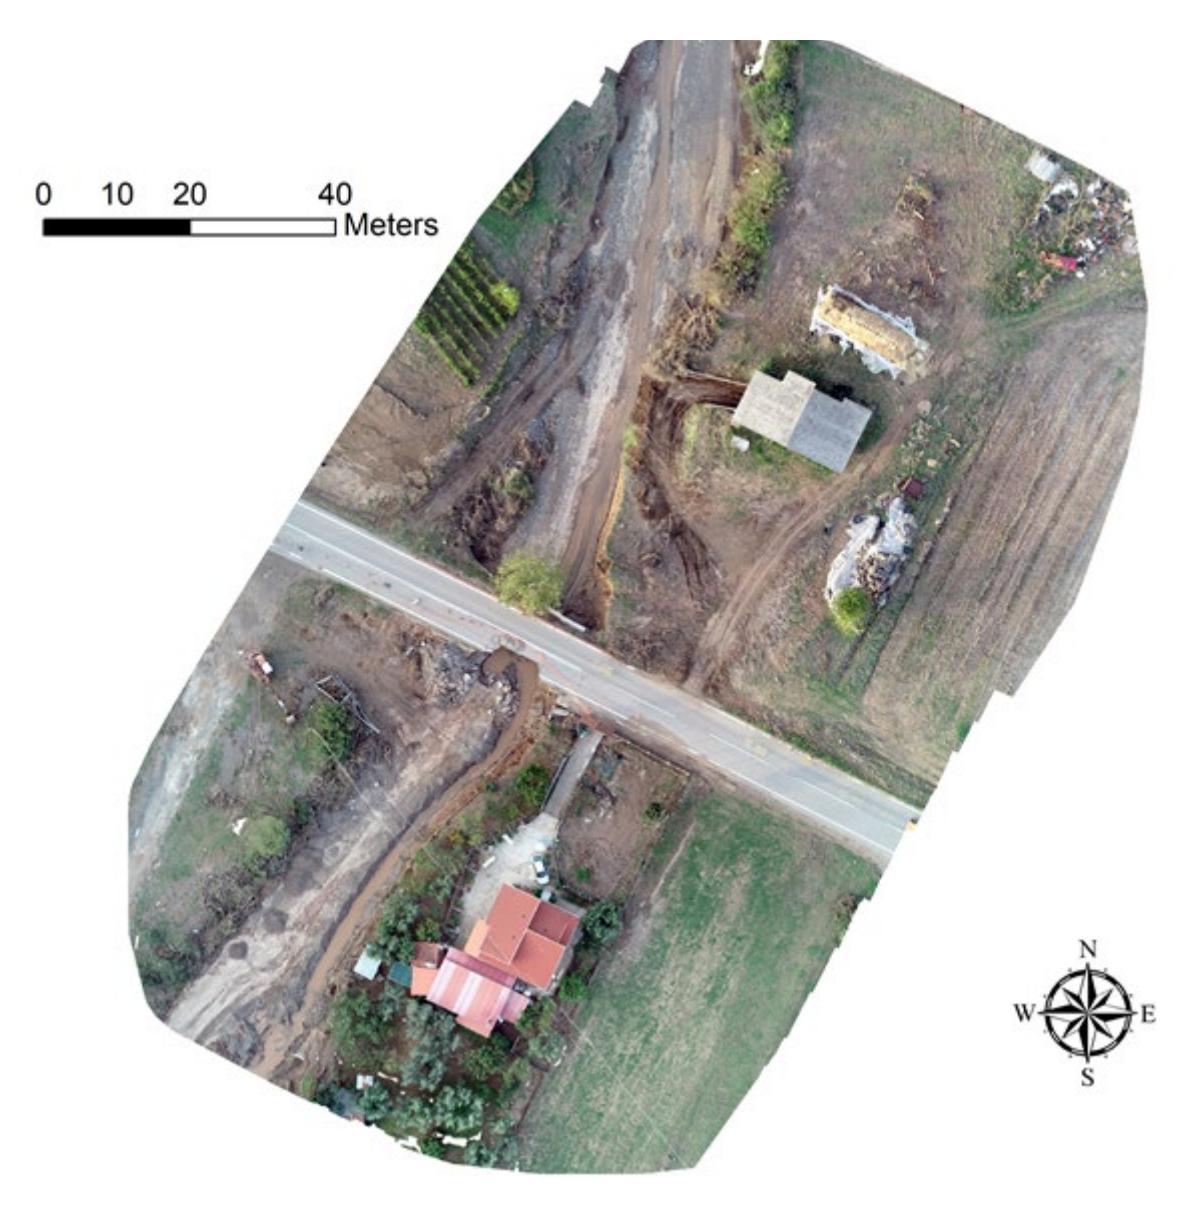
Figure 5.30. UAV-enabled orthophoto of road failure on E.O. Lamia-Karpenisi (38.94233611°N, 22.21619722°E)

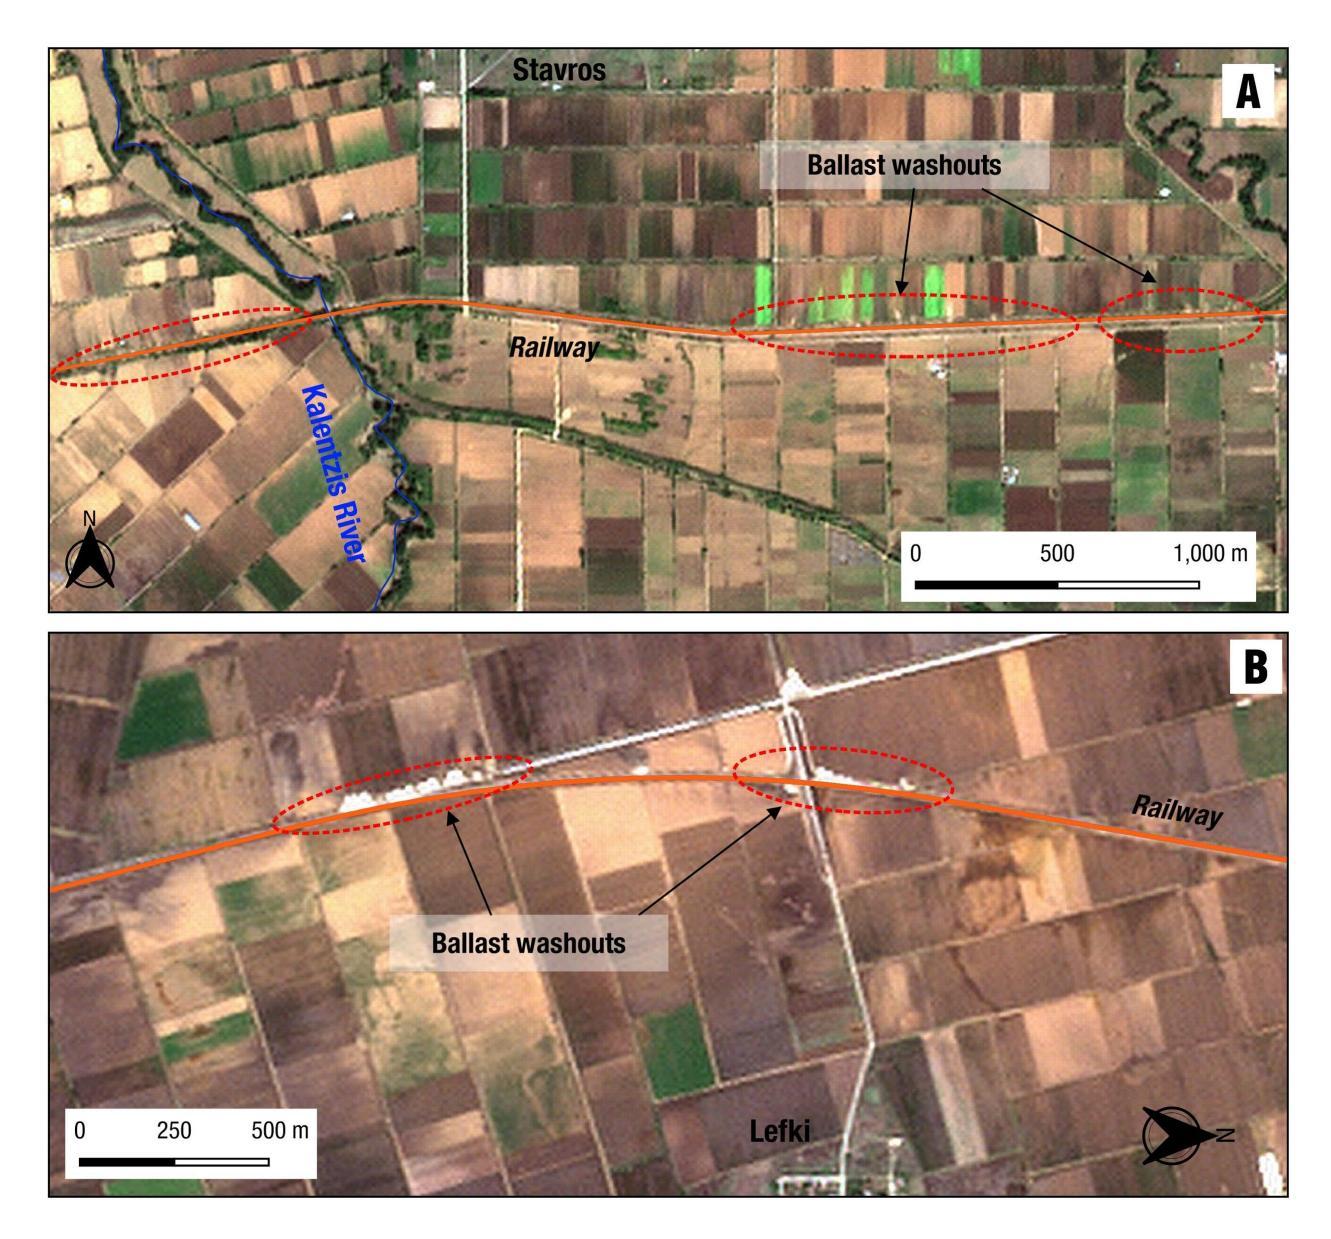
Figure 5.36. Locations of significant washout along the railway line embankment, distinguished by the lateral flow of eroded material (ballast washouts). A) Railway line Kalabaka-Paleofarsalos, east of Karditsa (map center location 39.34951°N, 21.9852°E). B) Railway line Paleofarsalos-Larisa, north of Paleofarsalos (Stavros) (map center location 39.3800°N, 22.2234°E). Sentinel-2 true color imagery (RGB432) acquired in September 25 2020, enhanced using Sub-Pixel Convolutional Neural Network (super-resolution).

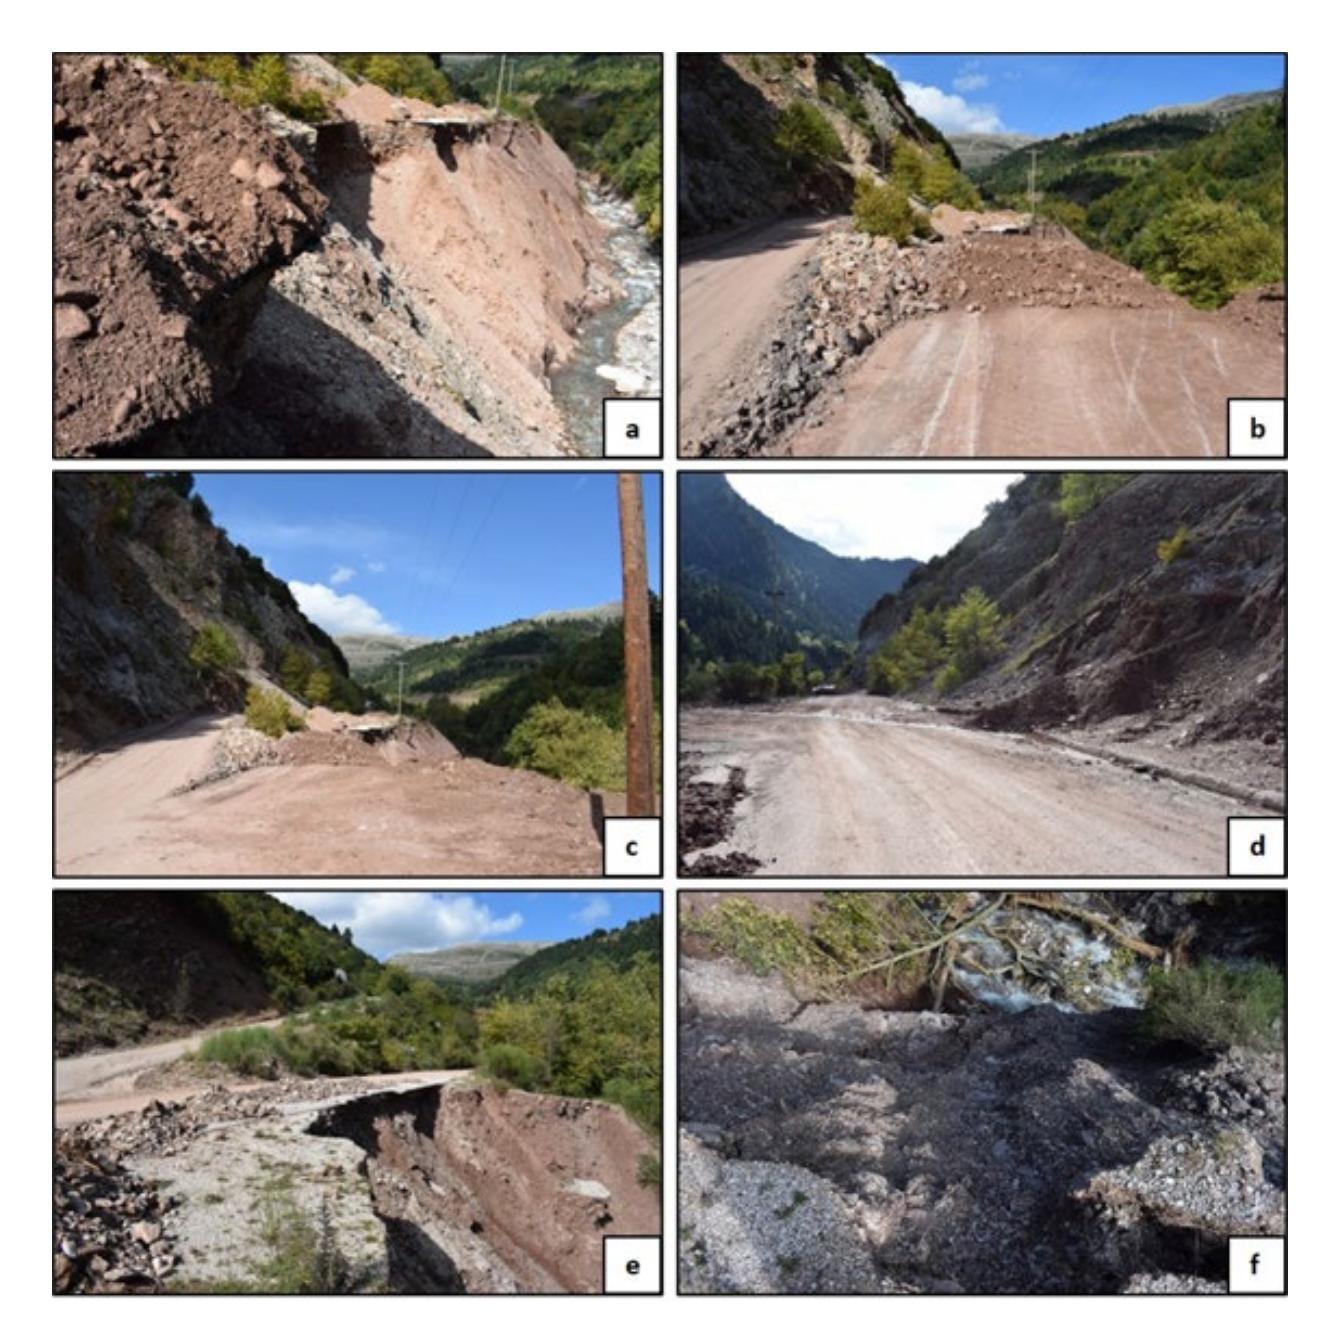
Figure 6.10. Rotational slide that caused road damage next to Argithea village (39.356111°N, 21.535556°E).

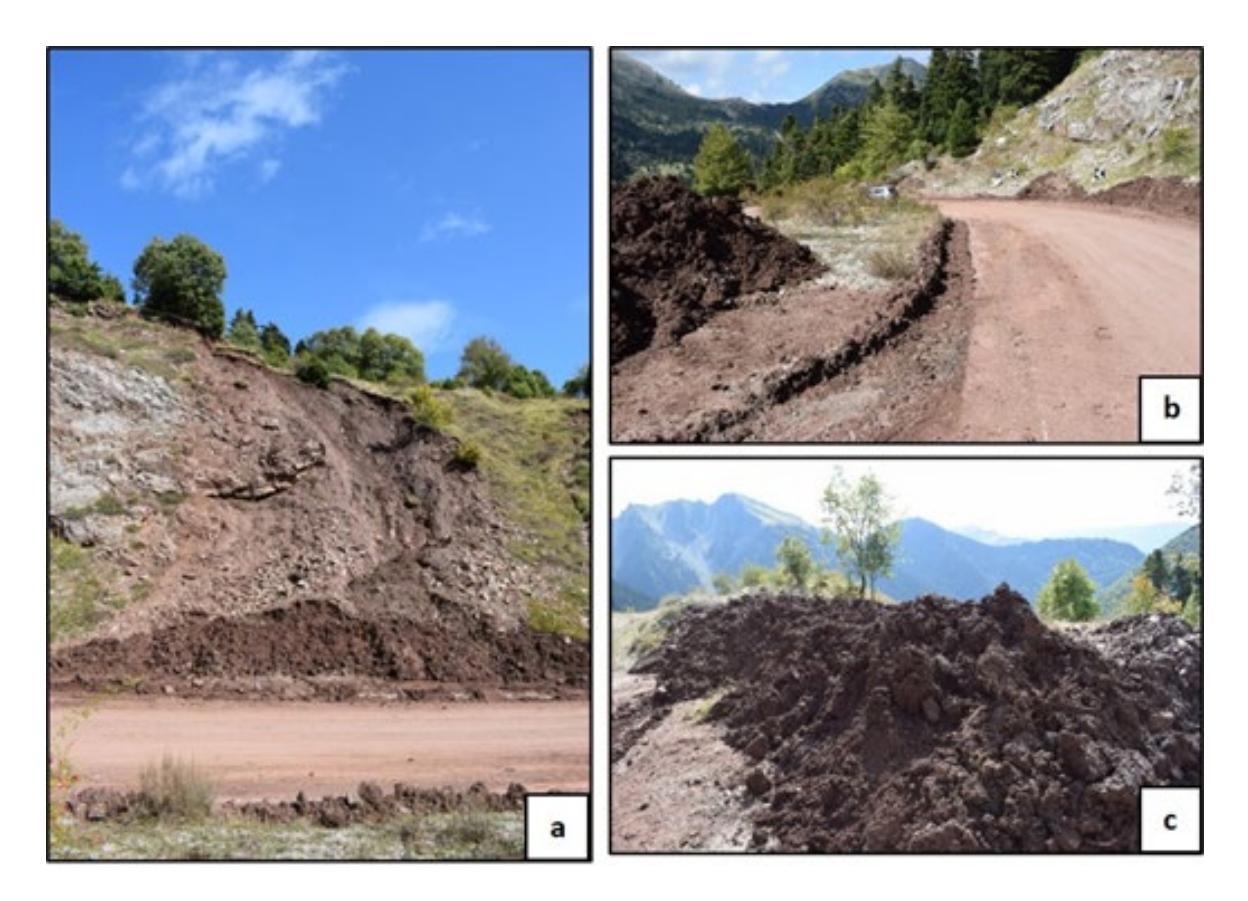
Figure 6.11. Rotational slide in Eastern Argithea area (39.364444°N, 21.541111°E)

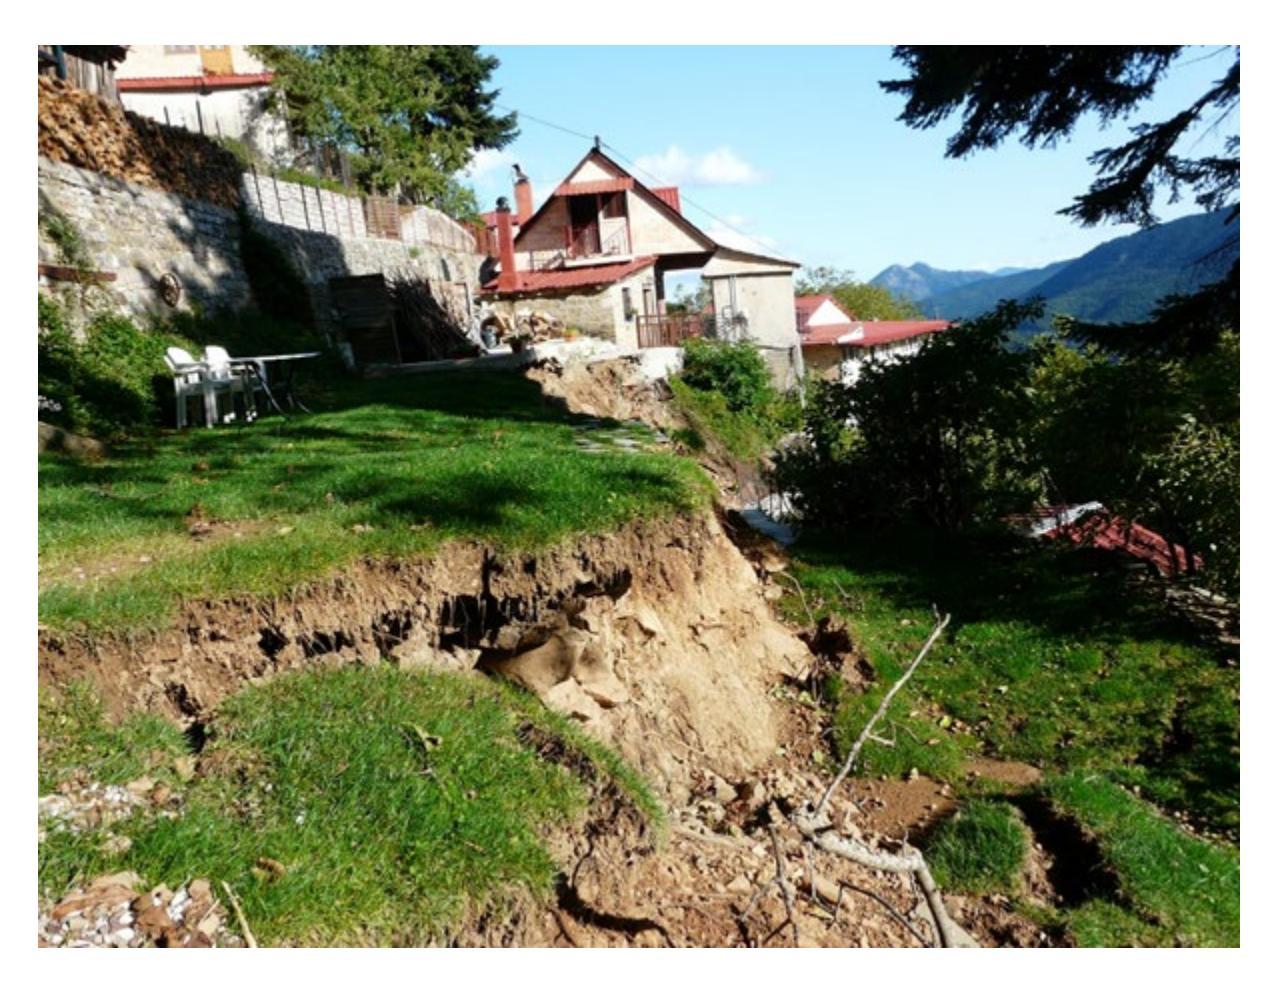
Figure 6.18. Rotational slide causing structural damage at the village of Rafina (39.27172°N, 21.69607° E)

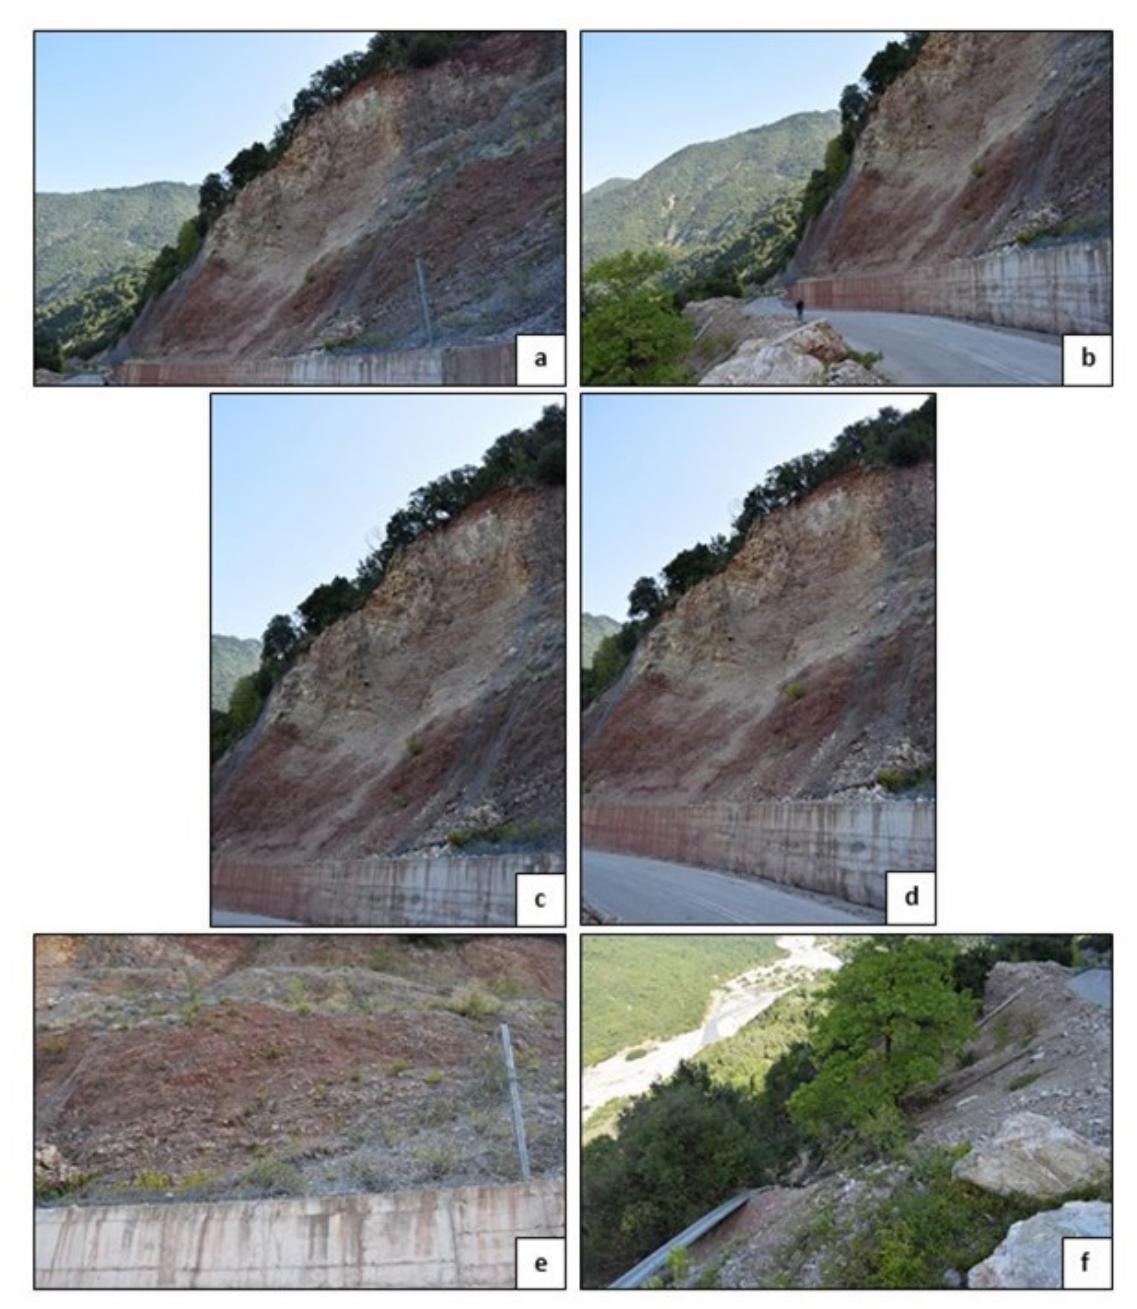
Figure 6.26. Rockfall failure at the area of Karpenisi - Agrafa

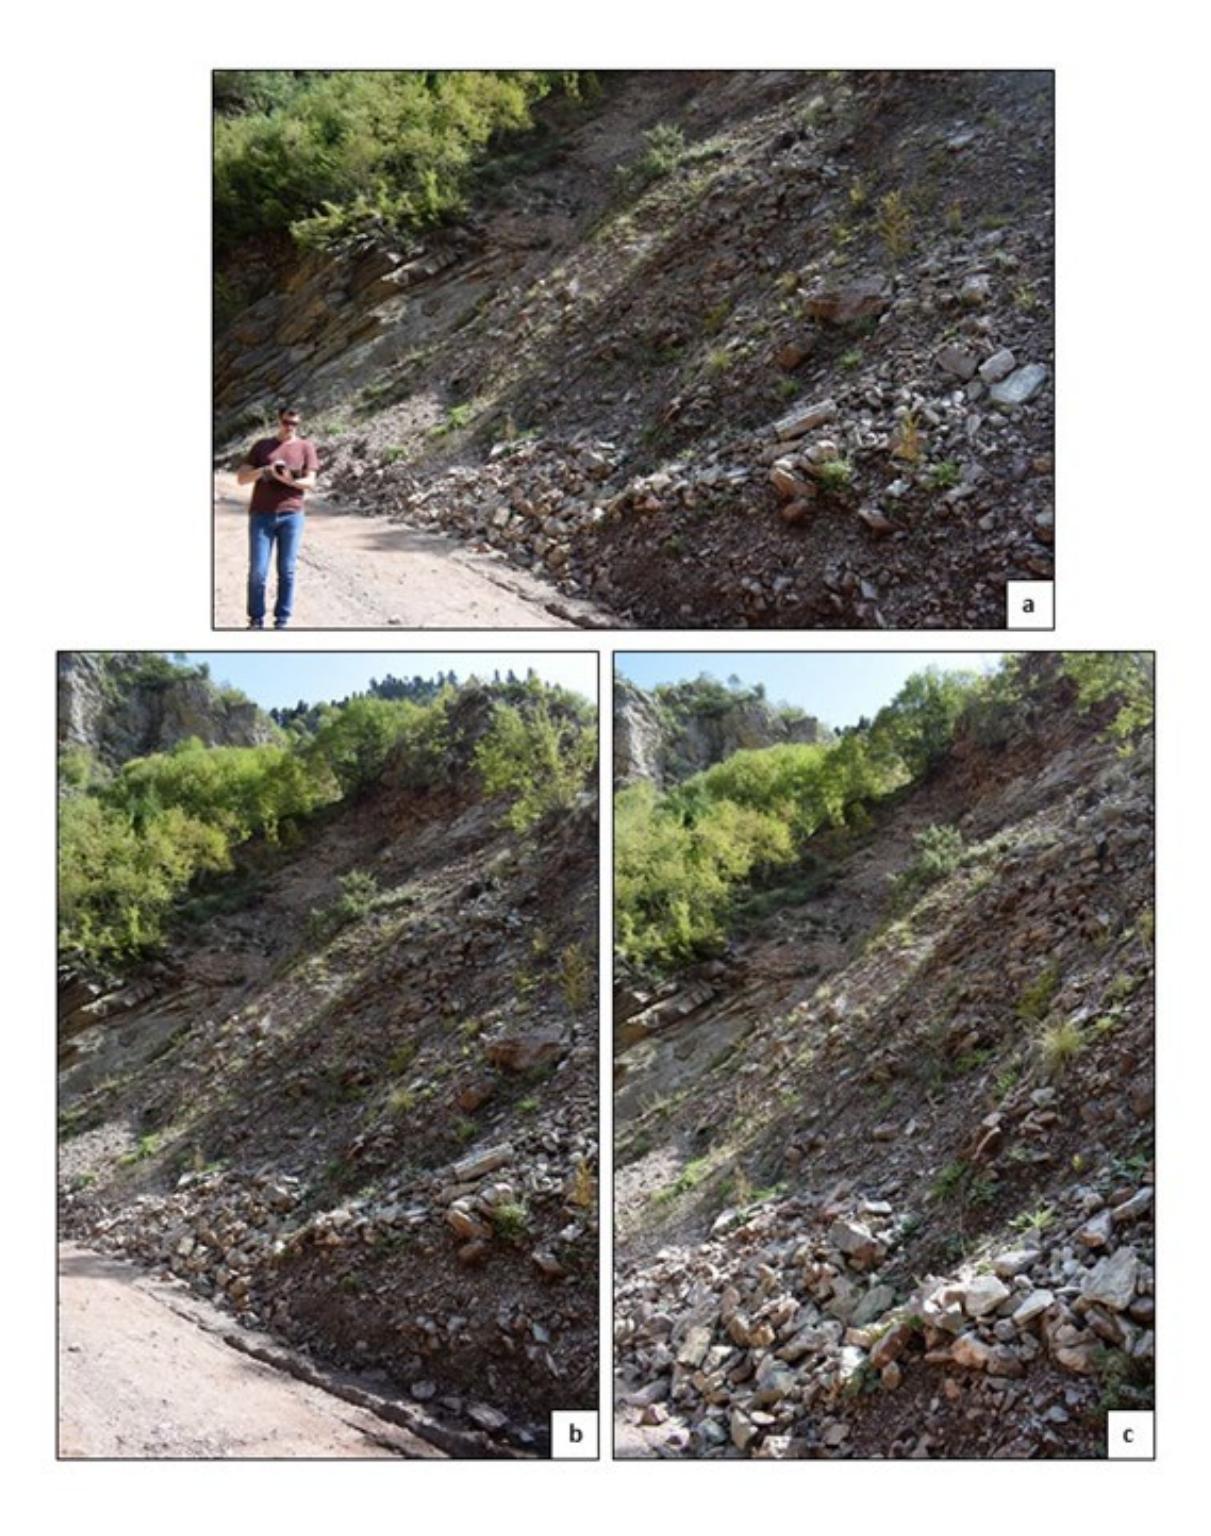
Figure 6.28. Rockslide along the road network of Karpenisi - Vraggiana

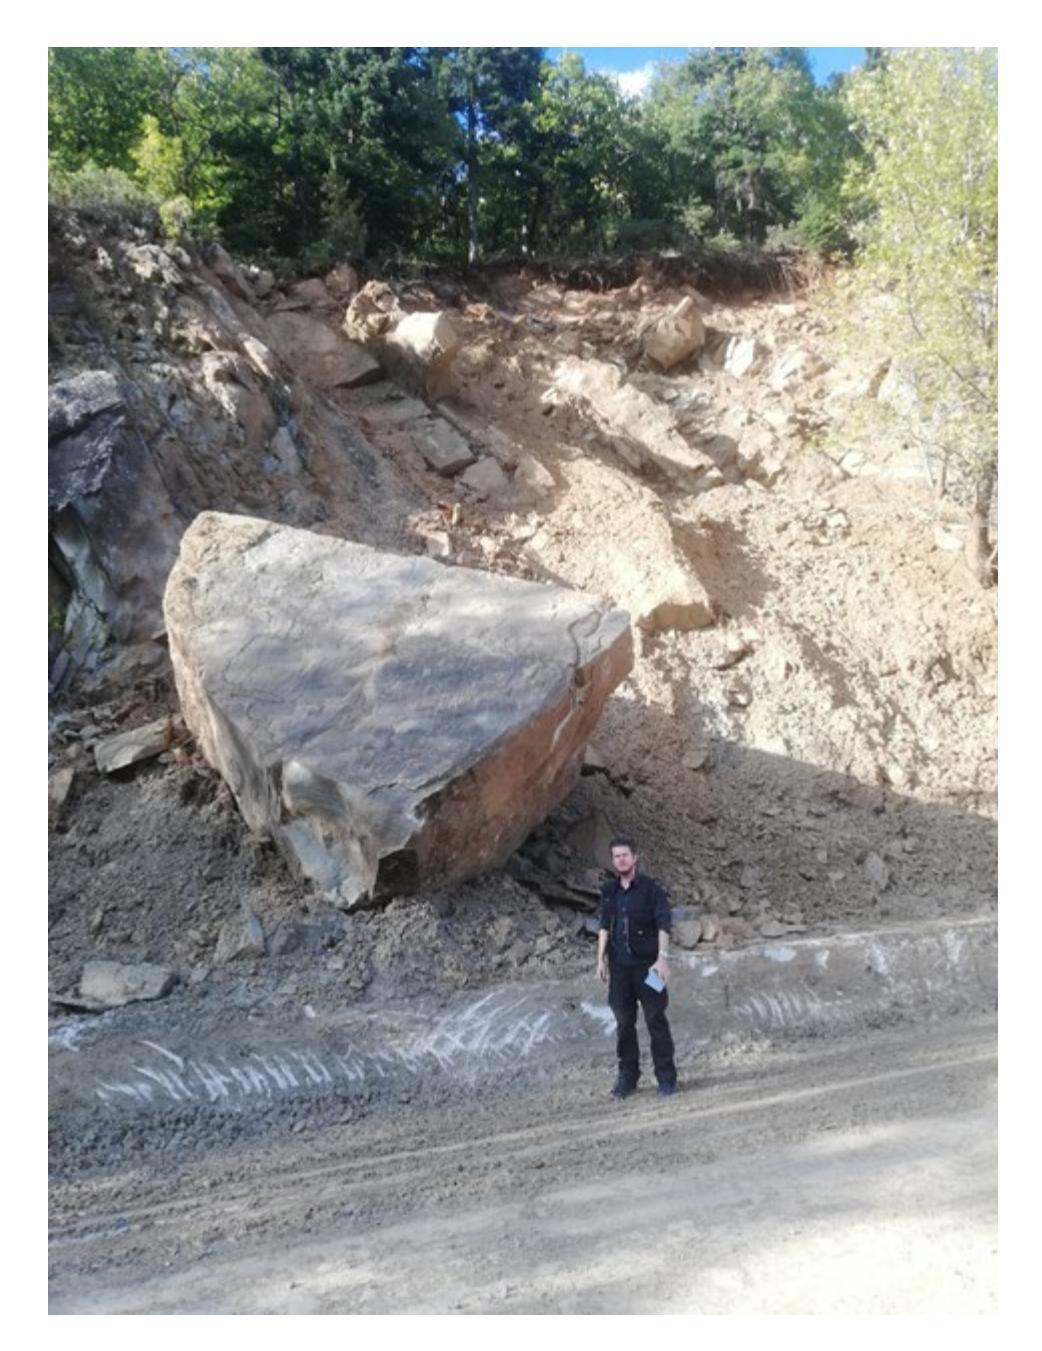
Figure 6.33. Wedge failure mechanism at the area of Belokomiti. (39.25325°N, 21.72192°E)

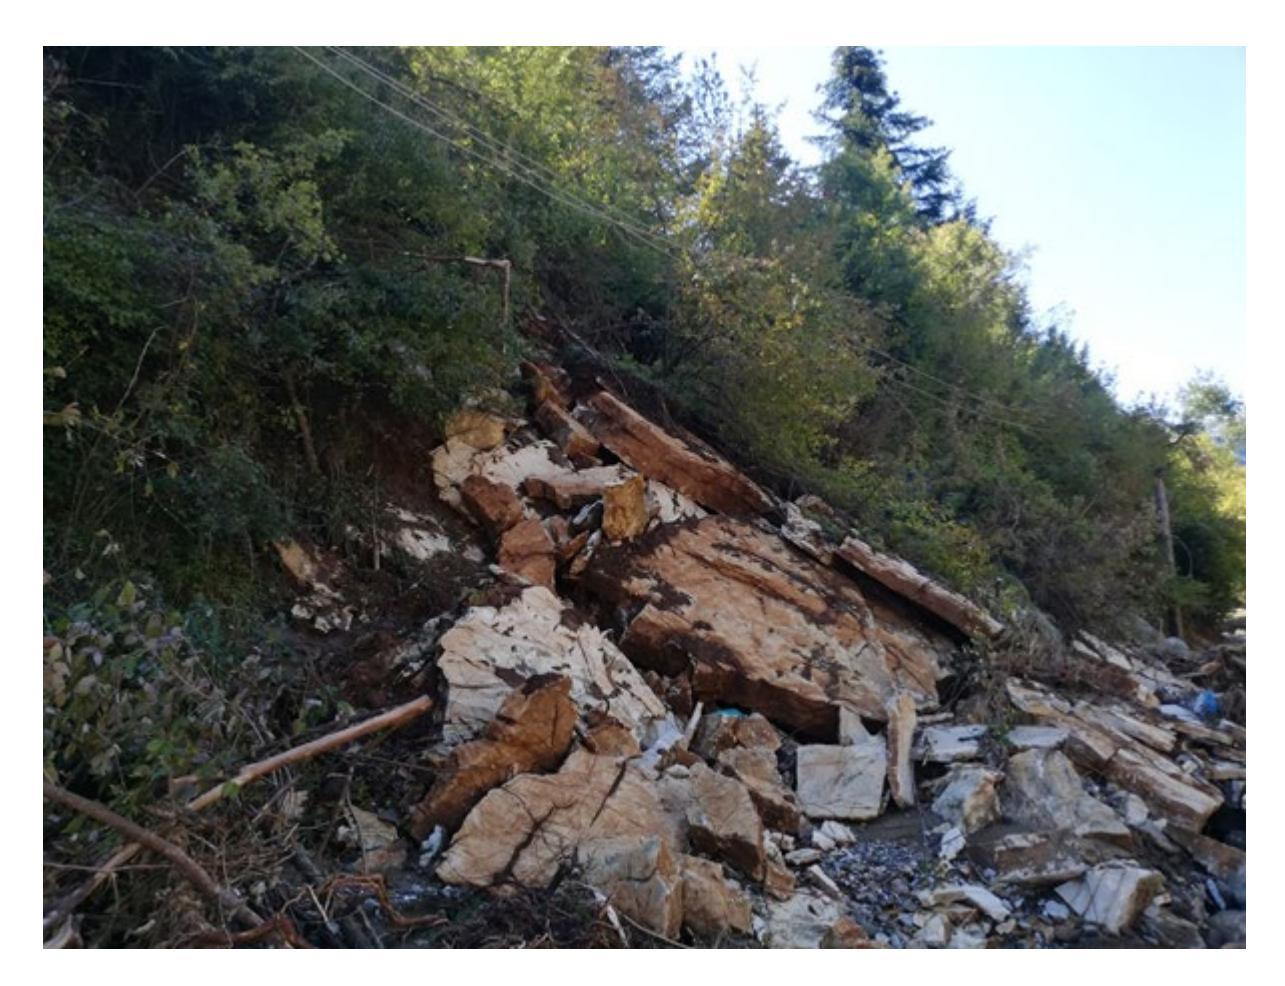
Figure 6.34. Planar sliding at the village Pezoula. (39.30406°N, 21.69014°E)

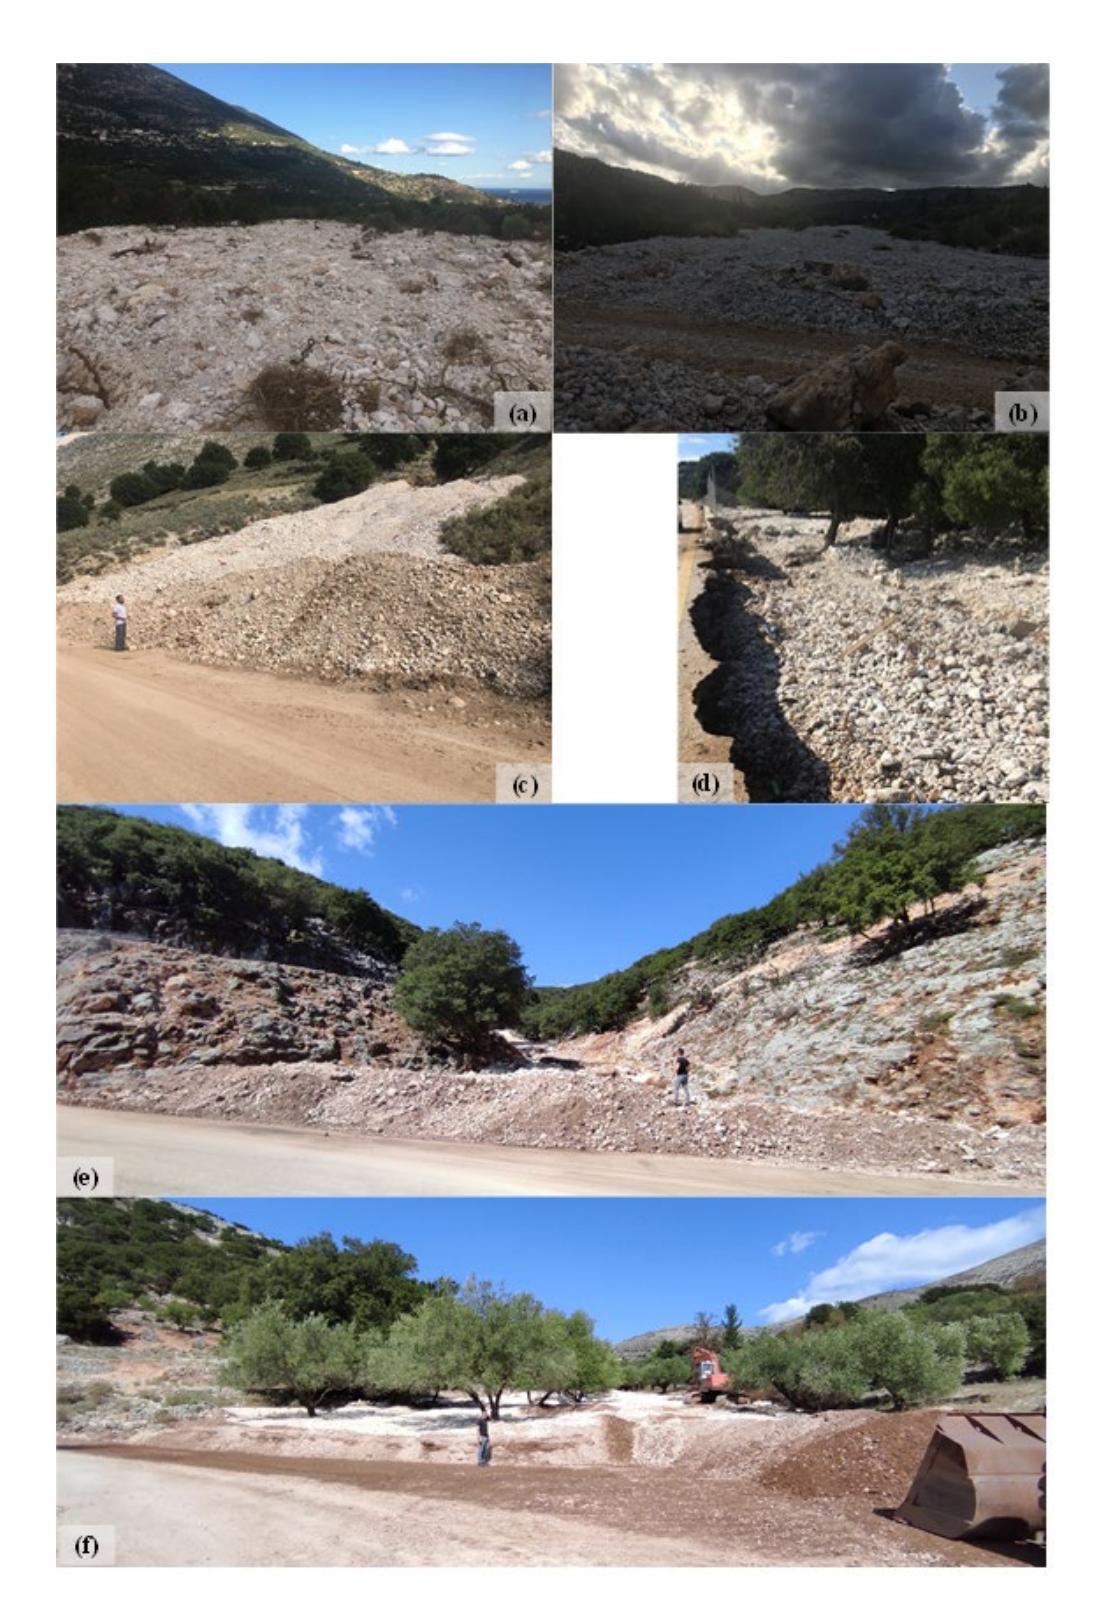
Figure 6.36. Debris flow manifestations across Cephalonia island: a) 38.309422222°N, 20.570208333°E, b) 38.309383333°N, 20.570166667°E, c) 38.307786111°N, 20.495036111°E, d) 38.291980556°N, 20.528944444°E, e) 38.306109972°N, 20.534586972°E, f) 38.231639972°N, 20.506282972°E

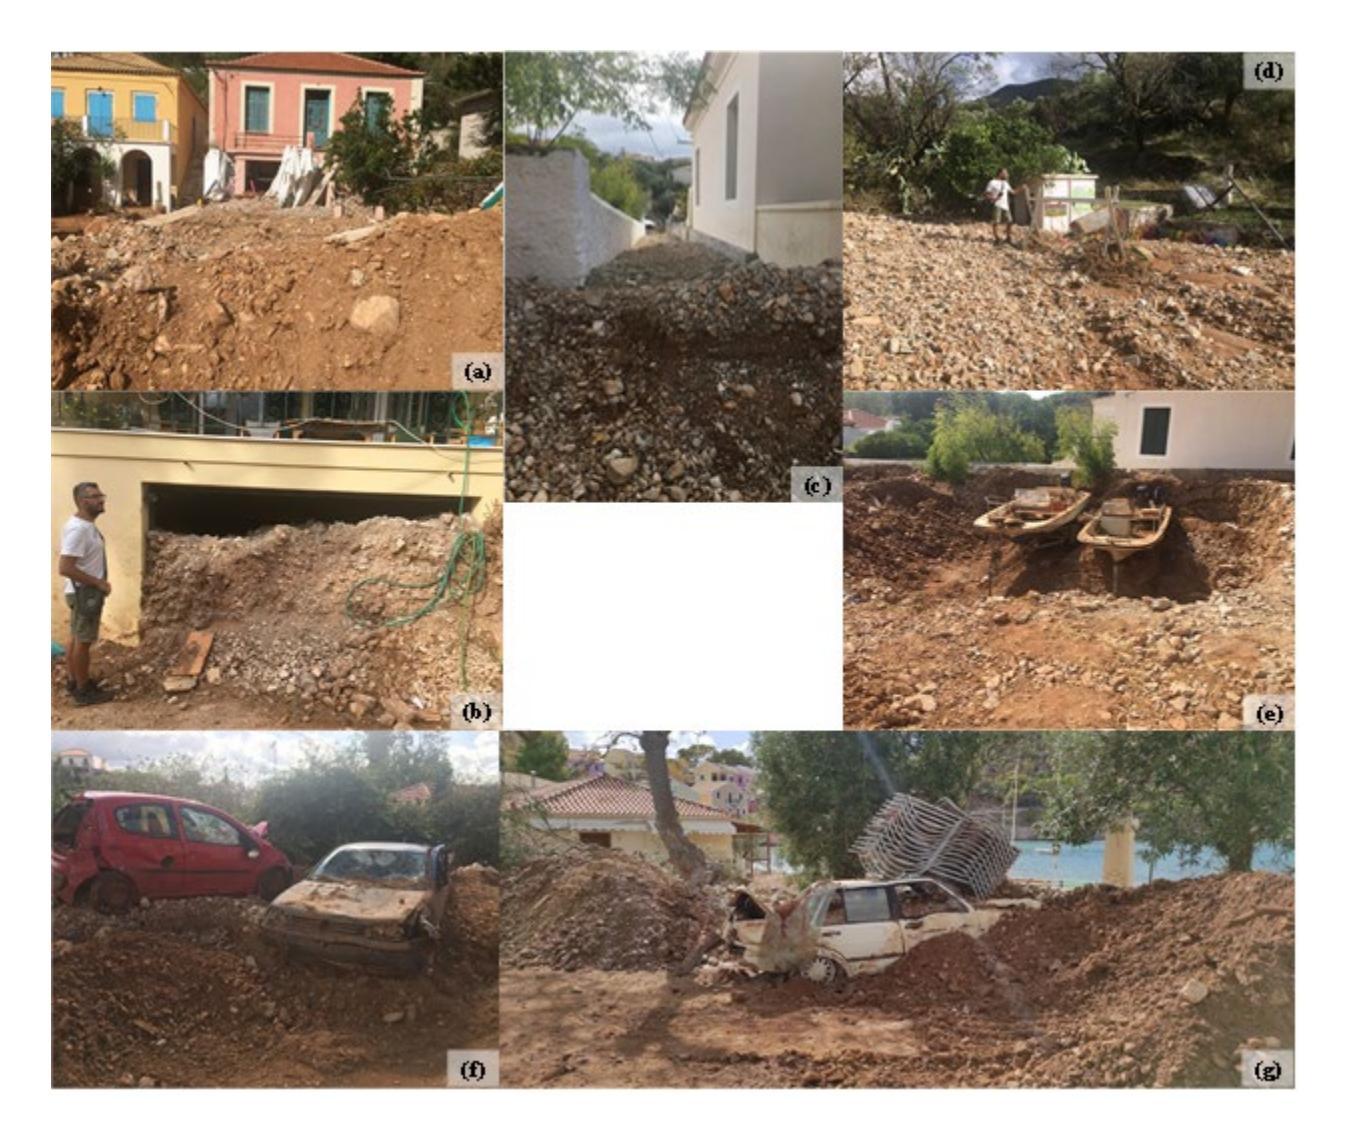
Figure 6.38. Debris flow within the village of Assos (38.319506°N, 20.508197°E), as of 9/29/2020
