The September 18-20 2020 Medicane Ianos Impact on Greece

Phase I Reconnaissance Report

Geotechnical Extreme Events Reconnaissance Association

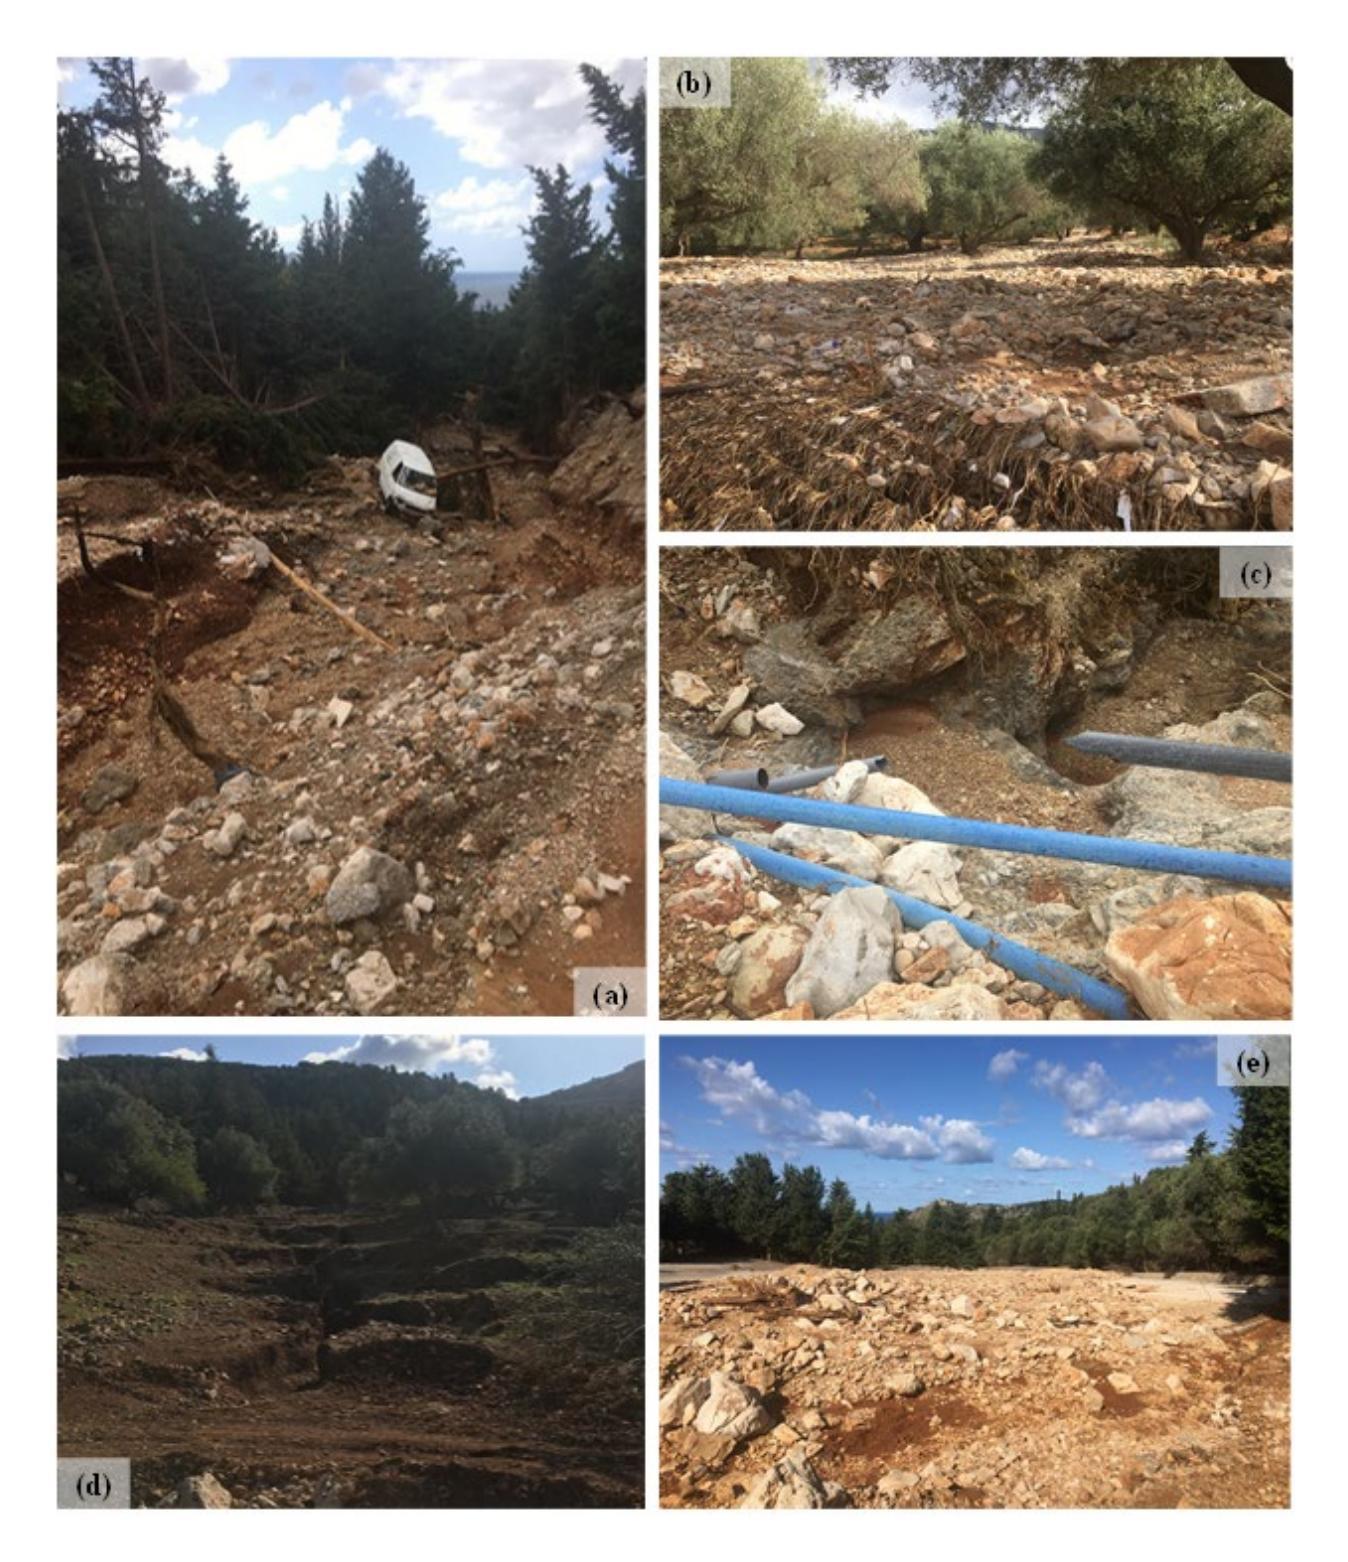
Figure 6.39. Debris flow manifestations outside of Assos village (view 3D model at: <u>https://skfb.ly/6WyTT</u>): a) severe surface erosion and debris (38.376281°N, 20.548333°E); b) olive tree field covered by debris (38.378158°N, 20.543012°E); c) broken utility lines (38.37639166°N, 20.549125°E); d) extensive ground cracking (38.376112°N, 20.551870°E) and e) indicative debris extent and size (38.376112°N, 20.551870°E)

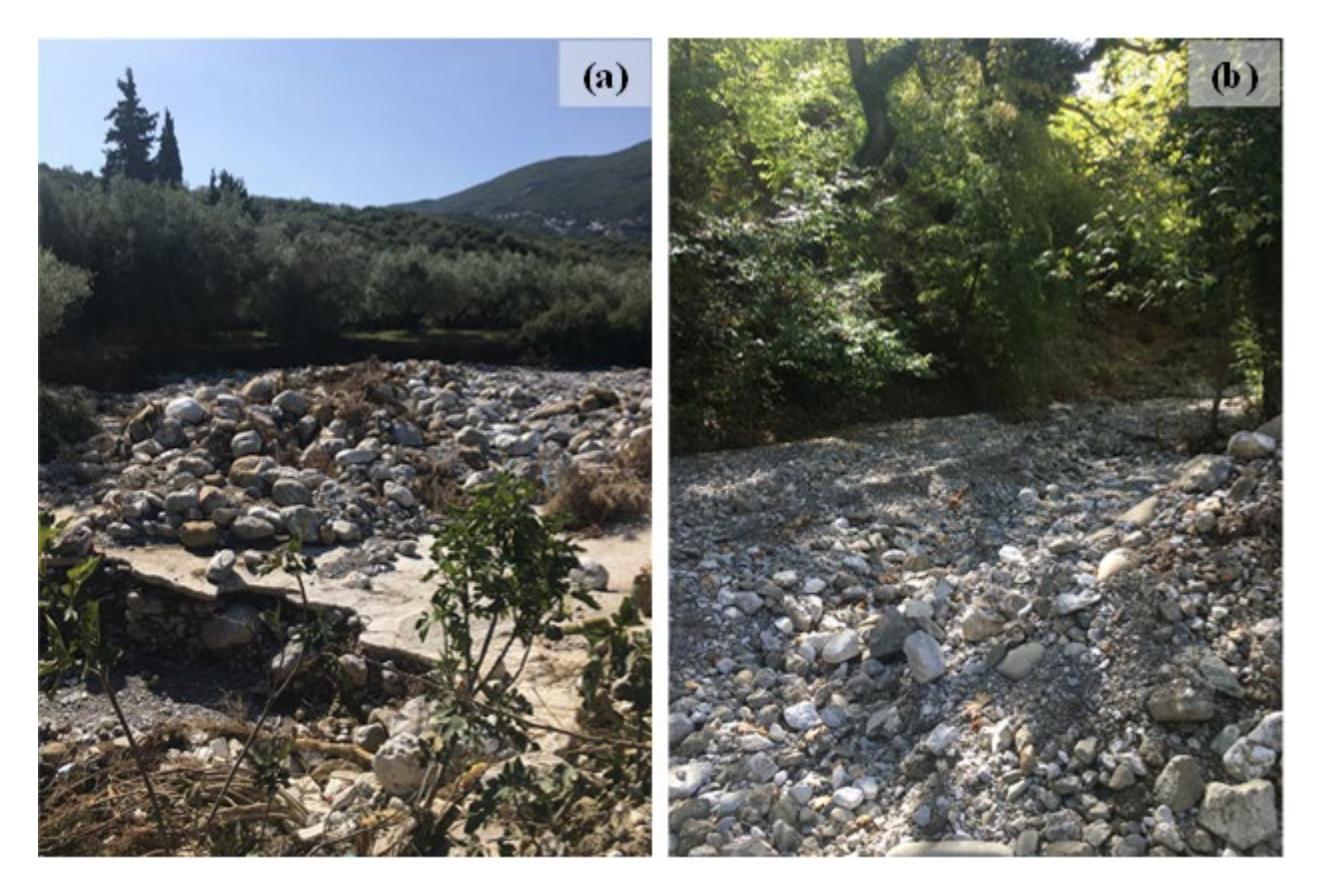
Figure 6.48. Manifestations of debris flow in the south side of Spercheios river valley: a) 38.85976388°N, 22.36969722°E; b) 38.874°N, 22.2538055°E

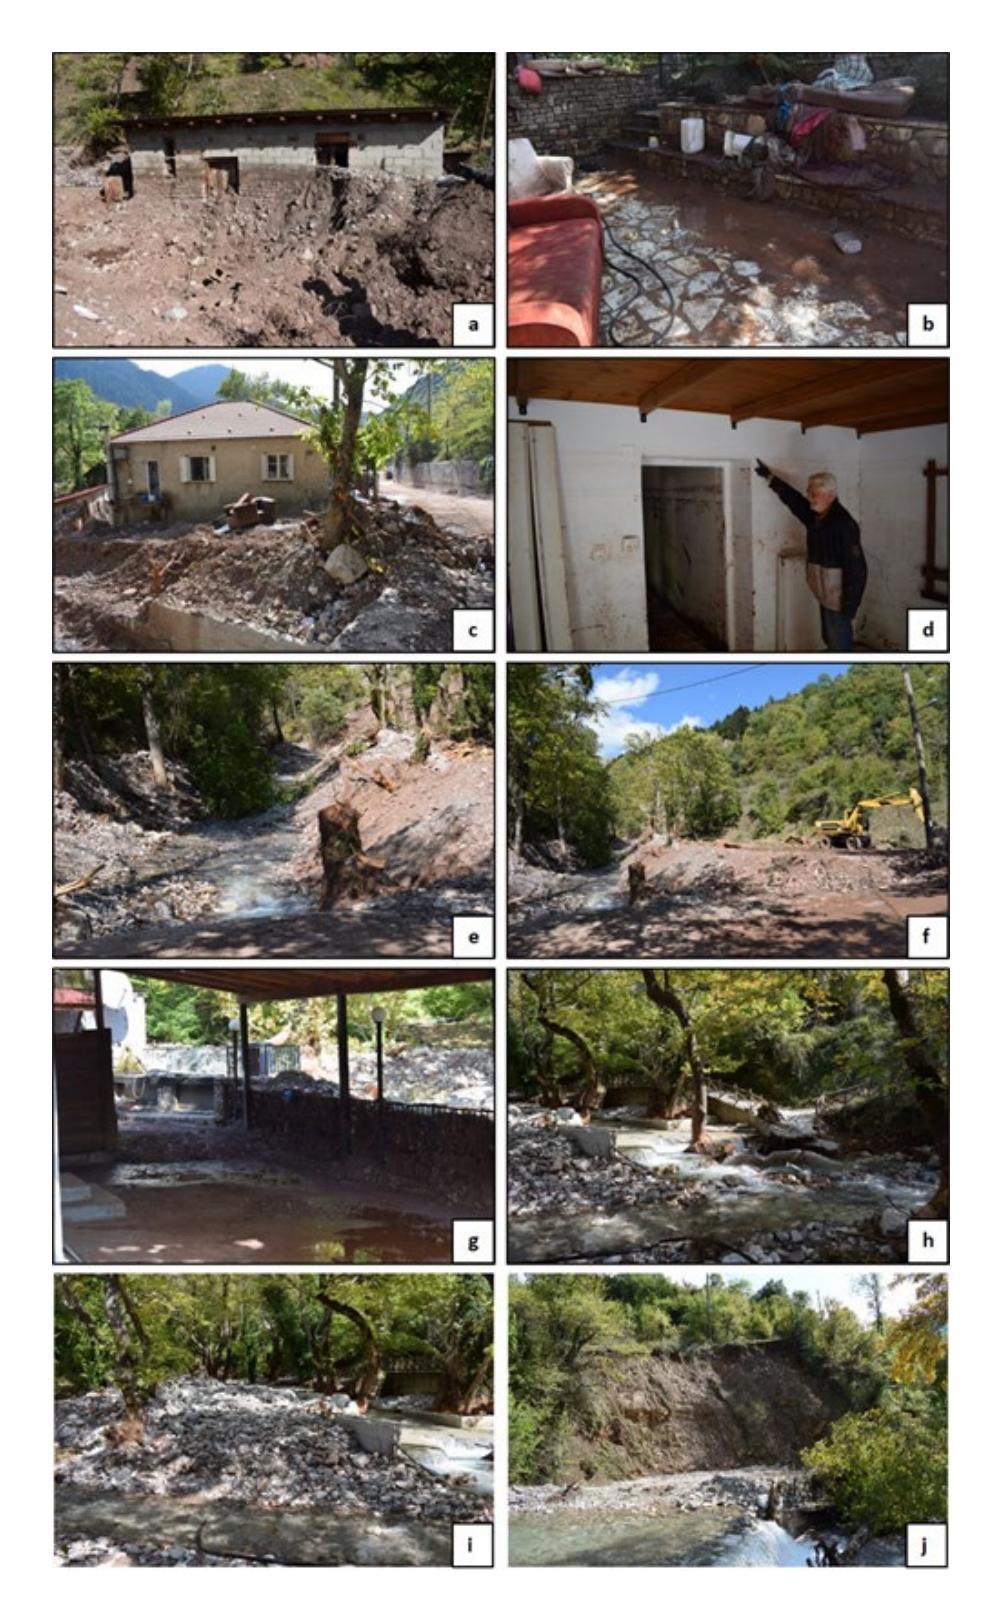
Figure 6.53. Complete destruction of Argithea village due to a debris flow. Structural damage on infrastructure has been observed (39.359444°N, 21.538056°E).

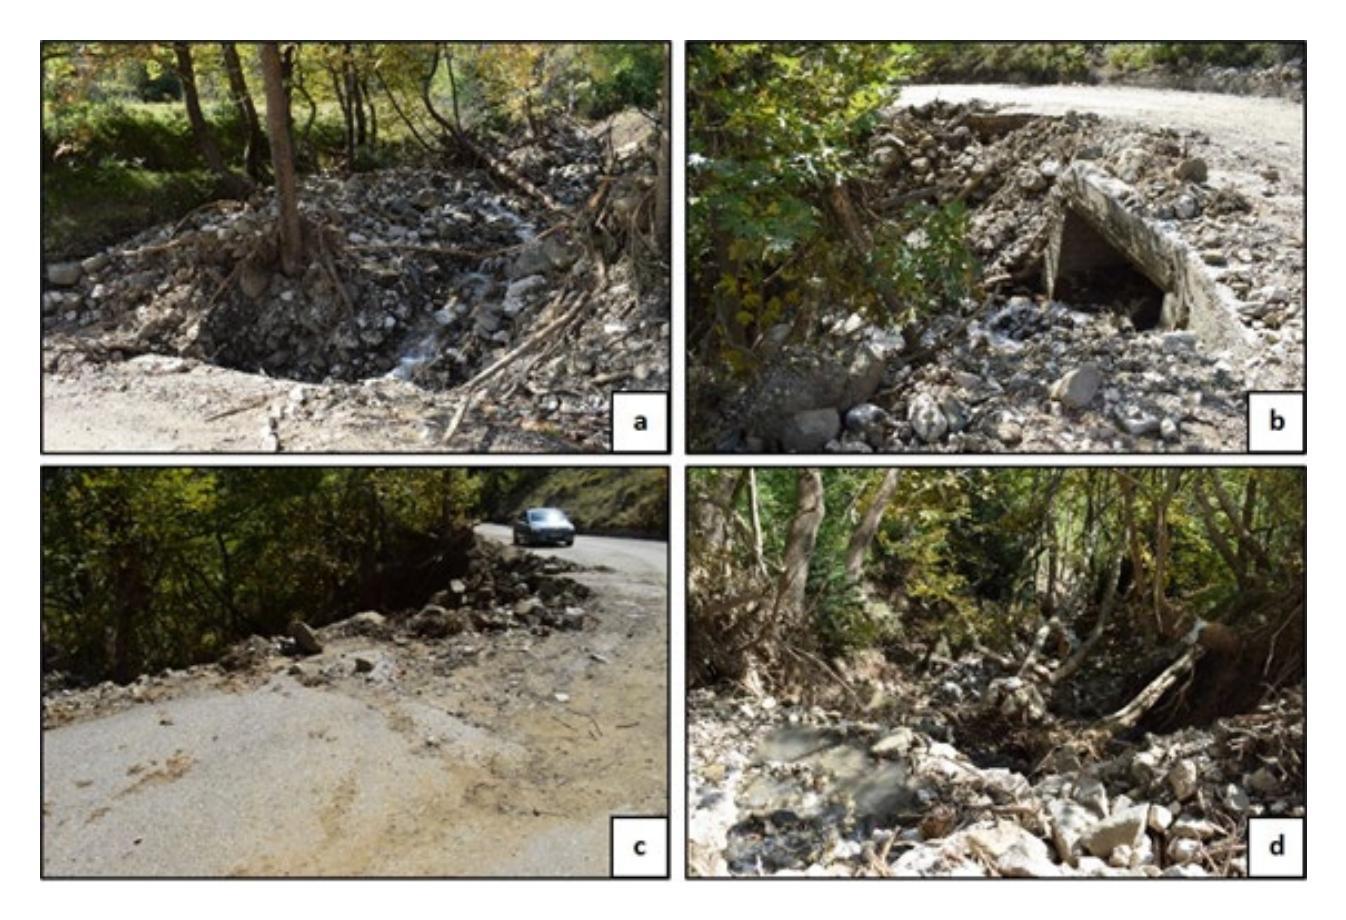
Figure 6.54. Debris flow towards Oxya village (39.366667°N, 21.592222°E).

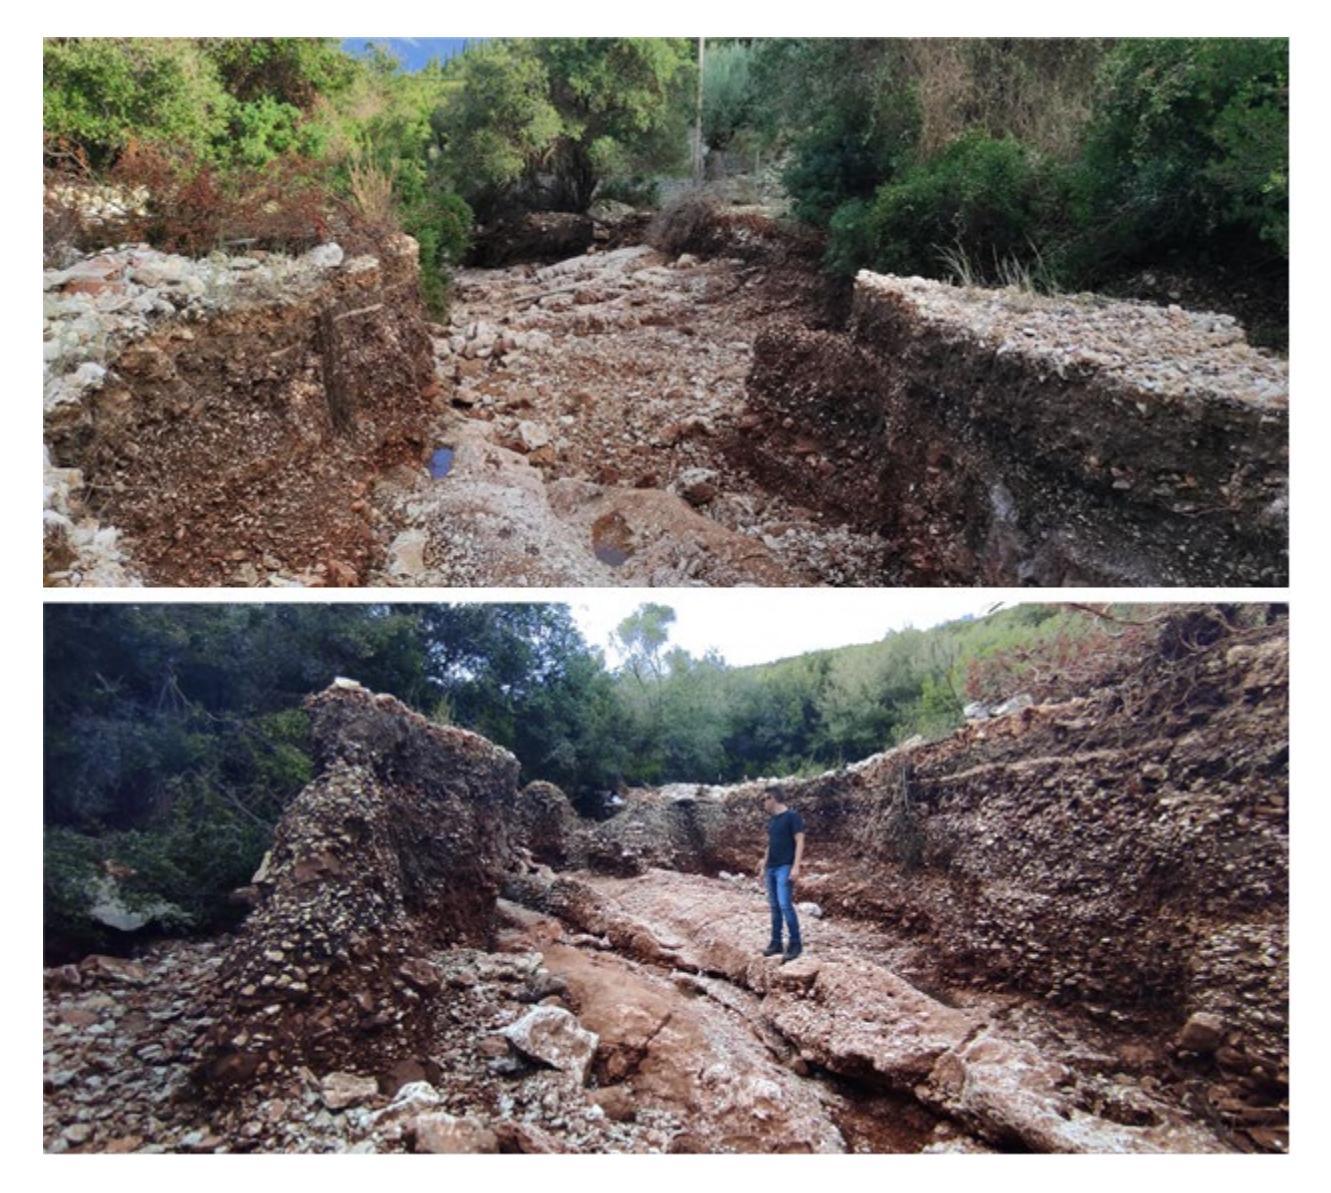
Figure 7.1. Surface erosion outside of Fiskardo village (38.459501°N, 20.57179499°E)

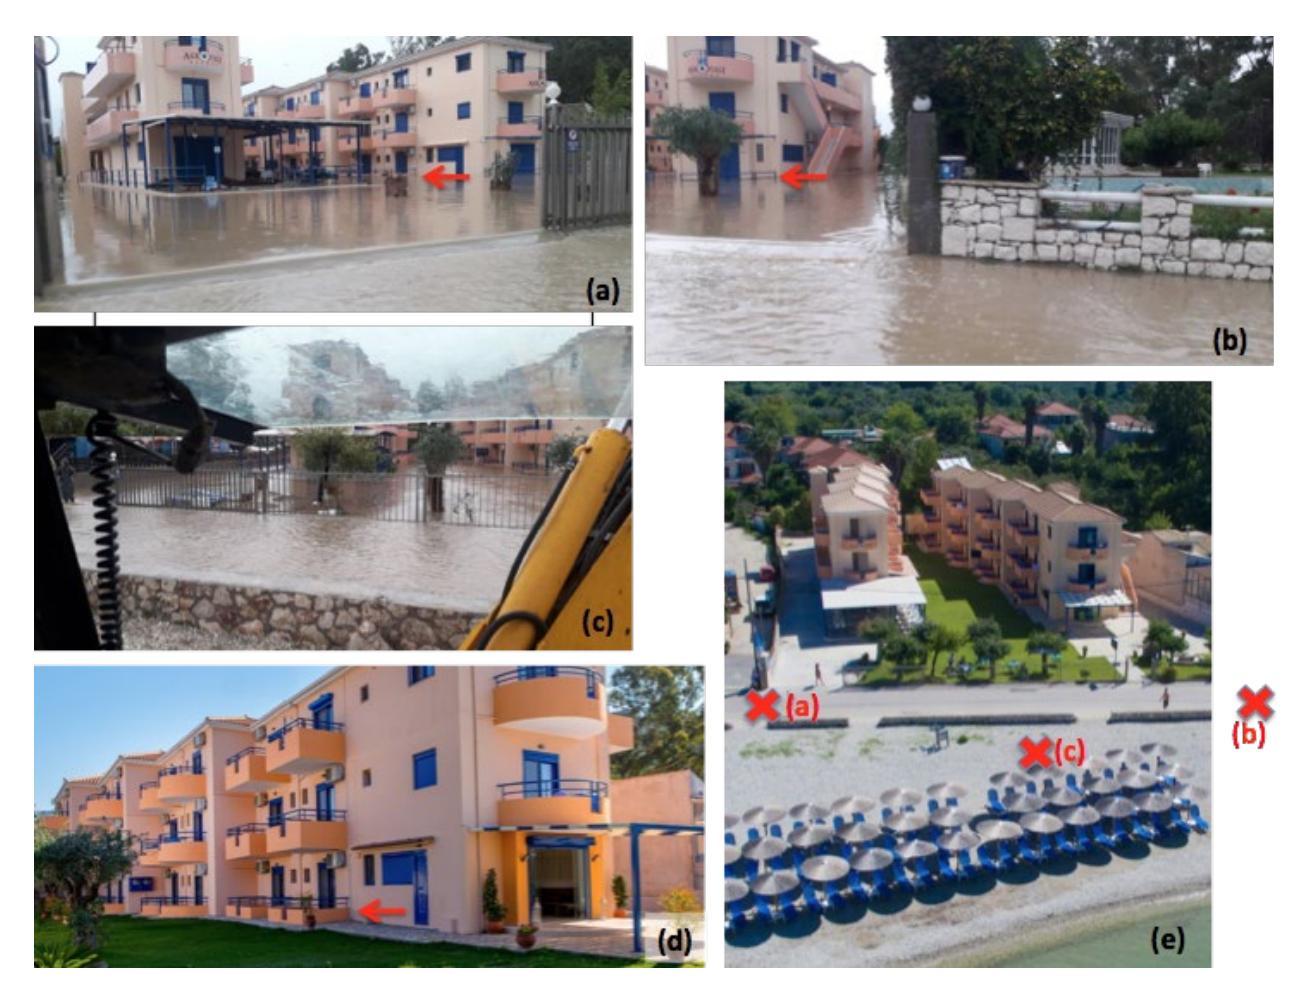
Figure 7.3. a,b,c) Flooding along the seaside at Vasiliki village, Lefkada, as photographed by an eye witness on the day vs. d,e) reference photos from GoogleMaps, indicating the view points for photos in a,b,c. Horizontal arrows indicate water level with respect to balcony railings (38.628758°N, 20.606678°E).

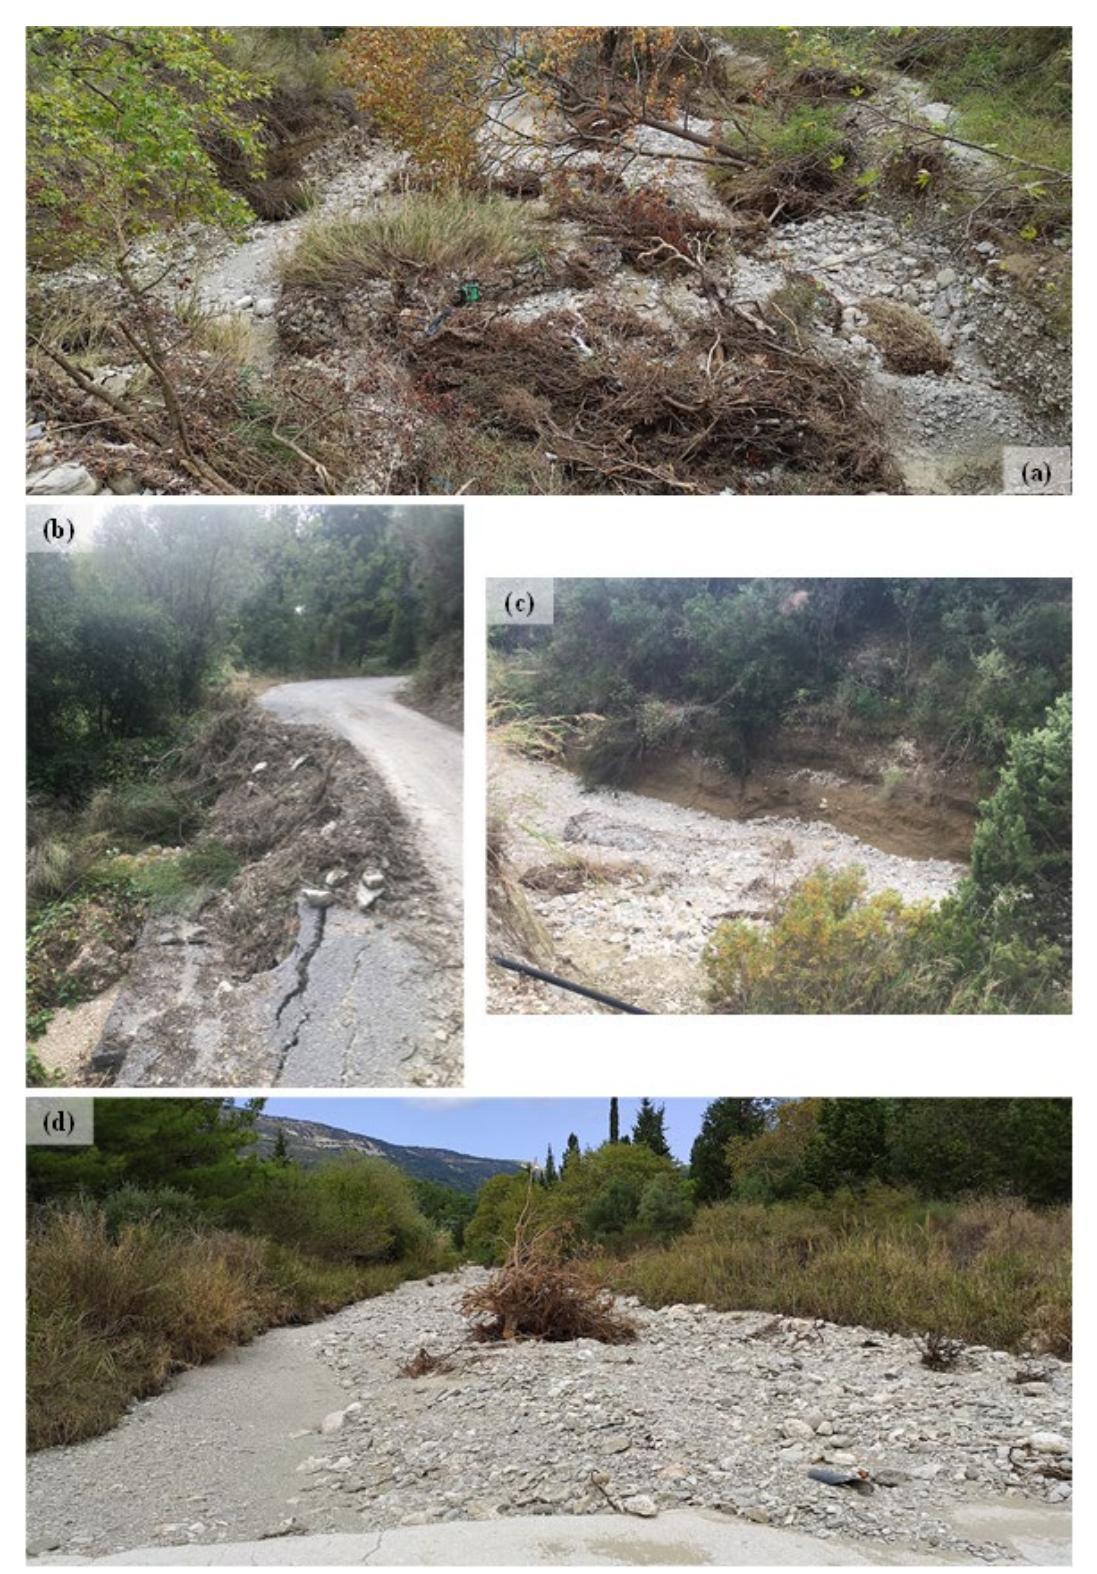
Figure 7.4. Typical features observed in Lefkada island: a) eroded material from flood protection levee (38.665858972°N, 20.620208°E); b) road embankment damage (38.67684167°N, 20.6093056°E); c) riverbank erosion (38.6646278°N, 20.623711°E); d) debris on riverbed (38.665858972°N, 20.620208°E).

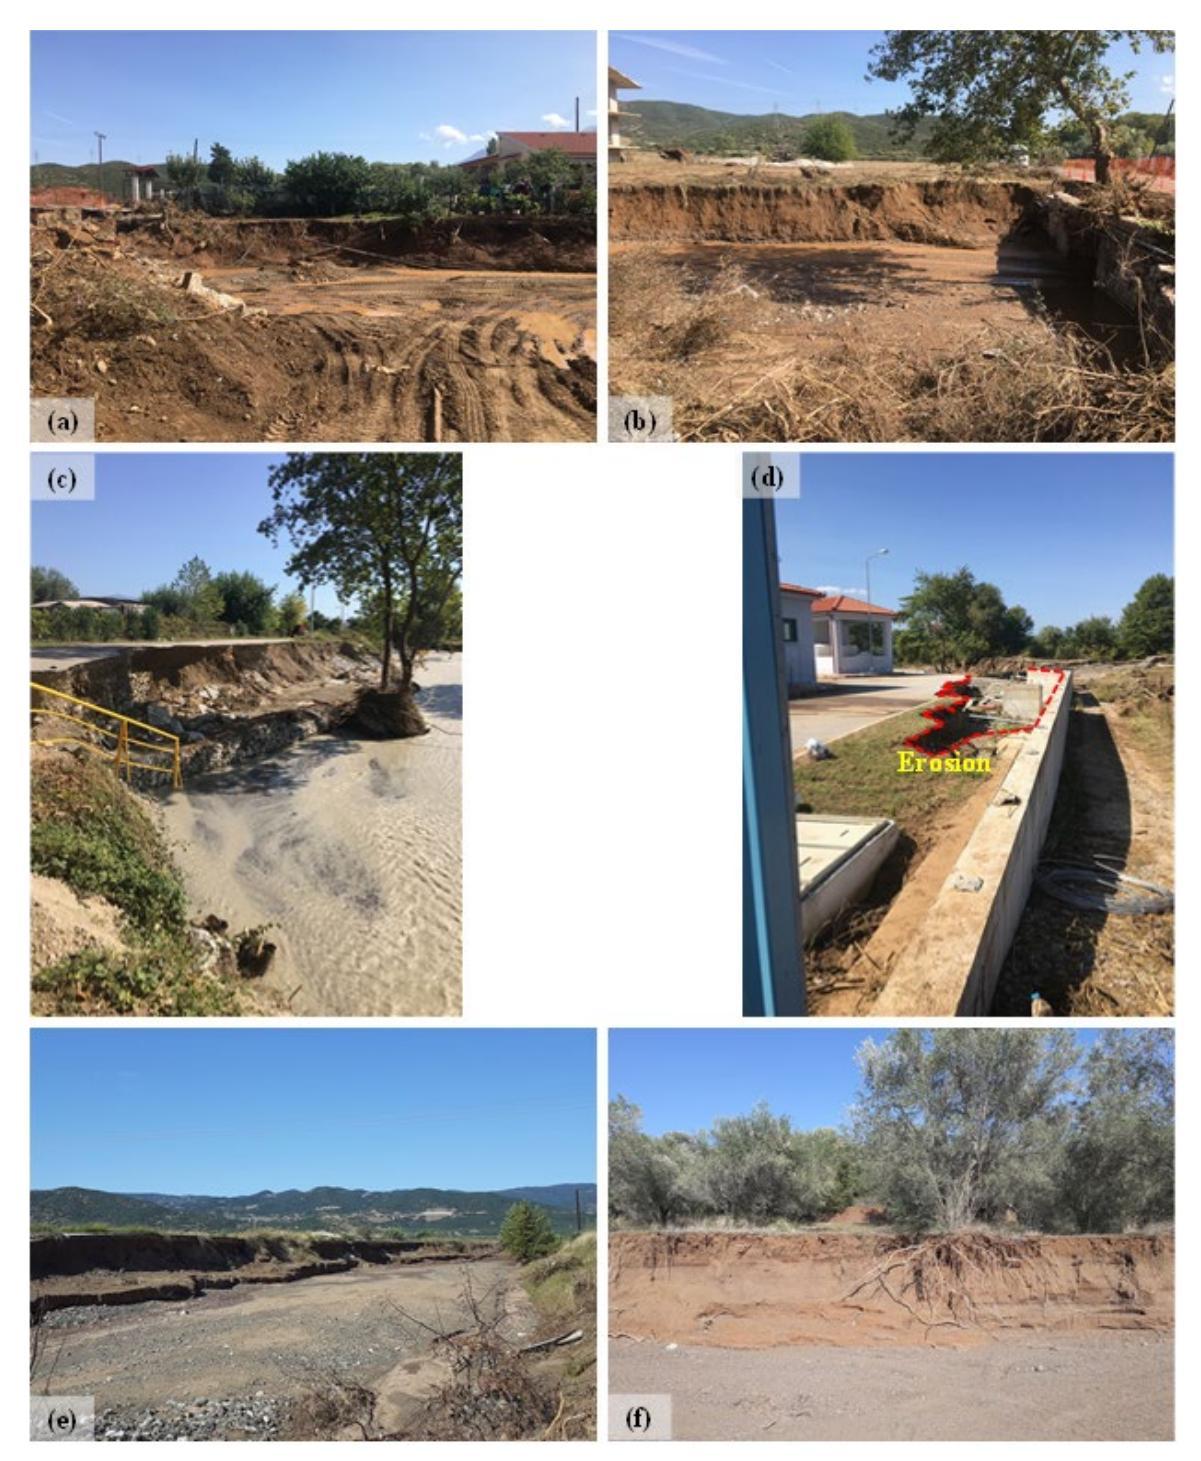
Figure 7.7. Riverbank erosion in Spercheios river valley: a and b) 38.94233611°N, 22.21619722°E; c) 38.83451944°N, 22.39527499°E; d) 38.90973611°N, 22.28436944°E; e) 38.92455°N, 22.27771944°E; f) 38.946288833°N, 22.270412388°E.

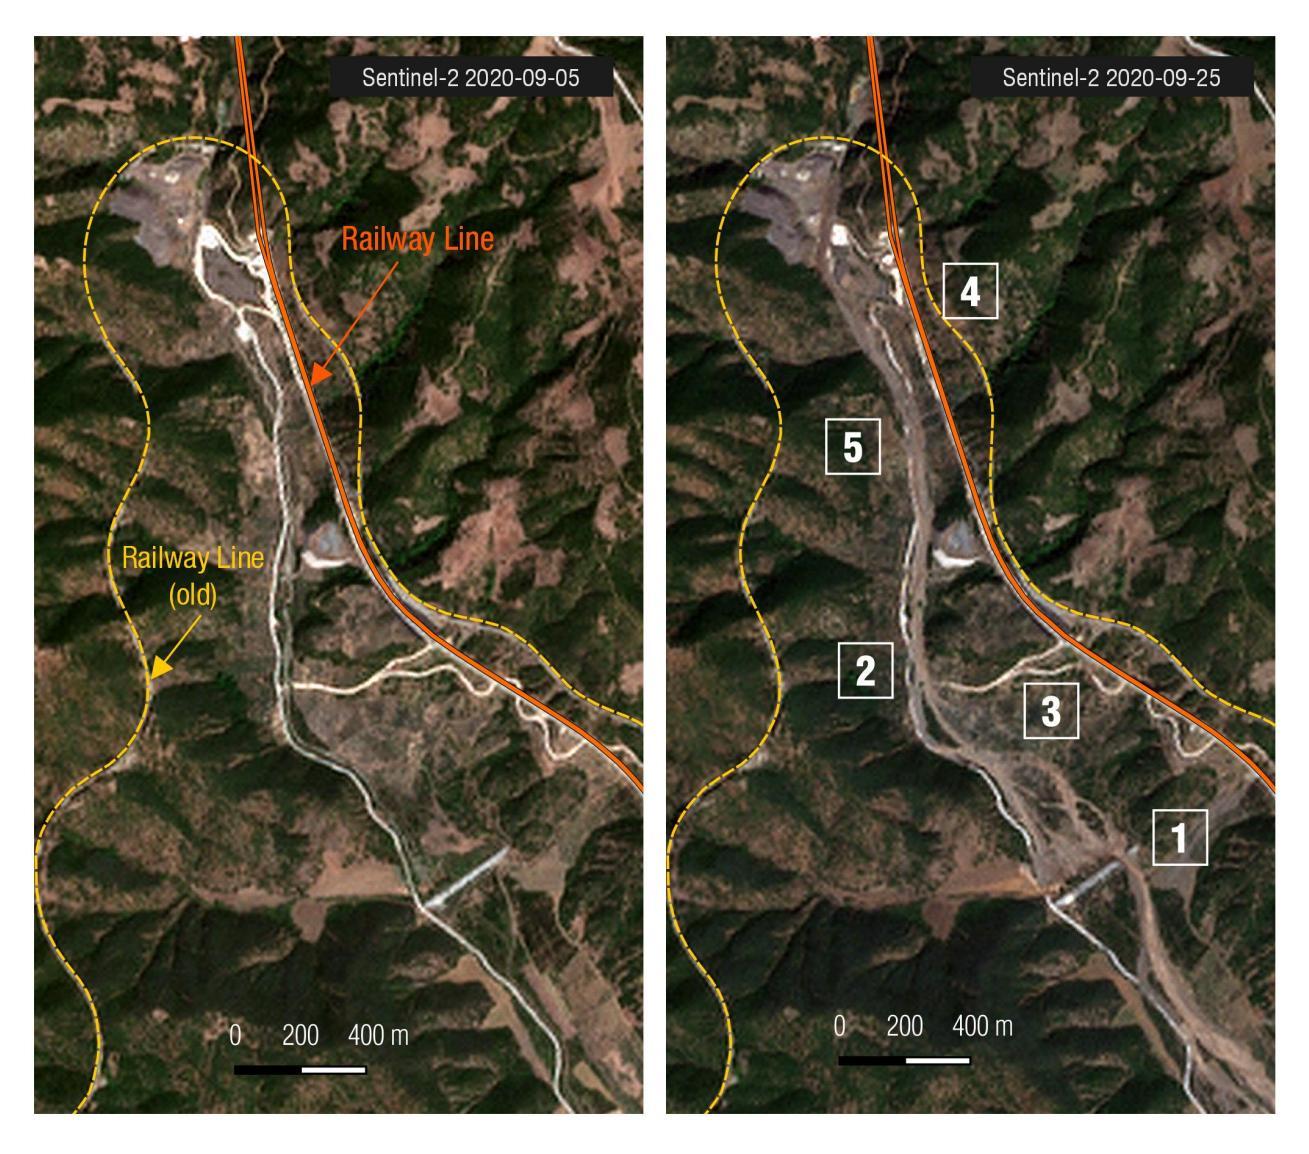
Figure 7.9. Flooding and debris effects on the streams northwest of Stirfaka, Lamia. Left: Sentinel-2 (super-resolution) image of September 5 2020. Right: Sentinel-2 (super-resolution) image of September 25 2020. Deposition of debris & flood sediments downstream along the torrent. Significant damages downstream that include breach of a flood-protection dam [1] (Location 38.9598°N, 22.27405°E), landslides along the old and new railway line (3,4) and service road damage (2,5).

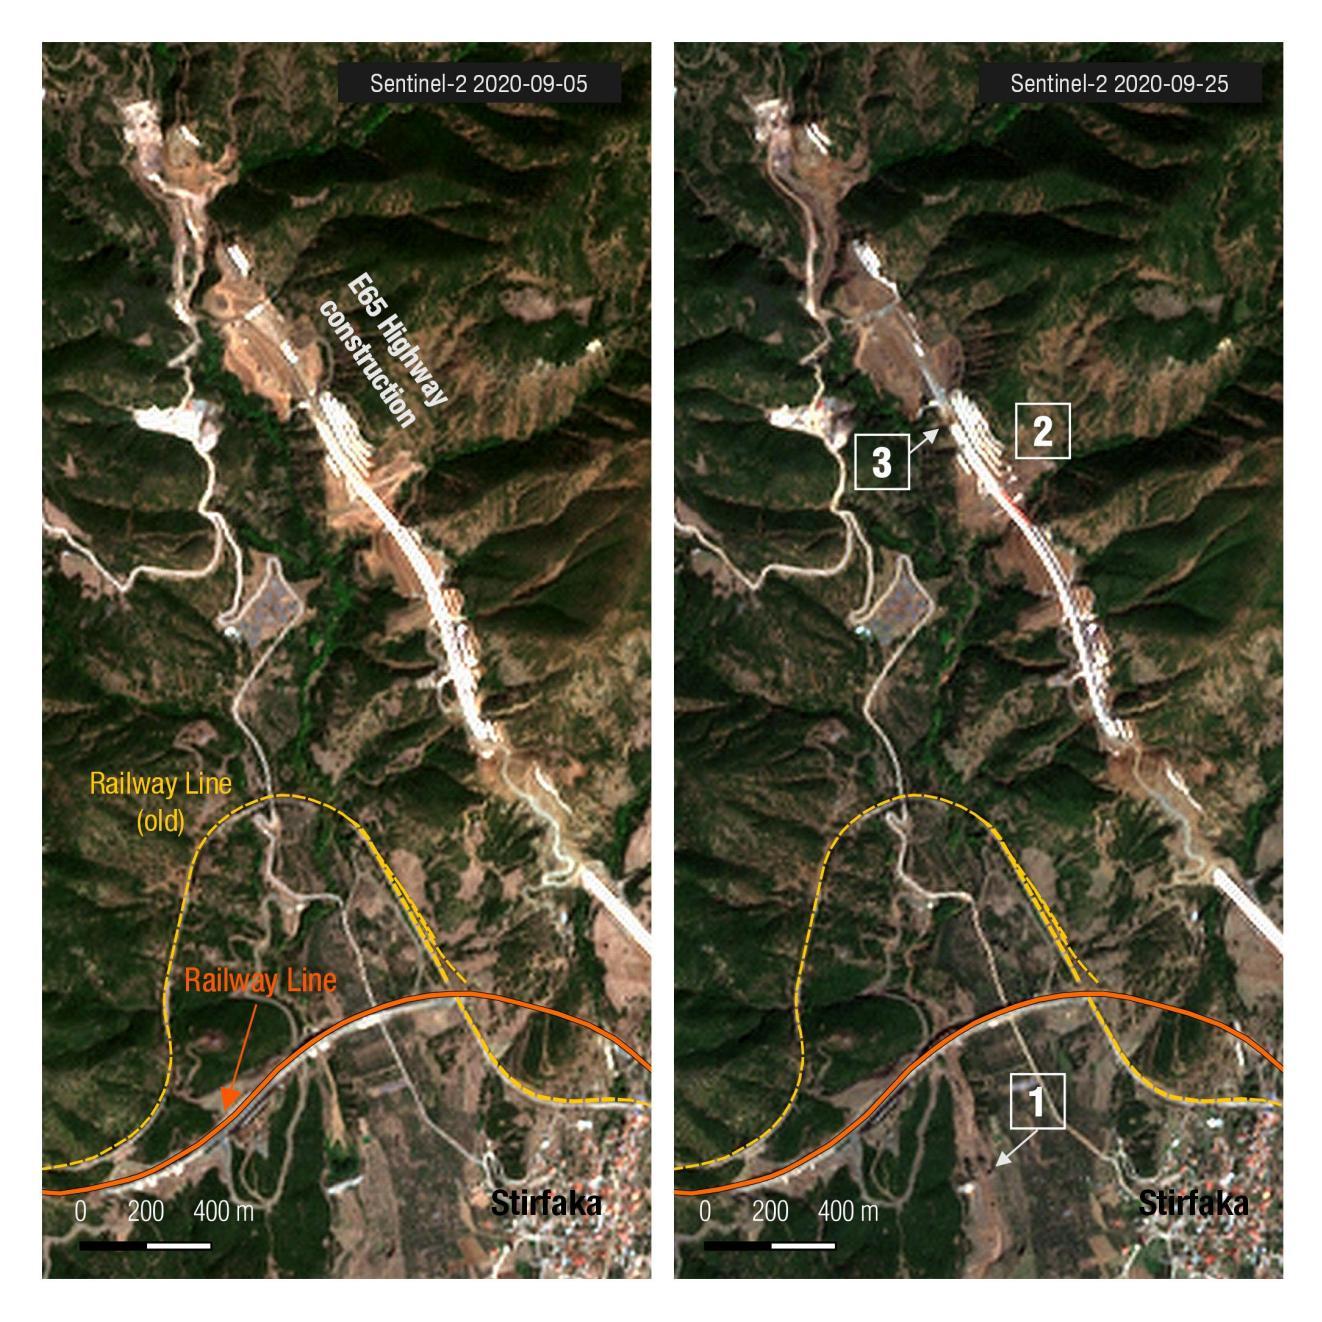
Figure 7.10. Flooding and debris effects on the streams and along the E65 highway construction site northwest of Stirfaka, Lamia. Left: Sentinel-2 (super-resolution) image of September 5 2020. Right: Sentinel-2 (super-resolution) image of September 25 2020. Deposition of debris & flood sediments downstream along the torrent. Significant damages downstream that include breach of a small flood-protection dam [1] (Location 38.9562°N, 22.29896°E), and landslides/failures along the E65 construction site (2,3).

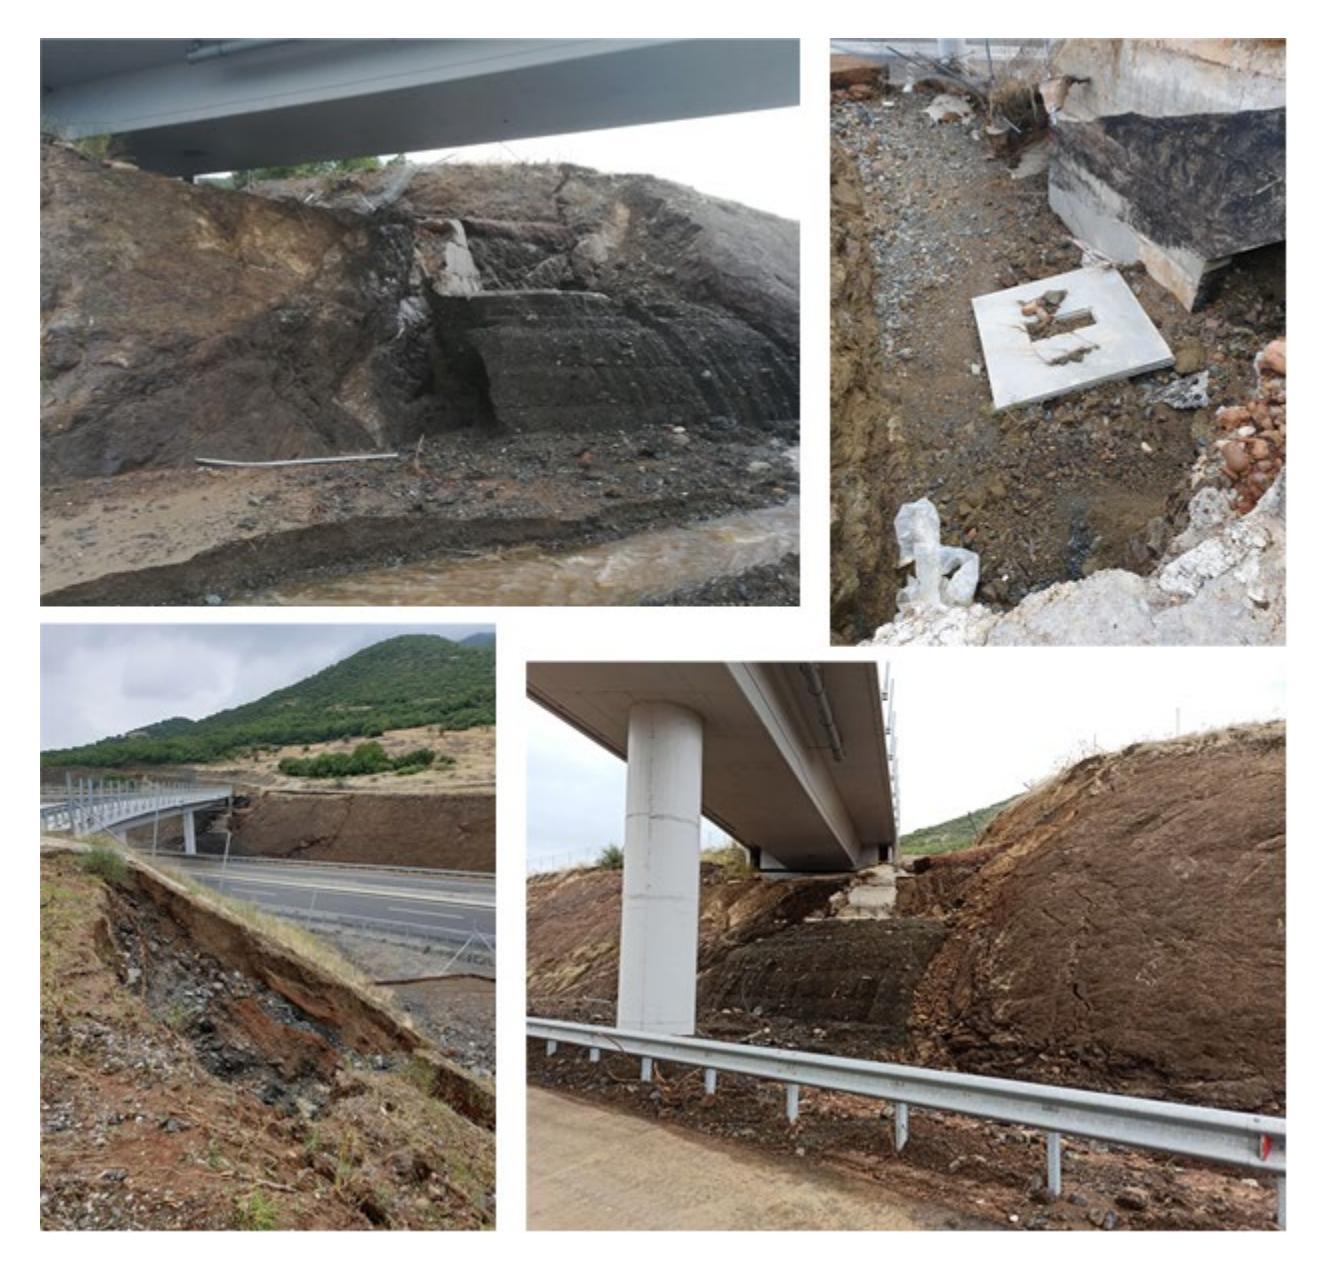
Figure 7.11. Bridge embankment erosion on Highway E65, km+56 outside the town of Anavra (39.172474°N, 22.091382°E) (view 3D model at: <u>https://skfb.ly/6W7AK</u>).

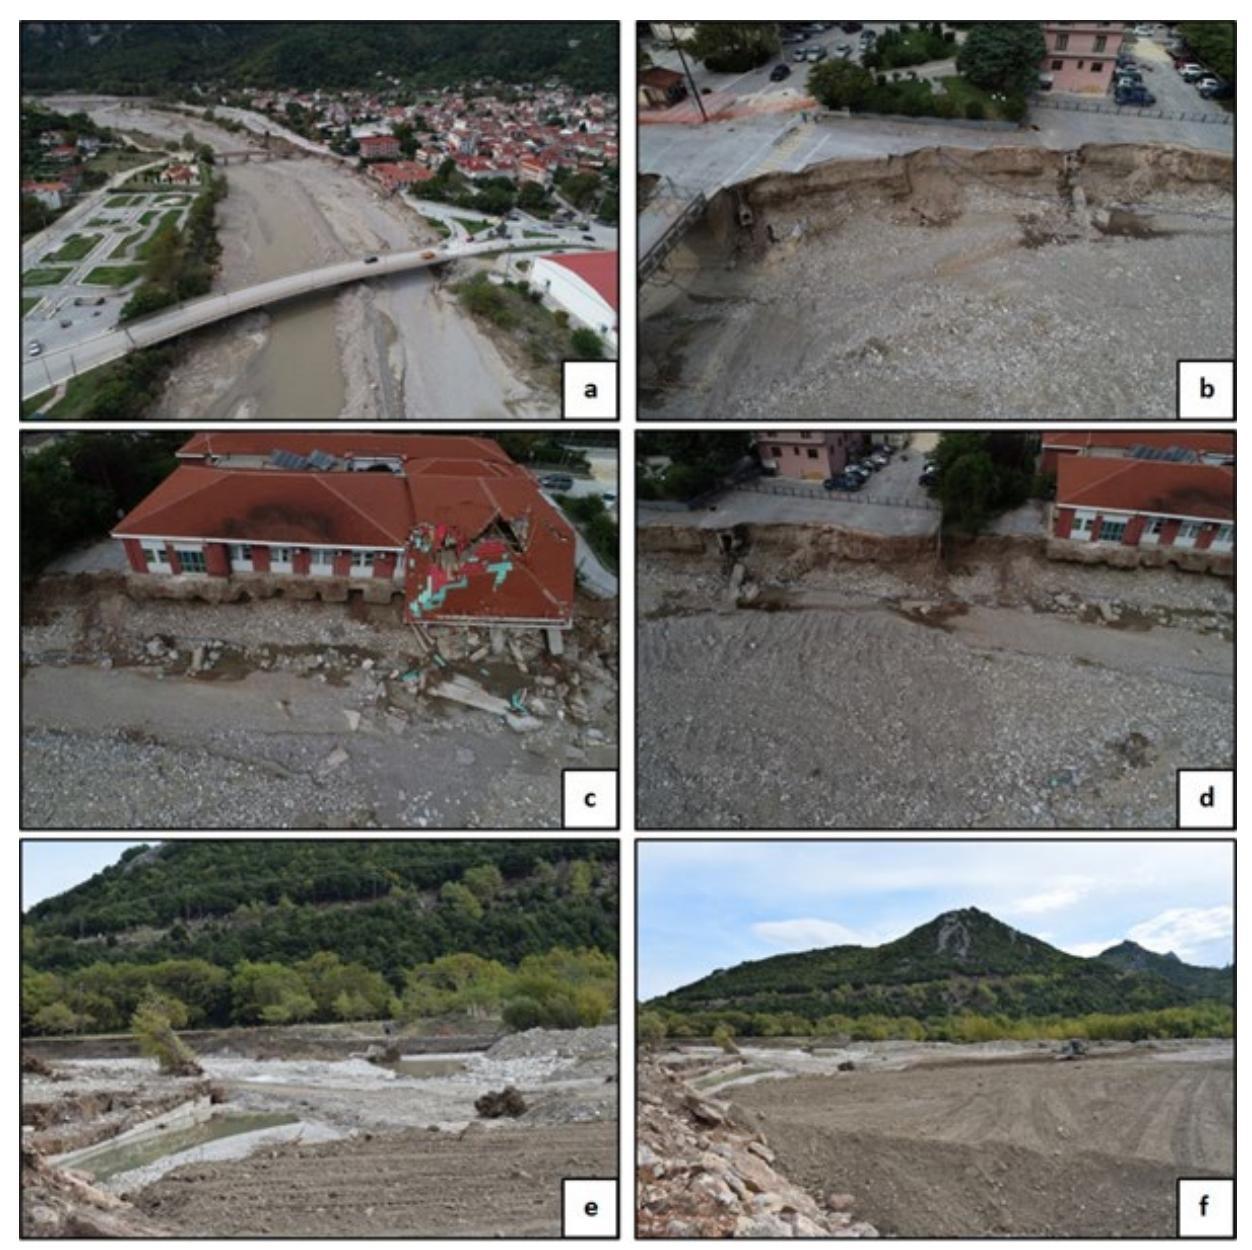
Figure 7.12. Mouzaki road failure (a-d) and remedial measures (e-f) on river embankments (39.427222°N, 21.666667°E).

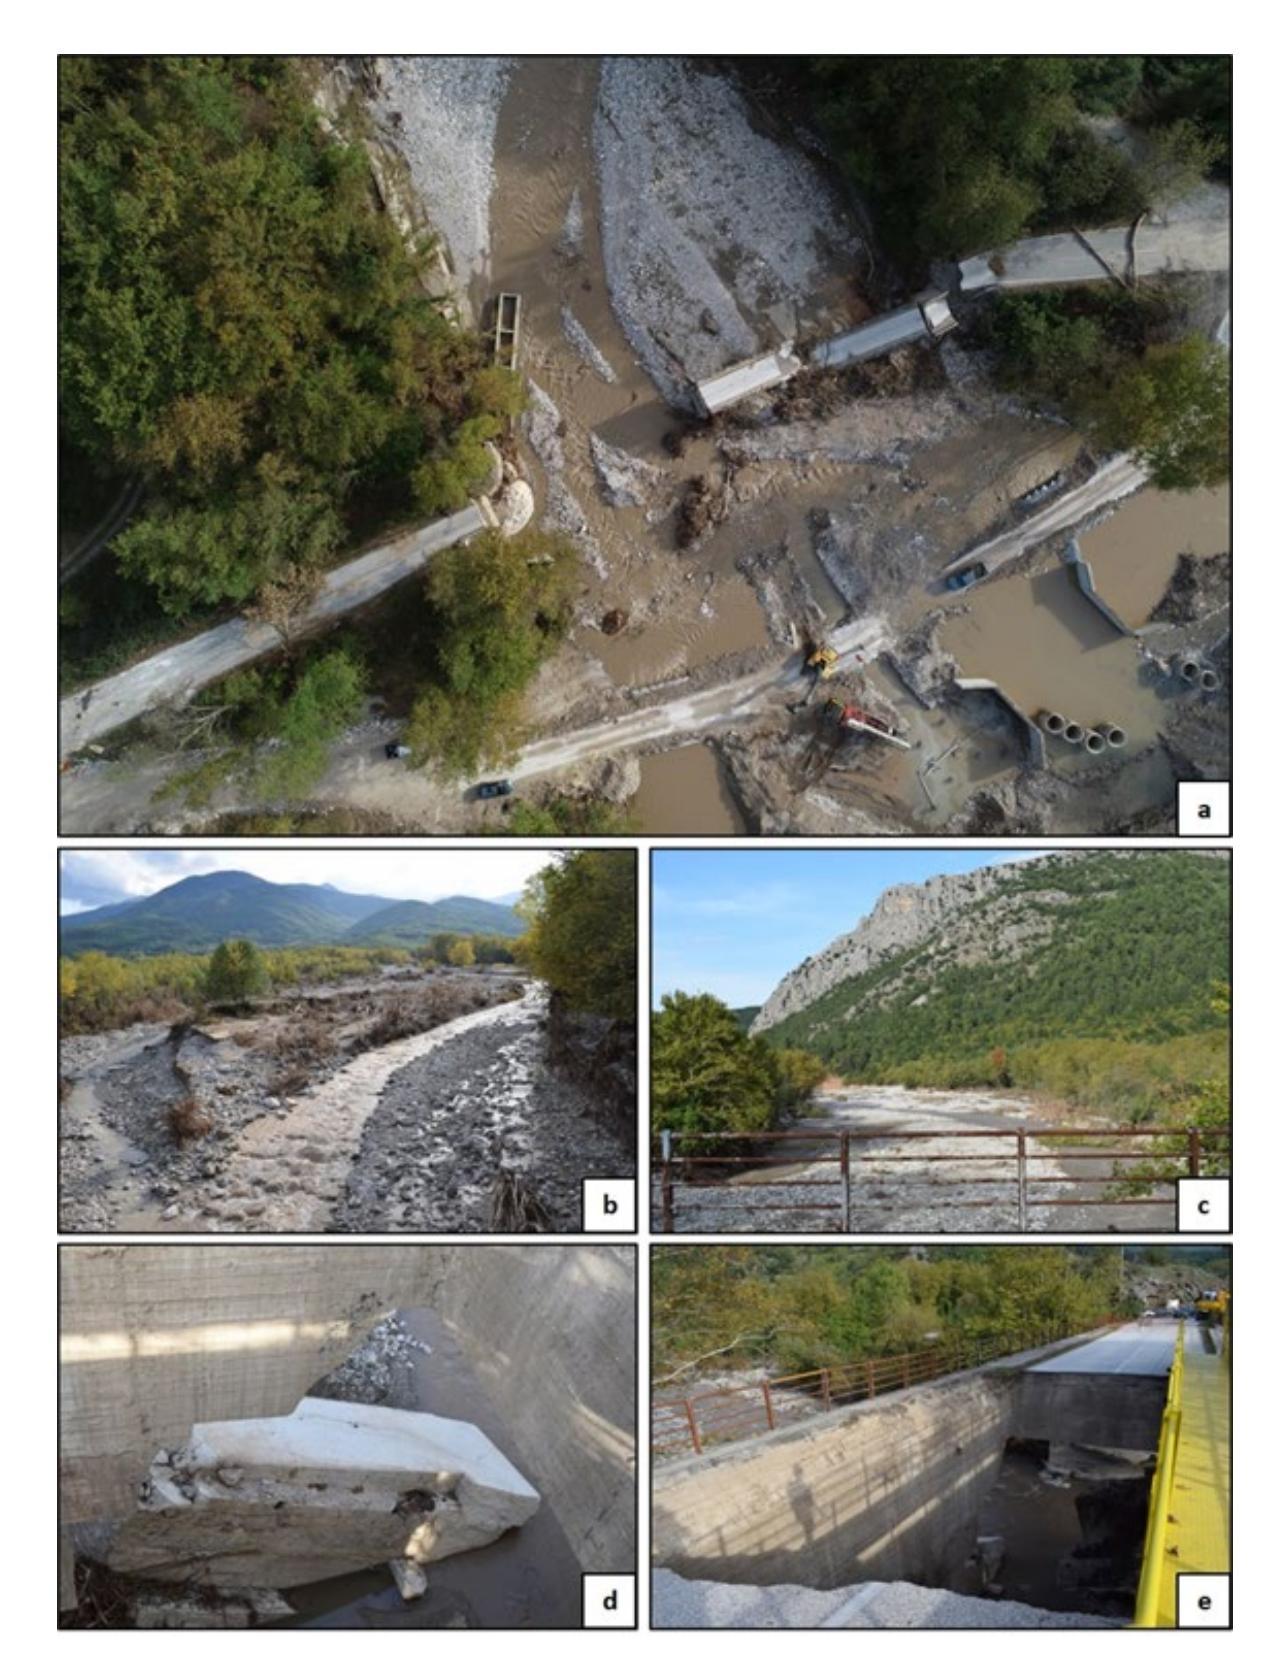
Figure 7.13. Debris flow caused damage to the bridges of a) Karaiskakis (39.401667 N, 21.653333 E), and b-e) Mpalanos (39.406111°N, 21.662778°E).
