The September 18-20 2020 Medicane Ianos Impact on Greece

Phase I Reconnaissance Report

Geotechnical Extreme Events Reconnaissance Association

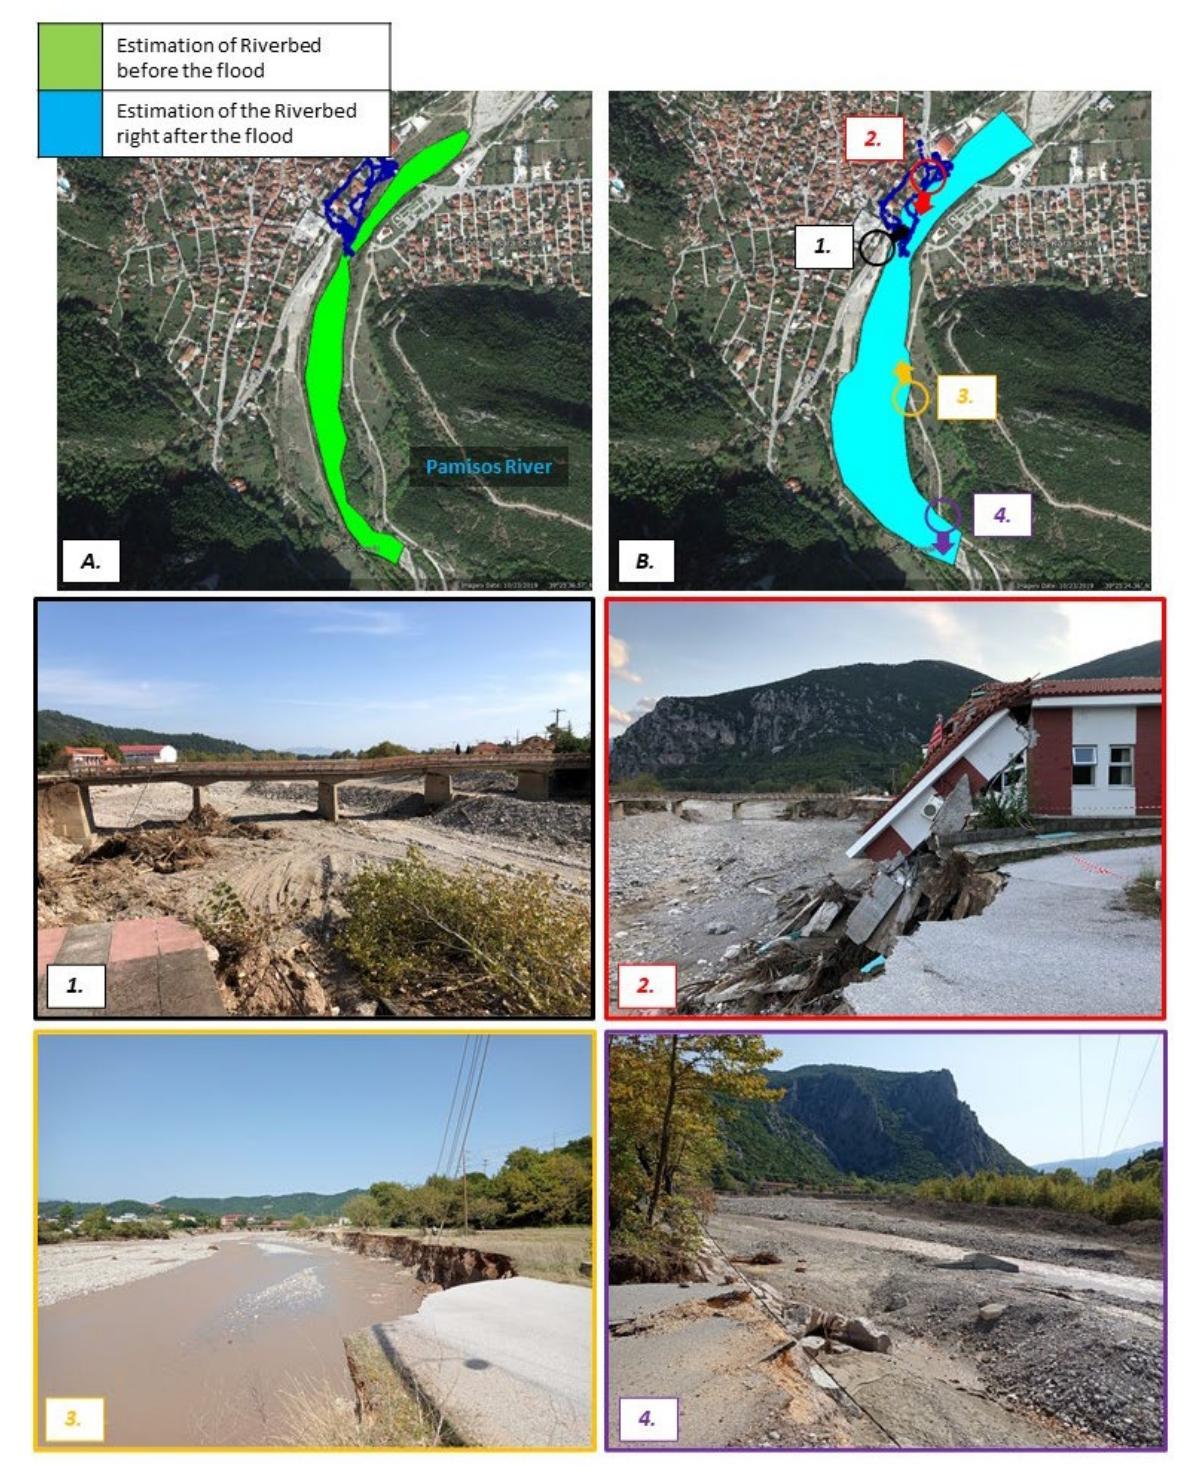
Figure 7.14. A) Pre-flood; and B) Post-flood riverbed area of the Pamisos river, estimated from the collapsed river embankments. The riverbed area increased by $\sim 120\%$. 1) embankment collapse – part of the riverside road collapsed in the river; 2) the spectacular collapse of the Mouzaki Health Center, due to the erosion and collapse of the founding embankment; 3,4) extensive embankment and road collapse upstream of Mouzaki.

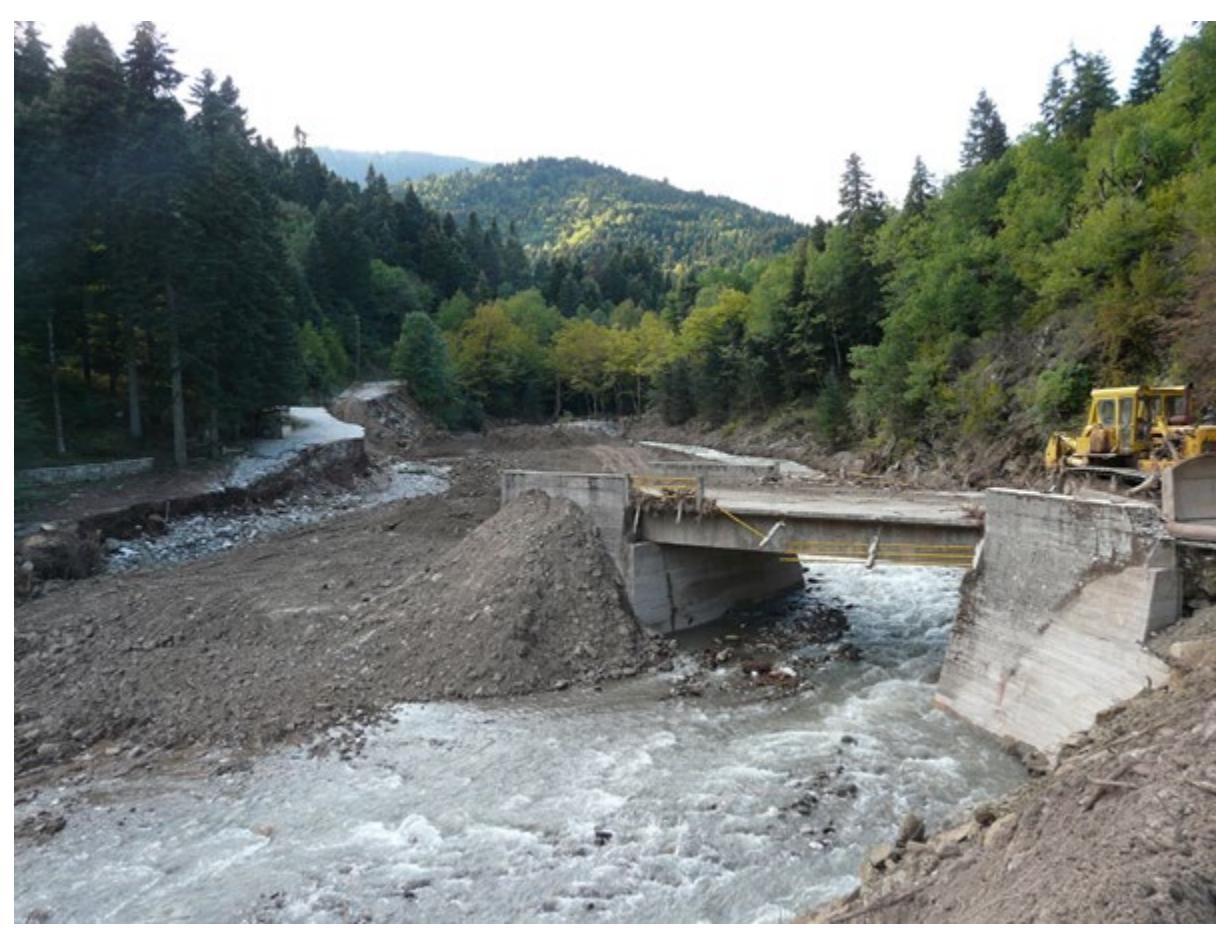
Figure 7.15. Riverbank erosion – slope failure that blocked the road. Karitsiotis river bridge, south of Belokomiti, Plastira Lake. (39.25381°N, 21.71591°E).

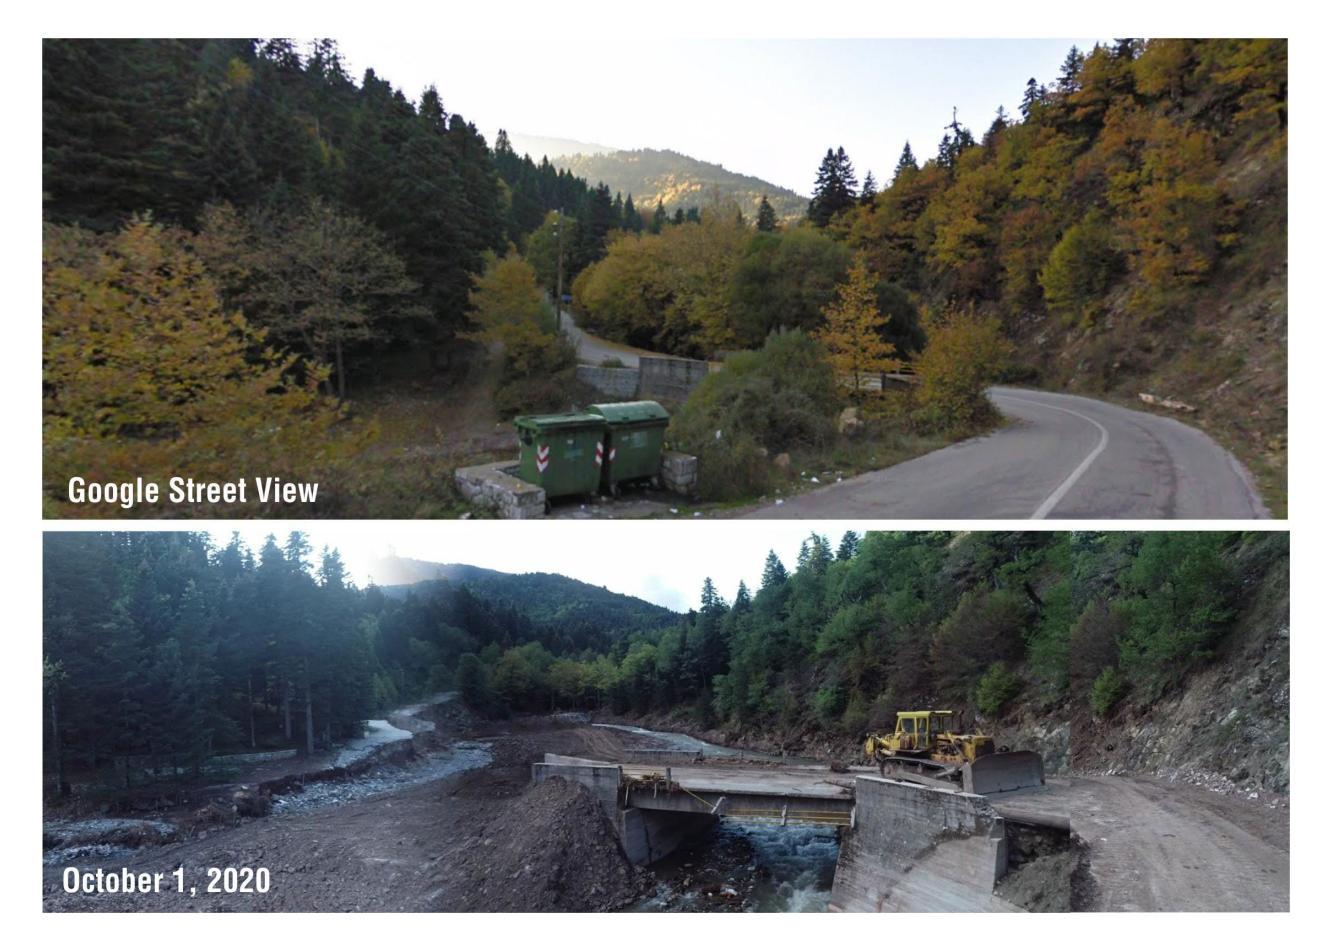
Figure 7.16. Comparison of previous state (Google Street View image) and post-Ianos damaged river pass at Karitsiotis river bridge, south of Belokomiti, Plastira Lake. (39.25381°N, 21.71591°E).

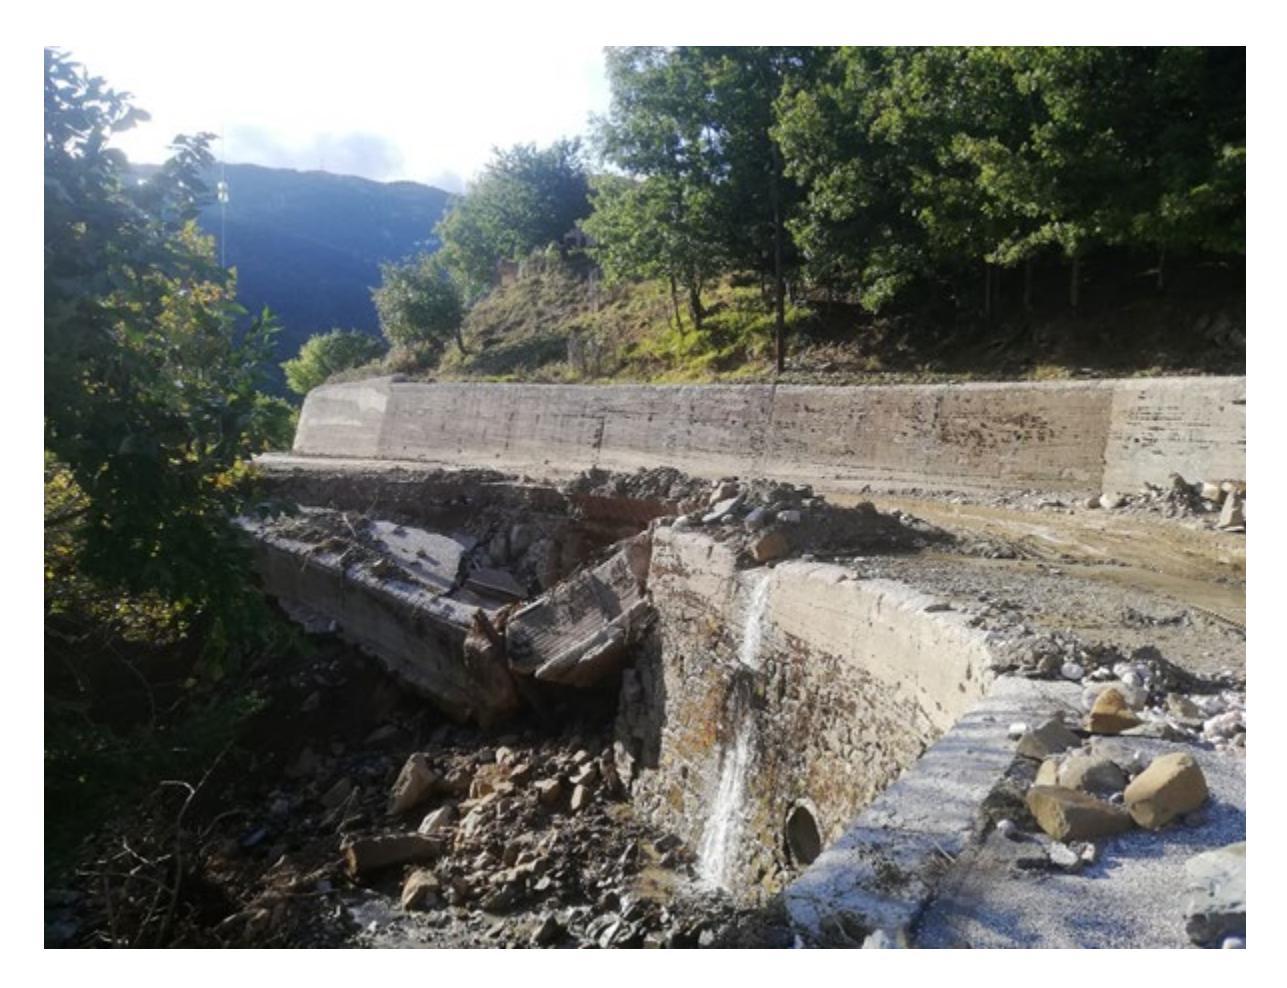
Figure 7.20. Riverbank erosion – slope failure that damaged partially the road. (39.26247°N, 21.71319°E)

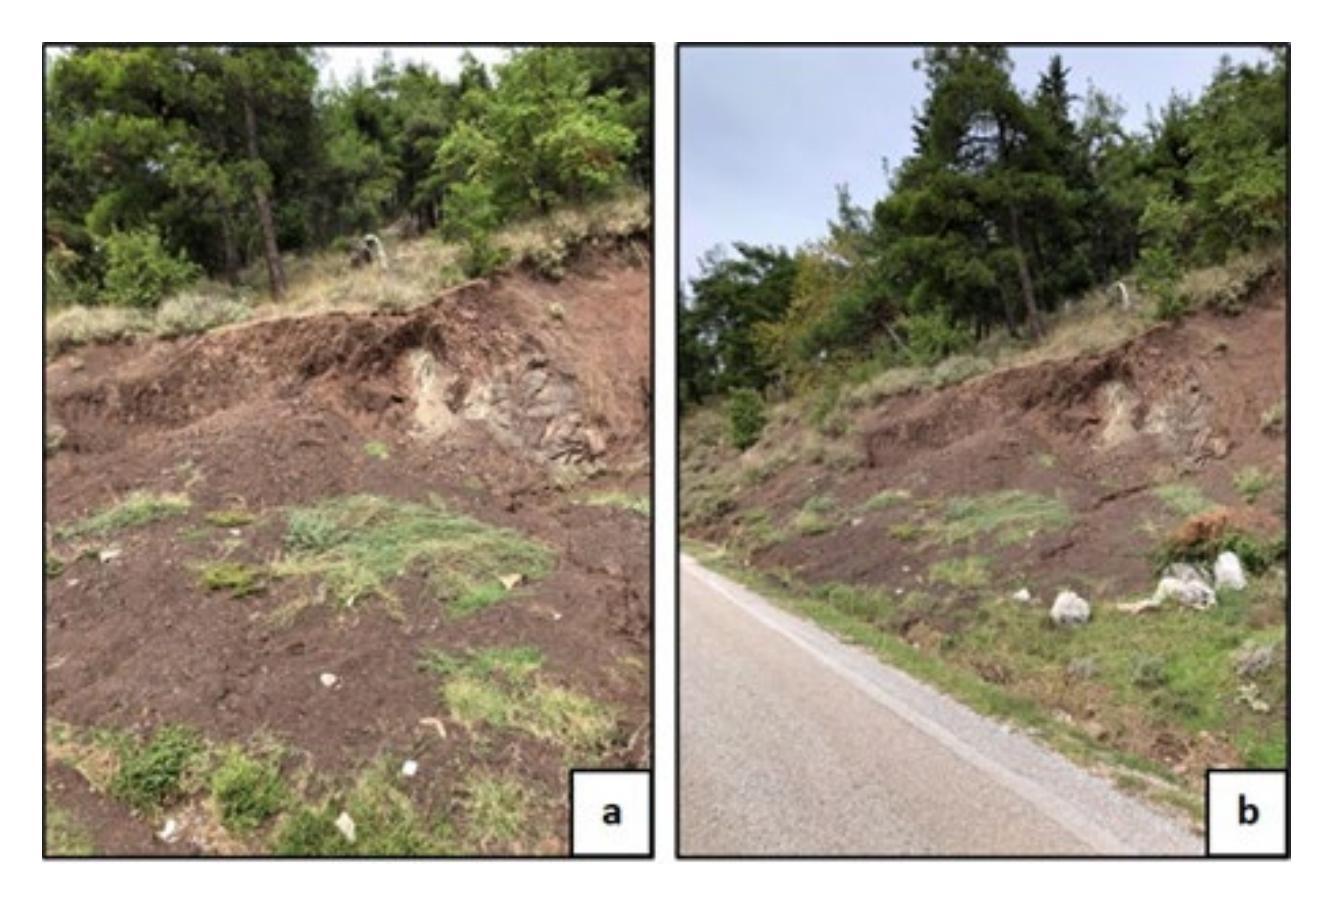
Figure 7.22. Surface erosion on Mouzaki to Porti road (39.410556°N, 21.658611°E).
