## Preliminary Report on Geotechnical Aspects of the May 15<sup>th</sup> 2020 Magnitude 6.5 Monte Cristo Range Earthquake in Nevada

A report of the NSF-Sponsored Geotechnical Extreme Event Reconnaissance Association

> Report GEER-71: <u>https://doi:10.18118/G67H4F</u> March 10, 2021 (version 1)

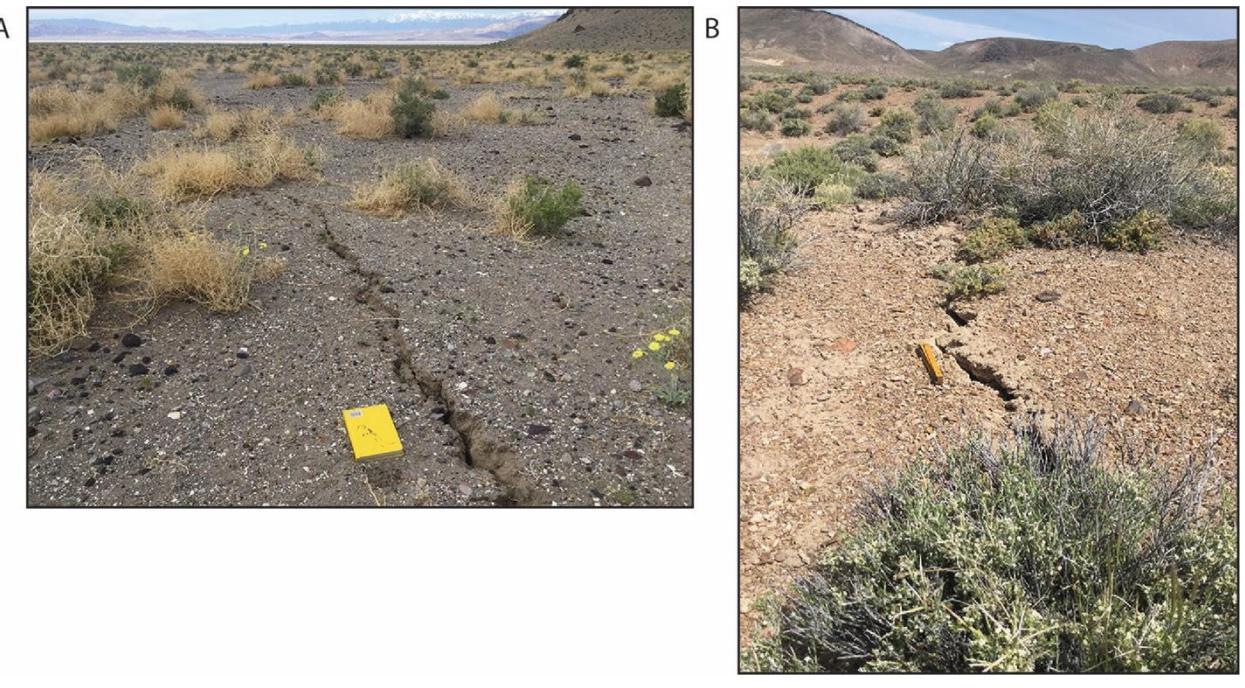
Distributed surface ruptures were observed across a 24 km generally east-northeast trending zone, predominantly west of the epicenter. Two distinct zones of surface rupture in terms of style and orientation of displacements were observed, roughly separated by US 95, and herein referred to as the eastern and western rupture zones. Within the eastern rupture zone, four distinct zones of generally north trending ruptures that exhibit predominantly extensional deformation were observed. Approximately 700 m east of US 95 (lat. 38.14867°, long. -117.93757°), a 30-40 m wide zone of sinuous overlapping ruptures extends 015° for about 1.5 km across relatively young alluvial fans and active washes (Figure 2-3A). There, individual ruptures are 20-45 m long and characterized by left and right steps, open fractures (0.5-3 cm), and occasional vertical separations of 2-3 cm. A similar set of ruptures occurs about 1 mile farther east (lat. 38.15897°, long. -117.91976°), has a N-S orientation, and is continuous for about a kilometer. Immediately west of the Monte Cristo Range, about 6 km east of HWY 95 (lat. 38.15732°, long. -117.88081°), a 600 m wide zone of parallel ruptures ranging in orientation from 355° to 30° extends across a relatively old alluvial fan surface with moderately- to welldeveloped desert pavement. Fractures in this area are typically open 1-2 cm. Finally, the easternmost observed rupture occurred within the Monte Cristo Range, approximately 12 km east of HWY 95 (lat. 38.16566°, long. -117.80527°). In this area, a 40 m wide zone of sinuous, anastomosing, extensional fractures (open 1-2 cm, occasionally up on the east 3 cm) extends for about 2 km and coincides with a fault mapped in bedrock (Figure 2-3B).

**Figure 2-3:** Photographs of surface rupture in the eastern surface rupture zone. (A) lat. 38.15229°, long. -117.93675°. (B) lat. 38.16693°, long. -117.80469°.

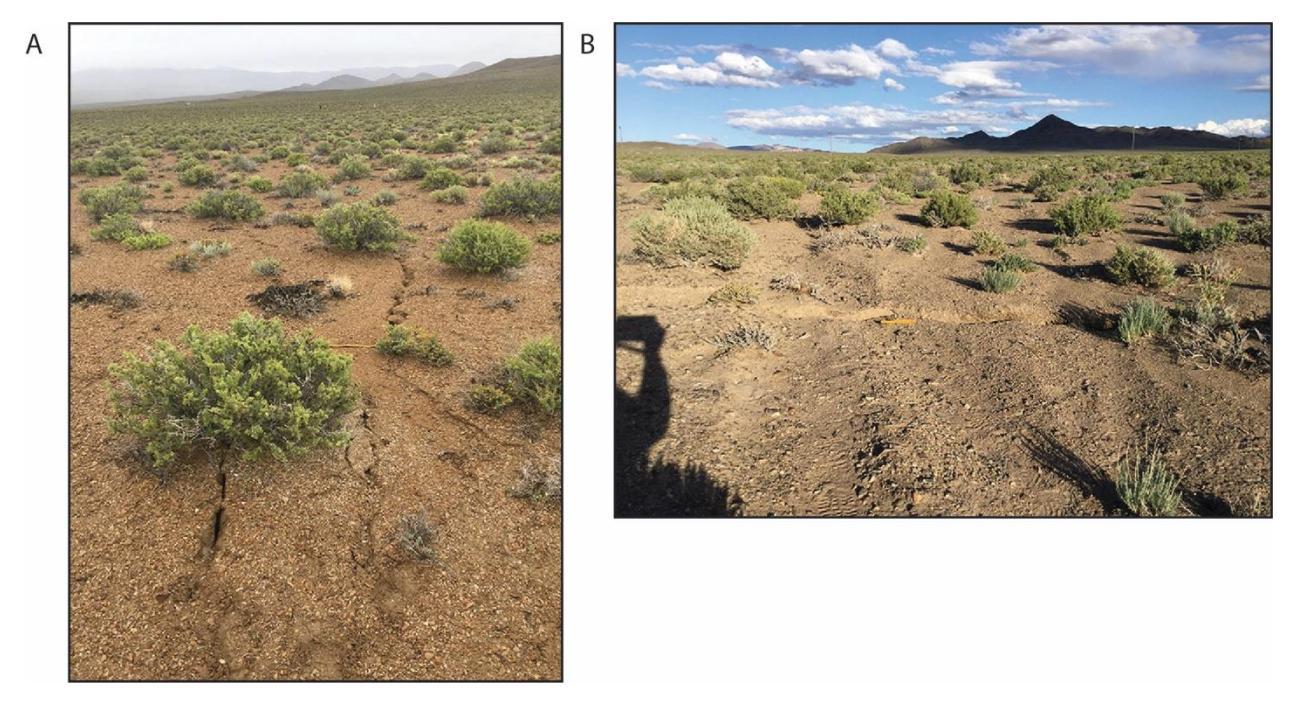
The western rupture zone extends east-northeast from the eastern end of the mapped trace of the Candaleria fault in the Candaleria Hills to US 95 for a total distance of about 10 km. There, ruptures extend across low bedrock hills, pediments, alluvial fans, and active washes. The zone is characterized by two subparallel main traces striking  $050^{\circ}$ - $070^{\circ}$  that exhibit a sinuous pattern in map view. Ruptures along these traces have right stepping en echelon surface breaks connected by small push up mounds and moletracks (Figure 2-4A), a text-book geomorphic expression of left lateral displacement analogous to the 2019 M6.4 Ridgecrest California earthquake. Left lateral displacements along these traces range from 5-15 cm, and possibly up to 20 cm, however subtle piercing points associated with wash margins precluded accurate measurement of displacement in many locations (Figure 2-4B). North-northeast striking ruptures (005°-020°) extend for lengths of 0.5 to 1 km, splay off both of the main northeast striking traces, and exhibit a right stepping pattern. Displacements along these traces are predominantly centimeter scale extensional separations with local vertical separations up to 7 cm. The majority of the ruptures in the western rupture zone are associated with broad zones of distributed extensional fracturing up to 500 m wide with 1-3 cm open surface cracks along individual fractures.

**Figure 2-4:** Photographs of surface rupture in the western surface rupture zone. (A) lat. 38.17316°, long. -118.02345°. (B) lat. 38.18315°, long. -118.00648°.

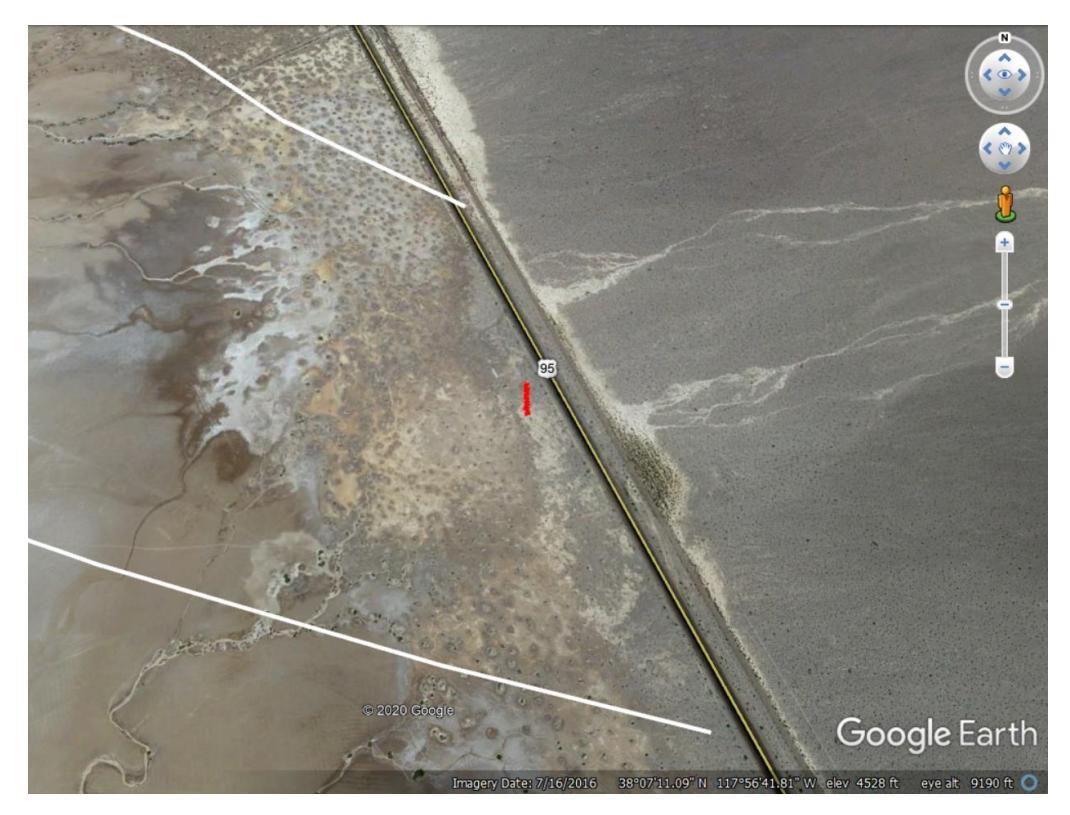
The location of the surface deformation trace of the lateral spread feature relative to previously mapped surface fault rupture traces is shown in Figure 4-1. Continuation of this feature was mapped by Conni De Masi Castillo via drone imagery (and also observed by the team members) as shown on Figure 4-2. The photos captured by Castillo suggest that the feature is possibly a surface deformation feature related to liquefaction (Figures 4-3 and 4-4). Figure 4-5 shows some of these distributed cracking features along the surface deformation trace. Some of the distributed cracks bound grabens with widths of approximately 23cm as shown in Figure 4-6 and vertical offsets of approximately 4cm. The ground surface elevation gradient on the

**Figure 4-1:** Surface deformation feature mapped by the GEER team (red) and surface fault rupture traces mapped by USGS (white; Elliot et al. 2020).

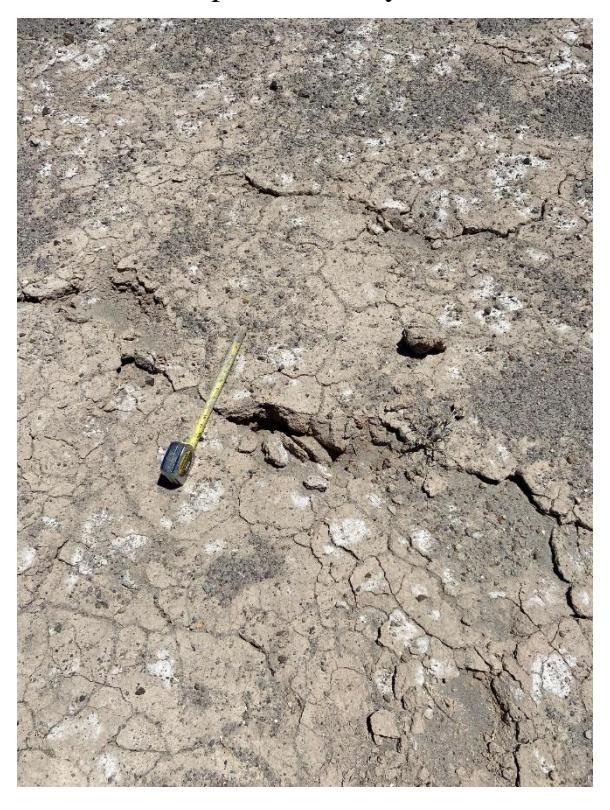
**Figure 4-5:** Distributed cracking features associated with the surface deformation trace shown in Figure 4-1 (*lat/lon = 38.11093611, -116.07064167*).

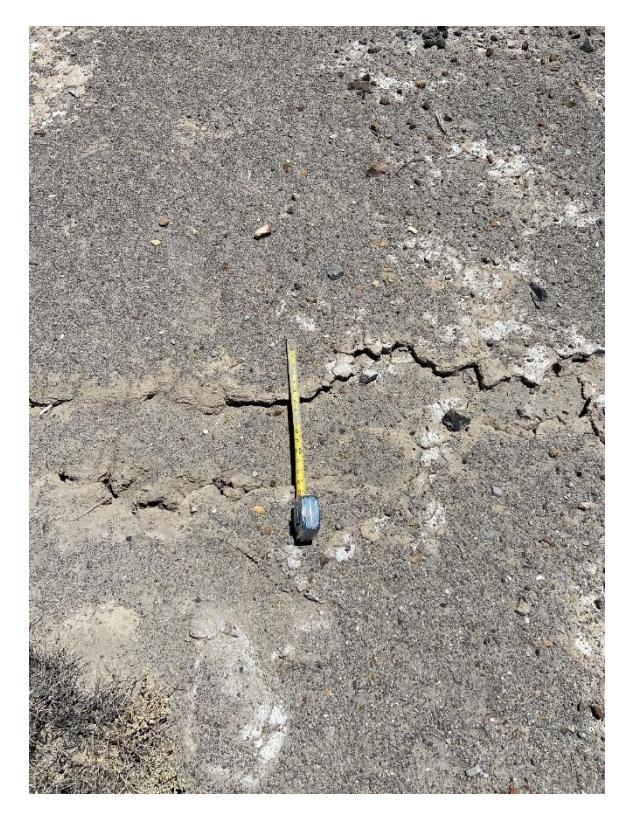
Figure 4-6: 23cm wide graben associated with the surface deformation trace (lat/lon = 38.11118056, -116.07064722).

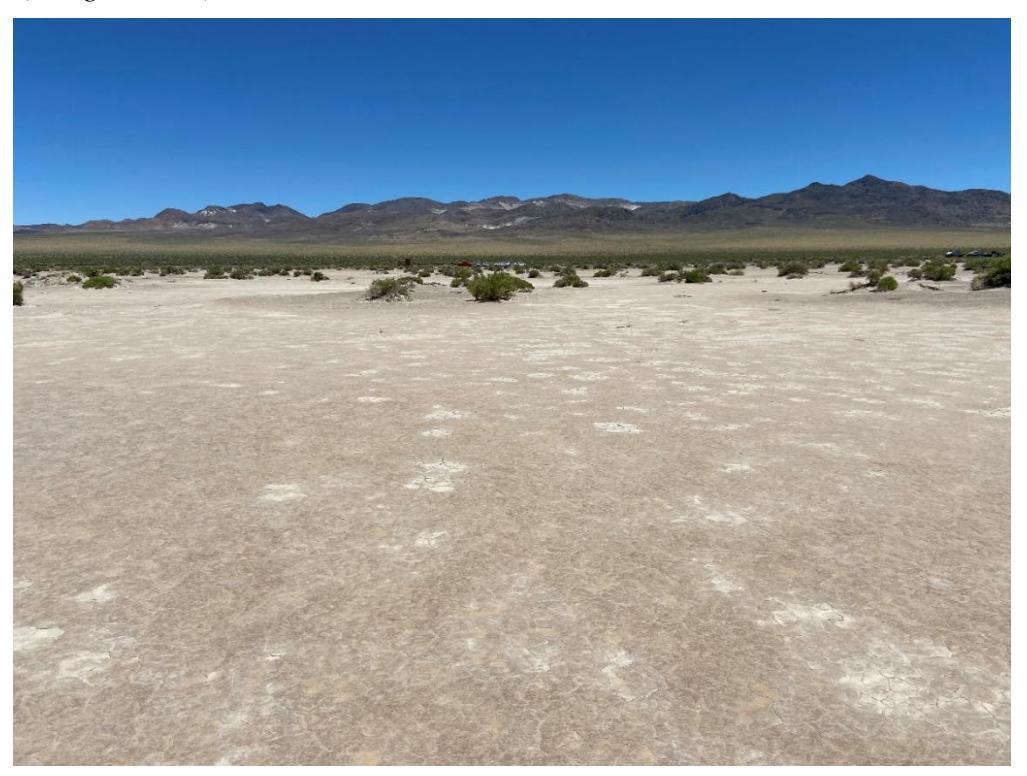
**Figure 4-8:** Area of observed sand boils, ejecta is lighter colored material (lat/lon = 38.1120, - 116.067).

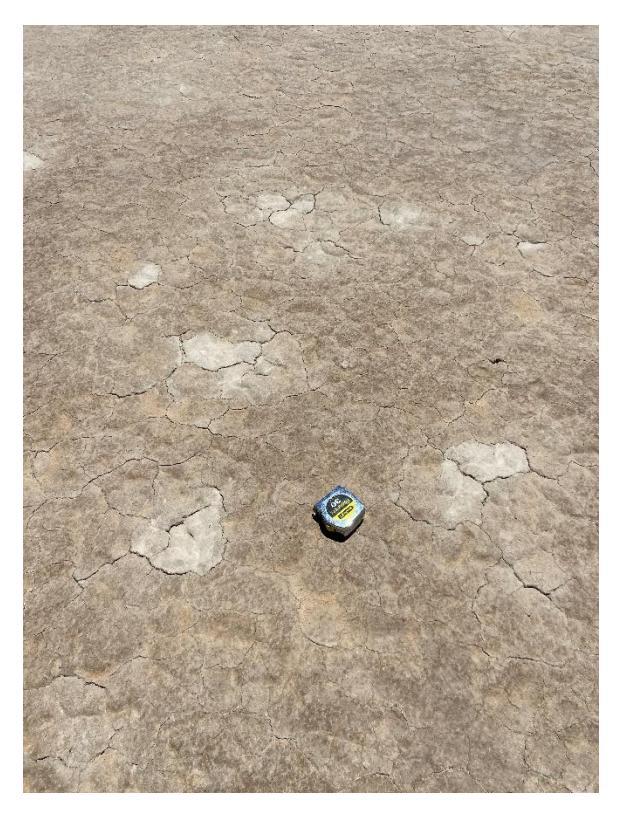
Figure 4-9: Sand boils showing light colored ejecta (*lat/lon = 38. 1121, -116. 067*).

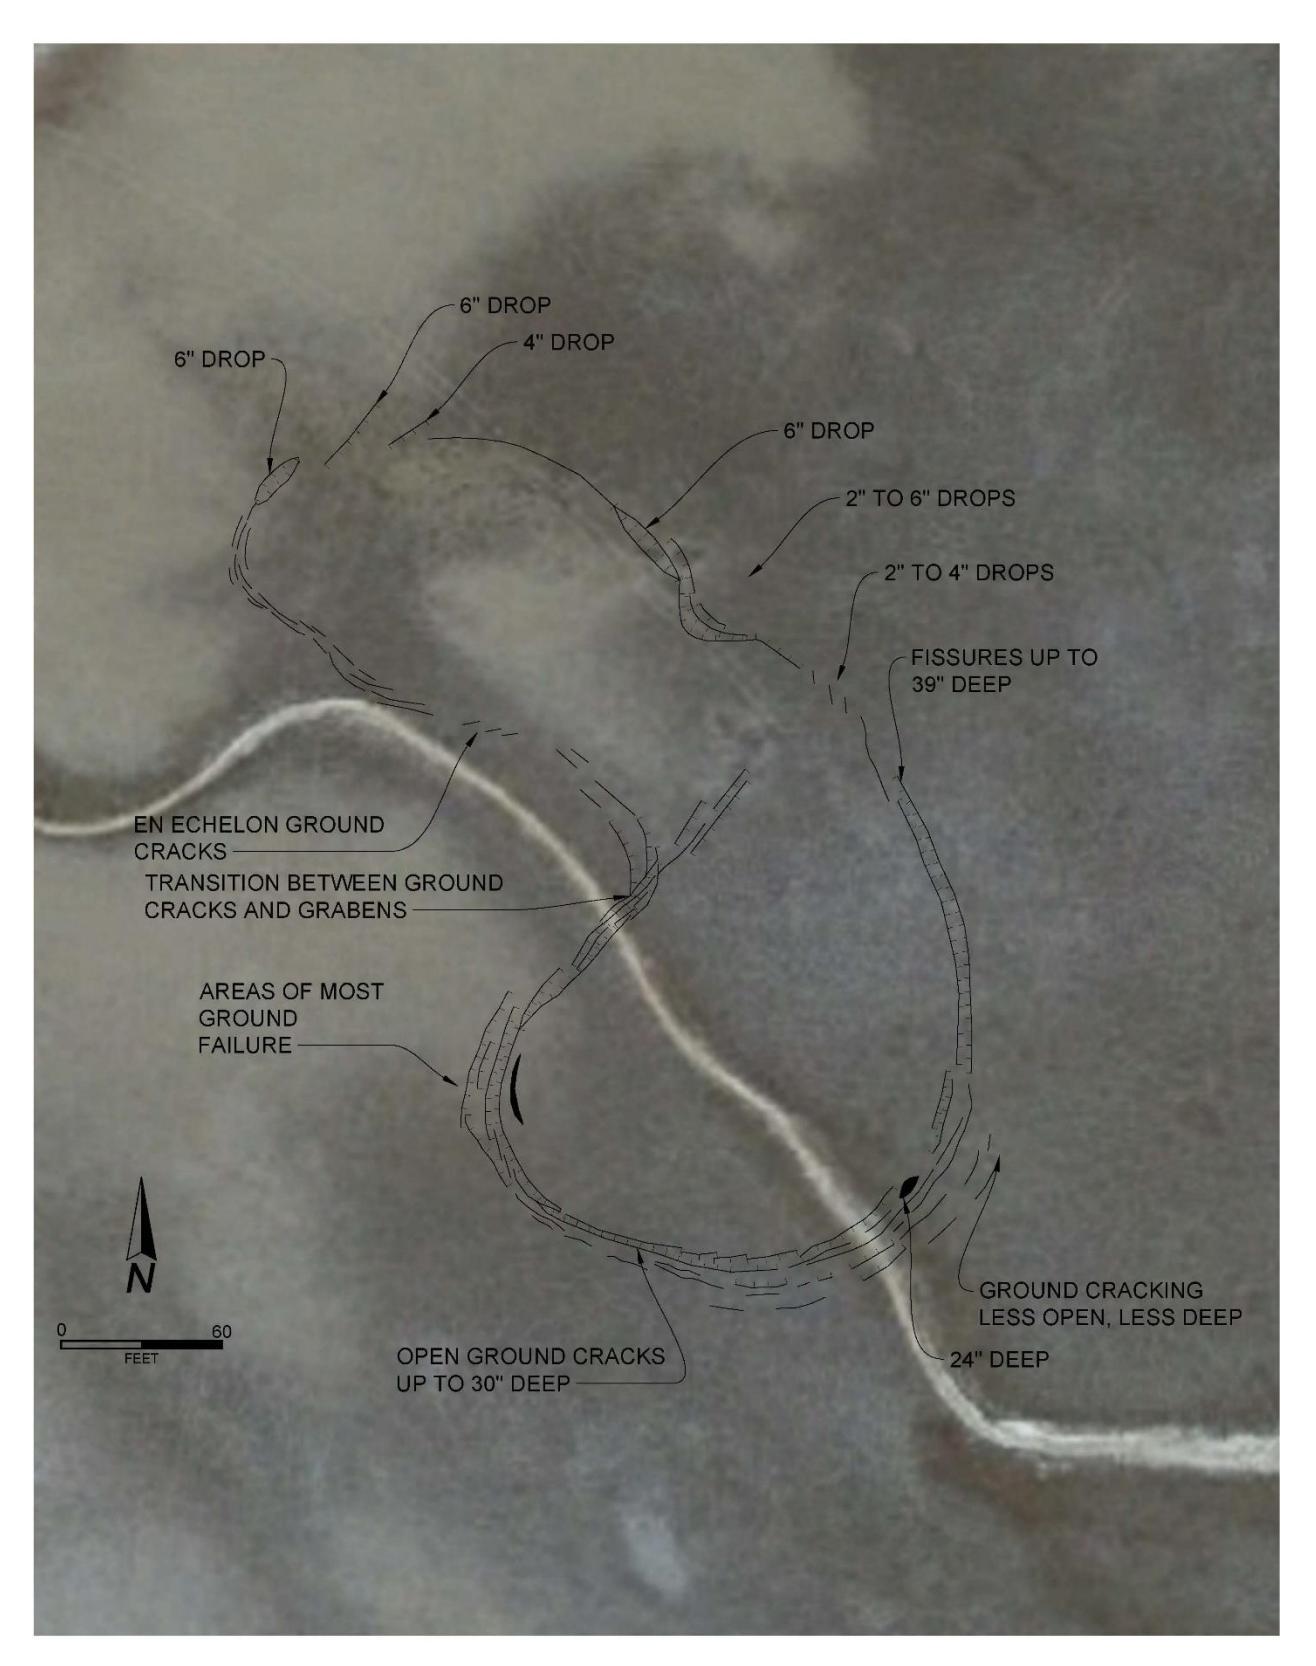
Feature GSS2 is a kidney-bean shaped subsidence feature with a concave portion on each of its E-W sides. The distance between Waypoint 1 and Waypoint 5 of GSS2 is 108.5m. Table 4-2 lists the observations associated with each waypoint, and Figures 4-38 through 4-50 show the associated photographs. As shown in Figure 4-39, the ground surface displacements associated with GSS2 cross an ephemeral stream channel within the Columbus Salt Marsh.

**Figure 4-15:** Feature GSS2 with mapped and notated features. Teeth indicate downdropped portion of grabens (Photo from Google Earth).

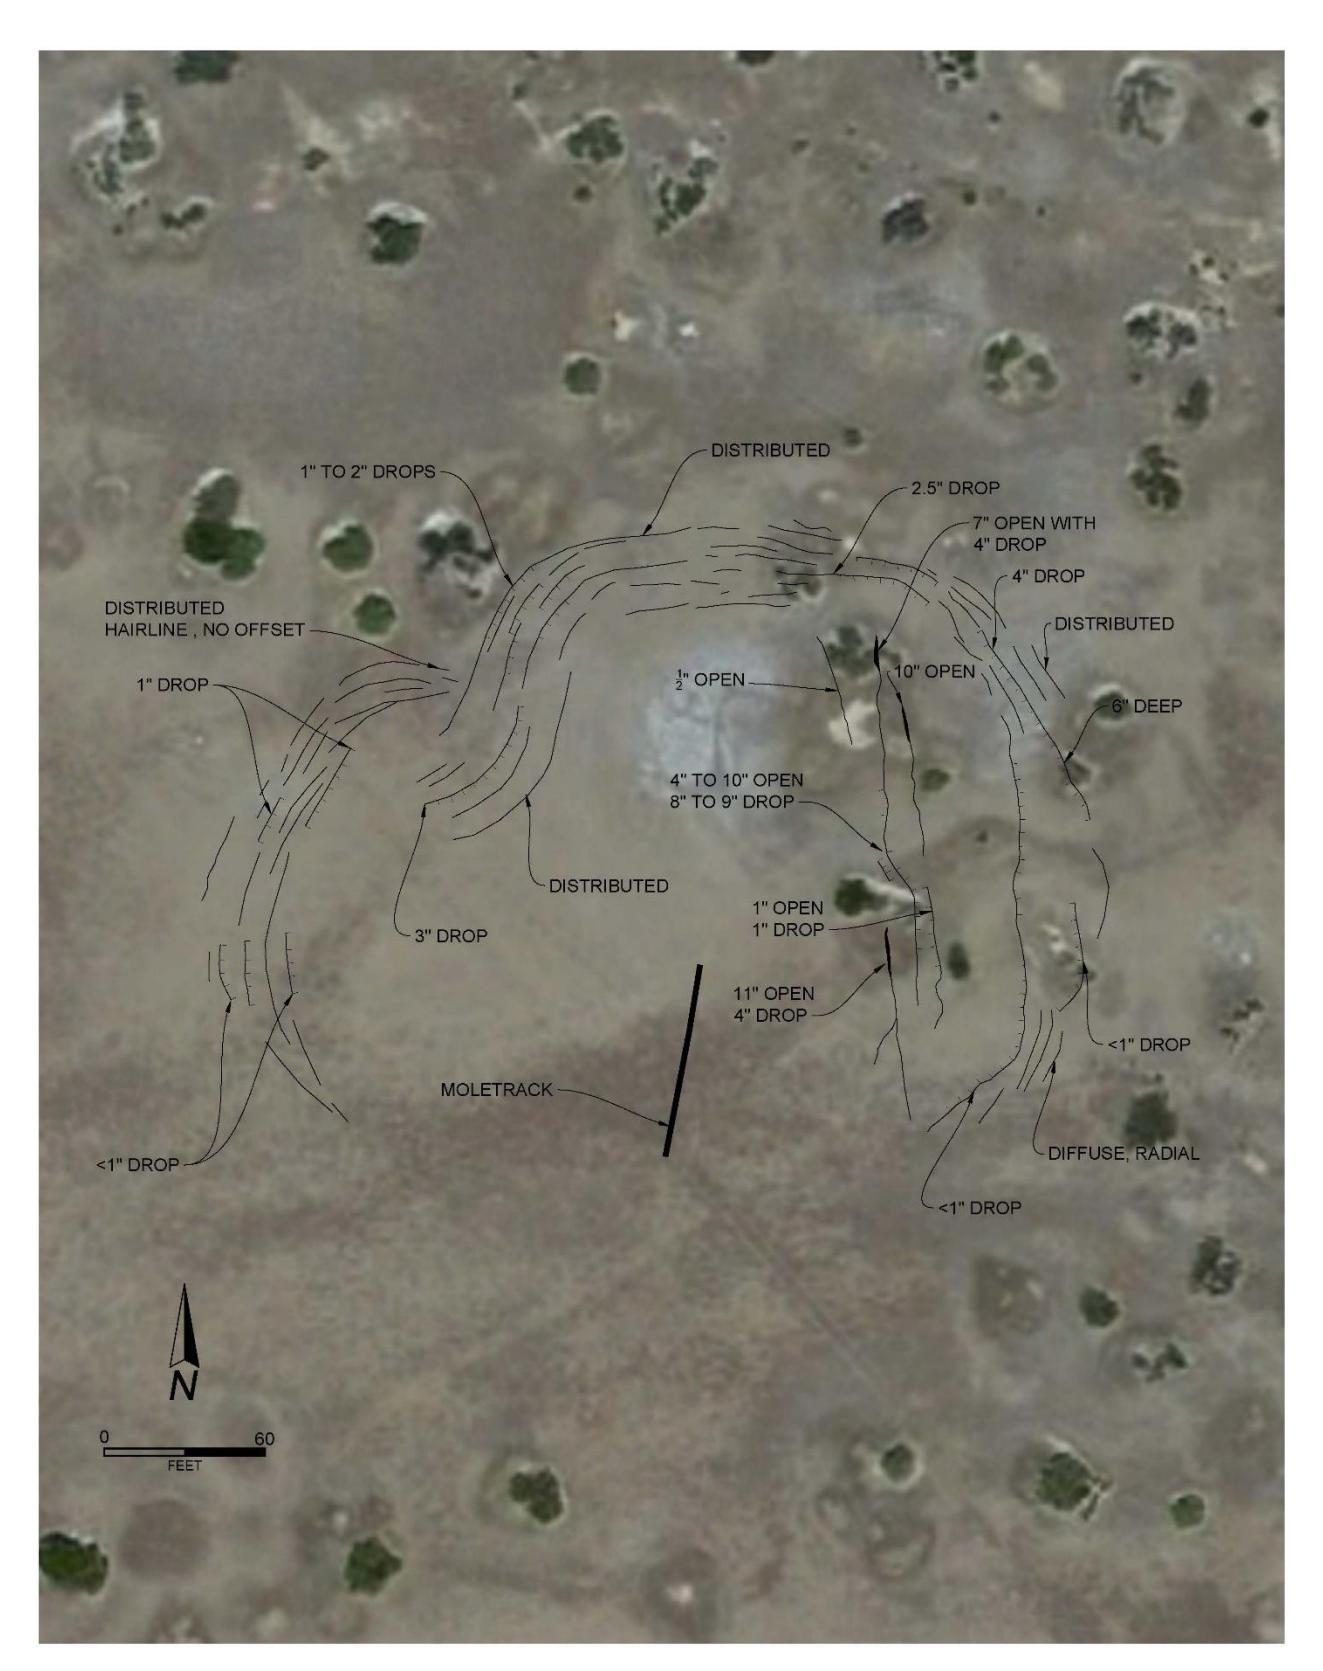
**Figure 4-16:** Feature GSS5 with mapped and notated features. Teeth indicate downdropped portion of grabens (Photo from Google Earth).

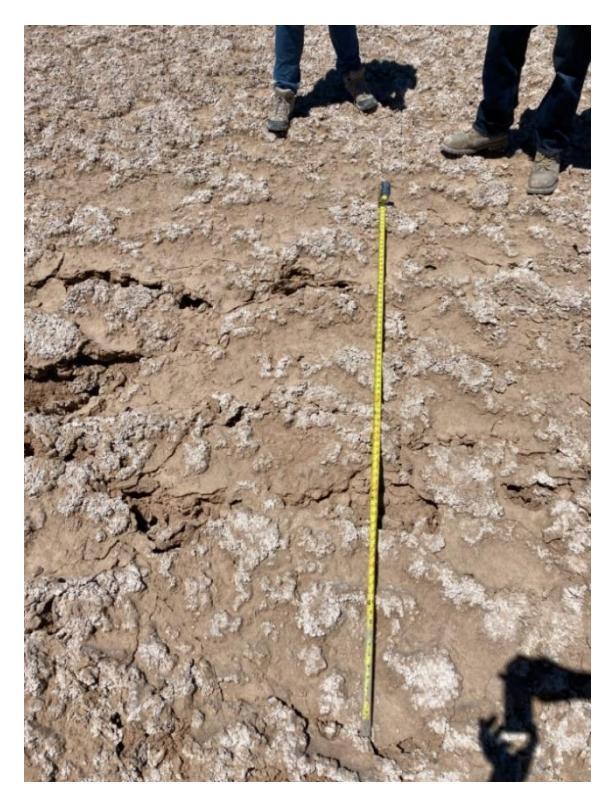
Figure 4-17: Waypoint 1 of subsidence feature GSS1 (*lat/lon = 38.11181, -117.93497*).

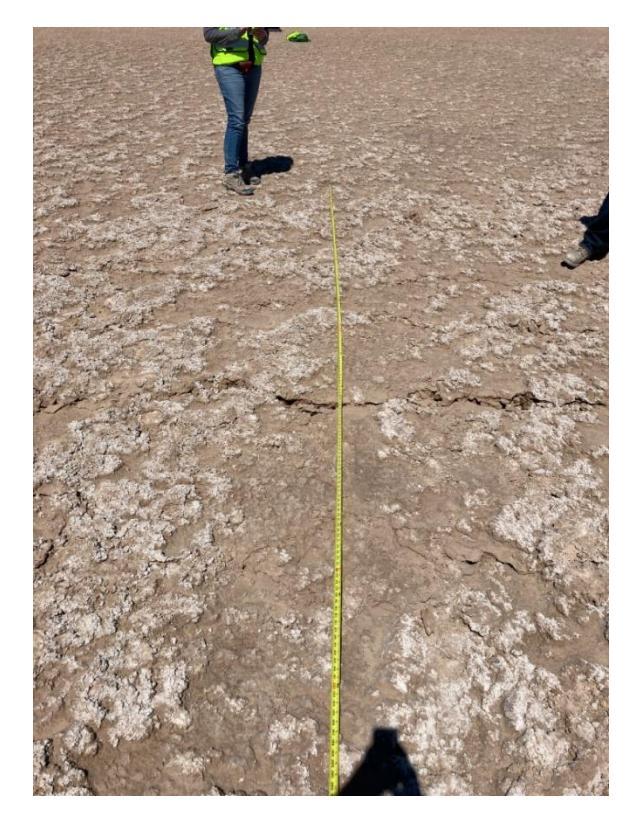
Figure 4-37: Waypoint 23 of subsidence feature GSS1 (*lat/lon = 38.11180*, -117.93487).

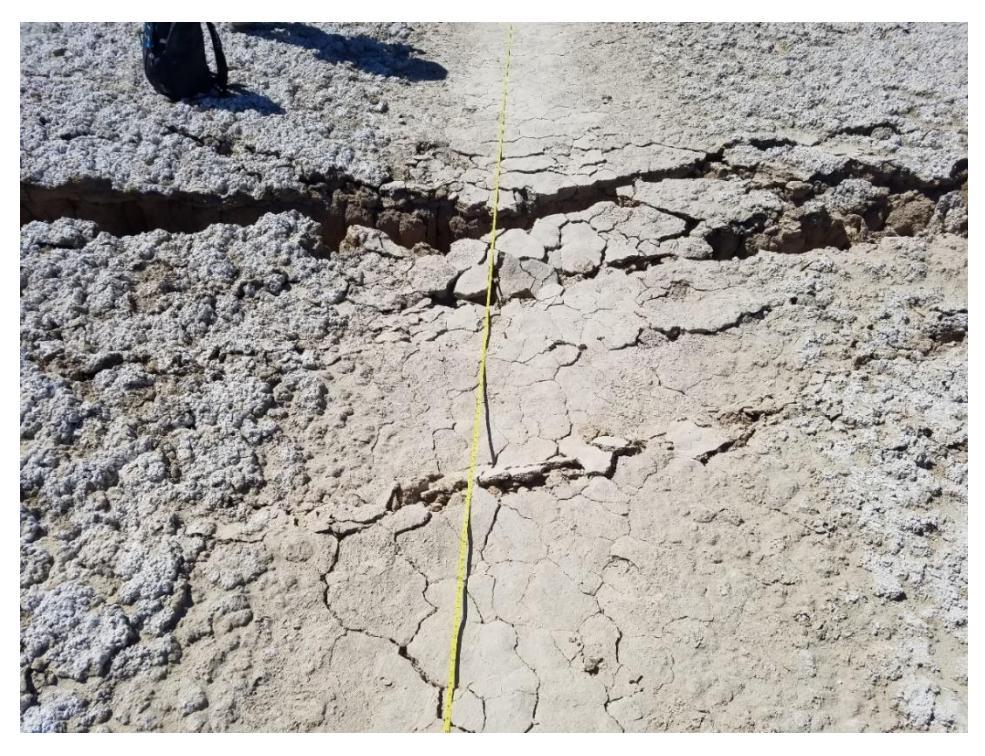
**Figure 4-38:** Ground surface displacements at Waypoint 1 of subsidence feature GSS2 (*lat/lon* = *38.11355*, *-117.93671*).

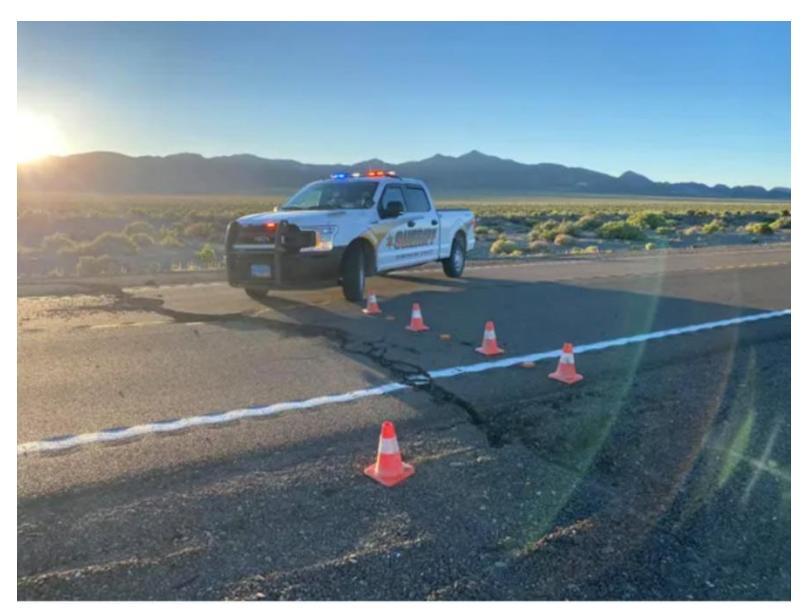
The Nevada Department of Transportation (NDOT) maintains US 95 and US 6 within the region. Highway US 95 north of Coaldale experienced one large transverse fracture across the pavement. Multiple small ground surface ruptures were observed west of the highway embankment running parallel and into the adjacent to Columbus Marsh. At the time of the reconnaissance US 95 was closed for emergency repairs, therefore the ruptured pavement section was not physically observed by our team. The following photo in Figure 8-1, sourced from a local newspaper, documents the rupture across US 95 the morning of the event. At the time of emergency repairs, NDOT closed that section of US 95 and rerouted traffic using an alternate route through US 6. NDOT escorted our reconnaissance team along the closed portion of US 95 to conduct our field observations. No visible damage was observed on the alternate route on US 6. Figure 8-2 presents the transverse cracks observed parallel to the highway and trending into Columbus Marsh.

**Figure 8-1:** Transverse crack across US 95 the morning of the event, looking east towards Monte Cristo Range (courtesy of Reno Gazette Journal, May 22, 2020 online edition) (approx. Lat./Long. 38.11226, -117.9290).

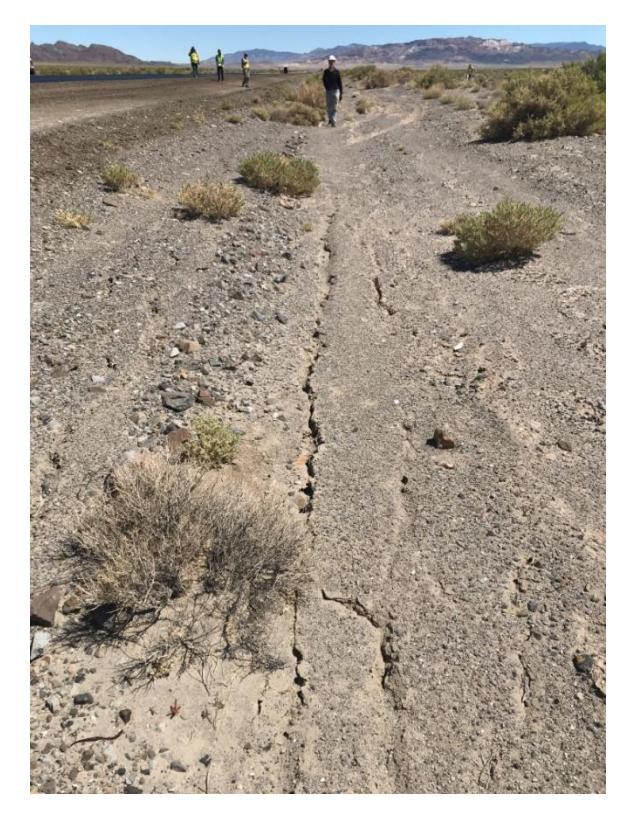
**Figure 8-2:** Transverse cracks observed parallel of western embankment of US 95 and looking south toward Coaldale (Photo taken June 9<sup>th</sup>, 2020) (Lat./Long. 38.11226, -117.9290).

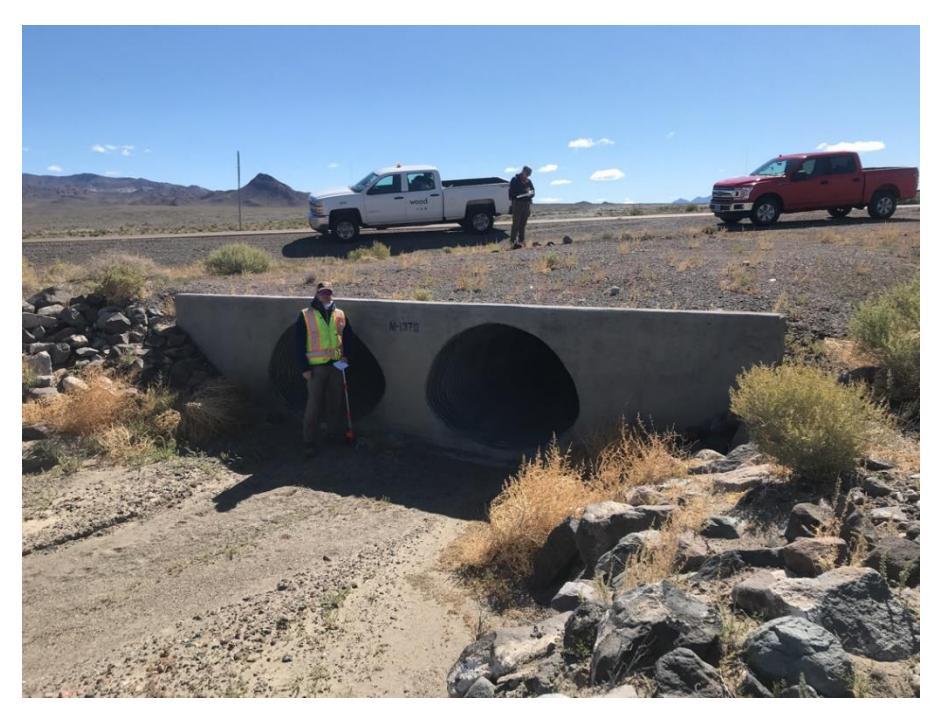
Our team inspected a box culvert, identified by NDOT as M-137B, just north of the junction of US 95 and US 6 at Coaldale. Structure M-137B provides flow underneath US 95 from the Coaldale Wash and is roughly 6 miles south of the epicenter at NDOT milepost marker 95ES-85.52. Structure M-137B consists of a concrete buttress on either side of US 95 and included corrugated metal pipe serving as a conduit for drainage beneath the highway. The dimensions of the concrete buttresses on M-137B were approximately 5 feet in height and 25 feet wide (Figure 8-3). The corrugated conduits were observed to contain detritus from previous drainage events through the wash (Figure 8-4). The conduits were approximately 4.2 feet in diameter. Each concrete buttress wall was inspected for signs of distress. No damage was observed in the structure resulting from the May 15<sup>th</sup> event.

**Figure 8-3:** Western concrete buttress of NDOT Structure M-137B at Coaldale Wash (Lat./Long. 38.03281, -117.888).

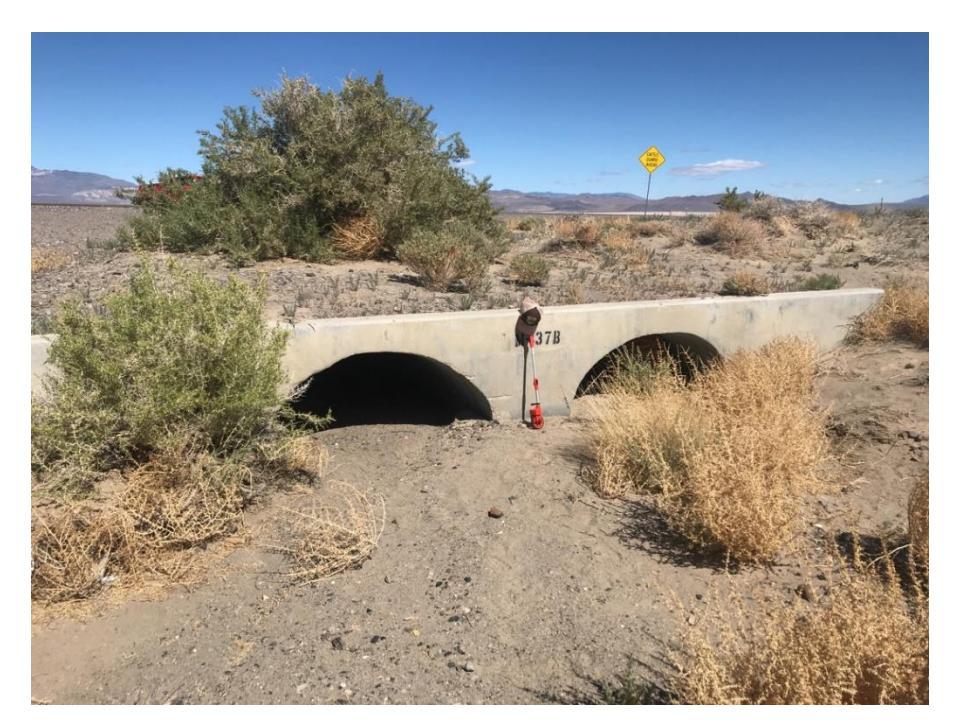
**Figure 8-4:** Eastern concrete buttress of NDOT Structure M-137B at Coaldale Wash showing infilling of detritus from previous flow events (Lat./Long. 38.03269, -117.887).

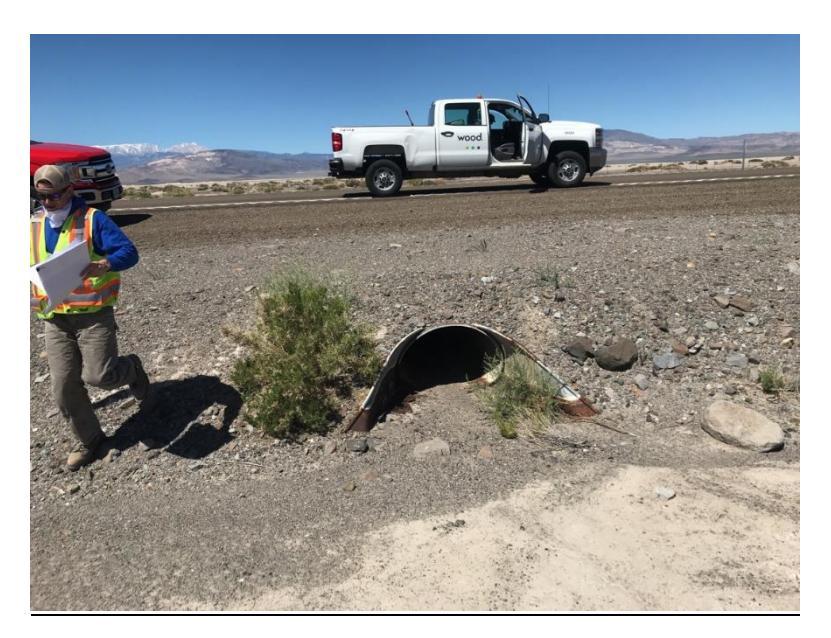
Additional corrugated metal pipe culverts (CMP) were also observed crossing US 95 in several sections near the epicenter. Figure 8-5 presents a typical CMP near the epicenter. No signs of distress or damage was observed with these structures.

**Figure 8-5:** Corrugated Metal Pipe Culvert crossing US 95 north of Coaldale Wash and south of epicenter (Lat./Long. 38.0679, -117.908).

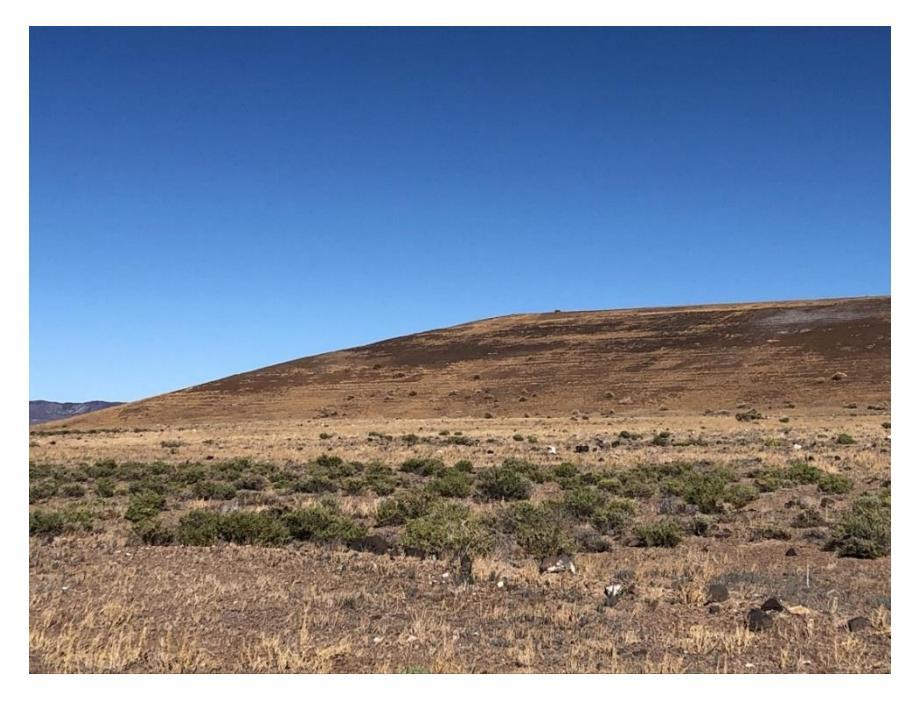
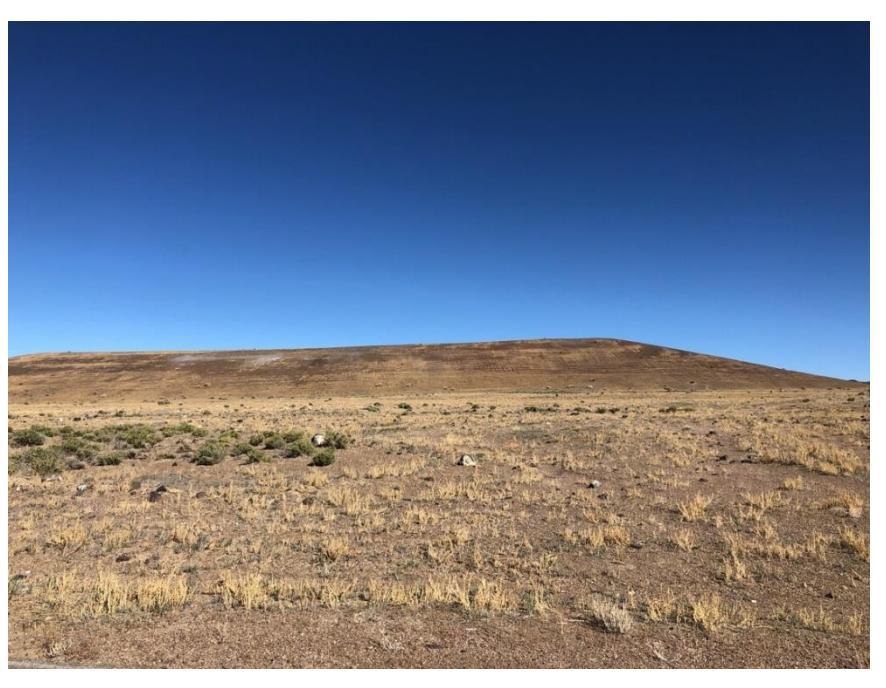
We observed the mine dumps from the access road (a distance of about 1,000 ft) and did not see any signs of slope failure, settlement, or distress, see Figures 9-2 and 9-3.

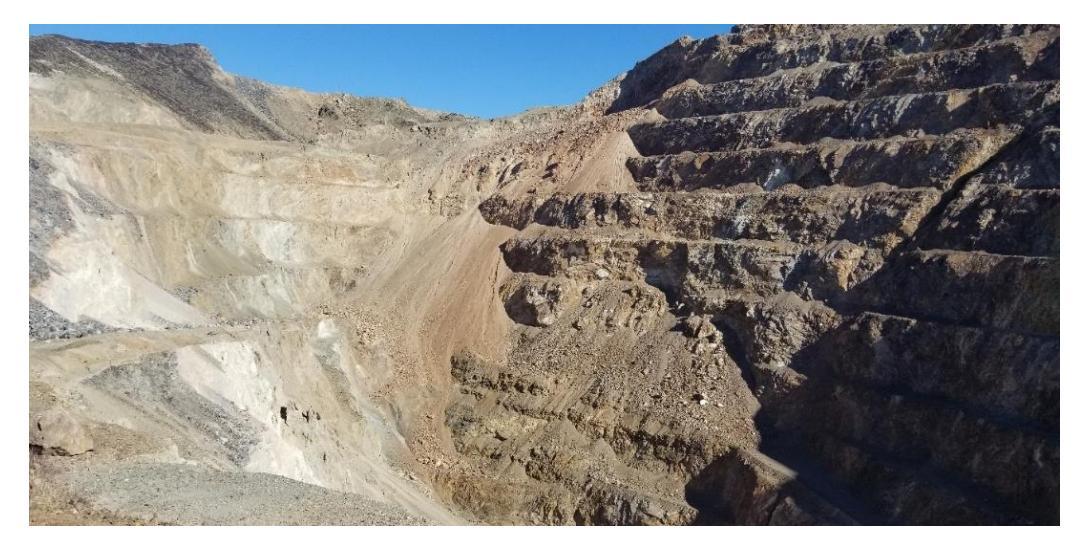
We also observed portions of the open pit high wall that were visible from near the access road (Figure 9-3). There were signs of shallow surface sloughing on the cut benches, but there was no indication that the sloughing was due to the earthquake.

**Figure 9-3:** Photo of Candelaria Mine open pit high wall looking South west from edge of pit. Photo GL16-1).

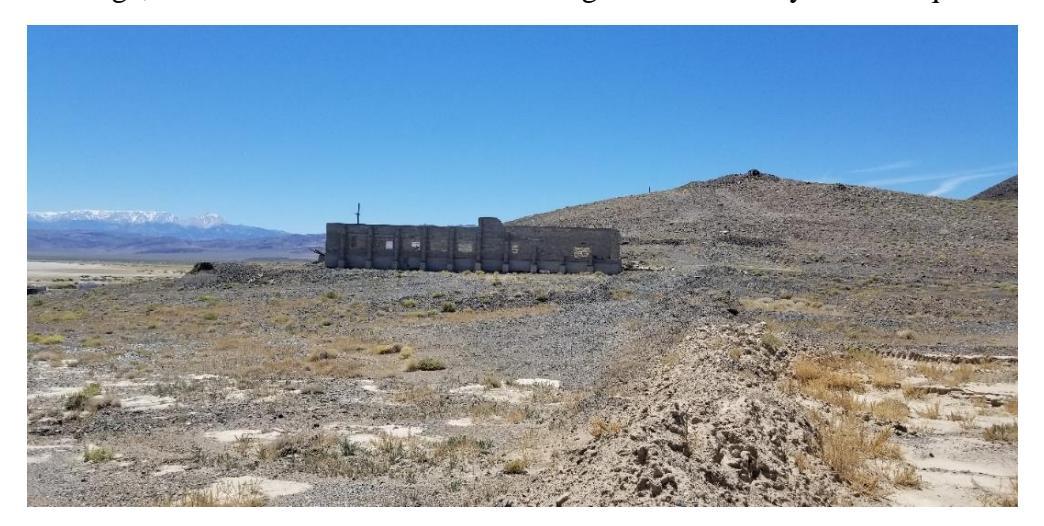
**Figure 9-5:** Partially built masonry block building at the Mine Processing Plant. Photo looking west. (Photo GL29-4).
