PRELIMINARY REPORT ON

THE PRINCIPAL GEOTECHNICAL ASPECTS OF

THE JANUARY 17, 1994 NORTHRIDGE EARTHQUAKE

Report No. UCB/EERC-94/08

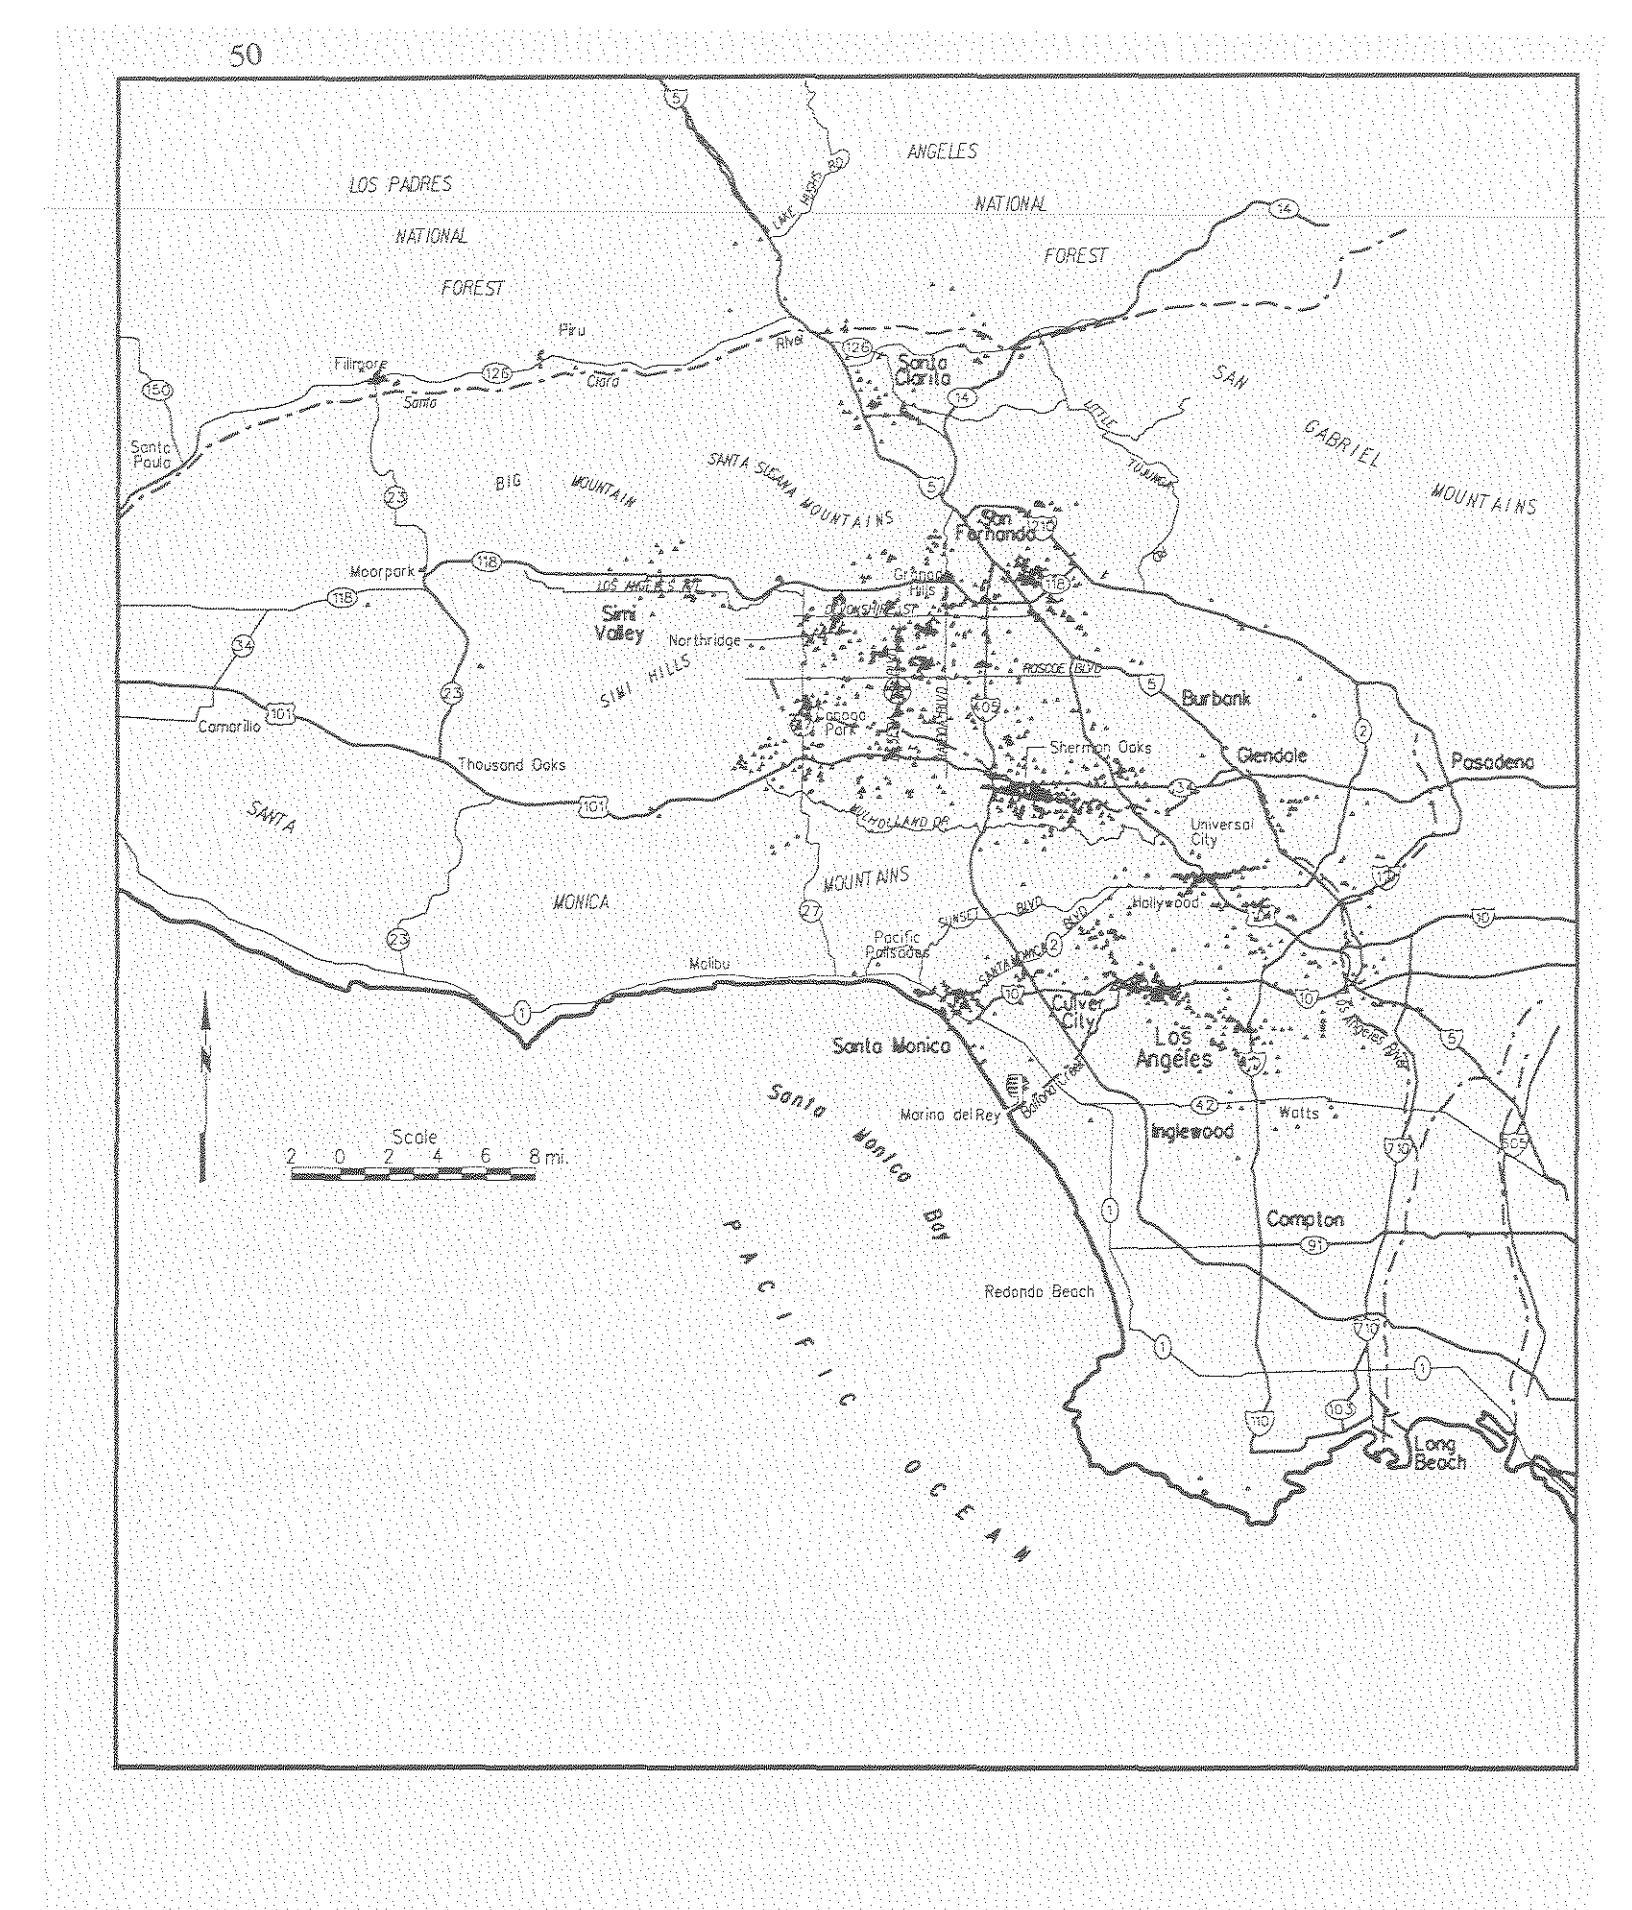
Fig. 3.23: Damage patterns from the 1994 Northridge Earthquake. Triangles represent red-tagged (unsafe) structures reported as of April 1994 to the Governor's Office of Emergency Services.

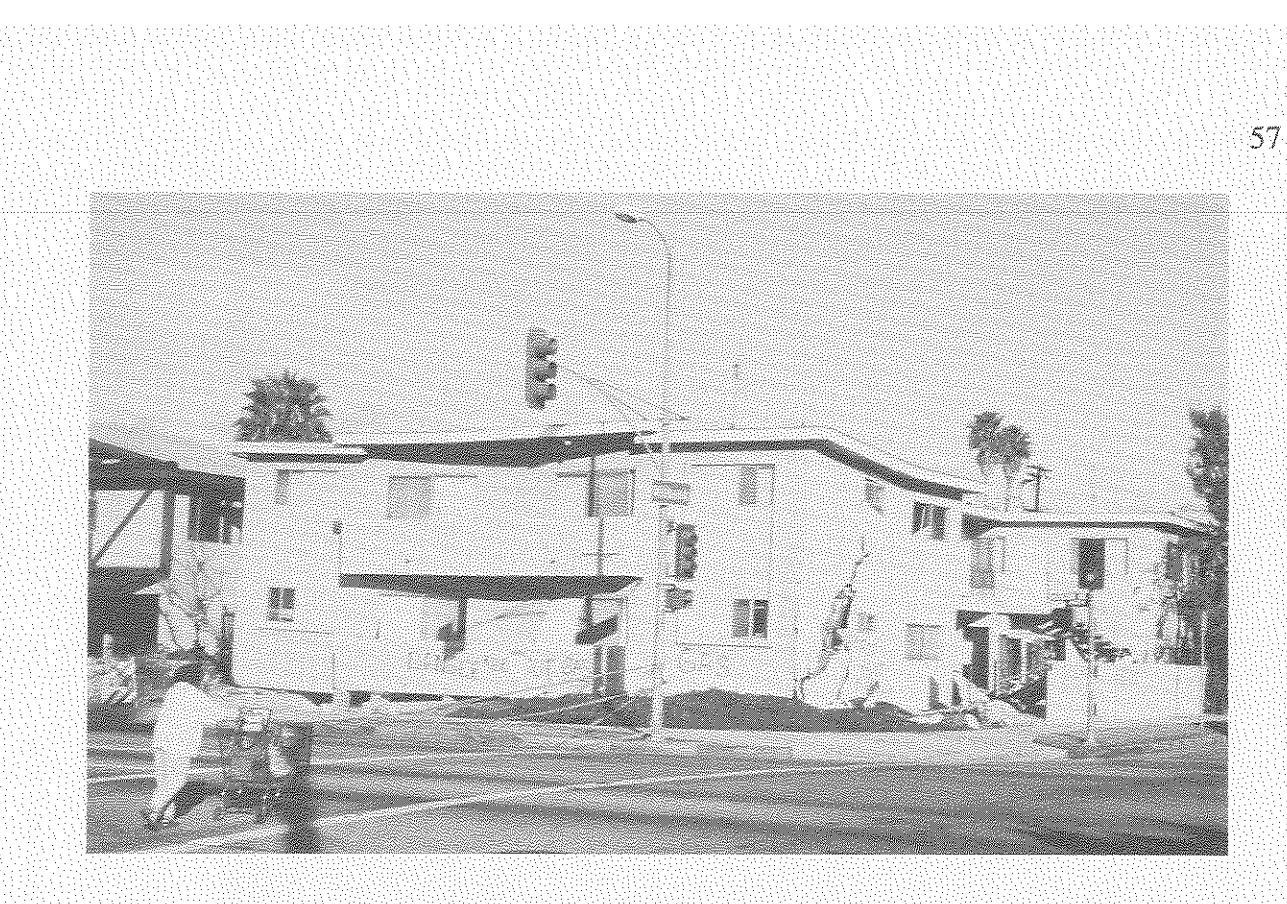
(a): Heavily damaged apartment building with soft story at Hazeltine Avenue and Milbank Street

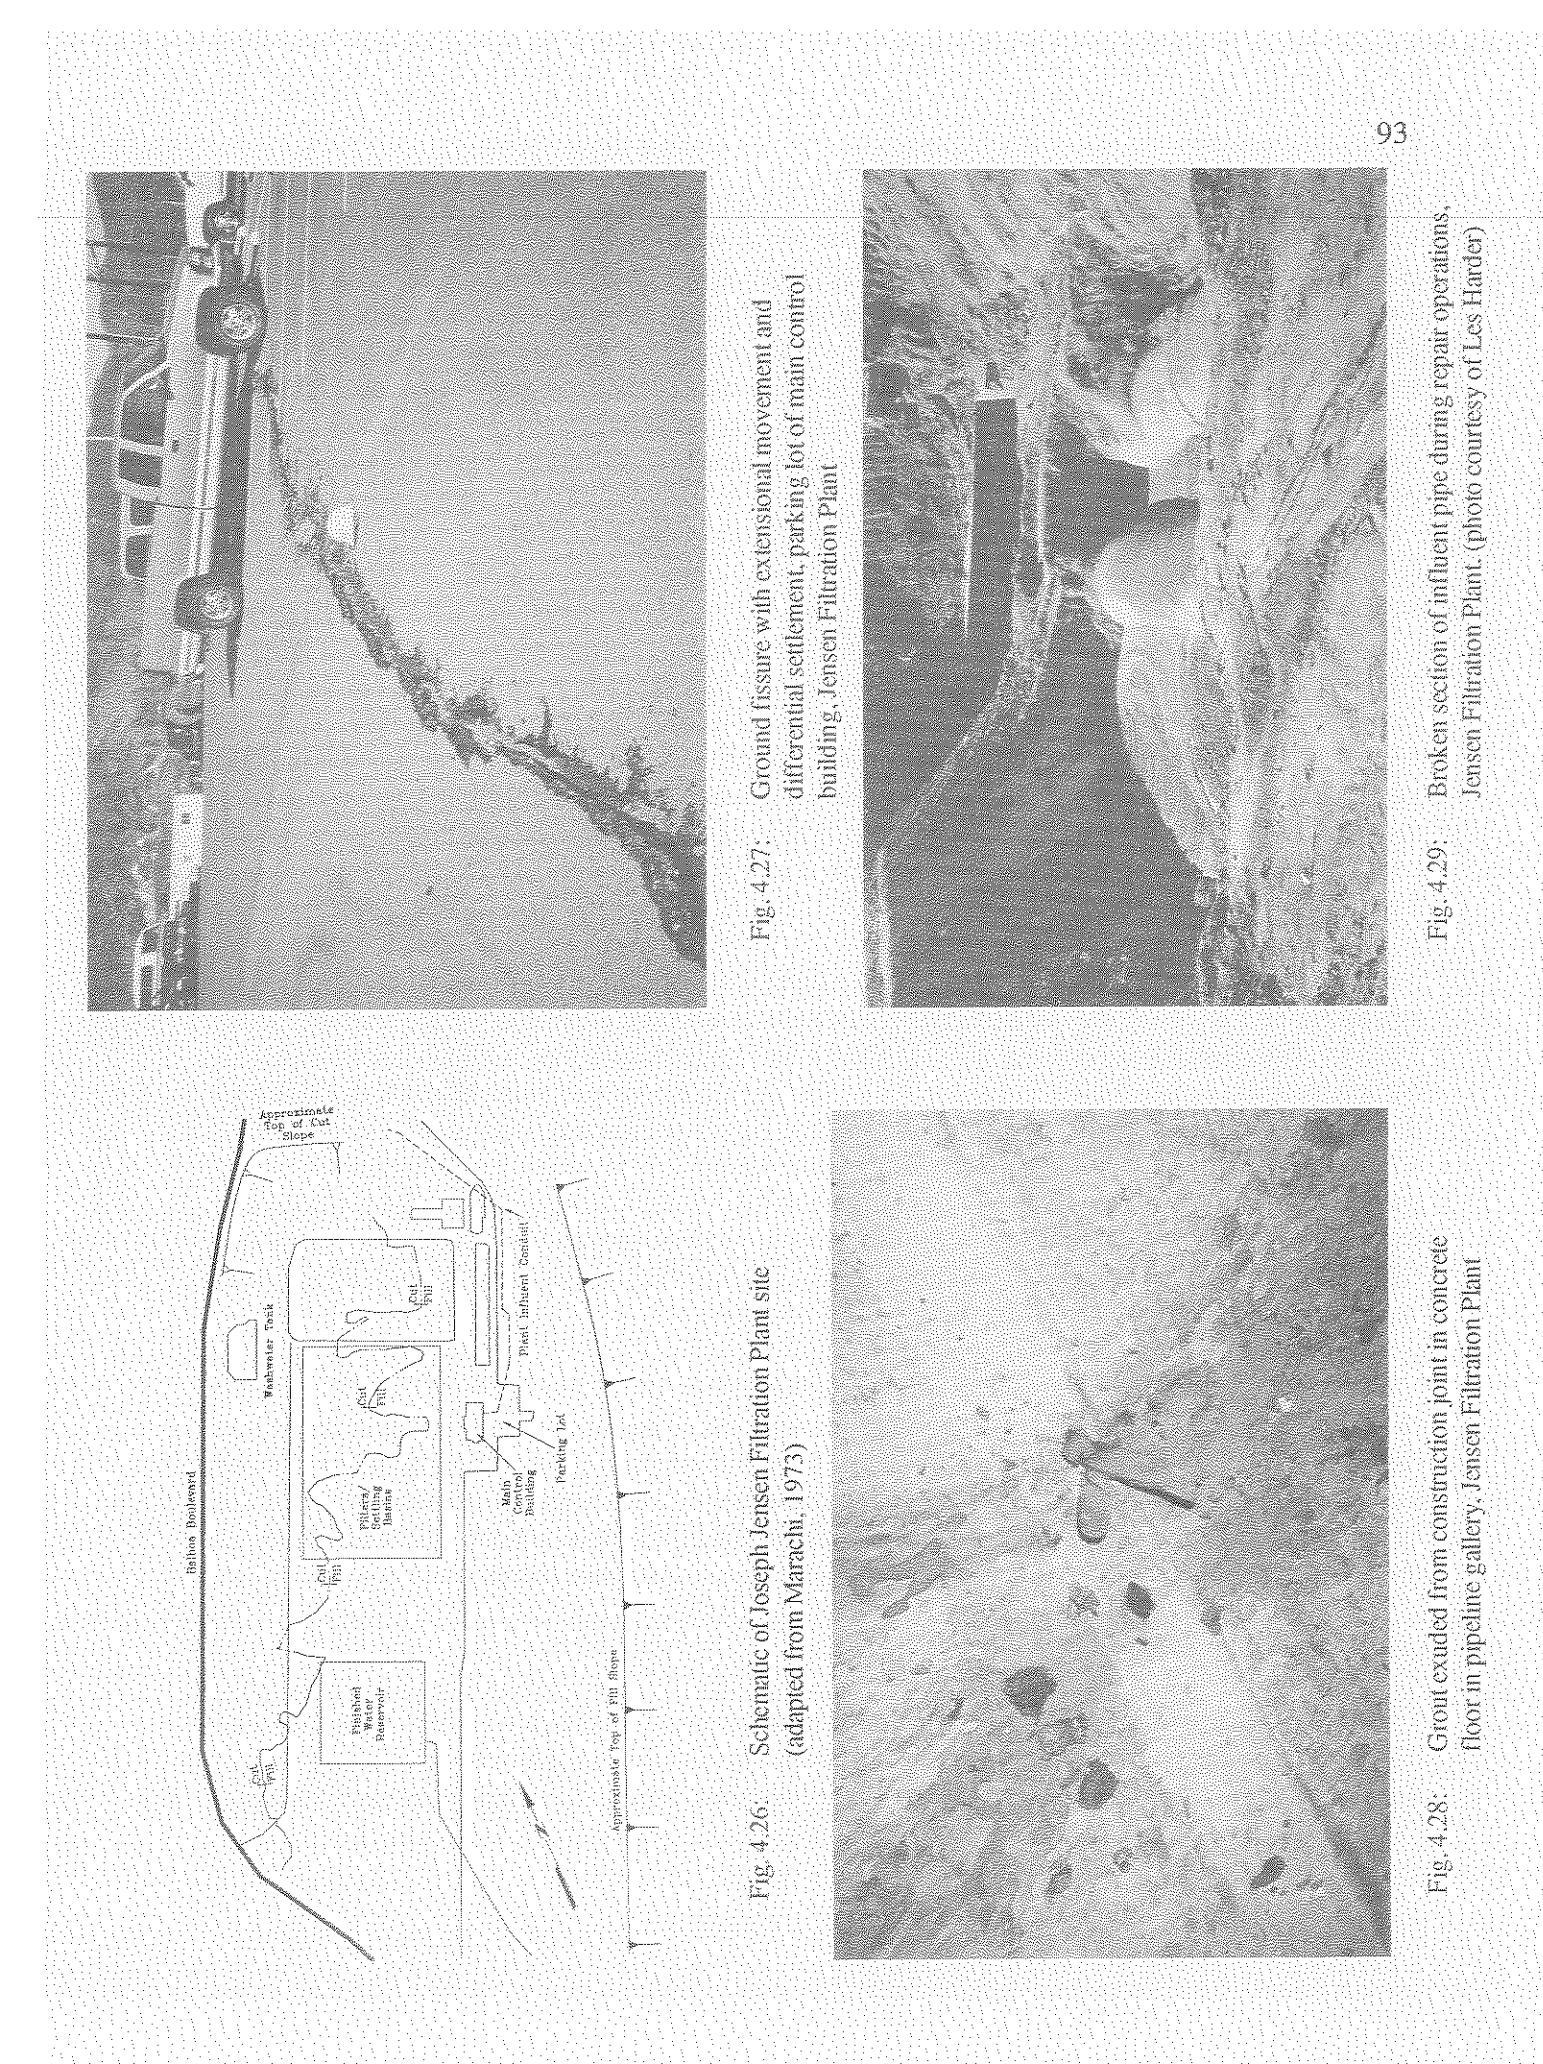
The temporary closure of the Jensen Filtration Plant was primarily necessitated by the rupture of several buried pipes, including a break in one of two influent aqueducts north of the main control building. Figure 4.29 shows the ruptured section of an 85-inch diameter

steel influent pipeline during repair operations which took about 2½ days to complete. In addition, numerous irrigation and chlorination lines were broken just south and north of the parking lot of the main control building, respectively. Towards the southern end of the facility, the fill surface around the perimeter of a 50 million gallon finished water reservoir settled approximately 2 to 4 inches relative to the reservoir. It is not known whether these movements resulted from dynamic compaction of the fill materials or re-consolidation of underlying liquefied alluvial soils. The northwestern portion of the plant, which is founded on bedrock materials, did not appear to have experienced significant ground failure during the Northridge Earthquake.

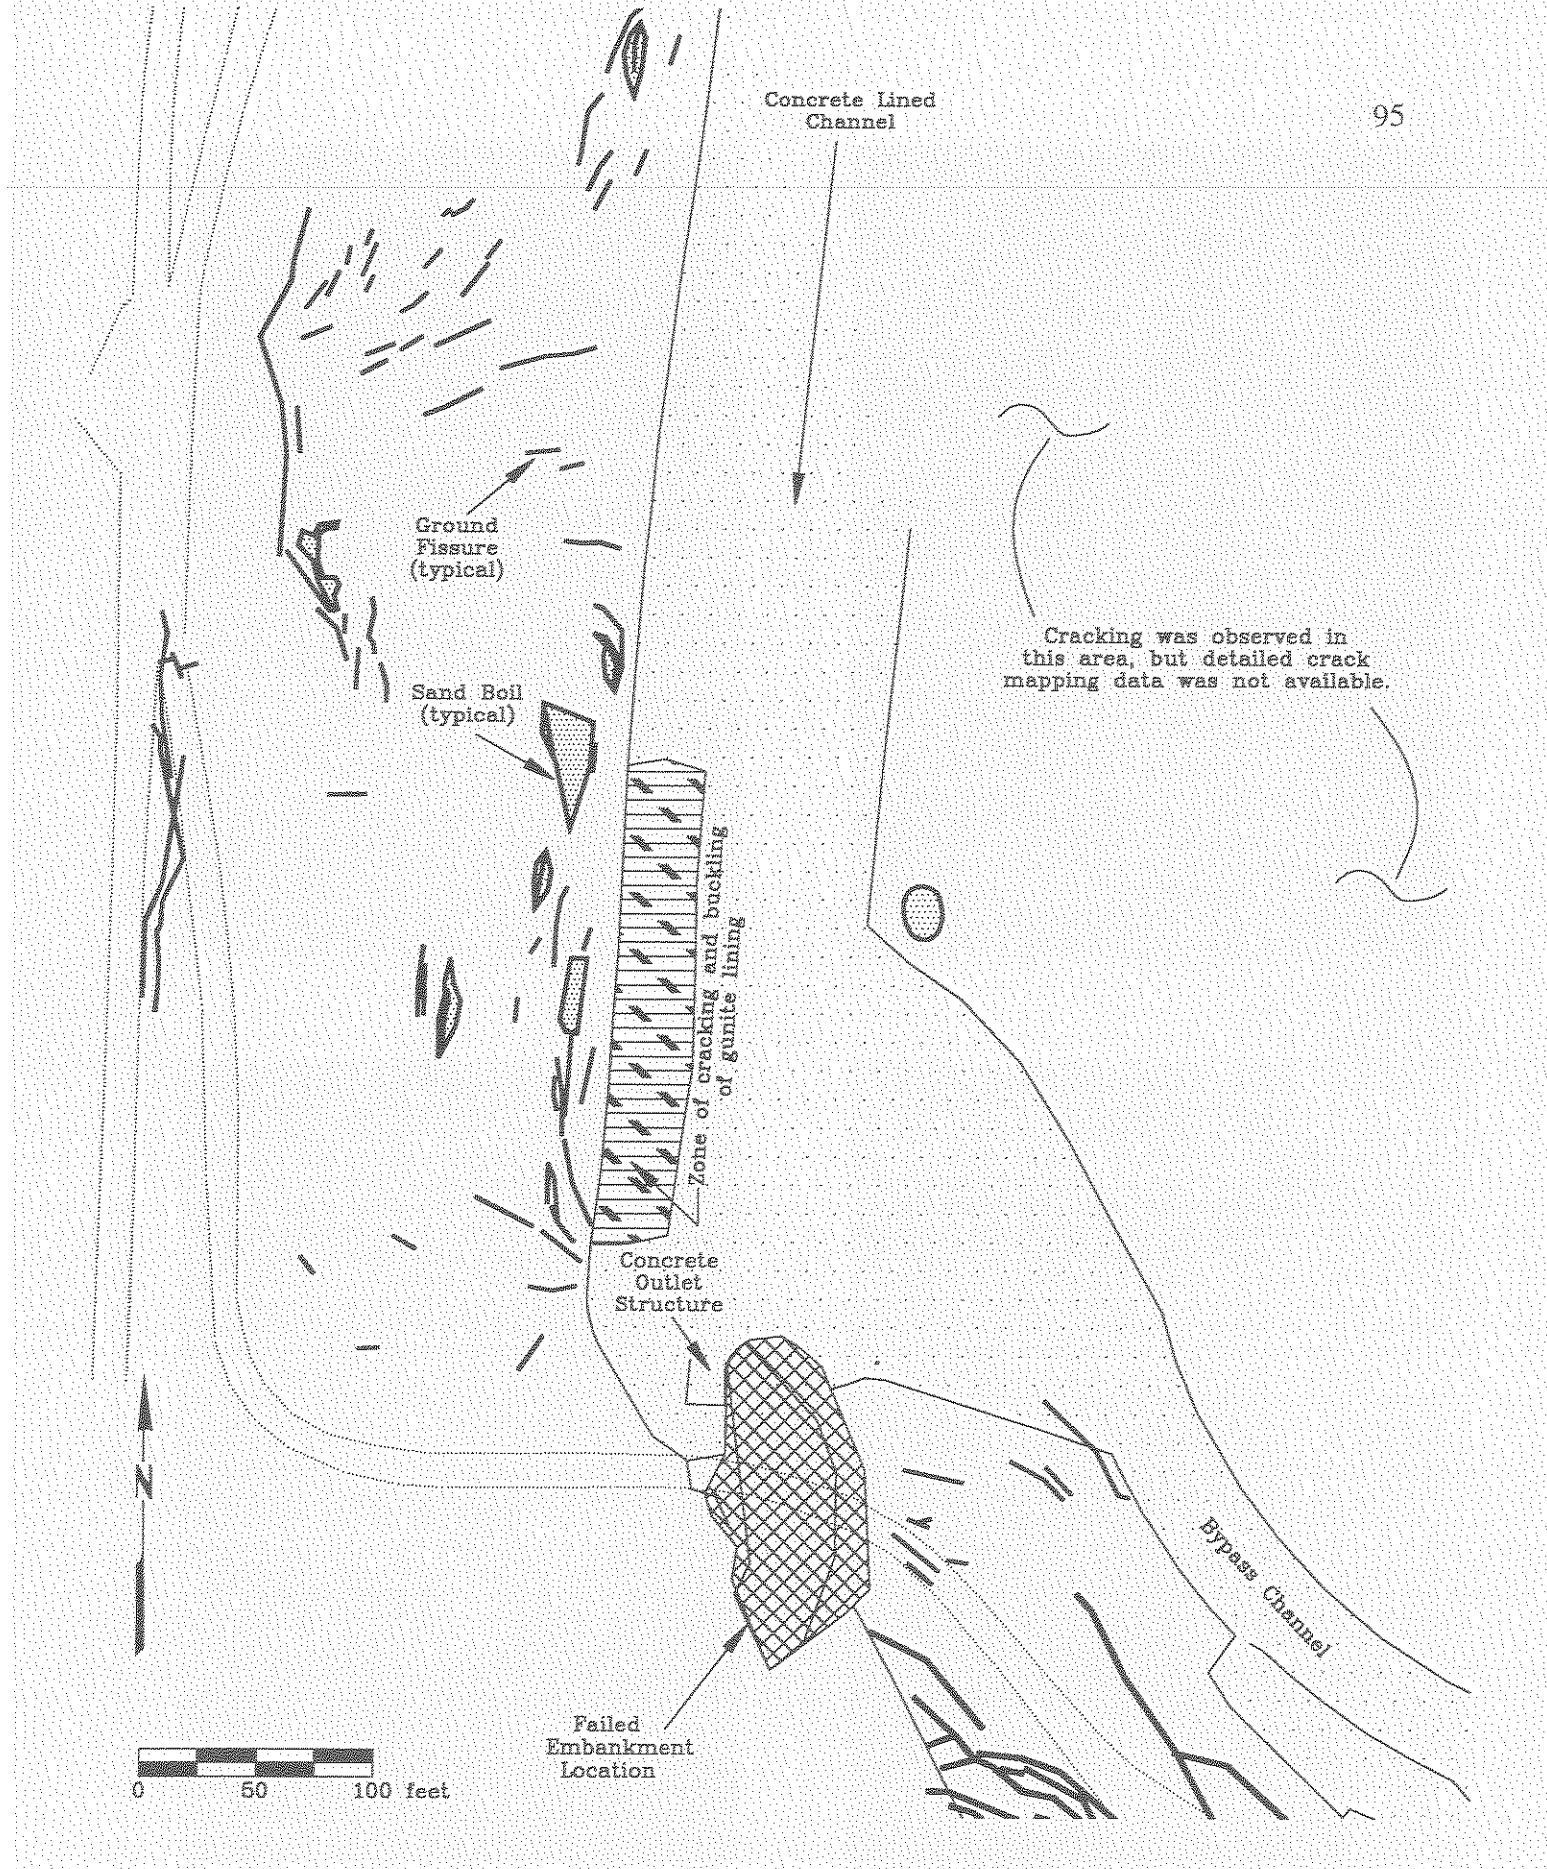
Map of San Fernando Power Plant Tailrace facility showing locations of embankment breach and cracks induced by lateral spreading during the Northridge Earthquake. (data courtesy of Los Angeles Department of Water and Power)

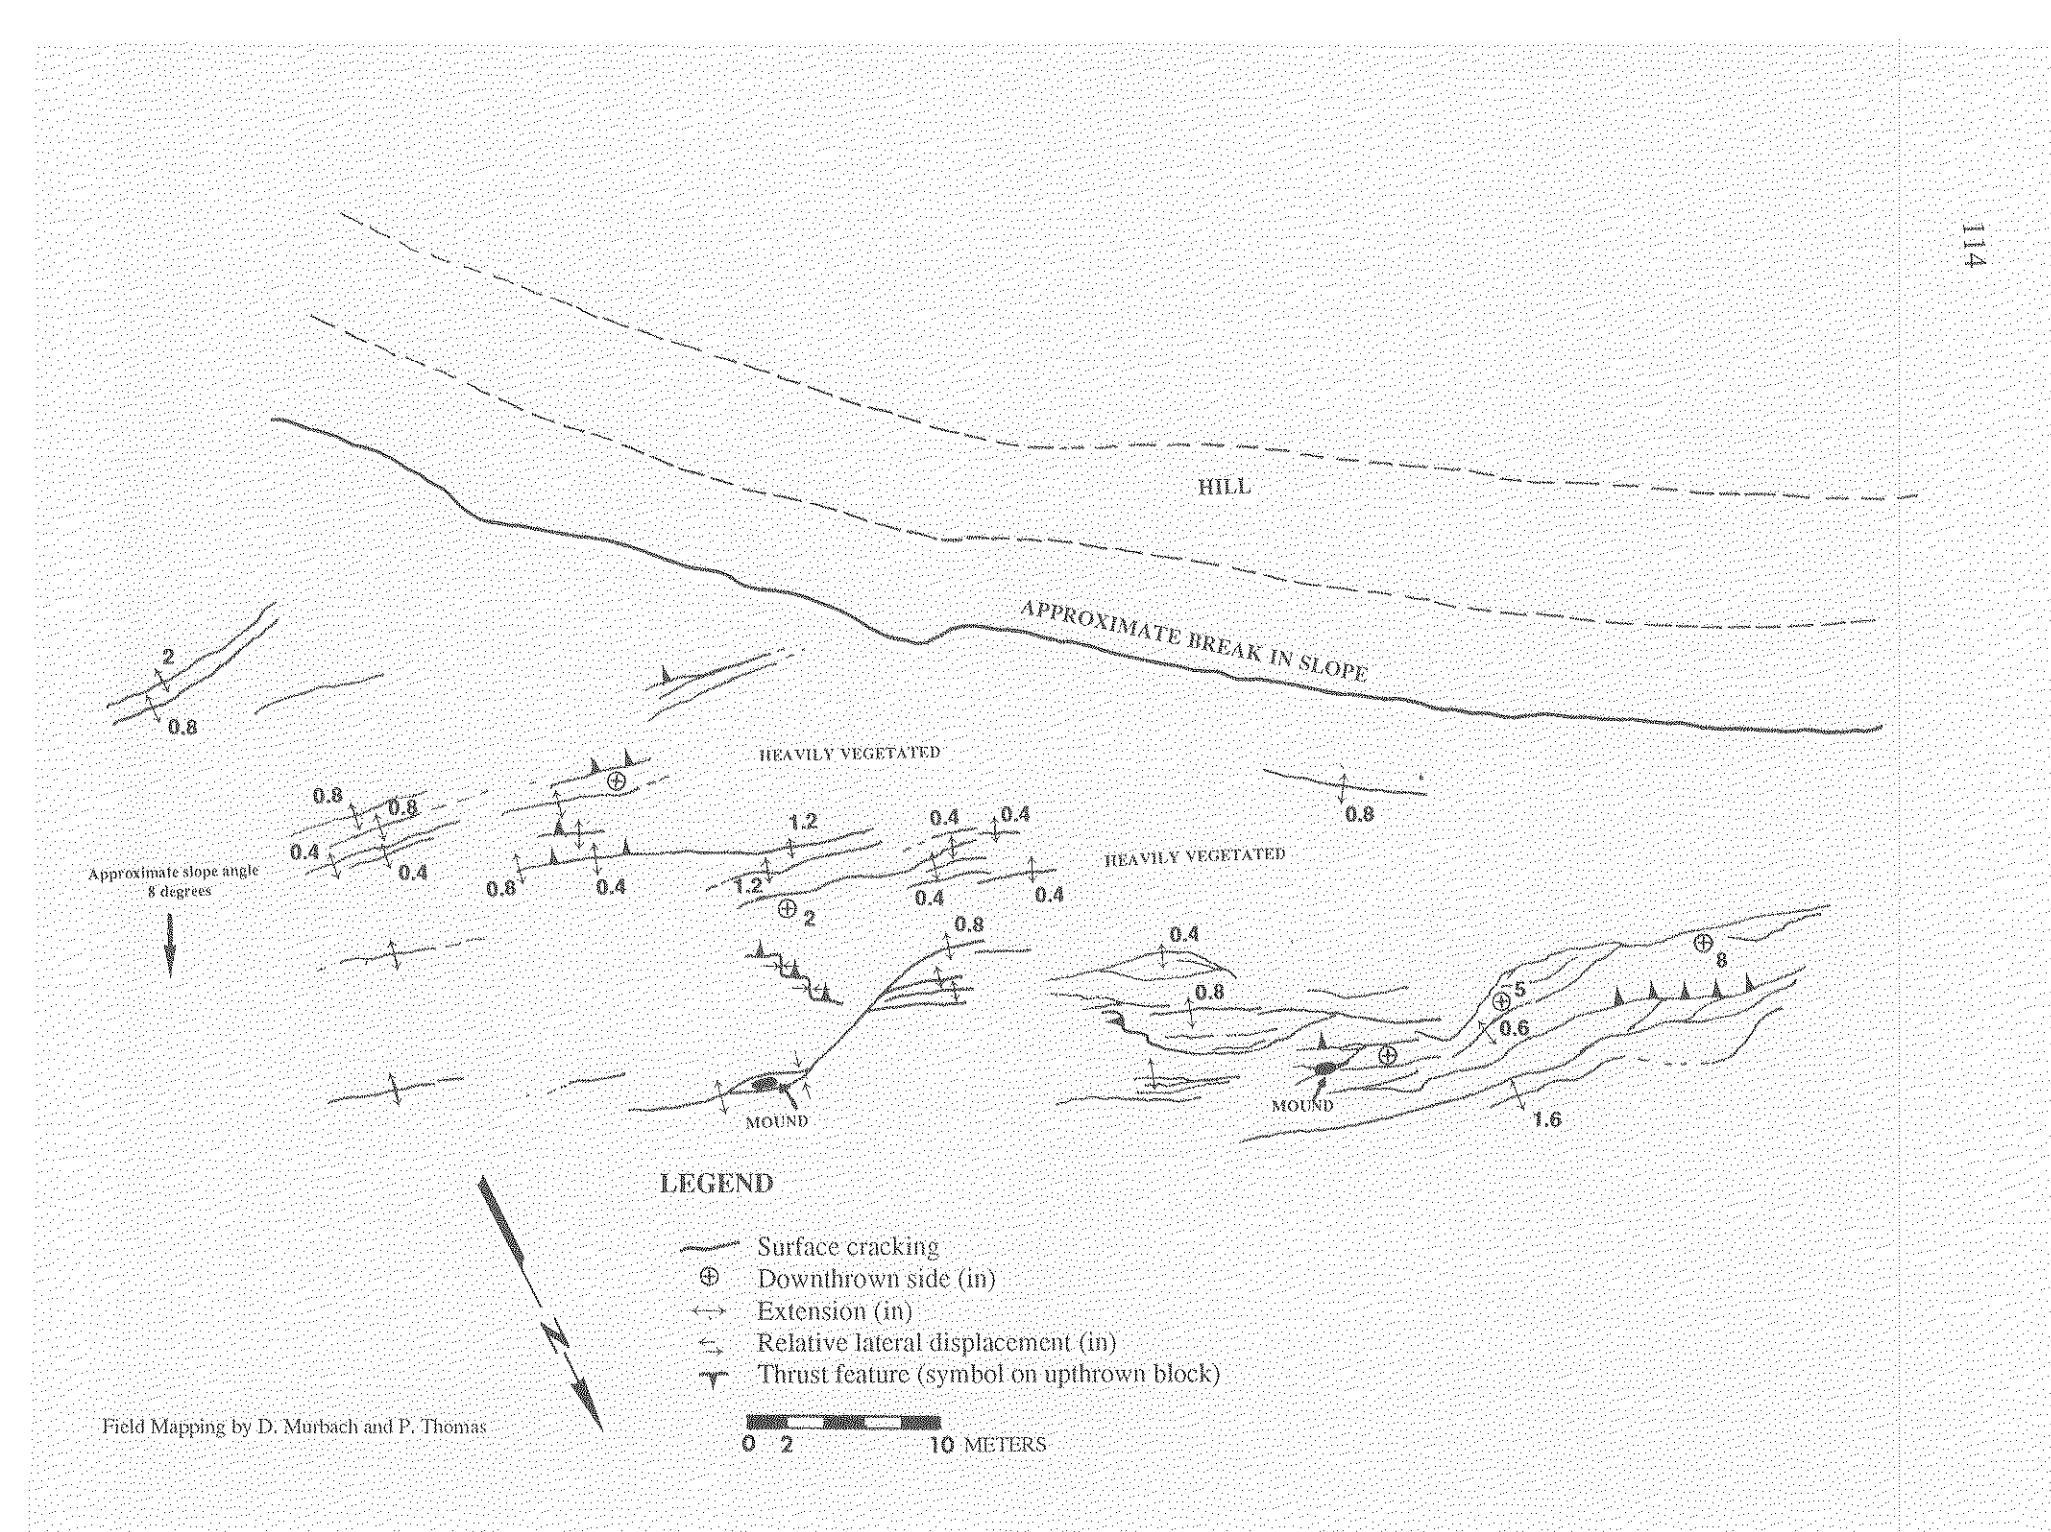
Fig. 4.62: Detail map showing crack patterns at Site B from Figure 4.52.

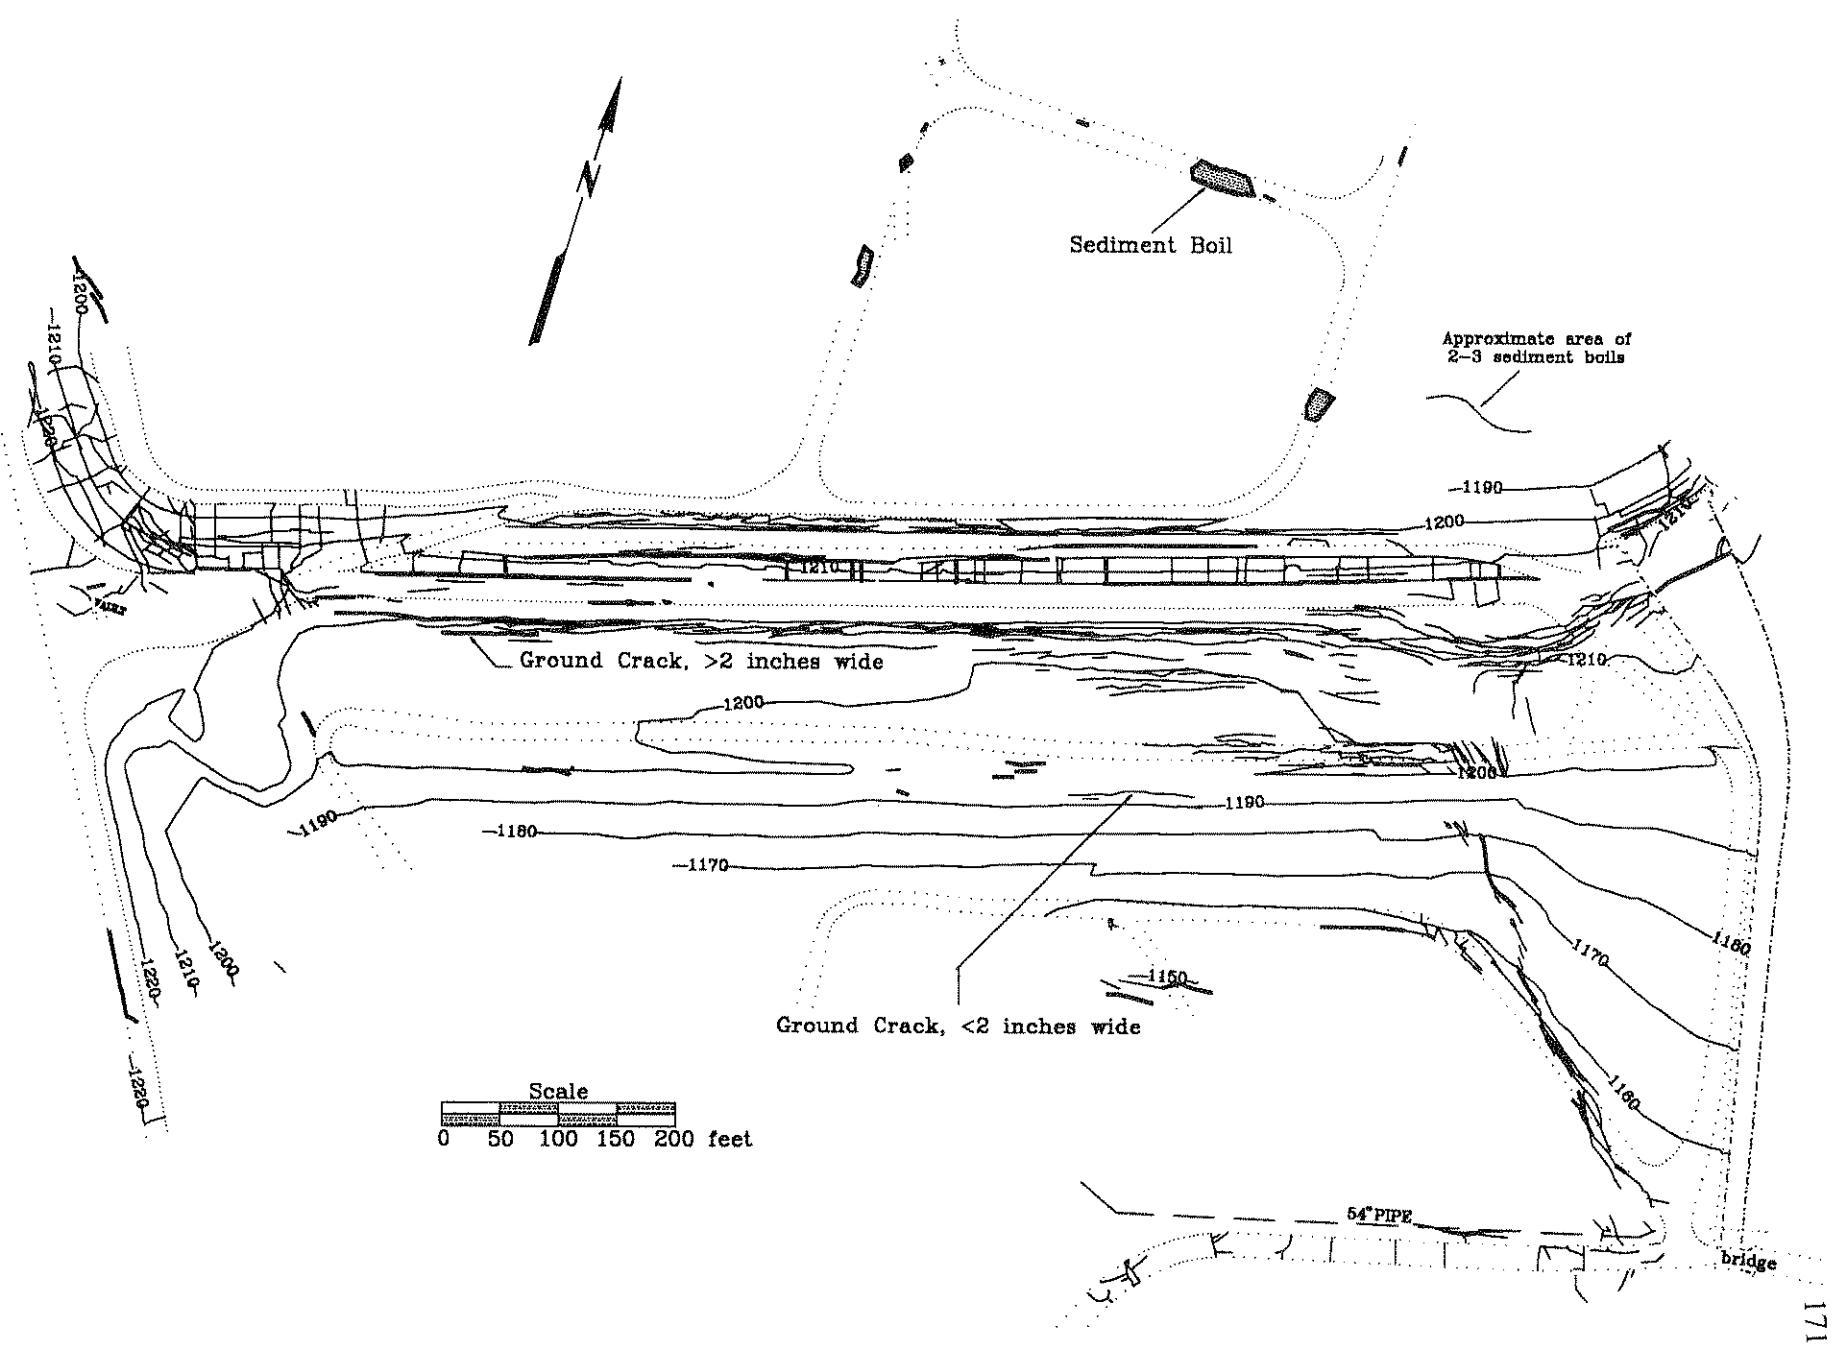
Fig. 6.23: Plan view of Upper San Fernando Dam showing locations of cracking and sediment boils (data courtesy Los Angeles Department of Water and Power)
