Geotechnical Extreme Events Reconnaissance (GEER)

# Preliminary Observations of Surface Fault Rupture from the April 11, 2011 Mw6.6 Hamadoori Earthquake, Japan (an aftershock of the March 11, 2011 Tohoku Offshore Earthquake, Japan)

Keith I. Kelson<sup>1</sup>, Leslie F. Harder, Jr.<sup>2</sup>, Tadahiro Kishida<sup>3</sup>, and Isabelle Ryder<sup>4</sup> June 5, 2011

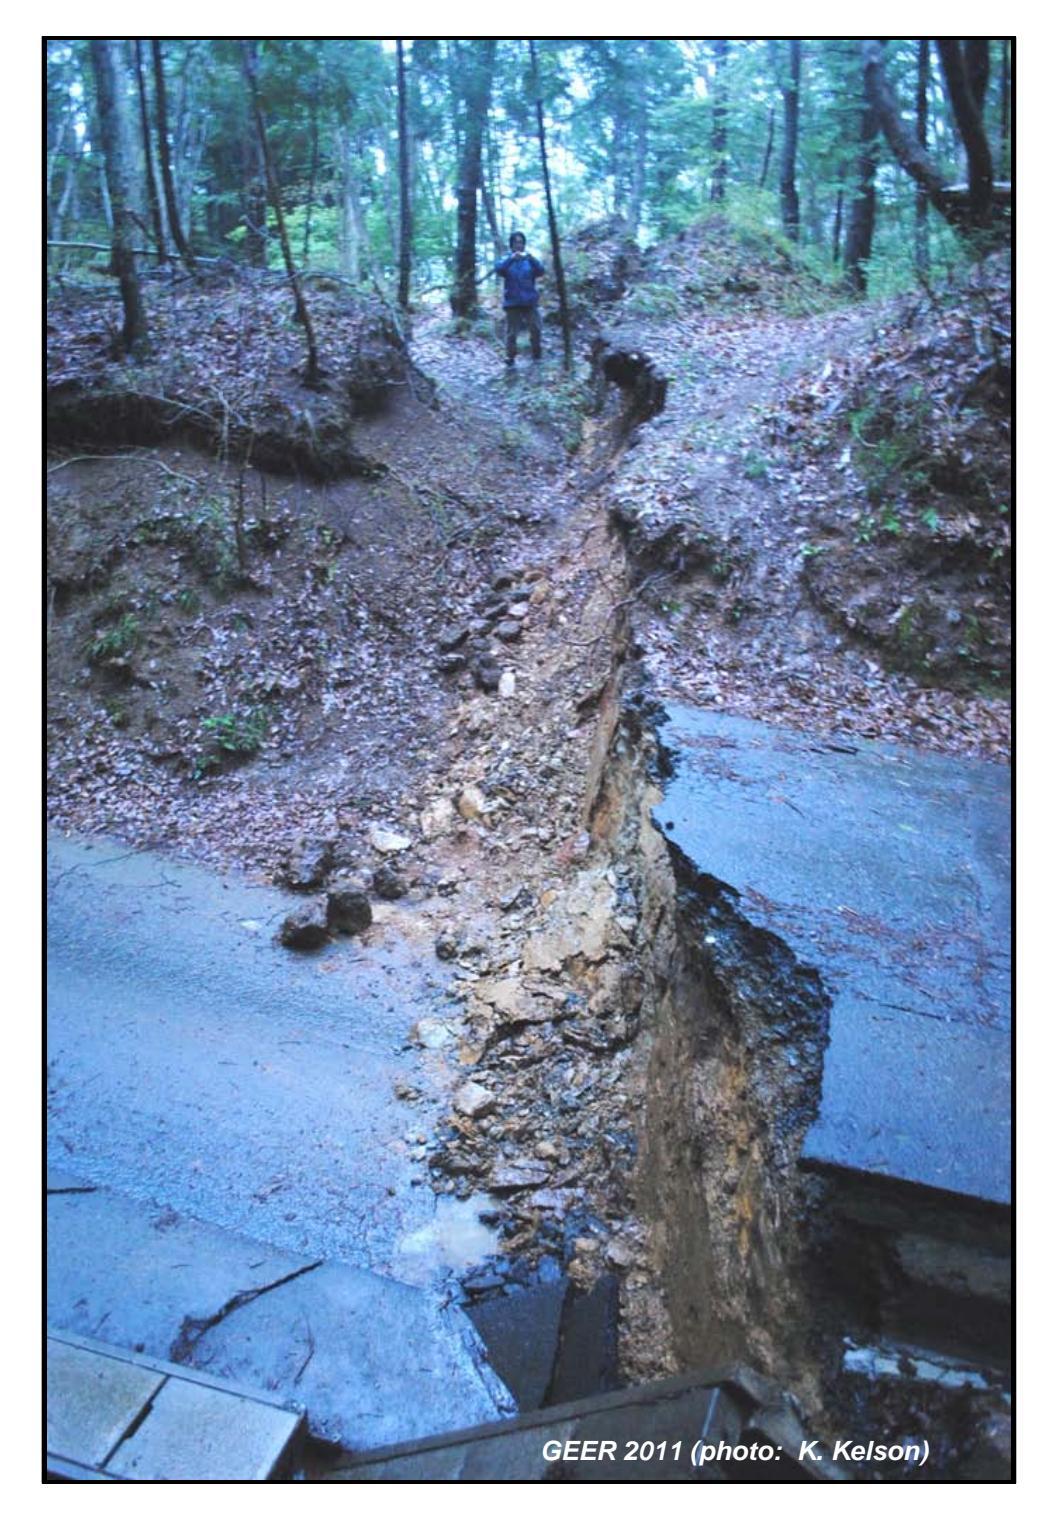
Figure 6: Photograph looking north along surface rupture at waypoint kk081 (N36.9735°, E140.6978°; April 23, 2011). West-facing fault scarp is approximately 1.5 m high along a near-vertical plane developed in weathered bedrock. Dr. Tadahiro Kishida is at the base of the scarp near the crest of the east-west-trending ridge.

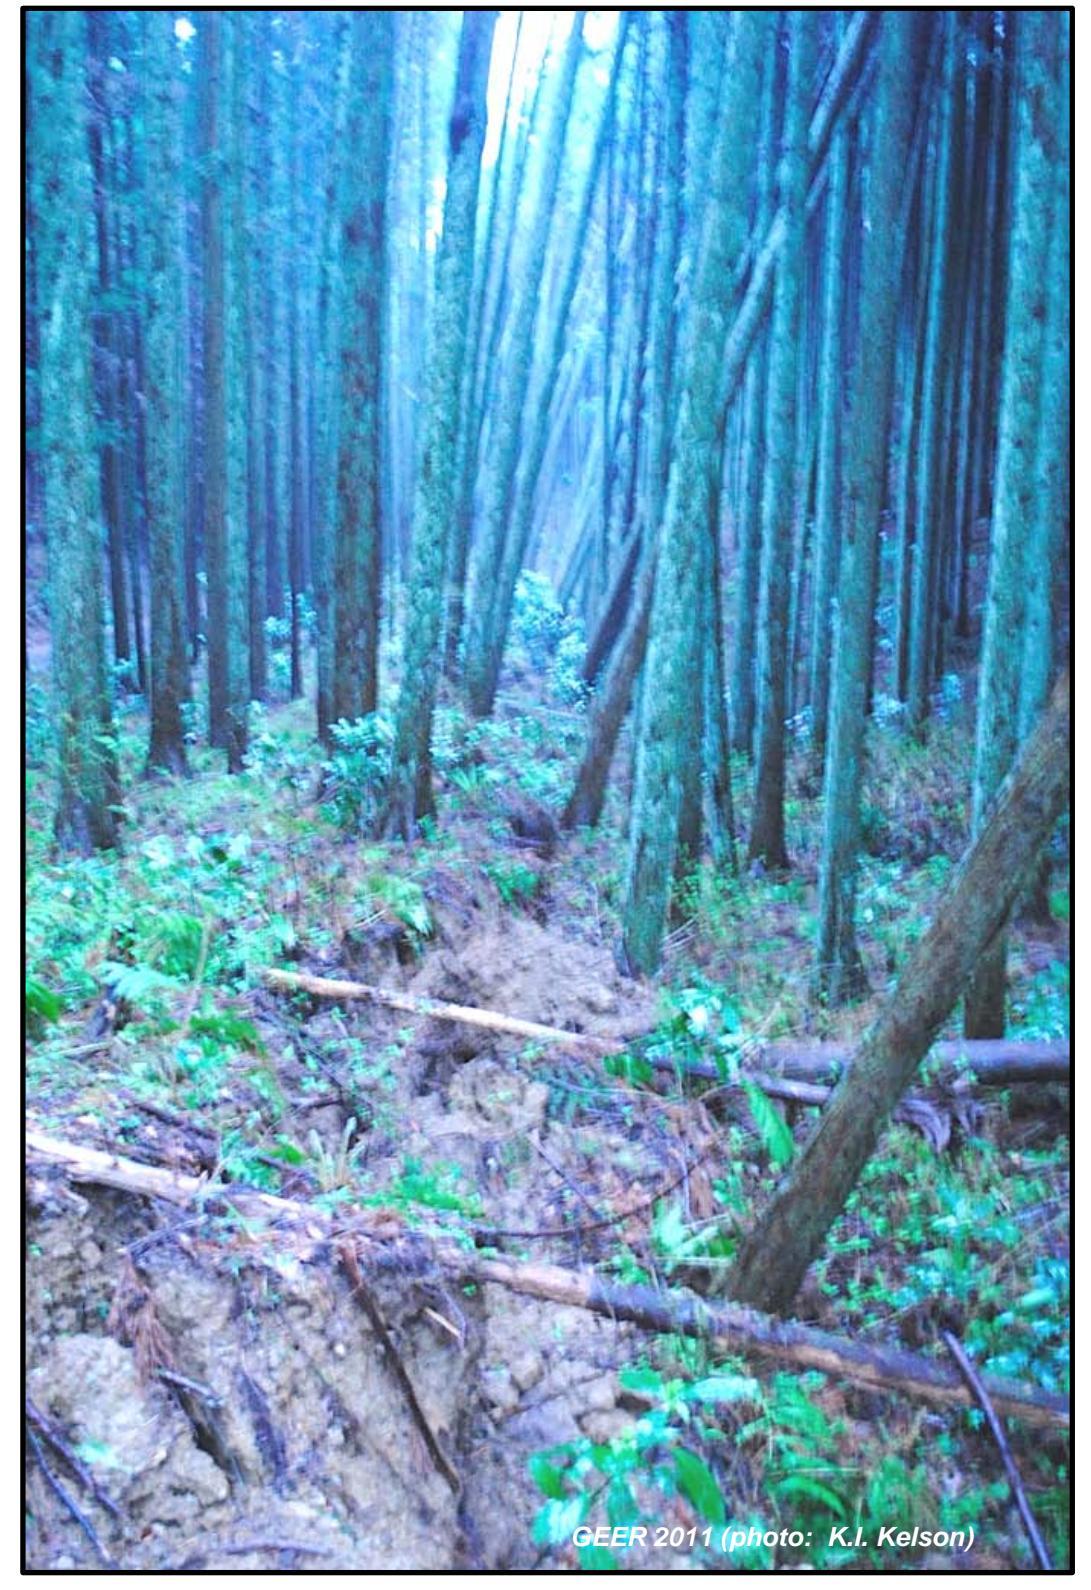
Figure 7: Photograph looking south along surface rupture at waypoint kk081 (N36.9735°, E140.6978°; April 23, 2011). Rupture traverses forest with primarily vertical trees, except where fault scarp caused westward tilting of trees along fault trace

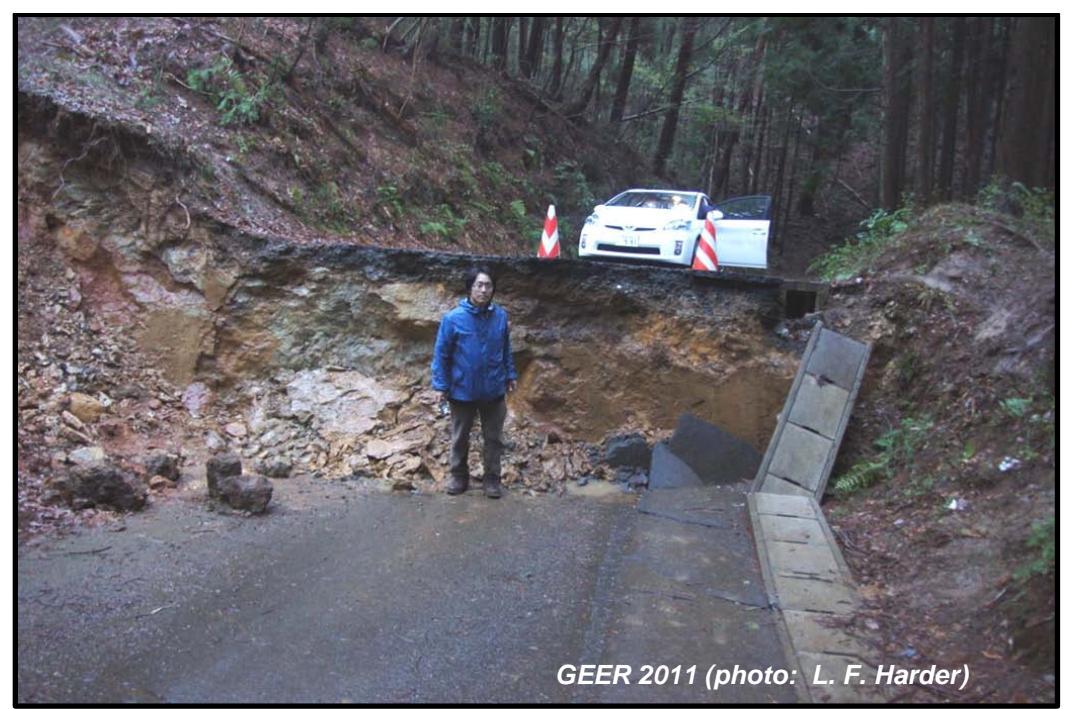
Figure 8: Photograph looking east at scarp face at waypoint kk081 (N36.9735°,E140.6978°; April 23, 2011). Slickensides on striated bedrock surface plunge steeply south (about 85° toward 170°), indicating dominantly vertical displacement with slight dextral offset. Roadside drainage box culvert on right side of photograph also shows component of dextral offset.

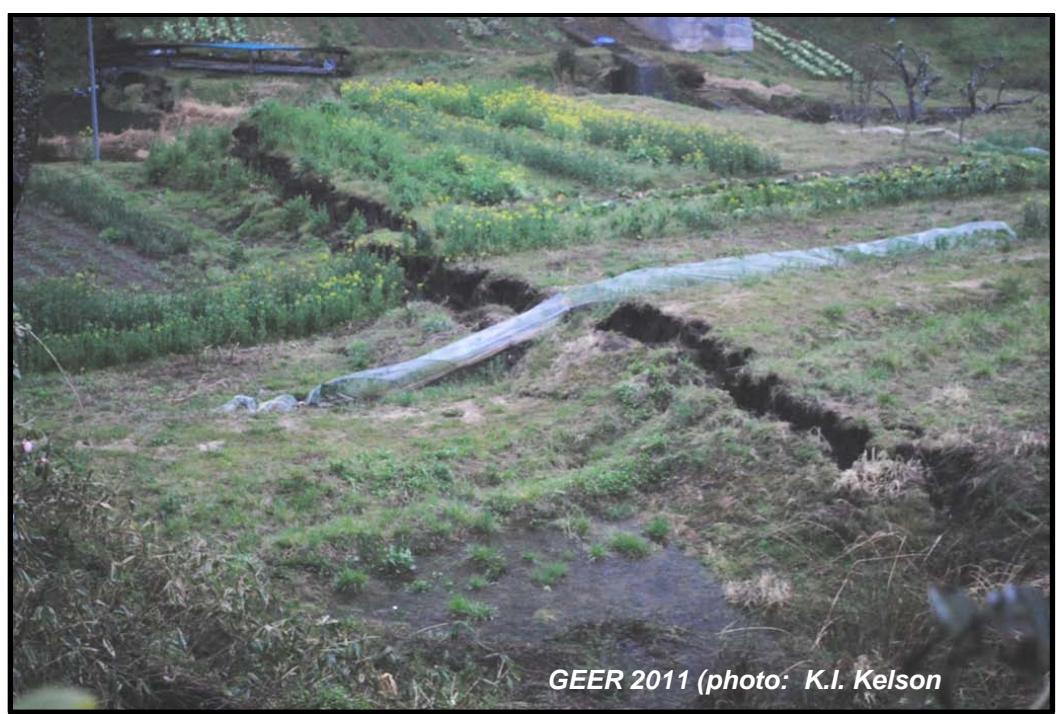
Approximately 0.8 km to the south of locality kk081 (Figure 5), the fault extends across the floodplain of Bettougawa Creek (Figures 9 and 10, Ishiyama et al., 2011a, b). West-down displacement on the western side of the scarp resulted in an uphill-facing scarp, ponding of the creek west of the fault, and flooding of the low floodplain (Figure 11). Deformation of the alluvium and agricultural fields in the valley suggests west-down net vertical displacement of about 1.2 m and a minor component of right-lateral offset. The fault strand is distinct here, lacks substantial off-fault folding, and appears to be continuous with the scarp at locality kk081 to the north.

Figure 9: Photograph looking northeast at west-facing scarp traversing floodplain of Bettougawa Creek (N36.9961°, E140.7008°; April 23, 2011). Scarp developed on agricultural fields that originally sloped gently east; plastic sheeting covered a crop row was extended and displaced.

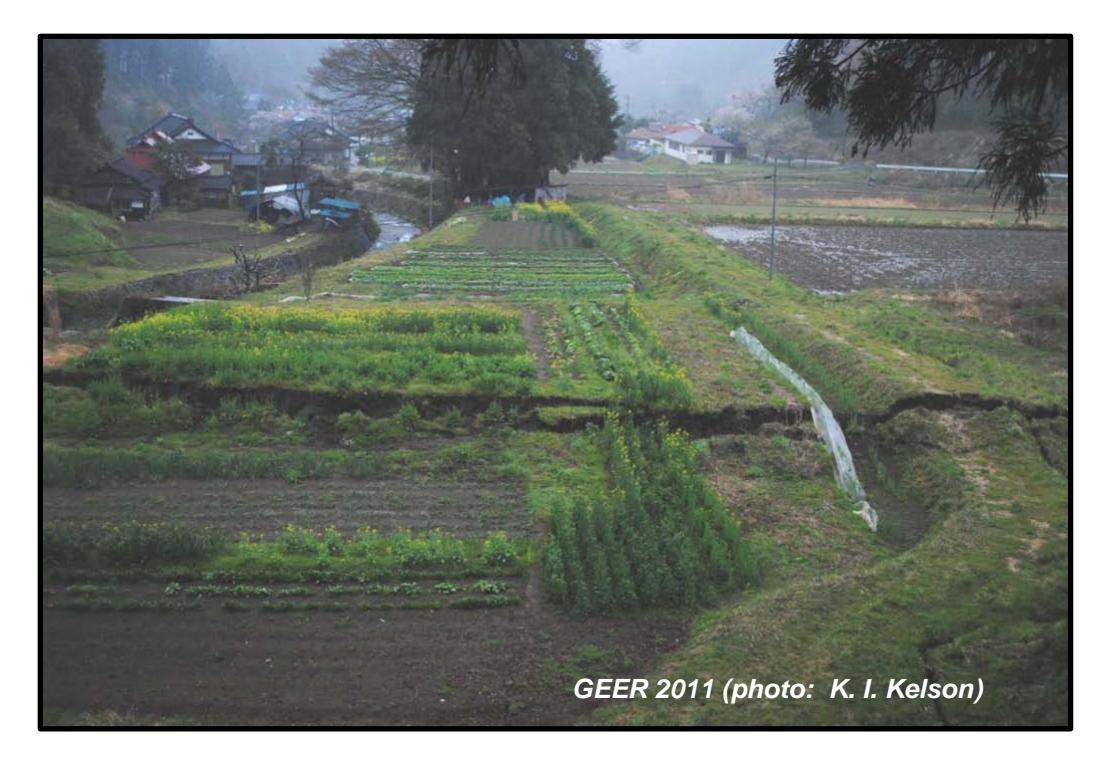
Figure 10: Photograph looking east at west-facing scarp traversing floodplain of Bettougawa Creek (N36.9961°, E140.7008°; April 23, 2011; also Location 4 of Ishiyama et al., 2011a, b). Vertical displacement ≈1.2 m, minor dextral slip suggested by offset of crop rows and levee.

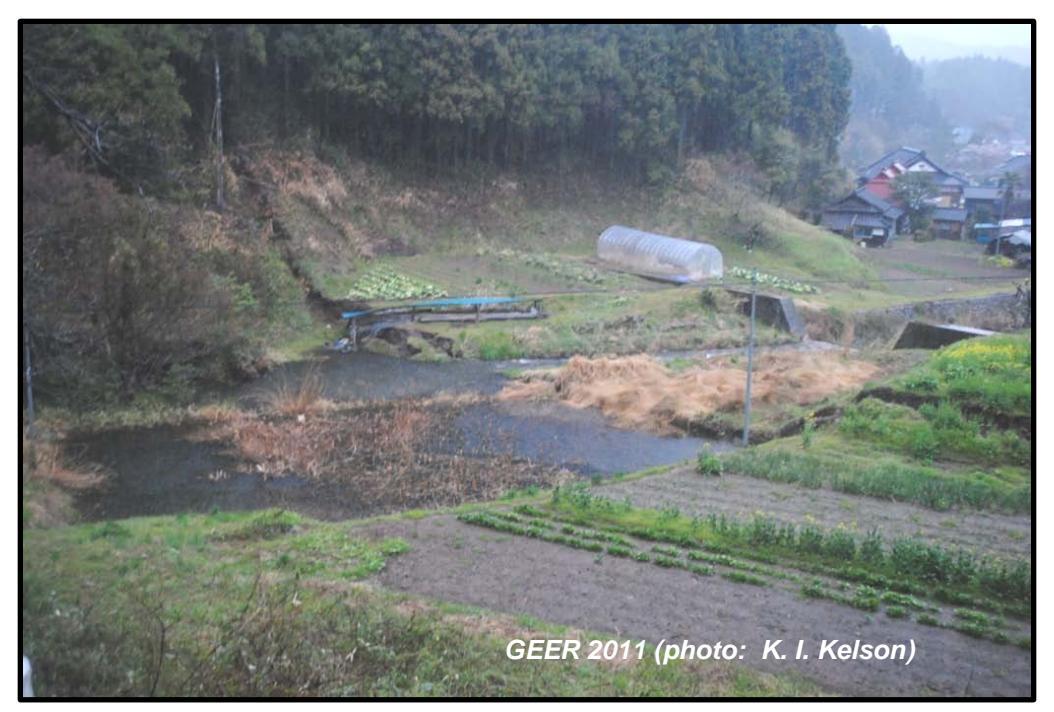
Figure 11: Photograph looking northeast at west-facing scarp traversing Bettougawa Creek (N36.9961°, E140.7008°; April 23, 2011; also Location 4 of Ishiyama et al., 2011a, b). Uplift on eastern side of fault resulted in ponding of creek and flooding of low terrace adjacent to channel.

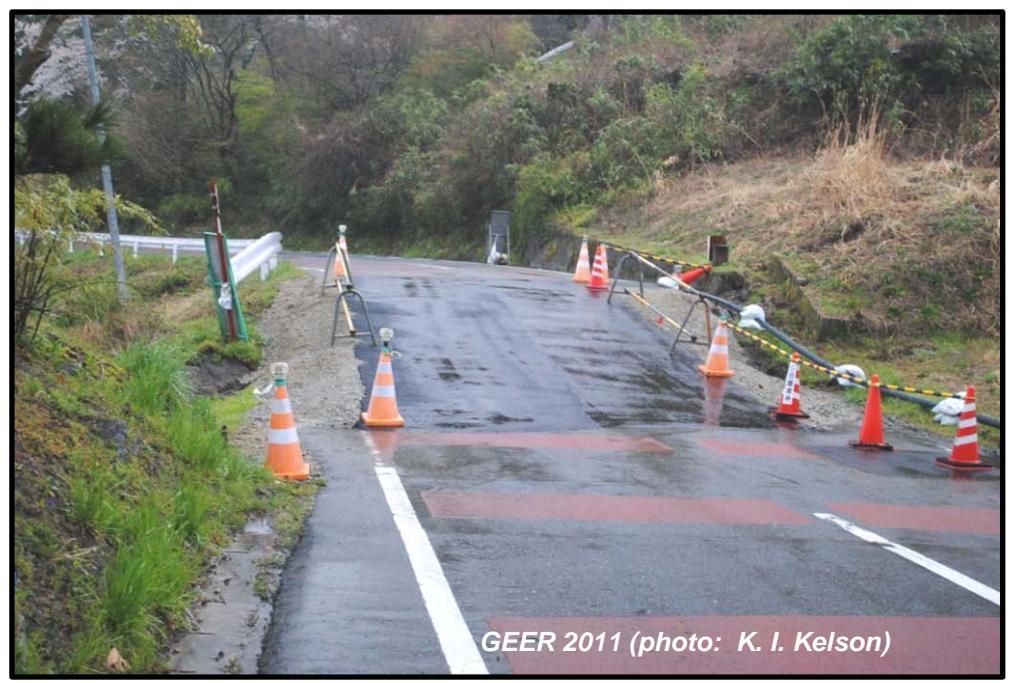
Figure 12: Photograph looking east at west-facing scarp developed in roadway between Bettougawa Creek and Tabito Middle School (waypoint jw15; N36.9649°, E140.7015°; April 23, 2011; also Location 3 of Ishiyama et al., 2011a, b). Ishiyama et al. (2011a) noted scarp height of approximately 1.1 m and dextral offset of approximately 0.3 m at this location. Fault rupture produced uphill-facing fault scarp across the roadway here.

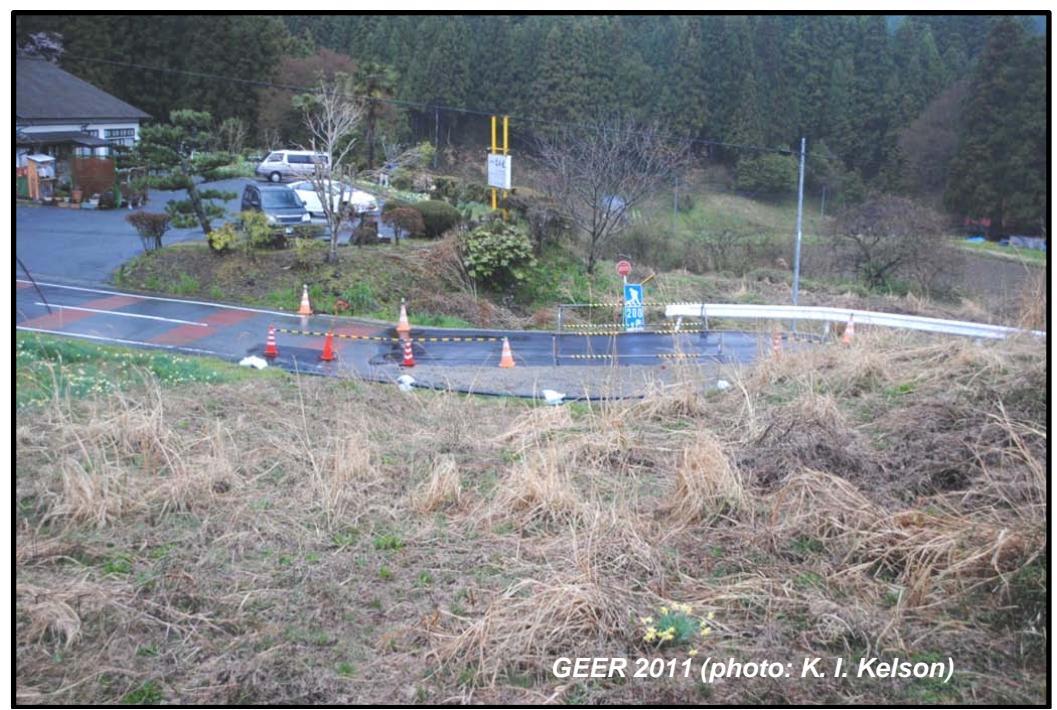
Figure 13: Photograph looking north at locality jw15 (Locality 3 of Ishiyama et al. 2011a, b), from locality kk080 (N36.9647°N, E140.7016°; April 23, 2011; also Location 2 of Ishiyama et al., 2011a, b). Repaired asphalt indicates location of fault scarp developed in roadway. Bettougawa Creek in distance, between roadway and forested slope.

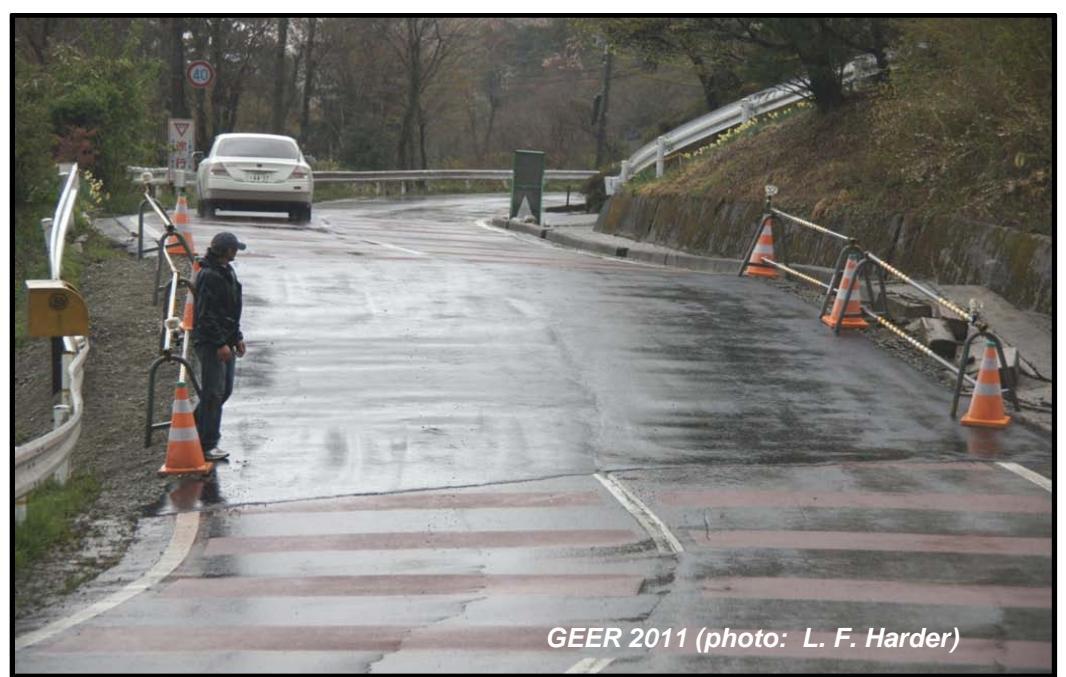
Figure 14: Photograph looking east at west-facing scarp developed in roadway between Bettougawa Creek and Tabito Middle School (waypoint kk080; 36.9647°N, 140.7016°W; April 23, 2011; also Location 2 of Ishiyama et al., 2011a, b). Fault rupture produced downhill-facing fault scarp across the roadway at this location.

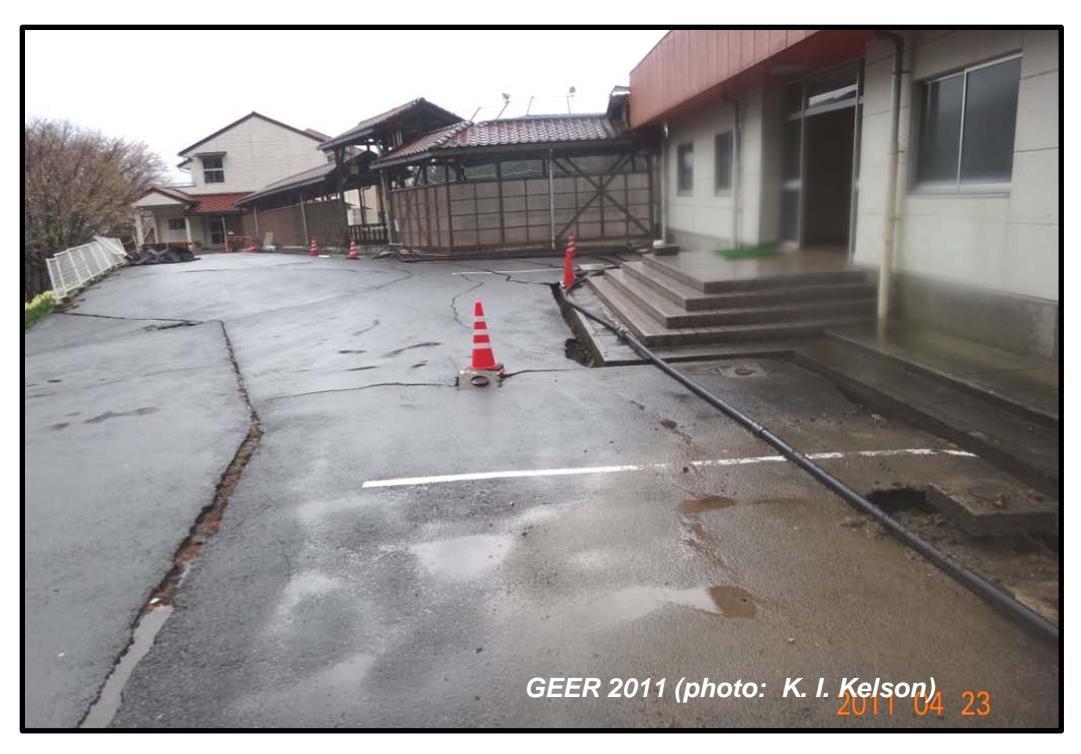
Figure 15: Photograph looking east at Tabito Middle School gymnasium (locality kk080; N36.9640°, E140.7015°; April 23, 2011). Damaged gymnasium on right side of photograph is within broad (100 m) wide zone of westward tilting (asphalt in middle ground). Closest traffic cone is located near base of west-dipping fold panel.

broad fold directly on projection with the fault scarps developed in the roadway (see above), and is surrounded by a cracked and tilted asphalt surface (Figure 15). The gymnasium is tilted about 3° westward, and no longer has rectangular doorframes or a level entryway (Figure 16). The building was not entered during our reconnaissance. Directly south of the gymnasium, the school pool is also deformed and tilted gently westward (Figure 17). Both the pool and gymnasium overlie the zone of faulting but do not exhibit evidence of distinct surface fault rupture; instead, these structures are tilted across a broad zone of deformation. It is not clear at this point if the buildings were positioned in an area that fortunately experienced distributed deformation, or if the buildings influenced the pattern and style of surface deformation.

- Tabito Middle School gymnasium should be evaluated further for damage and interrelationships with faulting and folding;
  - Residential structures directly south of Tabito Middle School should be assessed for possible rupture damage or influences on rupture patterns;

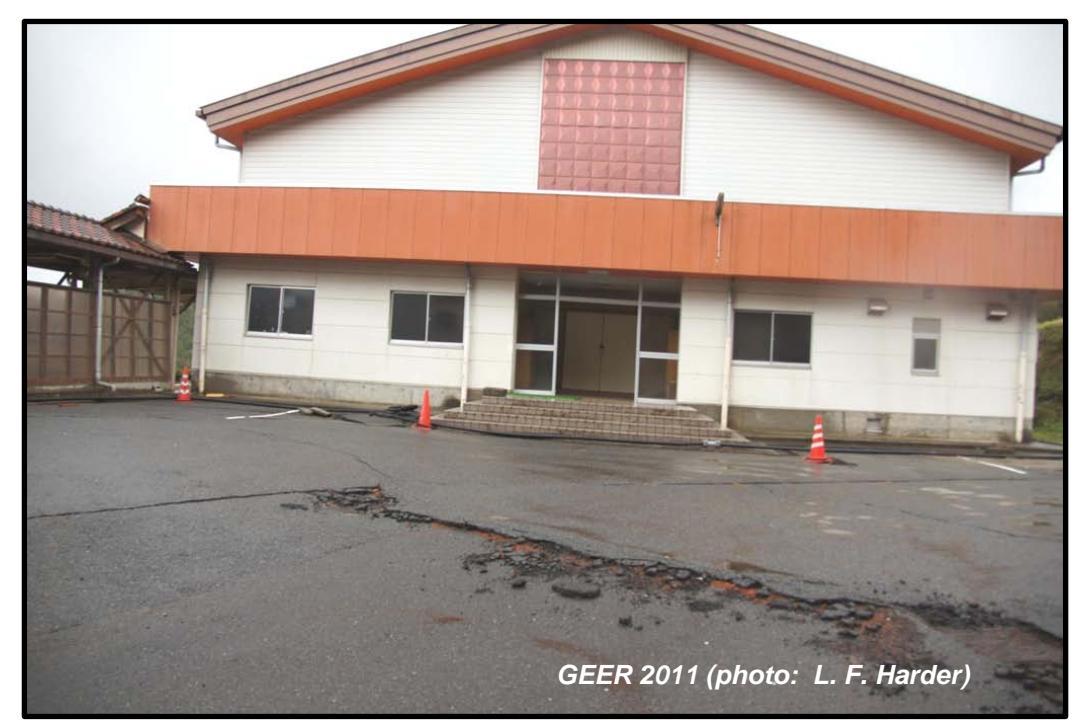
Figure 16: Photograph looking south at Tabito Middle School gymnasium (locality kk080; N36.9640°, E140.7015°; April 23, 2011). Doorframe of gymnasium is deformed and is tilted approximately 3° westward.

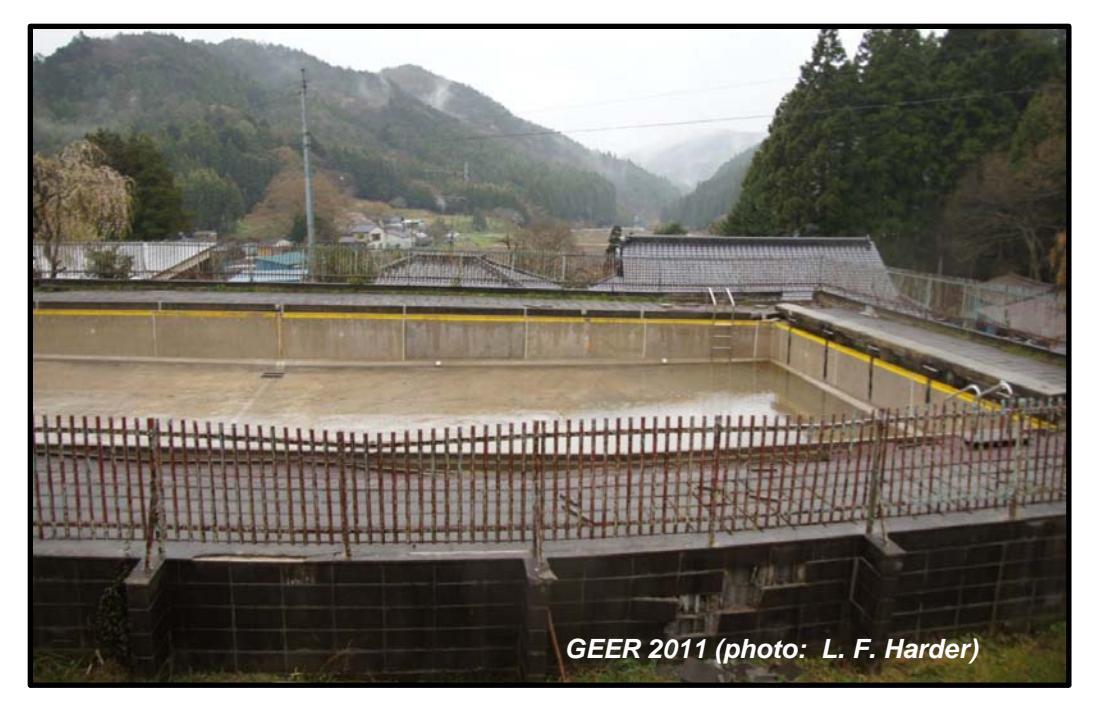
Figure 17: Photograph looking south at Tabito Middle School pool (36.9635°N, 140.7017°W;April 23, 2011). West-facing fold panel includes the western part of the pool; note ponded water in only the eastern part of pool. Field observations from area directly south of pool (in background of this photograph) indicate a 100-m-wide zone of distributed minor normal faults.

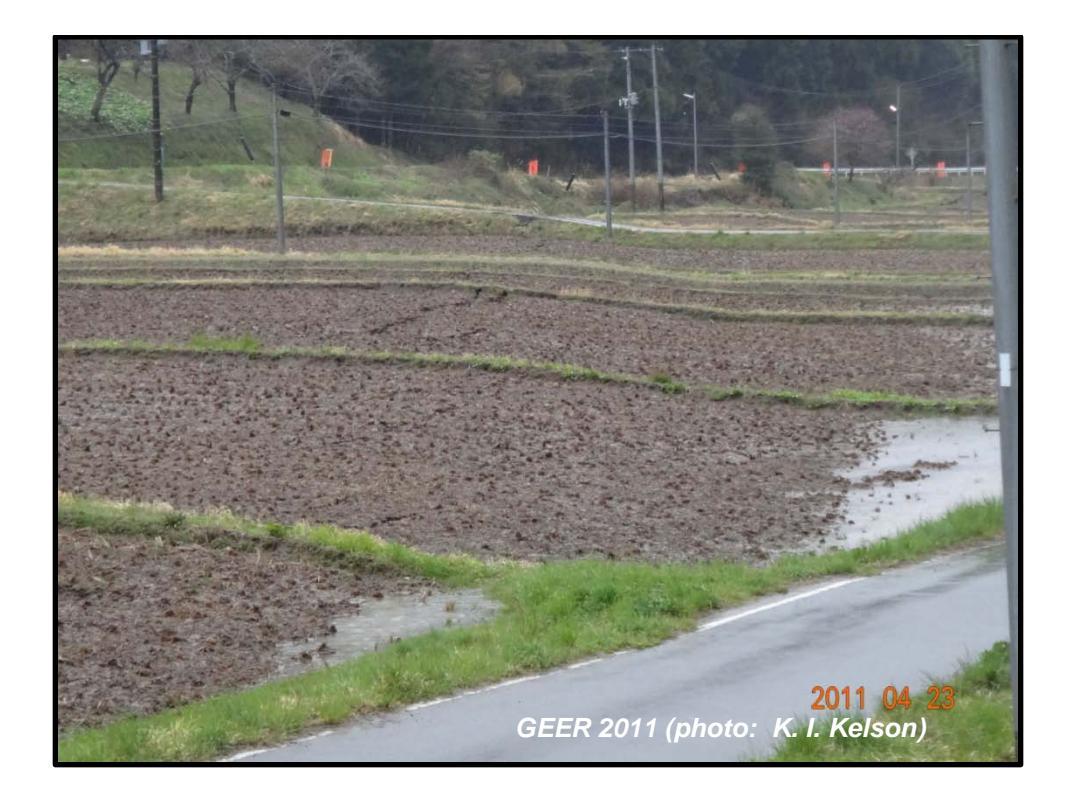
Figure 18: Photograph looking south across northern end of deformed rice field (near locality kk078; N36.9622°, E140.7023°; April 23, 2011; also Location 1 of Ishiyama et al., 2011a, b). West-facing fold is shown by grassy strips; the folding narrows southward to a more distinct fault scarp in distance.

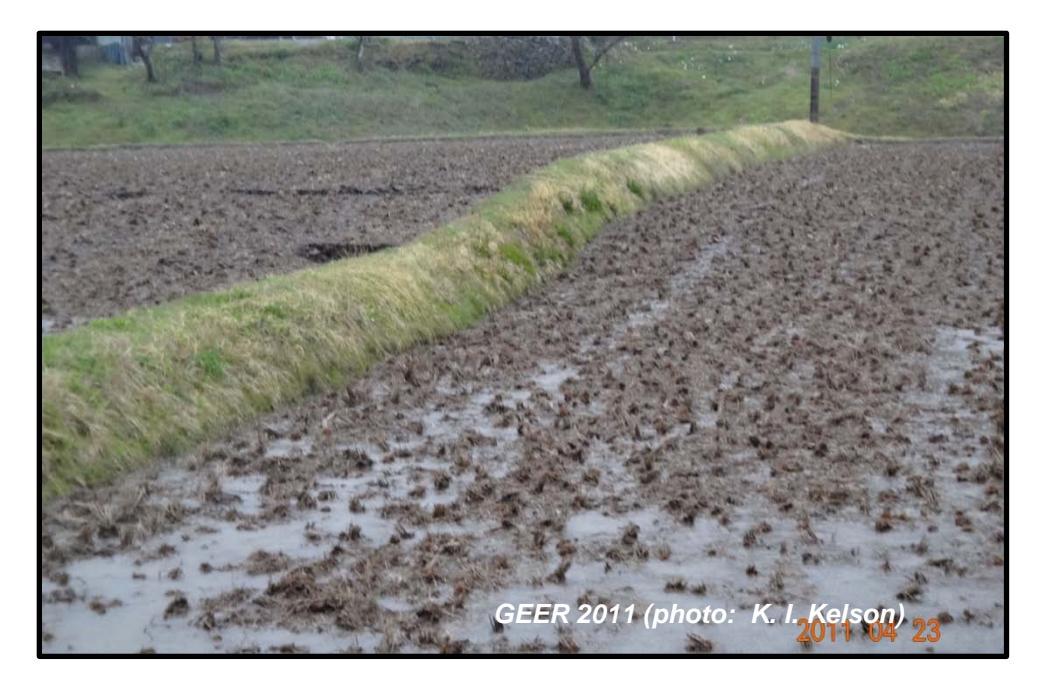
Figure 19: Photograph looking east at fold/fault scarp developed on deformed rice field (near locality kk078; N36.9611°, E140.7024°; April 23, 2011), and ground cracking present on crest of fault scarp. Ishiyama et al. (2011a, b) noted a scarp height of 0.8 m and dextral offset of about 0.3 m; total vertical deformation is probably greater than 0.8 m because of distributed folding away from distinct fold/fault scarp.

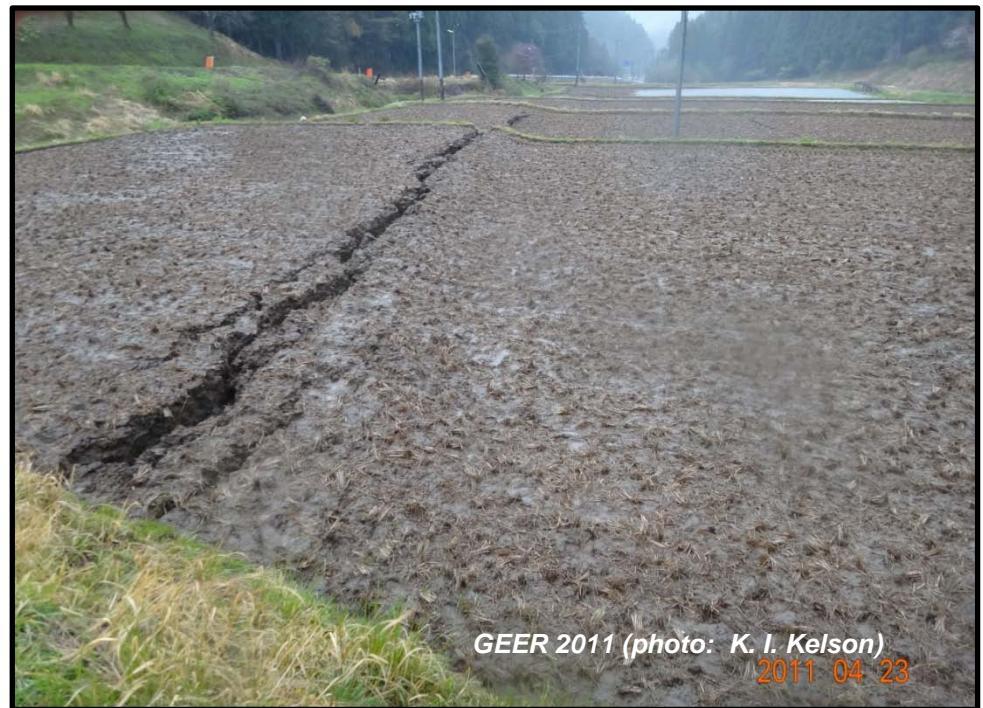
Figure 20: Photograph looking south across deformed rice field (locality kk078; 36.9608°N, 140.7030°W; April 23, 2011). West-facing fold panel shown by grassy borders of the fields; ground cracking represents minor graben formation on footwall of normal fault, as also noted by Ishiyama et al. (2011a, b).

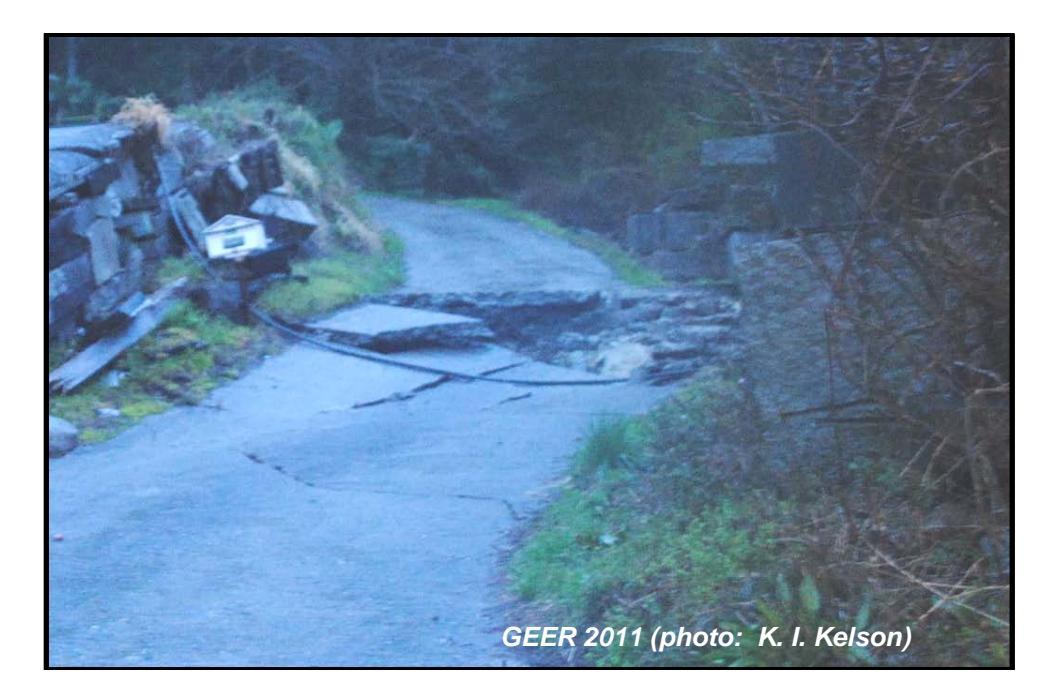
At the southern end of valley containing the rice fields, the fault strand obliquely crosses the main highway again, and deformation has been repaired. We observed fresh, west-facing scarps in asphalt driveways adjacent to the highway (Figure 21), but were unable to determine net displacements. These scarps are collinear with features observed across the rice fields and with repairs that were being completed in the roadway and a concrete-lined river channel west of the roadway. We interpret that the locations of these repairs reflect the pattern of surface deformation at the southern end of the Tabito valley. We were not able to make observations in the area south of the Tabito valley (because of darkness and rain), although it seems likely that the fault rupture extended farther south.

Figure 21: Photograph looking east at scarp across asphalt driveway at the southern end of the Tabito valley (near locality kk082; N36.9569°N, 140.7040°W; April 23, 2011). Scarp height approximately 0.5 m, although the total net vertical displacement is not known at this location.
