#### Geotechnical Extreme Events Reconnaissance (GEER)

# LiDAR and Field Investigation Of the March 11, 2011 M9.0 Great Tohoku Offshore Earthquake, and April 7, 2011 M7.4 Aftershock.

## July 20, 2011

#### Tohoku Earthquake Reconnaissance

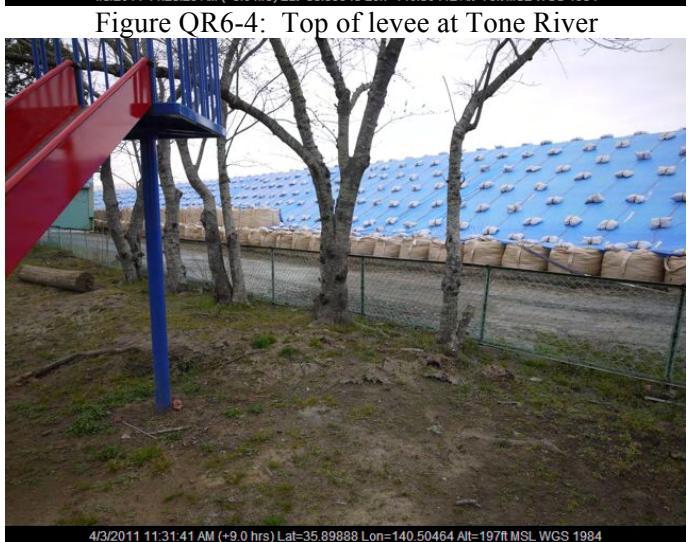
Liquefaction of river soil and rotational failure of wide section of the outboard levee slope. This wide section of Levee had a rotational failure with a headscarf near the crest of Levy and the toe in the playground adjacent to the base of the slope. At the time of the reconnaissance this portion of the levy was covered in blue tarps. Along the inboard side of the levee, the Park perimeter of the Tone River border had spatially extensive soil liquefaction on baseball fields, tennis, soccer fields and other nonstructural park facilities along the river's edge.

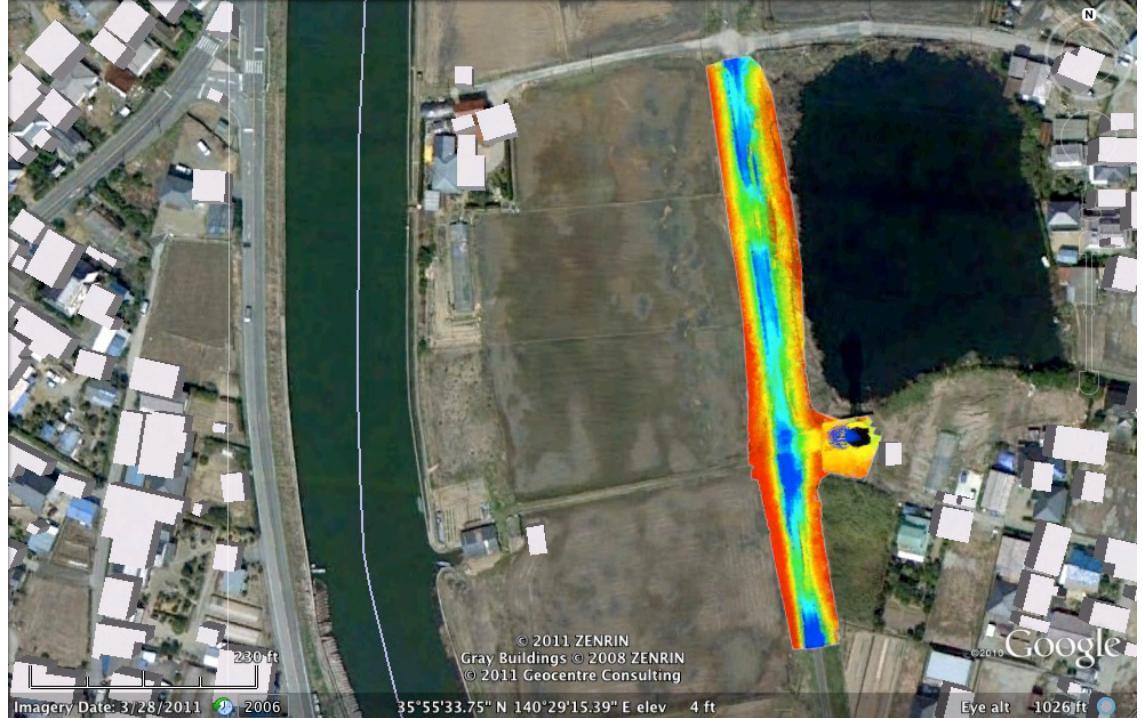
Figure QR6-7: LiDAR scanning at Yoko-Tone River. LiDAR coverage of the levee adjacent to the Yoko-Tone River. The data also covers a telecommunications tower pad. Lateral spreads were observed on the pond side of the embankment.

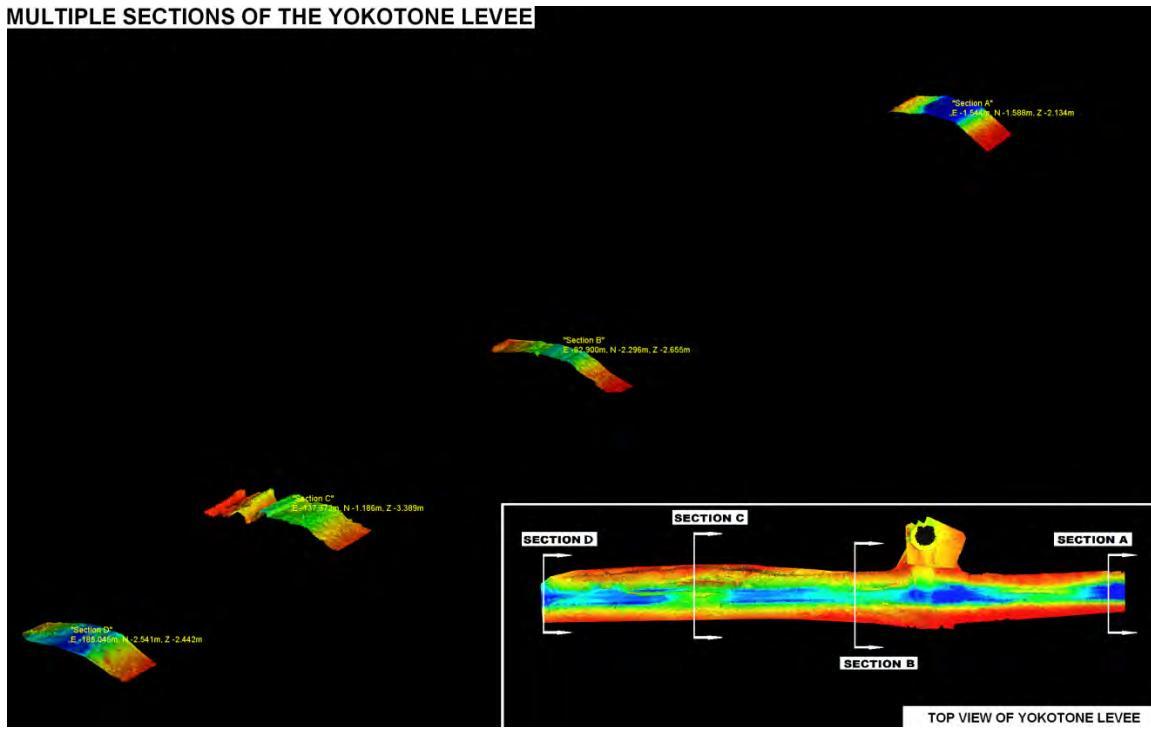
Figure QR6-13: Oblique view of cross sections A (unfailed), B (near tower), C (maximum deformation zone), and D (failed near cross road)

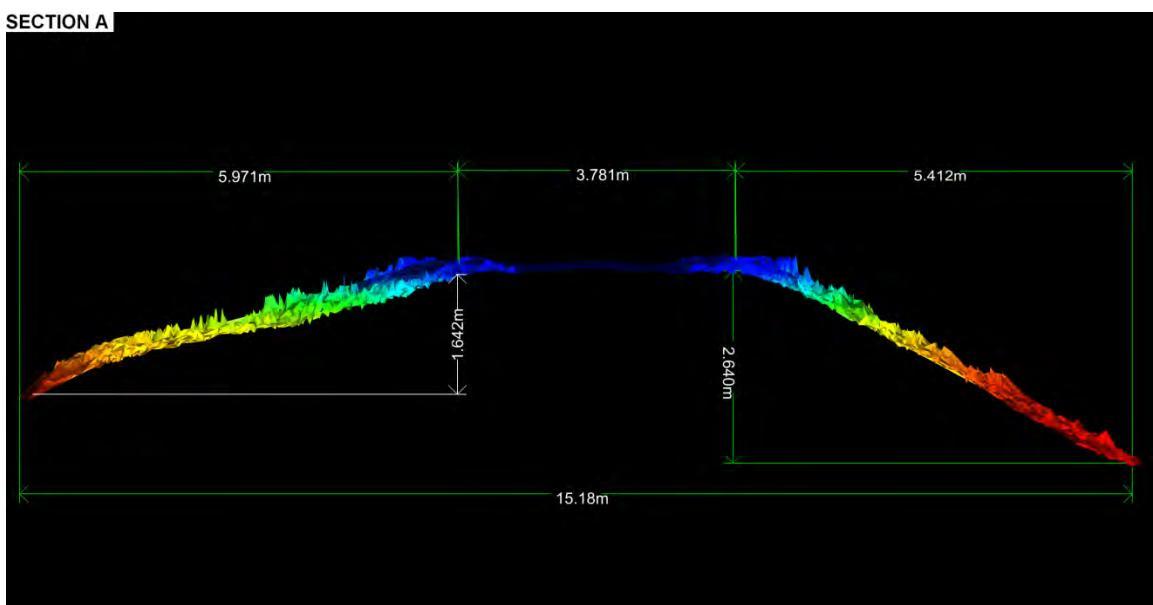
Figure QR6-14: Cross section A across the unfailed zone.

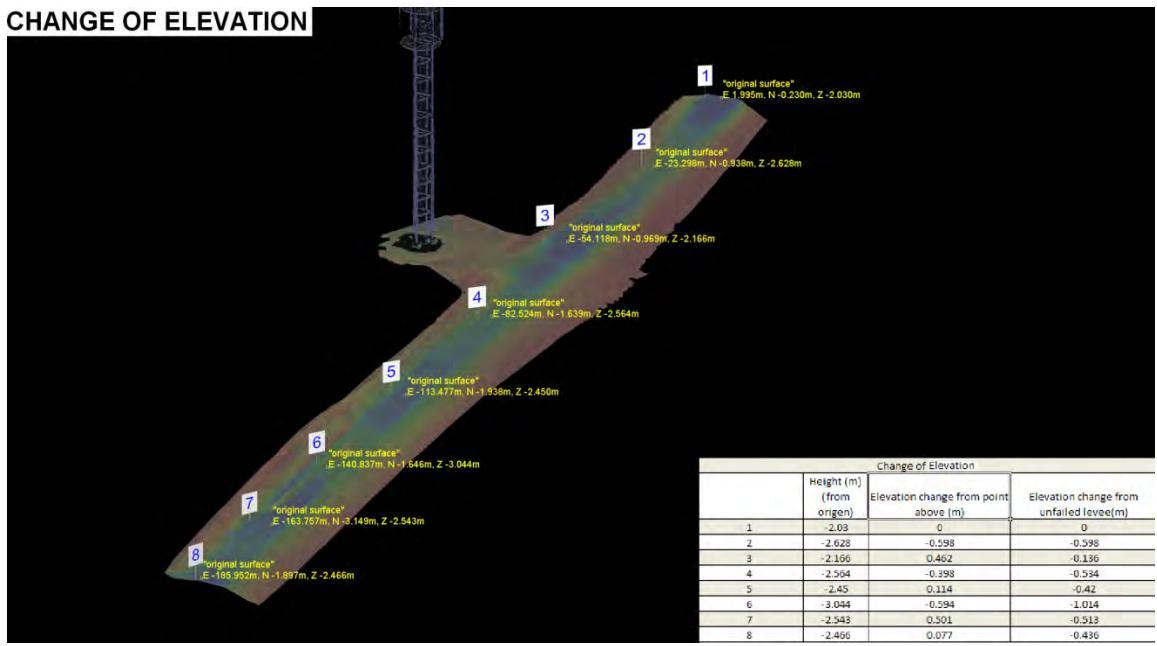
Figure QR6-16: Differential elevations across the levee crest. A maximum crest slumping of 1.01 meters was observed in the LiDAR data.

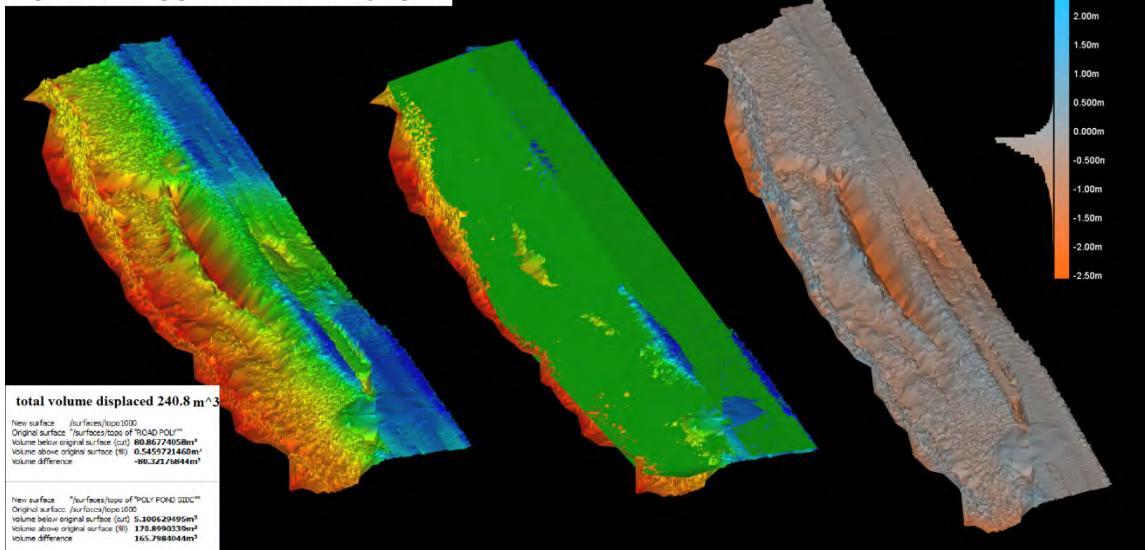
Figure QR6-18: Failure zone LiDAR data for section C (left), modeled pre-failure levee geometry (center), and change detection model that is the difference between the left and central models. The histogram indicates the distribution function for vertical deformations. Positive values represent gains in elevation from accumulation of soil at the toe of the spread or lateral movement toward the slope.

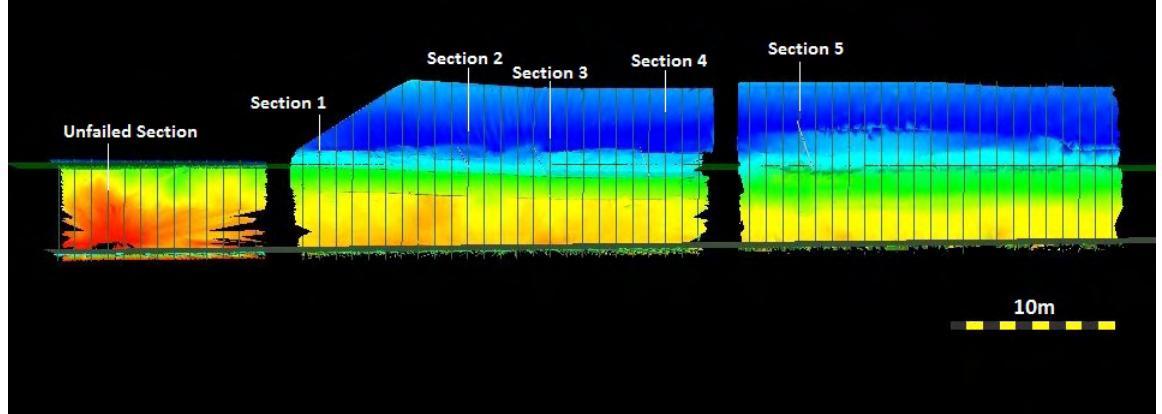
Figure QR6-21: Cross sections across Isobe

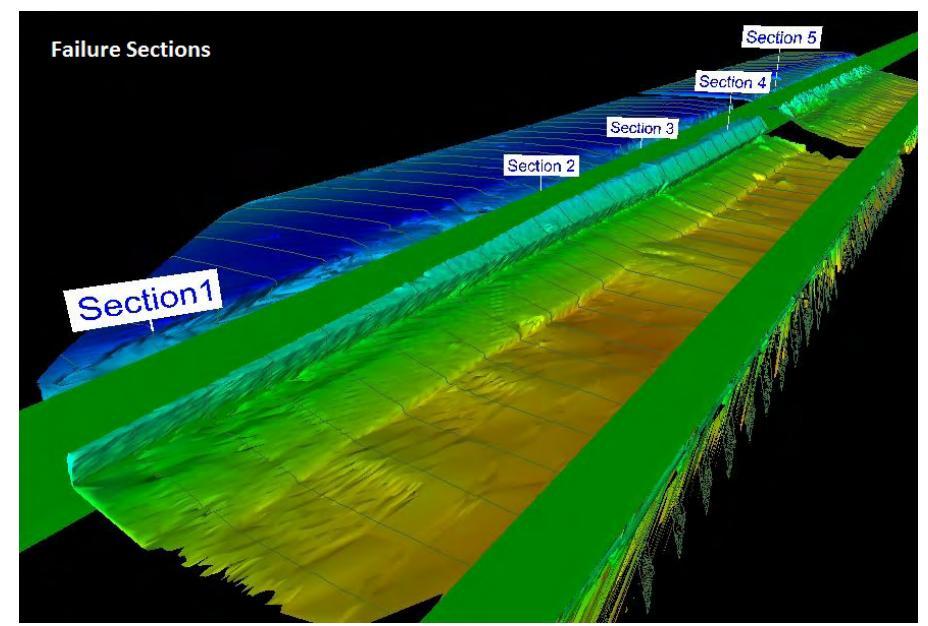
Figure QR6-23: Cross sections along the Isobe River. Section 1 is the first failed section after the unfailed section

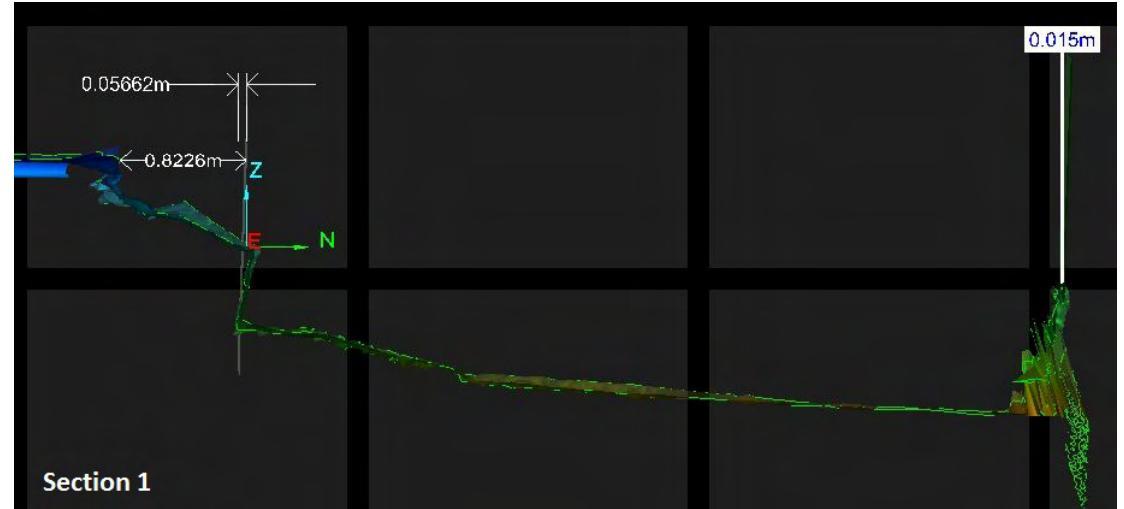
Figure QR6-26:. Failed cross section 1. Horizontal displacement of ground in the vicinity of the wall was 0.057m, failure zone width behind the wall was 0.823m, and river front railing displacement was 0.015m.

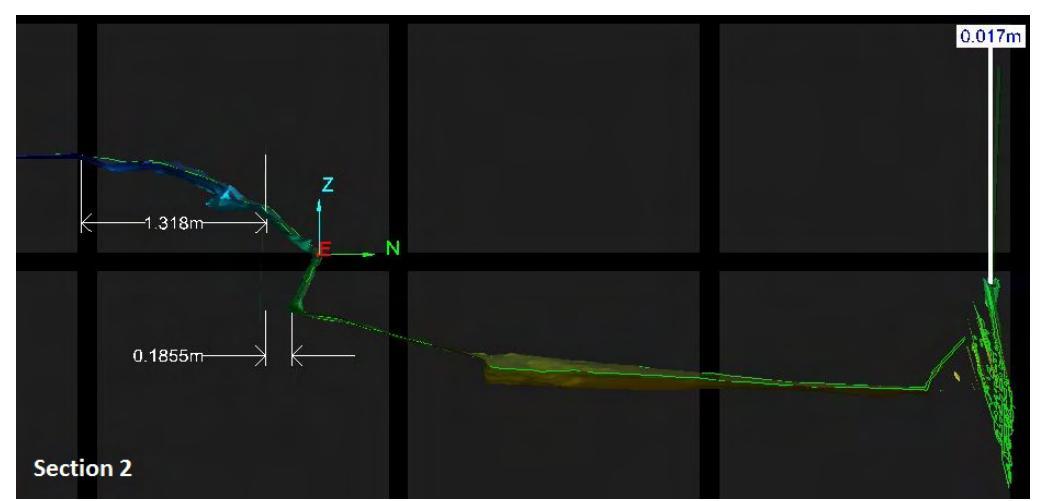
Figure QR6-27: Failed cross section 2. Horizontal displacement of ground in the vicinity of the wall was 0.19m, failure zone width behind the wall was 1.32m, and river front railing displacement was 0.017m.

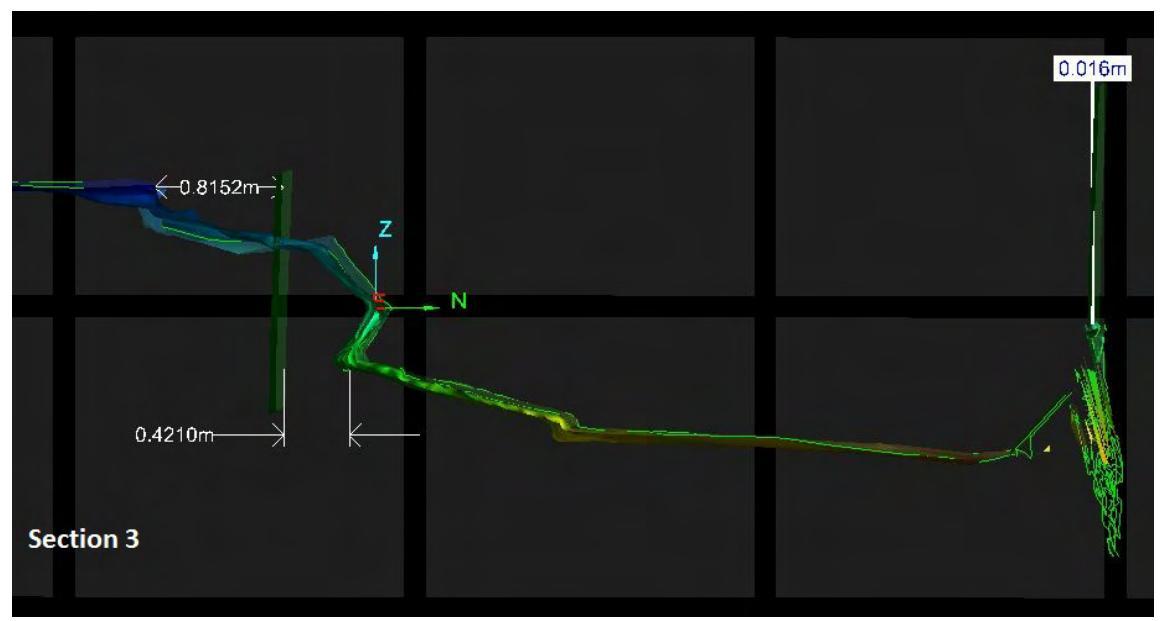
Figure QR6-28: Failed cross section 3. Horizontal displacement of ground in the vicinity of the wall was 0.42m, failure zone width behind the wall was 0.82m, and river front railing displacement was 0.016m

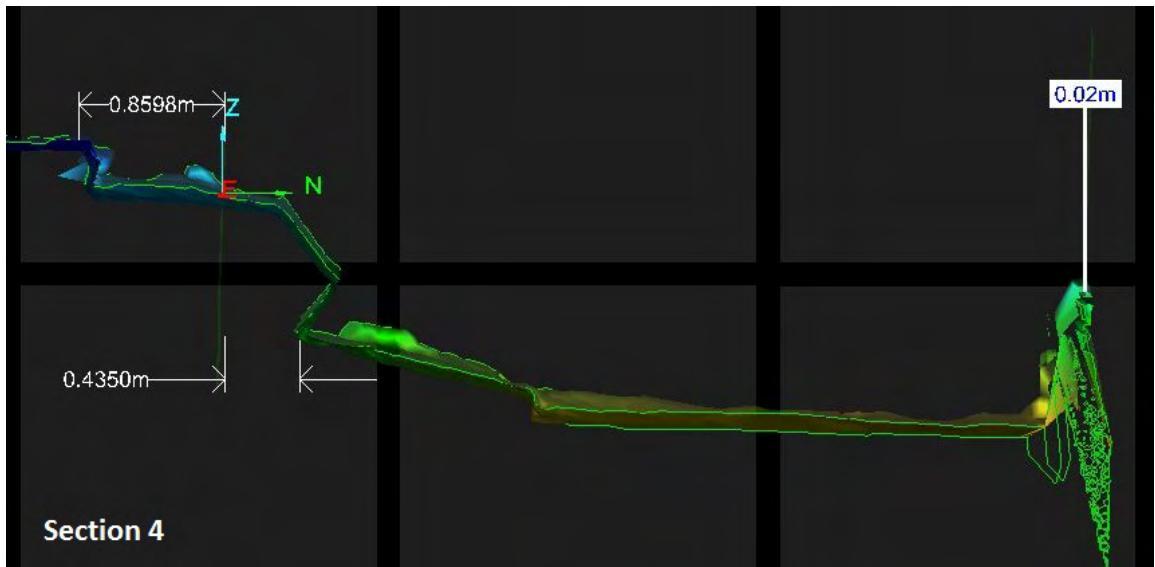
Figure QR6-29: Failed cross section 4. Horizontal displacement of ground in the vicinity of the wall was 0.44m, failure zone width behind the wall was 0.86m, and river front railing displacement was 0.02m.

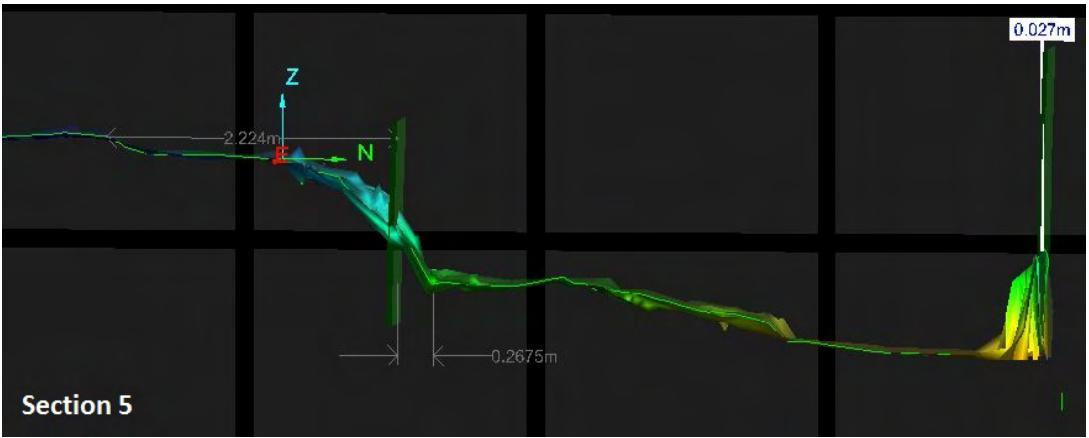
Figure QR6-30: Failed cross section 5. Horizontal displacement of ground in the vicinity of the wall was 0.27m, failure zone width behind the wall was 2.22m, and river front railing displacement was 0.027m. The river wall settlement in this zone is 0.08m.

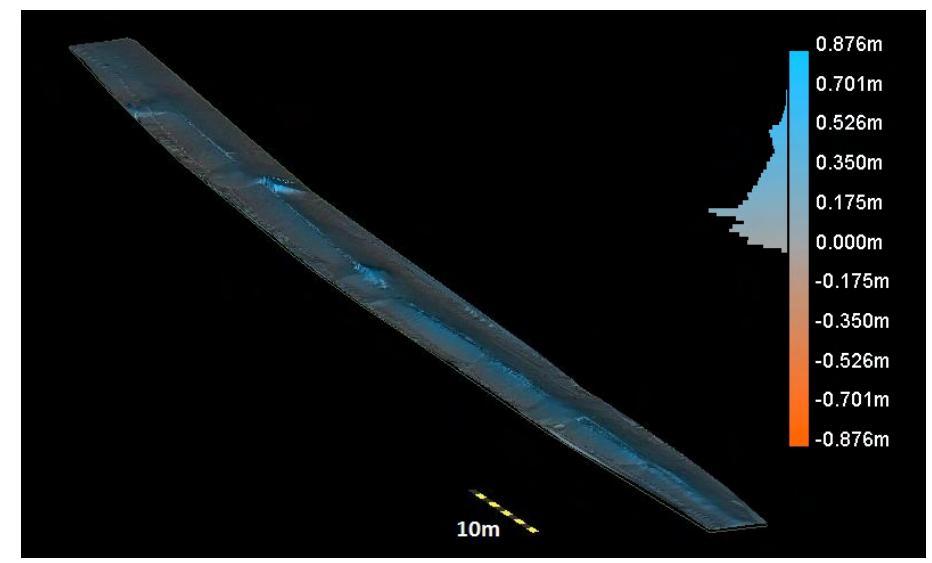
The LiDAR data was measured along the perimeter road on the south side of the elementary school. This area suffered storm drainage and sewer uplift in liquefied soil. On the surface, the centerline of the asphalt covered narrow road/path was lifted up. A light metal and construction block wall adjacent to the path on the north side marked the perimeter of the school, and this wall was not disturbed. At least in the vicinity of the public there does not appear to be lateral deformation occurring at this site. Jon Stewart noted that there may be lateral deformation occurring near the school foundation. Our LiDAR data does not cover that damage.

Figure QR6-31:. Histogram of uplift along path behind Sodegaura school due to buoyancy of buried storm water and sewer lines. The maximum uplift was approximately 0.70m.

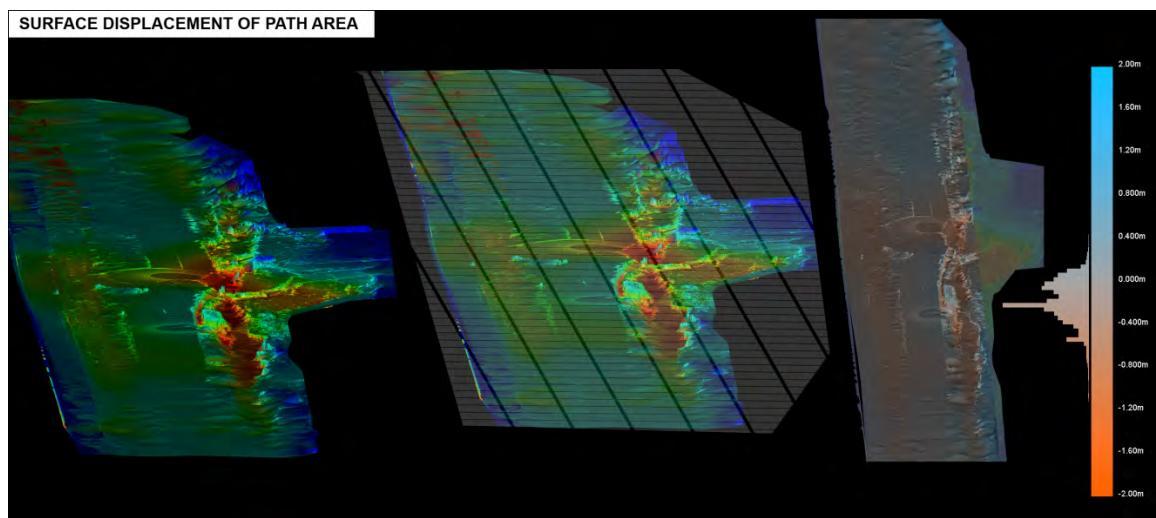
Figure QR6-36: Post failure surface (left), overlay of prefailure surface (middle) and histogram of vertical elevation change (right)

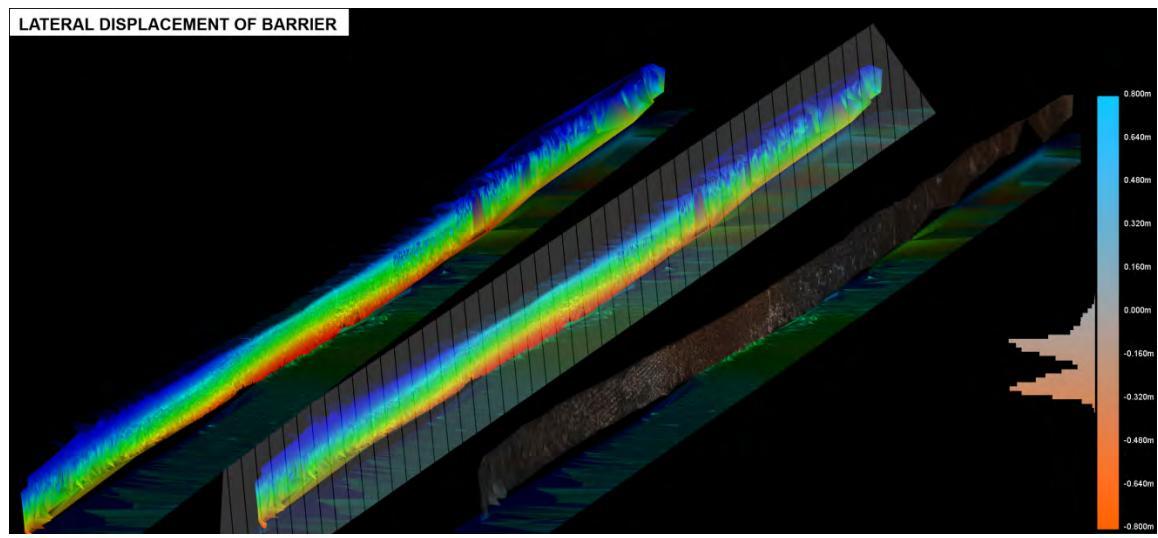
Figure QR6-37: Lateral sea wall displacement. The maximum horizontal wall movement was 0.35m.

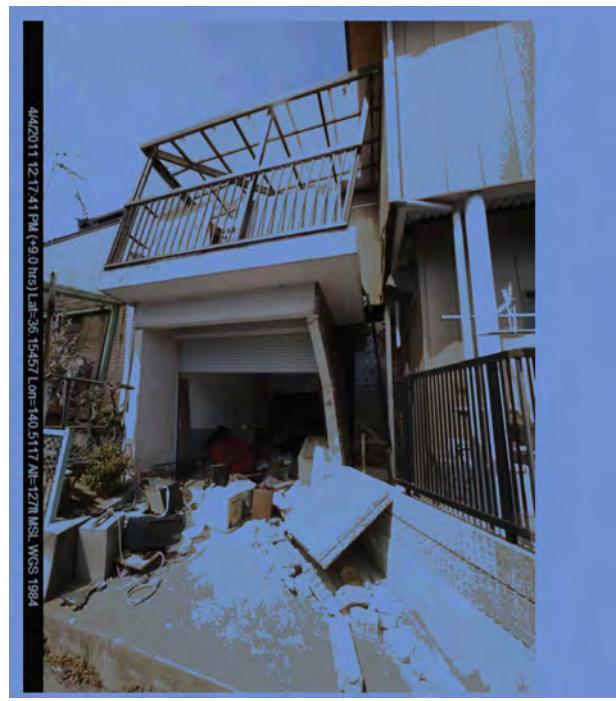
Figure QR6-41: Liquefaction and structural damage at Hokota

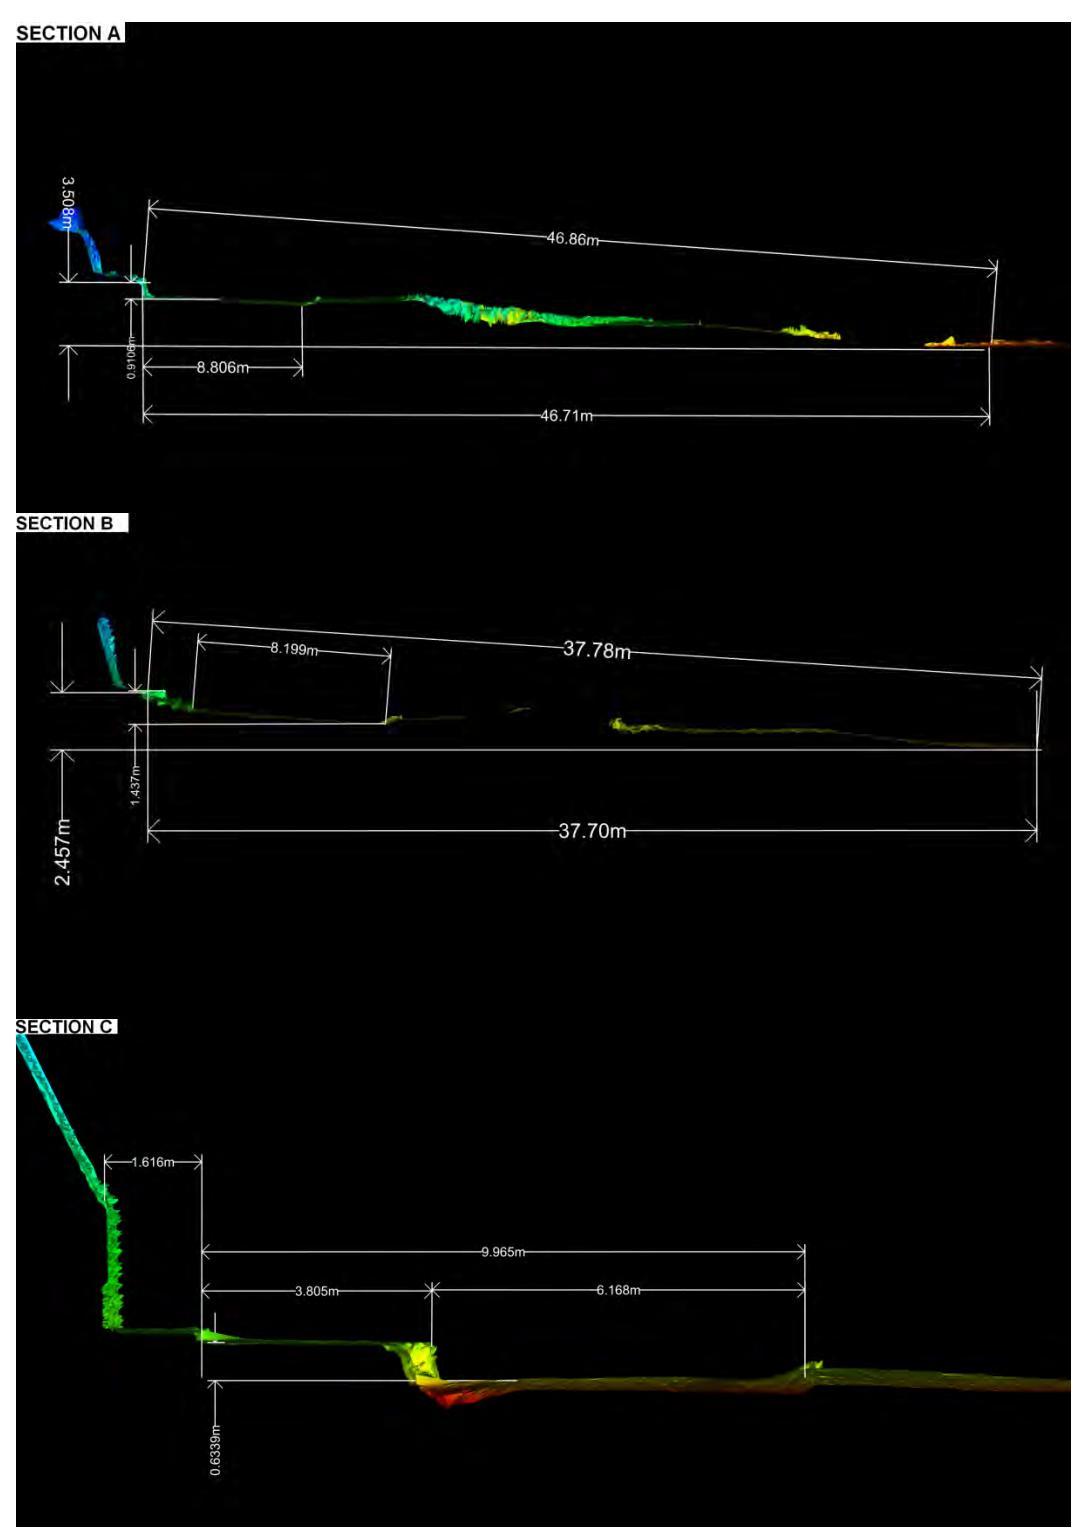
Figure QR6-65: Sections A, B, and C cross failure zones at Hitachinaka. Vertical settlment at the headscarp on the road is 0.91m on section A; section B 1.437m; and at Section C 0.633m.

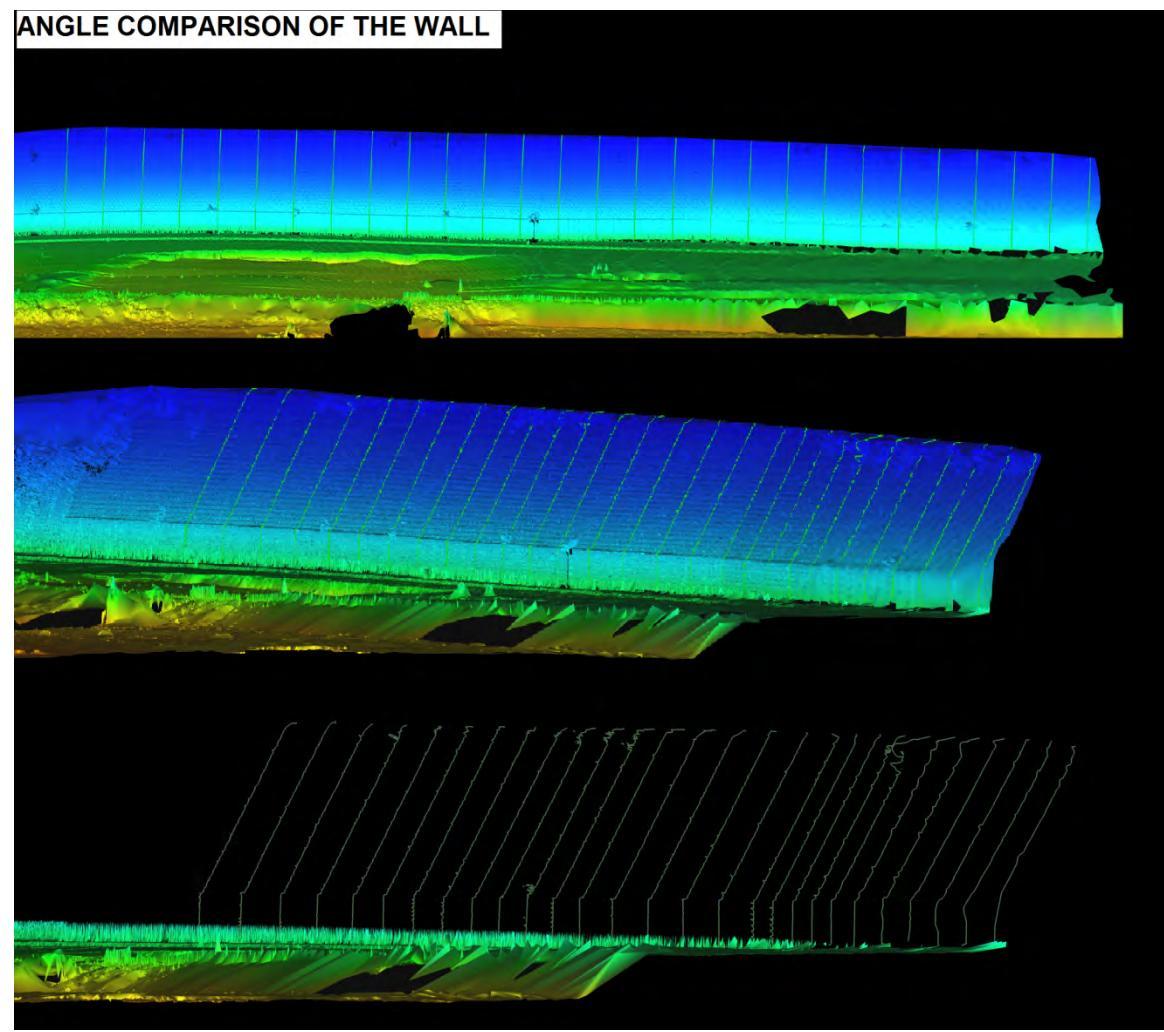
Figure QR6-66: Cross-sections along with the cut slope terrace deposits, faced with concrete indicates no deformation was observed above the landslides scarp.

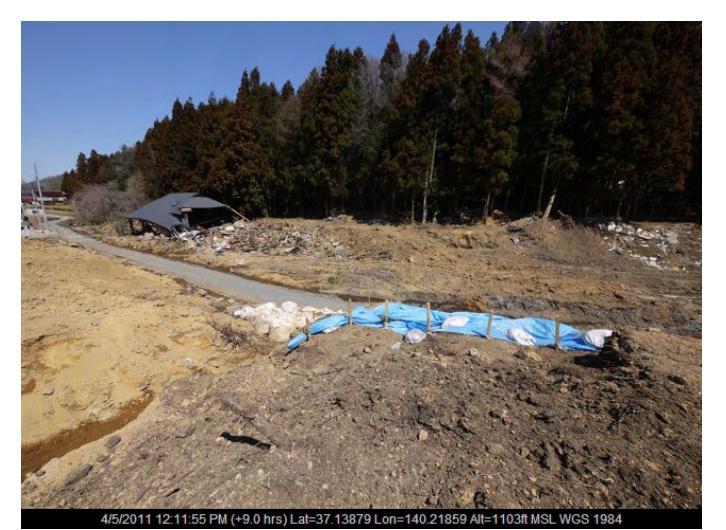
Figure QR6-73: An emergency road was bulldozed through a landslide debris at the toe of the failure, and to gain access to the location of homes buried by debris.

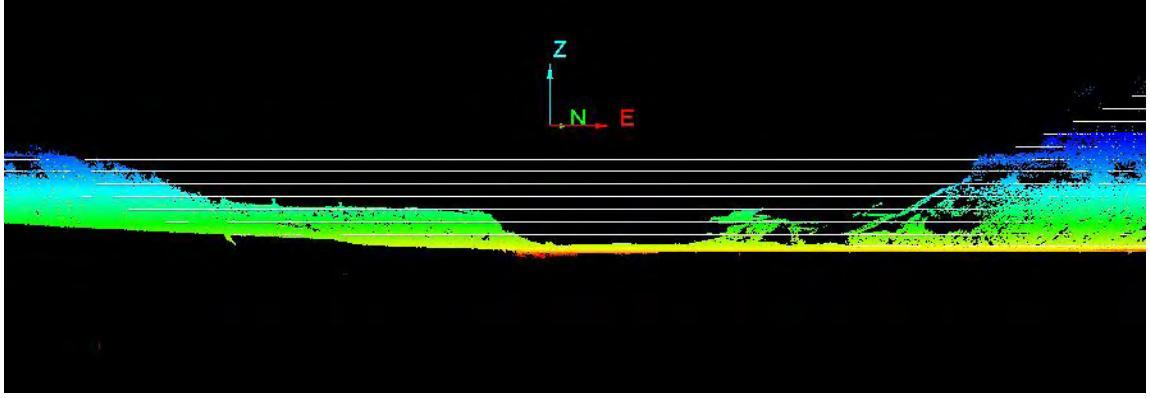
Figure QR6-93: LiDAR data plotted against 2m contours of the original dam surface looking directly at the dam from the reservoir side. At the maximum zone of cut down approximately 14m of embankment was lost. On the left about 8m of embankment was lost.

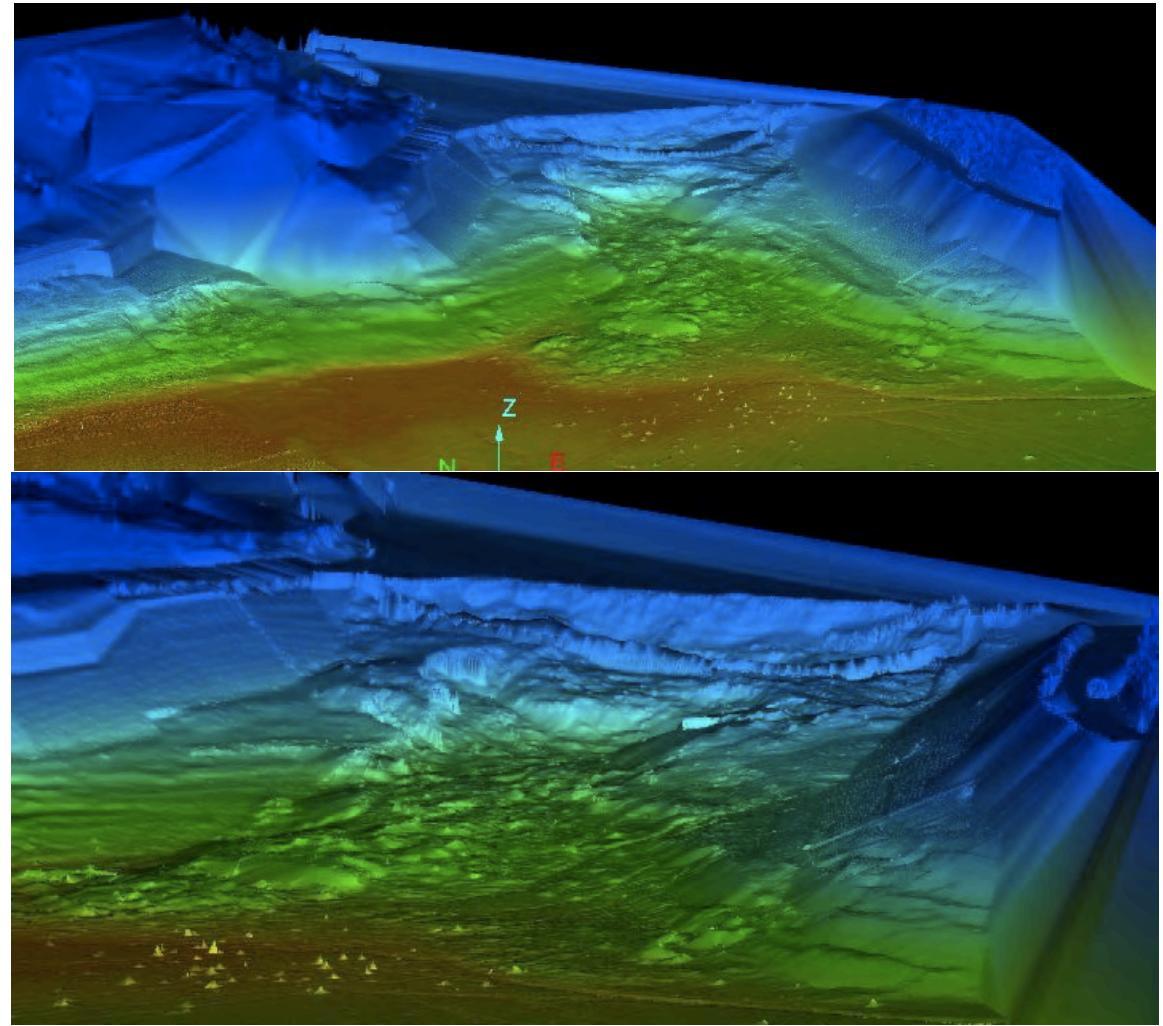
Auxilliary Dam

Figure QR6-94: Oblique LiDAR images of the auxiliary dam slope failure.

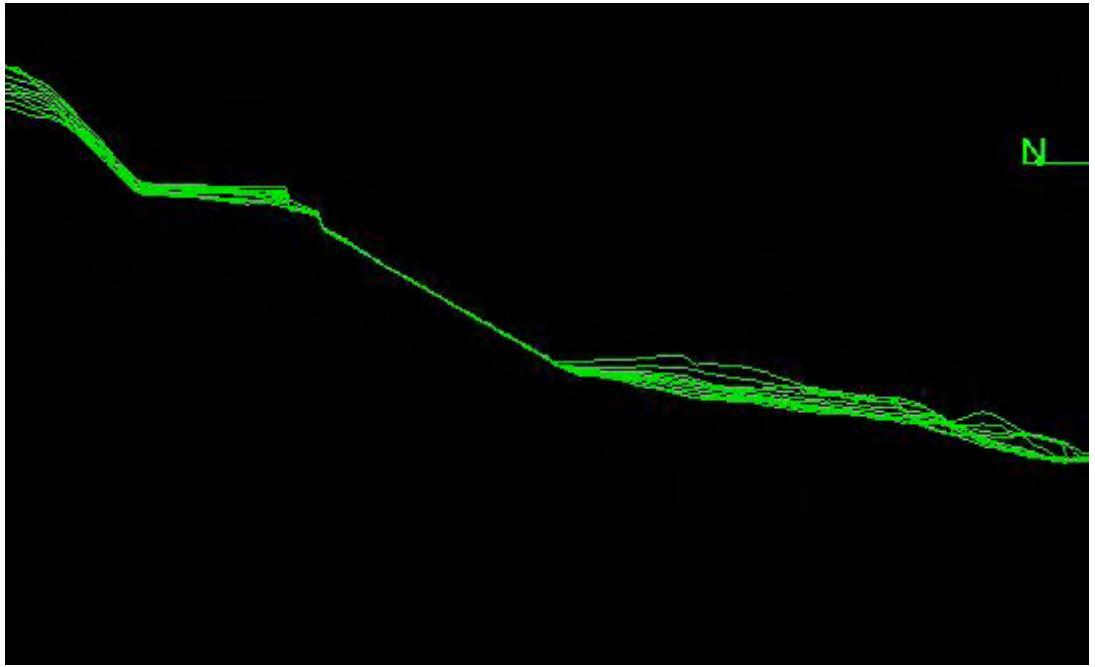
Figure QR6-95: Cross sections of the intact left slope adjacent to the auxiliary dam. Little deformation was observed on the slope.

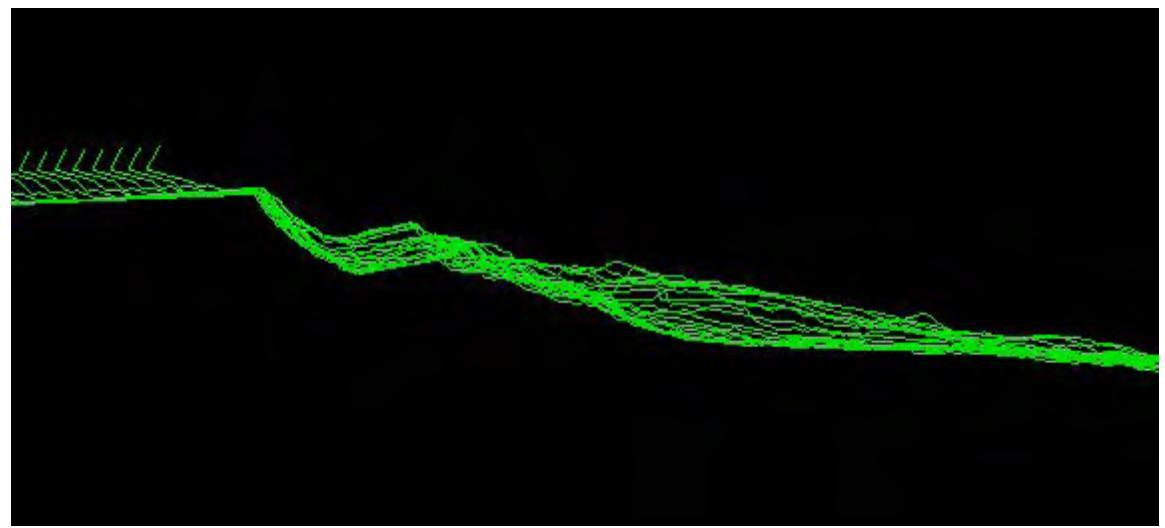
Figure QR6-97: Cross-sections through the failed portion of the auxiliary dam.

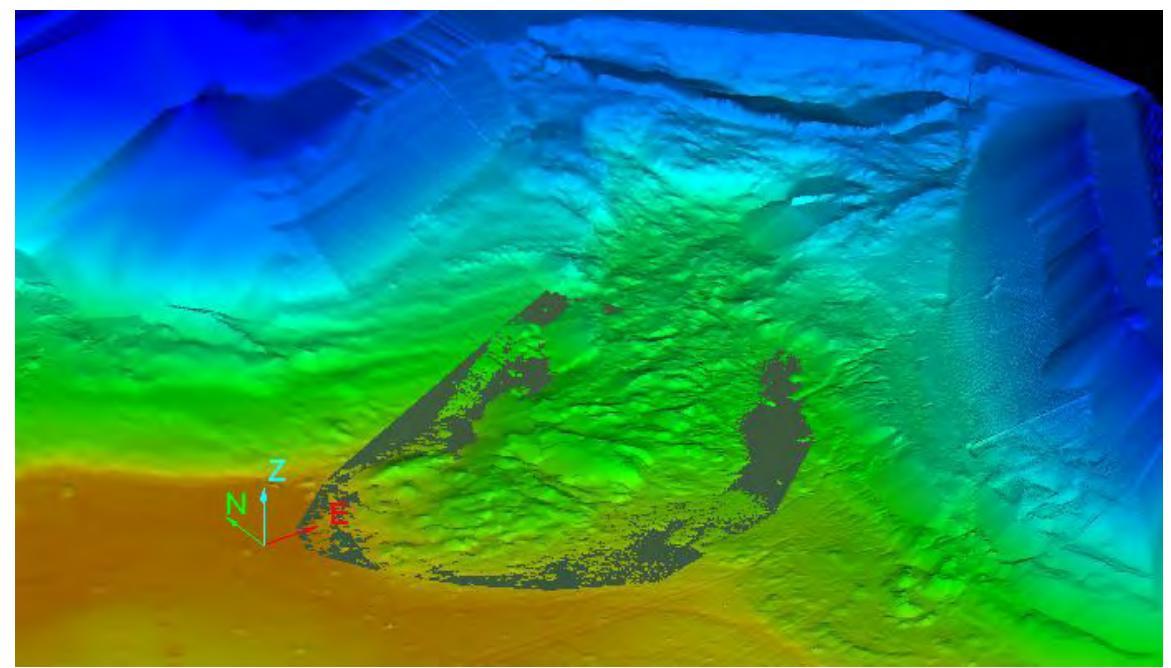
Figure QR6-99: Two model surfaces were constructed for the landslide debris and the headscarf of the auxiliary dam failure. Both volumes balanced to approximately 11,000 m of debris.

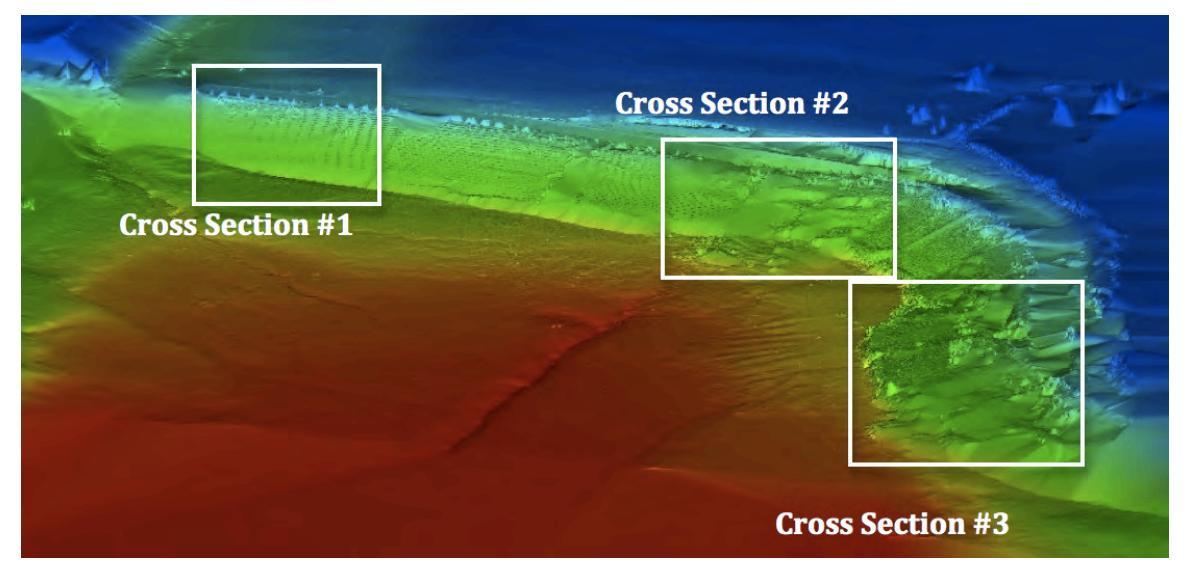
Figure QR6-100: Cross-sections were developed across three areas of the western part along the reservoir perimeter. Section one is an un-failed slope. Sections two and three are deformed sections of the reservoir embankment.

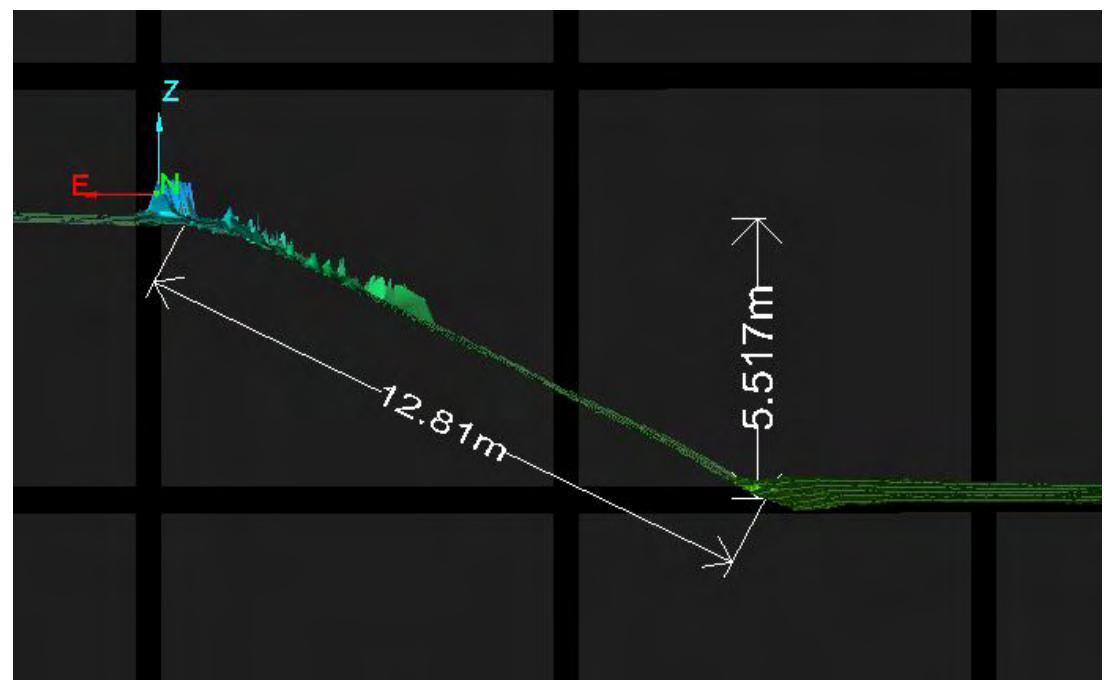
Figure QR6-101: Cross Section 1 (Unfailed). The slope has a height of 5.5 m and a grade of 1:2.0. Cross-sections from areas 2 and 3 have similar geometries prior to the earthquake.

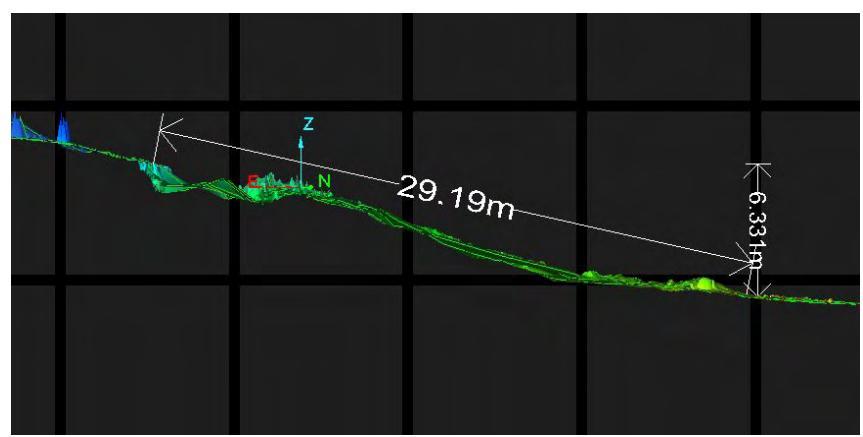
Figure QR6-103: Cross sections of area 2. Slope failure has pushed out the toe of the slope approximately 15 m in this area and reduced the slope inclination to 1:4.5.

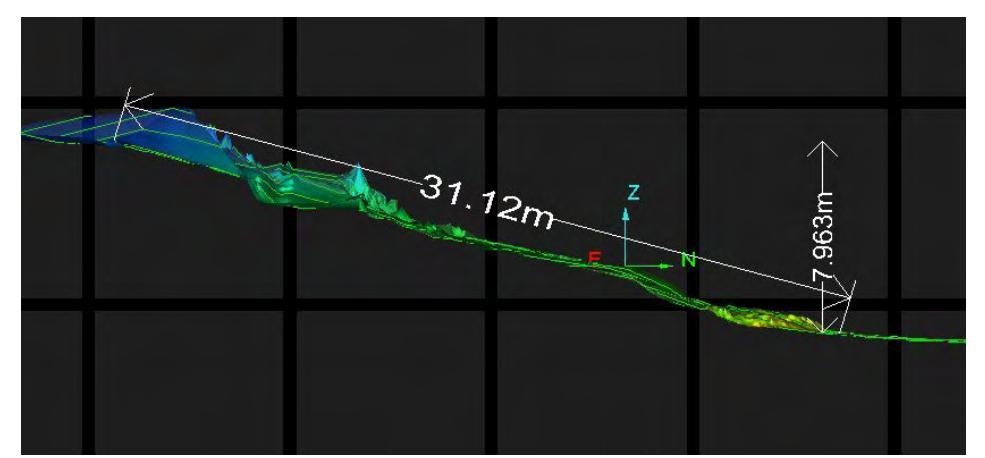
Figure QR6-105. Cross sections of area 2. Slope failure has pushed out the toe of the slope approximately 13m in this area and reduced the slope inclination to 1:3.8.

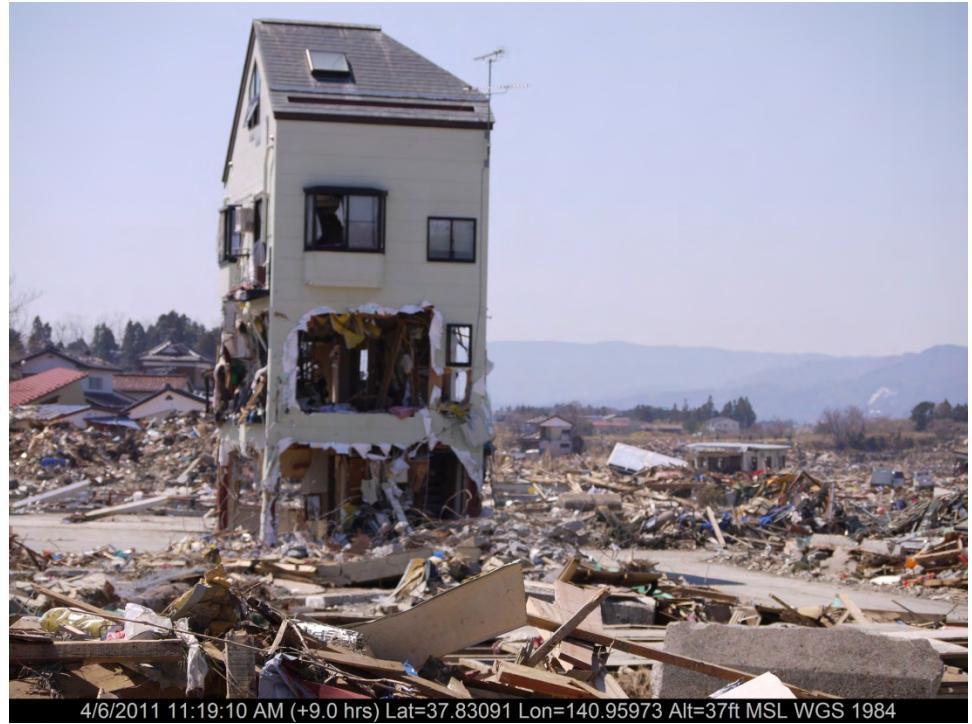
1) The PARI office at SOMA was destroyed by the tsunami. In general, the tsunami damage overprints or obliterates everything else one might observe at the waterfront.

Figure QR6-107: Damage near the PARI headquarters at Soma. The headquarters building is missing, but the foundation is preserved. This view is towards land from the PARI office floor slab

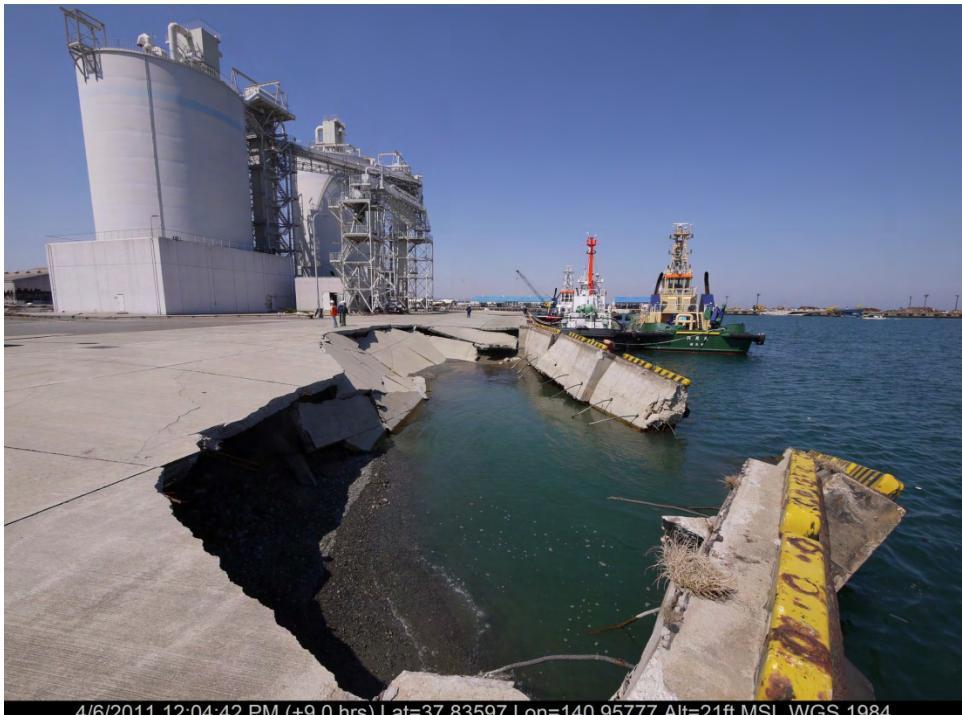
5) Along the port wharves, corner areas had severe or amplified damage. At corners, and other areas the seawall, openings in the caissons or sheet pile towards the sea eroded the soil behind the wall and beneath the pavement resulting in a collapse of the deck. Several quay wall blocks,  $\sim 5m^2$  area and  $\sim 3m$  tall were flipped over by the incoming tsunami and landed upside down on the wharf deck.

4/6/2011 12:04:42 PM (+9.0 hrs) Lat=37.83597 Lon=140.95777 Alt=21ft MSL WGS 1984 Figure QR6-108: Failure of a sheet pile wall and evacuation of soil.
