#### Geotechnical Extreme Events Reconnaissance (GEER)

# LiDAR and Field Investigation Of the March 11, 2011 M9.0 Great Tohoku Offshore Earthquake, and April 7, 2011 M7.4 Aftershock.

## July 20, 2011

#### Tohoku Earthquake Reconnaissance

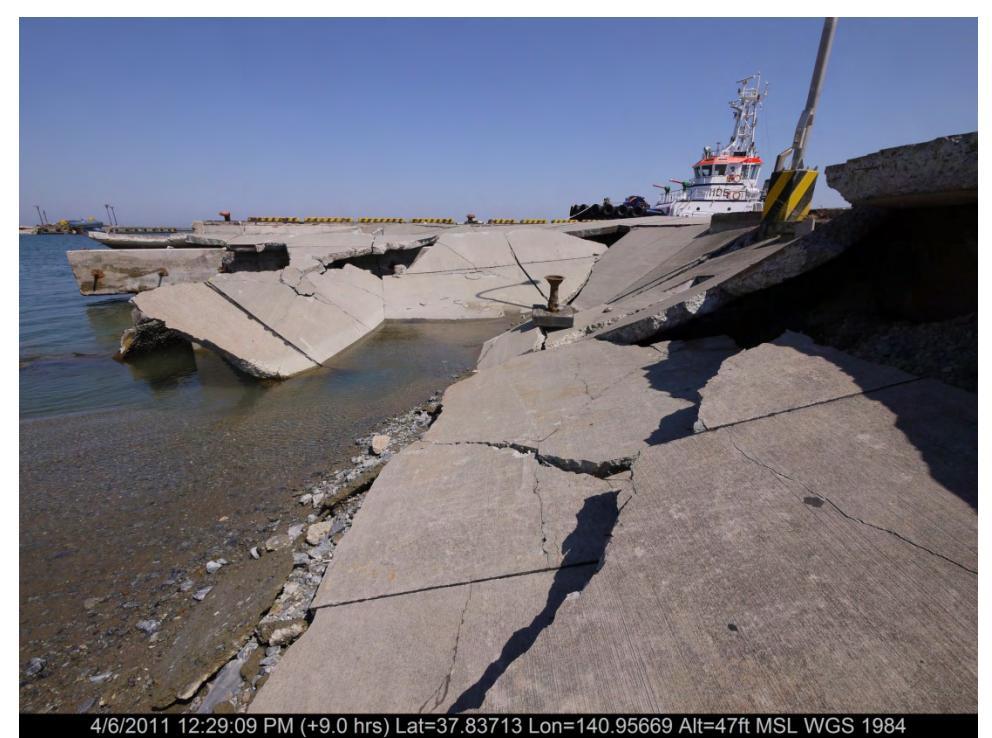
Figure QR6-109: Failure of a sheet pile wall at a corner area and evacuation of soil.

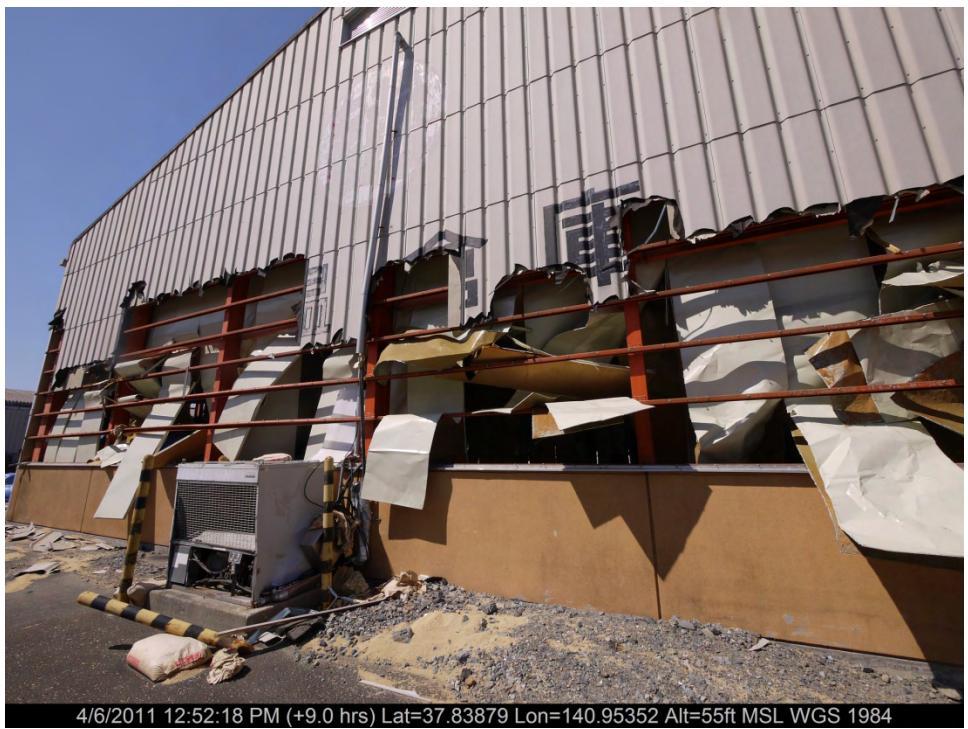
Figure QR6-110: Tsunami damage to a port warehouse at Soma.

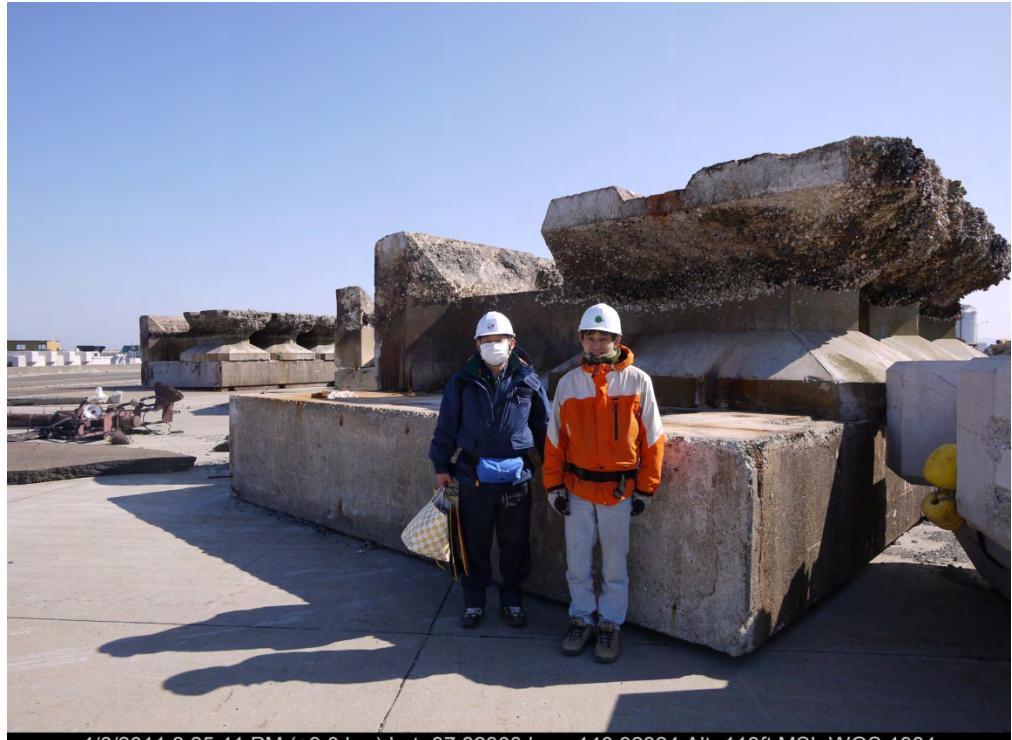
4/6/2011 2:25:41 PM (+9.0 hrs) Lat=37.82303 Lon=140.92324 Alt=113ft MSL WGS 1984 Figure QR6-111: Upside-down quay wall blocks on a wharf deck flipped over by the tsunami.

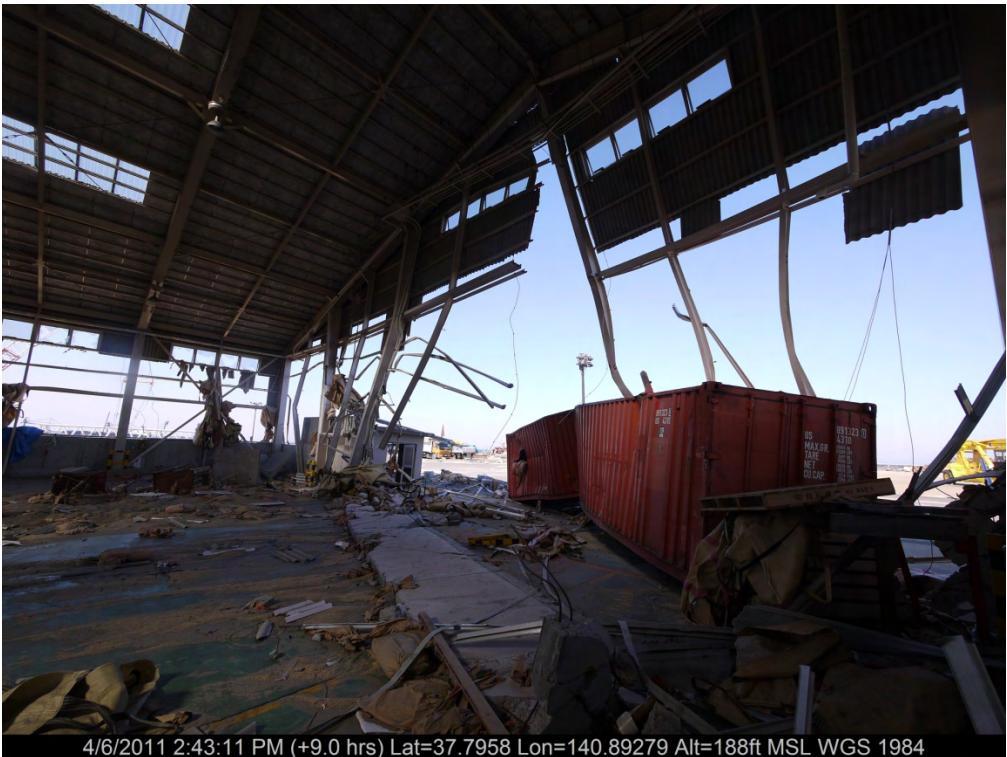
Figure QR6-112: Tsunami damage to a Soma Port warehouse.

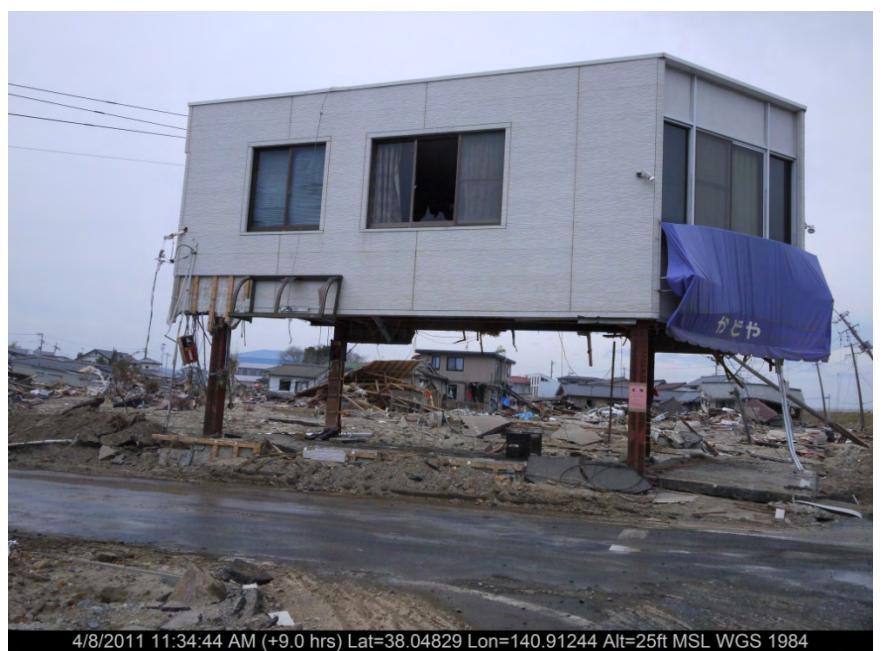
Figure QR6-115: Tsunami damage at Abukuma Edgetsu

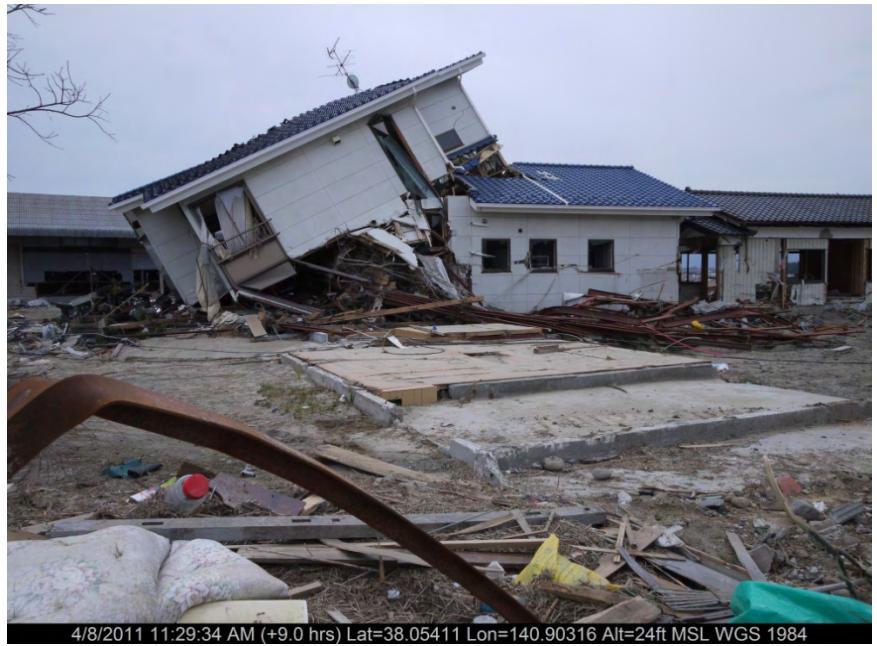
Figure QR6-116: Tsunami damage at Abukuma Edgetsu

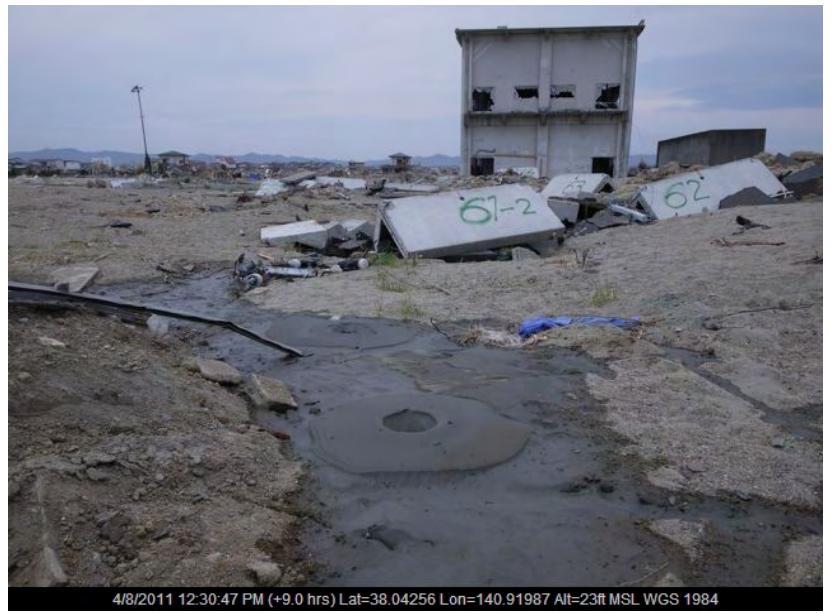
Figure QR6-118: Liquefaction damage east of the wastewater treatment plant. Liquefaction is associated with the April 7, 2011 aftershock. This site is located in the tsunami inundation zone and direct evidence of liquefaction from the main event of March 11, 2001 is masked by debris, hydraulic re-working, and tsunami soil deposits.

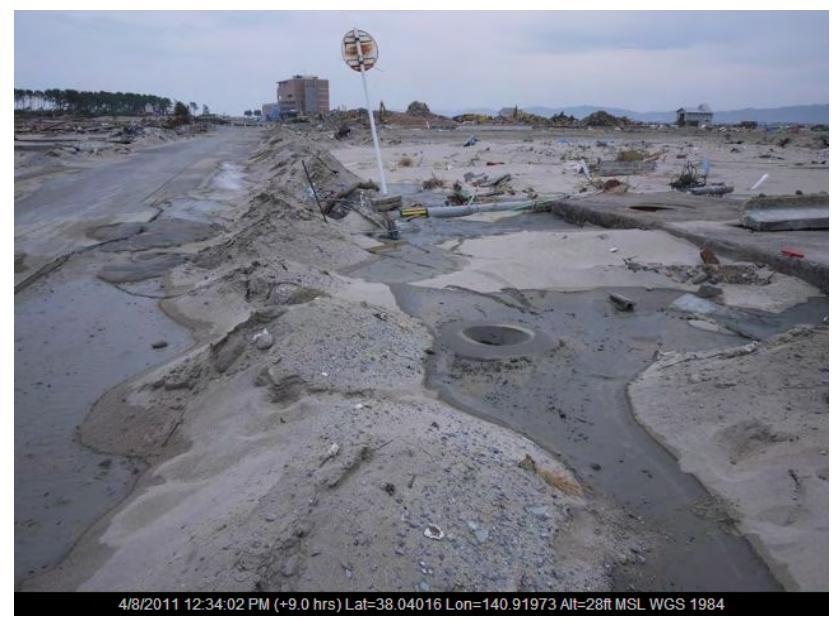
Figure QR6-119: Liquefaction damage and fissures south of the wastewater treatment plant.

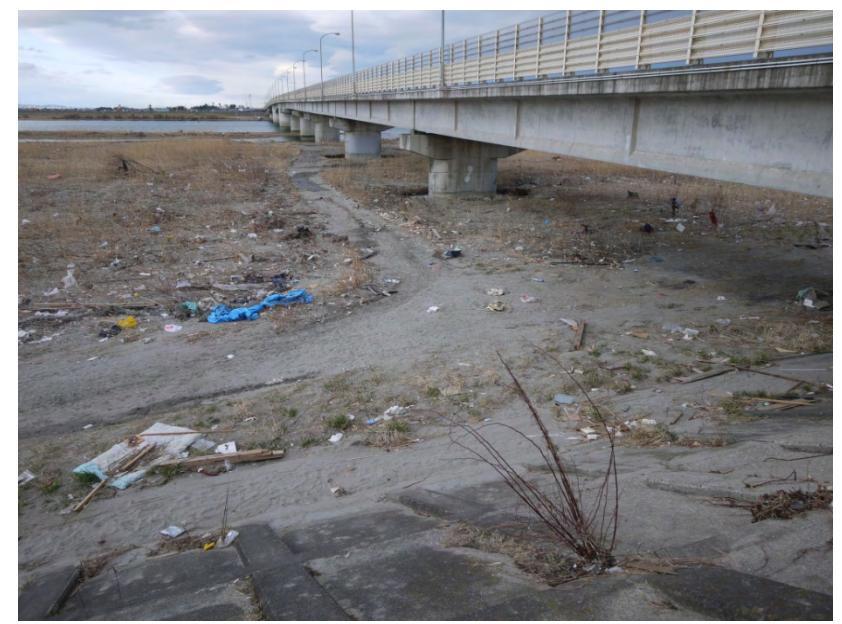
Figure QR6-124: Liquefaction and bridge scour was observed at RK24 along the eastern Yuriage Bridge.

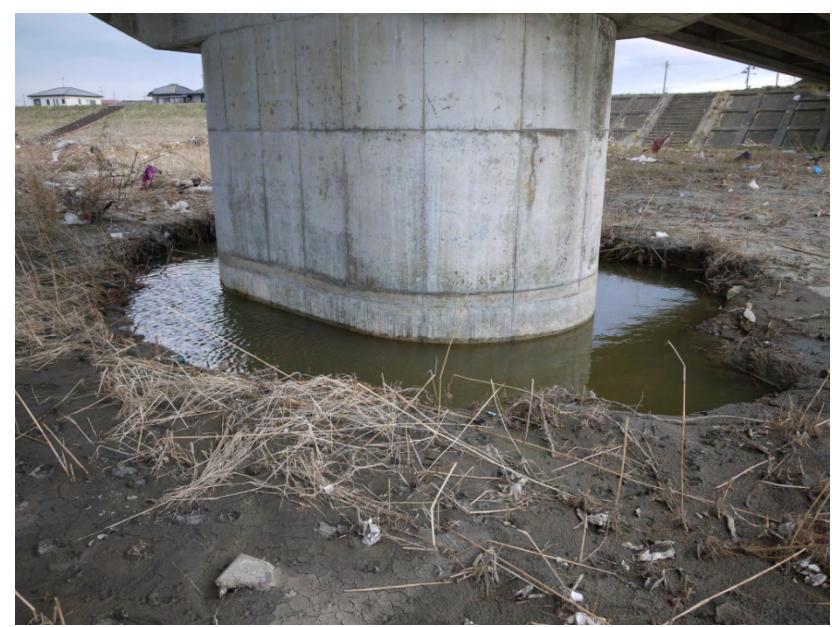
Figure QR6-125: Site RK24 detail of bridge scour up soil surrounding a bridge pier on the south bank of the Natori River at the eastern Yuriage Bridge.

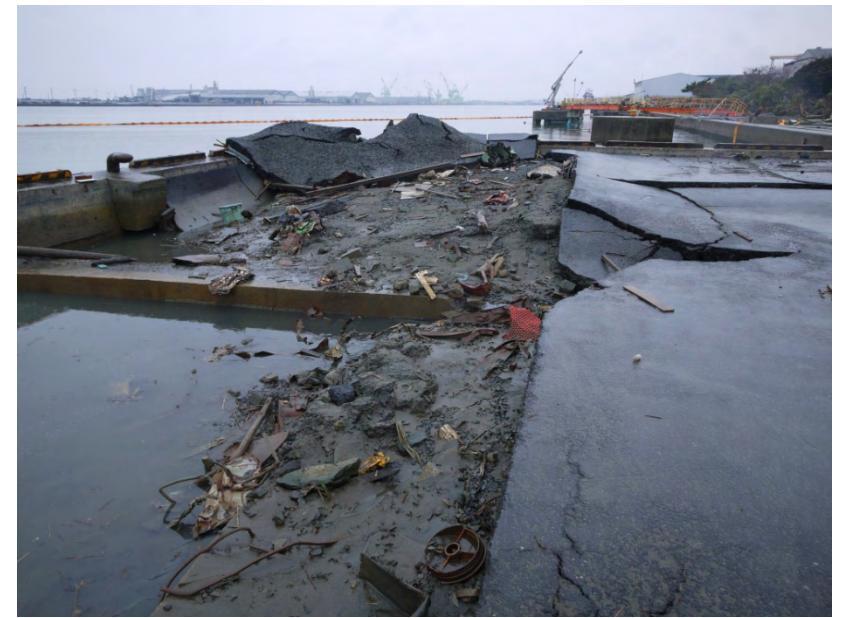
Figure QR6-134: Site RK27, also liquefaction test site 79ISHI. This site is called Nakajima Wharf and is adjacent to the Ishinomaki oil refinery and oil storage facility. This photograph shows tsunami damage but also likely liquefaction damage from the Main event that led to settlements along the wharf front. This photograph has the same perspective as photo C

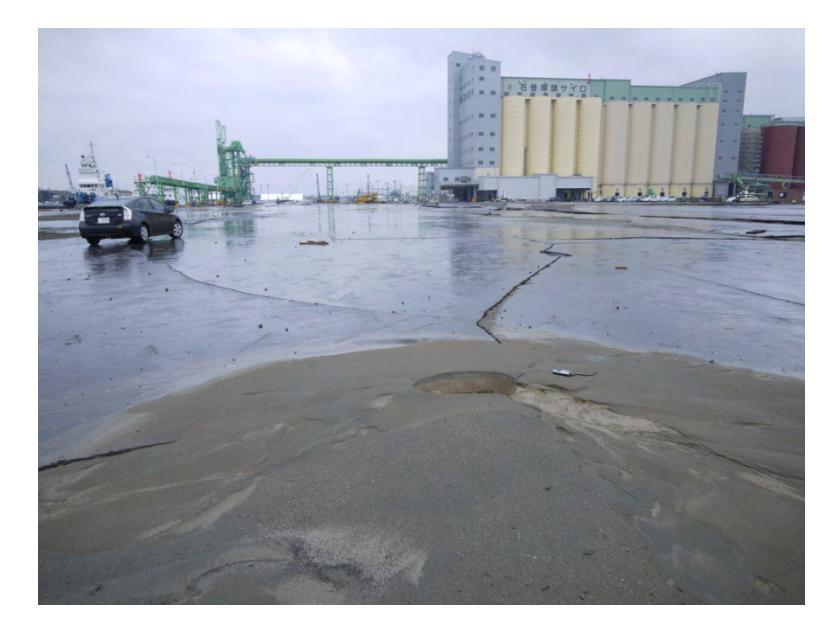
Figure QR6-135: Site RK28 Liquefaction. SASW test site 84HIYO on the Hiyori wharf, Port of Ishinomaki.

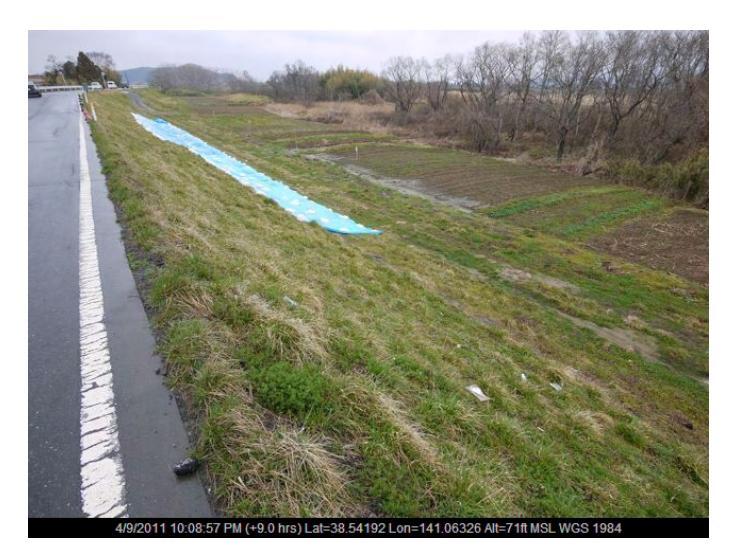
Figure QR6-143: Blue tarp draped over fissures on the east side of embankment highway 257 at Koguchi, Miyagi Prefecture facing the Eai River looking north.

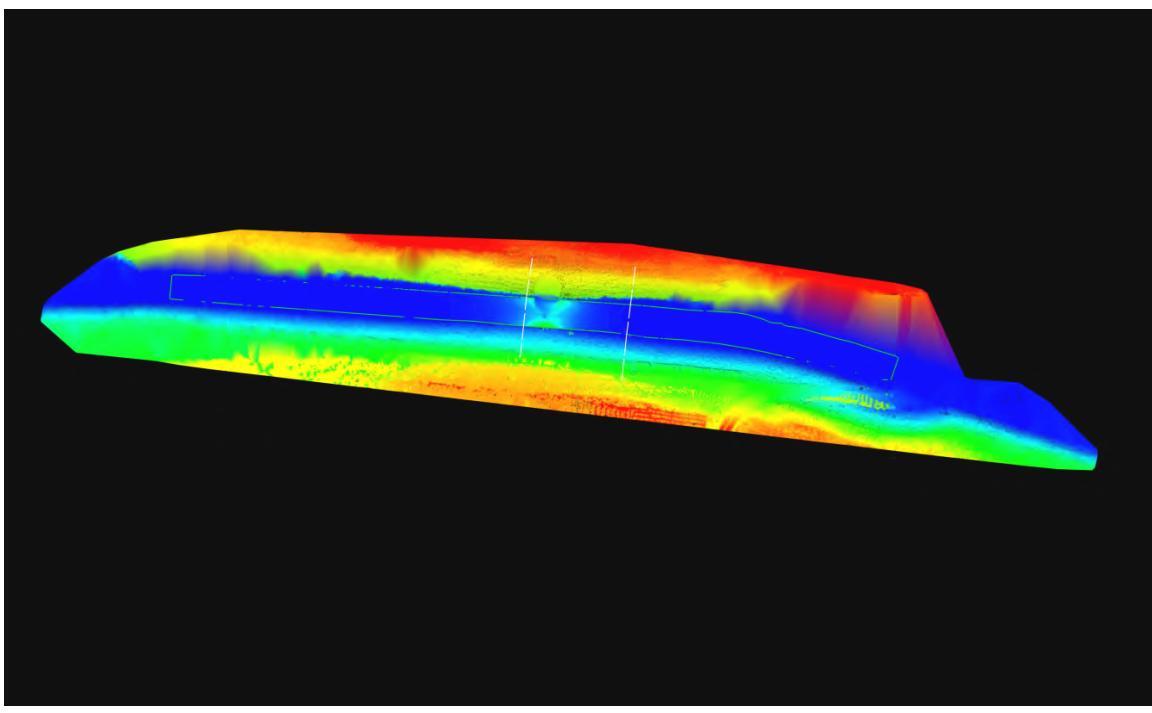
Figure QR6-145: LiDAR imagery of embankment highway 257 at Koguchi, Miyagi. The light blue segment along the road crest is an area of settlement.

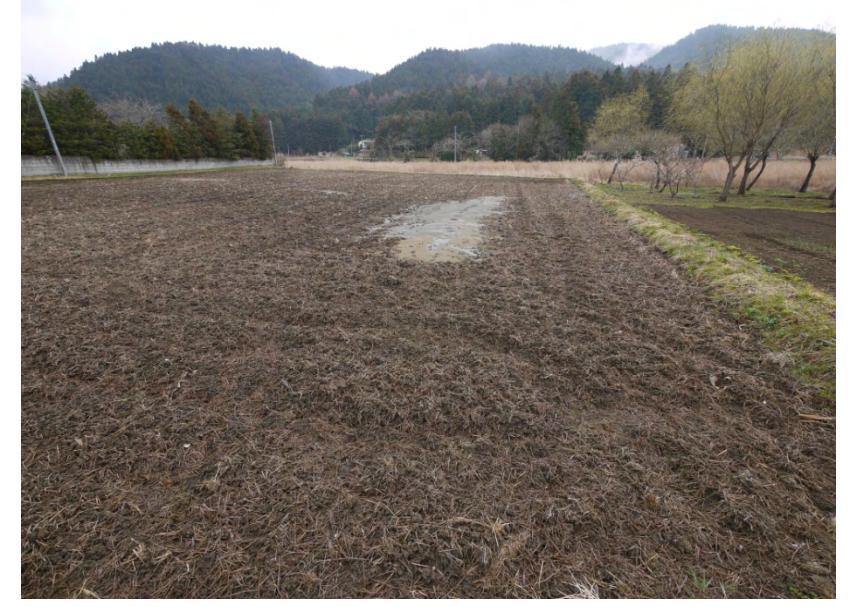
Figure QR6-147. Site RK33 correspond with 82KITA. At the siteRK33, there is overlapping evidence of liquefaction from aftershock of April 7 and the main shock of March 11, 2011.

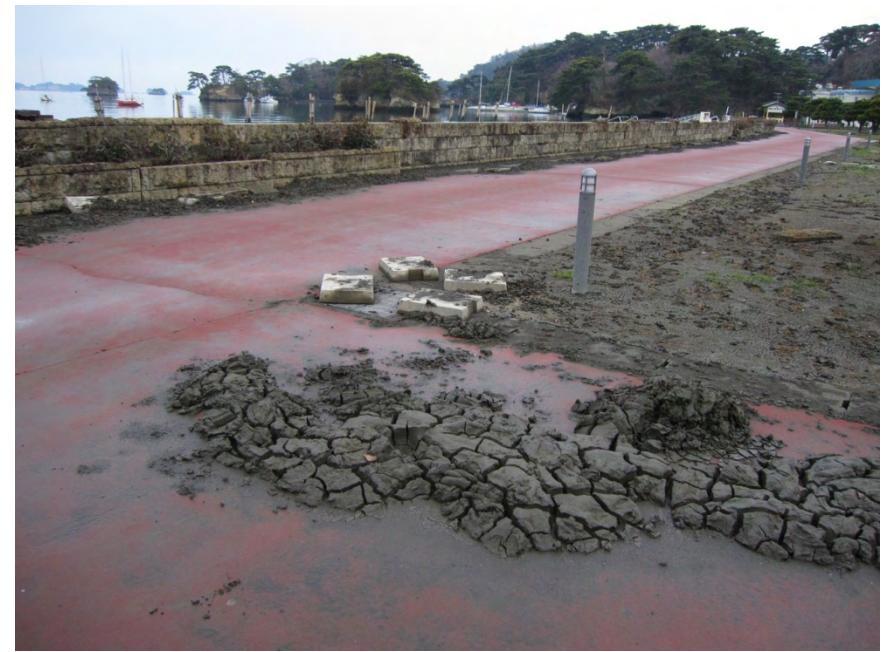
Figure QR6-152: Tsunami deposits of bay sediment in park at Matsushima.

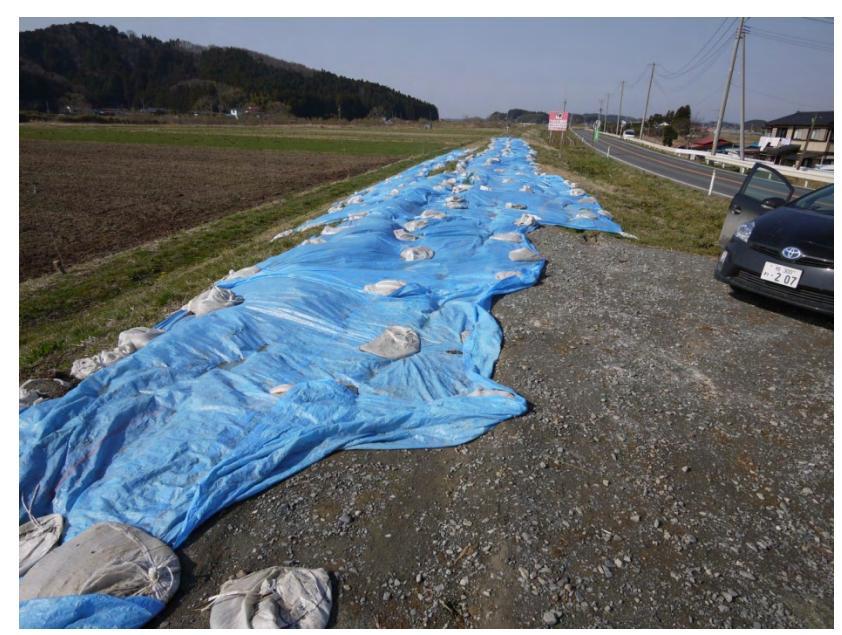
Figure QR6-153: (RK38) Small country highway road embankment failure due to liquefaction. Blue tarps cover fissures on the embankment slopes at Shakushi, Miyagi.

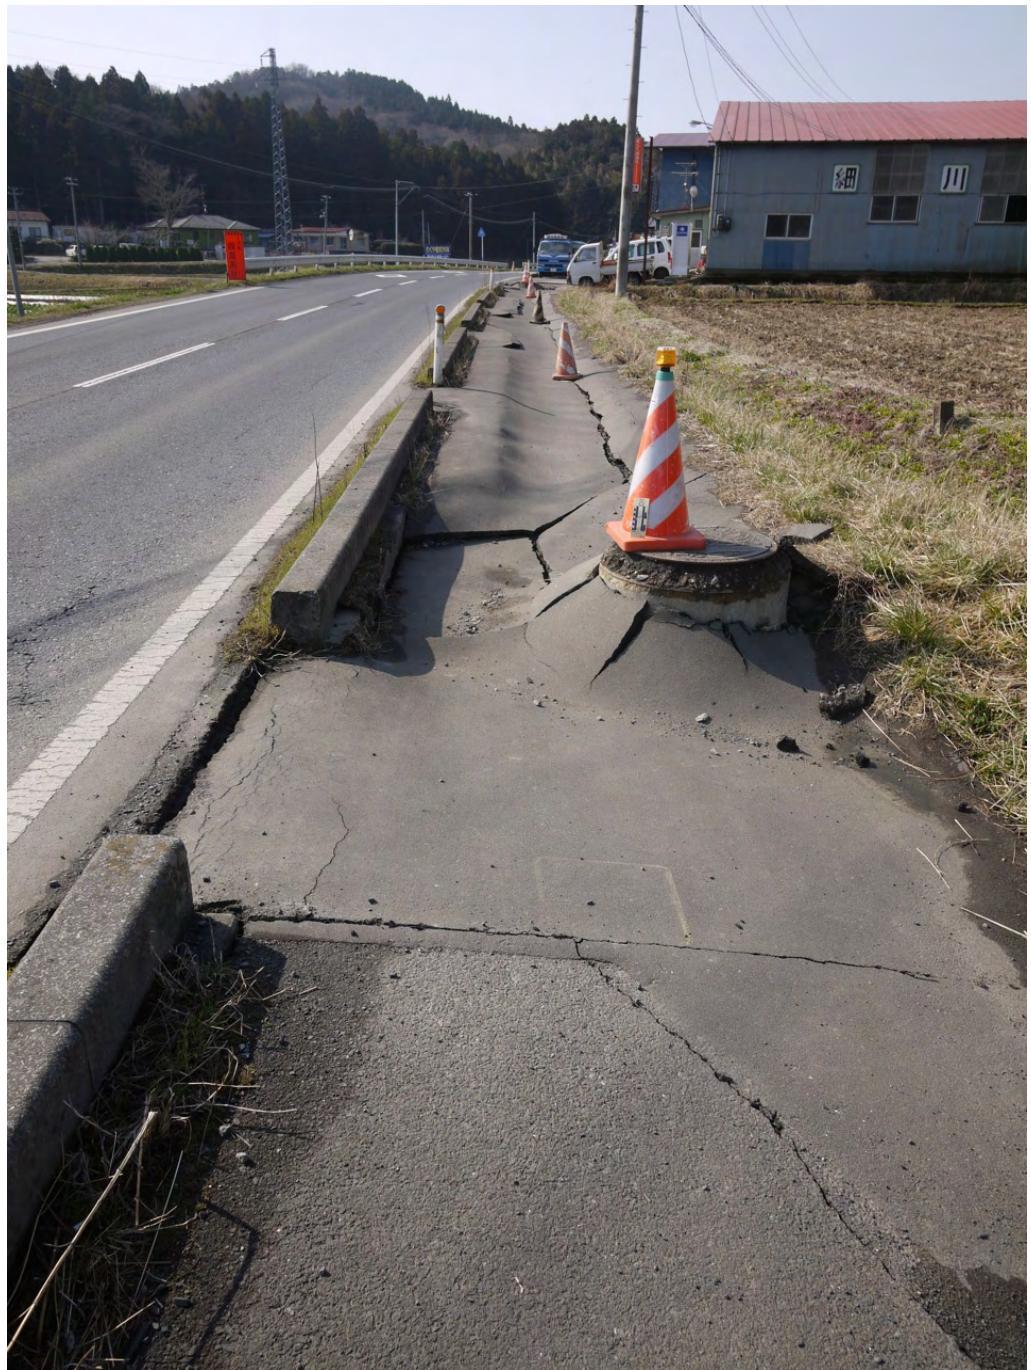
Figure QR6-154: (RK 39) Minor liquefaction features along the country highway at Kubota, Miyagi.

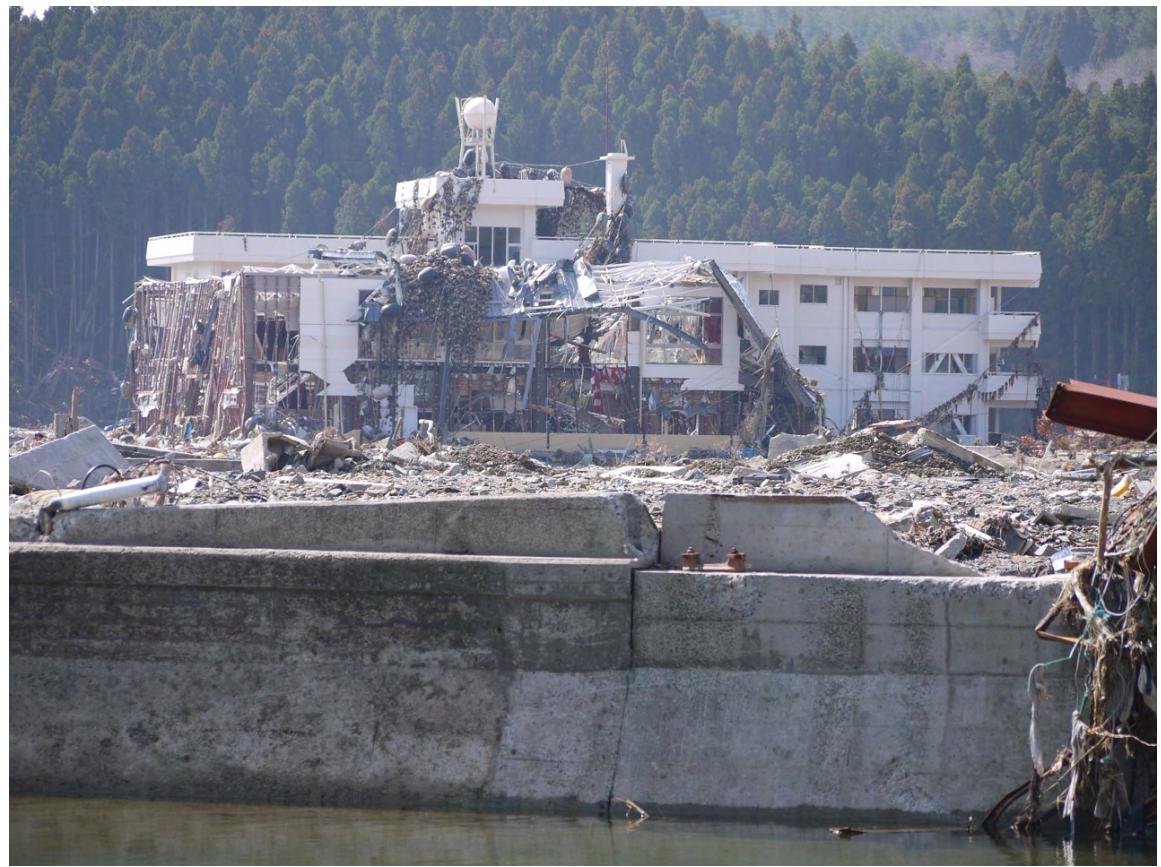
Figure QR6-157: (Site RK41/42) Minamisanriku in some cases 15 m high tsunami debris can be seen on the fourth floor level and rooftops of buildings. No landslides or other geotechnical aspects other than tsunami damage.

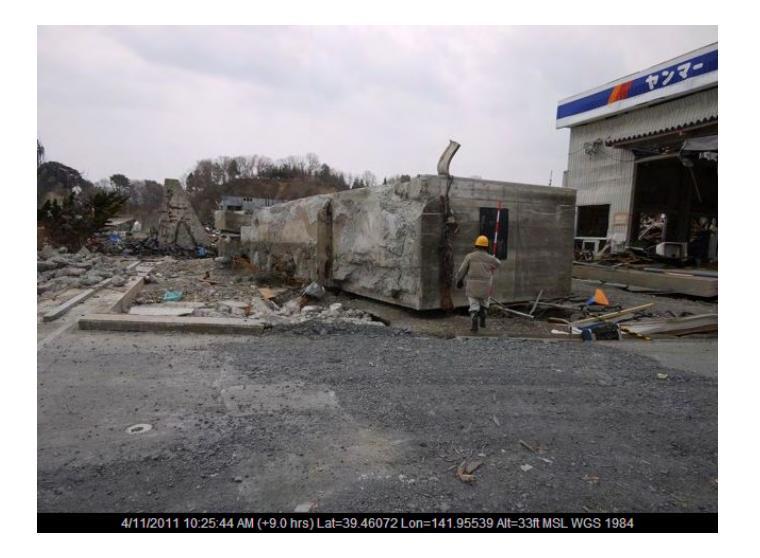
Figure QR6-164: (Site RK47) Yamada-machi - Miyako Town, Iwate Prefecture. Photograph of overturned tsunami seawall with meter stick from tsunami research team. In the central part of the city there was a fire after the tsunami and an unknown number of blocks of buildings were burnt.

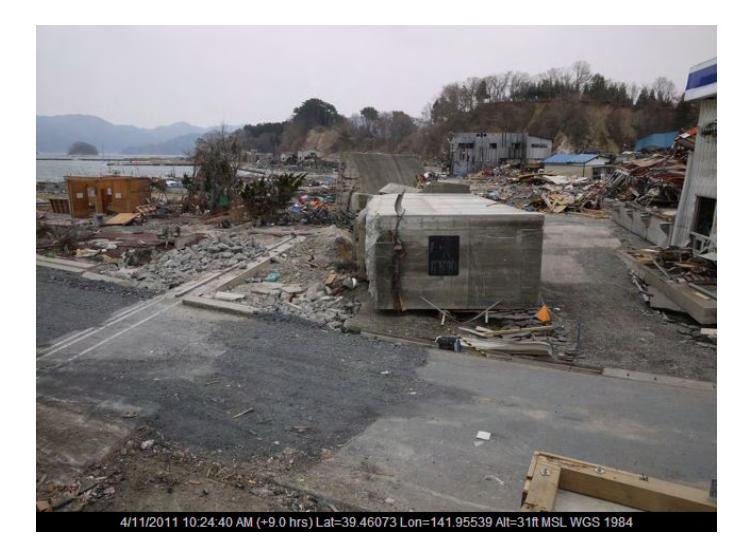
Figure QR6-165: (Site RK47) Yamada-machi - Miyako Town, Iwate Prefecture. Photograph of overturned tsunami seawall with meter stick from tsunami research team. In the central part of the city there was a fire after the tsunami and an unknown number of blocks of buildings were burnt.

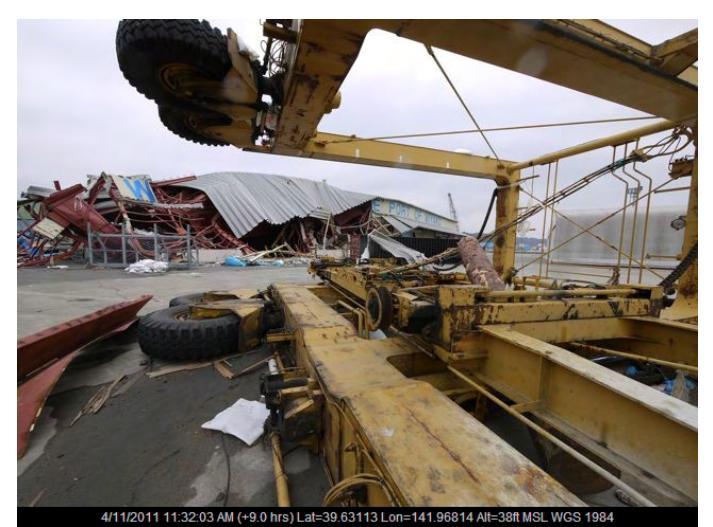
Figure QR6-167: (RK48) - Damage at Port of Miyako, Iwate. Overturned marine container carrier.

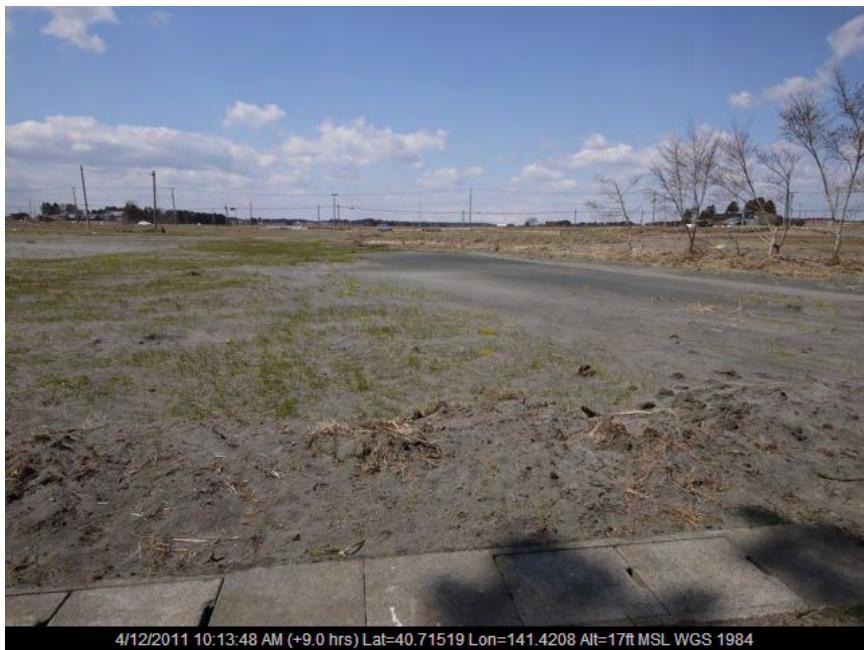
Figure QR6-172: (Site RK51) Tsunami deposits and debris scattered in a field adjacent to beach
