GEOTECHNICAL ENGINEERING RECONNAISSANCE OF THE 30 NOVEMBER 2018 M7.0 ANCHORAGE, ALASKA EARTHQUAKE

Geotechnical Extreme Events Association GEER Report GEER-059 January 2, 2019

GEER Team Co-Leaders: Kevin W. Franke (BYU) and Richard Koehler (UNR)

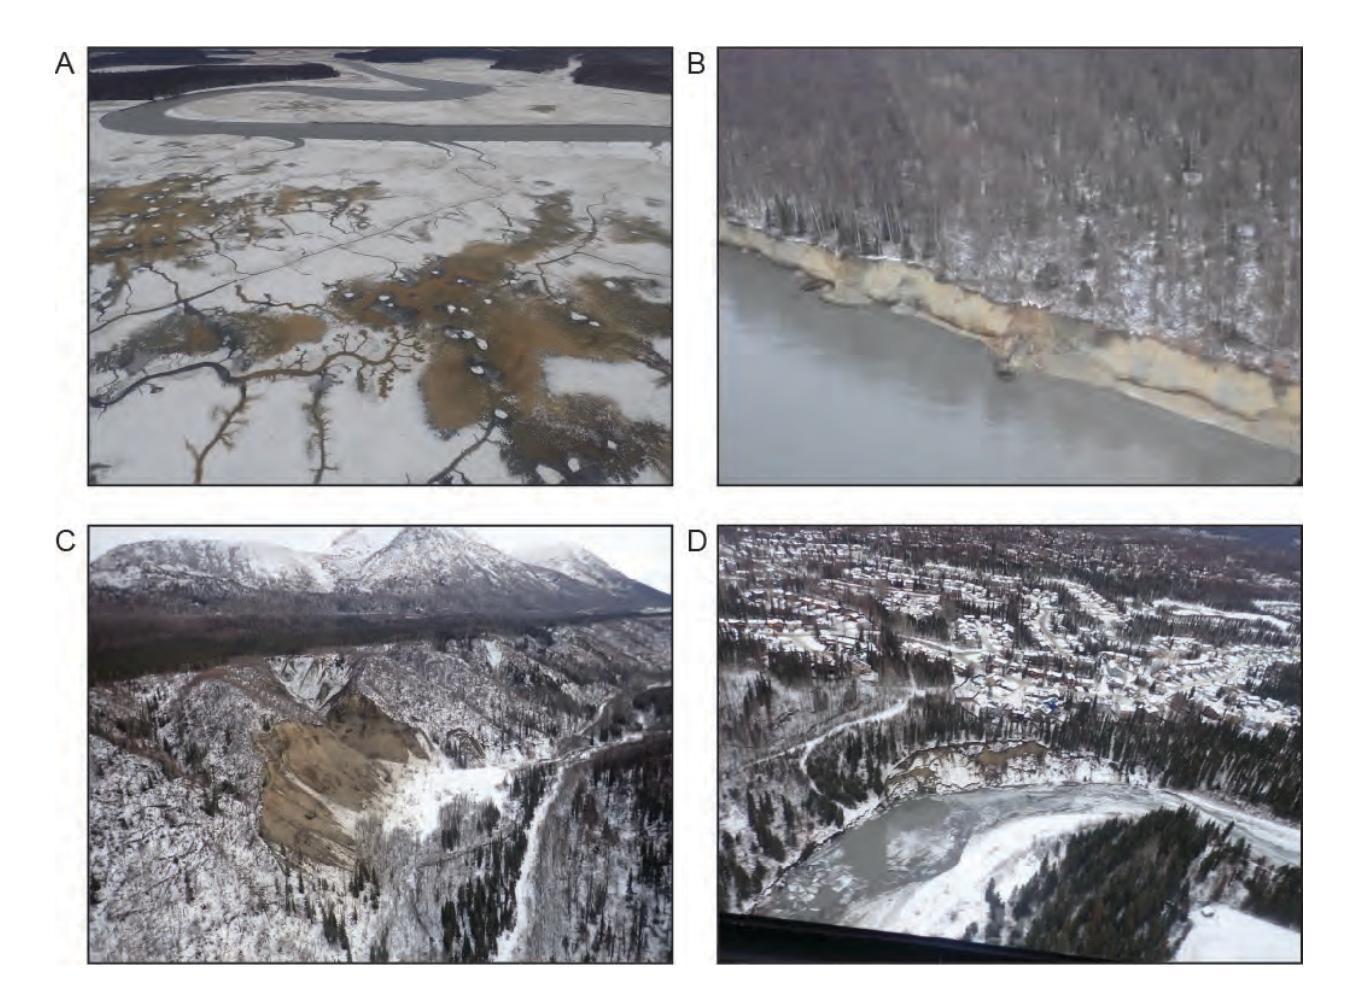
Figure 1-3. (A) Extensive liquefaction and ground cracking along the Little Susitna River floodplain (Lat/Long: 61.2792°, -150.3250°). (B) Mass failures along the Port Mackenzie Bluffs (Lat/Long: 61.4141°, -149.7978°). (C) Mass failure within the Eklutna River valley (Lat/Long: 61.4161°, -149.2062°). (D) Bluff failure along Eagle River (Lat/Long: 61.2972°, -149.5320°). Photos courtesy of Rob Witter.

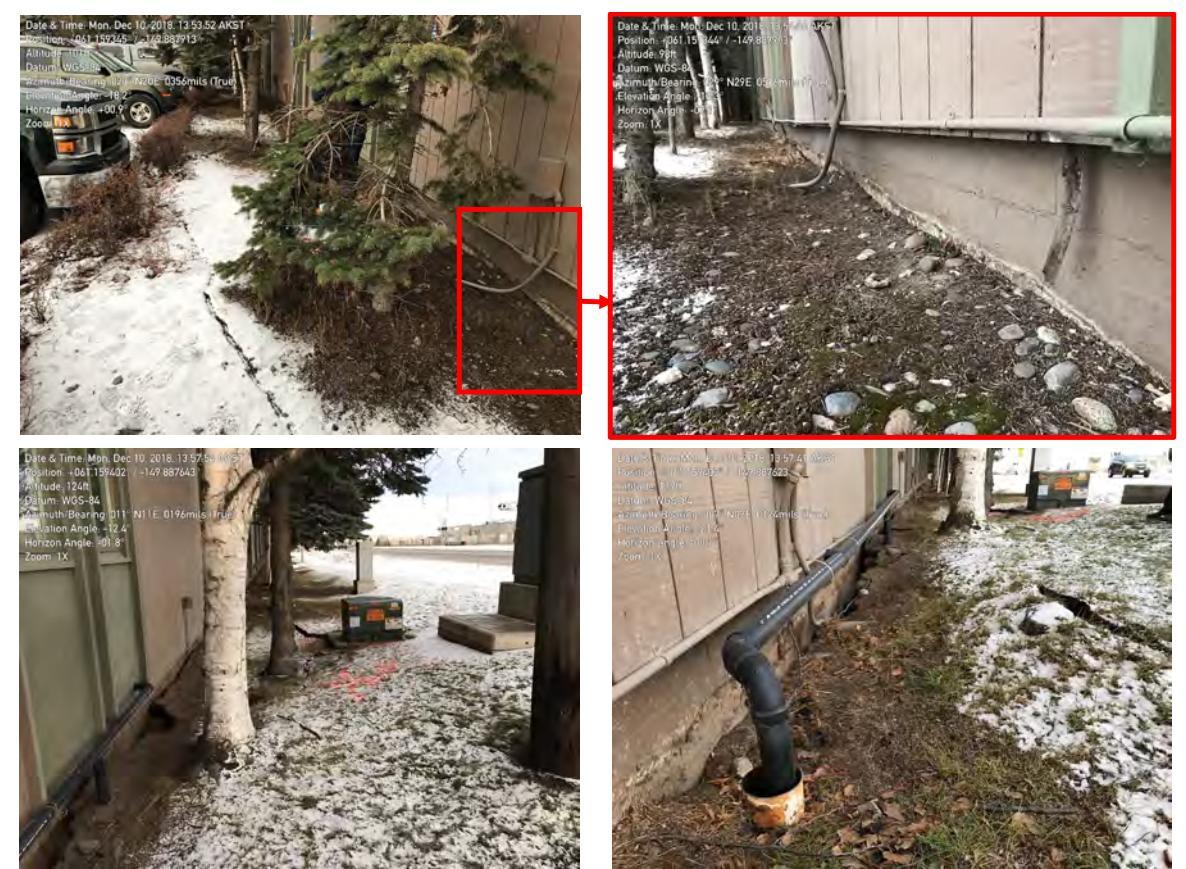
Figure 4-11. Settlement observed near recording station NSMP 8027 (Lat/Long: 61.1609°, - 149.8894°).

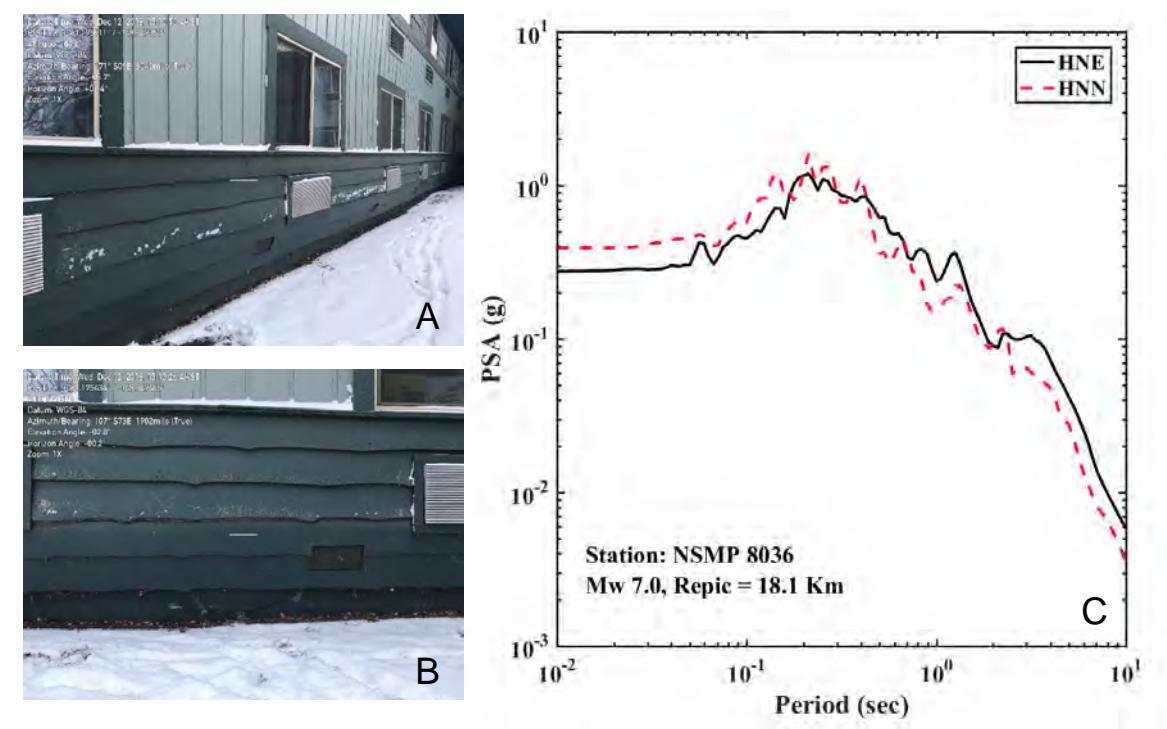
Figure 4-12. Damage observed at the Coast International Inn (Lat/Long: 61.1752°, -149.9475°), A) Shifted walls on the first floor, B) closer view of the deformation, and C) Pseudo-acceleration response spectra (5% damping) for two horizontal components recorded at station 8036 (Lat/Long: 61.1779°, -149.9657°).

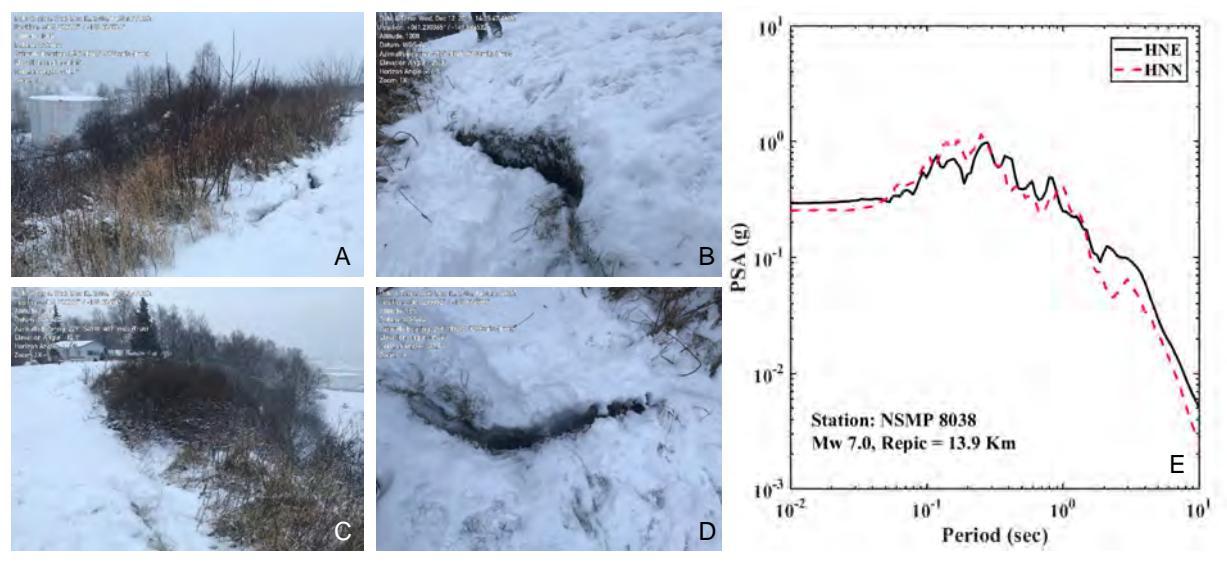
Figure 4-13. Slope failure adjacent to the Port of Alaska (Lat/Long: 61.2304°, -149.8846°); (A through C) an overall view of the slope and port facilities; (B) the 50-cm scarp; (D) a crack at this site with a width of approximately 20 cm; and (E) the pseudo-acceleration response spectra (5% damping) for two horizontal components recorded at the nearby station, NSMP 8038 (Lat/Long: 61.2184°, -149.8829°).

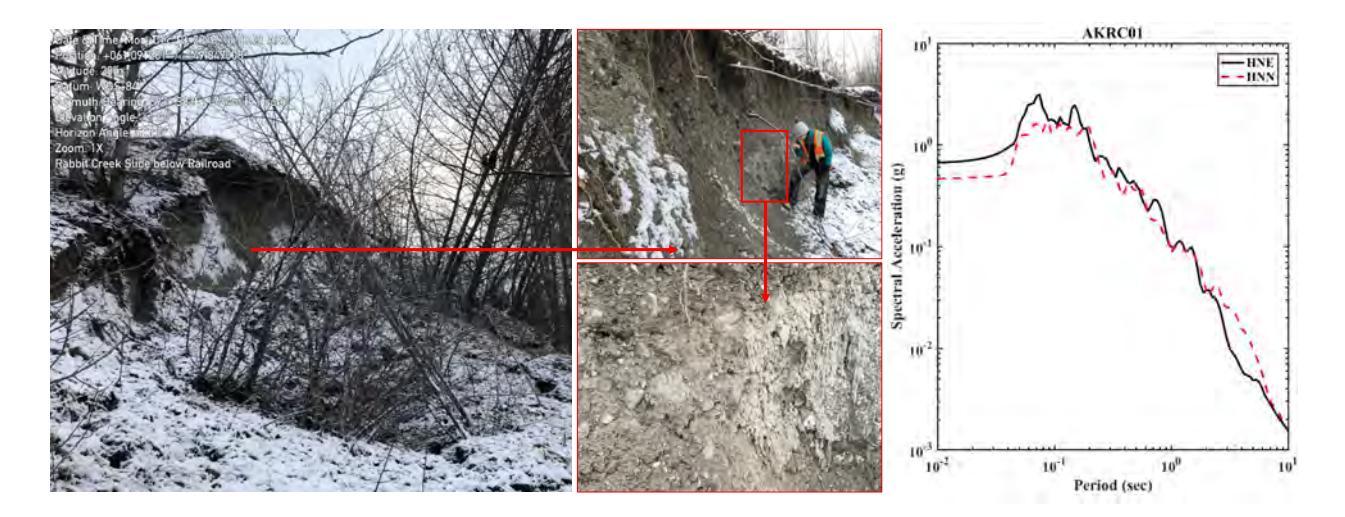
Figure 4-15. Damage observed at Rabbit Creek near the RC01 recording station. Pseudoacceleration response spectra (5% damping) for two horizontal components recorded at station RC01 (Lat/Long: 61.089°, -149.739°).

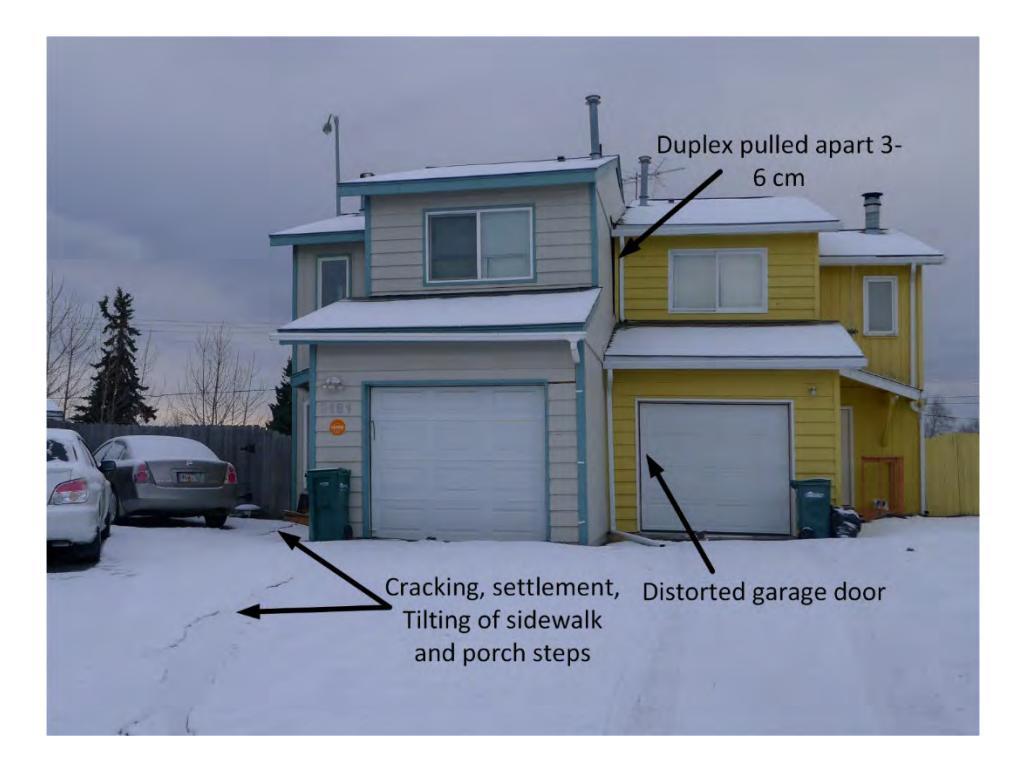
Figure 5-1. Example of the type of localized liquefaction-induced damage observed at many residences in Anchorage. In this example, slight settlement of the home is noted by cracks around the perimeter of fill materials (Lat/Long: 61.134291°, -149.919308°).

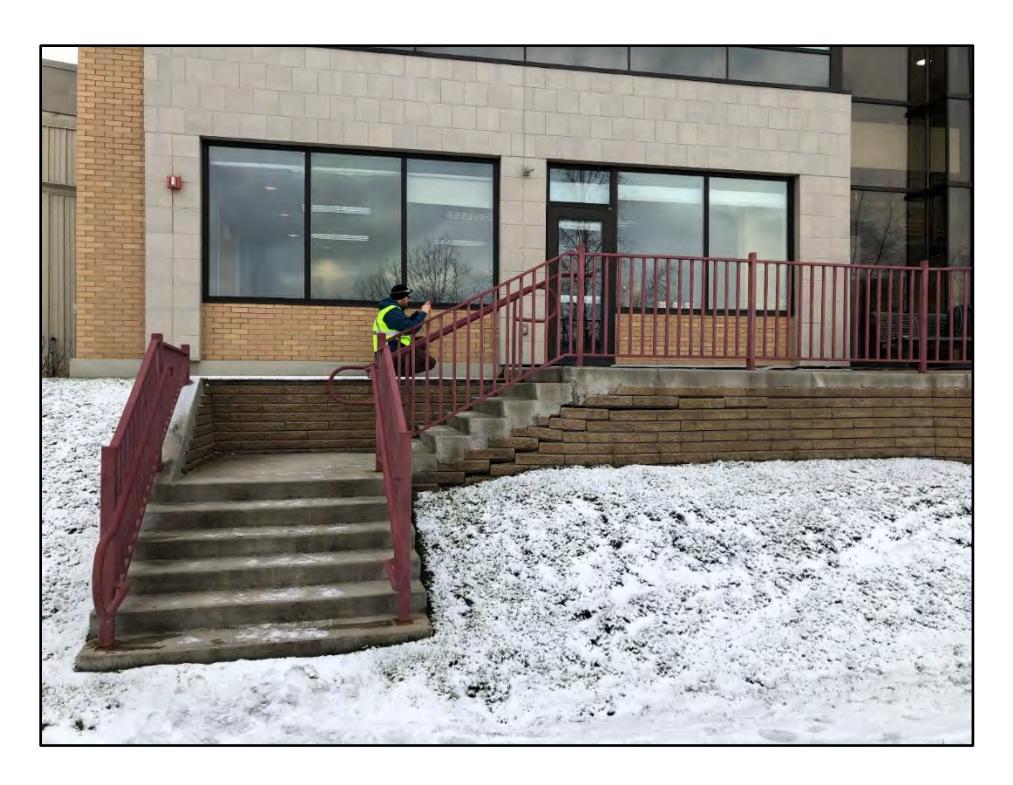
Figure 5-2. 4000 Ambassador Drive - brick deck structure exhibiting settlement and lateral movement (Lat/Long: 61.1826°, -149.8061°).

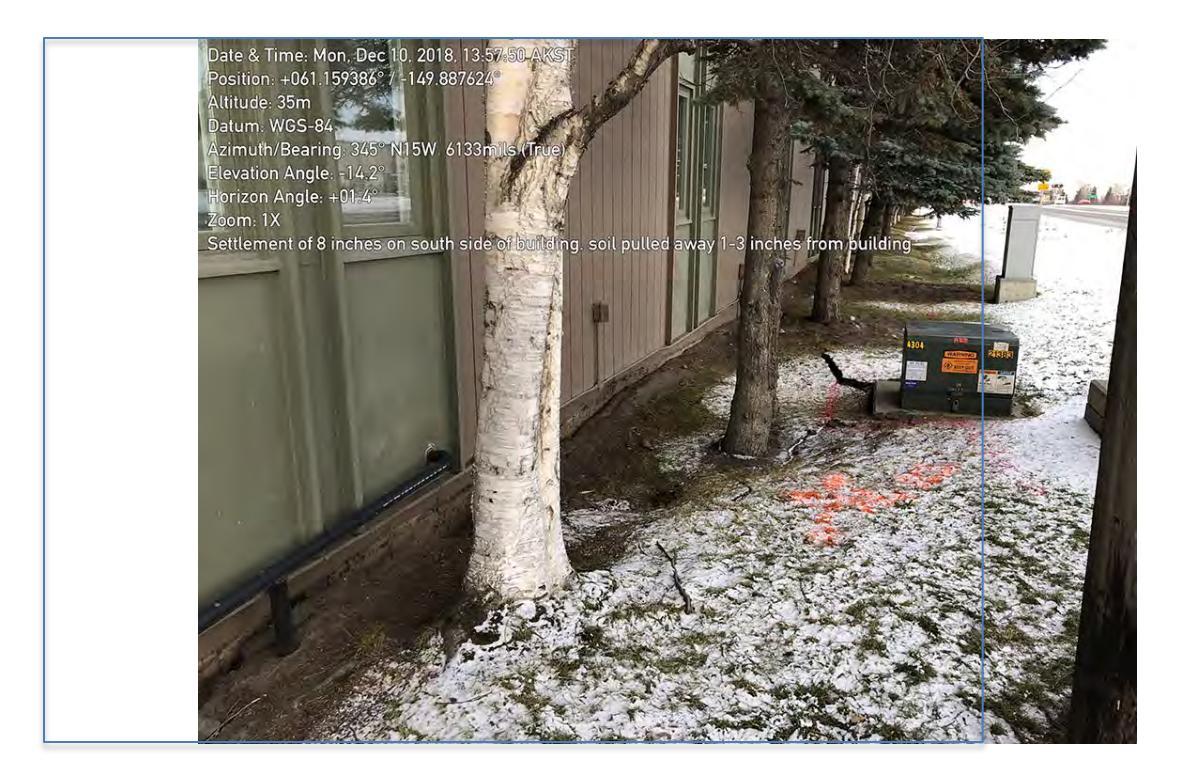
Figure 5-3. Photo of observed settlement at the south wing of the Alaska Department of Fish and Game Building (Lat/Long: 61.1592°, -149.8879°).

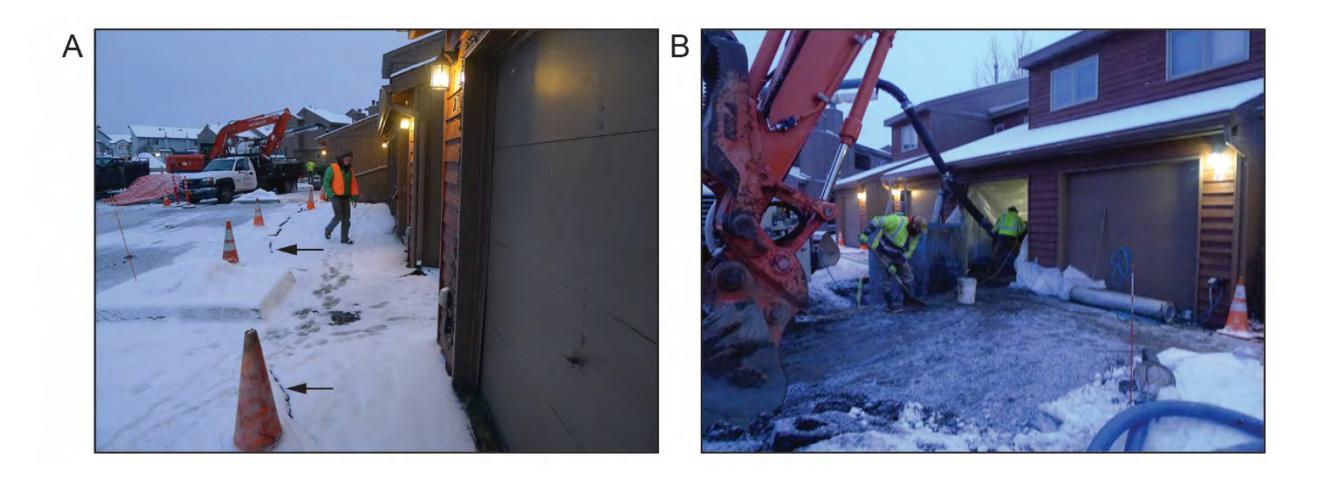
Figure 5-4. Settlement of condominium units along Jamestown Drive, Anchorage (Lat/Long: 61.12951°, -149.84587°). (A) Settlement cracks along the front driveways (black arrows). (B) Repair crews removing backfill materials.

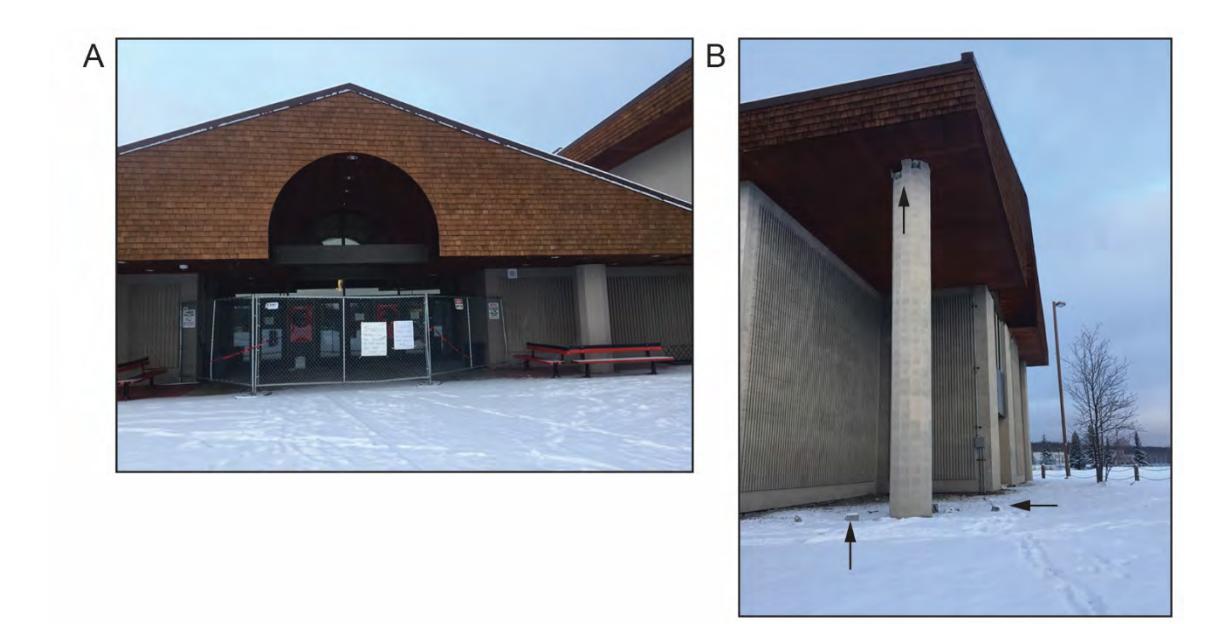
Figure 5-5. Red-tagged Houston Middle School in Houston (Lat/Long: 61.58634°, -149.77191°). (A) Fenced off entrance to the school. (B) Support column along southwest side of school showing displaced facade bricks (black arrows).

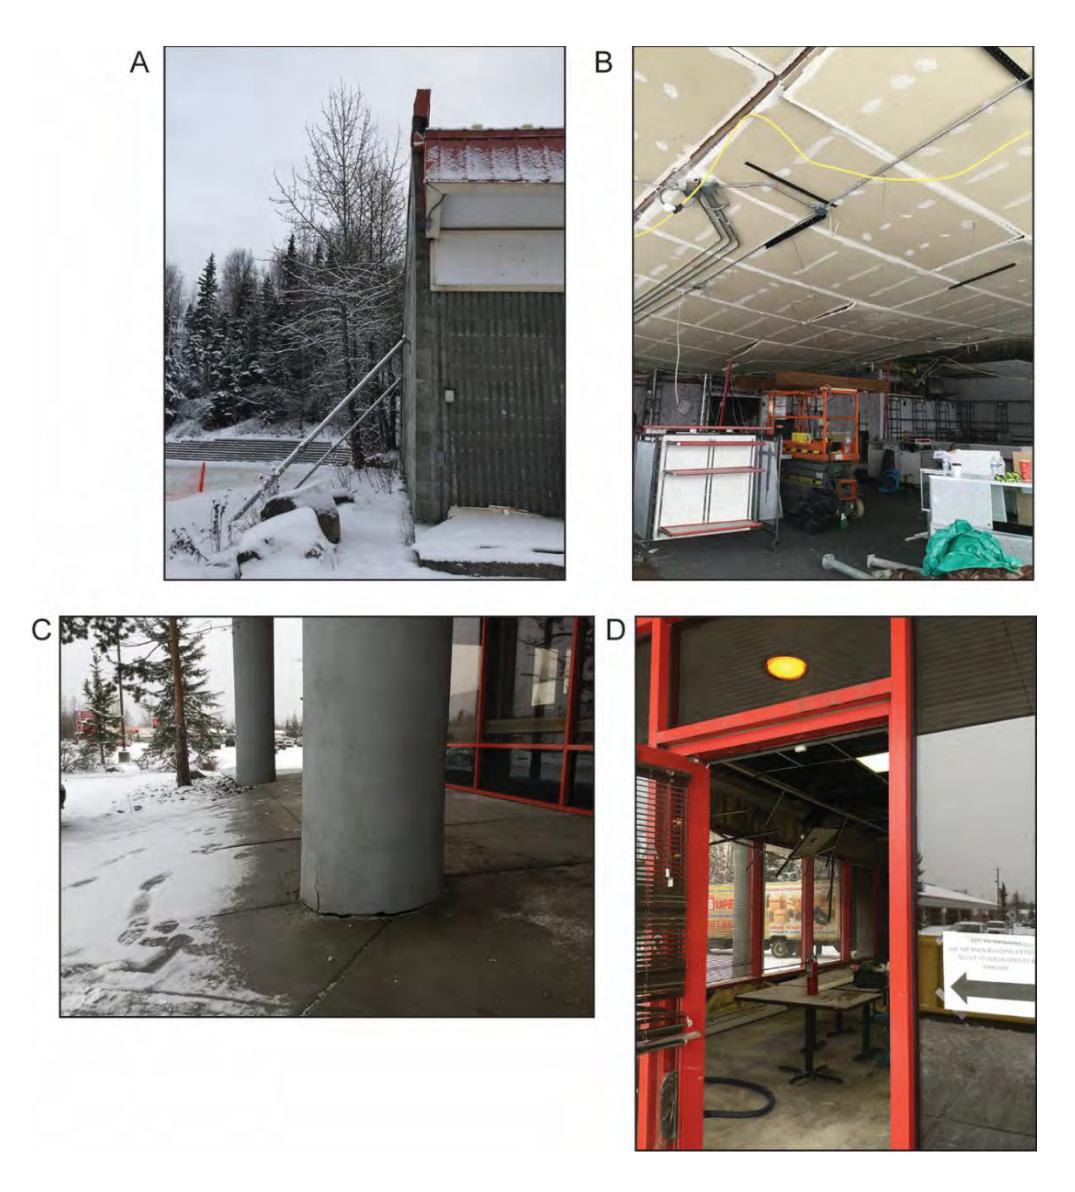
Figure 5-6. Building damage in downtown Eagle River. (A) bowing of the cinder block walls of the Eagle River pawn shop (Lat/Long: 61.33401°, -149.56367°), (B) partial collapse of the ceiling in the Eagle River pawn shop (Lat/Long: 61.33401°, -149.56367°), (C) sheared and cracked columns in the Garcias Cantina building (Lat/Long: 61.32774°, -149.57280°), and (D) water damage and ceiling tile failure in the Garcias Cantina building (Lat/Long: 61.32774°, -149.57280°).

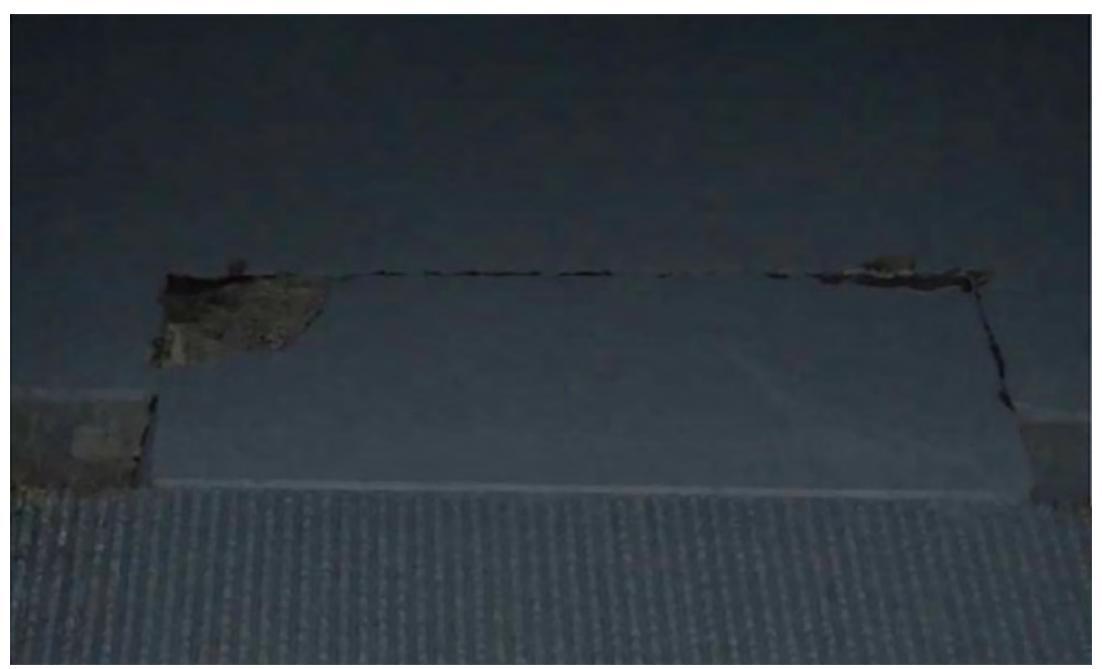
Figure 5-14. West Dowling Road Bridge – Spalling of concrete along shear key at abutments (courtesy of Dave Hemstreet, AKDOT).

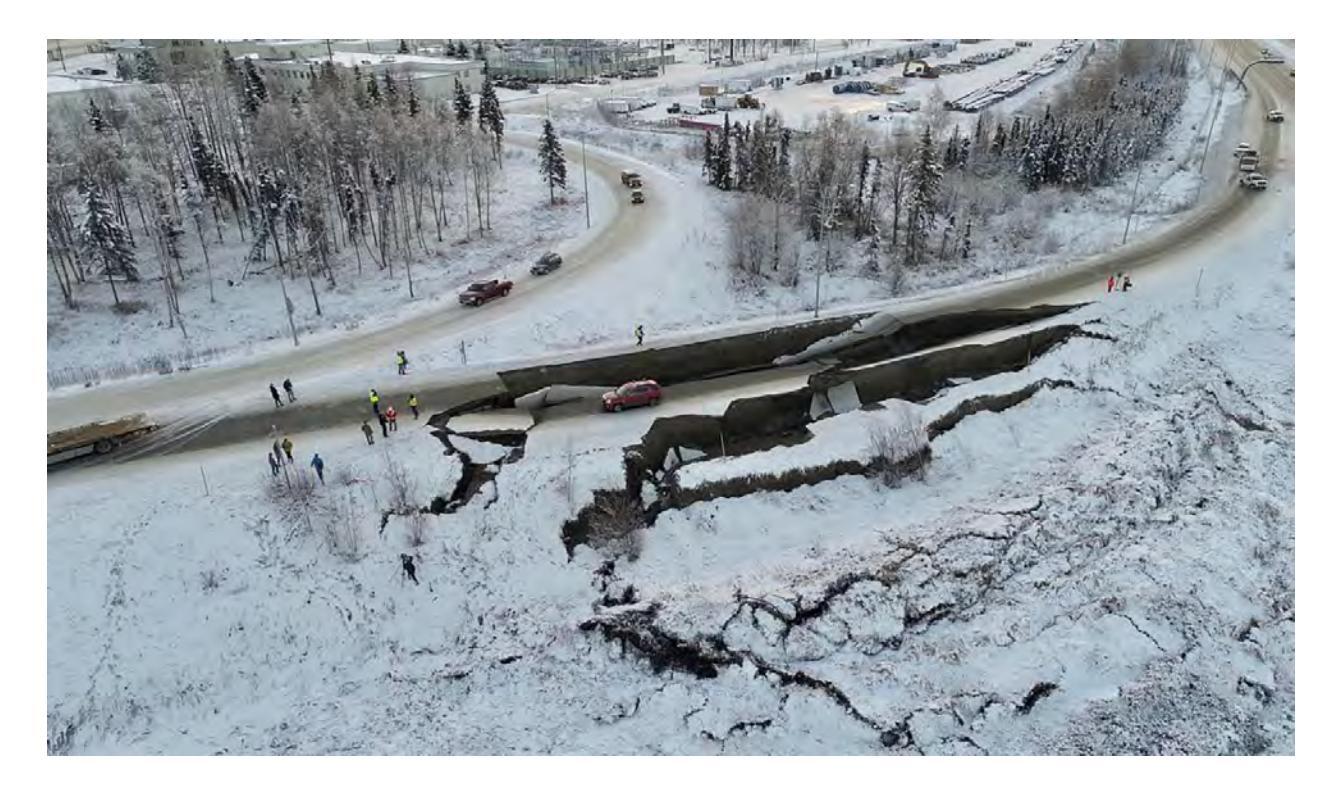
Figure 5-30. Aerial image of the Minnesota Boulevard embankment failure (Lat/Long: 61.171279°, -149.915547°). Photo source: Ryan Marlow, Alaska Aerial Media.

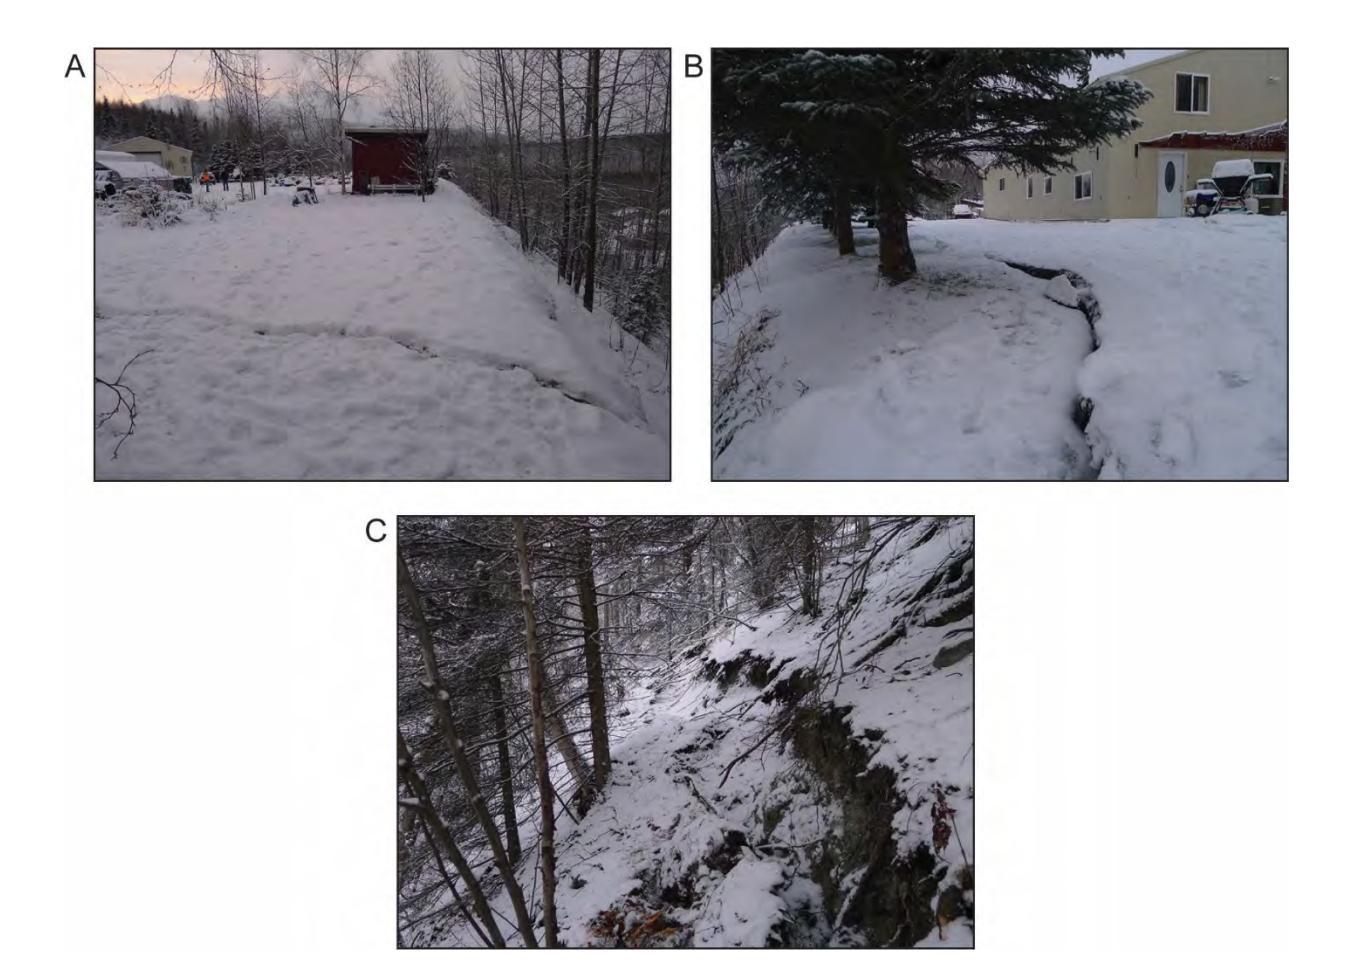
Figure 5-31. Field photographs of the Rivers View condominiums landslide in Eagle River. Cracks at the crest of the slope extend for 325 feet from the north (A) to the south (B) part of a flat graded residential property (Lat/Long: 61.312065°, -149.570379°). The cracks are up to 3 inches wide and 4 feet deep. The cracks extend down the slope and intersect the headscarp of a small landslide (C) at the base of the slope (Lat/Long: 61.312346°, -149.571359°) that is associated with a 3 to 5 foot high headscarp. This slide impacted residences in the Rivers View condominiums.

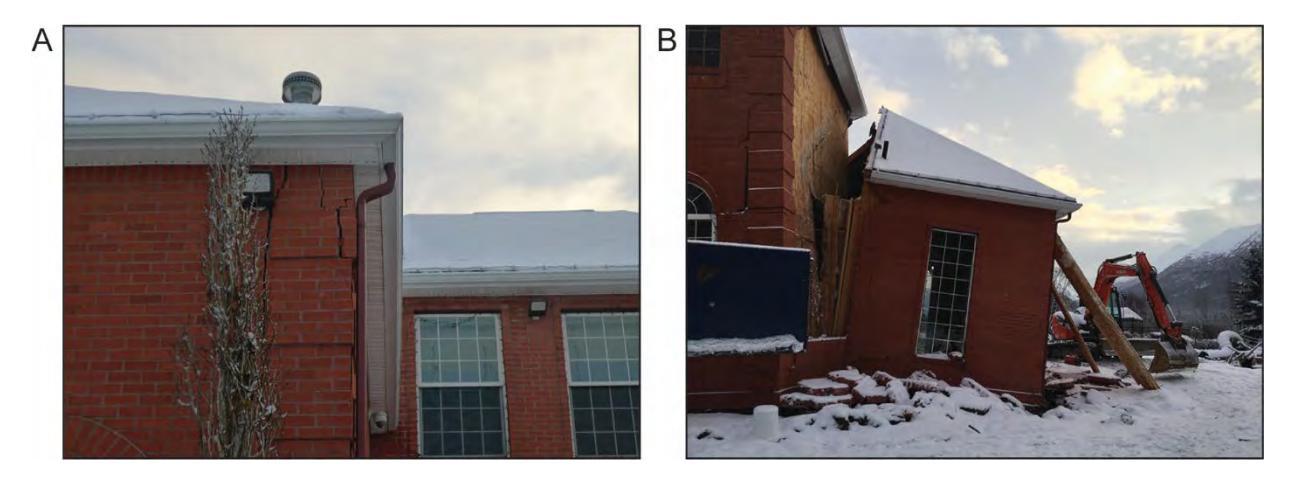
Figure 5-32. Damage to residence in the Ptarmagin Drive area of Eagle River (Lat/Long: 61.30494°, -149.49582°). Extensive facade cracking (A) and fill failure related tilting of a room associated with complete facade brick failure (B).

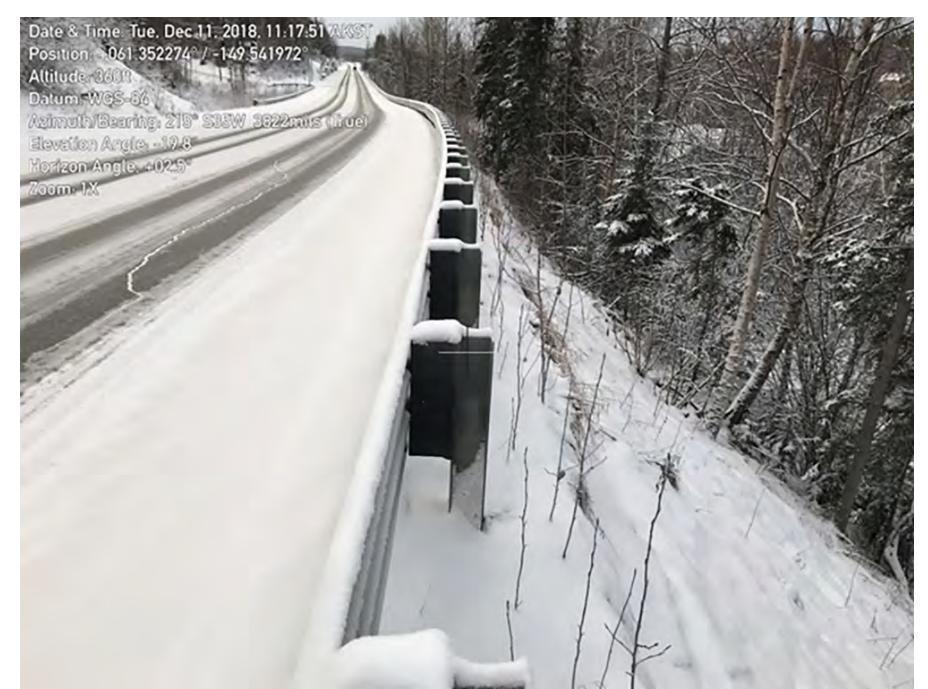
Figure 5-34. View of Old Glenn Highway from (Lat/Long: 61.352274°, 149.541972°) on 11 December 2018, looking southwest, indicating steep slope on the right with evidence of long-term slope movements (e.g., leaning trees) and longitudinal crack on the left.

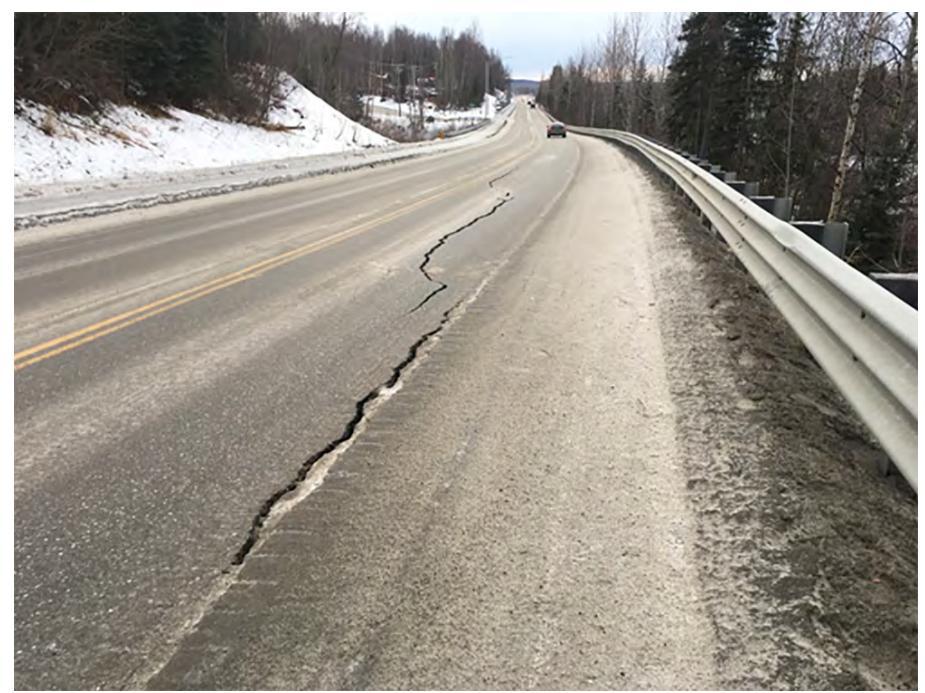
Figure 5-35. View of Old Glenn Highway from (Lat/Long: 61.35229°, -149.54193°) on 5 December 2018, looking southwest, indicating longitudinal crack in the foreground (photo courtesy of Dave Hemstreet, AKDOT).

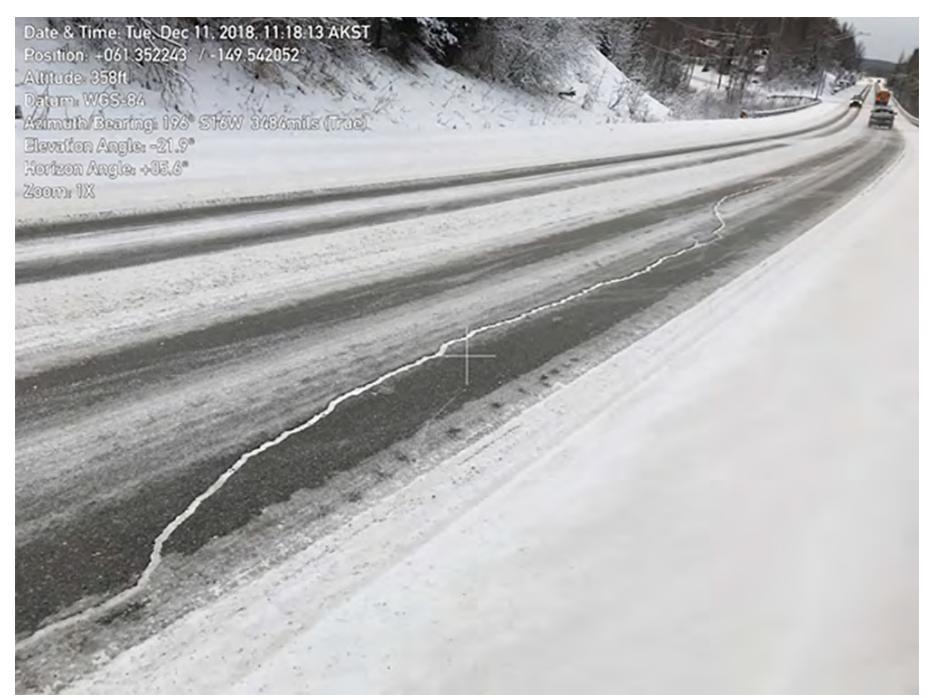
Figure 5-36. View of Old Glenn Highway from (Lat/Long: 61.352243°, 149.542052°) on 11 December 2018, looking south, indicating the longitudinal crack (corresponding to distance 32 m, see Figure 5-35) where settlement was noted.

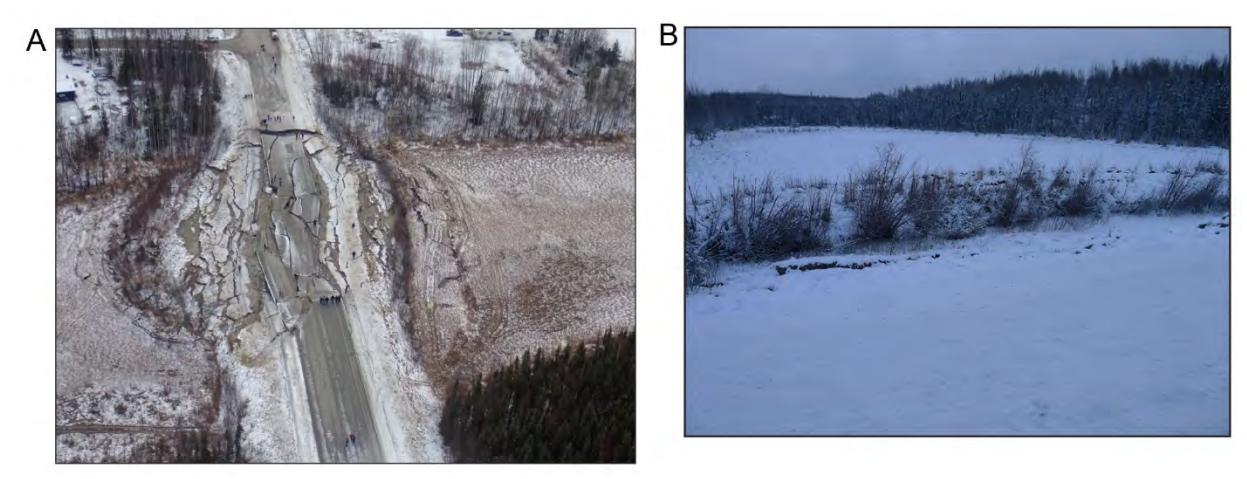
Figure 5-38. Damage to Vine Road (Lat/Long: 61.56863°, -149.60215°) south of Wasilla. (A) Aerial photograph of the road after the earthquake taken by Rob Witter (USGS) during helicopter reconnaissance. (B) ground photograph of pressure ridges (peat mounds) west of the road formed by lateral motion of the road fill. Note back-tilted trees.

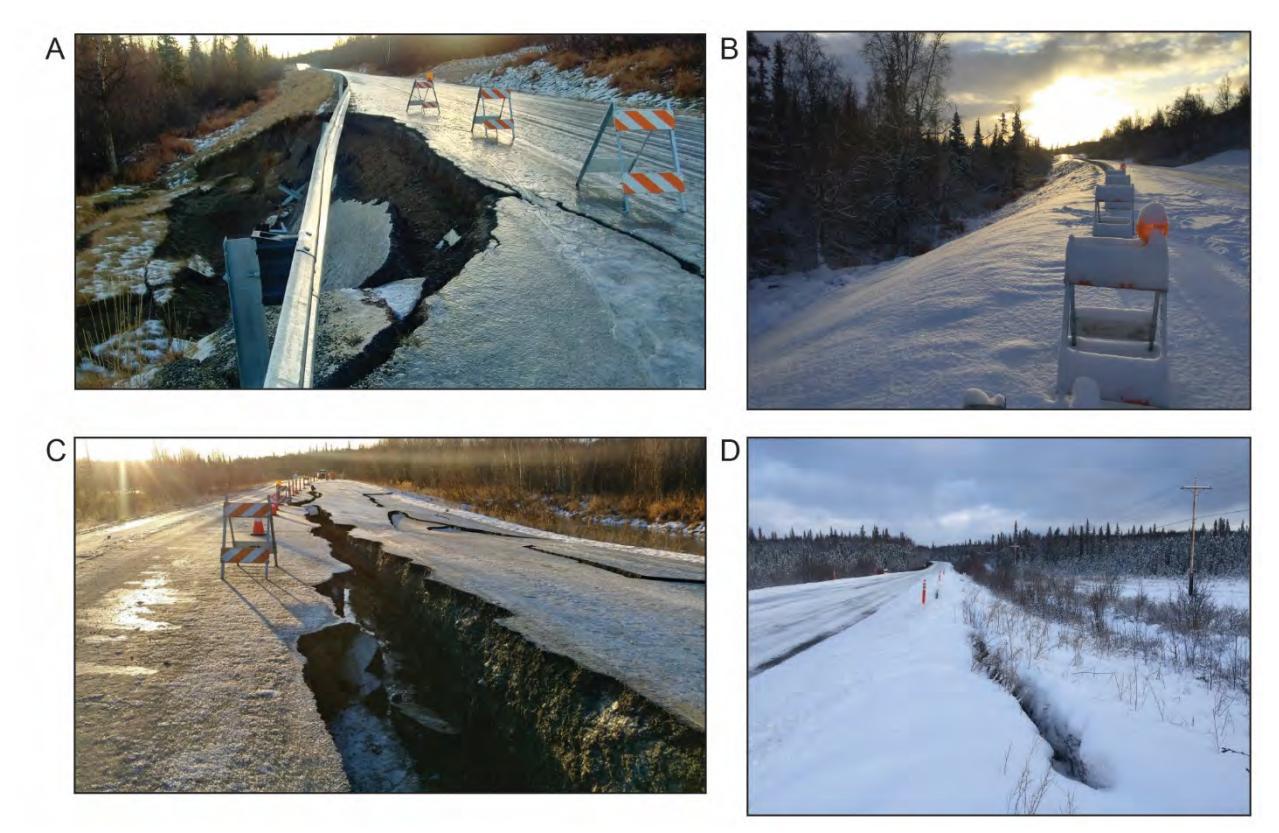
Figure 5-39. Road failure along the Port Mackenzie industrial area access road (Lou Young Road, Lat/Long: 61.28176°, -149.93002°) before (A) and after (B) repair. Road failure at mile 15.5 of the Port Mackenzie Road (Lat/Long: 61.31582°, -150.02627°) before (C) and after (D) repair. Pre-snow photographs provided by Bob Walden of Mat-Su Borough.

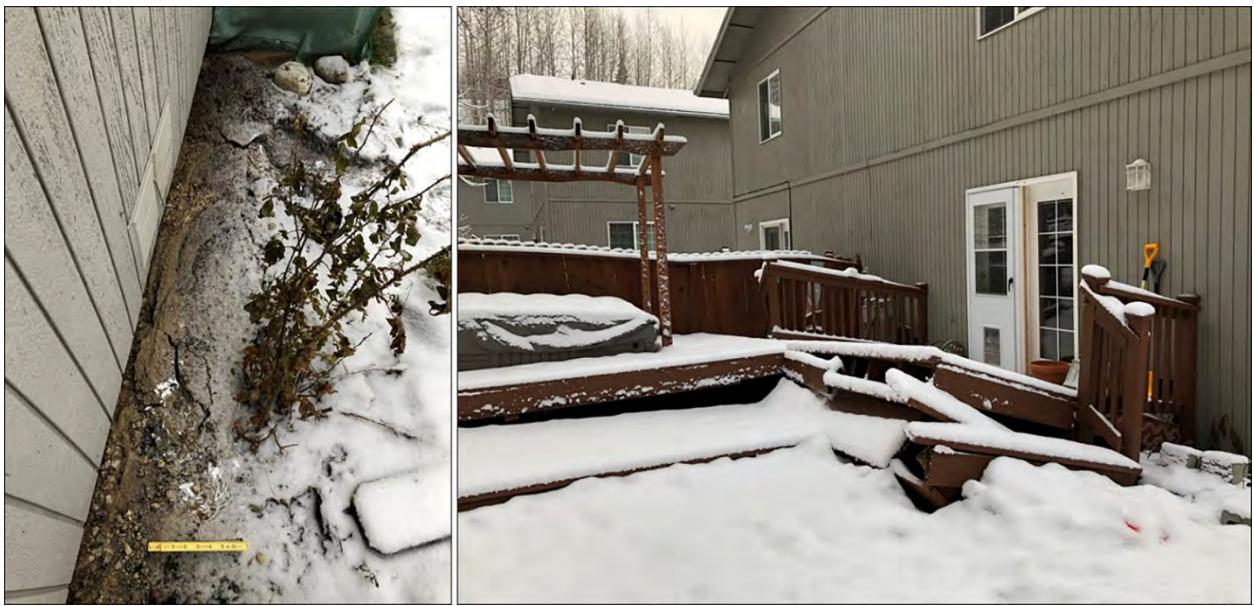
Figure 5-40. (Left) Ejecta observed at red-tagged home (Lat/Long: 61.3121°, -149.5714°), (Right) Backyard damage at another red-tagged home (Lat/Long: 61.3121°, -149.5721°).

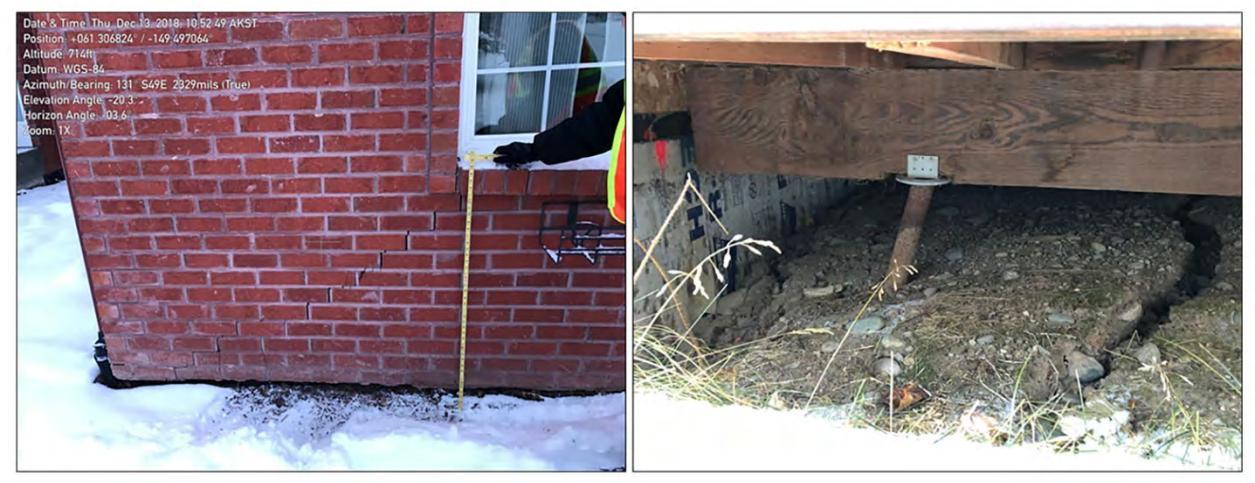
Figure 5-41. Ptarmigan settlement (left) and ground failure (right) (Lat/Long: 61.3067°, - 149.4968°).

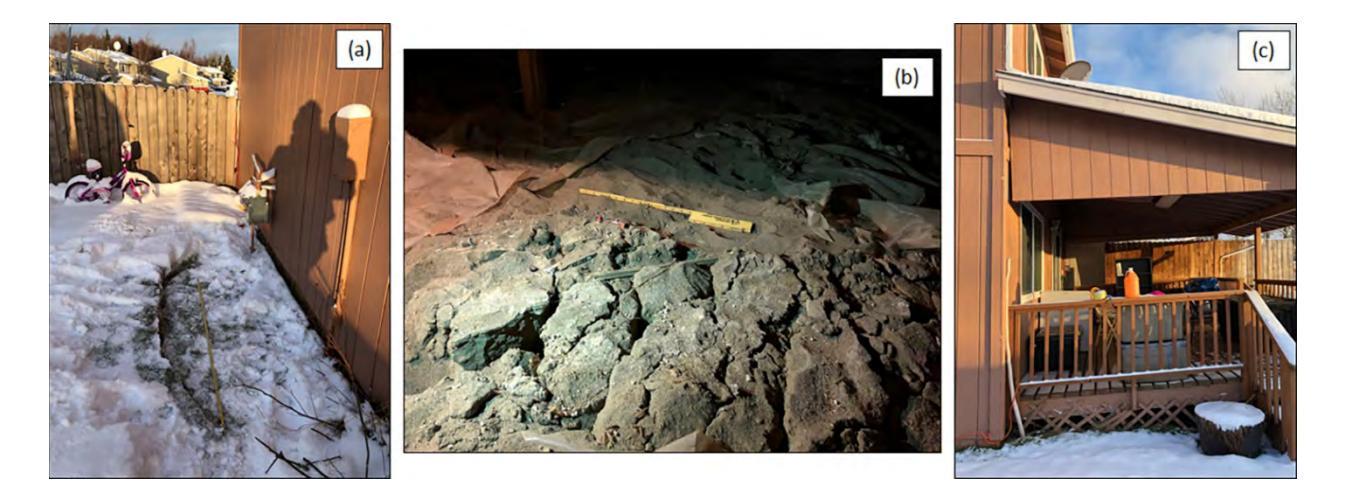
Figure 5-42. Jewel Lake residential damage: (a) settlement along foundation perimeter, (b) ground failure and possible ejecta in crawl space under the home, (c) settlement relative to back porch. (Lat/Long: 61.1380°, -149.9380°).

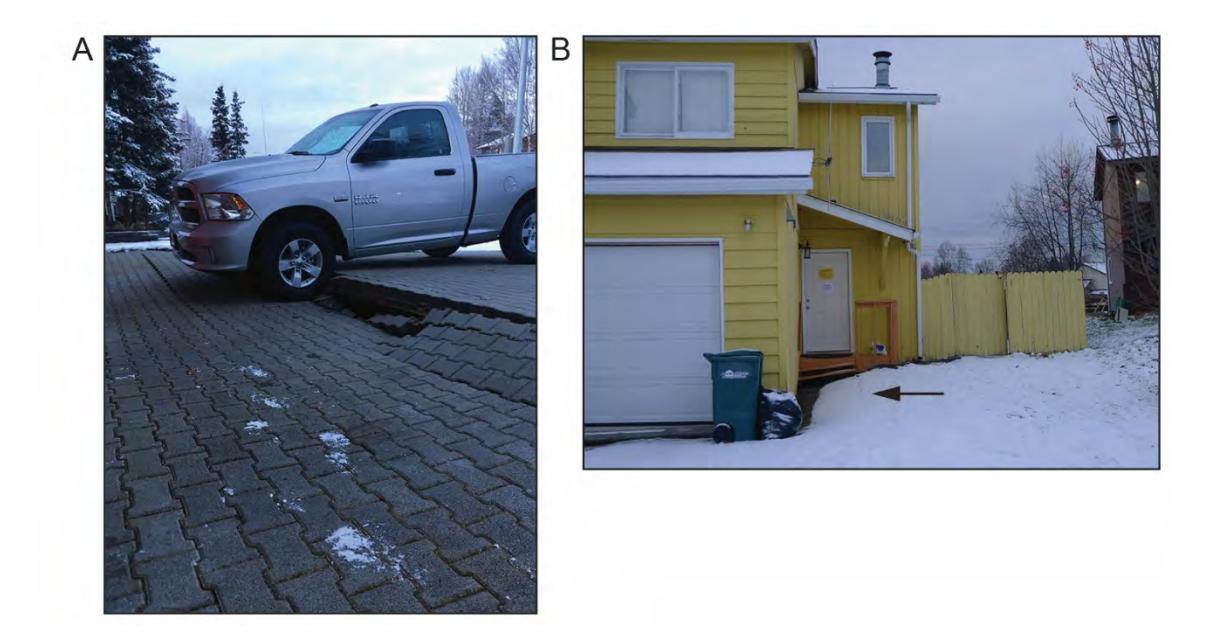
Figure 5-43. Typical foundation settlement damage in the Campbell Lake area of south Anchorage. (A) Drive way settlement (Lat/Long: 61.13337, -149.93126). (B) Duplex settlement along arrow (Lat/Long: 61.13794°, -149.9380°). Settlement was about 1 foot at each site.

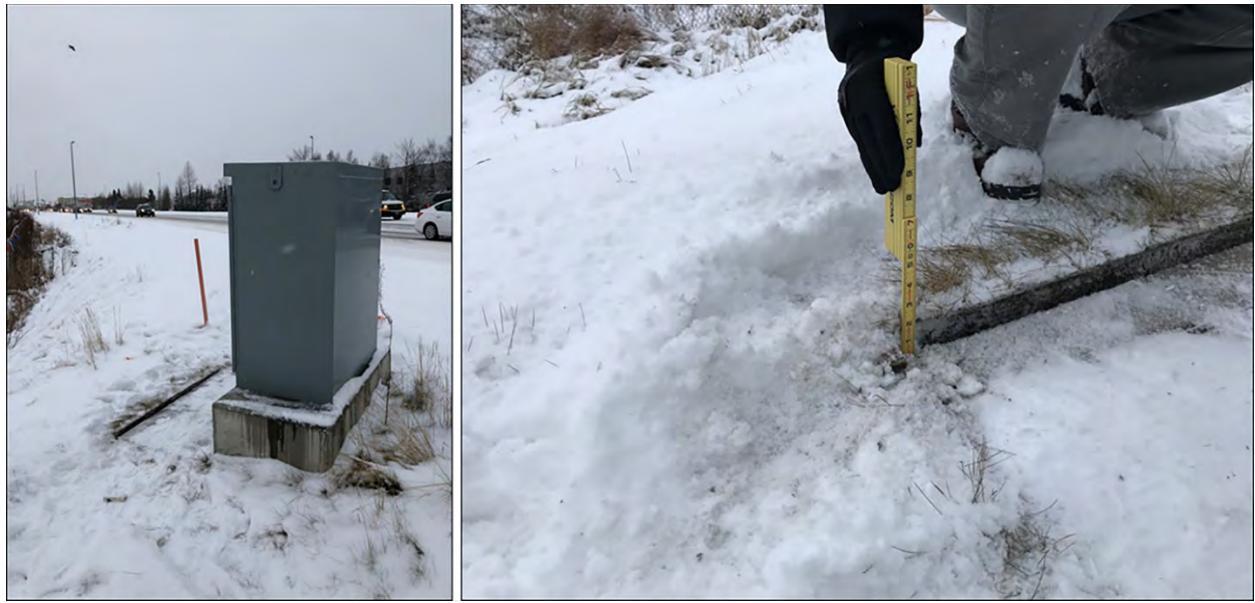
Figure 5-44. C Street & Dowling Road Intersection - settlement at electrical junction box (Lat/Long: 61.1670°, -149.8870°).
