GEOTECHNICAL ENGINEERING RECONNAISSANCE OF THE 30 NOVEMBER 2018 M7.0 ANCHORAGE, ALASKA EARTHQUAKE

Geotechnical Extreme Events Association GEER Report GEER-059 January 2, 2019

GEER Team Co-Leaders: Kevin W. Franke (BYU) and Richard Koehler (UNR)

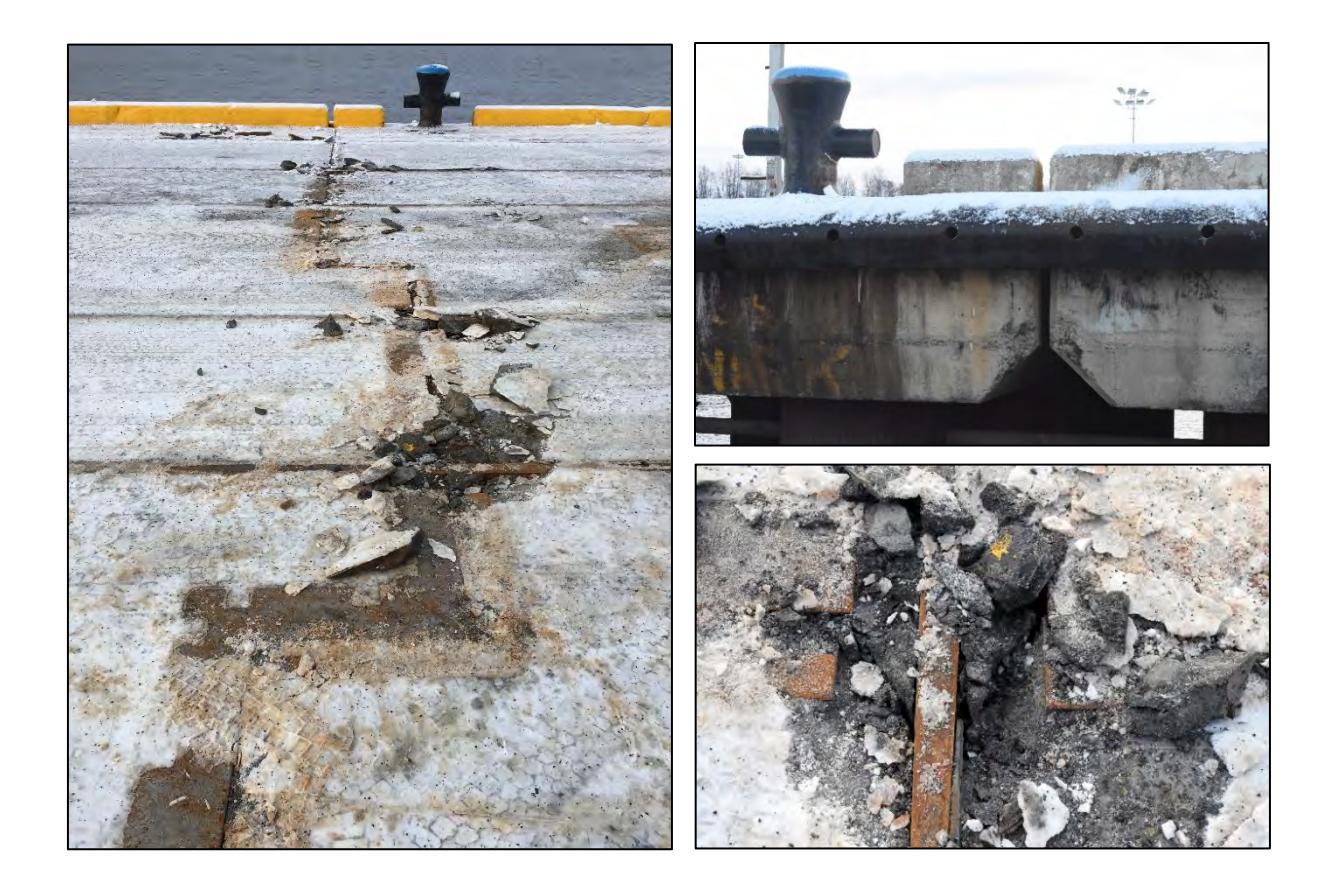
Figure 6-14. Port of Alaska – Evidence of pounding at the transition from Terminals 1 and 2, with spalling at the top and sides of the concrete apron (right) on 30 November 2018 (photographs courtesy of Jim Jager, PoA)

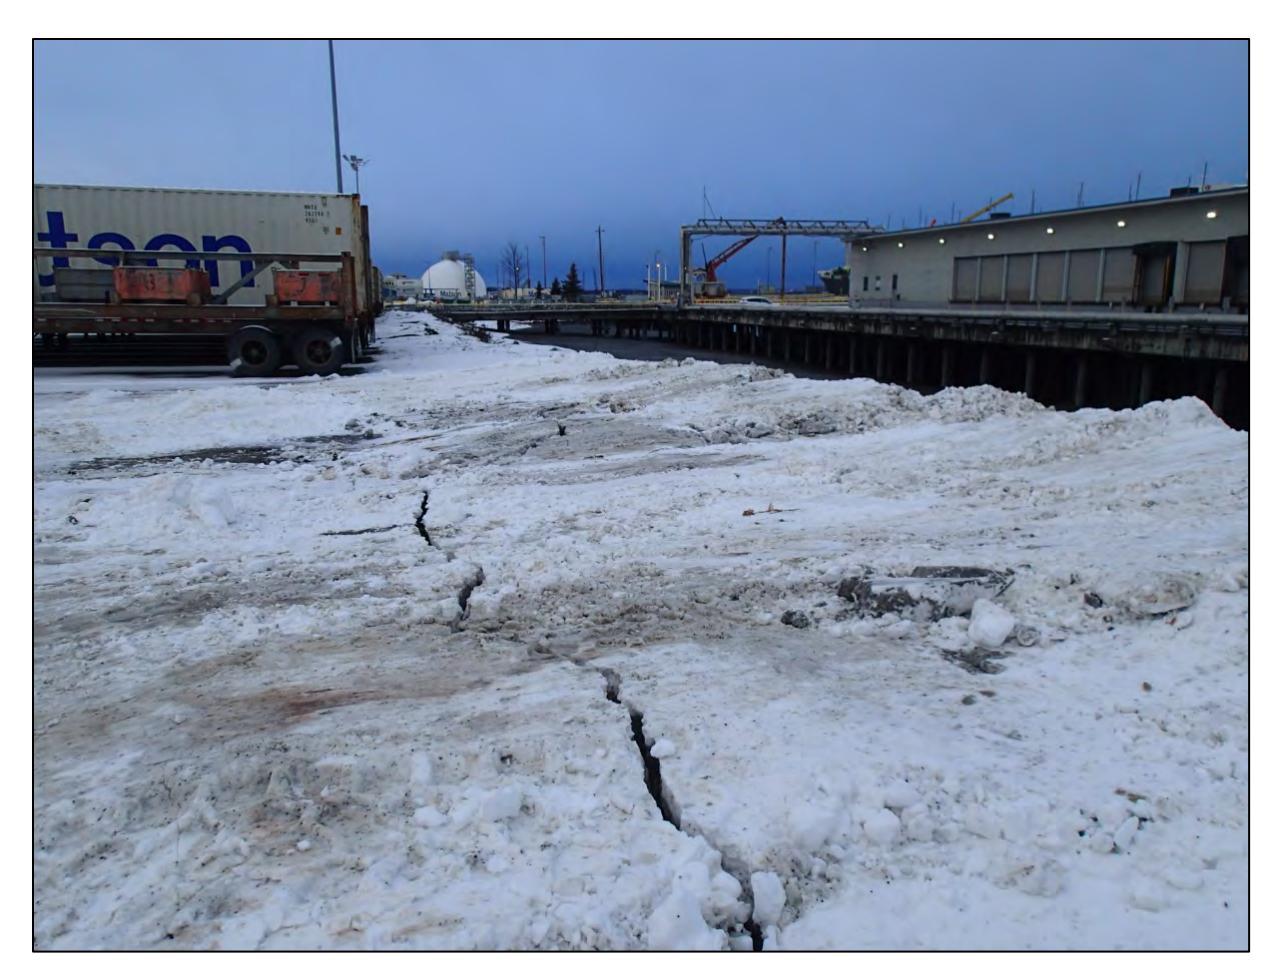
Figure 6-19. Port of Alaska – Transit Yard A: Tension cracks across from Administration Building on 31 November 2018 (Viewing South). (Photographs courtesy of John Daley, R&M Consulting)

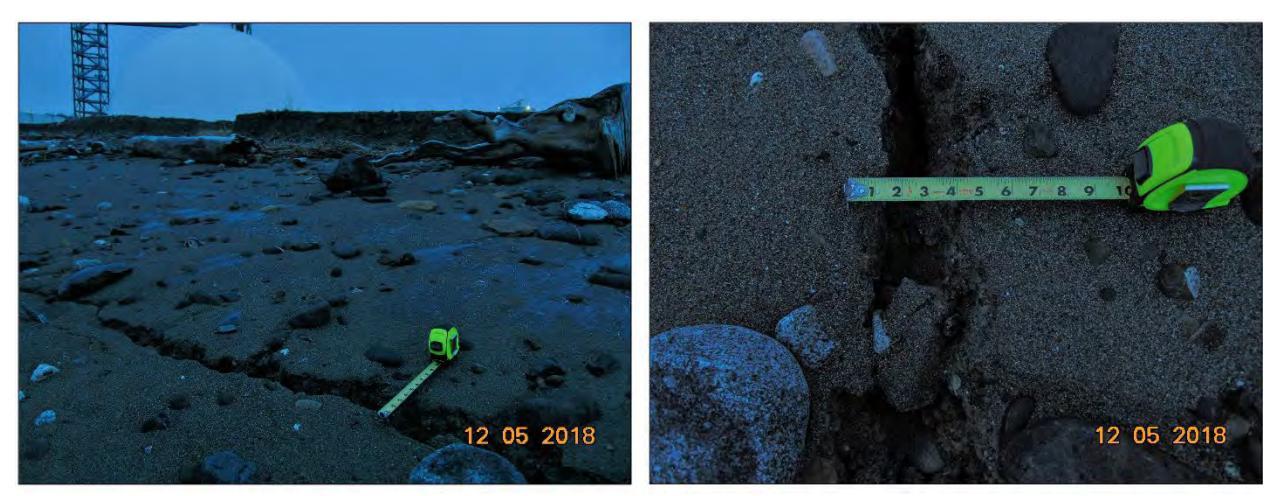
Figure 6-28. Port of Alaska – Tension Cracks on PCT Shoreline South of Cement Dome

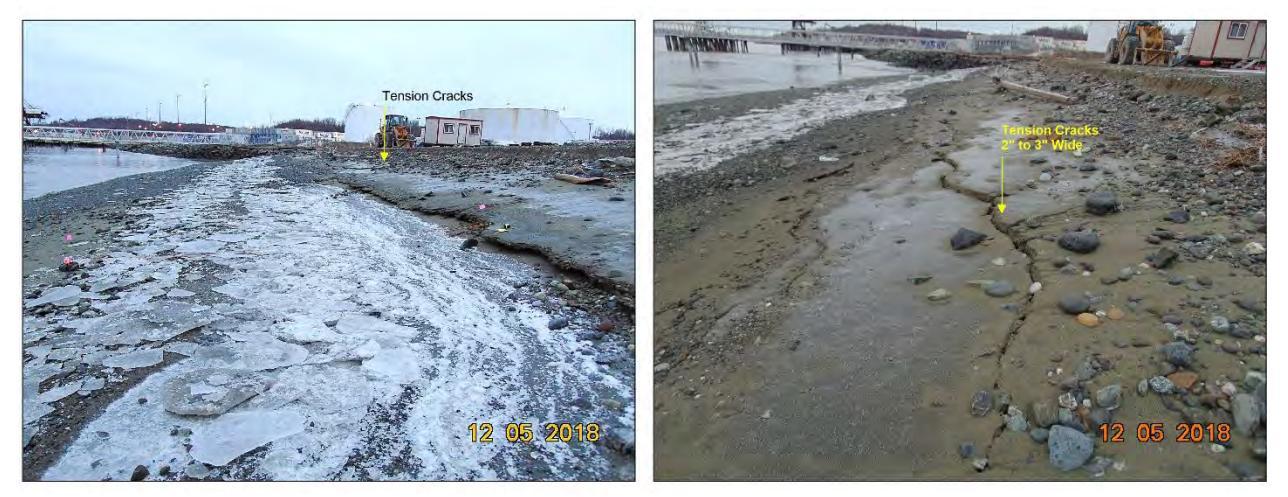
Figure 6-29. Port of Alaska – PCT Shoreline Tension Cracks (Viewing North of DSM)

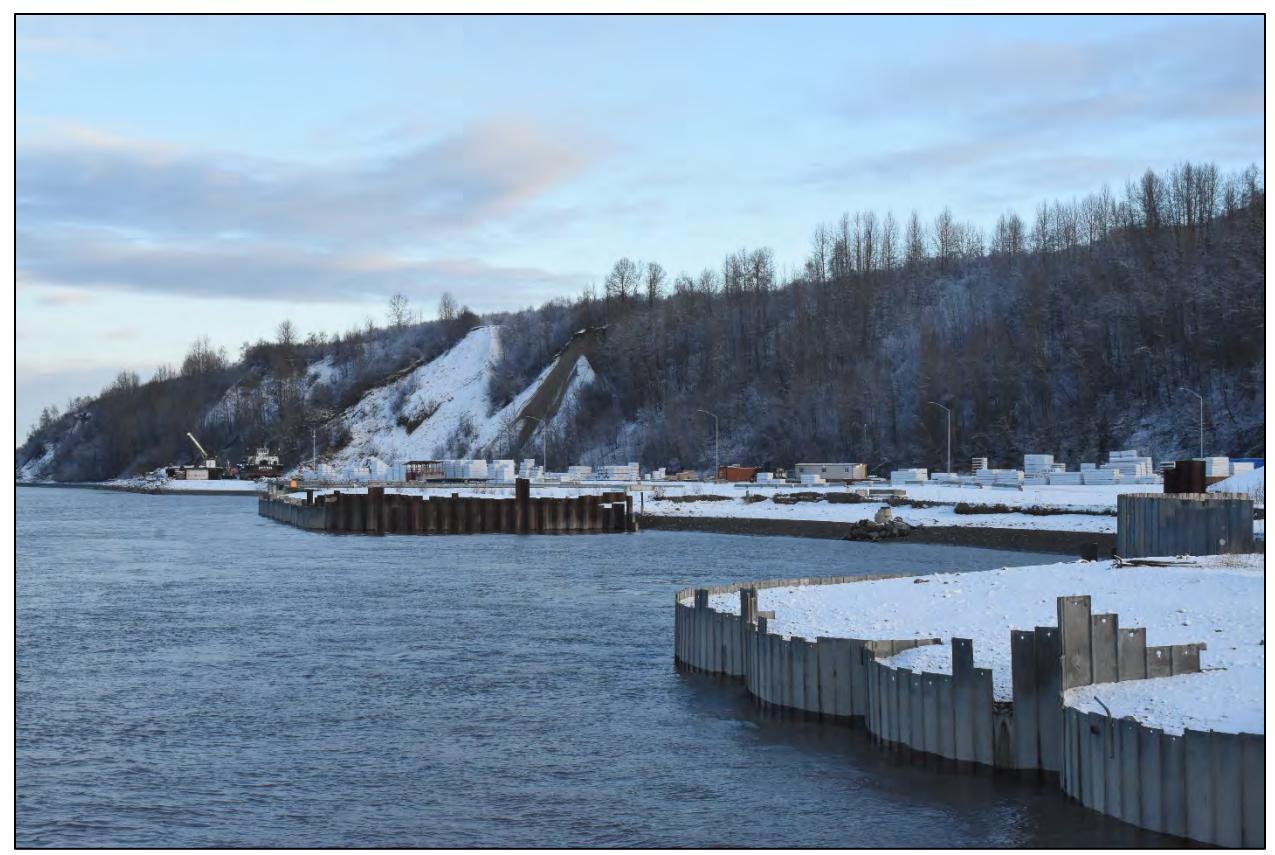
Figure 6-30. Port of Alaska –View of surficial bluff failure on 30 November 2018 (Photographs courtesy of Jim Jager, PoA)

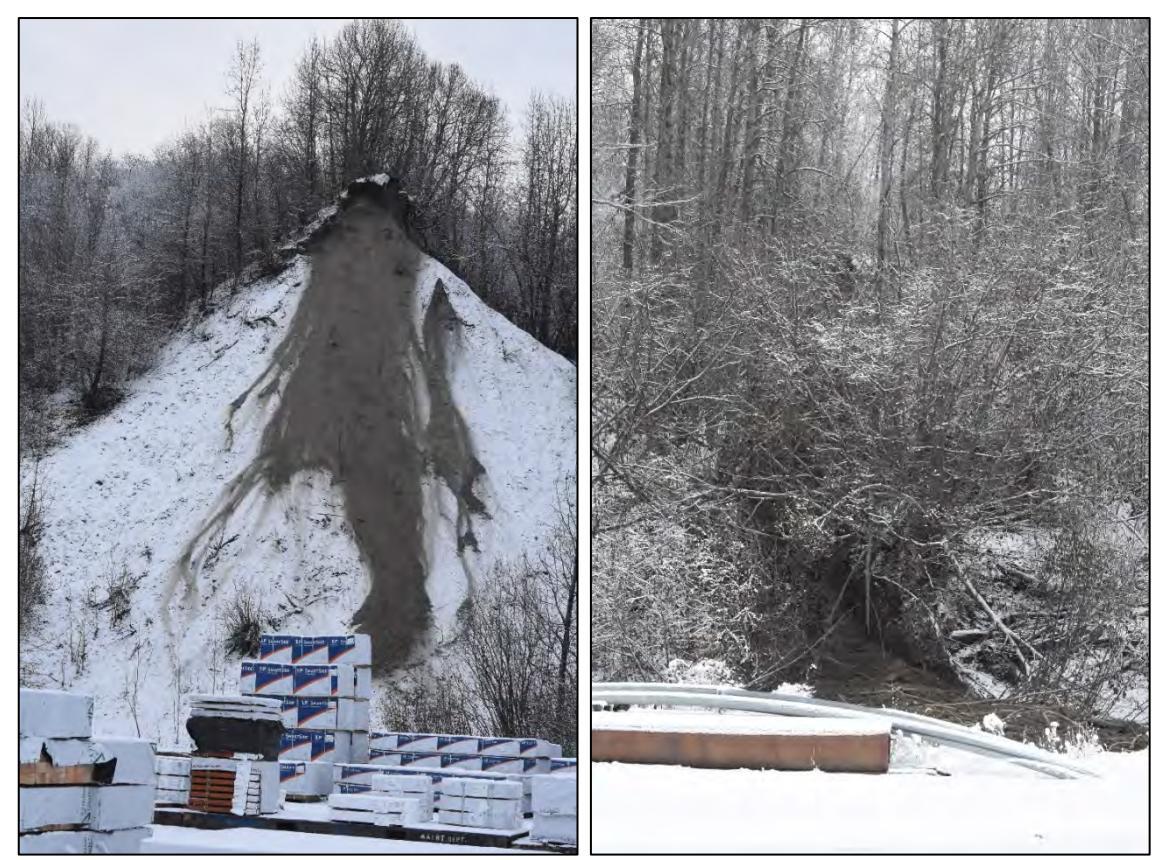
Figure 6-31. Port of Alaska – Fig. G. View of surficial bluff failure (left) and shallow slope movements (right) on 30 November 2018 (Photographs courtesy of Jim Jager, PoA)

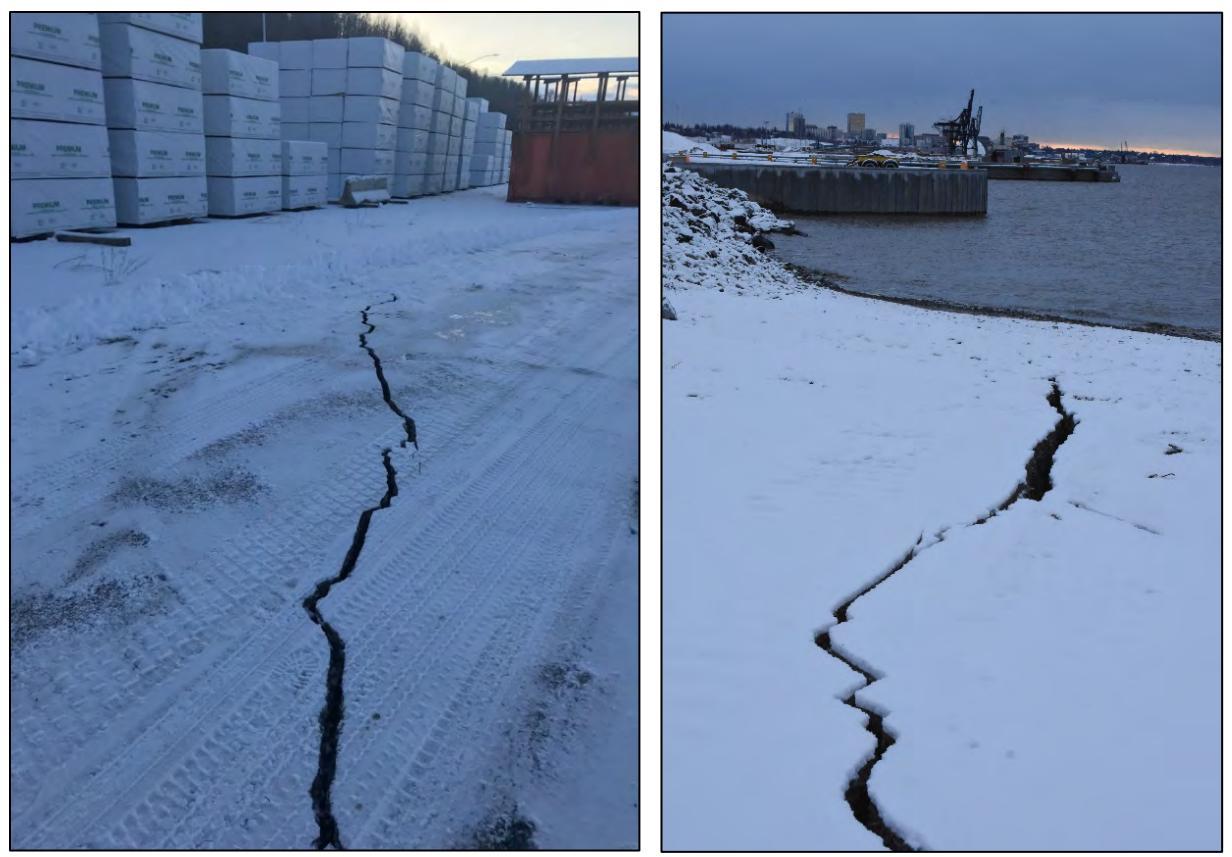
Figure 6-33. Port of Alaska – North Expansion Tension Cracks (Viewing South) on 30 November 2018 (Photographs courtesy of Jim Jager, PoA)

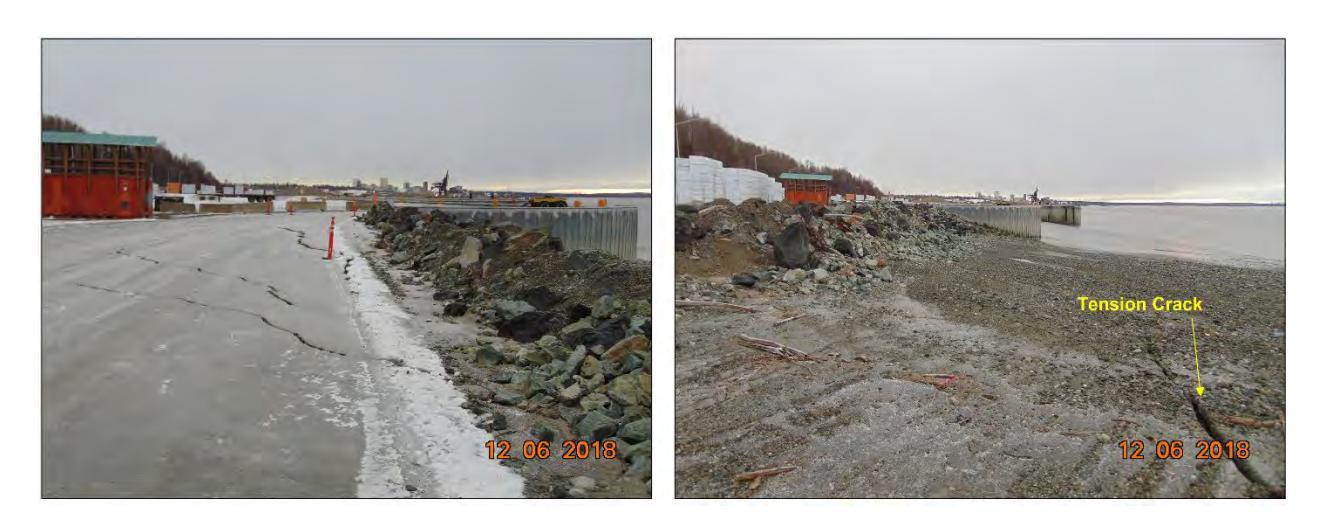
Figure 6-34. Port of Alaska – North Expansion Tension Cracks (Viewing South)

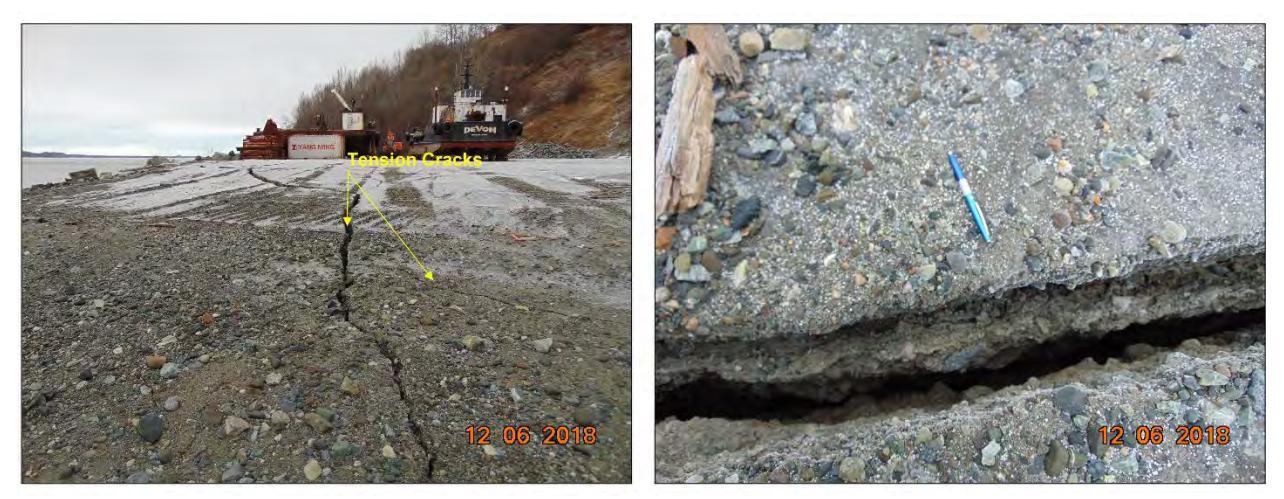
Figure 6-35. Port of Alaska – Northern Expansion Tension Cracks (Viewing North)

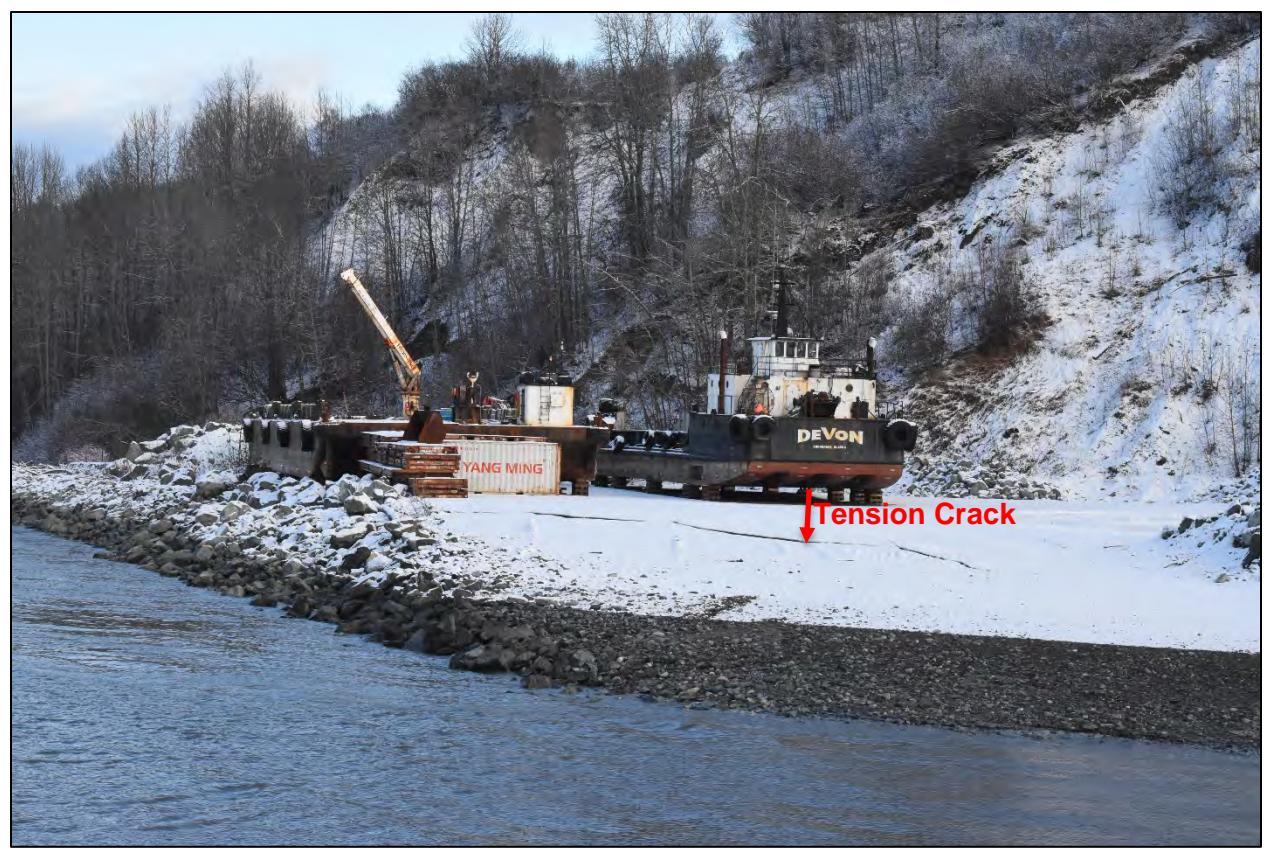
Figure 6-37. Port of Alaska – Northern Rock Slope Tension Crack (Viewing Northeast) (photographs courtesy of Jim Jager, PoA)

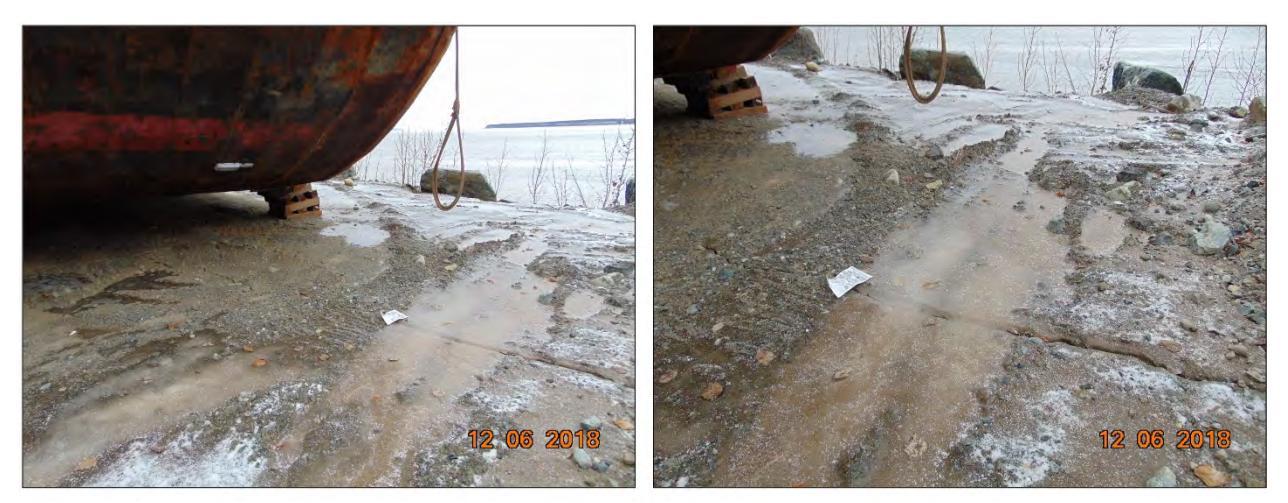
Figure 6-38. Port of Alaska – Northern Rock Slope Tension Cracks (Viewing South)

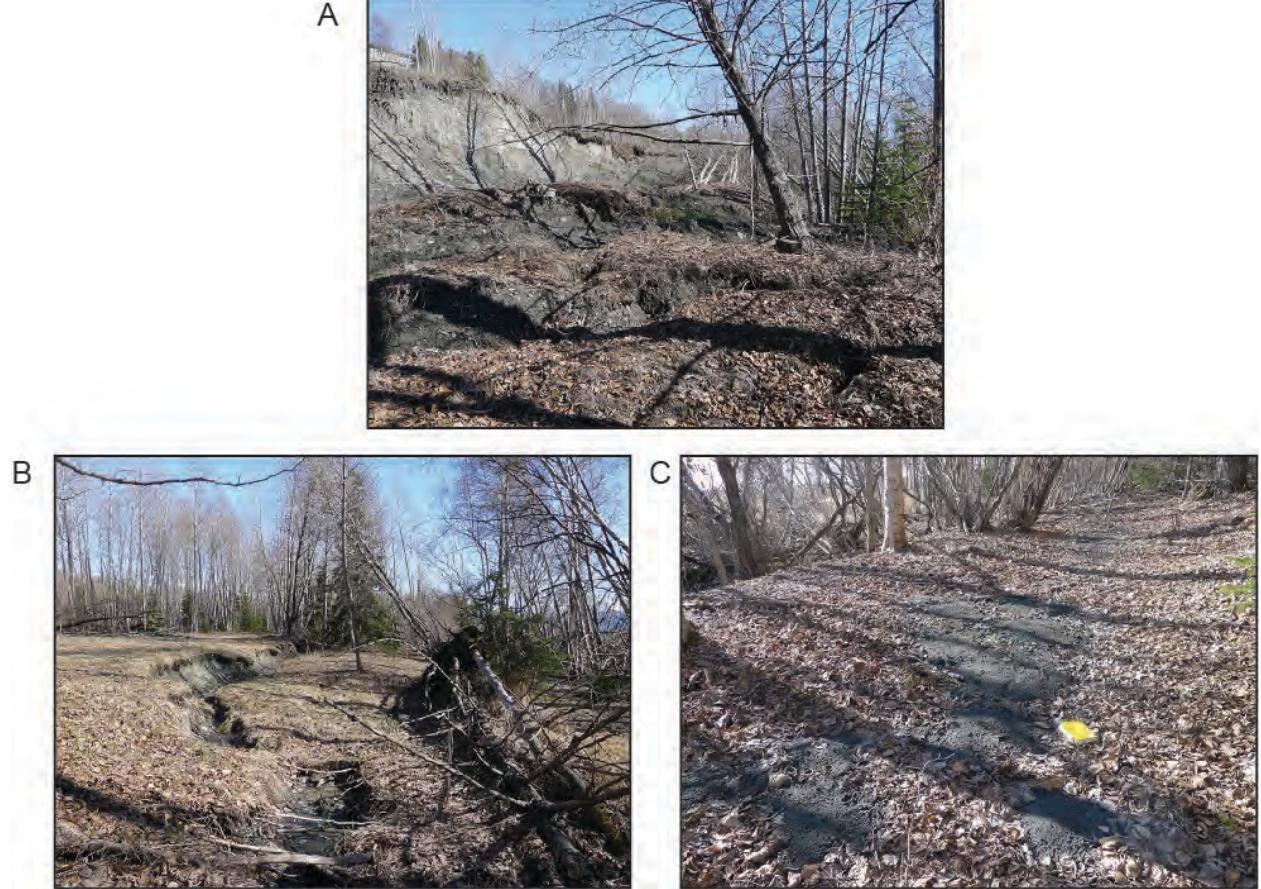
Figure B1. (A) Headscarp of the Rabbit Creek landslide showing slide blocks and backtilted trees. (B) Slide blocks near the toe of the Rabbit Creek landslide possibly related to lateral spreading. Movement of these blocks may have caused the larger failure at the headscarp. (C) Liquefied sand (dark gray material adjacent to yellow field book) on the surface of slide blocks near the toe of the slide. General location of the Rabbit Creek landslide (Lat/Long: 61.0912°, -149.8470°). See figure 5-28 in the body of the report.

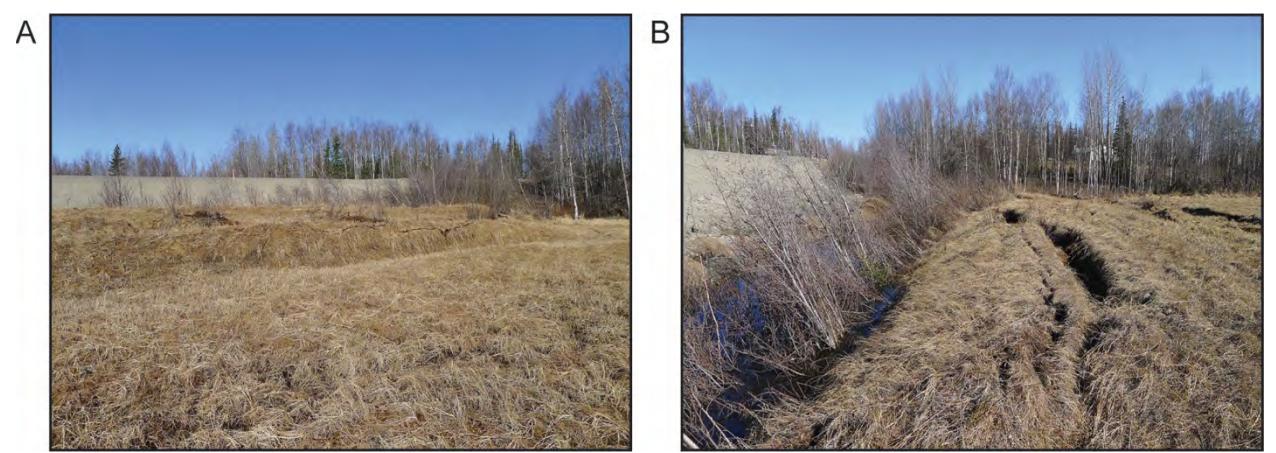
Figure B3. View west (A) and view north (B) of laterally spread soil mounds along the eastern side of the Vine Road failure. (Lat/Long: 61.568414, -149.601286). See figure 5-38 in the body of the report.

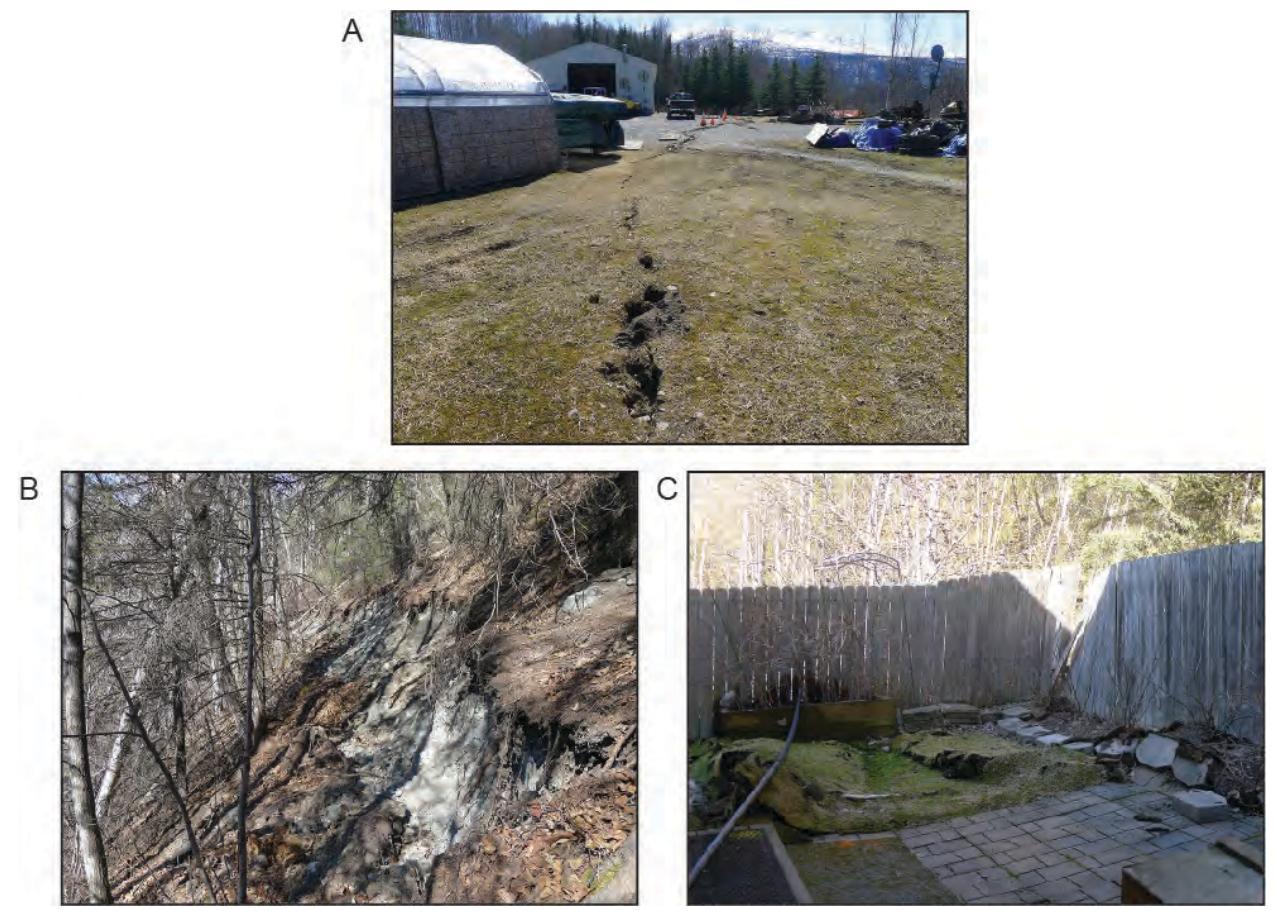
Figure B6. Photographs of the landslide above the Rivers Edge condominiums in Eagle River Lat/Long: 61.312065°, -149.570379°). Landslide features were observed during the Phase I investigation, however, no additional movement was observed in spring 2019. (A) Extensional cracks along the graded fill surface along the crest of the slope. (B) Landslide scarp along the base of the slope. (C) Buckled ground in the backyard of a Rivers Edge condominiums residence. See figure 5-31 in the body of the report.

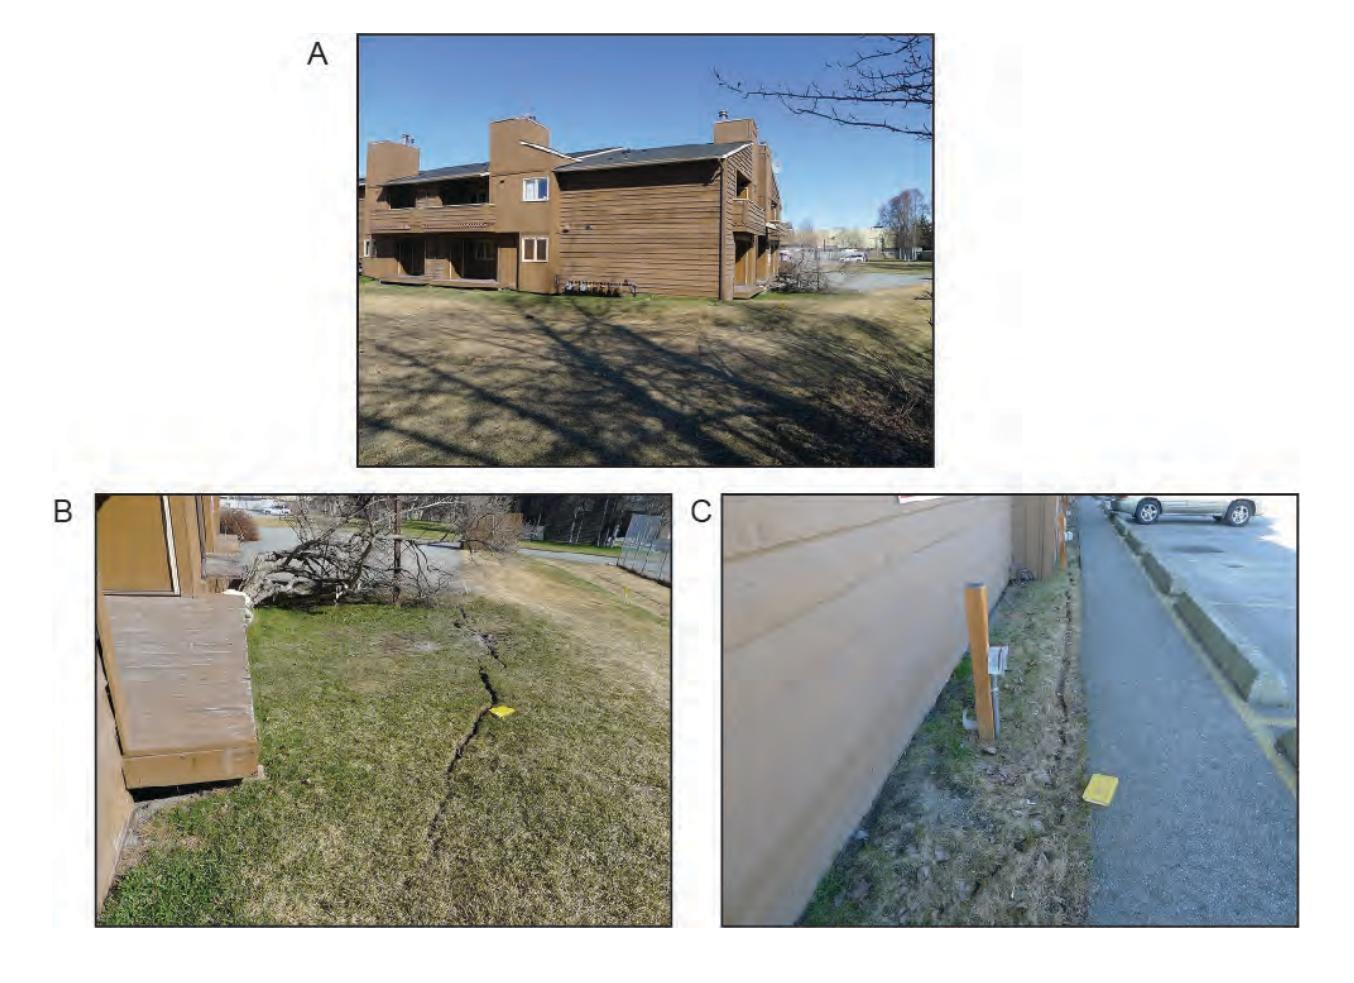
Figure B9. Photographs around the perimeter of the 2100 Minerva Road eastern apartment building showing ground settlement cracks (Lat/Long: 61.134367, -149.919633). The identical western apartment building was relatively undamaged.

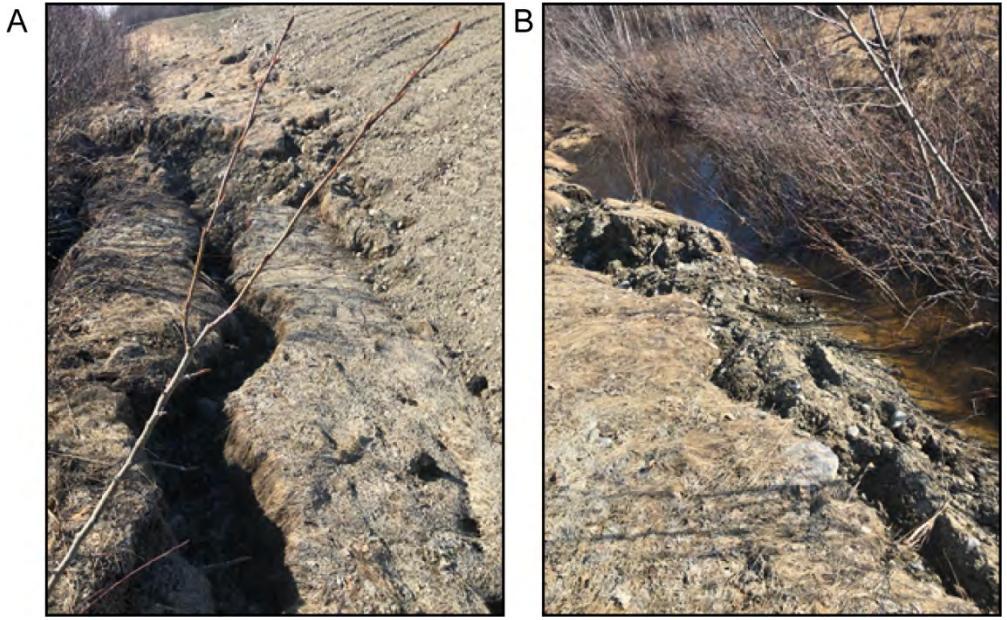
Figure B21. Embankment cracks along Vine road at both sides of the road. (A) cracks along the embankment; and (B) cracks along the water puddle that is near the road.
