## 2. HISTORY OF FLOODING IN CHRISTCHURCH

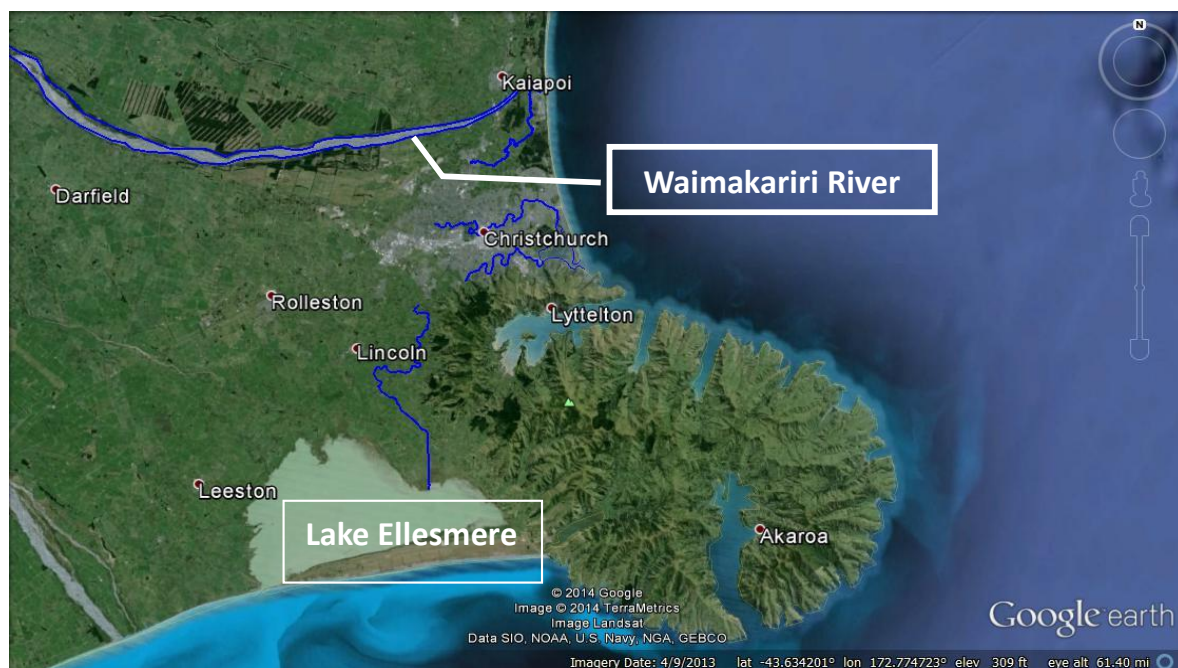
Figure 2-1 Christchurch City is bounded to the north by the Waimakariri River and to the south by the extinct volcanic complex of Banks Peninsula.

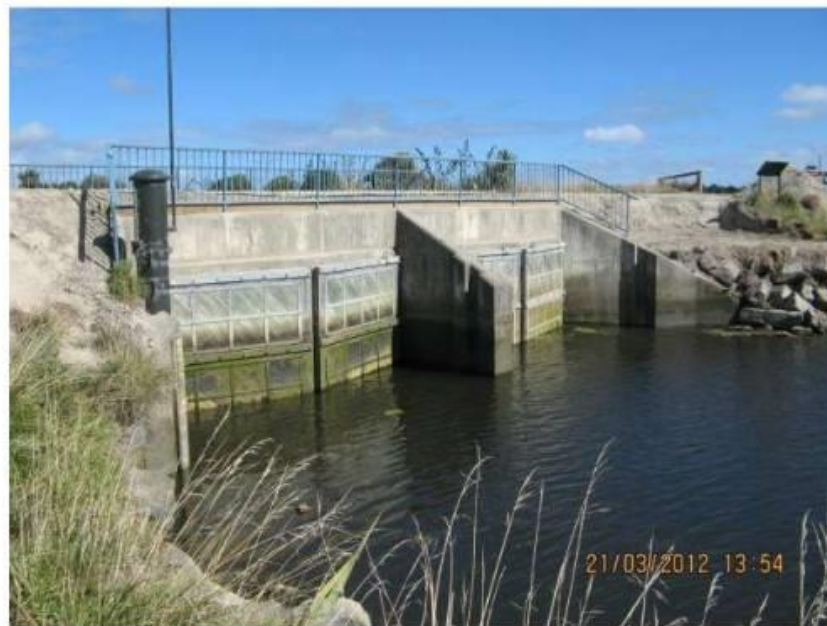
Figure 2-4 Tide-gates on the Styx River at Brooklands (Christchurch City Council, 2012).

The Styx River, to the north, has experienced floods and flooding exacerbated by tidal inundation. Commissioned in the mid-1980s, tide-gates have been installed on the Styx (Figure 2-4) to limit tidal effects upstream and to protect the floodplains near the stopbanks of the Waimakariri River to the north (Taylor, 2005).

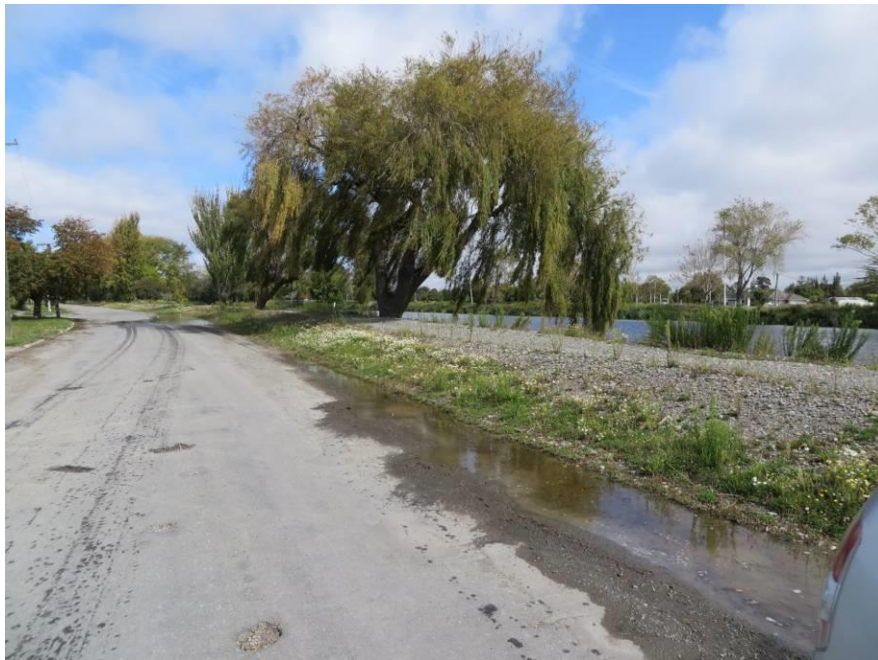
Figure 2-5 Stopbank along the Avon River on Avonside Drive (-43.503590°, 172.683632°).

In the Avon River basin, over 30 floods since 1883 have been documented and have caused damage ranging from stormwater ponding to river breakouts. In July 1955, March 1957 and August 1992, high tides exacerbated the flooding. Flood control measures, including stopbanks, are installed along the lower Avon to protect property from flood damage. The performance of these stopbanks is detailed in Chapter 6 of this report. Following the 2010-2011 earthquake sequence, the suburb of Avonside experienced extensive subsidence. As a result, the stopbanks were increased in height by up to 1 meter in some places (Figure 2-5).

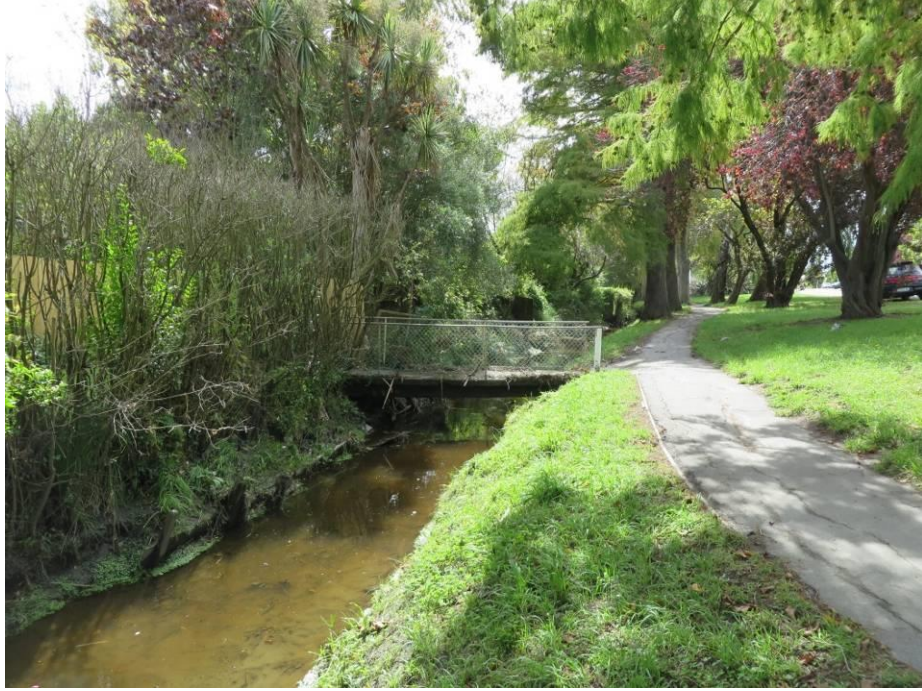
Figure 2-6 Bridge over Dudley Creek (-43°30' 40.41" S, 172°39' 18.52"E) along Stapletons Road.

The Flockton area or Dudley Creek basin, a sub-catchment of the wider Avon River basin, experiences frequent flooding. The Flockton area has experienced numerous flood events from Dudley Creek (Figure 2-6), which is a tributary of the Avon River. This area was flooded in August 2012, June 2013 and March 2014. Prior to the earthquake sequence, this area was prone to flooding, but the frequency and magnitude of flooding seems to have increased since the earthquakes. To alleviate flooding, a pump was installed to move the flood waters. Figure 2-7 shows the 50 year flood levels in the Flockton area before and after the earthquake sequence. As demonstrated by comparisons between Figures 2-7a and 2-7b, there are much larger areas potentially subject to flooding after the earthquake sequence as compared to before the earthquakes – shown as the larger extent of the areas colored orange to red to indicate deeper flood waters.

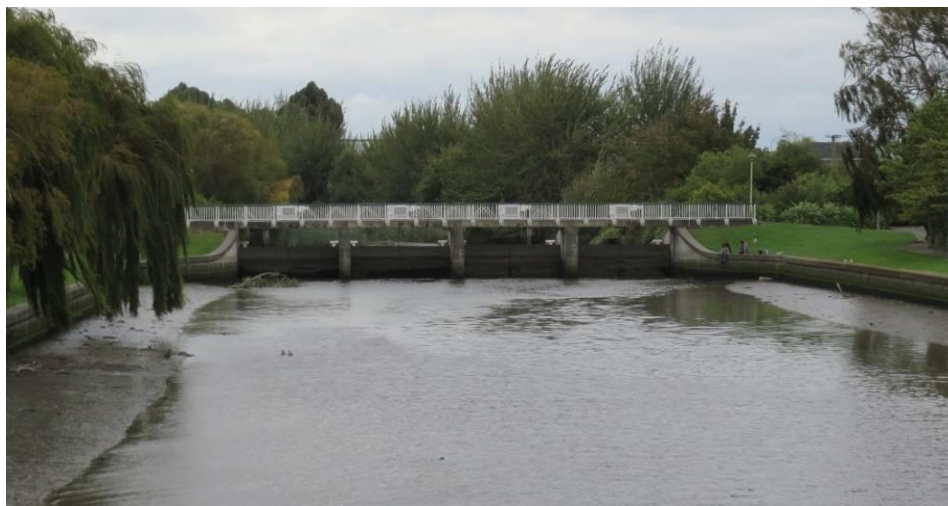
Figure 2-8 Barrage on the Woolston Cut section of the lower Heathcote River ( $-43^{\circ}33' 11.72''S$ ,  $172^{\circ}41'07.33''E$ ).

Similar to the Styx and Avon, the Heathcote River has had numerous floods. In 1941, the Woolston Cut was added in an attempt at river flood mitigation. However, this straightening of a lower river channel reach allowed saltwater to flow more readily back up the river. A barrage was added to prevent the saltwater backup Figure 2-8. Prior to the earthquake sequence floodwaters reached heights above house floor levels in the Heathcote River basins in 1968, 1975, 1977 and 1980 (Christchurch City Council, 2003).

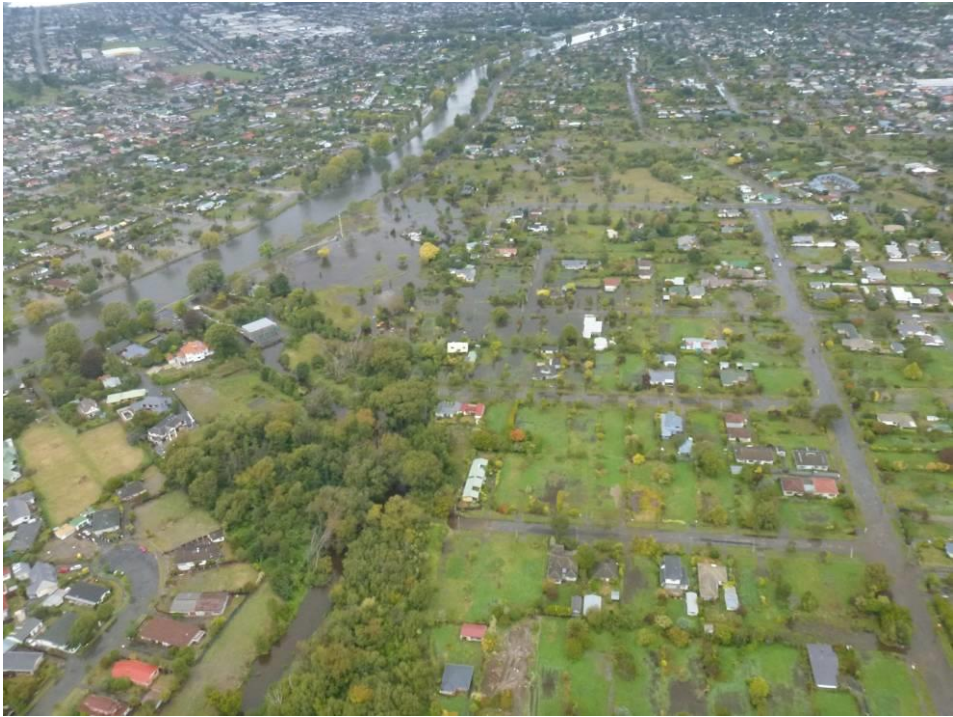
Figure 2-11 Lower Avon River at New Brighton Road (-43°30'02.52"S, 172°41'03.65"E). Photo courtesy of Tonkin & Taylor 2014.

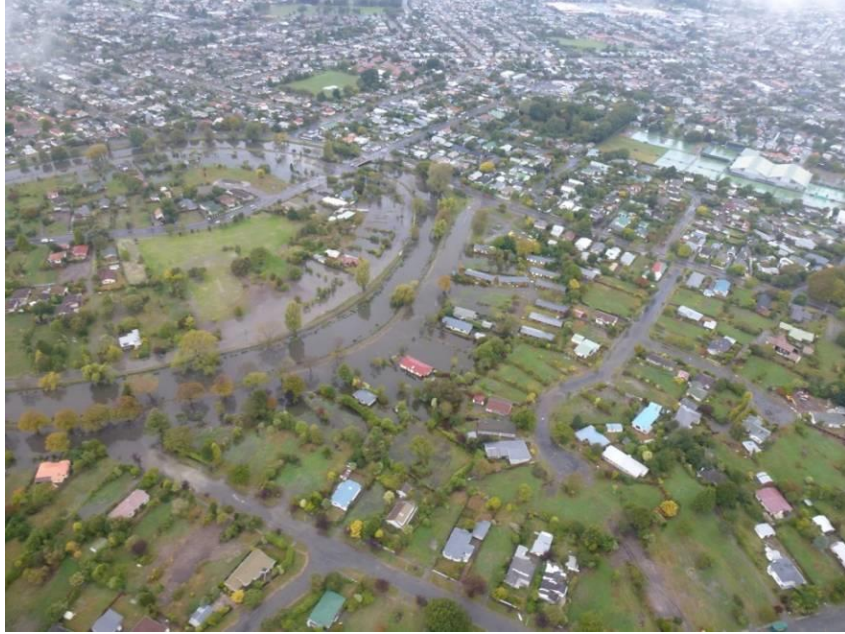
Figure 2-12 Avon River at Gayhurst Road (43°31'17.58"S, 172°, 40'21.96"E). Photo courtesy of Tonkin & Taylor 2014.

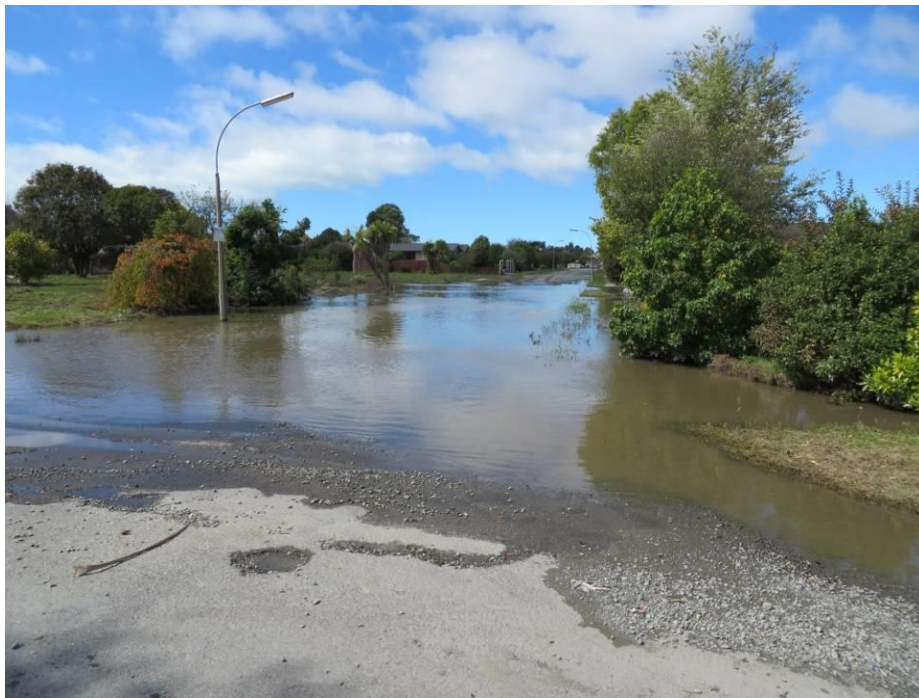
Figure 2-13 Localized flooding at the intersection of Prestwick Street and Avonside Drive (-43.503590°, 172.683632°). Photo courtesy of Tonkin & Taylor 2014.

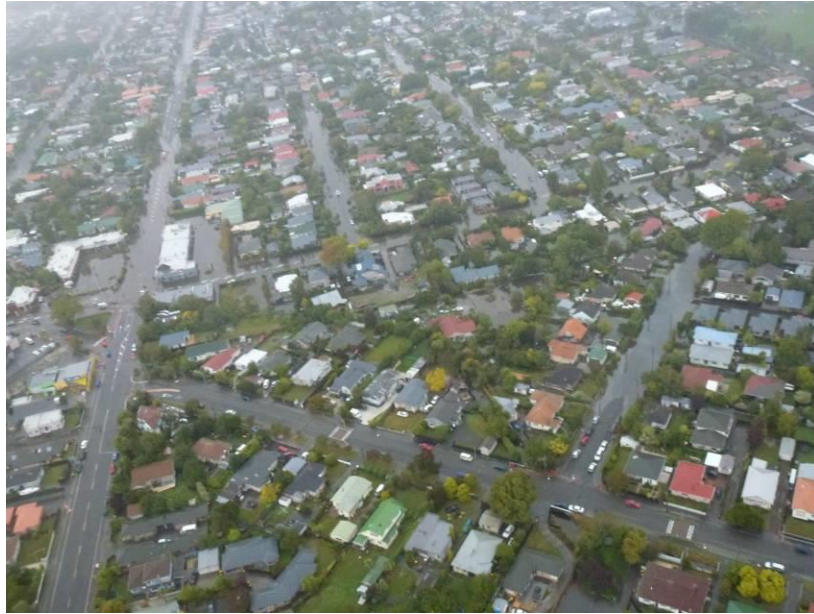
Figure 2-14 Flockton area from Woodville Street ( $43^{\circ}30'33.65\text{ S}''$ ,  $172^{\circ}39'00.65''\text{E}$ ). Photo courtesy of Tonkin & Taylor 2014.

The area that experienced the greatest flooding in this event is an area called Flockton. The Flockton area along Dudley Creek and the Avon River has experienced historical flooding. Due to the 2010-2011 earthquake sequence, ground subsidence has occurred in this area, making it more susceptible to flooding. Additionally, there was silting of the creek and lateral spreading that narrowed the channels, reducing their hydraulic capacity; these topics are discussed in detail

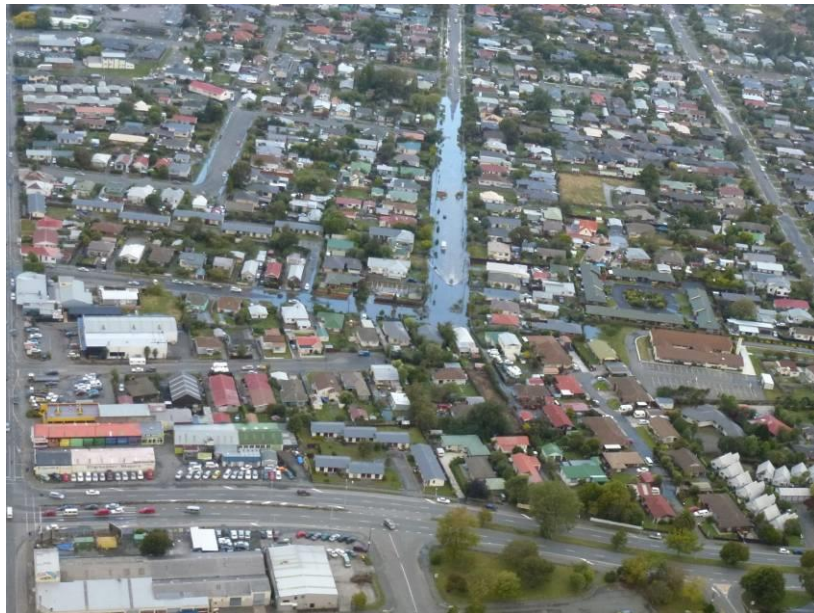
Figure 2-15 Localized flooding in Manning Place & Wilberry Street ( $43^{\circ}32'41.63\text{ S}''$ ,  $172^{\circ}39'58.28''\text{E}$ ). Photo courtesy of Tonkin & Taylor 2014.

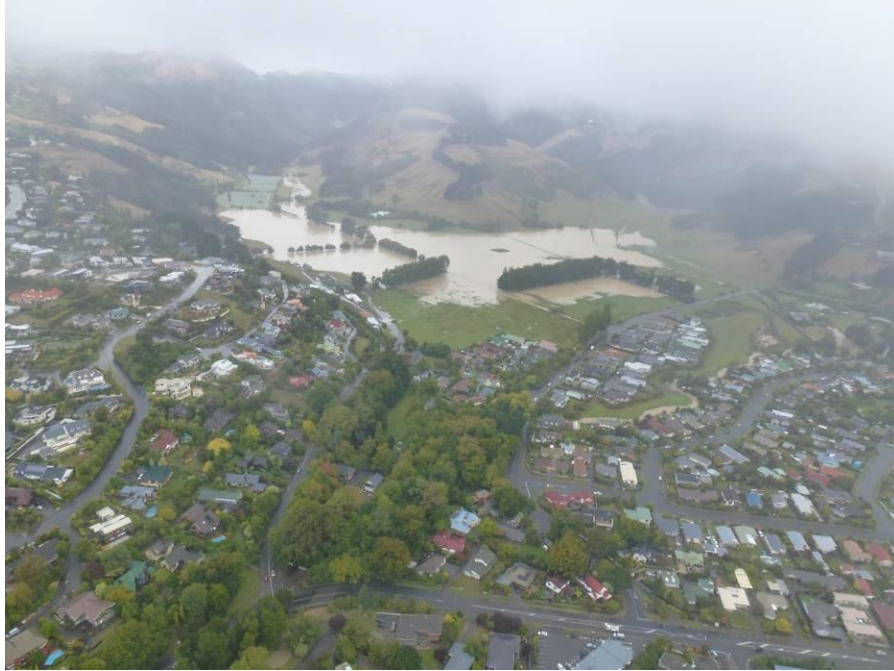
Figure 2-16 Heathcote River off Worsley Road ( $-43.580827^{\circ}$ ,  $172.616142^{\circ}$ ). Photo courtesy of Tonkin & Taylor 2014.

Similar to the Avon, the Heathcote also experienced flooding (Figure 2-16 through Figure 2-18). The photos provided from Tonkin and Taylor begin at the top of the basin and proceed towards the ocean. The upper part of the basin had ponding (Figure 2-16). This area has been identified by the Christchurch City Council as a natural ponding basin and has been left without development to capture flood waters. Figures 2-11 to 2-18 present photographs showing flood waters within the City of Christchurch. The Mayoral Task Force (Christchurch City Council, 2014) report provides more detailed descriptions of local flood impacts and temporary defense measures and the later chapters in this report summarize flood effects on geotechnical and lifeline systems.

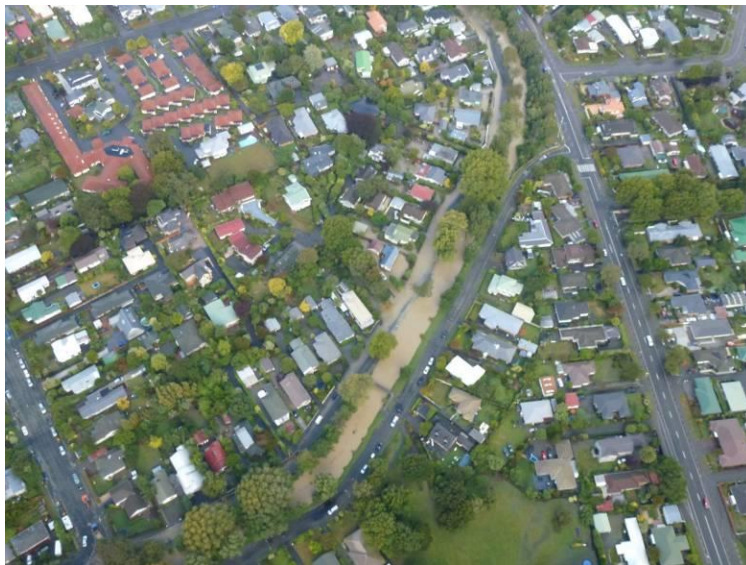
Figure 2-17 Heathcote River Waimea Tce ( $43^{\circ}34'08.59''$  S,  $172^{\circ}38'22.22''$  E). Photo courtesy of Tonkin & Taylor 2014.

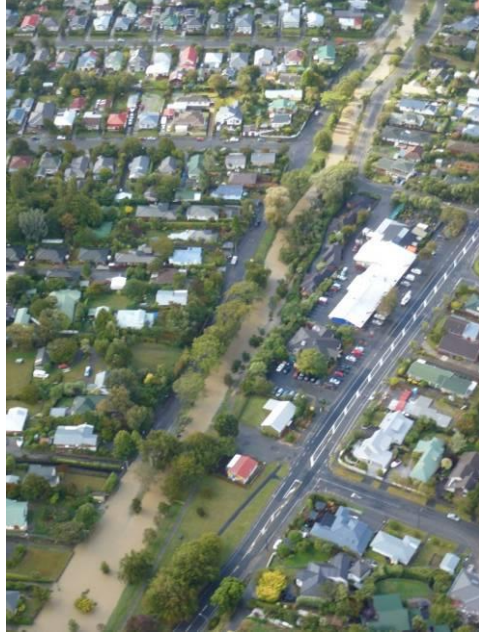
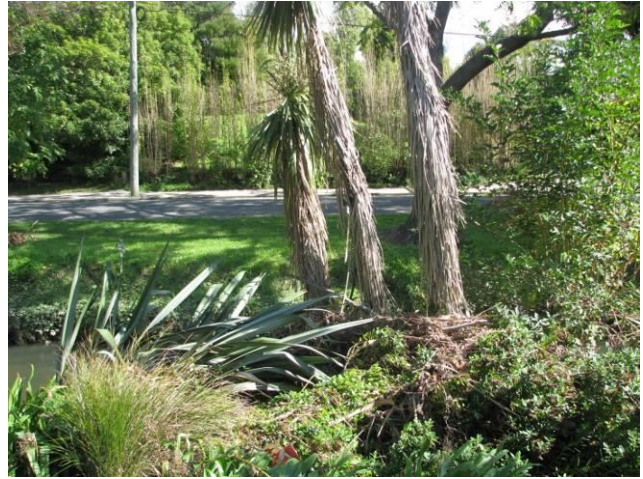
Figure 2-18 Heathcote River off Centaurus Road illustrating (a) flooding on March 5, 2014 (Credit: Tonkin & Taylor 2014) and (b) normal flow during GEER visit March 19, 2014. (43°34'01.69"S, 172°38'45.85"E).
