3. POST EARTHQUAKE SEQUENCE LAND DEFORMATION

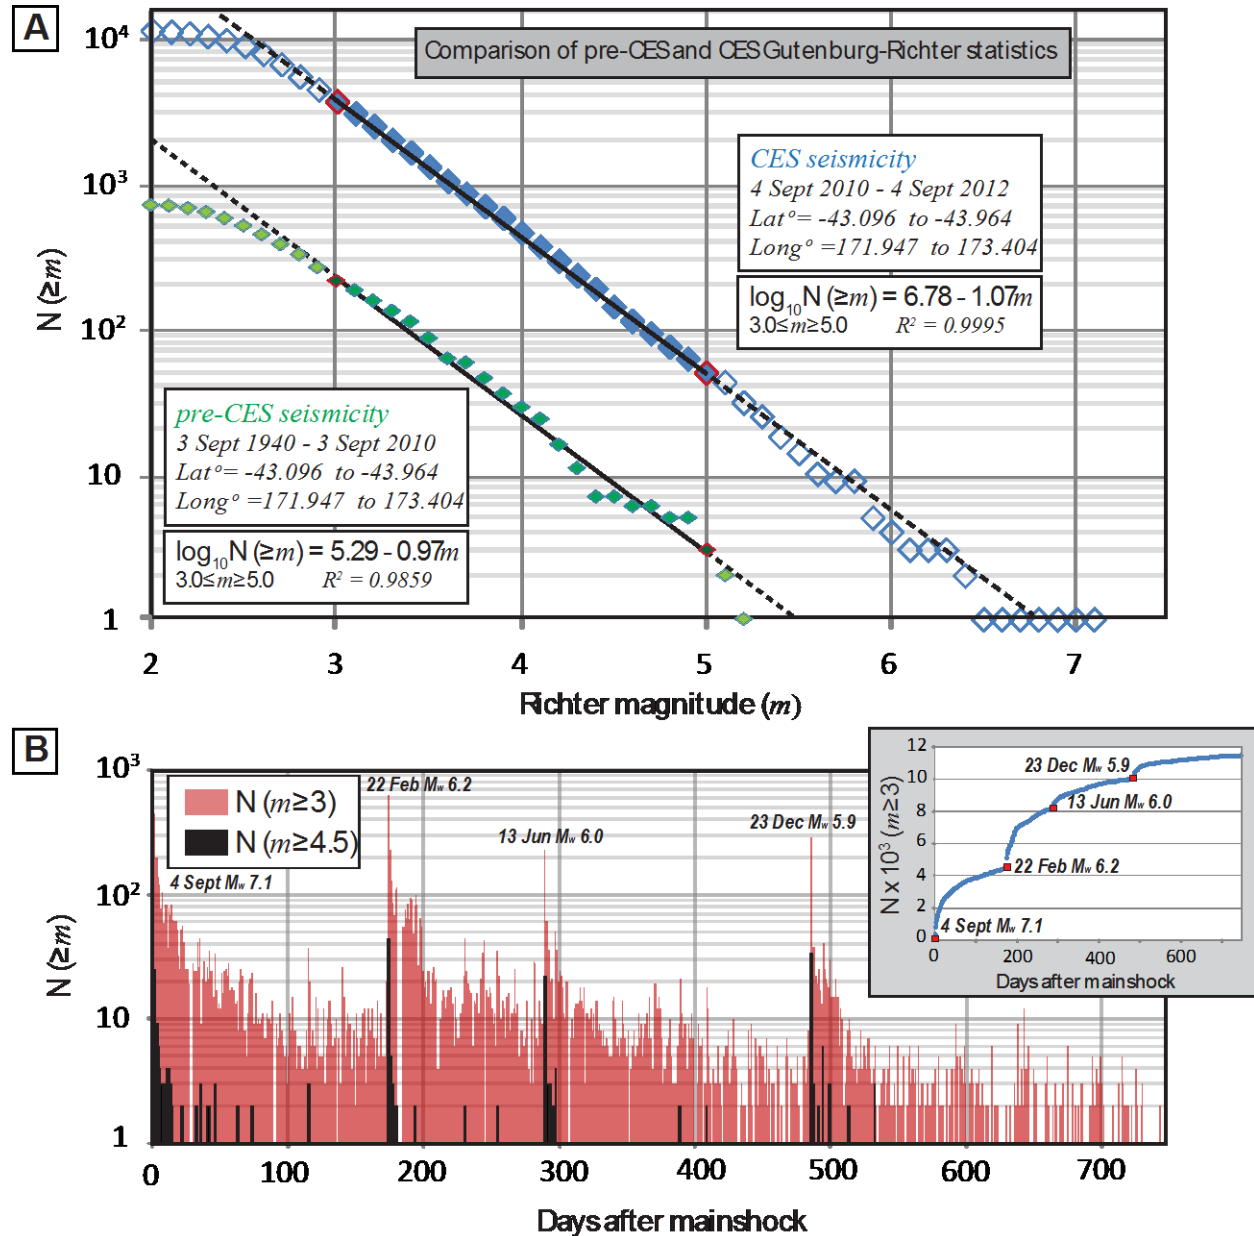
Figure 3-1 Seismicity of the Canterbury earthquake sequence (CES). A) Gutenberg-Richter frequency-magnitude plot comparing CES seismicity with seismicity in the same region over a 60 year period prior to the CES. The low earthquake frequency and magnitudes prior to the CES suggests that regional earthquakes over this time period are unlikely to have contributed to flood hazard via seismic shaking. See text for additional details. B) CES earthquakes plotted against time, showing increase in seismicity rate immediately following larger (e.g., $M_w \geq 5.5$) events and decay of seismicity rates following these events (inset).

Earthquake frequency-magnitude distributions during the CES are summarized in Figure 3-1 and Figure 3-2 (Li et al., 2013; Bradley et al., 2014; Quigley et al., in review). The eight largest earthquakes by magnitude include the 4 September 2010 (Mw=7.1), 22 February 2011 (three earthquakes: Mw=6.2, 5.5, 5.6), 13 June 2011 (two earthquakes: Mw=5.3, 6.0) and 23 December 2011 (two earthquakes: Mw=5.8, 5.9). Figure 3-1B shows how all of these earthquakes were accompanied by an increase in aftershock frequency (Figure 3-1B). Figure 3-3 presents the magnitudes weighted (to Mw7.5) peak ground accelerations (PGA7.5). As seen in Figure 3-3, all of the Mw ≥ 5.8 events, and the Mw 5.3 June event, caused ground shaking in eastern and southern Christchurch with PGA7.5 $\geq 0.10g$, and caused significant liquefaction damage, as indicated by the formation of sand blows and lateral spreading cracks in the most susceptible parts of eastern Christchurch (e.g., Quigley et al., 2013). Spatially localized, minor liquefaction was also reported in isolated areas following the 19 Oct 2010 Mw 4.8 (Green et al., 2010), 16 April 2011 Mw 5.0, and 21 June 2011 Mw 5.2 earthquakes (Quigley et al., 2013), although these events did not cause significant land damage and are thus unlikely to have contributed to increased flood hazard. The locations of major faults involved in the CES are shown in Figure 3-2. For detailed reviews of the geologic and seismic aspects of the CES see Quigley et al. (2010, 2012, 2013); Beavan et al. (2010, 2011, 2012), Kaiser et al. (2011); Duffy et al. (2012), Bradley et al. (2014); and Hughes et al. (in review). No pre-CES regional earthquakes since 1940 are likely to have been of sufficient magnitude and shaking intensity to induce liquefaction and impact on flood hazard (Figure 3-1A). A local earthquake (Mw 4.7-4.9) in 1869 caused pervasive damage in parts of Christchurch consistent with PGA $\geq 0.2 g$ shaking and may have induced tidal changes in the Heathcote River, as reported in the Weekly News 26 June 1869 (cited in Downes and Yetton, 2012).

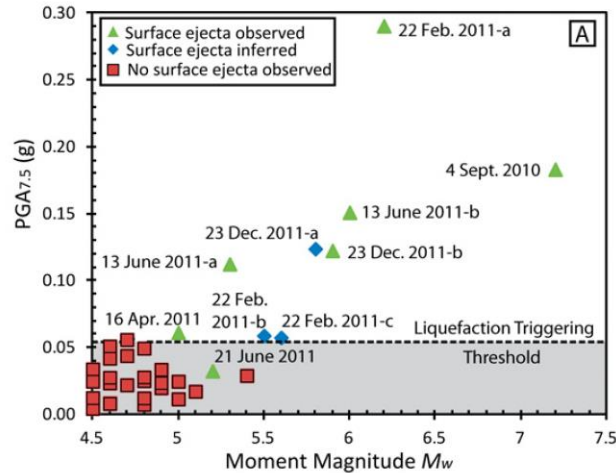
Figure 3-3 Relationship of magnitude-weighted PGA7.5 and Mw for largest CES earthquakes that did and did not create surface evidence for liquefaction at a selected study site adjacent to the Avon River in eastern Christchurch. PGA7.5 thresholds for inducing major liquefaction and lateral spreading at this site are 0.10 g, although surface features were created at shaking intensities as low as ≤ 0.06 g. A shaking threshold ≥ 0.1 g PGA7.5 for inducing land damage and influencing channel morphology, flood plain elevations, and consequently flood hazard at high susceptibility sites is likely. Figure from Quigley et al. (2013).

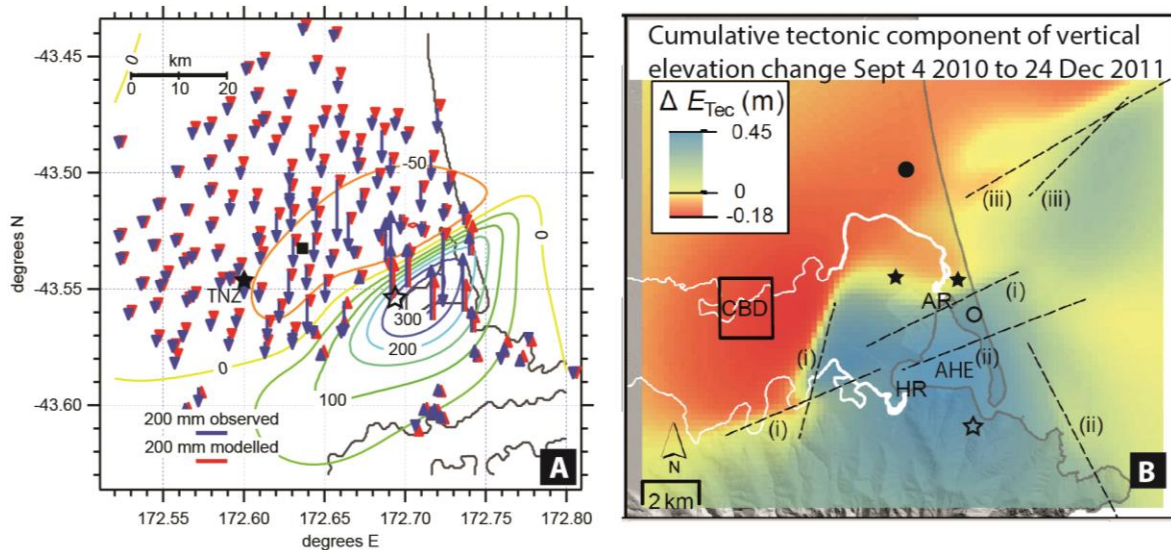
Figure 3-4 A) Vertical surface displacements in the 22 Feb Mw 6.2 Christchurch earthquake recorded by campaign GPS measurements ('observed') and modelled displacements from fault source models ('modelled') from Beavan et al. (2011). Contours of modelled vertical displacements shown in 50 mm increments. Location of cGPS station TNZ as shown. Site with maximum vertical uplift shown by open star. B) Tectonic component of cumulative vertical displacements (ΔE_{Tec}) in Christchurch and offshore, derived from fault source models of Beavan et al. (2012). The shaking-induced components of vertical deformation are not shown (see Figure 3-5). Up-dip surface projections of faults that ruptured in the 22 Feb (i), 13 June (ii), and Dec 23 (iii) earthquakes shown by dashed lines. See text for details.

The 13 June 2011 Mw 6.0 earthquake likely involved an intersecting ENE-striking reverse-right lateral fault and NW-striking left-lateral fault, shown in Figure 3-4B with ~ 1 km deep rupture extent and maximum subsurface slip of < 1 m (Beavan et al. 2012). Maximum campaign GPS recorded uplift exceeded 13 cm (open star in Figure 3-4B) and several locations in eastern Christchurch (see closed stars in Figure 3-4B for examples) recorded subsidence > 10 cm (Beavan et al., 2012). Differential InSAR reveals areas where combined differential vertical and horizontal movements exceeded 10 cm (Beavan et al., 2012) and differential LiDAR reveals large areas of eastern Christchurch that subsided ≥ 10 -20 cm.

The 23 December 2011 Mw 5.8 and Mw 5.9 earthquakes ruptured NE-striking reverse-right-lateral, blind faults primarily located offshore, shown in Figure 3-4B, with maximum slip of >1.4 m occurring at depths of 2-5 km and rupture extents of ~ 1 km depth (Beavan et al. 2012). Maximum campaign GPS recorded uplift of approximately 10 cm occurred along the eastern coast of Christchurch (open circle in Figure 3-4B); maximum subsidence occurred 5 to 8 km north of uplifted areas (closed circle in Figure 3-4B) (Beavan et al. 2012). Differential InSAR reveals areas where combined differential vertical and horizontal movements exceeded 5 cm

The tectonic component of total measured vertical and horizontal displacements was derived from the fault source models of Beavan et al. (2012) (Figure 3-4A); van Ballegooy et al. (2014) used these models to extract the tectonic component in order to document the shaking-induced component of total subsidence (see next section). Hughes et al. (in review) combined the fault source models of Beavan et al. (2012) to produce a composite map showing the cumulative tectonic component of vertical displacements throughout the CES (Figure 3-4B). Three key observations can be made from this modeled displacement field in terms of potential tectonic influence on flooding in Christchurch: (1) The Avon River (AR; Figure 3-4B) has been influenced by cumulative tectonic subsidence throughout its reach, until it crosses the up-dip surface projection of one of the 22 Feb 2011 fault ruptures (Fault i; Figure 3-4B) where it enters the Avon-Heathcote Estuary (AHE in Figure 3-4B), (2) The Heathcote River (HR; Figure 3-4B) has been influenced by cumulative tectonic subsidence in its upstream reach and cumulative tectonic uplift in its downstream reach, with a change across the up-dip surface projection of another one of the 22 Feb 2011 fault ruptures (Fault i; Figure 3-4B), (3) The Avon-Heathcote Estuary (AHE) has been largely influenced by cumulative tectonic uplift throughout its spatial extent. The associated tectonically-induced gradient changes on the Heathcote River are

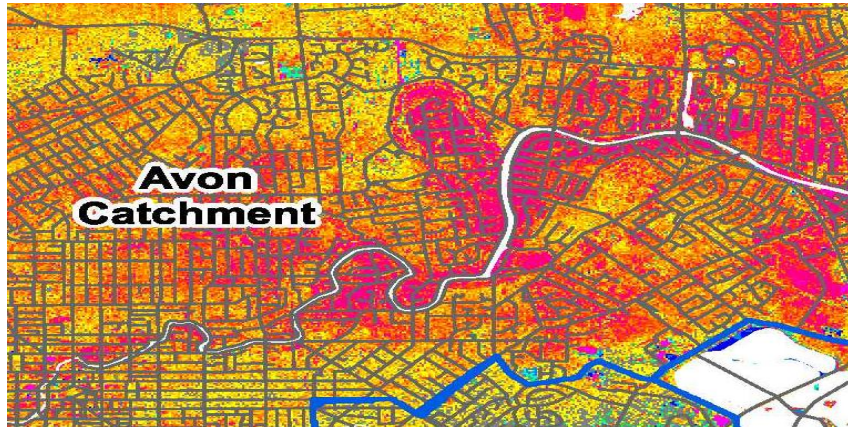
Figure 3-5 Cumulative elevation change along the Avon and Heathcote Rivers pre-2010 and post June/December 2011; (a) Avon Catchment and (b) Heathcote catchment. Maps (a) and (b) have different scales. (Tonkin & Taylor Ltd, 2013, Figure A10)

Liquefaction induced settlement was documented in Christchurch and the surrounding communities after the four events making up the 2010-2011 Canterbury earthquake sequence. Pre 2010 to post December 2011, elevation changes for the city were documented by Tonkin & Taylor (2013). Figure 3-5 shows cumulative settlements as a result of the four events in the Avon and Heathcote catchment areas. Cumulative settlements in excess of 1 m can be found within the Avon River catchment area. In the Heathcote catchment area both settlements and uplift of ≤ 0.3 m can be found. Van Ballegooy et al. (2014) found that $> 87\%$ of the settlement in Christchurch was associated with ejected soil.

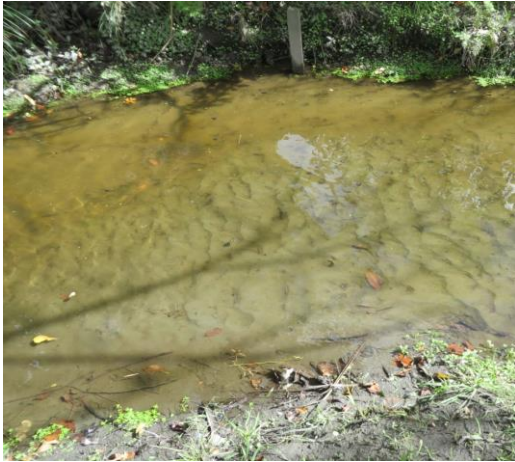
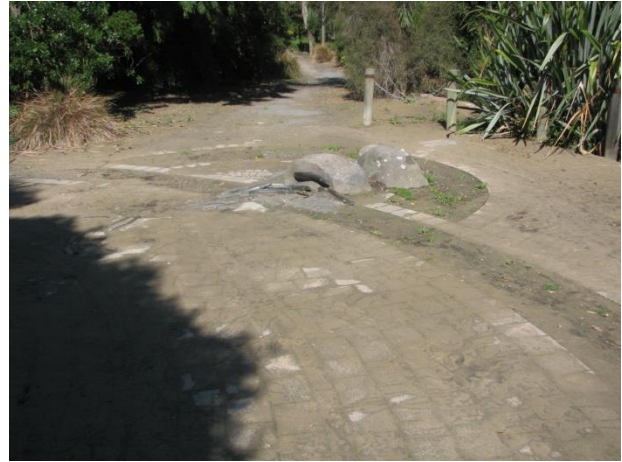
Figure 3-6 (a) Traces of ejected sand in Dudley Creek (Stapletons Rd: -43.511154° , 172.655033°) and (b) similar sediments deposited during the March 5th Heathcote flooding (Centaurus Rd: -43.567442° , 172.645985°).

GEER team members classified the ejected material as non-plastic fine sands and silty sands, during the Darfield Earthquake reconnaissance (NZ-GEER, 2010). Much of the silts and sands ejected due to liquefaction in the city were cleaned up after each of the events and placed in stock piles near the Bromley oxidation ponds and at the Burwood Landfill (NZ-GEER, 2011). Evidence of ejected material, as shown in Figure 3-6 was still found in Dudley Creek and along the banks of the Heathcote River near the high water marks during the GEER visit. CCC's Land Drainage Recovery Programme (2014) identified sediment volumes in excess of 350 truckloads have been removed since June of 2013 in ongoing attempts to restore channel morphology, and thus, flow capacity.
