Earthquake Reconnaissance Report:

**M7.8 Kaikoura, New Zealand**

**Earthquake on November 14, 2016**

**March 2017**

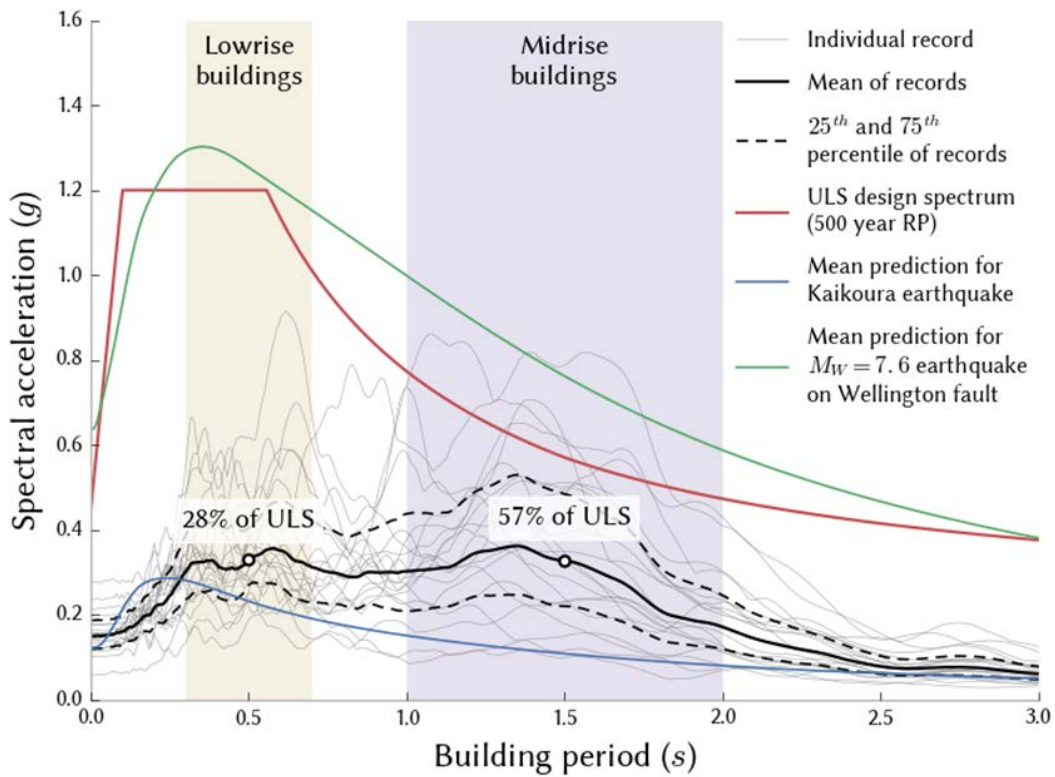
Figure 6. Observed ground motion response spectra in the urban Wellington region and the 500yr return period design spectra, compared with the empirically-predicted response spectrum for the Kaikoura earthquake; and the empirically-predicted spectra for a hypothetical Wellington fault earthquake (source: Brendon Bradley, Liam Wotherspoon).

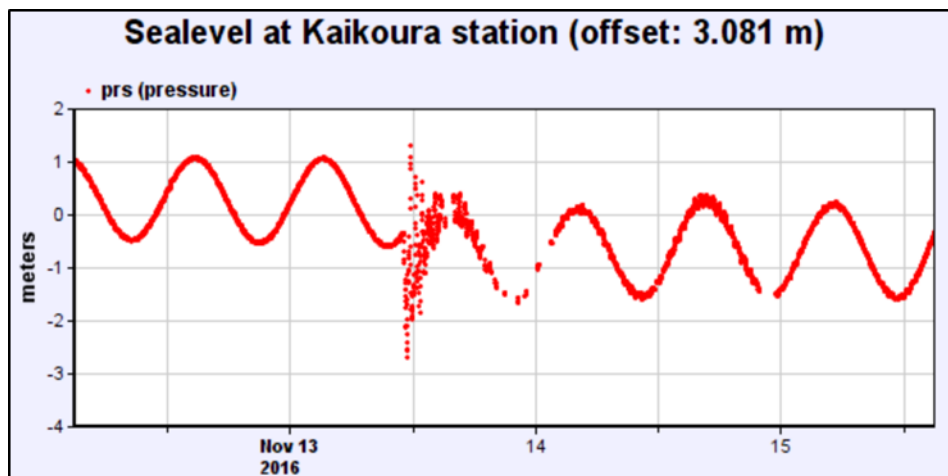
A small to moderate-sized local tsunami was generated by the vertical displacements along the offshore faults during this earthquake. The tsunami was recorded at four tide gauges in New Zealand (Table 1). The peak recorded tsunami amplitude was 2.31m at the tide gauge on the North Wharf at Kaikoura, which also experienced approximately 1m of uplift as observed on the marigram at the tide gauge (Figure 8).

Figure 8. Marigram from Kaikoura North Wharf tide gauge from November 12-15, 2016. The sudden, apparent 1m drop of the water level represents a 1m tectonic uplift at the tide gauge site. Shortly after this, the tsunami signal is noted by the water level fluctuations of 4m peak to trough (source: [IOC Sea Level Station Monitoring Facility website](#)).

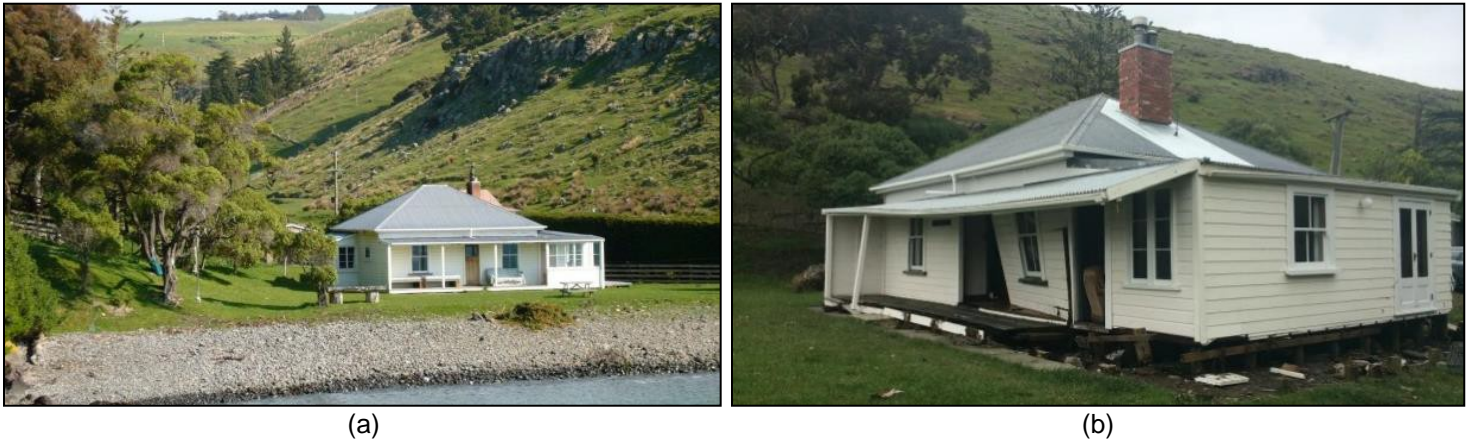
The one report of tsunami damage comes from the area that experienced high tsunami run-up (4-5m) in Little Pigeon Bay, east of Christchurch. Figure 9 shows photos of the structure that was damaged; Figure 9a is a picture of the structure before the tsunami, and Figure 9b shows the structure after the tsunami. According to the GeoNet website, the structure was pushed off its foundation, partly caving in the external walls. The maximum water level inside the structure was

measured to be approximately 1-1.5m. Damage to the structure may have been caused by a combination of the force of the water and debris; tree trunks and other large debris were found approximately 140 meters inland from the shoreline.

Figure 9. Before (a) and after (b) pictures of a cottage damaged by the tsunami at the north end of Little Pigeon Bay (photos: [Stuff website](#)<sup>13</sup>). The deck of the house was detached and deposited on the beach.

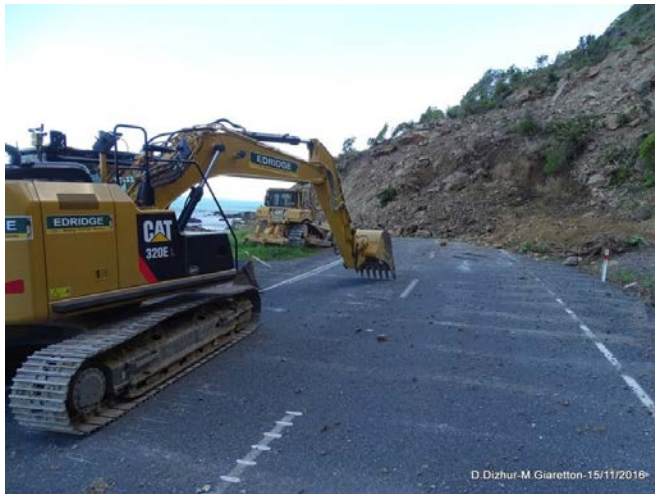
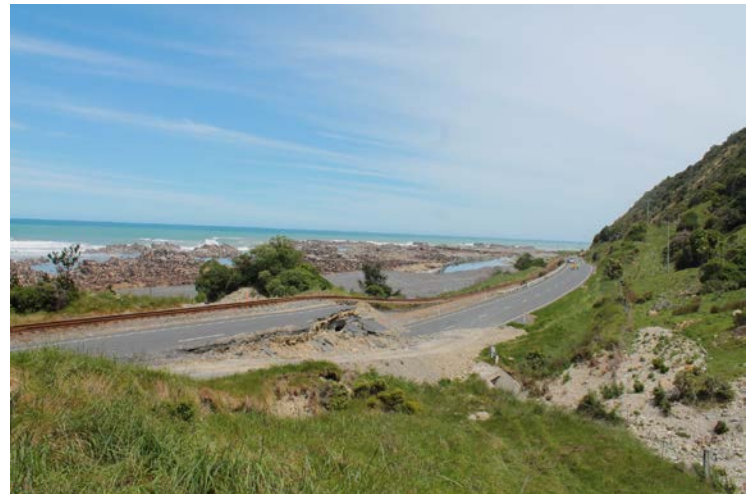
Figure 11. (a) Landslide crossing State Highway 1 north of Kaikoura at Okiwi Bay (photo: Dmytro Dizhur, Marta Giaretton), (b) Papatea fault rupture crossing State Highway 1 and the main north rail line north of Kaikoura (photos: Bellagamba).

large section of State Highway 1 north and south out of Kaikoura and the main north rail line from Ward south to Cheviot. Figure 11 shows examples of common damage observed along this route. Closure of the inland road route south from Kaikoura isolated the town. There was widespread slumping of bridge approaches, with main bridges north and south of Kaikoura experiencing vertical offsets between approaches and the deck, and lateral displacement of deck sections and piers. The timeline for full reinstatement of routes is at this stage not clear, with current estimates of months for road and over a year for rail. All rail transportation was halted, with freight shifted onto new coastal shipping services and additional road services. Kaikoura was inaccessible by land for three days, with an inland access road partially cleared initially for emergency vehicles and then opened for scheduled convoys 11 days after the event. Full access to Kaikoura for two way traffic via the inland route was opened on December 19, 2016, 35 days after the event. State Highway 1 south of Kaikoura reopened to traffic during daylight hours on December 21, 2016. There is currently little redundancy in the land transport network, with one 45 km stretch of highway serving as the only paved land transportation link between the northern and southern parts of the South Island, with all freight and normal traffic using this route. The significant increase in the level of traffic on this route will require accelerated maintenance and improvements of the surface.

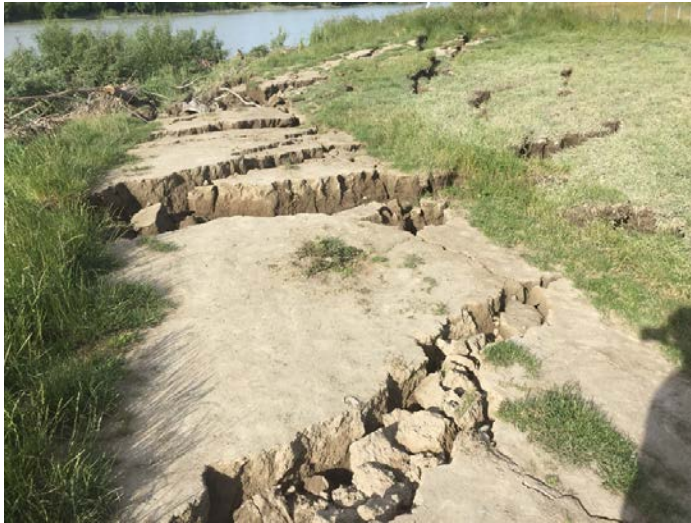
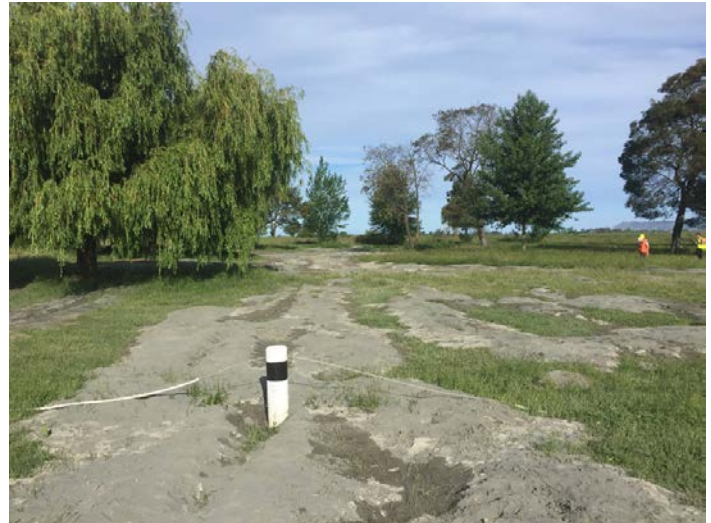
Figure 12. Liquefaction-induced lateral spreading along the Wairau River (Blenheim area): (a) large ground fissures and cracks in the zone adjacent to the river (spreading displacements in the area were in the range between 2m and 5m); (b) massive sand boils indicating severe liquefaction in the soils inland behind the river banks (approximately 20m to 50m distance from the river) (photos: Misko Cubrinovski).

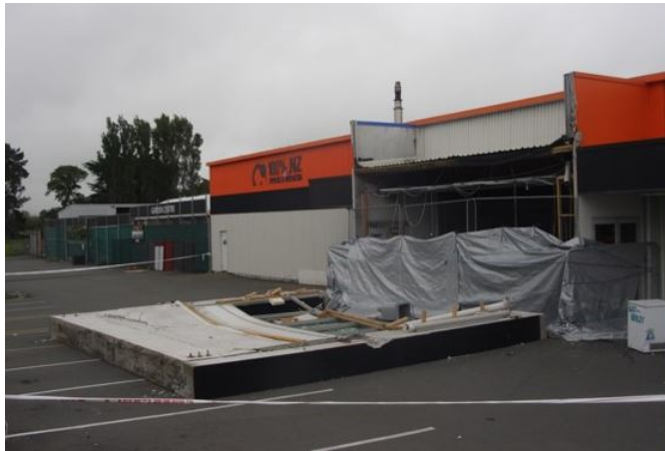
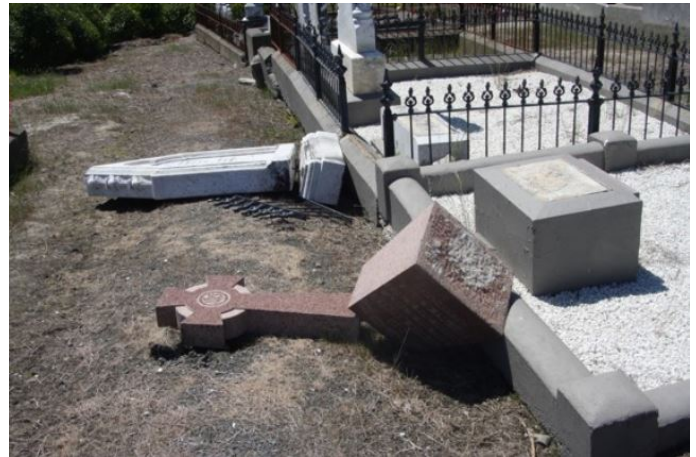
Other damage included street lights and power poles snapping at their bases or being tilted, cracking and displacement of road surfaces and footpaths, spalling of concrete street curbs and channels, and toppling of unreinforced masonry fences. Examples of damage are shown in Figure 14.

Figure 14. Damage in Kaikoura, including: (a) toppled entrance to the local hardware store, and (b) toppled and broken headstones at Kaikoura Cemetery (photos: Matthew Hughes).

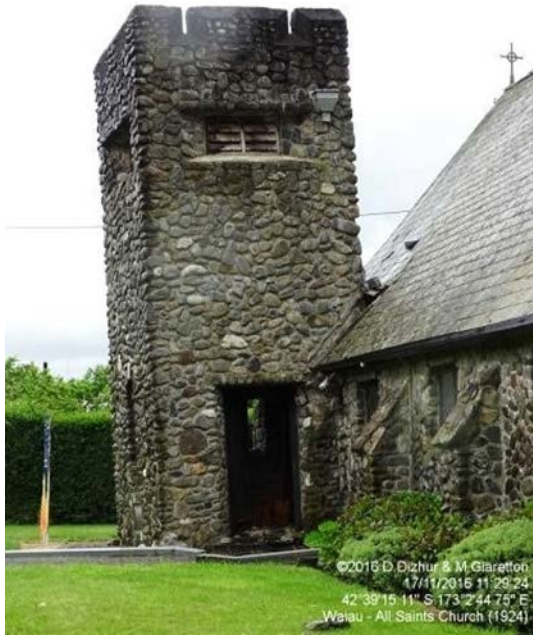
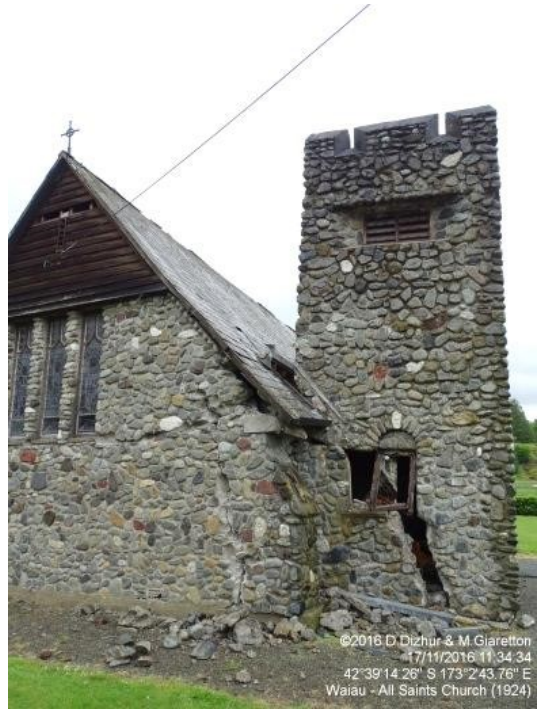
Figure 15. Damage to All Saints Church in Waiau showing tilting of the bell tower and significant settlement of tower foundation (photos: Dmytro Dizhur and Marta Giaretton).

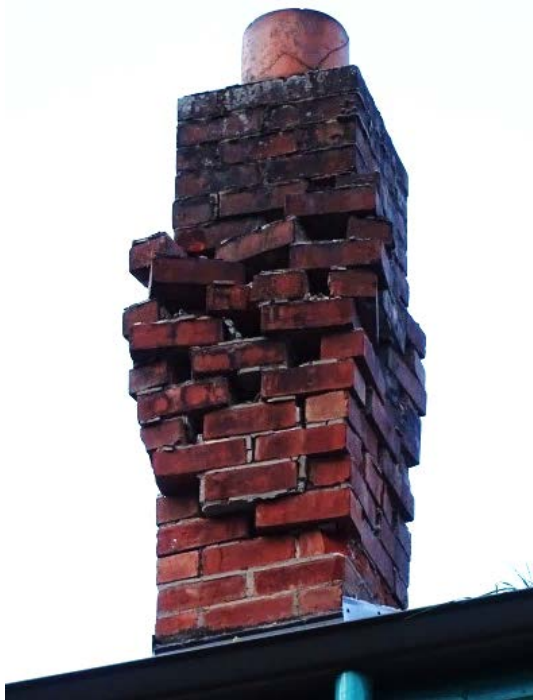
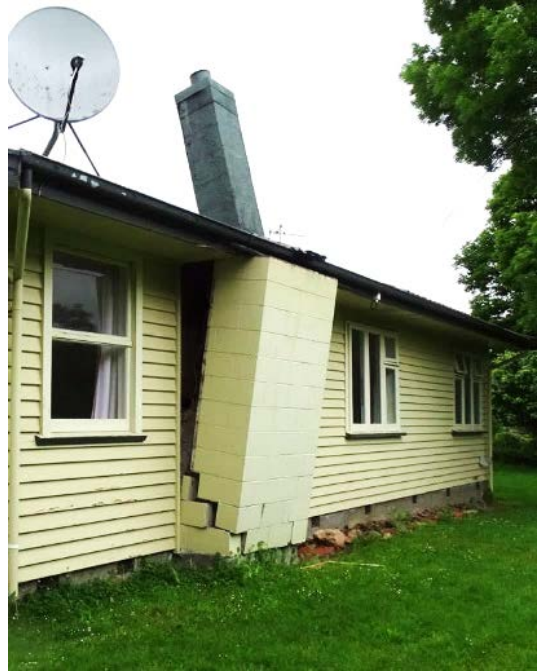
Similar damage was observed in the Marlborough region. Extensive damage to masonry veneers and chimneys, as shown in Figure 16 and Figure 17, was observed in communities as far north as Seddon. Damage to chimneys in the Marlborough area was less than expected however, because many unreinforced masonry chimneys had previously been removed or replaced with lightweight flues following the Canterbury Earthquake Sequence, the [2013 Seddon earthquake](#), and other recent earthquakes.

Figure 16. Widespread disintegration and detachment of chimneys, with examples from (a) Hamner Springs and (b) Waiau (photos: Dmytro Dizhur and Marta Giaretton).

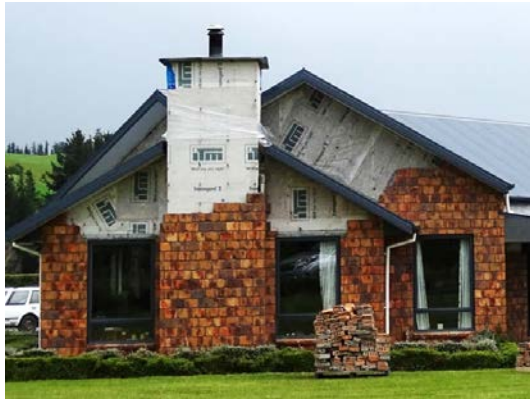
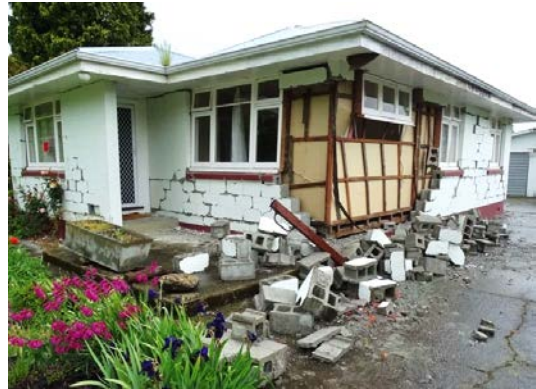
Figure 17. Damage to single family homes in Waiau including (a) partial collapse of modern brick veneer system, and (b) collapse of external house cladding (photos: Dmytro Dizhur and Marta Giaretton).

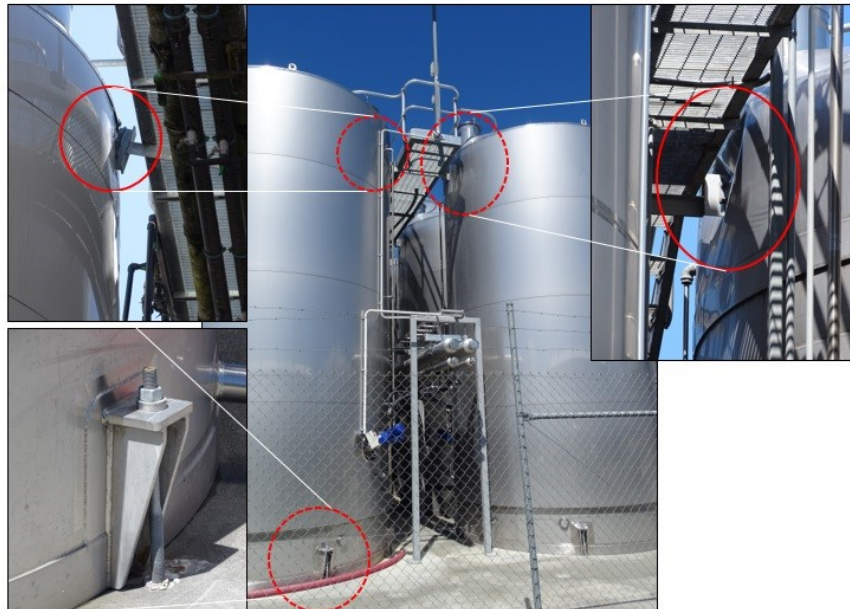
- Damage to tank anchoring systems
- Shear and pull-out failures of some storage tank anchoring connections
- Damage to the walking platforms atop of tanks due to tank movement
- Buckling and overturning of storage tanks
- Collapse of stacking systems - particularly wooden barrel storage.

Figure 18. Damage to the walking platforms atop of tanks and anchoring connections due to tank movement (photos and annotations: Dmytro Dizhur).

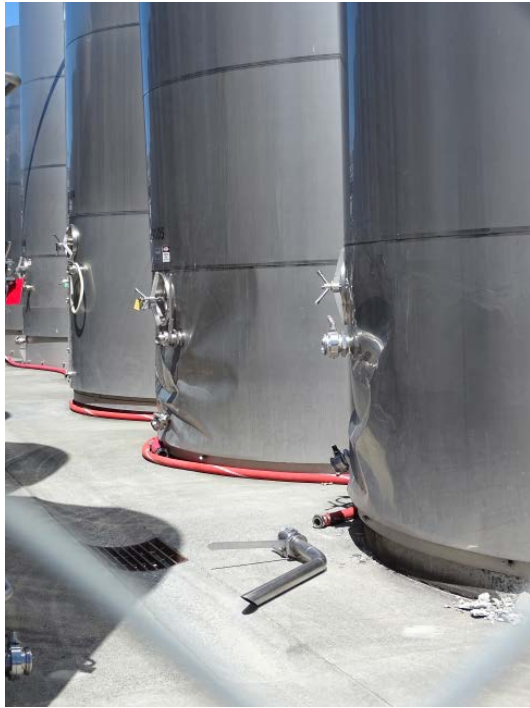
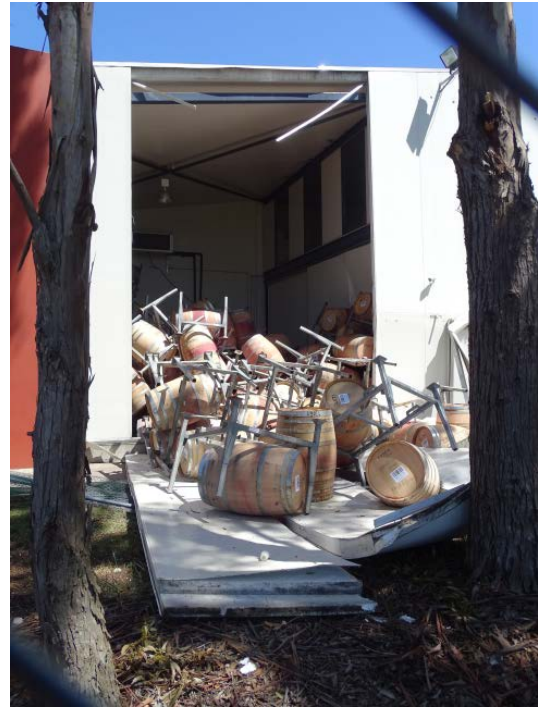
Figure 19. (a) Diamond buckling of tanks and shear failure of connections. (b) Collapse of stacking systems - wooden barrel storage (photos: Dmytro Dizhur).

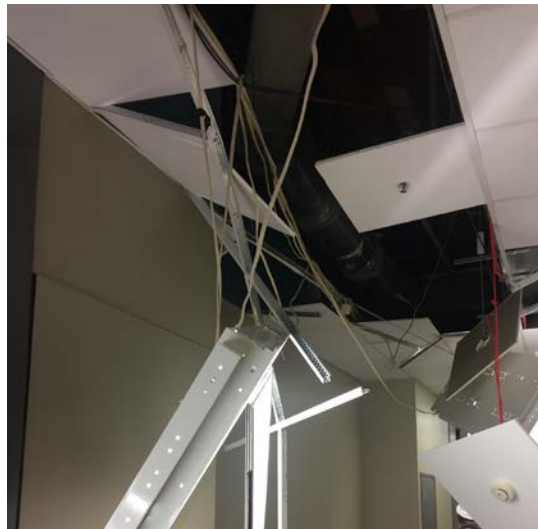
Extensive non-structural damage was observed to some commercial office buildings throughout the Wellington area including to hung ceiling and building services systems (Figure 20), external and internal wall cladding systems and architectural finishes at seismic joints within building complexes. The damage was similar to that observed in other recent earthquakes in New Zealand causing buildings to be closed for repairs and economic losses. Excellent performance of ceilings, building services and fire sprinklers was observed where these had been adequately braced for seismic impacts illustrating the benefits of bracing. Damage to exterior cladding systems was observed in multiple buildings including loss of connections for precast cladding panels and damage to curtain wall systems. In some cases, where damaged exterior cladding posed a potential threat to public spaces, affected roadways and sidewalks were closed.

Figure 20. Typical ceiling damage observed in commercial buildings (photo: Helen Ferner).
