**Preliminary Geotechnical Observations of the  
July 29, 2008  
Southern California Earthquake**

**Geo-Engineering Earthquake Reconnaissance (GEER) Association**

**Pirooz Kashighandi, Salih Tileylioglu, and Anne Lemnitzer**

August 11, 2008

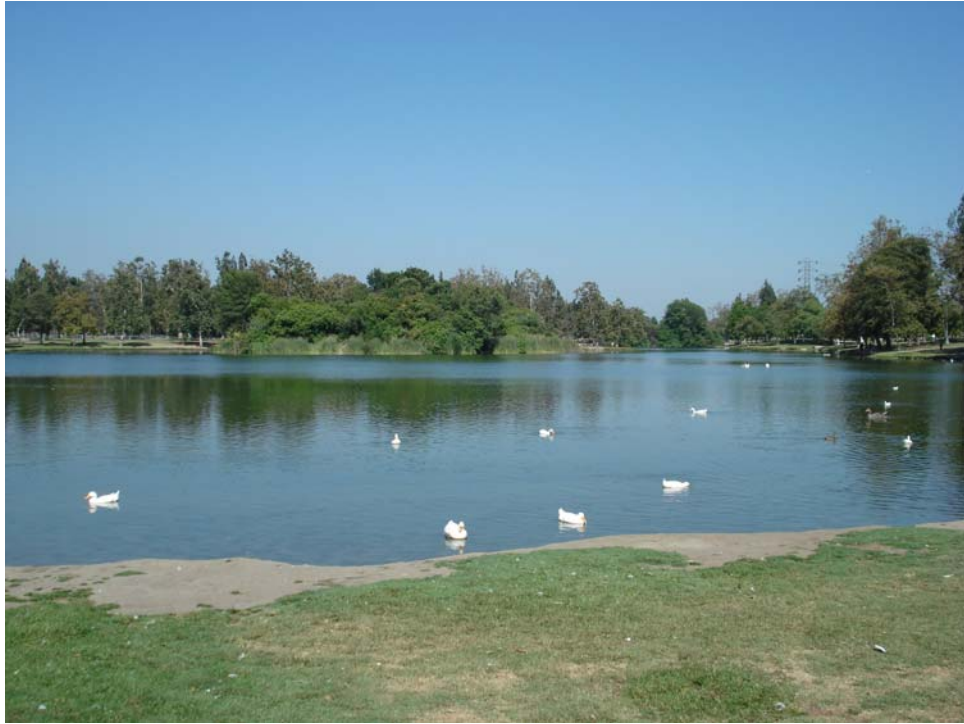
No signs of liquefaction or liquefaction-induced damage were observed during this reconnaissance effort in the areas that were investigated. While the focus of the investigation was mostly geotechnical, no signs of structural damage to bridges or buildings due to ground shaking or liquefaction were observed either. It was deduced that the ground shaking was probably not strong enough to cause liquefaction or liquefaction-related damage at areas of investigation around the epicenter of this Southern California Earthquake.

Figure 4: Close-up view of the land near North Lake in Whittier Narrows Recreation Area

The GPS track records of the observed areas during the reconnaissance are shown in Figure 3. The focus during the reconnaissance was to investigate mostly areas where the surface manifestation of liquefaction is more likely to be observed. Therefore, areas near a body of water, such as channels and ponds were investigated more rigorously. Several areas near bodies of water were investigated, while no sign of liquefaction was observed at any of those sites. Figs 4 and 5 show two views of the land around the North Lake at Whittier Narrows Recreation Area, which is only an example of many of similar sites visited. Surface evidence of liquefaction, such as ground cracks and sand boils, is not evident in Figs. 4 and 5, and was not found at any of the investigated sites.

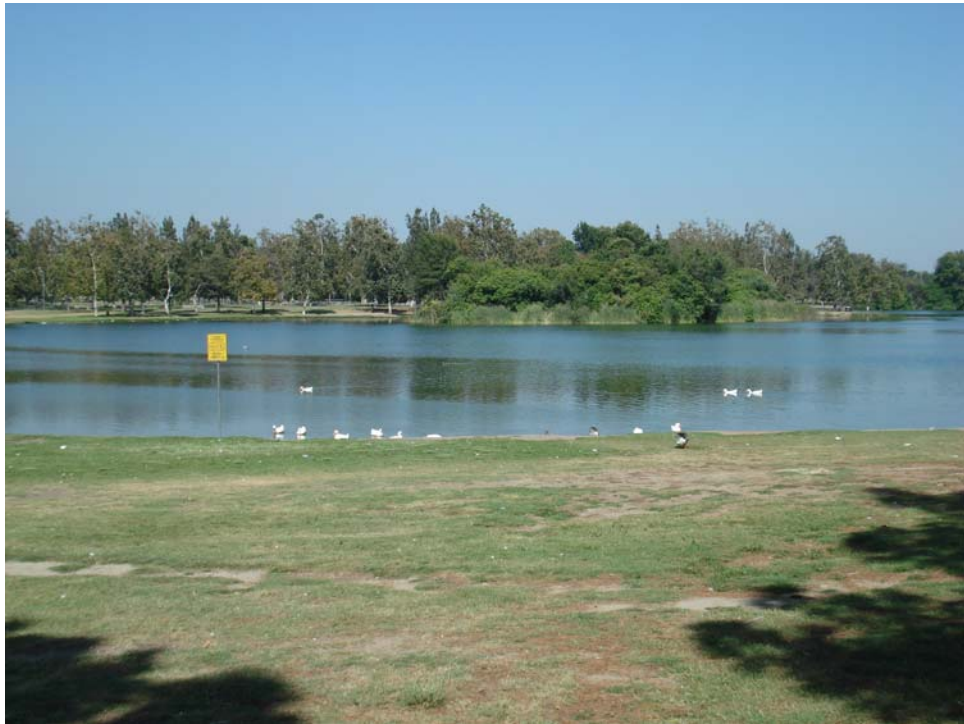
Figure 5: Another view of the land near North Lake in Whittier Narrows Recreation Area .
