Virtual Earthquakes

Jean-Pierre Bardet

GEER Workshop
UC Berkeley
May 18, 2009

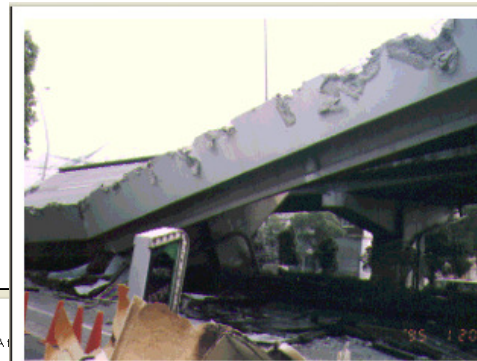
Photograph I3 Route 43 Iwaya Viaduct collapsed. Viewed from the north, the deck is leaning to the north.

1. Route 43 (Iwaya Viaduct-Kobe, Nada district). Reinforced Concrete columns of Iwaya Viaduct collapsed, and the superstructure fell down ([Photo I1](#), [Photo I2](#), [Photo I3](#), and [Photo I4](#)).

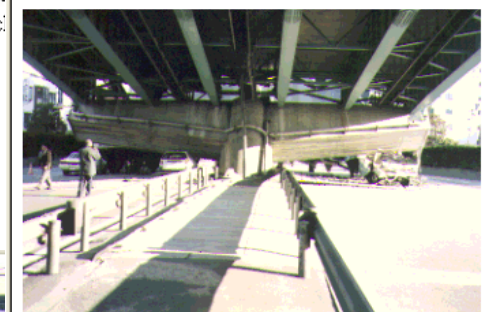
Photograph A2 Hanshin Expressway Bridge in Nishinomiya City. The photograph, taken under the collapsed deck, shows that the reinforced concrete pier is leaning sideways.

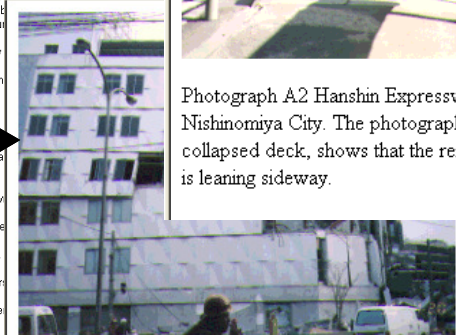
Photograph E7 Vicinity of Sannomia Station. The fourth floor of this six-storey building partially failed.

A large number of 7-12 floor reinforced concrete office buildings were damaged at middle or top floors ([Photo E1](#), [Photo E2](#), [Photo E3](#), [Photo E4](#), [Photo E5](#), [Photo E6](#), [Photo E7](#), and [Photo E8](#)). A large number of factories have been rendered inoperative by the earthquake, either directly by the destruction of their facilities, or indirectly by the interruption of their supply lines. The port of Kobe, which is the second largest port of Japan, was shut down. In Kobe, in contrast to Los Angeles, supplies are difficult to move through alternate routes. The damage to the traffic network in that small and narrow area where the mountains close in on the sea cannot be compared with Los Angeles where detours were possible when expressways collapsed during the 1994 Northridge Earthquake. The earthquake has been called Japan's greatest postwar disaster. At the present, it is difficult to assess the total amount of damage to the Japanese economy.

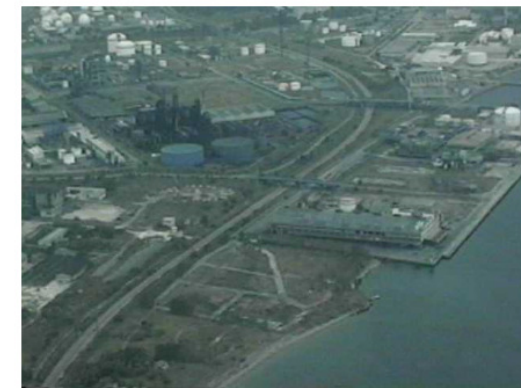
Overview of the TUPRAS refinery along the Izmit Bay after the fire that started right after the earthquake on August 17, 1999 (N40°45.938', E29°33.684', 8/24/99, 15:23:17).

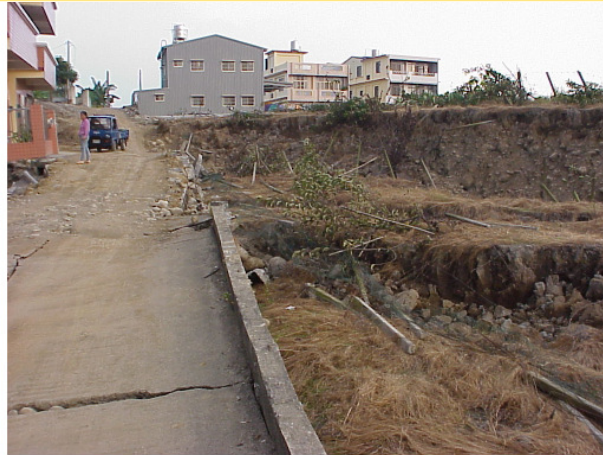
11. Close-up view of headscarp above collapsed bridge (N24.2854 E120.7969).

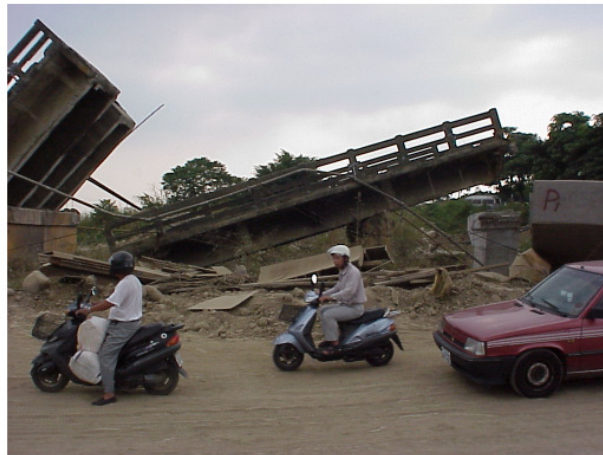
12. Collapsed bridge spans near Highway 129/136 intersection near Taiping (N 24.1335 E120.7352). The longitudinal direction for the bridge has an azimuth of approximately 300 degrees. The fault is known to pass beneath the bridge based on exposures west and east of the spans, but its precise location is unknown due to grading near the bridge. View in photo is to the NE. Note the spans have been pushed to the SE (to the right in the photograph) off their supports, possibly from compression associated with the faulting.

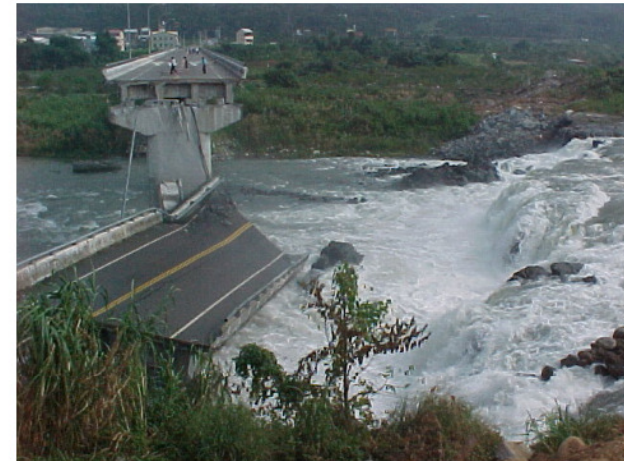
1. Waterfall created by reverse fault movement just north of the south abutment of heavily damaged multi-span bridge north of City of Fengyuan and to the west of the Shihkang Dam (N 24.2786 E 120.7592; 9/30/99)

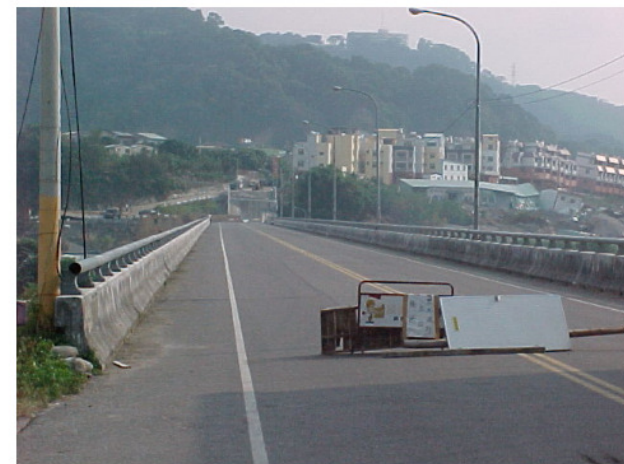
2. View to south showing right lateral offset of about 3 to 4 m and uplift or about 4 to 5 m in this bridge (N 24.28 E 120.76; 9/30/99)

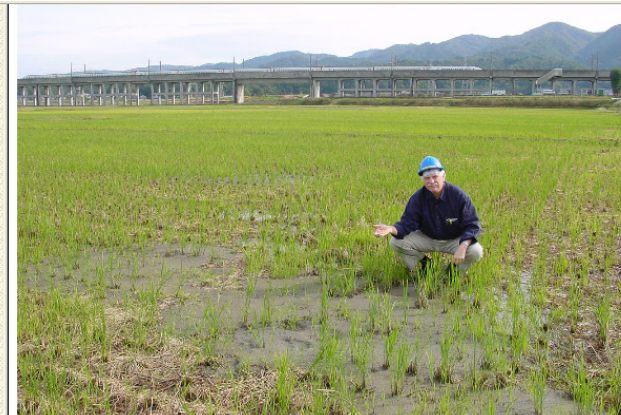
Figure 14. One of the possible explanations proposed for the Shinkansen derailment was the large amplitude of the transient viaduct displacement induced by the softening of the liquefied ground (10/31/2004 10:04:42 AM, N37.39094 E138.84270).

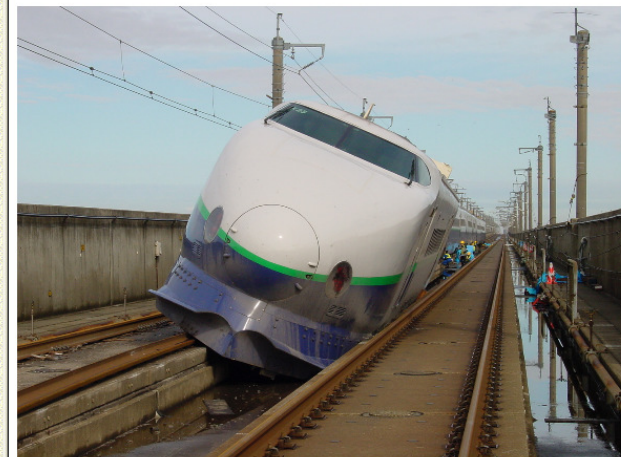
Figure 15. The last car of the Shinkansen was leaning on its side (10/31/2004 10:21:12 AM, N37.39063 E138.84570).

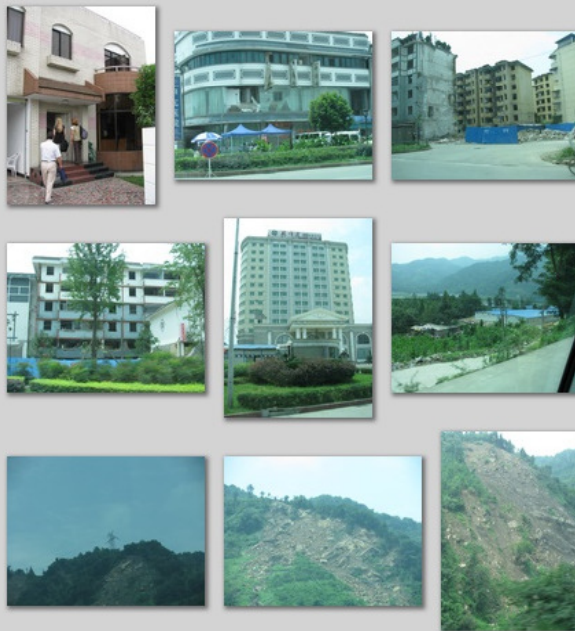
August 4, 2008 Post-Earthquake Reconnaissance of Wenchuan Earthquake, May 12, 2008 -- Landslide on rock ridge with debris flow
