# GEER Efforts in China after May 12, 2008 Sichuan Earthquake

J. David Frost Georgia Tech

#### **Event Summary**

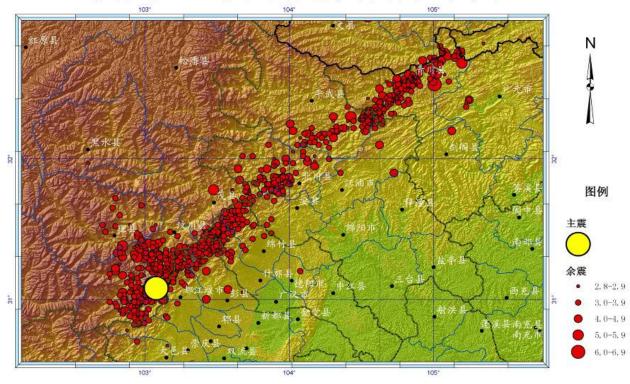
#### 汶川8.0级地震余震分布图

7 with Ms > 6 37 with Ms > 5 244 with Ms > 4

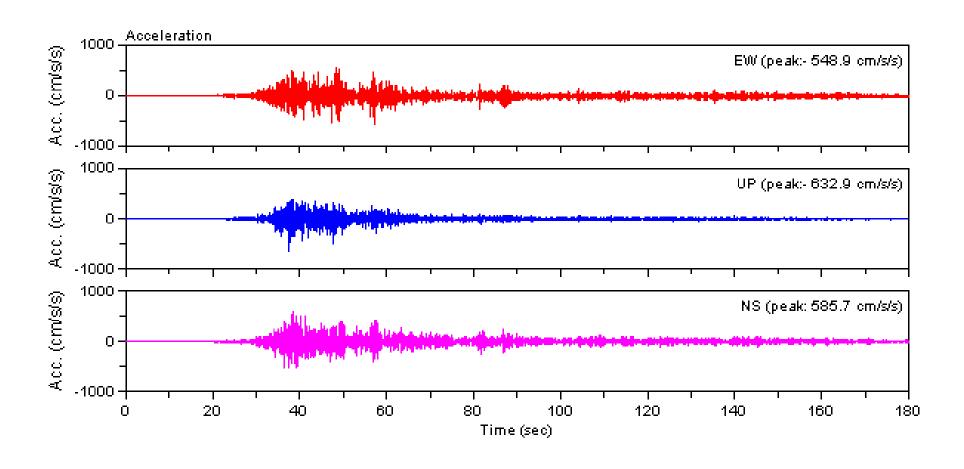
## **Example Ground Motion Record**

Bajiao Station – Shifang City Courtesy of IEM/CEA

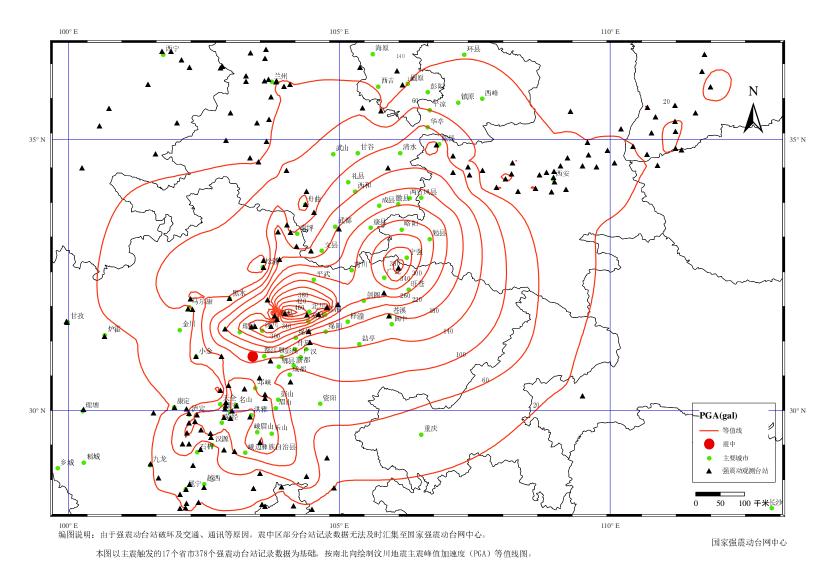
PGA (EW) Distribution

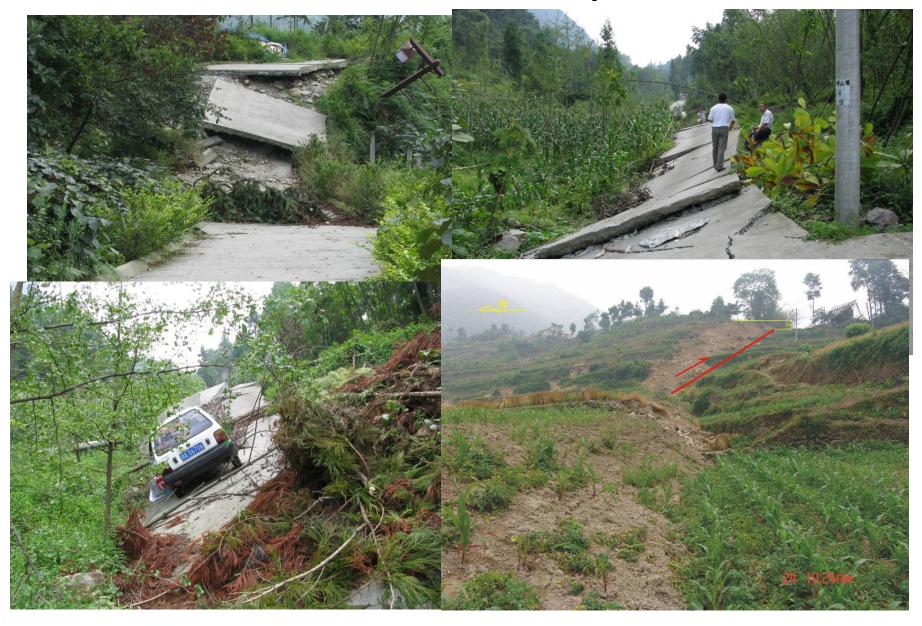
# Surface Fault Rupture

- Rupture occurred along multiple fault segments (Yingxiu-Beichuan and Pengguan faults)
- Yingxiu-Beichuan rupture produced both thrust and right lateral movements (similar magnitudes up to 5+ m)
- Smaller surface deformations along Pengguan fault
- Topographic variations produced locally complex surface deformations

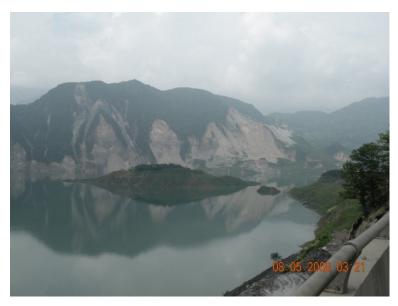
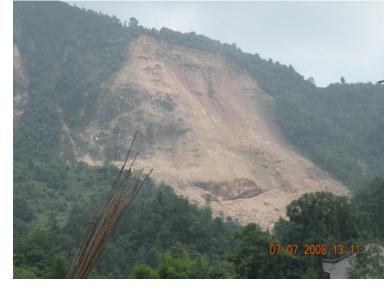
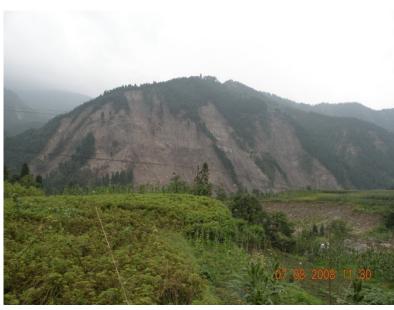
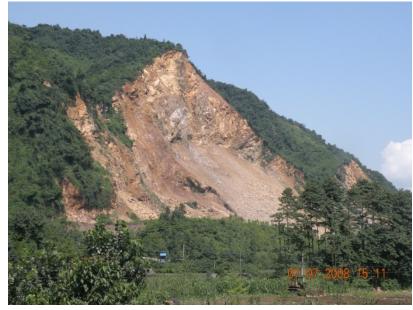
## Landslides

- Extensive post event field studies conducted by SKLGP-CUT show as of late July, 2008
- >9,600 geo-hazards (landslides, slope collapses, debris flows, unstable slopes)
- 26 landslides involved movement of > 10M m<sup>3</sup>
   (range 18M to 10 M m<sup>3</sup>)
- 16 landslides yielded > 30 casualties (range 1600 to 35)

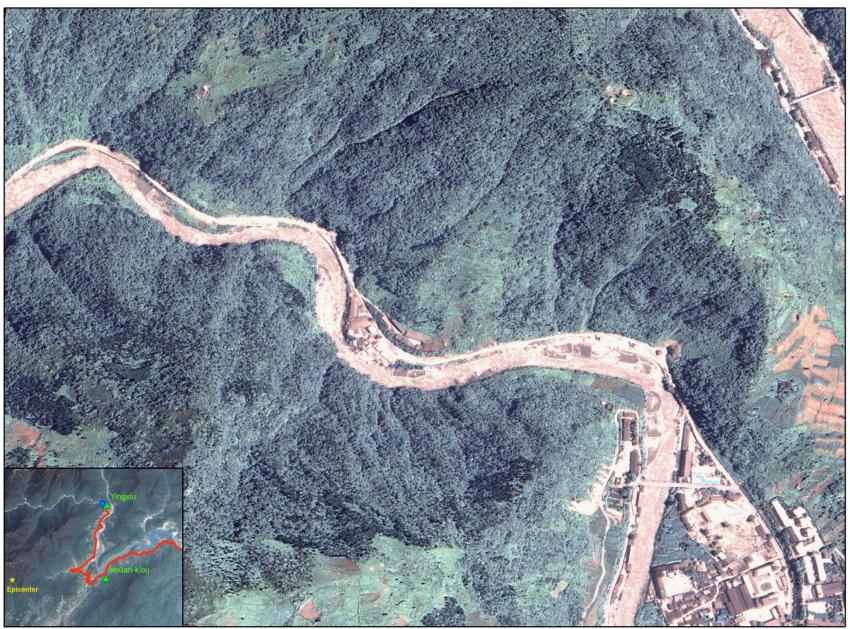
Image: Quickbird True Color Pan Sharpened Satellite Imagery Acquistion Date: June 26, 2005 Spatial Resolution: 0.6 Meters

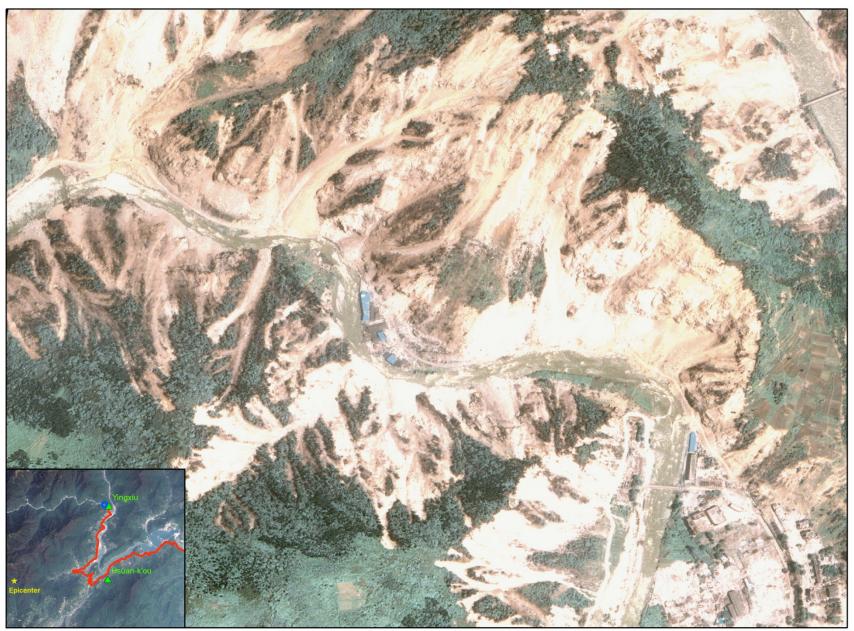
Image: Quickbird True Color Pan Sharpened Satellite Imagery Acquistion Date: June 3, 2008 Spatial Resolution: 0.6 Meters
