# RECONNAISSANCE FOLLOWING THE AUGUST 14, 2021 HAITI EARTHQUAKE: PERSPECTIVES FROM GEOTECHNICAL ENGINEERING AND SOCIAL/POLITICAL SCIENCES

Geotechnical Extreme Events Reconnaissance (GEER) Report No. 073

Version 1.0: February 3, 2021

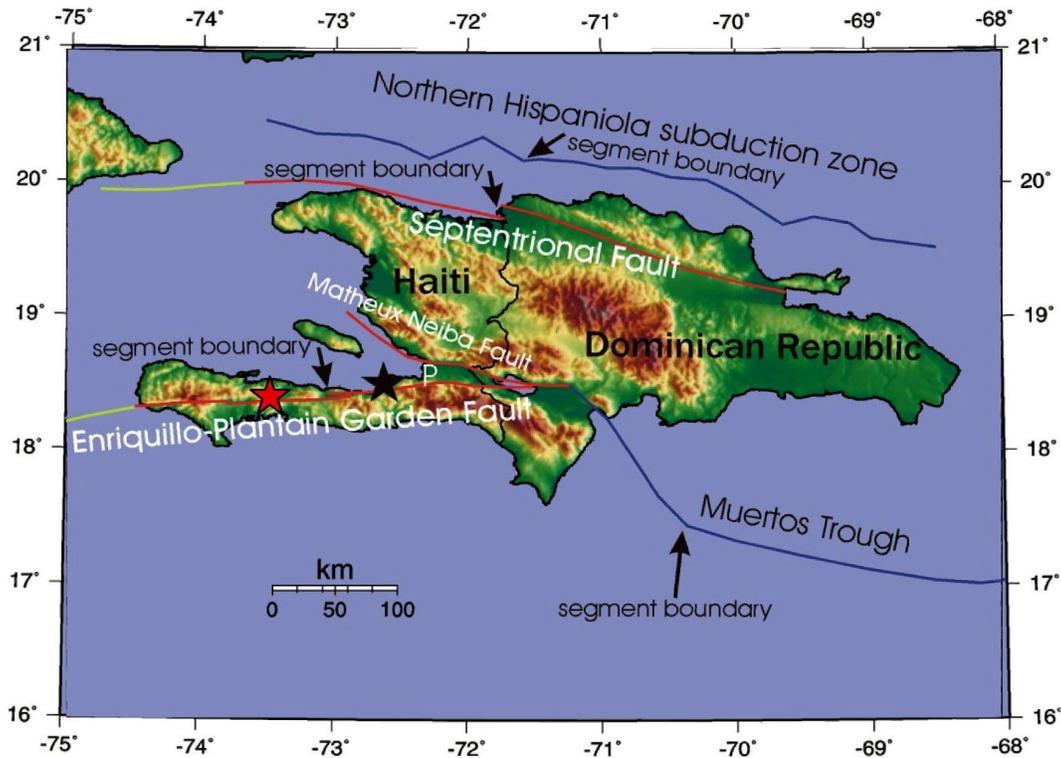
**Figure 3.3.** Crustal Faults are shown in red and green, while subduction zones are shown in blue. The black star shows the epicenter of the M7.0 12 January 2010 Haiti earthquake with respect to Port-au-Prince (denoted as “P”), while the red star depicts the epicenter of the M7.2 14 August 2021 Haiti earthquake (modified after Frankel et al 2011).

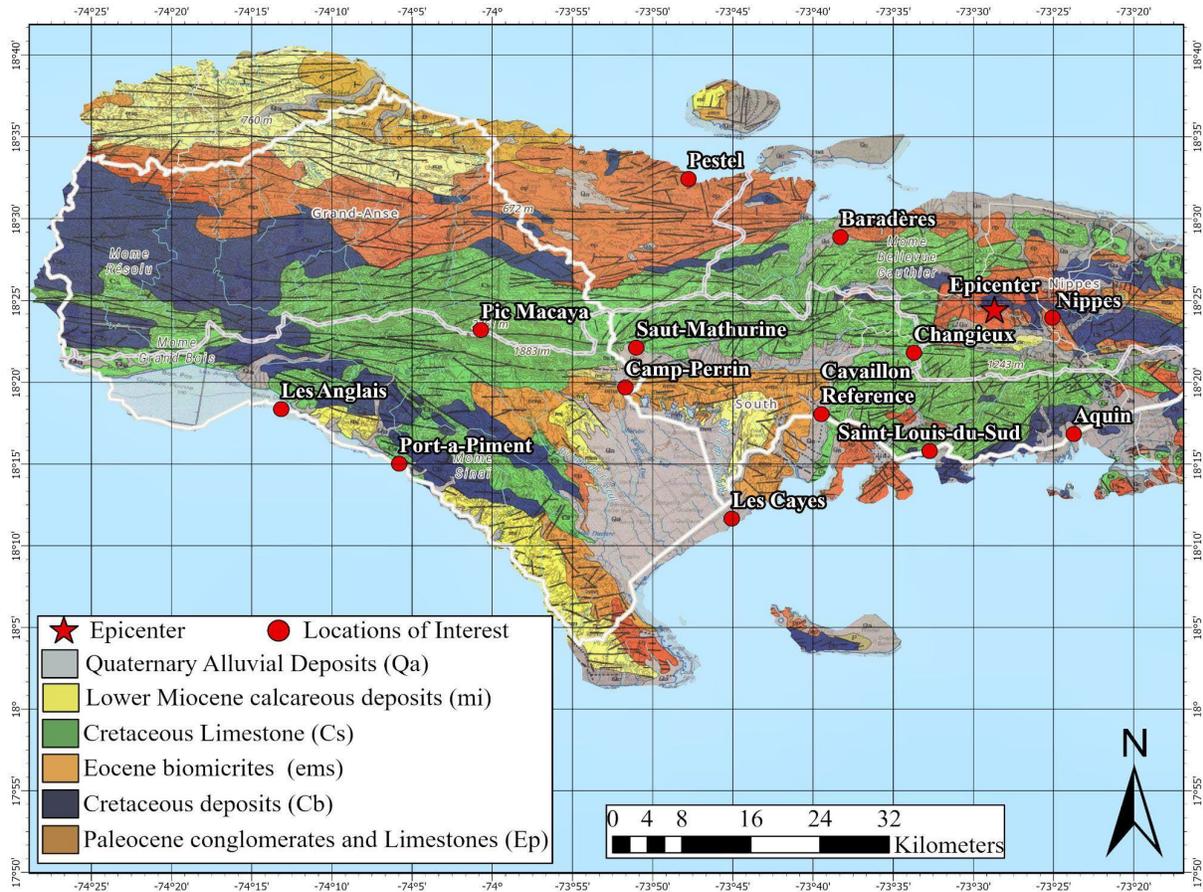
**Figure 4.2.** Regional geological map highlighting the locations where ground failure or damage was observed [Modified after Bureau des mines et de l'énergie d'Haïti (1986)]

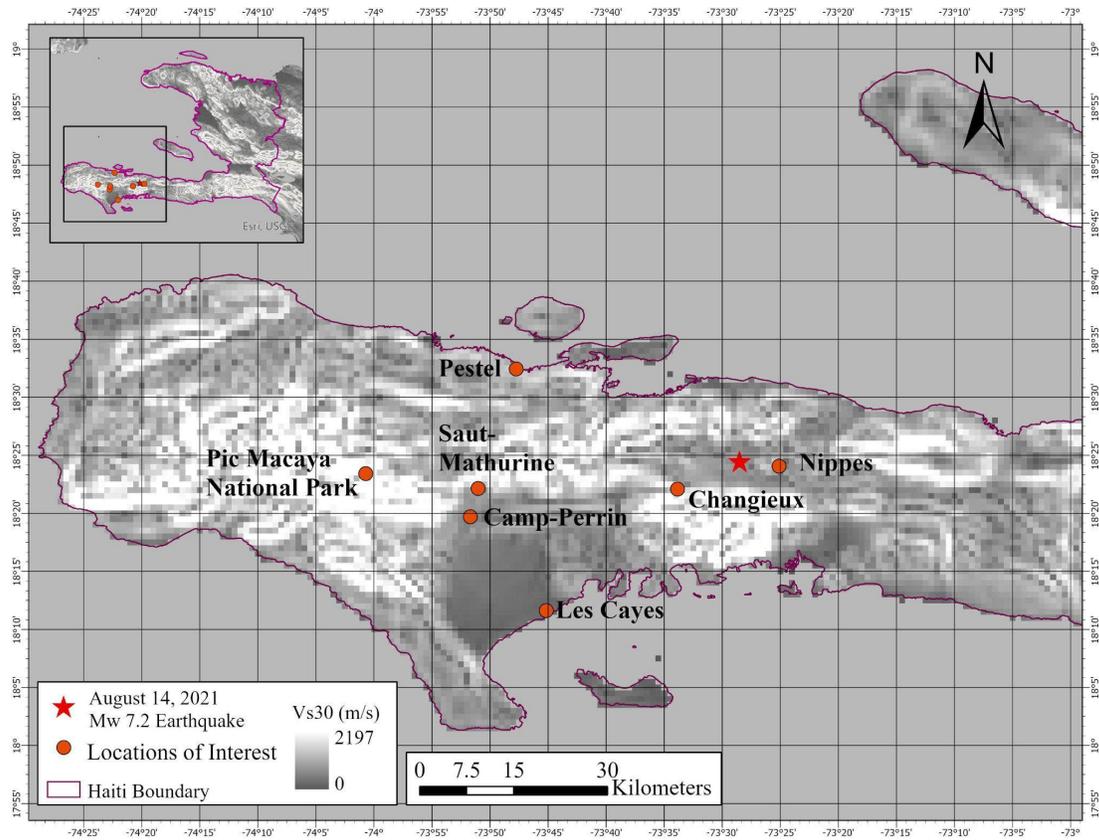
**Figure 4.4.** Regional map with the locations of interest overlaid on the proxy-based Vs30 distribution map of Haiti (from USGS).

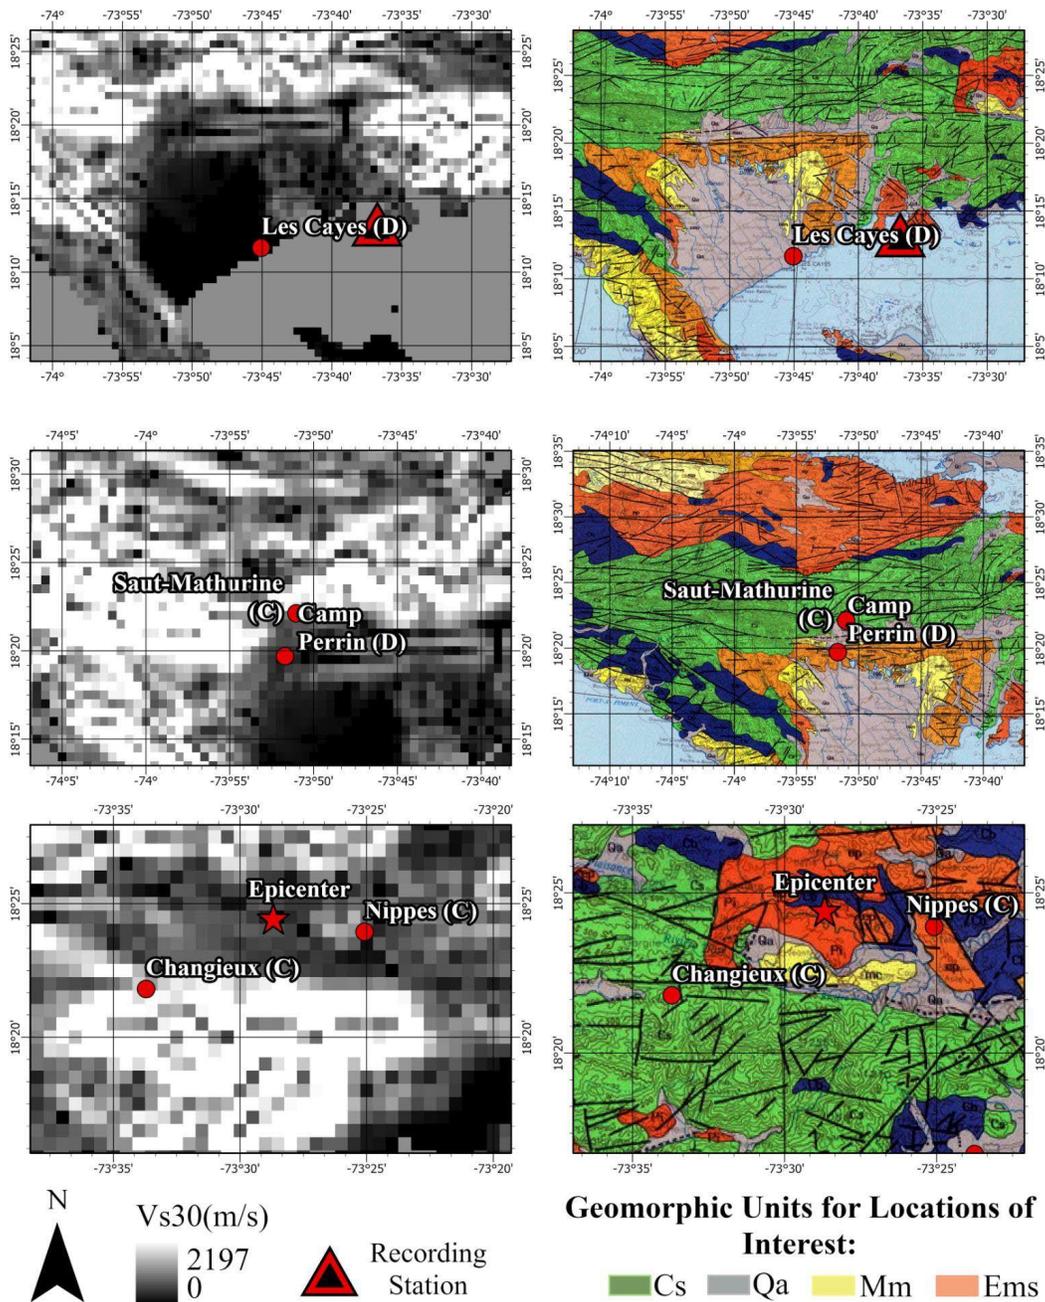
**Figure 4.5.** Comparison of the approximated Vs30 proxy maps with the regional geologic maps within the regions of interest and the corresponding NEHRP (BSSC, 2003) soil classification.

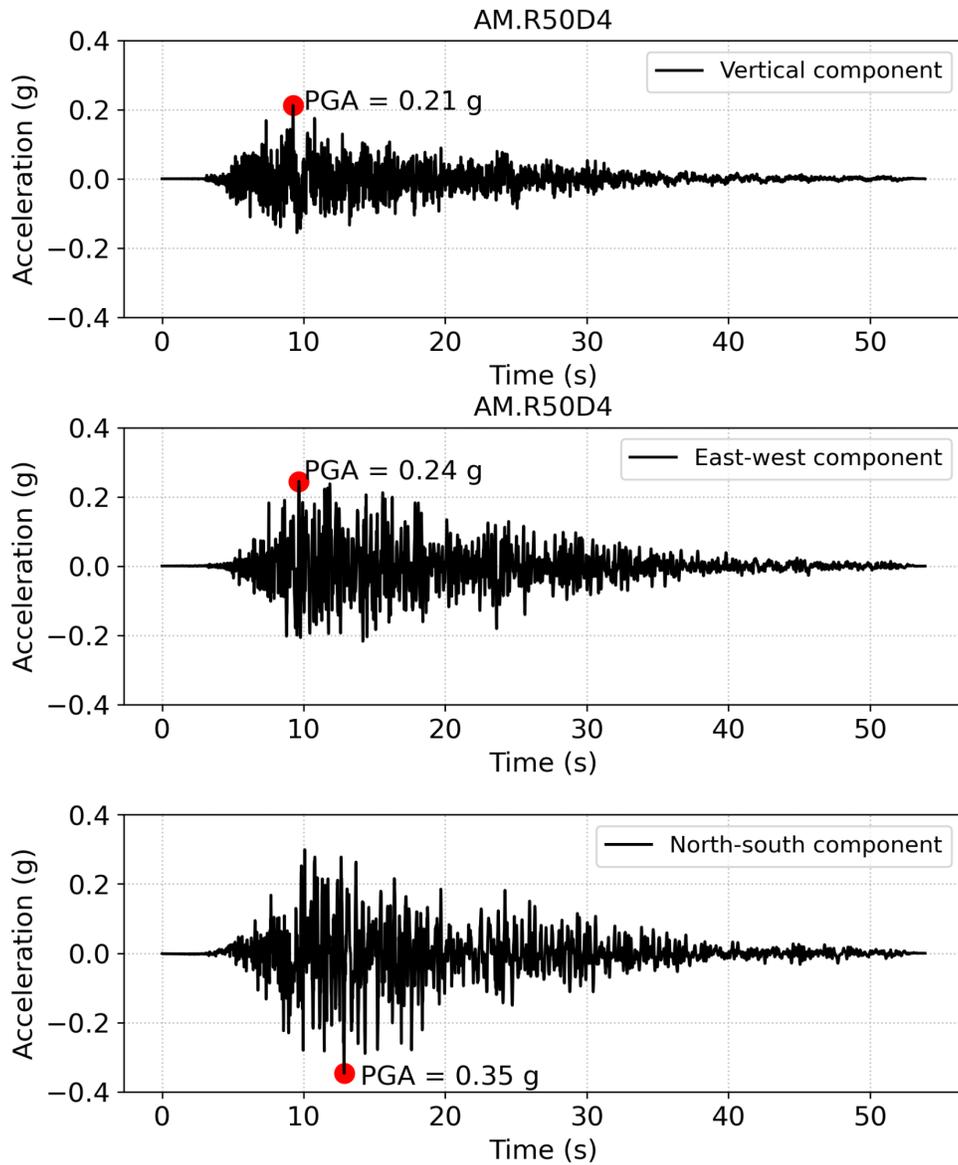
**Figure 5.8.** Acceleration time series observed at station AM.R50D4 during the 2021 Nippes Earthquake.

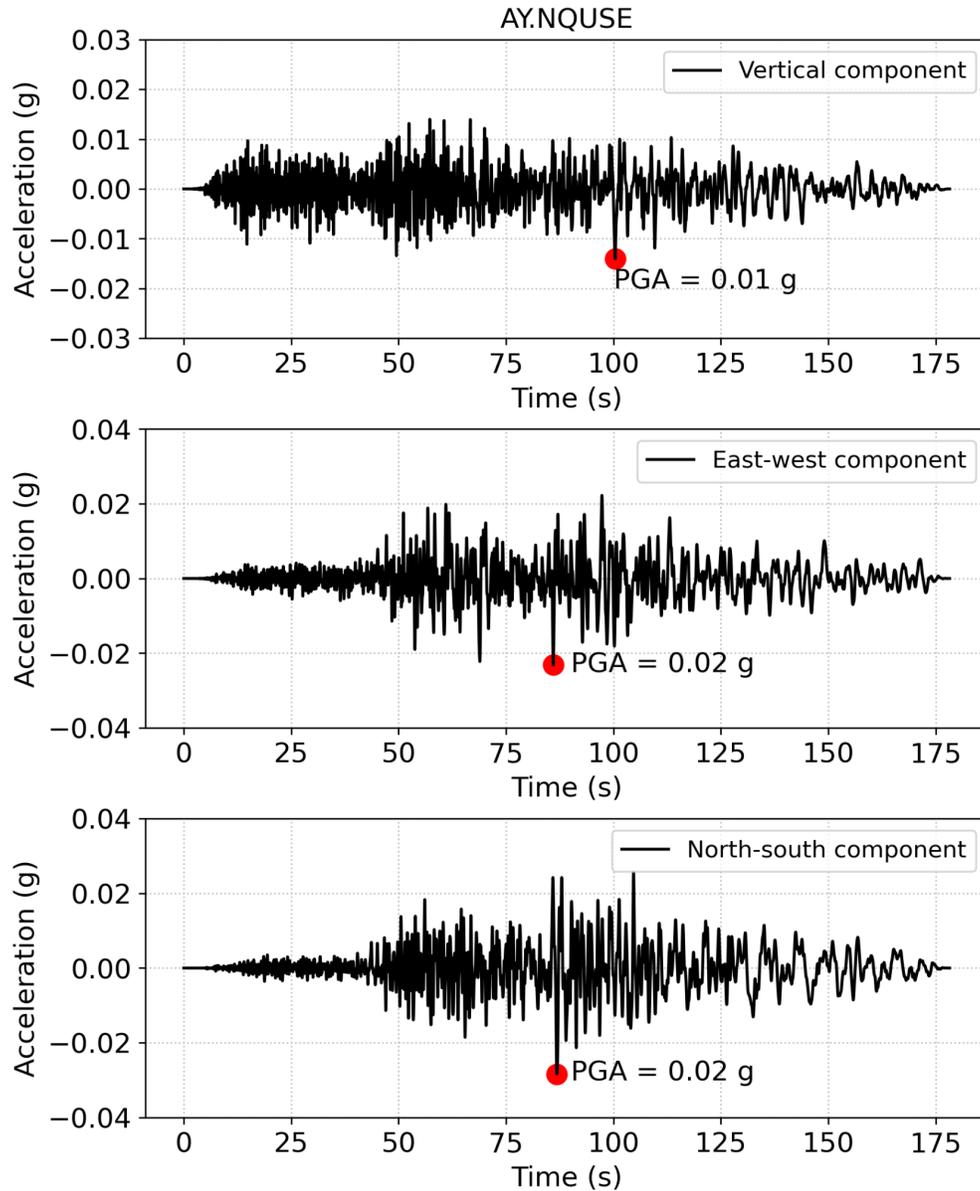
**Figure 5.9.** Acceleration time series observed at station AY.NQUSE during the 2021 Nippes Earthquake.

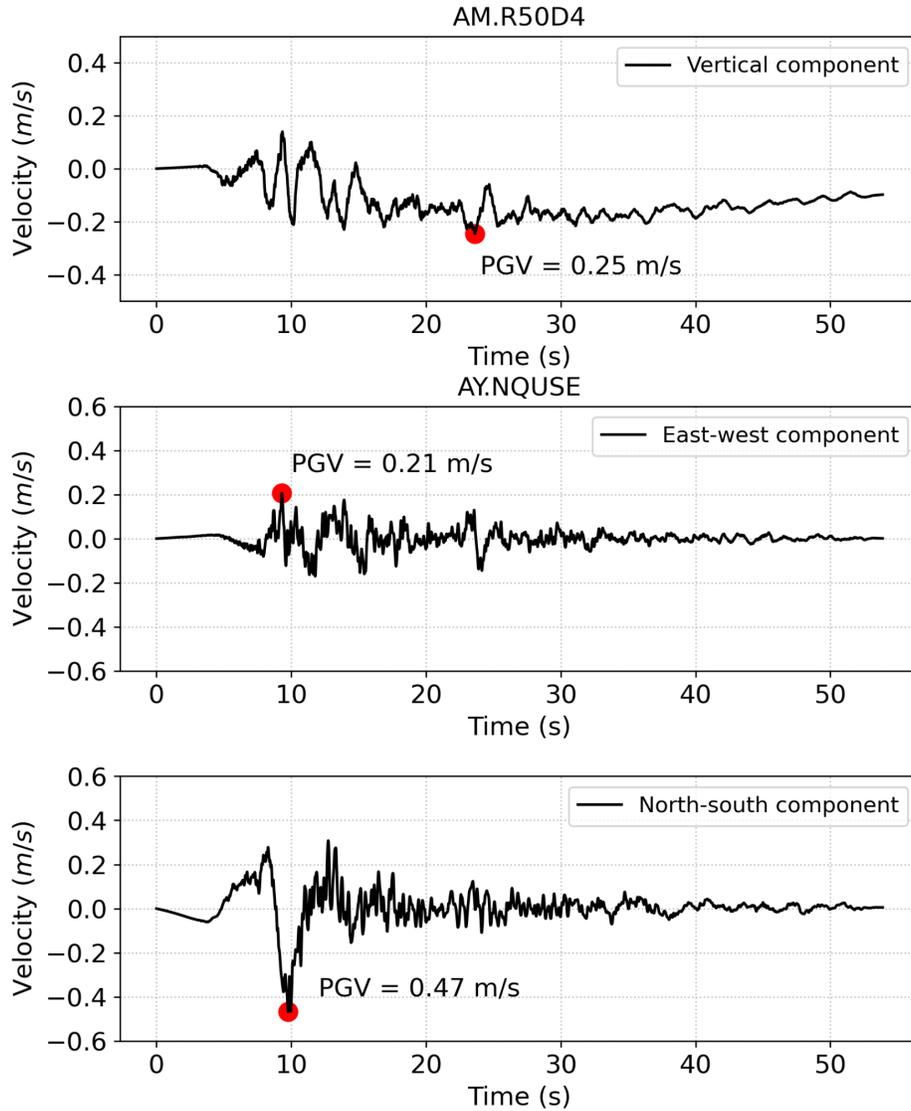
**Figure 5.10.** Velocity time series observed at station AM.R50D4 during the 2021 Nippes Earthquake.

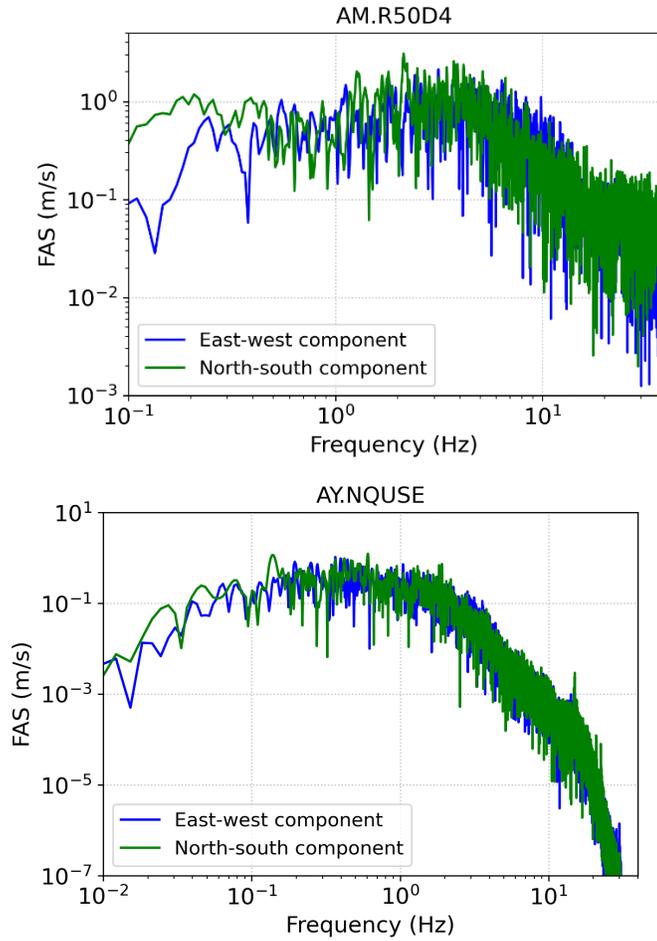
**Figure 5.11.** Comparison of the Fourier amplitude spectra in the two orthogonal horizontal directions observed at stations AM.R50D4 and AY.NQUSE. The AM.R50D4 may indicate potential directivity effects in the amplification of low-frequency motions in the north-south component.

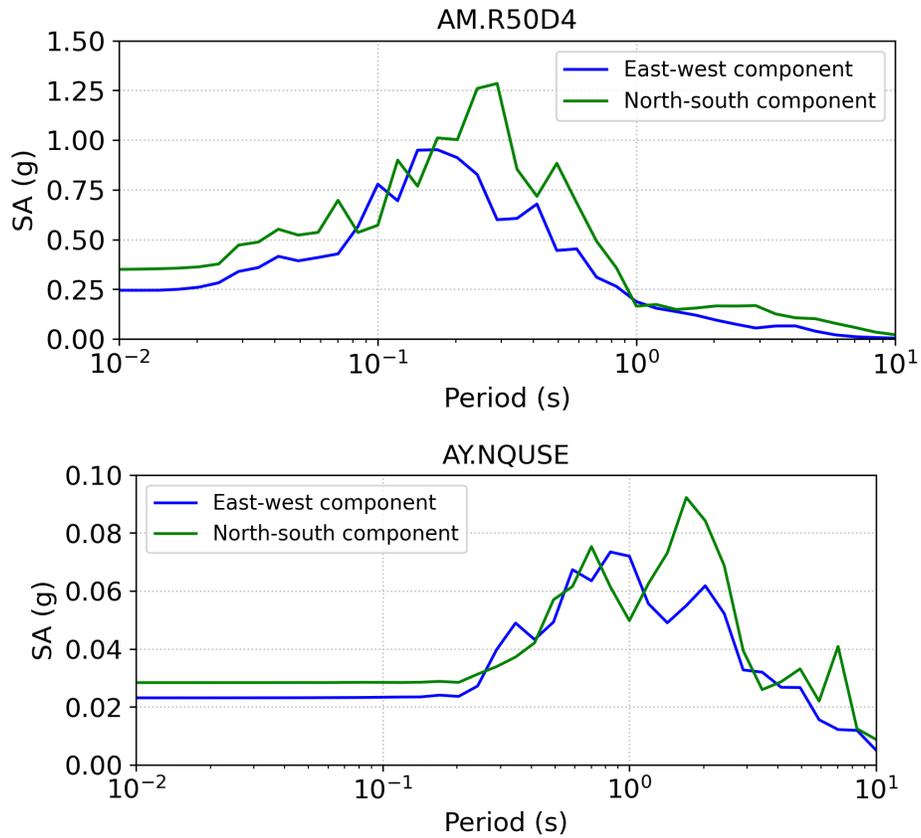
**Figure 5.12.** Comparison of the acceleration response spectra (5%-damped) in the two orthogonal horizontal directions observed at stations AM.R50D4 and AY.NQUSE. The AM.R50D4 may indicate potential directivity effects in the amplification of long-period motions in the north-south component.

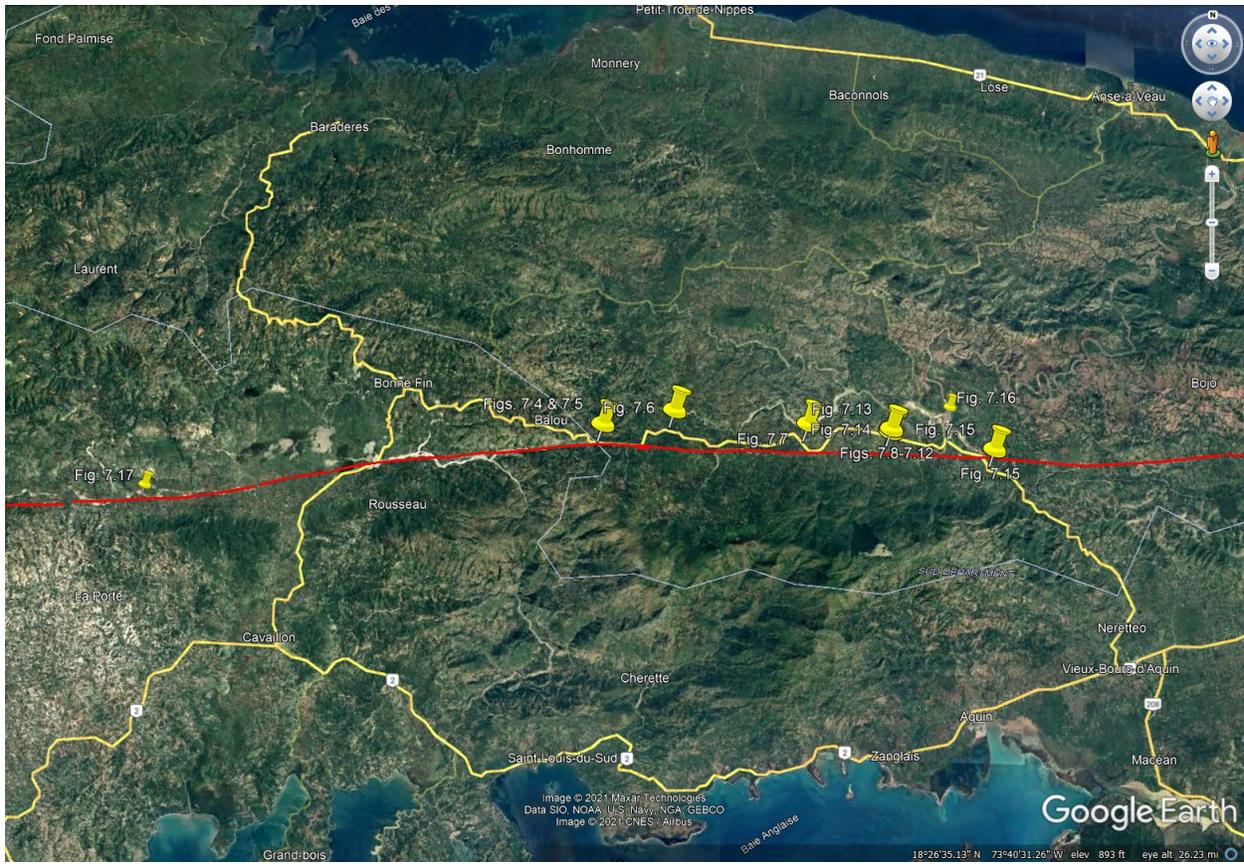
**Figure 7.3.** Locations of geotechnical observations nearest to the Enriquillo-Plaintain Garden Fault (courtesy of Google Earth). The Enriquillo-Plaintain Garden Fault is delineated in red by Saint Fleur et al. (2020). The pins correspond to the location of subsequent figures.

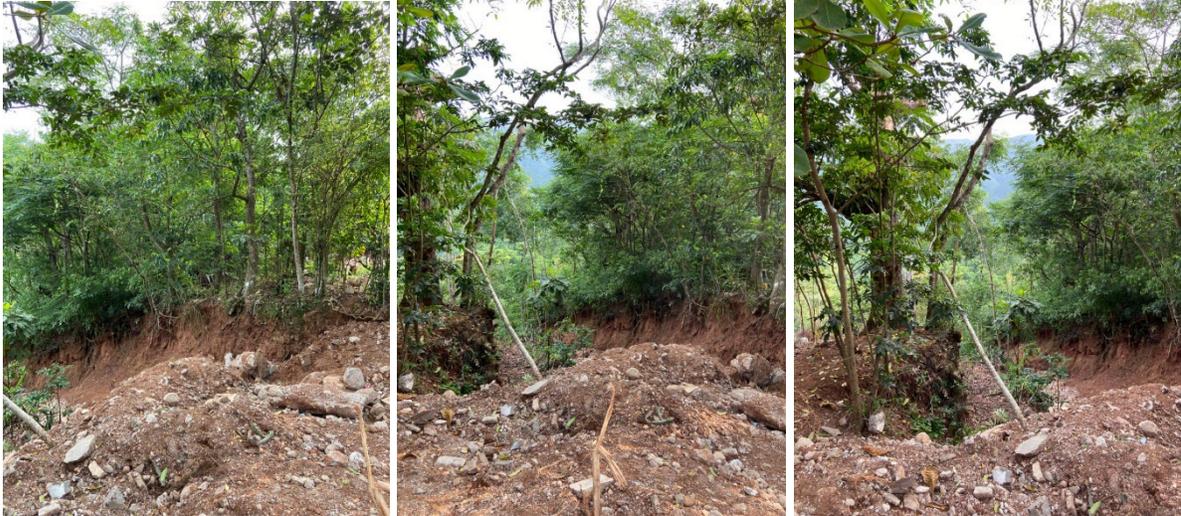
(a) (b) (c)  
**Figure 7.6.** Slope failure near Balou (Lat: 18.37866, Lon: -73.51278).

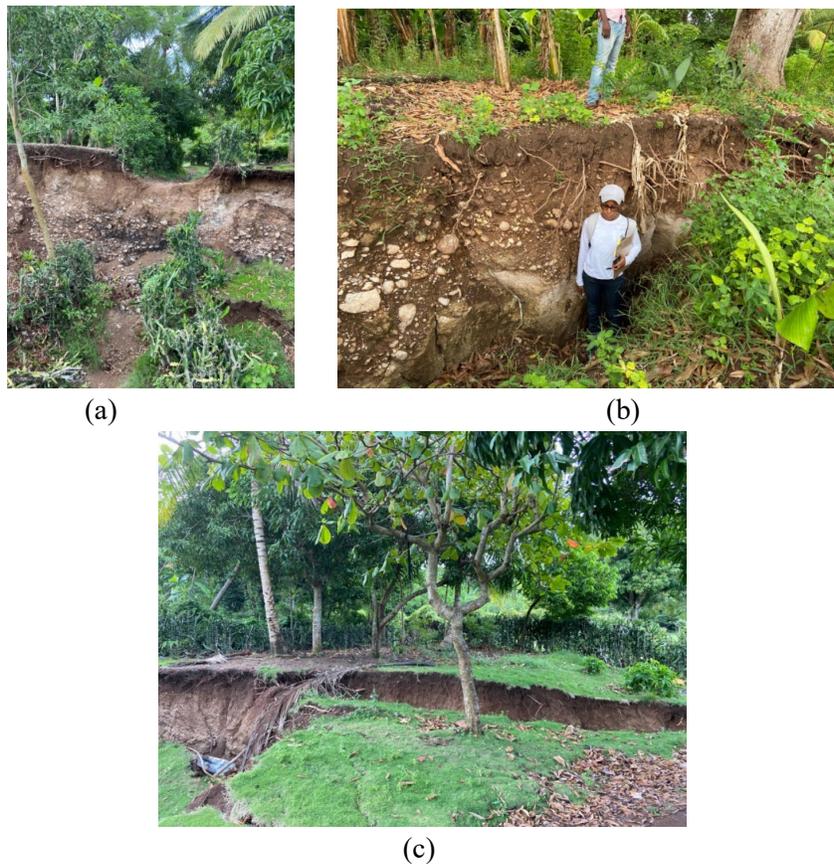
**Figure 7.8.** Upslope view of scarp associated with ground failure near L'Asile (Lat: 18.37444, Lon: -73.43278). For scale, person in (b) is 1.6 meters in height.

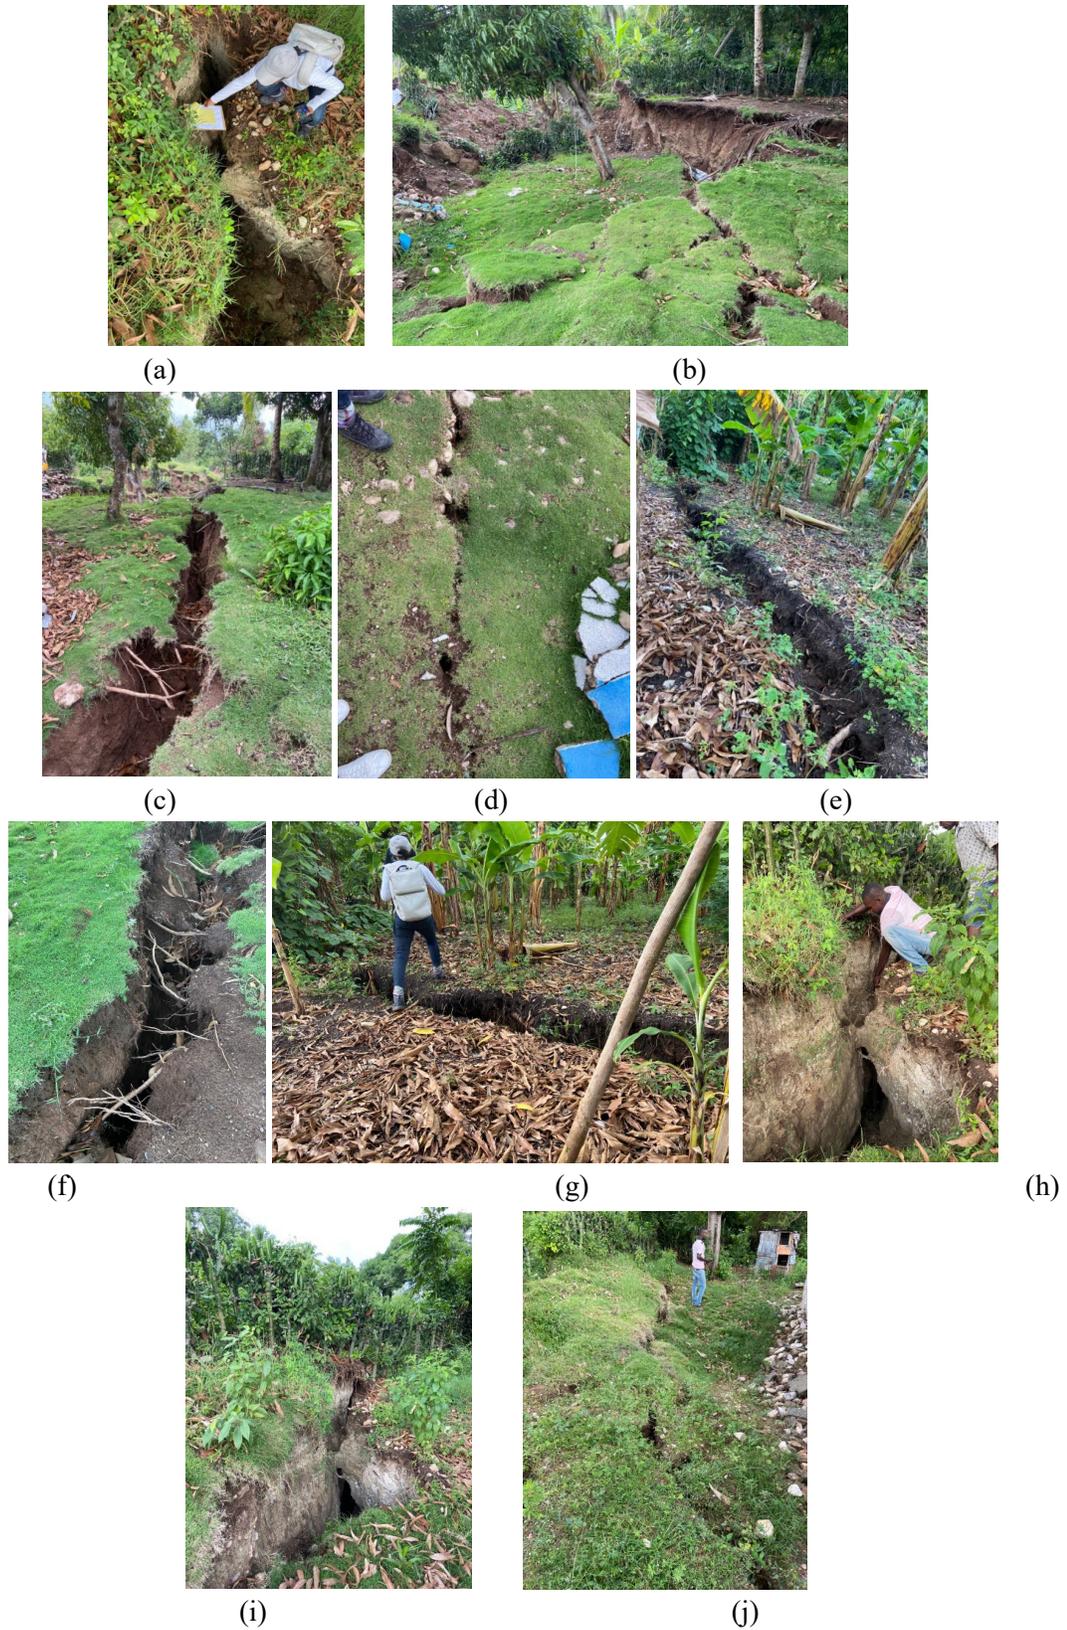
**Figure 7.10.** Ground cracking associated with ground failure near L'Asile shown in Figs. 7.8 and 7.9 (Lat: 18.37444, Lon: -73.43278).

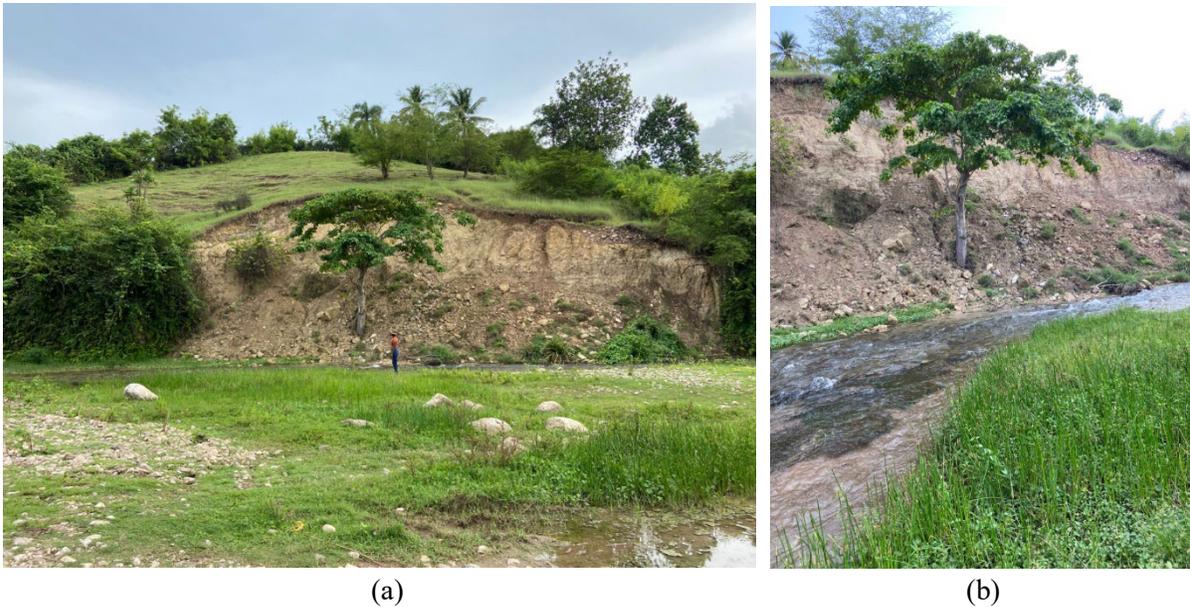
**Figure 7.14.** Landslide adjacent to river in Saint Ange (Lat: 18.37333, Lon: -73.43278)

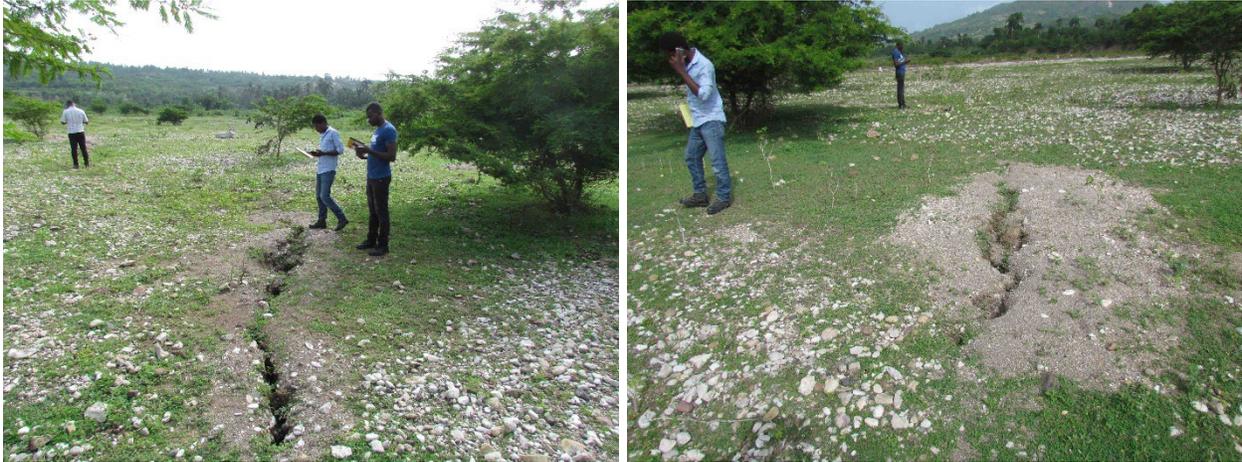
**Figure 7.16.** Surface cracks with evidence of sand ejecta immediately adjacent to the cracks (Lat: 18.38574, Lon: -73.41023). Photos taken on August 25, 2021, courtesy of Dr. Newdeskarl Saint Fleur.

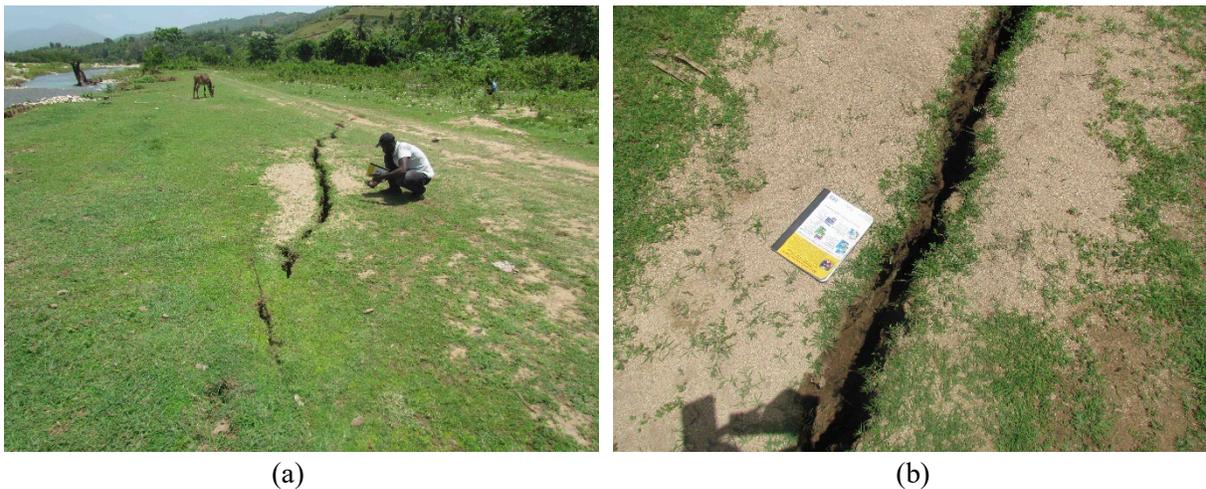
**Figure 7.17.** Surface cracks with evidence of sand ejecta immediately adjacent to the cracks (Lat: 18.35, Lon: -73.70694). Photos taken on August 28, 2021, courtesy of Dr. Newdeskarl Saint Fleur.

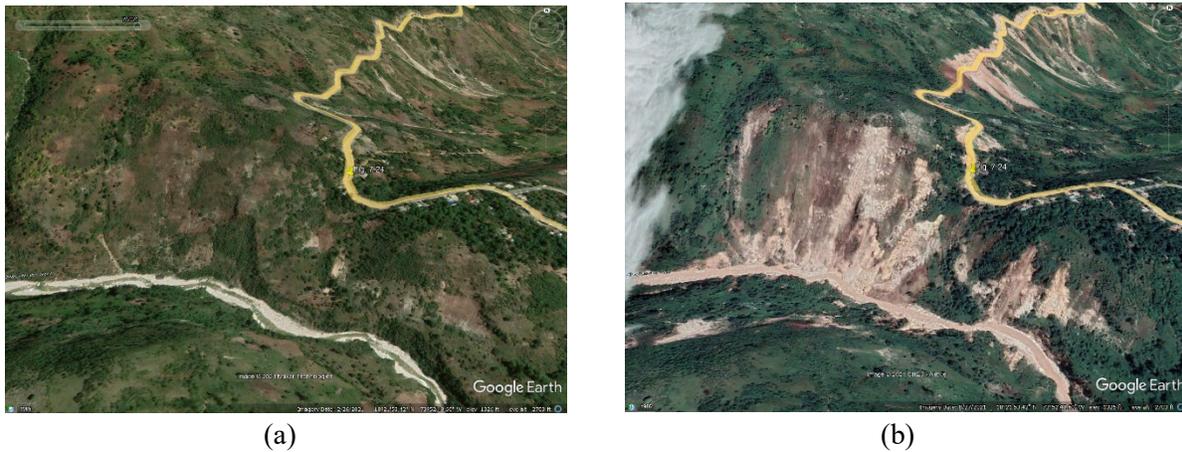
**Figure 7.27.** Pre-event and post-event satellite imagery of landsliding along RN7 west of Champlois (courtesy of Planet Labs, planet.com): (a) February 26, 2021. (b) August 27, 2021.

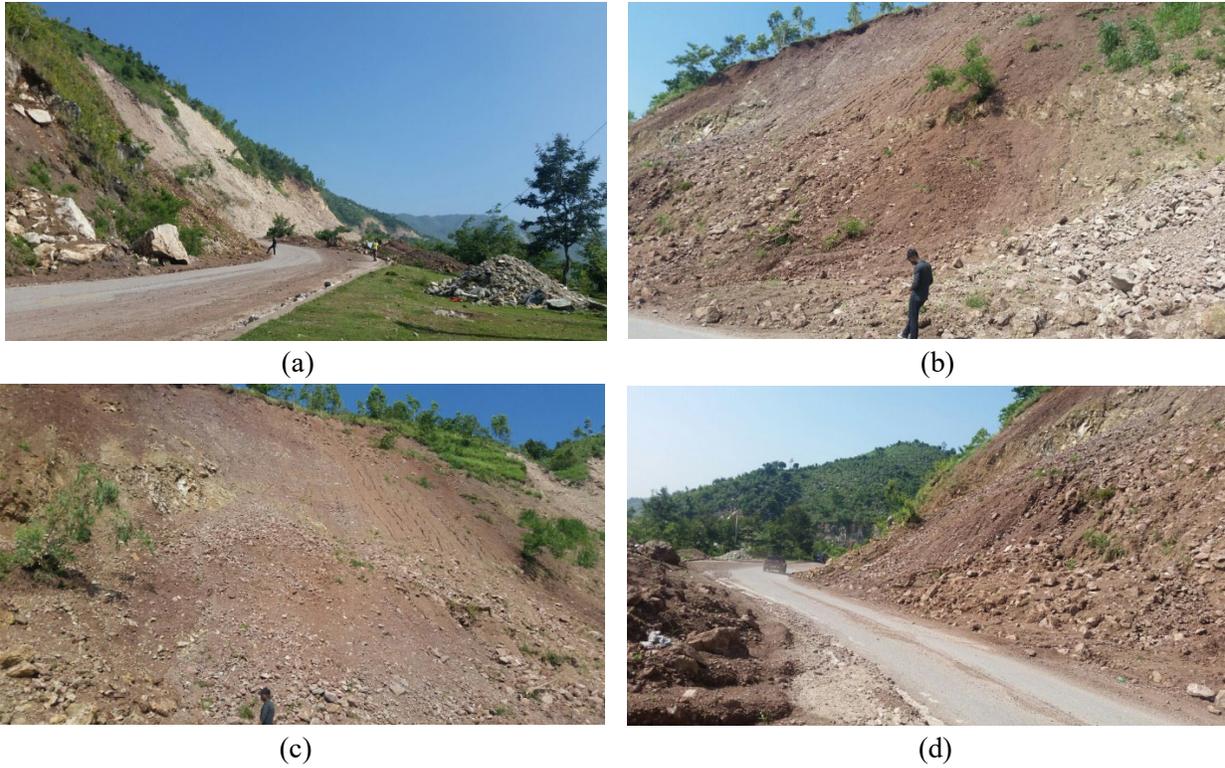
**Figure 7.29.** Slope failure along RN7 associated with 1.6 km stretch of landslide activity (Lat: 18.3688969905183, Lon: -73.8789592310786).

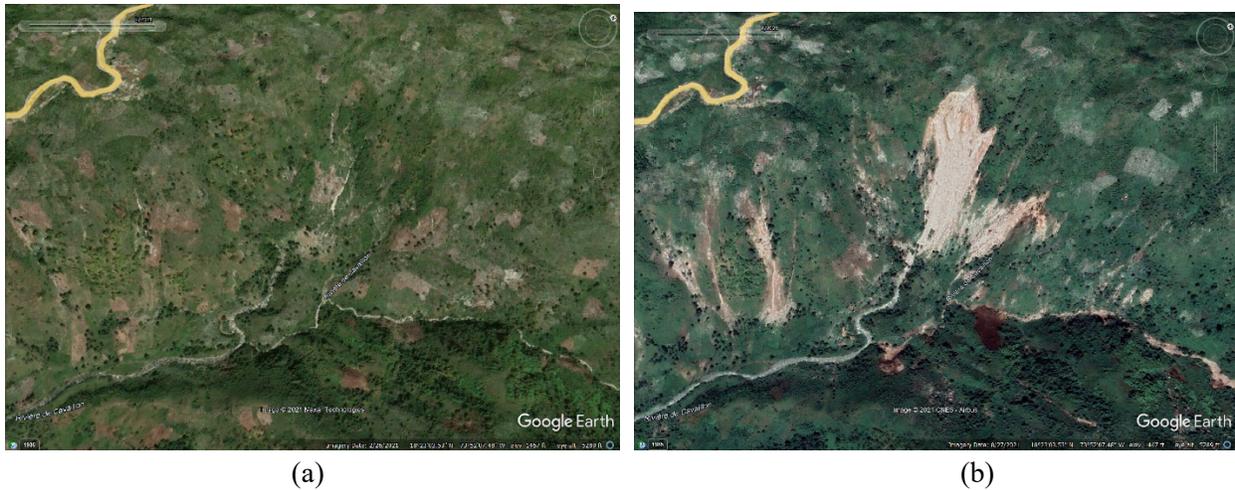
**Figure 7.41.** Landslide near RN7 with an average slope 47% over length of ~0.4 km as measured in Google Earth (18.385256, Lon: -73.869594). (a) February 26, 2021. (b) August 27, 2021.

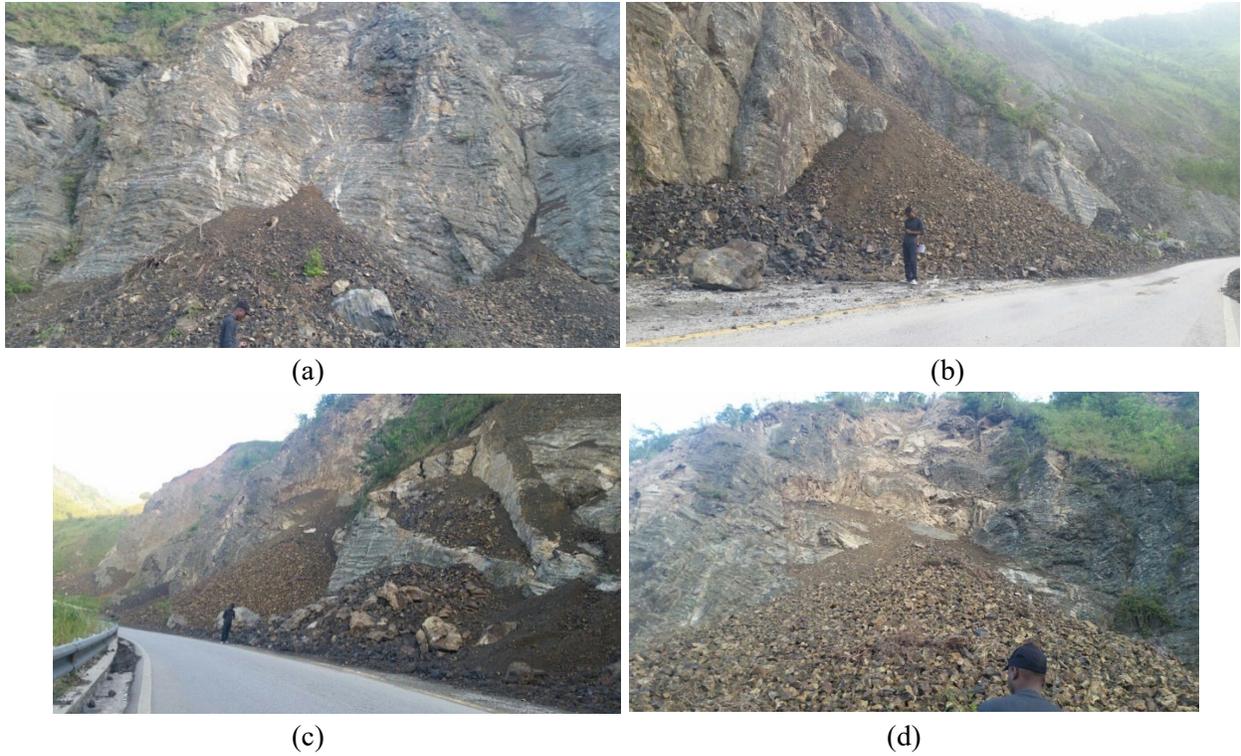
**Figure 7.52.** Slope failure along RN7 (Lat: 18.418817, Lon: -73.9027543).

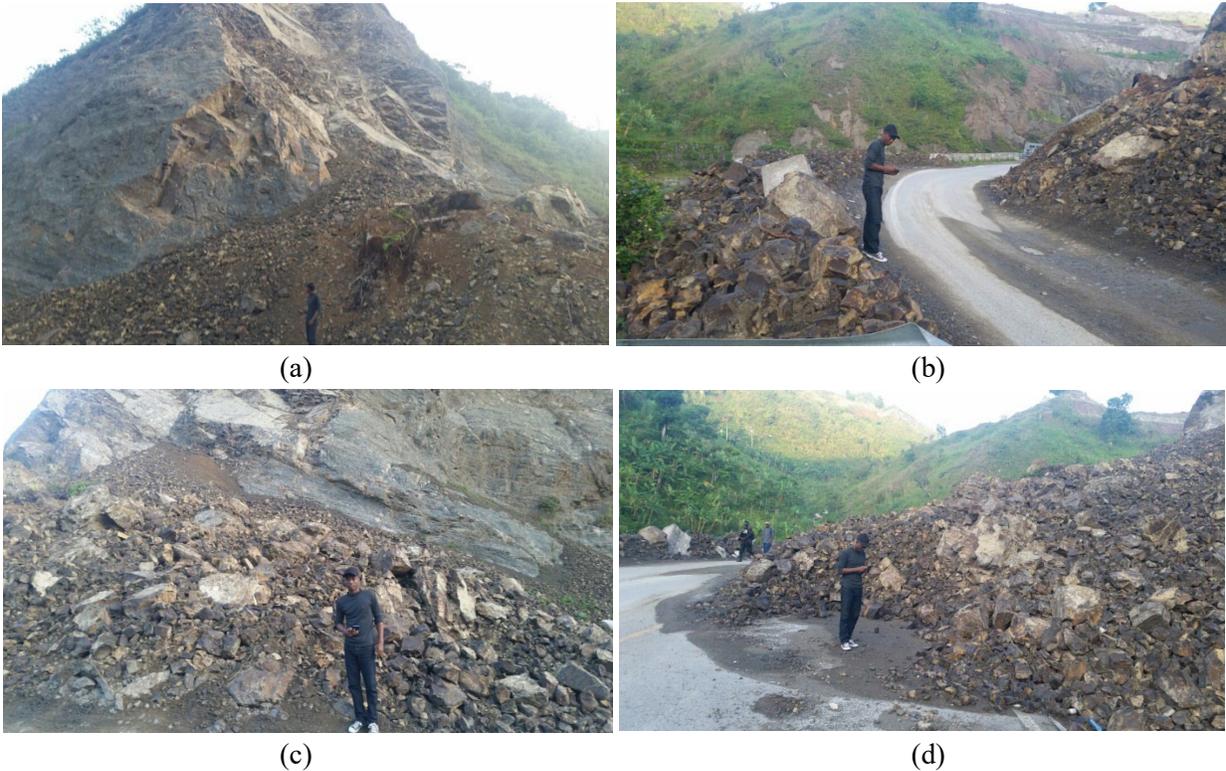
**Figure 7.53.** Debris flow on RN7 (Lat: 18.4189306, Lon: -73.903528)

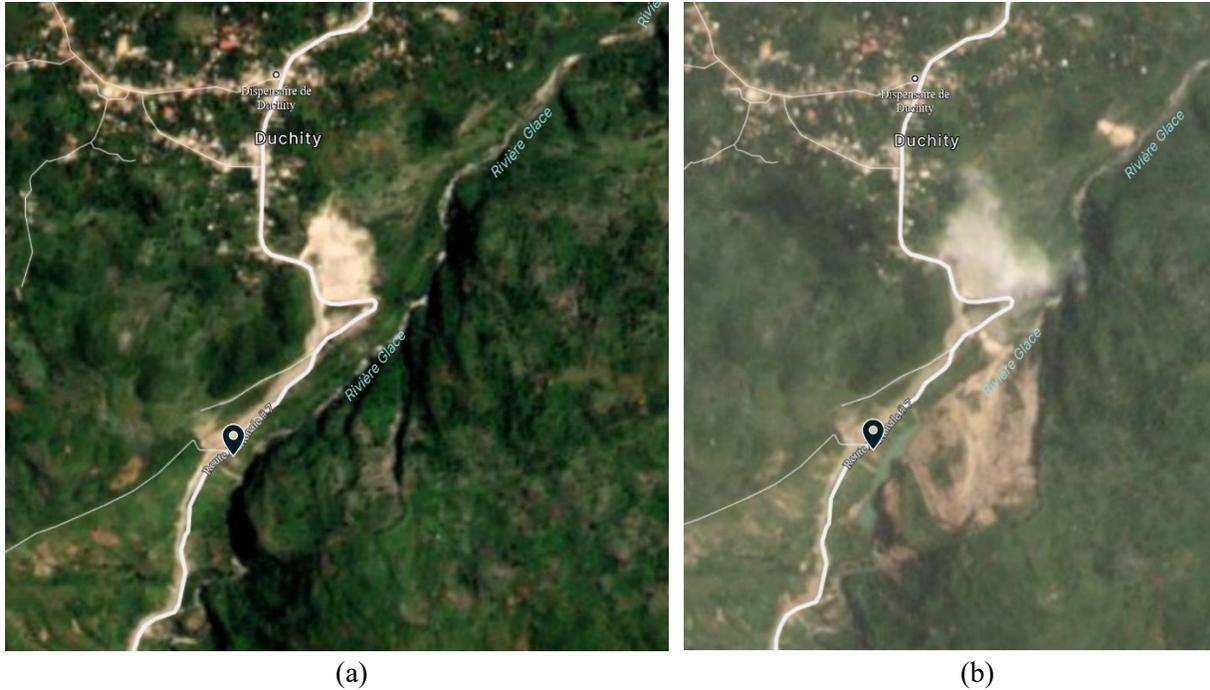
**Figure 7.57.** Satellite imagery for landslide shown in Figs. 7.29 and 7.30 (courtesy of Planet Labs, planet.com). Marker shown is where the photos in Fig. 7.29 were taken. (a) August 10, 2021. (b) August 30, 2021.

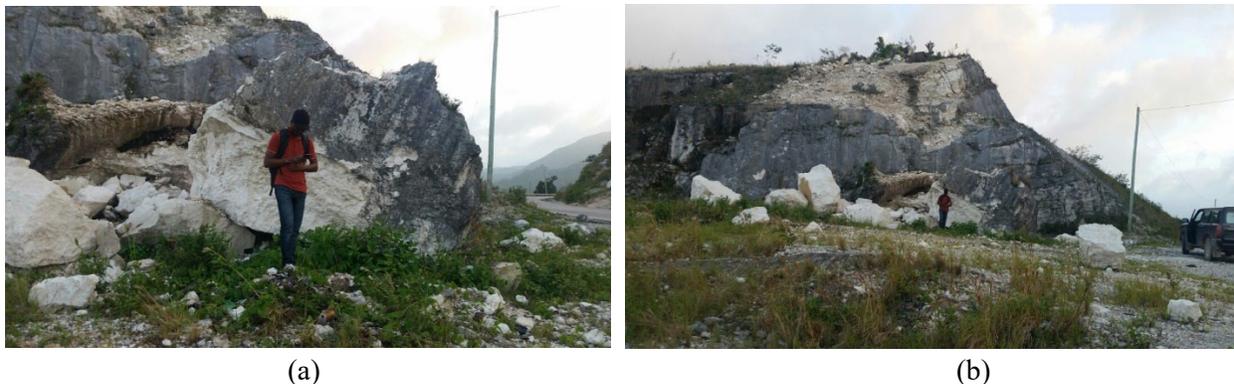
**Figure 7.58.** Possible failure of rockface along RN7 (Lat: 18.429466, Lon: -73.8998361).

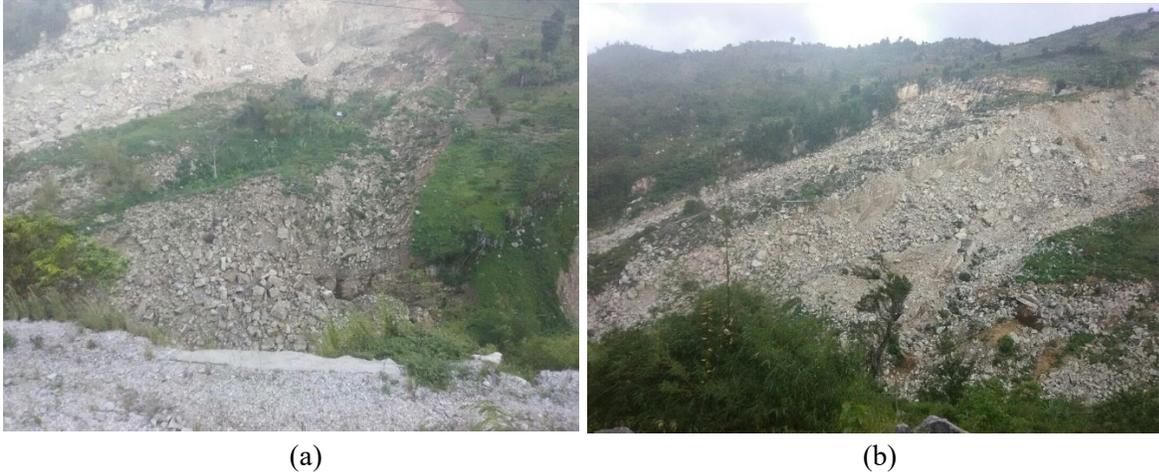
**Figure 7.59.** Possible landslide with boulder debris that may have occurred sometime prior to the August 14 earthquake, judging based on satellite imagery (Lat: 18.429649, Lon: -73.899932).

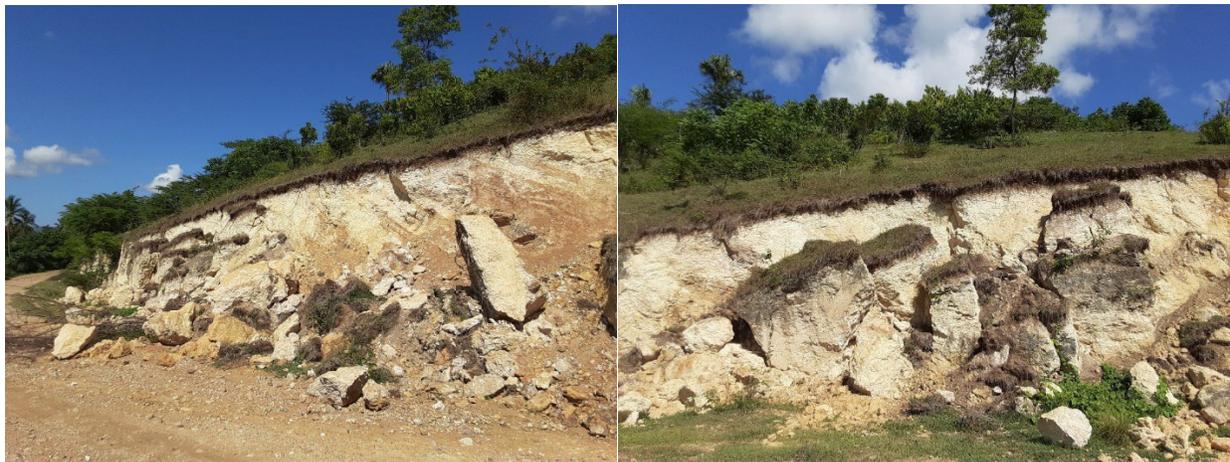
**Figure 7.70.** Toppling slope failure in Nippes. (a) Lat: 18.43791138, Lon: -73.49213398. (b) Lat: 18.437773, Lon: -73.4922458. Photos taken September 23, 2021.

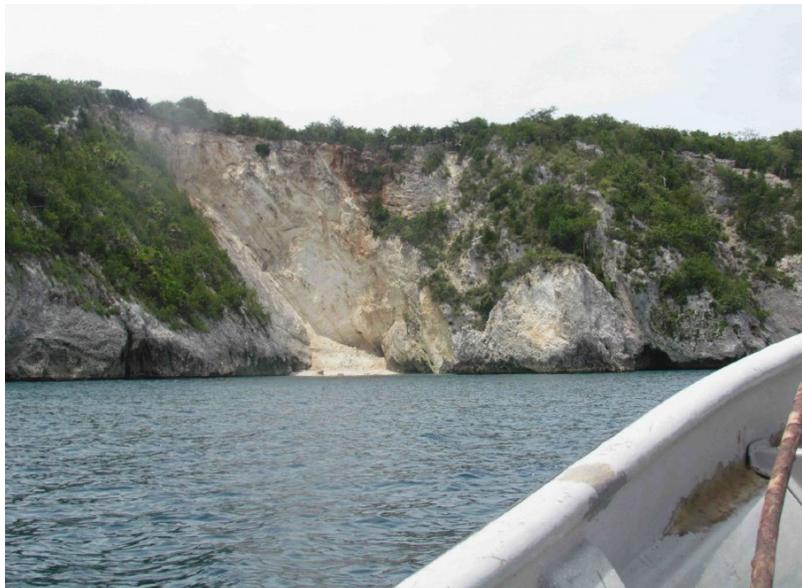
**Figure 7.74.** Rockfall along northern coast of southern peninsula of Haiti (Lat: 18.59722, Lon: -73.94528). Photo taken September 29, 2021 courtesy of Dr. Newdeskarl Saint Fleur.
