# RECONNAISSANCE FOLLOWING THE AUGUST 14, 2021 HAITI EARTHQUAKE: PERSPECTIVES FROM GEOTECHNICAL ENGINEERING AND SOCIAL/POLITICAL SCIENCES

Geotechnical Extreme Events Reconnaissance (GEER) Report No. 073

Version 1.0: February 3, 2021

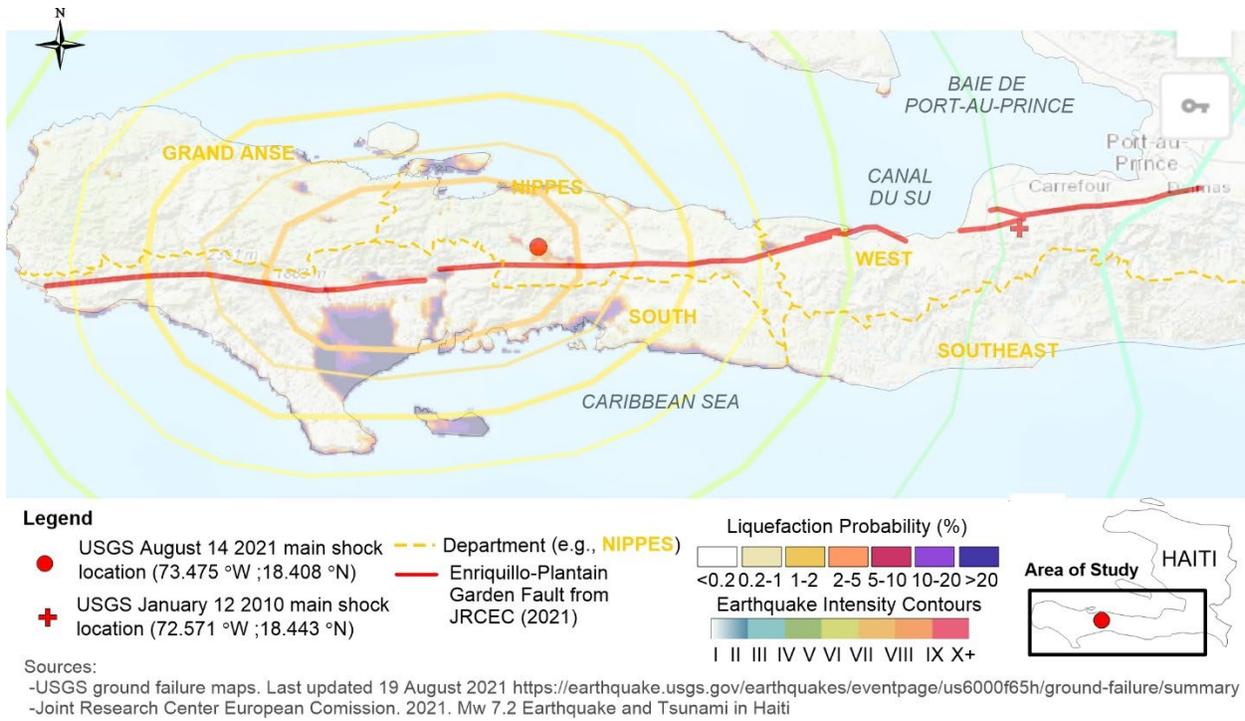
**Figure 7.80.** Liquefaction susceptibility base map.

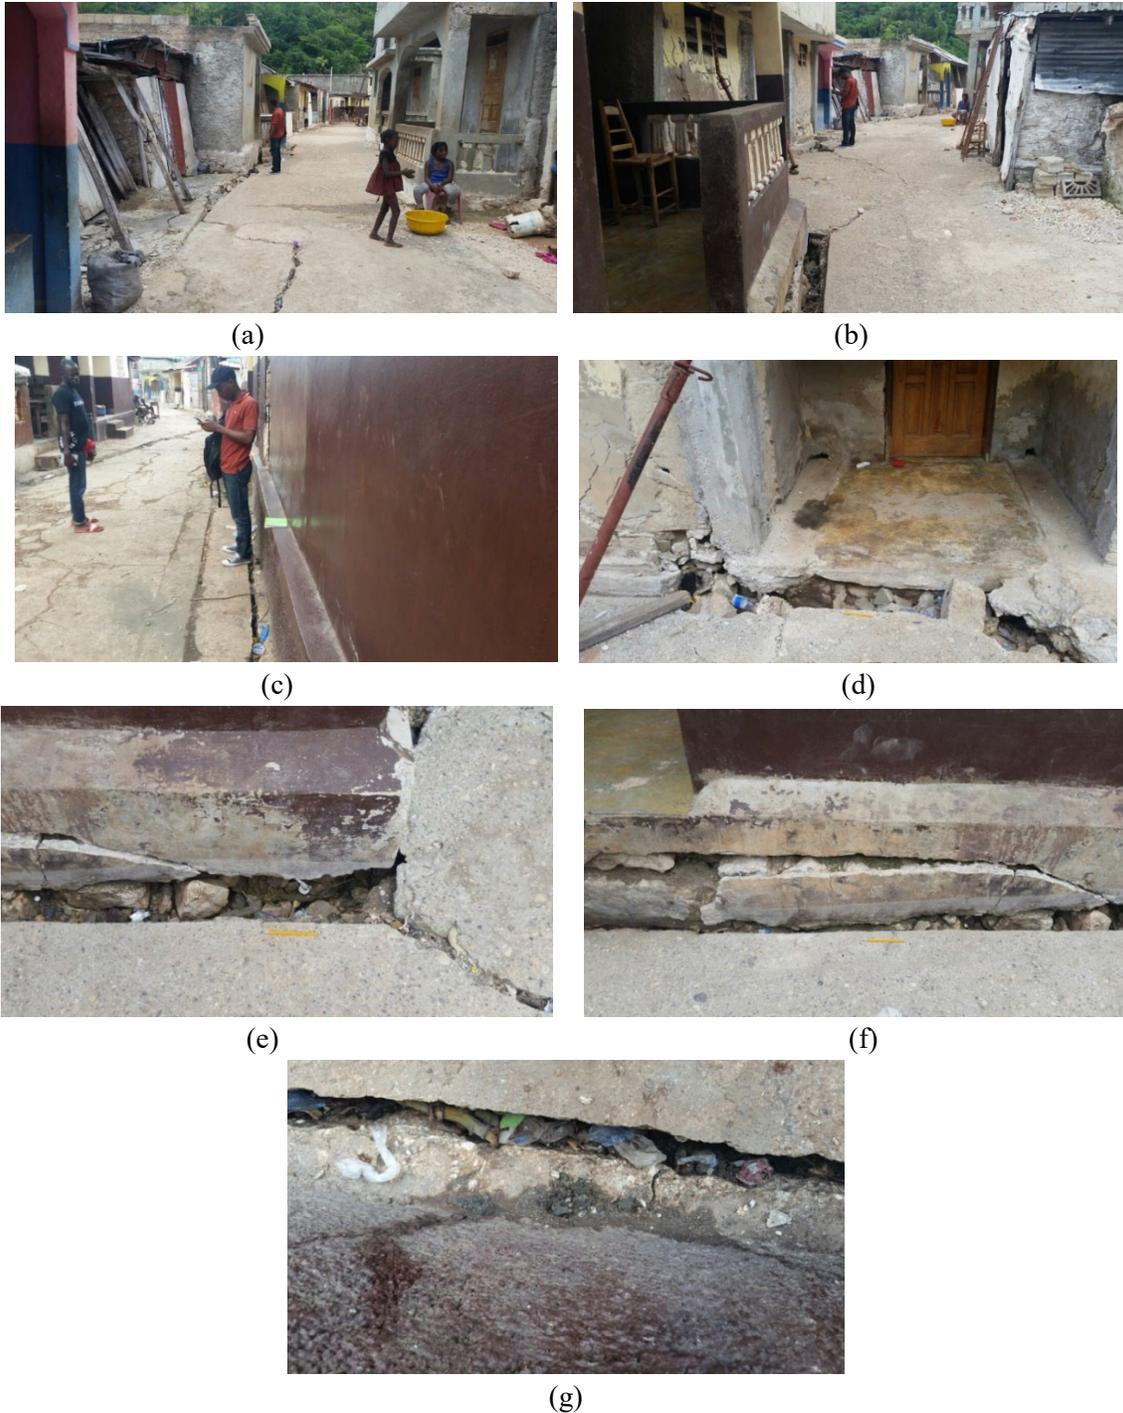
**Figure 7.82.** Reported observations of liquefaction during the August 14<sup>th</sup> Nippes Earthquake (Lat: 18.5435502, Lon: -73.7921043).

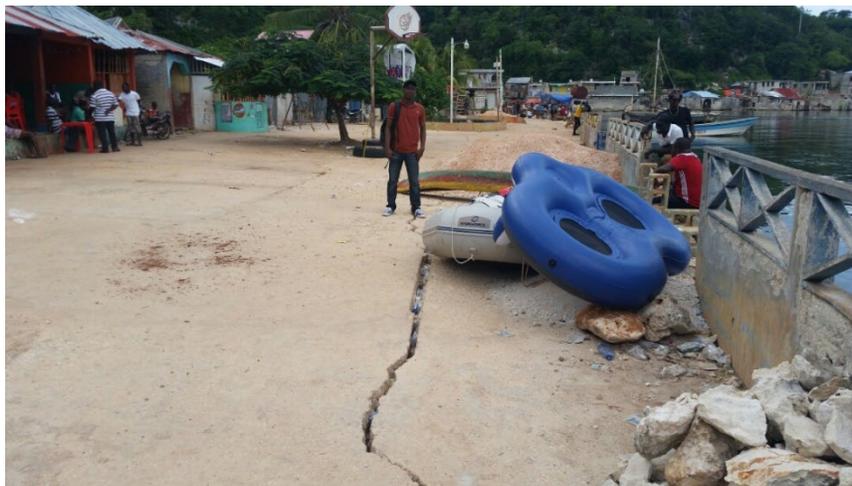
**Figure 7.84.** Ground cracking near the coast in Pestel (Lat: 18.5423509, Lon: -73.7906552).

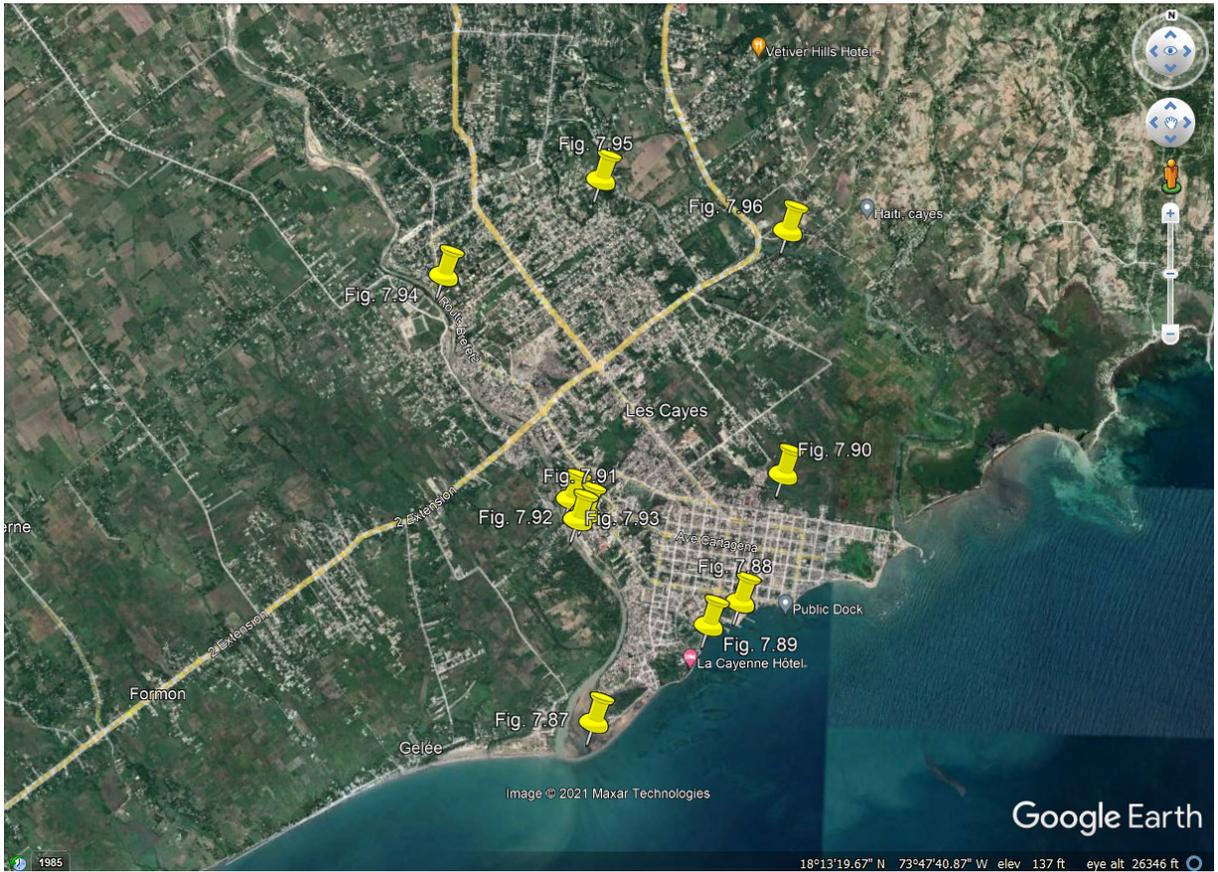
**Figure 7.86.** Drone observations of liquefaction in Les Cayes (courtesy of Google Earth).

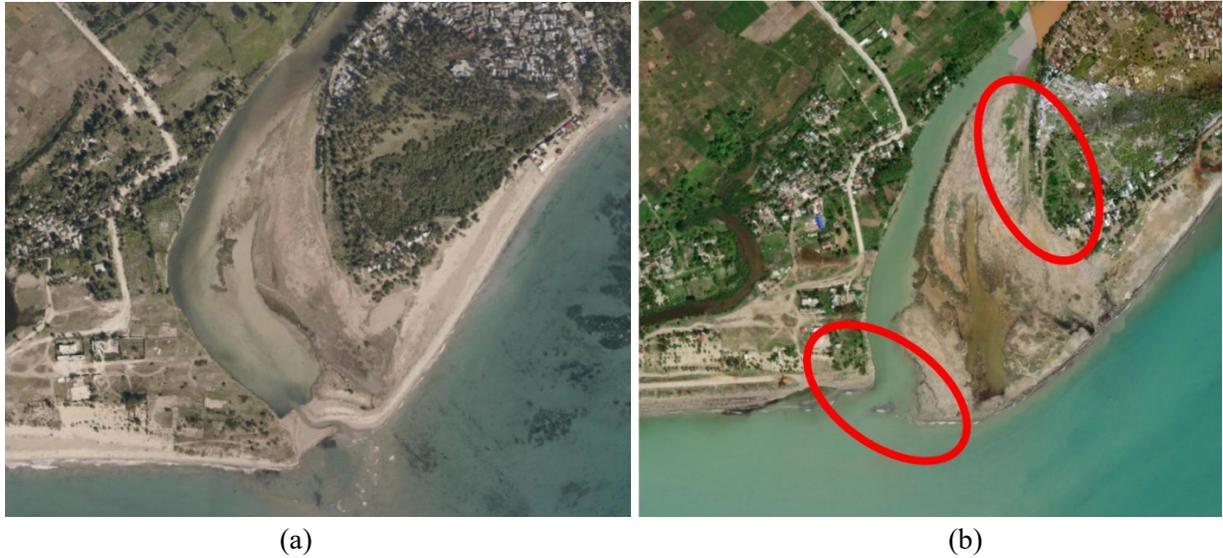
**Figure 7.87.** Coast and slope damage near south Les Cayes: (a) before the earthquake; (b) after the earthquake. Coordinates: 18.181111, -73.758611. Images courtesy of OpenstreetMap (Pierre Béland, <https://pierzen.dev.openstreetmap.org/>).

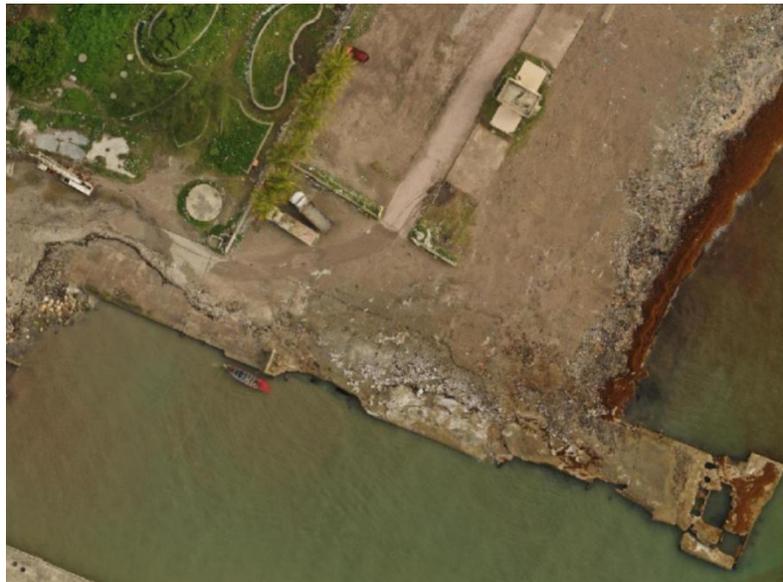
**Figure 7.88.** Coastal damage and possible evidence of liquefaction-induced lateral spreading in south Les Cayes. Coordinates: 18.189722, -73.748333. Images courtesy of OpenstreetMap (Pierre Béland, <https://pierzen.dev.openstreetmap.org/>).

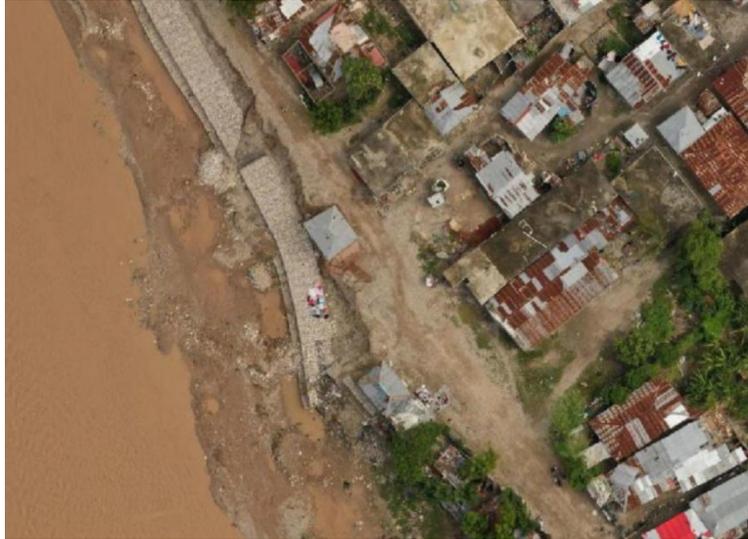
**Figure 7.91.** Damage and possible evidence of liquefaction-induced lateral spreading near river (Ravine du Sud) in Les Cayes. Coordinates: 18.195556, -73.759722. Images courtesy of OpenstreetMap (Pierre Béland, <https://pierzen.dev.openstreetmap.org/>).

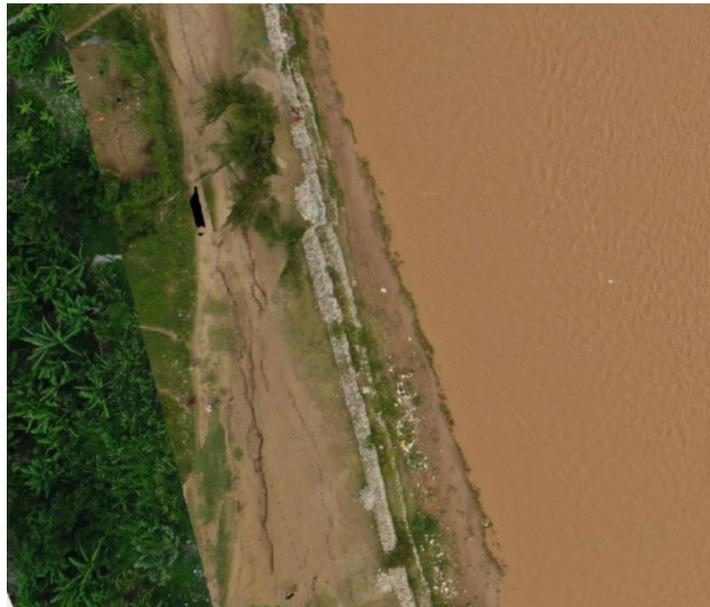
**Figure 7.92.** Damage and possible lateral spreading near river (Ravine du Sud) in Les Cayes. Coordinates: 18.195 -73.760278. Images courtesy of OpenstreetMap (Pierre Béland, <https://pierzen.dev.openstreetmap.org/>).

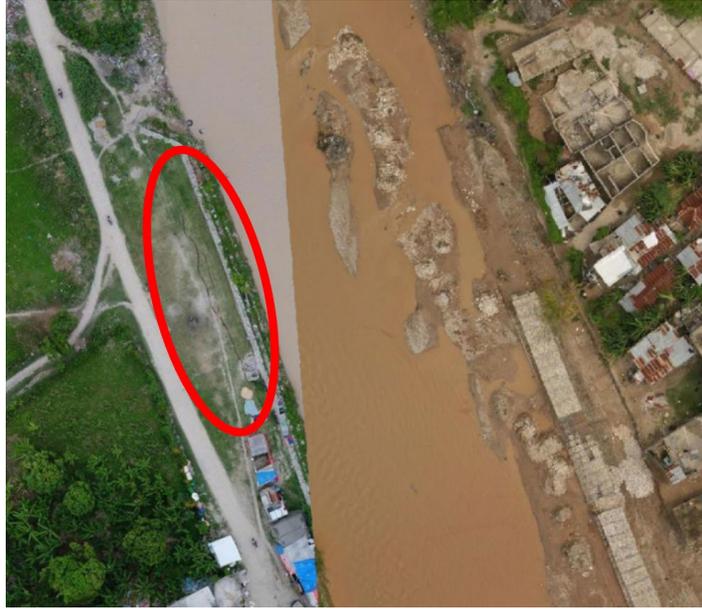
**Figure 7.93.** Damage and possible lateral spreading near river (Ravine du Sud) in Les Cayes. Coordinates: 18.195 -73.760278. Images courtesy of OpenstreetMap (Pierre Béland, <https://pierzen.dev.openstreetmap.org/>).

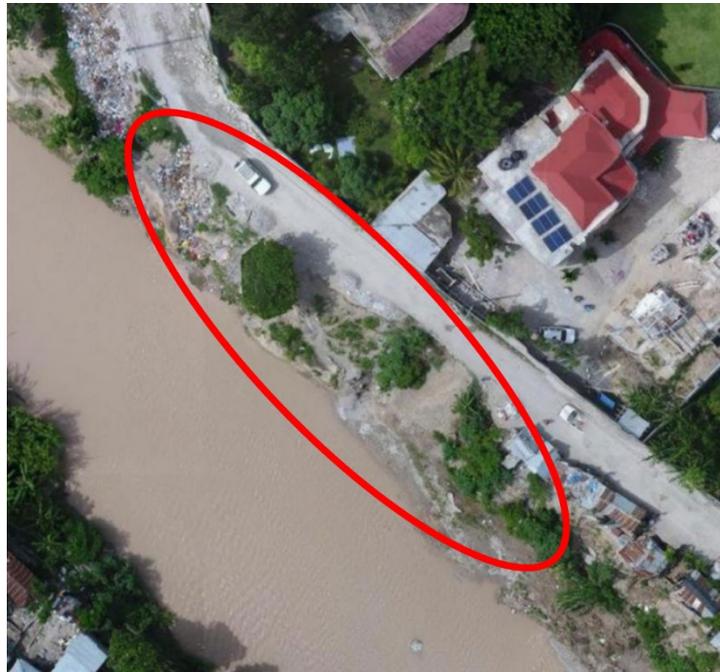
**Figure 7.94.** Damage and possible lateral spreading near river (Ravine du Sud) in Les Cayes. Coordinates: 18.196389, -73.760833. Images courtesy of OpenstreetMap (Pierre Béland, <https://pierzen.dev.openstreetmap.org/>).

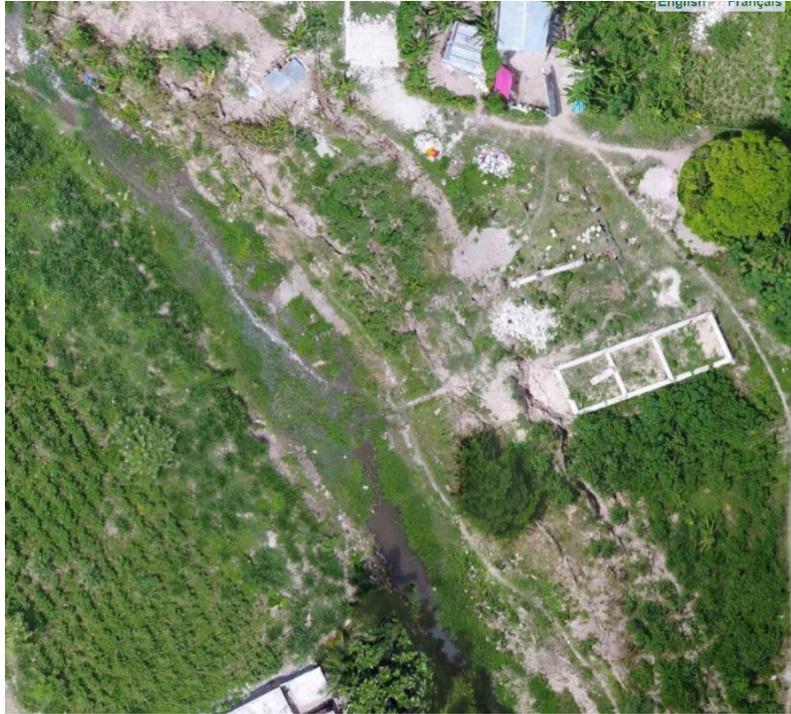
**Figure 7.95.** Damage and possible lateral spreading near river (Madan Samdi) in Les Cayes. Coordinates: 18.218333, -73.759444. Images courtesy of OpenstreetMap (Pierre Béland, <https://pierzen.dev.openstreetmap.org/>).

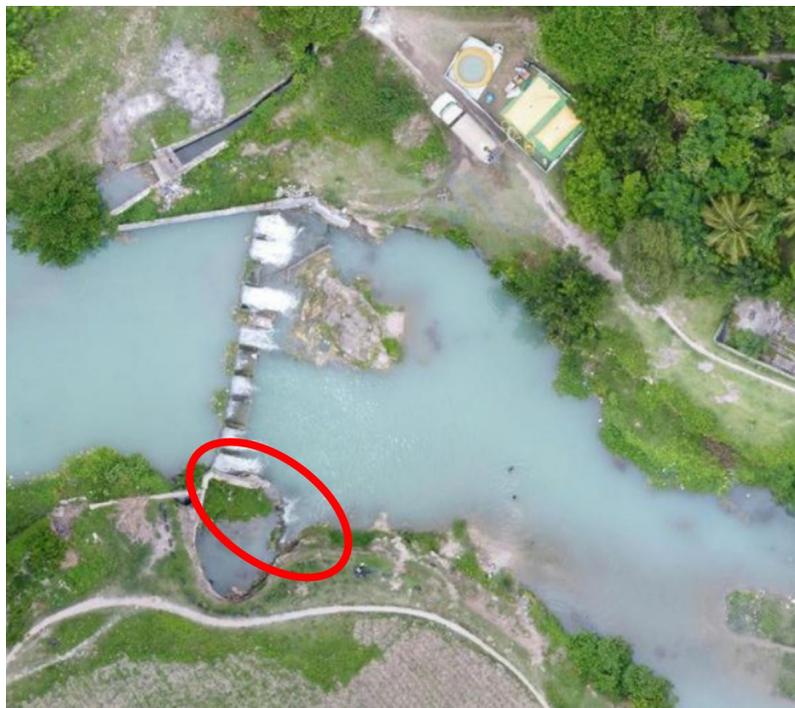
**Figure 7.96.** Possible damage of water facility near river (Riviere L'Islet) in Les Cayes. Coordinates: 18.215278, -73.745833. Images courtesy of OpenstreetMap (Pierre Béland, <https://pierzen.dev.openstreetmap.org/>).

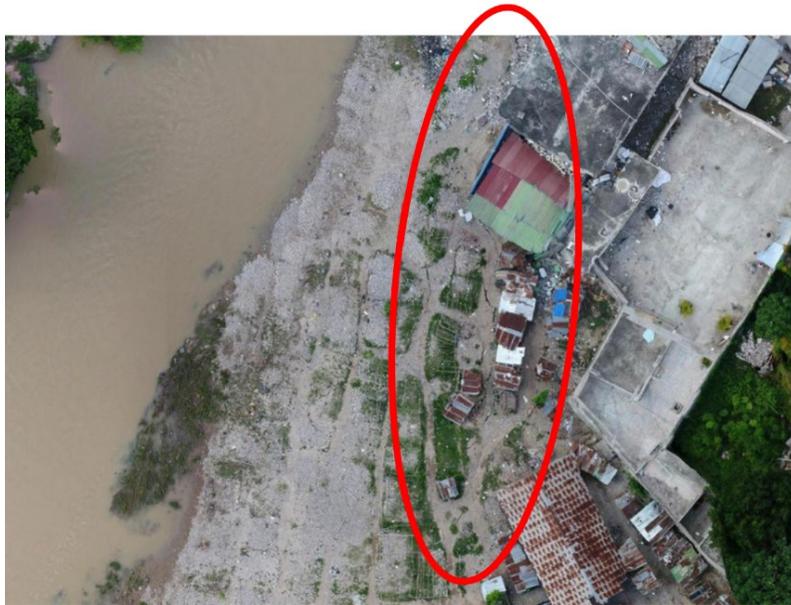
**Figure 7.97.** Damage and possible lateral spreading near river (Riviere de Cavaillon) in Cavaillon. Coordinates: 18.299167, -73.655833. Images courtesy of OpenstreetMap (Pierre Béland, <https://pierzen.dev.openstreetmap.org/>).

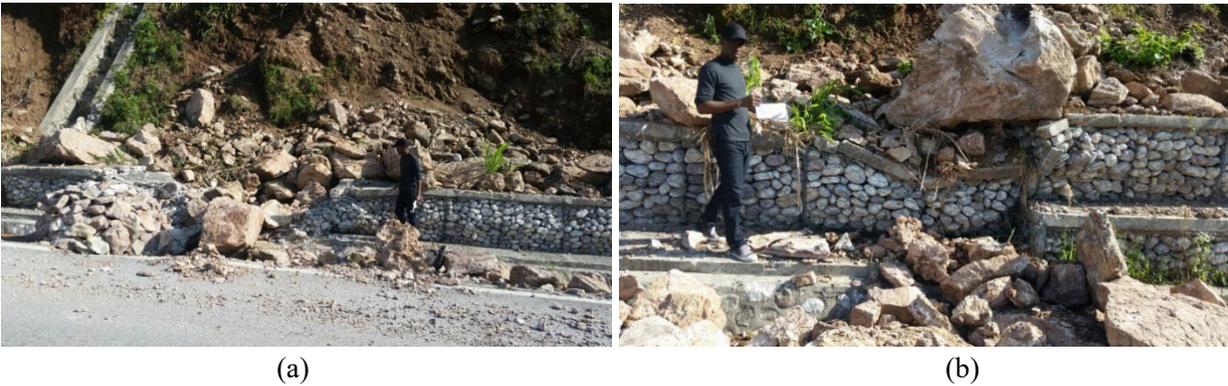
**Figure 7.99.** Retaining wall damage along RN7 (Lat: 18.403283, Lon: -73.8750032).

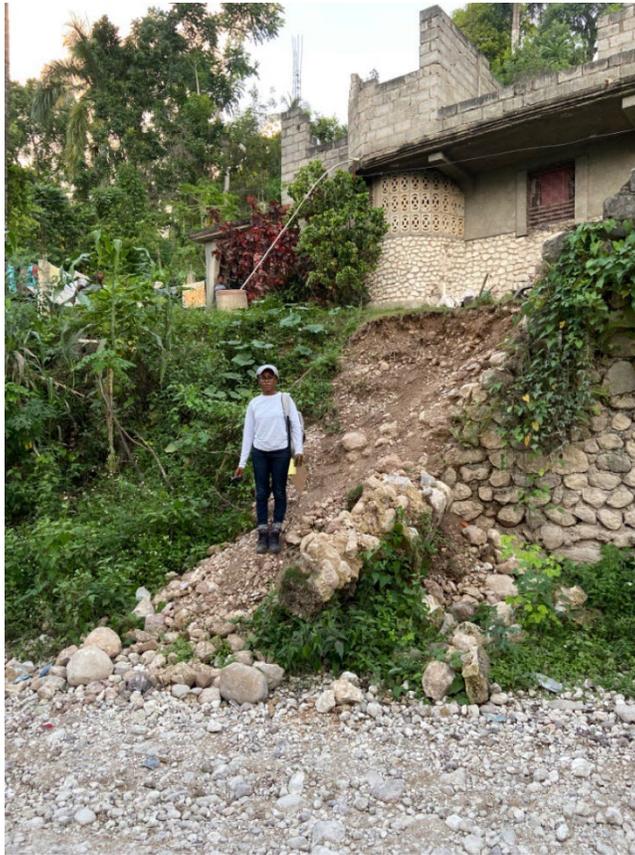
**Figure 7.102.** Retaining wall damage 2 km north of Enriquillo-Plaintain Garden Fault in Bonne Fin (Lat: 18.38944, Lon: -73.61028).

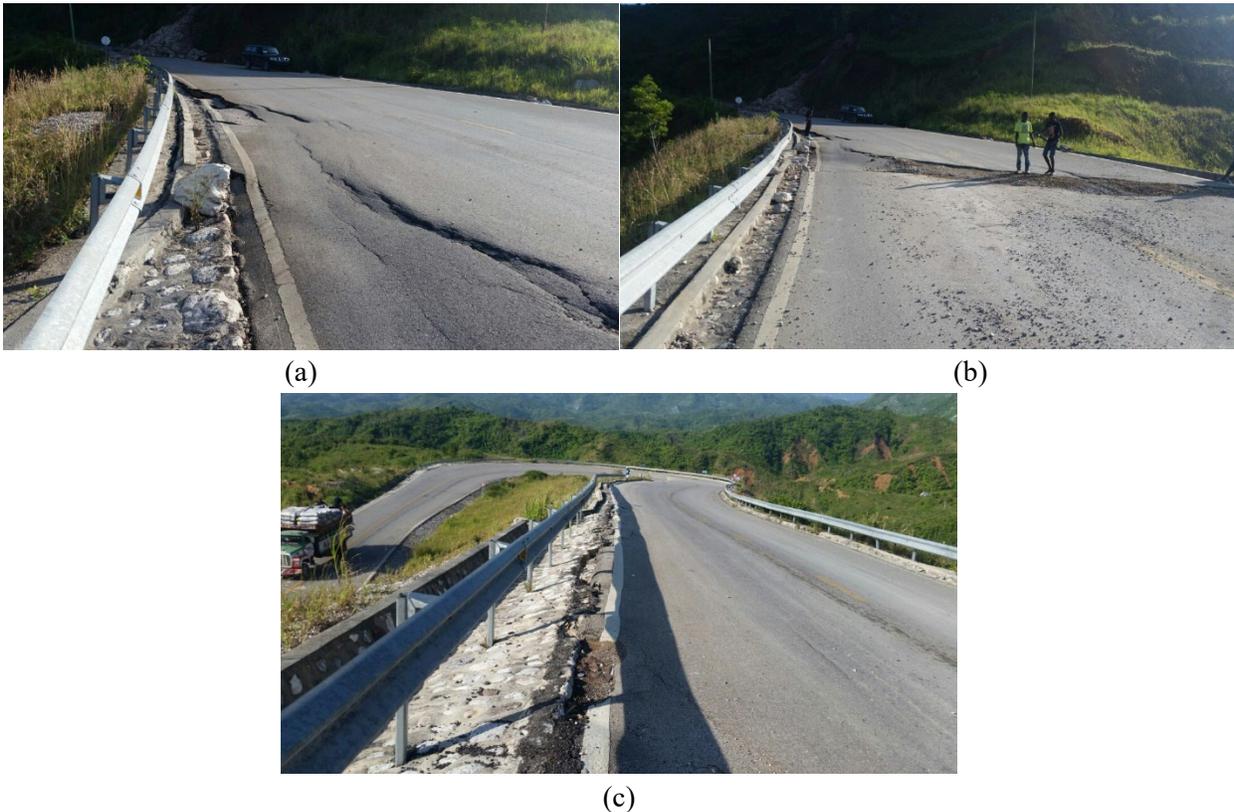
**Figure 7.106.** Pavement damage on RN7 (Lat: 18.4039901, Lon: -73.8770421).

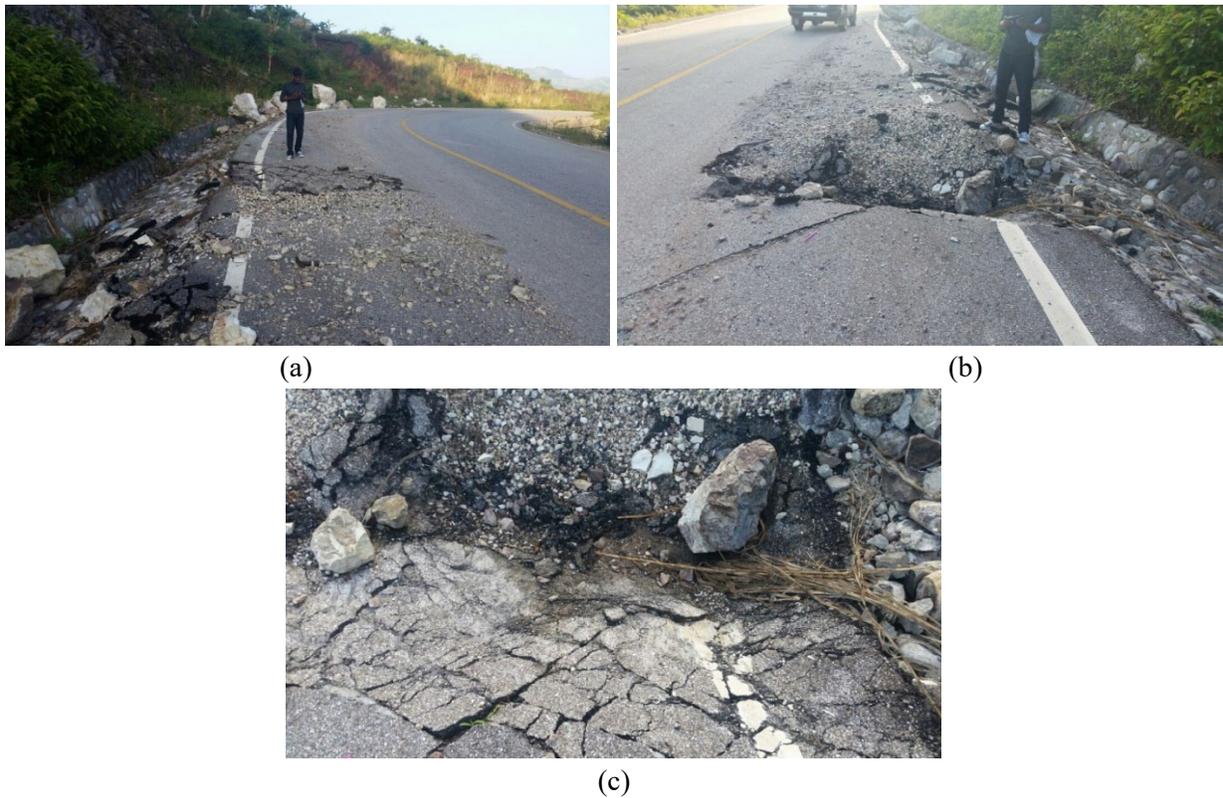
**Figure 7.110.** Pavement damage on RN7 (Lat: 18.410061, Lon: -73.8873537).

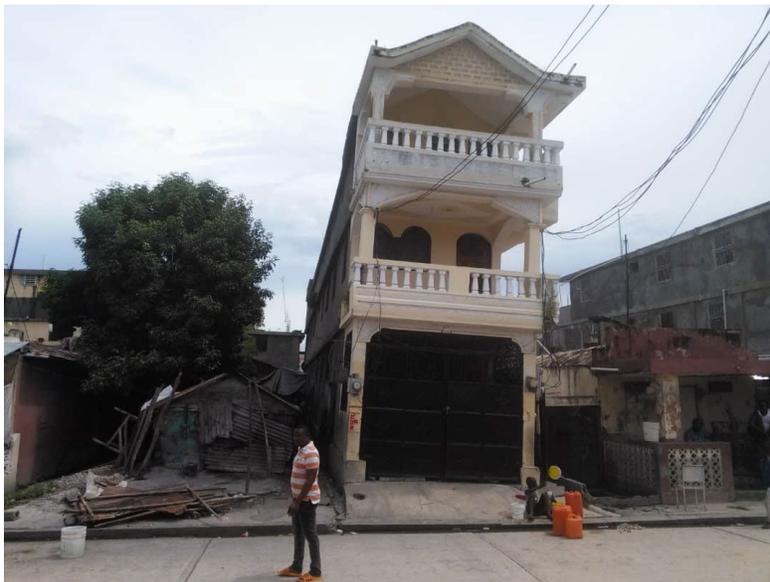
**Figure 7.112.** Damaged building in Les Cayes (Lat: 18.1956, Lon: -73.7456).

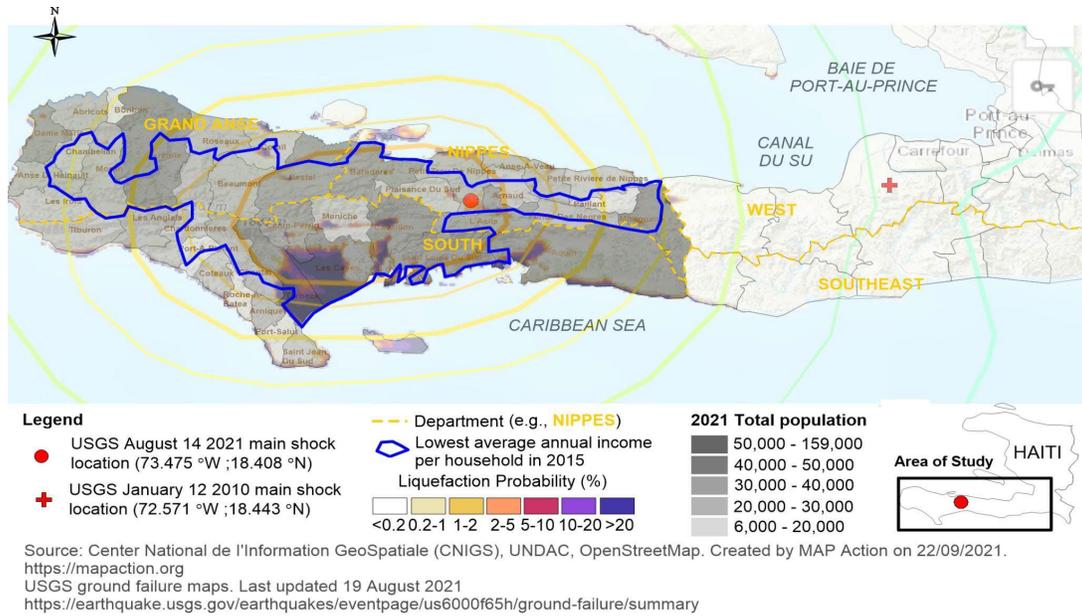
**Figure 8.6.** The USGS Liquefaction probability map and shaking intensity contours of the 2021 Nippes earthquake overlaid on the 2021 population map with the boundary of lowest average annual income within the study region in Haiti (sources noted in the legend).

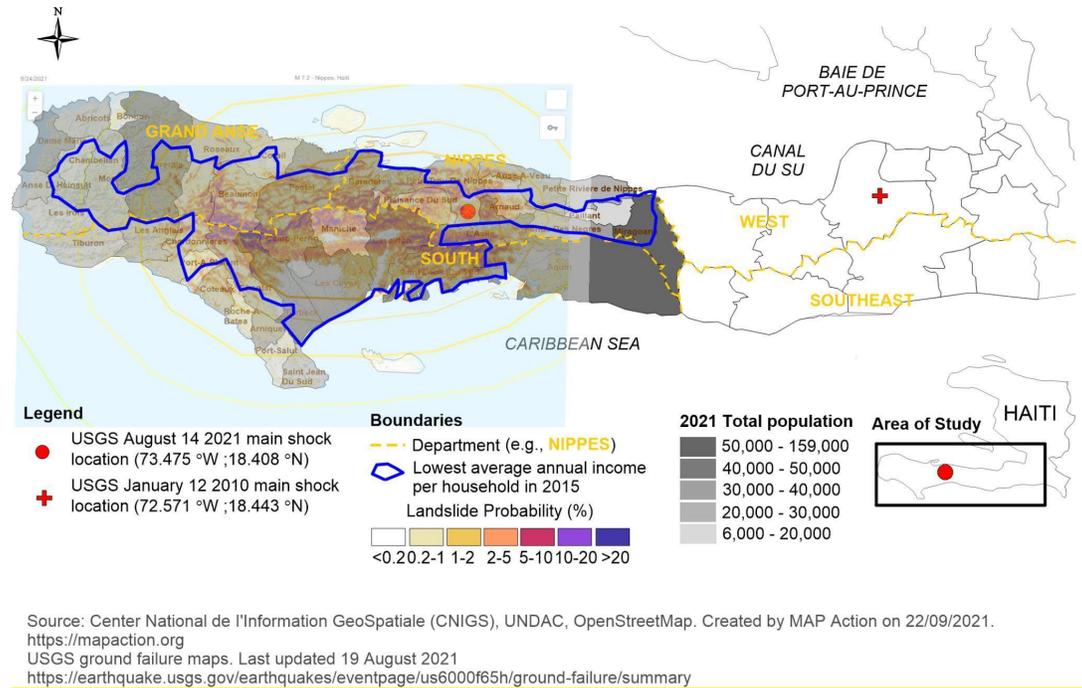
**Figure 8.7.** The USGS Landslide probability map and shaking intensity contours of the 2021 Nippes earthquake overlaid on the 2021 population map with the boundary of lowest average annual income within the study region in Haiti (sources noted in the legend).
