Geotechnical Reconnaissance and Engineering Effects of the December 29, 2020, M6.4 Petrinja, Croatia Earthquake, and Associated Seismic Sequence

Chapter 1: Introduction

Authors: Sonja Zlatović, Marta Miletić and Ingrid Tomac

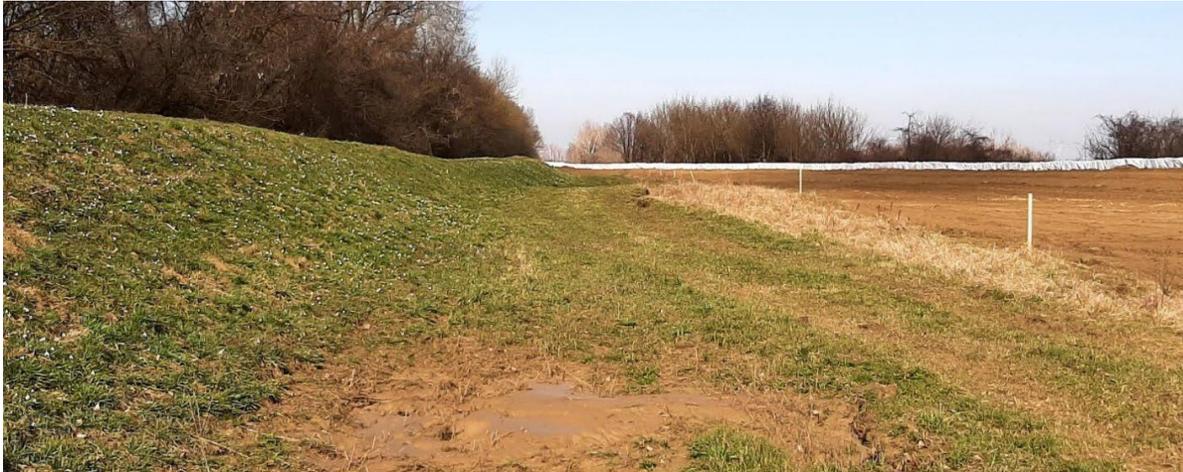
Figure 1.4 Levee south from Stara Drenčina, along the Kupa river. Sand ejecta are visible in front, levee on the left, settlement of the levee in the distance, and secondary levee (white box barrier) on the right side of the photograph (45.4609N, 16.3362E).

Geology of the area is presented in more details in Chapter 3. The area affected by the earthquake is the mostly flat valley of the meandering rivers Kupa and Sava with their tributaries, with mostly soft layers and a high ground water table. The underlying limestone is visible in rare locations. The levees erected to protect the cities, villages and the fields from the high waters of the Sava and Kupa rivers, were inspected by the geotechnical engineers who later joined the GEER team. Mostly built in or since the 1950s from the local clays, in several stretches, the levees got longitudinal cracks. In some cases, cracks crossed the levee crest, in some cases connection of two levees failed. Measured depth of the cracks is up to 2 m.

Along the toes of the levees sandy ejecta, were often found. Croatian Waters, the institution in charge of flood protection in Croatia, immediately repaired some of the damages, and built secondary levees where necessary. Descriptions of levee damages are presented in Chapter 8. Although liquefaction was observed in the past in Croatia, the sand boiling was a surprise (**Figures 1.4-1.6**). Sand ejecta were found in a series of yards and around family houses in Petrinja, Glina, some villages and in many fields (**Figure 1.7**).

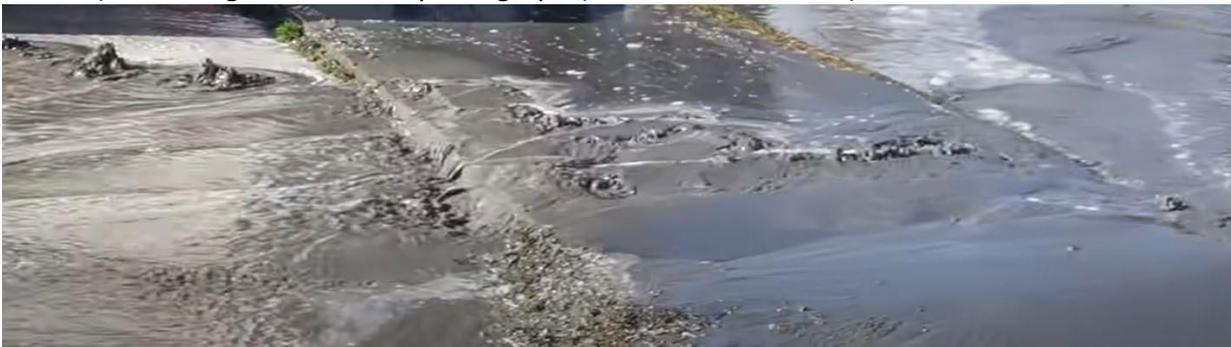
Figure 1.5 Sand boiling observed during the main shock in Sisak – a snapshot from the video recorded by Daniel Pavlić (45.4735N, 16.3926E) at the distance of 15km from the epicenter and under the levee along the Sava river.

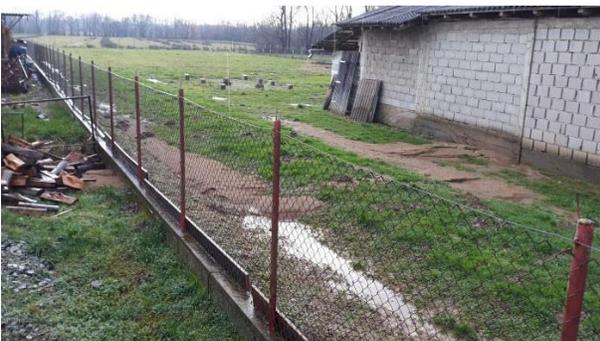
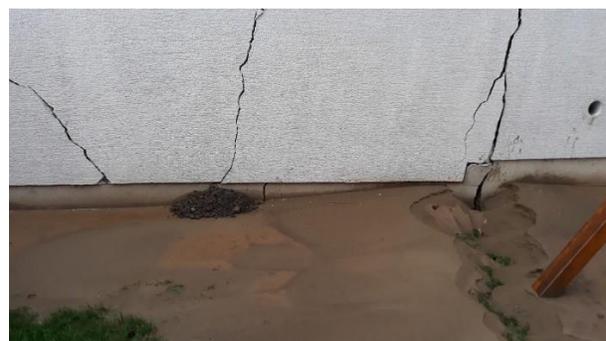
Figure 1.6 A crack in Brest Pokupski which opened through several yards and houses, ejecting water and sandy soil in time of the main shock (**left** 45.4553N, 16.2628E; **right** 45.4539N, 16.2611E; photos by Igor Gukov).

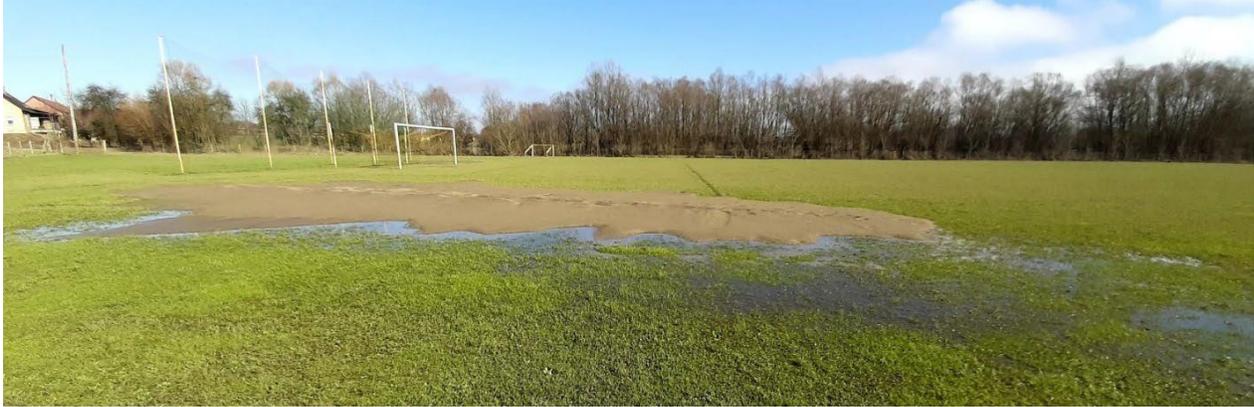
Figure 1.7 A 15 m long crack with sand ejecta at the football playground in Letovanić (45.5057N,16.1979E).

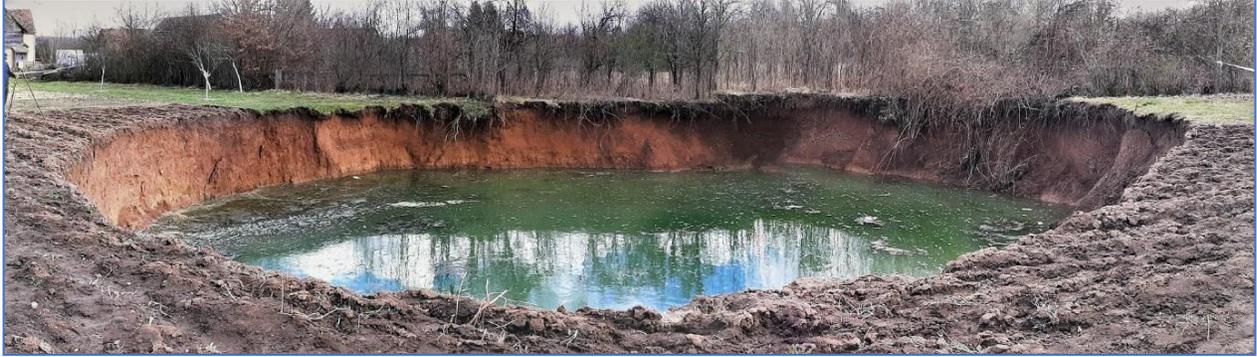
Figure 1.8 The largest (diameter of 26m) of the sinkholes which opened a week after the main earthquake in Mečenčani (45.2833N, 16.4259E; 26 February 2021).

The most prominent, surprising, and relatively rare geotechnical earthquake effect includes the collapse of numerous sinkholes in the time frame of three months after the main shock. Ninety-one new sinkholes collapsed within a 4km² area surrounding Borojevići and Mečenčani villages between Petrinja and Hrvatska Kostajnica. Sinkhole diameters vary from 1 m to 25 m, with a maximum depth of 11.7 m. Cover-collapse sinkholes occurred in the past but very sparsely and were considered rare events. Residents refer to historical sinkhole events through jokes, such as saying, “I wish your field turned into a pond”. The GEER team registered 136 sinkholes, 91 which opened after the 29 December, and 45 old ones, as well as three potential sinkholes, as shown in Chapter 6, together with an overview of the geological and hydrogeological characteristics of the area, and details of the most interesting sinkholes. The geotechnical and geophysical investigations consisted of 61 nanometrics ambient noise readings, four geotechnical boreholes, two Multichannel Analysis of Surface Waves (MASW) profiles, and one compound electrical resistivity tomography (ERT) profile performed by the joint effort of the US and local GEER teams in the period between March 15 and March 26. The comprehensive database of lidar images of around 60 sinkholes is available as open-source in DesignSafe Data Depot. The most interesting sinkholes are presented in detail in Chapter 6, with the results of geotechnical and geophysical investigation. Chapter 10 describes details of the extent of complementary investigation works. **Figures 1.8 - 1.10** show some characteristic examples. Although not included as part of this GEER report, the Croatian company Terra Compacta in cooperation with the University of Zagreb, Faculty of Mining, Geology and Petroleum Engineering, performed geophysical investigations in the area, in order to find a safe location for the temporary container settlement for the villagers of Mečenčani and Borojevići, and to inspect the roads. The Croatian companies Karst and Geotehnički studio performed borings in order to inspect safety of some houses, however, still uncertainty remains.

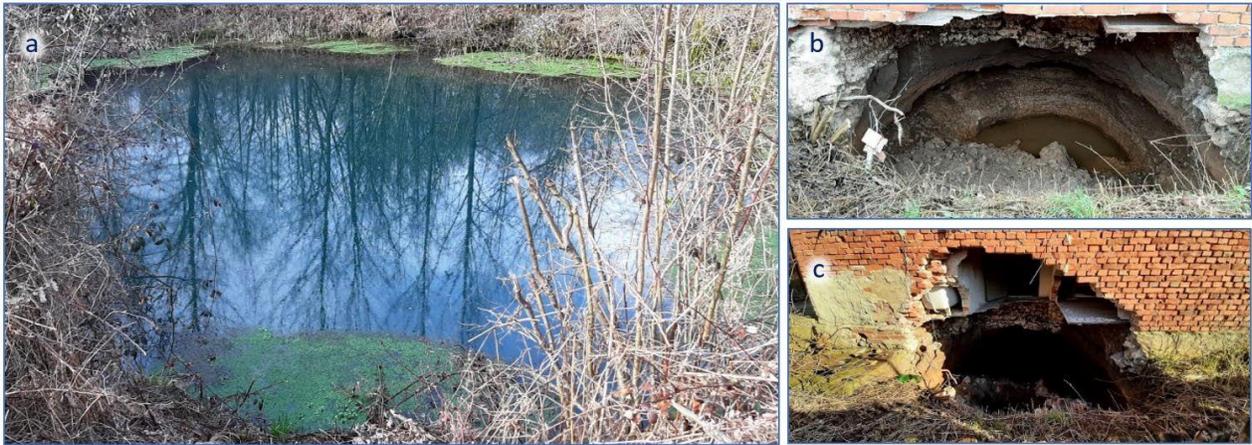
Figure 1.9 (a) One of the previously known sinkholes with pond containing spring (45.286953N, 16.426297E). (b, c) a sinkhole which opened under an unoccupied house two days after the main earthquake (45.283, 16.4295) photographed on 4 January and 15 February 2021.

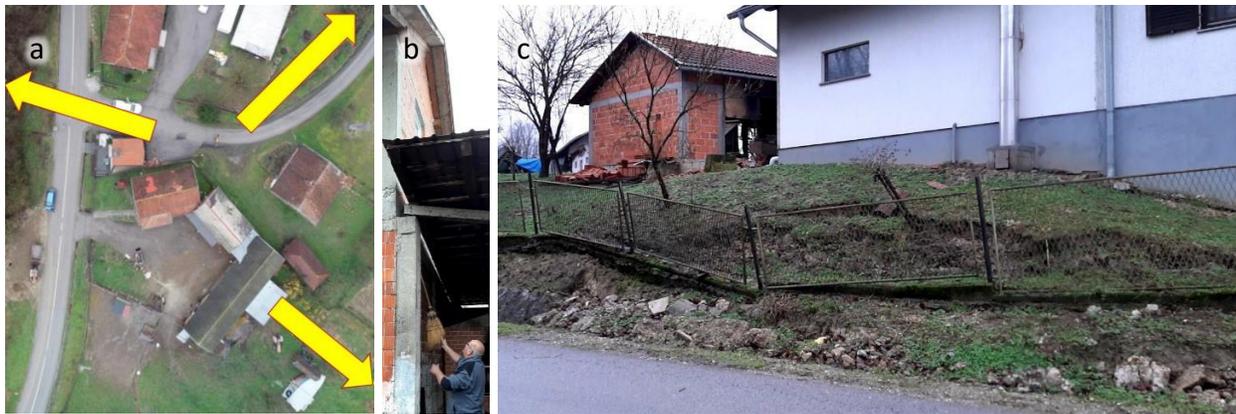
Figure 1.11 Sliding in Hađer on the top of a hill, (a) in three directions (45.3795N, 16.1200E; Bačić & Terzić 2021). Ground is recognized by the farmer as exceptionally soft (b) consequent gap opening (45.3793N,16.12016E). (c) An existing landslide situation worsened in the earthquake (45.3798N,16.1198E).

Some landslides were affected or initiated in the area. **Figure 1.11** shows sliding in Hađer, at the distance of around 8km from the epicenter. The Croatian volunteers, geotechnical engineers and geologists, detected 36 slides and 4 rockfalls Pollak et al. (2021). The data will be presented on the pages of the Croatian Geologic Survey (www.hgi-cgs.hr).

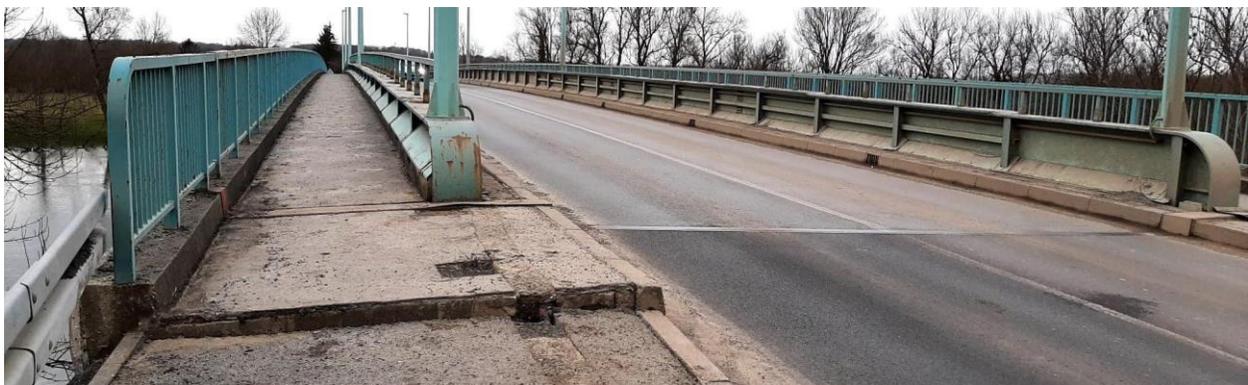
Figure 1.12 Bridge Brest after the earthquake (45.4481N,16.2600 E).

Damages on infrastructure - several bridges and roads are presented in Chapter 9. **Figure 1.12** shows Brest bridge near Petrinja after the earthquake. **Figure 1.13** shows building damage.

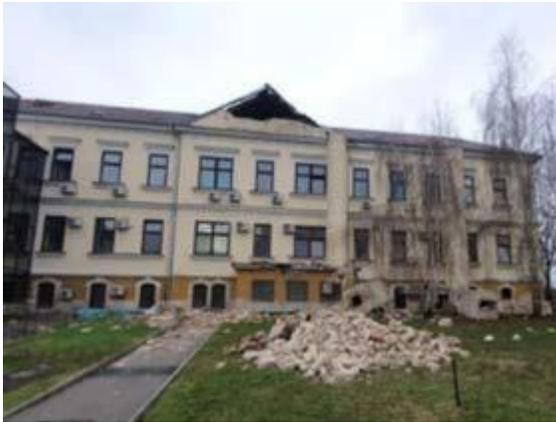
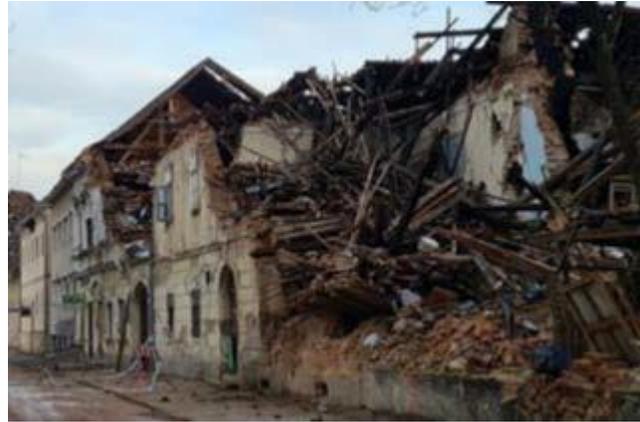
Figure 1.13 Photos of the damaged buildings after an earthquake rocked (a) Sisak, and (b) Petrinja, Croatia (Source: Miranda et al., 2021), Coordinates of the photo (a) 45.476794, 16.368347, and (b) 45.441082, 16.277061).

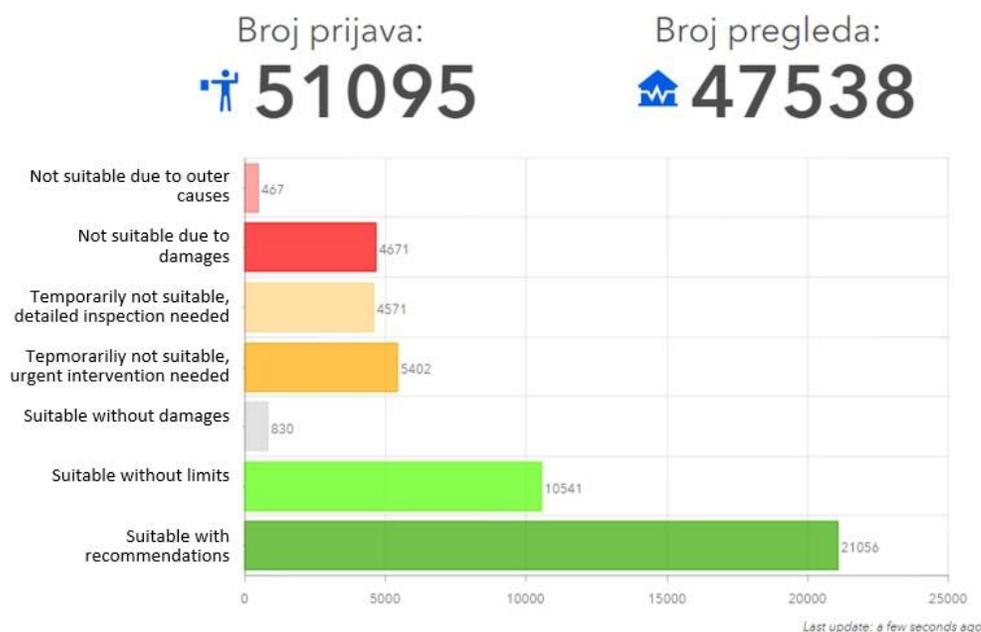
Figure 1.15 Results of the damage estimates on buildings after the earthquake near Petrinja in the year 2020 on the 20 May 2021 (HCPI, 2021).

A series of Croatian structural engineers who were inspecting the buildings contributed to the report. The structural engineers together with architects and other civil engineers, as volunteers, were invited and organized by the Croatian Center for Earthquake Engineering, HCPI. The citizens were invited to report on the damages, and the group of volunteers performed the preliminary inspection of the buildings. Total number of reported damages and an overview of the estimates is given in **Figure 1.14** for the 8 January and **Figure 1.15** for the 21 May 2021.
