GEOTECHNICAL RECONNAISSANCE OF THE DECEMBER 12, 2018 M4.4 DECATUR, TENNESSEE EARTHQUAKE

DOI: 10.18118/G6ZD3J

04/04/2019

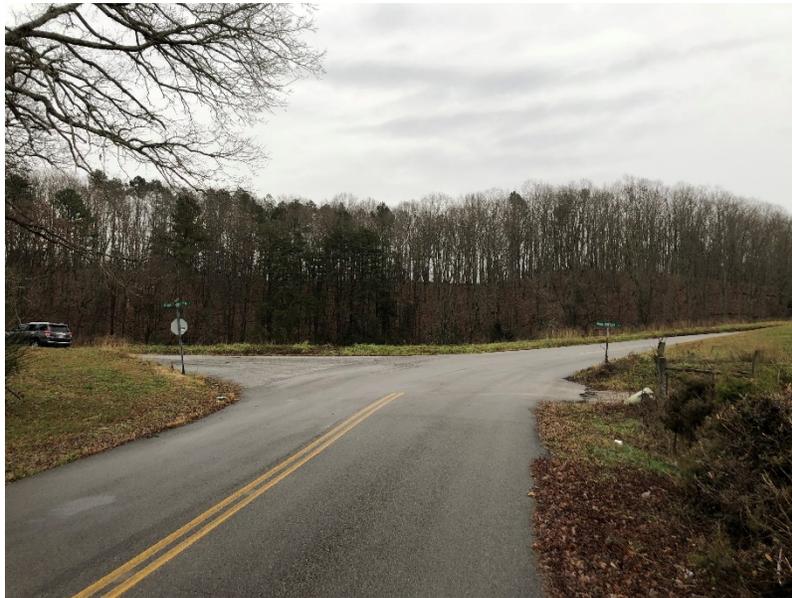
As part of the reconnaissance, Siegel photographed buildings, slopes, retaining structures, and surface items that would most likely be susceptible to earthquake-related damage. Figure 11 shows the locations where Figure 12 through Figure 15 were taken and the arrows point in the direction of the photographs. Figure 12 faces the location of the event epicenter when looking from the north.

FIGURE 12. PHOTOGRAPH (1) ALONG WOODS HOLLOW ROAD LOOKING SOUTH TO EPICENTER (35.617 °N 84.734 °W).

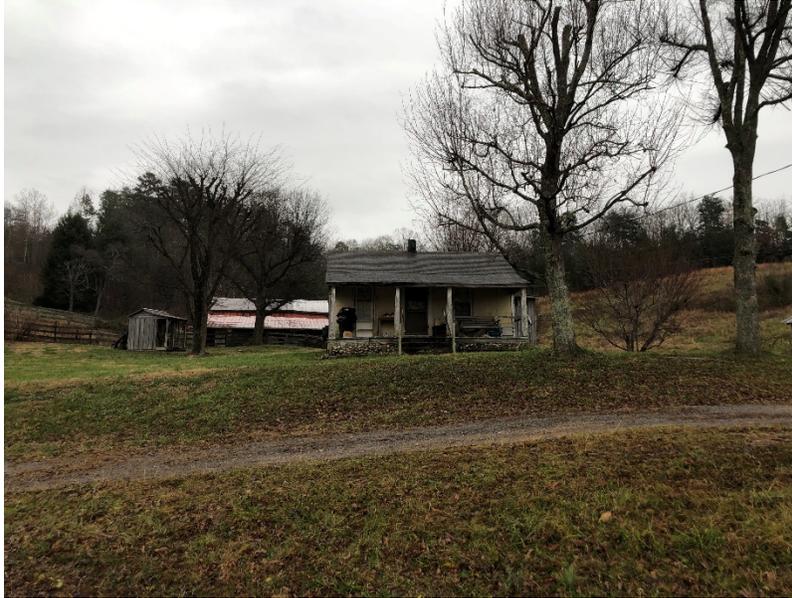
Figure 13 shows a one-story single-family residence that has a stacked stone foundation wall. This house is very near the epicenter and would have been subjected to ground shaking from the December 12, 2018 earthquake. The stacked stone foundation does not appear to exhibit any recent damage and appears intact and in good shape.

FIGURE 13. PHOTOGRAPH (2) OF SINGLE-FAMILY RESIDENCE ALONG WOODS HOLLOW ROAD (35.611 °N 84.736 °W).

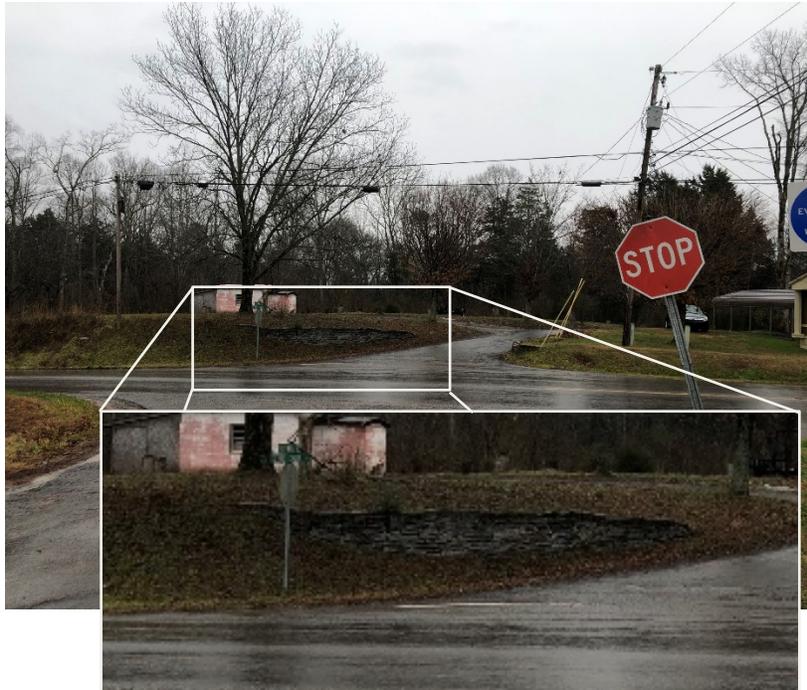
Figure 14 shows a stacked stone retaining wall on the southeast corner of the intersection of Tennessee Highway 58 and Fezzell Road. The wall is near vertical and a few feet in height. There were no indications that suggest that this small retaining wall experience earthquake-induced damage. Figure 15 faces the location of the event epicenter when looking from the southeast.

FIGURE 14. PHOTOGRAPH (3) STACKED STONE RETAINING WALL (35.598 °N 84.719 °W).

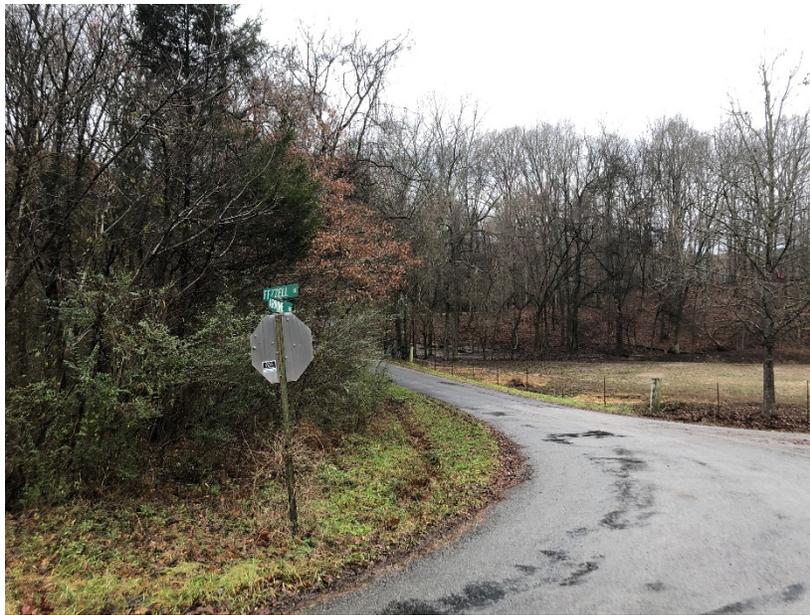
FIGURE 15. PHOTOGRAPH (4) ALONG FEZZELL ROAD (35.608 °N 84.197 °W).

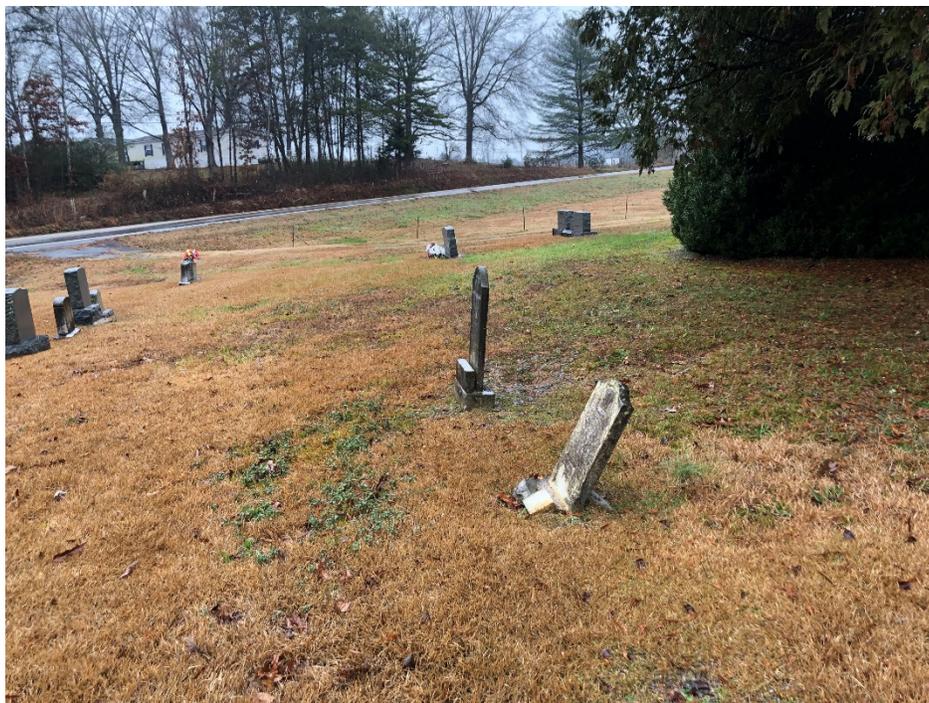
Figure 16 shows the location where *Figure 17* was taken and the arrow points in the direction of the photograph. Figure 17 is a photograph taken in a cemetery located northwest of the epicenter. The headstone in the foreground is dramatically tilted. Even in its fragile condition, it did not fall over as a result of the earthquake. Overall the headstones and other ornaments showed little or no damage from the December 12, 2018 earthquake.

FIGURE 17. PHOTOGRAPH (5) OF A LEANING HEADSTONE NORTH OF EPICENTER (35.631 °N 84.748 °W).

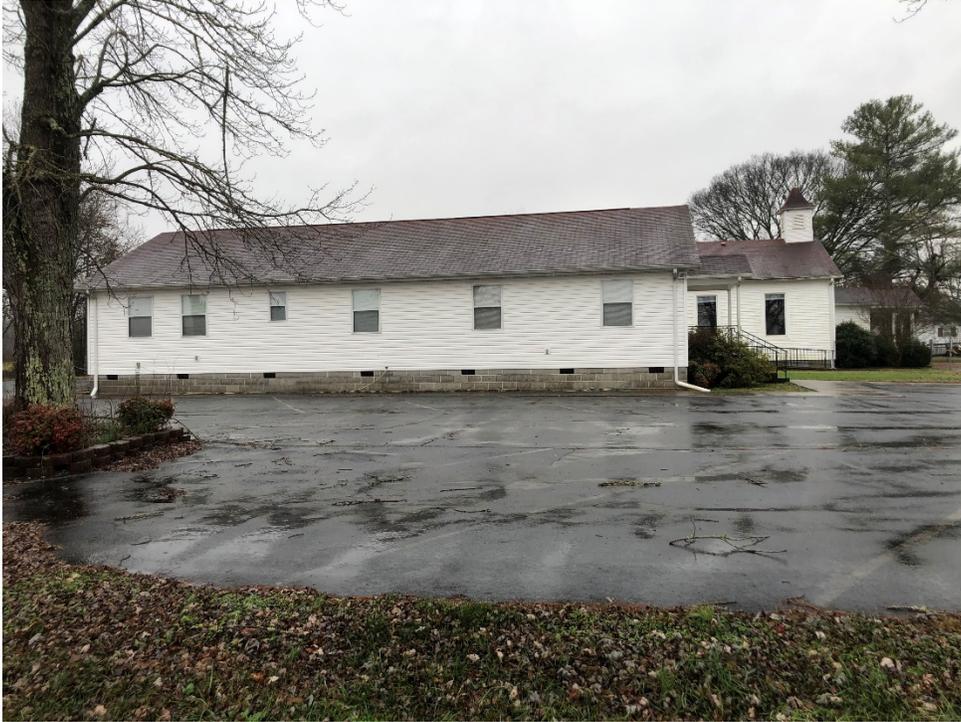
Figure 18 shows the locations where Figure 19 through Figure 21 were taken and the arrows point in the direction of the photographs. Figure 19 shows a single-story church building with the masonry foundation wall that is west of the epicenter. No cracks or other signs of distress were observed in the masonry wall or any other part of the church exterior. Figure 20 shows a slope along Tennessee Highway. The slope is covered with vegetation with some exposed rock debris but did not appear to have any instability, surficial or otherwise. The cooling towers of the Watts Bar Nuclear Plant are shown in the background of Figure 21 which was taken from Tennessee Highway 304 looking west. The nuclear plant is downstream of the Watts Bar dam which is one of the three priority dams inspected by TVA.

FIGURE 19. PHOTOGRAPH (6) OF UNDAMAGED MASONRY BLOCK FOUNDATION WALL (35.597 °N 84.826 °W).

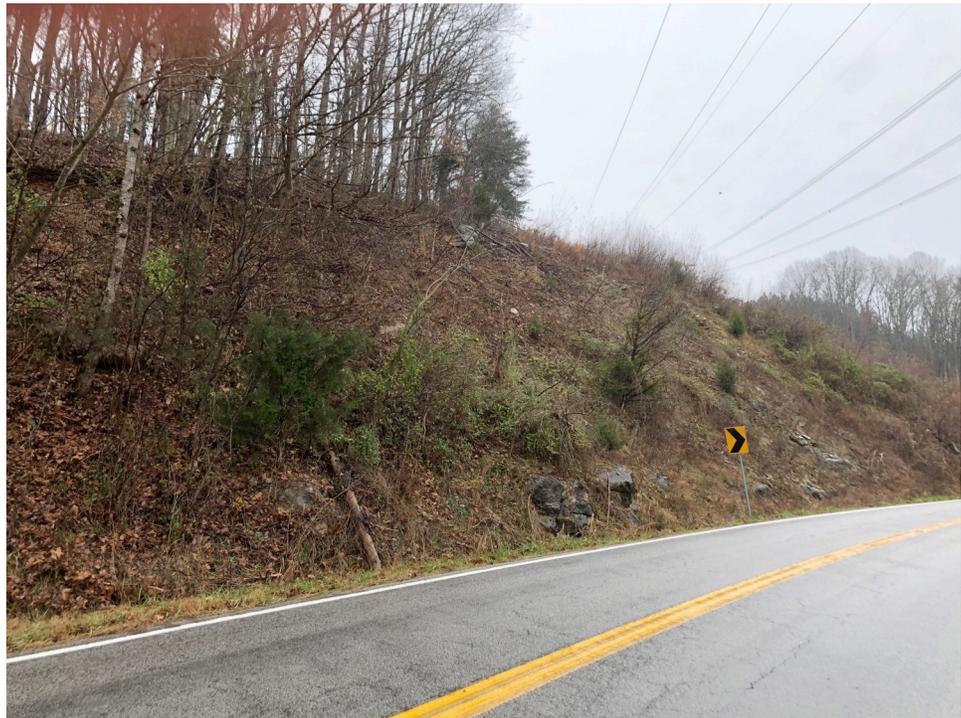
FIGURE 20. PHOTOGRAPH (7) OF SLOPE ALONG HIGHWAY 304 WITH NO SIGNS OF RECENT INSTABILITY (35.601 °N 84.767 °W).

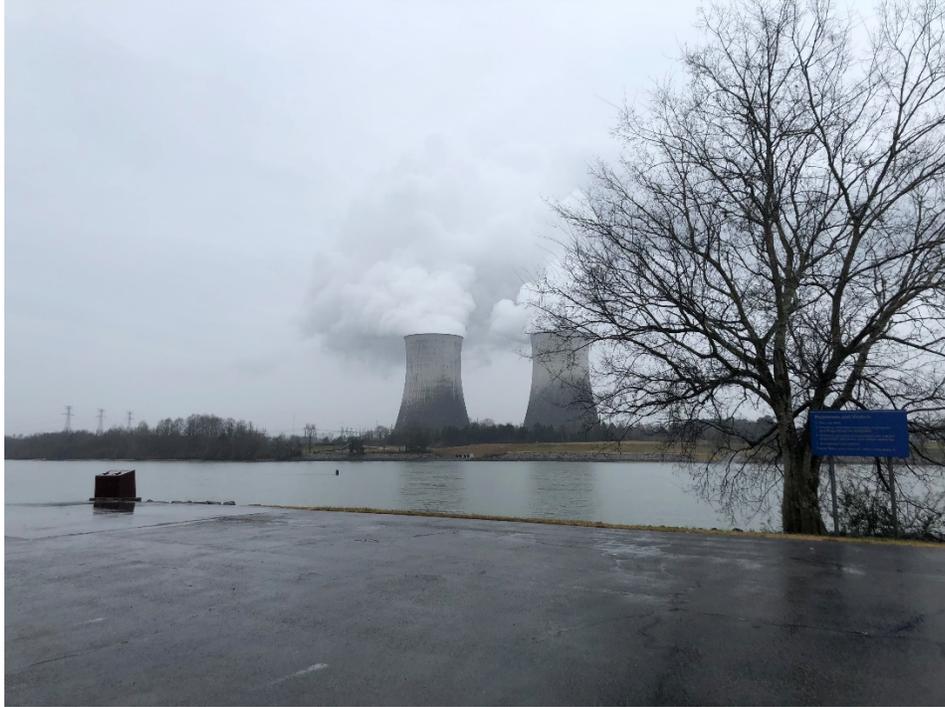
FIGURE 21. PHOTOGRAPH (8) WATTS BAR NUCLEAR PLANT DOWNSTREAM FROM DAM (35.605 °N 84.774 °W).
