Geotechnical Impacts of Hurricane Fiona in Puerto Rico

Event Date: September 18, 2022

GEER Association Report No. GEER 81

March 8, 2023

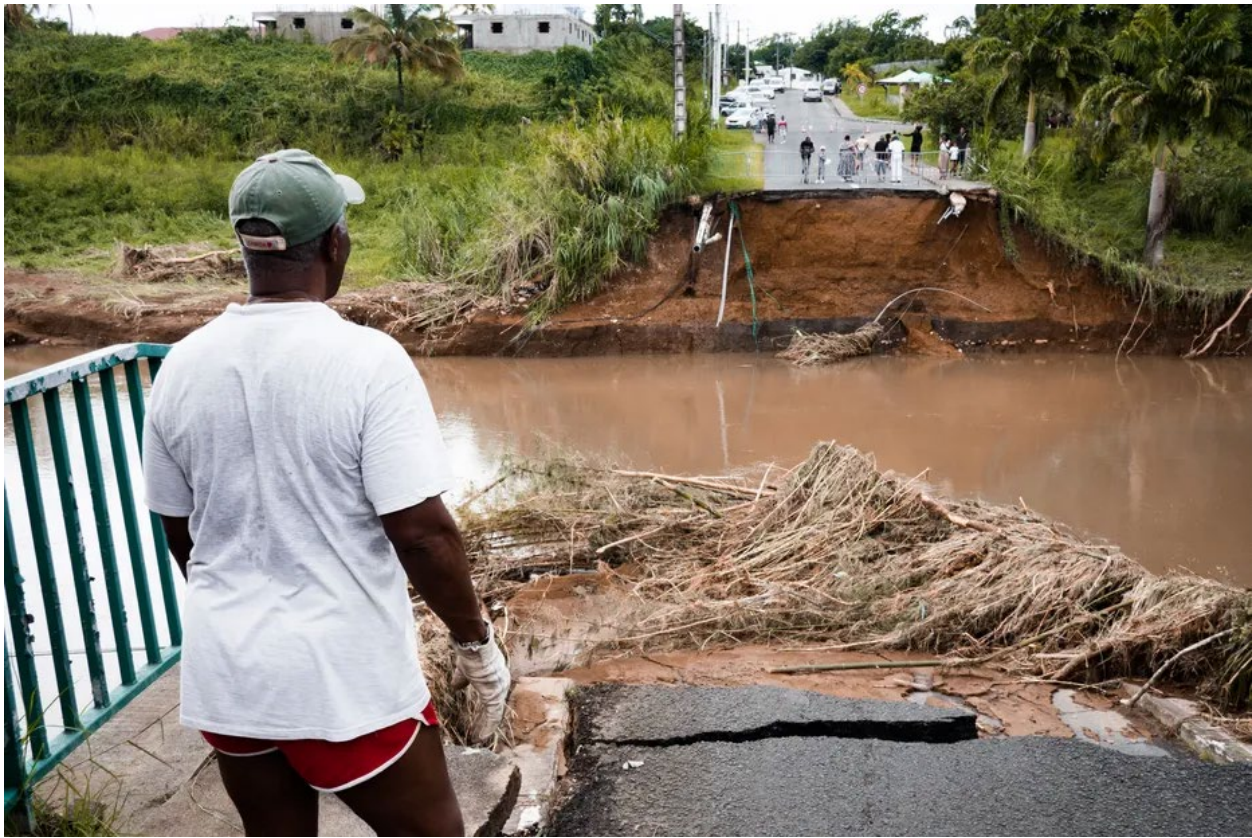
Figure 2: Tropical Storm Fiona damage in Guadeloupe. From: <https://la1ere.francetvinfo.fr/guadeloupe/tempete-fiona-l-etat-de-catastrophe-naturelle-reconnu-pour-22-communes-de-guadeloupe-1324712.html>

The tropical storm moved across Guadeloupe on 16-17 Sept-2022 with wind gusts of 100+ km/hr, sea swell of 4m, and maximum rainfall intensities up to 150+ mm/hr, 200+ mm/3hr and 300+ mm/6hr; these effects caused flooding and landslides, resulting in around 2 dozen rescues, one death, and damage to infrastructure that led to the declaration of a local state of disaster (Figure 2;

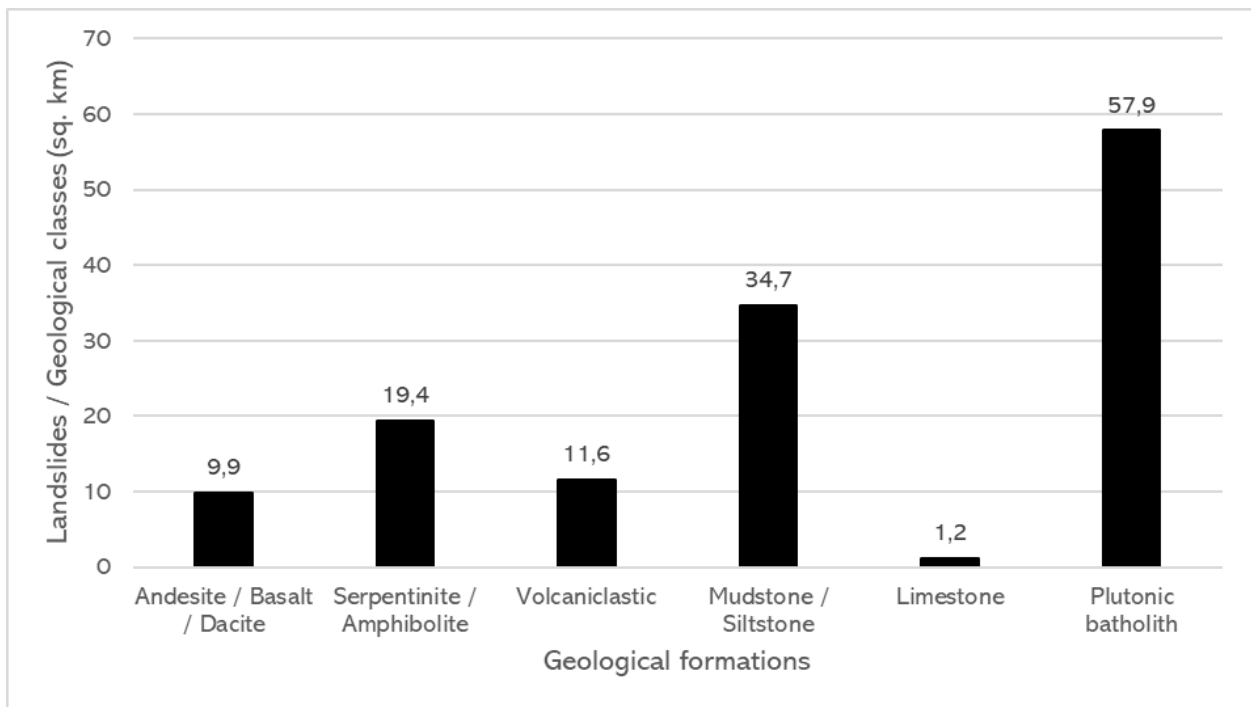
Figure 16: Number of landslide failures per square kilometer for the distinct geological formations in Puerto Rico

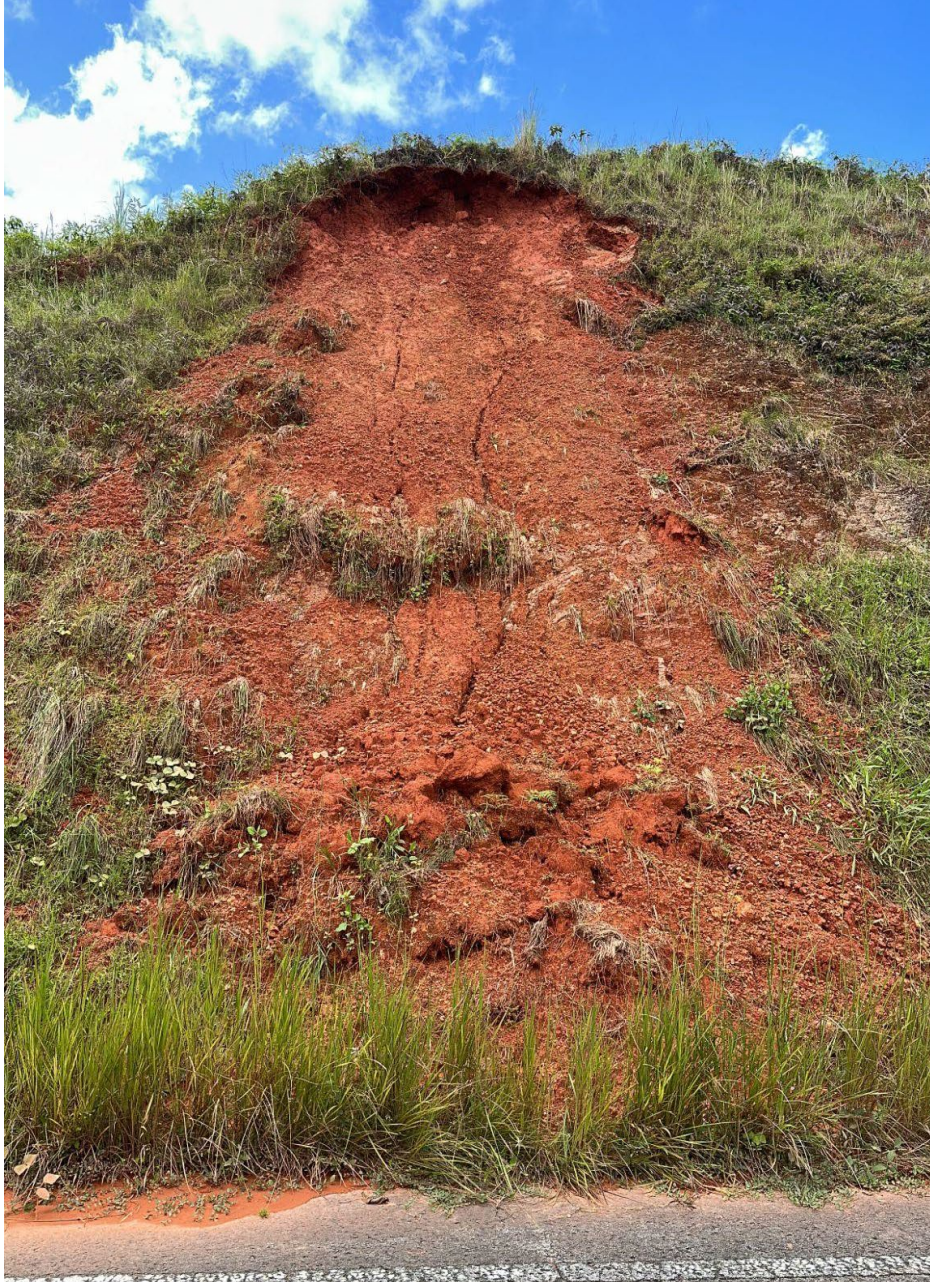
*Figure 17: Typical shallow landslide induced by Hurricane Fiona along PR-52 (18.09637, -66.18862).
Photo taken on 04-Nov 2022.*

While the degree of landsliding in the two hurricane events is dissimilar, the dominant mechanism of slope failure is identical. The majority of the observed landslide sites are small and shallow rather than bedrock failures, with a few notable exceptions occurring at select large failures across the island. The vast majority of slides encountered during reconnaissance were small: on the order of several tens of square meters. Typical shallow translational failure mechanisms induced by Hurricane Fiona are shown in Figure 17. The failures that occur in first order channel hollows very often transitioned into debris flows (Figure 19).

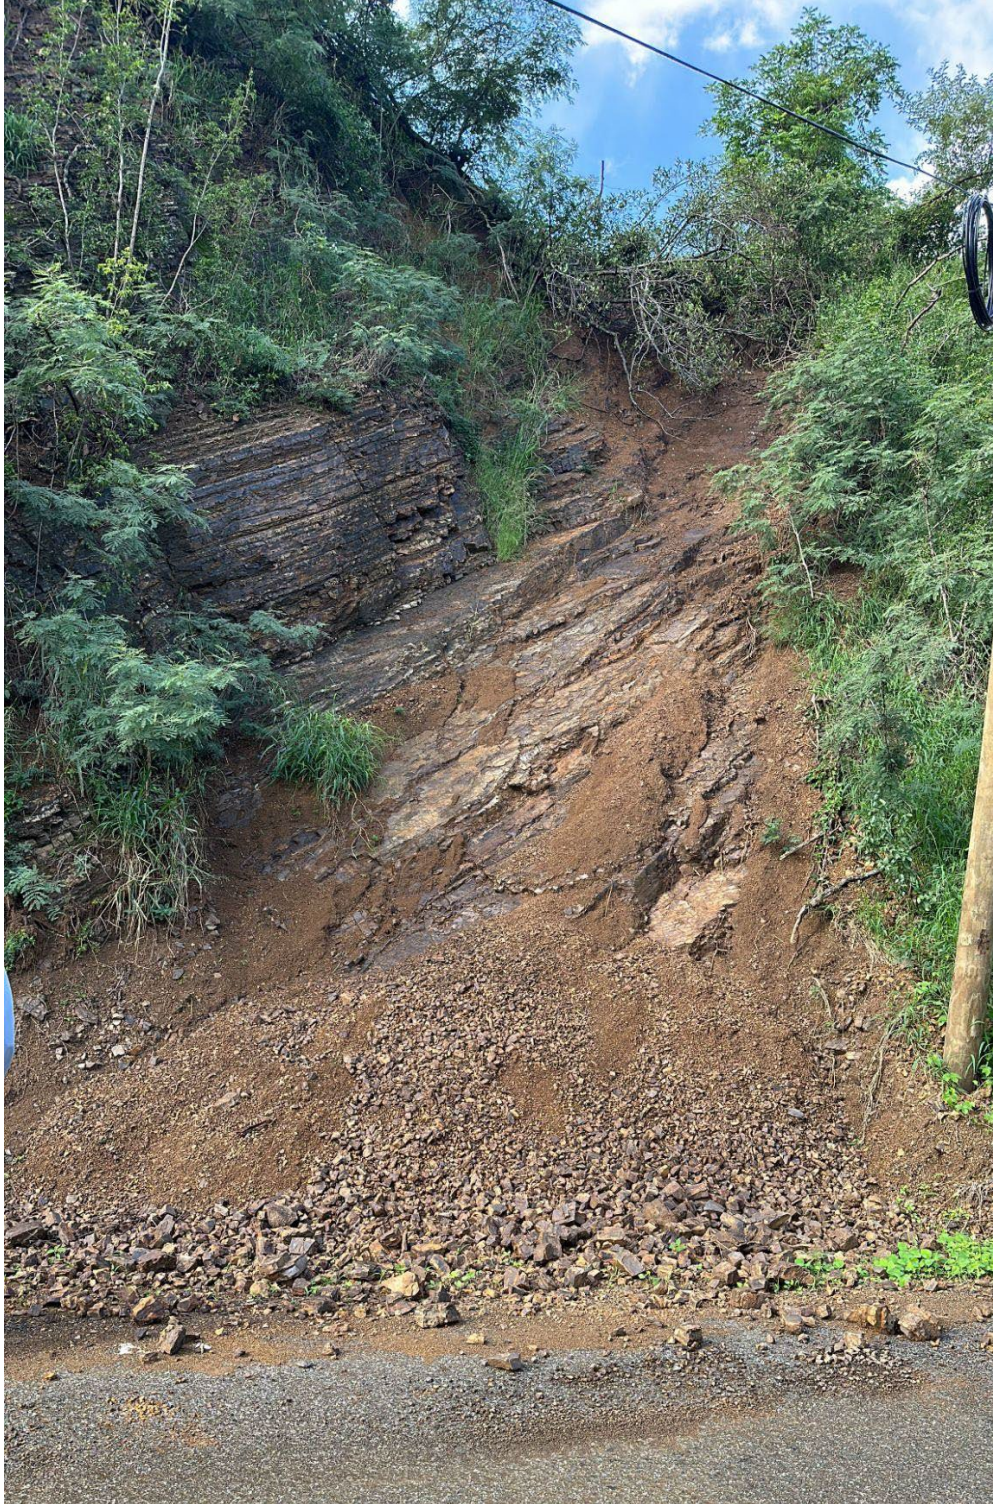
Figure 18: Failure plane at the boundary of soil/regolith and less weathered bedrock material along PR-128 in Rio Yauco (18.05961, -66.86041). Photo taken on 07-Nov 2022.

The failure plane is most often located at the boundary between soil/regolith and less weathered bedrock material (often saprolite) as shown in Figure 18. These slopes were initially stable given the matric suction in the unsaturated zone that translated into significant effective stress values.

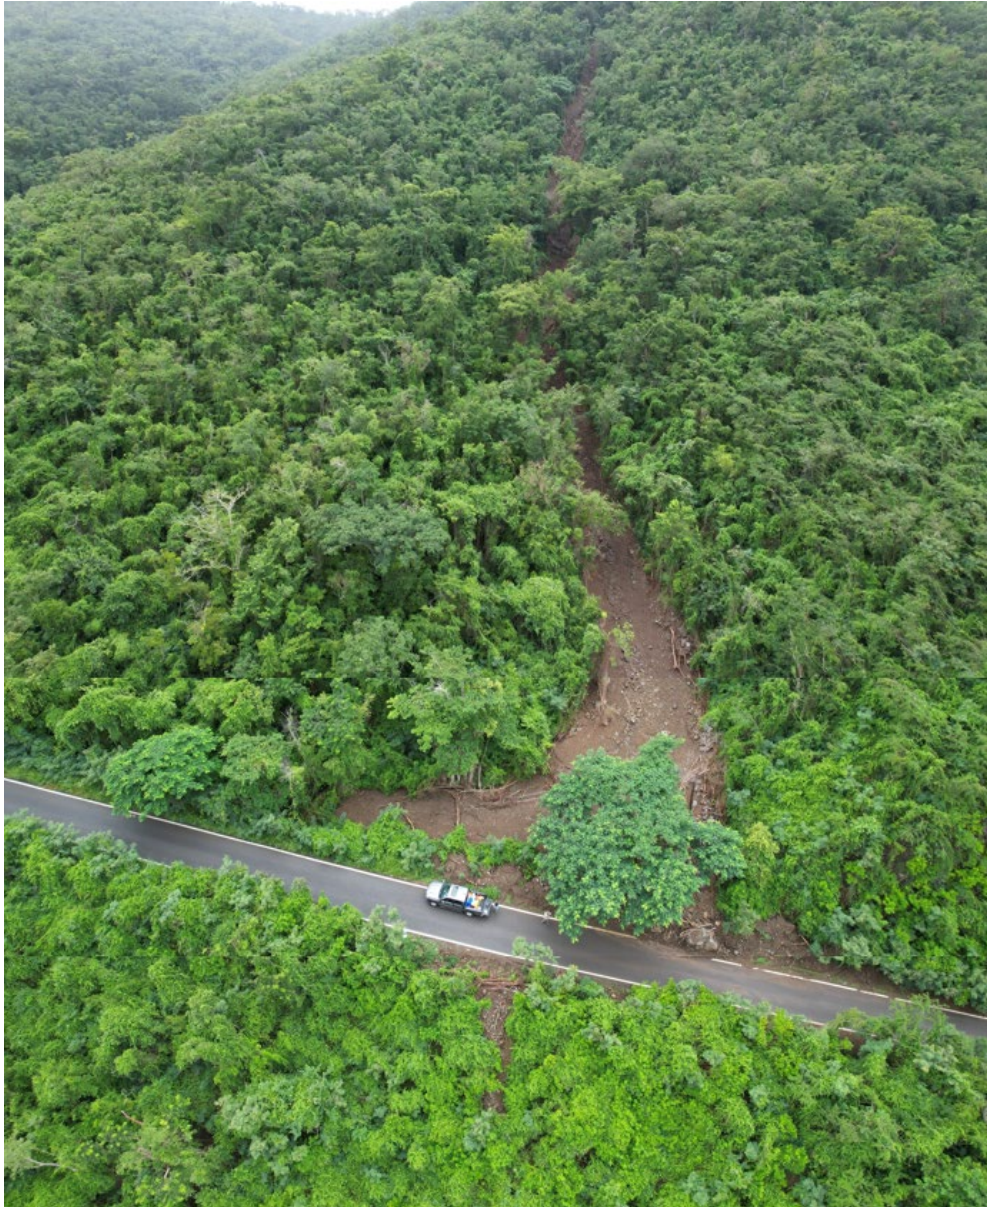
Figure 19: Aerial imagery of shallow debris flow site along PR-712 in Salinas (18.04221, -66.18957). Pickup truck for scale. Photo taken on 30-Oct 2022 and the view is looking generally south.

At this site, we encountered a long debris flow runout that had covered the road at some point (Figure 19). We were not able to access the initiation point, but the feature was at least 200 meters long. As seen in pre-event LiDAR (Figure 20), it appears that the site may be a reactivation from a previous mass movement. The road was not damaged, only temporarily covered.

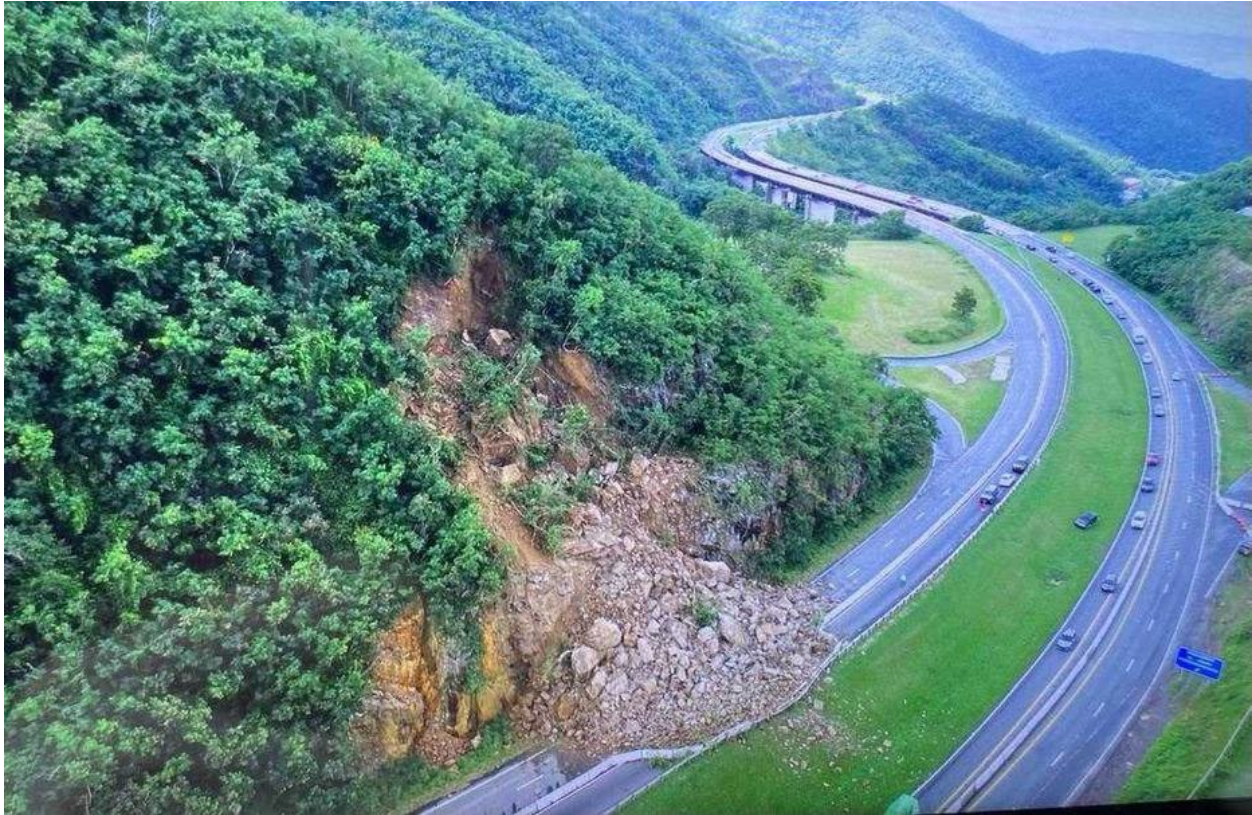
Figure 21: Rockfall along PR-52 in Salinas, near the border with Cayey (18.0711, -66.2172). Photo is from <https://www.primerahora.com/noticias/puerto-rico/fotogalerias/fotos-graves-danos-a-carreteras-a-causa-de-las-fuertes-lluvias>

This landslide was not triggered during Fiona, but several weeks later during our 2nd phase of reconnaissance on 06-Nov 2022. In the entire month after Hurricane Fiona, tropical rains continued. In early November, one event included an additional 5-8" of precipitation over 48 hours (NWS San Juan). The excess rainfall on already saturated hillslopes caused frequent new landslides across many parts of the island, so much so that at several sites we were unable to recognize if the failure was directly related to Hurricane Fiona, some time after, or both. The site on PR-52 is especially important because it blocked one complete direction of travel along the main expressway that connects the San Juan metropolitan area to the south coast of the island (Figure 21). From pre-event LiDAR derived digital elevation data, it is evident that the site is a large benched cut slope that was engineered during the construction of the freeway (Figure 22).

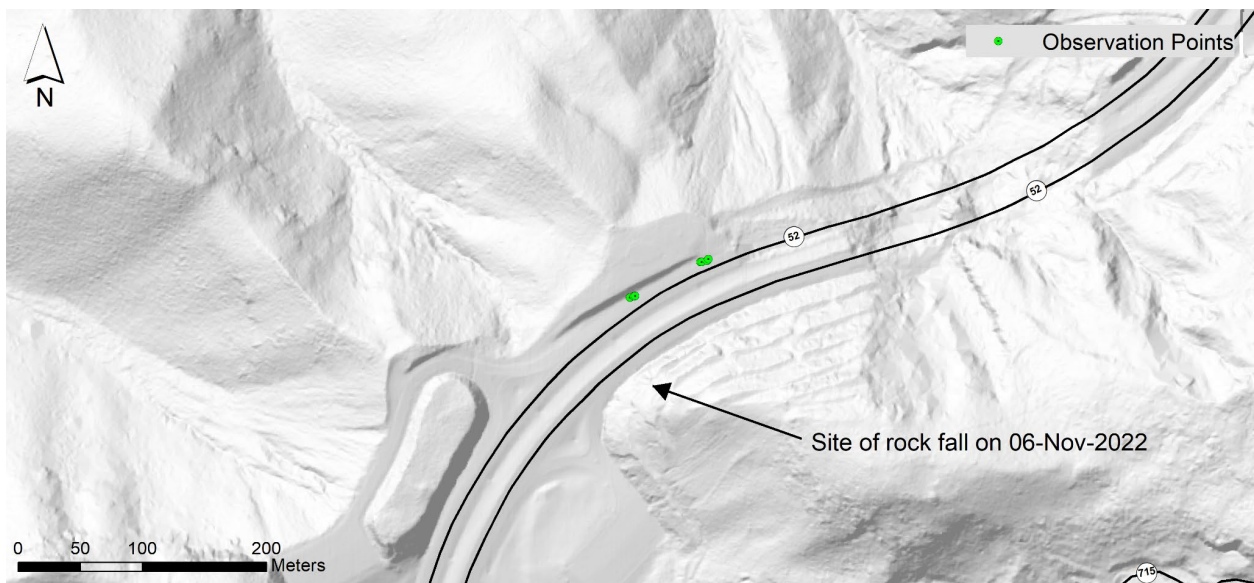
Figure 22: 2016 1m resolution LiDAR derived hillshade map of the PR-52 site in Salinas (18.0711, -66.2172)

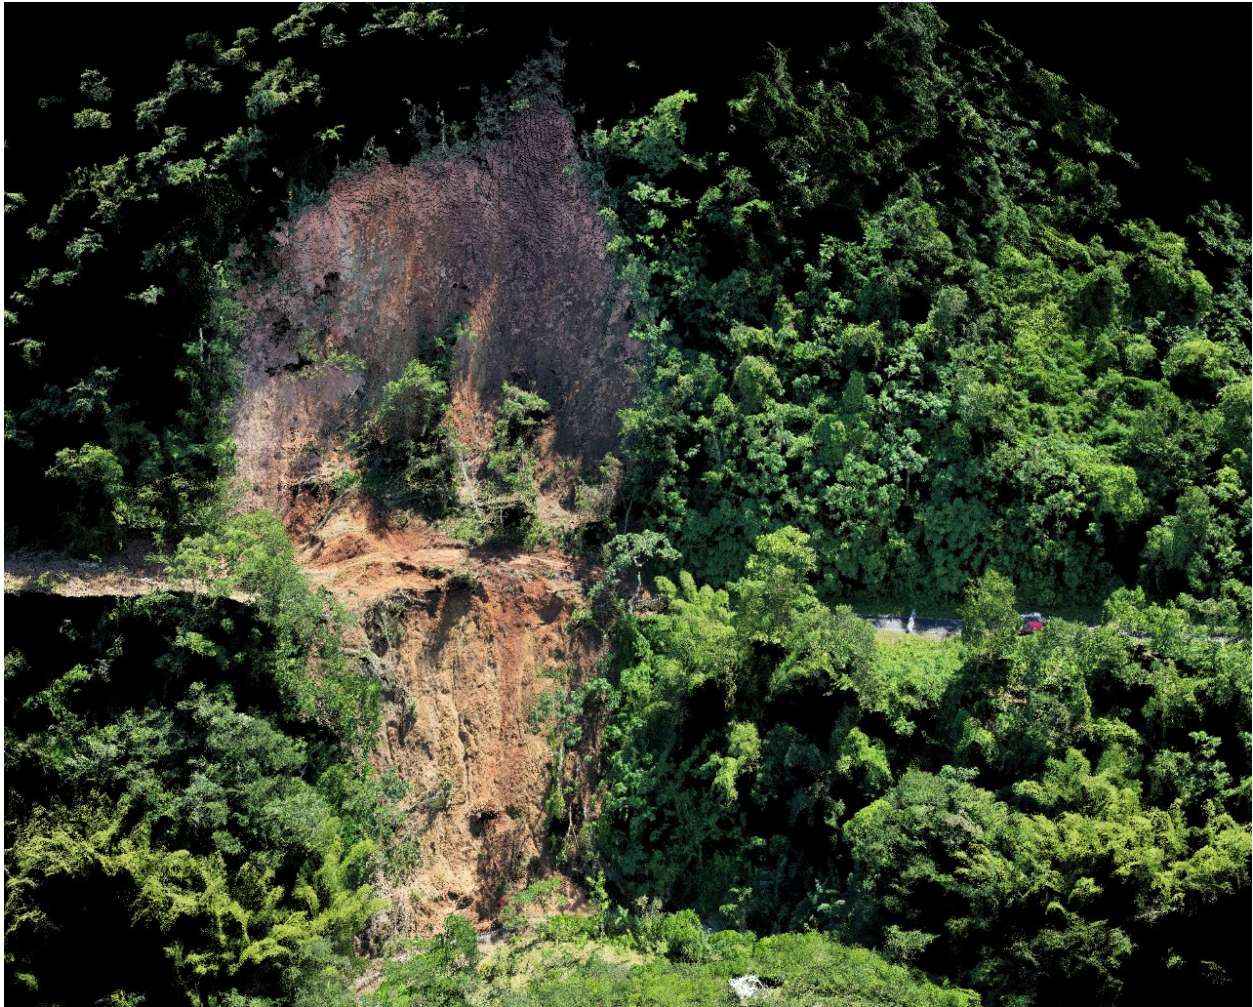
Figure 23: Photo mosaic of over 250 aerial photographs of a large rotational slump landslide along PR-409 in Las Marías (18.2061, -66.94397). Vehicles at the right center of the photo for scale.

This is one of the larger sites that we documented after Hurricane Fiona. The site is a rotational slump landslide that covered the road in ~10m of weathered regolith material and also introduced a small landslide dam in the creek below (Figure 23). Back rotated trees were very evident along the slide body (Figure 24) and based on an analysis of pre-event LiDAR digital elevation data, the site is considered a new failure (Figure 25).

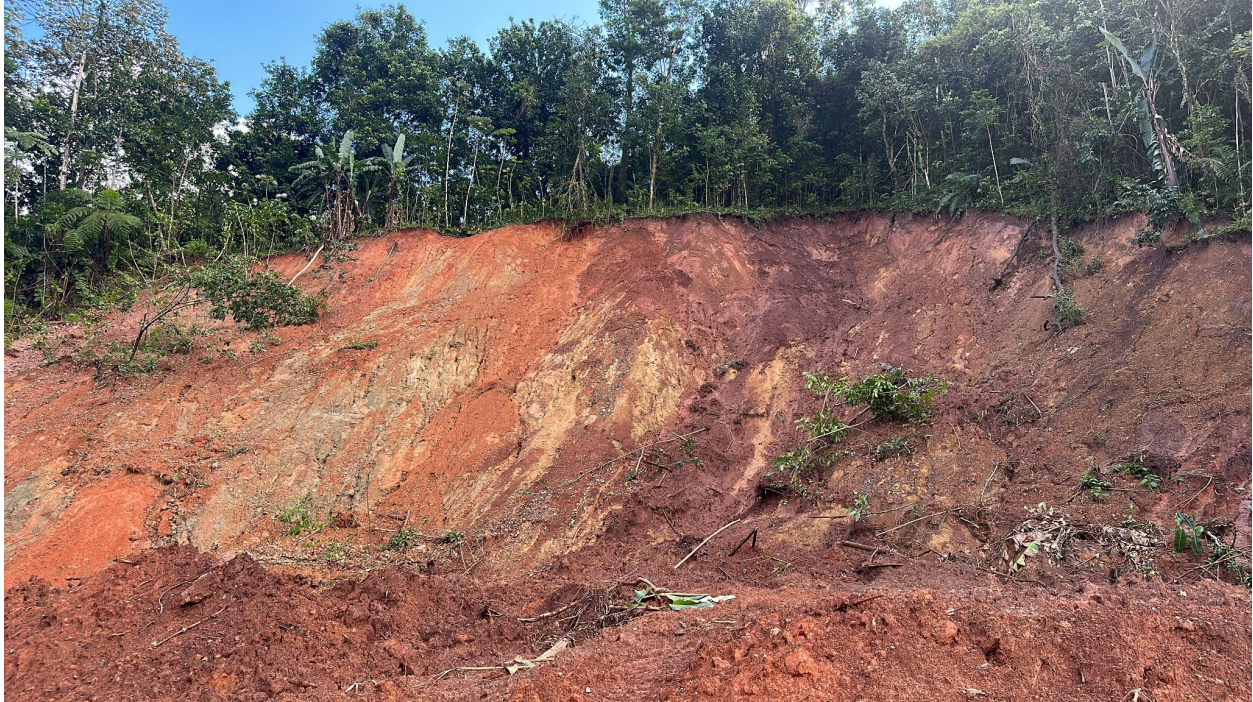
Figure 24: View of the headscarp of the PR-409 landslide standing on the toe material that covered the road. Note the deep weathering profile.

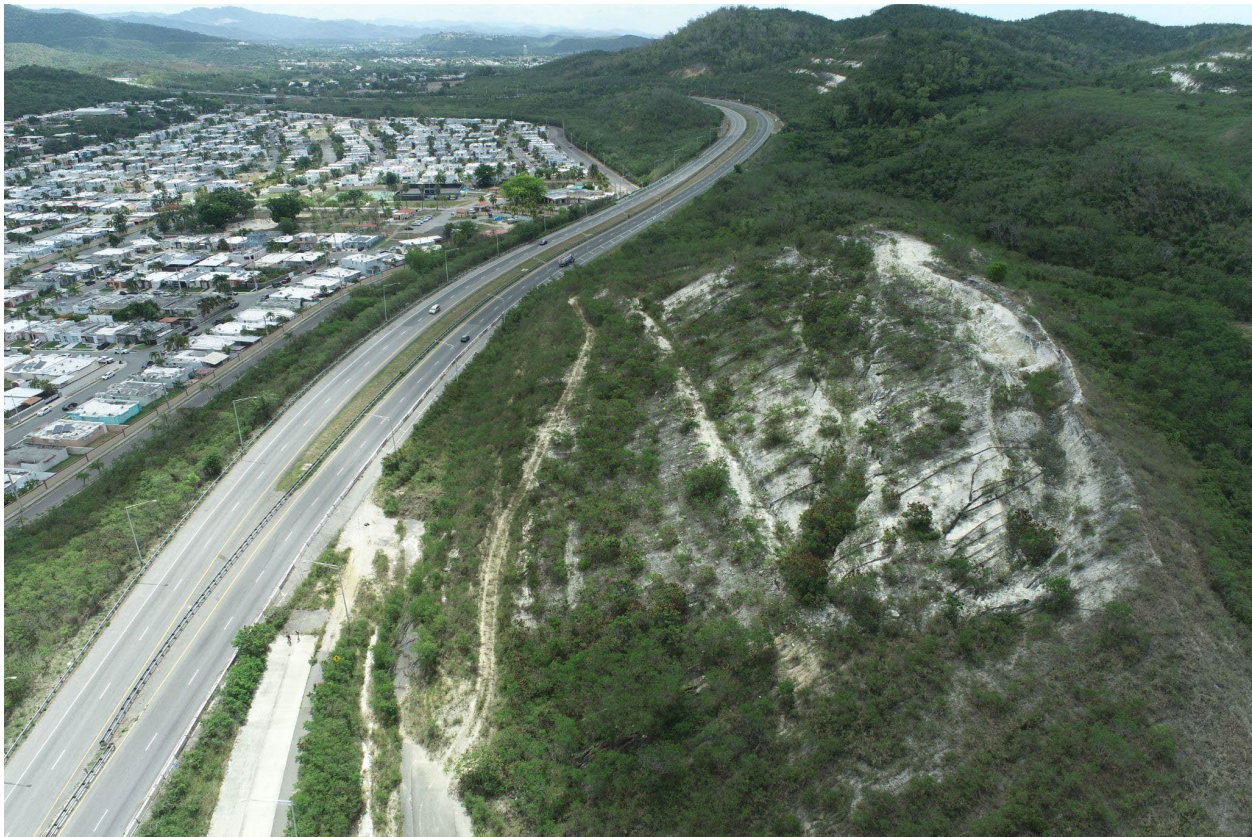
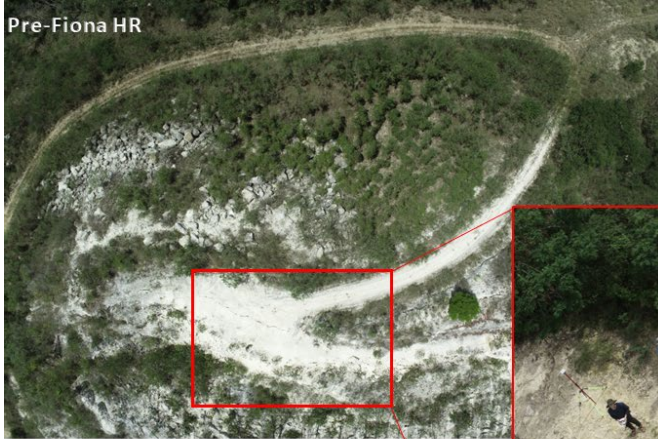
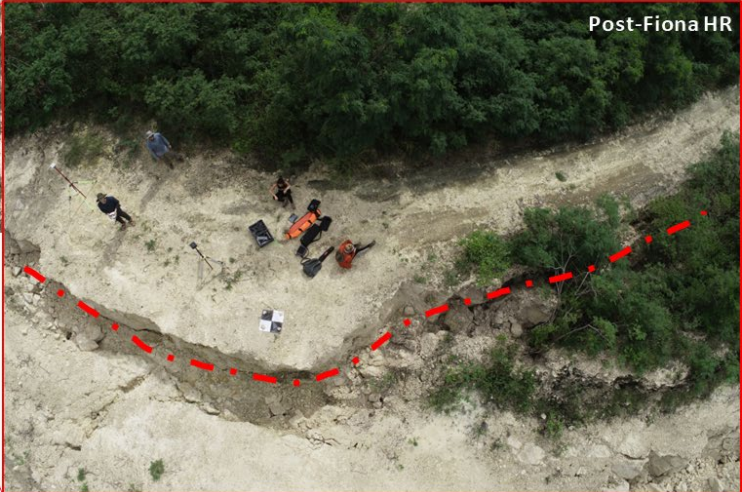
Figure 27. Aerial photos of the Ponce landslide indicating the landslide failures.

A large bedrock landslide along PR-9 to the North of the city of Ponce initiated well before Hurricane Maria (2017). This landslide is located in the Juana Diaz Formation which was the geological unit that experienced large failures during the nearby Mameyes landslide disaster of 1985. The geology at the site consists of basal gravel to conglomerate overlain by chalky limestone. No observable changes in the landslide site were noticed with respect to the pre-hurricane Maria as reported by the GEER team that visited the site before Hurricane Maria (June 2017) and after the hurricane (October 2017). Changes were documented related to the 2020 Puerto Rico M6.4 earthquake. Hurricane Fiona; however, has reactivated the landslide at this site. Cracks at the site induced by previous failures were expanded amid hurricane Fiona. Figure 26 shows a differencing model between May 2022 and November 2022 at the Ponce landslide site.

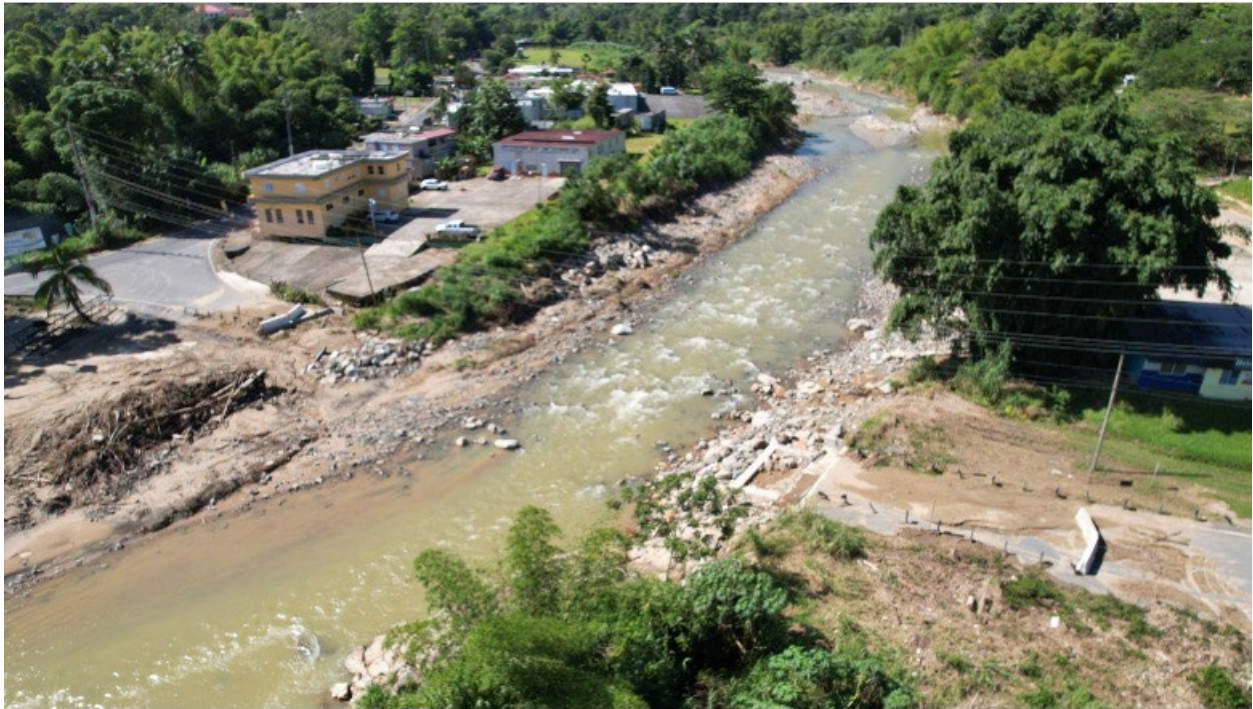
Figure 30: Aerial photograph looking south at the location where a temporary bridge structure across the Río Grande de Arecibo in Utuado was washed away during Hurricane Fiona. Video of bridge failure here: <https://www.telemundopr.com/noticias/puerto-rico/colapsa-puente-en-utuado/2394672/>

After Hurricane María in 2017, several bridges that were destroyed were replaced by temporary bridges that were then taken out by Hurricane Fiona. Below are two examples. These types of structures cannot withstand the drag of floodwaters and abundant debris that are loaded onto their upstream side during extreme precipitation events. Our observations show that the simple hardware that bolts the bridge structure to concrete abutments is not sufficient.

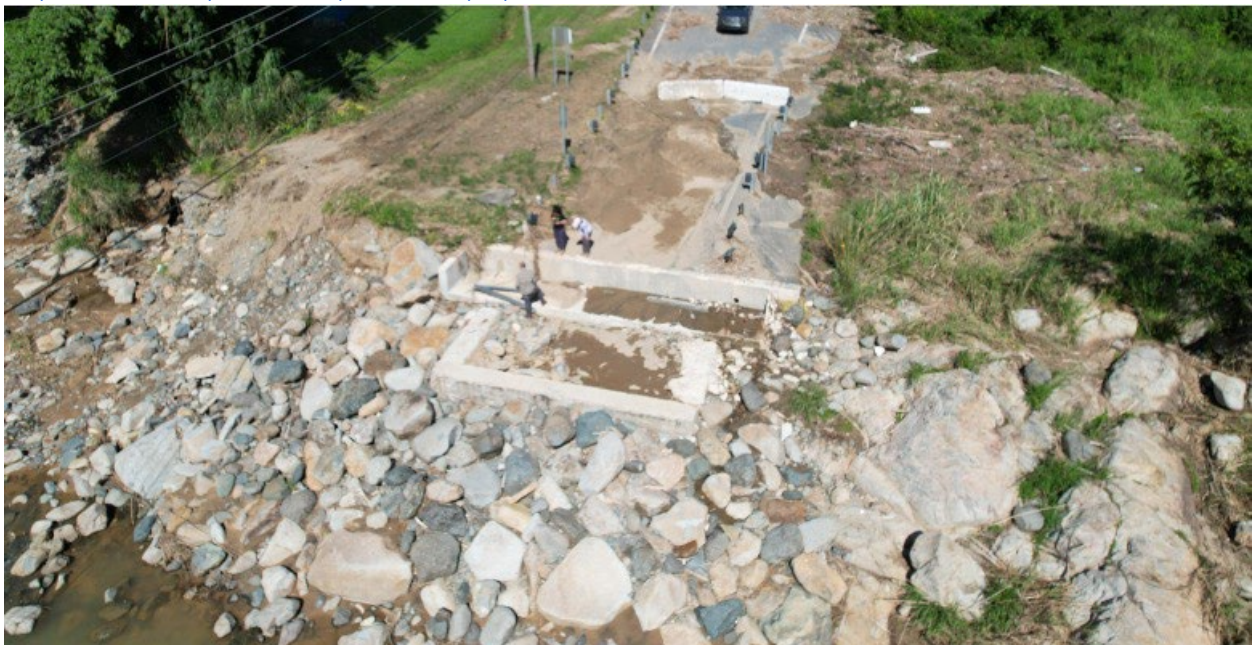
Figure 31: Aerial view of the western abutment of the temporary bridge in Utuado that was washed away

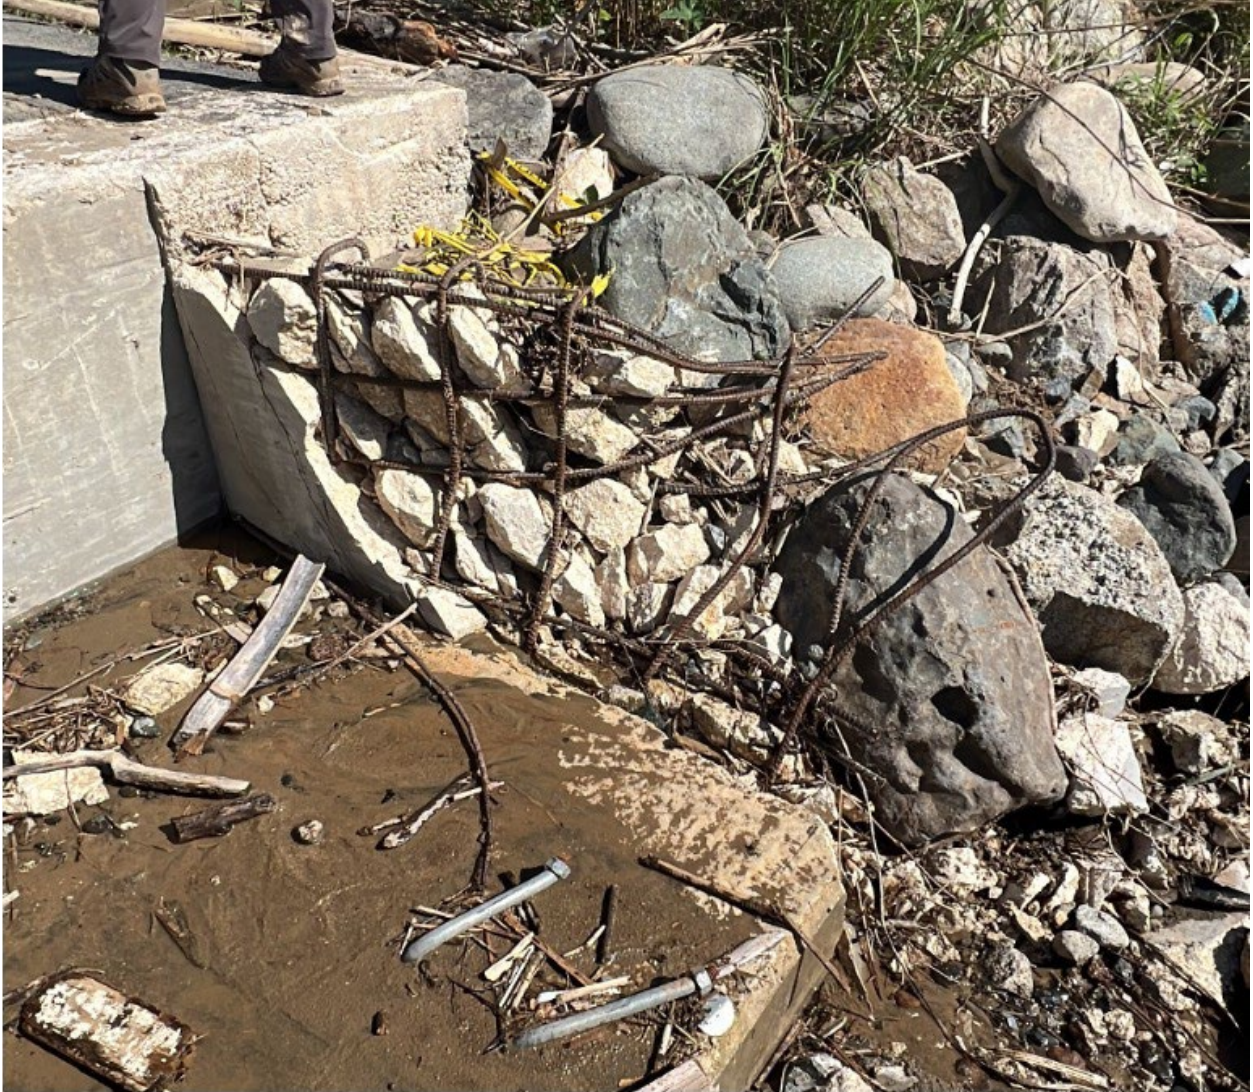
Figure 32: Destroyed concrete structure with rebar (deflected in downstream direction) on the western abutment of the temporary bridge in Utuado that was washed away during Hurricane Fiona

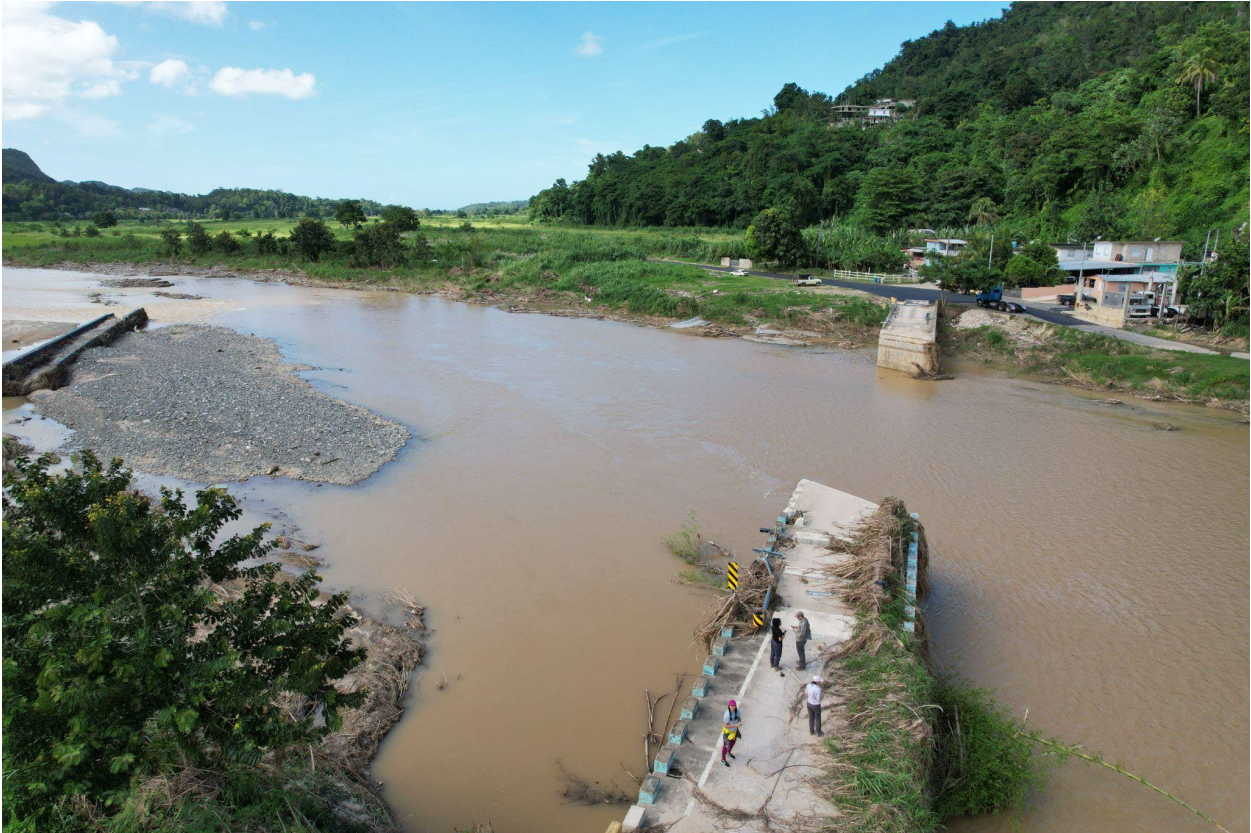
Figure 33: Aerial view of a temporary bridge failure along the Río Grande de Arecibo in Arecibo (18.3917, -66.6805). View is looking North. Note large amounts of vegetation that was caught by the bridge and the section of bridge washed away at the left center of the photo. Humans on bridge for scale

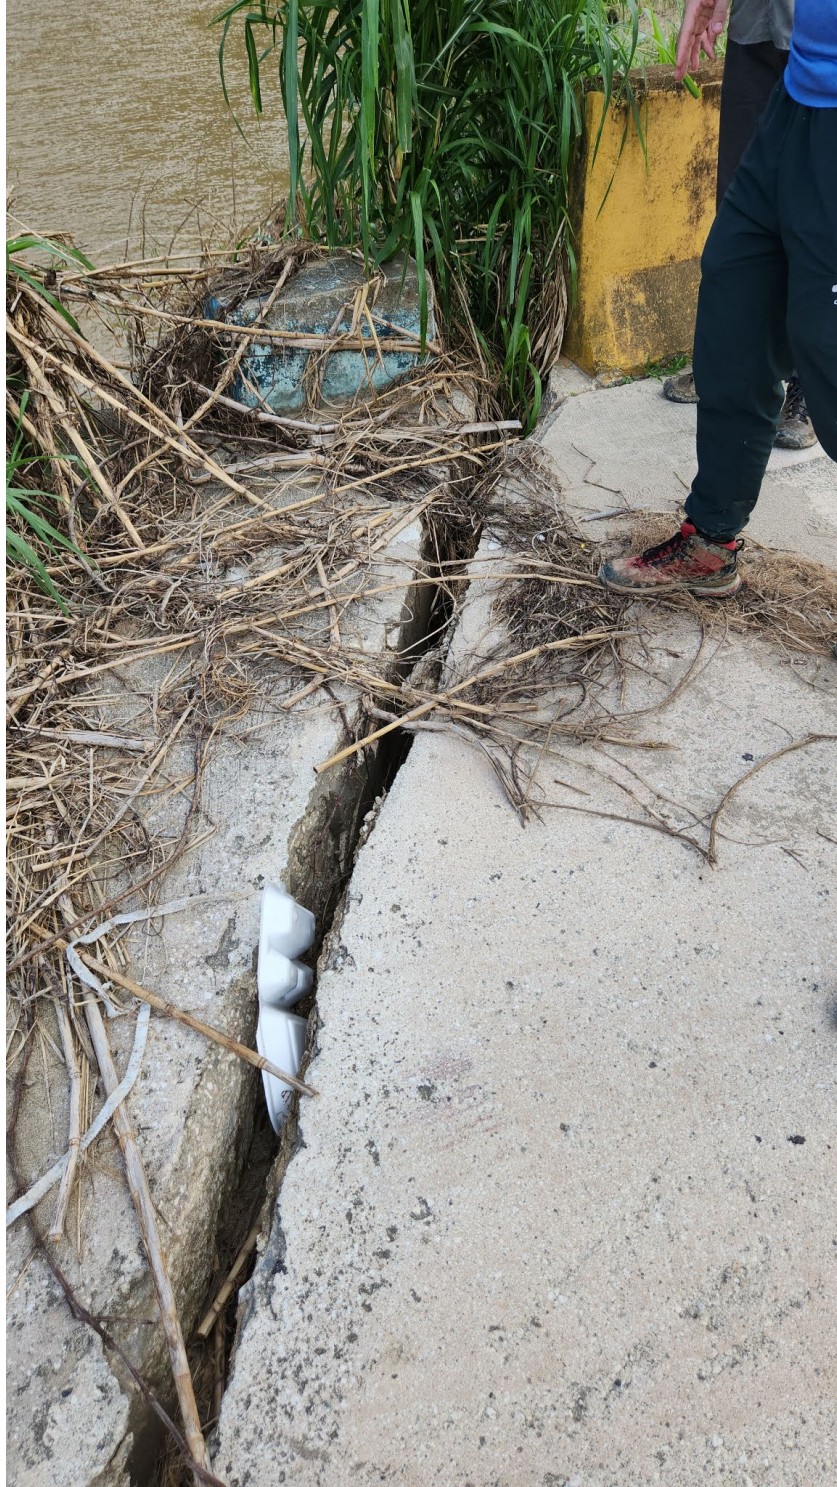
Figure 34: Horizontal separation of bridge segments along the Rio Grande de Arecibo bridge failure site in Arecibo. Separation is wider on the upstream side of the structure, indicating downstream rotational movement.

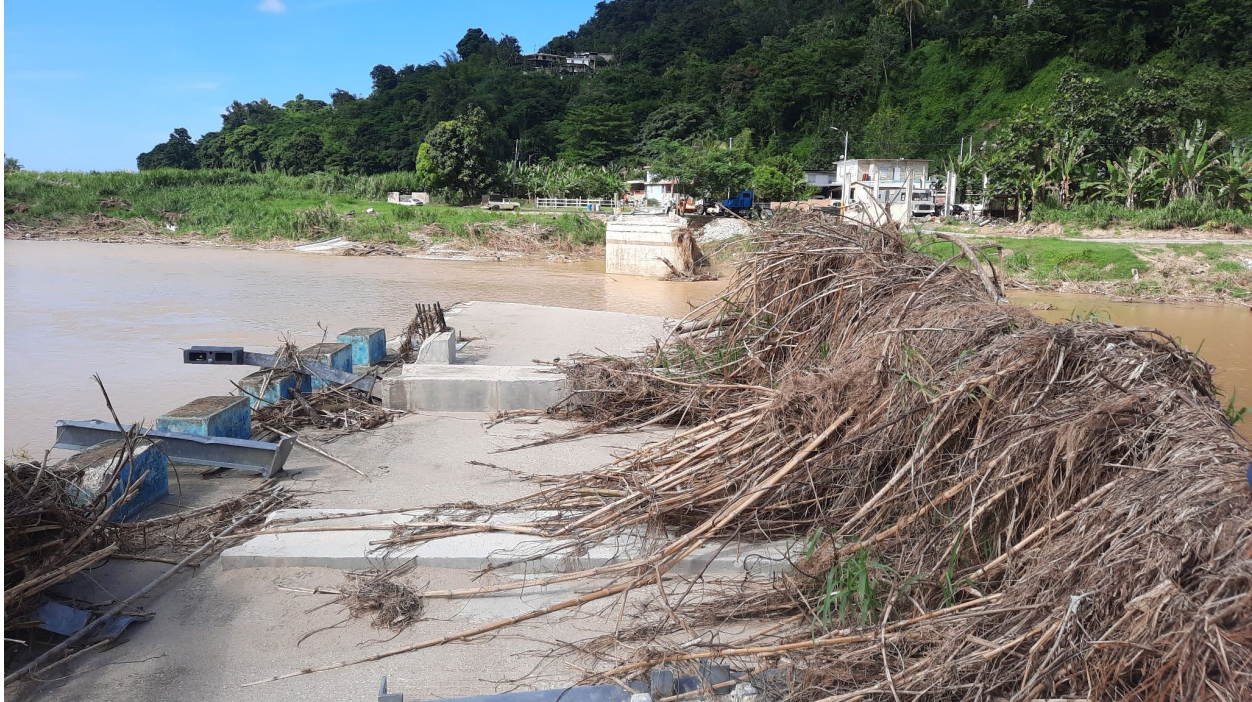
Figure 35: View of the missing segment of the temporary bridge of Rio Grande de Arecibo in Arecibo. Note the sheared rebar at center left of the photo that was used to anchor the temporary segment.

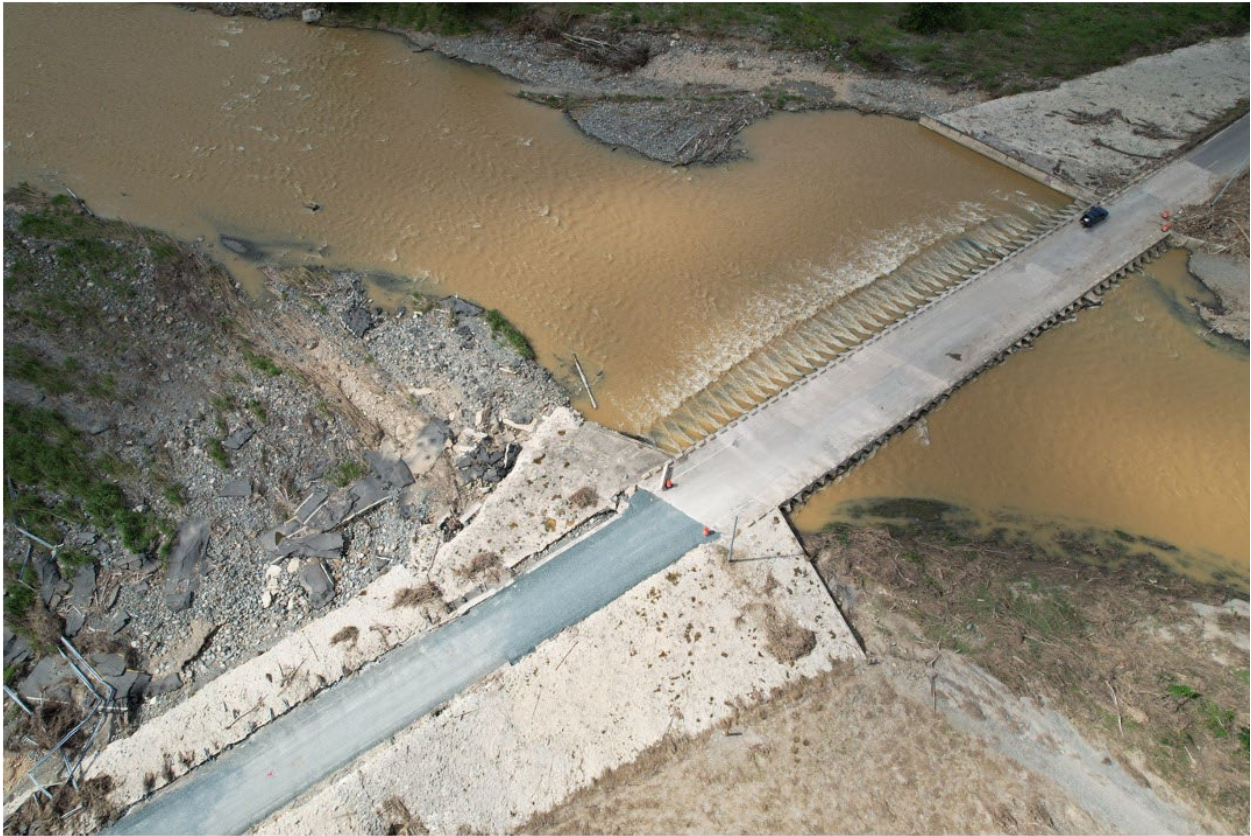
Figure 36: PR-123 bridge over the Rio Grande de Arecibo in Arecibo (18.368, -66.684). This bridge did not fail during Hurricane Fiona but the approaching abutments on either side had to be rebuilt following the storm. View is looking Northwest.

Several other bridges were left unusable after Hurricane Fiona not because of bridge failure, but because of the erosion of the structural abutments of earthen material. Some typical examples are described below.

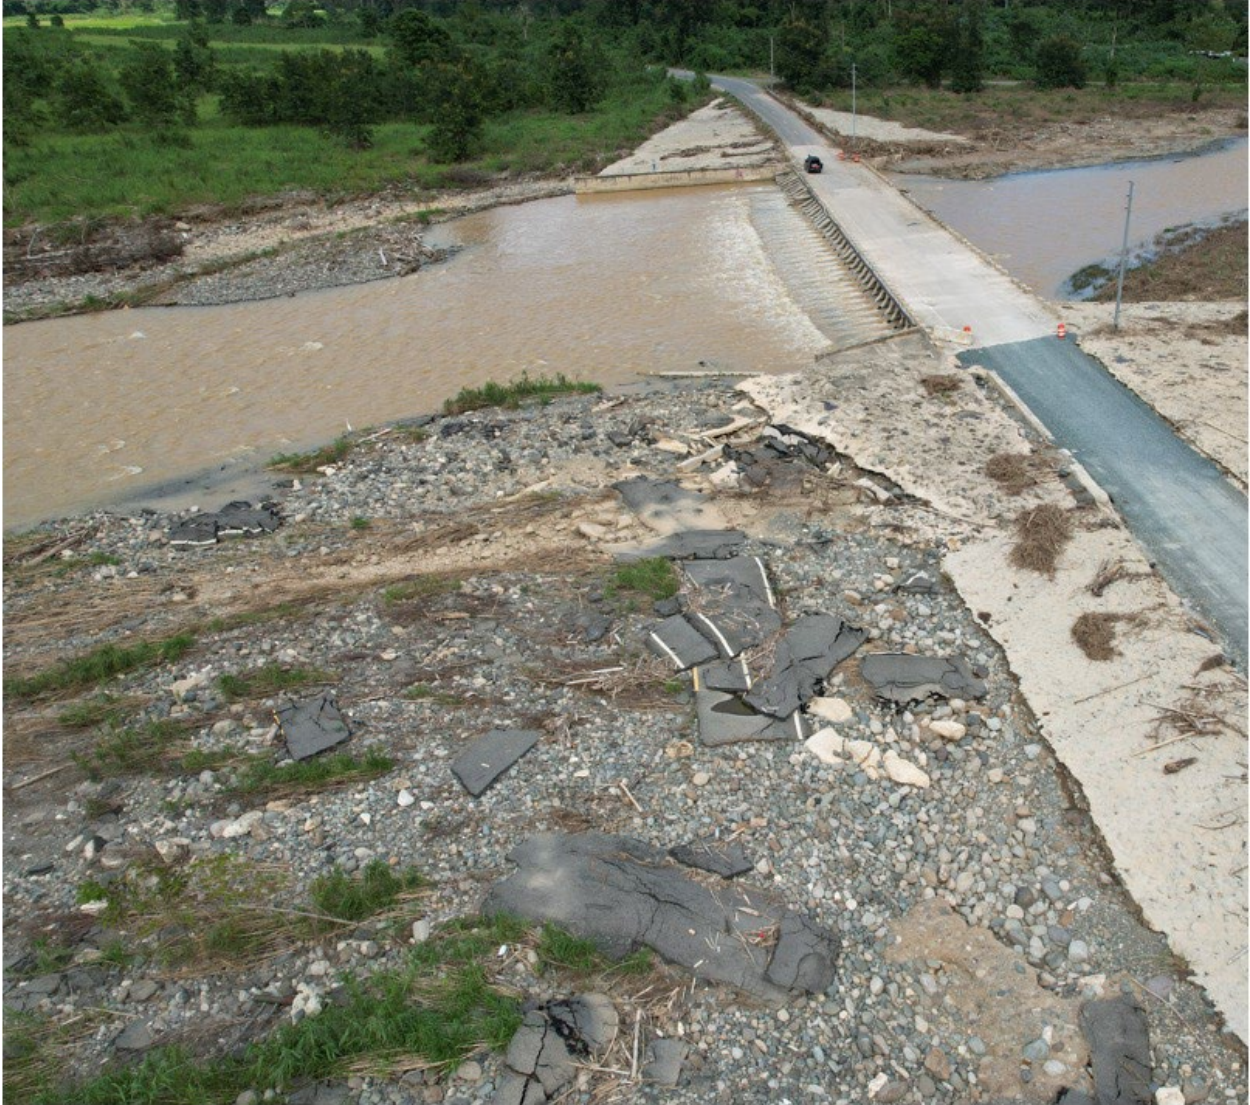
Figure 37: Aerial view of pieces of PR-123 approach segments that were washed downstream by the Rio Grande de Arecibo (18.368, -66.684). View is looking north.
