Geotechnical Impacts of Hurricane Fiona in Puerto Rico

Event Date: September 18, 2022

GEER Association Report No. GEER 81

March 8, 2023

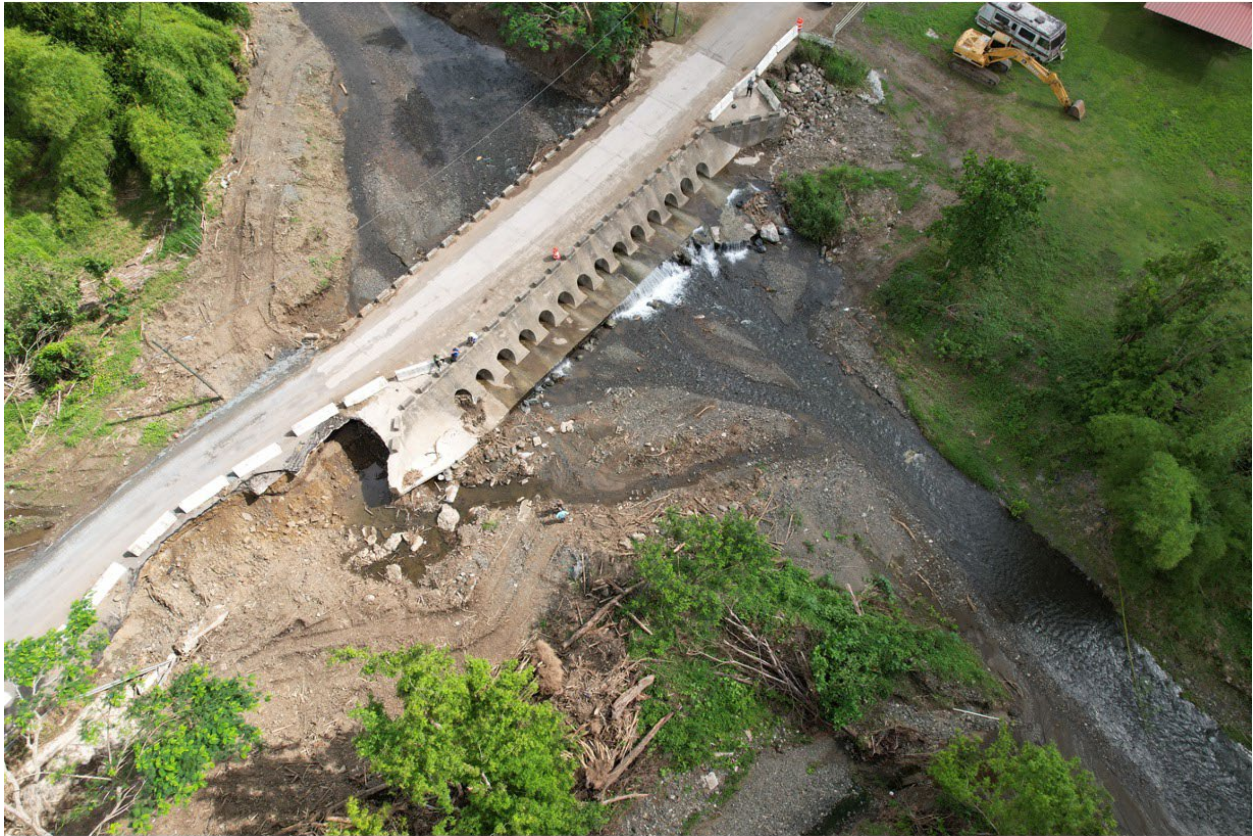
Figure 38: Aerial view of the PR-358 bridge over the Rio Hoconuco in San Germán (18.116, -67.071). The bridge structure did not fail, however, the abutments on both sides partially failed due to high discharge over and around the bridge during Hurricane Fiona.

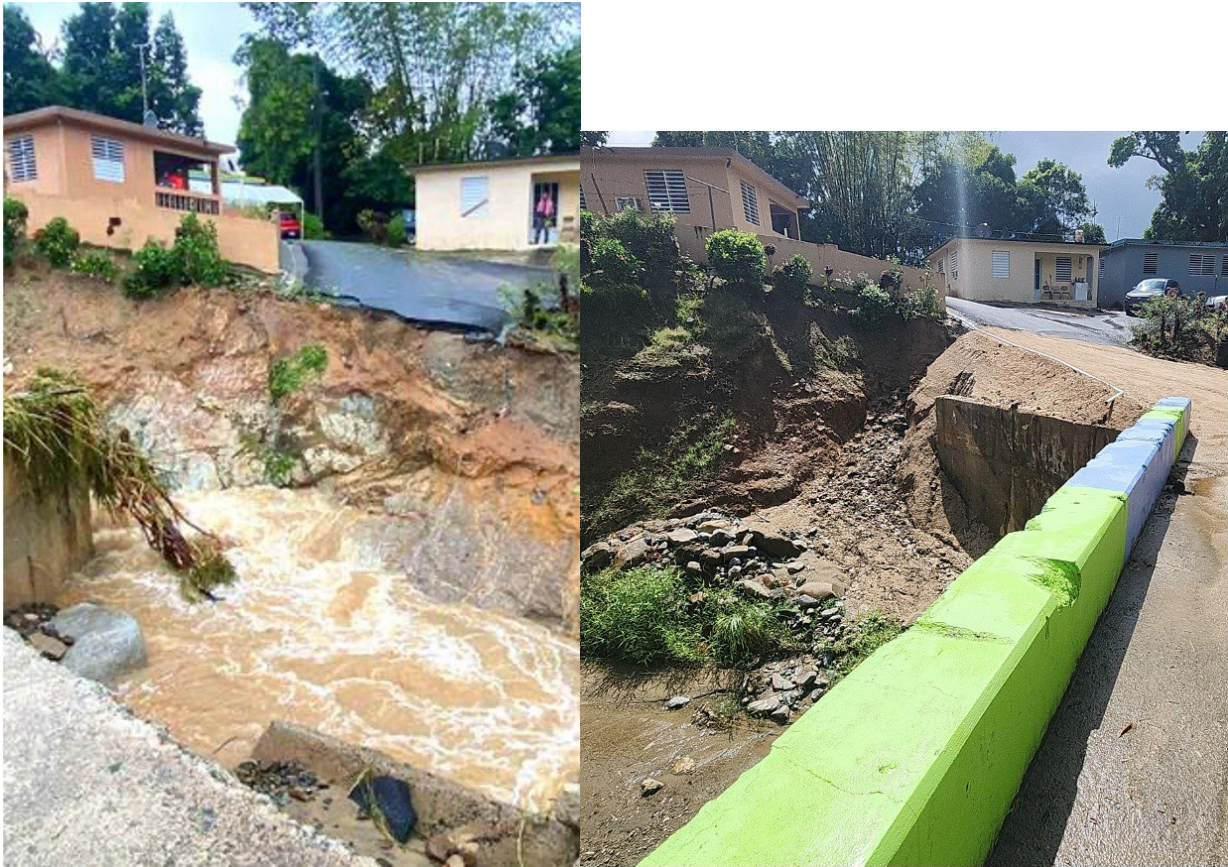
Figure 39: Example of bank erosion along the abutment of a small bridge over the Rio Maunabo in Maunabo (18.0289, -65.9475). The bridge did not suffer but the complete abutment and river bank was washed away. The area washed out was replaced with fill material to provide access to residents of a small isolated community beyond the bridge crossing.
