**GEOTECHNICAL EXTREME EVENTS
RECONNAISSANCE (GEER) ASSOCIATION**

**EXECUTIVE SUMMARY OF **GEOLOGICAL
RECONNAISSANCE** OF THE FEBRUARY 06, 2023,
KAHRAMANMARAŞ EARTHQUAKES, TÜRKİYE**

EXECUTIVE SUMMARY

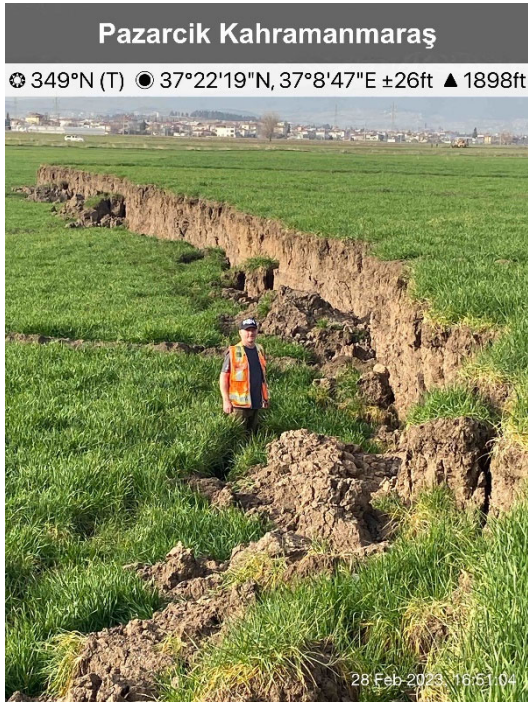
Figures 2a, b, c, d (clockwise from top left): **2a**, fault surface rupture of a portion of the Mw 7.8 earthquake; **2b**, rock falls near Nurdağı; **2c**, liquefaction sand blows near Antakya; **2d**, fault surface rupture of a portion of the Mw 7.5 earthquake near Ekinözü with 8.6 m of recorded left lateral displacement.
