14.0 GEOLOGIC AND TSUNAMI HAZARDS, URBAN PLANNING, AND RECONSTRUCTION

14.1 Introduction

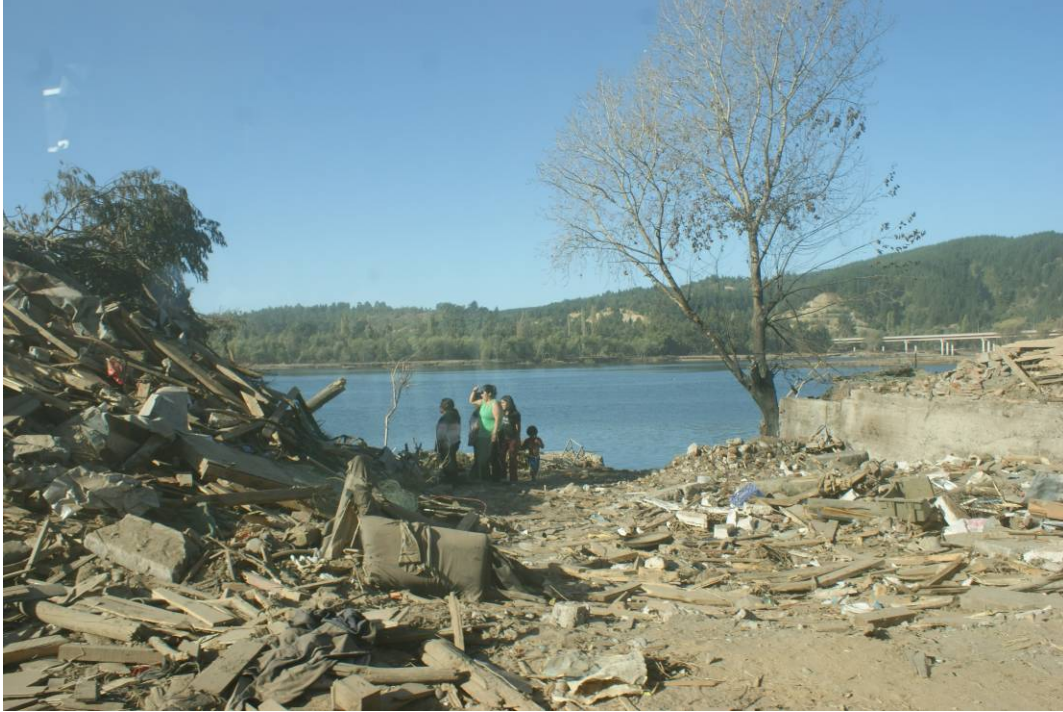
Figure 14.2. Constitucion. Debris removal and road clearing still underway in the tsunami inundation zone along the Maule River. (S35.340323°, W72.396772°; 16:54 hours on 3/15/2010).

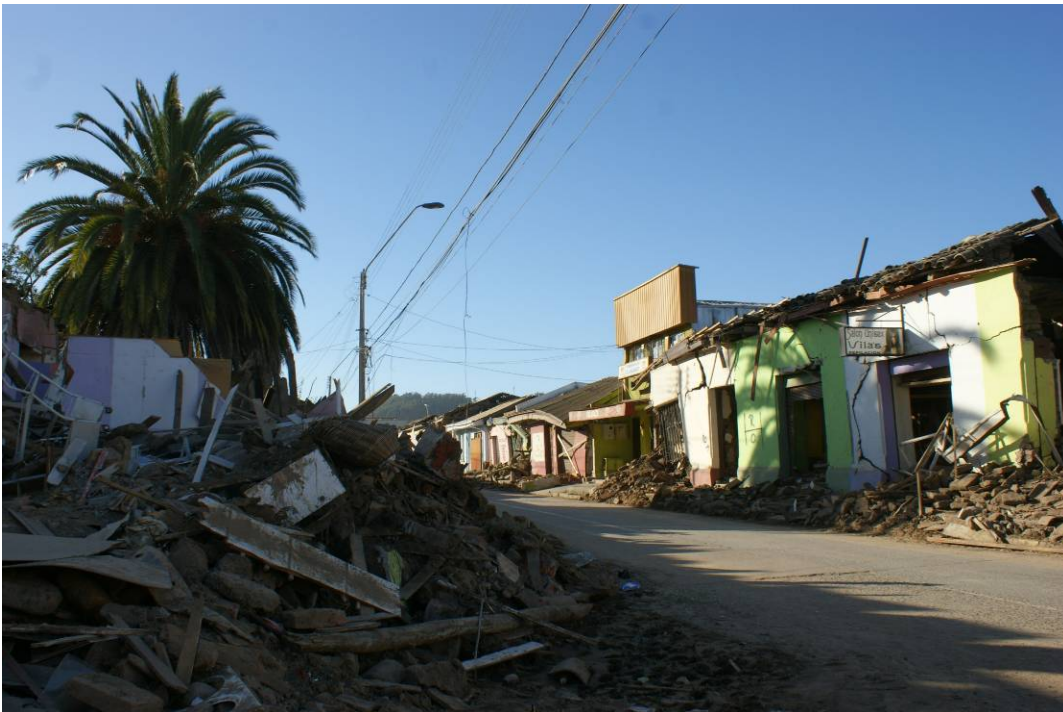
Figure 14.3. Constitucion. Tsunami damage merges with shaking related damage in the older section of the city center with its many adobe and unreinforced masonry buildings. (S35.335383°, W72.410055°; 17:25 hours on 3/15/2010).

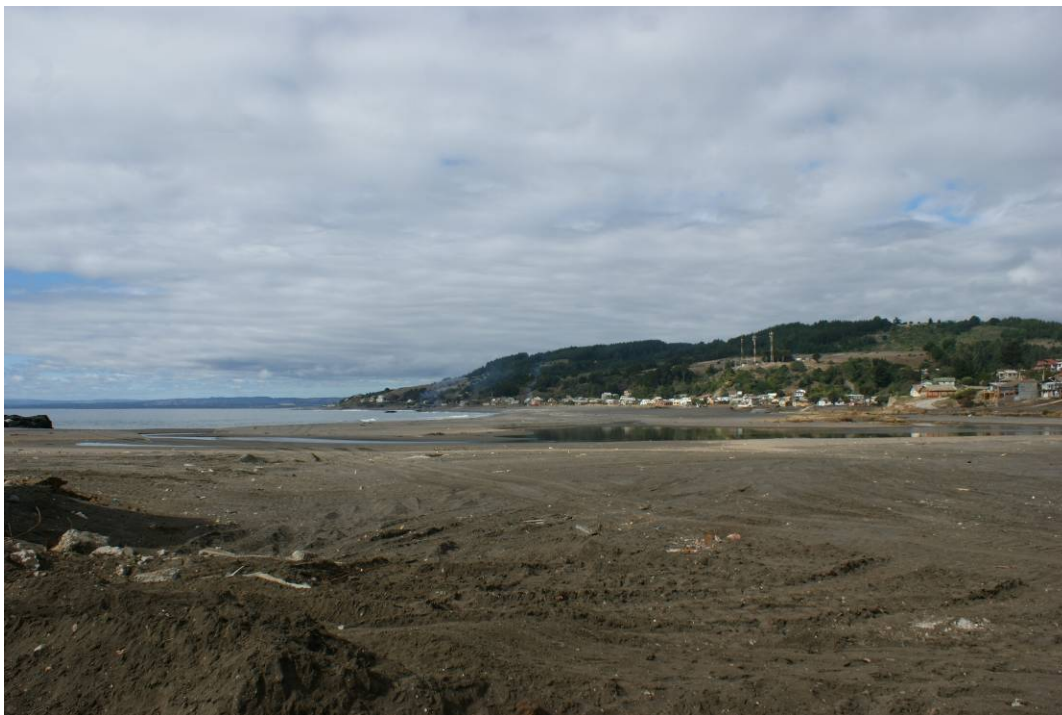
Figure 14.4. Curanipe. Main beach and much of town's debris has been completely cleared.
(S35.843823°, W72.6385°; 15:58 hours on 3/17/2010)

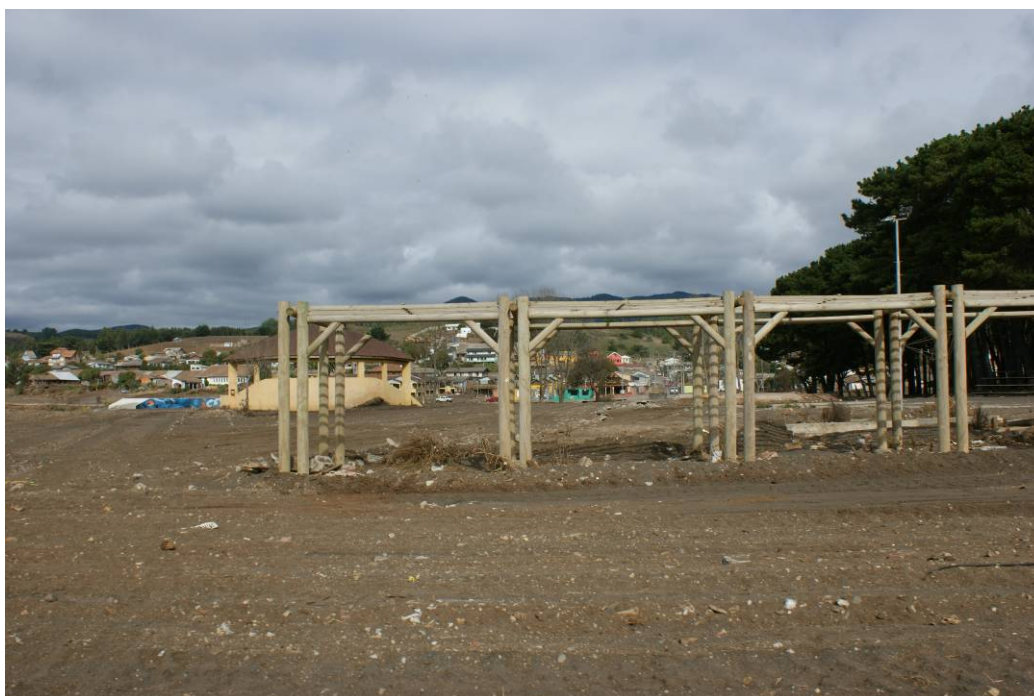
Figure 14.5. Curanipe. According to locals, hundreds were at a campground in this grove of trees. Many ran to the beach to avoid falling trees and were swept away by the tsunami.
(S35.843957°, W72.69647°; 15:59 hours on 3/17/2010)

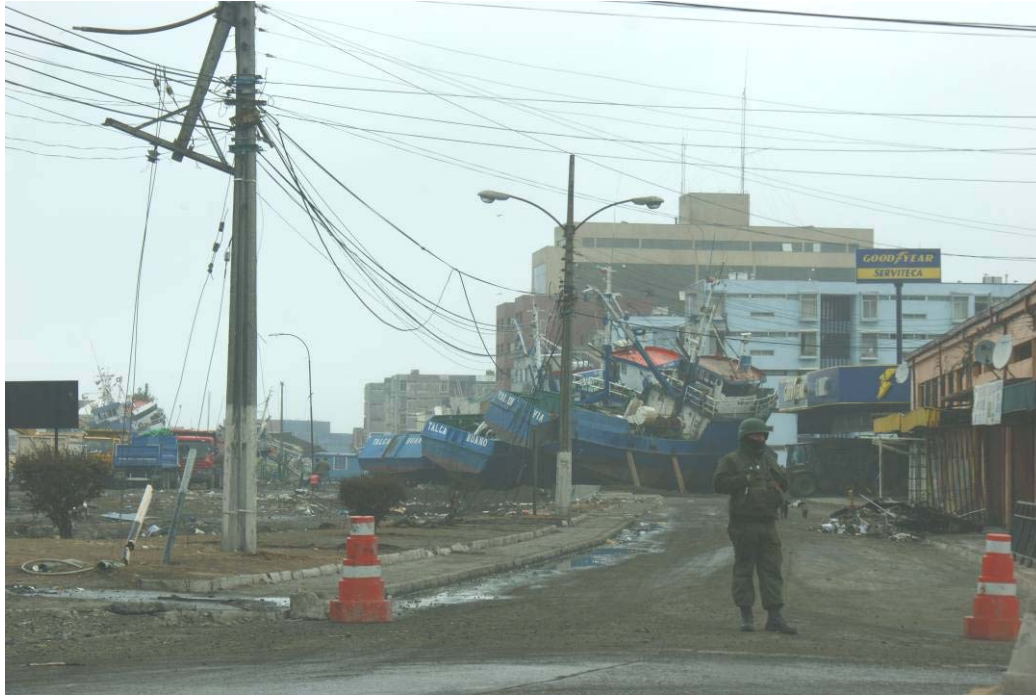
Figure 14.6. Tsunami damage near Navy facilities and bayside port of Talcahuano.
(S36.711305°, W73.114808°; 12:39 hours on 3/16/2010)

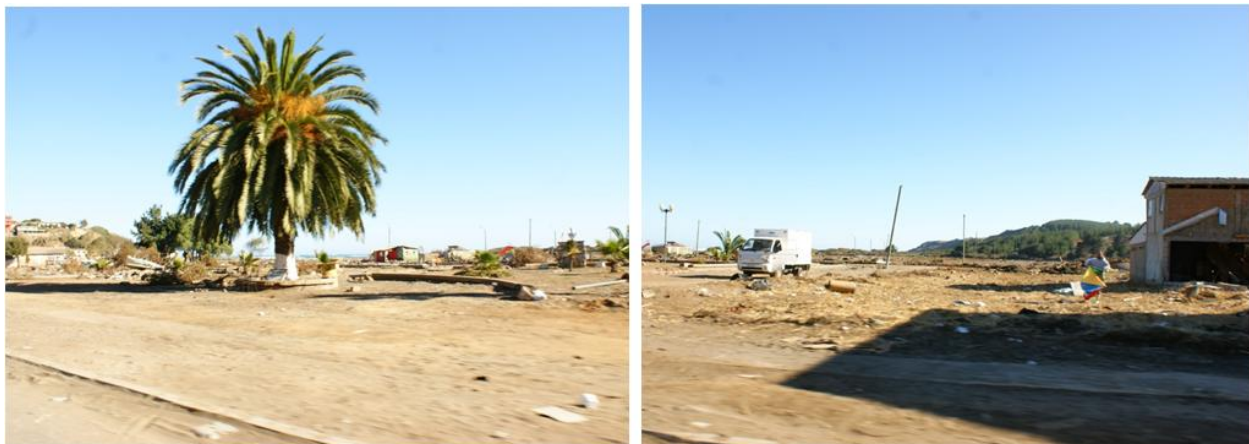
Local policeman say that there were many cabanas, campgrounds, and discos along the estuary, and about 500 people were in this low-lying area when the earthquake hit (see Figures 14.7a and 14.7b). There was a lot of moonlight and many people were out dancing. There was no tsunami alarm. But, many of the local people, firemen and police shouted to get out knowing that a tsunami might strike after the earthquake shaking stopped. Some saw the ocean receding and knew it was a forewarning of tsunami. Vacationers jumped into their cars and drove inland and up into the hills above the town. The tsunami was up to 2 meters deep in the estuary valley area and penetrated nearly 1 kilometer up the river, pushing fishing boats upstream under the coast highway bridge.

Figure 14.7a and 14.7b Bucalemu.. Much of the tsunami debris and damaged structures had already been removed from the low-lying area along the estuary that had campgrounds, hotels, restaurants, and discos. As many as 500 people were in this area when the earthquake struck. (S34.62552°, W72.038395°; 09:05 hours on 3/15/2010)

Bualemu's physical geography has been dramatically altered by the earthquake and tsunami. High-density tourist-oriented uses that were previous adjacent to the estuary may be much more vulnerable to flooding, storm surge, and tsunami hazards. As part of the rebuilding, changes in land use, reductions in allowable densities, and condemnation or acquisition of low-lying areas both along the estuary and the adjusted shoreline, may be considered in addition to other risk reduction and community improvement measures.

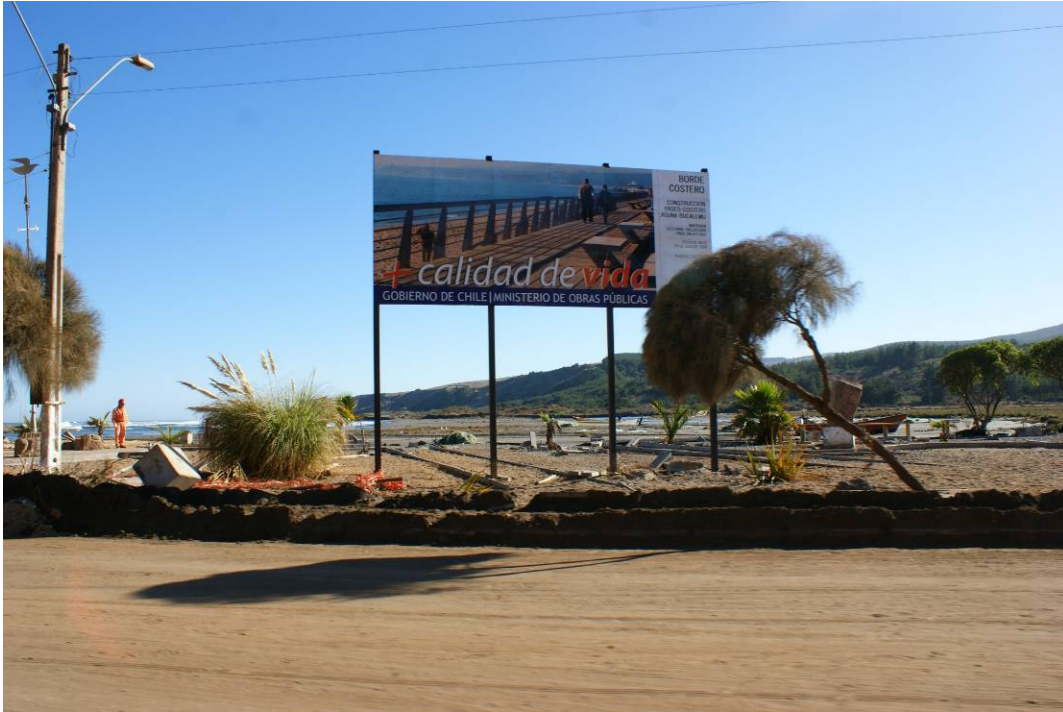
Prior to the earthquake, the town had been embarking in a fairly significant capital improvement project that included expansion of the lagoon and construction of a boardwalk along the shore (see Figures 14.8 and 14.9). Local residents say that the lagoon used to be only 10 meters wide and did not have a permanent opening to the sea and the rough waves like it does now. They say the beach extended about 20 meters beyond the arched, orange bridge out next to the pub building at the rocky point. Now the waves are crashing up against the pub building (see Figure 14.10). The cement boat launch ramp next to the pub building is now under water and the beach that local fisherman used to pull their boats up onto is gone.

Figure 14.8. Bucalemu. Prior to the earthquake, the town had been expanding the lagoon and constructing a boardwalk along the shore. (S34.642367°, W72.040965°; 09:06 hours on 3/15/2010)

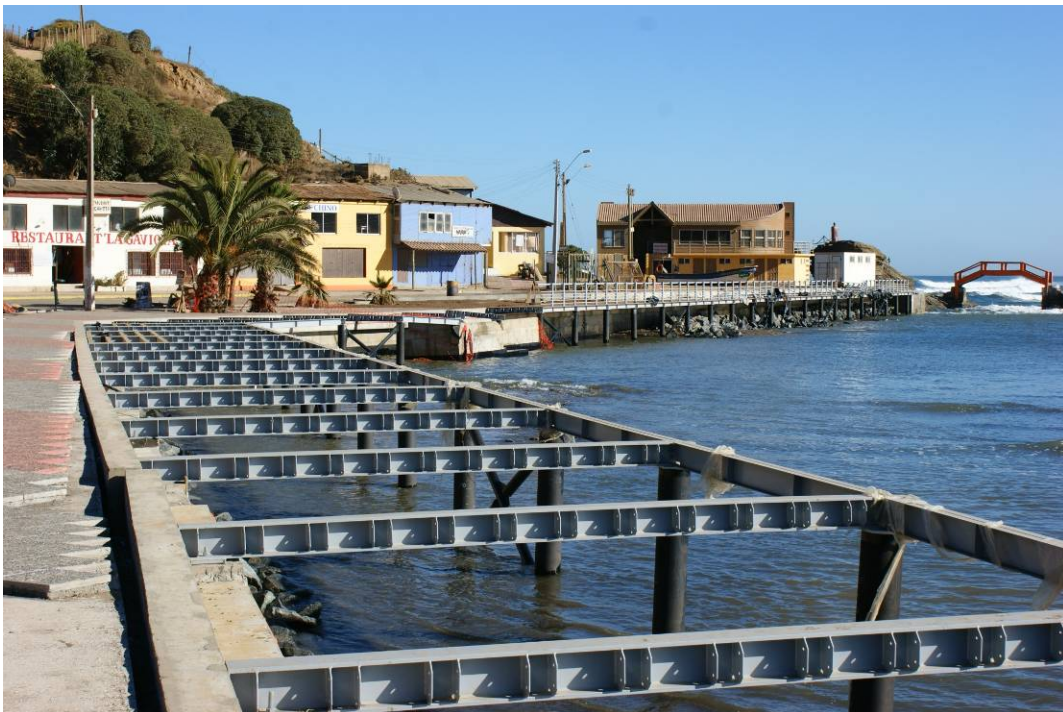
Figure 14.9. Bucalemu. Local residents say the beach extended about 20 meters beyond the arched, orange bridge out next to the pub building at the rocky point. (S34.641713°, W72.043115°; 09:09 hours on 3/15/2010)

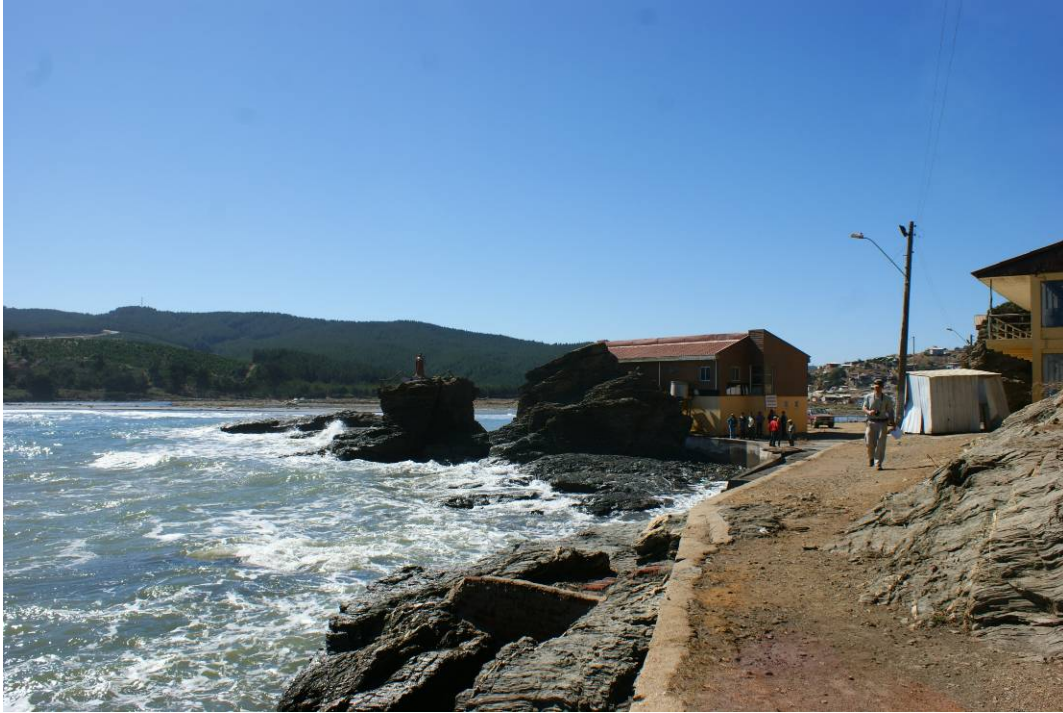
Figure 14.10. Bucalemu. Waves crashing up against the pub building. The cement boat launch ramp and former beach are now submerged after the tsunami. (S34.474325°, W72.023918°; 10:42 hours on 3/15/2010)

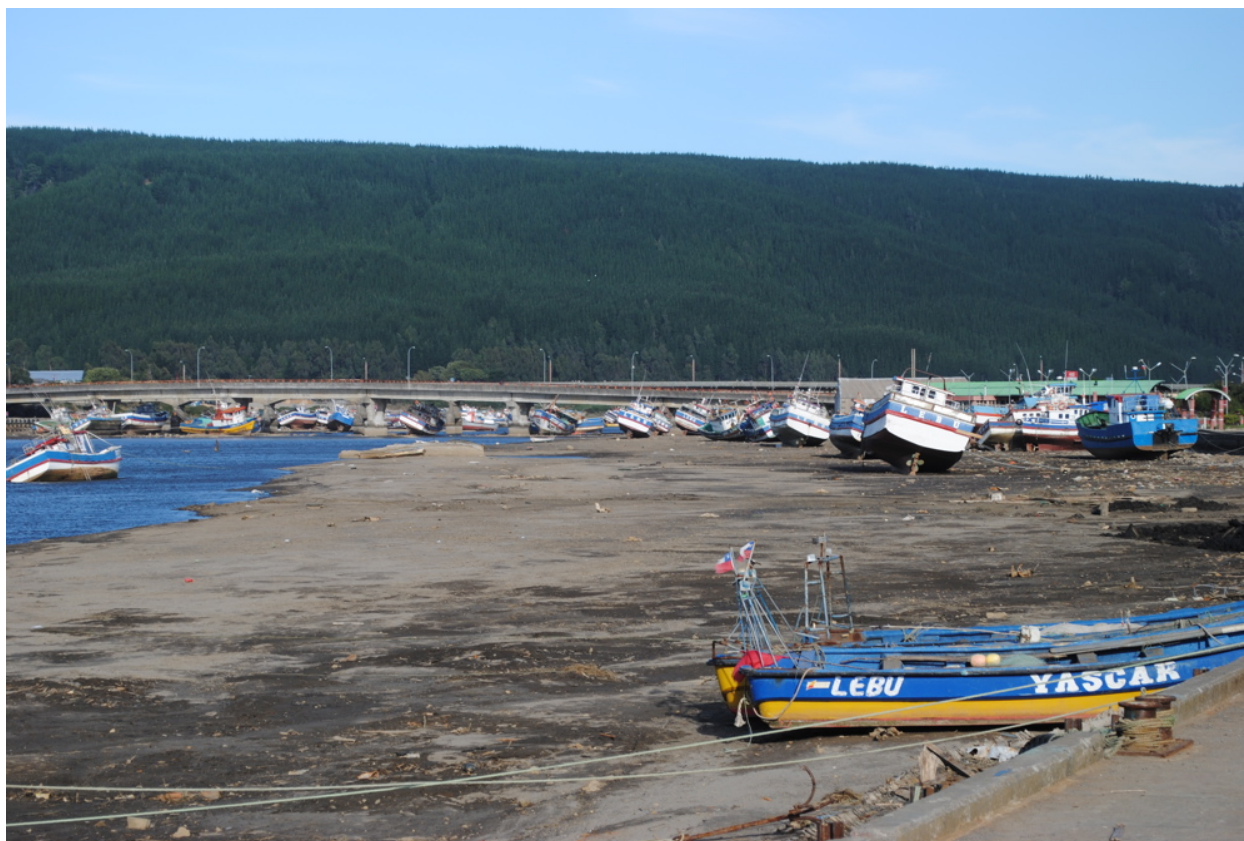
Figure 14.11. Boats stranded in Lebu's Harbor. (S37.603694° W73.654372°; 1800 hrs on 03/10/2010).

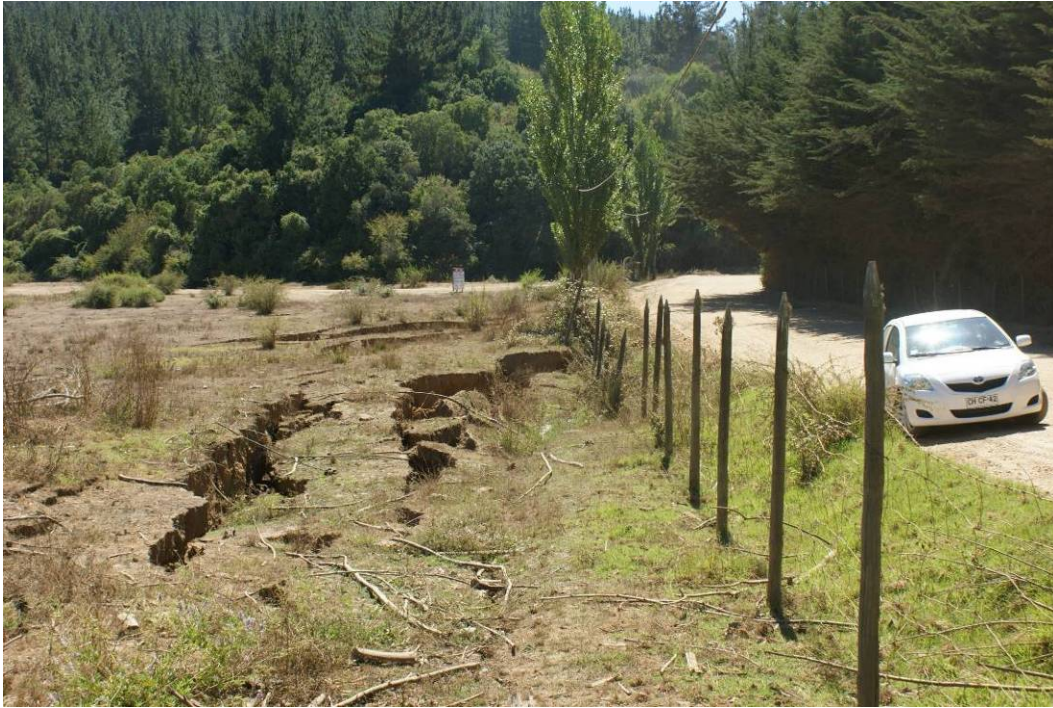
Lateral spreading along the banks of Lago Vichuquen (S34.796068°, W72.078810°), near the Laguna Torca National Reserve, severely impacted the road bed, underground utilities, and lakeside properties (see Figures 14.12, 14.13, and 14.14). Much of the ground underlying a small lakeside cabana hotel has been affected. Over 50 feet of shoreline was submerged and there was evidence for submarine landsliding as well. Sections of lawn, trees, and boat docks were all submerged. The shore side piers of several cabanas were also submerged and there was evidence of structural damage as well. The future viability of this property is definitely in question since there is not adequate land area between the cabanas and the road to setback and reconstruct. Ground deformation was observed in another location along the lake road but did not appear to be a consistent feature along the shoreline. Other boat docks along the shoreline did not appear damaged or submerged, but further study is needed.

Figure 14.12. Lago Vichuquen,. Lateral spreading on the inland side of the lakefront road.
(S34.39097°, W72.077815°; 12:46 hours on 3/15/2010)

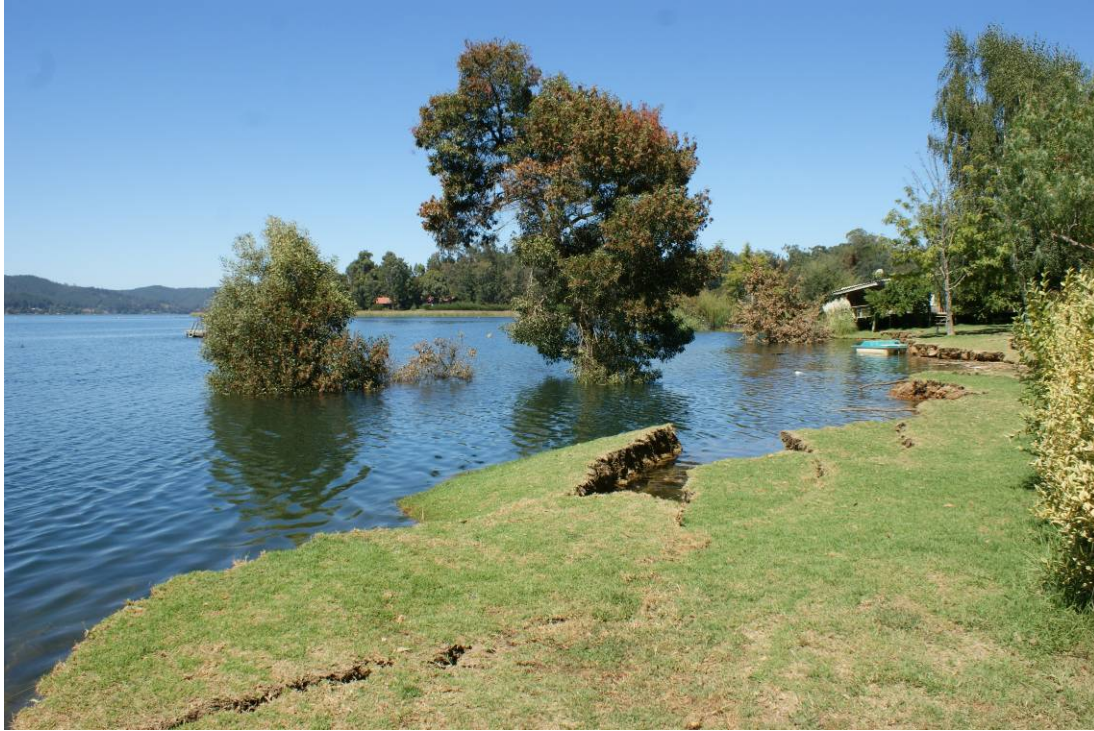
Figure 14.14. Lago Vichuquen, March 15. The lawn, trees, and boat docks are all submerged and there was evidence for submarine landsliding as well. (S34.79634°, W72.078852°; 12:52 hours on 3/15/2010)

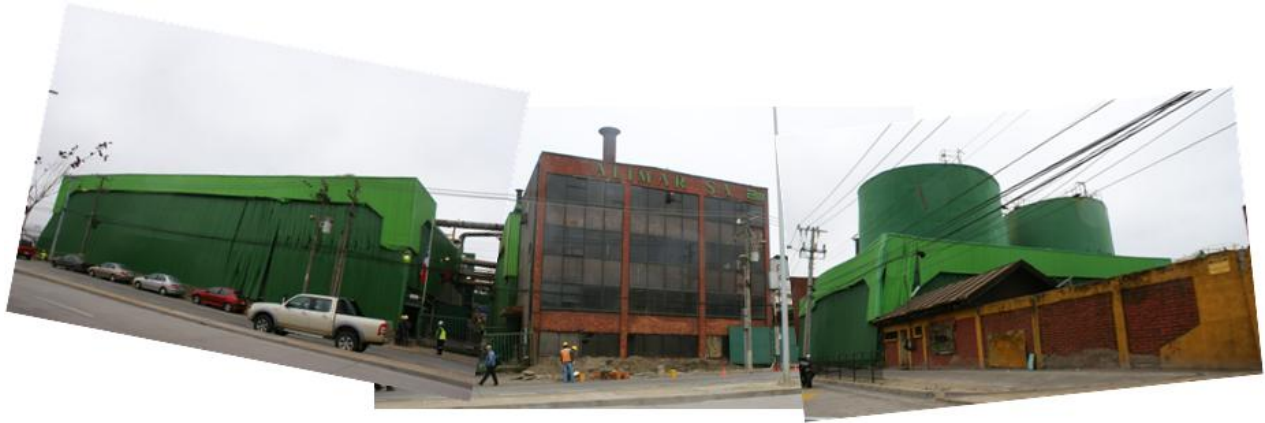
Several port side properties at Port San Vicente in Talcahuano were also significantly damaged by lateral spreading and ground deformation (S36.72593°, W73.12872°). Two fish processing plants, Alimentos Marinos and Concession Maritima, were both severely damaged and not in operation on March 15 (see Figures 14.15 and 14.16).

Figure 14.15. Port San Vicente, Talcahuano. The damaged Alimentos Marinos fish processing plant will likely not be rebuilt at this port. (S36.725983°, W73.128817°; 11:45 hours on 3/16/2010)

Port San Vicente is a major fish processing facility and the two plant closures are likely to have prolonged impacts on the region's fishing economy. On March 14, fishing boats were observed dropping their loads in the harbor since the plants were not operational. Alimentos Marinos employed 300 people directly and another 300 indirectly. Insurance adjusters were onsite on March 15 and the former plant manager said the facility will likely not be rebuilt in this location. This type of relocation could have significant local economic ripple effects. The suitability of the port side land for rebuilding is also a major question. Across the port road from the two damaged plant is a tank farm facility that had no observable damage (see Figure 14.17). Perhaps, the tank farm had better site preparations as part of its construction. Also, the port road was slightly elevated from surrounding lands and may be part of a levee system along a former shoreline. The fish processing facility may be sited on much more vulnerable bay fills than the tank farm. Additional study is needed to clarify these concerns.

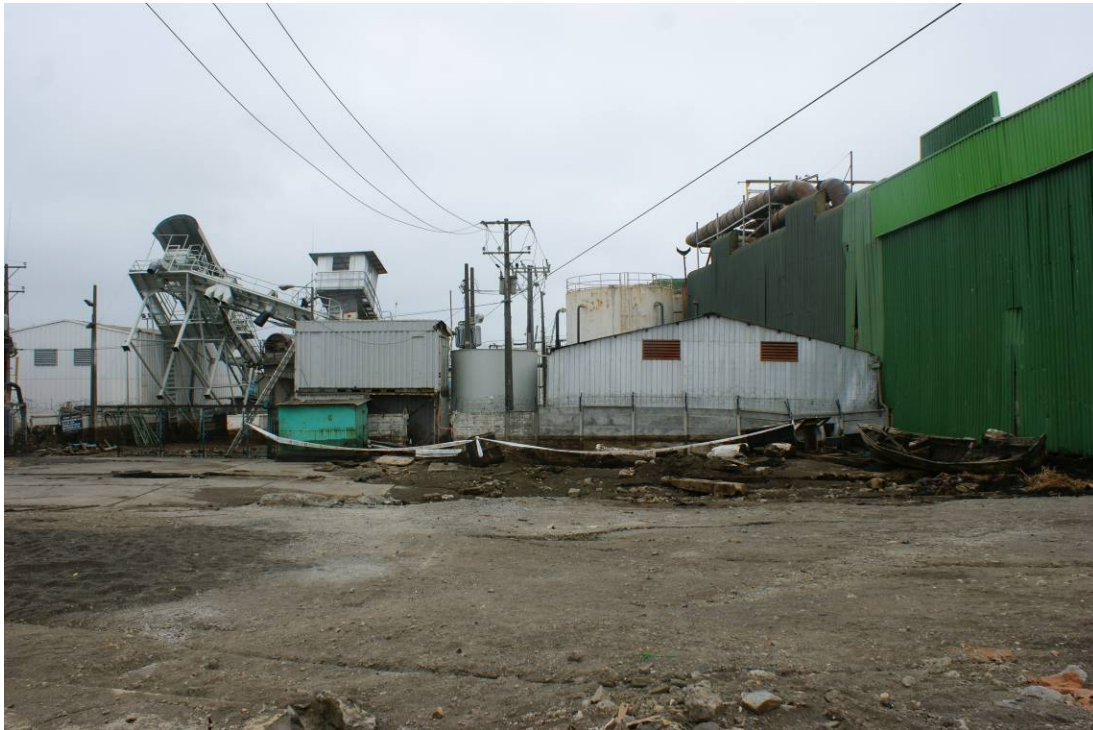
Figure 14.16. Port San Vicente, Talcahuano. The damaged Concesion Maritima fish processing plant. (S36.725892°, W73.128678°; 11:50 hours on 3/16/2010)

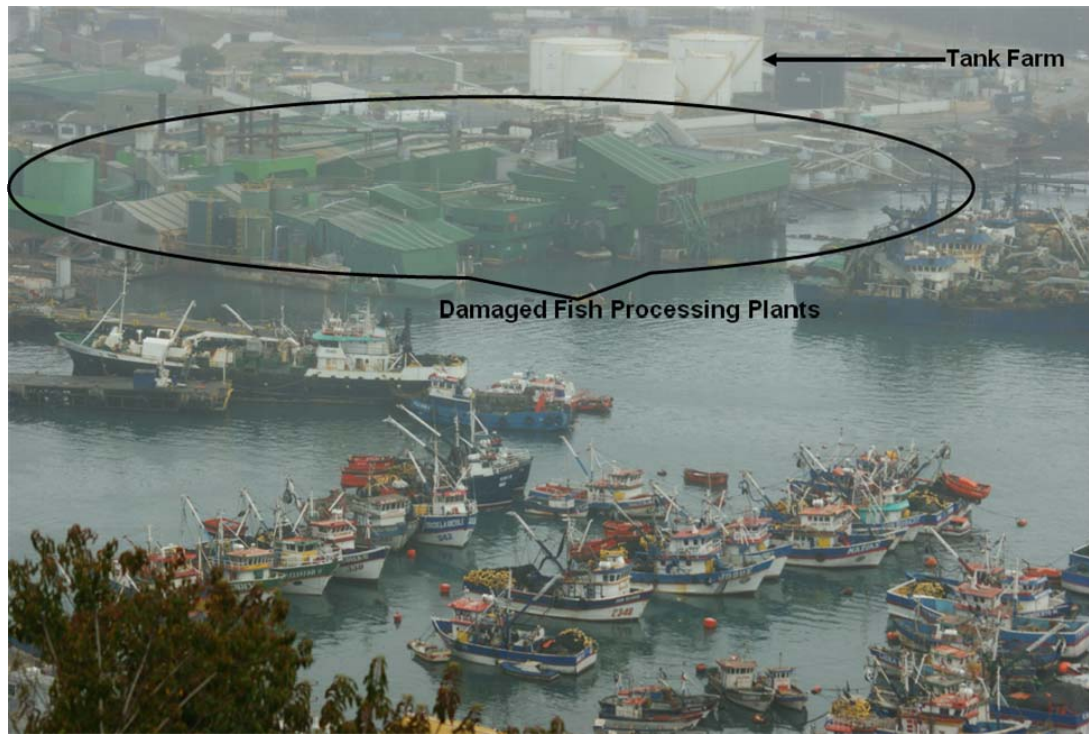
Figure 14.17. Port San Vicente, Talcahuano. View of two damaged fish processing plants and nearby tank farm. (S36.724605°, W73.136475°; 12:18 hours on 3/16/2010)

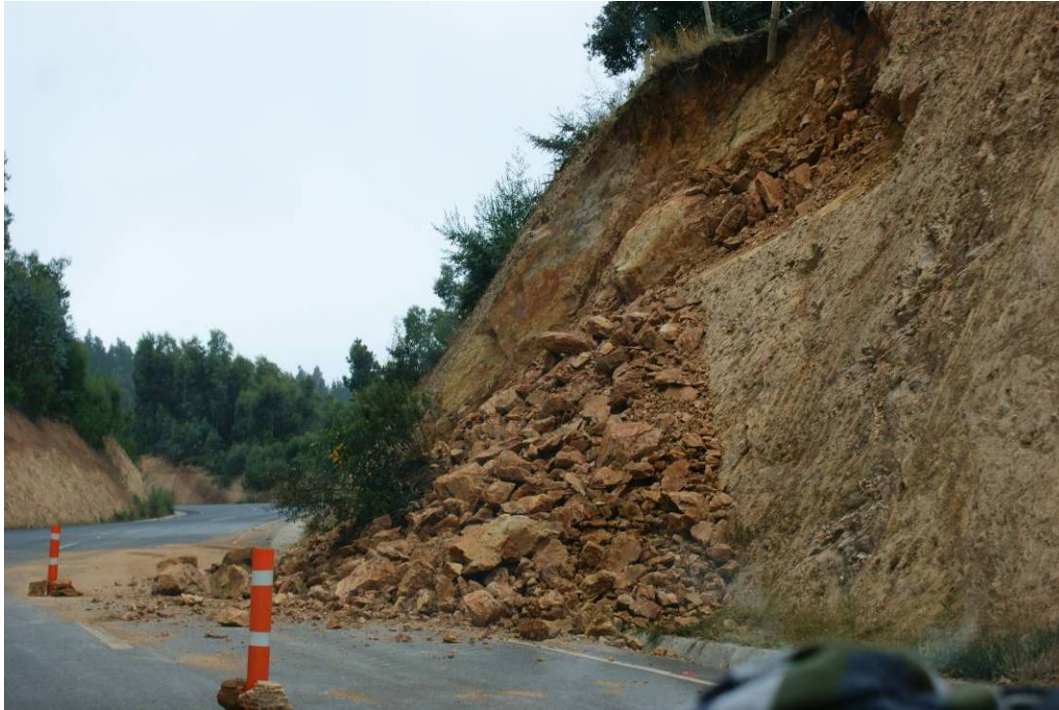
Earthquake-induced landsliding was not prevalent in this earthquake. Section 12 documents the landsliding observations made as part of the GEER reconnaissance. Rockfalls and slides were observed in highway road cuts traversing the coast ranges (see Figure 14.8). Slumping was also observed along coastal bluffs and river banks. While, there do not appear to be any large-scale landslides that would have significant long-term rebuilding issues, landsliding may have some important near- to medium-term implications for recovery.

Figure 14.18. Lota Alto, Bio Bio region. Failures on the road cuts along one of two main highways leading to the Port of Coronel and surrounding coastal cities. (S37.047677°, W73.061597°; 15:30 hours on 3/16/2010)

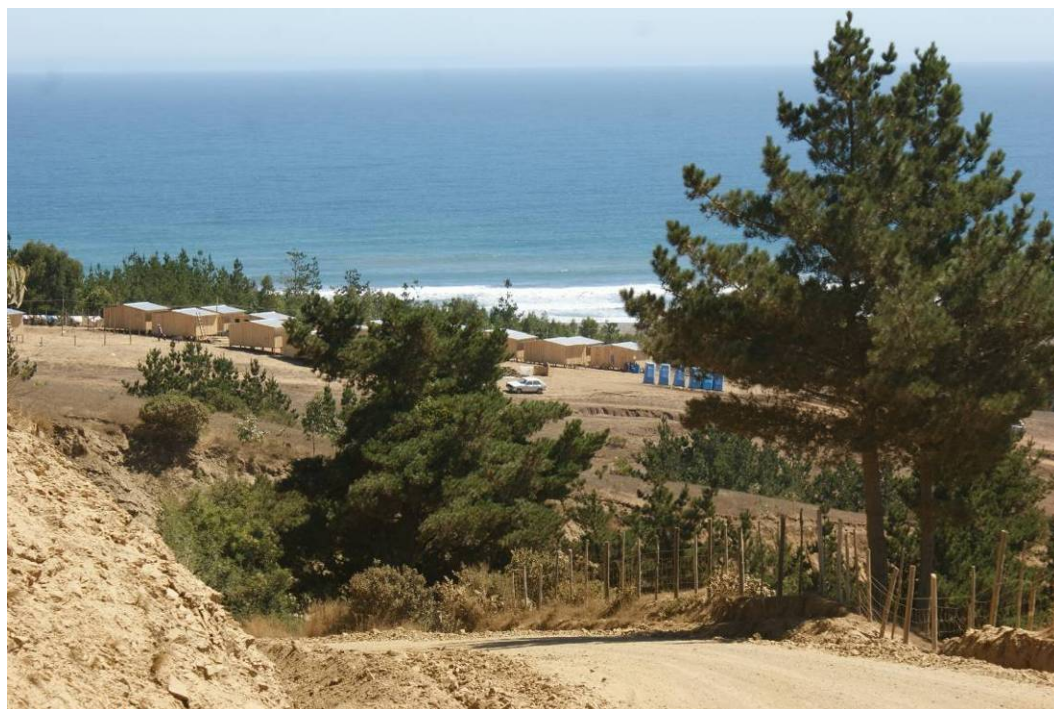
Also, many temporary settlements were observed in hillsides and on coastal bluffs (see Figure 14.19). The site selection of both informal and formal (organized) encampments is likely being driven by tsunami-hazard related concerns. Formal encampments established by the government and non-governmental organizations seem to have included some site preparations. However, informal settlements did not. These encampments may be vulnerable to landsliding in future aftershocks or with increased rainfall and soil moisture conditions. Local architects report that there is a history of temporary encampments becoming permanent, low-cost housing.

Figure 14.19. Temporary housing settlement being established in the hills above the coast near the town of Lipimavidia. (S34.853393°, W72.135148°; 13:41 hours on 3/15/2010)
