## 2. Route 20 - Nanbu Cross-Island Highway (南部橫貫公路)

### 2.1 Jia Xian (甲仙鎮)

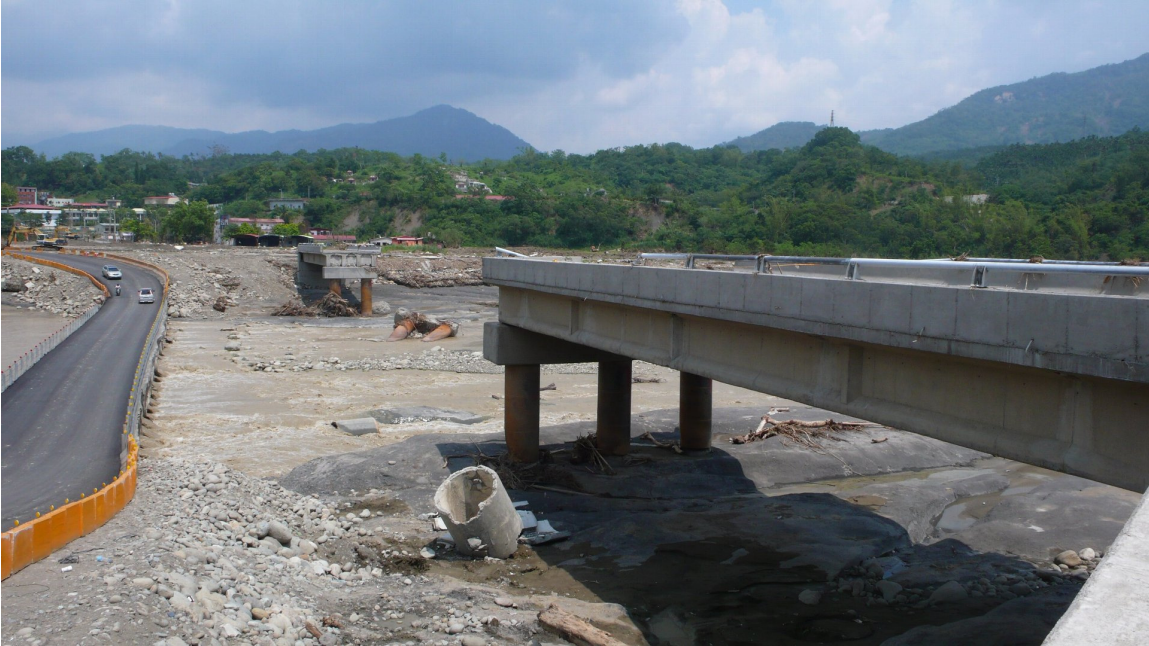
Photo 2-1-1. Collapsed Jia Xian Bridge.

The Jia Xian Bridge was severely damaged by flooding (Photo 2-1-1) and a temporary access was built, as shown in Photo 2-1-2. Part of the bridge deck and piers (with steel pipe) disappeared. The retaining walls near the bridge abutment collapsed due to scouring (Photo 2-1-3).

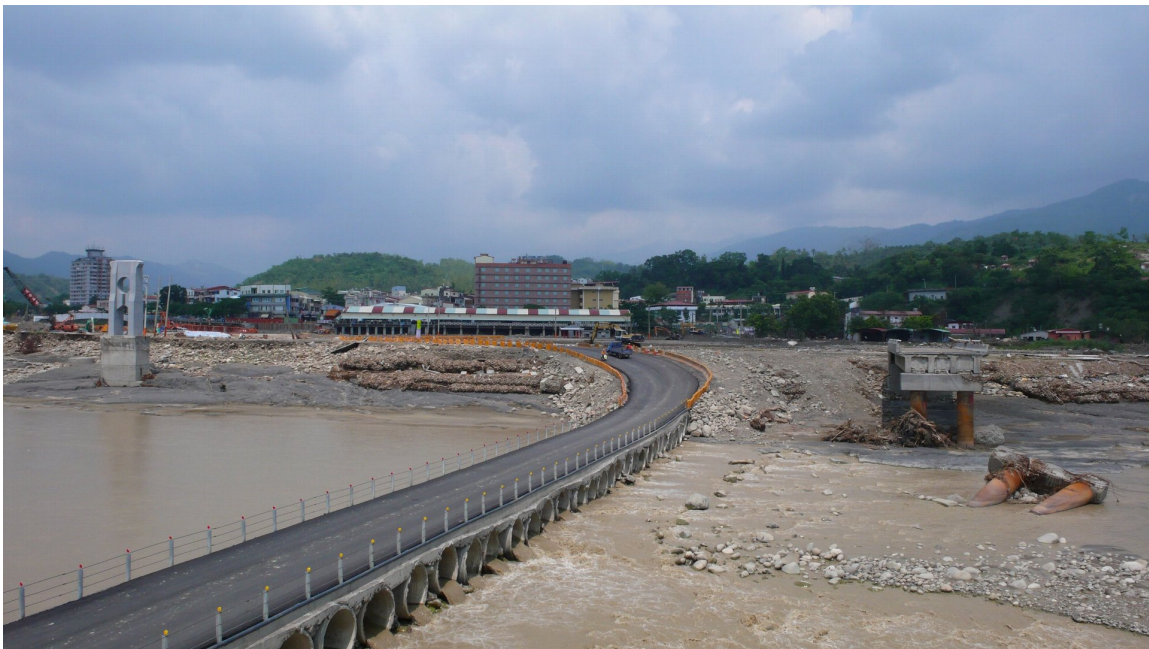
Photo 2-1-2. Temporary access bridge near Jia Xian Bridge.

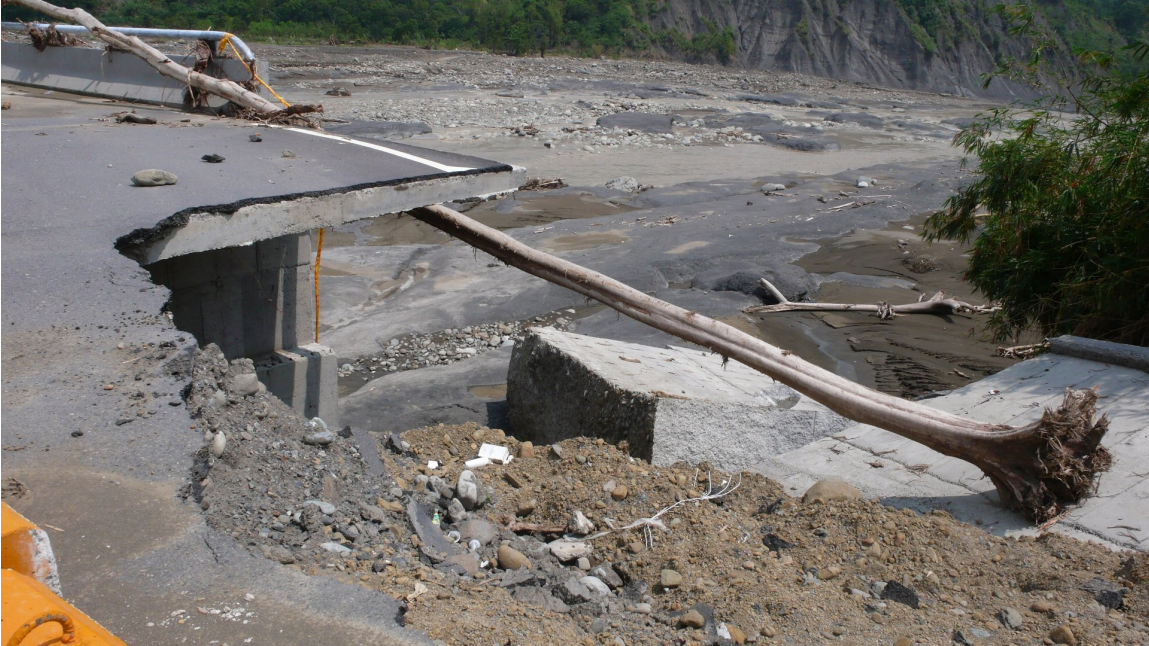
Photo 2-1-3. Collapse of retaining walls at the abutment of Jia Xian Bridge.

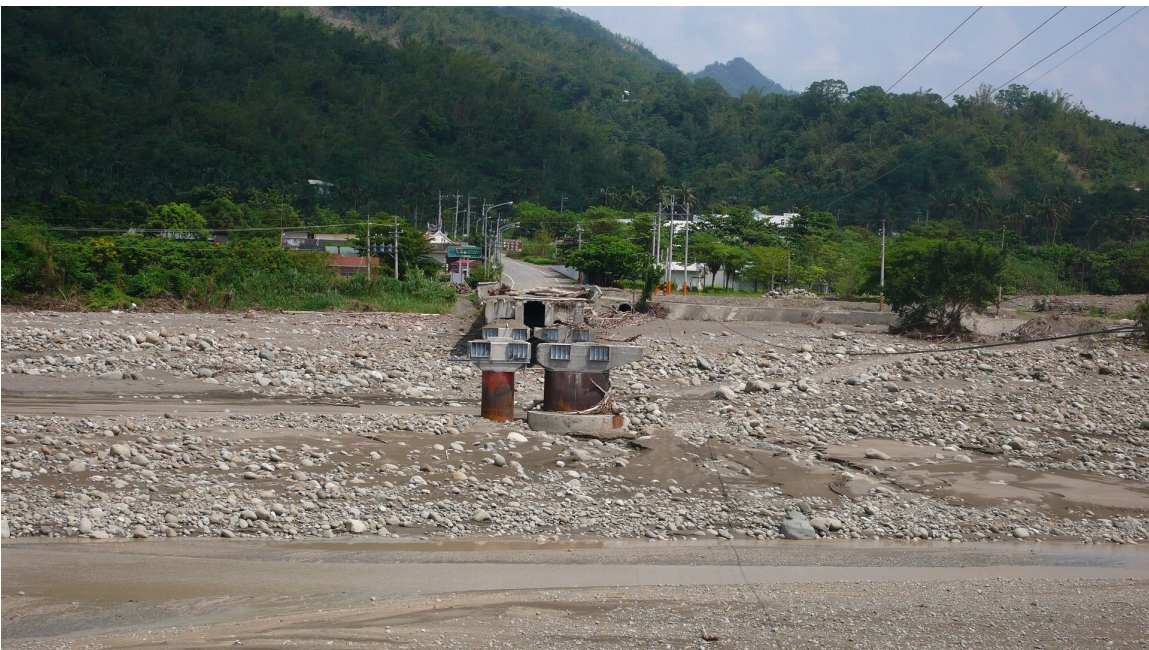
Photo 2-1-4. Part of the superstructure and pier foundation disappeared (Side Bridge).

Side Bridge was also damaged by flooding. Almost the entire bridge deck disappeared, and part of the span was carried a distance down the river. Several piers disappeared, though the abutments remained. Timber debris piled at the site. The retaining walls near the bridge failed by scouring.

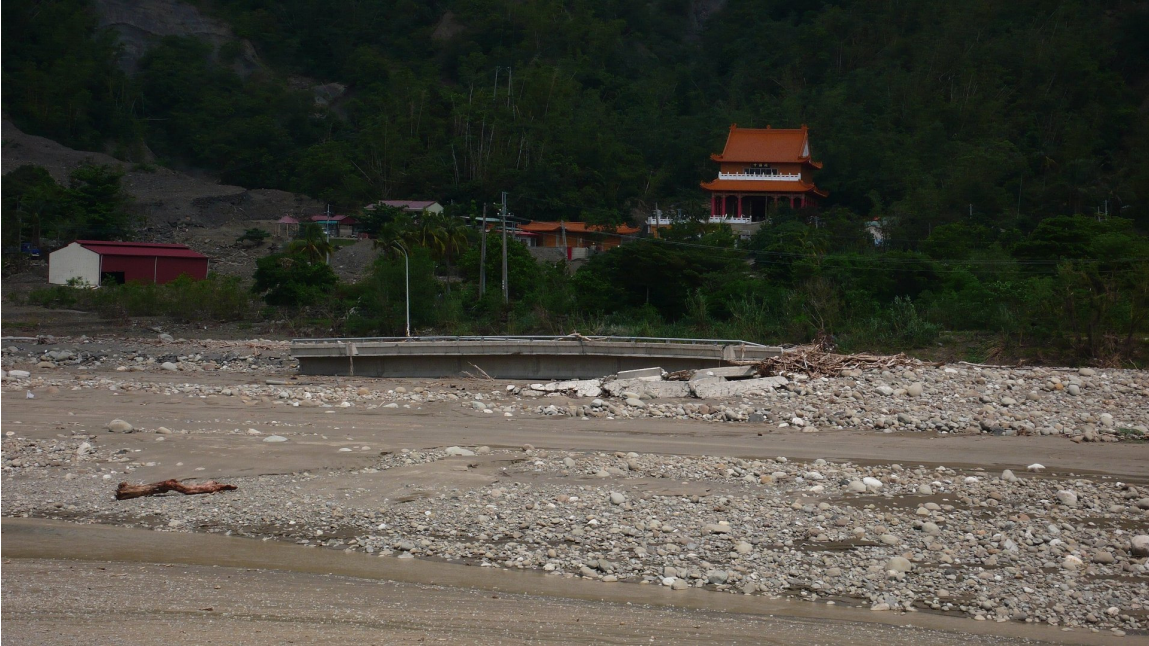
Photo 2-1-5. A span was washed downstream (Side Bridge)

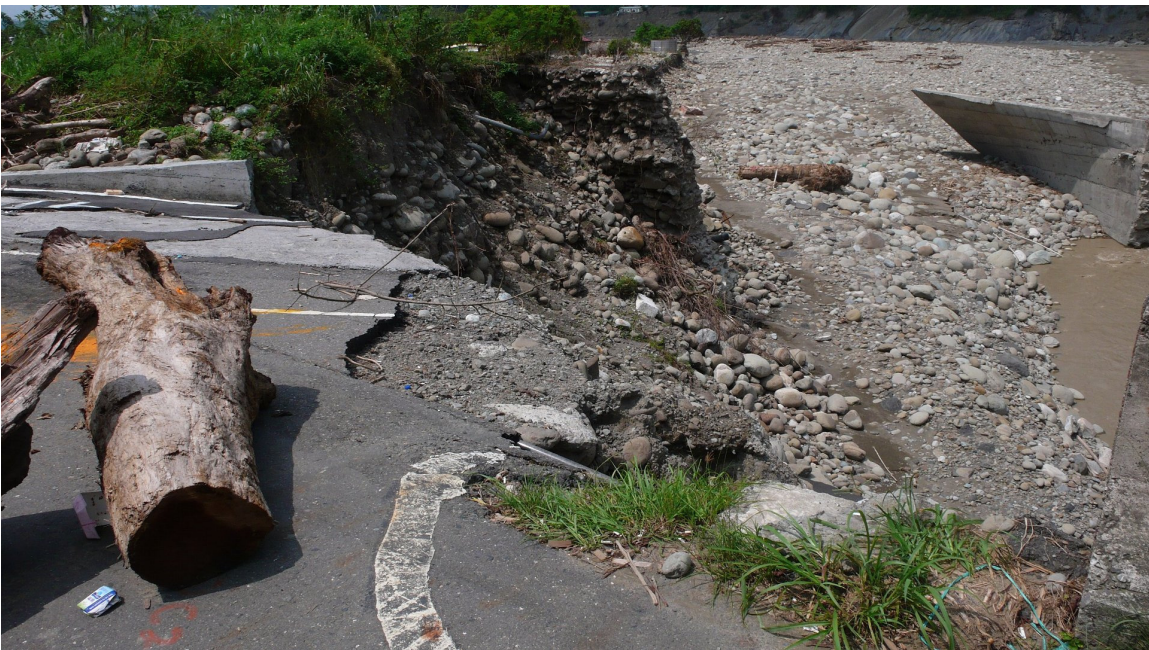
Photo 2-1-6. Scouring of the river bank and road. Note that part of a retaining wall stayed in the riverbed (Side Bridge).

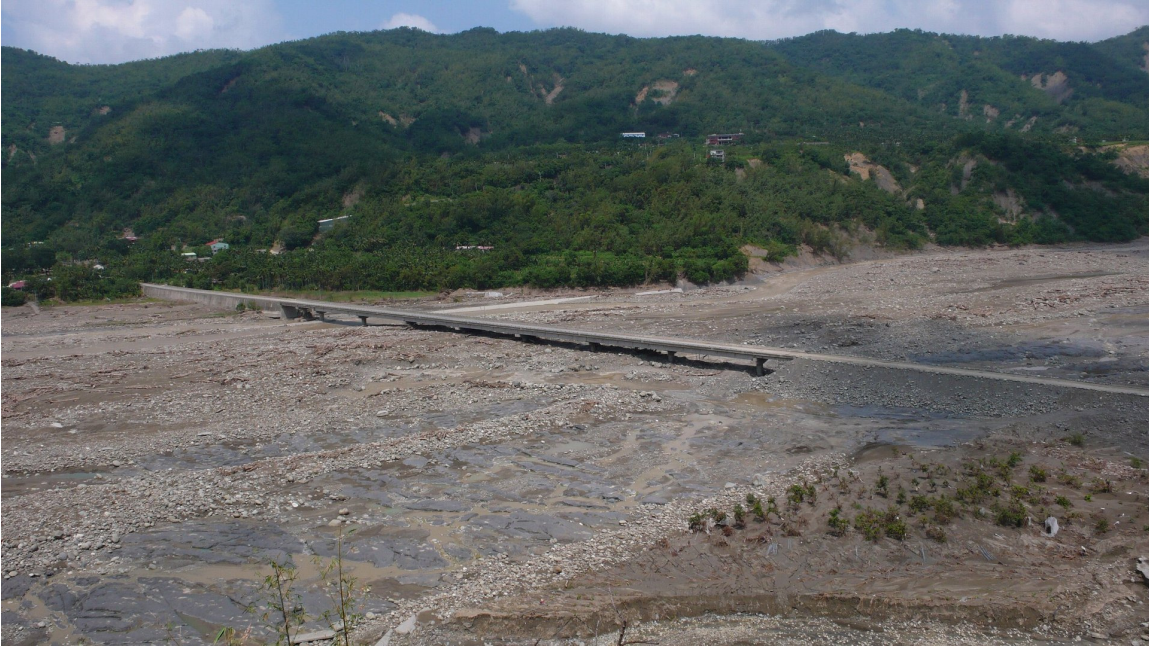
Photo 2-1-7. A bridge nearby Jia Xian Bridge remained intact. The river was filled with debris.

Another bridge nearby the site (marked as 3 in the map;  $23^{\circ}05'44''\text{N}$   $120^{\circ}35'39''\text{E}$  elev. 262 m) remained intact, but significant amounts of gravel and timber debris were deposited under the deck and on the road (Photo 2-1-7). Many landslides occurred in the mountains near the site (Photo 2-1-8).

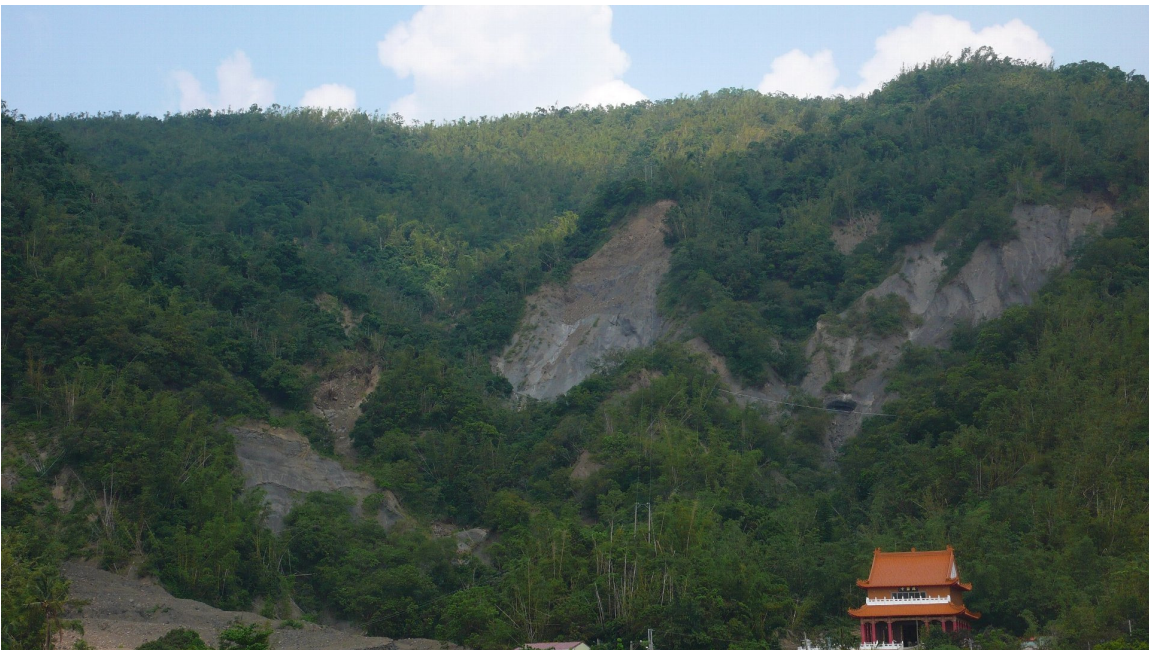
Photo 2-1-8. Landslides in the surrounding mountains.

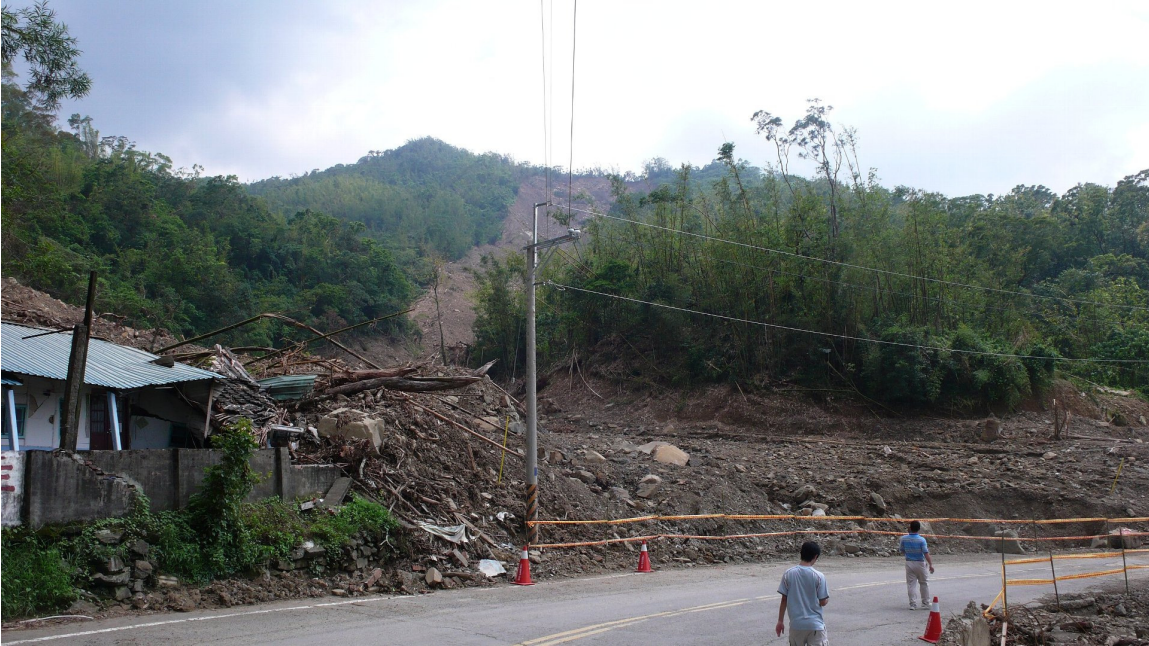
Photo 2-1-9. Debris flow that originated from the mountain buried a home.

Along Wenhua Road (文化路), a debris flow inundated a residence and crossed over the road. Boulders of different sizes were observed (Photo 2-1-9).

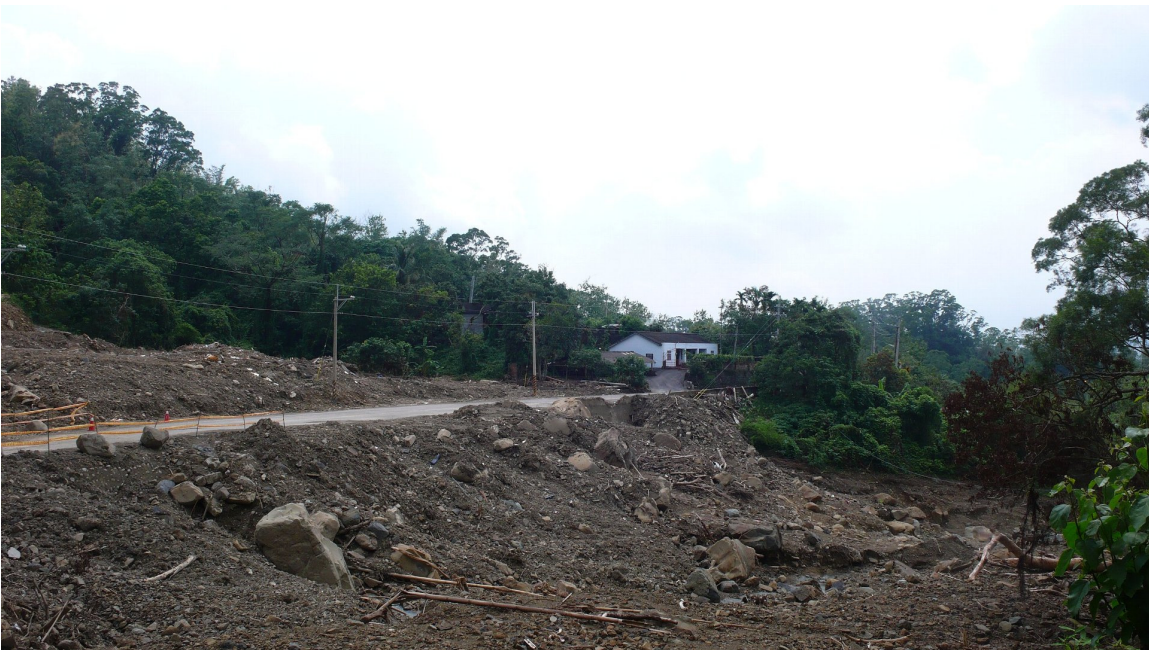
Photo 2-1-10. Overview of debris flow at the road (after cleaning up), leading to a stream on the right.

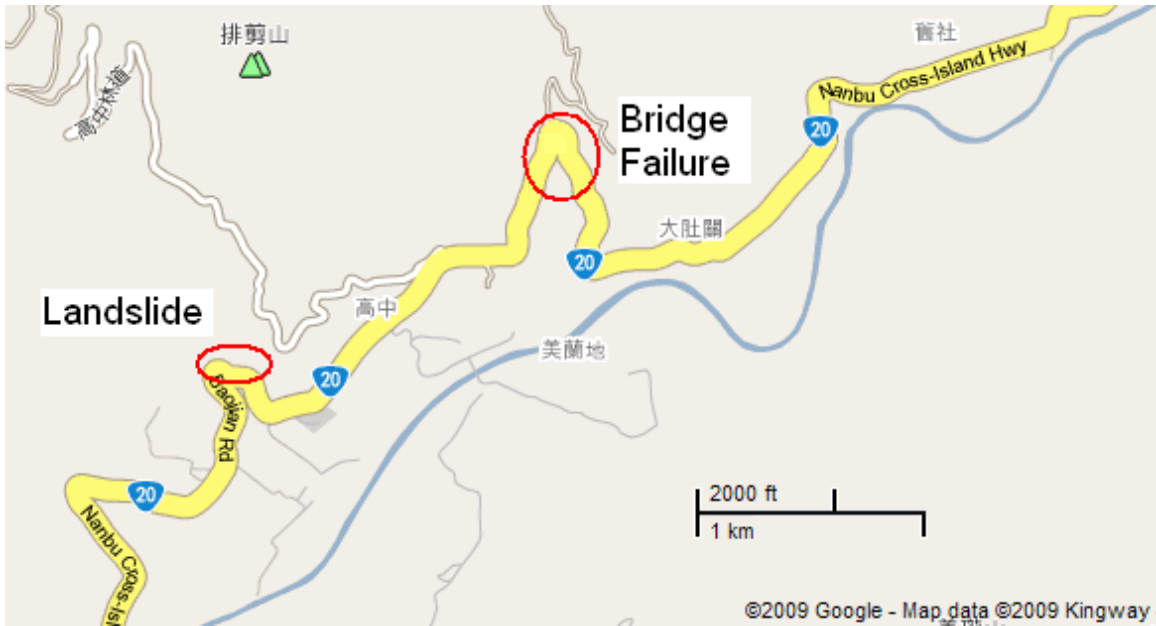
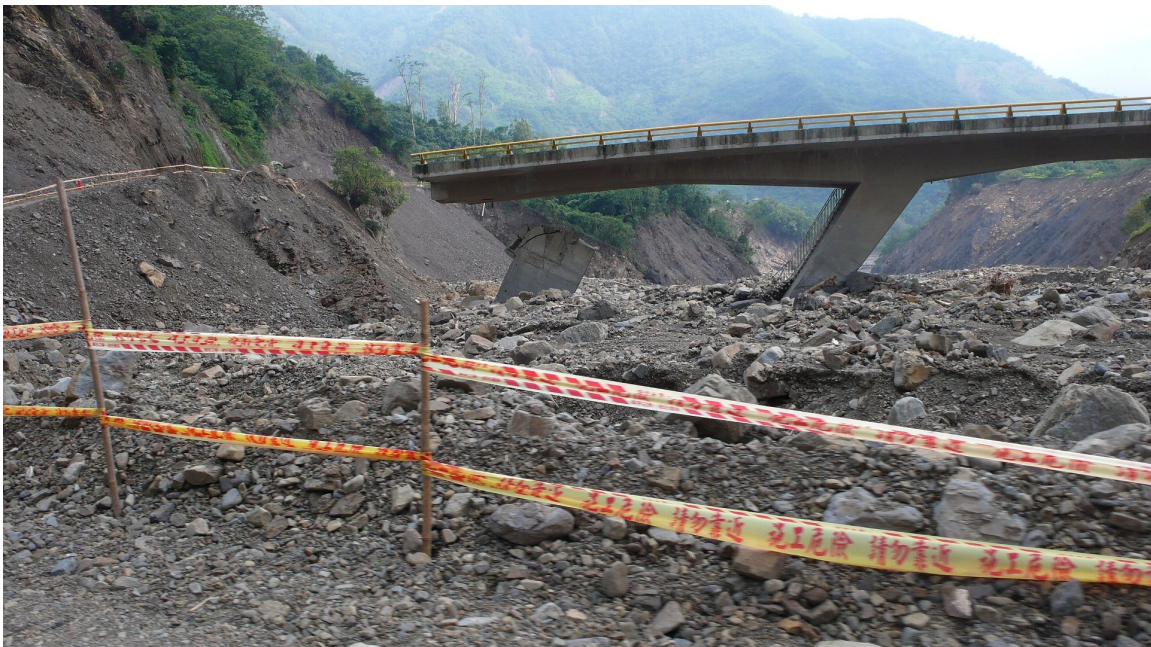
Photo 2-2-1. Failure of the abutment and superstructure of a bridge.

Not far from Taoyuan Village (桃源鄉) (2:43 pm; 23°08'24"N 120°43'47"E elev 558 m), a debris flow occurred. The abutment of a bridge failed, leading to the failure of the superstructure. See also the cover photo, which was taken from the end of the bridge.

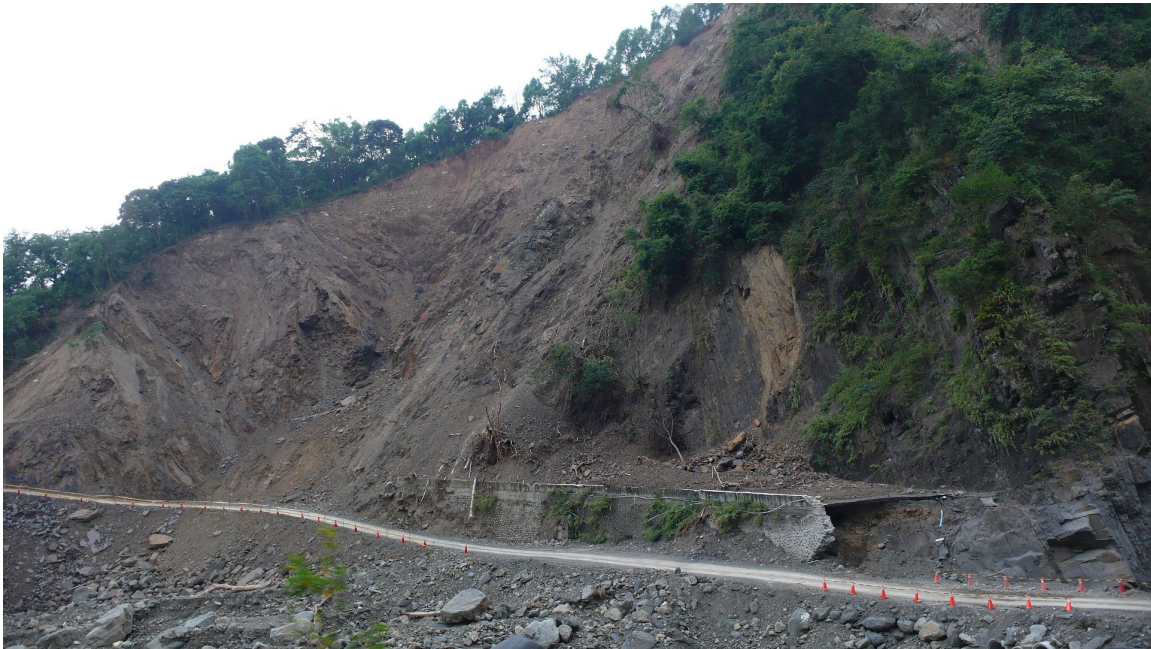
Photo 2-2-2. Significant slope failure on both sides of the road in Jia Xian Village.

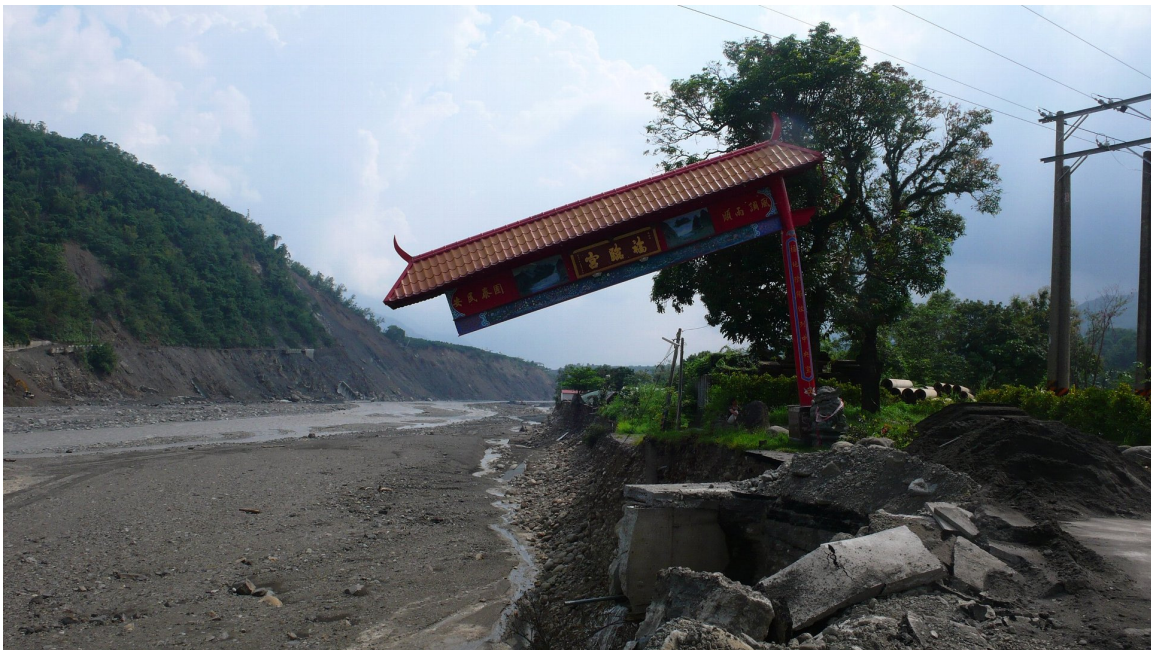
Photo 2-3-1. "Hanging Gate" of a temple [Location 1]

Baolai is an inland resort village, well known for its hot springs. At Baolai, significant scouring occurred along the banks of the river. Buildings were buried by debris or washed away by flooding. The gate of a temple was seen hanging on the bank after significant erosion [Photo 2-3-1; 23°06'39"N 120°42'17"E elev 399 m].

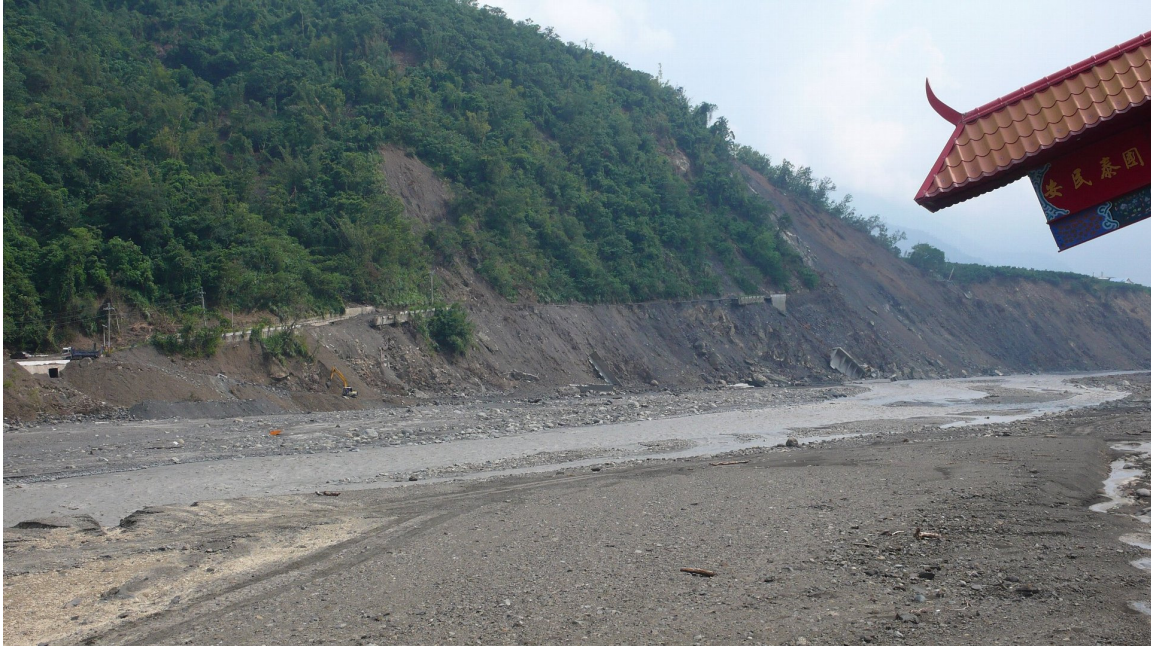
Photo 2-3-2. Large scale landslides along Shinbao Road [Location 2]

Landslides occurred over an extended length of Shinbao Road (新寶路) [Photo 2-3-2; 23°06'36"N 120°42'34"E elev 436 m]. Buildings and a hotel located at the river bank were partially buried by the debris [Photos 2-3-3, 2-3-4; 23°06'36"N 120°42'29"E elev 413 m].

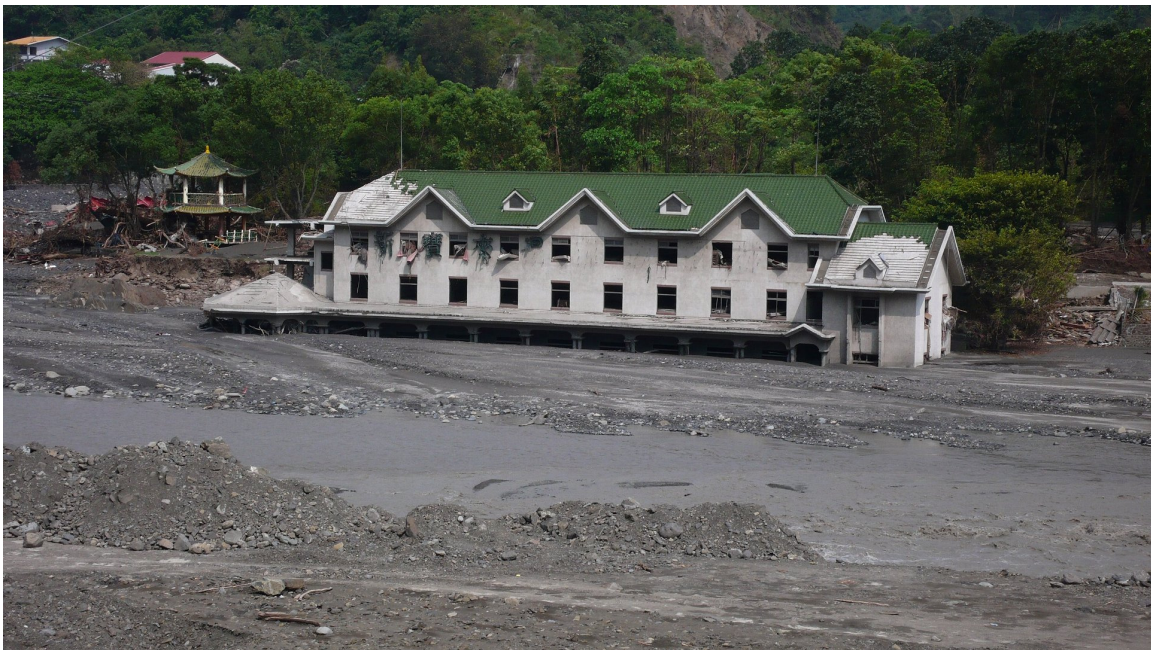
Photo 2-3-3. First floor of a hotel buried by debris [Location 3]

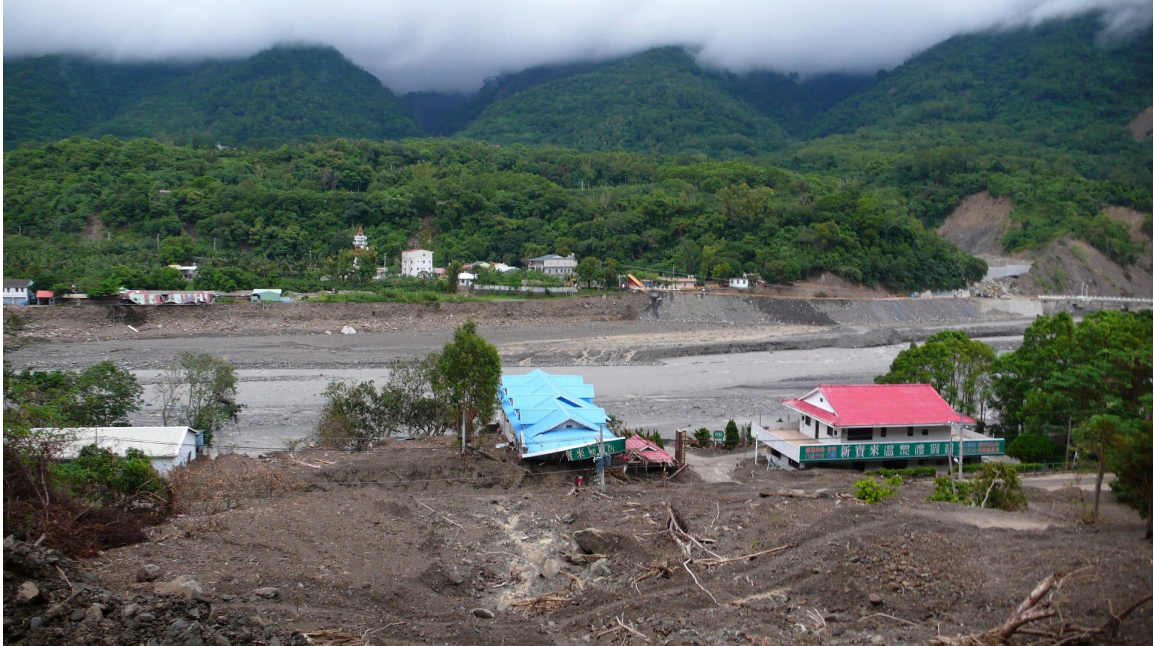
Photo 2-3-4. Buildings damaged by scouring and debris flow [Location 3]

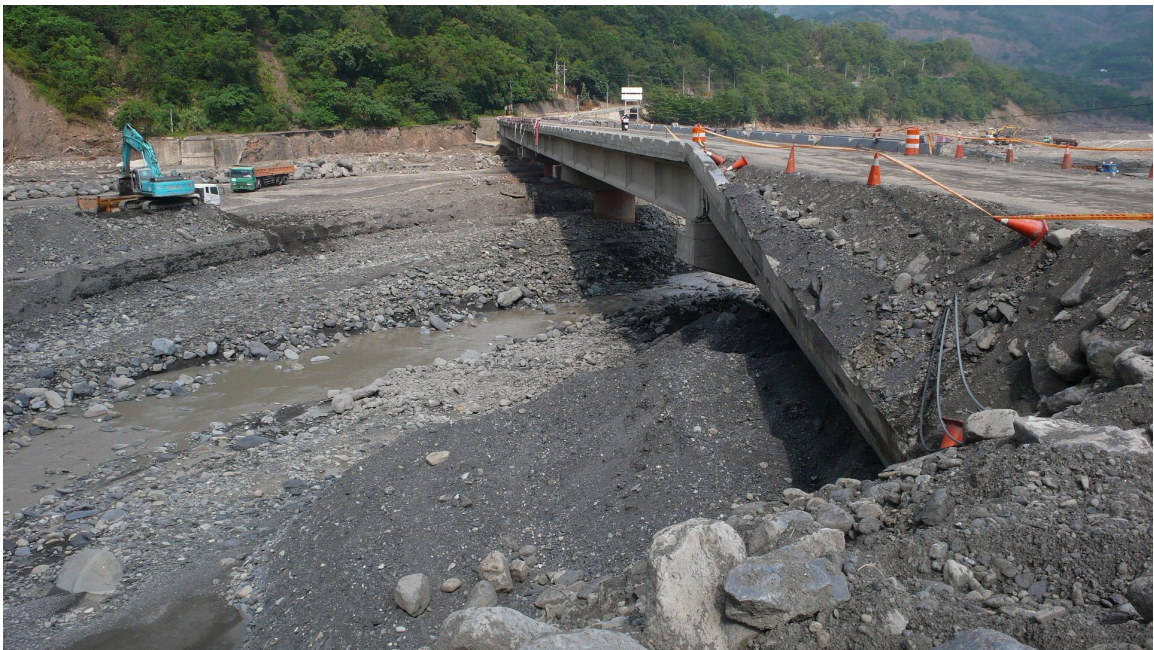
Photo 2-3-5. Damaged abutment and deck of Bridge #2 .

One of the abutments of Baolai Bridge #2 (L=174.4 m; 23°06'41"N 120°42'18"E elev 398 m) was damaged (Photo 2-3-5; ). The depth from Bridges #1 and #2 to the water was reduced from 10+ m to just a few meters due to debris deposition (Photo 2-3-6). A building located at the north end of the village, close to Bridge #2, was damaged by the debris (Photo 2-3-7; 23°06'40"N 120°42'12"E elev 399 m). Landslides were seen along the sides of the river, at the northern end of the map (Photo 2-3-8; 23°06'48"N 120°42'08"E).

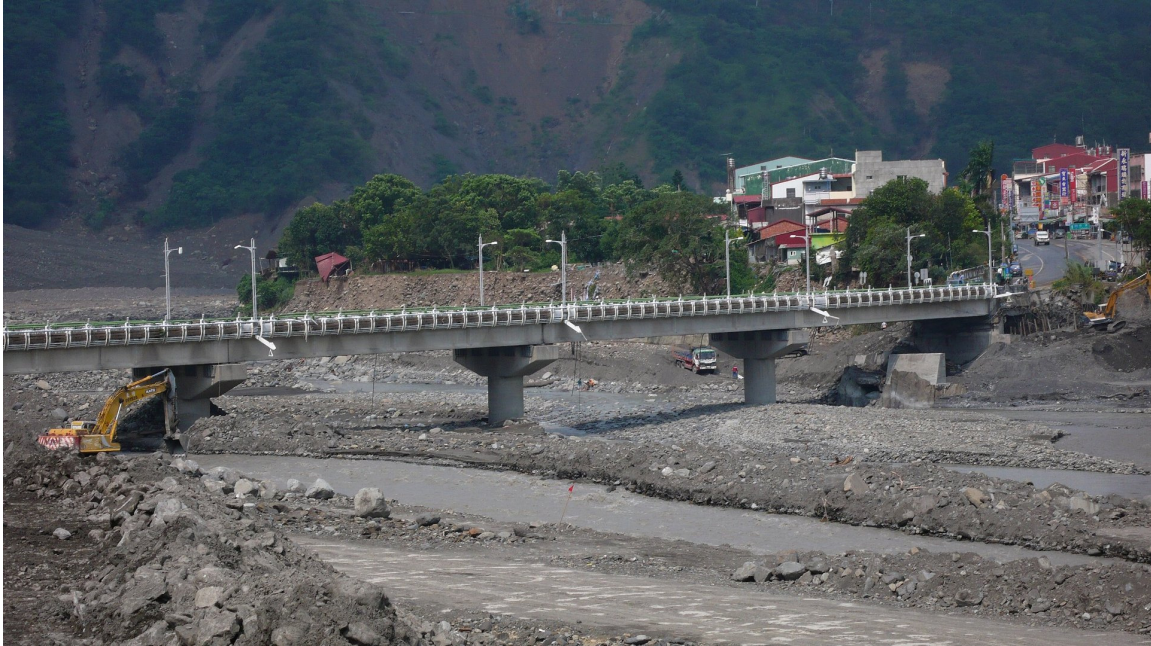
Photo 2-3-6. The vertical clearance of Bridge #2 was significantly reduced by debris deposition.

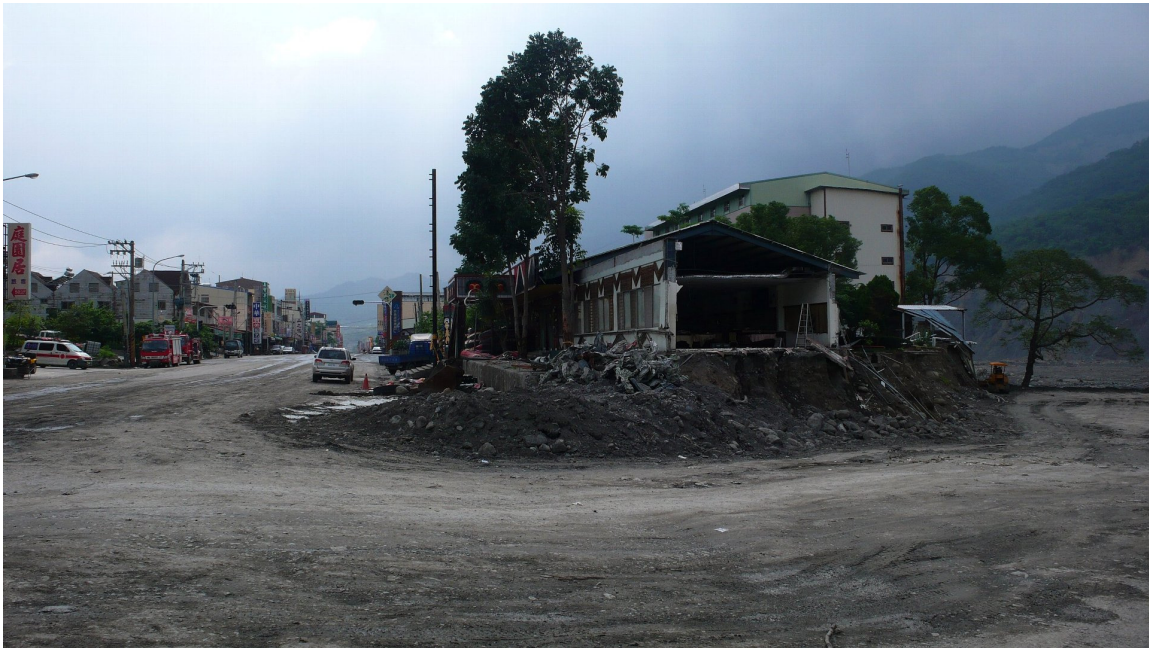
Photo 2-3-7. A building near Bridge #2 was damaged by the debris flow.

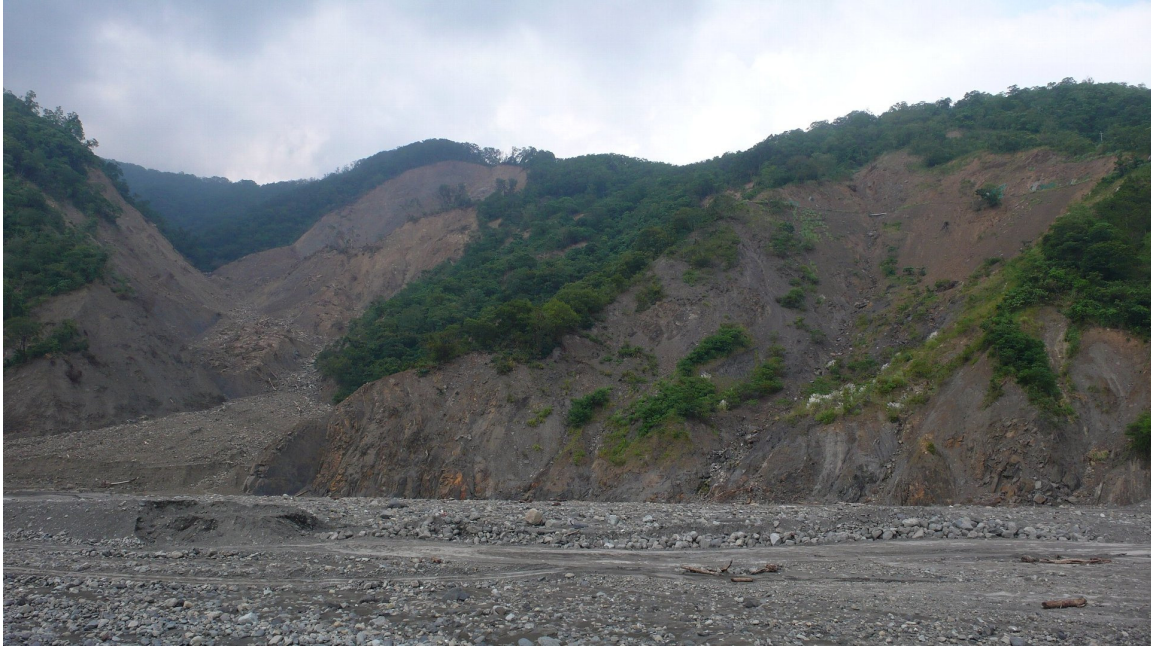
Photo 2-3-8. Large-scale slope failure near the river bank [Location 4]

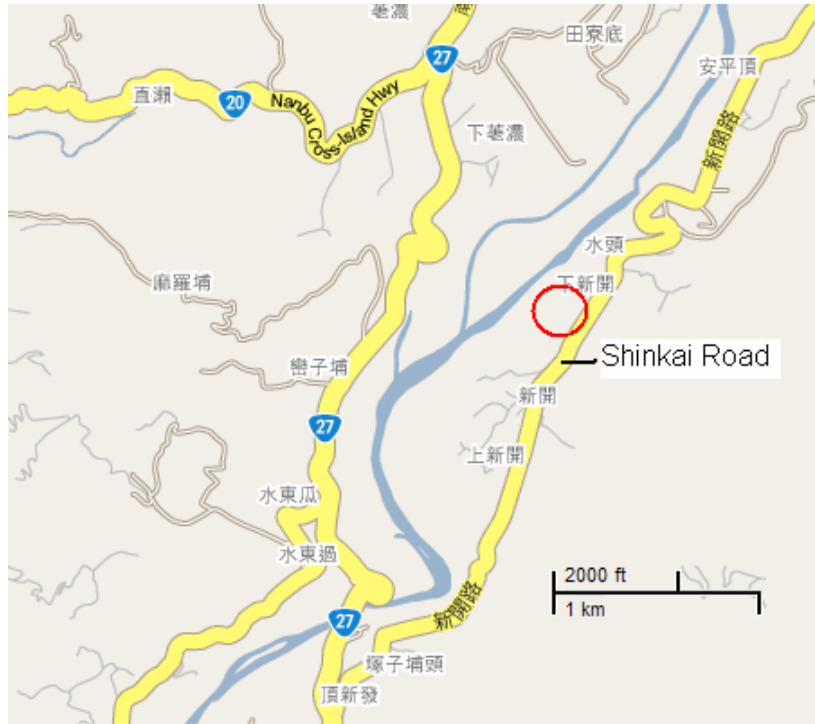
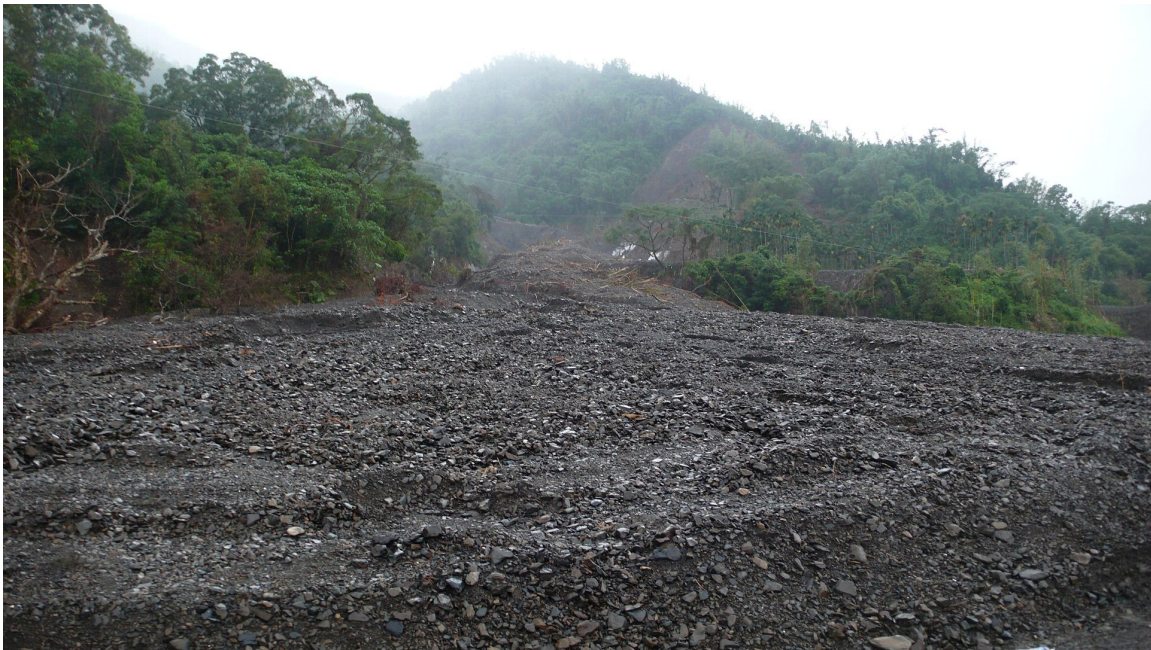
Photo 2-4-1. Debris flow at Shinkai Village.

In the village of Shinkai, 32 persons were buried alive by a debris flow. The village was cut off for many days due to the damage of its bridge. Buildings were covered by material deposited from the debris flow. Several buildings were excavated, leaving behind ponds of water.

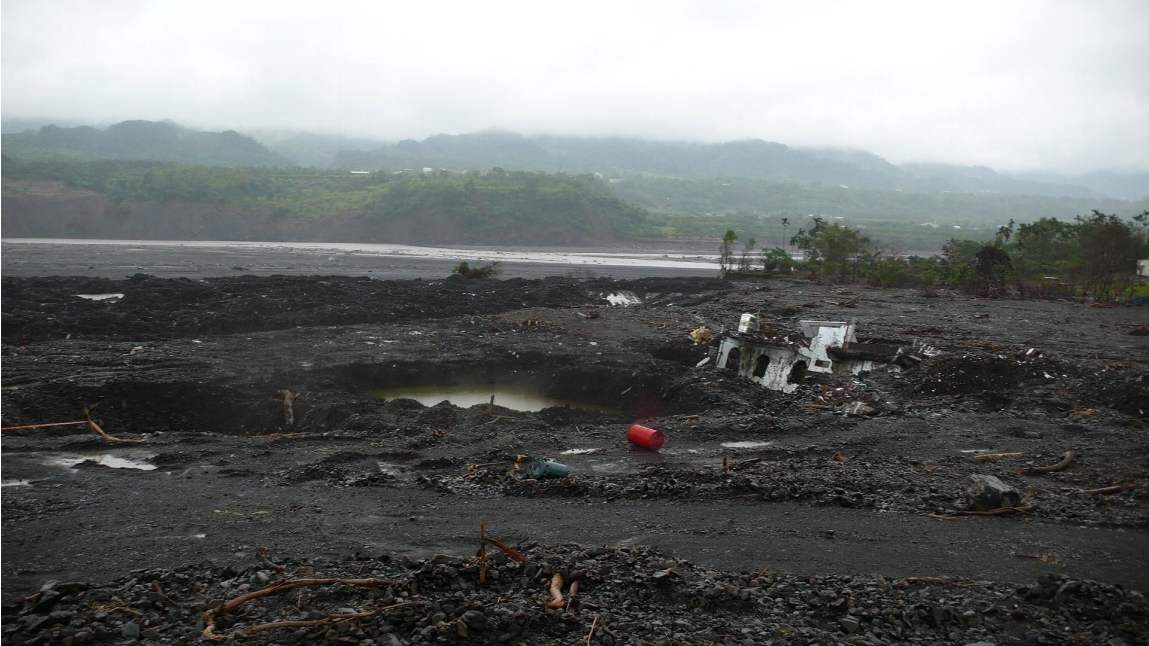
Photo 2-4-2. Excavation of buried buildings.

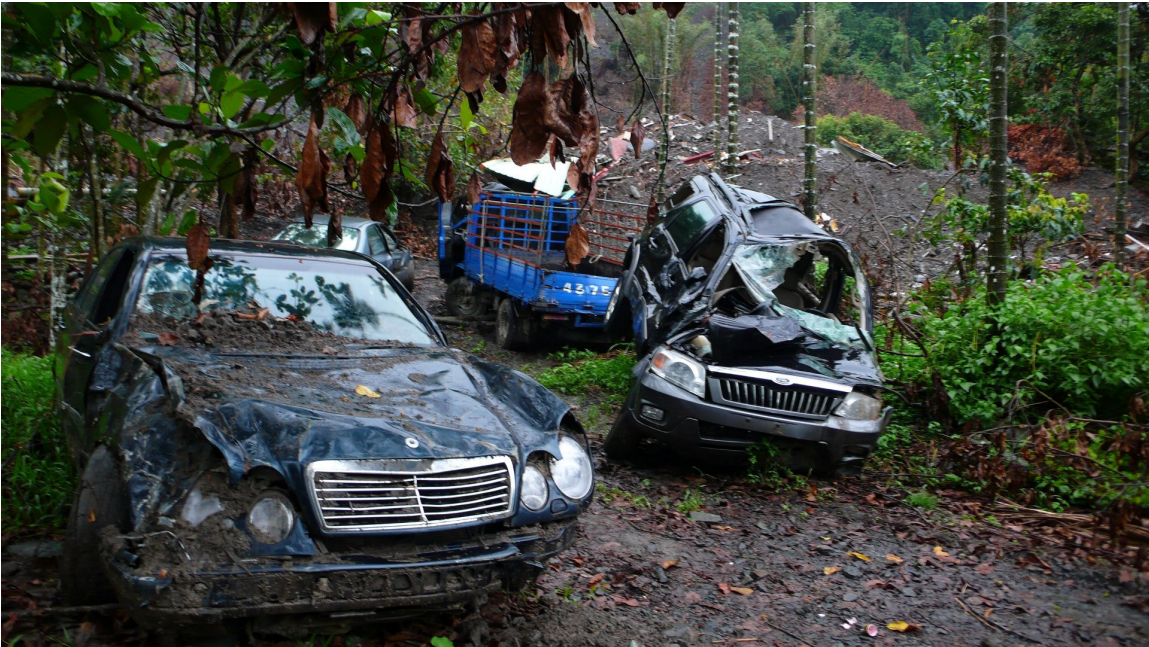
Photo 2-4-3. Car remains found near the village.
