5. ROUTE 18 - Alishan Highway

5.1 General

Many sections of Route 18 were damaged by Typhoon Morakot. Reconstruction may take up to 2 years, posing a serious threat to the local economy. The damages of the following sites (1-5) are presented in this report.

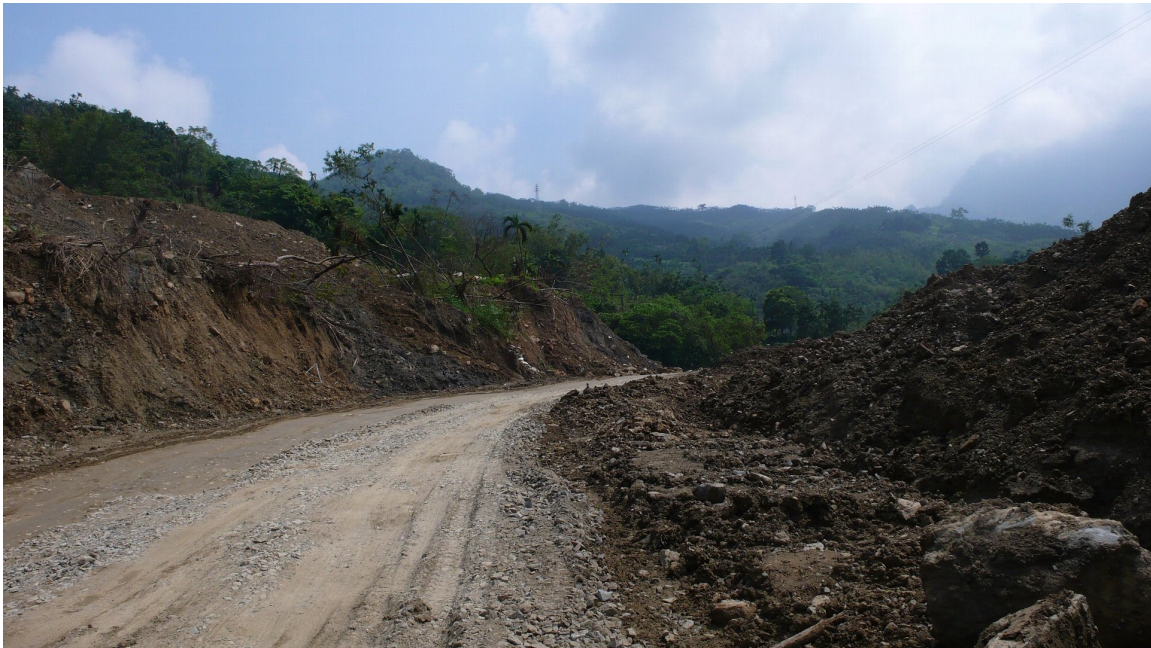
Photo 5-2-1. The road was buried by a debris flow which traveled from the top of a mountain down to a stream.

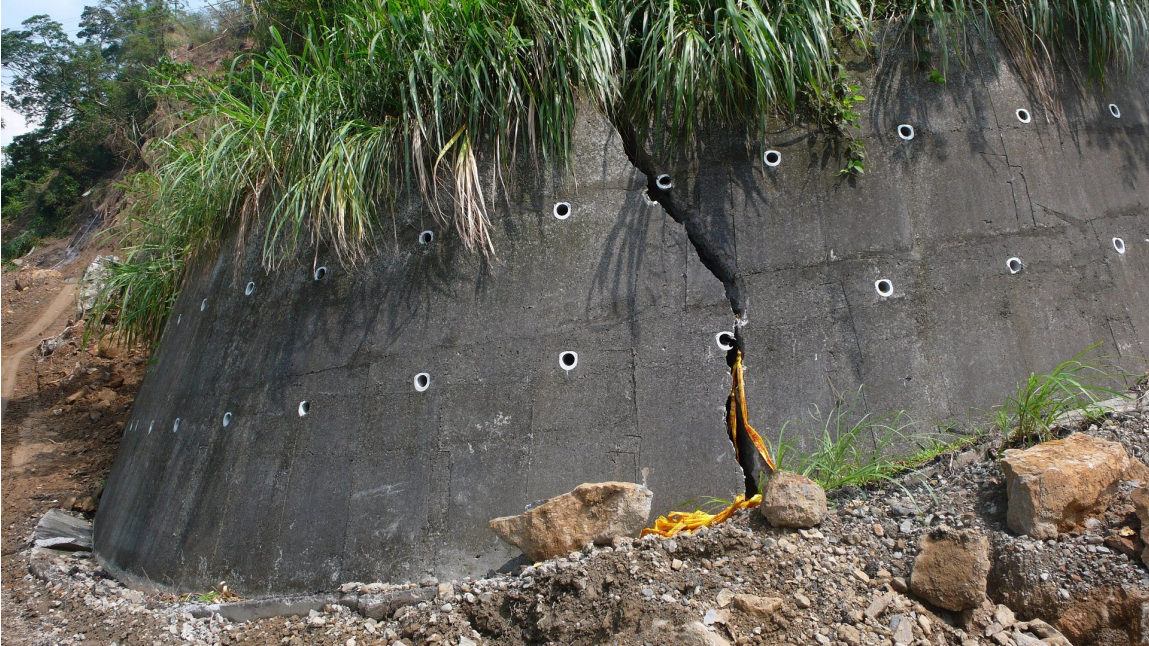
Photo 5-2-2. A retaining wall damaged by landslides.

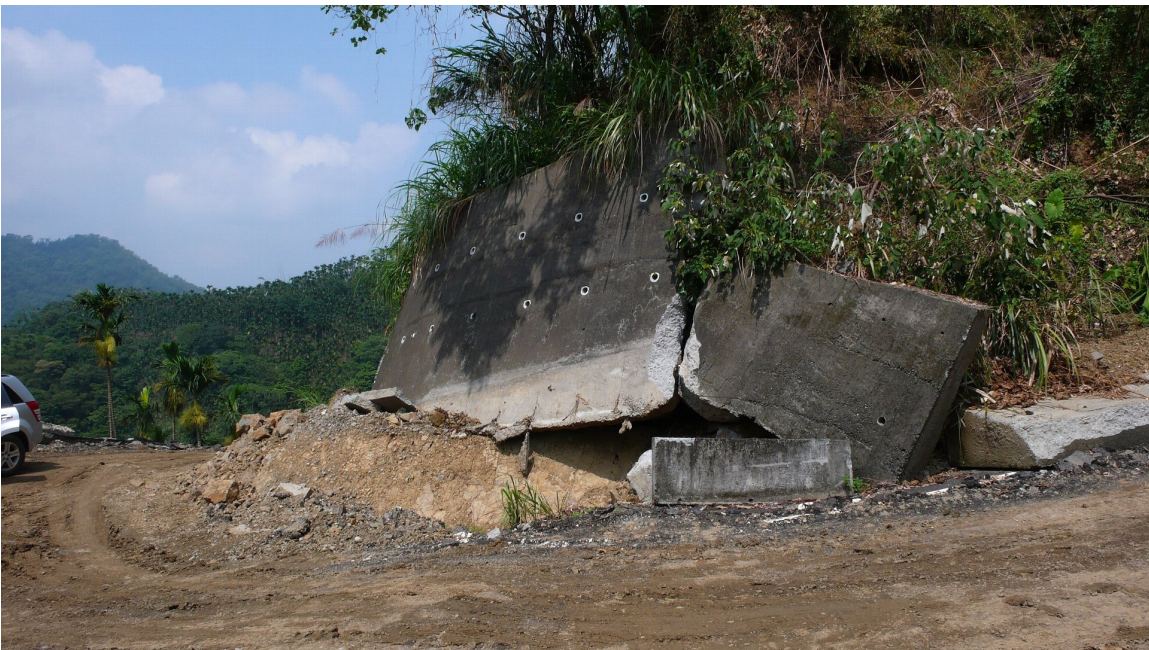
Photo 5-2-3. Another damaged retaining wall.

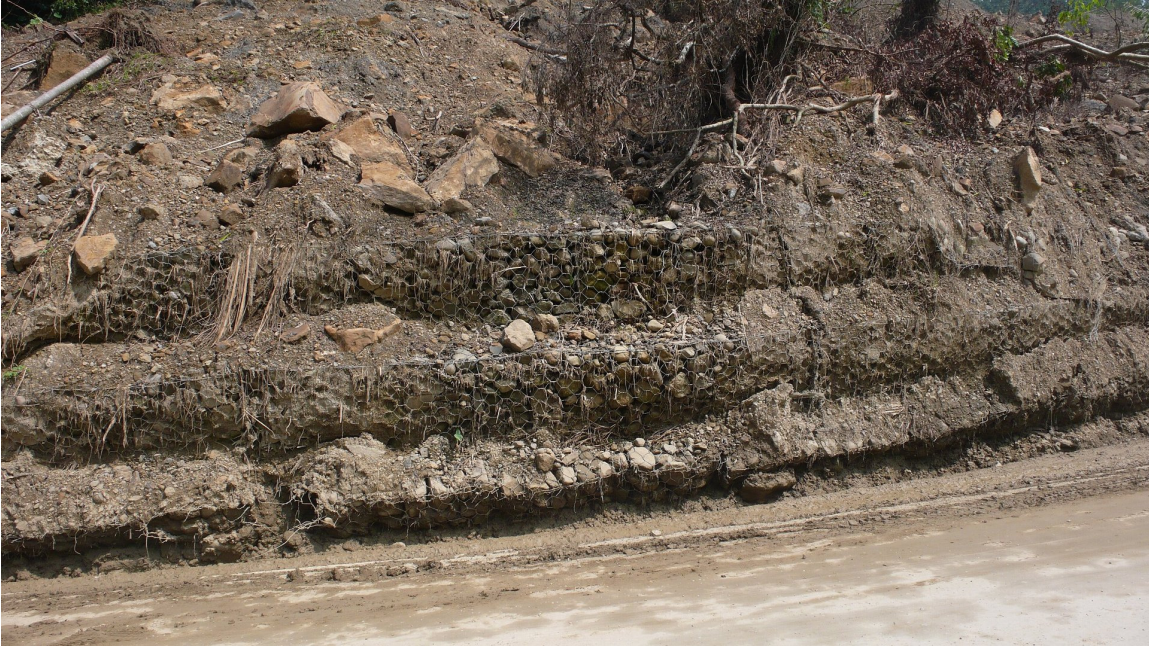
Photo 5-2-4. Gabions were used in the lower part of the slope.

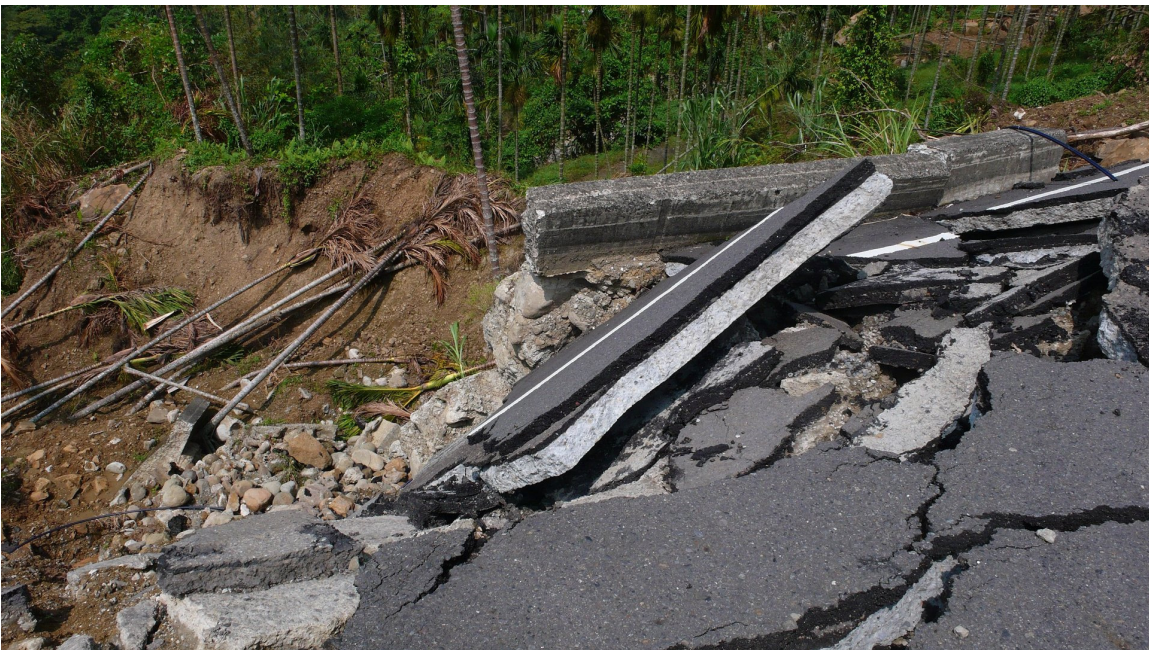
Photo 5-2-5. Pavement damaged by slope movement.

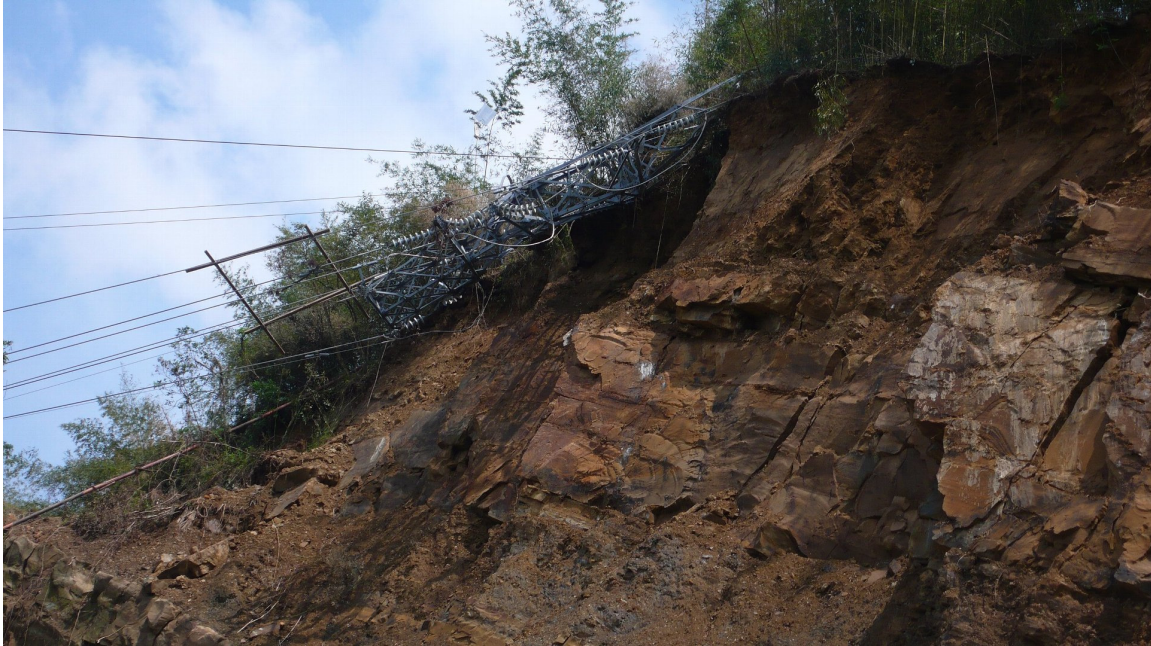
Photo 5-2-6. An electricity transmission tower damaged by landslides.

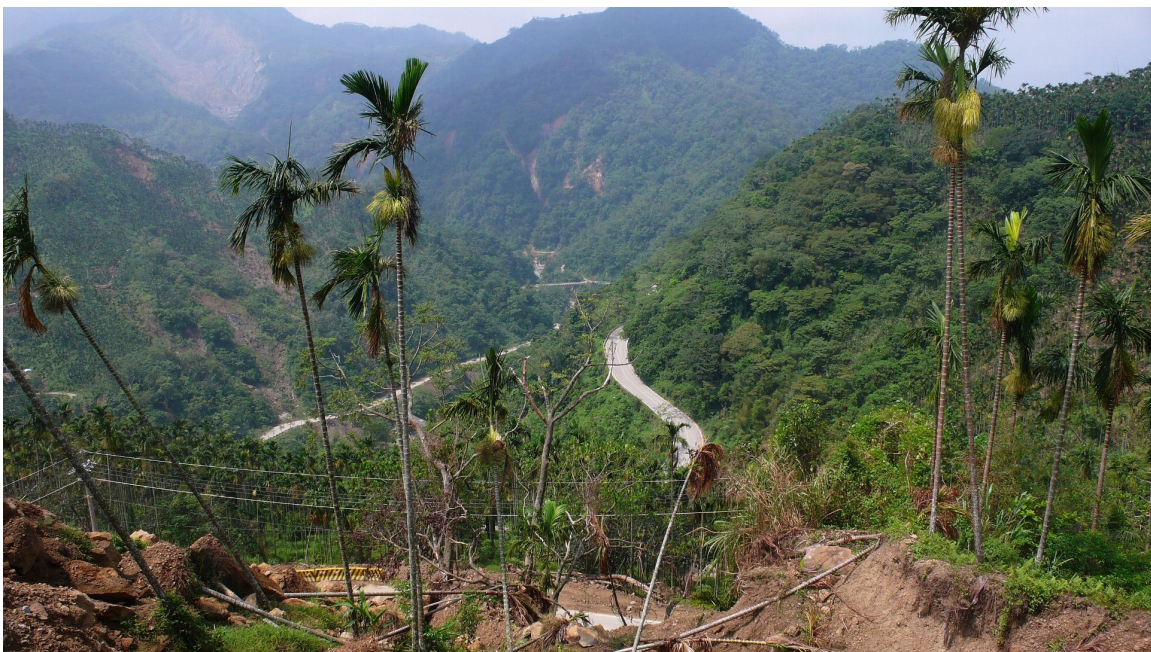
Photo 5-2-7. The beetle nut plantation was damaged by soil movement. Part of Route 18 and other landslide sites can be seen in the photo.

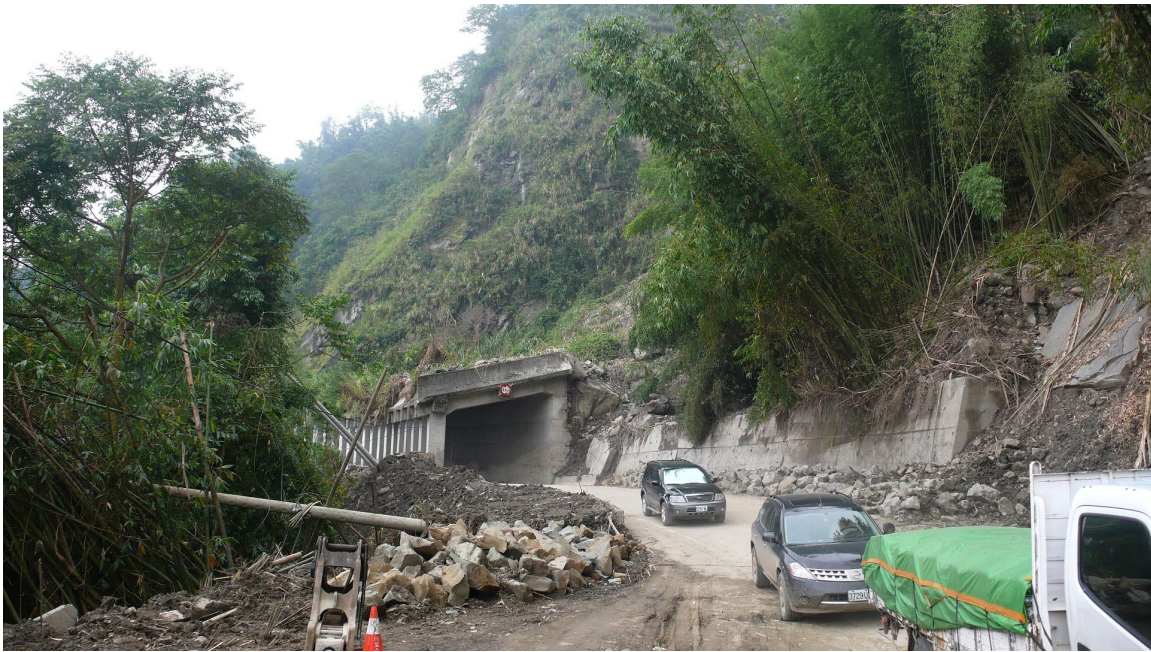
At this site, a shed was constructed to protect the highway from debris flow and to divert the debris toward the valley. Since the shed was built in more than one section, soil movement caused differential settlement of the road within the structure. Part of the shed also moved laterally.

Photo 5-3-1. Debris flow was seen at one end of the shed. Part of the shed was buried.

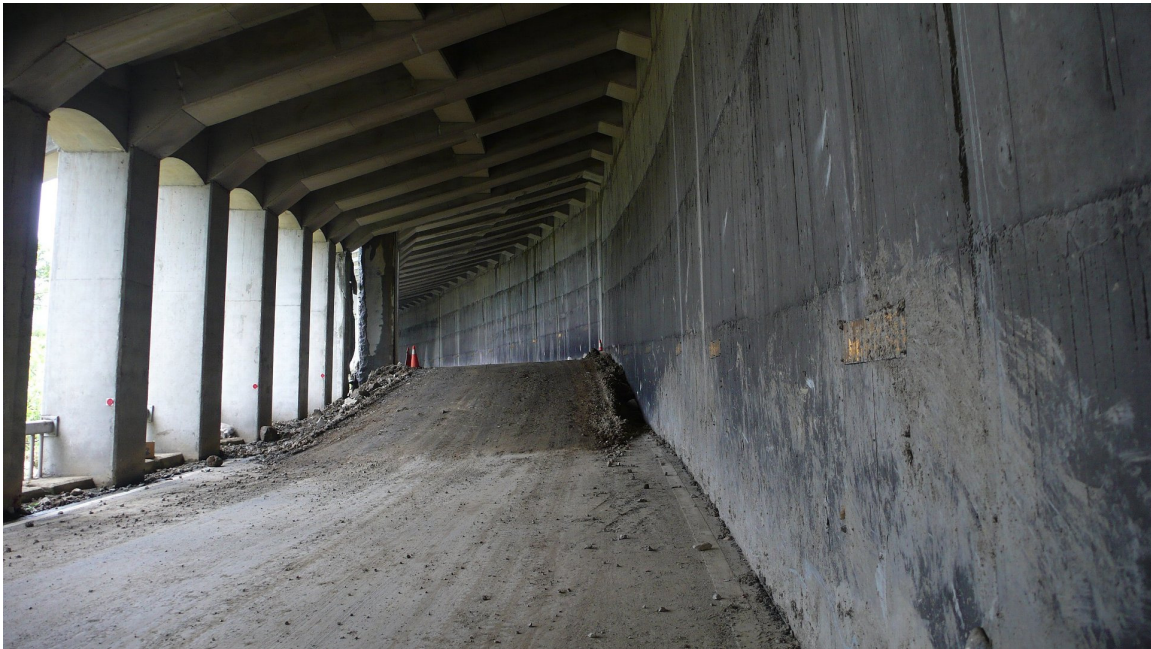
Photo 5-3-2. Differential settlement of road inside the shed.

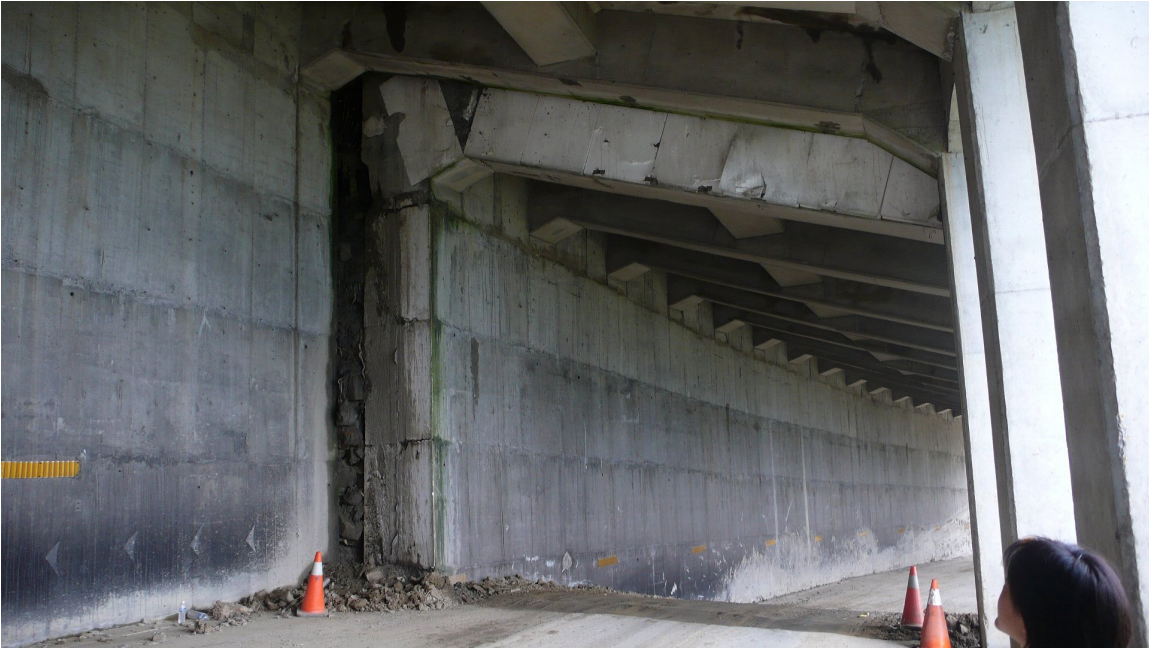
Photo 5-3-3. One of the sections of the shed displaced relative to the stable section.

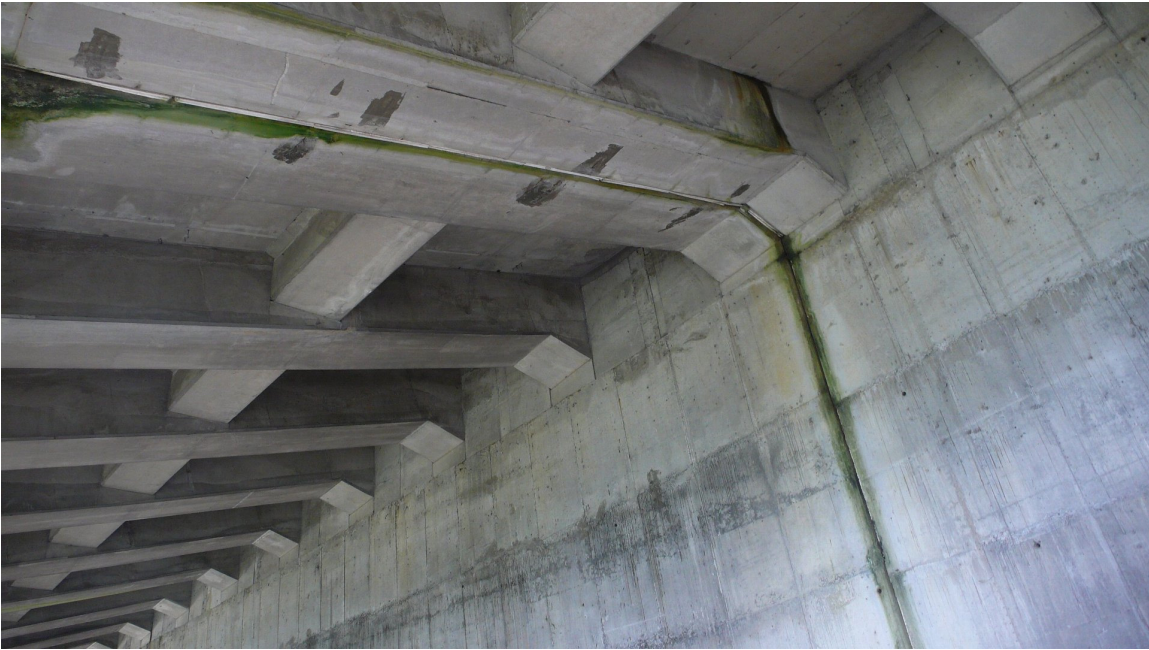
Photo 5-3-4. The other sections did not exhibit relative displacement.

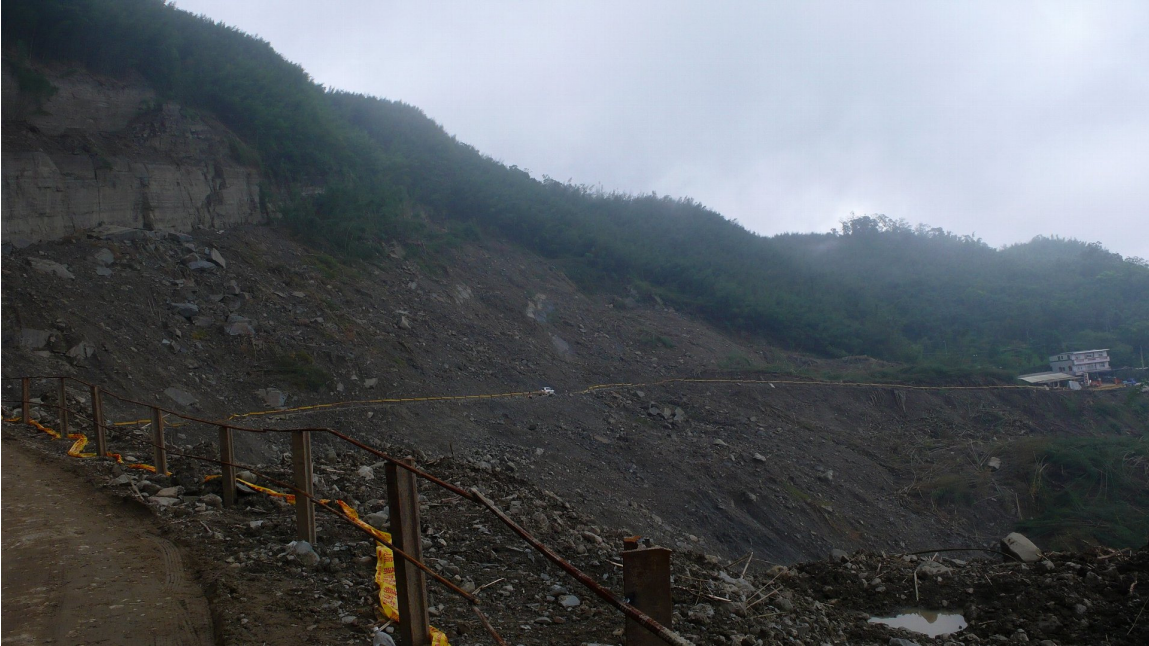
A short distance away from the shed, a large stretch of highway collapsed due to landslides.

Photo 5-3-5. Landslides damaged several hundred meters of the existing roadway. The mountain was cut to create a new access road.

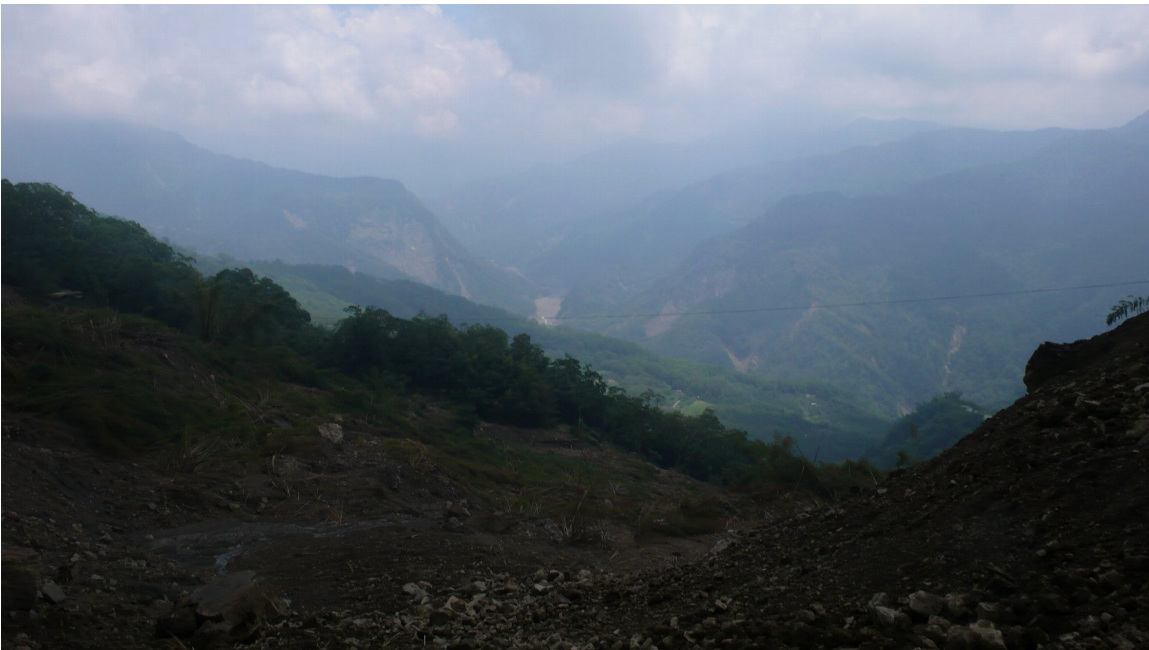
Photo 5-3-6. The surrounding area was dotted with many landslides.

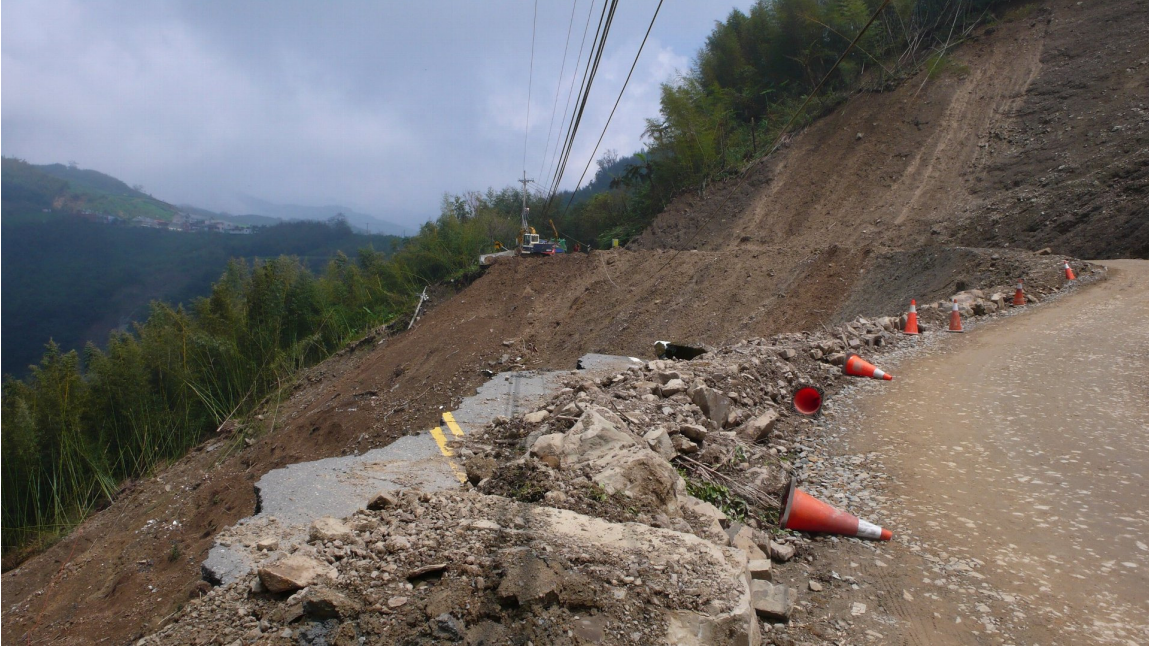
This was the site of a large landslide. The highway was lost and an access road was constructed.

Photo 5-4-1. Landslides. Note the original location of highway and new access road

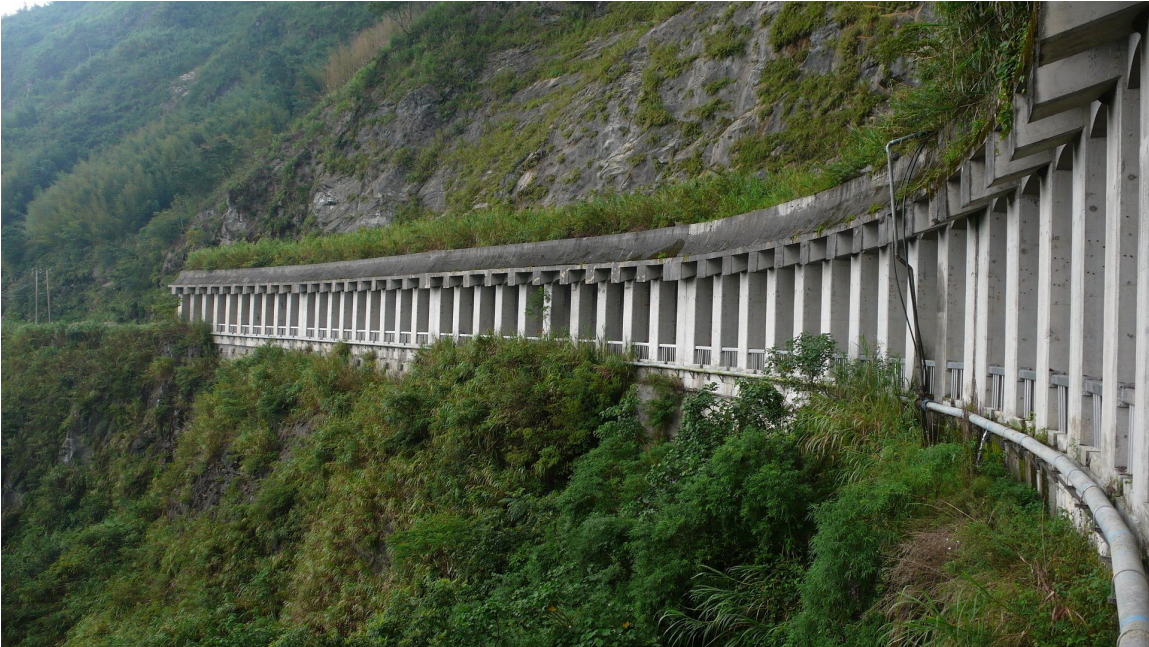
Photo 5-5-1. Another site with the shed.

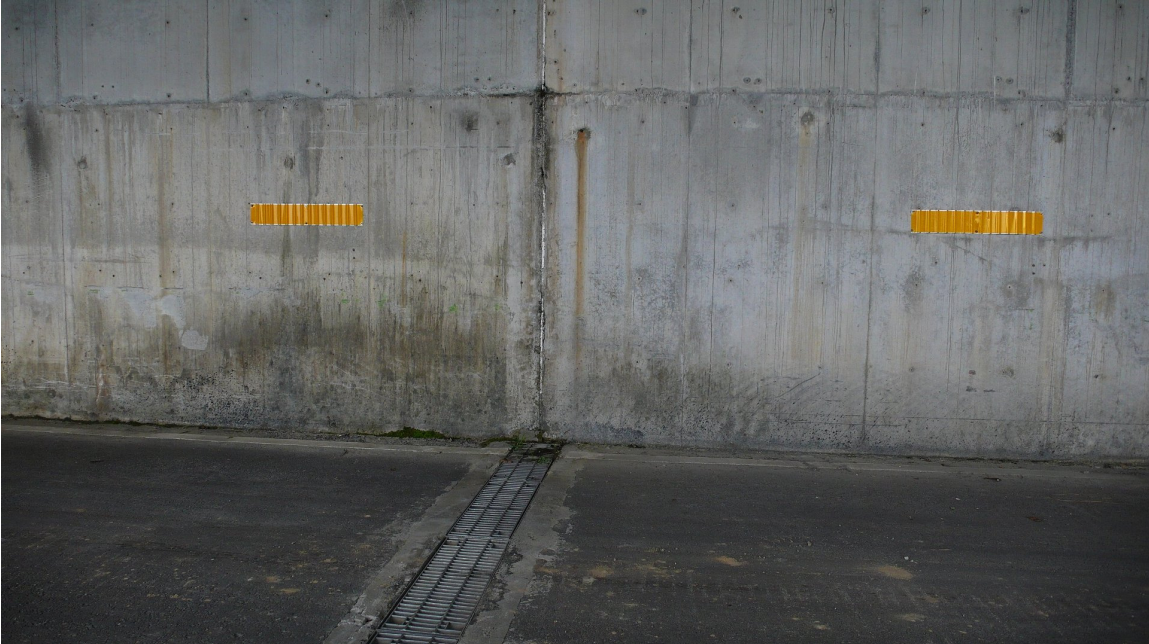
Photo 5-5-2. Construction joints remained intact; these did not show evidence of relative displacement.

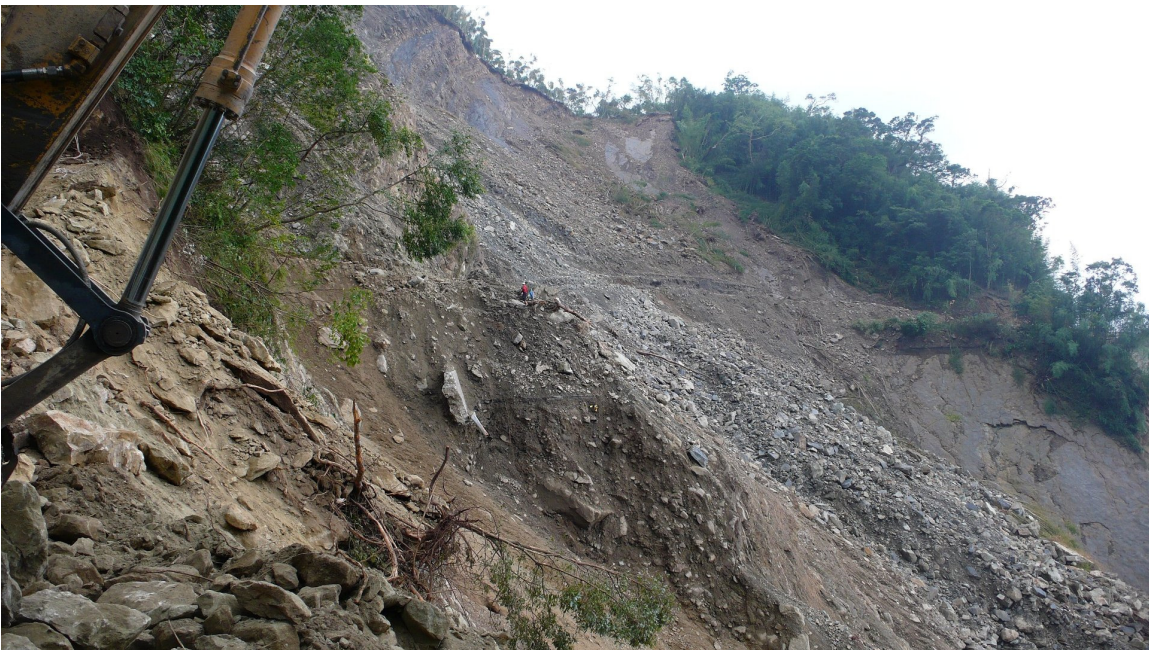
Photo 5-5-3. Several hundred meters of the highway were lost due to a landslide.

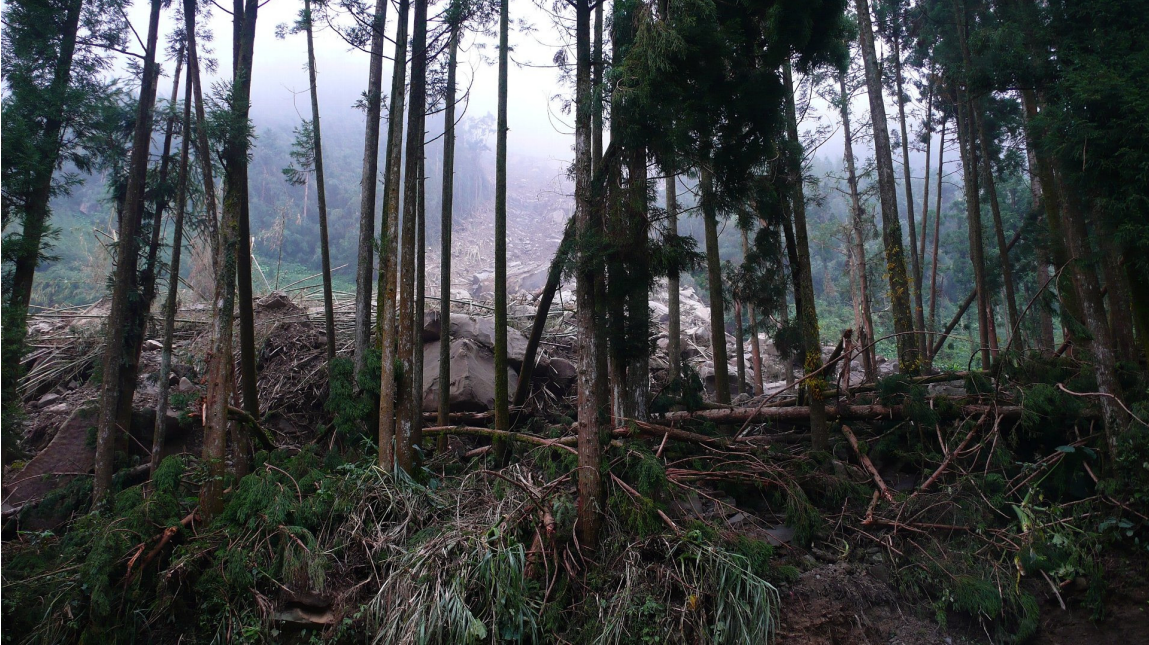
Photo 5-6-1. Source of debris flow can be seen in the distance, up the mountain.

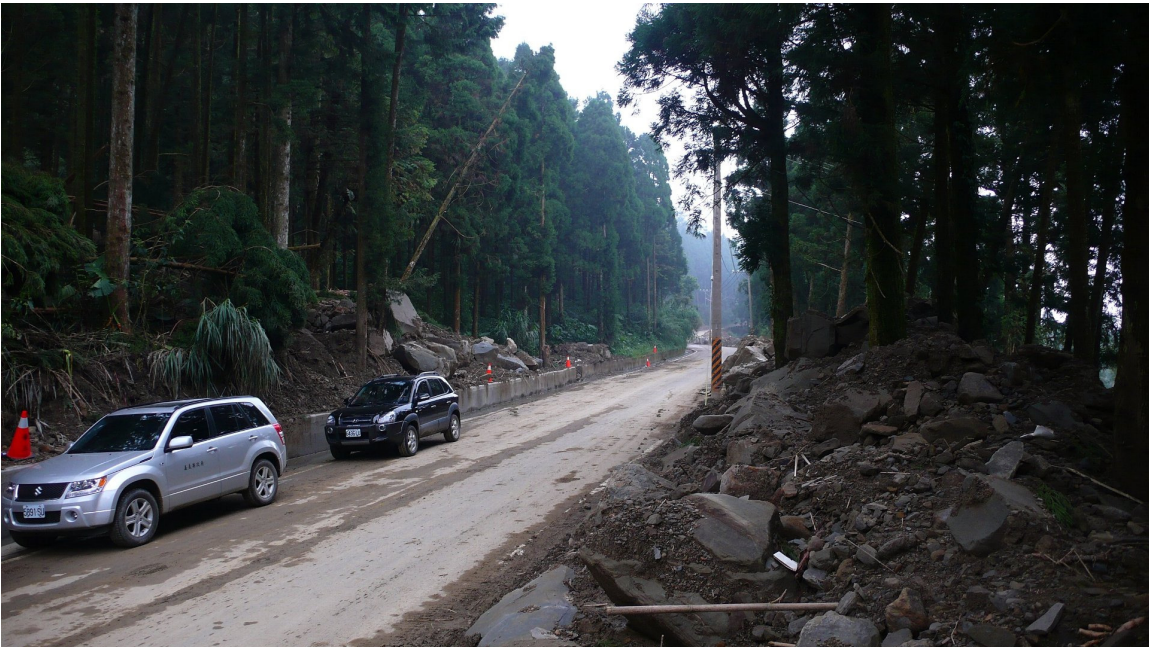
Photo 5-6-2. Debris flow with boulders and gravel of various sizes. The road has been cleared for traffic.

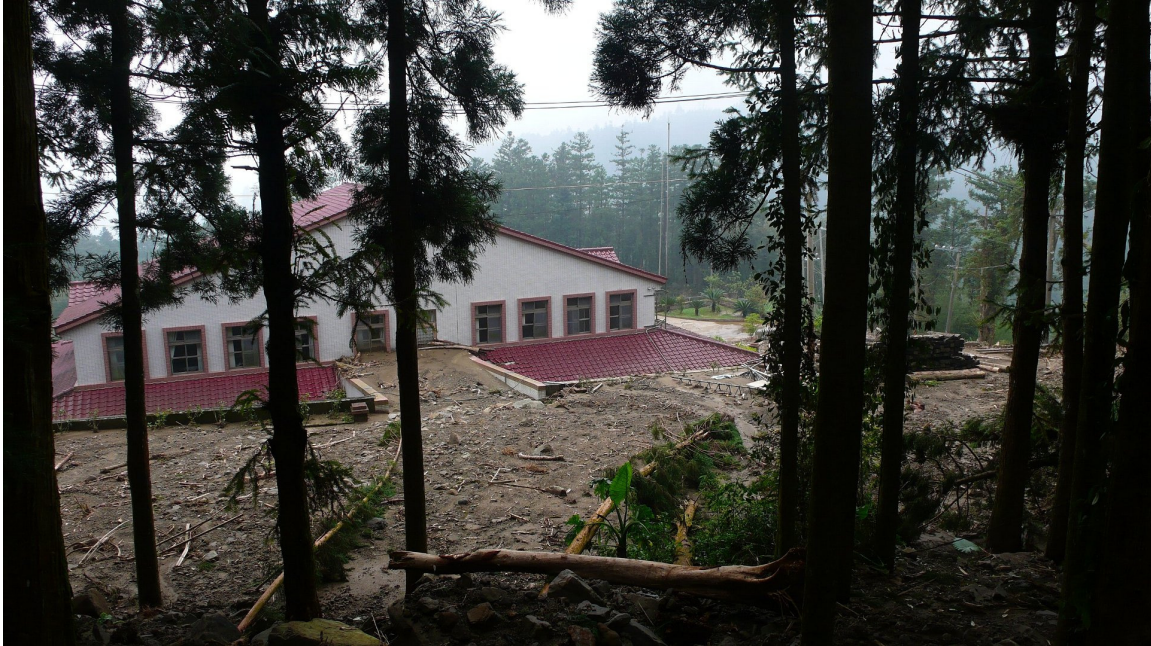
Photo 5-6-3. A building partially buried by debris flow

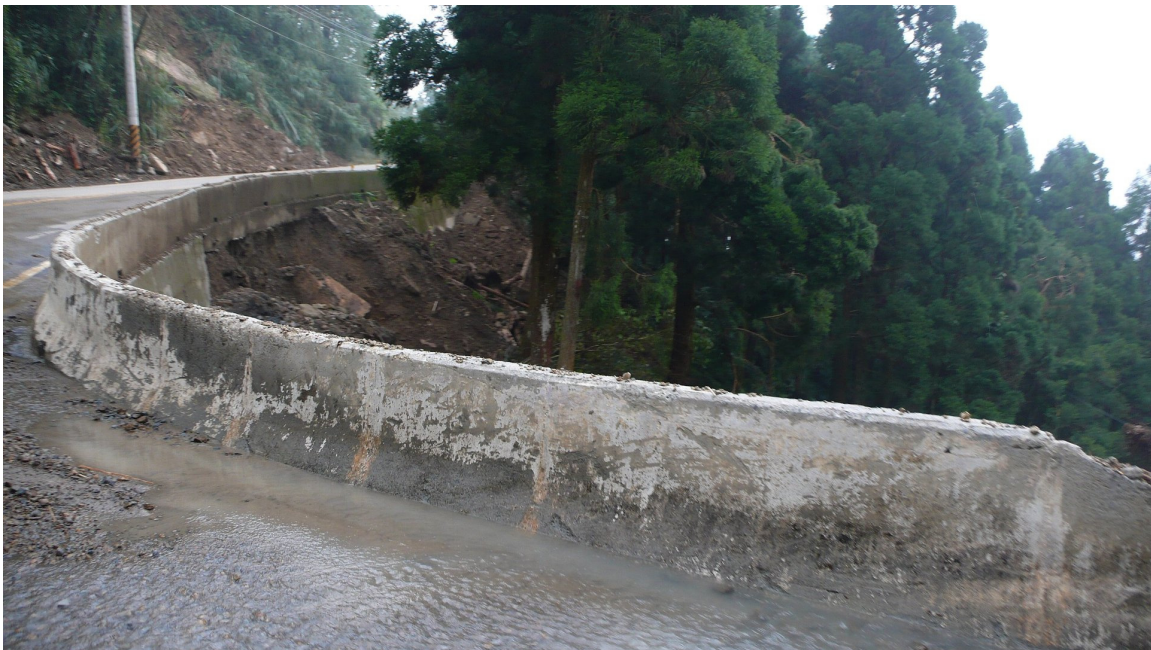
Photo 5-6-4. The Jersey Barrier was reported to have blocked the water from draining during heavy rainfall

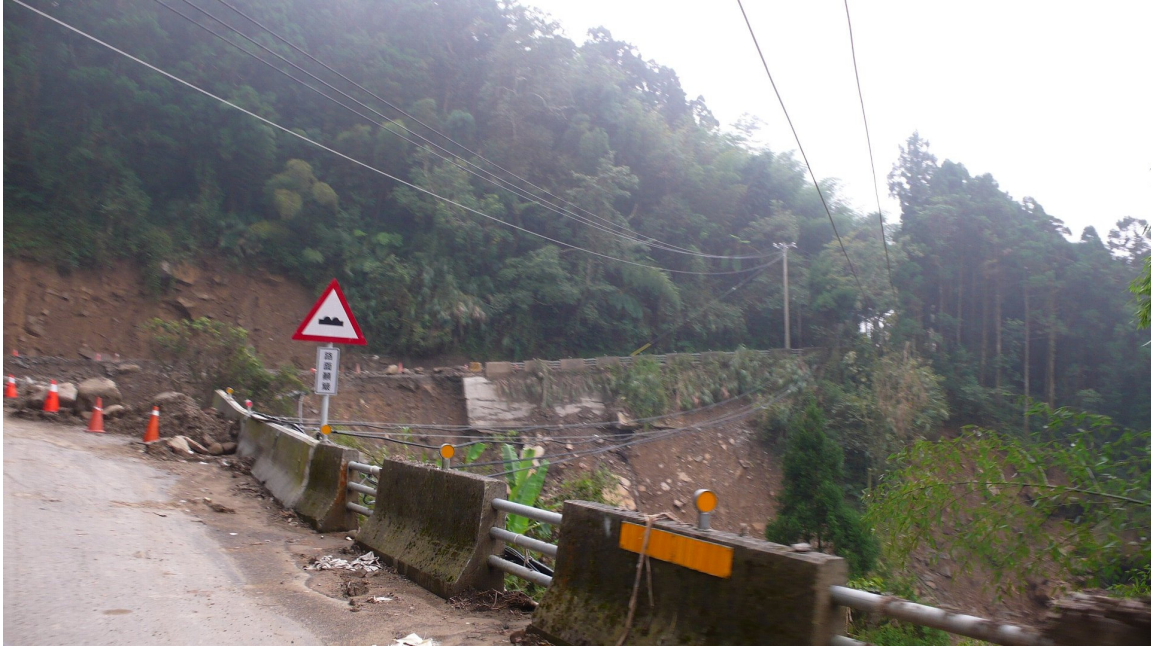
Photo 5-6-5. A different form of barrier which allowed free drainage of rainwater.

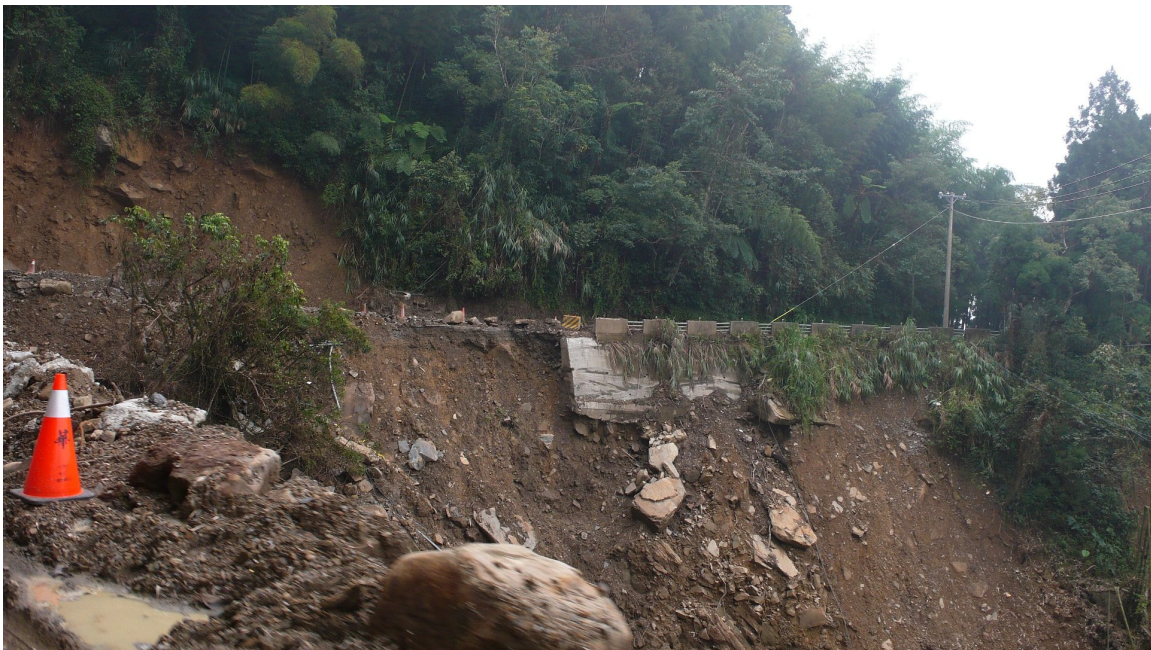
Photo 5-6-6. The loss of foundation due to landslides led to the collapse of many retaining walls.

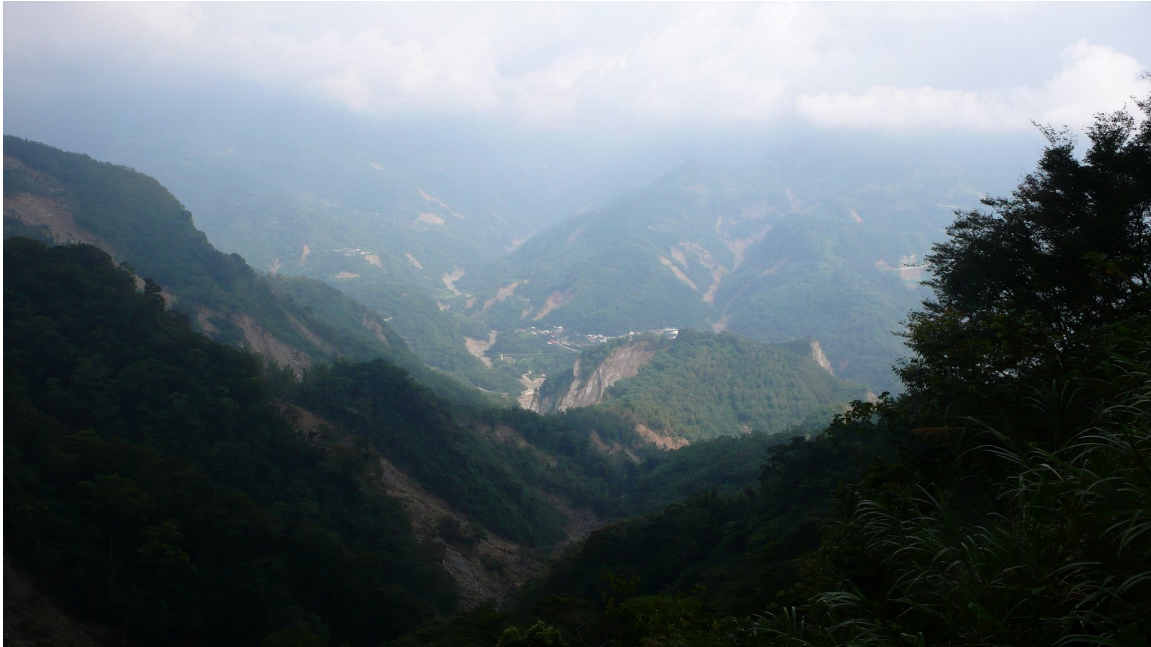
Photo 5-7-1. Landslides

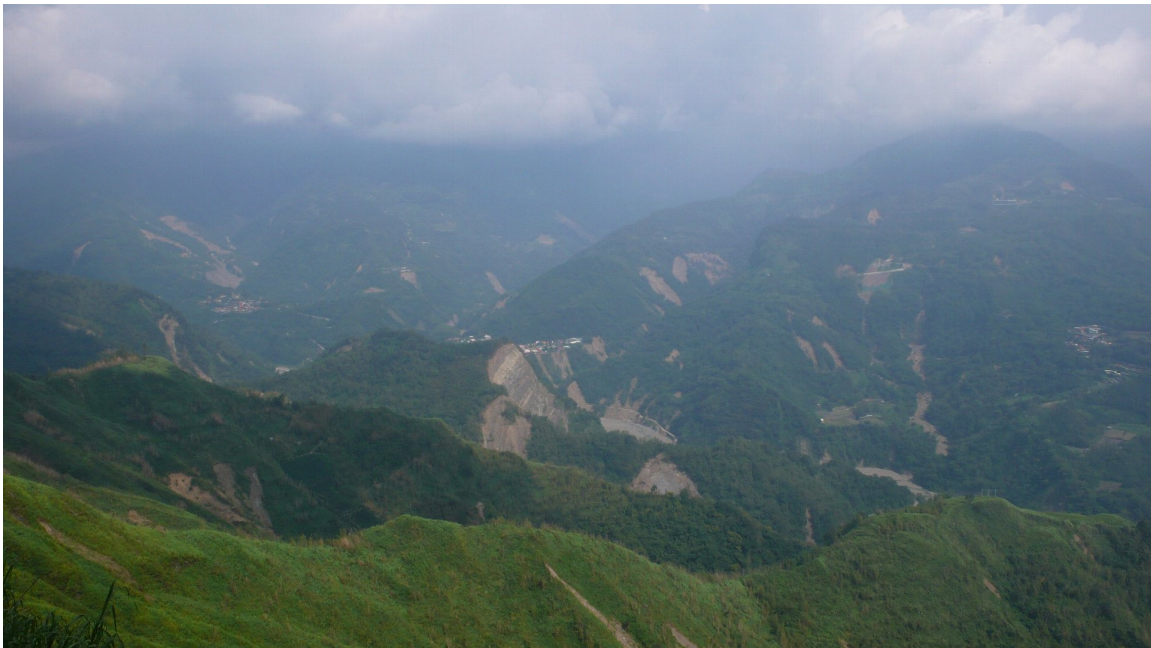
Photo 5-7-2. Landslides

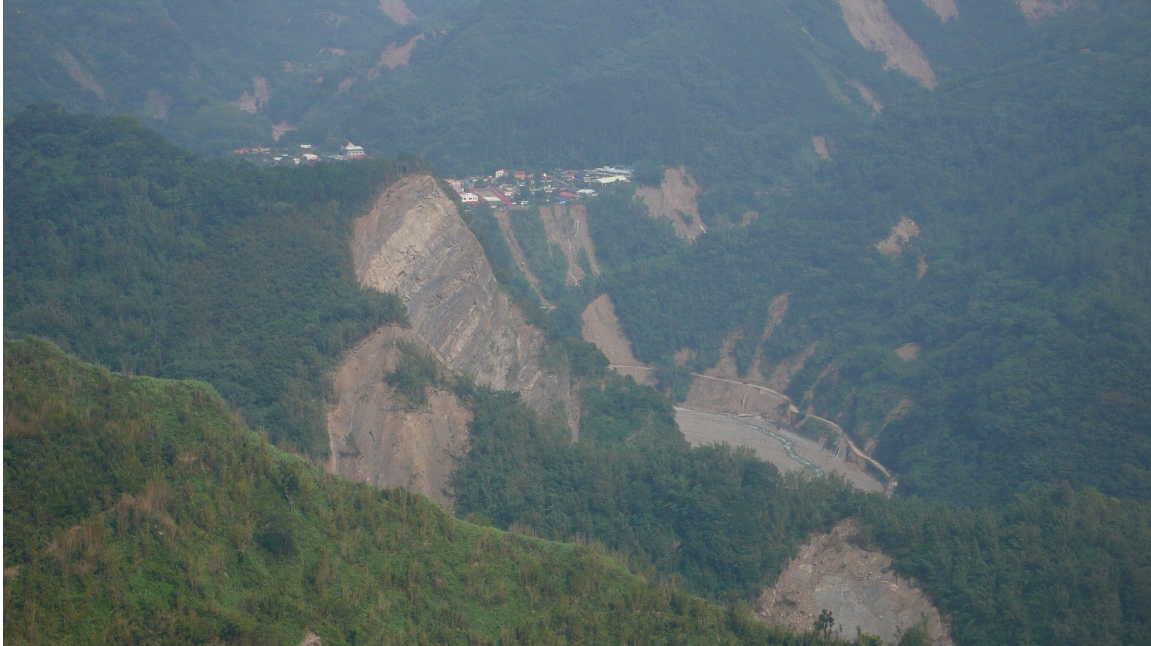
Photo 5-7-3. A closer view of huge landslides of Photo 5-7-2

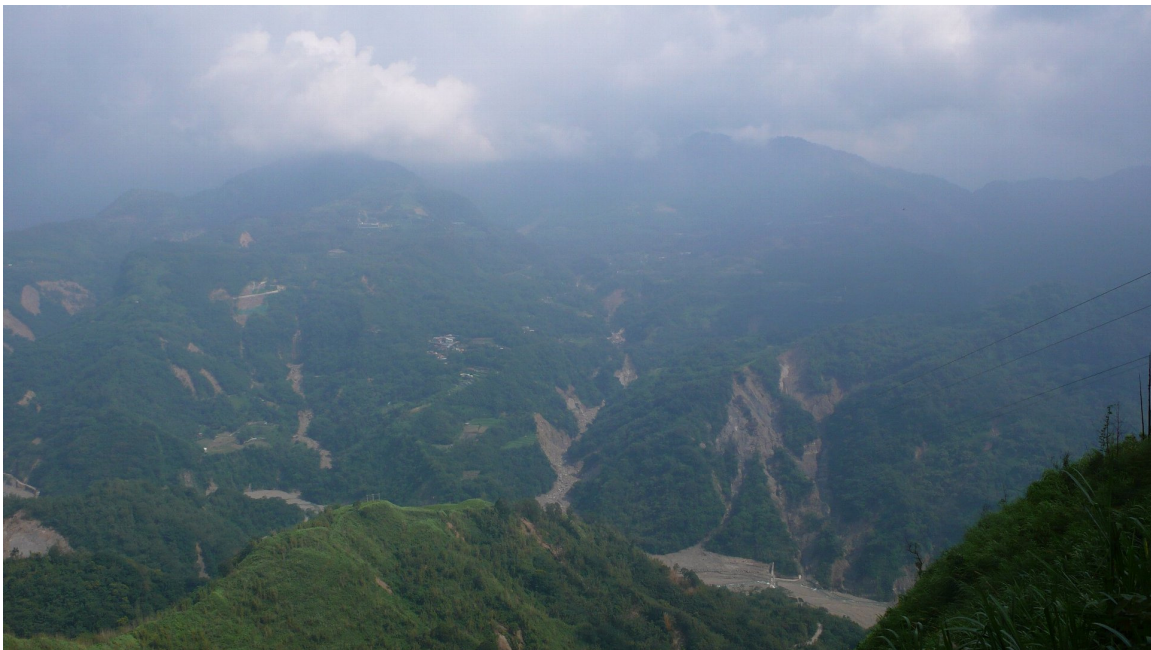
Photo 5-7-4. Landslides
