Using Satellite Images in Post-Earthquake Geotechnical Reconnaissance

GEER Advisory Panel Meeting

7 January 2004

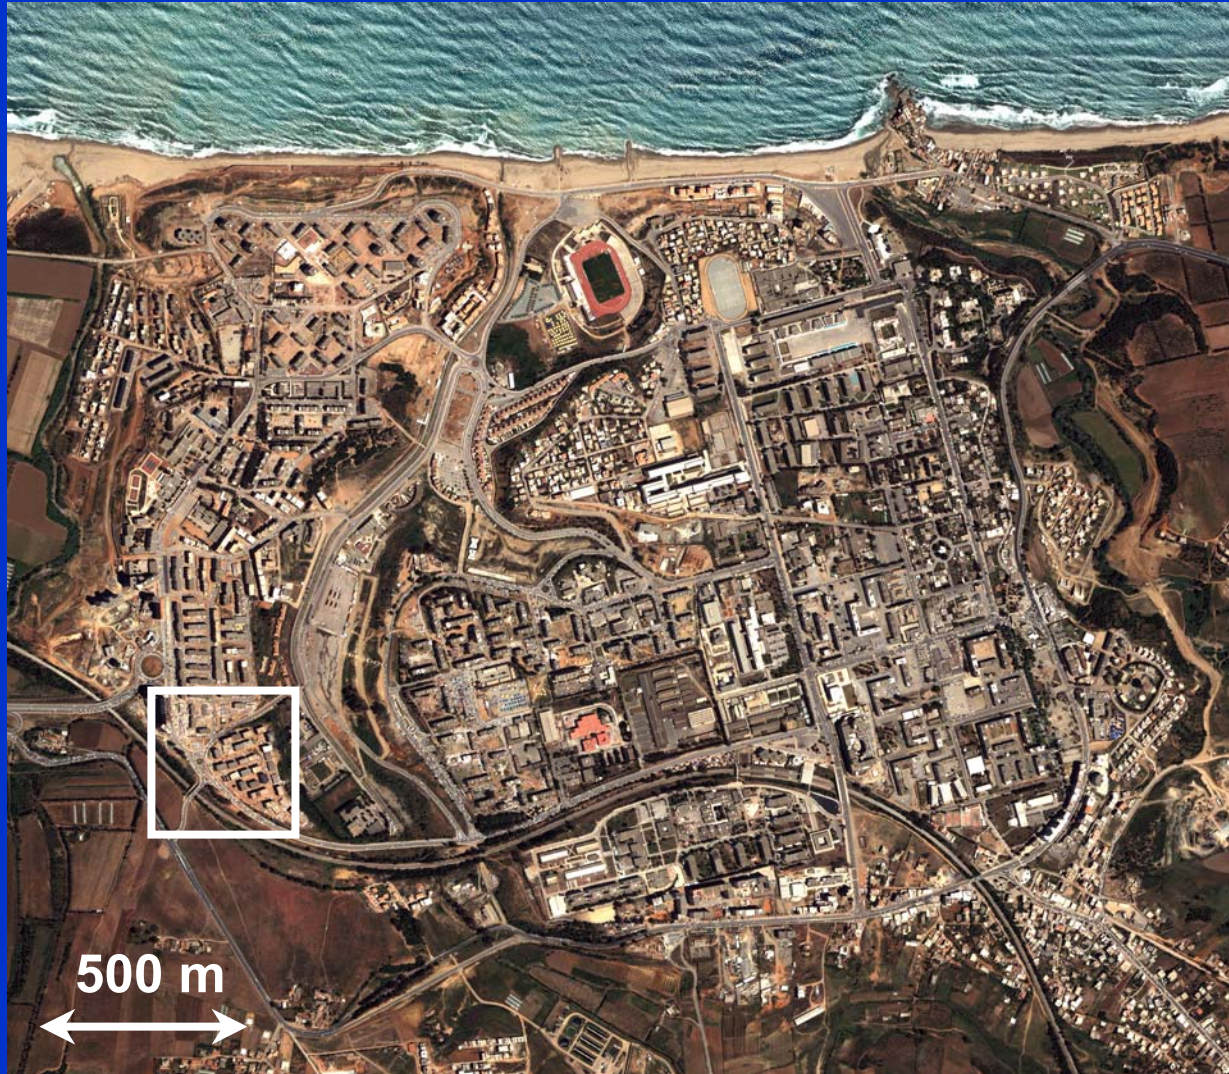
Boumerdes 23 May 2003

- 3 Quickbird images of Boumerdes
 - 22 April 2002, 11° OFF NADIR
 - 23 May 2003, 24° OFF NADIR
 - 18 June 2003, 8° OFF NADIR
- All images from DigitalGlobe archive
 - 25 km² minimum order size
 - ~\$30/km² for standard pan/ms data
 - 2 to 3 day delivery
 - Tasking requires 64 km² minimum size

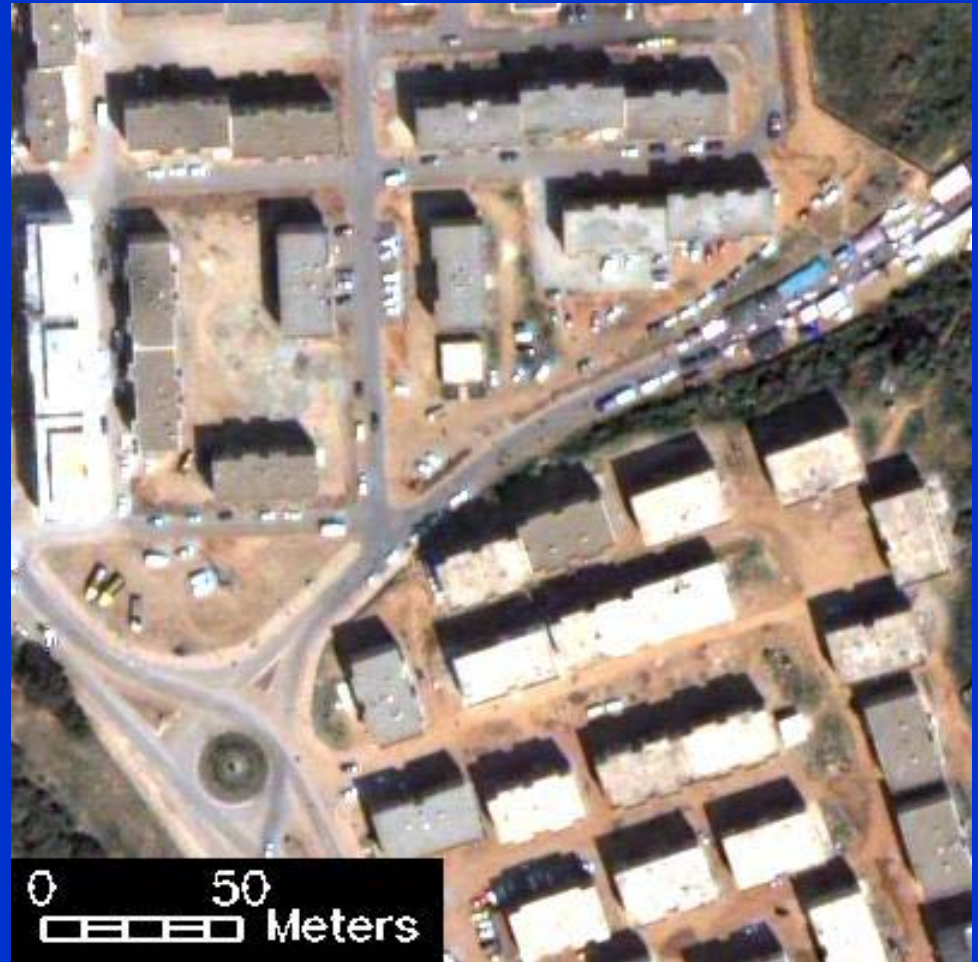
SW Boumerdes – April 02

Buildings, roads, and cars readily visible

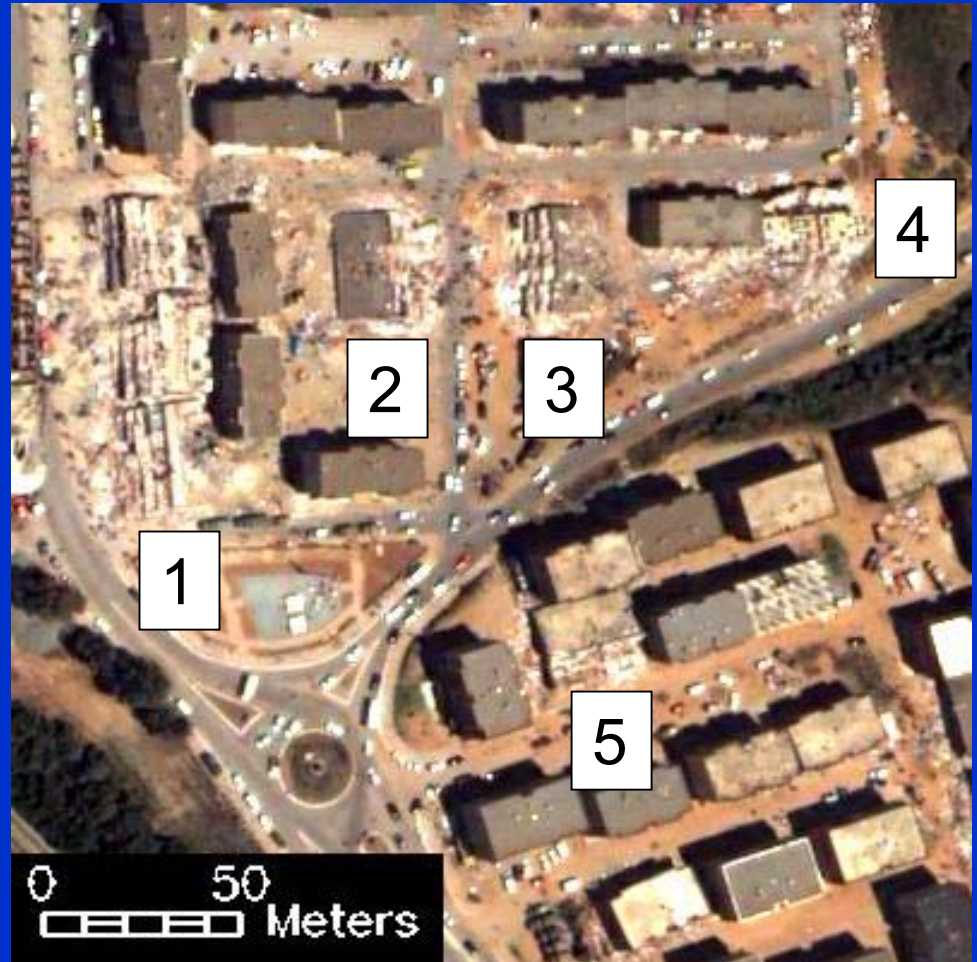
SW Boumerdes – May 03

- Pancaked buildings easily identified

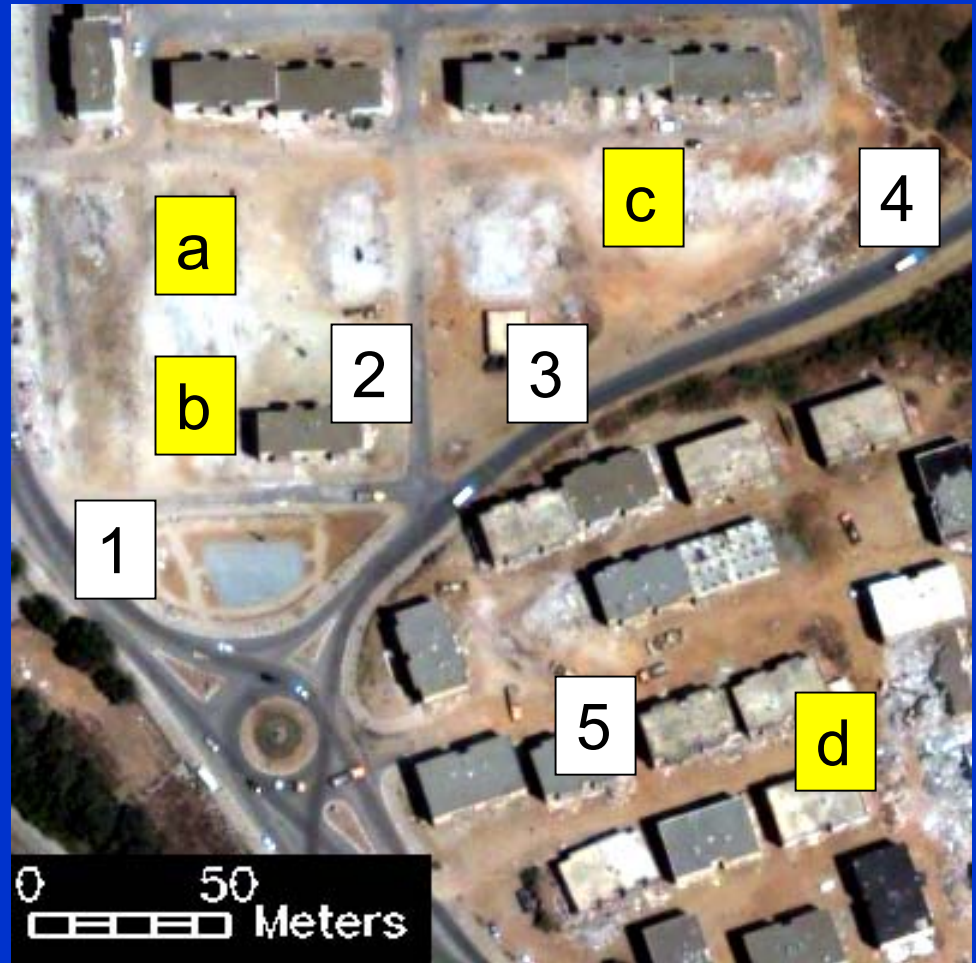
SW Boumerdes – June 03

- Five pancaked buildings removed
- Other buildings removed

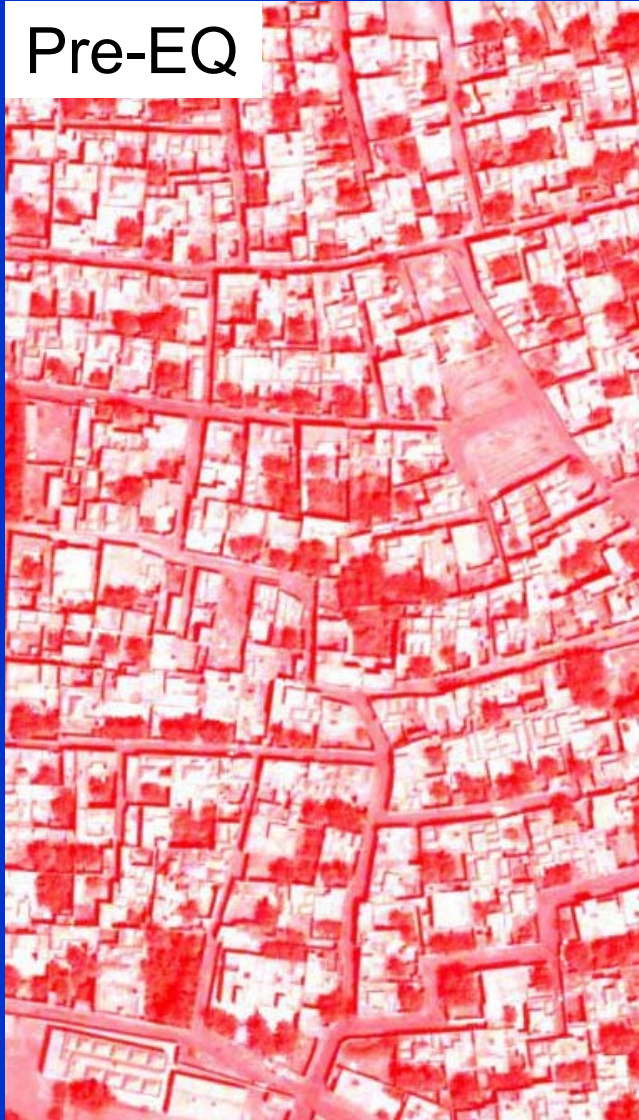
Zone 1

Pre-EQ

Post-EQ

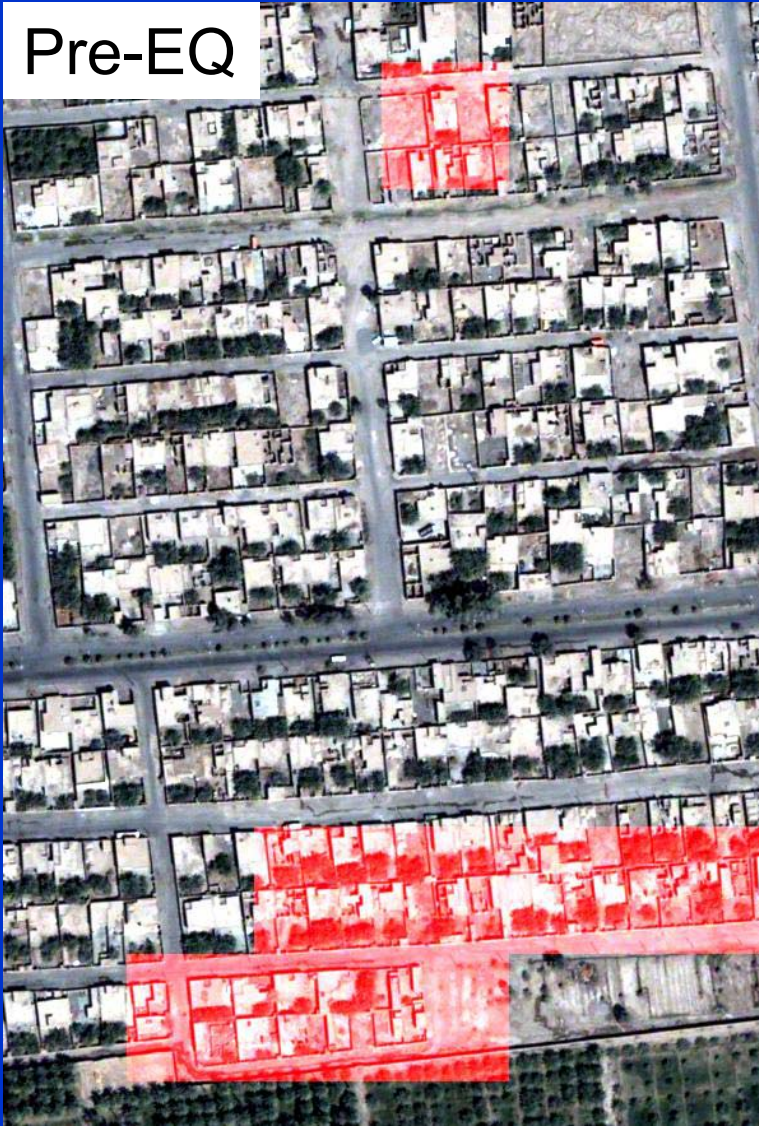
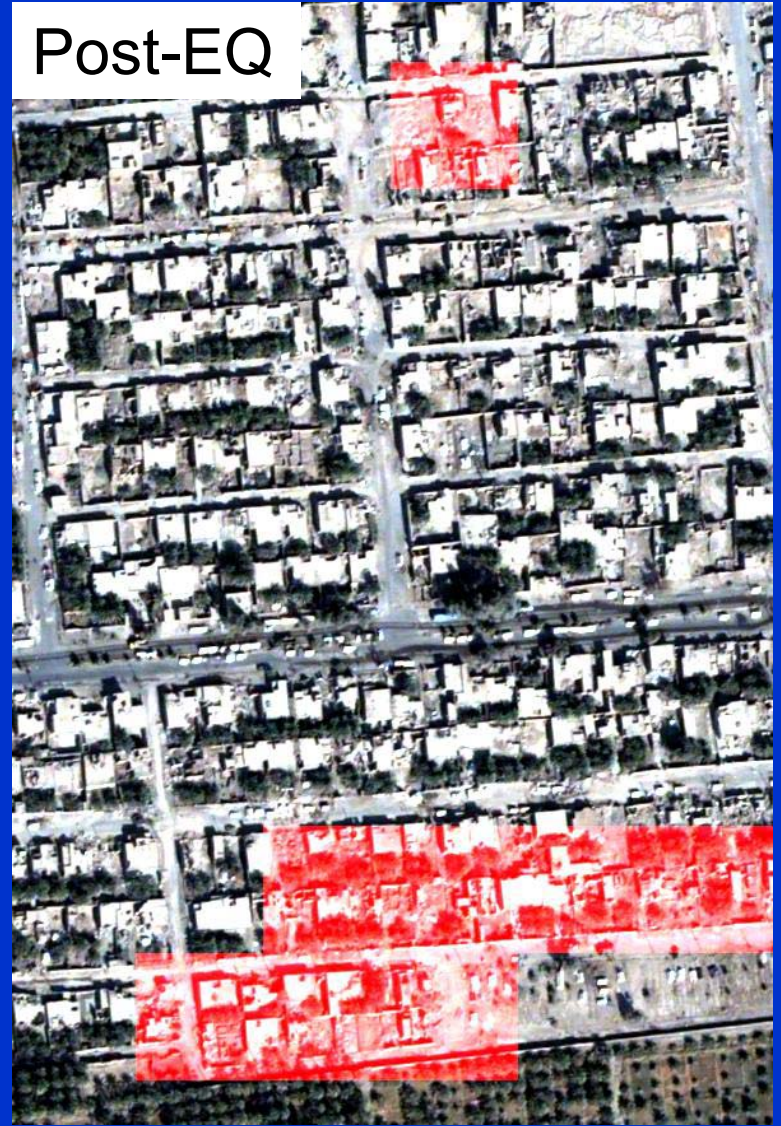
Zone 3

Pre-EQ

Post-EQ
