## 4 GEOTECHNICAL ASPECTS ON THE SOUTH ISLAND OF NEW ZEALAND

This chapter identifies locations of liquefaction manifestations and discusses the effects of liquefaction and related phenomena on the South Island of New Zealand resulting from the 2016,  $M_w$ 7.8 Kaikoura earthquake. Detailed observations are recorded to document the occurrence and non-occurrence of liquefaction in areas shaken at different levels of intensity. Strong motion recordings indicate high peak ground accelerations (PGA) occurred in the Waiiau valley of North Canterbury (marked “Area C” in Figure 4.1). Horizontal accelerations at the Waiiau strong motion station (WTMC) were in excess of 1 g and vertical accelerations in excess of 2.7 g. The ground motions were significantly attenuated in the main urban areas of the South Island; the recorded peak ground accelerations were in the range of 0.14 g to 0.27 g in the areas around Blenheim (Area A) and Kaikoura (Area B). A more detailed summary of the ground motion characteristics across the South Island is provided in Chapter 3 of this report.

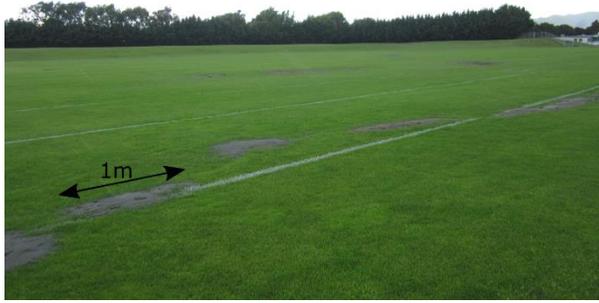
The sand boils discovered at Lansdowne Park were typically of the order of 1-2 m in diameter, and in many cases formed linear features, as shown in Figure 4.8, with a typical example shown in Figure 4.11. In a few limited locations, larger ejecta features of around 25 m<sup>2</sup> (plan area) were observed (Figure 4.12). Liquefaction ejecta were not observed around the edges of the foundations of the main stadium buildings. Small features were observed on the earthen bank on the south edge of the stadium (i.e. at the locations of LDP-4 and LDP-5 shown in Figure 4.8). Additionally, a small amount of ejecta was located at the base of a floodlight tower, as shown in Figure 4.13.

Figure 4.11: Linear liquefaction feature at Lansdowne Park (close to location of sample LDP-1, S41.4990, E173.9586, looking SE, 17 Nov 2016).

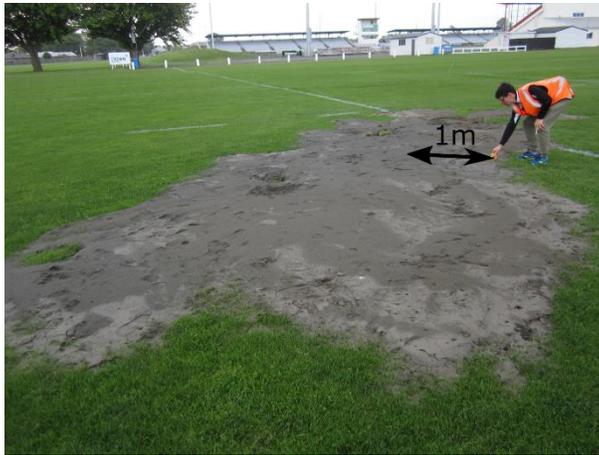
Figure 4.12: Largest liquefaction feature at Lansdowne Park (17 Nov 2016, S41.4996, E173.959, facing W).

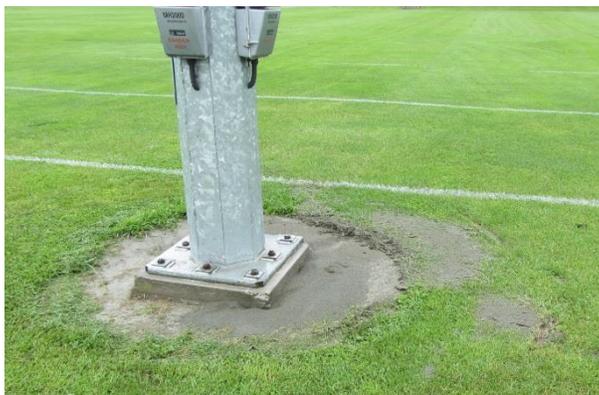
Figure 4.13: Liquefaction ejecta at flood light tower (17 Nov 2016, S41.5003, E173.9572, facing N).

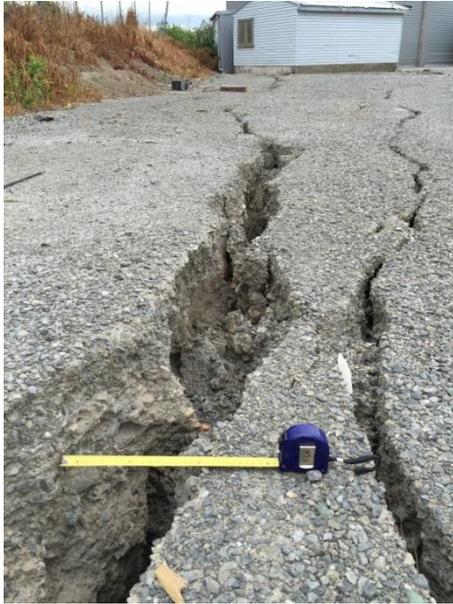
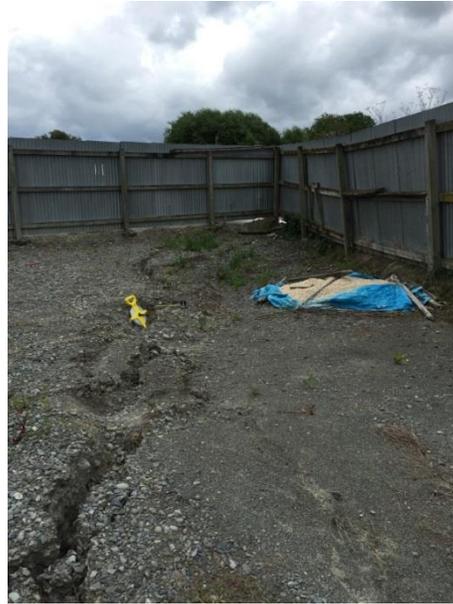
Cracks propagated across a number of properties, resulting in permanent ground deformation, differential settlement of structures, separation between foundation slabs and the surrounding ground, and damage to the stopbanks. Details of the cracking are shown in Figure 4.16, Figure 4.19 to Figure 4.21 and Table 4.1.

Figure 4.20: Examples of cracks along Park Terrace properties (5 Dec 2016): S41.5122 E173.9649, facing E; (b) S41.5121, E173.9647, facing W.

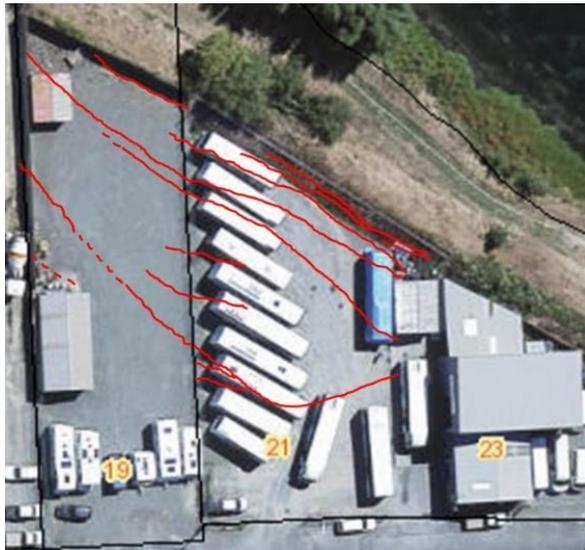
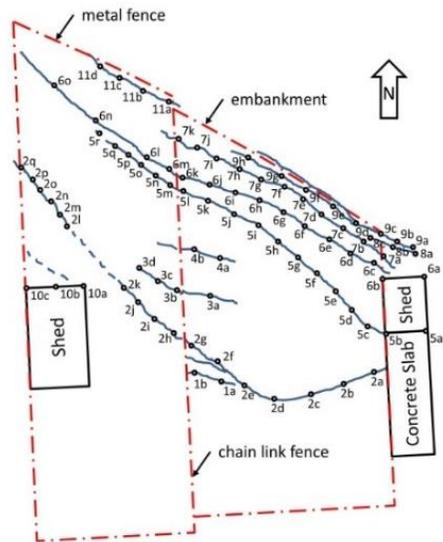
Table 4.1: Horizontal and Vertical (H:V) displacements measured at locations of Figure 4.21.

location	H:V(mm)	location	H:V(mm)	location	H:V(mm)	location	H:V(mm)	location	H:V(mm)												
1a	100:10	2a	10:0	3a	40:0	4a	50:0	5a	130:0	6a	100:20	7a	0:0	8a	0:0	9a	220:0	10a	80:50	11a	400:130
1b	50:50	2b	140:4	3b	60:70	4b	60:0	5b	180:0	6b	130:0	7b	160:0	8b	250:0	9b	120:0	10b	30:60	11b	350:160

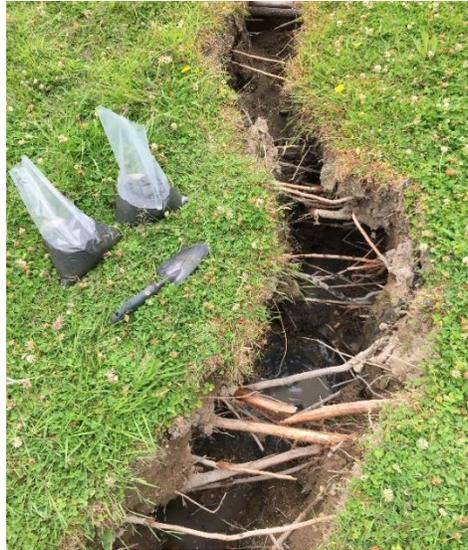
The lateral spreading/slumping cracks in the area was oriented approximately parallel to the riverbanks on either side of the apex of the inner bank of the meander bend. Cracking orientated perpendicular to the river bank occurred at the apex of the meander bend. A summary of the lateral and horizontal displacement across the cracks is presented in Figure 4.22, with up to 50 cm of horizontal displacement and 10 cm of vertical displacement recorded. Cracks were up to 1 m in depth. Near the edge of the river the lateral spreading cracks extended to the water table and were filled with blueish grey fine-medium ejecta. A significant number of roots crossed through the cracks that were oriented perpendicular to the river and may have acted to reduce the severity of the cracking in this area (Figure 4.23).

Figure 4.23: Crack at Elizabeth Street perpendicular to river filled with bluish-grey ejecta and intersected with roots (7 Dec 2016, S41.5088, E173.9635, facing E).

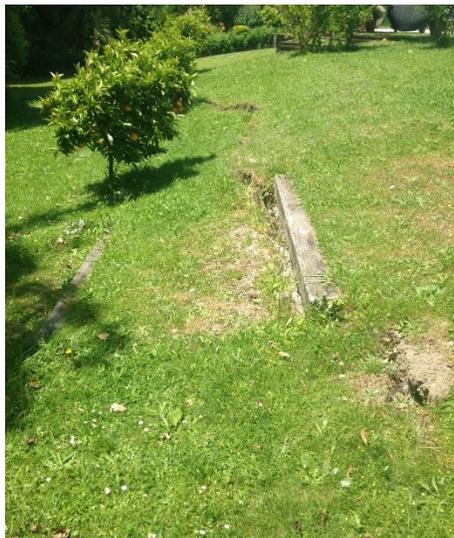
Between the Lansdowne Park area and Park Terrace, Location 6 in Figure 4.5 was the only other site along the Opaoa River with evidence of liquefaction-related damage. This site was on the inner bank of a meander bend in the river and only experienced minor lateral spreading that had no impact on nearby structures (Figure 4.26).

Figure 4.26: Minor lateral spreading adjacent to the Opaoa River (6 Dec 2016, S41.5046, E173.9633, facing E).

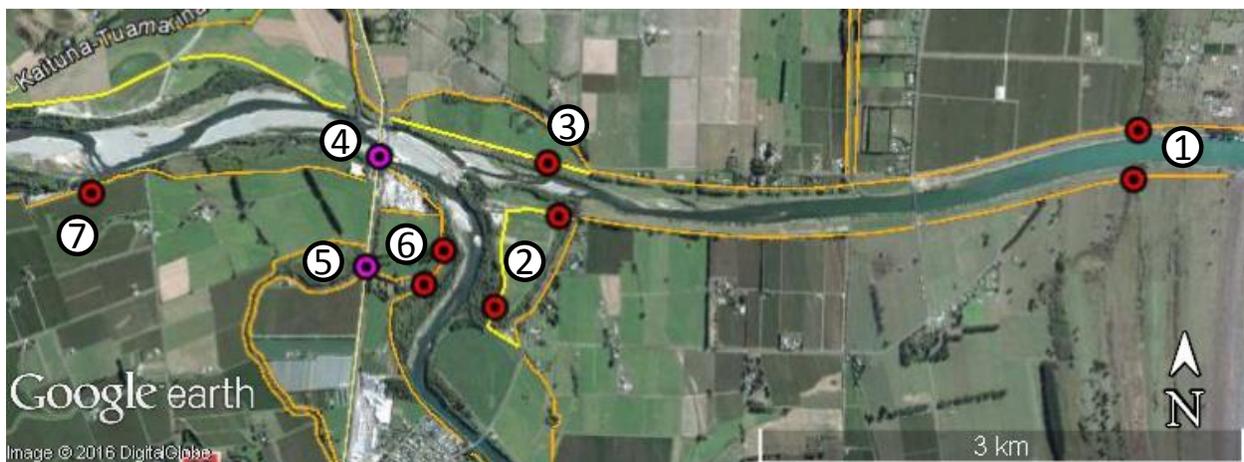
Figure 4.29: Map of liquefaction related damage in the northern Wairau River and Wairau Diversion area. Orange are the main stopbanks, and yellow are the secondary stopbanks. (approx. centre of image: S41.4484, E173.9831)

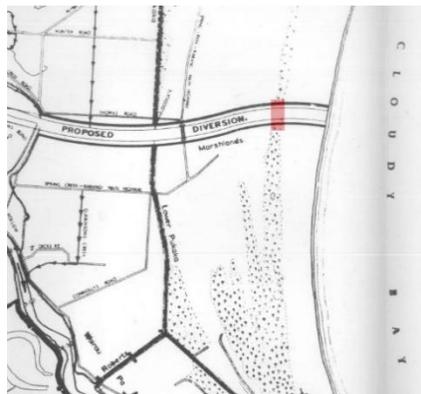
Figure 4.31: Historical drawing of Wairau Diversion. The dotted regions indicate locations of swamps, with the location of failed stopbank highlighted in red (approx. centre of image: S41.4401, E174.0206, Marlborough Catchment Board, 1959)

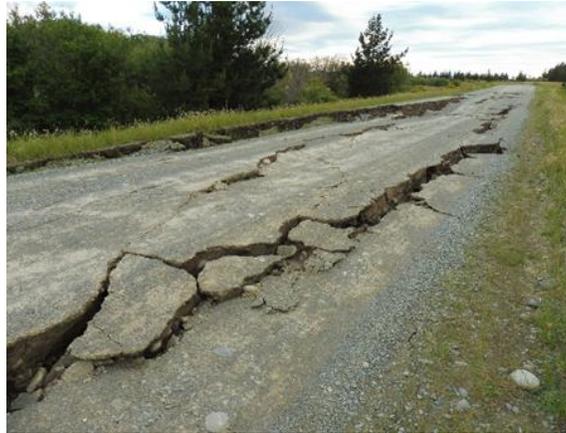
Lateral spreading and slumping of the northern stopbank was characterised by cracking along the top of the stopbank (Figure 4.32). The cracks ranged in width from approximately 30 to 50 cm and were associated with 10 to 50 cm of vertical settlement (Figure 4.33). The cracks all ran sub-parallel to the closest bank of the river. Localized cracking, approximately 2 to 10 cm wide, was observed at the base of stopbank proximal to the river (Figure 4.34a). No liquefaction ejecta were observed at the site, and no liquefaction induced damage was observed proximal to a culvert exiting the stopbank at the easternmost extent of the affected area (Figure 4.34b).

Figure 4.32: Lateral spreading induced cracking along top of northern stopbank (17 Nov 2016, S41.4387, E174.0214, facing E).

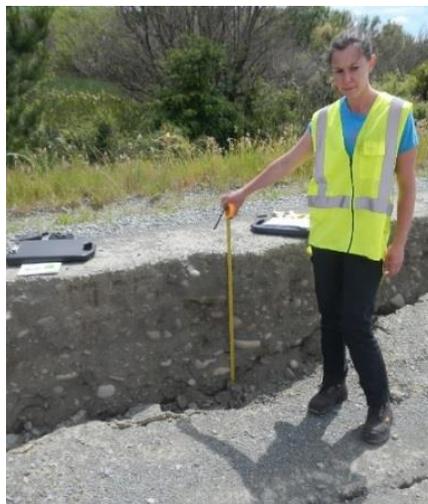
Figure 4.33: Maximum vertical settlements of 50 cm were observed along the cracks in the northern stopbank (17 Nov 2016, S41.4386, E174.0216, facing N)

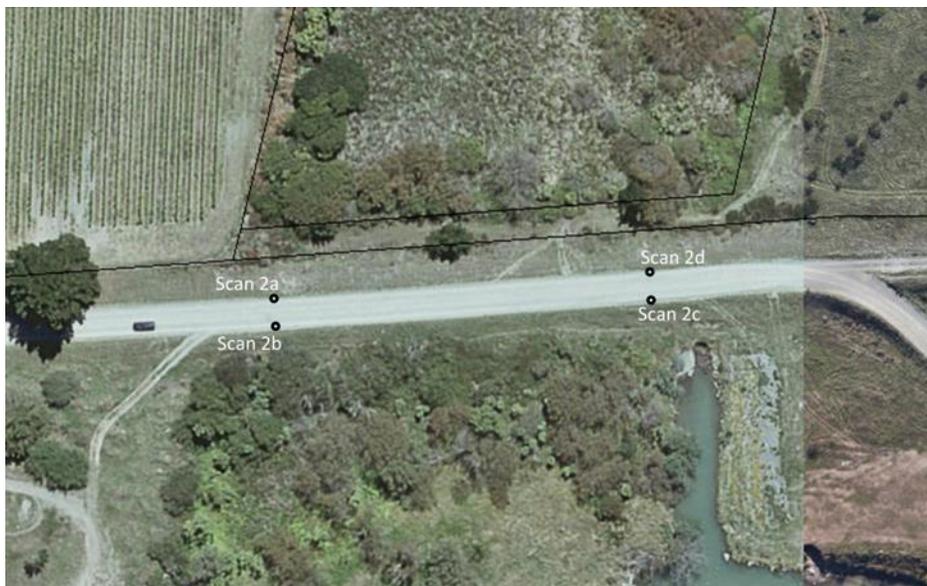
This site was scanned using a terrestrial LiDAR scanner (Optech, Inc. ILRIS-3D laser scanner) on 6 December 2016. Four scans were performed from the approximate locations shown in Figure 4.35. The data from the scans are still being processed, but will result in a three-dimensional point cloud that will allow cm-scale determination of horizontal and vertical displacements of the stopbank due to lateral spreading or slumping.

Figure 4.35: Approximate locations of four LiDAR scans performed on 6 Dec 2016 (approx. centre of image: S41.4387, E174.0218).

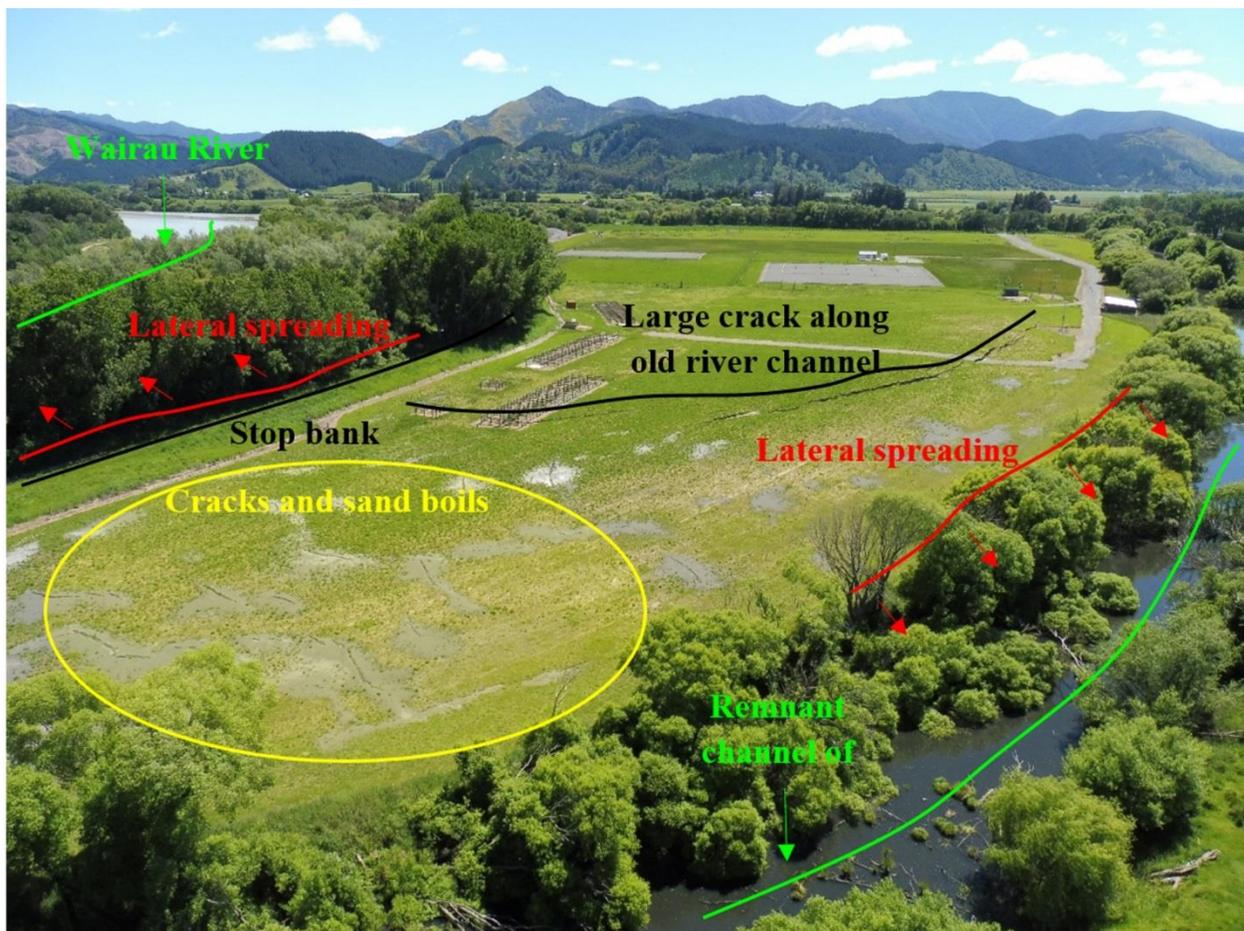
Figure 4.38 provides a detailed summary of the lateral spreading and liquefaction features across the park, and Figure 4.39 provides an aerial overview of the damage, with extensive lateral spreading, differential settlement, deformation of pavement, and extensive sand boils observed at the site. The red lines represent lateral spreading cracks and the blue dots represent sand boils. This detailed map was developed by Davidson Group and the GEER team after the earthquake. The southern part of the park was more affected by the earthquake than the northern part of the park. It is possible, however, that the mapping of some cracks and sand boils in the northern part of the park was obscured by vegetation

Figure 4.39: Aerial view of Marlborough Equestrian Park (14 Nov 2016, S41.4474, E173.9768, facing NE, Marlborough District Council 2016).

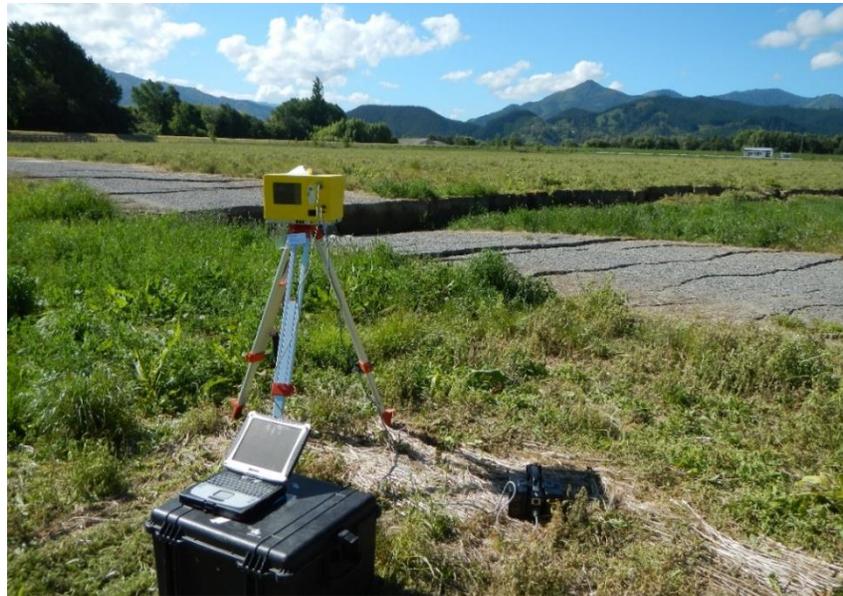
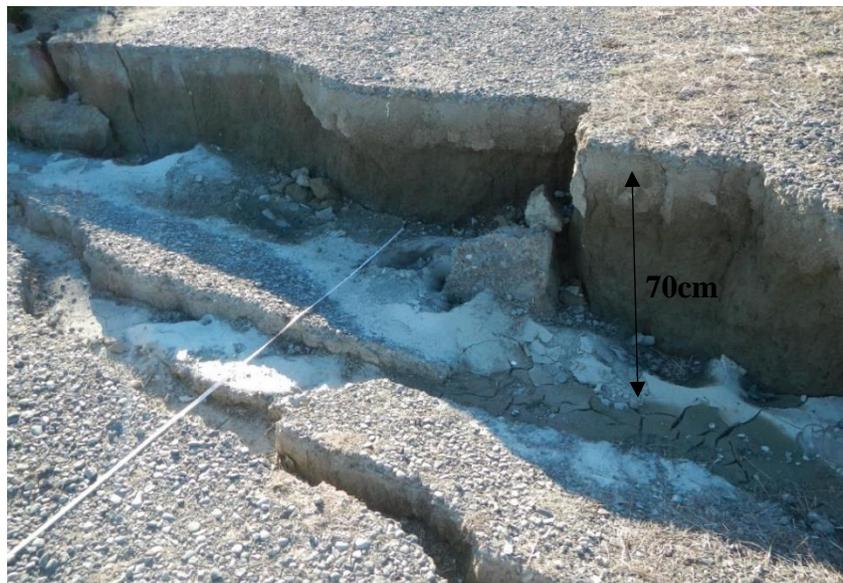
Group B cracks, the most significant crack system in the park, were oriented in the NE-SW direction and were characterized by small to large openings (~10-70 cm) and up to ~70 cm vertical displacement (Figure 4.41a). In this area there was settlement of the ground surface within the infilled historic channel, with the largest cracks aligning with the northern bank of the historic channel (Figure 4.38). Cracking propagated out from this main crack in both directions, with the cracking related to the slumping more than to significant global lateral movement (Figure 4.41b). The cracks in this area were filled with grey ejecta. Further evidence that this cracking followed the infilled historic channel is the coincidence of this cracking with the strip of lush vegetation shown in Figure 4.42.

Figure 4.41: Most severe lateral spreading at the Equestrian Park with 70 cm of vertical offset, with ejecta in the crack: (a) facing NE (b) facing NW (5 Dec 2016, S41.4474, E173.9760).

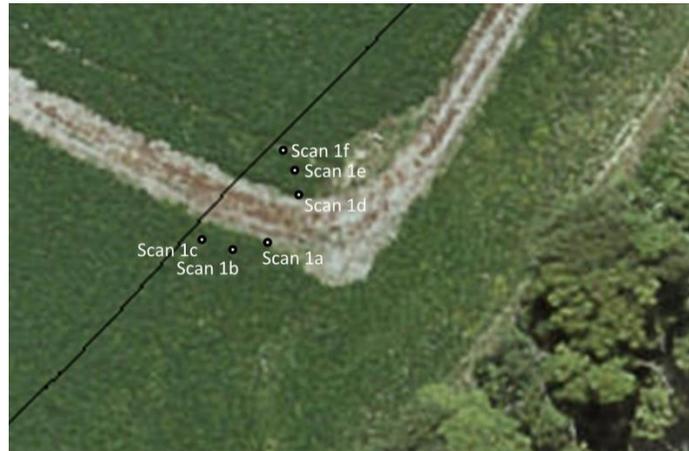
The portion of the Group B lateral spread cracks that crossed the dirt access road to the Equestrian Park was scanned using a terrestrial LiDAR scanner (Optech, Inc. ILRIS-3D laser scanner) on 5 Dec 2016. Six scans were performed from the approximate locations shown in Figure 4.43. The data from the scans are still being processed. They will produce a three-dimensional point cloud that will allow cm-scale determination of horizontal and vertical displacements of the lateral spreading features.

Figure 4.43: Approximate locations of six LiDAR scans performed on 5 Dec 2016 (The black line is the approximate location of the largest lateral spread crack; approx. centre of image: S41.4477, E173.9760).

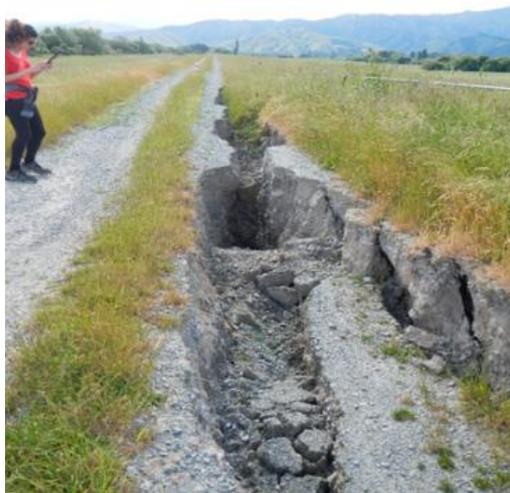
An aerial view of the stopbank damage is presented in Figure 4.48. Cracks up to 1 m wide and 1 m deep developed along the stopbank (Figure 4.49), suggesting the development of slumping and horizontal displacements away from the major axis of the stopbanks in the north and south directions (Figure 4.47). Sand boils were observed on the foundation soils surrounding the stopbank closer to the river's edge and on the northern side of the stopbank within the paleo-channel (Figure 4.50). Slumping of the stopbank was also observed where Blind Creek flows underneath the stopbank through a culvert.

Figure 4.49: Damage to the secondary stopbank at Blind Creek (5 Dec 2016, S41.4407, E173.9791, facing W).

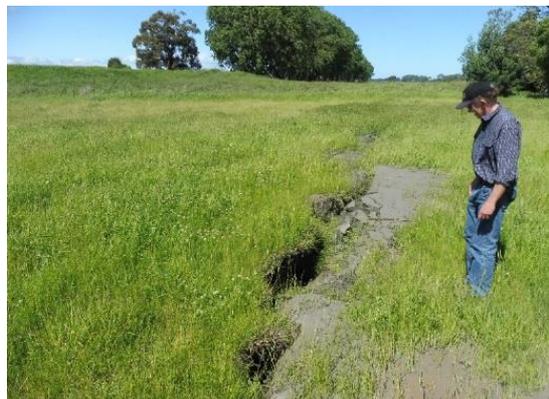
Figure 4.50: Cracks and ejecta on the foundation soil between the secondary stopbank and the river (5 Dec 2016, S41.440967, E173.980122, facing NE).

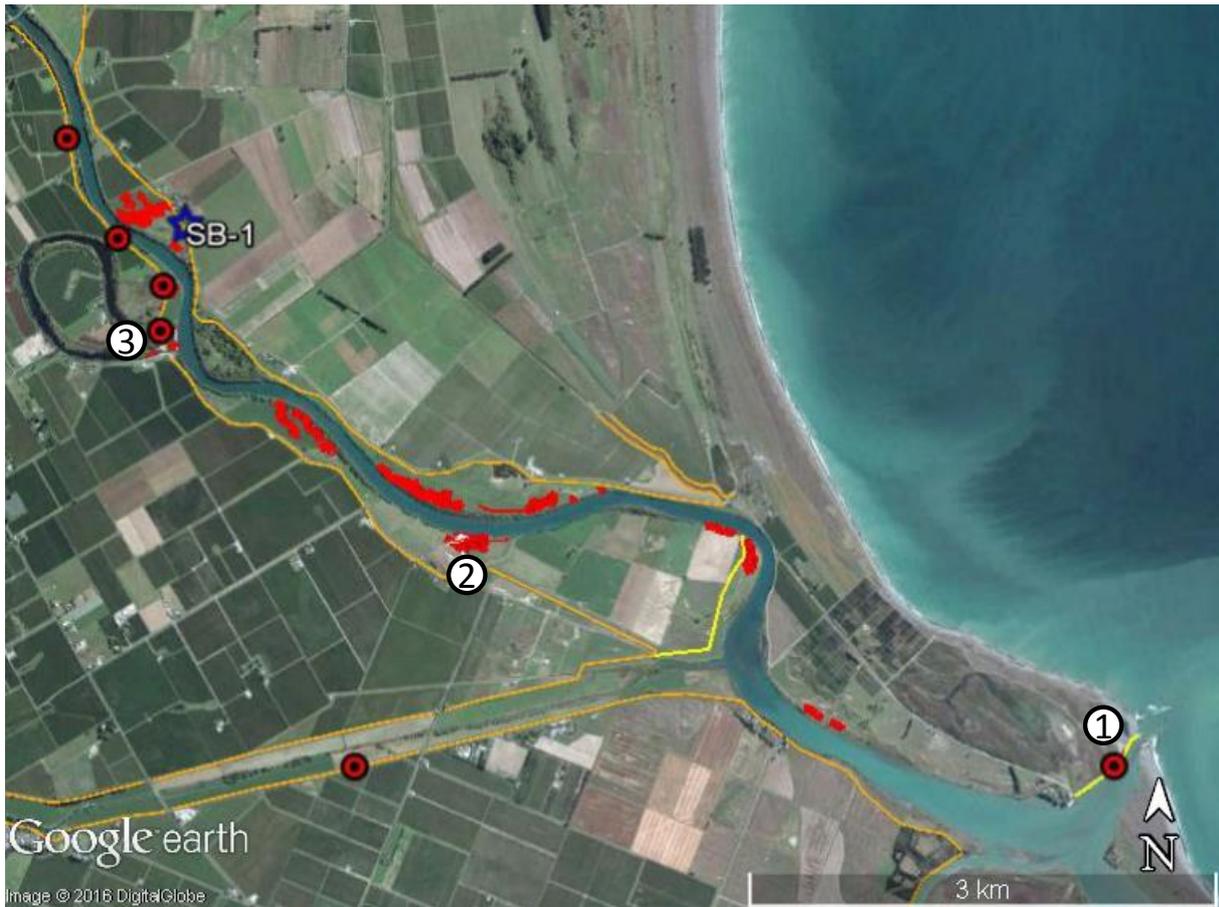
Figure 4.51: Aerial overview of the reconnaissance along the Lower Wairau River. Locations with detailed investigations are identified numerically, and locations where samples have been collected from are shown by blue stars. (Approx. centre of image: S41.4871, E174.0127).

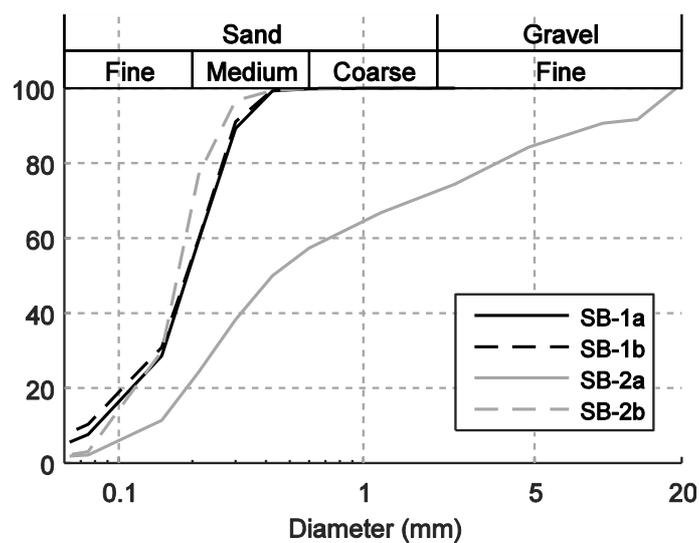
Figure 4.52: Particle size distributions of ejecta samples from the stopbanks along the Wairau River. Locations of these samples summarised in Figure 4.51.

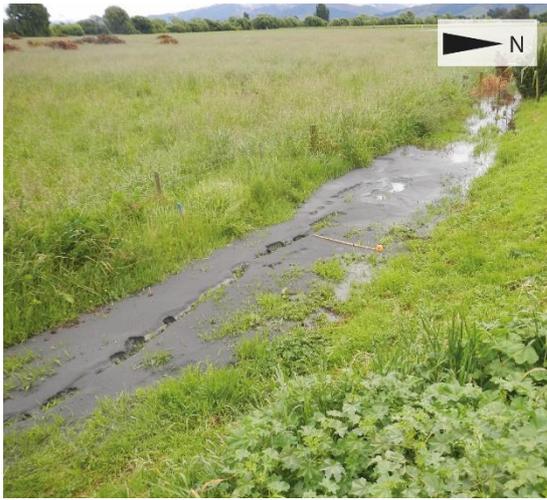
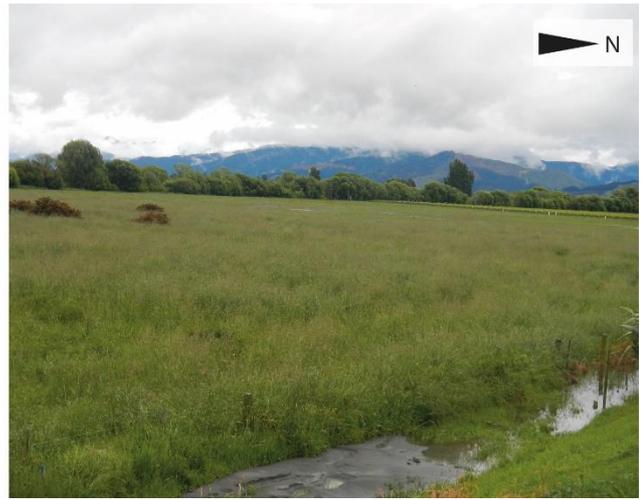
A localized elliptical liquefaction ejecta feature, measuring approximately 8 m in length and 2 m in diameter, was observed in a ditch along the southern margin of the stopbank at 188 Wairau Bar Road (Figure 4.57a, location 2 in Figure 4.53). The feature was composed of grey fine sand which was still wet during the reconnaissance visit on 17 Nov 2016, and was associated with standing water in the ditch. Elliptical liquefaction ejecta features of similar dimensions were observed scattered throughout the adjacent farmland and were orientated sub-parallel with the river in this location (Figure 4.57b). The river bank was not surveyed at this location, but a neighbouring land owner indicated that lateral spreading induced cracking occurred within 10 m of the river bank, while localized ejecta were present at distances >10 m.

Figure 4.57: a) Liquefaction feature in ditch next to the stopbank at 188 Wairau Bar Road. b) Evidence of similar liquefaction features in adjacent farmland, between the stopbank and the river bank (both S41.468902, E173.986465, facing W).

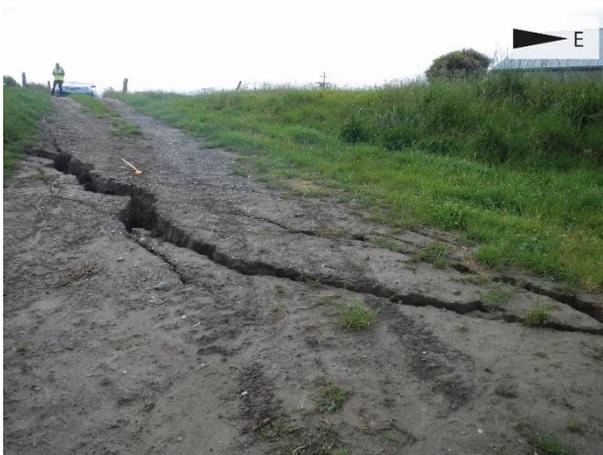
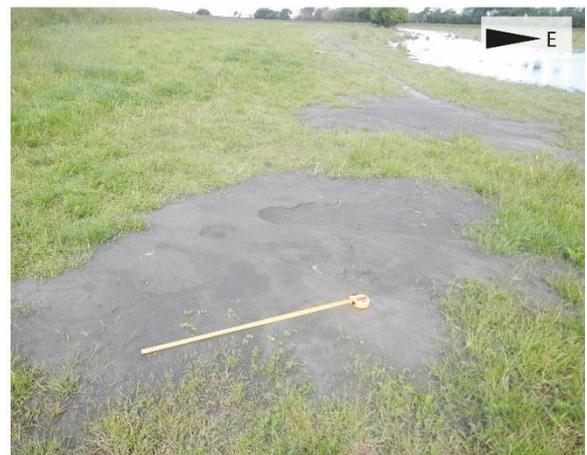
Localized cracking was also observed along the southern margin of the stopbank in the farmland opposite 515 Wairau Bar Road (Location 3 in Figure 4.53). The cracks were confined to the stopbank and range from 10 to 20 m in length and approximately 20 to 50 cm in width (Figure 4.58a). No liquefaction ejecta were observed associated with these cracks.

A series of localized elliptical liquefaction ejecta features were observed within the farmland extending from the base of the stopbank to the river bank (Figure 4.58b). The features range in length from 5 to 7 m and 1 to 2 m in diameter, and are uniformly composed of grey, fine sand. The river bank was not surveyed at this location; however, it is assumed that localized lateral spreading occurred within 10 m of the river bank.

Figure 4.58: a) Cracks within the southern side of the stop bank opposite 515 Wairau Bar Road. Features ranged in width from 20 to 50 cm (tape set at 1 m for scale). b) Liquefaction ejecta features within the farmland between the stop bank and river mouth (tape set at 1 m for scale). (17 Nov 2017): (a) S41.4843, E174.0147, facing N; (b) S41.4847, E174.01523, facing N.

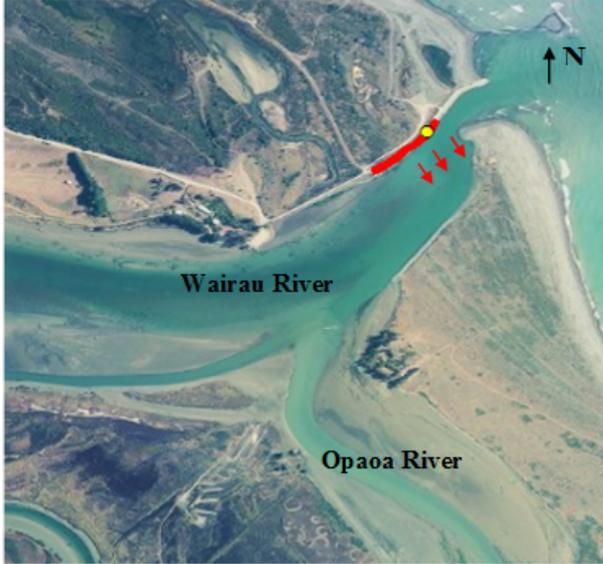
Lateral spreading was observed along Wairau Bar stopbank on the northern bank of the mouth of the Wairau River (Location 1 in Figure 4.51). An overview of the site is presented in Figure 4.59, where cracking was observed along an approximately 100 m long section of the stopbank. Historical aerial photos of the river mouth showed that the damaged section of the stopbank was built on an old river channel that ran parallel to the coast prior to the stopbank construction (Figure 4.60).

Figure 4.59: Top view of stopbank along Wairau River (centre of image S41.502404, E174.058915).

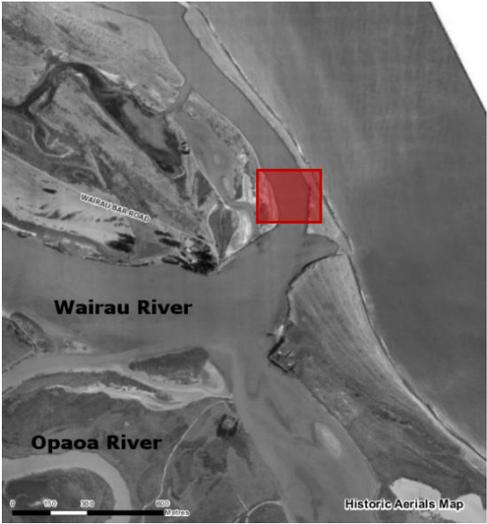
Figure 4.60: Aerial photo of the Wairau river mouth in 1948. In red: location of failed stopbank (centre of image S41.5027, 174.05777, Marlborough District Council 2017).

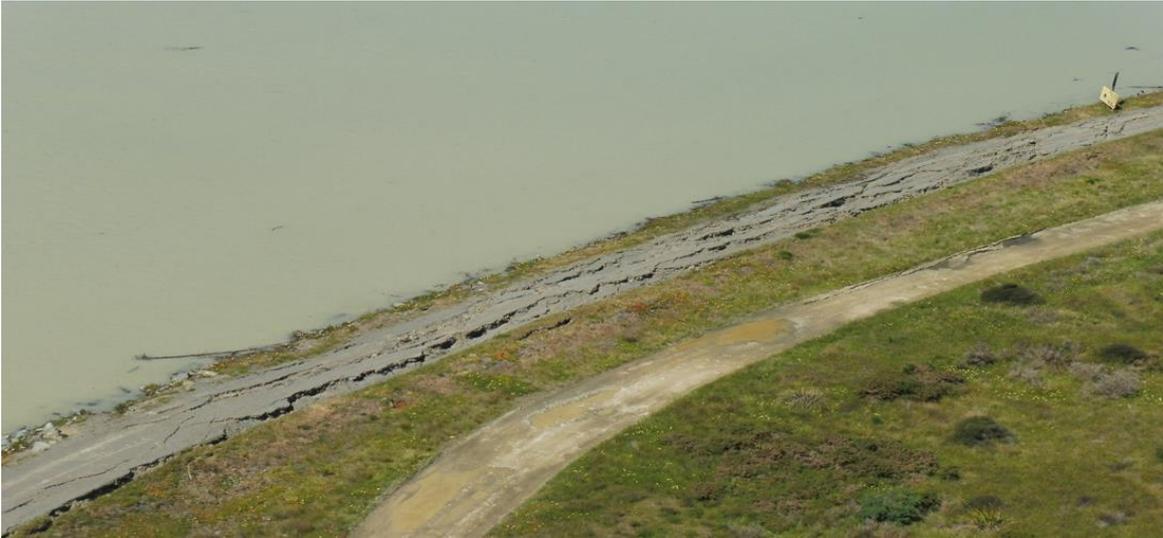
An aerial view of the damage is presented in Figure 4.61. The eastern and western termini of the affected area exhibited cracks that varied in width from approximately 2 to 5 cm and were associated with vertical displacements of 1 to 5 cm. The central affected area exhibited a series of sub-parallel cracks that varied in width from 30 to 50 cm and were associated with vertical settlements of 20 to 120 cm (Figure 4.62 and Figure 4.63). No liquefaction ejecta were observed in the cracks along the stopbank nor in the mudflats exposed within the river channel.

Figure 4.61: Aerial view of left stopbank at Wairau River mouth (18 Nov 2016, S41.5003, E174.0600, facing S, Marlborough District Council 2016).

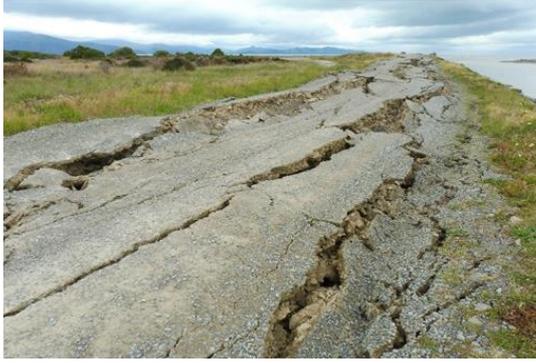
Figure 4.62: Severe cracking of levee (17 Nov 2016, S41.50122, E174.060071, facing E).

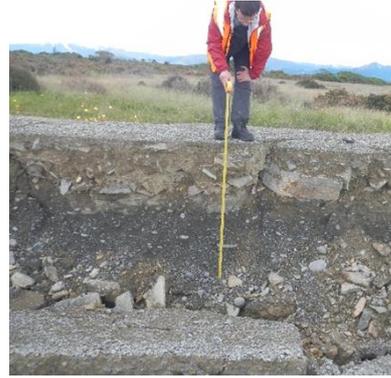
Figure 4.63: Measurement of vertical relative displacement along crack, tape set at 150 cm (17 Nov 2016, S41.5012, E174.0603, facing N).

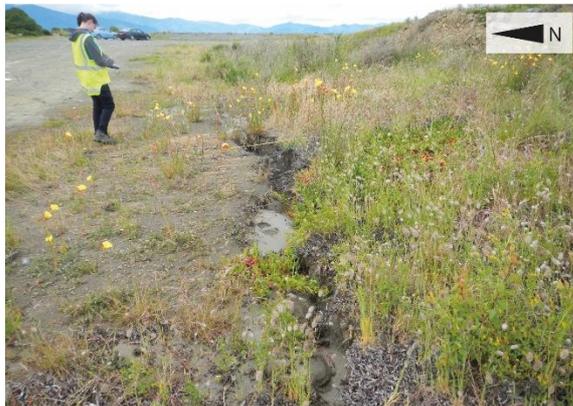
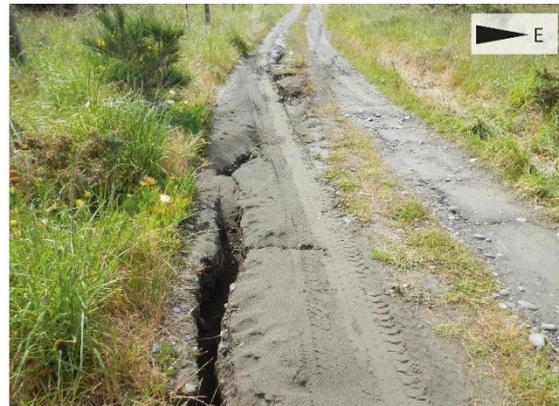
Figure 4.64: a) Cracks, running sub-parallel to the stopbank, with associated liquefaction ejecta along the northern (inland) margin of the stopbank. b) Fissure with associated liquefaction ejecta in a side road; the feature is orientated parallel to an adjacent small stream and perpendicular to the stopbank (17 Nov 2016): (a) S41.5005, E174.0607, facing E; (b) S41.5016, E174.0589, facing N..

A series of lateral spreading cracks were also observed along the inland (northern) margin of the stopbank and extended 15 to 20 m inland (Figure 4.64a). The cracks varied in width from 20 to 40 cm and were surrounded by liquefaction ejecta composed of grey fine sand. The features were observed on the road running along the base of the inland margin of the stopbank and were all orientated parallel with the stopbank.

A lateral spreading crack surrounded by liquefaction ejecta composed of grey fine sand was observed in a side road that runs perpendicular to the stopbank (Figure 4.64b). The feature was located adjacent and sub-parallel to a small stream that feeds into the Lower Wairau, and perpendicular to the cracking observed within the stopbank.

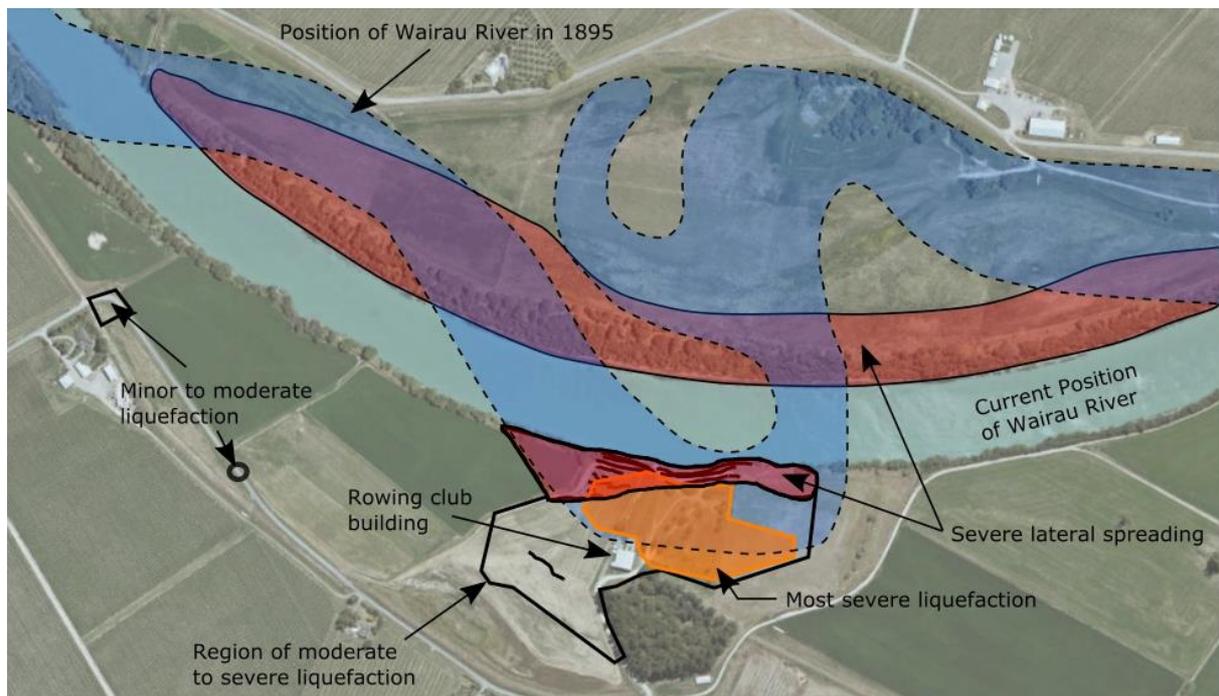
The Blenheim Rowing Club (BRC) is located on the western bank of the Wairau River, and severe liquefaction manifestations and lateral spreading occurred in the area (Location 2 in Figure 4.51). This was the only location in the region where significant liquefaction related damage was present on the outer bend of a river. However, historic maps (Cook, 1895) and property boundaries show that there was an S-bend in the river in this area that was straightened (Figure 4.65). Much of the damage that occurred was confined to the boundaries of the paleo-channel. Figure 4.65 provides a summary of the damage in and around the rowing club, with large areas affected by lateral spreading and significant volumes of ejecta. A sample of ejecta was taken north of the main clubhouse building, and the particle size distribution is presented in Figure 4.66.

Figure 4.65: Summary of observations at Blenheim Rowing Club (approx. centre of image: S41.4860, E174.0105, Basemap: Marlborough District Council, 2017)

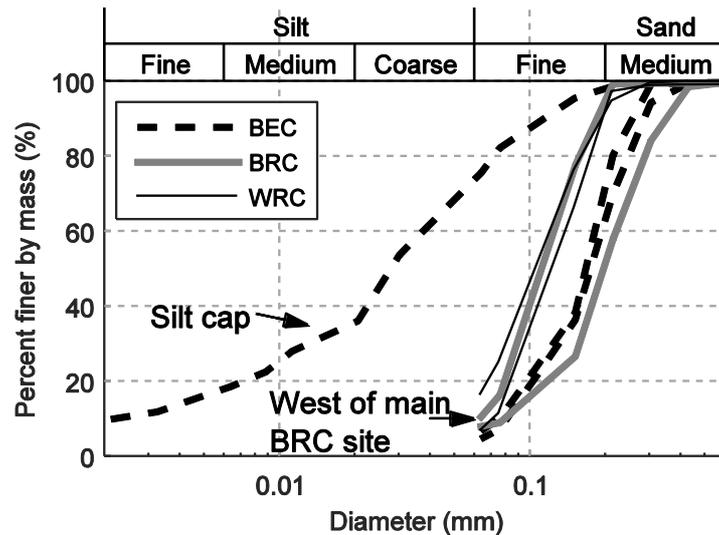
Figure 4.66: Particle size distributions of ejecta samples from along the Wairau River. (BEC=Equestrian Club (S41.4476, E173.9761), BRC=Blenheim Rowing Club (S41.4882, E174.0088), and WRC=Wairau Rowing Club (S41.5003, E174.0600)).

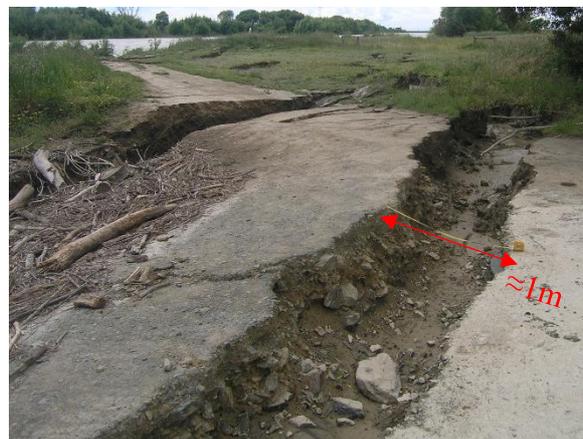
Numerous lateral spreading cracks were observed at this site and varied in width from approximately 10 cm (at distances of approximately 60 m from the river) to over 1 m at locations close to the river channel (Figure 4.69 and Figure 4.70). Transects of the cumulative crack widths at this site summarized in Figure 4.71 and Table 4.2 show that lateral spreading displacements of the order 2-5 m accumulated over a horizontal distance of approximately 60 m from the river.

Figure 4.69: Lateral spreading at the east end of the rowing club site. Note: measuring tape set to 1m. (17 Nov 2016, S41.4882, E174.0105, facing E).

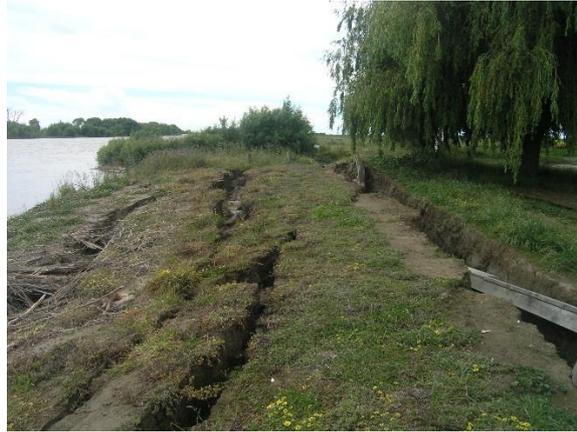
Figure 4.70: Lateral spreading at the west end of the rowing club site. (17 Nov 2016, S41.4881, E174.0101, facing E).

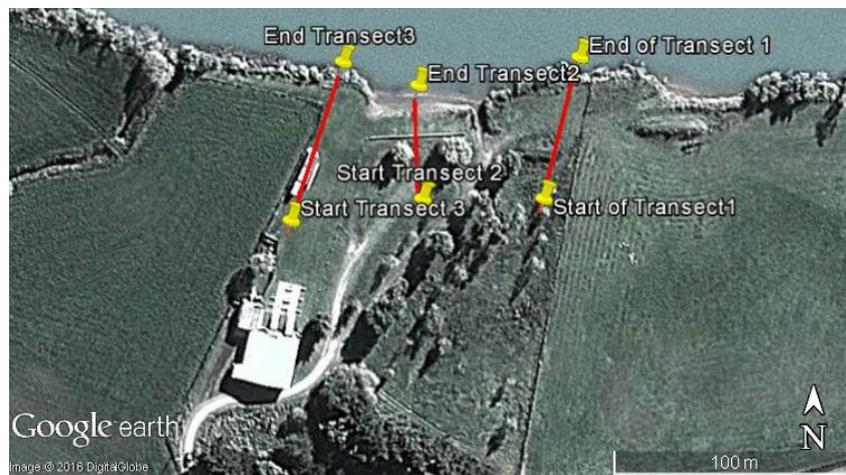
Figure 4.71: Transects where cumulative crack widths were measured to estimate lateral spreading displacements. (Approx. centre of image: S41.4886, E174.0102, Imagery from GoogleEarth).

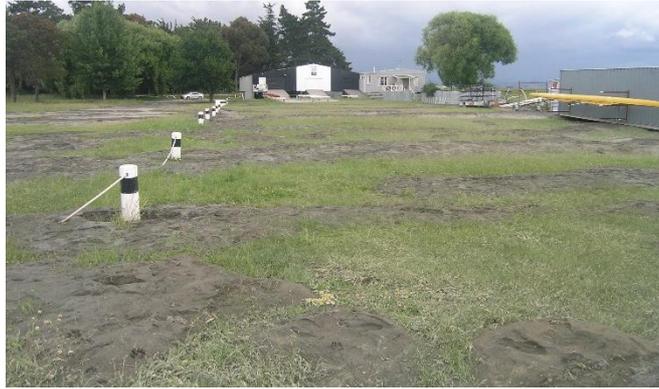
Figure 4.72: View close to river looking back towards clubhouse. Lines of ejecta are associated with lateral spreading cracks. (17 Nov 2016, S41.4881, E174.0099, facing W).

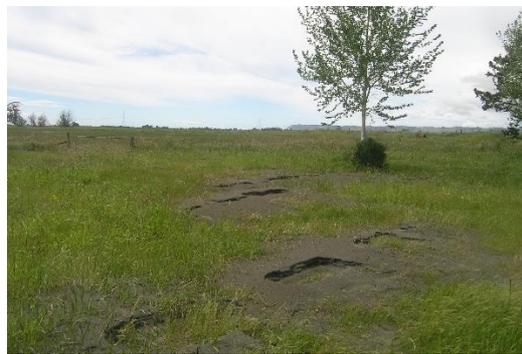
Figure 4.73: Liquefaction ejecta located 90 m east of clubhouse. (17 Nov 2016, S41.4890, E174.0105, facing E).

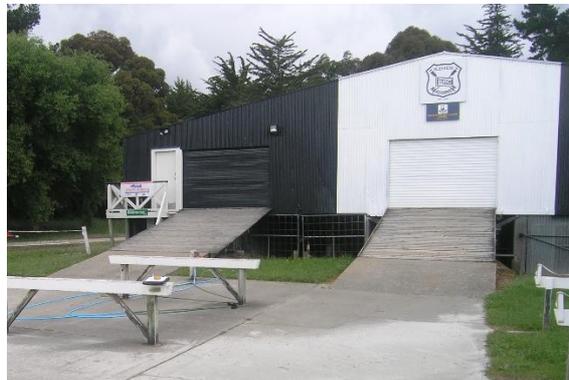
Figure 4.74: View of Blenheim rowing clubhouse from the north (17 Nov 2016, S41.4886, E174.0096, facing S).

The clubhouse structure at the site was a light-weight timber framed structure, with a number of timber and concrete piles visible at the rear of the structure (Figure 4.74). While ejecta were observed across large areas around the clubhouse, only minor evidence of liquefaction was observed around the perimeter of the building itself. On the western side of the building, some minor gapping (approximately 2.5 cm) was observed on the North side of a limited number of piles (Figure 4.75).

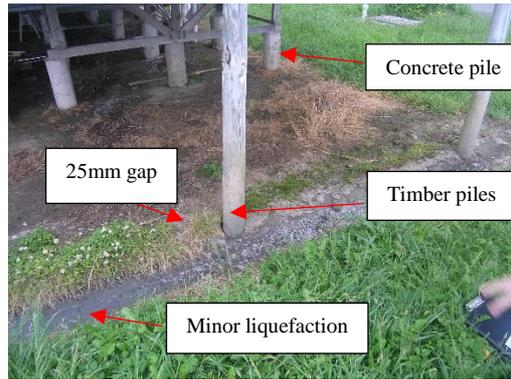
Figure 4.75: Gapping on North side of timber pile (17 Nov 2016, S41.4890, E174.0092).

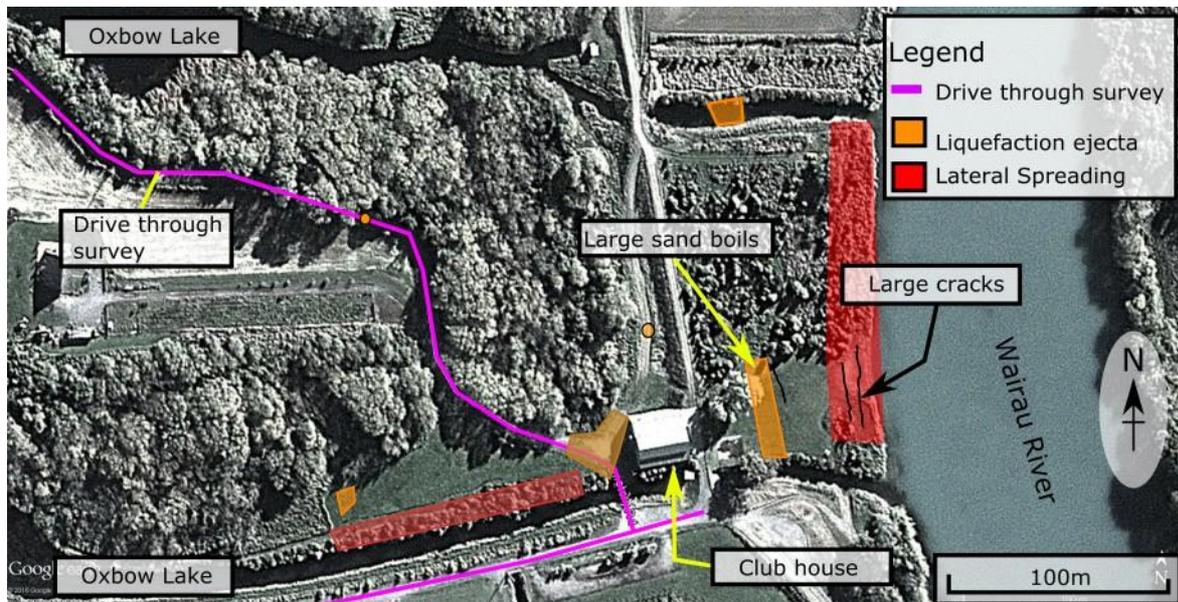
The largest lateral spreading cracks were observed in an area up to 20 m from the riverbanks, with the largest crack width being approximately 2 m. At the northern end of the grassed area to the east of the clubhouse the lateral spreading was associated with a 50 cm vertical settlement. This lateral spreading extended between the two drains linking the Wairau River and the Oxbow lake. Examples of this lateral spreading in the grassed area is shown in Figure 4.78 and near the northern drain in Figure 4.79.

Figure 4.77: Summary of observations at Wairau Rowing Club (approx. centre of image: S41.4762, E173.9843, Imagery from GoogleEarth).

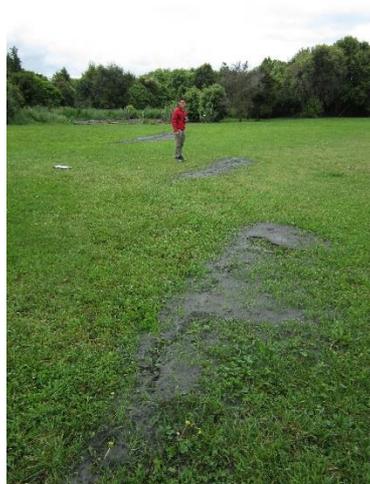
A line of sand boils was located approximately parallel to the river, half way between the embankment and the river bank, and extended into the bushes immediately north of the grassed area (Figure 4.80). A 10 cm wide lateral spreading crack was observed at the northern end of this line of sand boils. A significant volume of ejecta was identified in the drainage channel between the oxbow lake and the Wairau River on the day of the earthquake (Figure 4.81a). The ejecta were quickly removed and stockpiled adjacent to the drain as shown in Figure 4.81b.

Figure 4.80: Sand boils on lawn in front of club house shown as large sand boils in Figure 4.77 (17 Nov 2016, S41.4766, E173.9858, facing N).

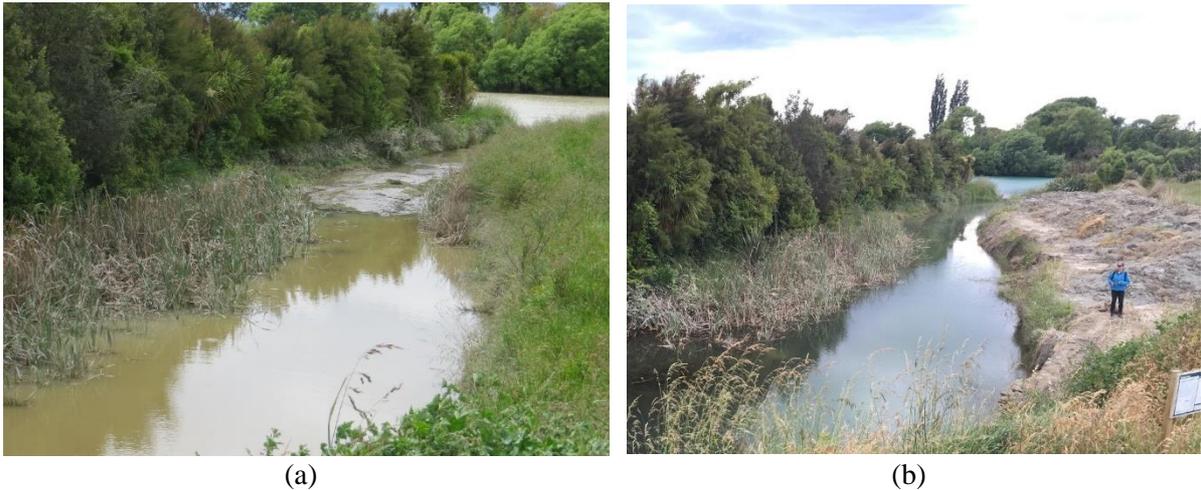
Figure 4.81: a) Ejected sand evident in the drain channel (14 Nov 2016). b) Pile of excavated ejecta from the drain channel (6 Dec 2016, S41.4754, E173.9854, facing E).

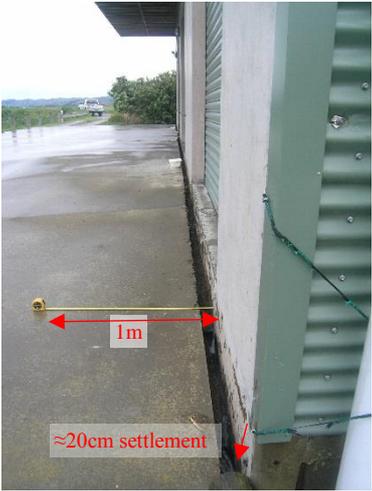
Figure 4.82: Gapping and settlement on eastern side of club house (17 Nov 2016, S41.4766, E173.9855, facing S).

The clubhouse building consists of three vertical levels and four lateral bays. The bottom level is accessible on the western side of building, while an embankment runs along the eastern side of the building with the 2<sup>nd</sup> level of the building opening out onto the top of the embankment. A 10 cm gap between the structure and the surrounding soil was apparent along the northern and eastern sides of the building. On the Eastern side in Figure 4.82, the exterior concrete slab had pulled free of the main clubhouse (attached by straight rebar), while at the north-east corner, the slab had settled 20 cm relative to the building (Figure 4.83).

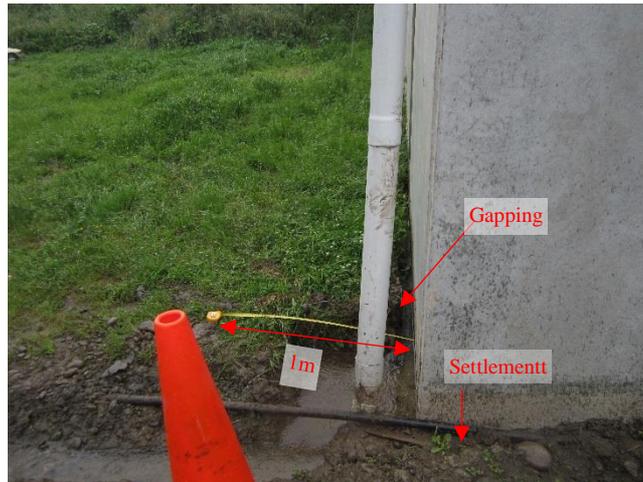
Figure 4.83: Gapping and settlement on northern side of club house (17 Dec 2016, S41.4767, E173.9851, facing E).
