## 4 GEOTECHNICAL ASPECTS ON THE SOUTH ISLAND OF NEW ZEALAND

This chapter identifies locations of liquefaction manifestations and discusses the effects of liquefaction and related phenomena on the South Island of New Zealand resulting from the 2016,  $M_w$ 7.8 Kaikoura earthquake. Detailed observations are recorded to document the occurrence and non-occurrence of liquefaction in areas shaken at different levels of intensity. Strong motion recordings indicate high peak ground accelerations (PGA) occurred in the Waiiau valley of North Canterbury (marked “Area C” in Figure 4.1). Horizontal accelerations at the Waiiau strong motion station (WTMC) were in excess of 1 g and vertical accelerations in excess of 2.7 g. The ground motions were significantly attenuated in the main urban areas of the South Island; the recorded peak ground accelerations were in the range of 0.14 g to 0.27 g in the areas around Blenheim (Area A) and Kaikoura (Area B). A more detailed summary of the ground motion characteristics across the South Island is provided in Chapter 3 of this report.

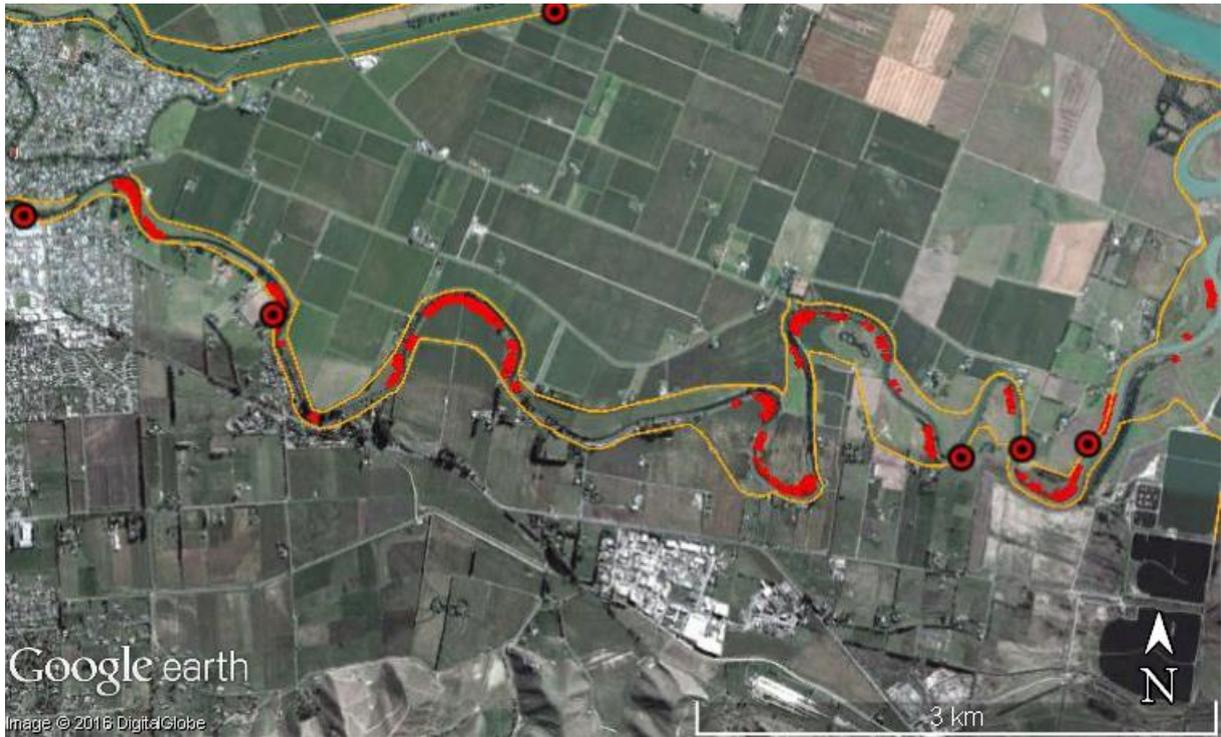
Downstream of the Blenheim urban area there was significant lateral spreading and large volumes of ejecta were observed along the inner banks of the meander bends of the Lower Opaoa River. Figure 4.86 provides a summary of the damage observed from ground and aerial reconnaissance.

There was damage to the stopbank network in four locations along this stretch of the river as shown in Figure 4.86. The main impact was to wineries situated along the river, with large areas of vines affected as indicated in Figure 4.87 and Figure 4.88. Many of these areas were rapidly cleared following the earthquake, and new end-posts were installed to allow the rest of the vines to continue to grow.

Figure 4.86: Summary of damage along the Lower Opaoa River. Red areas indicate locations of cracking and ejecta, with stopbank damage shown by the red symbols in this figure. Orange lines indicate locations of stopbanks. (Approx. centre of image: S41.5219, E174.0076, Imagery from GoogleEarth).

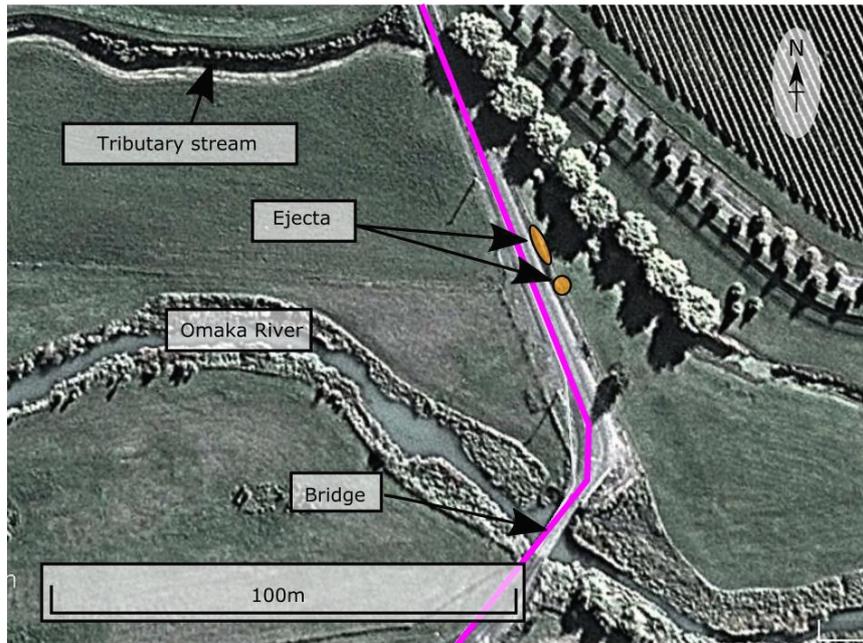
Upstream from the Blenheim urban area (starting at Lansdowne Park) there was evidence of minor liquefaction, but it did not have any significant effect on the built environment. Ejecta were observed at the side of O'Dwyers Road as indicated in Figure 4.89, between 85 and 65 m from the crossing over the Opaoa River. Ejecta closest to the river were brown in colour, while it became grey in color moving away from the river. At this location, a small tributary stream runs parallel to the road, 15 m to the East.

Figure 4.89: Summary of observations at O’Dwyers Road/Thomsons Ford Road bridge (approx. centre of image: S41.4825, E173.9336, Imagery from GoogleEarth).

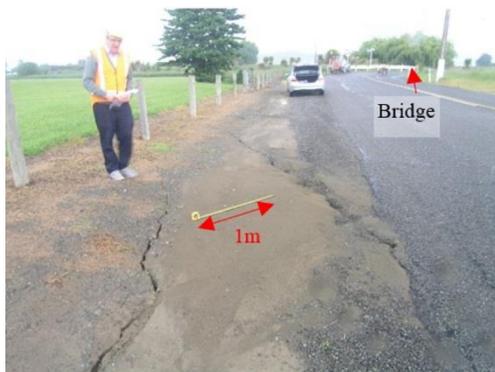
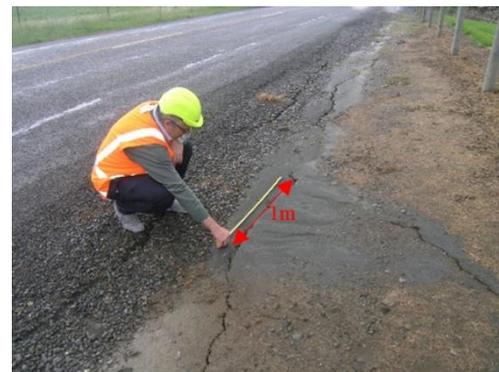
Figure 4.90: Sand boils at O’Dwyers Road. (a) facing SE (b) facing NW (17 Nov 2016, S41.4822, E173.9340).

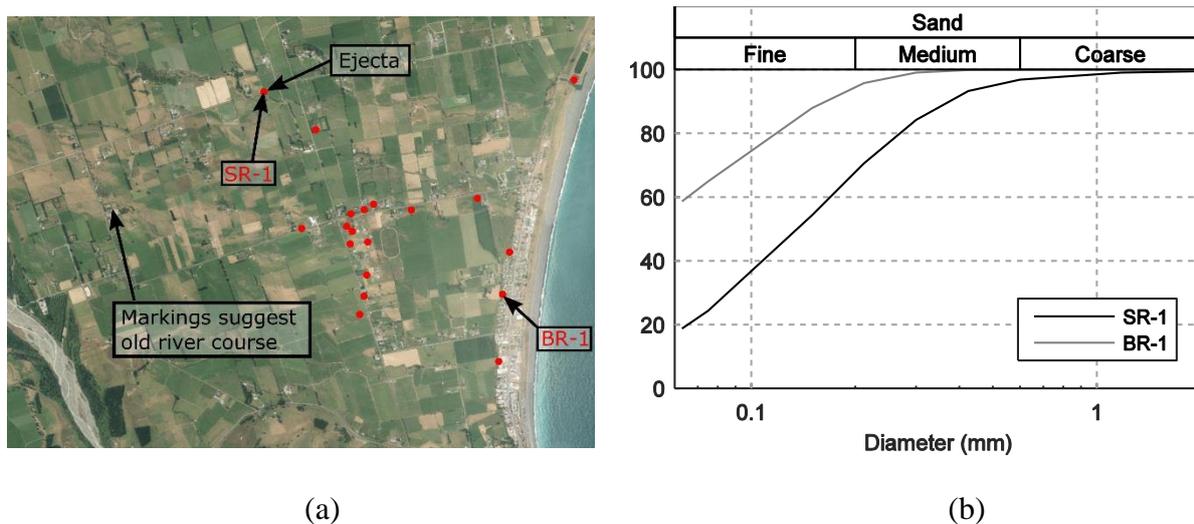
Liquefaction was observed in a limited number of locations in the Kaikoura area, with most located along Mt Fyffe Road and along Lyell Creek which runs parallel to and just west of Beach Rd (shown in Figure 4.). The locations where liquefaction ejecta was observed are shown in Figure 4.92. In each case, the amount of ejecta was considered minor to moderate; examples of the ejecta features observed are shown in Figure 4.93 to Figure 4.98. Surface colouring visible in aerial photography of the area (courtesy LINZ) suggests that these ejecta could be associated with paleo channels of the Kowhai River, which currently reaches the sea to the south of Kaikoura. Samples of ejecta material were recovered from two locations, marked as “SR-1” and “BR-1” in Figure 4.92; the first from a sand boil at the roadside on Schoolhouse Road (Figure 4.93), and the second from an area of intense cracking along Lyell Creek, behind Beach Road (Figure 4.94). Figure 4.93 (b) shows the particle size distributions of these samples, which were obtained by wet sieving. Laboratory testing confirmed that both samples were non-plastic.

Figure 4.92: (a) Locations of observed liquefaction ejecta; SR-1 and BR-1 refer to locations where ejecta samples were obtained (approx. centre of image: S42.375, E173.647). (b) Particle size distribution of the samples SR-1 and BR-1.

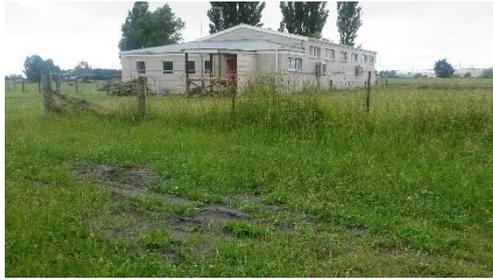
Figure 4.93: Liquefaction ejecta on Schoolhouse Road where sample SR-1 was taken (-9 Dec 2016, S42.3681, E173.6496, facing SE).

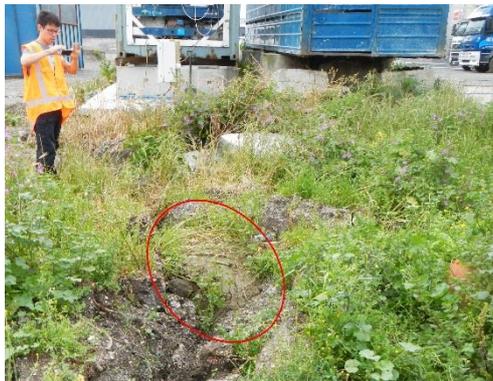
Figure 4.94: Liquefaction ejecta in the bank of Lyell Creek inland of Beach Road where ejecta sample BR-1 was obtained. Note the light colour of the material (-9 Dec 2016, S42.3916, E173.6777, facing E).

Despite the large lateral movements, ejecta were not widespread on the east side of Lyell Creek, with only relatively small sand boils (~50 cm diameter) being observed at a few locations along Beach Road (visible in Figure 4.94).

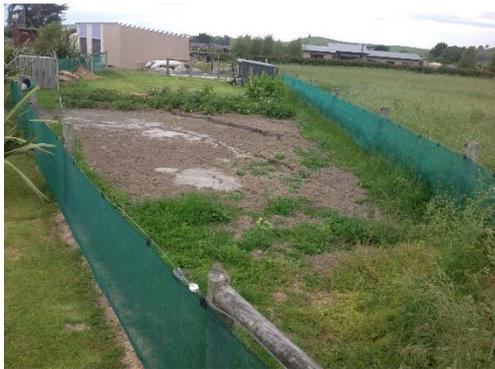
Figure 4.95: Liquefaction in a vegetable patch on Mt Fyffe Road. Note the ejecta issued from ground cracks (-date to be added in V2.0 of report, S42.3813, E173.6622, facing S).

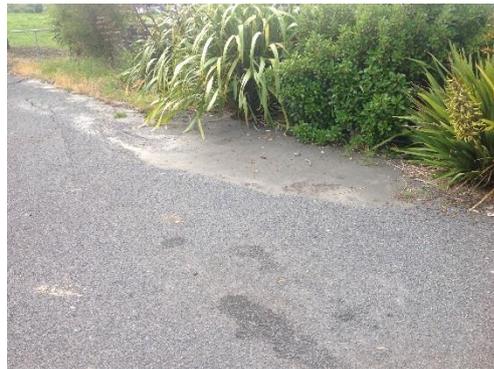
Figure 4.96: Liquefaction in driveway on Mt Fyffe Road (- date to be added in V2.0 of report, S42.3800, E173.6600).

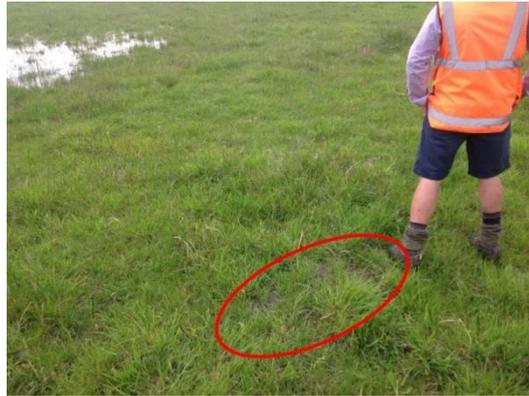
Figure 4.97: Ejecta in the field 50 m west of Mt Fyffe Road (– date to be added in V2.0 of report, S42.3877, E173.6610).

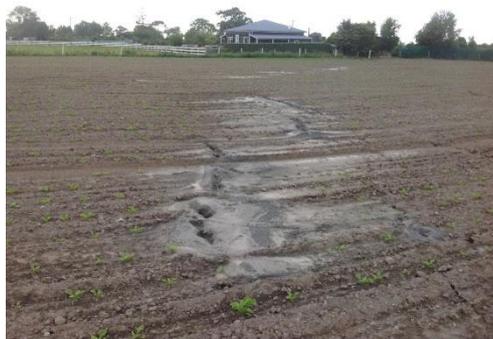
Figure 4.98: Liquefaction ejecta in the field south of Mill Road. Note: the ejecta is concentrated in lines which continue in the background over a total length of 100 m (– date to be added in V2.0 of report, S42.3772, E173.6753, facing SE).

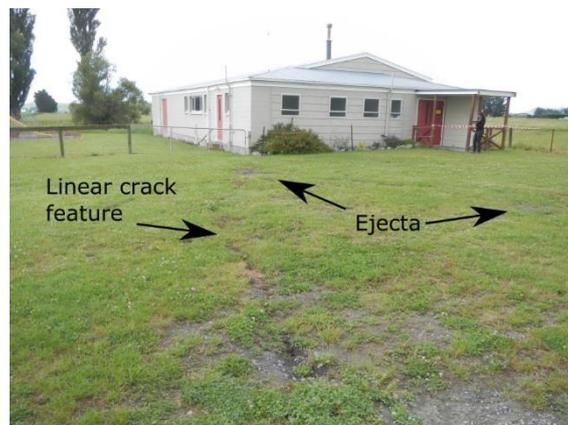
Figure 4.99: Front area of house on Schoolhouse Road (–9 Dec 2016, S42.3680, E173.6500, facing SW).

On Schoolhouse Road north of Mt Fyffe Road (Figure 4.93 and Figure 4.99), a structure had visibly settled, with markings on a wastewater vent pipe suggesting the settlement on the eastern side of the house was approximately 6 cm (Figure 4.100). Misalignment of a drainpipe with its associated drain shown in Figure 4.101 indicates that the house had also moved 10 cm parallel to its major plan axis (SSE) relative to the ground. Additionally, a vertical gap up to 20 cm wide was present on the eastern side of the house. The combined settlement and lateral movement of the house resulted in cracking of the unreinforced block (Figure 4.102). On the front lawn of the structure, a 5 cm ground crack appeared to follow the line of buried services to the road (Figure 4.100).

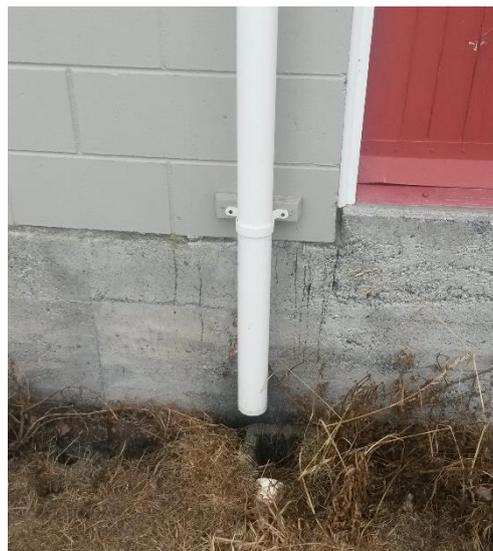
Figure 4.101: Misalignment of drain pipe and drain on east side of house on Schoolhouse Road (-9 Dec 2016, S42.3683, E173.6501).

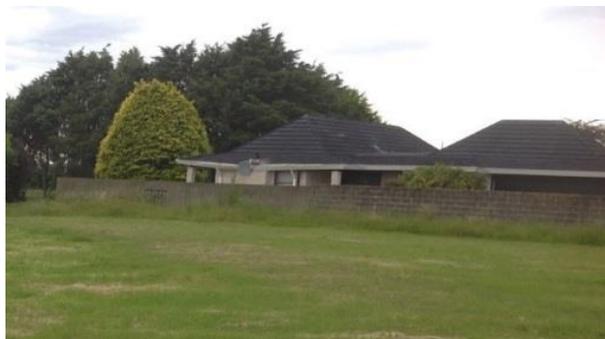
Figure 4.103: Damage caused to house on Mill Road by lateral ground movements (- date to be added in V2.0 of report, S42.3784, E173.6675, facing NE)

A number of sand boils were observed around the intersection of Mt Fyffe and Mill Road, minor to moderate in size. At a house on Mill Road, damage to the structure shown in Figure 4.103 was caused by an outdoor concrete slab displacing laterally to the north relative to the house (Figure 4.104). Also, a newly built house located on Mt Fyffe Road experienced some settlement, and vertical gaps up to 10 cm wide had formed at some places around the perimeter (Figure 4.105). In front of the house, a buried septic tank had floated approximately 30 cm relative to the ground (Figure 4.106). While no obvious ejecta were observed at the house, small sand boils were discovered in the fields approximately 50 m west of the house (Figure 4.97).

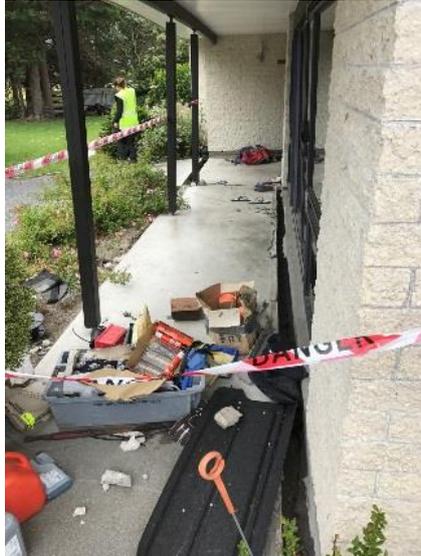
Figure 4.104: Separation of outdoor slab from main foundation slab (date to be added in V2.0 of report, S42.3784, E173.6675, facing E)

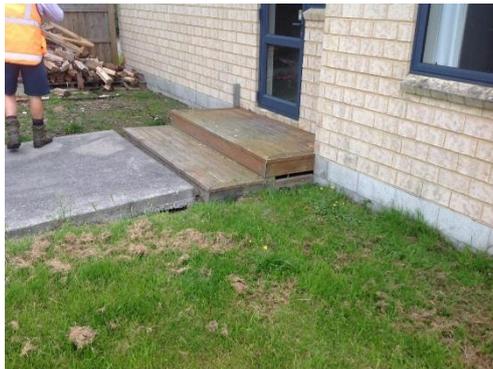
Figure 4.105: Southern side of new house on Mt Fyffe Road (8 Dec 2016, S42.3877, E173.6620, facing W).

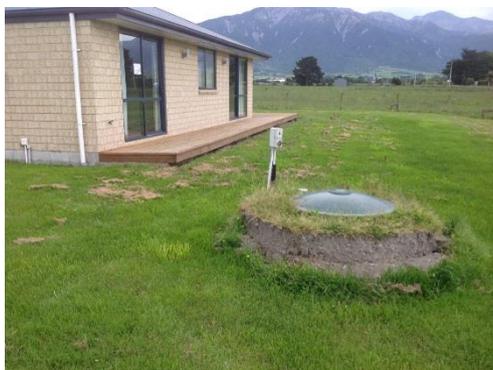
Figure 4.106: Floation of septic tank at SE corner of house on Mt Fyffe Road (8 Dec 2016, S42.3876, E173.6621, facing N).

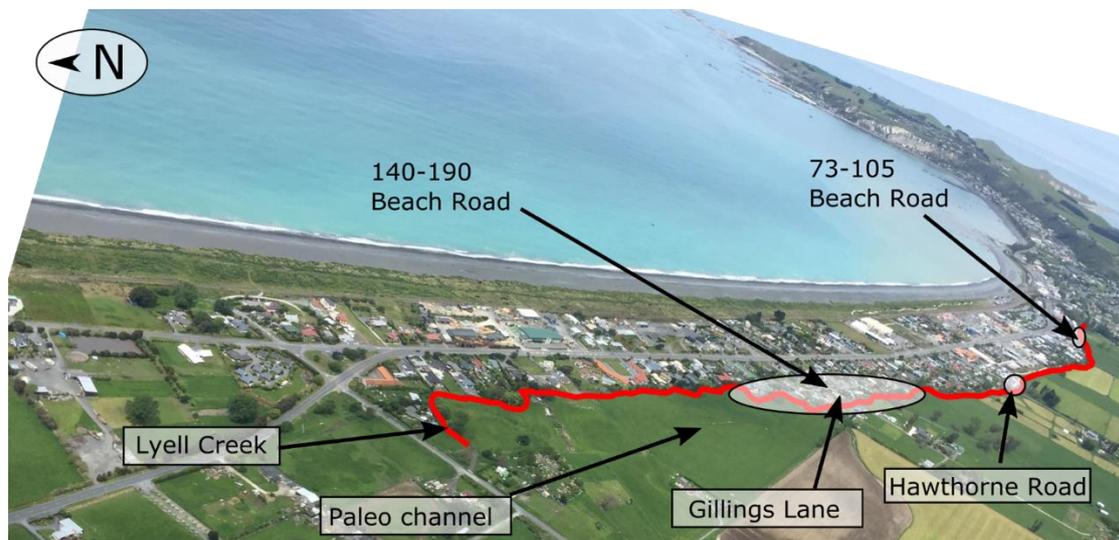
Many instances of lateral ground movement were observed on the banks of the creeks and drainage ditches in the Kaikoura area. The most significant impacts to infrastructure, as well as some of the most severe lateral displacements and/or ground failures, occurred along an ~2 km stretch of Lyell creek which forms the western boundary of the heavily developed region of Kaikoura, as shown in Figure 4.107.

Figure 4.107: Lyell Creek and locations of photographs of interest (for reference the coordinates of 4 Gillings Ln are S42.3841, E173.6786).

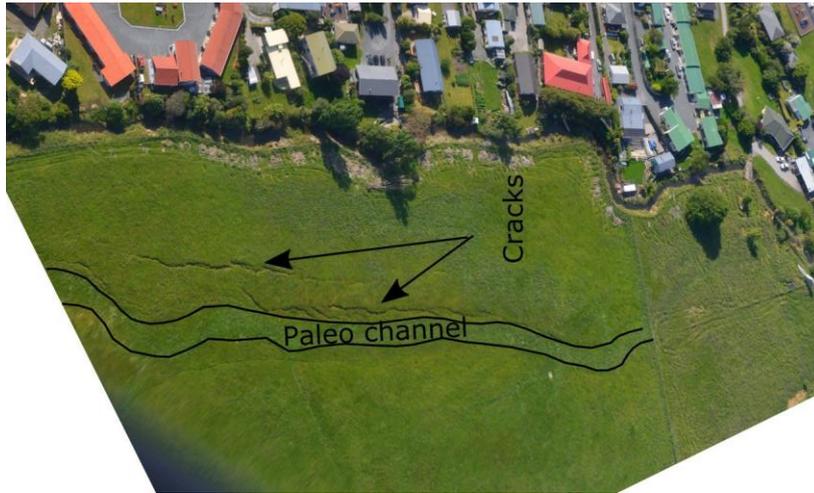
Figure 4.108: Lateral displacement associated with a paleo channel (approx. centre of image: S42.3808, E173.6787).

No foot surveys were carried out on the western side of the creek; however, some cracks were visible from the eastern bank and in aerial photographs. Figure 4.108 shows a pair of large lateral spreading cracks which were spotted during a helicopter flight. These cracks are approximately 50 m west of Lyell Creek, significantly further than the majority of other cracks. Inspection of aerial photographs indicates that these cracks are likely to be associated with the paleo channel marked in Figure 4.107.

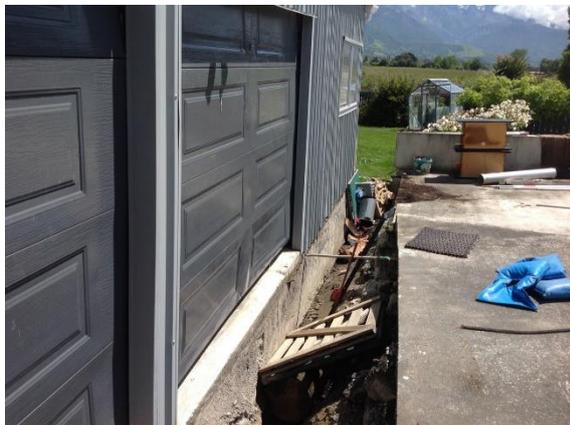
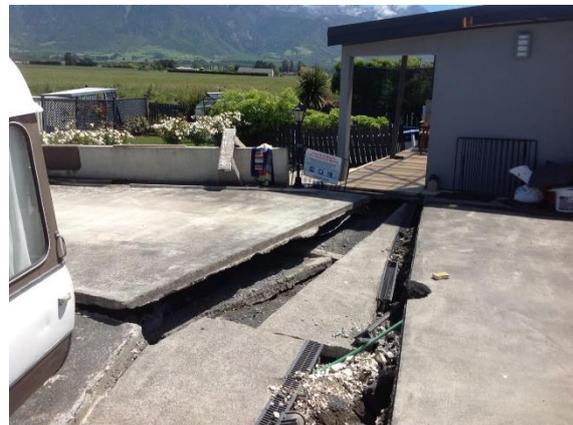
Figure 4.109: Separation of concrete slabs and garage (70 cm wide) due to lateral ground movements towards Lyell Creek (date to be added in V2.0 of report,): (a) S42.3822, E173.6801; (b) S42.3821, E173.6802. Note the garage has moved laterally in the picture (i.e. Lyell Creek is behind the garage, to the left of the picture).

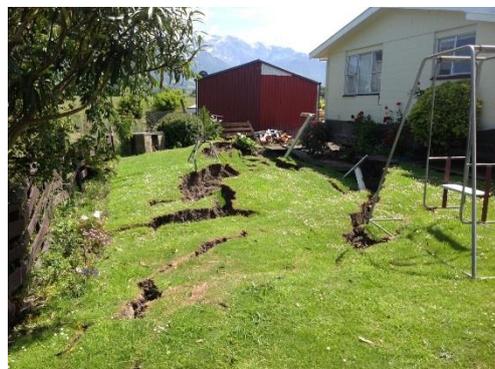
Figure 4.110: Lateral displacements (approx. 1.5 m in total) caused a loss of support at the NW corner of a house on Beach Road, causing cracking in the brick wall (date to be added in V2.0 of report, S42.3823, E173.6800).

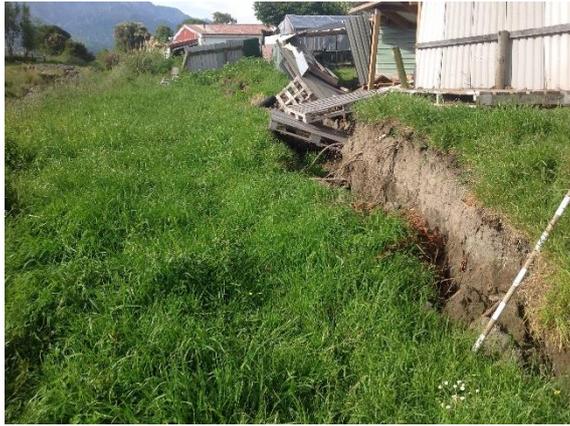
Figure 4.111: Large vertical offset (50 cm) associated with the ground movement north of Gillings Lane (– date to be added in V2.0 of report, S42.3841, E173.6784).

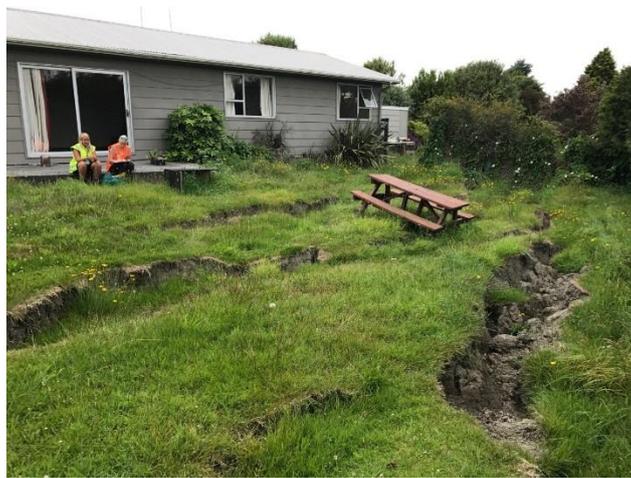
Figure 4.112: Lateral displacements with large vertical offsets at Gillings Lane (– date to be added in V2.0 of report, S42.3841, E173.6784).

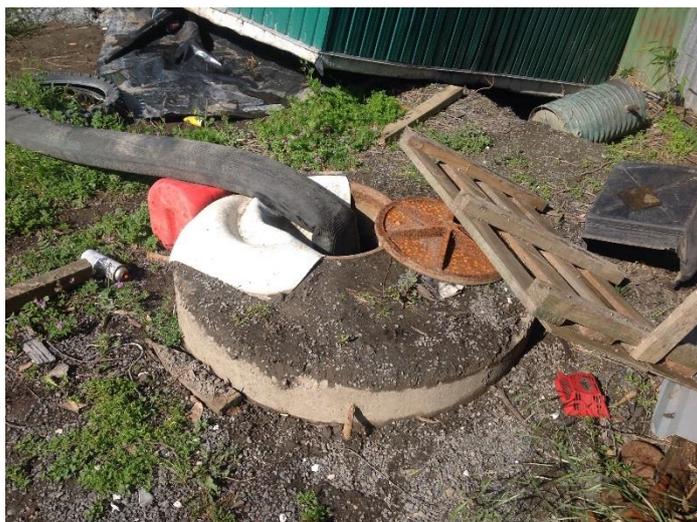
Figure 4.113: Floatation of manhole on Beach Road near to Lyell Creek (– date to be added in V2.0 of report, S42.3848, E173.6783).

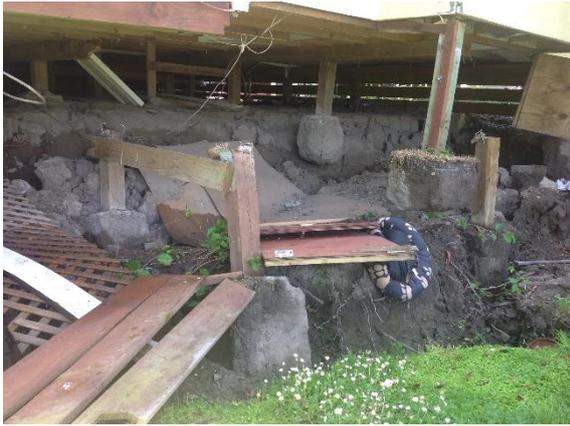
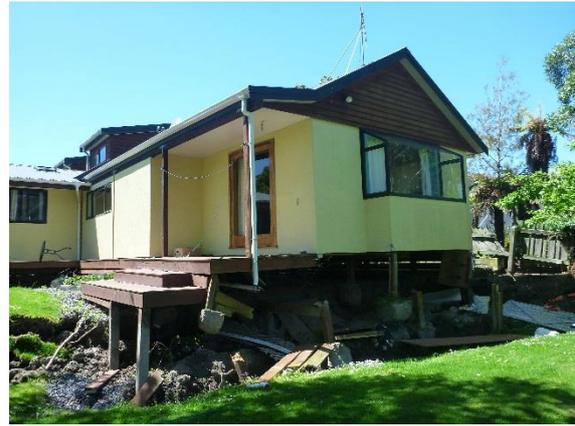
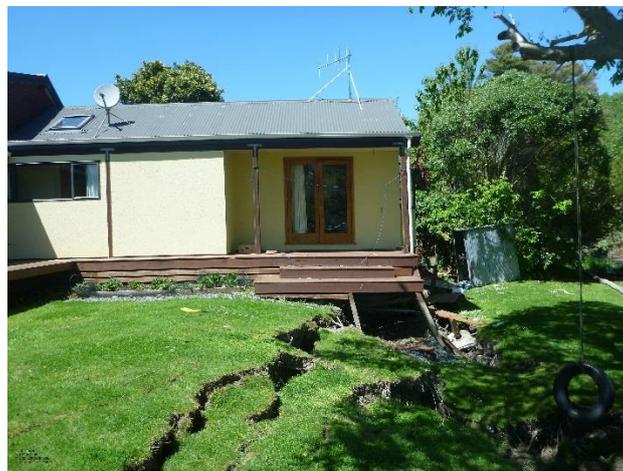
Figure 4.114: Complete loss of support to foundations at west end of house on Beach Road (– date to be added in V2.0 of report, S42.3851, E173.6783).

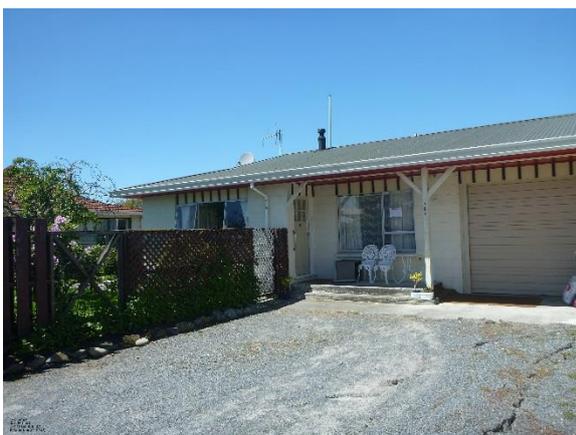
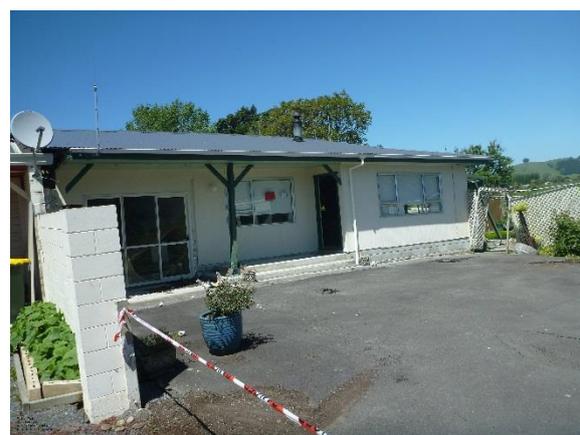
Figure 4.115: Lateral ground movement caused separation of two semi-detached houses on Beach Road (– date to be added in V2.0 of report, S42.3857, E173.6783).

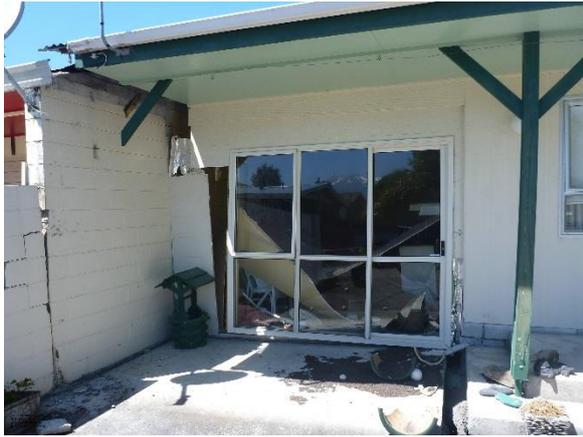
Figure 4.116: Cracks running through the house closer to Lyell Creek (– date to be added in V2.0 of report, S42.3857, E173.6783).

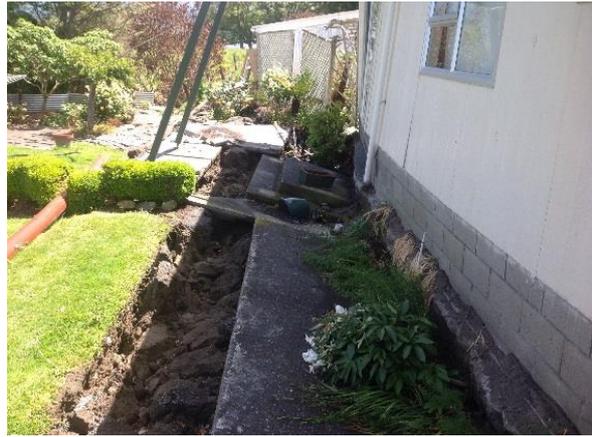
Figure 4.117: Gapping at the west side of the house closer to Lyell Creek (date to be added in V2.0 of report, S42.3857, E173.6783).

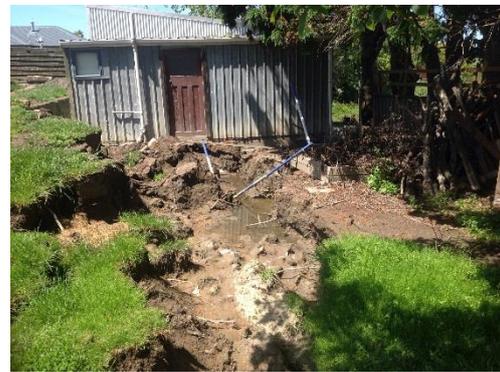
Figure 28: A garage/shed at a house on Beach Road displaced approx. 1 m towards the Lyell Creek, and moved downwards approx. 1 m (– date to be added in V2.0 of report, S42.3860, E173.3860).

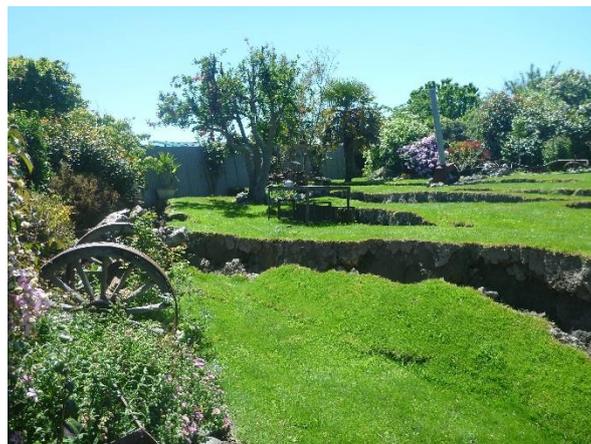
Figure 4.118: Lateral displacement with vertical offsets close to Hawthorne Road Bridge (– date to be added in V2.0 of report, S42.3885, E173.6776).

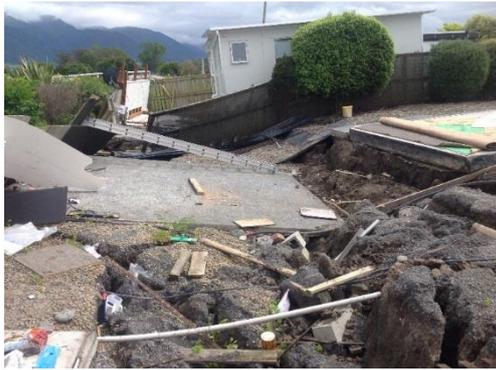
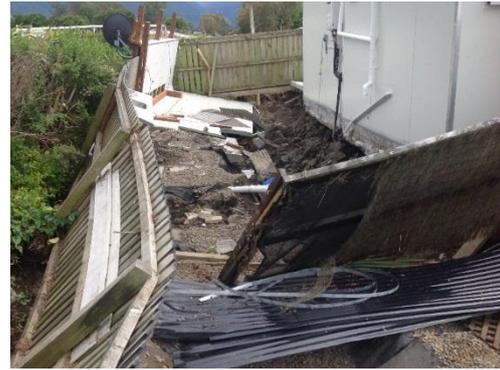
Figure 4.119: Lateral movement south of Hawthorne Road Bridge (– date to be added in V2.0 of report, S42.3894, E173.6775).

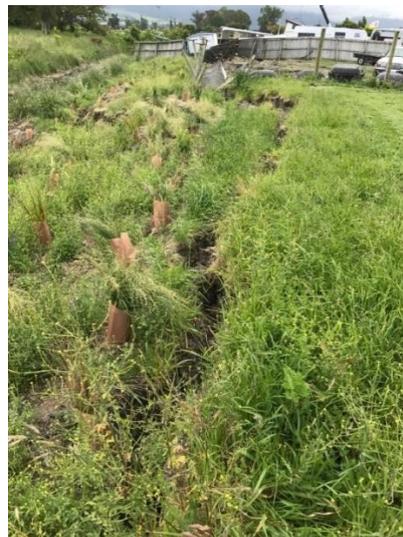
Figure 4.120: Lateral displacements at 105 Beach Road. Note: Cracks are associated with vertical offsets and blocks have rotated away from the river (i.e., slumped) (9 Dec 2016, S42.3902, E173.6777).

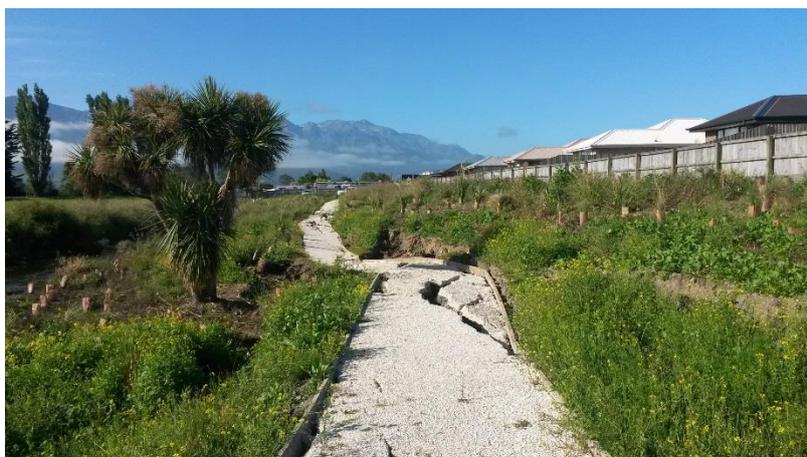
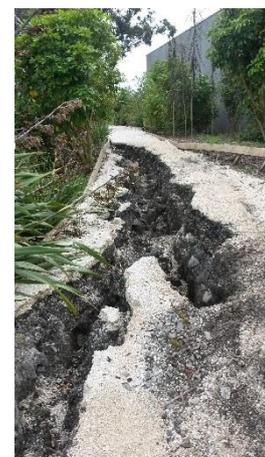
Figure 4.121: Cracks in footpath between 105 and 73 Beach Road, running east of and parallel to Lyell Creek. Largest crack in footpath (right hand photo) was 1 m wide and 70 cm deep (9 Dec 2016): –(a) S42.3916, E173.6778; (b) S42.3926, S173.6777.

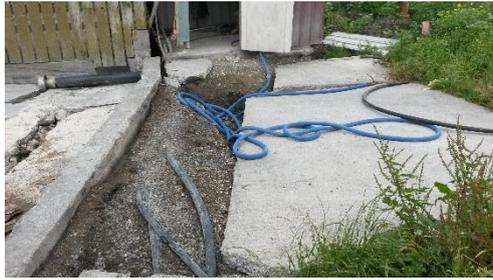
Figure 4.122: Lateral displacement at 87 Beach Road 13 m east of Lyell Creek (date to be added in V2.0 of report, S42.3917, E173.6778).

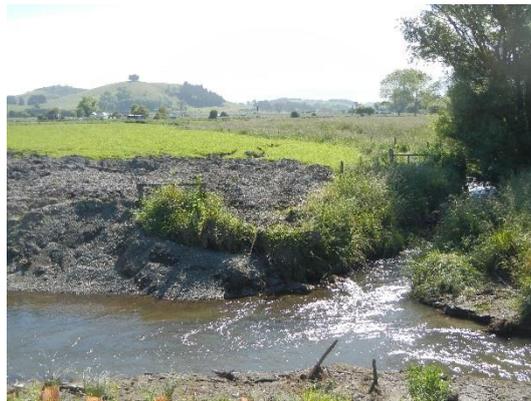
Figure 4.123: Recent earthworks on west side of Lyell Creek, opposite 87 Beach Road. (9 December 2016, S42.3922, E173.6777).

It is expected that there were many cracks that were not observed as a result of the heavy vegetation obscuring individual cracks. Additionally, at the time of the visit on the 9<sup>th</sup> December 2016, recent earthworks were visible on the western bank of the creek (shown in Figure 4.123) , which are assumed to indicate that some bank stabilization or dredging of the creek was carried out soon after the earthquake.

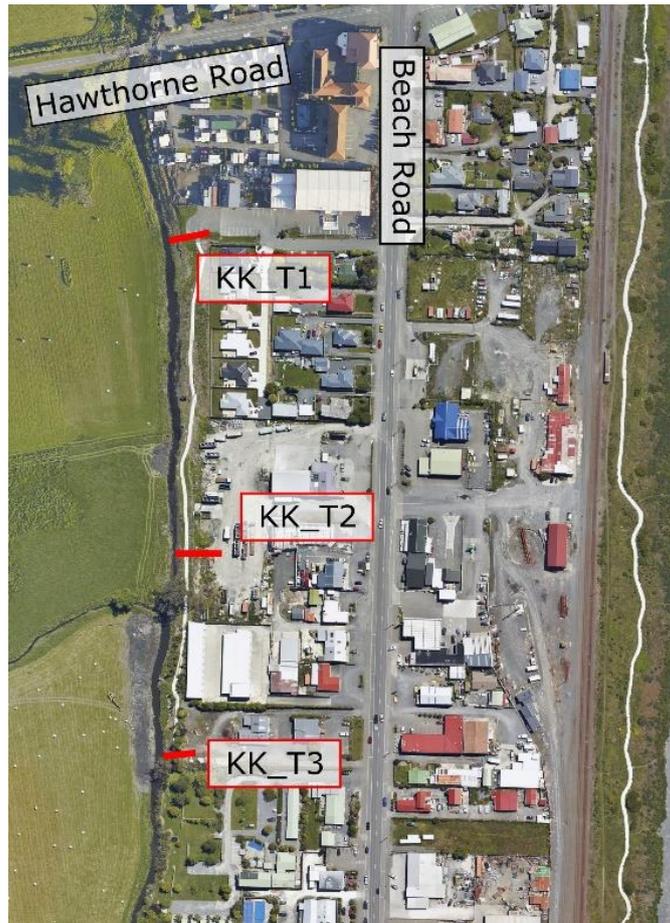
Detailed transects were carried out at three locations along Beach Road following the approach used by Robinson et al. (2011), as shown in Figure 4.124. At each location, individual crack widths, distance from the river channel, and the change in vertical elevation were measured using a tape measure and a range finder. Additionally, the height of the free-face, determined using a tape measure, was used to estimate the difference in height between the bank and the base of the river channel directly next to the start of the transect. The red

lines in the figure indicate the zone of significant cracking. The data from these transects (summarised in Table 4.3) indicate that the lateral displacements in these locations were in the range of 0.6 to 1.1 m, while cracking was typically concentrated within 15 m of the river channel.

Figure 4.124: Location of transects (approx. centre of image: . S42.3922, E173.6791).

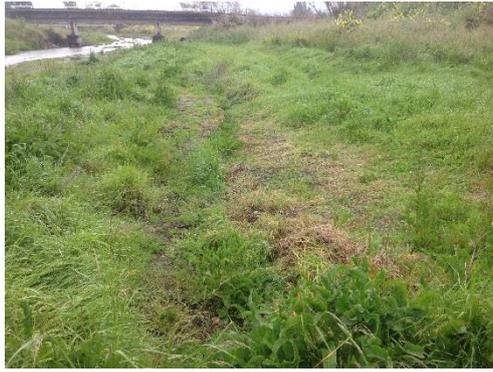
This facility was inspected by Tonkin +Taylor engineers following the earthquake on the 22<sup>nd</sup> November 2016. At the time of inspection, KK-OPS had been fully drained. Lateral spreading cracks were present on the river side of the bank at the south end of the pond (Figure 4.126) while liquefaction ejecta were also present on the river terrace close to one of the piers of the railway bridge (discussed in Chapter 6). Deformations were visible along the crest of the pond, particularly at the most westerly corners, where significant settlement was visible (Figure 4.127 to Figure 4.129). The deformation at these corners was sufficient to cause tearing in the pond's geo-liner, shown in Figure 4.127. Significant settlement was also evident on the eastern side, and a second major tear in the geo-liner was present close to a number of transverse cracks in the bank (Figure 4.128). A concrete slab supporting a vent pipe was completely exposed by the settlement of the ground (Figure 4.131). Aeration lines were strung between posts on the north and south edges of the pond. These posts rotated significantly, particularly on the south edge of the pond (Figure 4.132).

Figure 4.126: Lateral spreading in the bank on south edge of oxidation ponds (– date to be added in V2.0 of report,, S42.3672, E173.6866, facing W.)

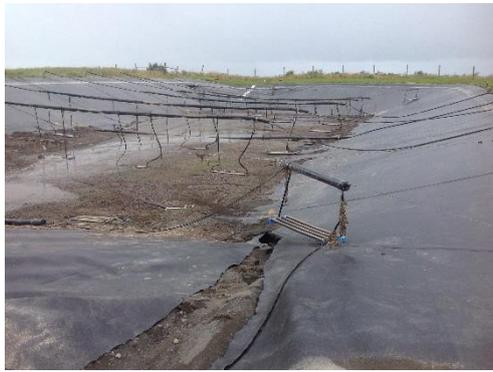
Figure 4.127: KK-OPS looking from the SW corner. Note: geo-liner in the foreground has ripped (– date to be added in V2.0 of report,, S42.3668, E173.6865, facing E).

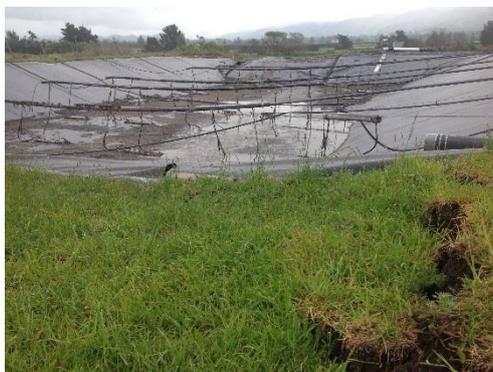
Figure 4.128: KK-OPS from eastern edge. Note geo-liner is ripped in foreground and uneven settlement on the west side is visible in the background (– date to be added in V2.0 of report, S42.3669, E173.6874, facing W).

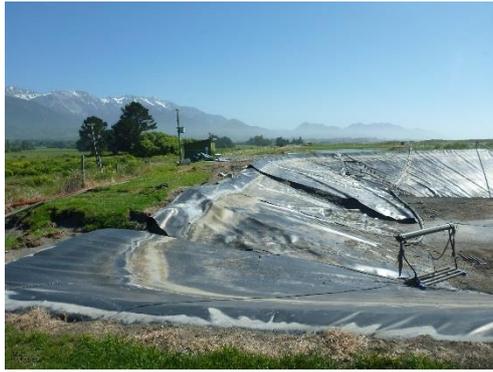
Figure 4.129: West edge of KK-OPS. Large differential settlements of the crest are visible (– date to be added in V2.0 of report, S42.3668, E173.6865, facing N).

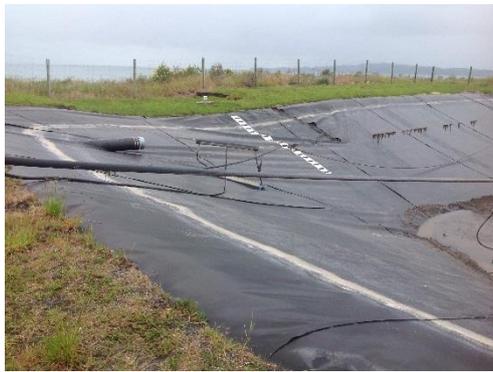
Figure 4.130: East side of KK-OPS. Note ripped geo-liner in line with crack by third post from left (– date to be added in V2.0 of report, S42.3667, E173.6875, facing SE).

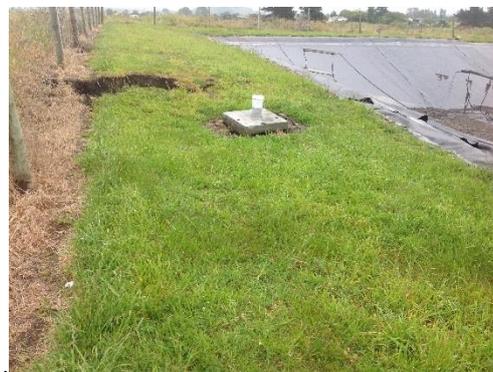
Figure 4.131: Protruding vent pipe on east edge of KK-OPS due to ground settlement (– date to be added in V2.0 of report, S42.3668, E173.6875, facing S).

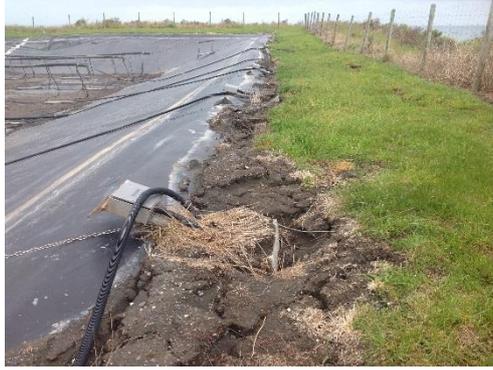
Figure 4.132: Rotation of the aeration-line control posts on the south side of KK-OPS (– date to be added in V2.0 of report, S42.3669, E173.6867, facing E).

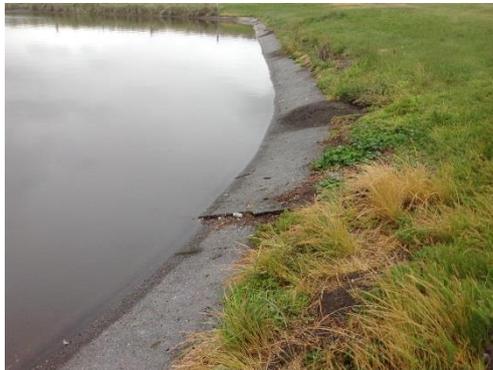
The larger oxidation pond (KK-OPN) was still full at the time of the inspection, however, transverse cracks in the concrete lining were visible (Figure 4.133). Figure 4.134 shows a section of concrete lining which had moved laterally towards the centre of the pond near the SW corner of KK-OPN. In addition to this movement, general lateral movement of the ground towards the pond was highlighted by gapping around a metal anchor rod at the edge of the pond.

Figure 4.133: North edge of KK-OPN. Note cracking and overlayering of concrete. Ejecta visible on concrete. (– date to be added in V2.0 of report, S42.3647, E173.6884, facing W).

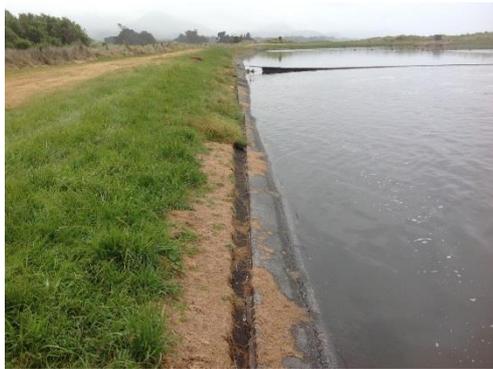
Figure 4.134: West edge of KK-OPN. Note concrete panel has displaced into pond (– date to be added in V2.0 of report, S42.3660, E173.6868, facing N).

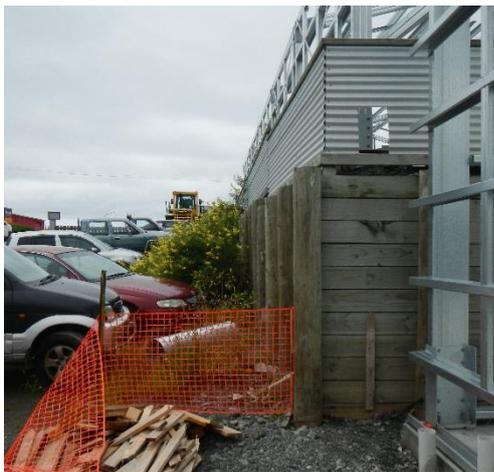
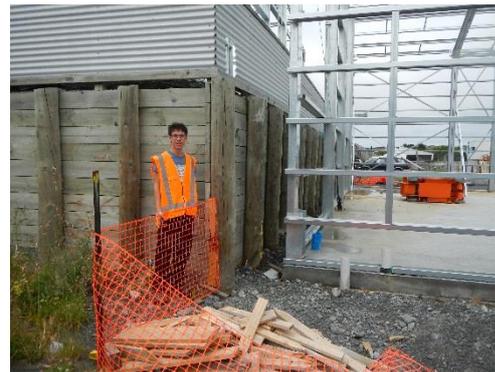
Several properties to the east of Lyell Creek had constructed wooden retaining walls. At 87 Beach Road, a 2 m tall wooden retaining wall had been built at approximately 70 m west of Lyell Creek and appeared to have performed well with no signs of lateral displacement (Figure 4.135). However, at 29, 33, and 35 Beach Road, the retaining walls showed signs of failure.

Figure 4.135: Good performance of retaining wall at 87 Beach Road (–9 Dec 2016, S42.3917, E173.6785: (a) facing E; (b) facing SE.

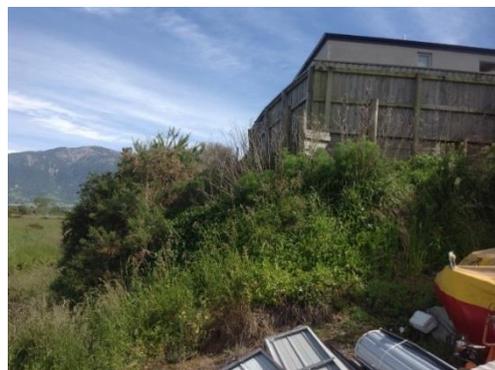
On Beach Road, a retaining wall had been built at the rear of a long motel building. The timber retaining wall was constructed approximately 12 m from Lyell creek, on a section of raised ground, which is visible in Figure 4.136. The crest of the retaining wall had moved 30-40 cm towards the river, based on gaps which had opened up between the concrete slab and the fence on the retained side of the wall.

Figure 4.136: Failure of retaining wall (– date to be added in V2.0 of report, S42.3973, E173.6798, facing N).

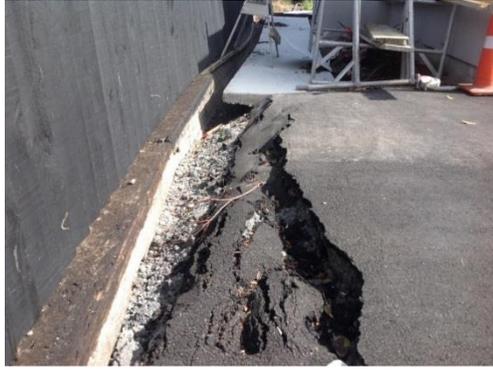
Figure 4.137: Cracks behind retaining wall (– date to be added in V2.0 of report, S42.3971, E173.6798, facing N).

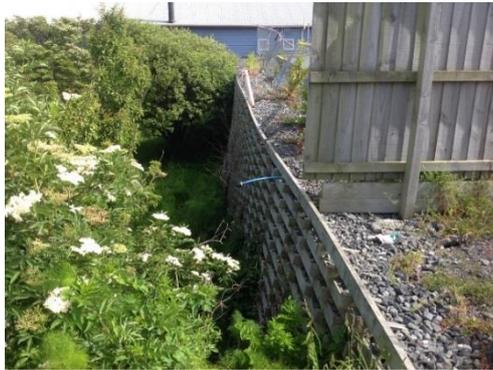
A second retaining wall on Beach Road is located roughly 30 m east of Lyell Creek. Figure 4.138 shows this retaining wall, where the top of the retaining wall had bulged 20-30 cm towards the creek. Cracks of up to 5 cm wide were present in the concrete slab approximately 5 m back from the top of the wall and are visible in Figure 4.139.

Figure 4.138: Failure of retaining wall (– date to be added in V2.0 of report, S42.3964, E173.6793, facing N). Note: Cracks visible in the car park on the retained side of the wall.

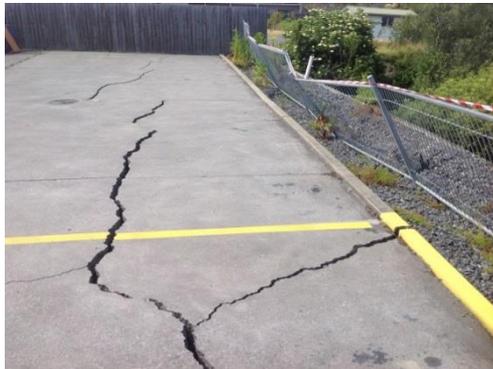
Figure 4.139: Cracks visible behind retaining wall (– date to be added in V2.0 of report, S42.3968, E173.6796, facing S).

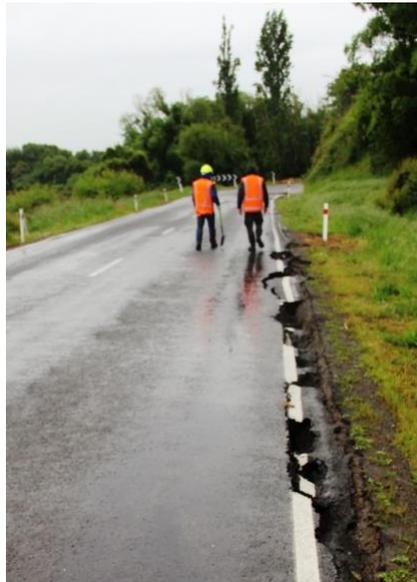
Despite the strong shaking in Rotherham, no evidence of liquefaction was observed in the town. North of Rotherham, cracking both in the road and on the road sides were observed as shown in Figure 4.141 and Figure 4.142, and are representative of damage in the area (noting that the area was more severely affected by landslides).

Figure 4.141: Cracks alongside Rotherham road (S42.6908, E172.9470, 17 Nov 2016).

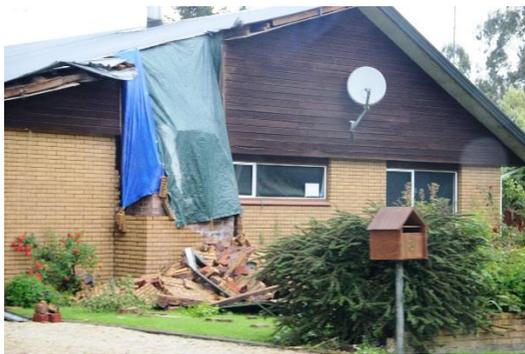
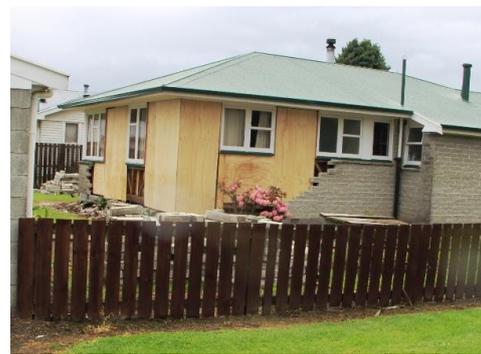
In the town of Waiau, the strong shaking caused damage to a large number of building facades and chimneys (examples are shown in Figure 4.143), however there was only evidence of liquefaction at two locations at the south end of the town. In this part of town, there were a number of cracks in the road, and the two locations of ejecta were either associated with the cracks (Figure 4.144), or with fence posts which surrounded a paddock SW of the end of Parnassus Street. The particle size distribution of a sample of this ejecta is shown in Figure 4.145. It was reported by utility workmen that there was a significant amount of ejecta inside the paddock, but the owner could not be located to obtain access to this area.

Figure 4.143: Damage to houses in Waiau. (a) fallen chimney (b) damage to façade. (S42.66, E173.04, 17 Nov 2016)

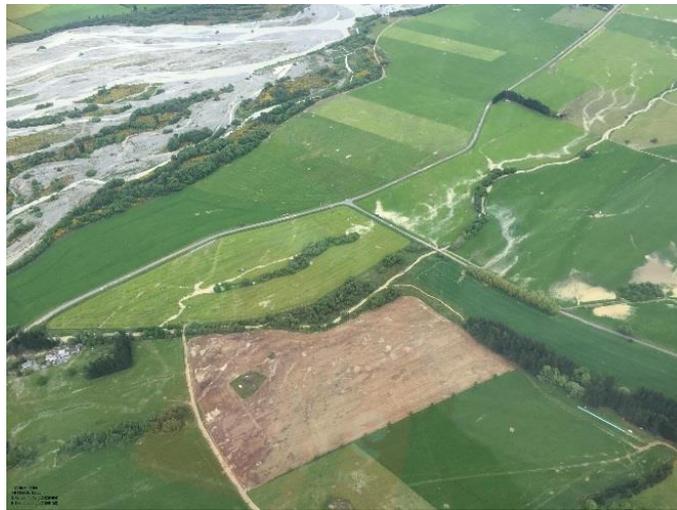
Figure 4.146: Standing water and ejecta west of Waiiau town (date to be added in V2.0 of report, S42.638, E172.993).

Liquefaction was observed in the agricultural areas close to the Waiau River, west of Waiau town. Aerial photography of this area (Figure 4.146) shows standing water and ejecta in the fields as well as on the roads. The presence of sand boils in this area was confirmed by ground teams, who noted the presence of a number of ground cracks in the same area.

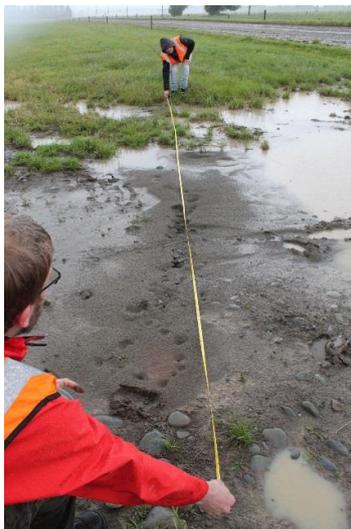
Figure 4.147: Liquefaction ejecta on River Road (S42.6427, E172.9743, 17 Nov 2016).
