5. LIQUEFACTION EFFECTS AND ASSOCIATED DAMAGE AT THE PORT OF WELLINGTON

5.1 Introduction

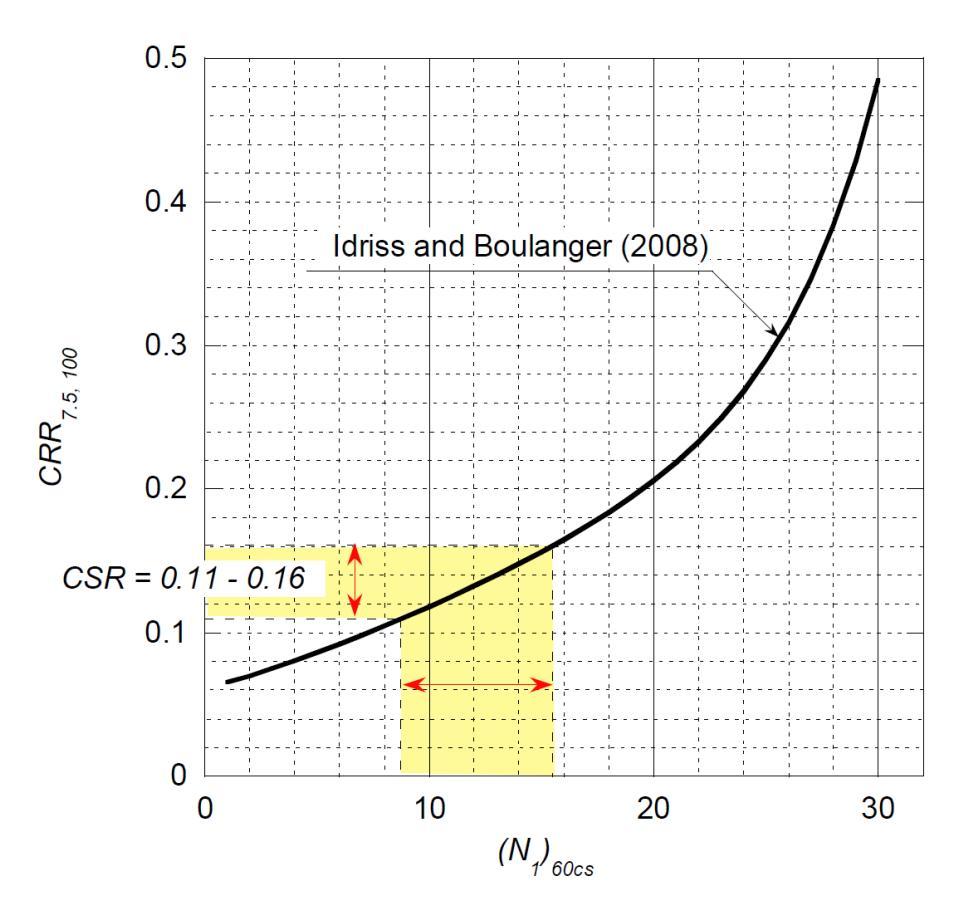
The estimated CSR_{wt} values for the SMS sites are summarized in Table 1. $CSR_{wt} = 0.11 - 0.000$ 0.16 for the three SMS sites closest to the port (i.e., CPLB, TFSS, and PIPS). This demand in terms of CSR is illustrated in Figure 5.16 together with the equivalent sand liquefaction resistance (CRR7.5,101) as a function of the SPT blow count (shown with the solid line), as defined in the semi-empirical liquefaction evaluation procedure of Boulanger and Idriss (2014). Note that the product of $MSF \times K_{\sigma}$ in Equation (1) is approximately 1.0 for the combination of M_w7.8 earthquake and an effective overburden stress of about $\sigma'_{vo} = 40$ to 60 kPa corresponding to a water table depth of 2 m to 3 m. Thus, the computed CSR_{wt} can be directly compared to the liquefaction resistance expressed in terms of CRR7.5,101 shown in Figure 5.16. If one accounts for the conservatism in this deterministic relationship of CRR7.5,101, which corresponds to a 15% liquefaction probability (Boulanger and Idriss, 2012), then the plot roughly indicates that the seismic demand was sufficient to trigger liquefaction in deposits having an equivalent clean sand SPT blow count of less than 10 to 14 blow counts. This simplified estimate of seismic demand applies to the soil at the depth of the ground water table and serves only as a rough indicator of the imposed seismic demand for assessing liquefaction triggering. The Boulanger and Idriss (2014) CRR correlation was developed based on case histories on sandy soils, and therefore its applicability to gravelly soils is affected by several factors including the conversion of the penetration resistance of gravelly soils to an equivalent clean sand blow count. Hence, the plot shown in Figure 5.16 is only an indicator of the seismic demand in relative terms (i.e., in relation to an equivalent clean sand liquefaction resistance), and further research is needed to determine directly the cyclic resistance of the reclaimed deposits.

Figure 5.16: Illustration of seismic demand for assessing liquefaction triggering by the 2016 Kaikoura earthquake at depth of the water table for the three sites on reclaimed soils in the vicinity of the port (PIPS, TFSS and CPLB).

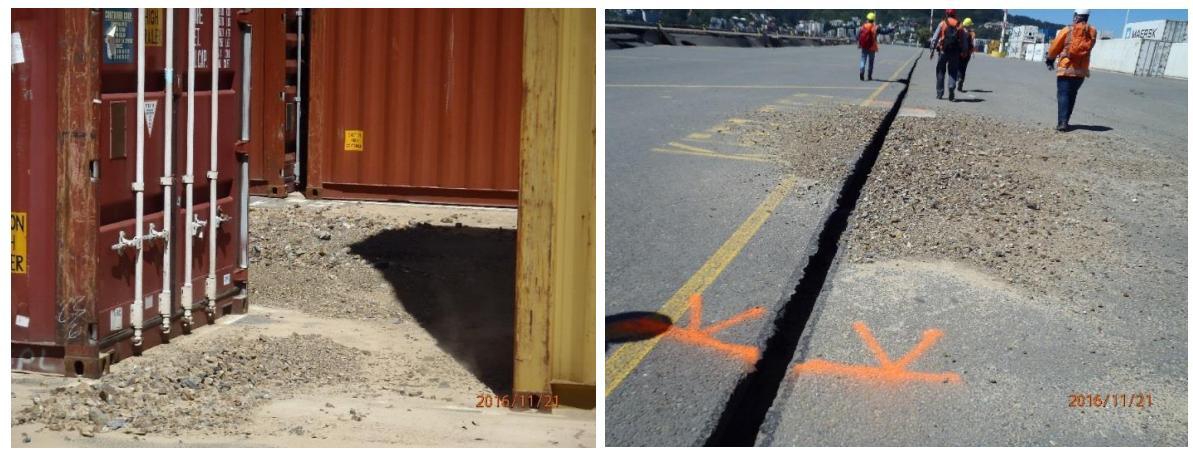
Figure 5.18: High gravel content quarry rock ejecta in the container storage area upland of Thorndon Container Wharf. (a) Looking south along eastern wall of Substation B (S41.277699°, E174.788277°), (b) looking south along lateral spread crack and ejecta 45 m upland of bulkhead at approximately STA 230 (S41.278286°, E174.788830°), (c) coarse gravel and cobble ejecta (S41.280225° E174.787828°), (d) containers 20 m south of Substation B (S41.278020°, E174.788213°), and (e) looking south along lateral spread crack and ejecta 12.5 m upland of bulkhead at approximately STA 150 (S41.278887°, E174.789413°, taken on 21NOV16).

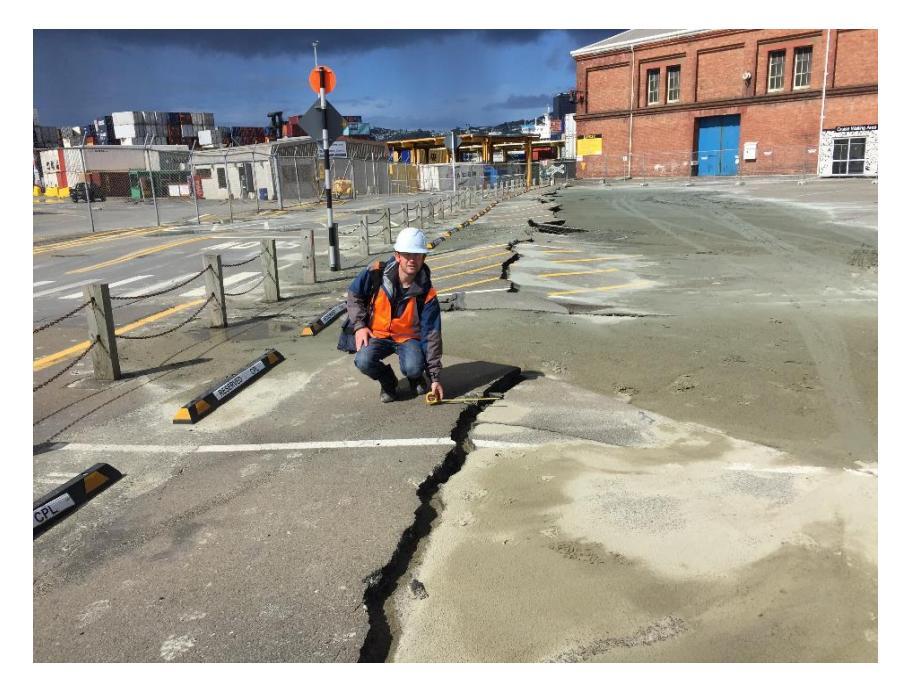
Figure 5.20: Sandy liquefaction ejecta behind buried mass concrete seawall looking southwest along seawall. On the right side of seawall: area of end-dumped quarry rock reclamation from 1904-1916 (Sample S2), left side of seawall: area of end-dumped quarry rock reclamation from 1970's Thorndon Reclamation. (S41.278454°, E174.785154°, taken on 17NOV16)

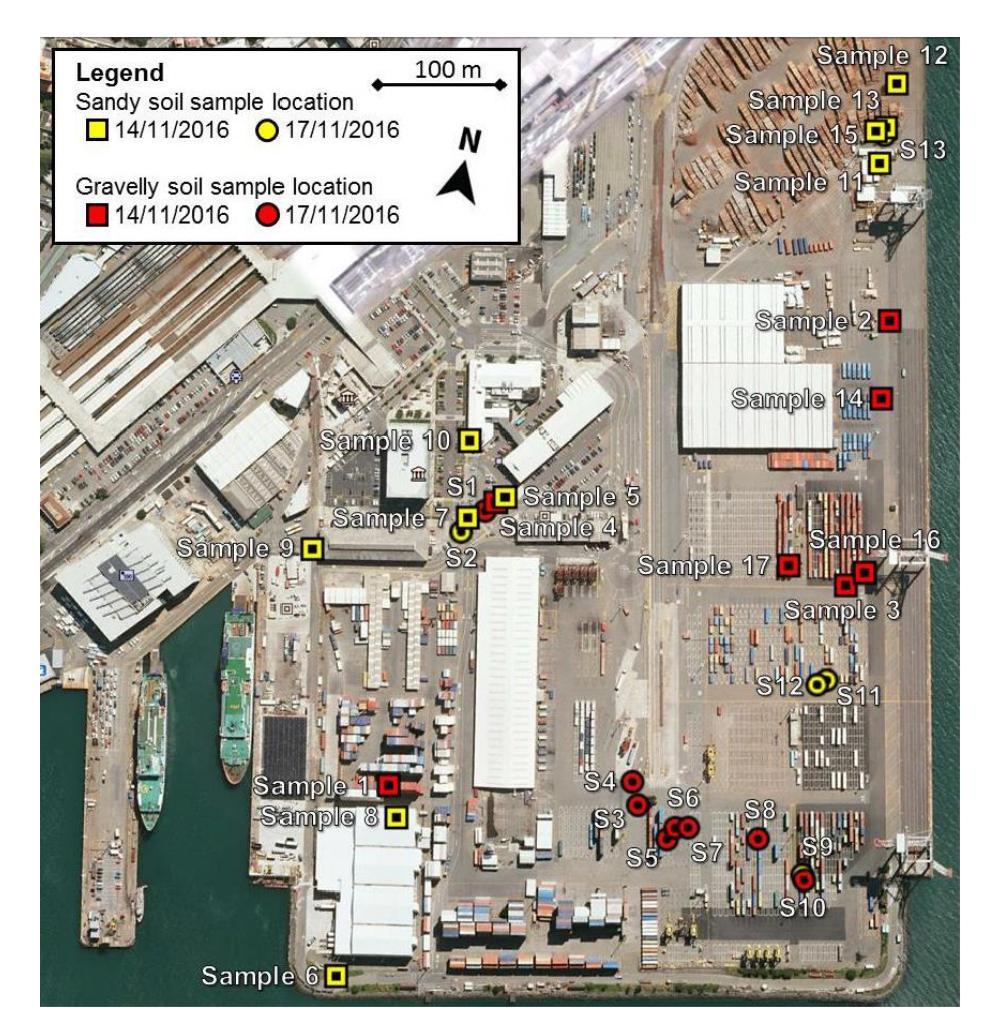
During the first field survey on 17 November, several ejecta samples were collected for index testing in the laboratory. Thirteen of those samples, indicated as S1 to S13 in this report, were collected from the locations shown in Figure 5.22. Sand liquefaction ejecta were observed at three different areas. These areas are: (1) in the Thorndon container stacking area at samples S11 and S12 (Figure 5.19), (2) immediately upland of the buried mass concrete seawall at sample S2 (Figure 5.20), and (3) in the log stacking area at sample S13 (Figure 5.21). Interestingly, only the log stacking area at S13 coincides with mapped area of sandy hydraulically-placed dredged fill (i.e., purple shaded area in Figure 5.2). Gravelly liquefaction ejecta were present over large portions of the Thorndon Reclamation and the Thorndon Reclamation Extension. This material is the end-dumped quarry rock referred to above as "common fill." The remaining samples were collected from this material. Several photos of this gravelly liquefaction ejecta are shown in Figures 5.17 and 5.18.

Figure 5.22: Location of liquefaction ejecta samples collected on 14 November (Sample 1 to Sample 17), and 17 November (S1 to S13). (Base image from Google EarthTM)

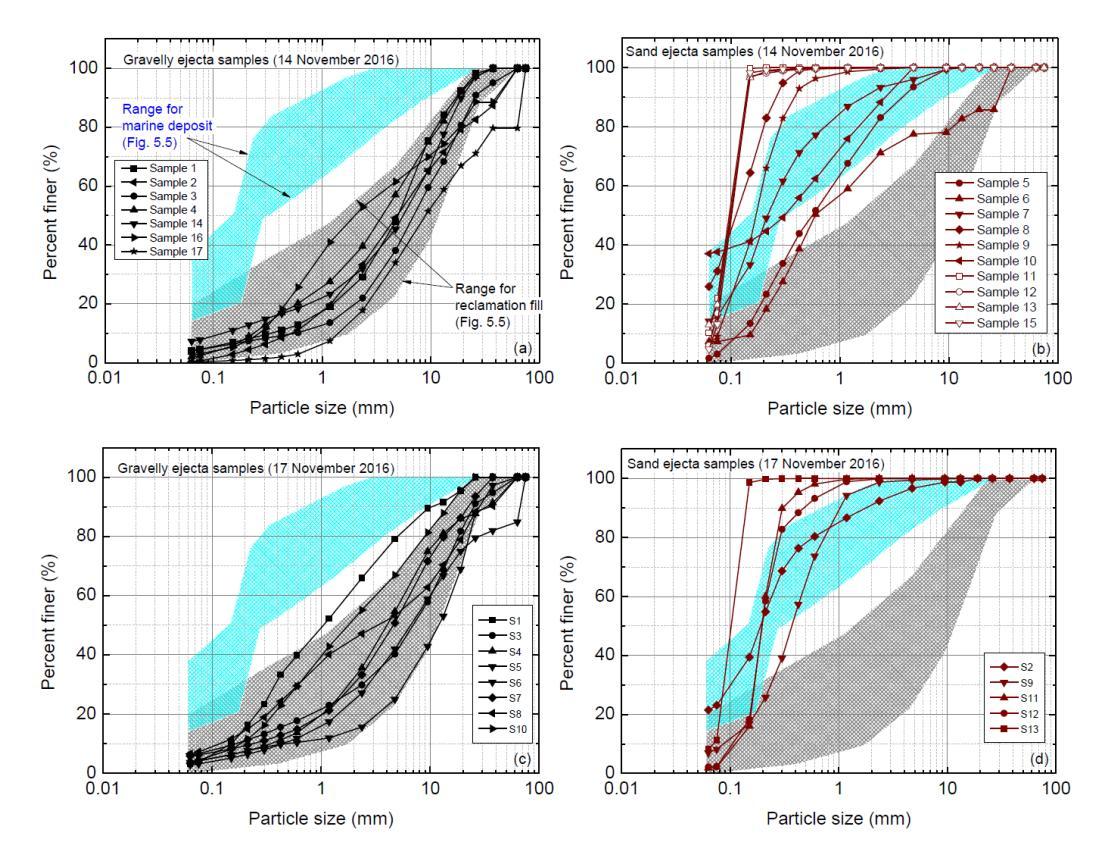
the reclamation fill and marine deposit samples (collected from subsurface explorations) indicated in Figure 5.5. The grain-size curves of the gravel ejecta (solid lines in Figure 5.23c) are in good agreement with the grain-size distribution range of the gravelly soils of the Thorndon reclamation (shaded zone in Figure 5.23c). Similarly, the grain-size distribution curves of the sand ejecta (solid lines in Figure 5.23d) are generally consistent with those of the marine deposits, except that ejecta samples show more uniform composition. Note that the hydraulically placed sandy fill was dredged from the original seabed, and hence has the same composition as marine deposits. The grading of the ejected soils is also consistent with the sand fractions of the fill material. Samples from the ejected soils were also collected from additional 15 locations (shown in Figure 5.22) by Tonkin+Taylor, on 14 November. Importantly, these samples were collected before the severe rainfall on 14-15 November that potentially washed out some of the fines fractions of the ejected soils. Grain size distribution curves of the gravelly samples and sandy samples collected on 14 November are shown in Figures 5.23a and 5.23b in the same fashion as Figures 5.23c and 5.23d. By and large, both gravelly samples (solid lines in Figure 5.23a) and sandy samples (solid lines in Figure 5.23b) are in good agreement with the respective range of grain-size distribution curves obtained from borehole samples (shaded areas). Tables 5.3a and 5.3b summarize the field visual classification (Tonkin+Taylor, private communication), the mean grain size (D₅₀), and fines content (FC) obtained from the laboratory tests on the samples collected on 14 November (Sample 1 to 15) and 17 November (S1 to S13) respectively.

Figure 5.23: Grain size distribution for liquefaction ejecta samples collected on reclaimed land from (a) gravelly quarry rock fill on 14 November, and (b) sandy fill on 14 November, (c) gravelly quarry rock fill on 17 November, and (d) sandy fill on 17 November. Shaded regions show ranges of grain size for marine deposits and reclamation fill collected from subsurface explorations (plotted in Figure 5.5).

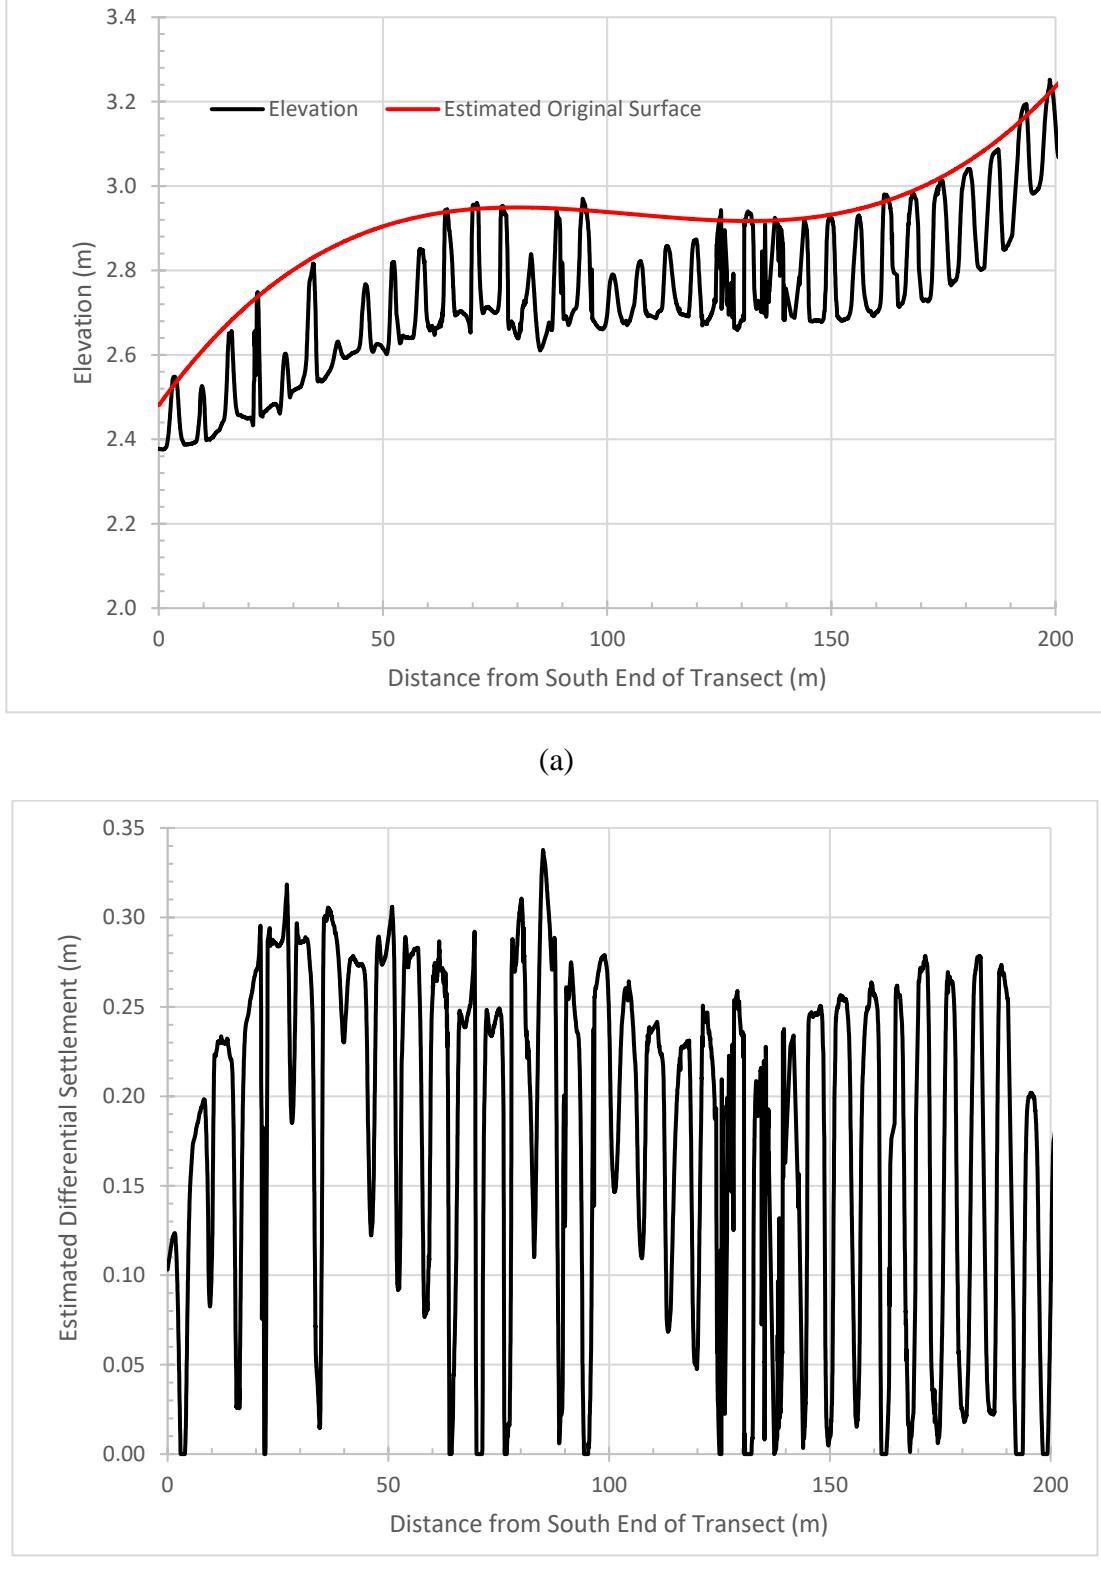
Figure 5.29 shows a cross-section obtained on the west edge of the road immediately west of Building S37. The peaks are locations of the buried piles and the lower portions are settlement of the pavement surface around those piles. In absence of detailed survey data prior to the event, the original surface was estimated by fitting a 3^{rd} order polynomial ($R^2 = 0.99$) to the tops of piles with higher elevations in the local area. Given this assumption, the differential settlement calculations (Figure 5.29(b)) do not account for any settlement of those piles which may have occurred given that some of the piles in that sequence appear to have settled. Regardless, the trends are reasonably consistent with the values shown in Figure 5.24.

Figure 5.29: (a) Post-earthquake elevations for transect (LT1) along west side of roadway west of S37; the red line represents the estimated pre-elevation surface. (b) Estimated settlements. (Distance 0 is approximately 15 m south of the south wall of Building S37 and the 200 m transect runs to about 3 m north of the north wall of Building S37).

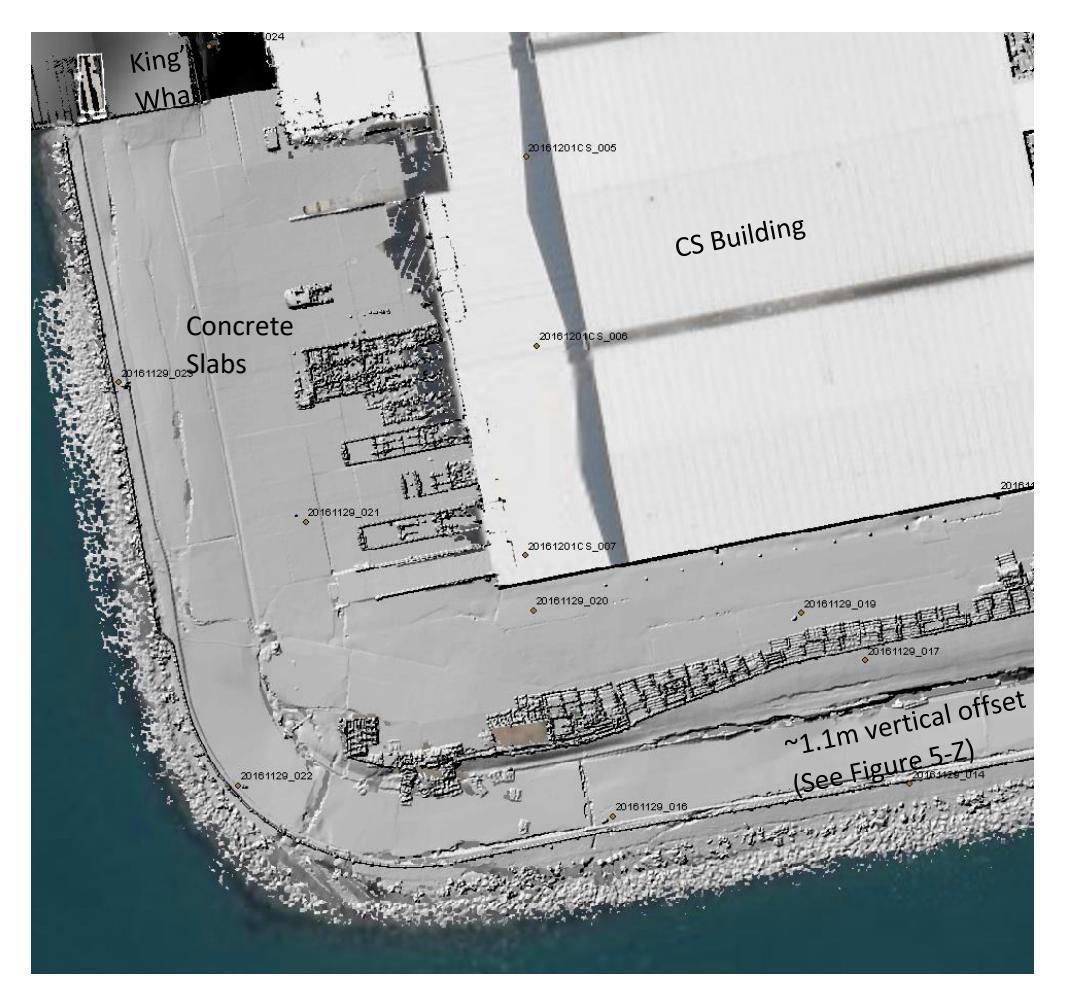
Several TLS observations were obtained throughout the area surrounding the CS building at the southwest corner of the port, which experienced widespread liquefaction-induced ground deformations. The lidar DEM was converted to a hillshade to enhance visualization of cracks and other features in this area (Figure 5.30). The hillshade visualization highlights discontinuities in the data and provides detailed information on cracking patterns observed. In addition, differential settlement between the concrete slabs between the road and cold store building are apparent.

Figure 5.30: Example hillshade for the SW corner of the port, south of the CS building. This dataset was coarsely cleaned and still contains several artifacts from railing and metal racks.

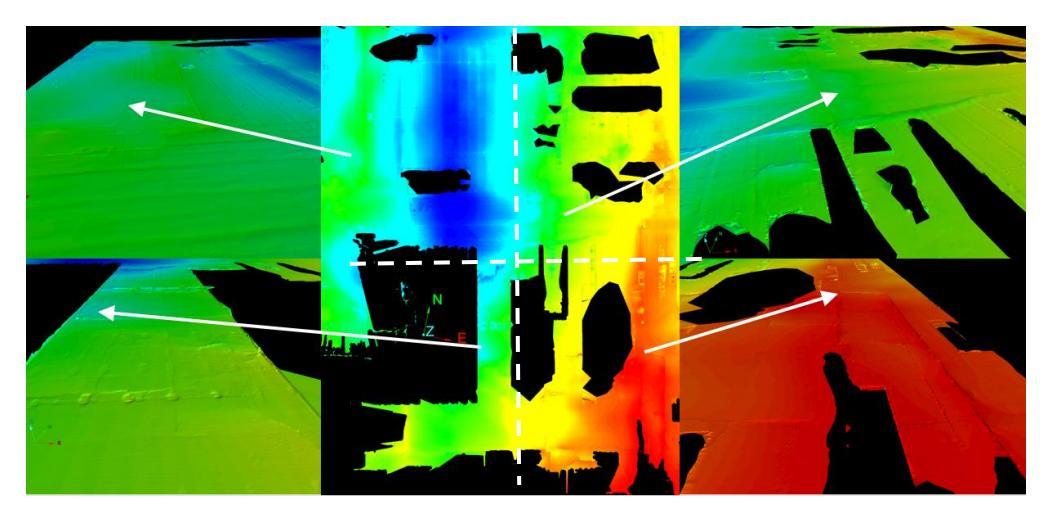
Figure 5.31 presents example DEMs with perspective views. From the lidar scans, significant differences in elevation from liquefaction are apparent. Figure 5.32 presents two cross-sections through this locale, one running north to south (Figure 5.32(a)) and one running west to east (Figure 5.32(b)). Although the pre-event surface was not available for comparison, it is likely that settlement increases significantly towards the south as a result of the increased liquefaction-induced ground spreading towards the south and west.

Figure 5.31: Example DEMs of the southeast portion of the port (next to, but not including Thornton Wharf) highlighting various liquefaction settlements and accretion of materials. Elevation ranges from 2.05 m (Red) to 3.80 m (Blue). The center image is a plan view, and the other images are perspective views to show detail.

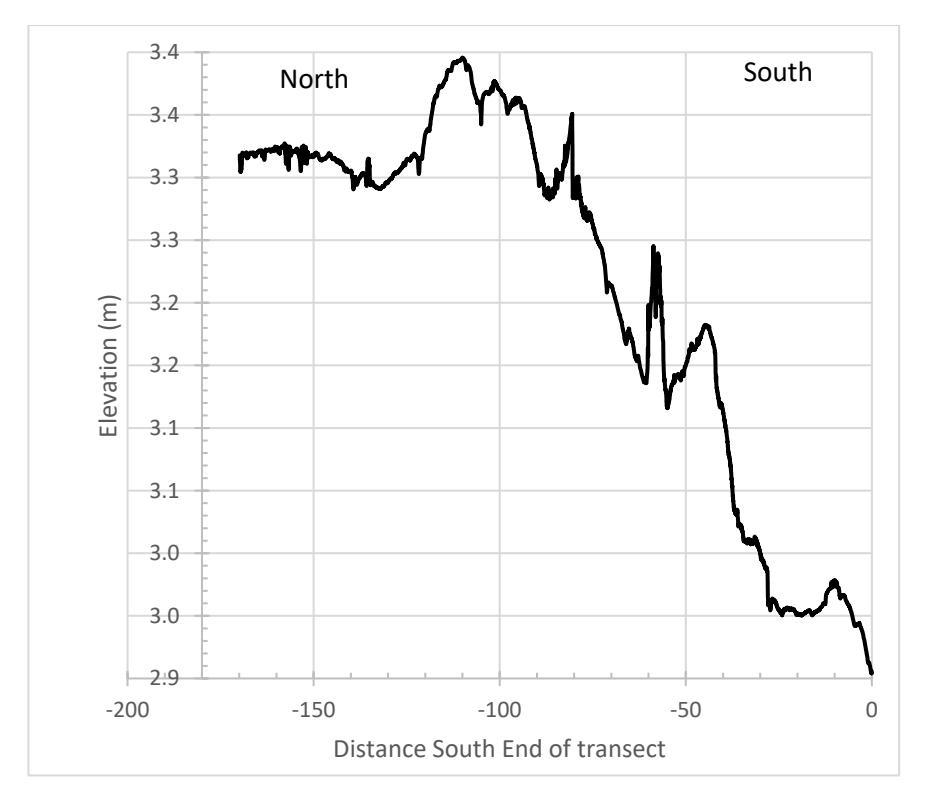
Figure 5.32: Cross sections across the southeast portion of the Thorndon Reclamation: (a) North South Transect LT2, and (b) East-West Transect LT3. Locations of transects are identified in Figure 5.27.

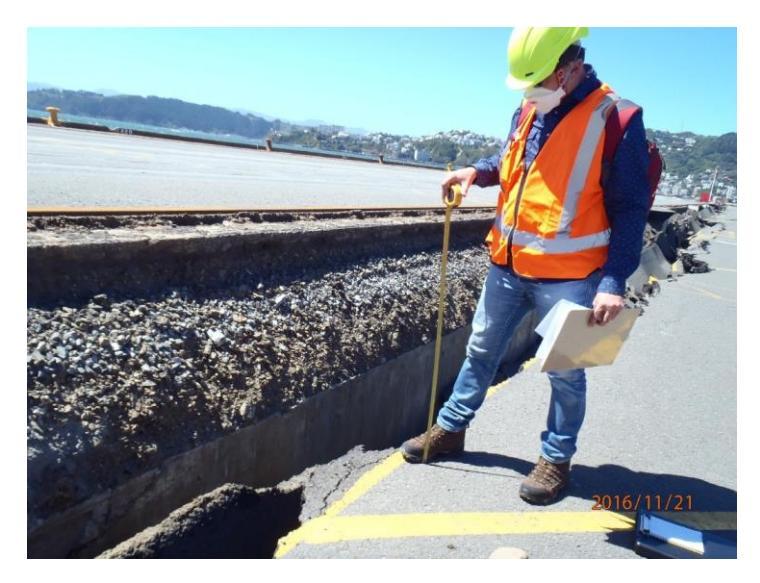
ground immediately inland of it are listed in Table 5.7 and indicated in Figure 5.25. These measured values range from 200 to 500 mm. Ground settlement immediately inland of the bulkhead, relative to the wharf deck, was estimated to be 600 mm. Figures 5.35 and 5.36 show the vertical offset created between the pile supported wharf and reclaimed fill behind the wharf.

Figure 5.35: Looking south along Thorndon Wharf bulkhead at approximately STA 240. Approximately 600 mm of ground settlement measured relative to pile-supported wharf. (S41.278250° E174.789205°, taken at 1124 hrs on 21NOV16)

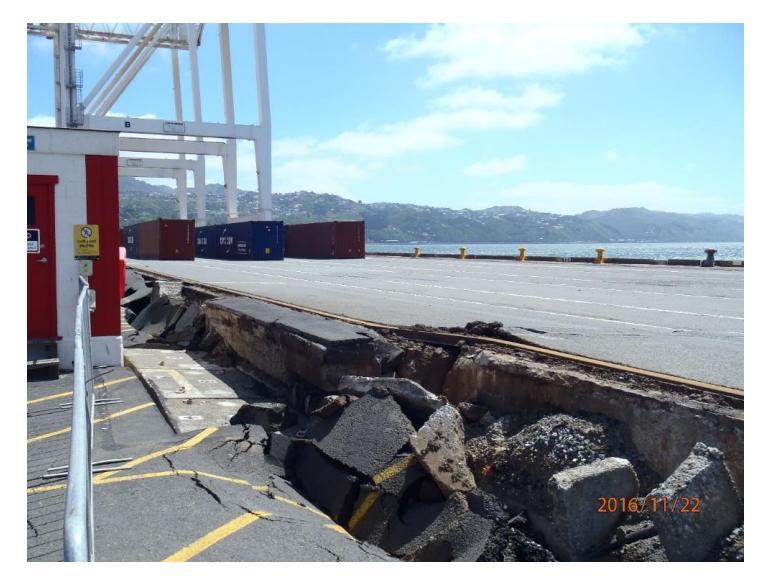
Figure 5.36: Looking north along Thorndon Wharf bulkhead at approximately STA 280. Approximately 600 mm of ground settlement measured relative to pile-supported wharf. (S41.277743° E174.789236°, taken on 22NOV16)

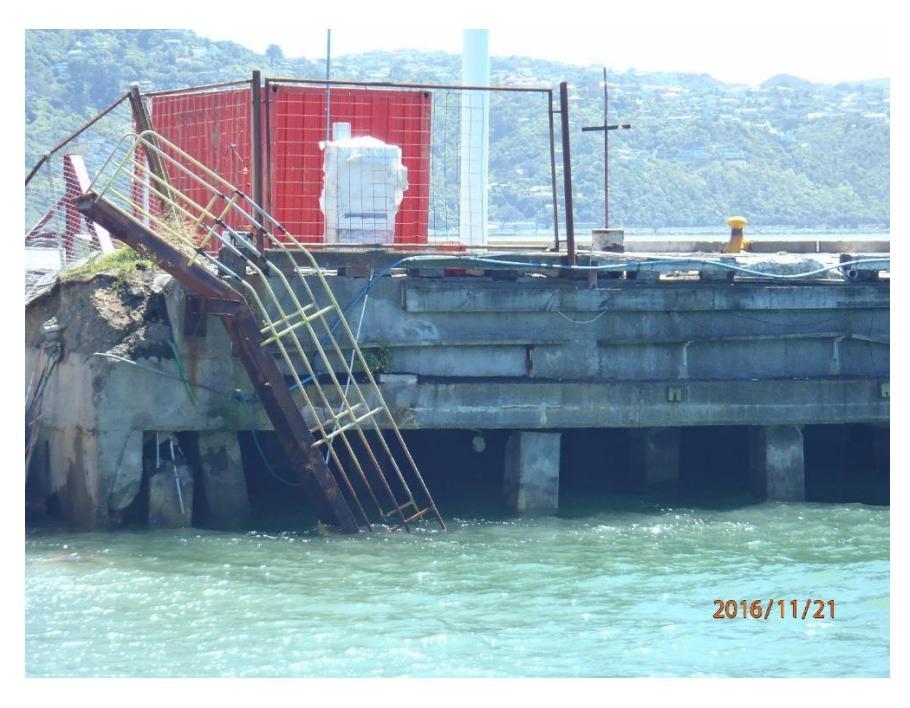
The QuakeCoRE-GEER team was informed that concrete piles had been sheared near the pile cap (from a boat survey by others; T+T (2016) private communication). From the south side of the port, the QuakeCoRE-GEER team did observe a vertical bulkhead pile sheared just below the pile cap (Figure 5.37a). During a site visit in May 2017, the team observed that the bulkhead piles (both plumb and battered) near the north end of the Thorndon Reclamation were damaged immediately below the deck (Figure 5.37b). Cardno performed an aerial survey of the port that captured vertical settlement and lateral movement, which is shown in Figure 5.38. The magnitude of lateral spreading displacement and settlement measured by Cardno are generally consistent with those measured by the QuakeCoRE-GEER team, which are provided in this report.

Figure 5.37: (a) Looking north towards the southern end of Thorndon Wharf. The vertical bulkhead pile is sheared just below the pile cap. QuakeCoRE-GEER team was informed that many piles in this area were sheared near the pile cap (from a boat survey by others; T+T (2016) private communication) (S41.280219° E174.789974°, taken at 1152 hrs on 22NOV16) (b) Looking north under the Thorndon Wharf bulkhead toward damaged plumb and battered bulkhead piles. (S41.277312° E174.789081°, taken at 13:38 hrs on 08MAY17)

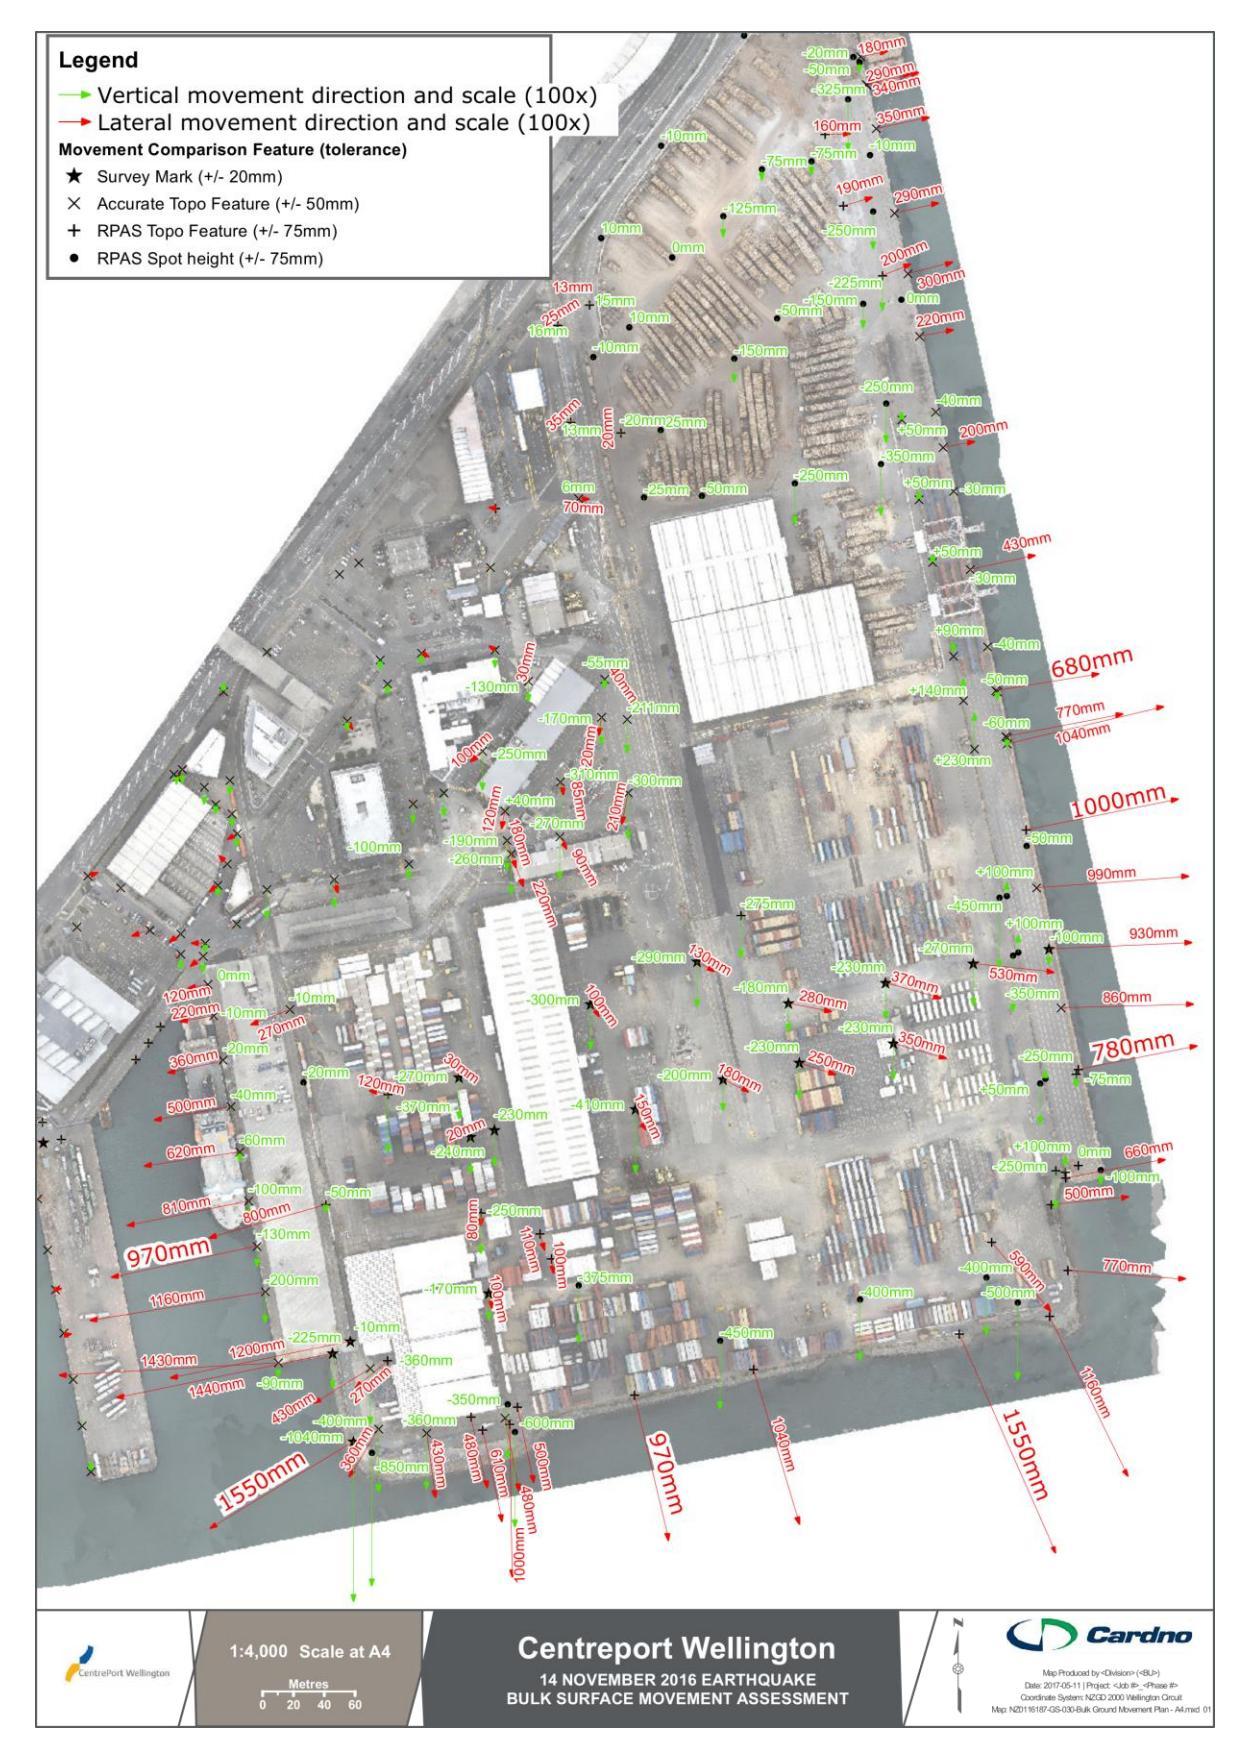
Figure 5.38: Aerial survey of Thorndon Reclamation and Wharf (performed by Cardno).

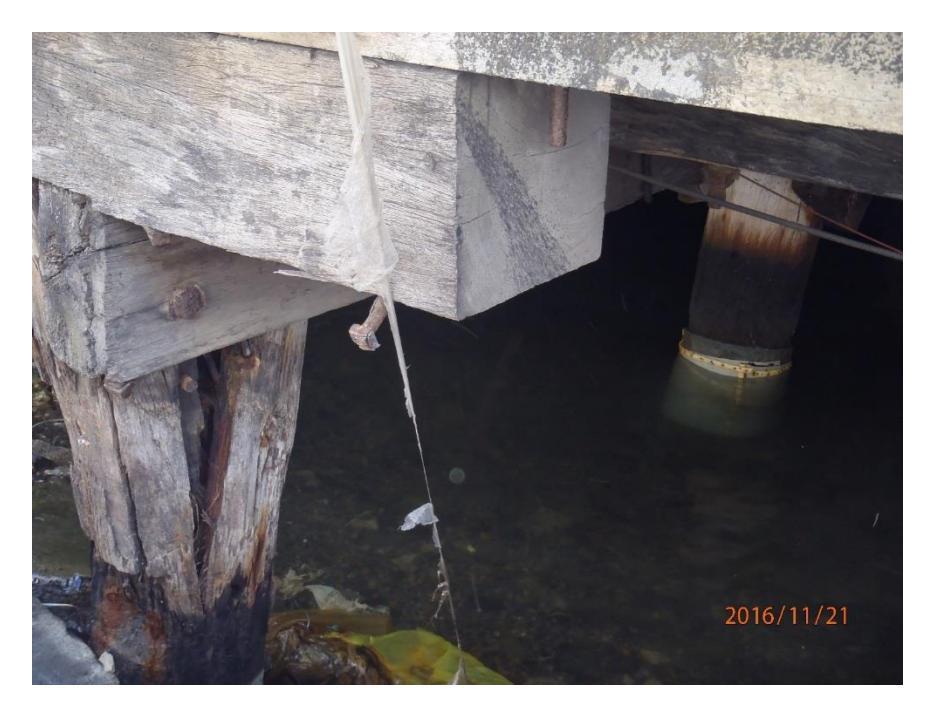
The inland timber piles split due to seaward (westward) lateral movement of the deck relative to the piles (Figure 5.43). Westward movement of the structure is visible in Figure 5.44, in which the southern row of piles is shown leaning to the west. Some vertical curvature of the wharf deck can be observed in the LiDAR DEM (Figure 5.45) and associated cross section in Figure 5.46. Differential settlement between the wharf and adjacent ground range from 475 mm to 630 mm as measured from the LiDAR-derived DEM. The wharf deck exhibits significant concavity (downward) as observed in the cross section plotted on Figure 5.46.

Figure 5.43: Looking under King's Wharf at an inland bulkhead pile. Timber pile is split from lateral movement (seaward/westward) of the deck relative to the pile. (S41.280900° E174.784375°, taken at 1412 hrs on 21NOV16)

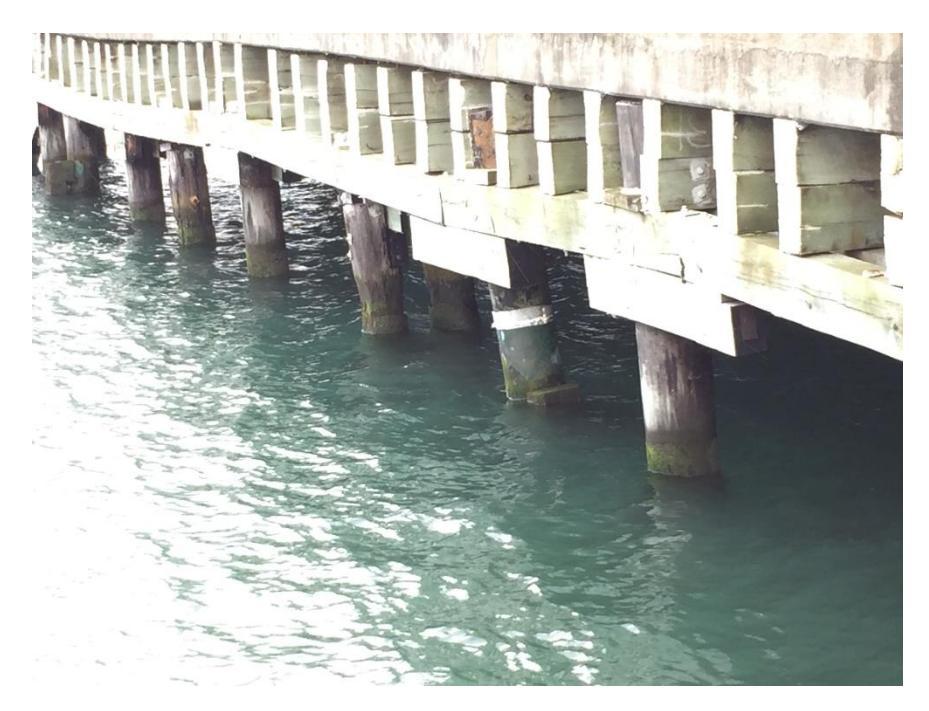
Figure 5.44: Looking west along southern end of King's Wharf. Westward tilt of piles is visible. (S41.281281° W174.784097°, taken on 17NOV16)

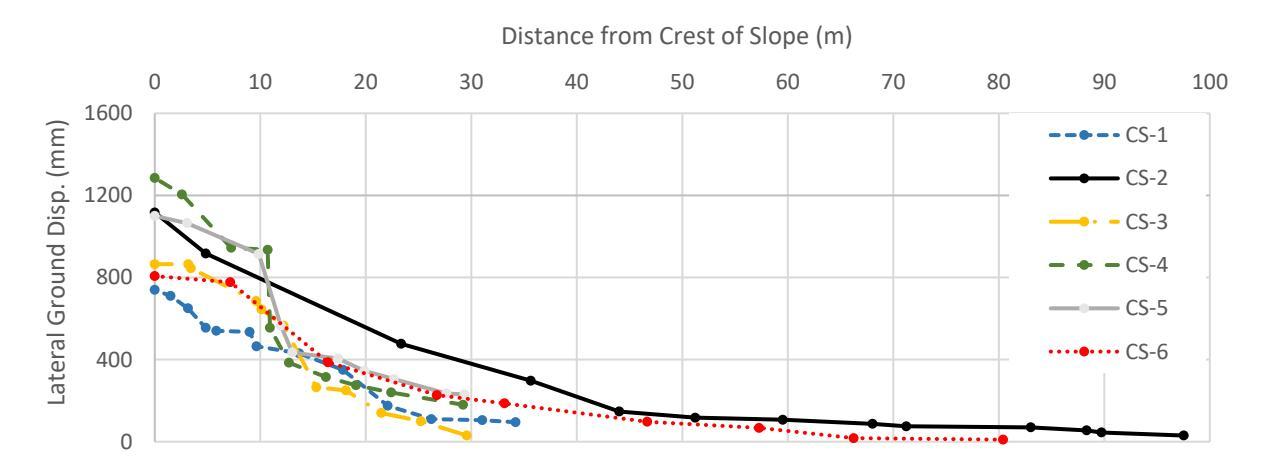
The differential ground movements across the building footprint induced structural deformation in the CS building. Seaward lateral ground movements on the order of 1 m occurred towards the western and southern slopes in the southwest corner the CentrePort reclaimed land. Figure 5.50 shows the location of six transects along which the location and width of lateral ground cracks in the pavement surrounding the CS building were recorded. Superimposed on this figure are plots of cumulative lateral ground displacement as a function of distance from the crest of the waterfront slopes for each transect. They show that, at the south side of the building, the fill moved towards the sea (southward) approximately 0.8 to 1.3 m. Similarly, the fill moved 0.8 to 1.1 m to the west direction. The top plot in Figure 5.50 indicates that the foundations of the building were subjected to a lateral stretch of approximately 200 mm. This stretch occurred over a column span of approximately 8.8 m, which corresponds to a lateral strain of about 2.3 percent. Tables 5.8 and 5.9 provide the measured crack widths and distances from the transect reference point for the east-to-west (CS-1, CS-2, and CS-6) and north-to-south (CS-3, CS-4, and CS-5) transects, respectively. Data for all six transects are plotted in Figure 5.51.

Figure 5.51: Cumulative lateral ground displacement versus distance from the crest of the waterfront slope for Cold Store lateral spread transects.

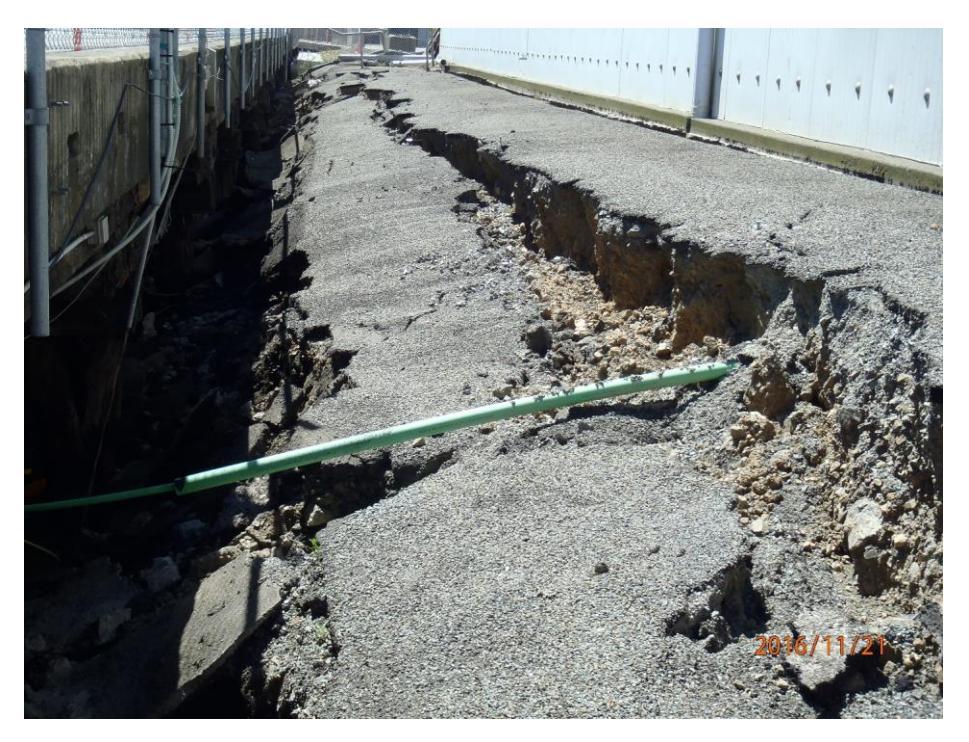
Figure 5.54: Looking north along the west wall of the CS building. The ground settled approximately 530 mm relative to the pile-supported bulkhead of King's Wharf, which is shown at the left side of the photograph. (S41.280923° E174.784389°, at 1411 hrs on 21NOV16)

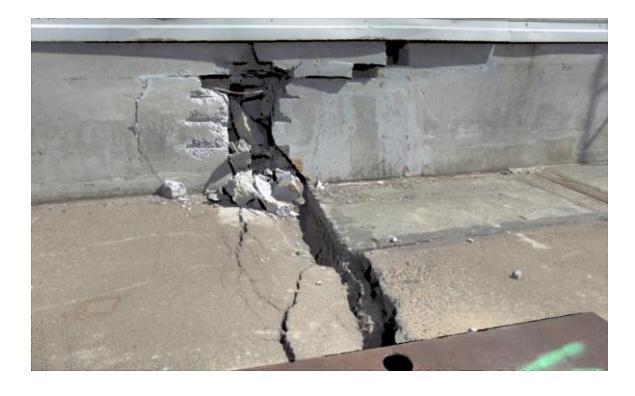
Figure 5.59 documents significant cracking resulting in exposure of rebar in the foundation of the CS building on the north side from a LiDAR scan. Figure 5.59(a) looks south at the north wall of the CS building while Figure 5.59(b) shows the same crack running northward. The width of this crack is fairly consistent at 200 mm for much of the length as was observed in the LiDAR scan; however, it widens to 500 mm at some locations in the north and narrows to approximately 180 mm closer to the building (minimum width is 150 mm).

Figure 5.59: (a) Significant damage and cracking observed in the LiDAR scan data at the north end of the CS building. (b) The same crack extending northward across the port.

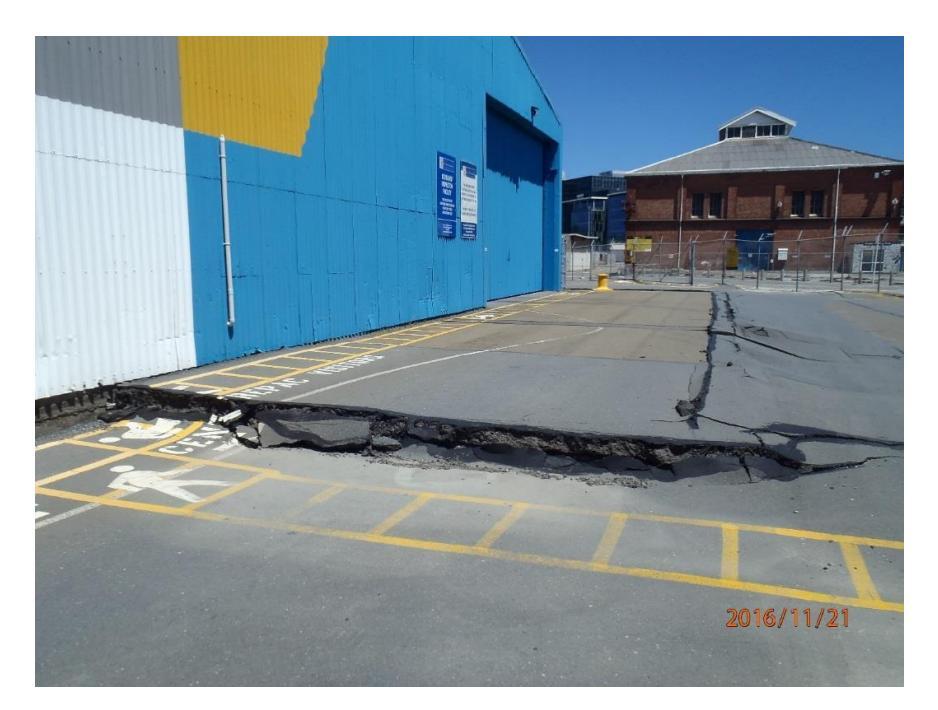
Figure 5.73: Looking west across north wall of Building S37. Approximately 400mm of differential settlement between ground and deck of buried, pile-supported Pipitea Wharf that supports the western side of the shed. (S41.278571°, E174.785632°, taken at 1227 hrs on 21NOV16)

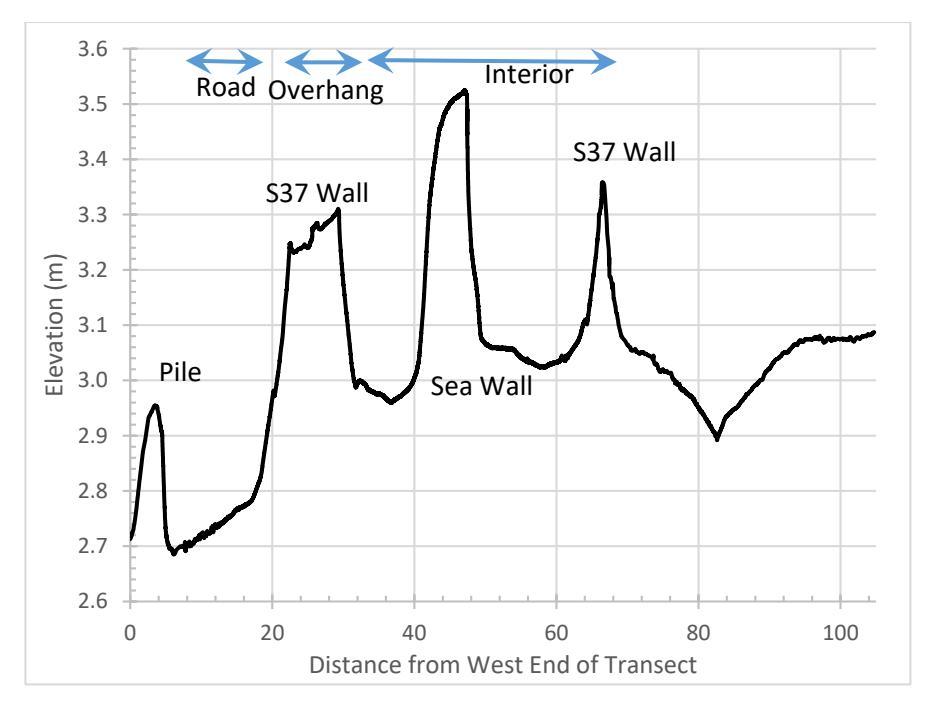
Figure 5.74: East-west cross-section (LT6) through the northern part of Building S37. Note the significant vertical exaggeration.

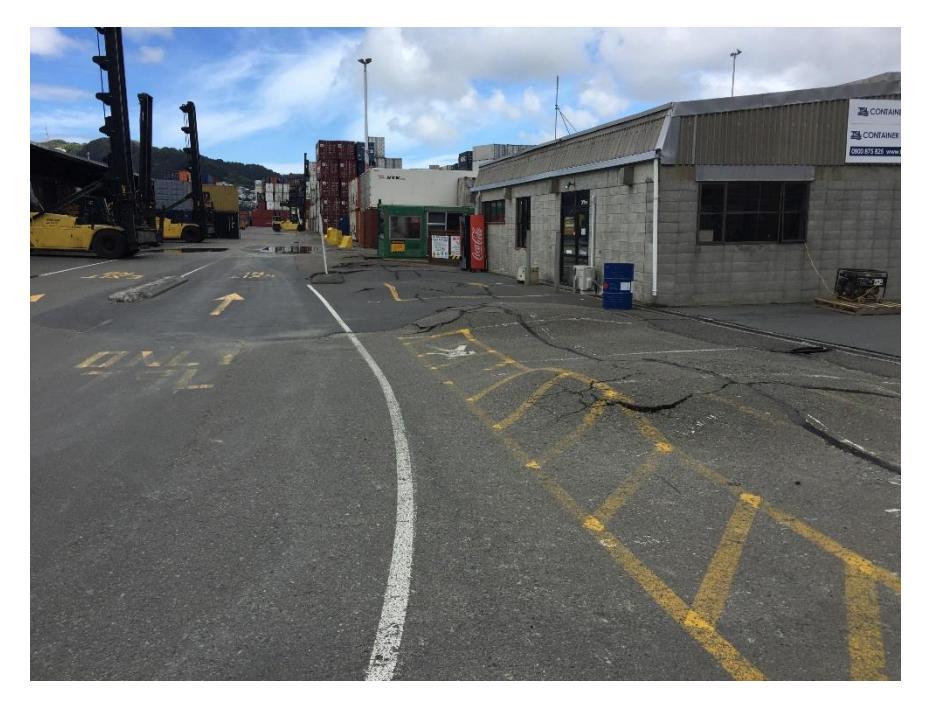
The western half of the S37 building is founded on the deck of the buried, partially demolished pile-supported old Pipitea Wharf, and the east wall of the building is supported on piles. The precast seawall that formerly ran along the bulkhead of the Pipitea Wharf is now buried and runs south-to-north through about the centerline of the building. The ground floor slab not supported either on piles, the old wharf deck, or the precast seawall settled up to 550 mm relative to these structures (Figures 5.72, 5.74, and 5.75; from LiDAR scan). The ground settled approximately 375 mm relative to the building along the exterior of the east wall of the S37 building (Figure 5.76). Figure 5.74 plots elevations from transect LT6 (see Figure 5.27 for transect location) through the S37 Building, and Figure 5.75 provides a 3D view of the building interior from a LiDAR scan. Approximately 16 m west of the western wall of the S37 building, a buried row of piles from the old Pipitea Wharf protruded from the ground as the surrounding fill settled approximately 300 mm relative to the piles (Figure 5.77).

Figure 5.77: Looking south along western-most row of piles from partially demolished and buried Pipitea Wharf, which is approximately 16 m west of Building S37. Fill settled 300 mm relative to embedded piles (S41.278798°, E174.785186°, taken on 17NOV16). A cross section (LT1) is shown in Figure 5.29.

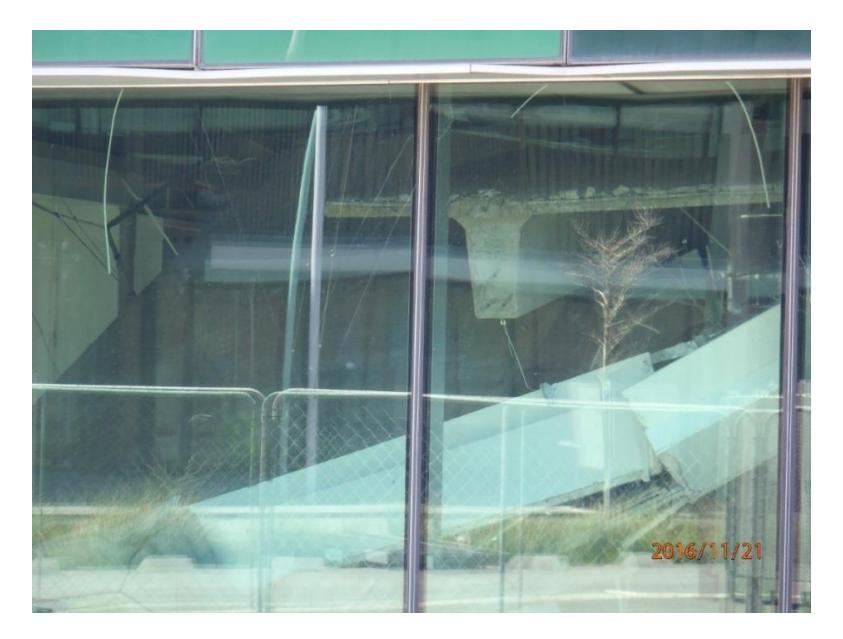
The S building is a relatively new (i.e., constructed in 2006) 5-storey reinforced concrete building founded on piles. The corners are on driven reinforced concrete piles while the interior columns are founded on cast-in-place concrete piles. No ground improvement was performed under the building. The building suffered structural damage, and is being investigated thoroughly by CentrePort. The interested reader is referred to publications that will be forthcoming by others. No signs of foundation damage were visible at the ground surface during the QuakeCoRE-GEER team visit though some level of distress in the ground adjacent to the building was evident. The ground settled 100 to 200 mm relative to the pile-supported building (Figure 5.80), in a relatively uniform fashion though some deviations from this pattern were also evident. Ground floor infill walls along the perimeter of the building were cracked in places (Figure 5.81), and the Level 1 floor slab pulled out and partially collapsed (Figure 5.82).

Figure 5.82: Pull-out and partial collapse of Level 1 floor slab in the S building taken along the west wall of the building. (S41.277982°, E174.784255°, taken at 1246 hrs on 21NOV16)
